# **‘GREEN AND HEALTHY’ ASSESSMENT OF PIMA COUNTY’S EMERGENCY SHELTERS AND TRANSITIONAL HOUSING**

*For Pima County Community Development and Neighborhood Conservation Department*  
FINAL DRAFT REVISED July 23, 2012

# Existing Conditions and Green/Health Assessment

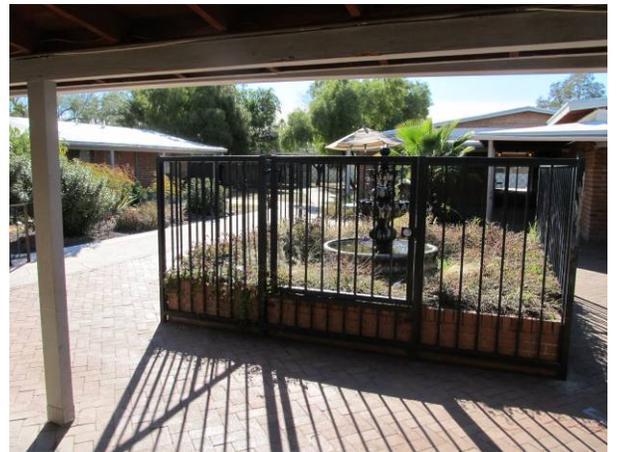
## Emerge! Renewal Center (50 beds)

Main Needs: Insulation furr-out, double-pane windows, low-flow fixtures, some electrical upgrade, water harvesting

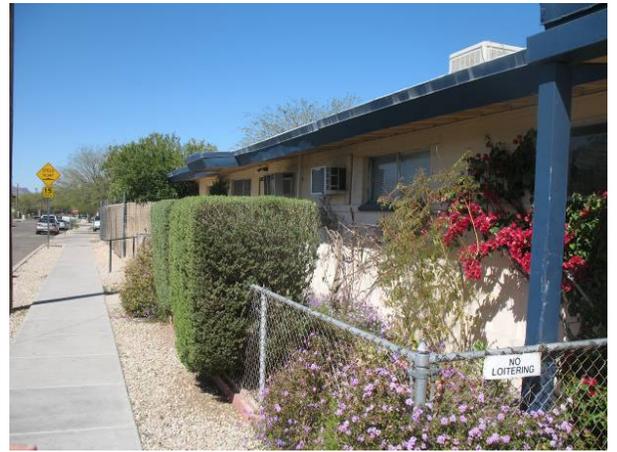
## Gospel Rescue Mission Men's Center (100 beds)

Main Needs: EIFS, new packaged AC, accessibility improvements, some remodel, double-pane windows, window shading, low-flow fixtures, energy-efficient lighting, electrical upgrade, water harvesting/landscaping, site planning & development

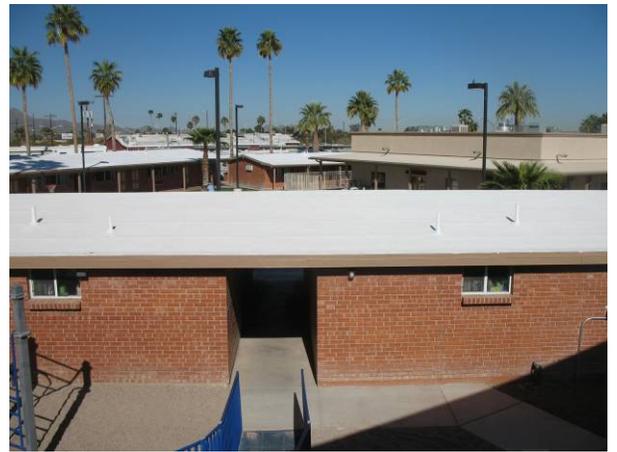
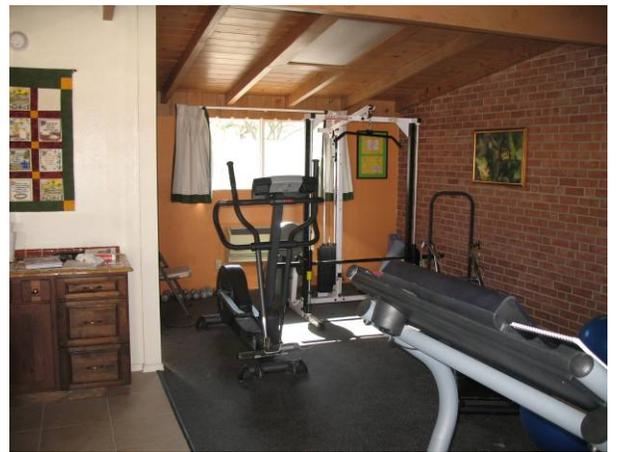
## Gospel Rescue Mission Women & Children's Center (32 units)

Main Needs: Insulation furr-out, some window shading, water harvesting, accessible unit

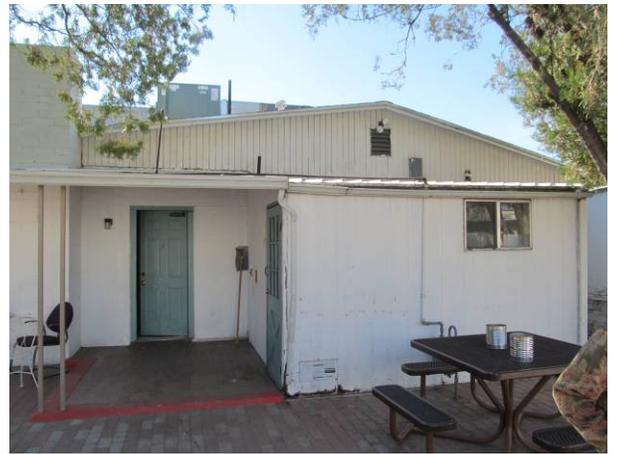
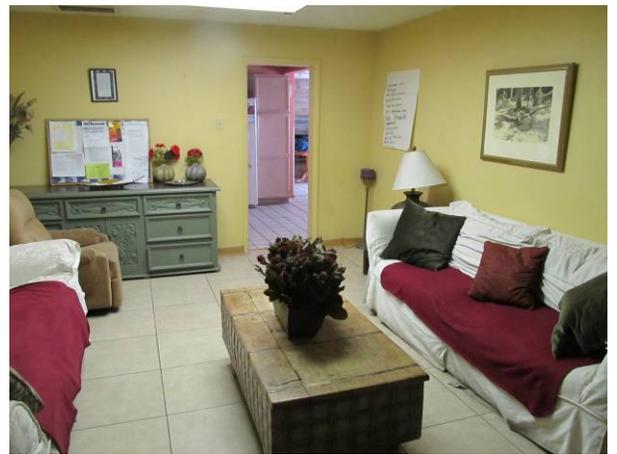
## New Beginnings for Women & Children Emergency Shelter (13 units)

Main Needs: Double-pane windows, window shading, low-flow fixtures, new packaged AC, electrical upgrade, water harvesting/landscaping, site planning & development

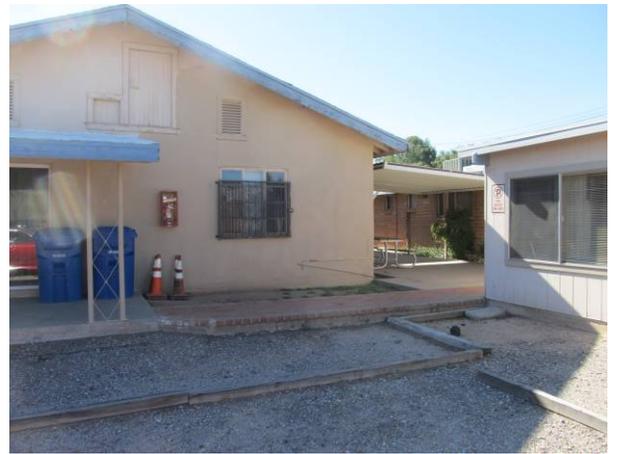
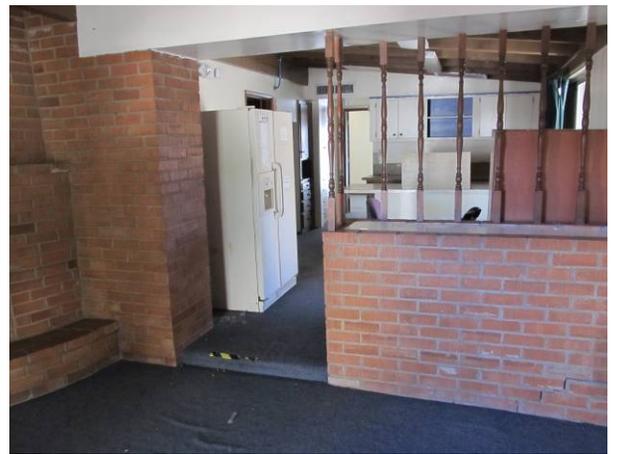
## Open Inn Louis Street Shelter (vacant)

Main Needs: Insulation and/or EIFS, double-pane windows, some window shading, low-flow fixtures, new packaged AC, water harvesting/landscaping, site planning & development

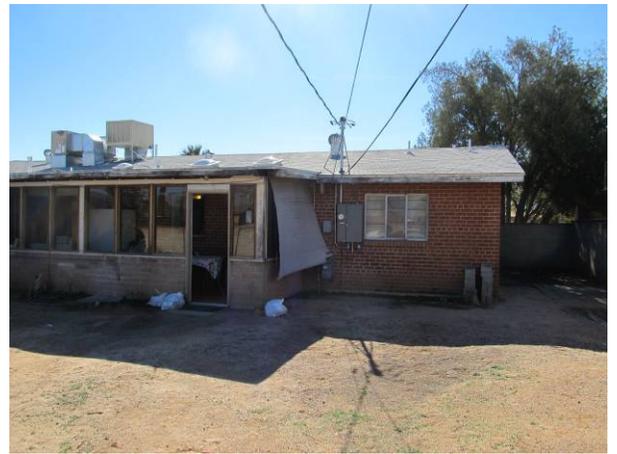
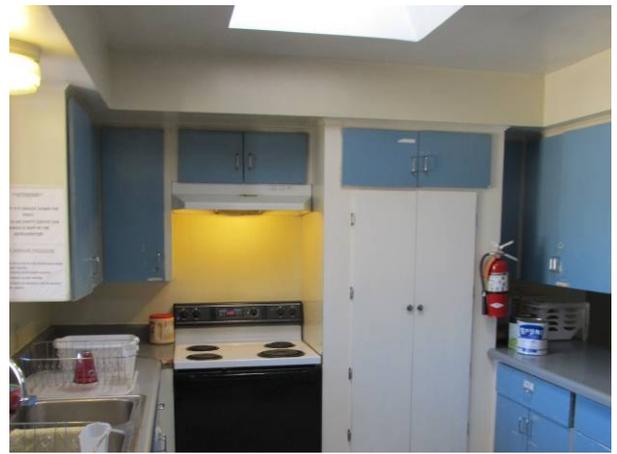
## Open Inn Linden Street Shelter (7 beds)

Main Needs: Insulation and/or EIFS, double-pane windows, window shading, low-flow fixtures, new packaged AC, water harvesting/landscaping, site planning & development

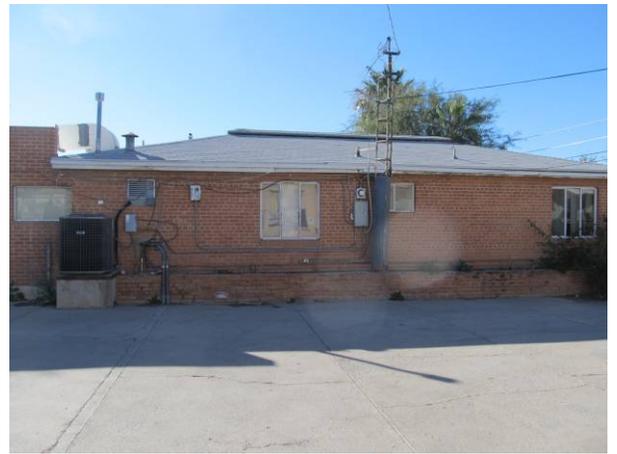
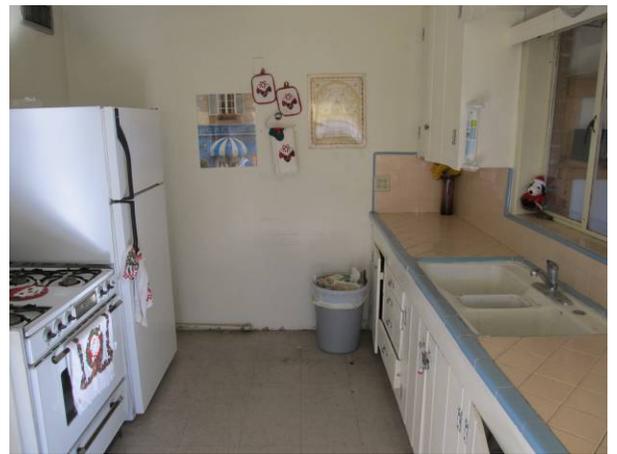
## Open Inn Ironhorse Shelter (temporary)

Main Needs: Insulation furr-out, double-pane windows, window shading, low-flow fixtures, electrical upgrade, water harvesting/landscaping, site planning & development

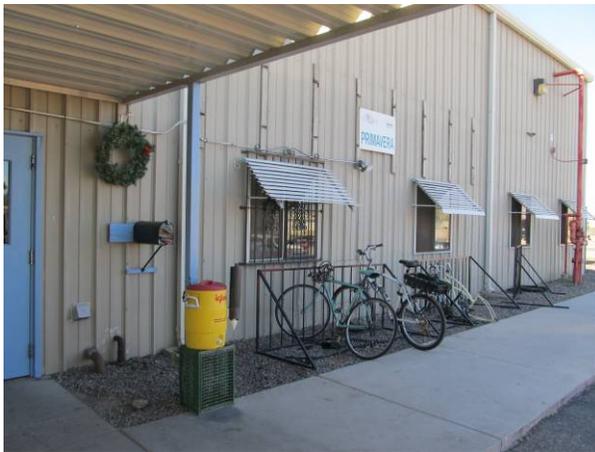
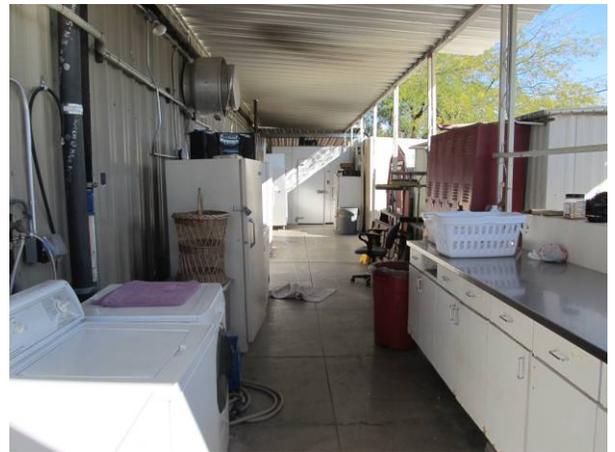
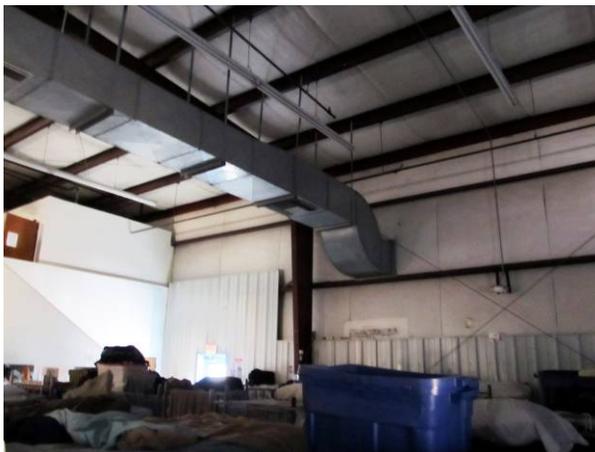
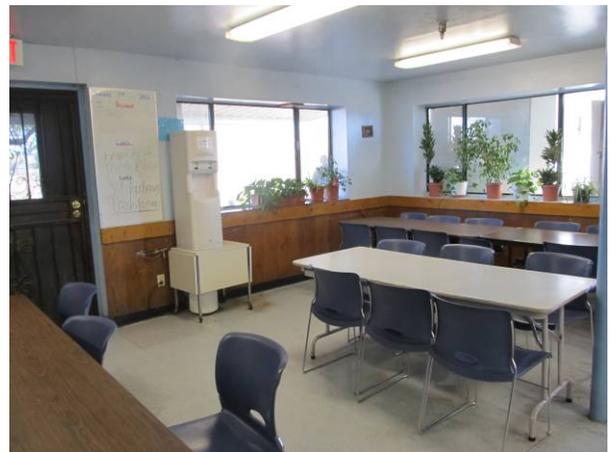
## Primavera Men's Shelter (100 beds) 200 E. Benson Highway Tucson, AZ 85713

Main Needs: Water harvesting, replace equipment & appliances

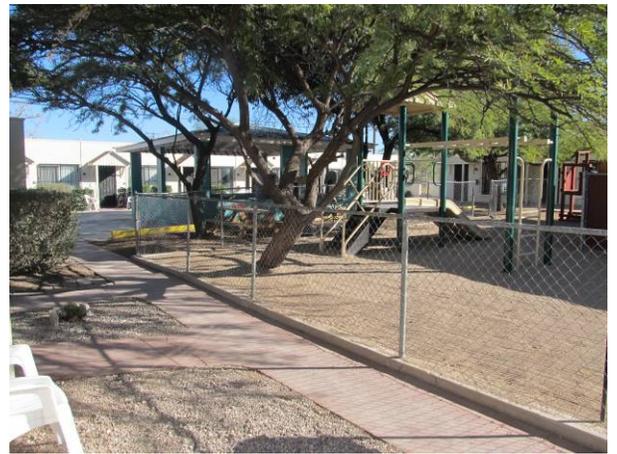
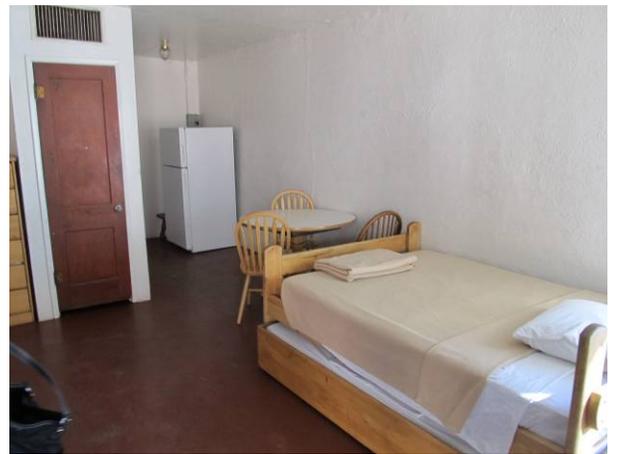
### Greyhound Family Shelter (17 units, 34 beds)

Main Needs: EIFS, window shading, ceiling fans

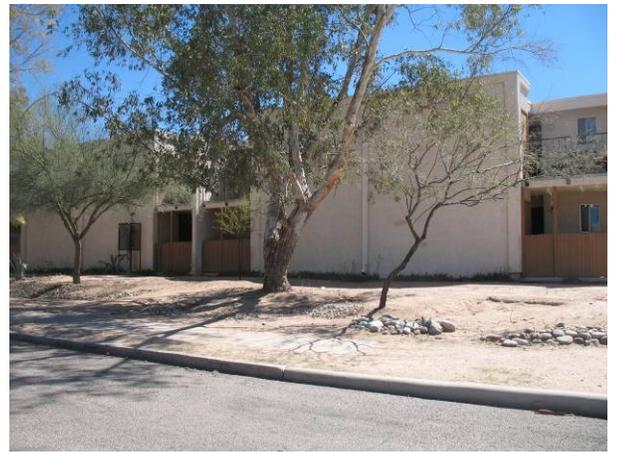
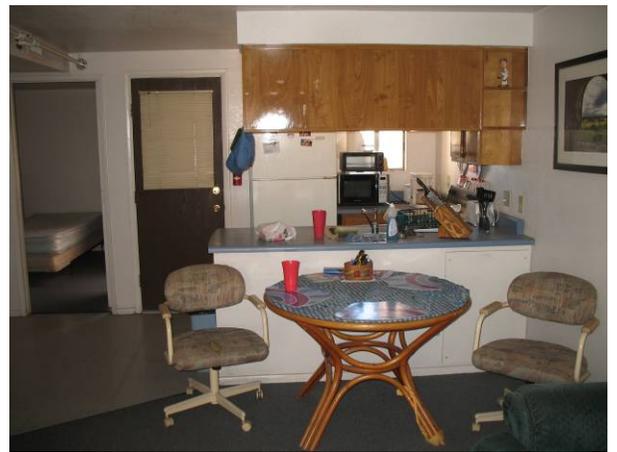
### Comin' Home – Apartments (15 units, 30 beds)

Main Needs: Double-pane windows, window shading, low-flow fixtures, water harvesting, accessibility improvements

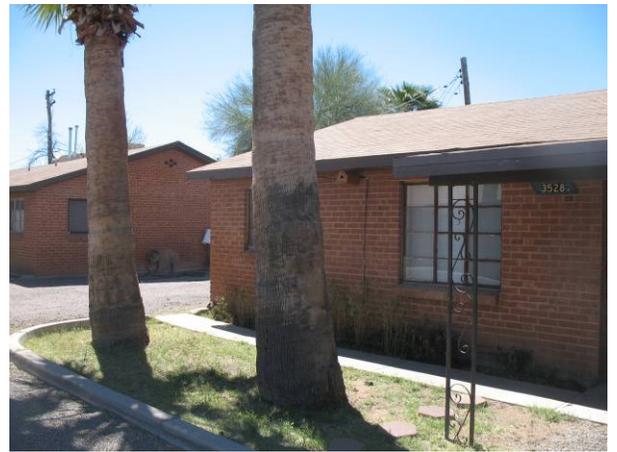
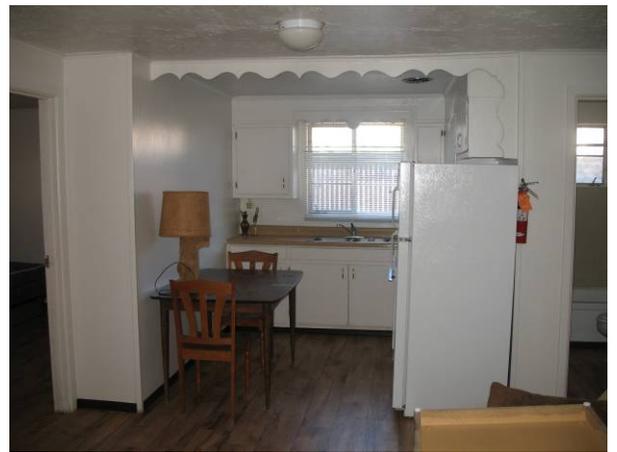
### Comin' Home – Duplexes (7 duplexes, 22 beds)

Main Needs: Insulation and/or EIFS, new packaged AC, accessibility improvements, double-pane windows, window shading, low-flow fixtures, electrical upgrade, water harvesting/landscaping, site planning & development

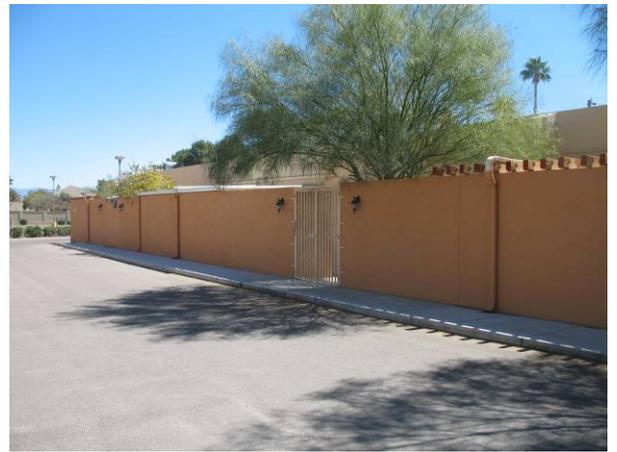
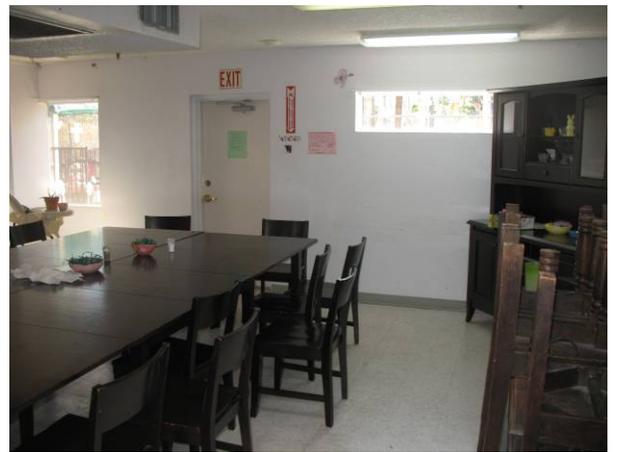
### Las Amigas (9 rooms, 21 beds)

Main Needs: Accessibility improvements, double-pane windows, some window shading, low-flow fixtures, energy-efficient lighting, water harvesting

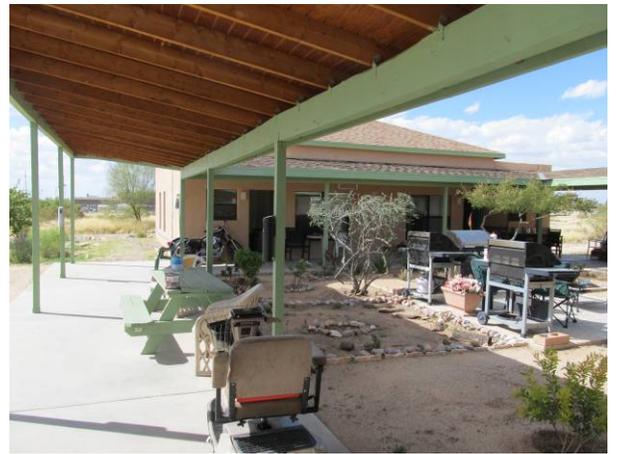
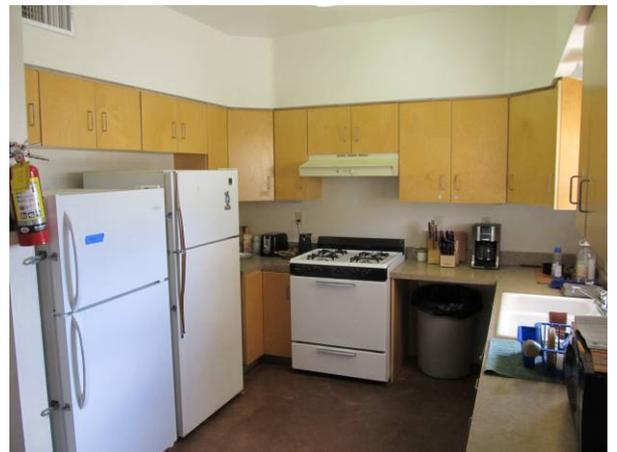
## Esperanza En Escalante Disabled Units (3 units, 15 beds)

Main Needs: New packaged AC, some window shading, may need low-flow fixtures, site planning & development

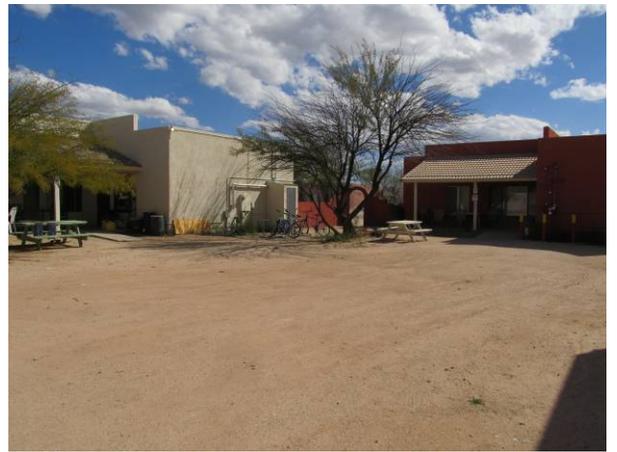
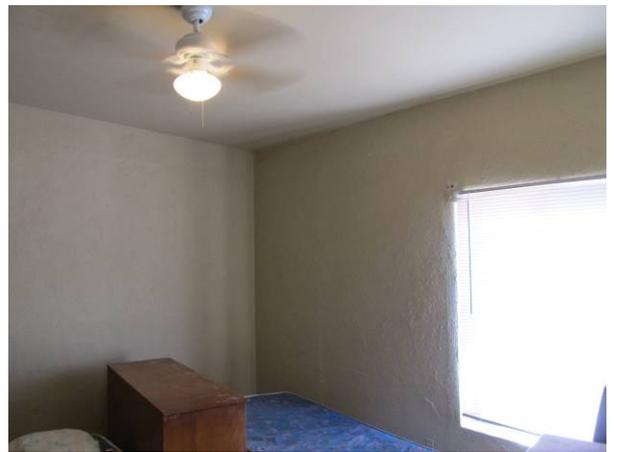
## Esperanza En Escalante Individual Units (5 units, 23 beds)

Main Needs: New packaged AC, some window shading, low-flow fixtures, water harvesting/landscaping, site planning & development

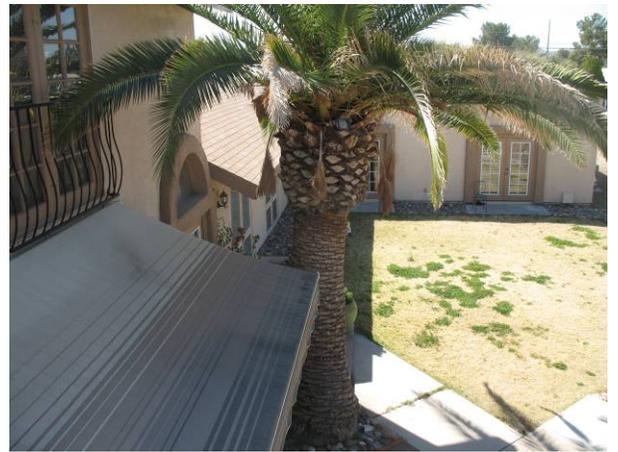
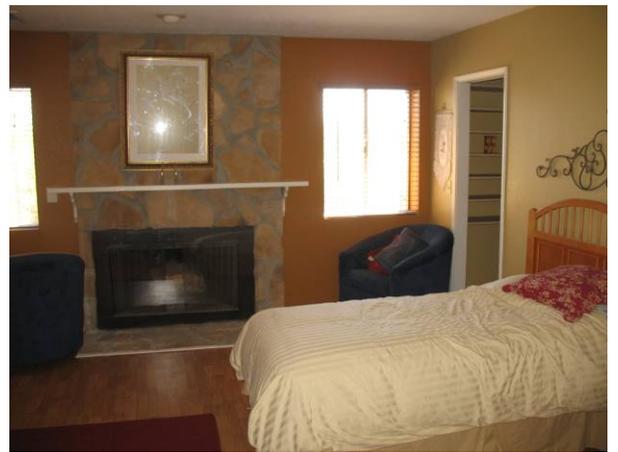
## Gospel Rescue Mission Women's Transitional (6 bedrooms)

Main Needs: Accessibility improvements, double-pane windows, some window shading, low-flow fixtures, water harvesting

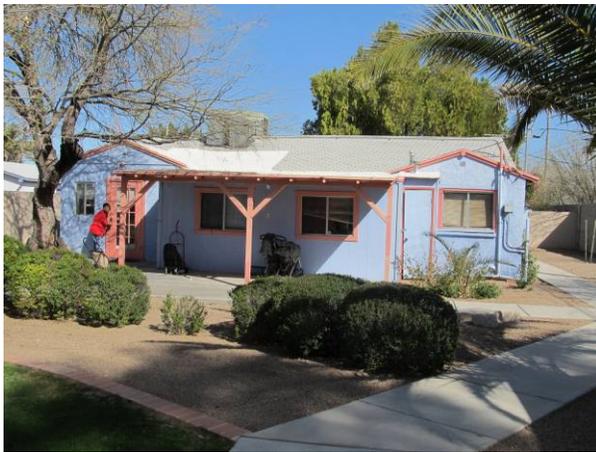
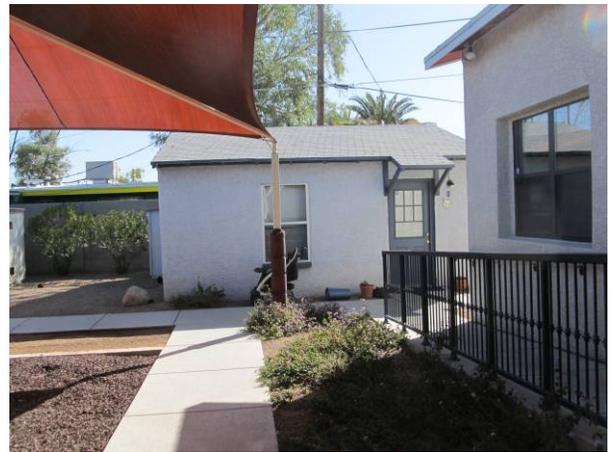
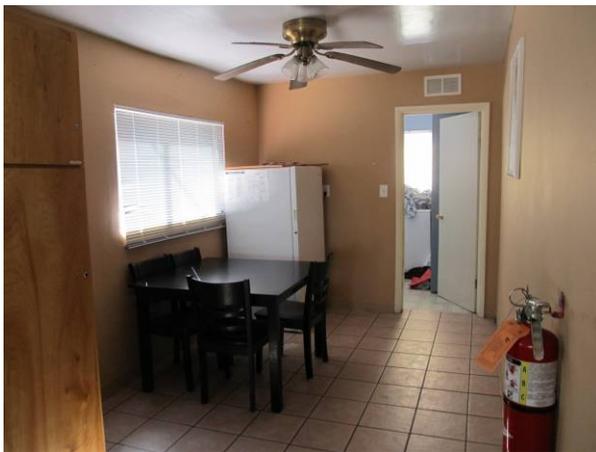
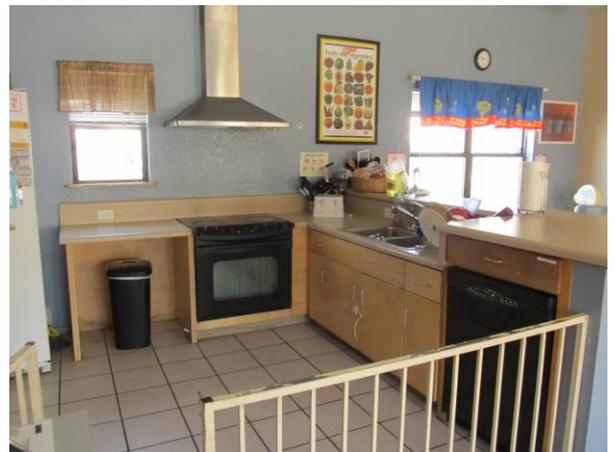
## La Paloma Family Services Amparo de las Angeles (20 beds)

Main Needs: Treat/repair termite damage, some insulation and/or EIFS, some new packaged AC, accessibility improvements, window shading, some low-flow fixtures, some electrical upgrade, water harvesting

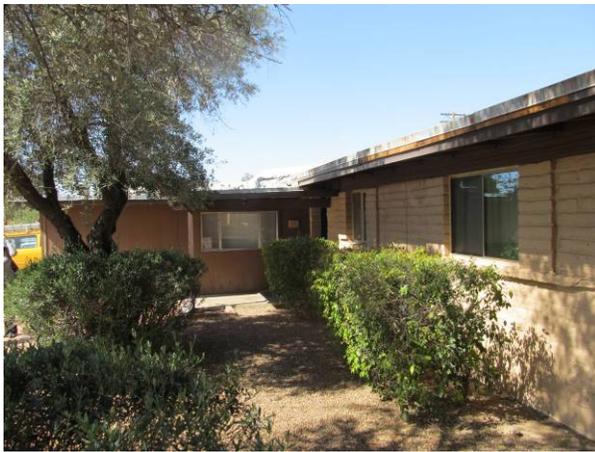
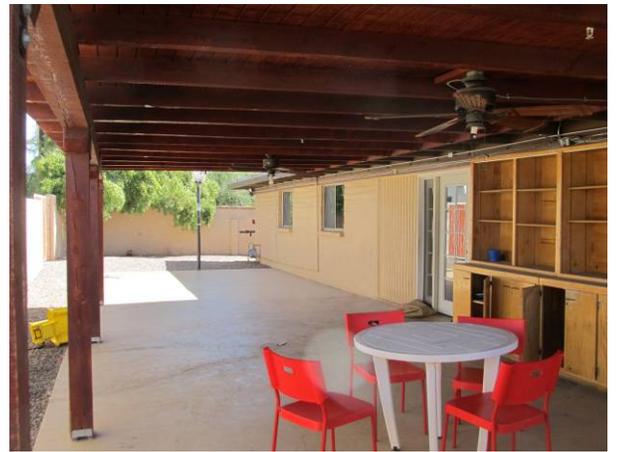
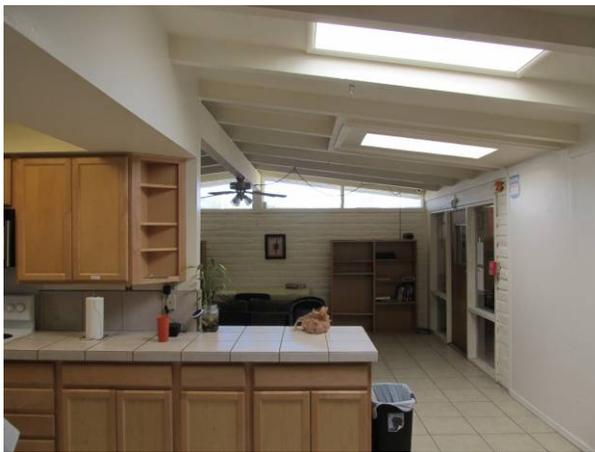
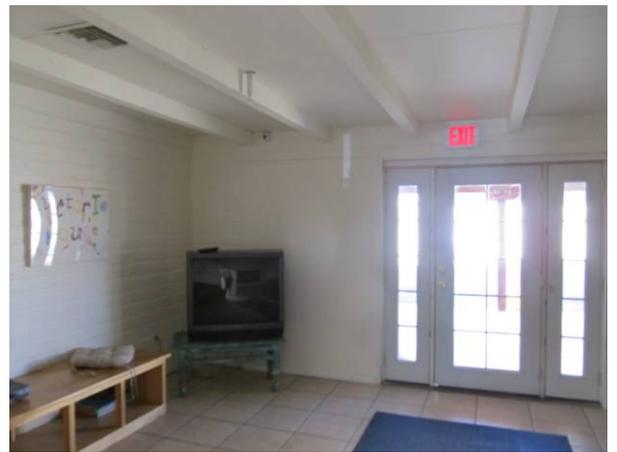
## La Paloma Family Services Victoria House (10 beds)

Main Needs: Treat/repair termite damage, insulation and/or EIFS, accessibility improvements, some double-pane windows, some window shading, some low-flow fixtures, water harvesting/landscaping

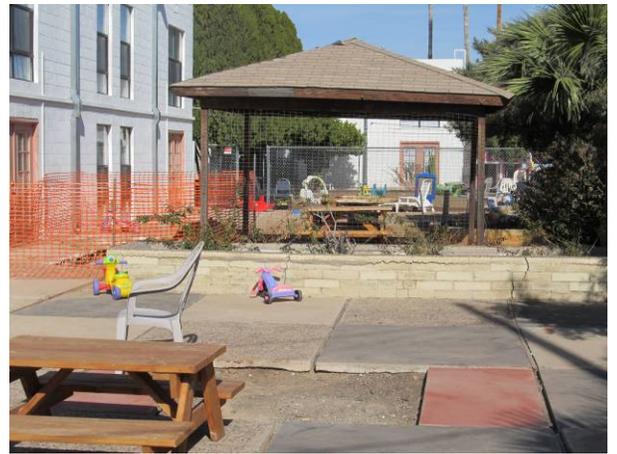
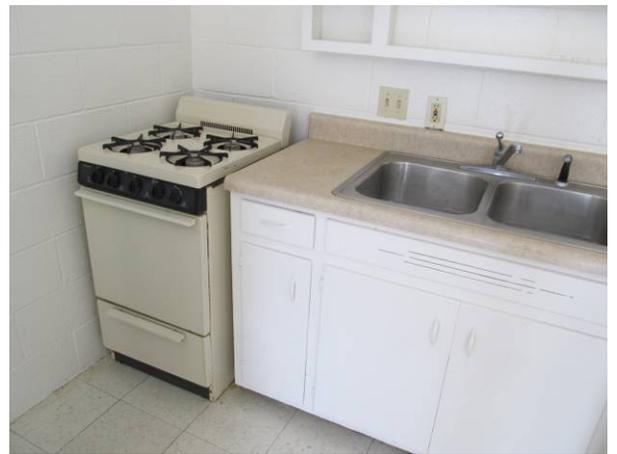
### Bridges: Mohave (15 units)

Main Needs: Insulation and/or EIFS, new packaged AC, accessibility improvements, window shading, low-flow fixtures, energy-efficient lighting, electrical upgrade, water harvesting/landscaping, site planning & development

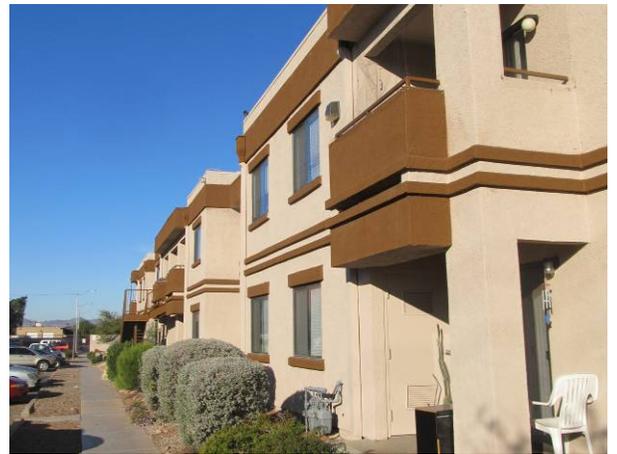
### La Promesa Apartments (23 units)

Main Needs: Accessibility improvements, window shading, low-flow fixtures, energy-efficient lighting, water harvesting

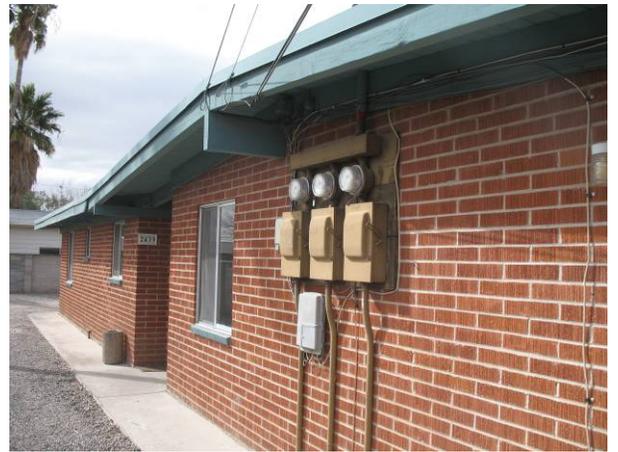
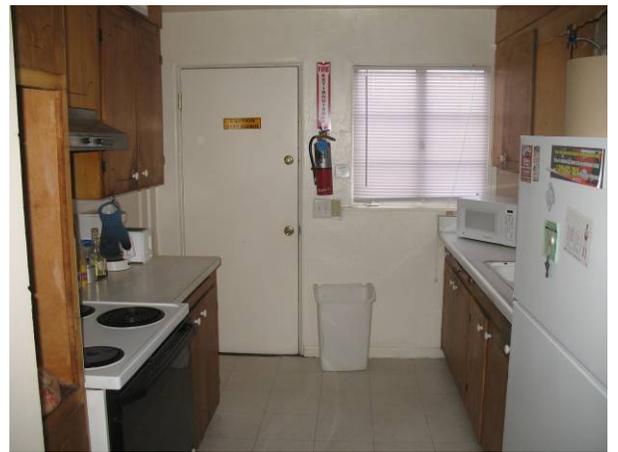
### Sparkman (11 beds)

Main Needs: New packaged AC, accessibility improvements, double-pane windows, some window shading, low-flow fixtures, electrical upgrade, some site development, water harvesting/ landscaping, site planning & development

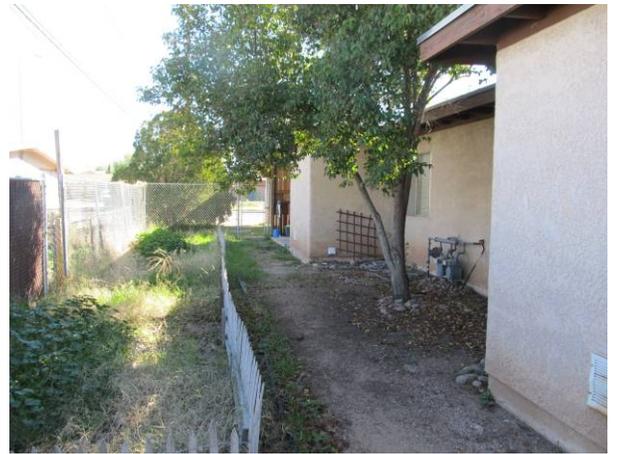
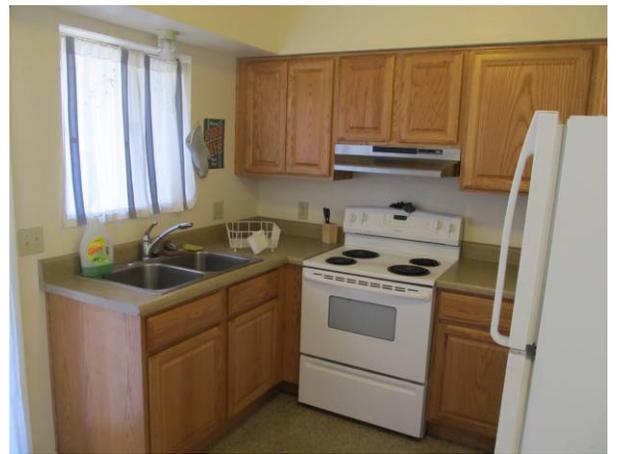
Open Inn  
TALP (8 beds, 4 units)  
Tucson, AZ

Main Needs: New packaged AC, accessibility improvements, double-pane windows, some window shading, low-flow fixtures, electrical upgrade, water harvesting/landscaping

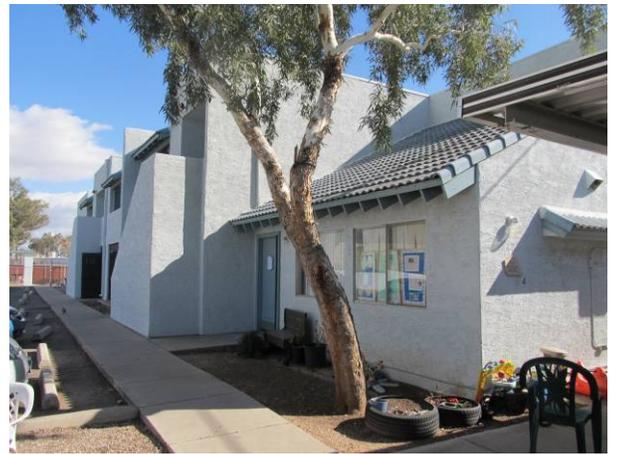
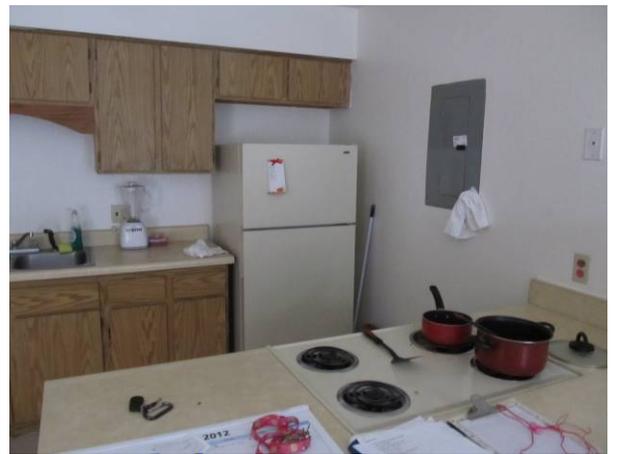
### Common Unity – Apartments (20 units)

Main Needs: Accessibility improvements, double-pane windows, some window shading, low-flow fixtures, energy-efficient lighting, water harvesting/landscaping

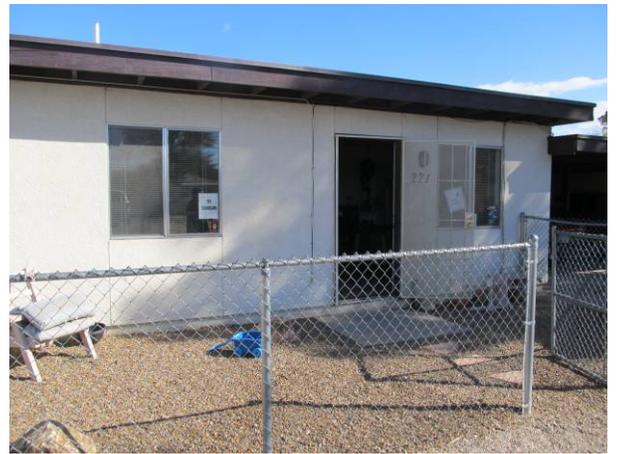
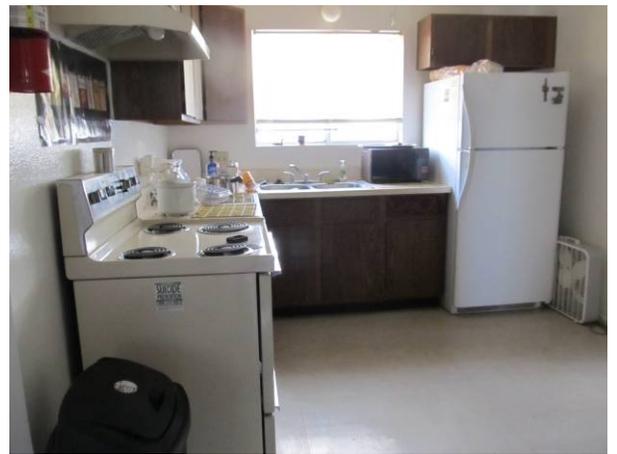
## Our Family Services The Hearth (6 units)

Main Needs: (Some units) insulation and/or EIFS, new packaged AC, accessibility improvements, double-pane windows, some window shading, low-flow fixtures, energy-efficient lighting, electrical upgrade, water harvesting/landscaping, site planning & development

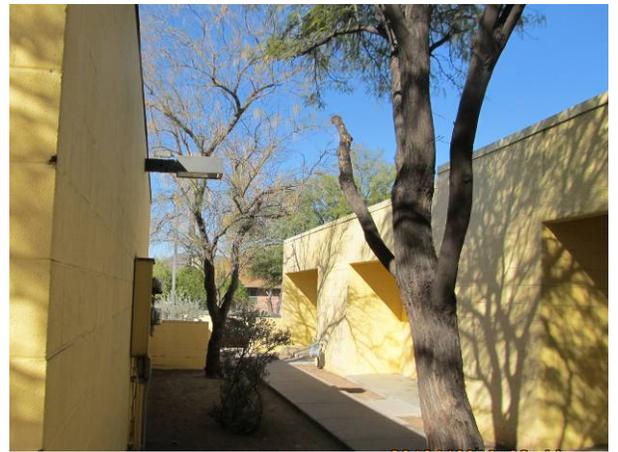
## Catholic Community Services Pio Decimo Center – Short Term (12 units)

**Main Needs:** Some plumbing & site grading work, insulation and/or EIFS, new packaged AC, accessibility improvements, low-flow fixtures, energy-efficient lighting, electrical upgrade, water harvesting/landscaping

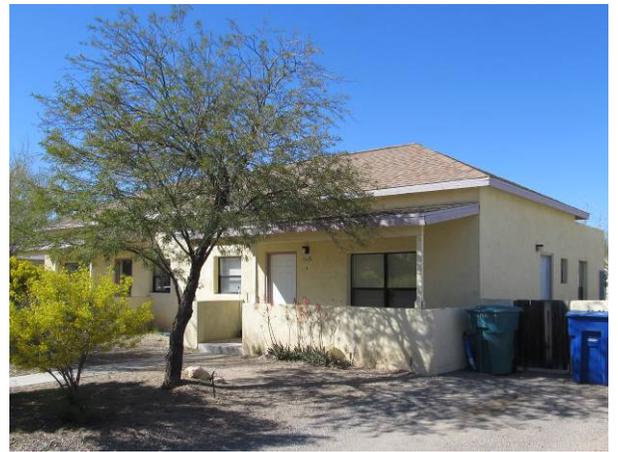
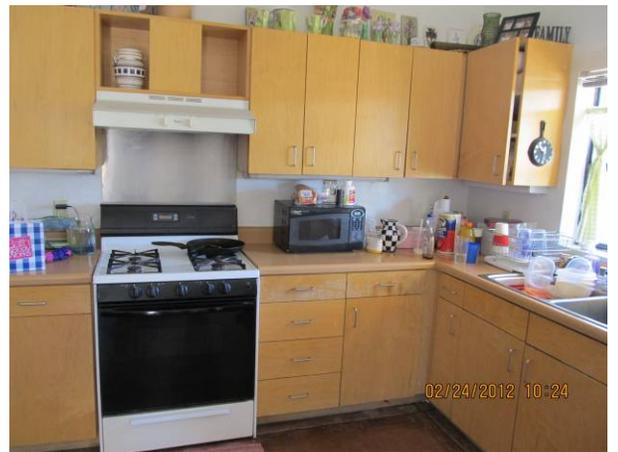
## Catholic Community Services Byas – Pio Decimo – Long Term (8 units)

Main Needs: New packaged AC, some window shading, water harvesting/landscaping, ceiling fans

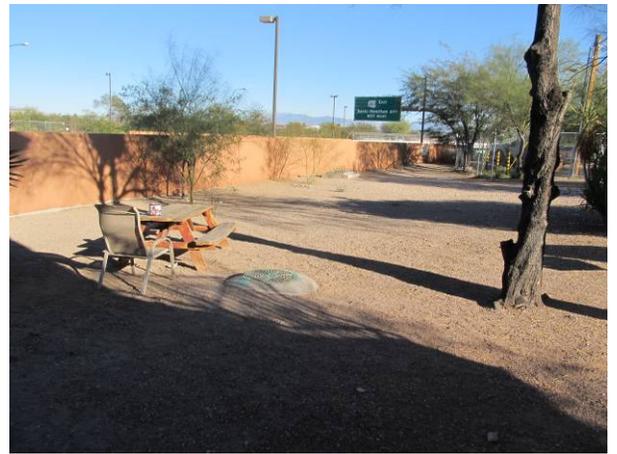
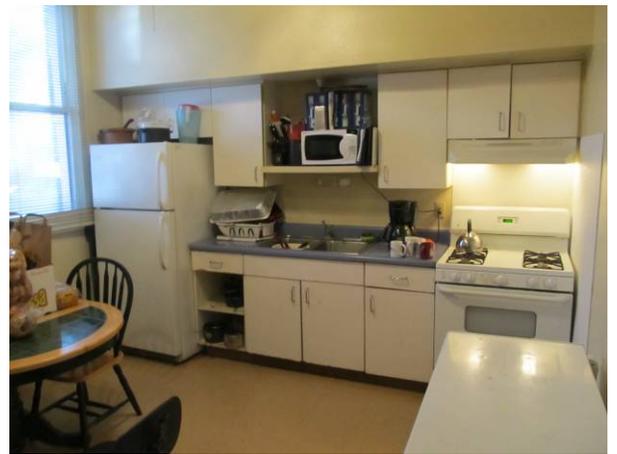
### Catalina House (20 bedrooms)

Main Needs: Double-pane windows, may need low-flow fixtures, water harvesting/landscaping

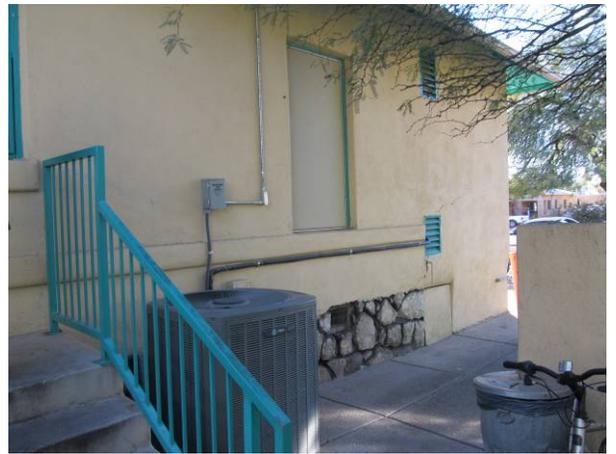
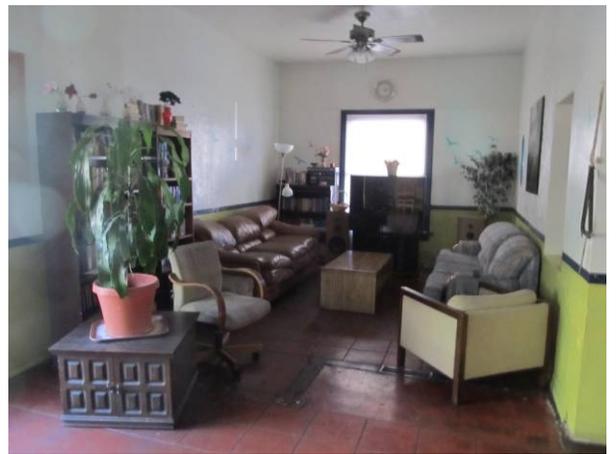
### 5 Points Transitional Housing (28 bedrooms)

Main Needs: New packaged AC, double-pane windows, may need low-flow fixtures, water harvesting

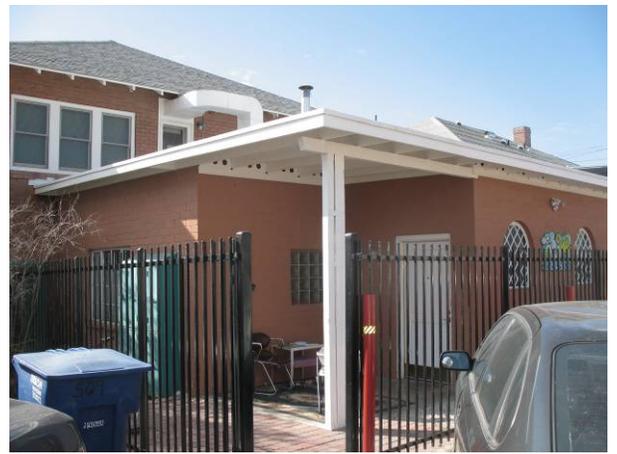
### Women in Transition – WIT (10 bedrooms)

Main Needs: Water harvesting/landscaping, more ceiling fans, hide garbage bins

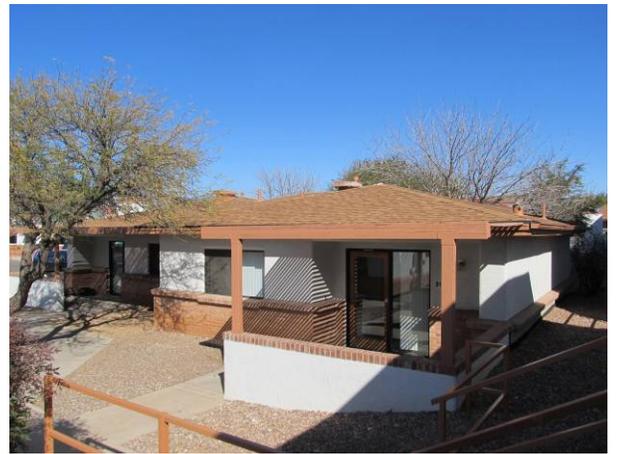
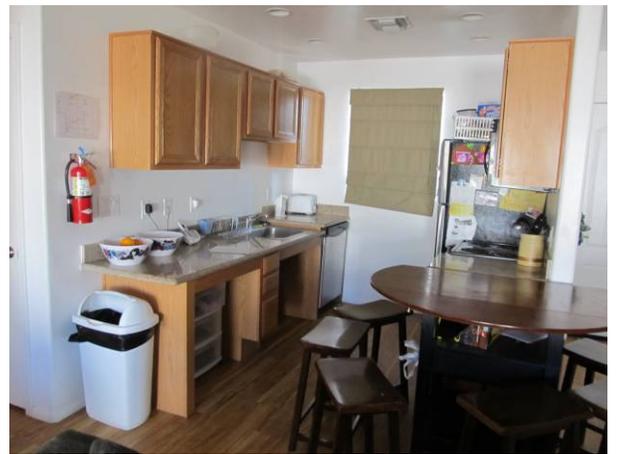
## TMM Family Services Children's Village (30 beds) 1550 N. Country Club Road Tucson, AZ 85716

Main Needs: Accessibility improvements, energy-efficient lighting, water harvesting/ landscaping

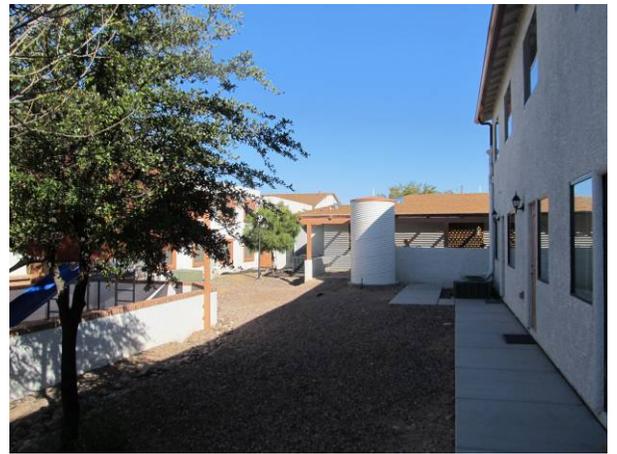
## TMM Family Services Fairhaven North (5 units)

Main Needs: Some window shading, energy-efficient lighting, continue water harvesting/  
landscaping

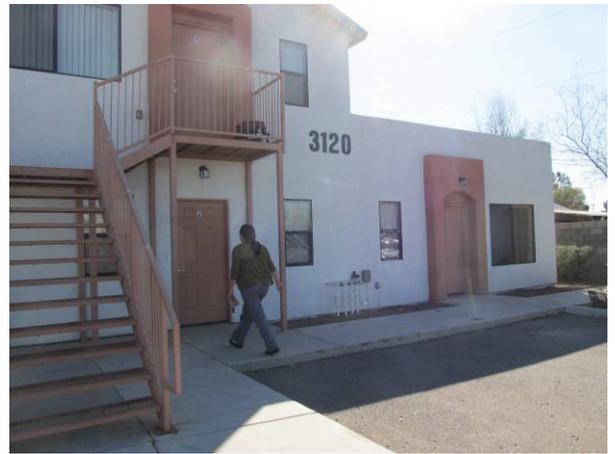
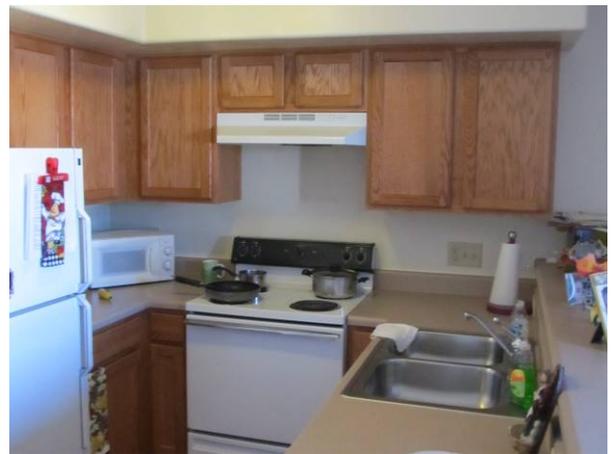
## TMM Family Services Fairhaven South (4 units)

Main Needs: May need some window shading, energy-efficient lighting, water harvesting/landscaping

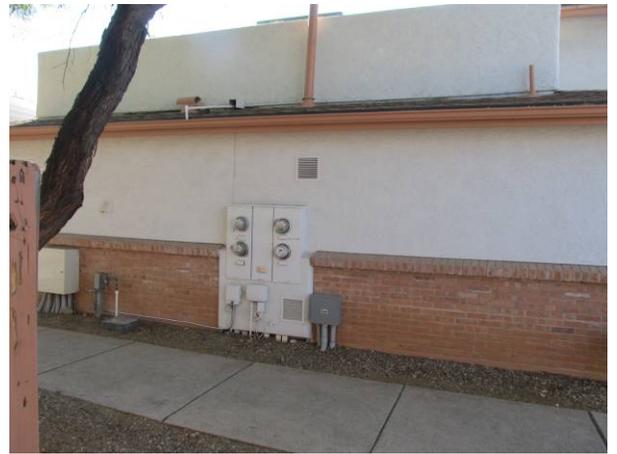
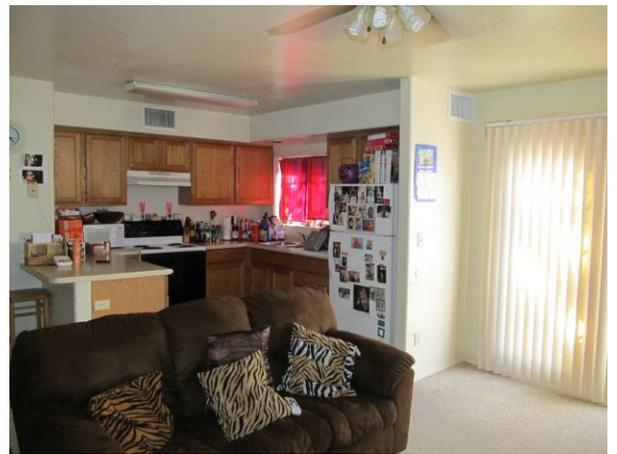
## TMM Family Services Older 2-Bed Units (11 units)

Main Needs: Accessibility improvements, some window shading, low-flow fixtures, energy-efficient lighting, water harvesting/landscaping, upgrade equipment
