OPPORTUNITY TO CORRECT - PC1602-106

Compliance Determination Report

Tracking ID: 6067-OR:29

Inspection Report

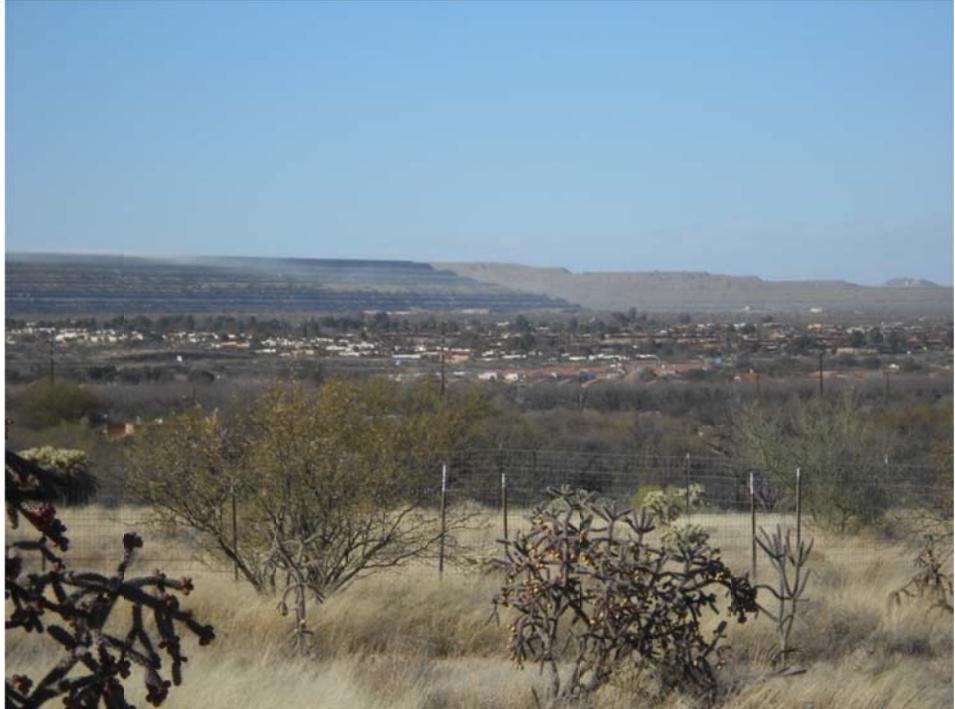
Photo No. 1

Visible emissions of light colored dust generating from the Sierrita tailings impoundment surface on the east side of the North dam that were observed and photographed by Janice Easley on January 31, 2016, blew northeast and diffused across Continental Road. Permit condition II.E.1 requires FMSI to cease temporarily the activity or operation which is causing or contributing to the emissions until reasonably necessary and feasible precautions are taken. Tailings storage is an operation that cannot be ceased during wind events and precautions are required to be taken to prevent diffusion of visible dust beyond the property boundary before and during wind events. Permit condition II.E.2 exempts II.E.1 during high wind events if control measures taken were

The Pima County Department of Environmental Quality (PDEQ) received two complaints regarding “heavy clouds” and a “massive amount” of dust blowing from the tailings piles of the Freeport-McMoRan Sierrita, Inc. (FMSI) mine located at 6200 W. Duval Mine Road, Green Valley, Arizona, at 2:00 PM and 4:00 PM on January 31, 2016. PDEQ staff member, Janice Easley, took photos of light colored dust emissions generating from the surface of the tailings impoundment and blowing downward across the northern section of the eastern face from approximately 3:30 PM to 5:30 PM on January 31, 2016 (Attachment 1, Photos No. 1 through 5).

Date: 1/31/16
Photo by Janice
Easley

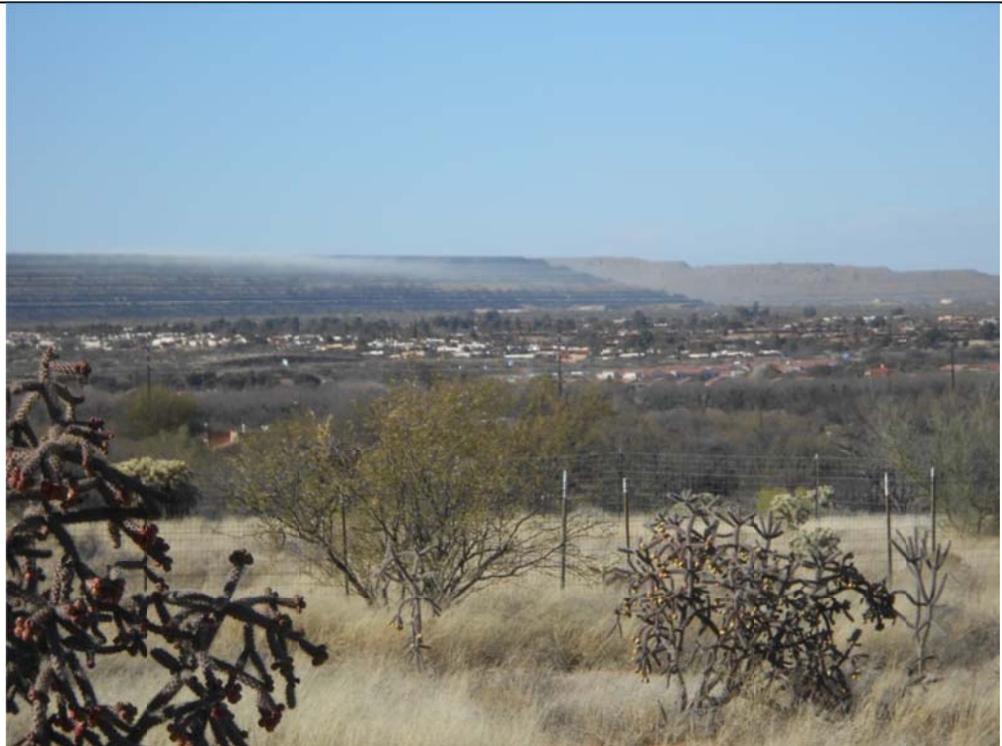
Photo No. 2

Date: 1/31/16
Photo by Janice
Easley

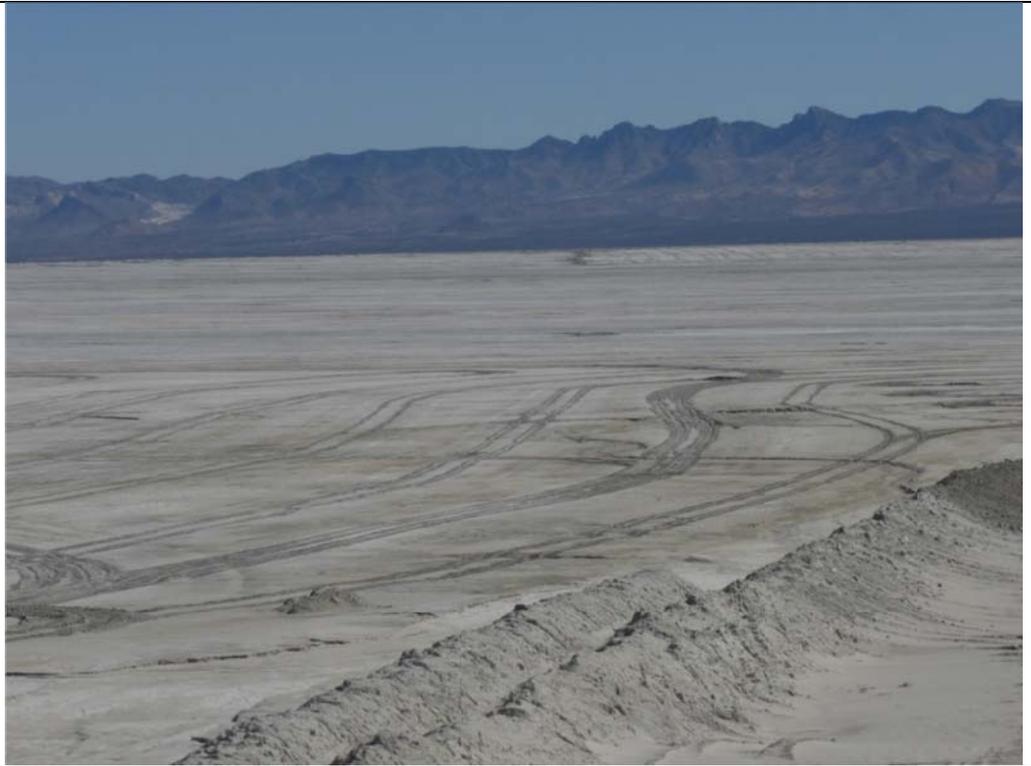
Photo No. 9

Date: 2/9/16

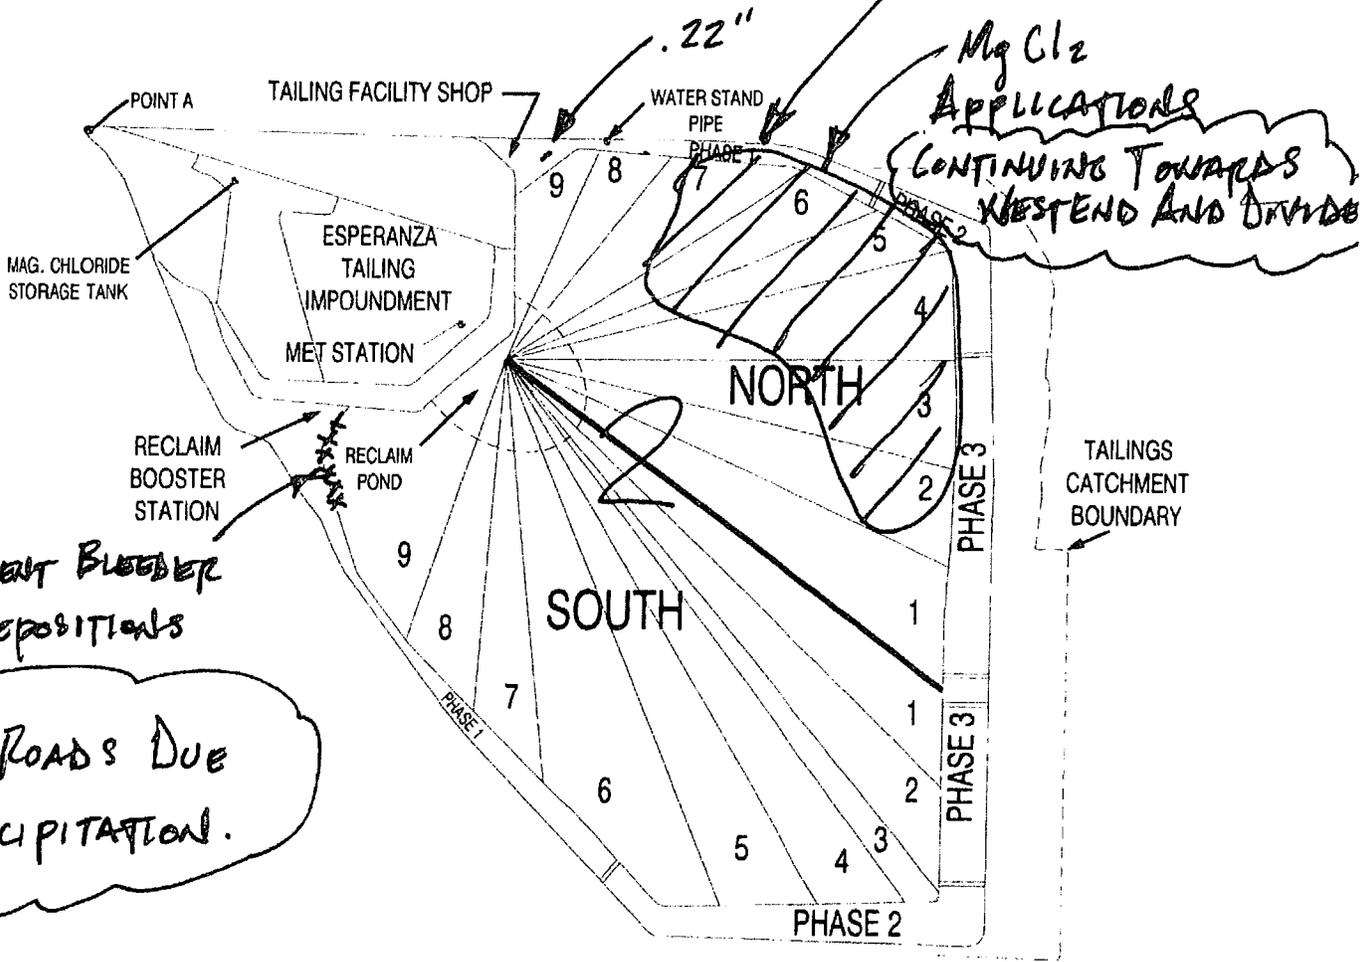
Date: 02/01/16
 Time: 1030
 Conditions: HIGH WINDS, LIGHT PRECIP
 Dam Inspected: ALL Phase(s): ALL
 GPS Coordinates: _____

SEVERE DUNING

MUDDY ROADS DUE TO PRECIPITATION.

Action Plan: H2O TRUCKS STANDING BY. ALL TRACKS ACTIVE.
