Attachment No. 6  
Notice of Violation (#PC0911-061)  
issued for 11/13/09 violations

### **NOTICE OF VIOLATION # PC 0911-061**

ATTACHMENT 2  
Inspection Photo Log

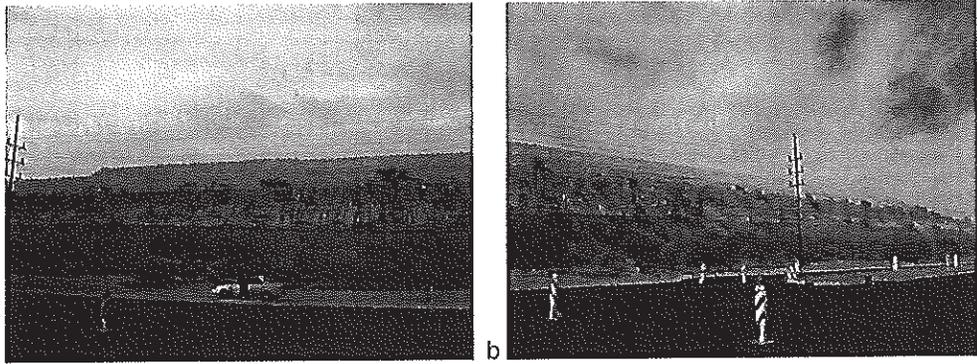
<b>Site Location:</b> ASARCO, LLC - Mission Complex 4201 W. Pima Mine Road, Sahuarita, AZ		<b>Photographer:</b> J. M. Jones	<b>Camera:</b> Canon A620
<b>Photo No. 1 a, b</b>

<b>Date:</b> 11/12/2009			
<b>Photo Description:</b> View of the east slope of talings pile #8 at the ASARCO, LLC – Mission Complex property viewed from La Canada Drive when the inspector arrived at 12:30 pm.  No construction activity was observed at the time of this observation.

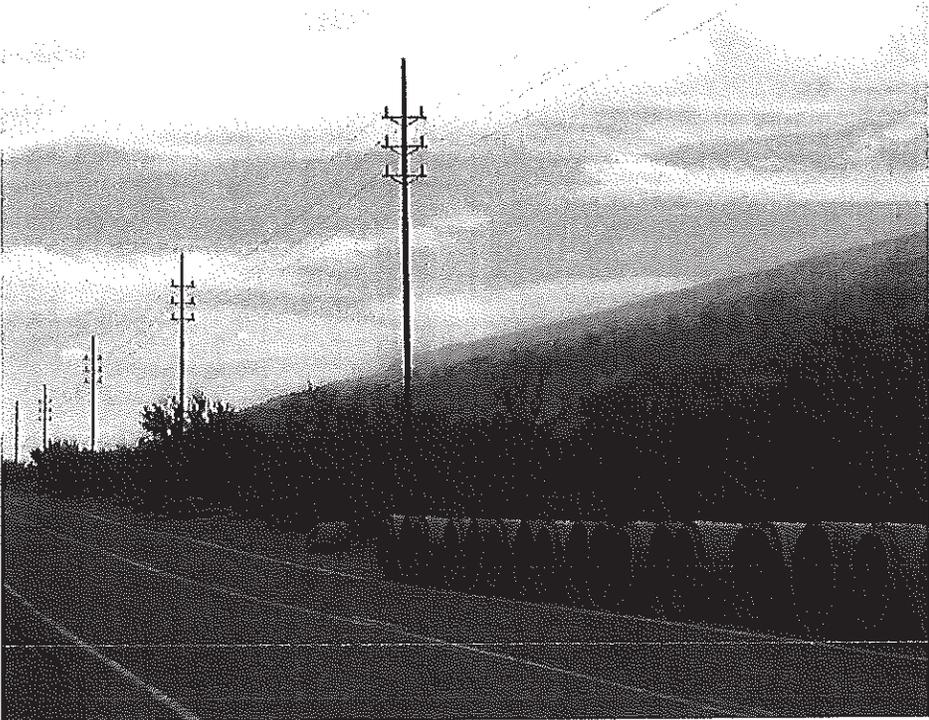
<b>Photo No. 2</b>

<b>Date:</b> 11/12/2009	
<b>Photo Description:</b> View of the east slope of tailings dam #8 at 12:45 pm.  The inspector observed some fugitive dust emissions from the upper slope of the southernmost 40' of new berm up to the point where the new construction had progressed. This end area was not covered with polymer stabilizer like the rest of the berm. Winds were from the south/southwest.

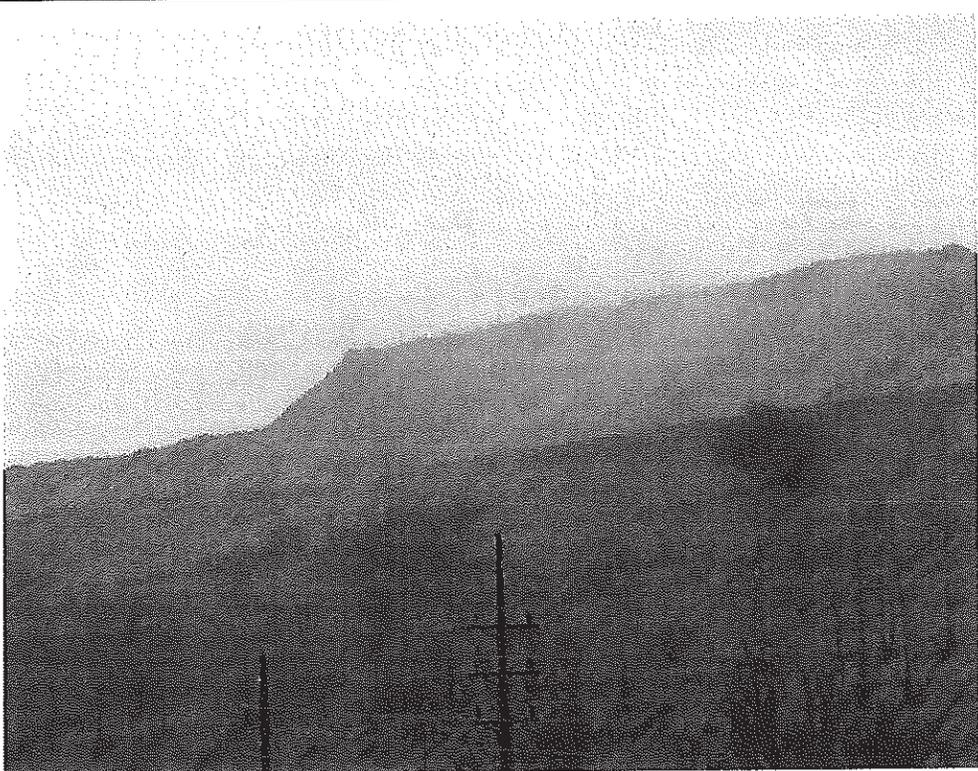
<b>Photo No. 3</b>

<b>Date:</b> 11/12/2009	
<b>Photo Description:</b>  Another view of the area above where fugitive dust emissions were observed. Winds were from the south/southwest.

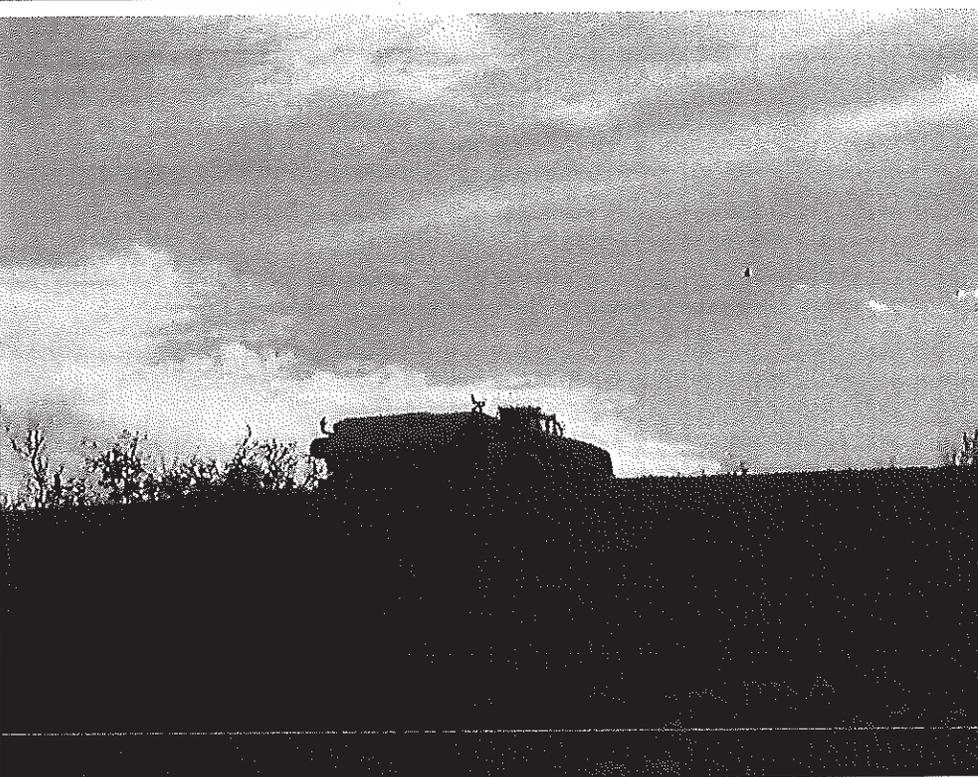
<b>Photo No. 4</b>

<b>Date:</b> 11/12/2009	
<b>Photo Description:</b>  View of a water/polymer truck returning from tailings dam #8 around 1:12 pm as observed from Helmet Peak Road.

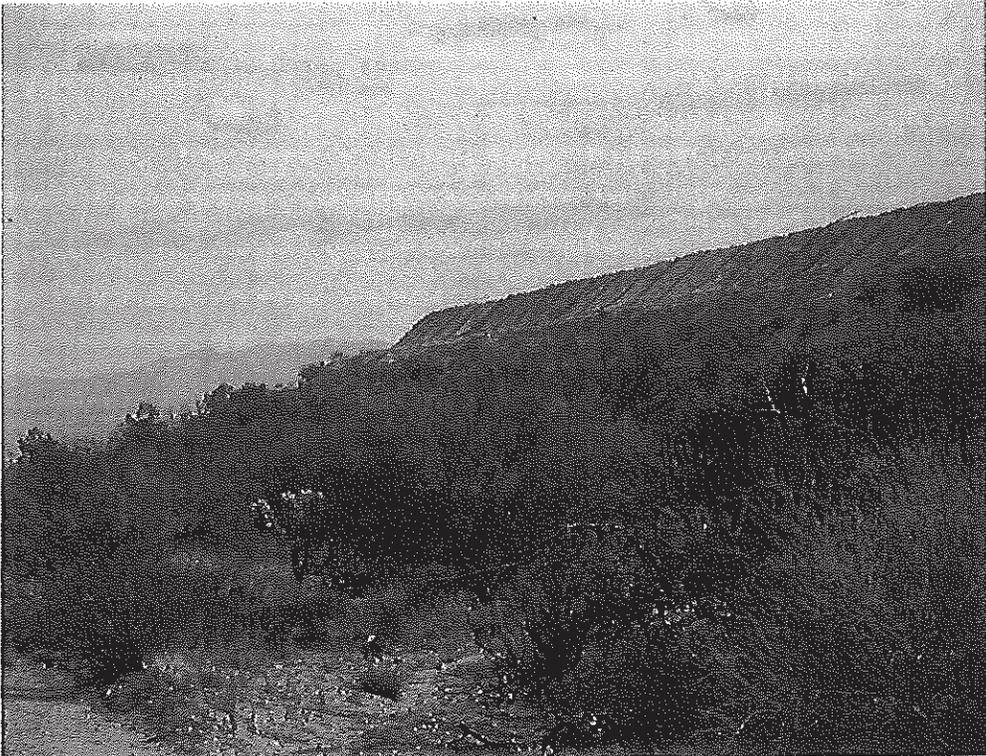
<p><b>Photo No. 5</b></p>

<p><b>Date:</b> 11/12/2009</p>	
<p><b>Photo Description:</b></p> <p>View of the north slope of tailings dam #8 at 1:20 pm from along Helmet Peak Road.</p>

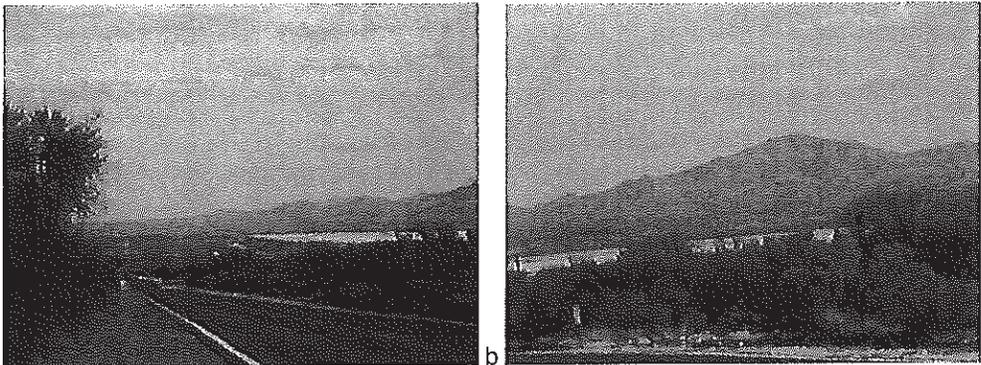
<p><b>Photo No. 6 a, b</b></p>

<p><b>Date:</b> 11/12/2009</p>		
<p><b>Photo Description:</b></p> <p>View of the top surface of tailings dam #8 as the inspector observed from the side of Helmet Peak Road.</p>

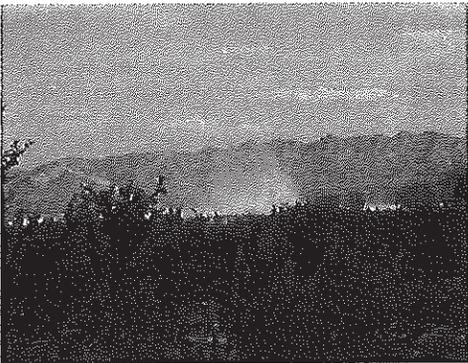
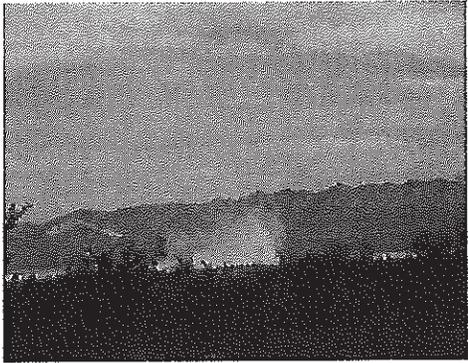
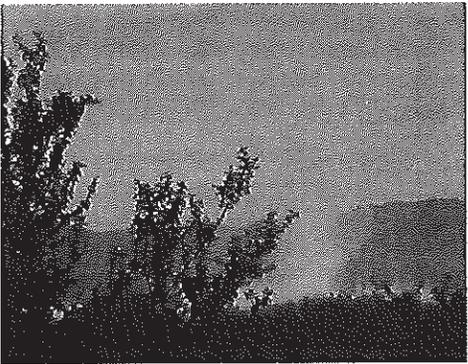
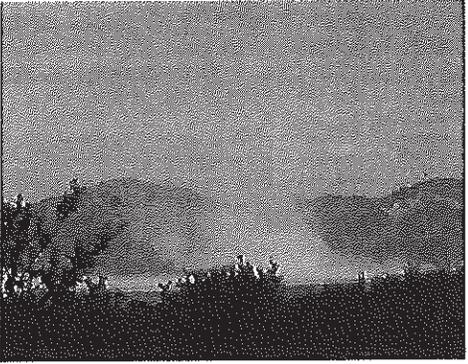
<p><b>Photo No. 7 a, b, c, d</b></p>

Between 1:39 pm and 1:41 pm, the inspector observed a large fugitive particulate plume that originated on the top surface of tailings dam #8 near the southern end that continued north along the top of the tailings dam and diffused across the property boundary at Helmet Peak Road (Attachment 2, Photo No.'s 7-8).

<p><b>Date:</b> 11/12/2009</p>		
<p><b>Photo Description:</b></p> <p>View of a fugitive dust plume generated on the top surface of the tailings dam #8 observed by the inspector. The observation was made between 1:39 pm and 1:41 pm.</p> <p>The windspeed was measured at 17 mph average, 25 mph maximum, and direction from the south/southwest.</p>	<p>a</p>

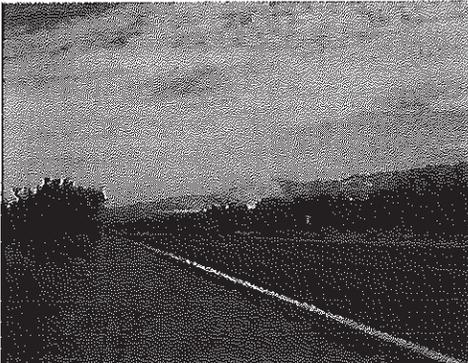
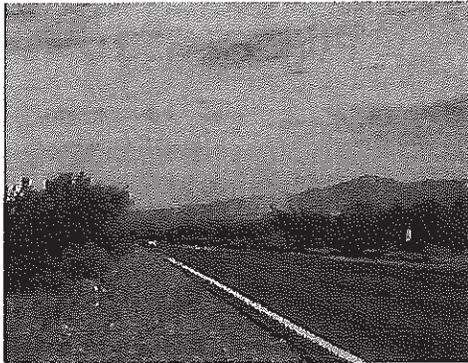
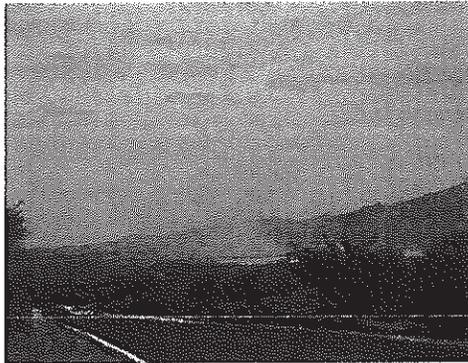
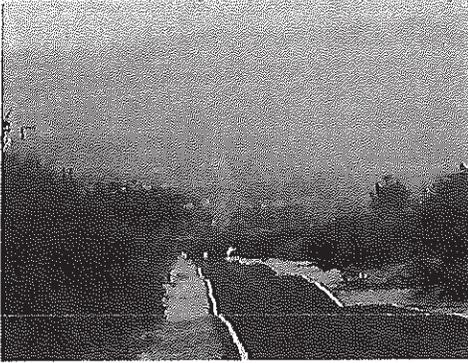
<p><b>Photo No. 8 a, b, c, d</b></p>

ASARCO, LLC – Mission Complex caused and permitted diffusion of visible emissions from tailings dam #8 beyond the property boundary line of Helmet Peak Road, as prohibited by Permit Condition, Part B, Section I.C.3 and Pima County Code Title 17, Chapter 17.16.050.D.

<p><b>Date:</b> 11/12/2009</p>		
<p><b>Photo Description:</b></p> <p>View of the above fugitive dust plume continuing north and diffusing across the property boundary at Helmet Peak Road.</p>	<p>a</p>

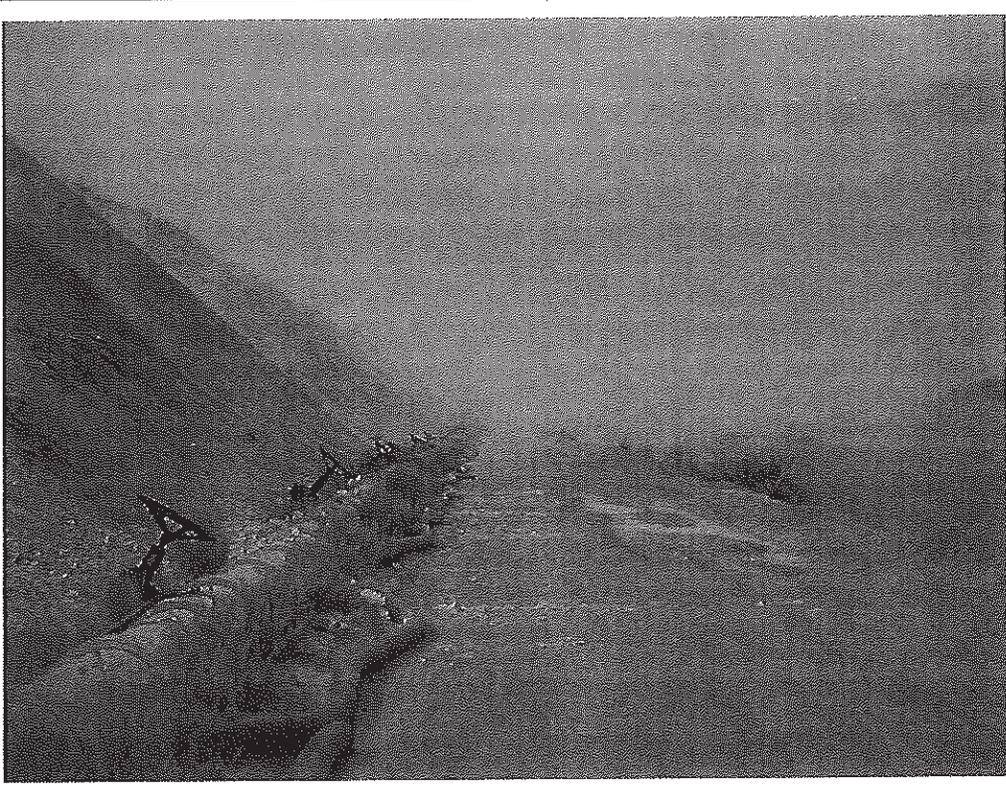
<p><b>Photo No. 9</b></p>

<p><b>Date:</b> 11/12/2009</p>	
<p><b>Photo Description:</b></p> <p>Fugitive emissions observed at 2:29 pm coming off the end of the new berm area shown in photo #3 as viewed looking North. A VE could not be properly conducted because the emissions were blowing parallel with the viewing direction at the point of observation.</p>

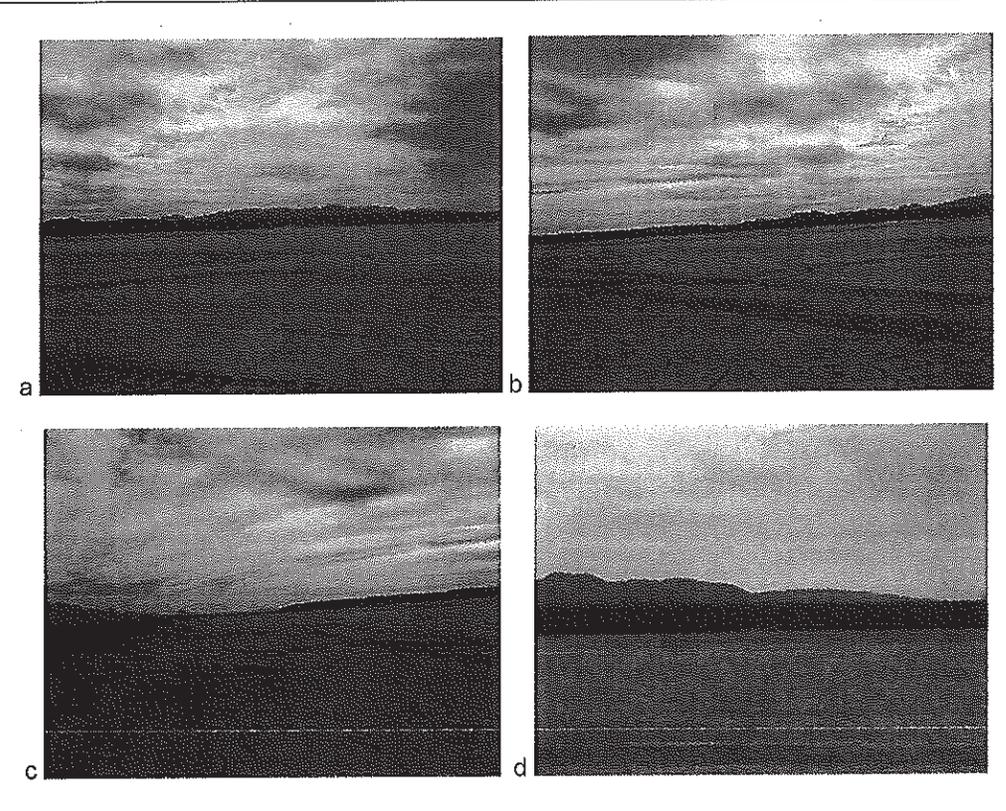
<p><b>Photo No. 10 a, b, c, d</b></p>

The inspector observed some fugitive particulate emissions that swept the surface on the southwest side of tailings dam but none that were as large as the plume observed earlier or that would appear to exceed the applicable opacity standard. The inspector observed that a considerable portion of the south area of the tailings surface was coated with polymer and observed a truck applying the polymer in that area (Attachment 2, Photo No. 10).

<p><b>Date:</b> 11/12/2009</p>		
<p><b>Photo Description:</b></p> <p>View of the top surface of tailings dam #8. Some minor fugitive particulate emissions were observed generated on the west side but quickly dissipated.</p> <p>Some emissions were observed from the activity of the water truck applying polymer to the surface.</p> <p>A portion of the south side of the dam was colored blue indicating the area was sprayed with polymer. The windspeed measured 19 mph average, 26 mph maximum, and a direction of south/southwest.</p>

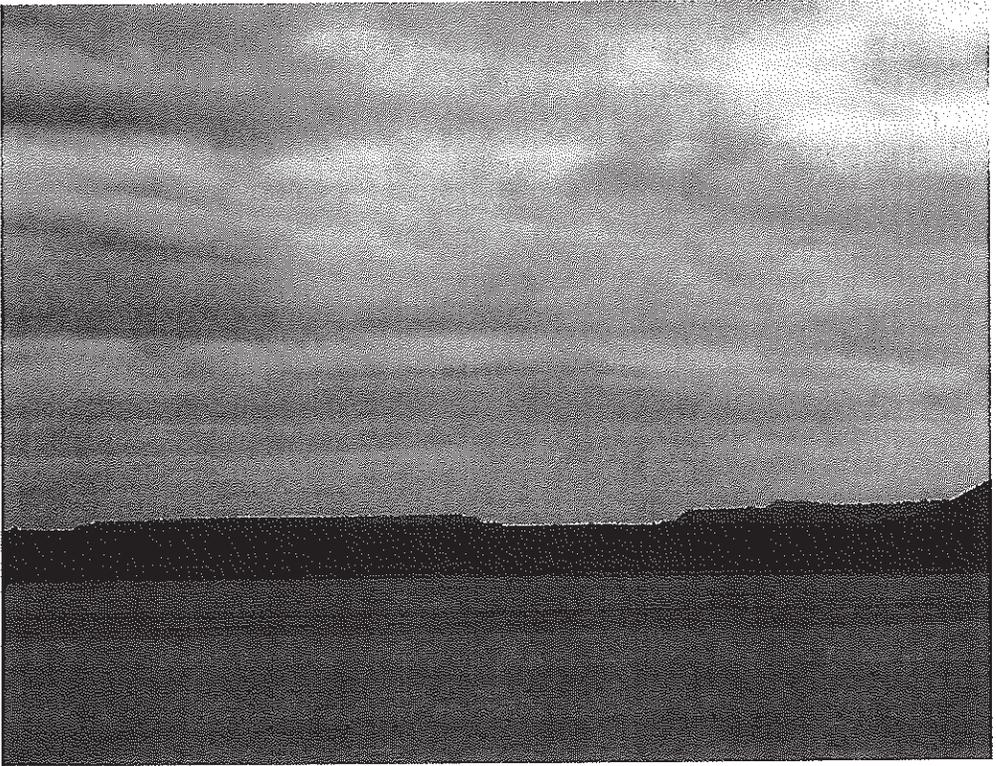
<p><b>Photo No. 11</b></p>

<p><b>Date:</b> 11/12/2009</p>	
<p><b>Photo Description:</b></p> <p>View of the southwest area of the top surface where polymer has been applied to tailings dam #8.</p>

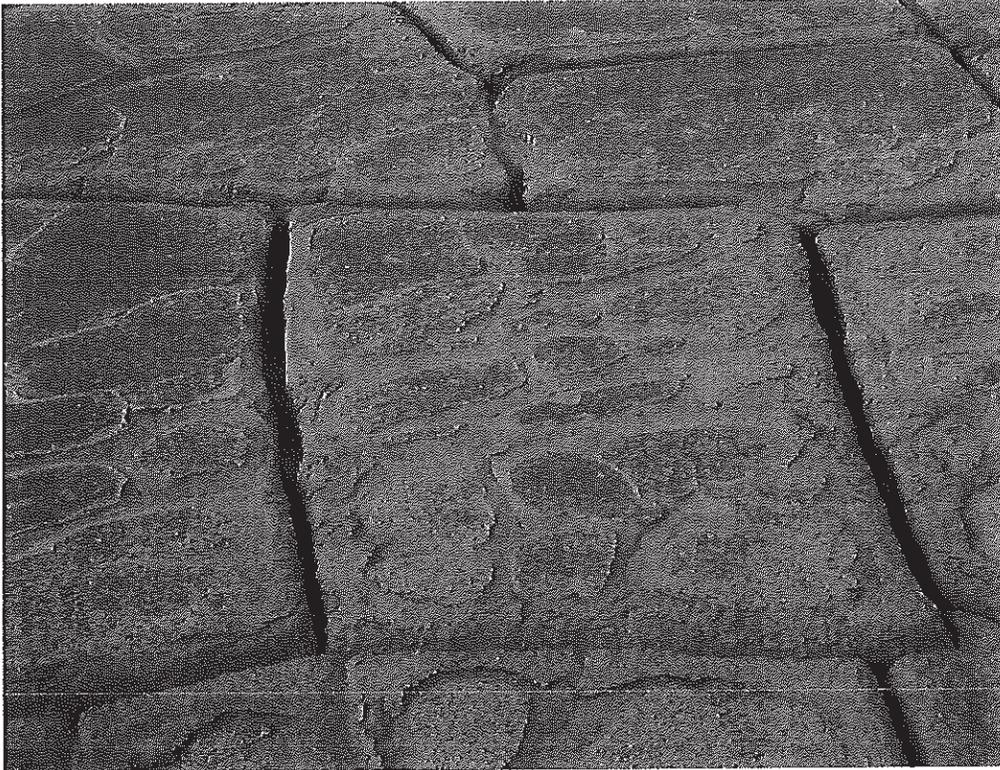
<p><b>Photo No. 12</b></p>

<p><b>Date:</b> 11/12/2009</p>	
<p><b>Photo Description:</b></p> <p>View of the tailings dam #8 surface. The cracks in the surface are from the shrinkage of the dry tailings at the surface.</p> <p>The scale like areas bounded by salt are the hard encrusted surface that remains from the evaporation of the tailings.</p> <p>The furrowed areas around the scales and between the cracks are where the encrusted surface has eroded exposing unstable tailings below.</p>

High winds over the past few weeks have scoured the protective crust on Tailings Impoundment #8. Due to ongoing berm building, Asarco has not been able to apply wet tailings to the surface of the impoundment. Although Asarco began immediately applying dust suppressant polymer to Tailings Impoundment #8's surface, the large size of the dam precluded Asarco from being able to repair the entire crust layer at once. The broken crust and excessive wind gusts on November 12<sup>th</sup> were the cause of the excess emissions as described above.

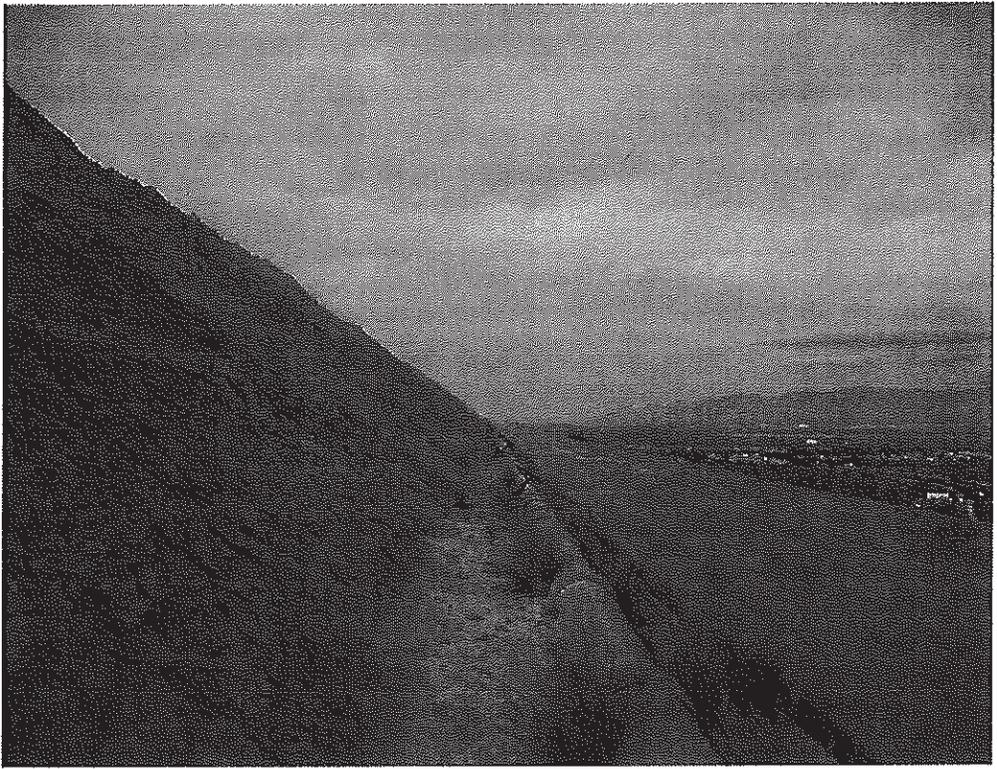
<b>Photo No. 14</b>

<b>Date:</b> 11/12/2009	
<b>Photo Description:</b>  View of the east slope shown in photo # 9 observed at 2:47 pm returning to the vehicle. The fugitive emissions had diminished considerably.

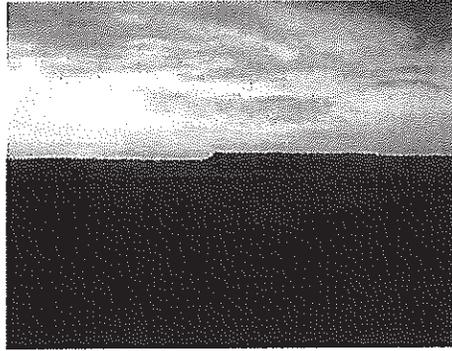
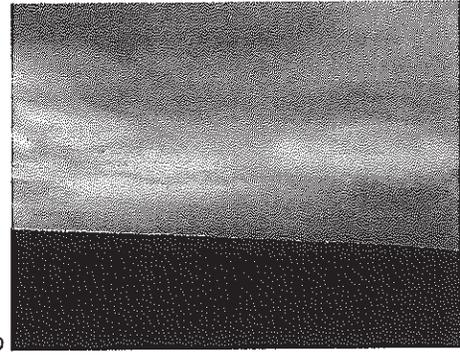
**Photo No. 15 a, b**

View of the east slope shown in photo # 9 observed at 4:15 pm after returning from surveillance in Green Valley. The inspector observed that polymer had been applied to the newly constructed berm area.
