**PIMA COUNTY DEPARTMENT OF ENVIRONMENTAL QUALITY  
AIR PROGRAM**

**Site Inspection Report**

**Tracking ID: PC 1307-099**

**Permit #:** 6067  
**Source:** Freeport-McMoRan Sierrita Inc.  
**Location:** 6200 W. Duval Mine Road, Green Valley, AZ  
**Date:** July 29, 2013  
**Arrival Time:** 1:00 pm  
**Departure Time:** 3:30 pm  
**Inspectors:** Anna Martin  
Elizabeth Quinley  
Janice Easley  
**Spoke With:** Kali Hoyak, Environmental Engineer II  
Eric Werner, Environmental Engineer I  
Procopio Gonzales, Senior Tailings Supervisor  
**Phone #:** 520-393-2603 (Hoyak)  
**Reason for Inspection:** Complaint  
**Compliance Status:** Noncompliant

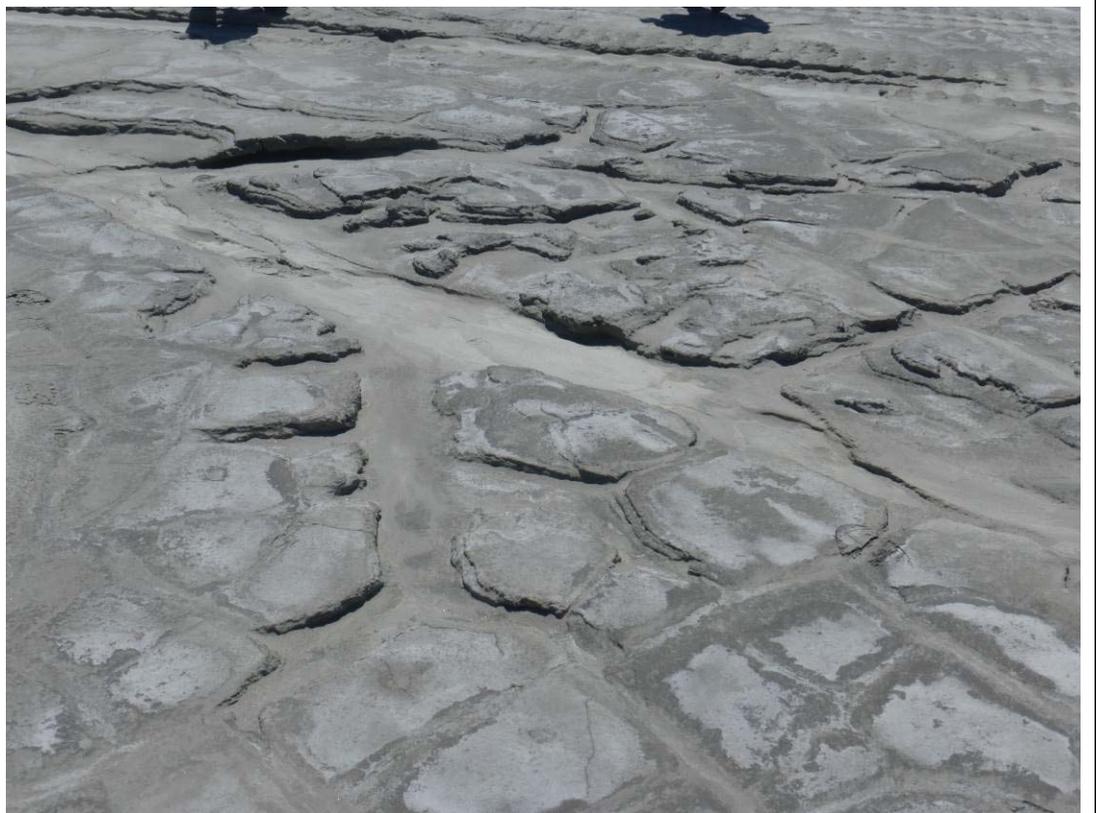
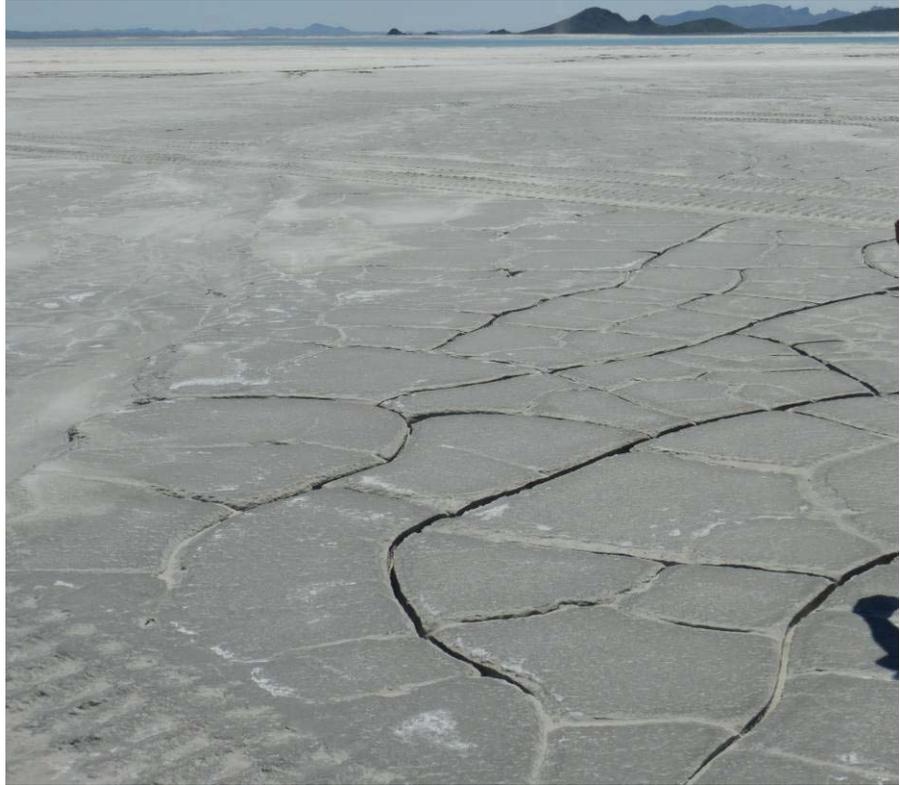
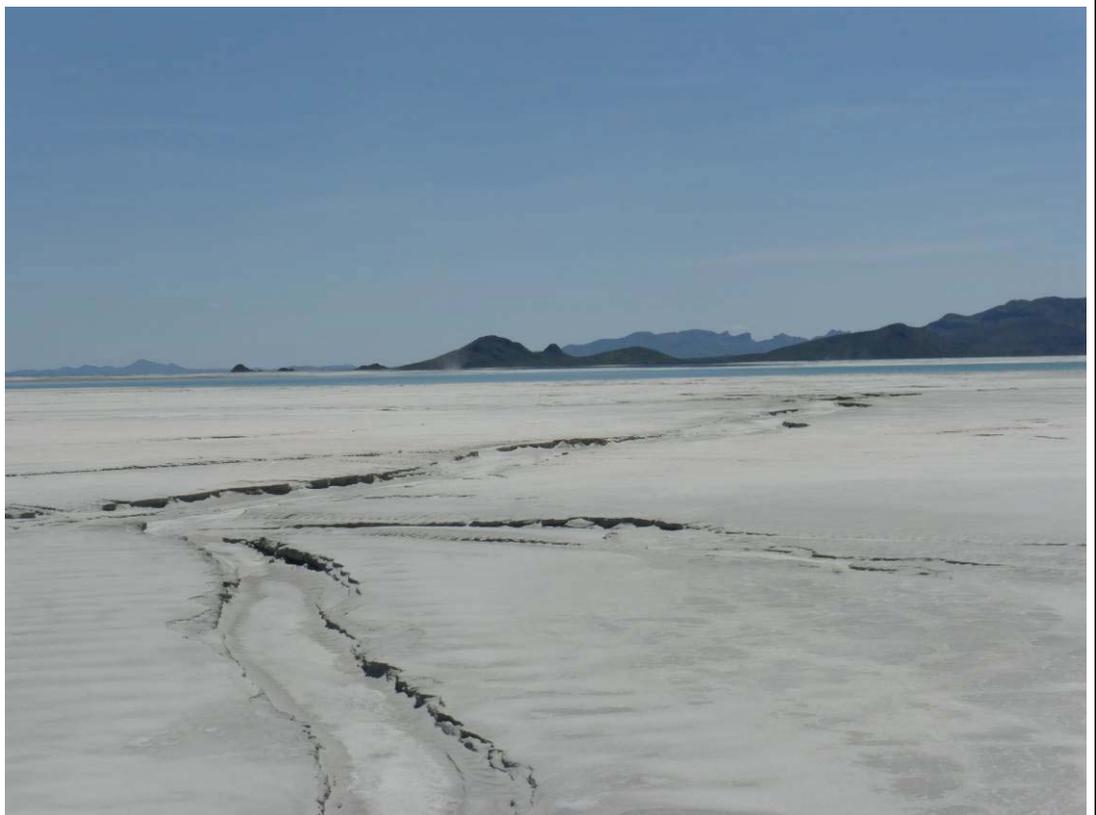
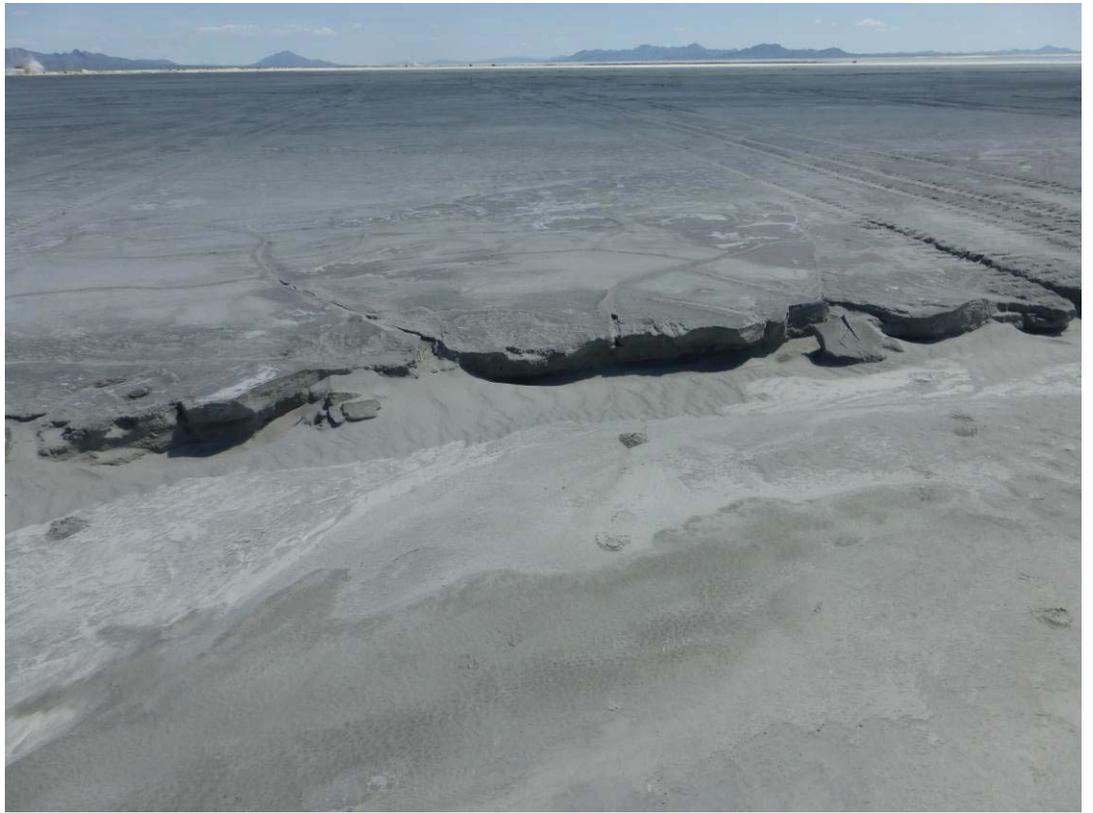
In general, we found the north dam surface to contain cracks and channels of varying depths (Attachment 1, Photos 10 – 13). The cracks, and especially the channels, contained loose, dry particulate. Mr. Gonzales indicated that cracking may be caused by light rain followed by hot, dry weather. The loose material in the channels appeared sandy and was somewhat aligned along southeast edges of channels. The loose channel material was not as fine as particulate created by disturbing the surface and did not appear highly susceptible to becoming windblown. Mr.

Gonzales indicated that channeling is caused by the deposition and flow of tailings slurry. Three All-Track vehicles were applying magnesium chloride in the southeast area of the north dam during the inspection. We did not observe any excessive dust while inspecting the north dam. A wind measurement while on the dam showed winds from the southwest at a maximum speed of 10.2 mph and an average speed of 7.5 mph.

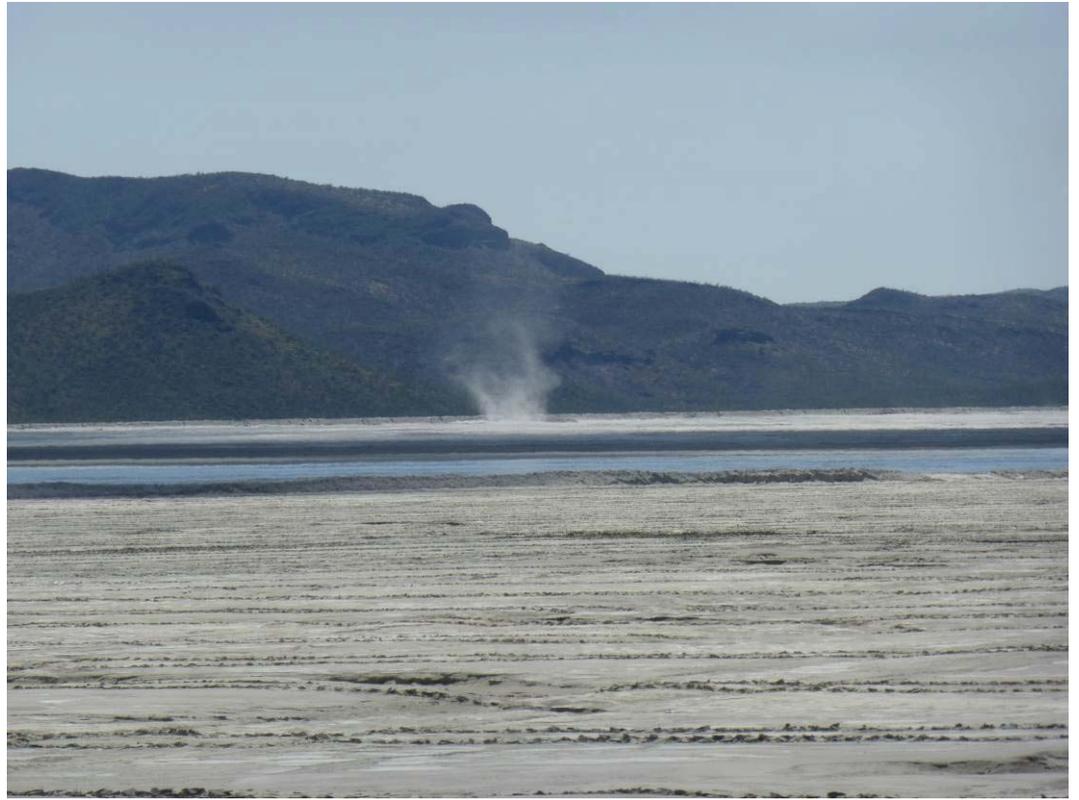
**Photo No. 15**

While on the north dam, we saw dust devils originate along the berm of the southwest portion of the south dam (Attachment 1, Photo 15). The dust devils dissipated soon after leaving the edge of the dam as they traveled northeast onto the south dam surface. We drove to south dam area and saw loose material in cracks on the berm, the apparent source of dust for the dust devils. The south dam surface appeared stable and Mr. Gonzalez called the water truck to increase stabilization of the berm areas. The dust devils were the only airborne fugitive particulate matter observed during the inspection.

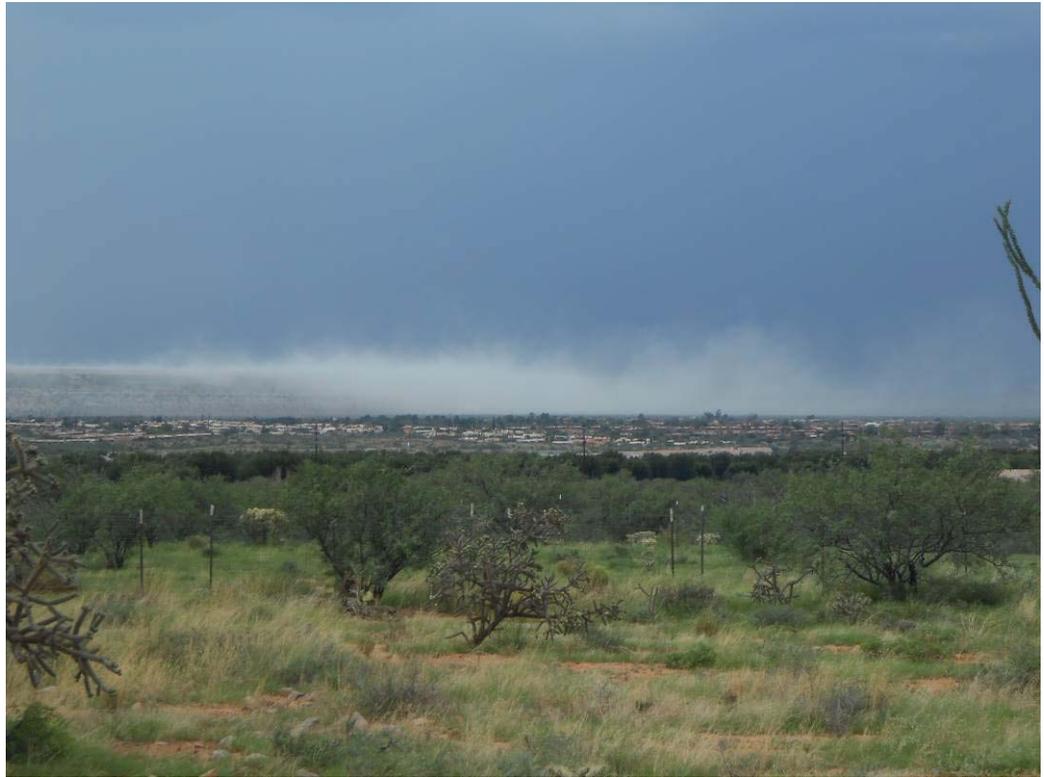
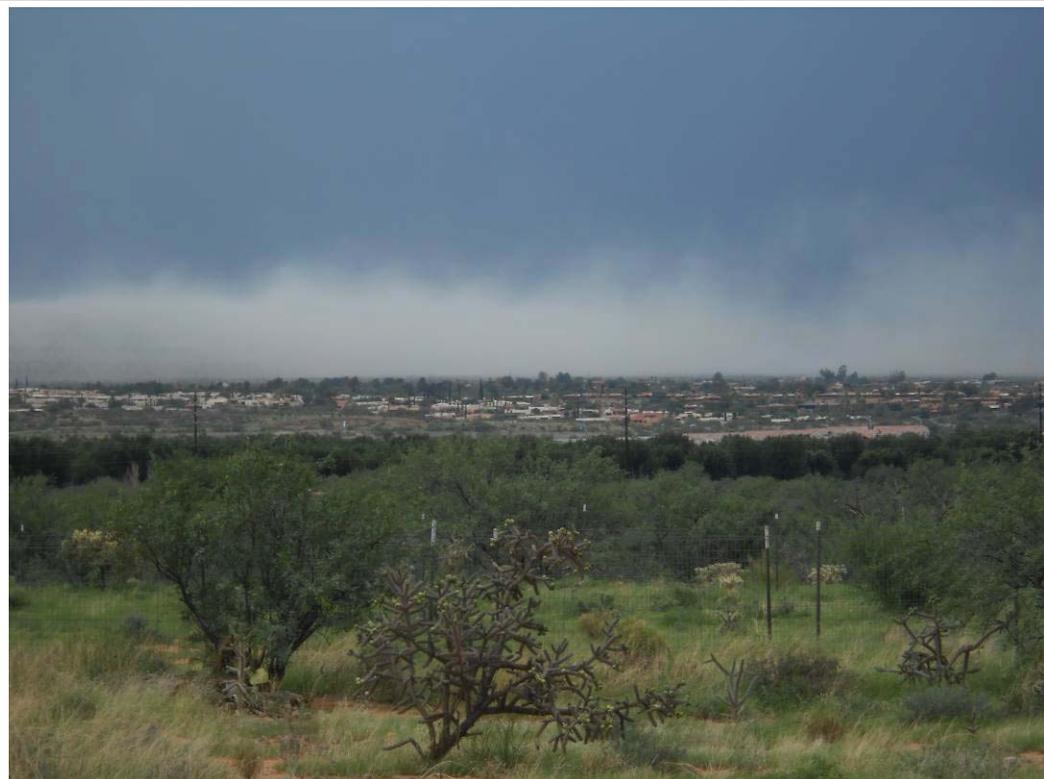
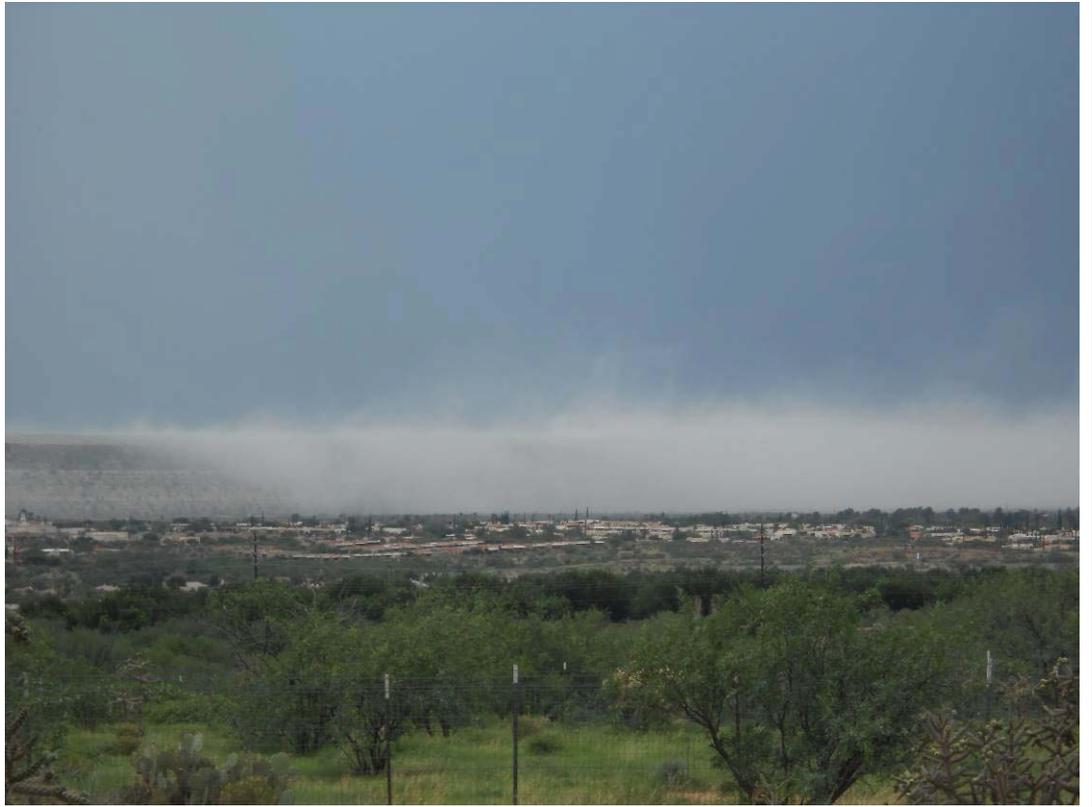
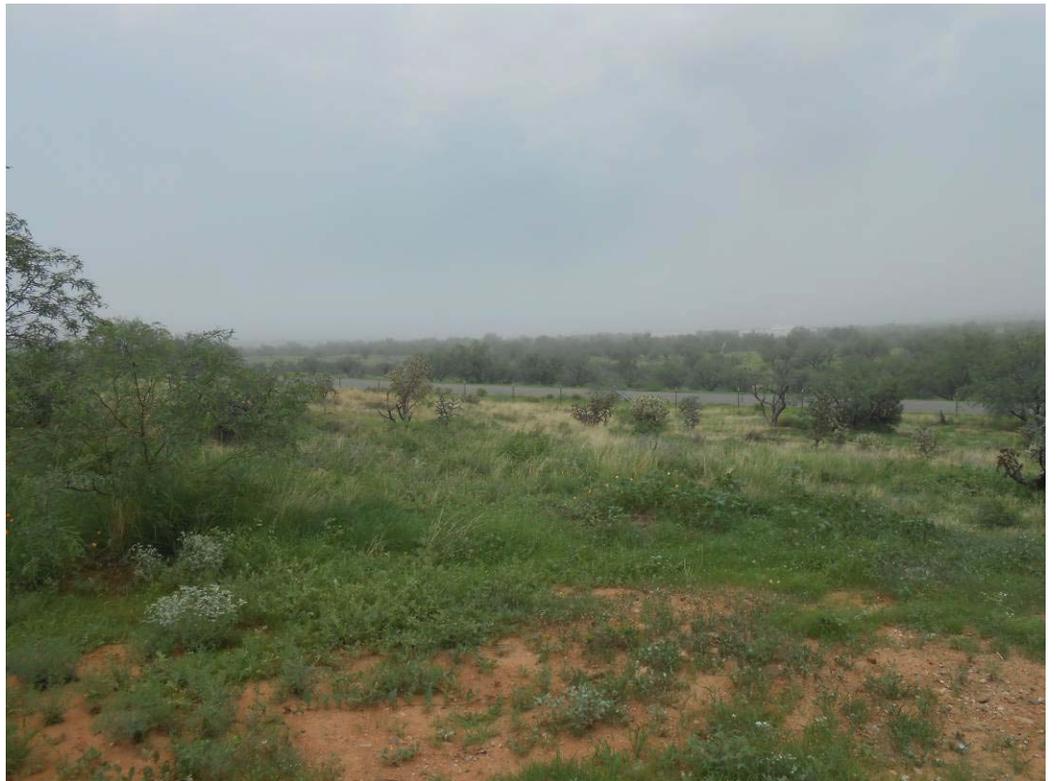
Fugitive dust emissions from the FMSI tailings impoundment were photographed by a PDEQ inspector from 3:21 pm to 3:41 pm on July 27, 2013. A complaint received by PDEQ reported a 3:27 pm fugitive dust emission from tailings. Photographs, PDEQ inspector observations, and on-site inspection reveal the emissions originated from the north section of the north dam. The inspector observed white dust clouds originating from the north dam travel eastward over the side of the dam. The dust moved southeast, crossing I-19. The inspector observed fine, white tailings dust of sufficient density to obscure local vegetation on property over 2.25 miles from the closest FMSI property boundary. The inspector observed the dust continue to travel toward the Santa Rita Mountains.

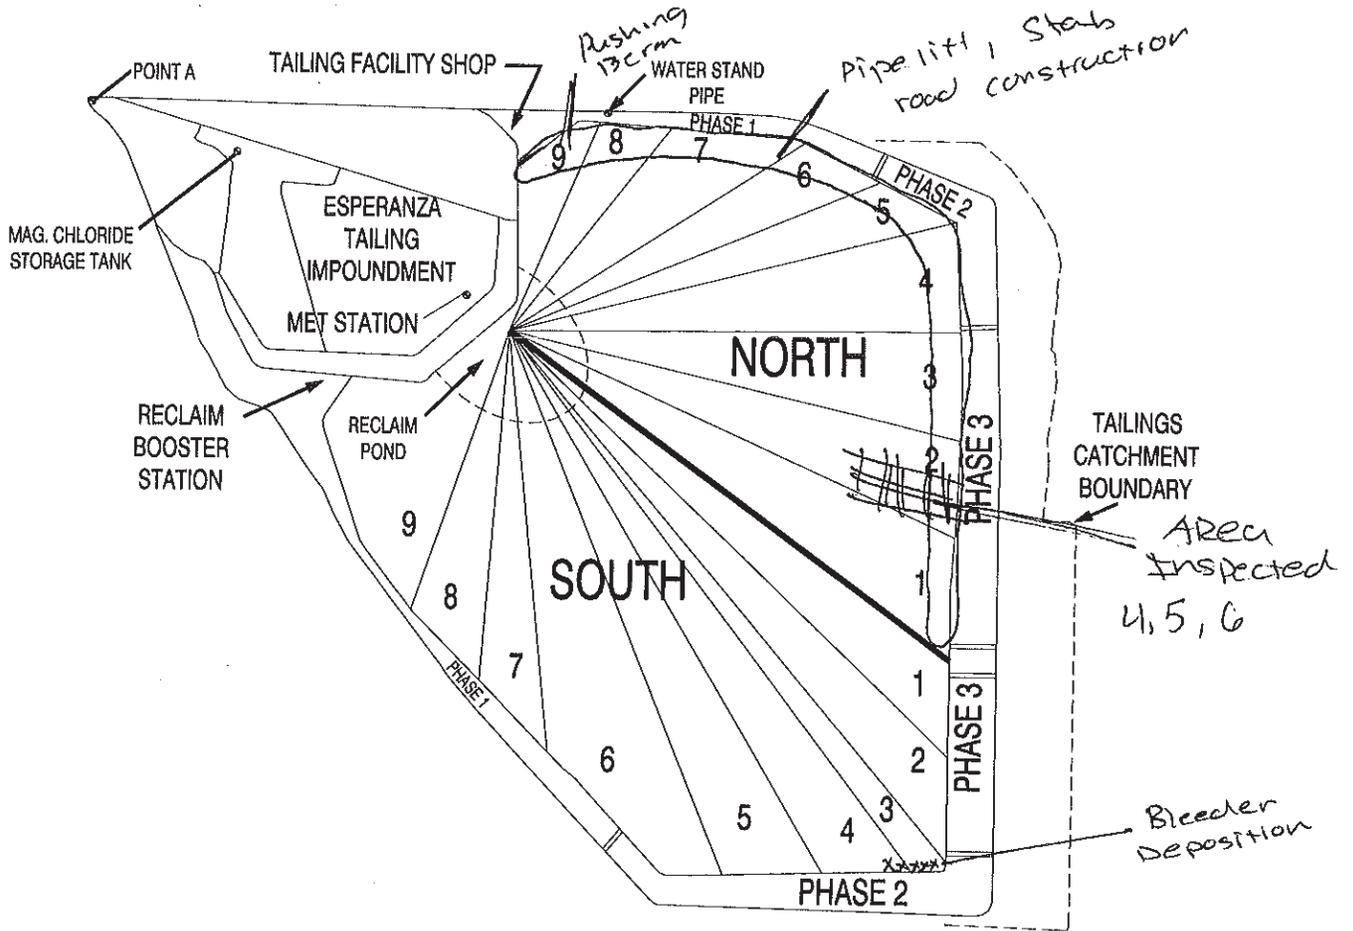
Date: 7/25/13  
 Time 8:00 AM  
 Conditions Cloudy  
 Dam Inspected Norm D. Phase(s) 3  
 GPS Coordinates \_\_\_\_\_

FMSI conducted a surface inspection on part of the north dam on July 25, 2013. This inspection revealed conditions where action was required. The inspection form for July 25, 2013 states the following for an action plan: “Water trucks in all areas, and berms. All-Tracks on standby”. There is no specific record of application of magnesium chloride on the north dam on July 25 or 26, 2013.
