Paseo de las Iglesias Phase I: Santa Cruz River Bank Protection, Ecosystem Restoration, and Linear Parkway, Ajo Way to Silverlake Road

Site Visit Photos, May 18, 2010

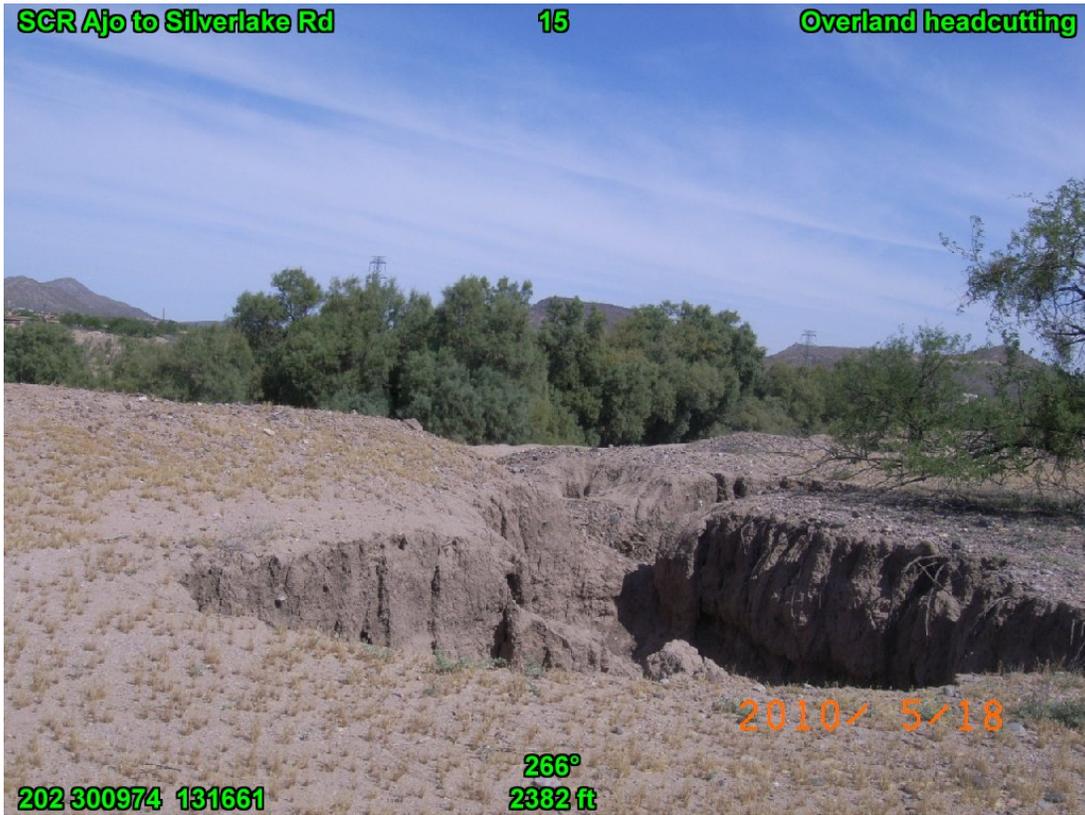
Photo 15 - Overland flow creating scour holes

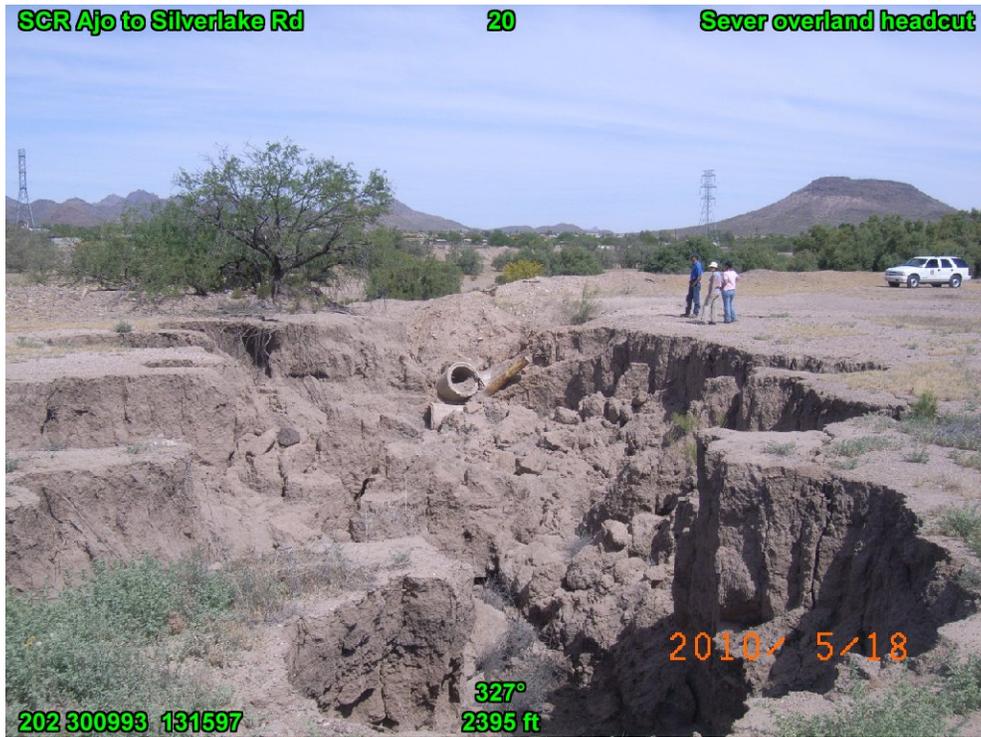
Photo 20 - Overland flow creating a large headcut

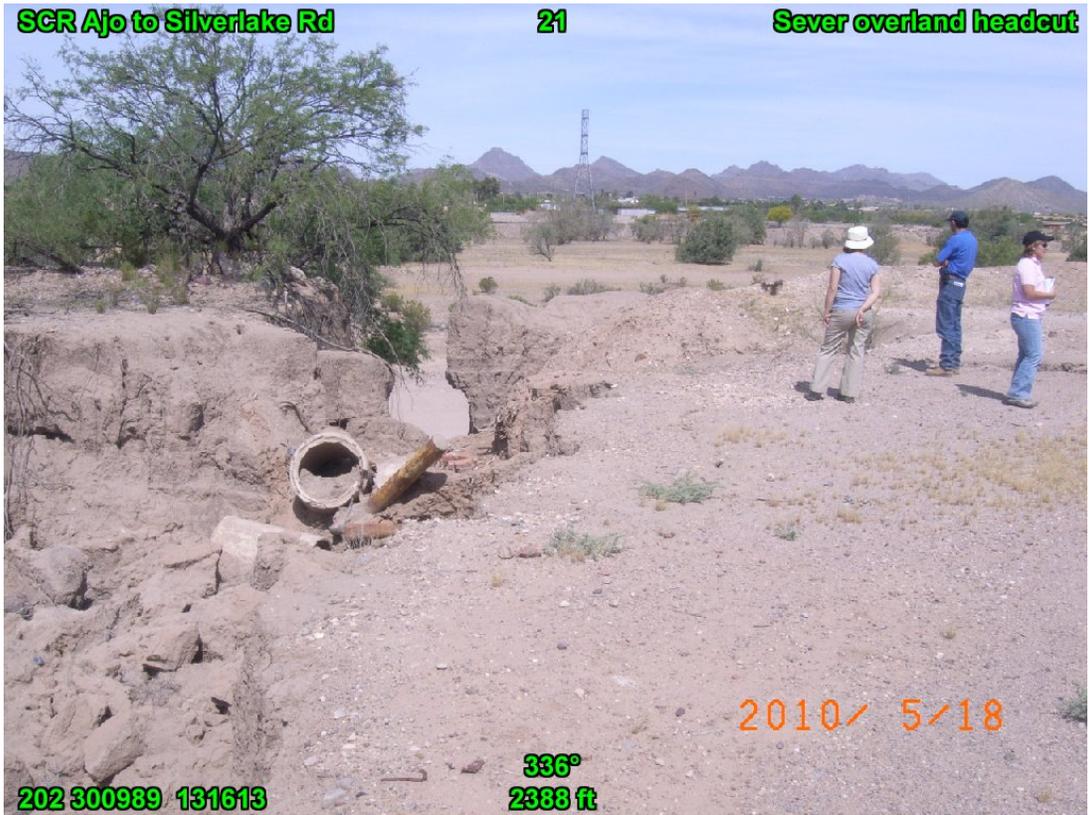
Photo 21 - Overland flow creating a large headcut

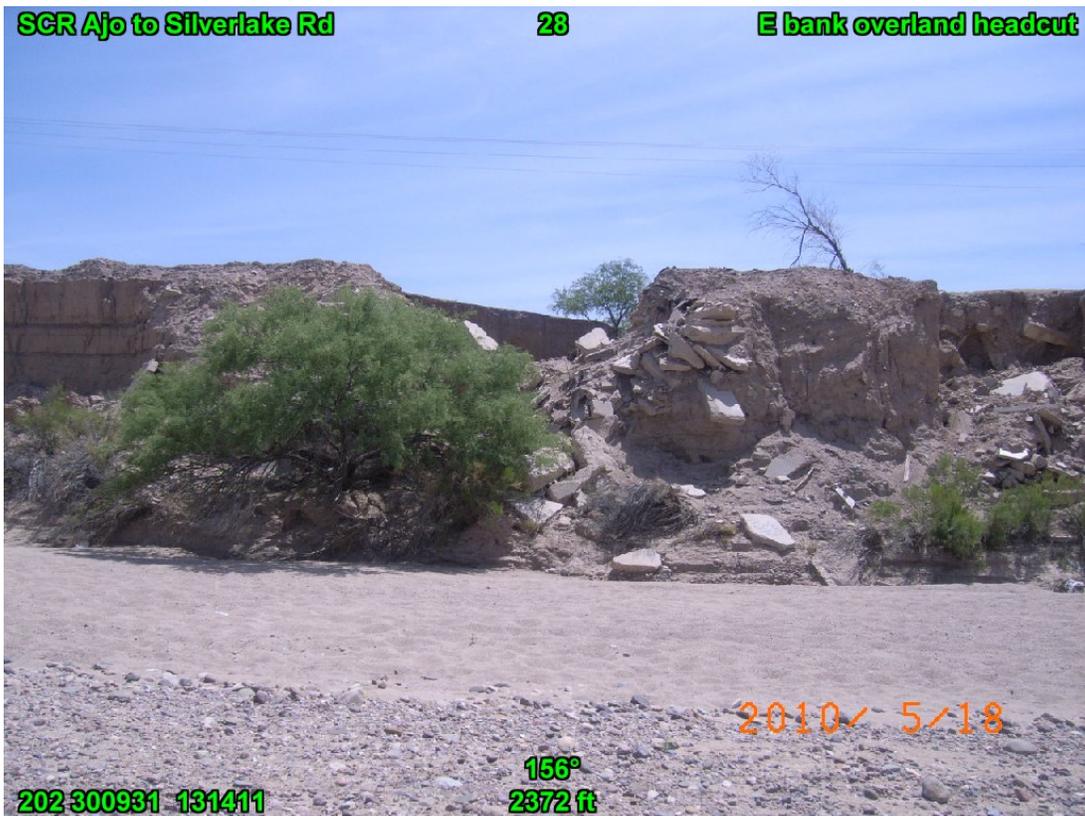
Photo 28 - East bank slope failure

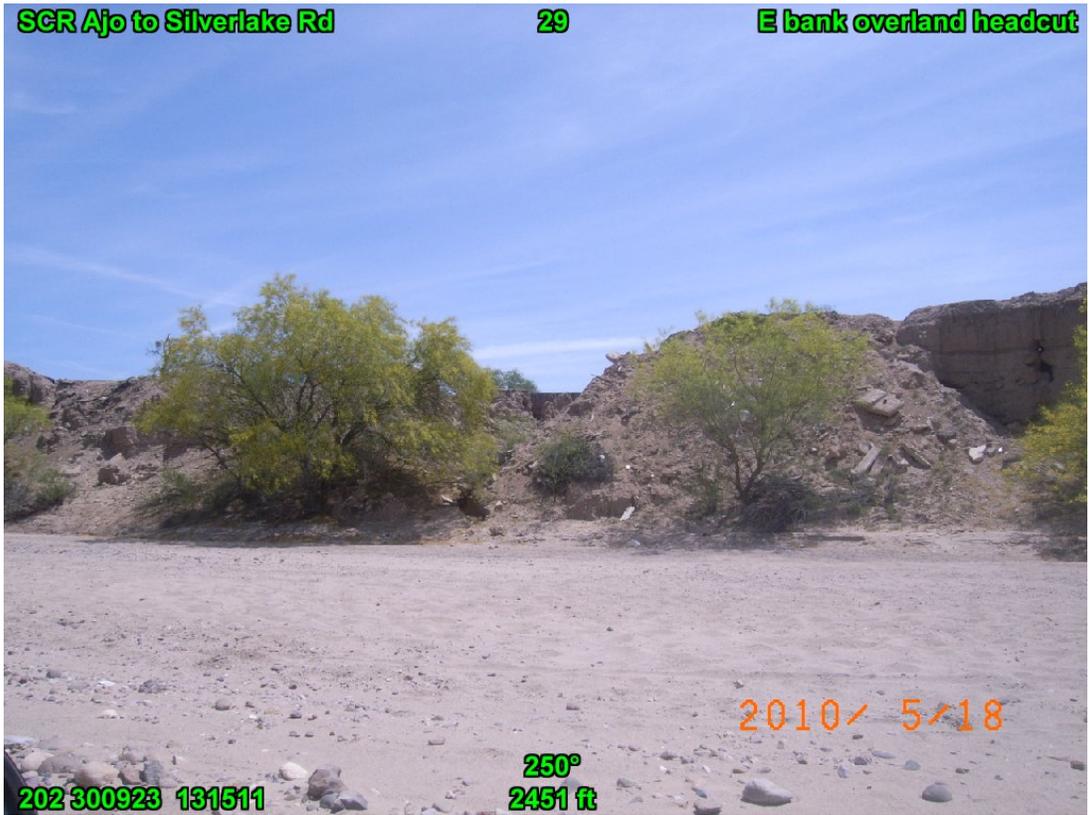
Photo 29 – East bank overland headcut

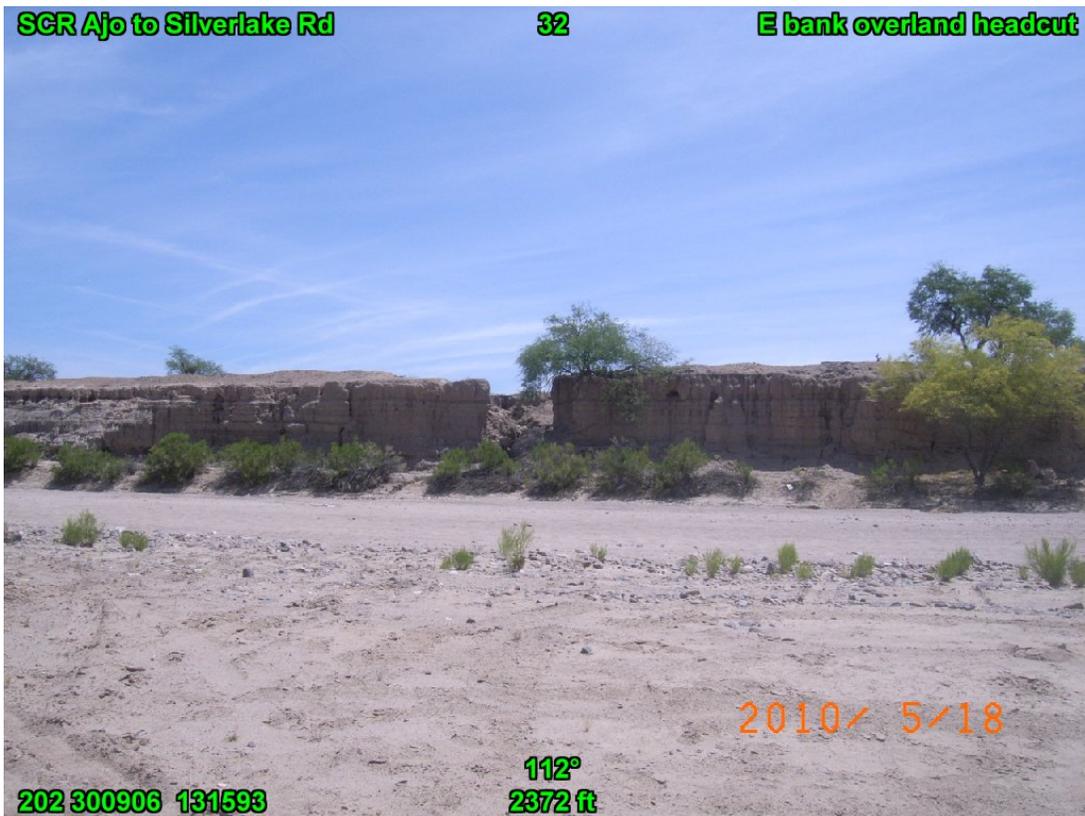
Photo 32 – East bank slope failure
