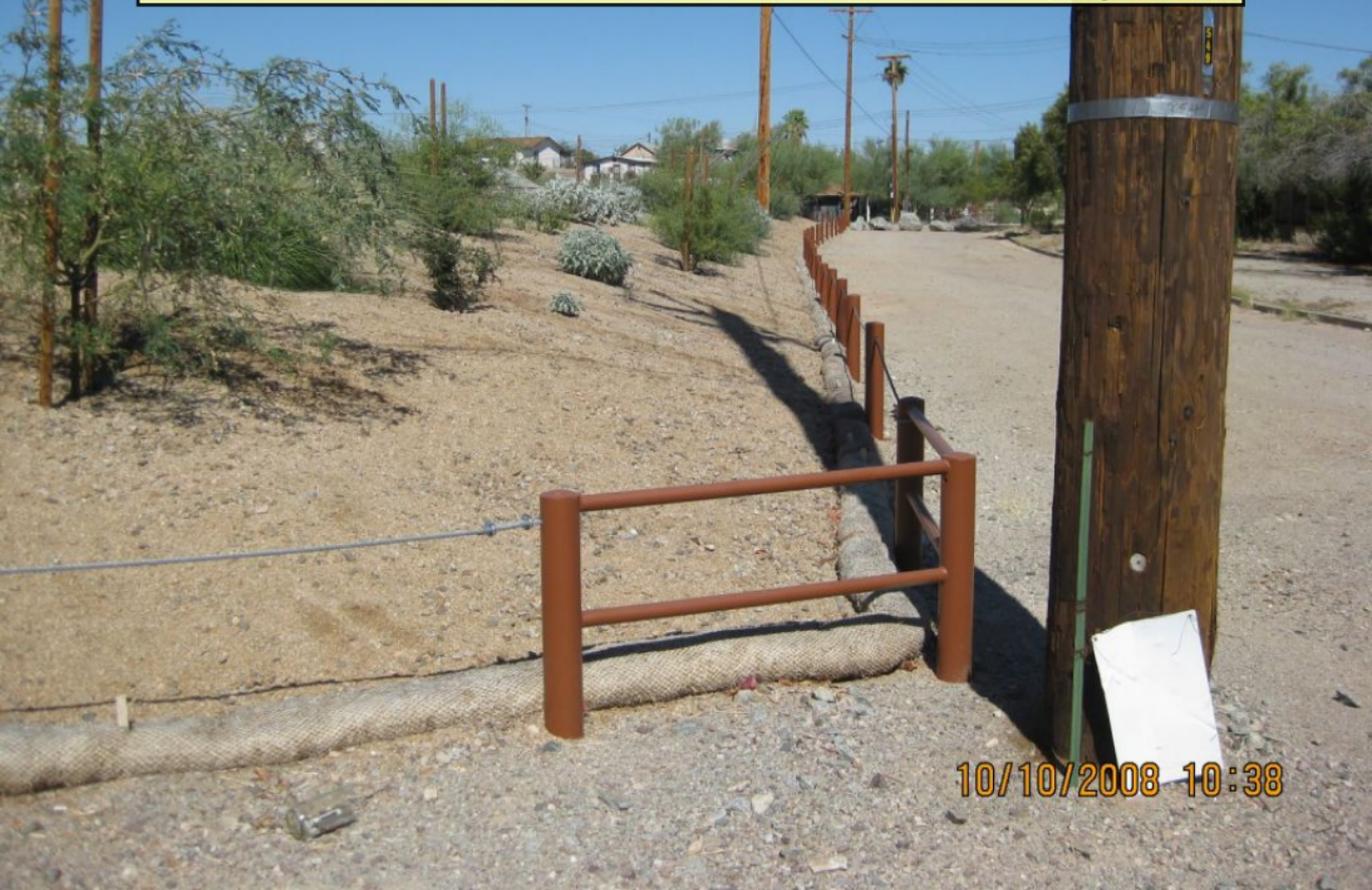
Looking north along the eastern outside slope of the basin. Just to the right, and out of the picture is the Curley School. The street shown is Orilla. New post and cable fence and landscaping.

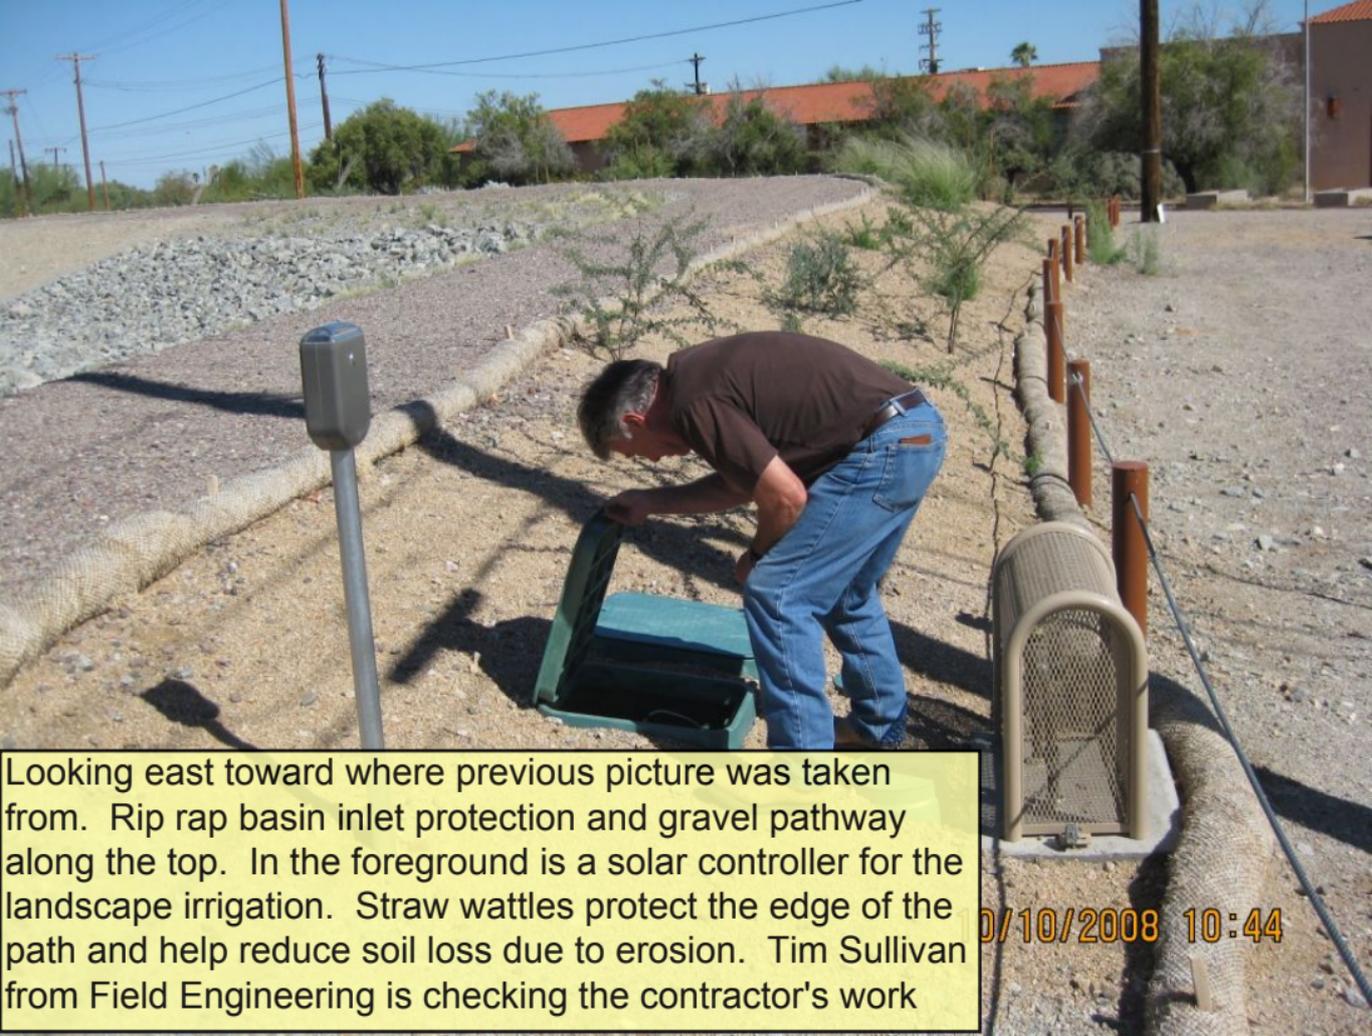
Looking east toward where previous picture was taken from. Rip rap basin inlet protection and gravel pathway along the top. In the foreground is a solar controller for the landscape irrigation. Straw wattles protect the edge of the path and help reduce soil loss due to erosion. Tim Sullivan from Field Engineering is checking the contractor's work

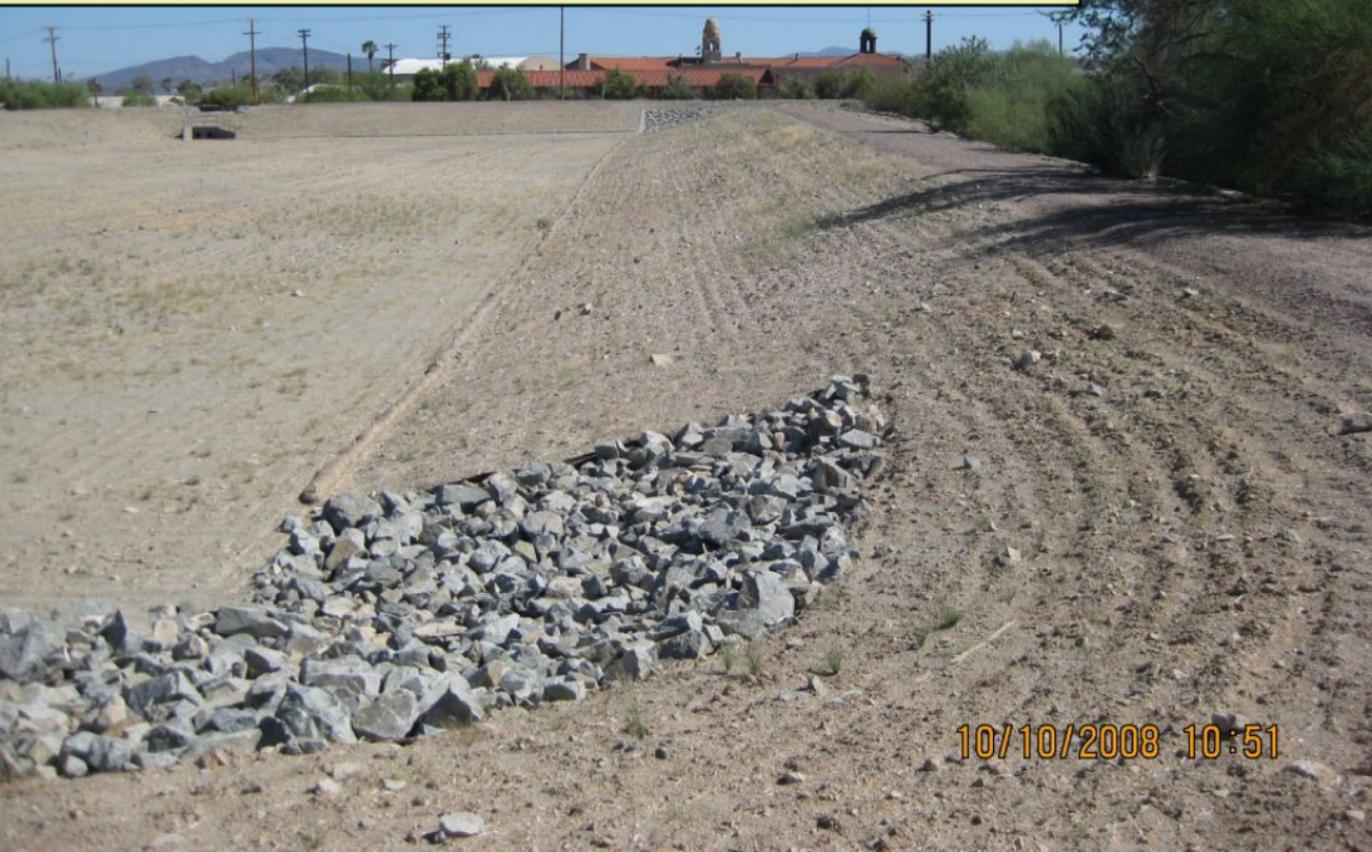
Looking east from the southwest corner of the basin. It's hard to see, but hydroseeding has worked to some extent with grasses being present throughout all graded areas. The outlet structure is visible at the far left of the basin.

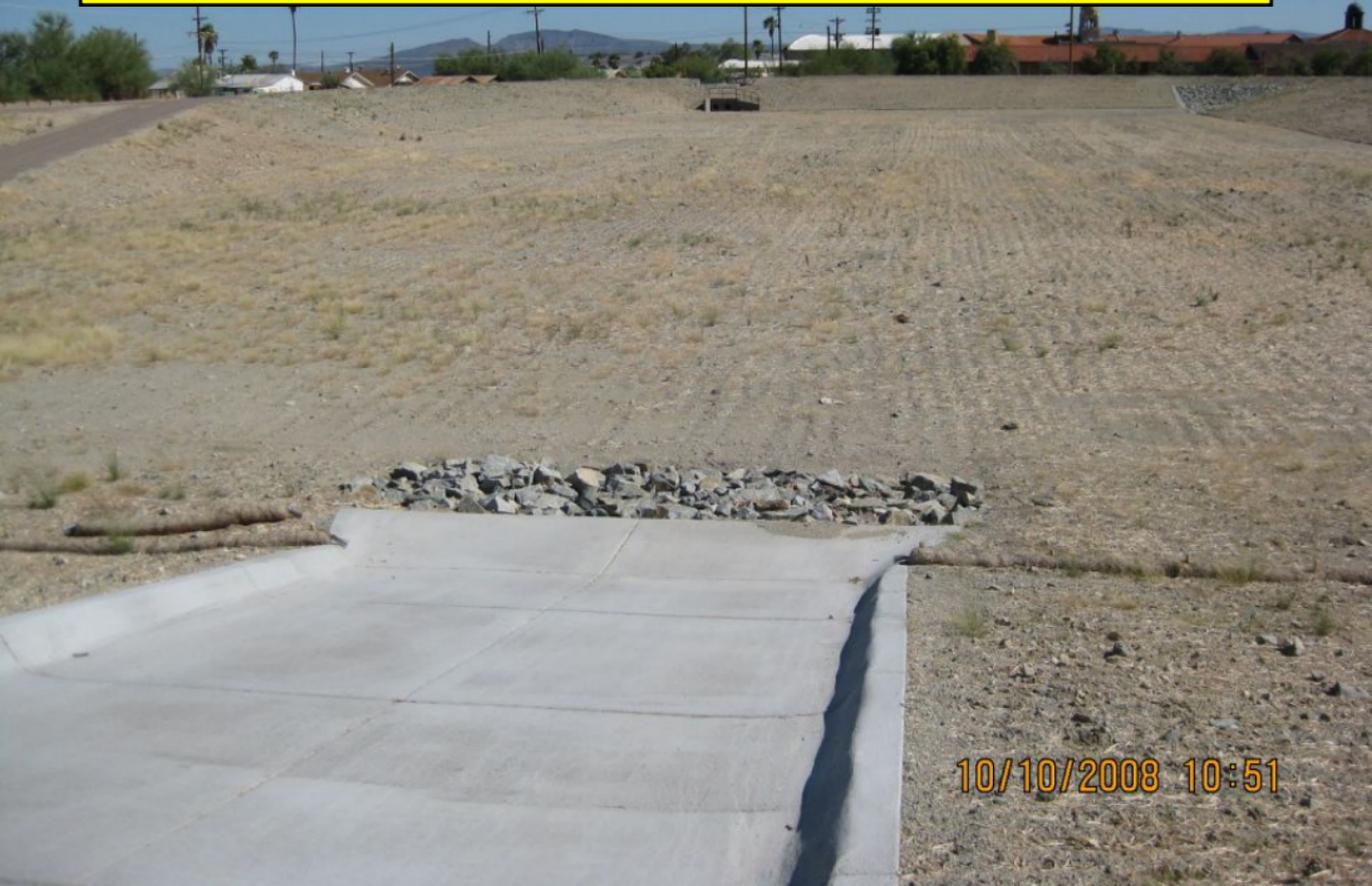
The basin from the west end looking east. The concrete spillway directs off-site flows down the slope to reduce soil loss due to erosion of the slope. Straw wattles can be seen at the toe to further reduce erosion.
