Board of Supervisors Memorandum

**Canoa Hills Golf Course Donation Acceptance Final Two Reports
for Addendum Items Number 8 and Number 12**

RE: Asbestos inspection – Canoa Hills Golf Course

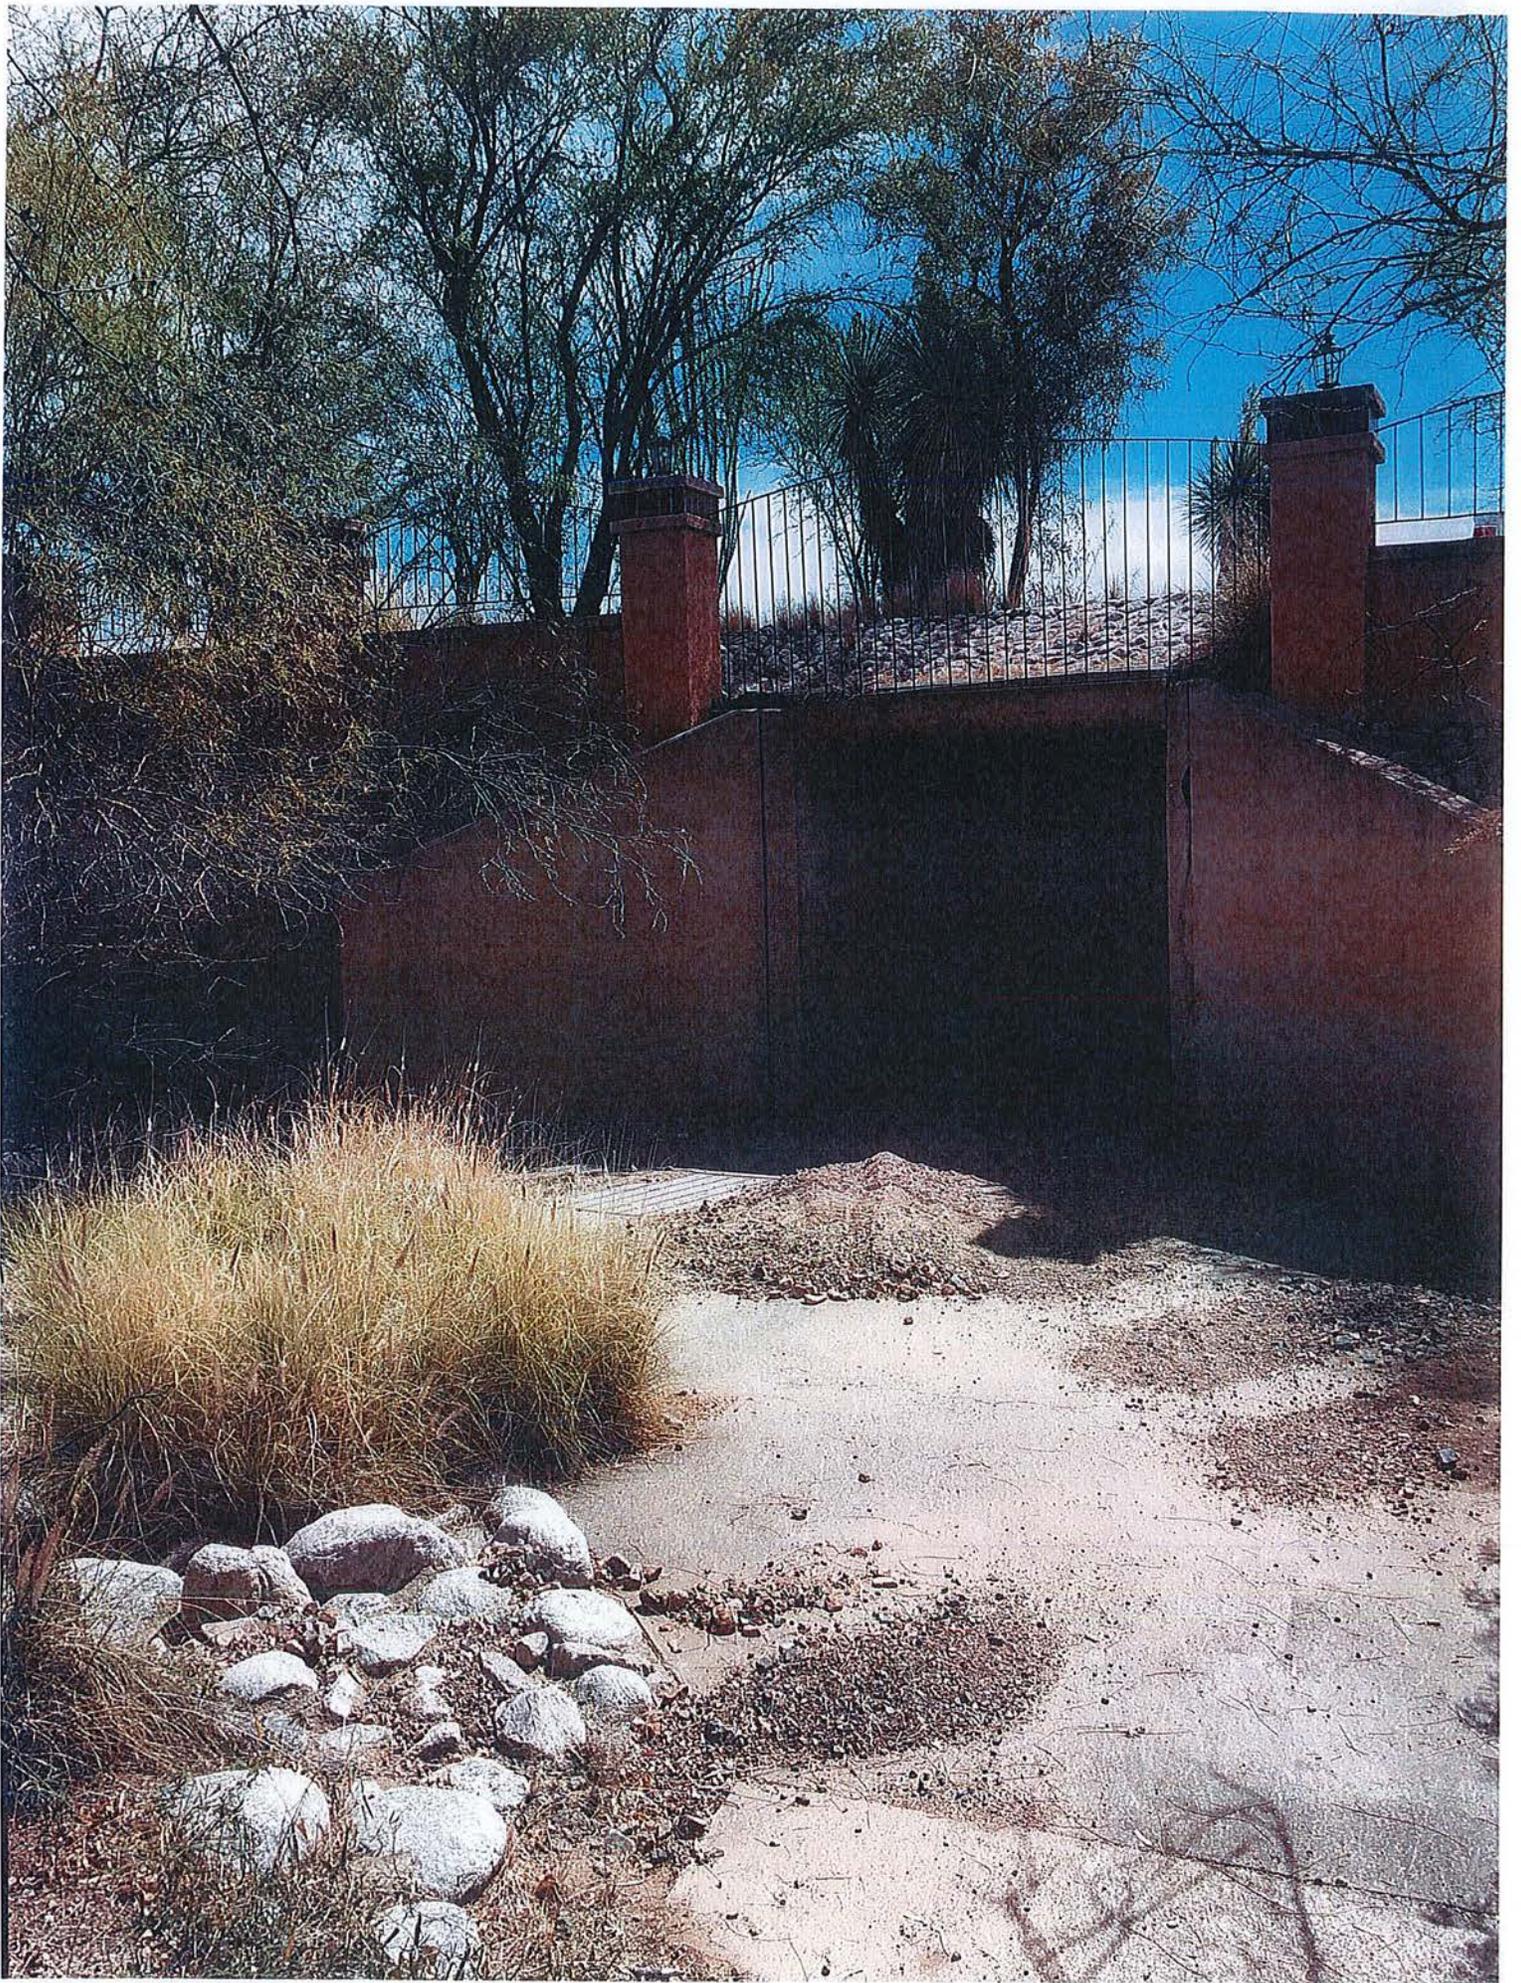
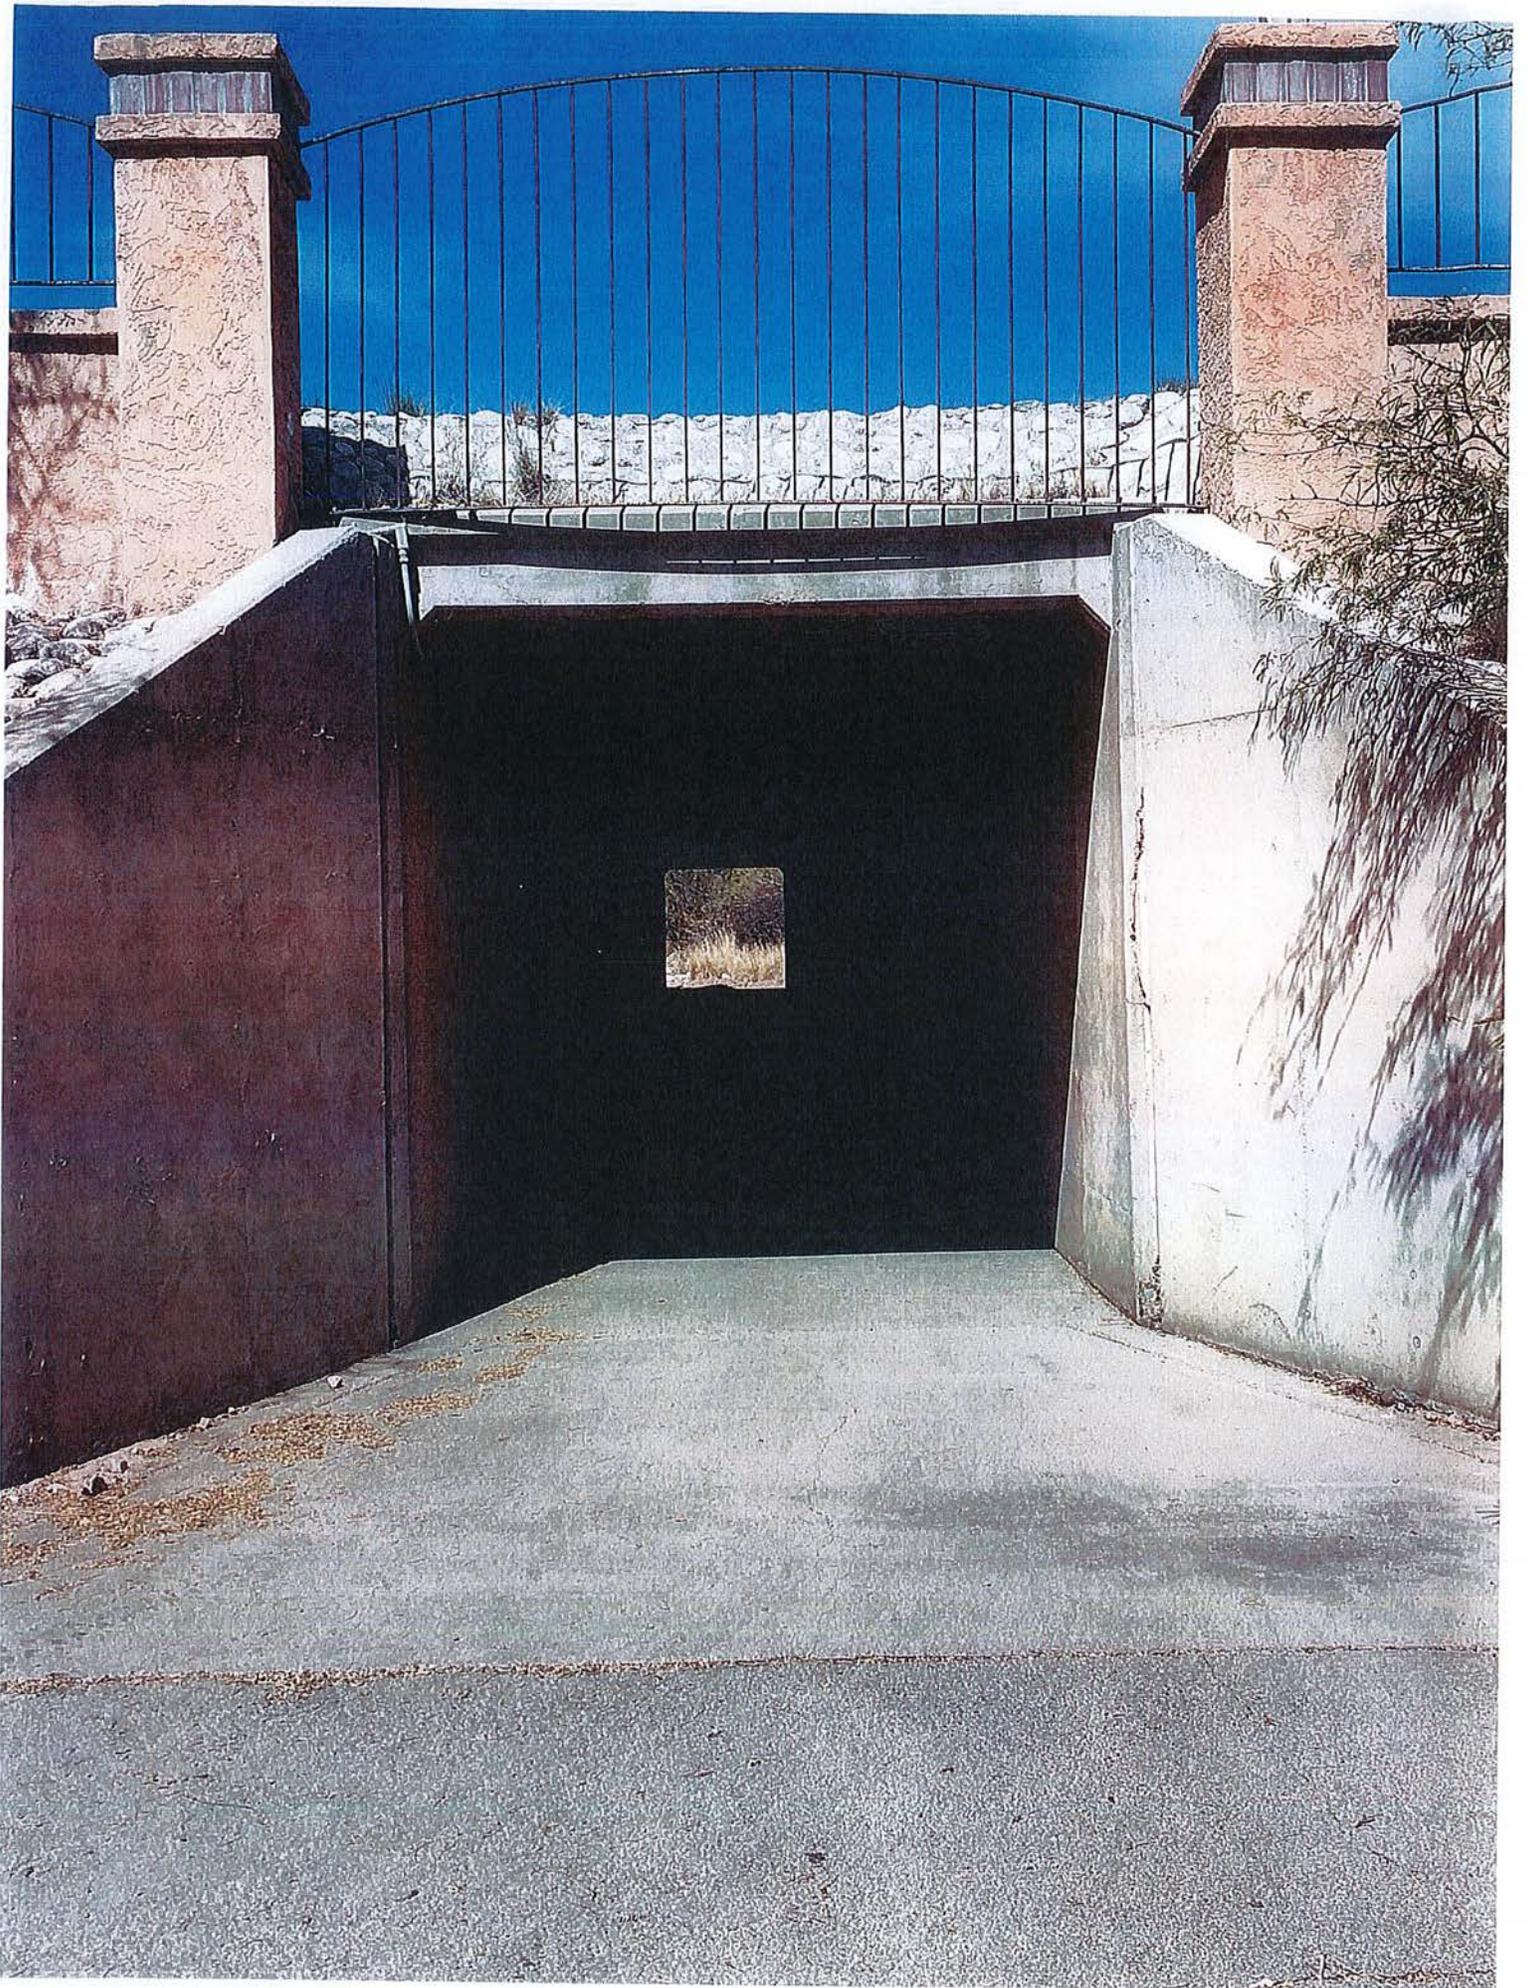
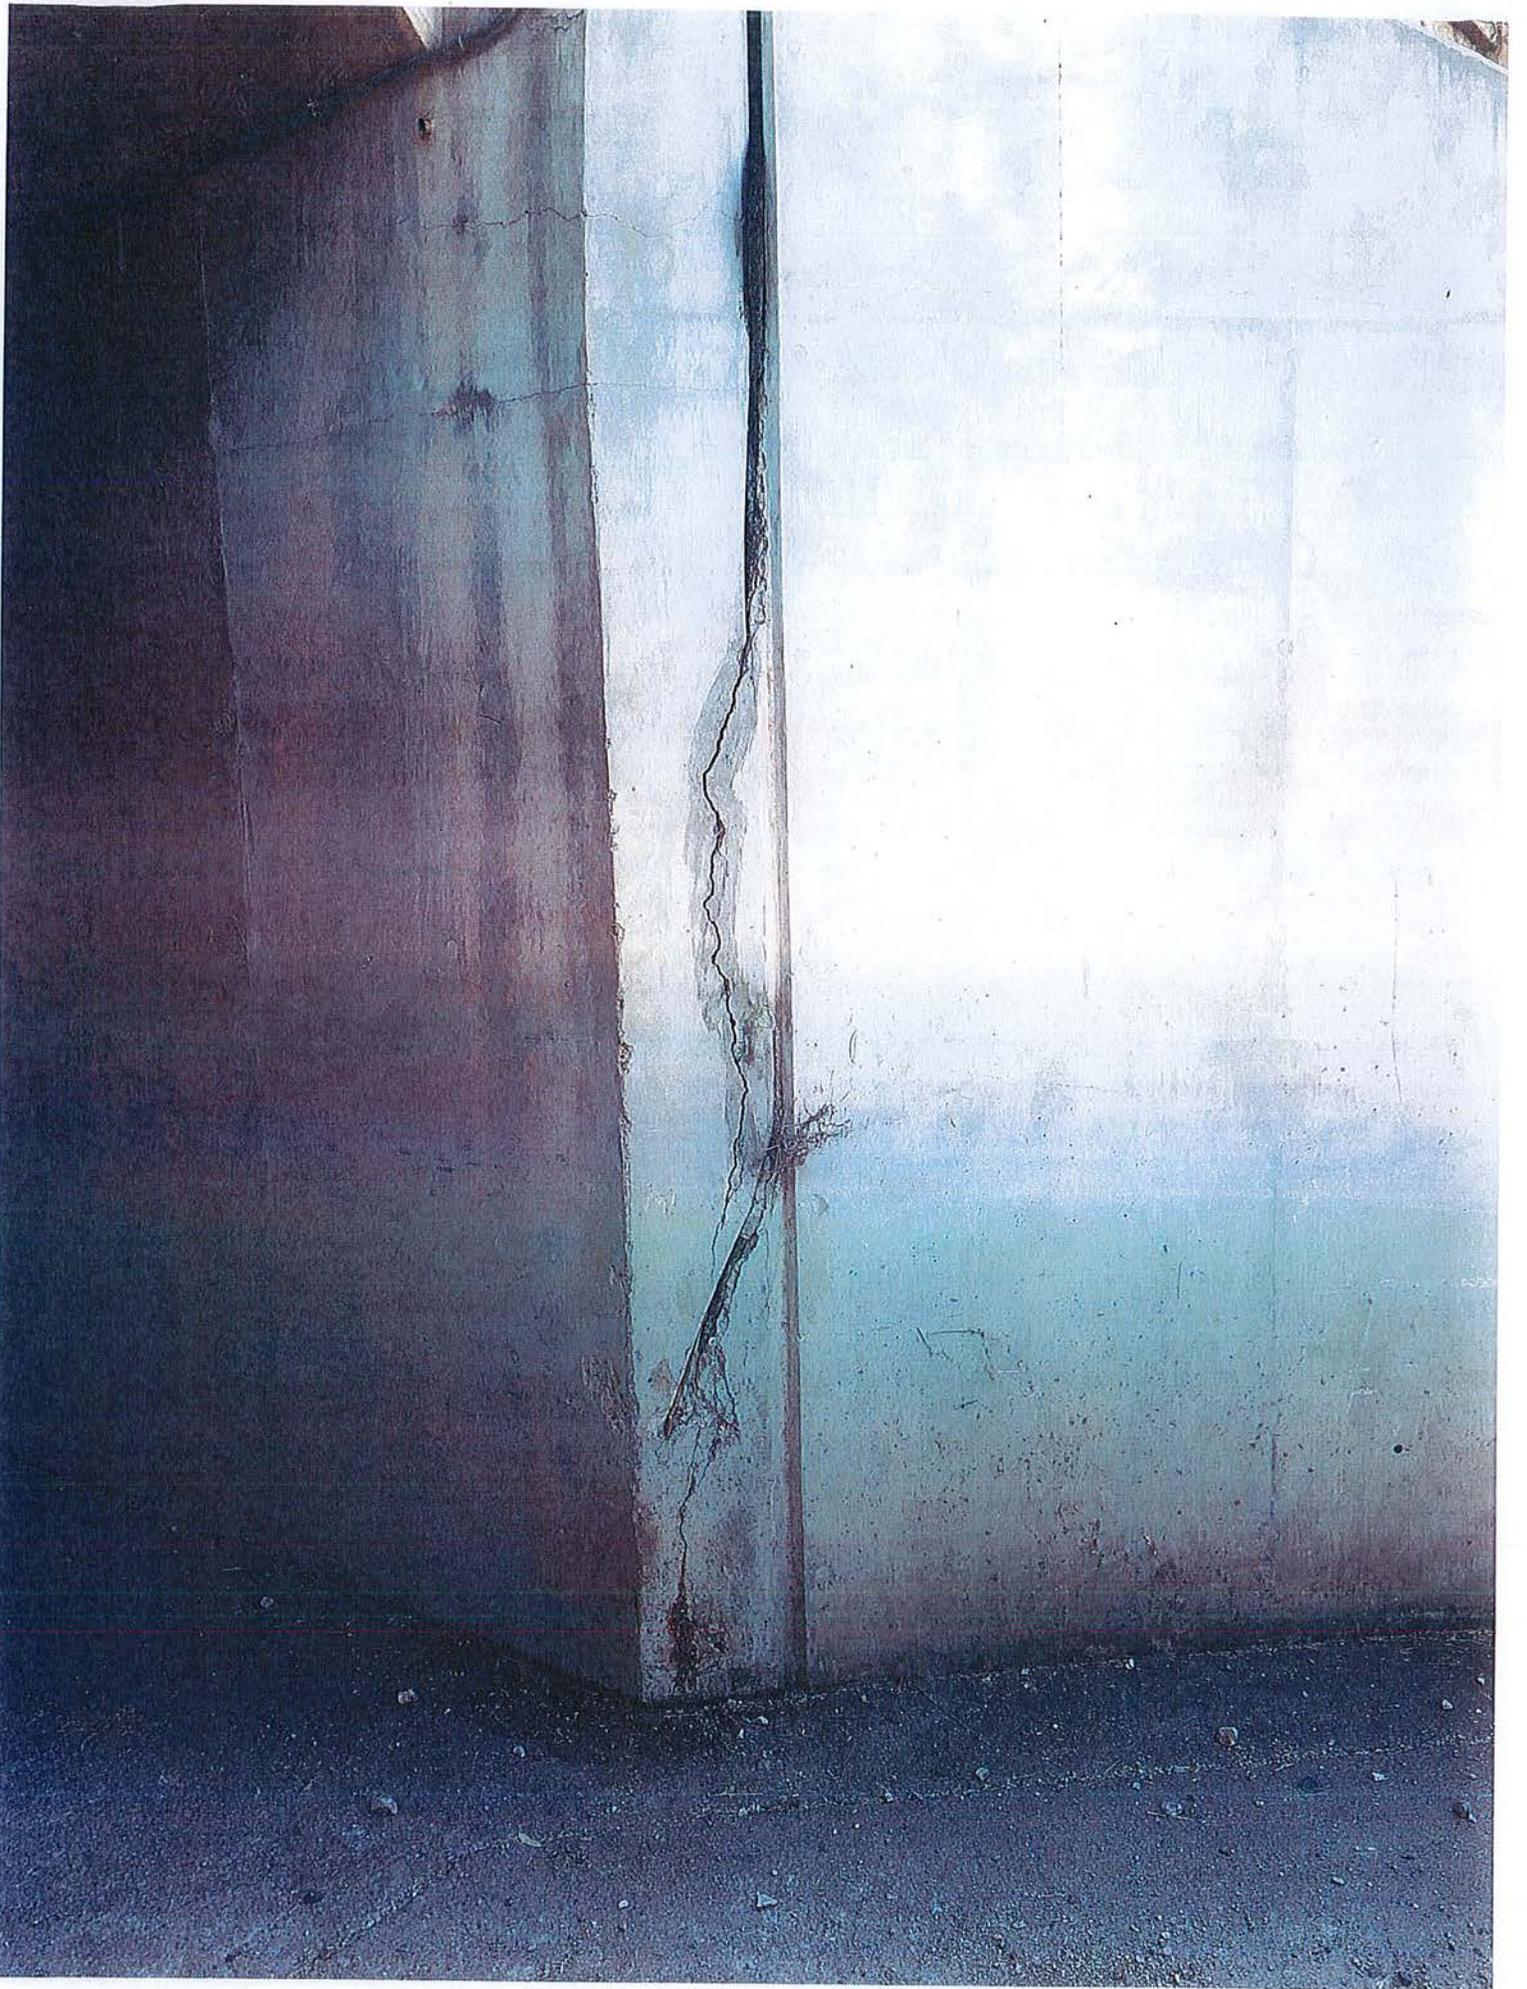
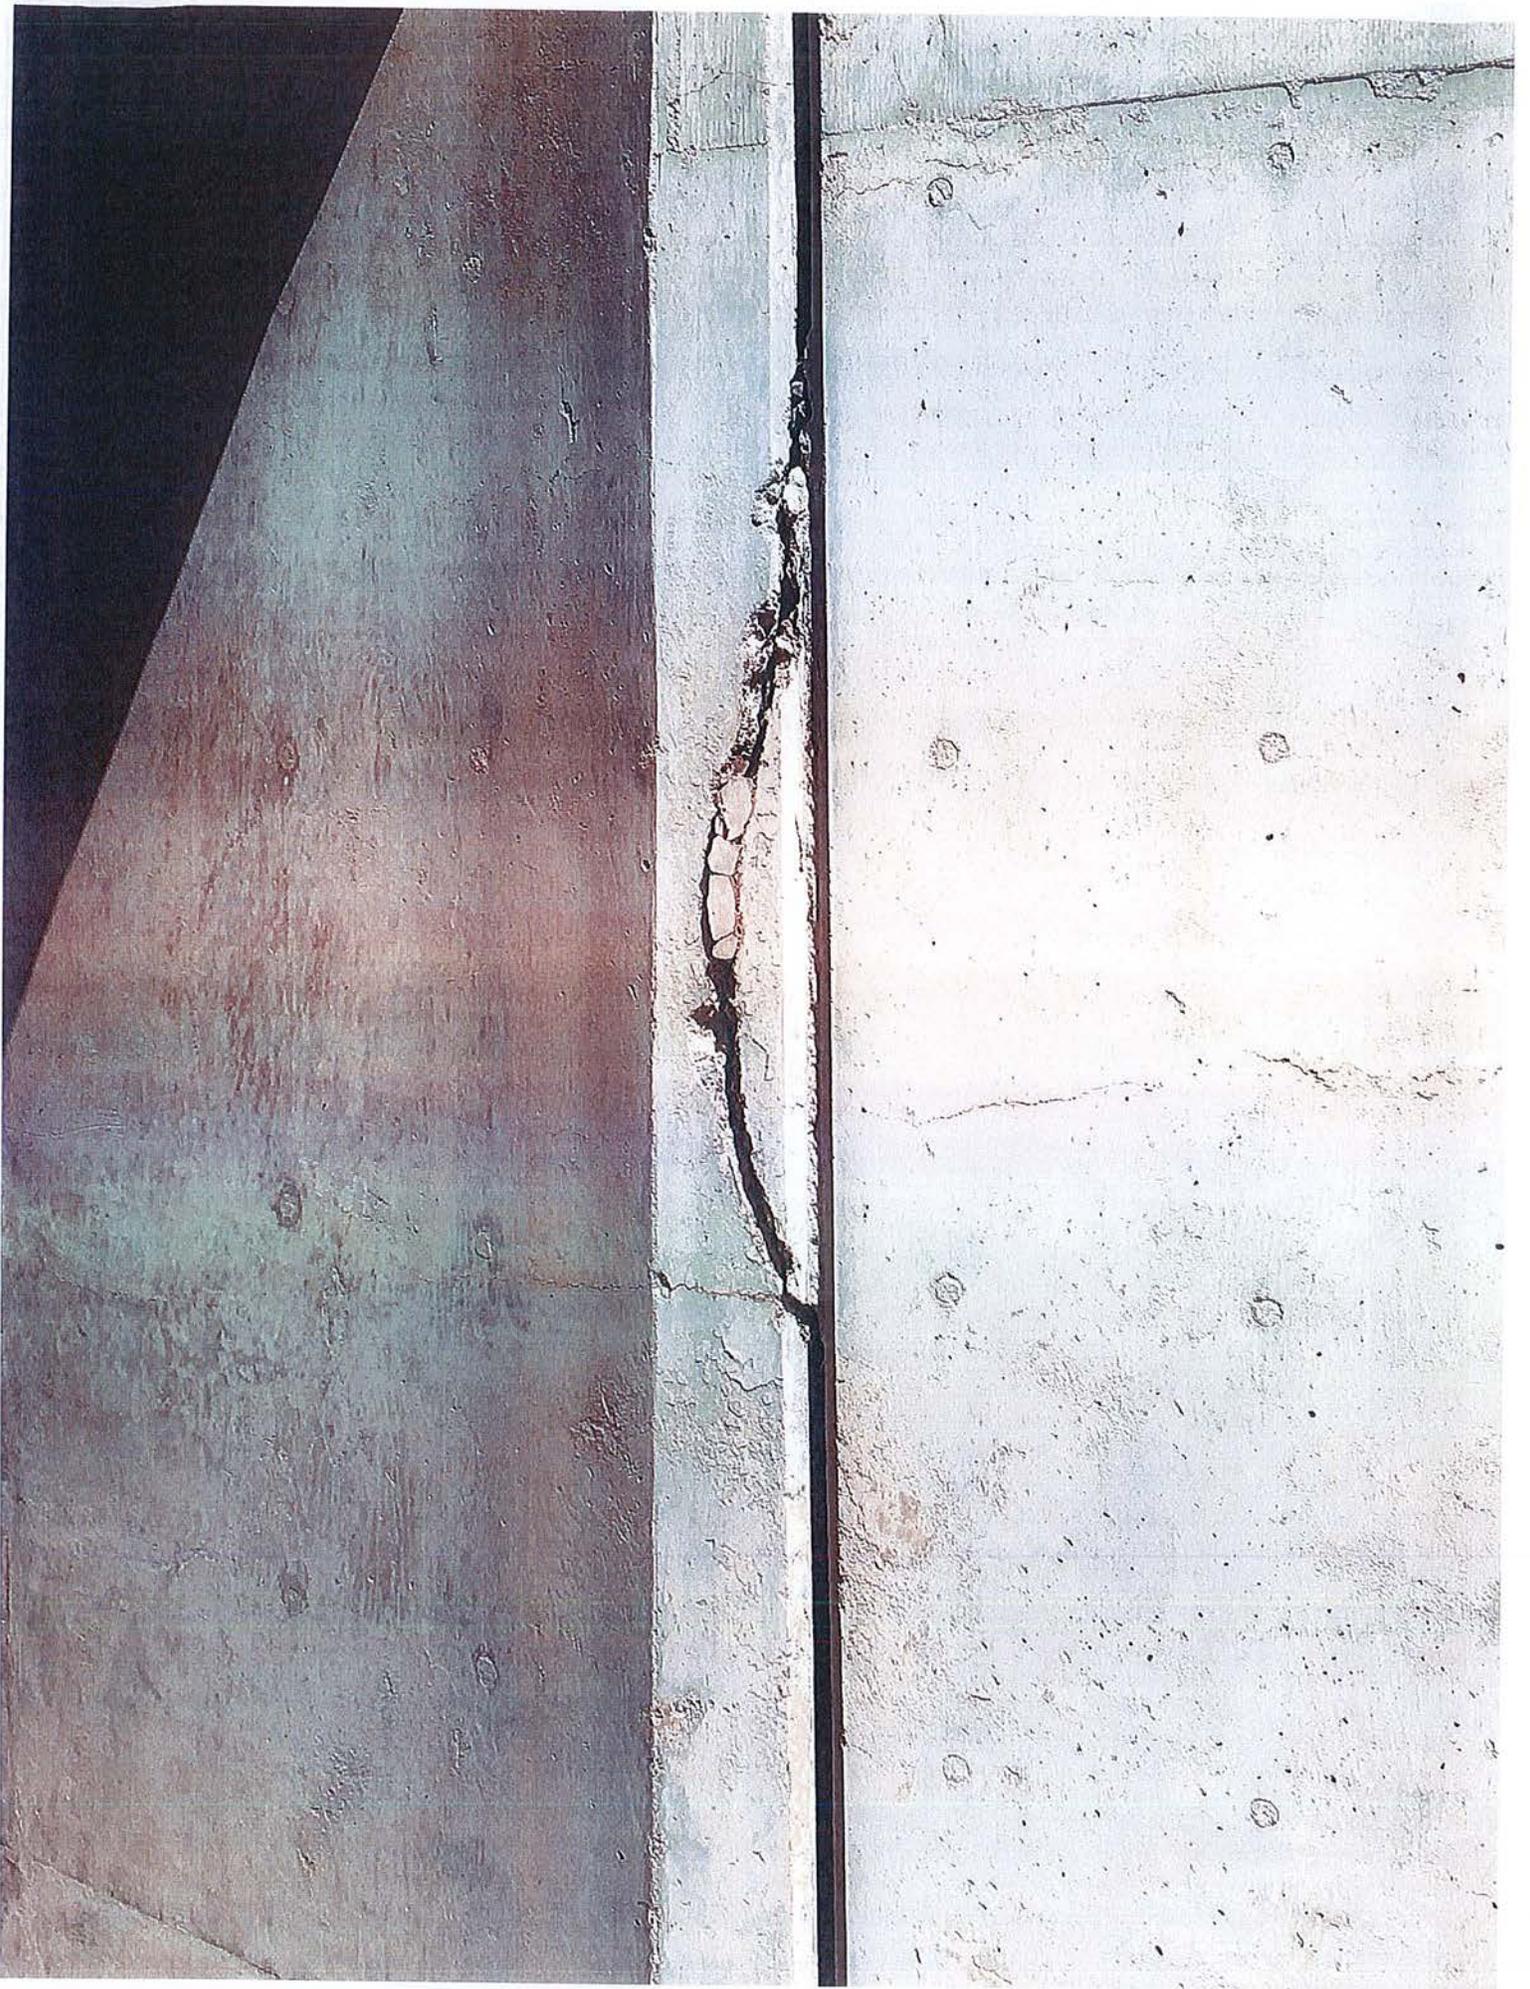
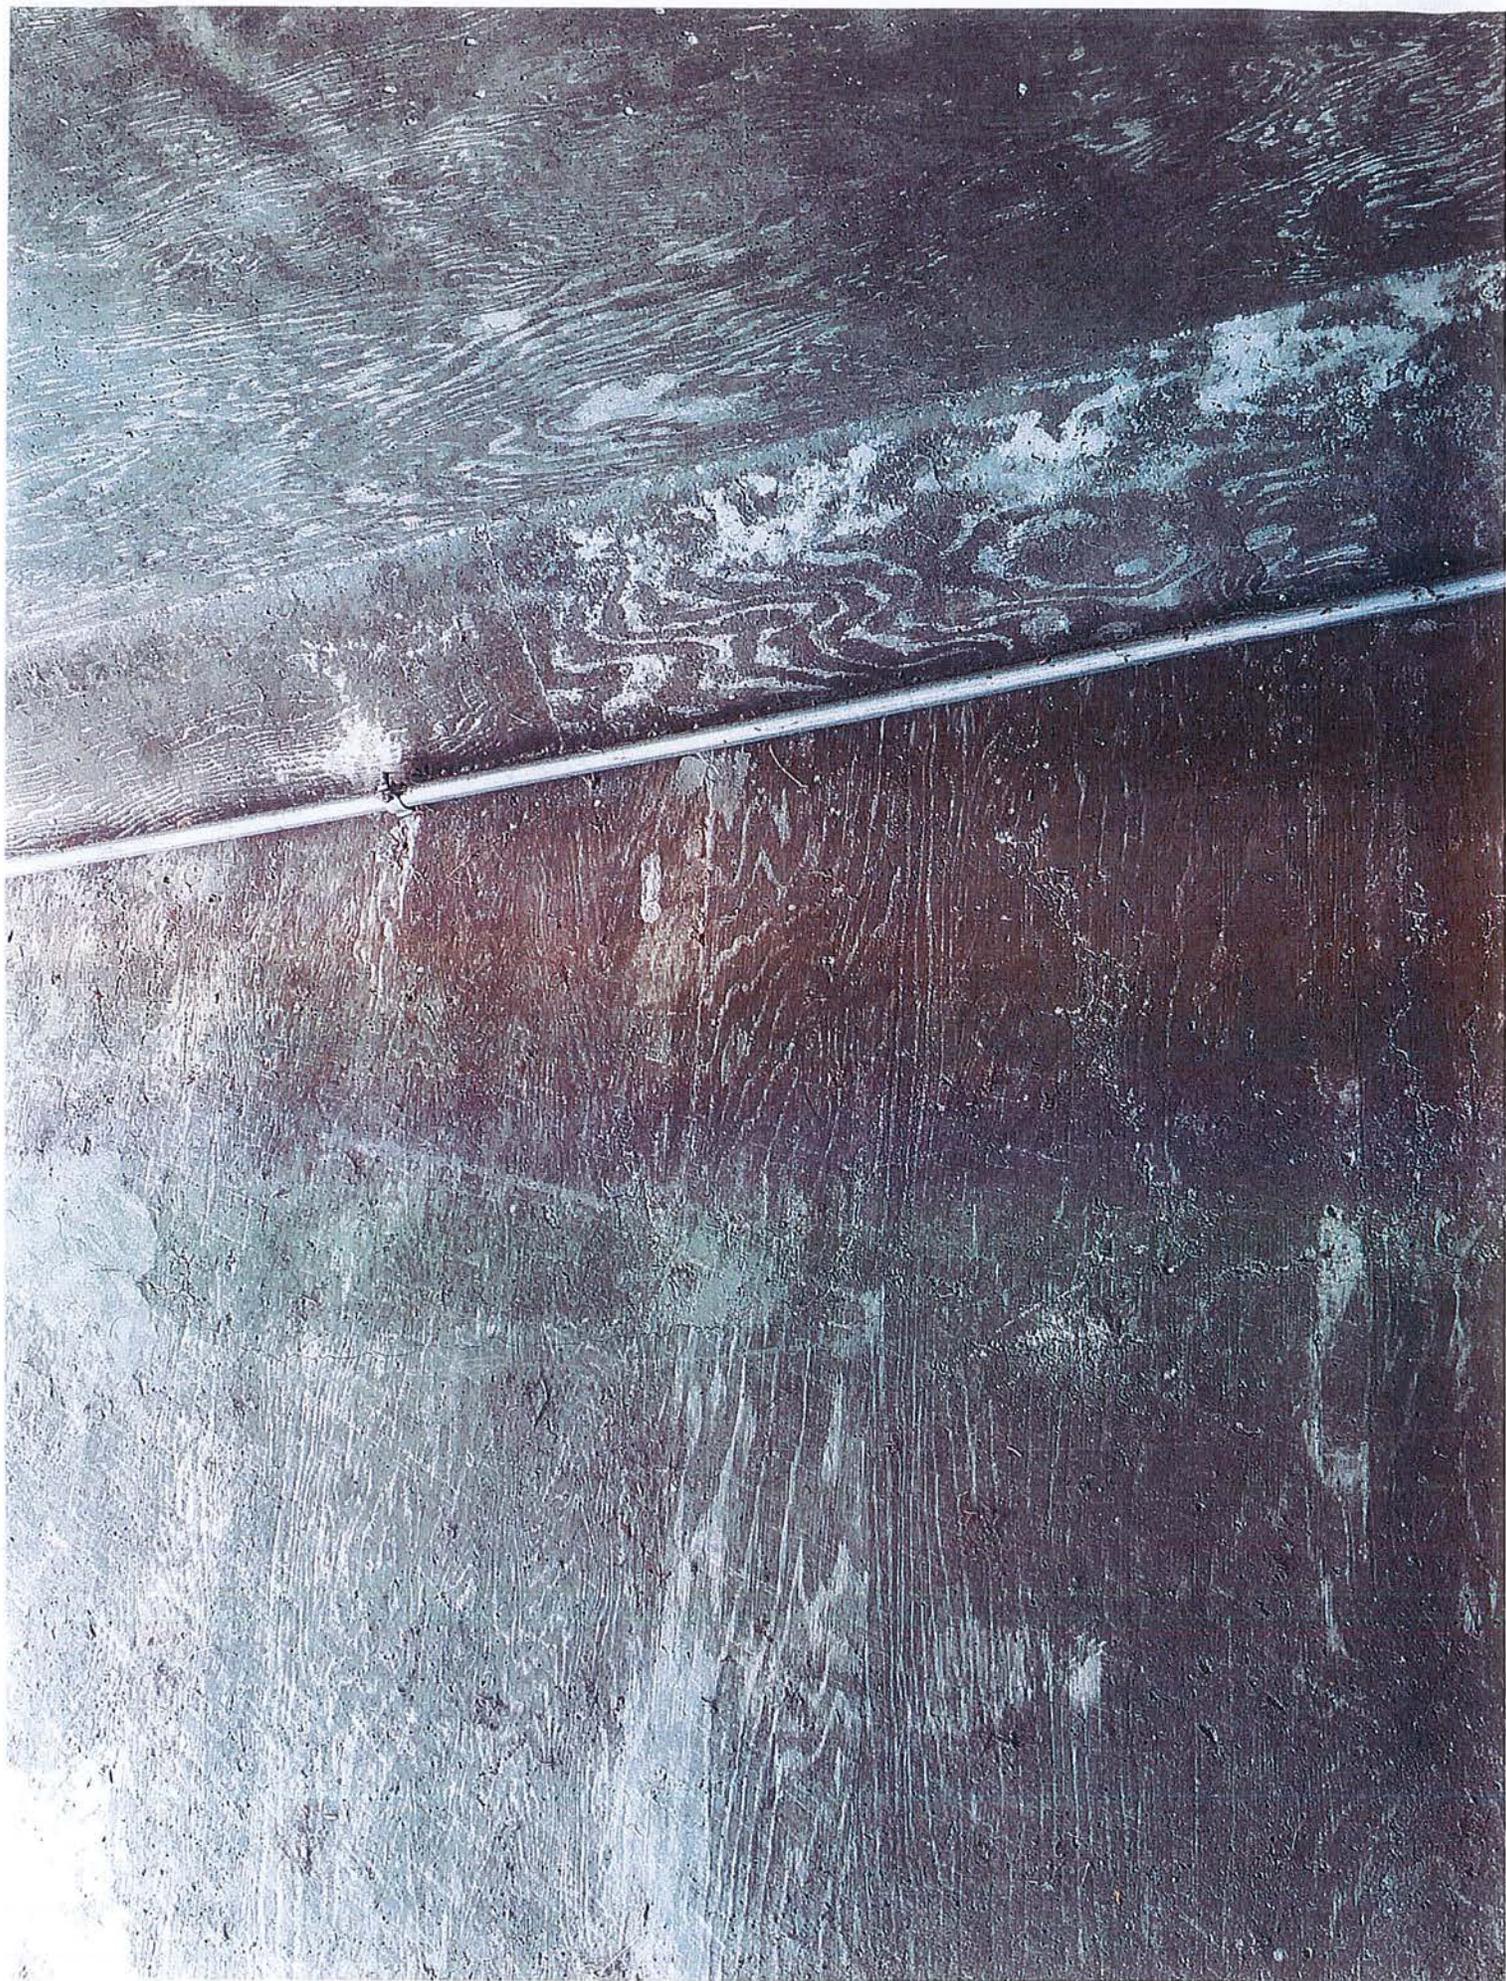
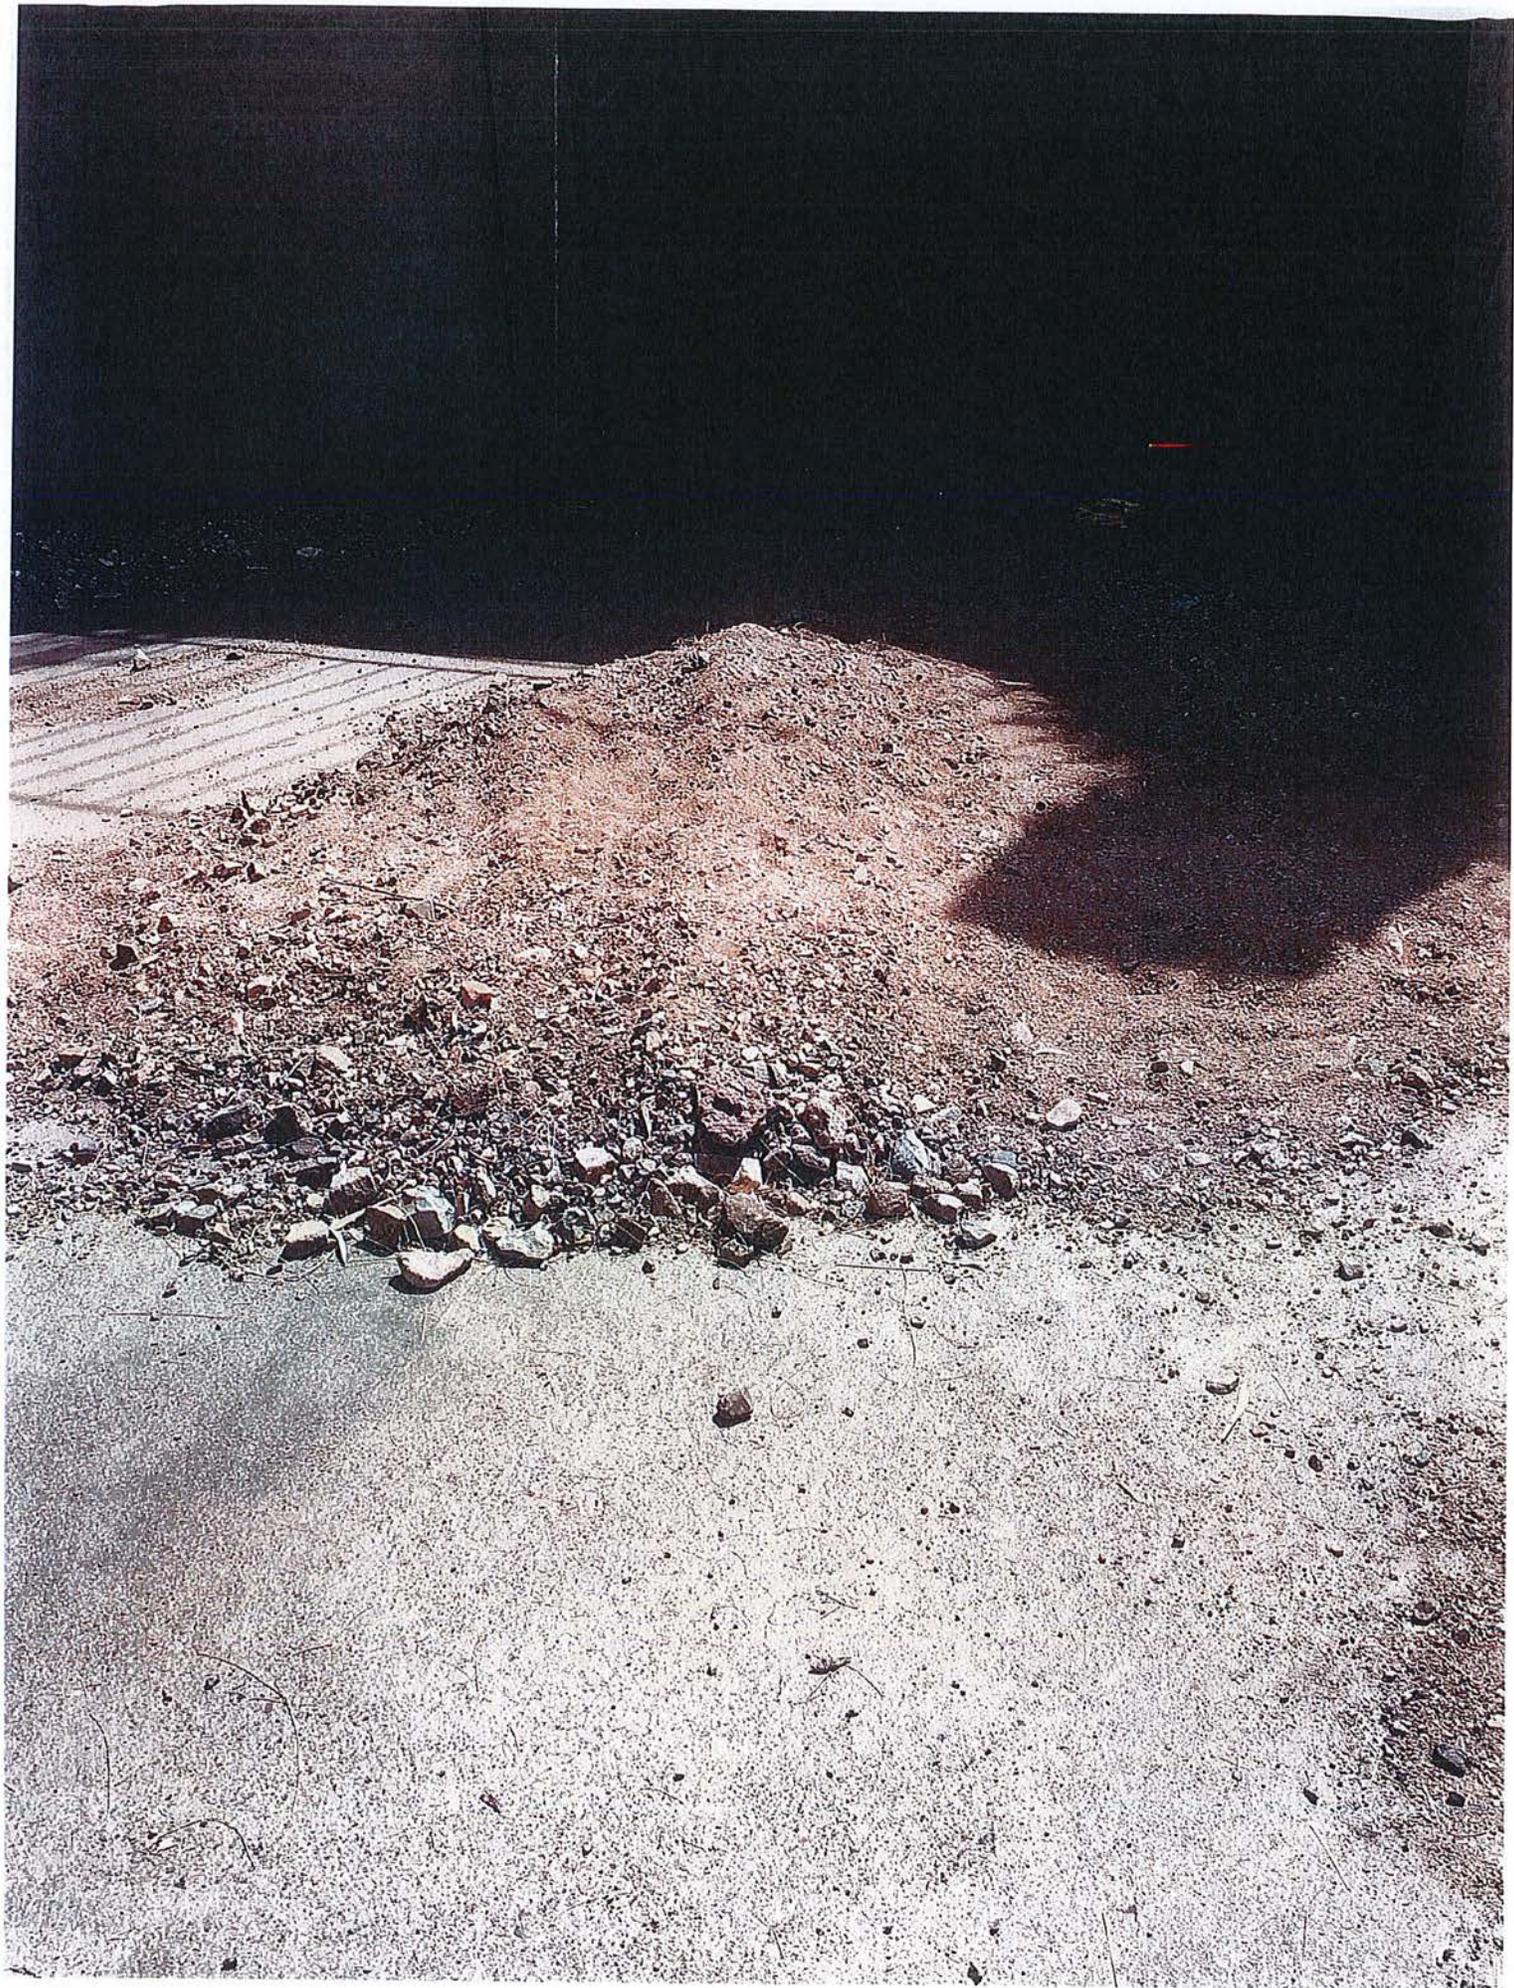
The structure to the northern area of the golf course is a 10x10 reinforced concrete box culvert. There are some cracks with small sections of exposed steel reinforcing at the interface between the headwall and wingwalls. This defect occurs at one location on the west side and one on the east side of the structure. There are also some minor horizontal cracks in a wingwall at the east end of the structure. There are very few, minor vertical shrinkage cracks in the walls of the culvert, and many scattered shrinkage cracks in the floor of the structure. The construction joints are in good condition with no signs of water seepage, efflorescence or corrosion passing through the joints. There is a metal conduit at the top of the interior wall and passes through the entire structure. The structure overall is in good condition and requires little or no repairs or maintenance at this time, except for patching the cracks and exposed reinforcing by the wingwall/headwall interface.

The structure located to the south along Camino del Sol is a two barrel, 10x10 reinforced concrete box culvert. This structure has a couple vertical cracks in the wingwalls on the west entrance, and has very few vertical shrinkage cracks in the walls or cracks in the floor. There is some efflorescence and corrosion present at the construction joints throughout the structure, but there is not active water seepage at this time. The structure overall is in good condition and requires little or no repairs or maintenance at this time. However, the entrance at the west side of this structure has wood planking embedded into earthen areas (fills) with a maximum height of about five feet, and the wooden planks are splitting and many sections have broken and have failed allowing earthen fills to drop out. Additionally, the concrete cart path has many large, scattered cracks, and there is some sediment buildup in the barrels from local drainage activity. These wooden earth retention planks will need to be replaced with some type of soil retention system, and the cart path may require replacement to remove these cracks which could create tripping hazards.

One other general observation is that the asphaltic concrete cart paths at both locations have many scattered, large cracks and potholes. An assessment of the total path system in the golf course would be required to ascertain corrective work. Inspection of the asphalt paving for Camino del Sol above both of these structures show no signs of settlement and that paving is in good condition.

Overall, these two structures are in good condition and will require very little repairs initially, and should not require any longterm maintenance. Please see the attached photos and let me know if you require further action on my part at this time.
