Re: **Technical Reports and Analysis Completed by County Staff Regarding the Canoa Hills Golf Course Proposal**

DATE: March 15, 2018

SUBJECT: Canoa Hills Golf Course – Proposed Donation

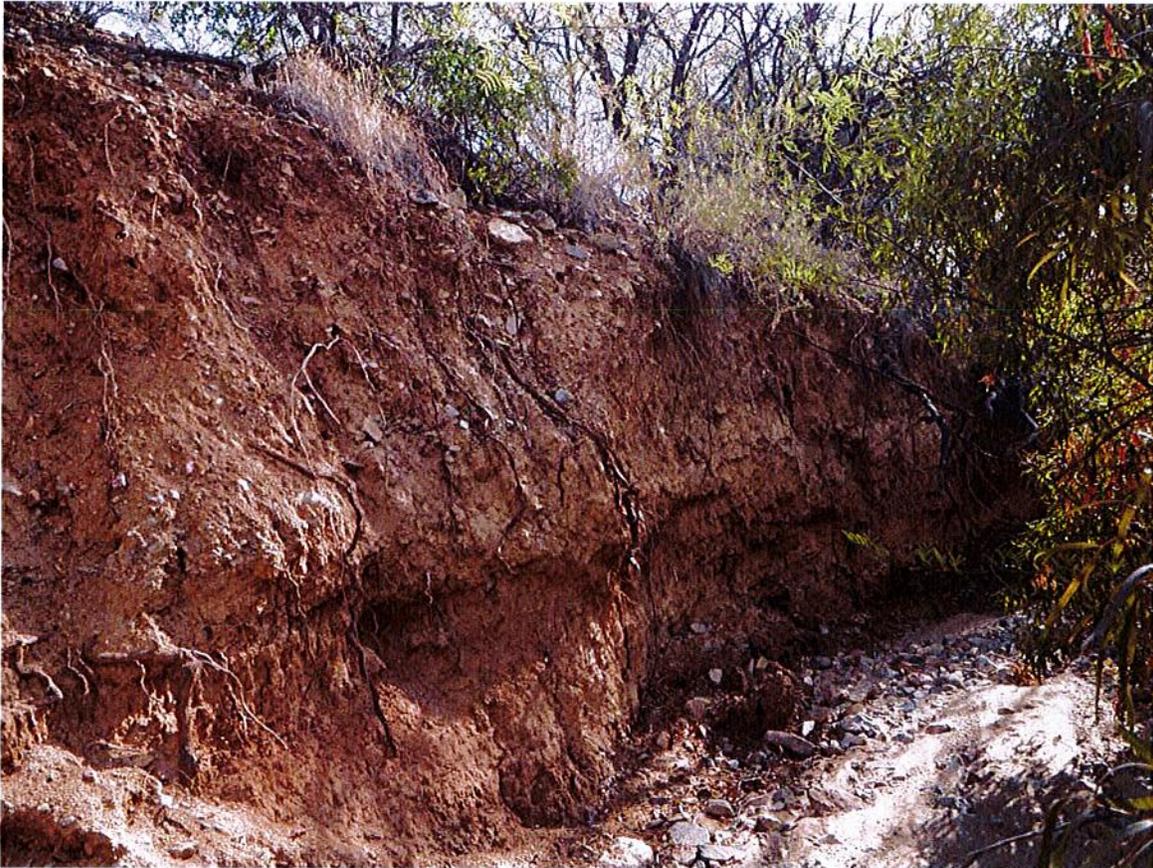
During the 100-year storm event, Drainage Way 1 (Watershed 1) generally inundates the entire fairway, up to the steep slopes coming off the subdivisions. Stormwater will fill the ponds used as water features for the golf course. There is 1-10'x10' concrete box culvert that is under Camino Del Sol which is undersized and model results show the roadway being overtopped. The culvert causes backwater which inundates the club house with up to 1 foot of water. Downstream of Camino Del Sol the channel is reestablished and runs along the north side of the fairway. The channel is a natural sand and rock bottom and has fairly dense vegetated overbanks. During a field visit, significant downcutting was observed and railroad ties used as bank stabilization. In some places banks were more than 6 feet tall. At the downstream end of this drainage way the fairway widens and flows spread. Underneath the I-19 frontage road there are 2-6' corrugated metal pipe culverts, which are also undersized, model results show flow overtopping the frontage road.

Downcutting in Drainage Way 1

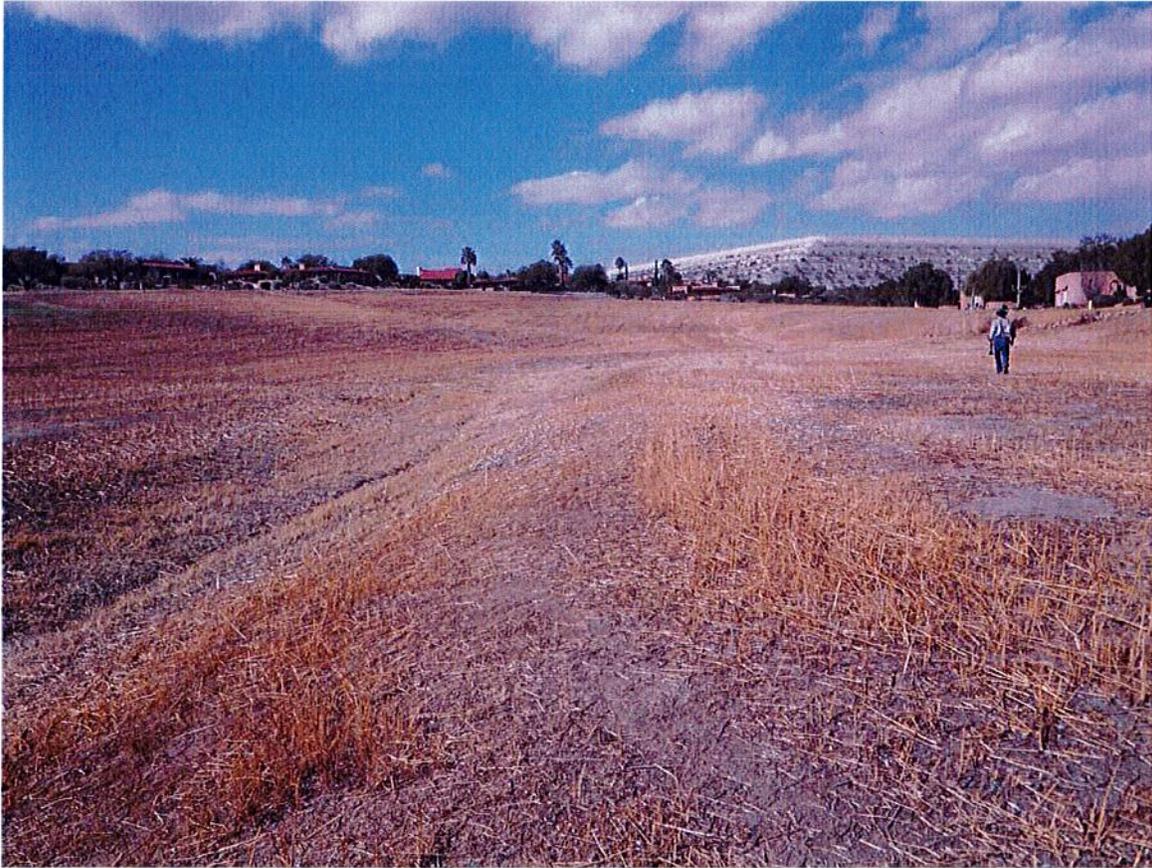
Drainage Way 2 (Watershed 2) originates within the former driving range. The 2-10'x10' concrete box culverts under Camino Del Sol contain the flow 100-year discharge. These culverts are also used as a golf cart path under the roadway. The 100-year floodplain within this drainage way is generally along the low flow area on the north side of the fairway. The floodplain widens and flow depths become deeper downstream as undersized culverts cause backwater. There are 2-4' corrugated metal pipe culverts under Camino Del Pato and 1-5' corrugated metal pipe culvert under the I-19 frontage road. Model results show that both of these roadways are overtopped during the 100-year event.

Driving Range, Headwaters of Drainage Way 2, looking upstream (to the NE)

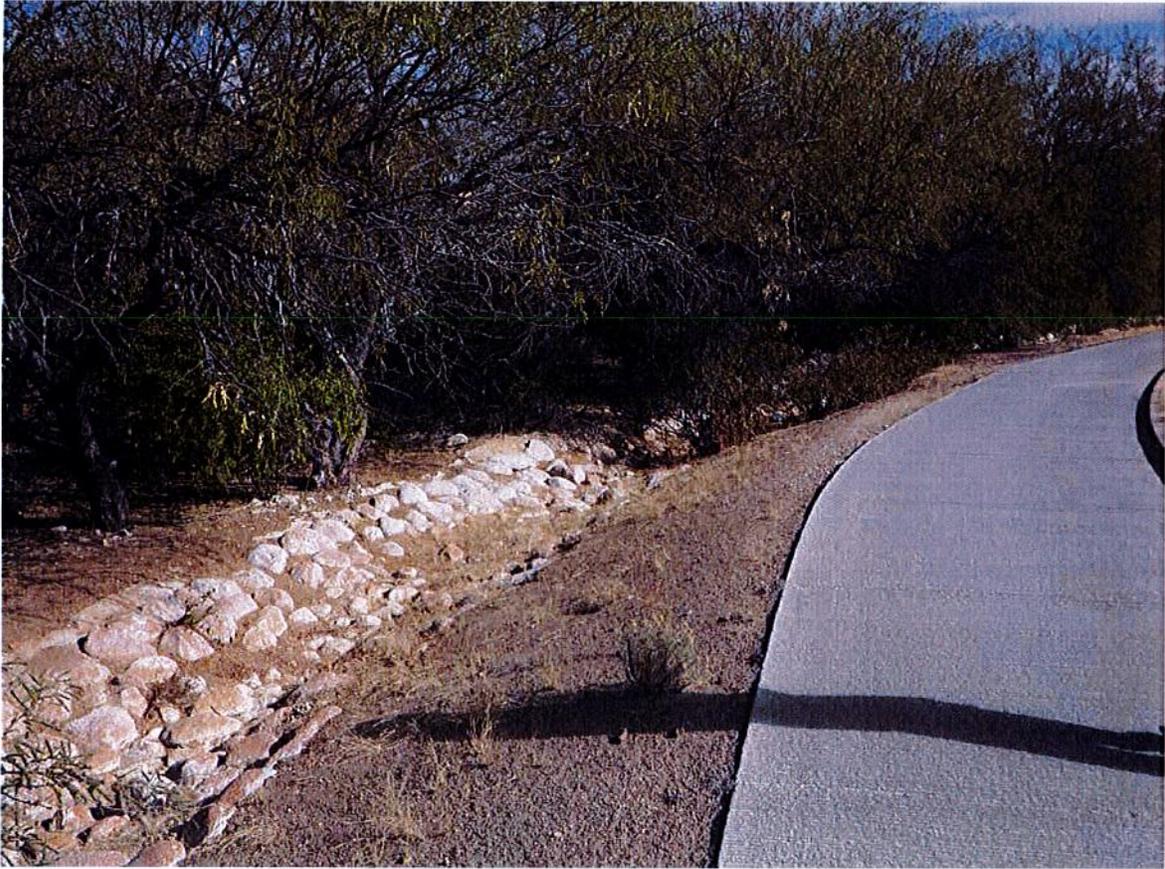
Drainage Way 3 (Watershed 3) is a tributary to Drainage Way 4. Drainage Way 3 begins just upstream of Camino Urbano, where there is 1-30" corrugated metal pipe culvert, which cannot contain the 100-year discharge and does overtop this residential road. However, downstream of Camino Urbano, the fairway provides adequate capacity, leaving much of the fairway outside of the 100-year floodplain. At Camino Del Sol there are 2-48" corrugated metal pipe culverts, which contain the 100-year discharge. Downstream of Camino Del Sol there is a small grouted rock channel that flows downstream about 500 feet then discharges into the golf course green. The confluence of Drainage Way 3 with Drainage Way 4 occurs about 600 feet south of where Via De La Gloria dead-ends.

Gouted Rock Channel, Drainage Way 3

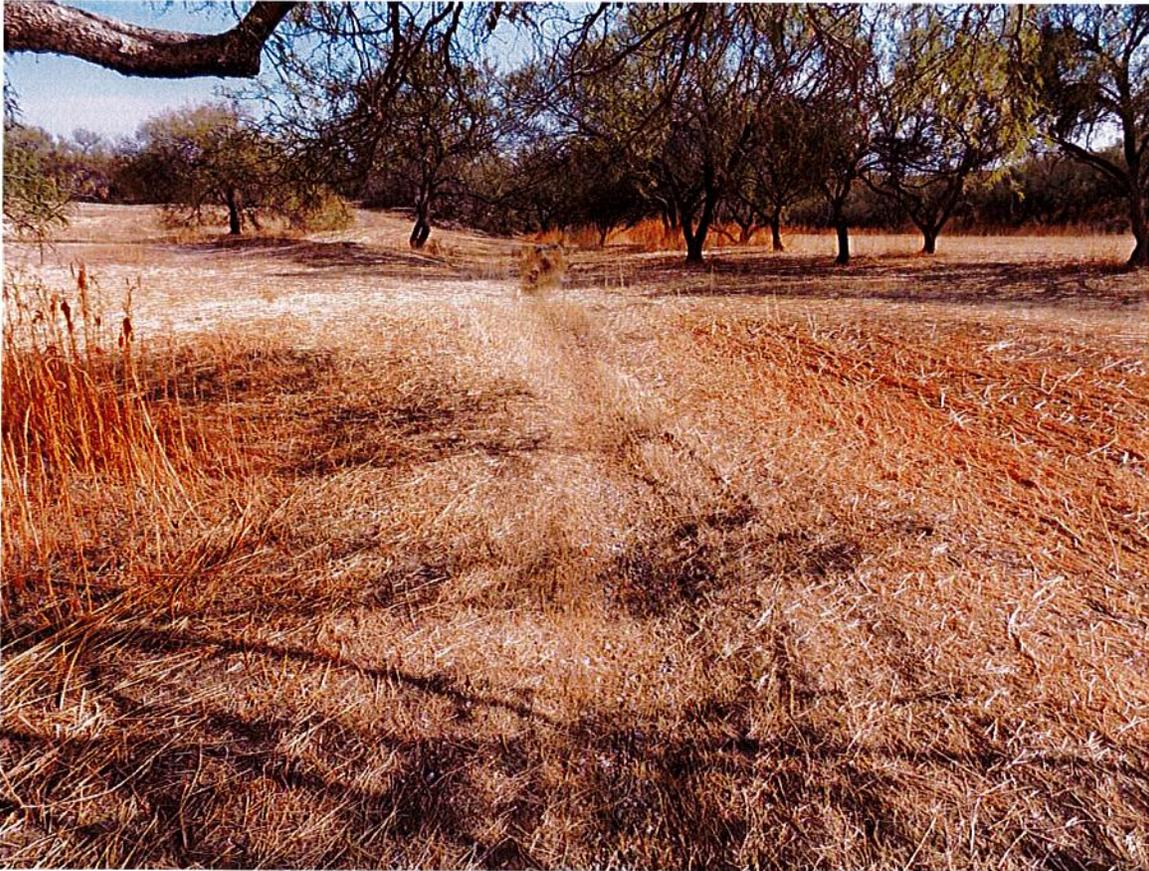
Drainage Way 4, like Drainage Way 1, is generally inundated the entire width of the fairway during the 100-year event. There are 2-10'x5' concrete box culverts at Camino Del Huarache which are undersized and model results show flow going over the road. At Camino Del Sol, flow is constricted through 1-8'x8' concrete box culvert which is also undersized and overtopped during the 100-year event. Downstream of Camino Del Sol and the confluence with Drainage Way 3, flows spread out to fill the fairway, with the exception of small hills along the golf course. At the downstream end of the drainage way, there are 2-10'x6' concrete box culverts under I-19 which contain the 100-year discharge.

Typical Low Flow Path

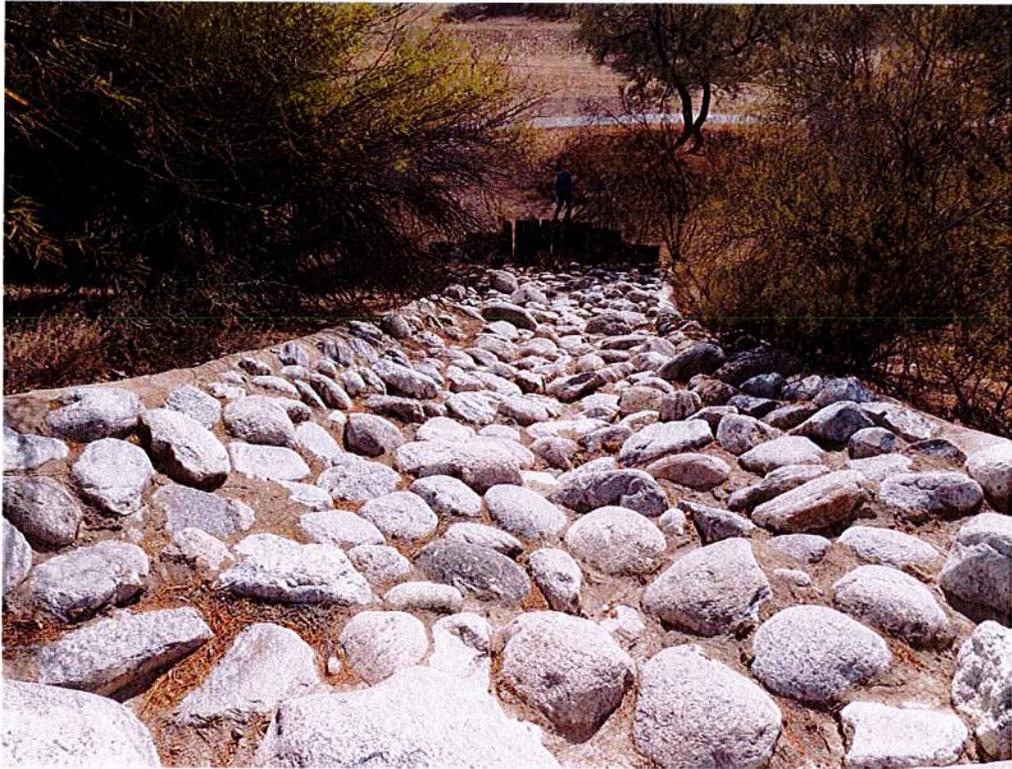
This subdivision drainage infrastructure seems to be functioning properly and constructed well. It is assumed that allowing the subdivision drainage to disperse over the golf course supplemented the irrigation needs of the golf course. Maintenance will be needed downstream of these drainage outlets, as erosion could occur easily with high velocity flows coming off the steep slopes.

Grouted Rock Outlet from Subdivision with Railroad Tie Dissipater at Downstream End

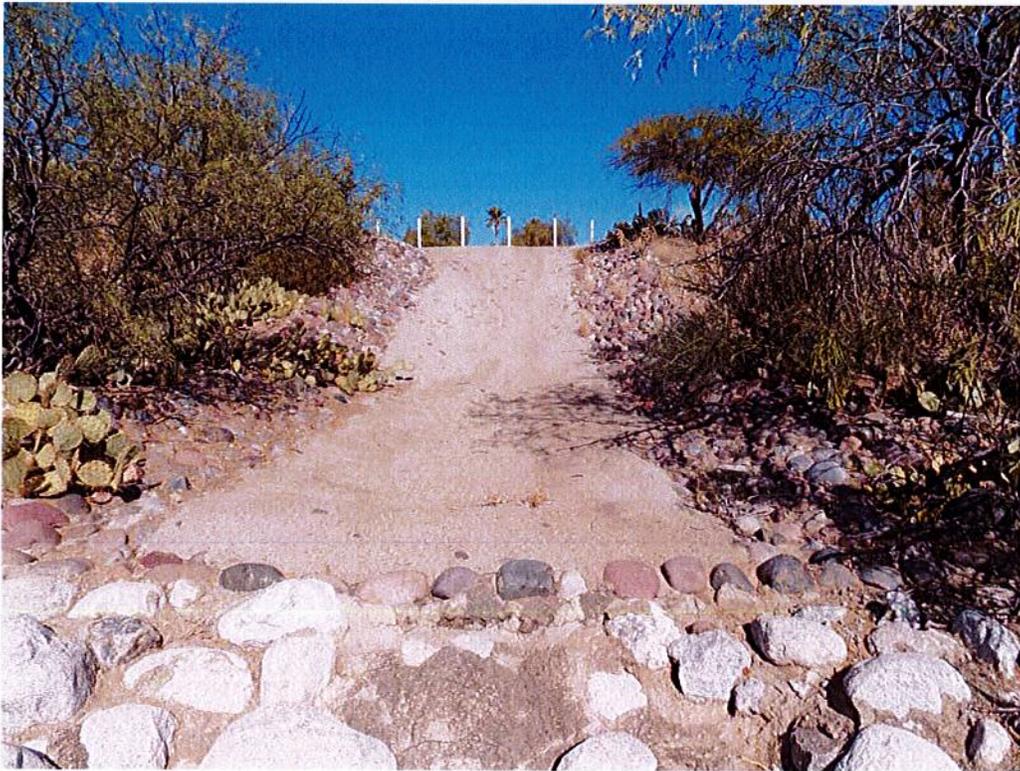
Concrete Paved Outlet from Subdivision with Grouted Rock at Downstream End

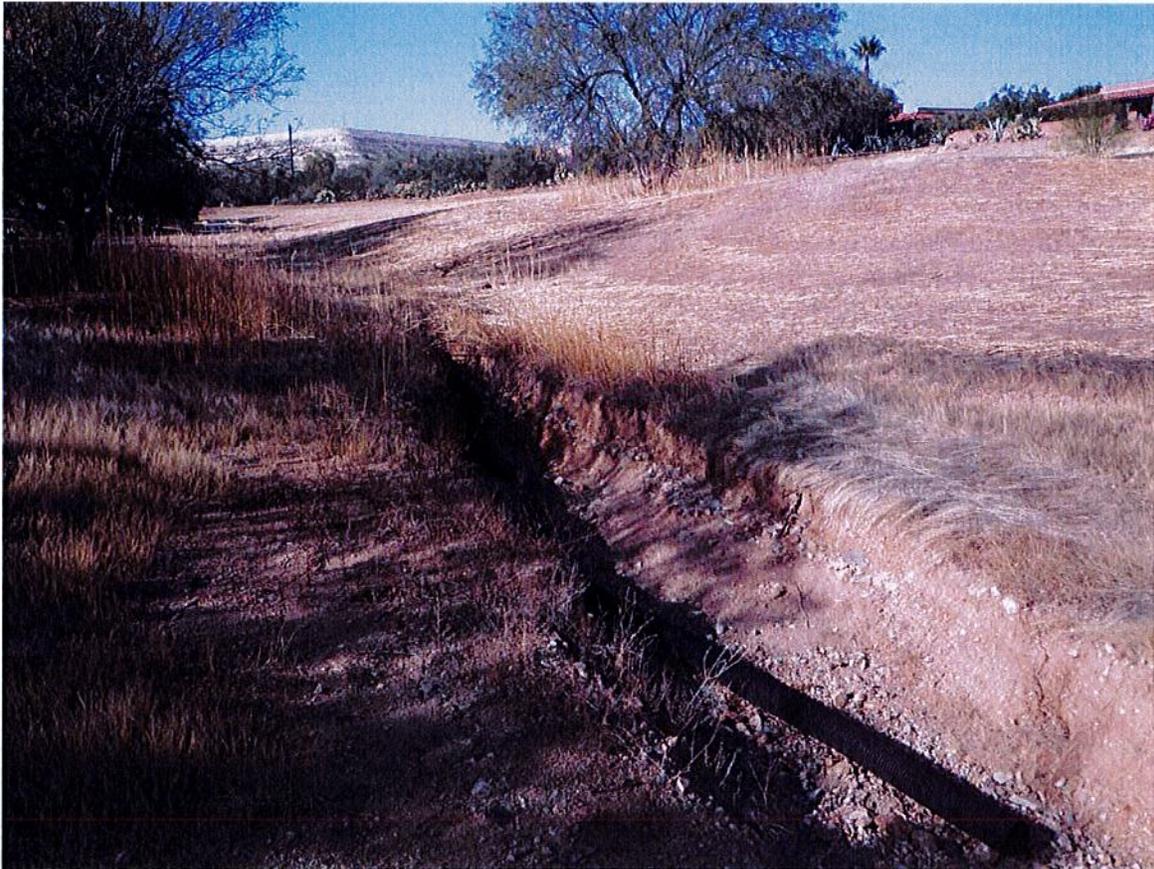
Without maintenance of the fairways for the last few years, the low areas of the fairways have begun to erode and develop small channels. In many places, this erosion has exposed corrugated plastic drain piping (approximately 6 inches in diameter). This piping was installed about 6 inches below ground in the low areas of the fairway, presumably to prevent the fairways from becoming water-logged during Monsoons. In addition, at a few locations channels are beginning to reestablish adjacent to the golf cart paths and eroding underneath the path. A byproduct of the erosion is sedimentation, which was also witnessed along the path.

Erosion Reestablishing Channel, Exposed Piping

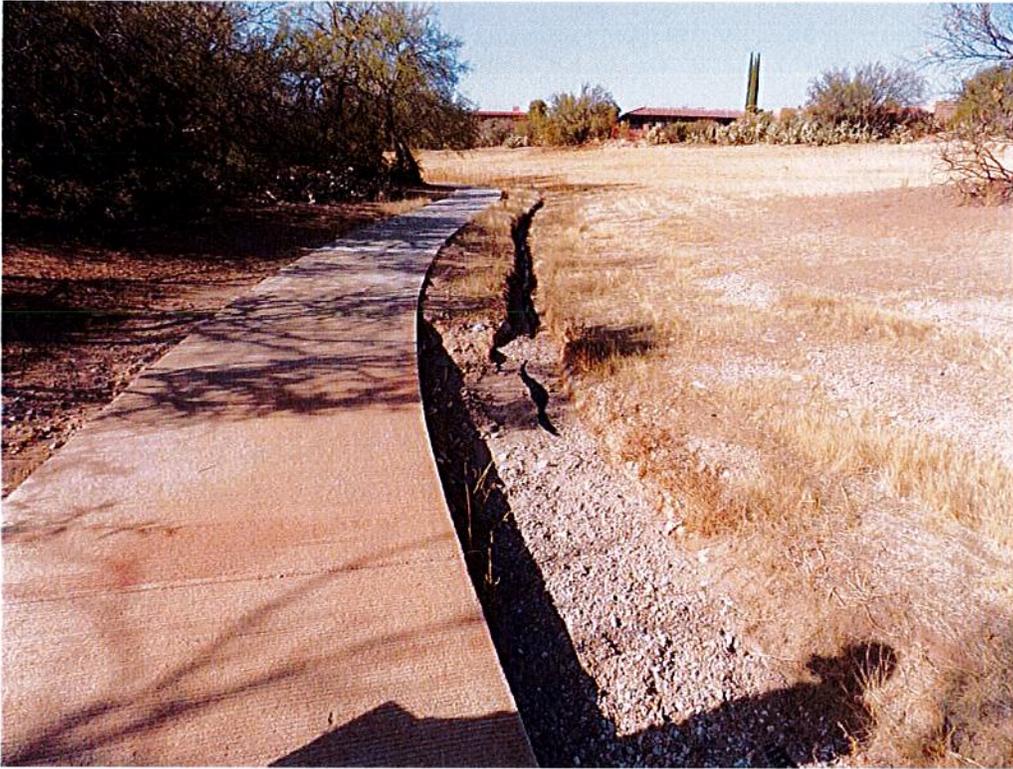
Erosion along Golf Cart Path, Exposed Piping

- Golf Cart Path. Address erosion repairs, sediment removal, vegetation and tree trimming, and safety improvements including handrails where necessary;

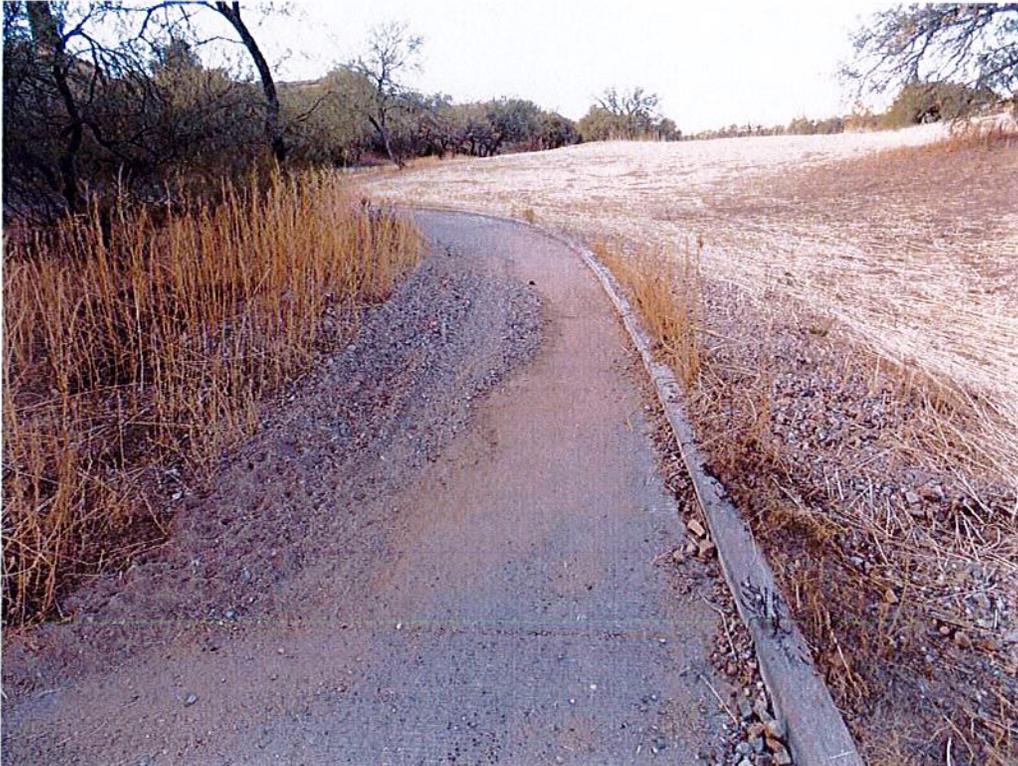
Sedimentation along Golf Cart Path

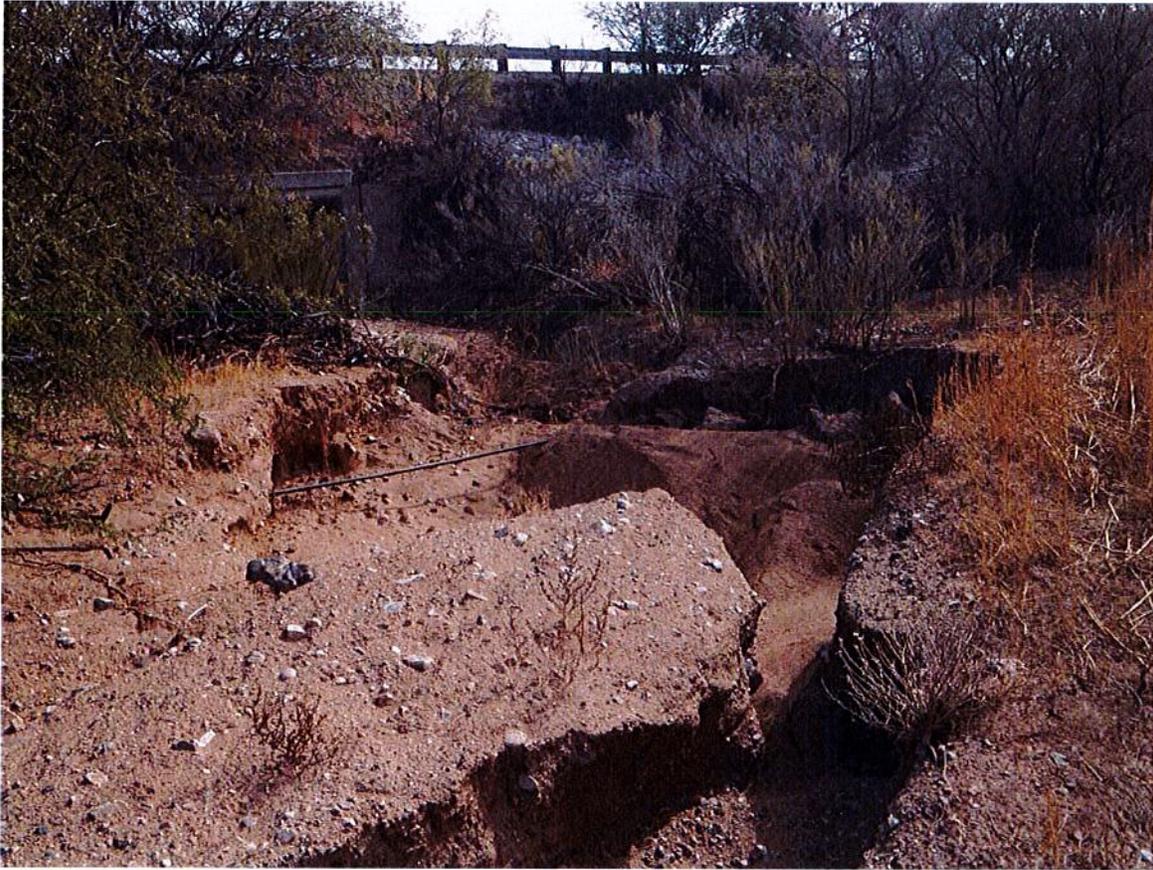
Erosion Upstream of Culvert at I-19 Frontage Road

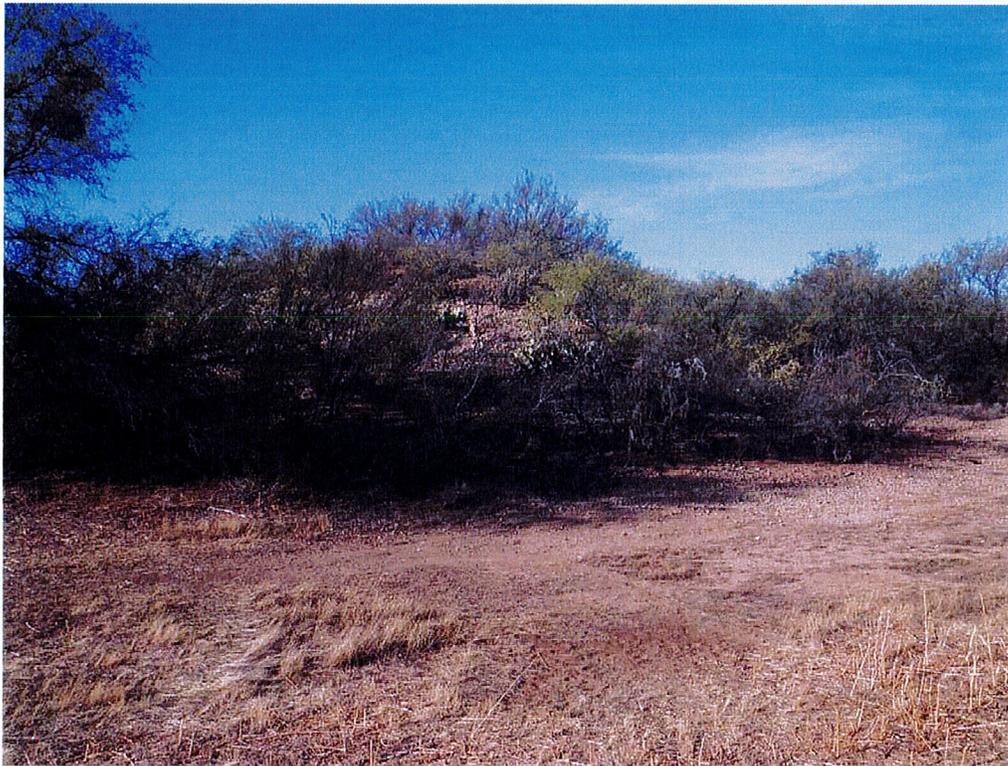
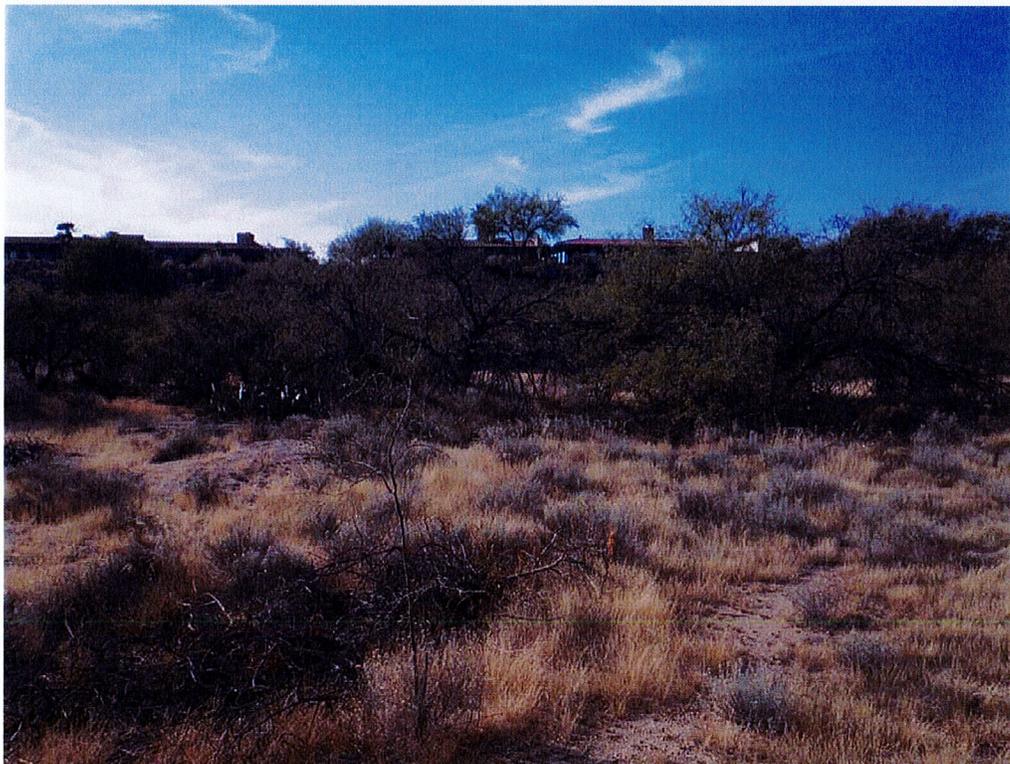
Vegetation communities outside of the constructed course were mostly preserved in place (see Photos 1 and 2) and contain large remnant patches of native vegetation that support a diverse array of species (Table 1 – Existing Plant List). Generally, these areas are topographically higher than the golf course and would provide a local source of native seed over time.

Photo 1. Sonoran Desert Scrub plant community preserved in place.

Photo 2. Semidesert Grassland plant community preserved in place.

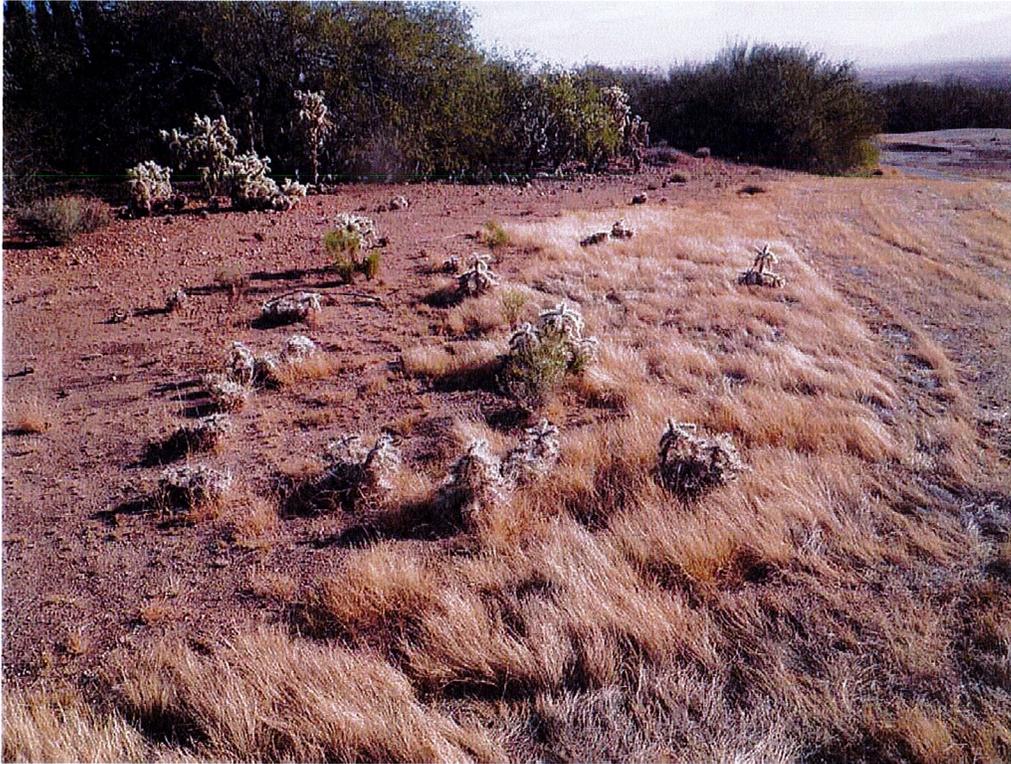
While there is an abundant seed source nearby, staff observed minimal recruitment of native perennial plants on the golf course with the exception of a small patch of Cholla cactus and mesquite trees (photos 3 and 4), although it is very likely the mesquite trees are hybridized.

Photo 3. Cholla Cactus Recruitment

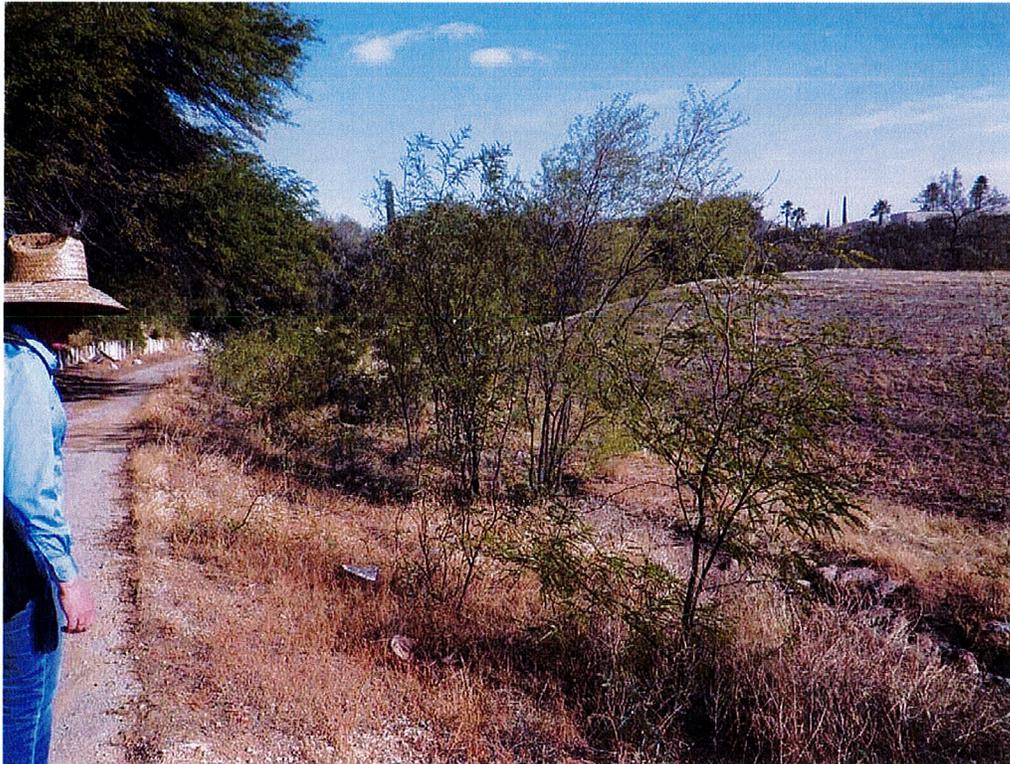
Photo 4. Mesquite Tree Recruitment

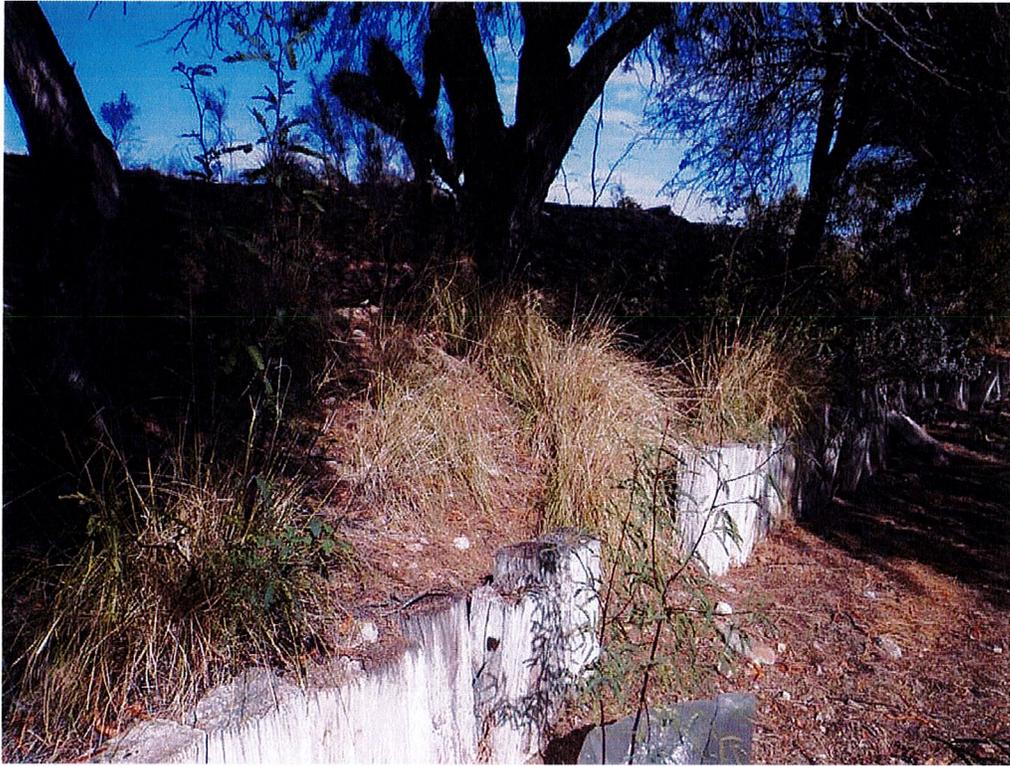
Staff observed several locations along the path where non-native species have been intentionally planted including the non-native invasive Fountaingrass (Photo 5). We also found patches of various annual and perennial non-native invasive species throughout the site, either along the edge of the golf course or within the preserved in place plant communities (Table 1). The bulk of the perimeter edge of the golf course is residential landscape. Proximity to these residential landscapes could lead to a potential source of seed both native and non-native.

Photo 5. Landscaped area containing Fountaingrass.

1. Map and remove non-native invasive species. Methods to remove invasive species may include mechanical, chemical or biological. Staff recommends solarization to treat the few patches of Bermuda grass.

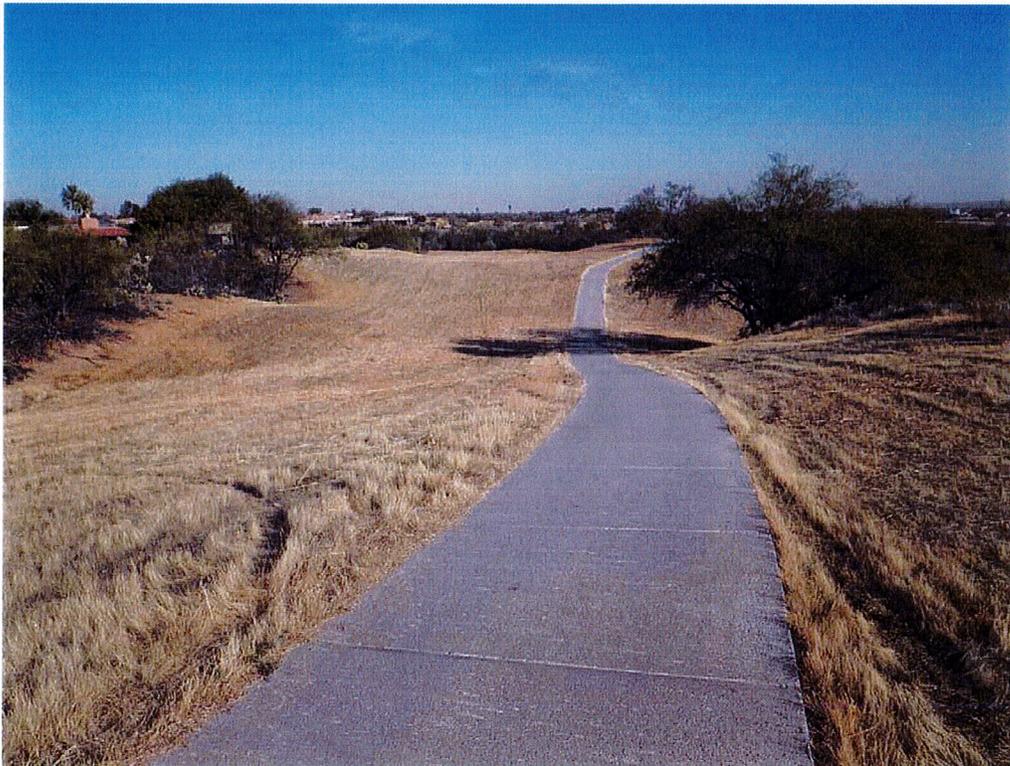
Land cover Class 1, retired golf course converting to an annual native plant community with low species richness. This class consists of large patches of either Palmer's amaranth, or annual native grasses, primarily needle grama (*Bouteloua aristidoides*) and sixweeks threeawn (*Aristida adscensionis*), which are typically the first species to colonize a disturbed area. An occasional subshrub or forb/herb was observed, but these areas appear mostly homogenous including just a few species.

Photo 6. Retired golf course converting to annual native grasses.

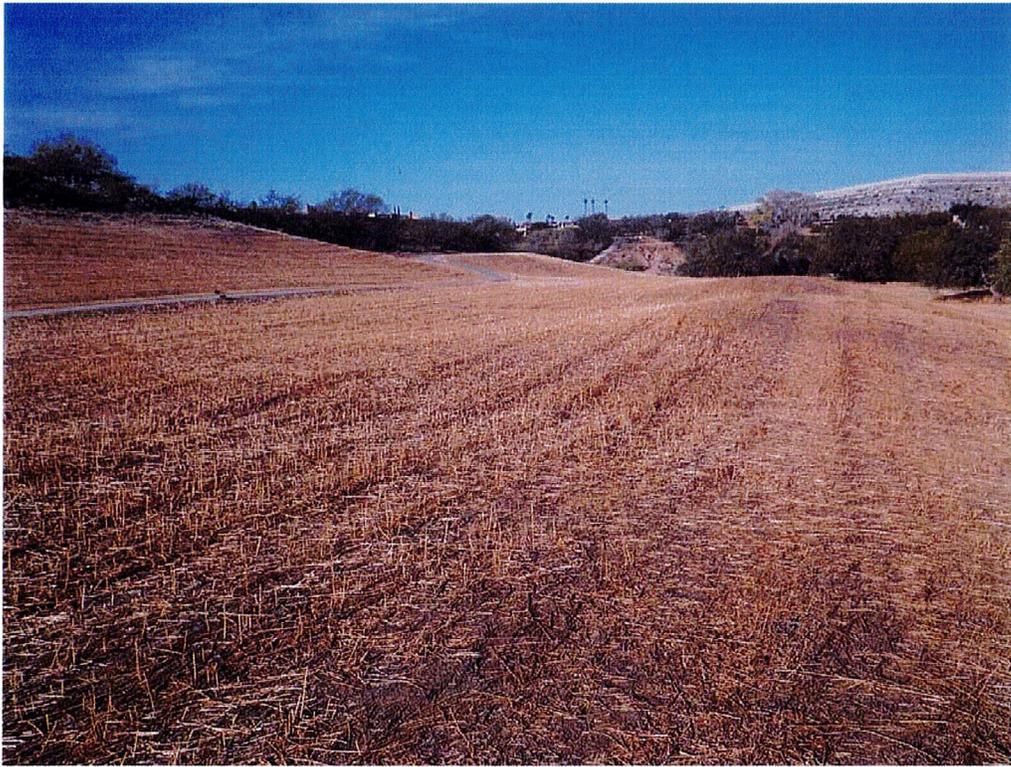
Photo 7. Retired golf course converting to Palmer's Amaranth

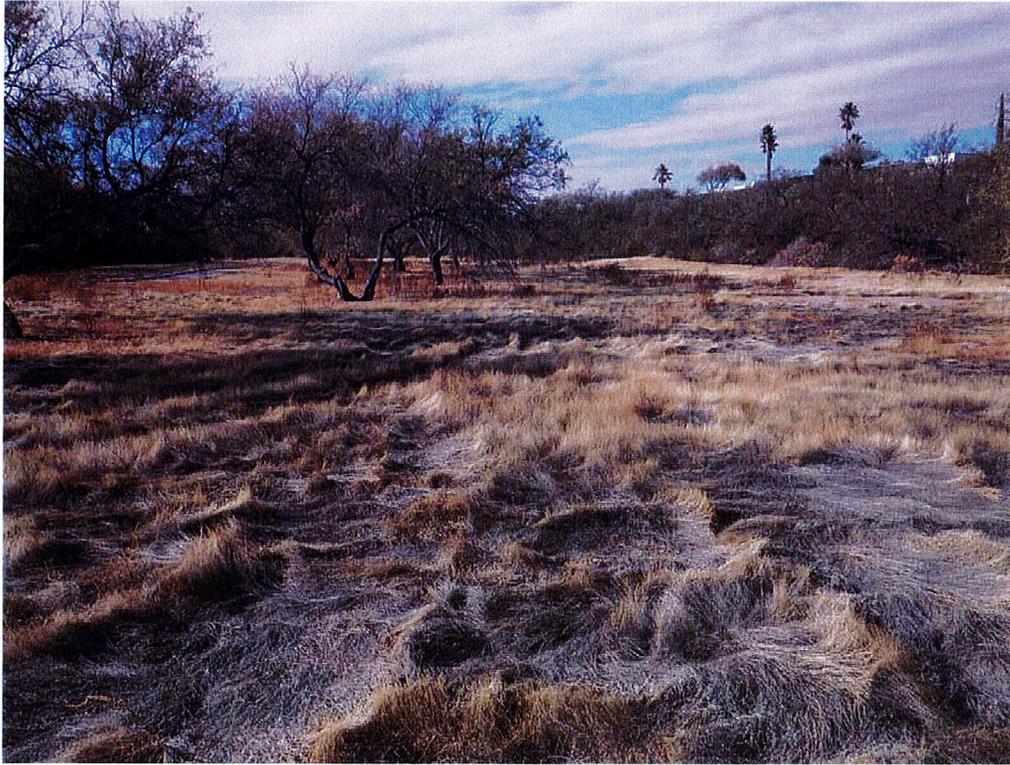
Land cover Class 2, native trees preserved in place with understory in the process of converting to an annual native plant community. This class contains primarily mature velvet mesquite (*Prosopis velutina*) trees with an understory of either Palmer's amaranth or annual native grasses. The understory plant community is similar to Class 1 with a slightly higher plant species richness that includes perennial shrubs. The increased species richness is likely due to tree shading, cycling of nutrients and possibly reduced disturbance.

Photo 8. Land cover Class 2; native trees preserved in place with native understory.

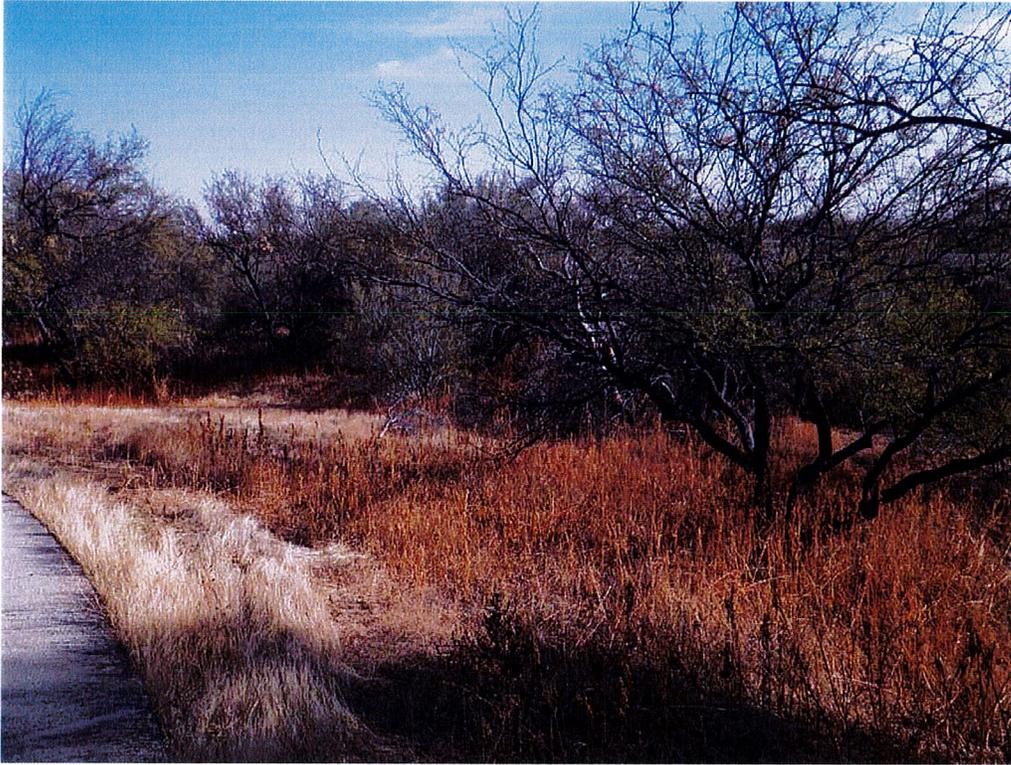
Land cover Class 3, Native plant communities preserved in place. Varying topography throughout the site supports three separate plant communities including Sonoran Desertscrub, Semidesert grassland, and Xeroriparian habitat. The Sonoran Desertscrub is located on the hilltops and slopes (Photo 1), Semidesert grassland (Photo 2) is between the base of slopes and floodplain/riparian areas, and Xeroriparian habitat (Photo 9) is along the wash corridors and areas of ponding. These remnant habitat fragments provide resources for native animals, birds and insects. Native plant communities that have been preserved in place could provide a seed source for plant recruitment or for collection and growth at the Native Plant Nursery.

Photo 9. Example of a Xeroriparian habitat preserved in place.

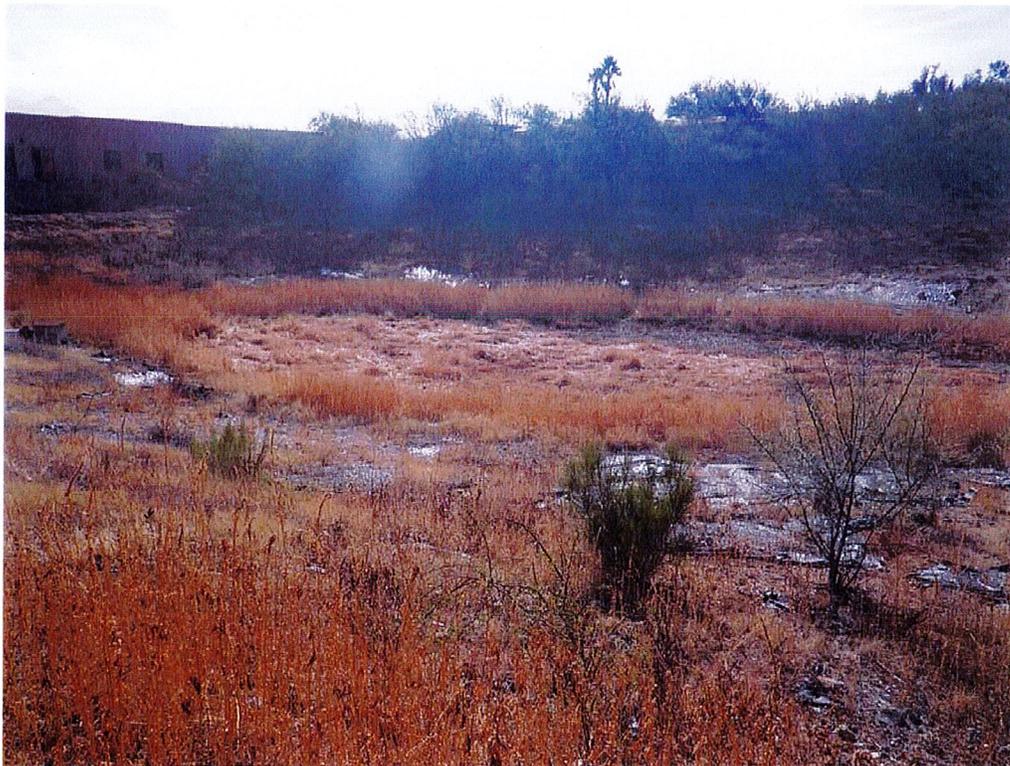
Land cover Class 4, former ponds. The former ponds are low depressions on the landscape that collect water during storm events and support vegetation that tolerates periodic inundation. Vegetation in the ponds consists mostly of non-native invasive species such as Bermuda grass and tamarisk, and the weedy native Palmer's amaranth. Also present was the native perennial Desertbroom (*Baccharis sarothroides*), a common pioneer species on disturbed soils. We did observe one partially dead Gooding's willow tree, a remnant from when the ponds held water. At two of the ponds, we observed a torn and exposed liner, which may indicate the ponds no longer hold water for extended periods.

Photo 10. Example of land cover Class 4; area was former pond.

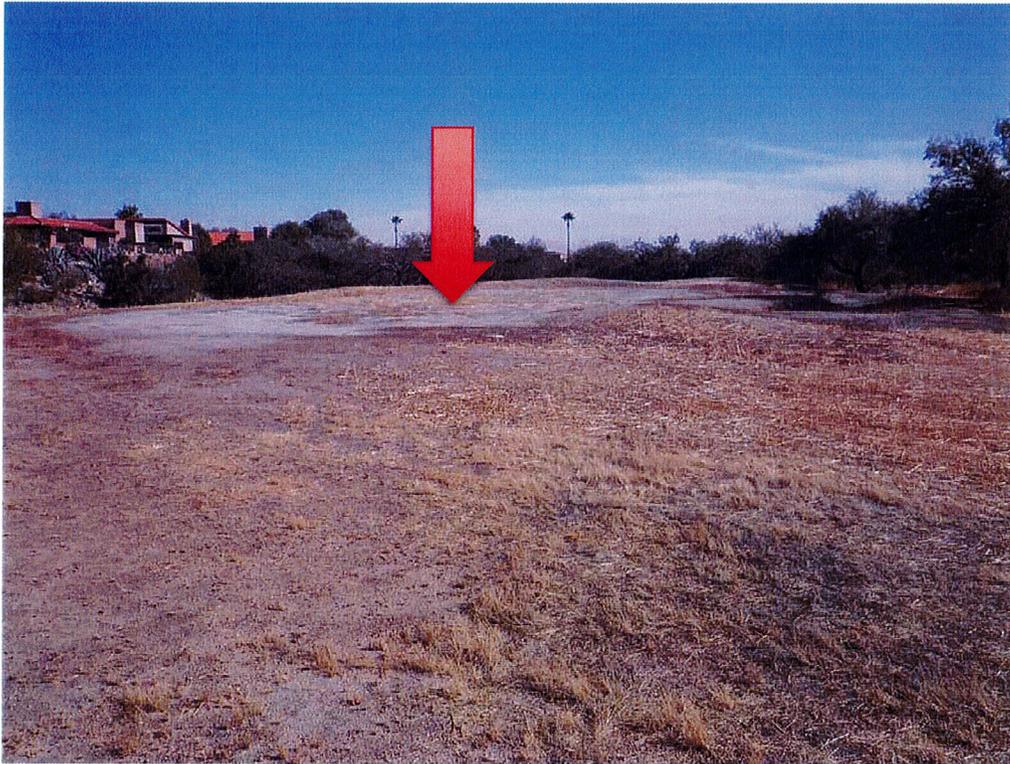
Land cover Class 5, denuded areas including sand traps and tee boxes. There was very little vegetation growing in these areas, possibly due to a soil fertility issue from lack of organic matter present. These areas contained coarse sand and it is possible the soil was compacted when originally constructed.

Photo 11. Land cover Class 5, Sand Trap

2. Identify soil fertility problems and improve problem areas with soil amendments. The highly disturbed nature of golf courses from long-term management actions such as excessive irrigation, soil amendments, etc., may have modified native soils by increasing soil salinity, leaching out soil minerals, or other adverse effects. As such, staff recommends soil fertility testing prior to undertaking restoration and amending problem areas, if needed.

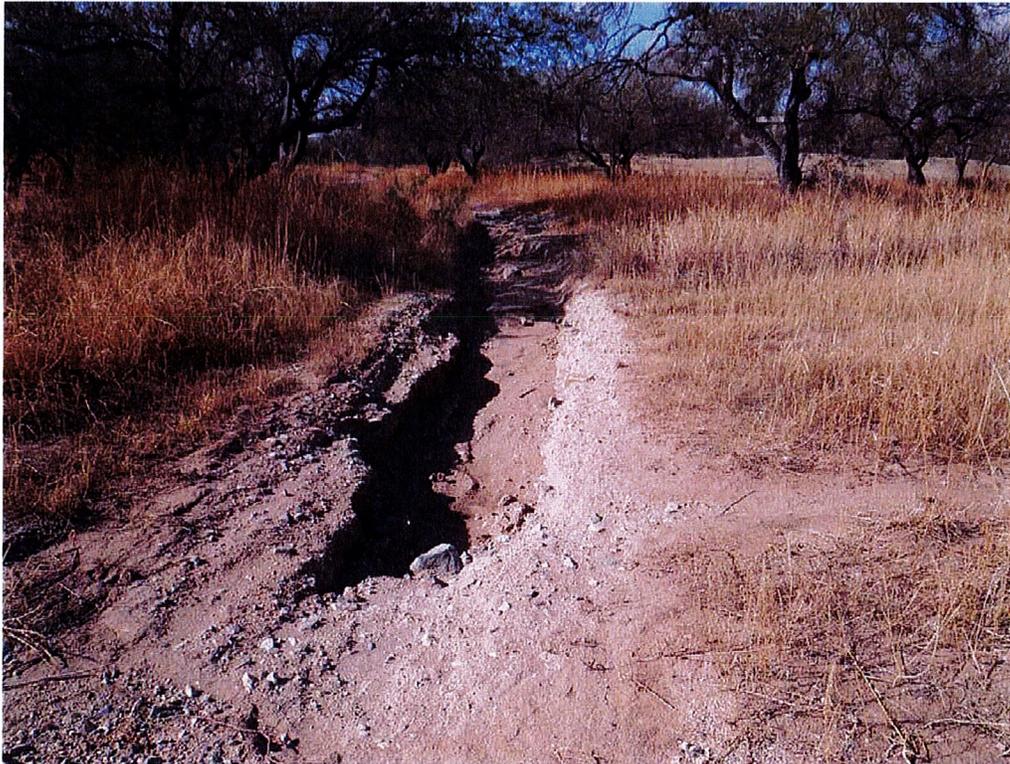
While the disturbed areas contained low species richness, it was promising to find native plants have successfully re-established on their own. Land cover Class 5, sand traps and tee boxes, contained very little vegetation, which may be due to a soil fertility issue. Staff recommends testing soil fertility prior to undertaking restoration efforts. We also observed several areas of active erosion, primarily headcuts along drainage swales (Photo 12).

Photo 12. Headcut with Active Erosion

4. Use natural channel design techniques (one-rock dams, media lunas, and rock rundowns) to slow and infiltrate stormwater and mitigate erosion.
5. Increase species richness by planting native plants using both container plants and seed mix. Staff recommends a plant palette (Tables 2 and 3) modified from the Canoa Ranch restoration project plant list. Additional actions to help achieve this goal include reducing the amount of Palmer's amaranth during the active growing season using chemical and/or mechanical means and considering the site's topographic variability when installing container plants to locate in areas where they will most likely succeed.
