MEMORANDUM

Re: **Santa Cruz River Sedimentation**

From: Andy Dinauer
Sent: Friday, March 23, 2018 10:55 AM
To: Chuck Huckelberry <Chuck.Huckelberry@pima.gov>; Carmine DeBonis <Carmine.DeBonis@pima.gov>
Cc: Suzanne Shields <Suzanne.Shields@pima.gov>; Eric Shepp <Eric.Shepp@pima.gov>
Subject: Caterpillar Storm Drain Outlet vrs Santa Cruz River Sedimentatioin

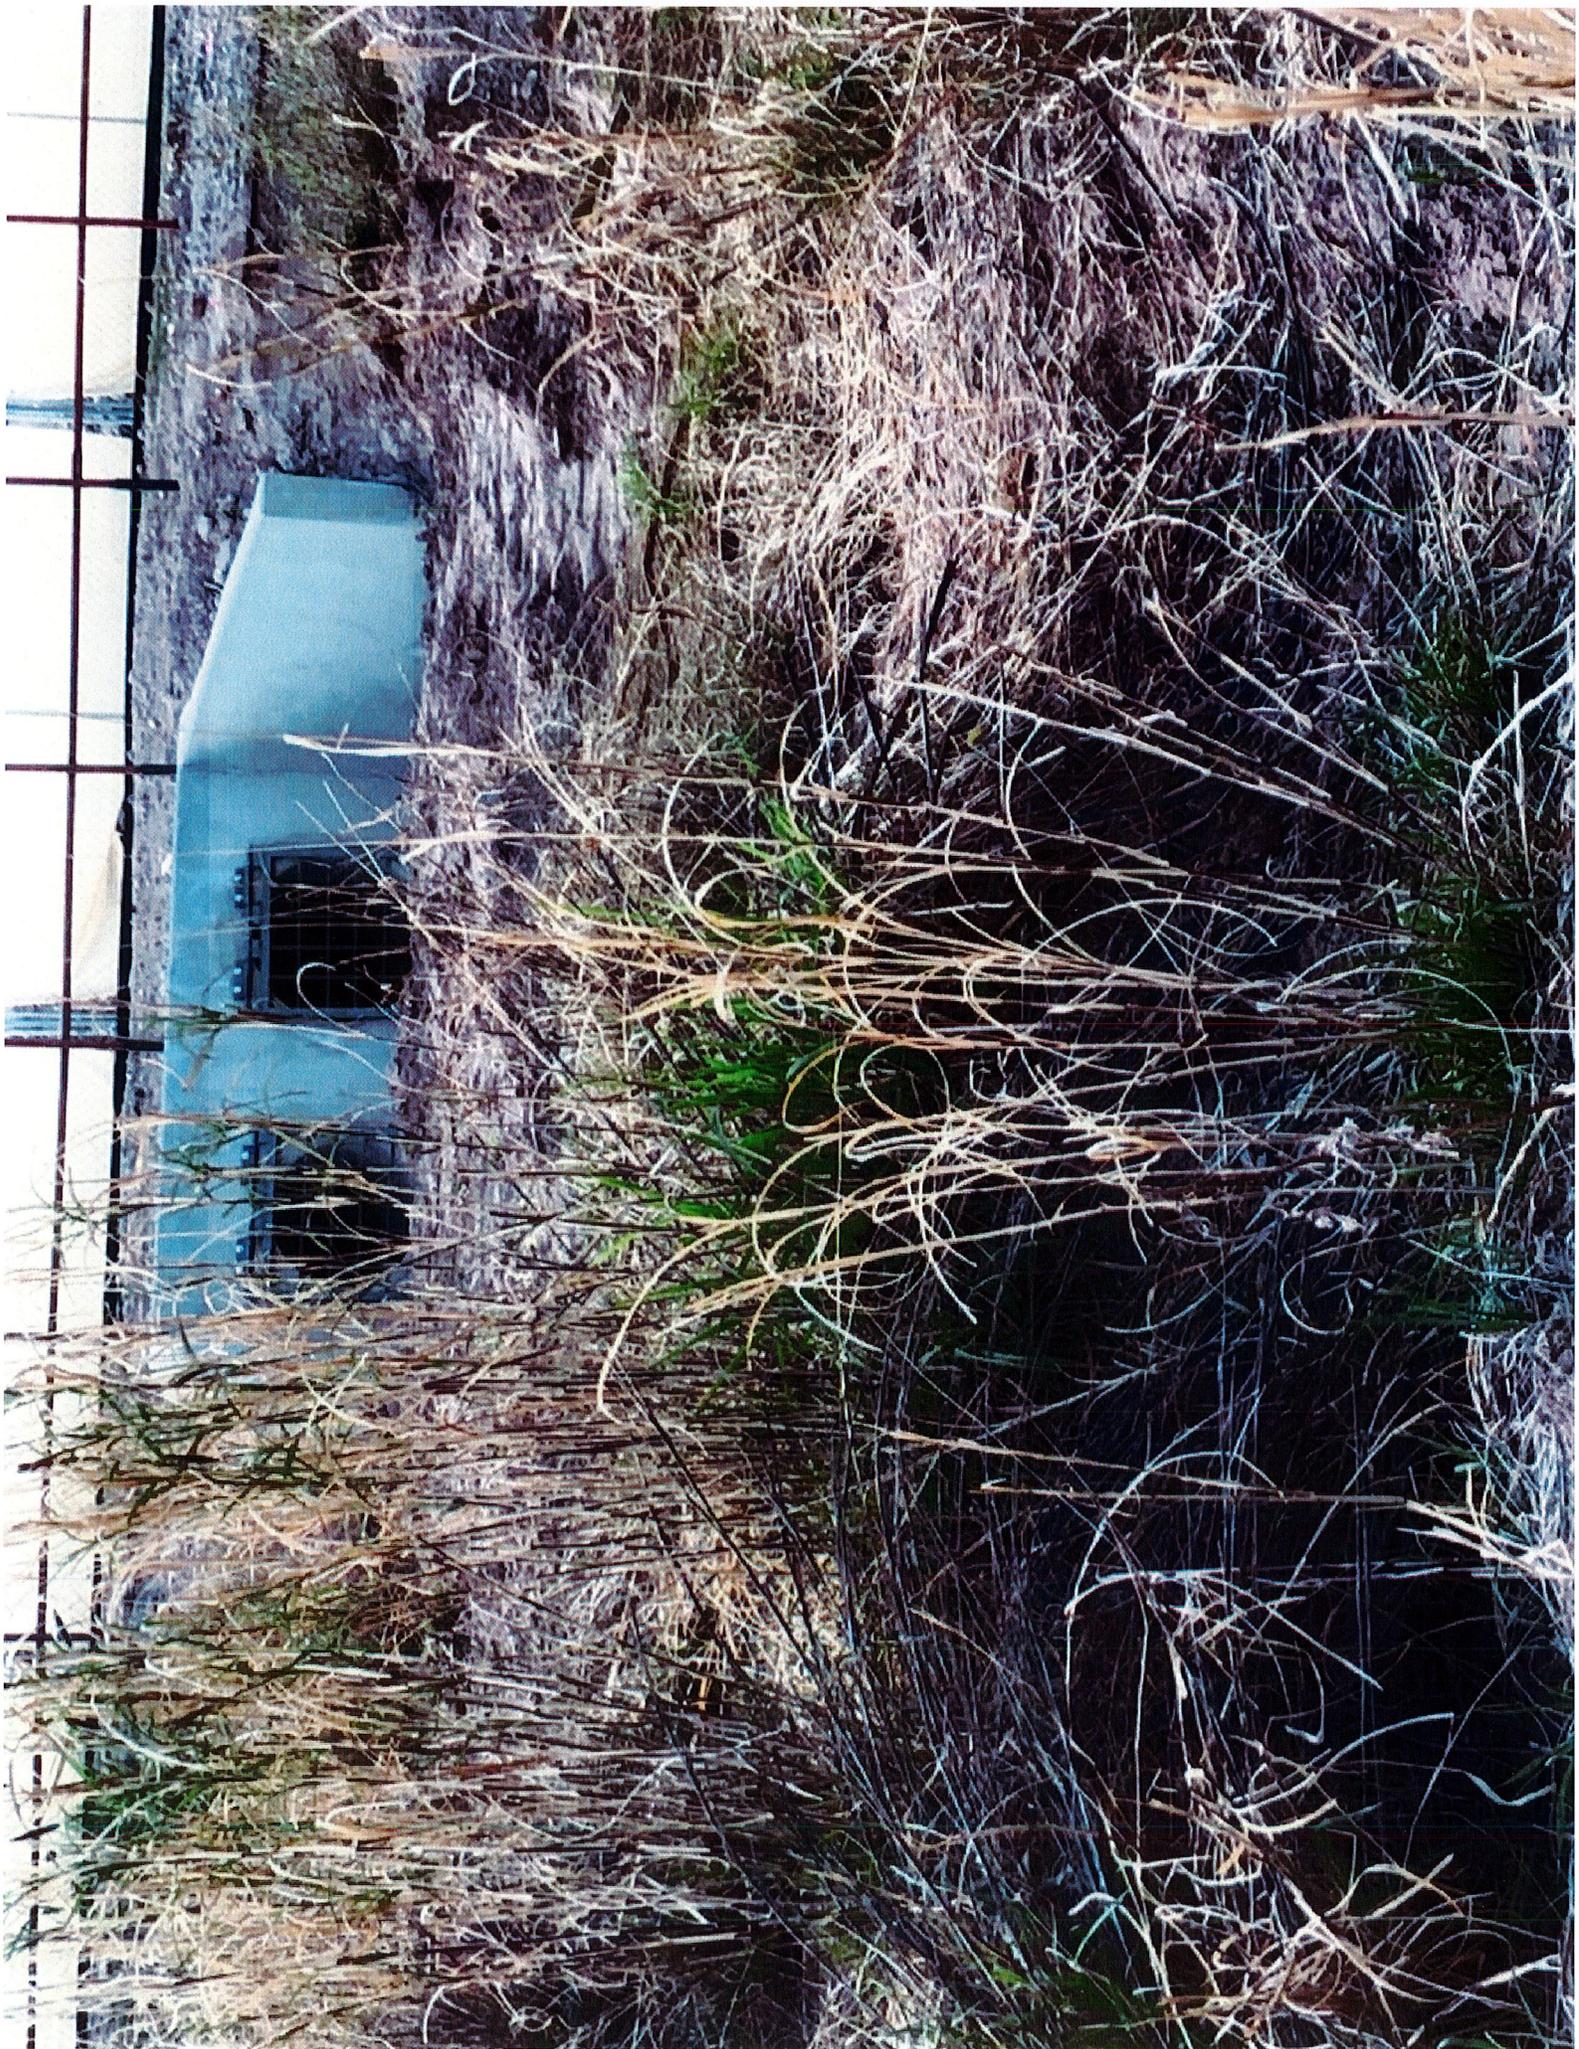
Attachments 1 and 2 show sedimentation levels adjacent to the respective north & south outlet headwalls for the Caterpillar storm drain.

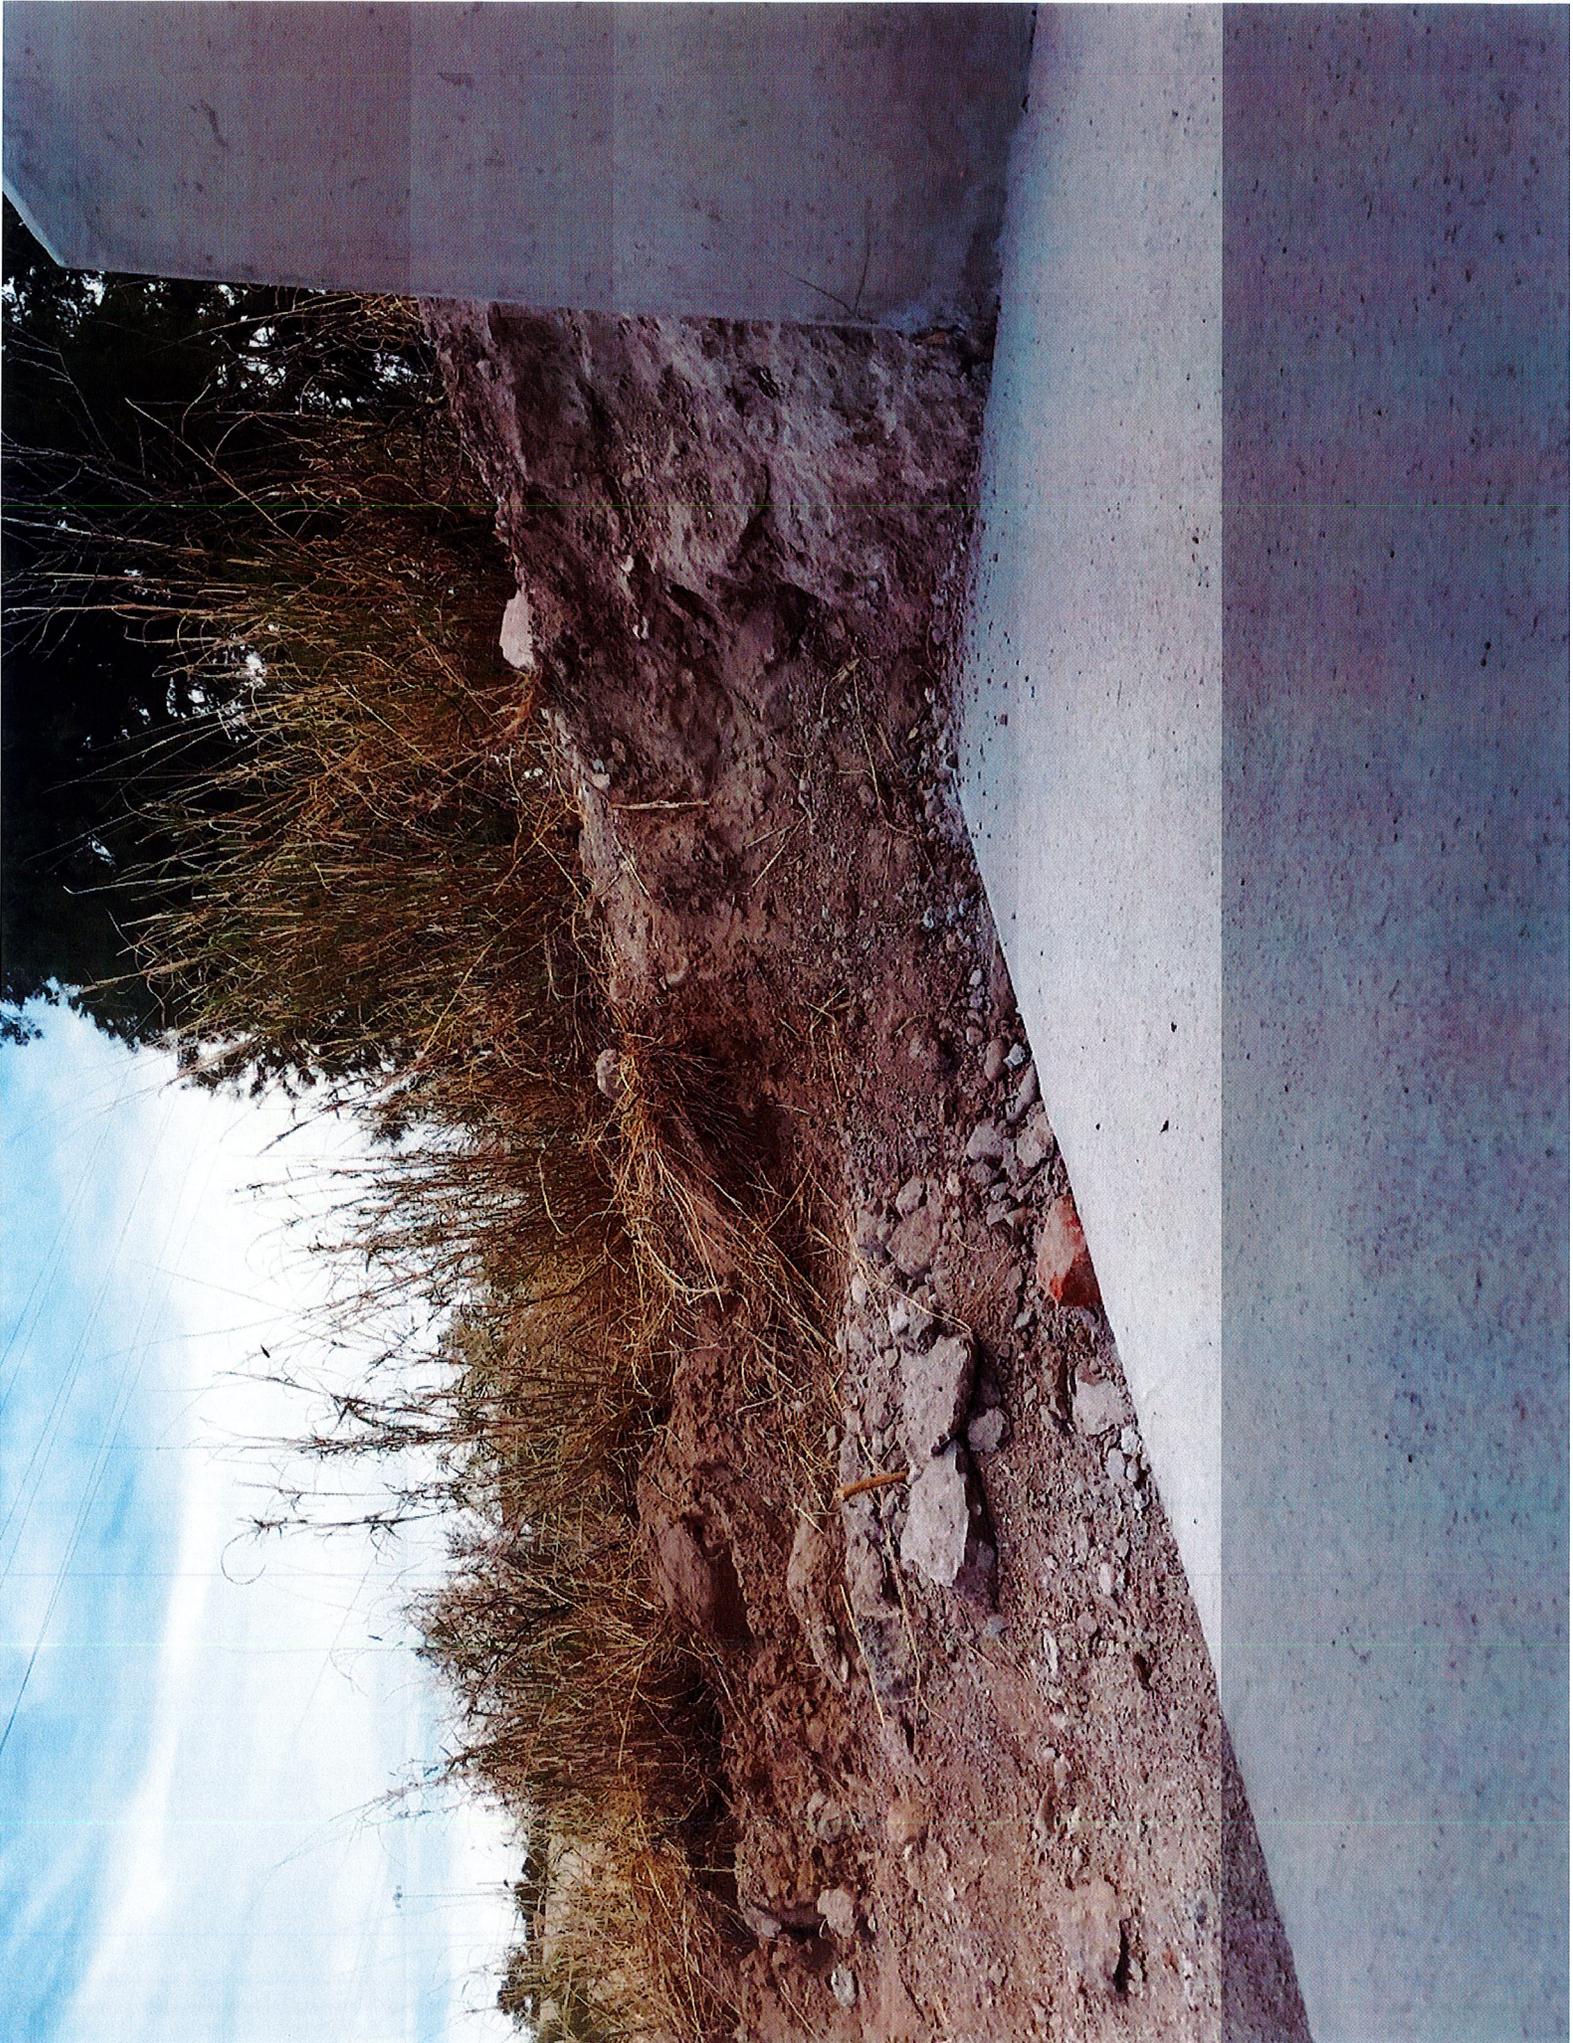
Attachment 3 is a (eye-level) view from the Caterpillar storm drain outlet apron to the east bank of the Santa Cruz River (this photo shows the Santa Cruz sedimentation level will result in a pond at the Caterpillar storm drain outlet when in fact the outlet invert is designed to be 6' above the Santa Cruz River channel bottom).

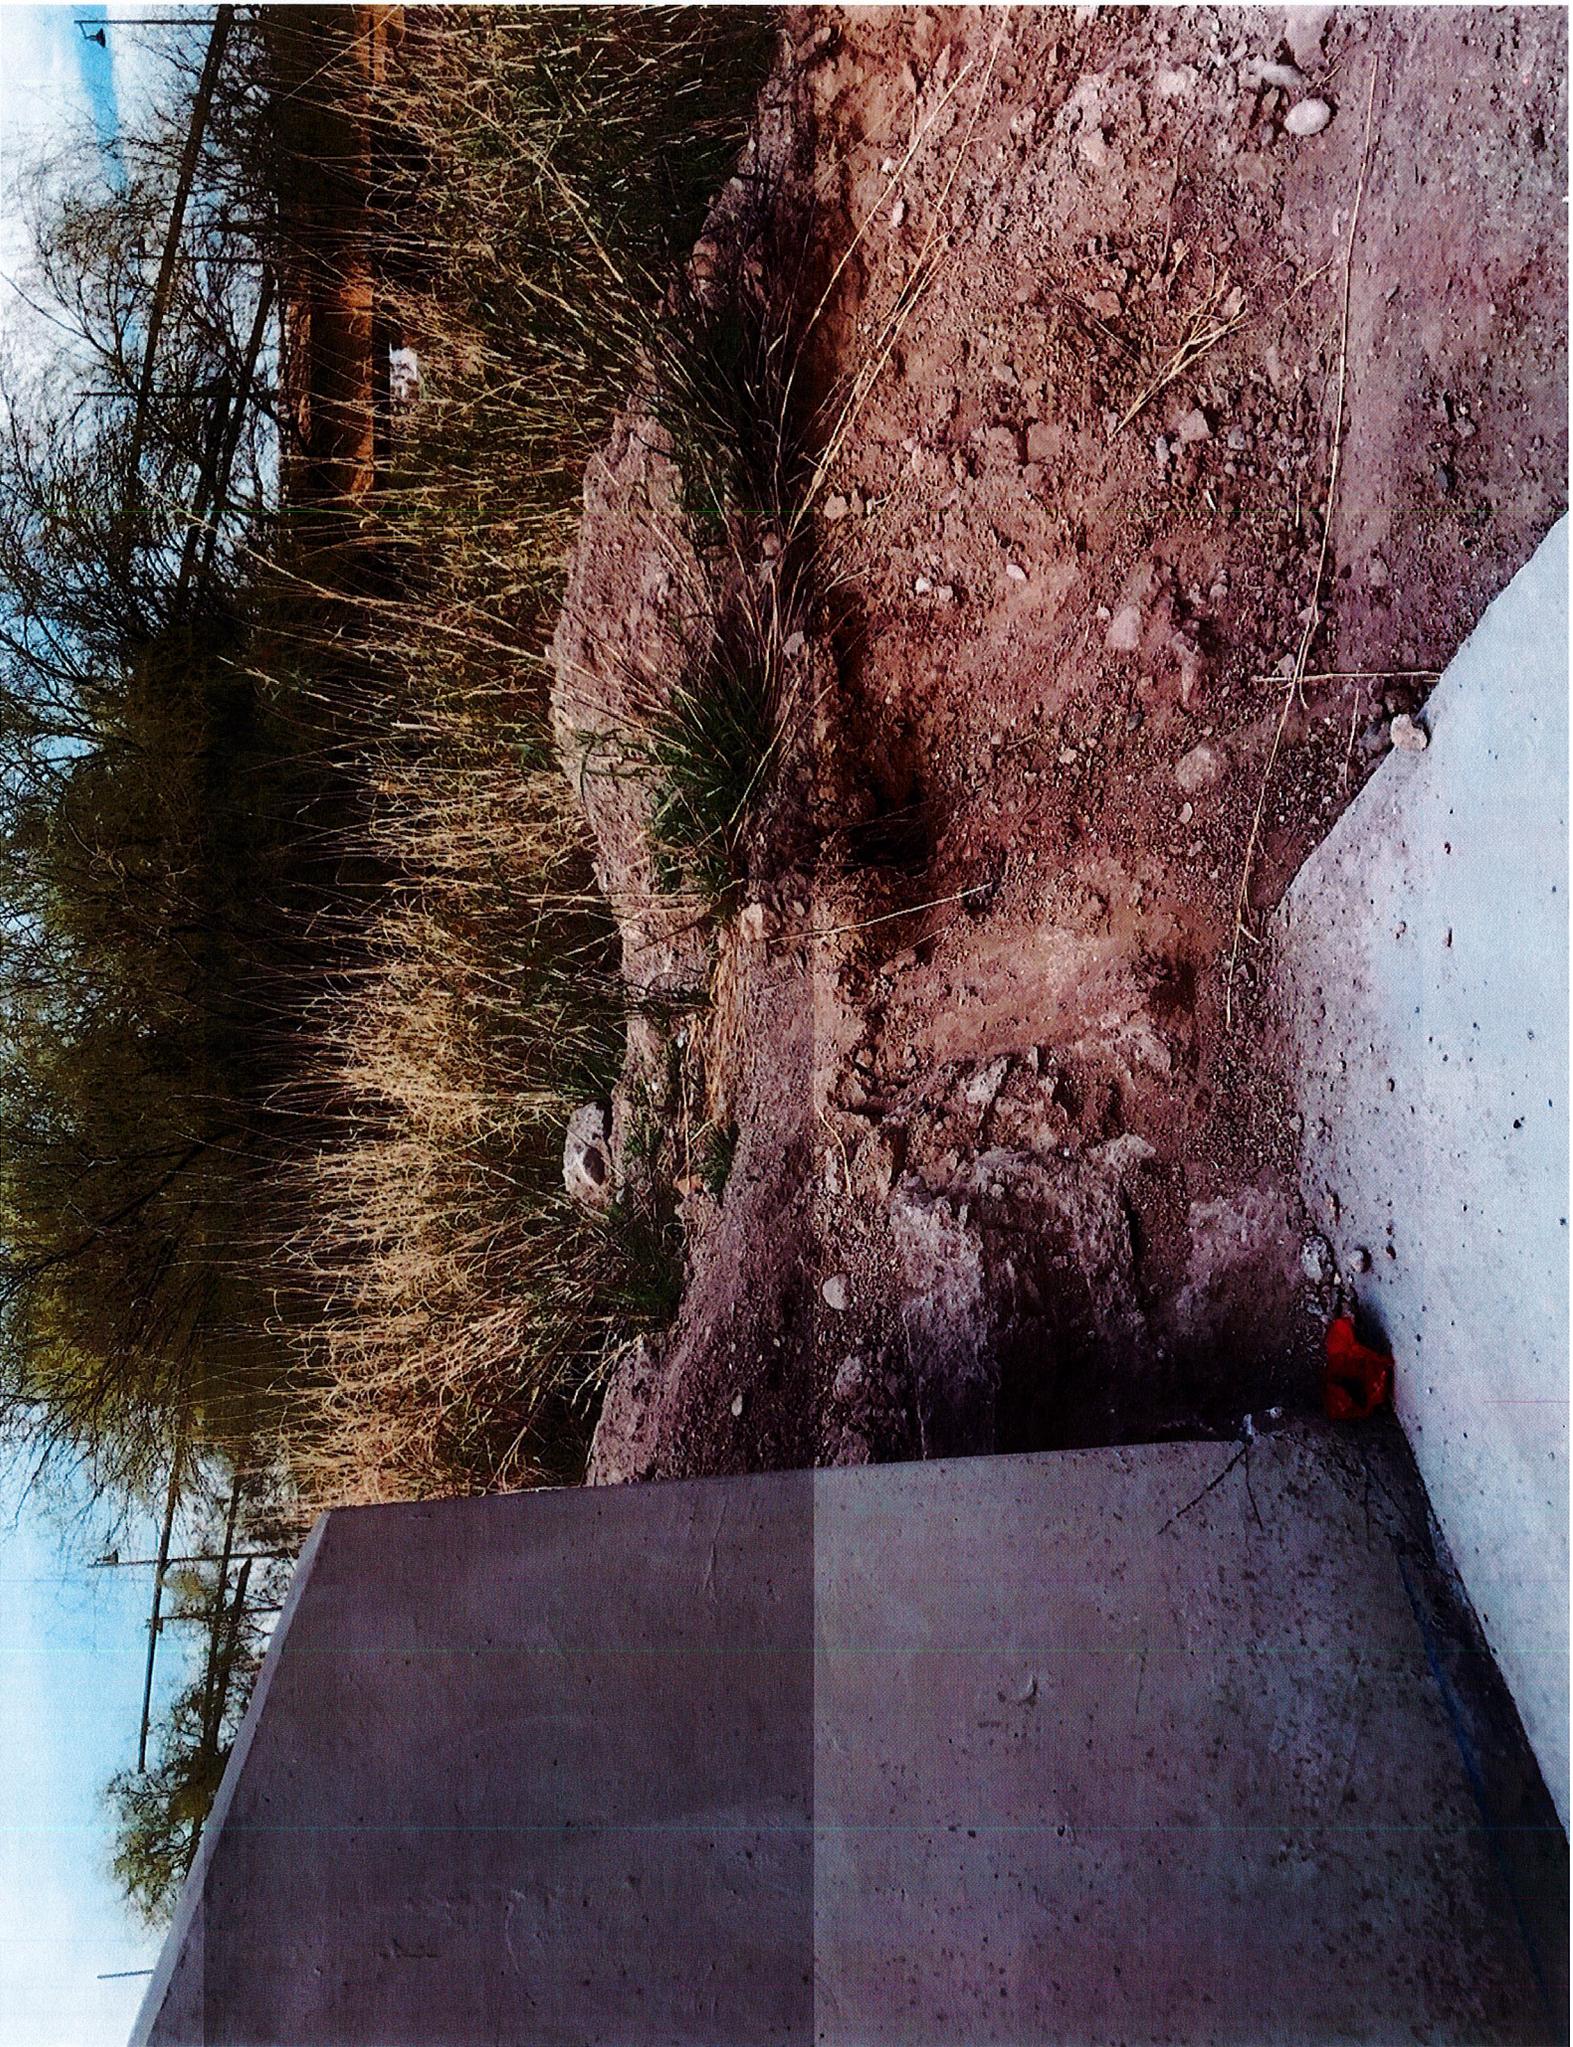
Attachment 4 is a westward view looking back at the Caterpillar storm drain outlet pipes (the Santa Cruz River channel bottom should actually be 6' below the bottom of the outlet pipes, not 3' above the pipes as can be seen by the vegetation levels to the left and right of the outlet headwalls).

**8' OF SEDIMENT!
CURRENT CHANNEL
BOTTOM**

**CHANNEL BOTTOM
SHOULD BE HERE**

**CATERPILLAR
OUTLET SHOULD BE
6' ABOVE CHANNEL
BOTTOM BUT IS BURIED
IN 3' OF SEDIMENT**

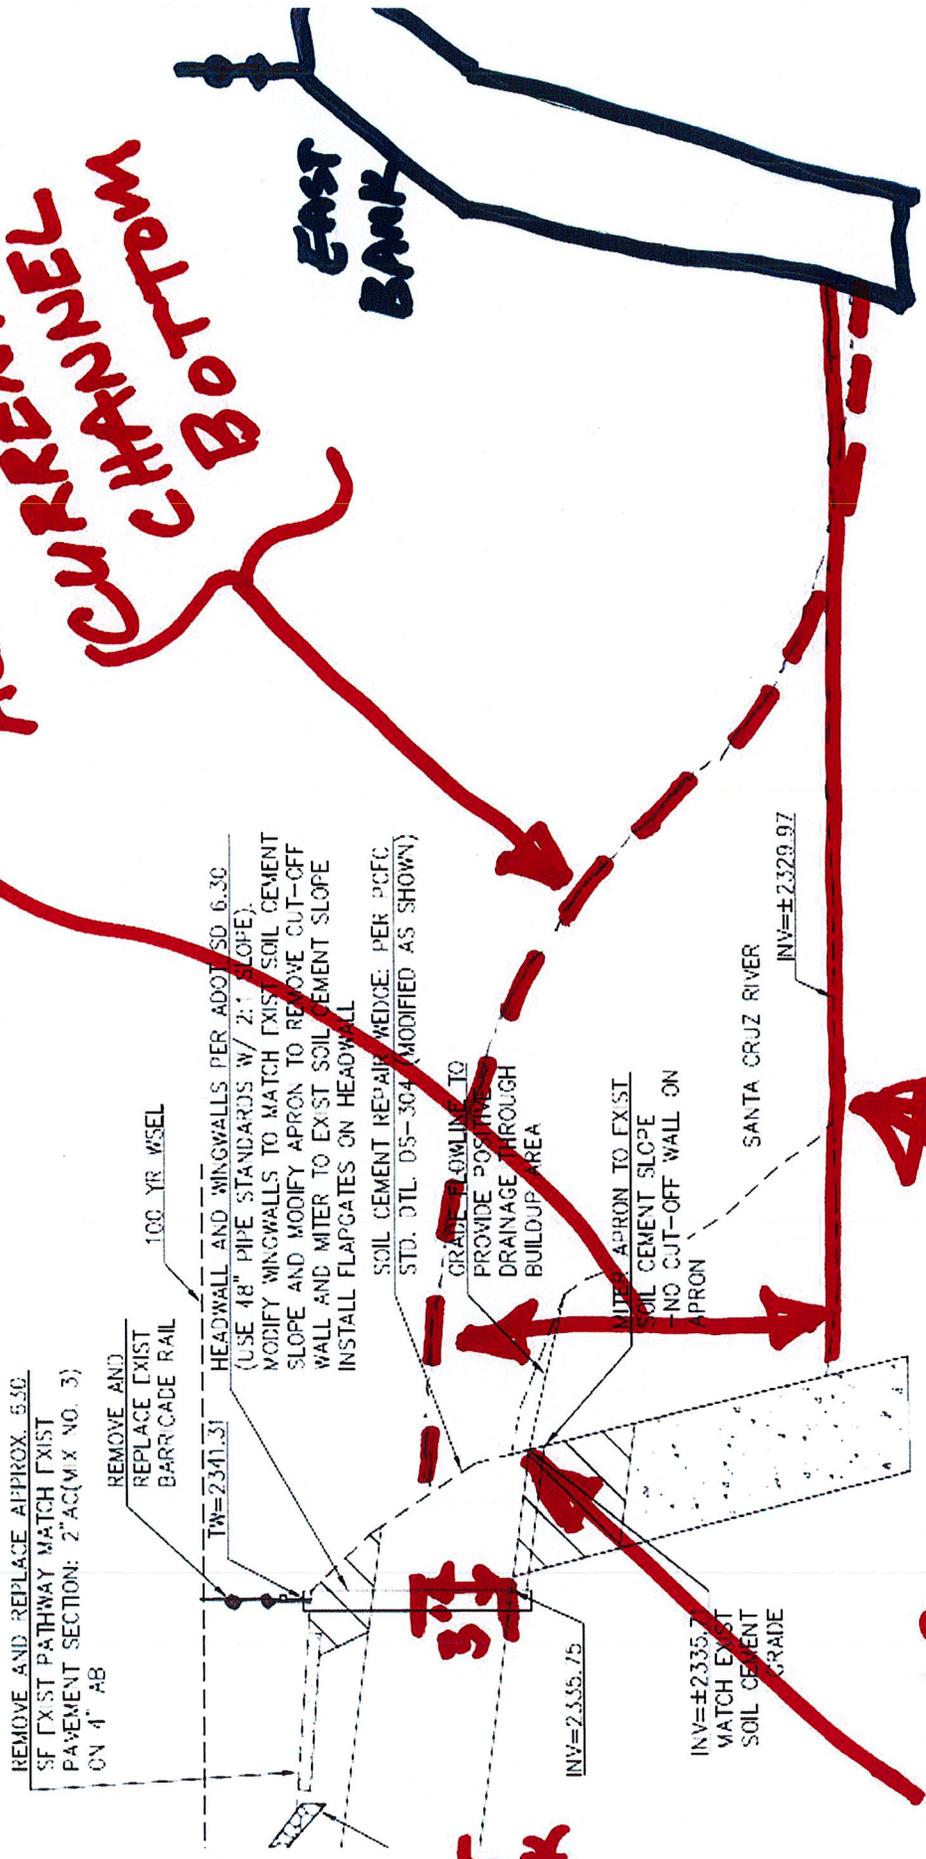
Attachment 5 is a cross-section of the existing condition for the Caterpillar storm drain outlet as it relates to the existing conditions (sediment levels) in the Santa Cruz River channel.

HEADWALL AND WINGWALLS PER ADOT SD 6.30
(USE 48" PIPE STANDARDS W/ 2:1 SLOPE).
MODIFY WINGWALLS TO MATCH EXIST SOIL CEMENT
SLOPE AND MODIFY APRON TO REMOVE CUT-OFF
WALL AND MITER TO EXIST SOIL CEMENT SLOPE
INSTALL FLAPGATES ON HEADWALL

SOIL CEMENT REPAIR WEDGE PER PCFC
STD. DET. DS-304 (MODIFIED AS SHOWN)

GRADE FLOWLINE TO
PROVIDE POSITIVE
DRAINAGE THROUGH
BUILDUP AREA

MITER APRON TO EXIST
SOIL CEMENT SLOPE
AND CUT-OFF WALL ON
APRON
