# MEMORANDUM

Re: **Town of Ajo Flooding**

Town of Ajo Curley School Basin Post Storm Event 7-31-19

Re: Water Damage in Ajo, Arizona

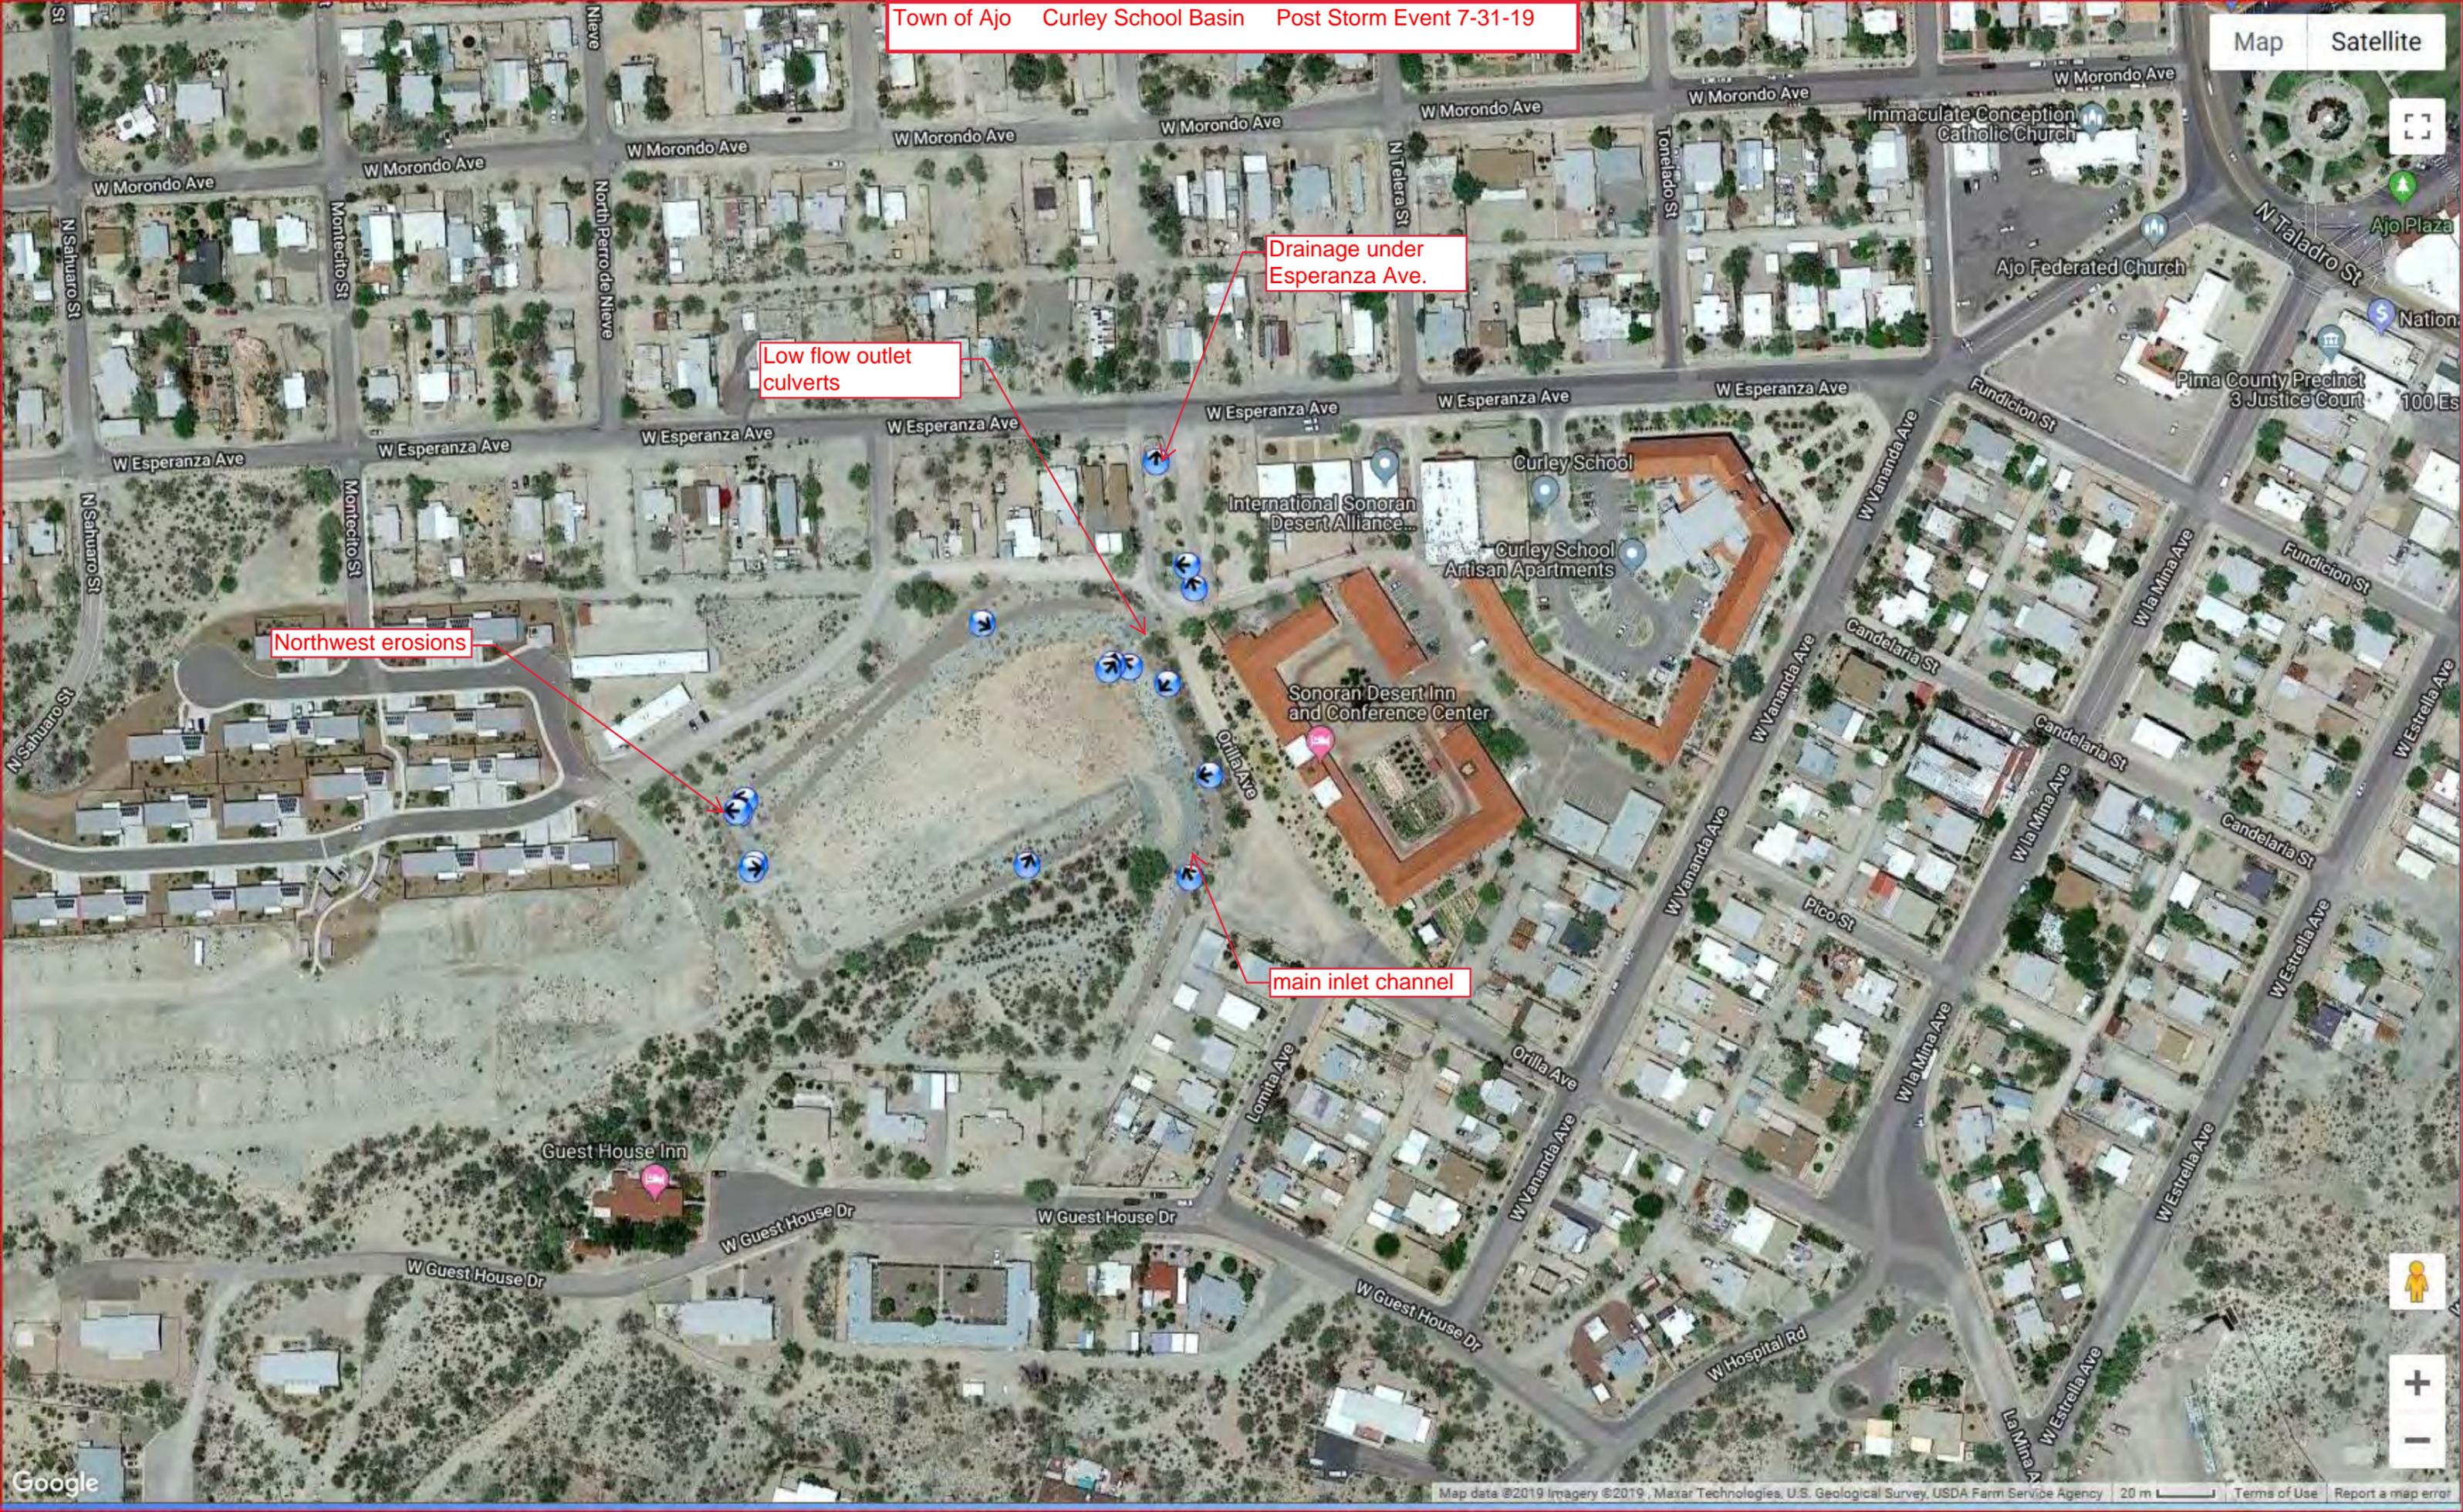
Drainage under Esperanza Ave.

Low flow outlet culverts

Northwest erosions

main inlet channel

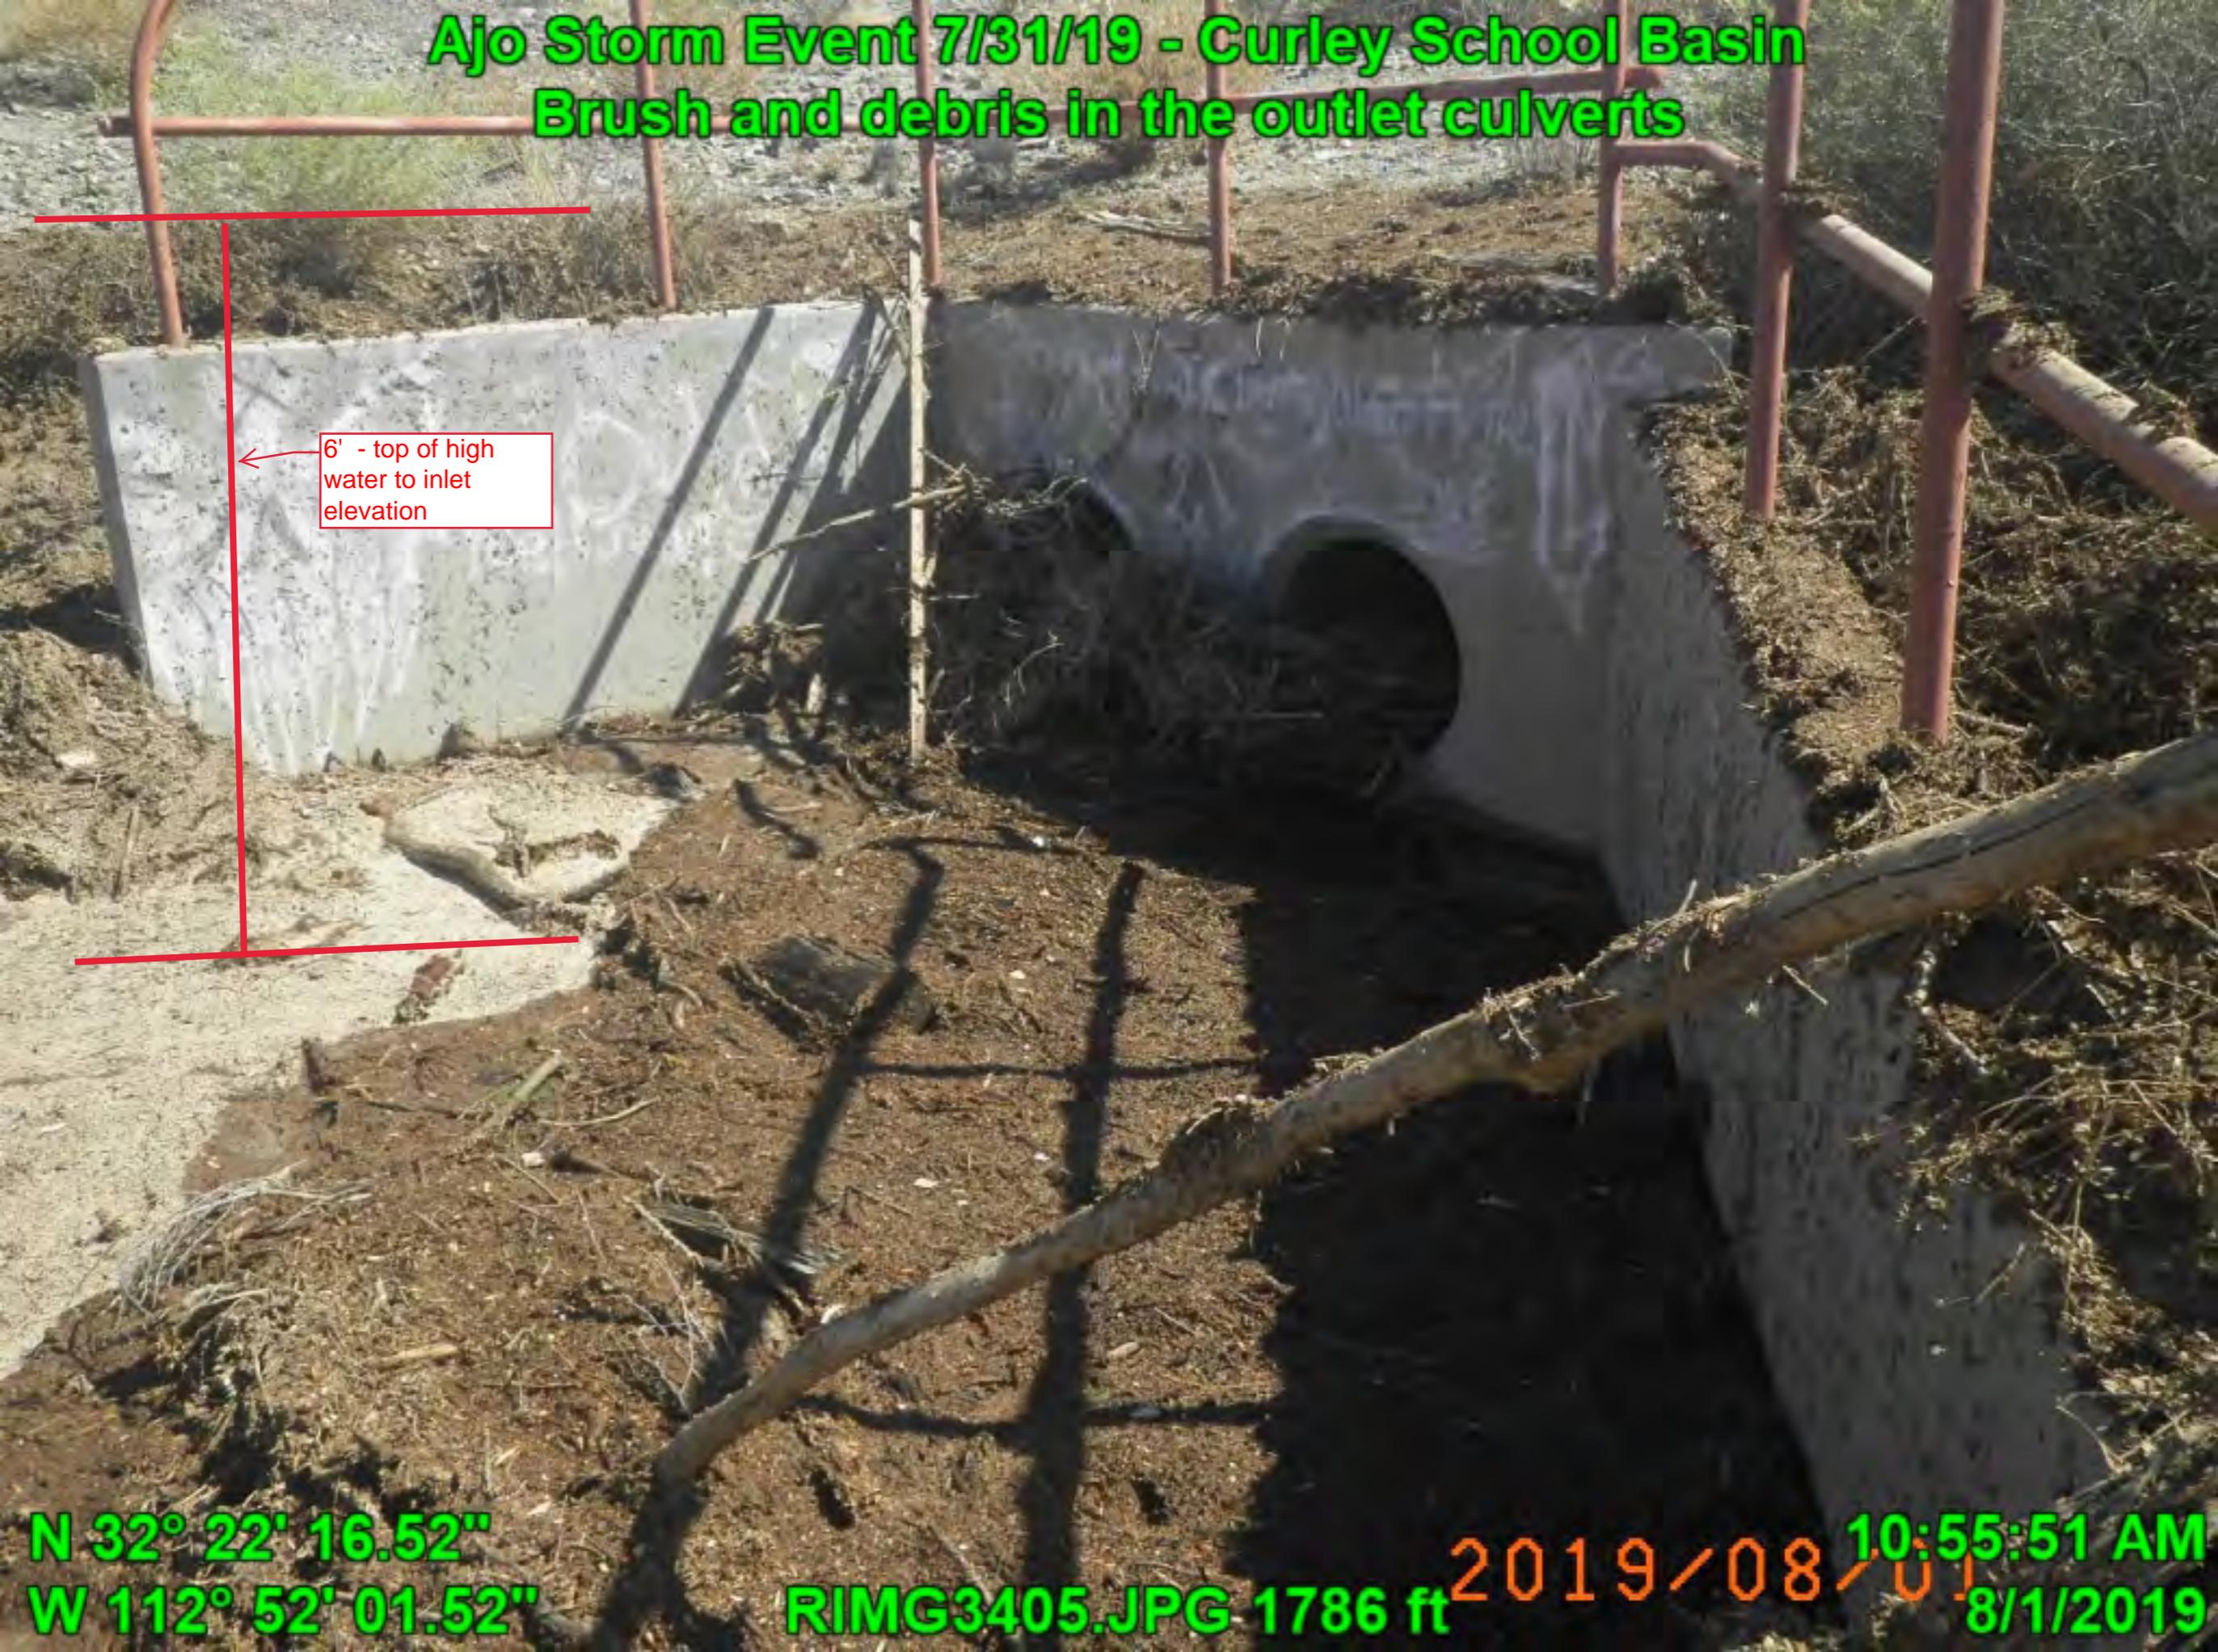
# Ajo Storm Event 7/31/19 - Curley School Basin

## Brush and debris in the outlet culverts

6' - top of high water to inlet elevation

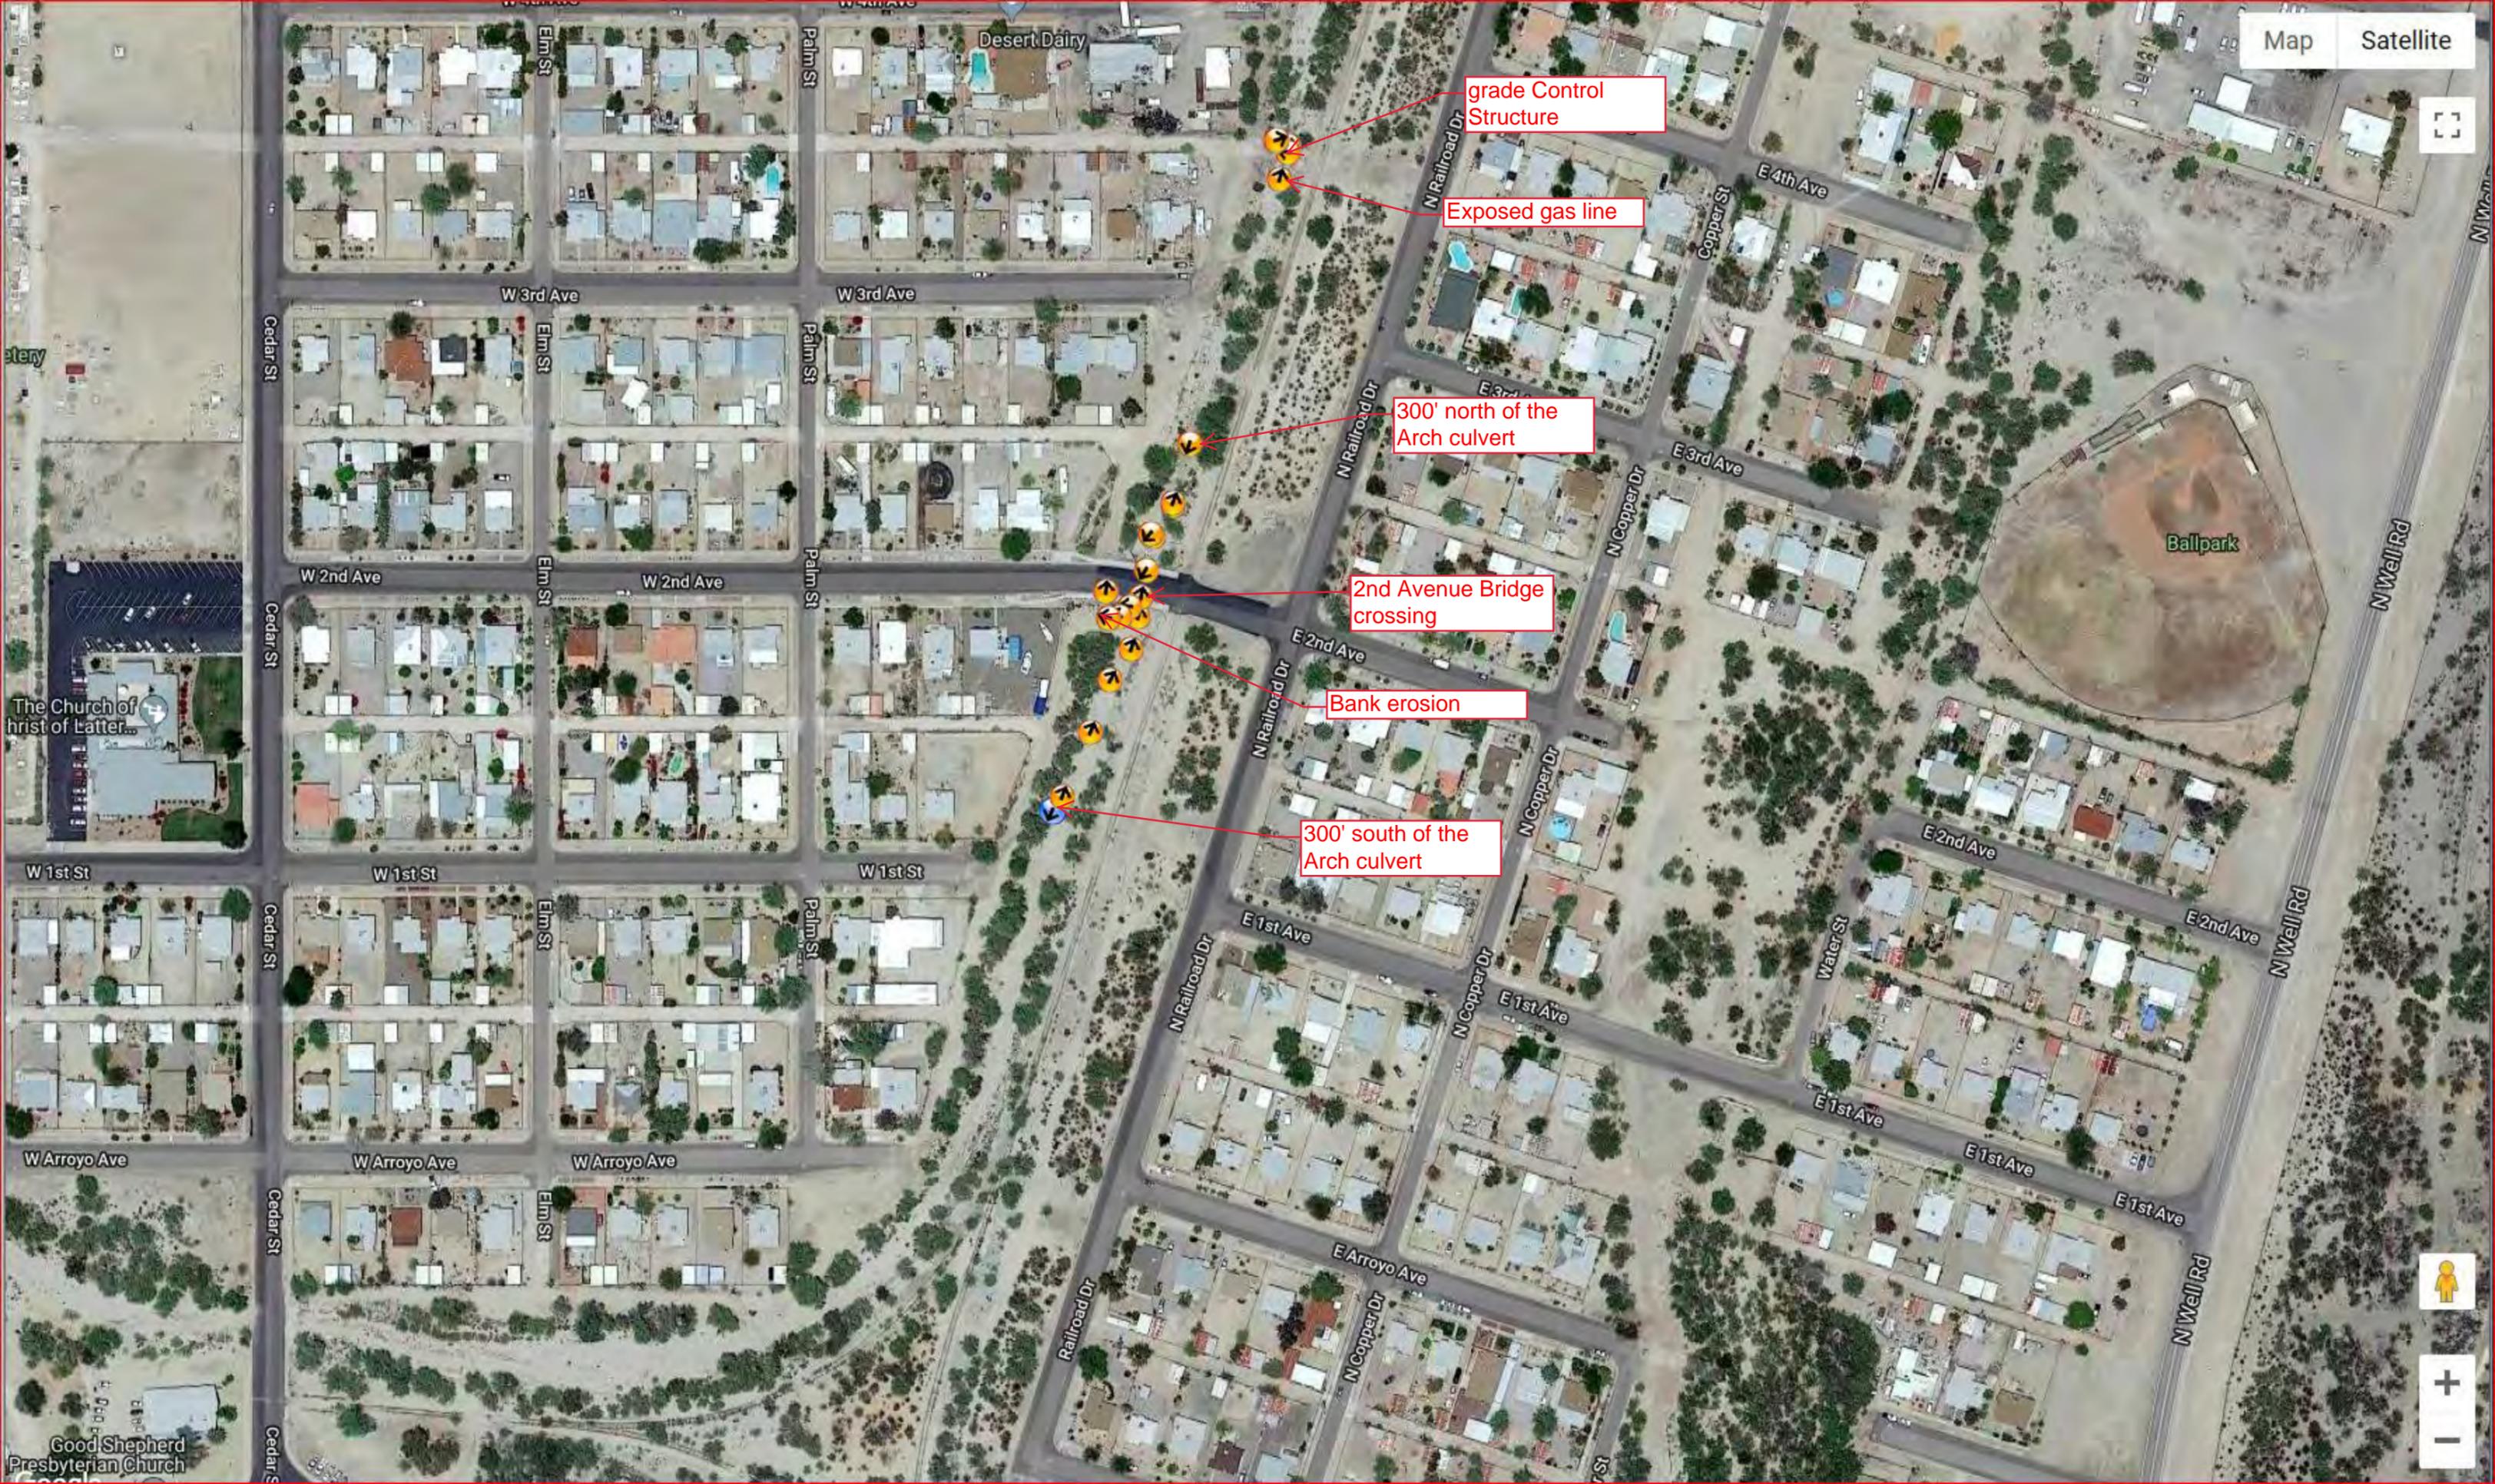
grade Control Structure

Exposed gas line

300' north of the Arch culvert

2nd Avenue Bridge crossing

Bank erosion

300' south of the Arch culvert

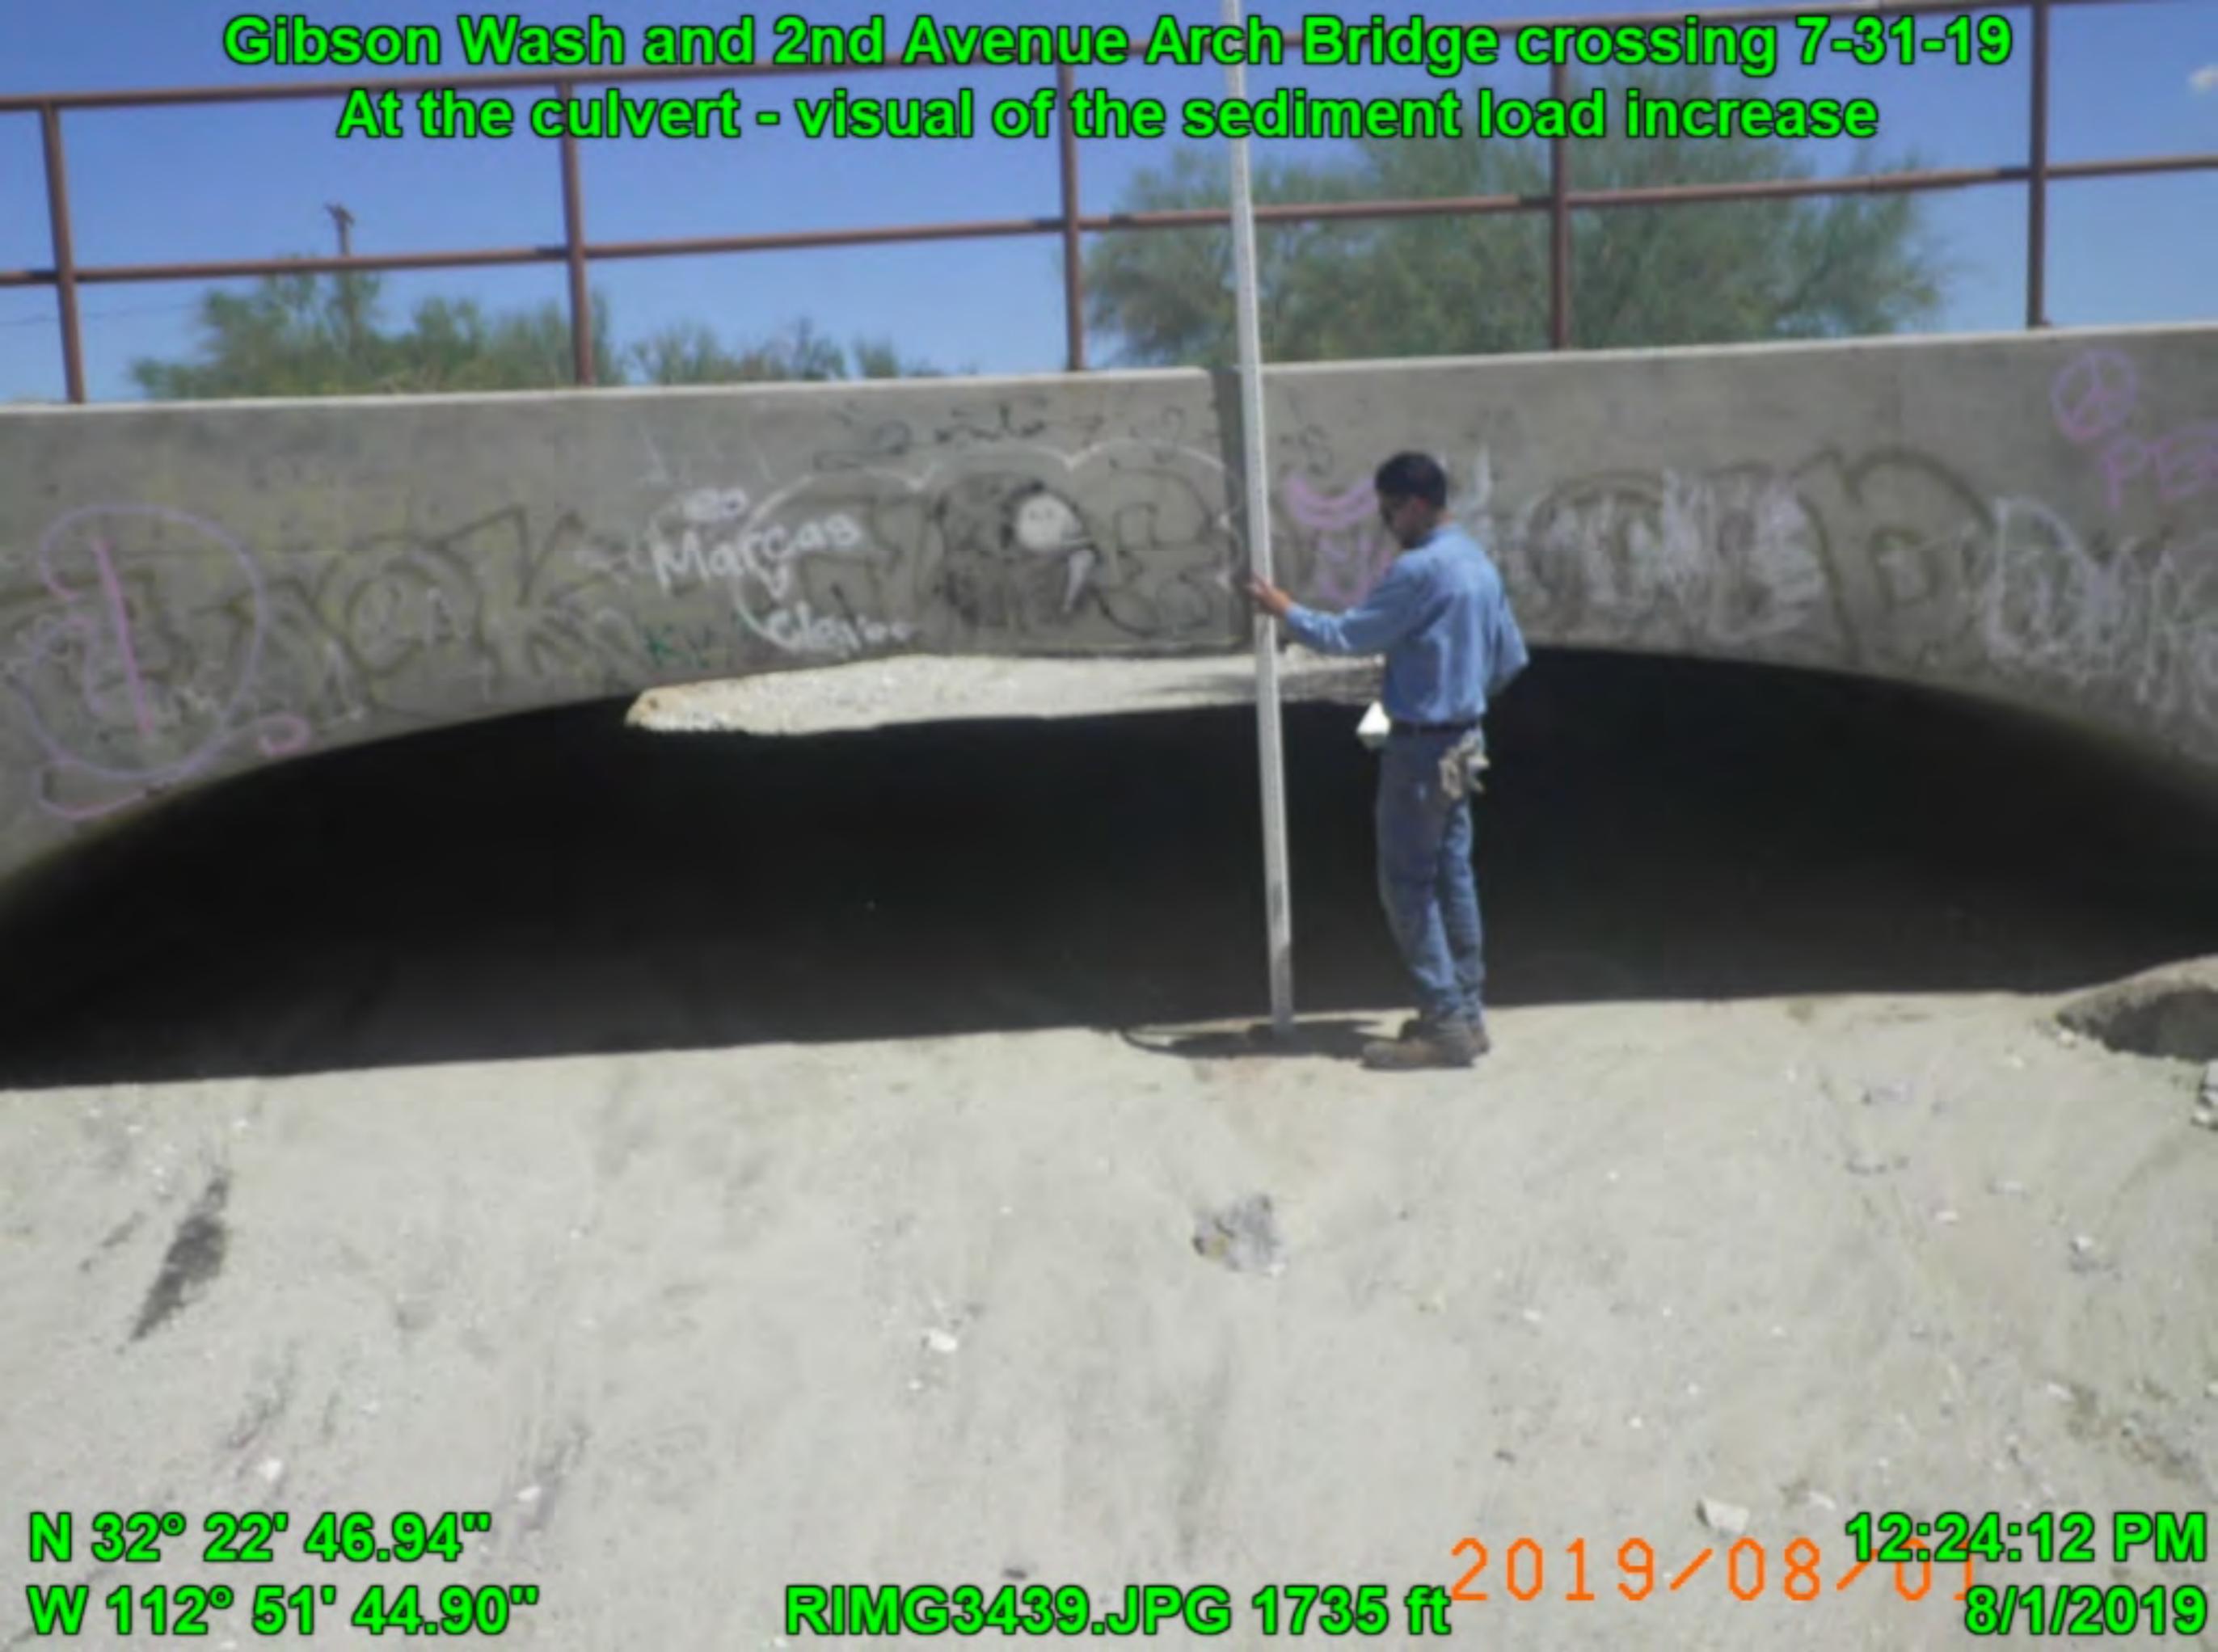
**Gibson Wash and 2nd Avenue Arch Bridge crossing 7-31-19**  
**At the culvert - visual of the sediment load increase**

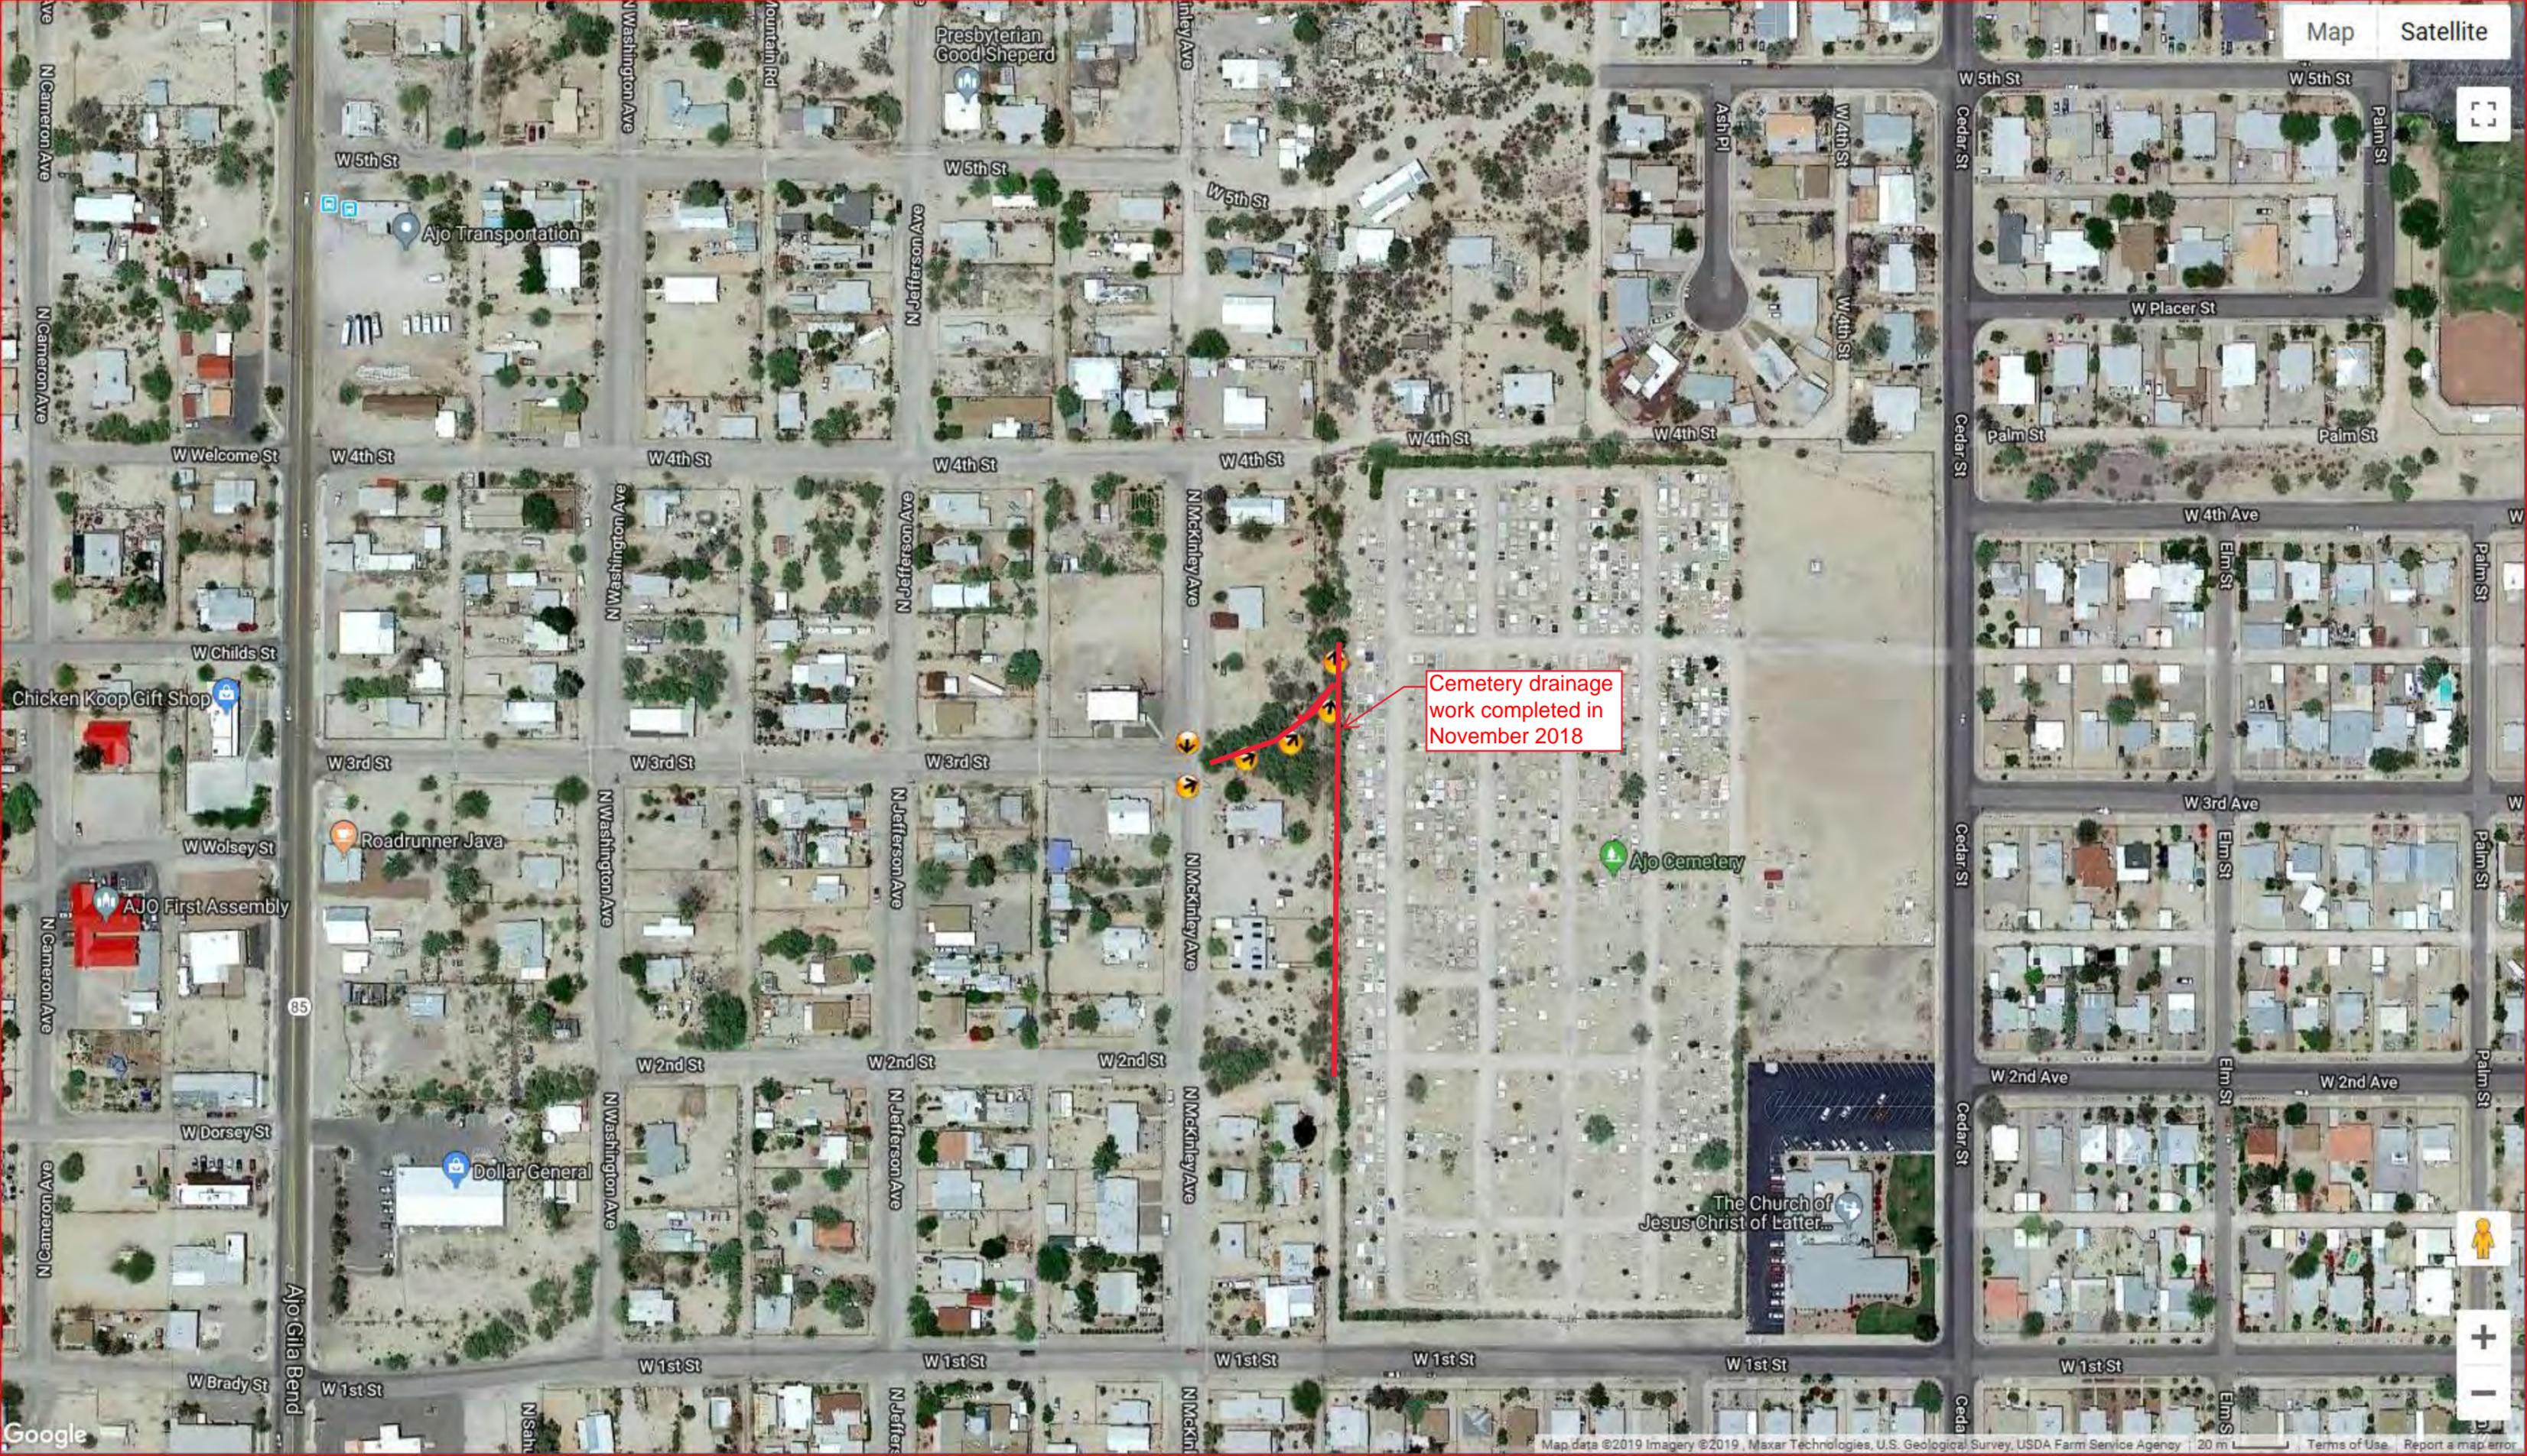
Cemetery drainage work completed in November 2018
