**PIMA DEPARTMENT OF ENVIRONMENTAL QUALITY
AIR PROGRAM**

OPPORTUNITY TO CORRECT - TRACKING # 0910-122

Complaint Investigation Report

Tracking ID: PC0910-086

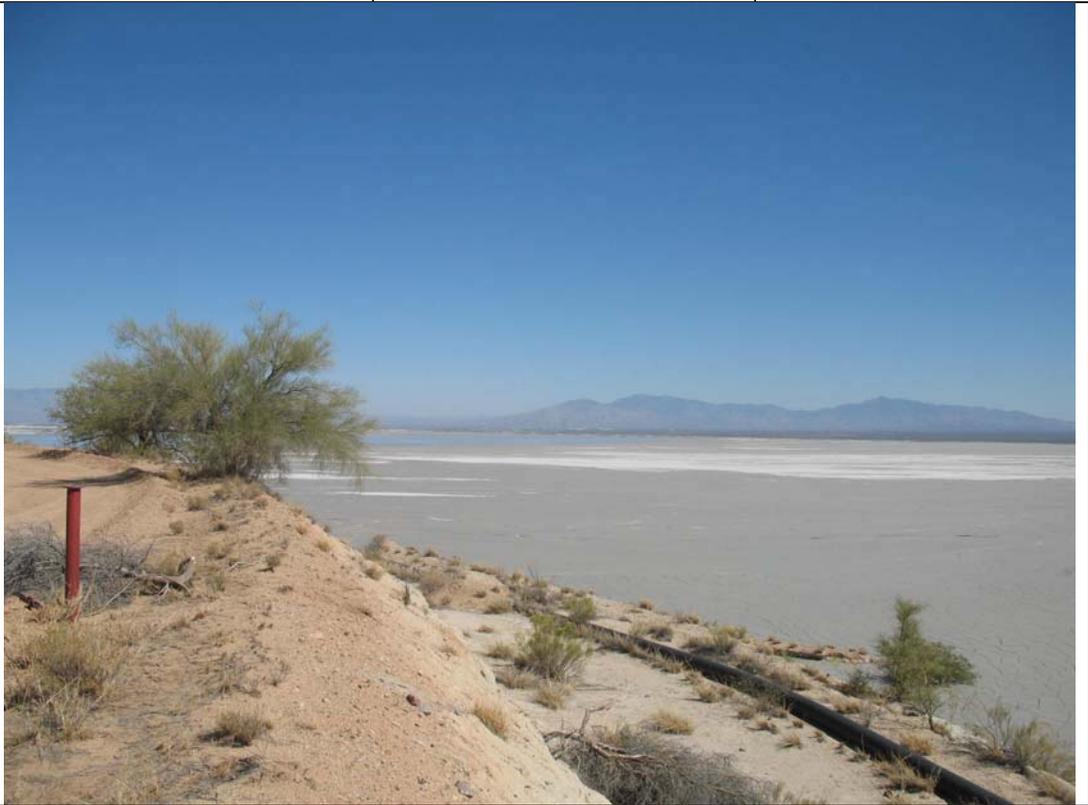
Photo No. 2

of the tailings dam. The inspector observed the blue coloring of the new berm indicative of applied polymer soil stabilizer (Attachment 2, Photo No.'s 2-4). The inspector examined the stability of the north slope of the tailings dam and found the soils to be stable and encrusted (Attachment 2, Photo No.'s 5-6). The inspector observed that polymer had been applied along the inside top surface of the north berm (Attachment 2, Photo No. 7). The inspector did not observe any fugitive emissions or unstable conditions at the time of the inspection. The condition of the open surface of the tailings dam was observed to be relatively dry but encrusted and stable at the time of inspection.

View of the tailings dam #8. A new berm has been built on the west and north faces. The slopes are colored blue from the polymer stabilizer applied to the surface.

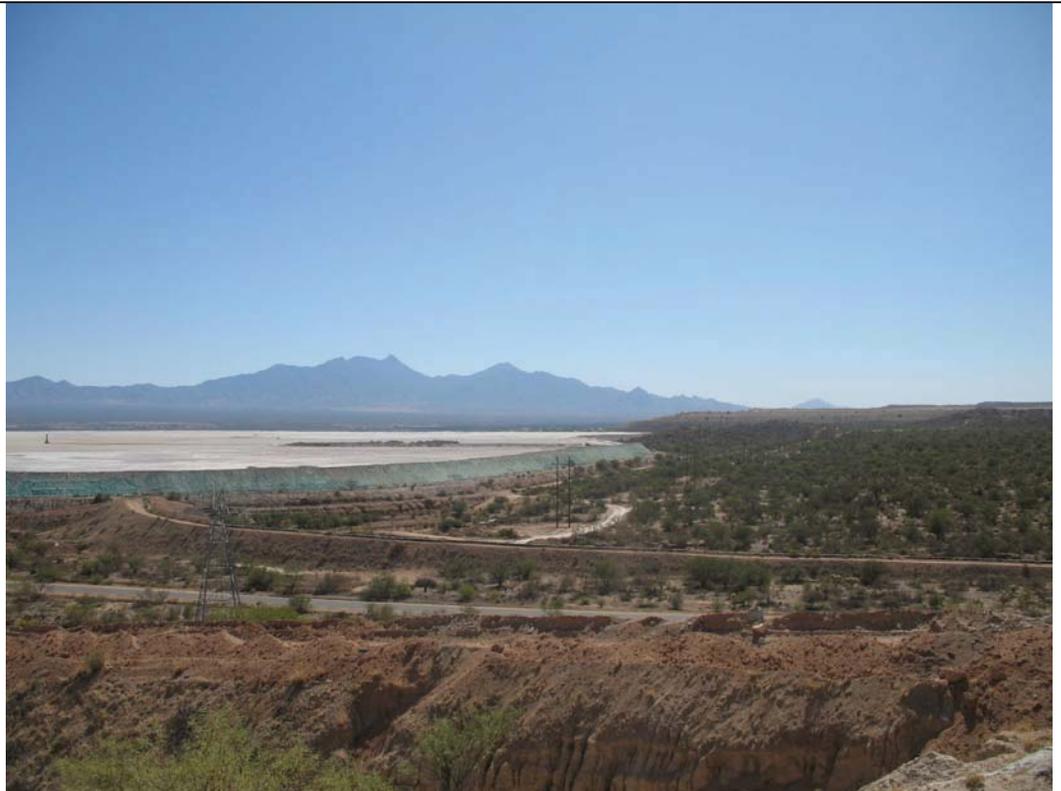
Photo No. 3

Date: 10/21/2009	
Photo Description: View of the tailings dam #8. A new berm has been built on the west and north faces. The outer sides of the slopes are colored blue from the polymer stabilizer applied to the surface.

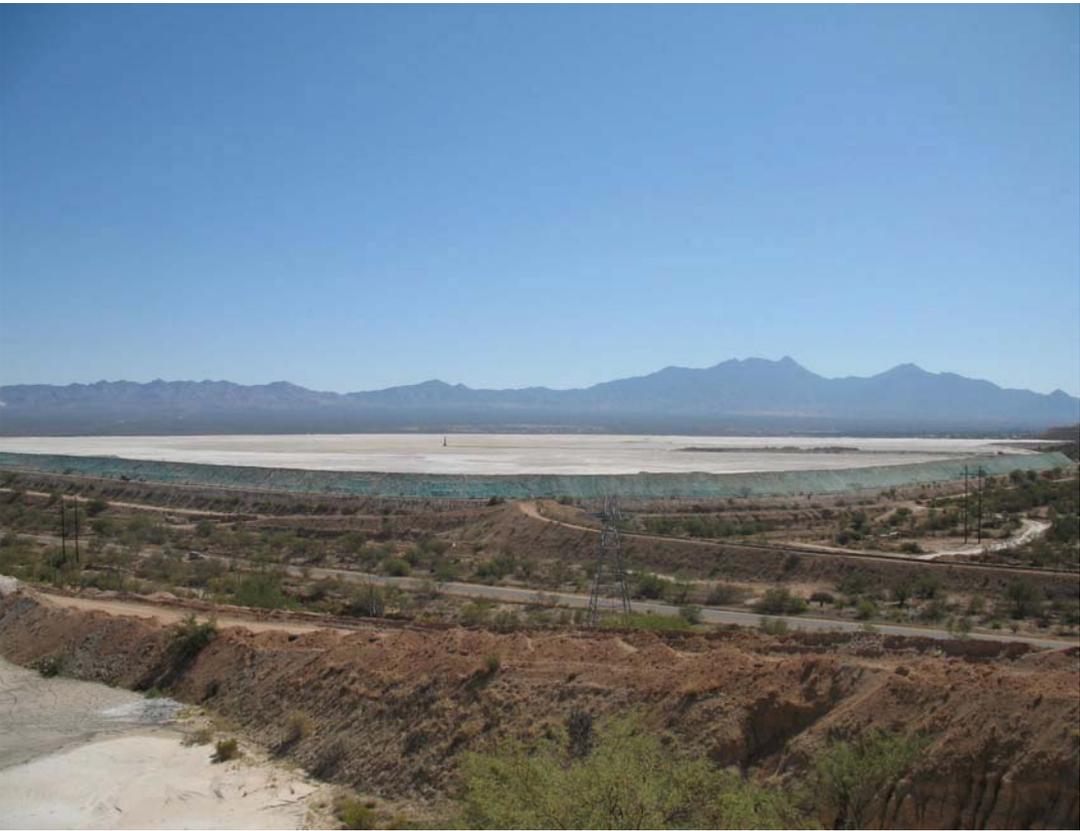
Photo No. 4

Date: 10/21/2009	
Photo Description: View of the tailings dam #8. A new berm has been built on the west and north faces. The outer sides of the slopes are colored blue from the polymer stabilizer applied to the surface.

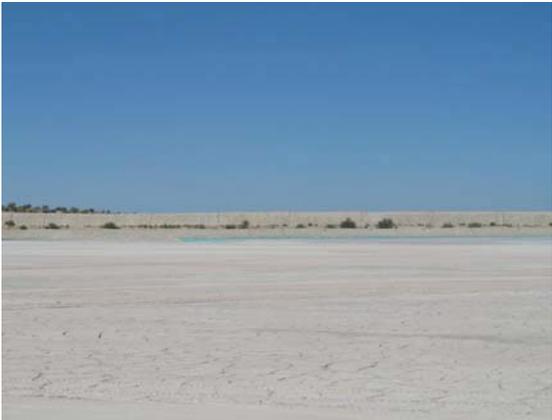
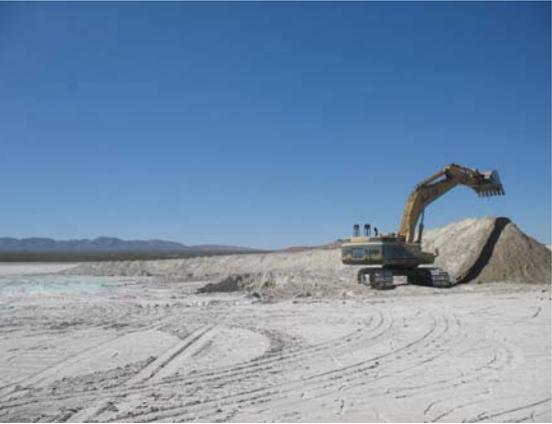
Photo No. 7 a, b	
Date: 10/21/2009	
Photo Description: View of polymer stabilized areas on inner base of the north berm (blue). Bucket excavator at the present point of berm building.	<p data-bbox="690 577 706 598">a</p>

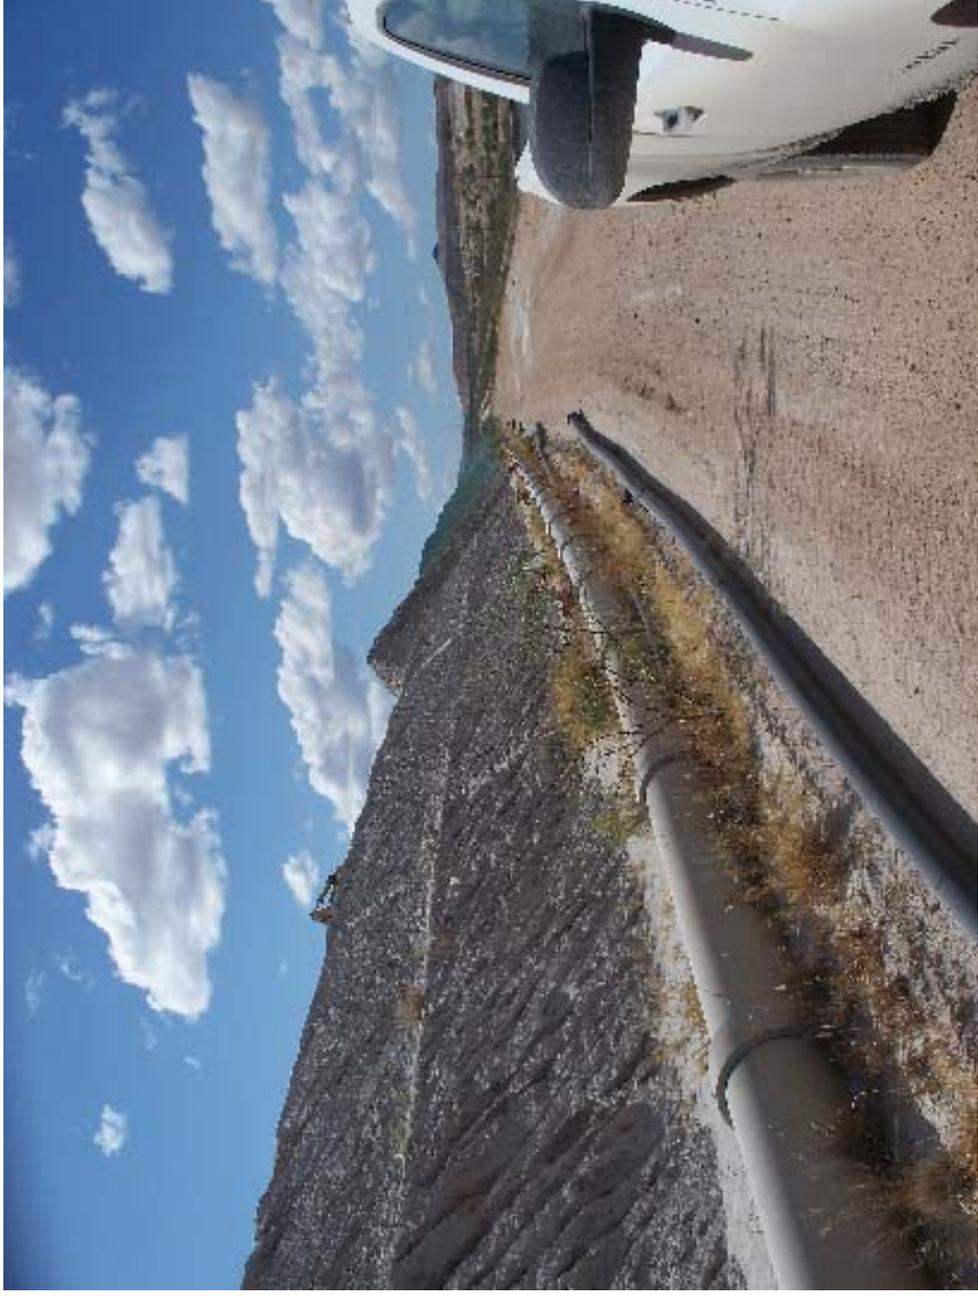
Berm Building Area. North side of Tailing # 8.
Berm building stopped

- Berm building activities on Tailing # 8 were immediately stopped.
- Mission Mine General manager was updated on the windy situation and got his approval for overtime labor to ensure that the sources generating dust within Tailing # 8 were properly addressed
- Immediately mobilized two dedicated water trucks to the area.
 - A total of 9 totes of polymer were applied in the area for a total usage of 22500 gallons
 - Additionally, 24000 gallons of water were sprayed to suppress dust conditions

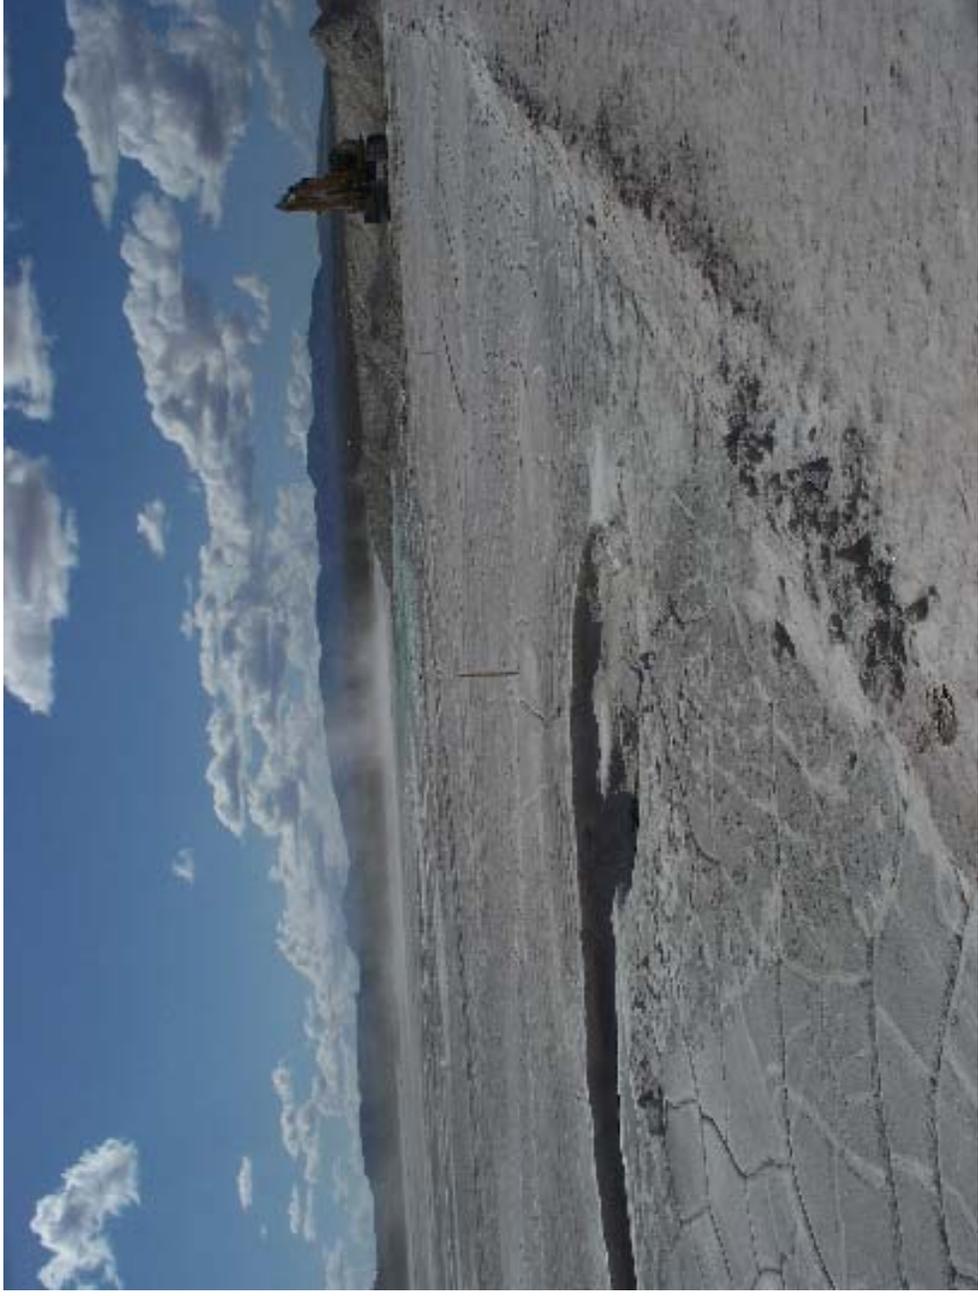
On top of Tailing # 8. looking West.
Dusty conditions generated by the water truck

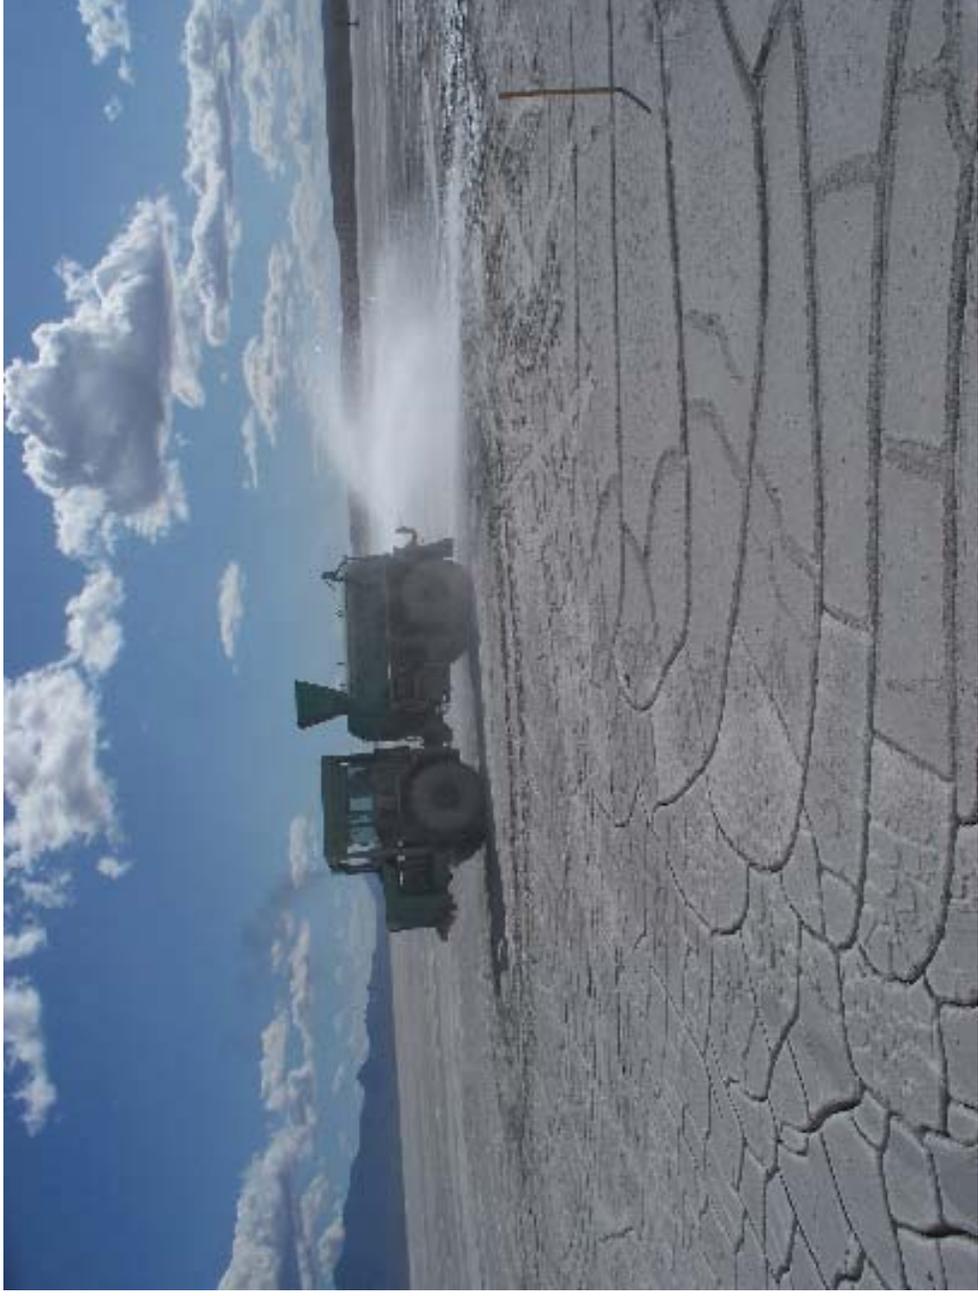
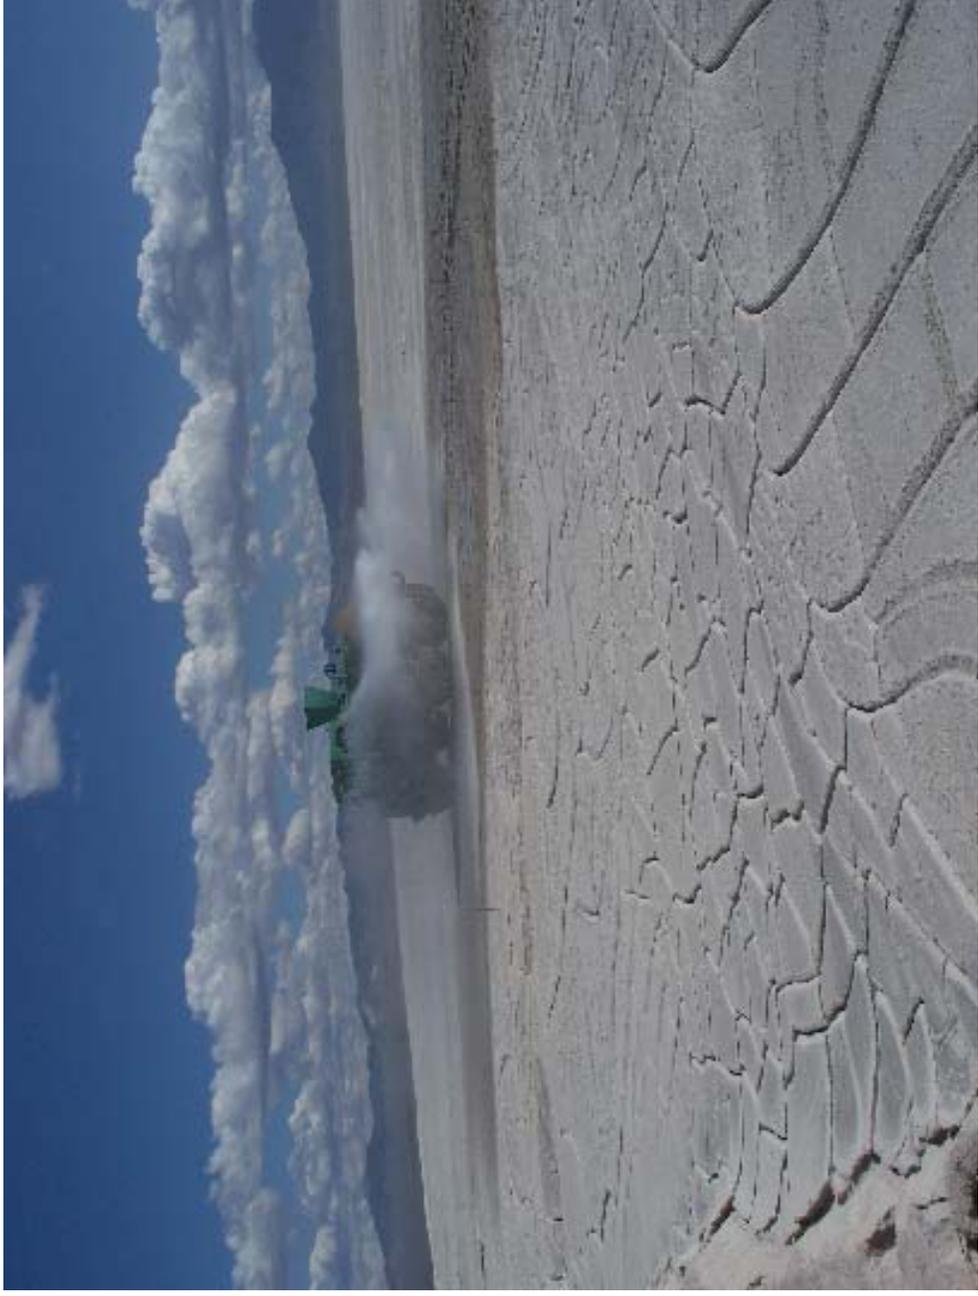
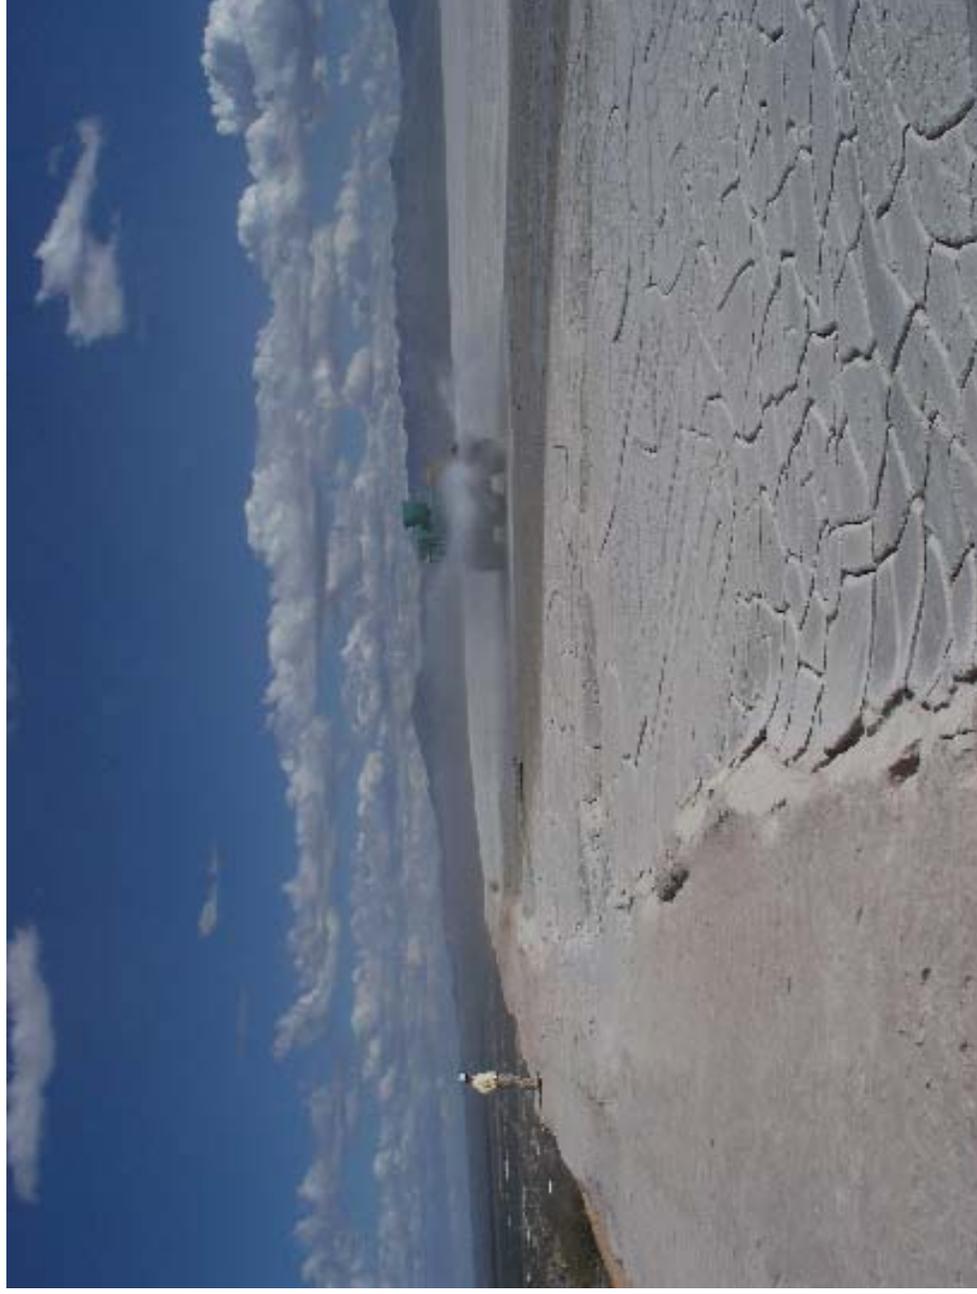
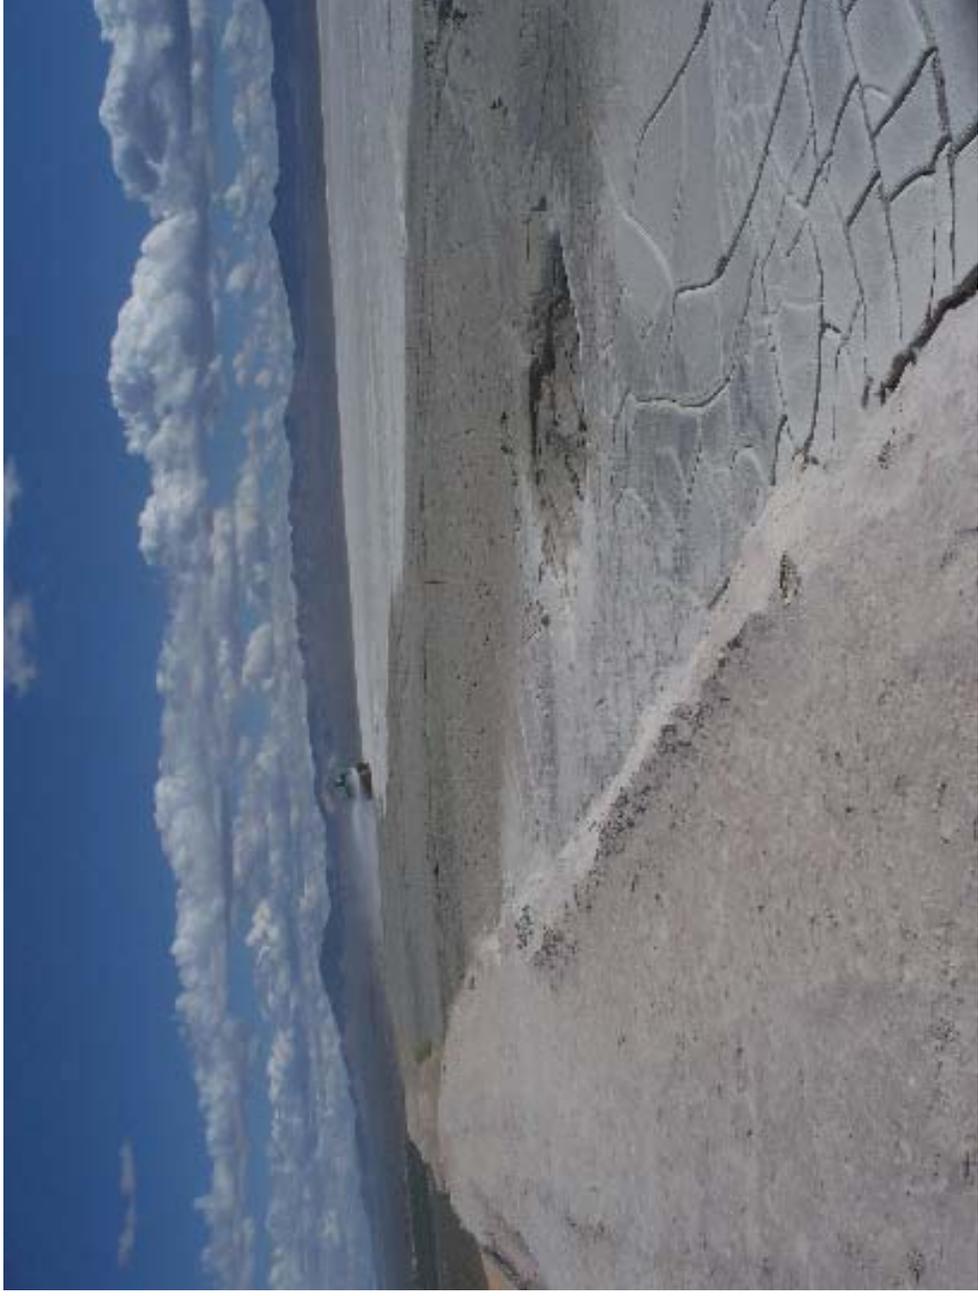
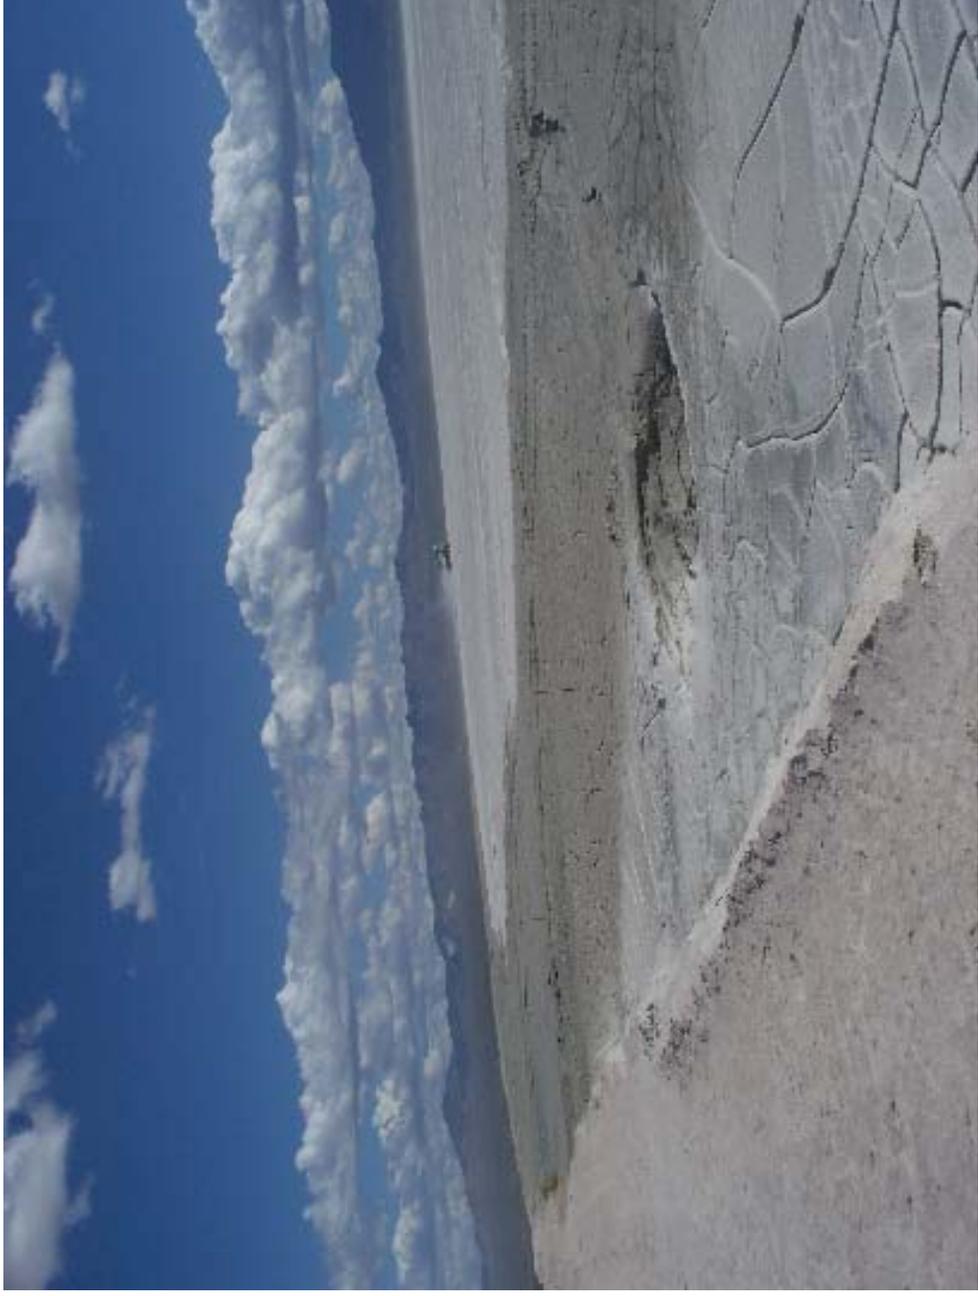
On top of Tailing # 8. Water being applied to areas suspect to generate dust

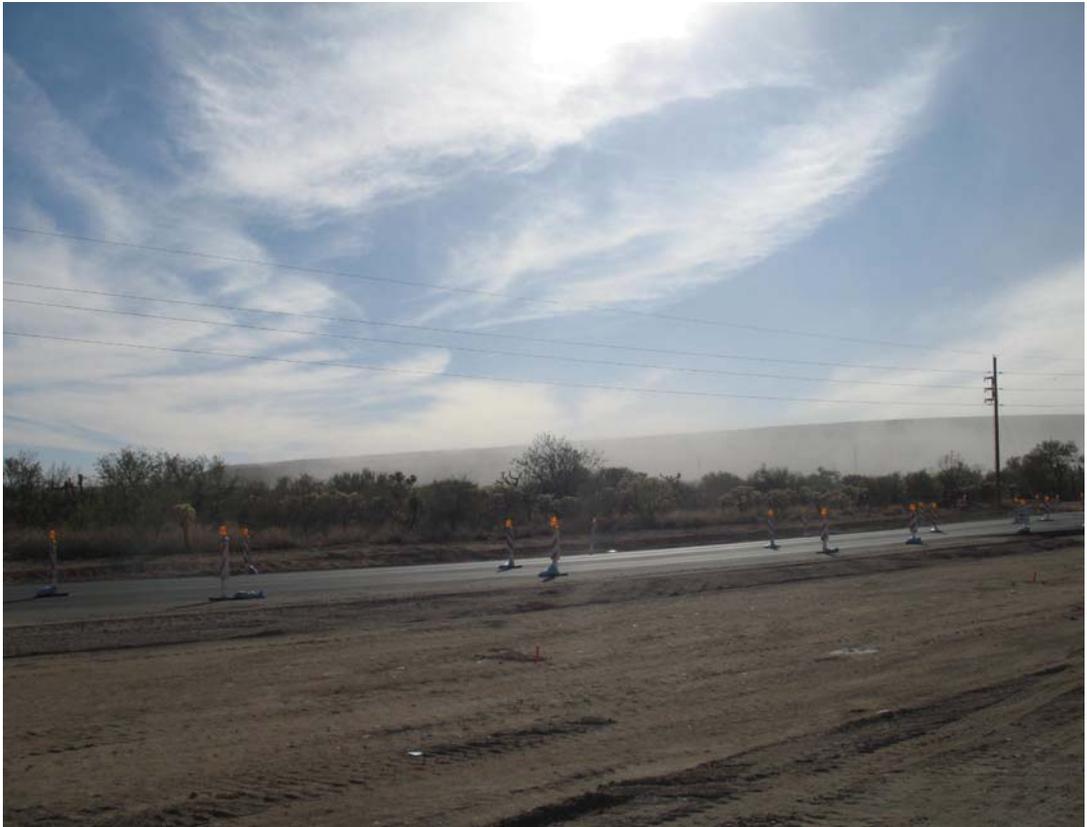
<p>Photo No. 3</p>

Upon arriving at the complaint location the inspector observed fugitive particulate emissions from tailings dam #8 (Attachment 1, Photo No's 2-4). The inspector observed that the excavator on top of the tailings dam was not operating. Between 2:58 pm and 3:00 pm the inspector observed fugitive particulate matter emissions along the edge of the east slope of tailings dam #8 that appeared to be swept by the winds from the top of the dam across Helmet Peak Road. The inspector's viewing position was not at a proper angle in relation to the sun location to perform a Method 9 Visible Emission evaluation (VE). The inspector measured the windspeed to be 12 mph average, 17 mph maximum, and direction from the southwest at the time of the observation.

<p>Date: 10/27/2009</p>	
<p>Photo Description:</p> <p>View fugitive particulate matter emissions from tailings tam #8 between 2:58 pm and 3:00 pm at the intersection of La Canada Drive and Helmet Peak Road.</p> <p>Fugitive particulate matter was observed crossing the property boundary along Helmet Peak Road.</p> <p>Windspeed and direction was measured to be 12 mph average, 17 mph maximum at the time and location of the observation from the south/southwest.</p>

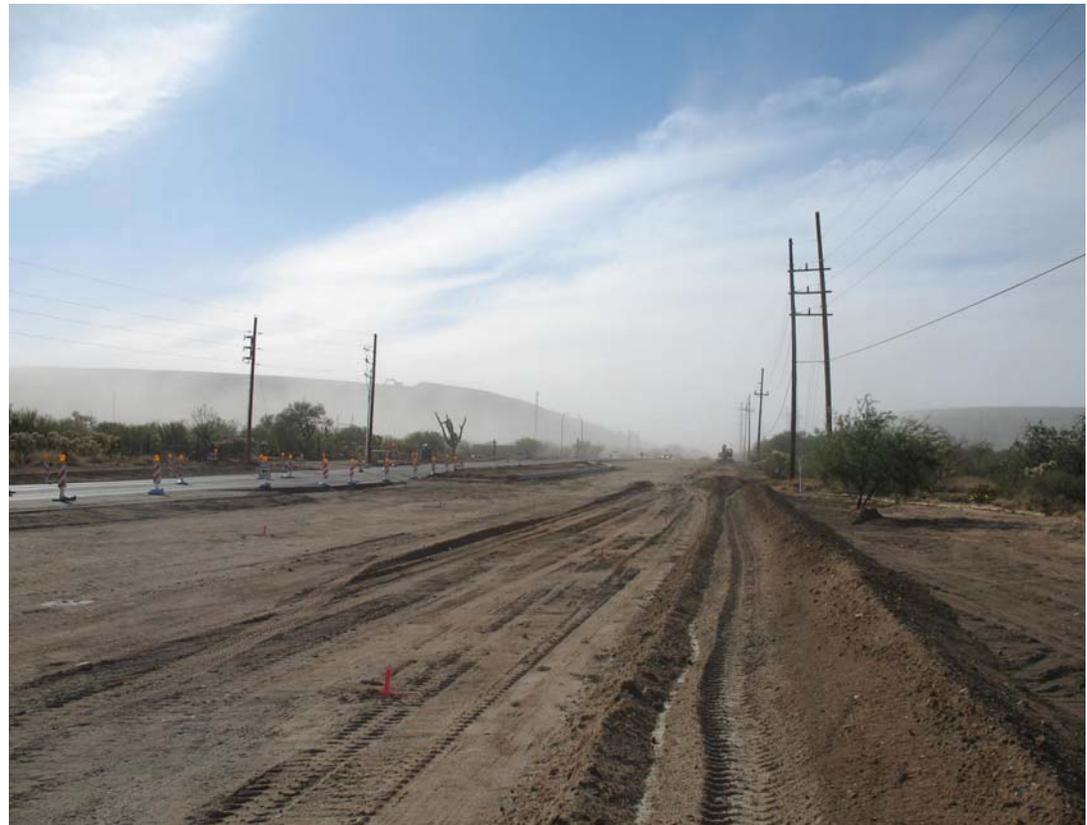
<p>Photo No. 4</p>

<p>Date: 10/27/2009</p>	
<p>Photo Description:</p> <p>View fugitive particulate matter emissions from tailings tam #8 between 2:58 pm and 3:00 pm at the intersection of LaCanada Drive and Helmet Peak Road.</p> <p>Windspeed and direction was measured to be 12 mph average, 17 mph maximum at the time and location of the observation from the south/southwest.</p>

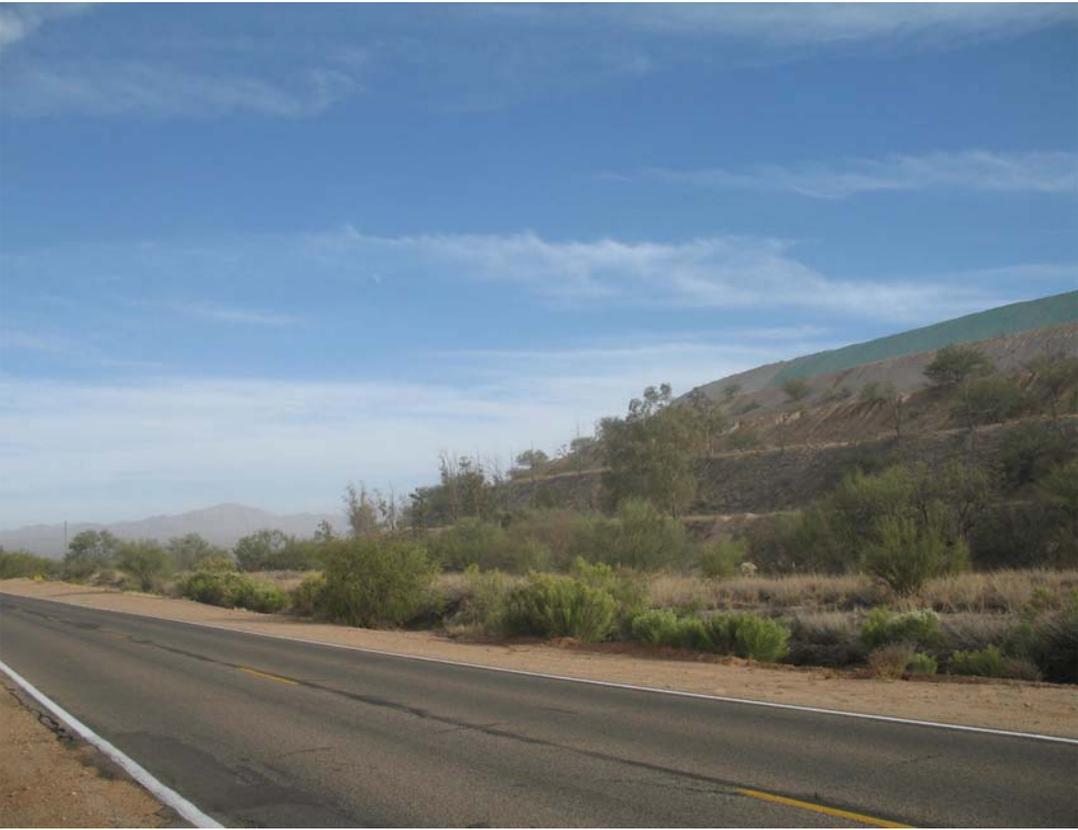
<p>Photo No. 5</p>

The inspector drove west on Helmet Peak Road to get a better vantage looking east that would provide an acceptable angle to perform a VE. The inspector observed that the sun was at an acceptable angle for a VE, but not ideal for the observation of emissions over the east slope of the tailings dam (Attachment 1, Photo 5). The inspector measured the windspeed to be 7 mph average, 16mph maximum, and direction from the southwest at the time of the observation. The inspector performed a VE (Attachment 2). The opacity was measured to be 0.6% between 3:21 pm and 3:27 pm at the time of the observation.

<p>Date: 10/27/2009</p>	
<p>Photo Description:</p> <p>View of northeast corner of tailings dam #8 looking southeast on Helmet Peak Road at 3:22 pm. A Method 9 VE reading was taken from this location (see Attachment #2).</p> <p>The windspeed was measured to be 7 mph average and 16mph maximum with a direction from the southwest at the time of the observation.</p>

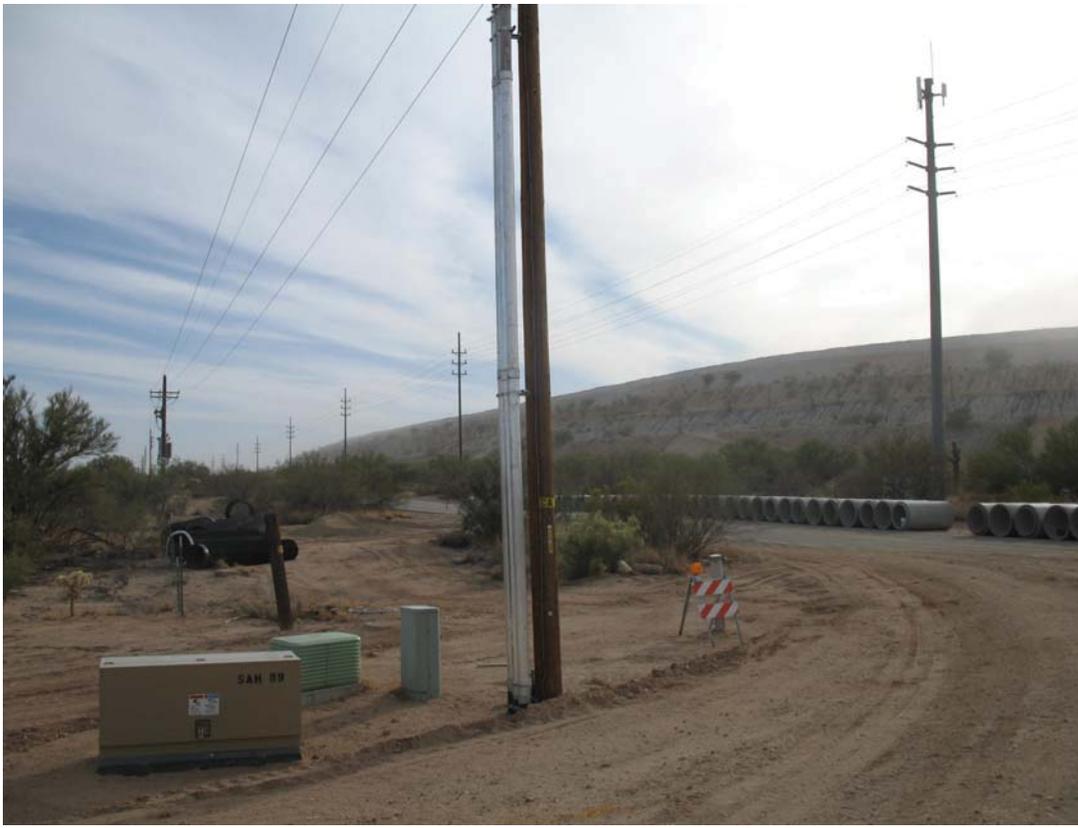
<p>Photo No. 6</p>

<p>Date: 10/27/2009</p>	
<p>Photo Description:</p> <p>View of northeast corner of tailings dam #8 looking south at 3:38 pm.</p>

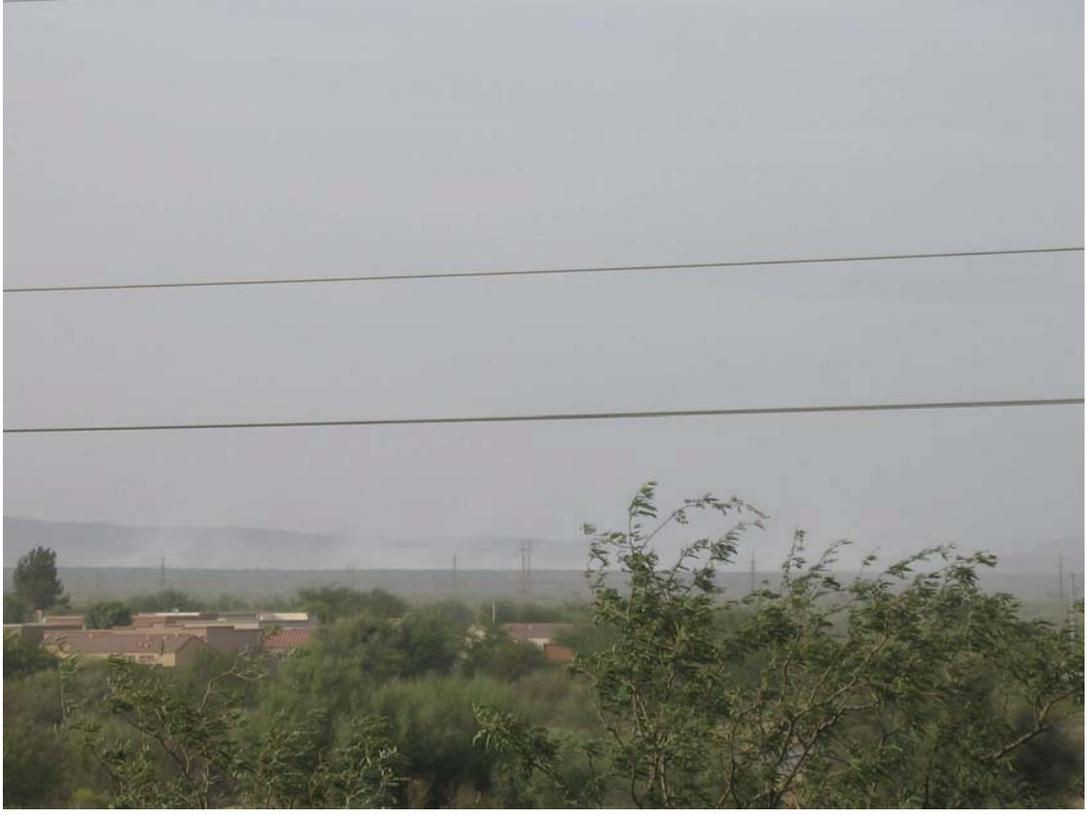
<p>Photo No. 7</p>

<p>Date: 10/27/2009</p>	
<p>Photo Description:</p> <p>View of fugitive particulate matter plume observed at 3:41 pm from the Sahuarita Road/ I-19 overpass looking northwest. The plume is north of tailings dam #8.</p>

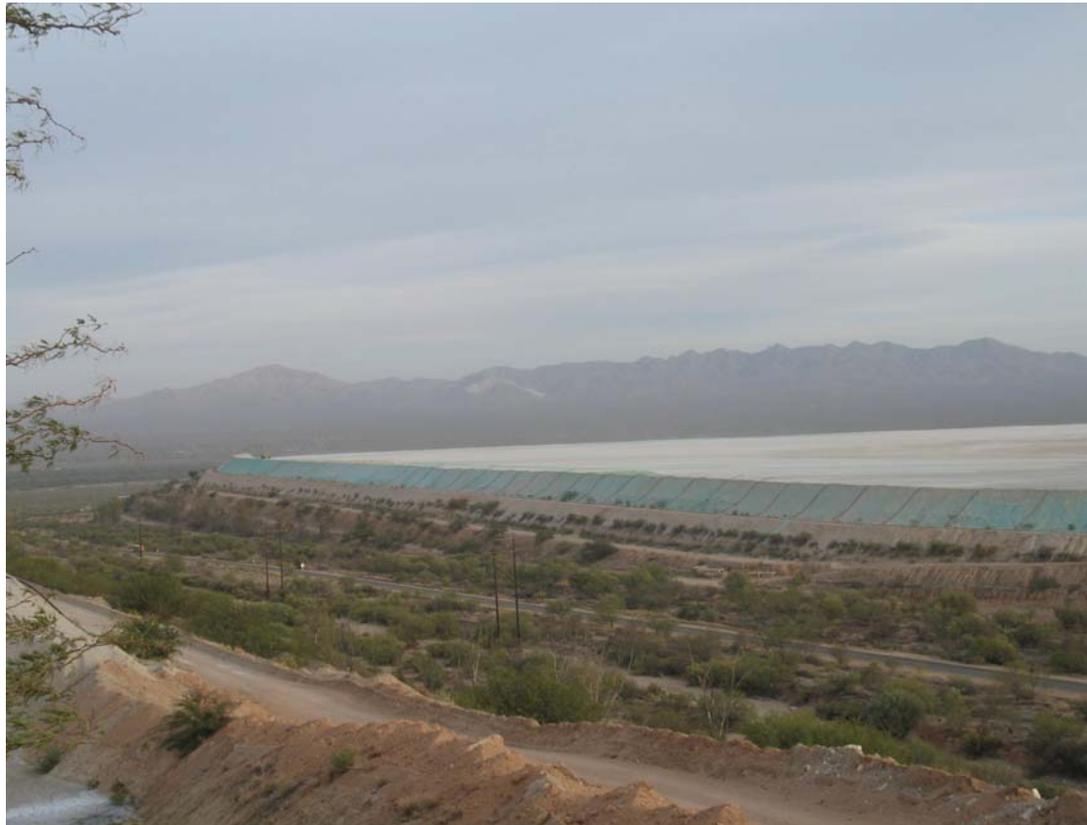
<p>Photo No. 8</p>

<p>Date: 10/27/2009</p>	
<p>Photo Description:</p> <p>View of the northeast corner of the top of tailings impoundment #8 from the southeast corner of tailings impoundment #6 (Point T-5 of Visual Observation Plan) at 4:56 pm.</p> <p>Windspeed was measured to be 18 mph average, 24 mph maximum at the time of the observation with direction from the southwest.</p> <p>No fugitive emissions were observed at the time of the observation.</p>

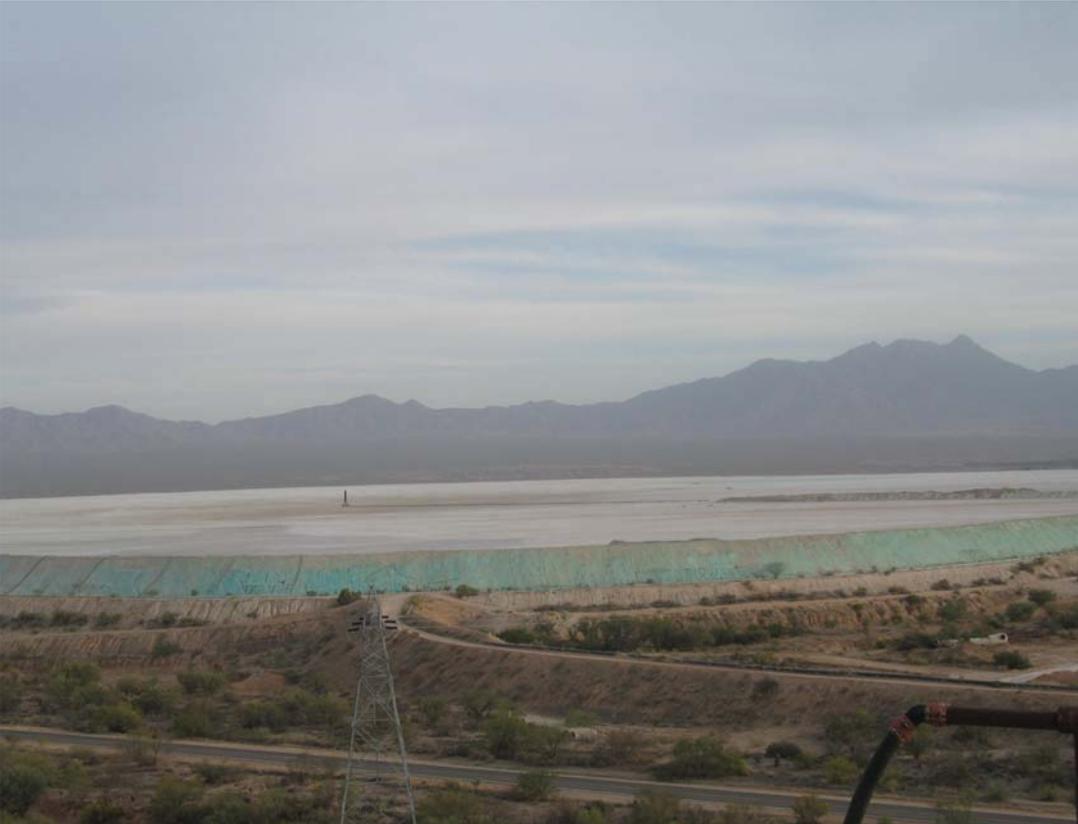
<p>Photo No. 9</p>

<p>Date: 10/27/2009</p>	
<p>Photo Description:</p> <p>View of the central area of the top of tailings impoundment #8 from the southeast corner of tailings impoundment #6 (Point T-5 of Visual Observation Plan) at 4:54 pm.</p> <p>Windspeed was measured to be 18 mph average, 24 mph maximum at the time of the observation with direction from the southwest.</p> <p>No fugitive emissions were observed at the time of the observation.</p>

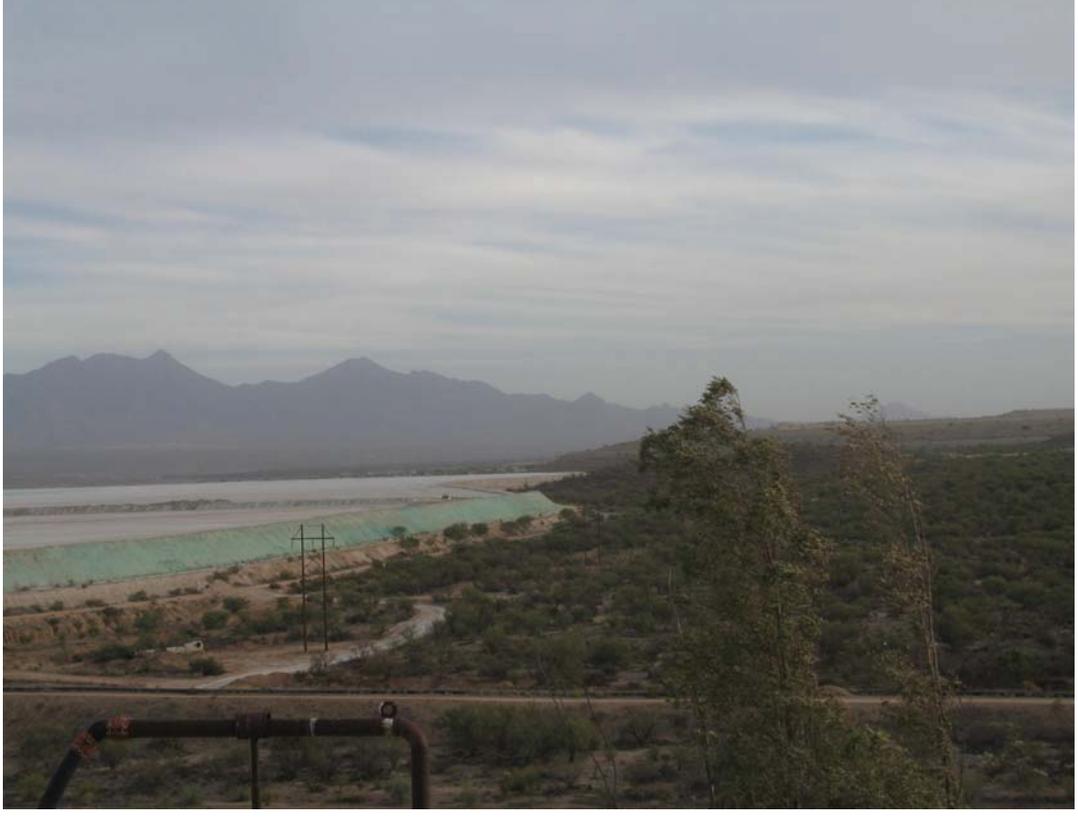
<p>Photo No. 10</p>

<p>Date: 10/27/2009</p>	
<p>Photo Description:</p> <p>View of the south west area of the top of tailings impoundment #8 from the southeast corner of tailings impoundment #6 (Point T-5 of Visual Observation Plan) at 4:54 pm.</p> <p>Windspeed was measured to be 18 mph average, 24 mph maximum at the time of the observation with direction from the southwest.</p> <p>No fugitive emissions were observed at the time of the observation.</p>

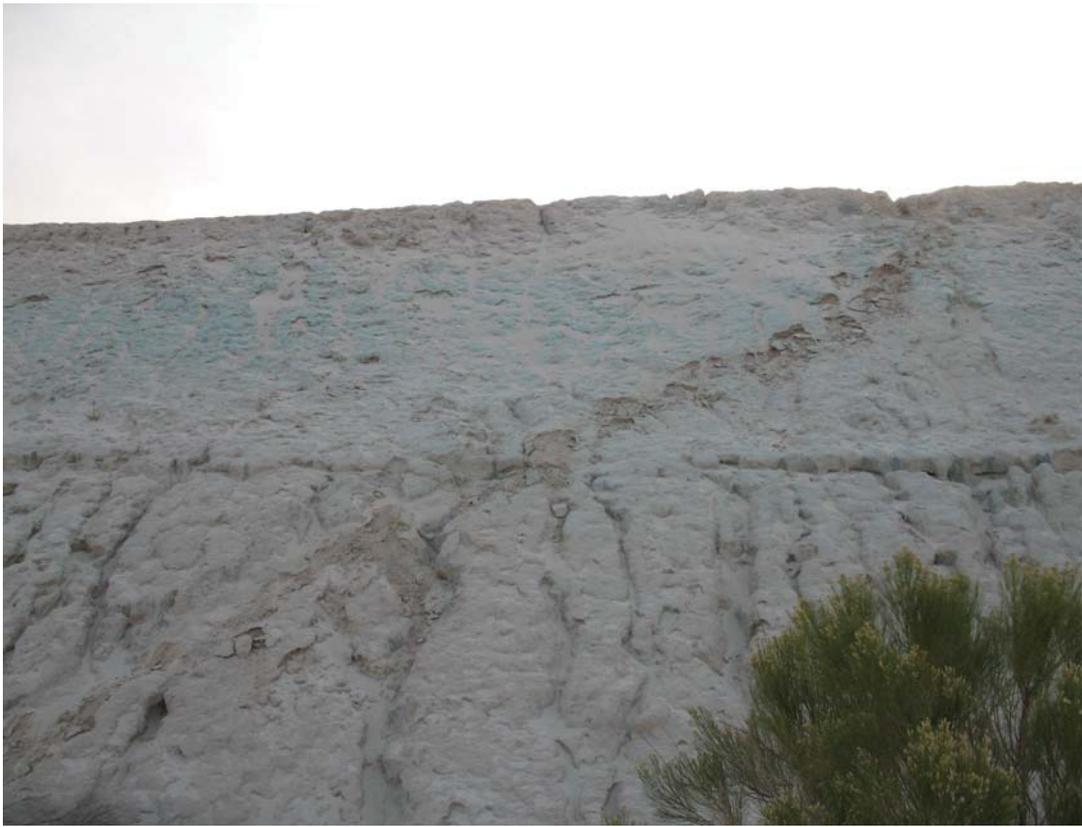
<p>Photo No. 11</p>

At the base of the upper east slope of tailings dam #8, the inspector observed tailings particulates strewn on the surface of the slope from fugitive emissions carried over the edge from the top surface of the tailing impoundment (Attachment 1, Photo No.11). The inspector observed the dam surface of the east slope to be relatively stable and encrusted. The inspector walked up the slope with Mr. Ekholm to the top of the tailings impoundment and observed the top surface from the southeast side around 5:15 pm (Attachment 1, Photo No. 12). The inspector observed that selective areas on the inside perimeter of tailings dam #8 had a blue green color indicating that polymer had been strategically applied to areas of the tailings dam. The inspector measured an average windspeed of greater than 25 mph and increasing at that time and observed across the top surface that there were relatively light particulate emissions sporadically generated from the top surface by the action of the winds. No significant fugitive particulate plumes were observed at that time. A layer of light colored particulate matter could be seen on the east access road of tailing dam #8, which appeared to have been carried by winds from the surface of the tailing impoundment (Attachment 1, Photo No. 13).

<p>Date: 10/27/2009</p>	
<p>View of the east slope of the upper tailings dam of tailings dam #8, where the inspector accessed the top of the dam to make observations.</p> <p>Coarser tailings particulates were observed on the slope surface carried over from emissions from the top surface.</p>
