**PIMA DEPARTMENT OF ENVIRONMENTAL QUALITY
AIR PROGRAM**

OPPORTUNITY TO CORRECT - TRACKING # 0910-122

Complaint Investigation Report

Tracking ID: PC0910-086

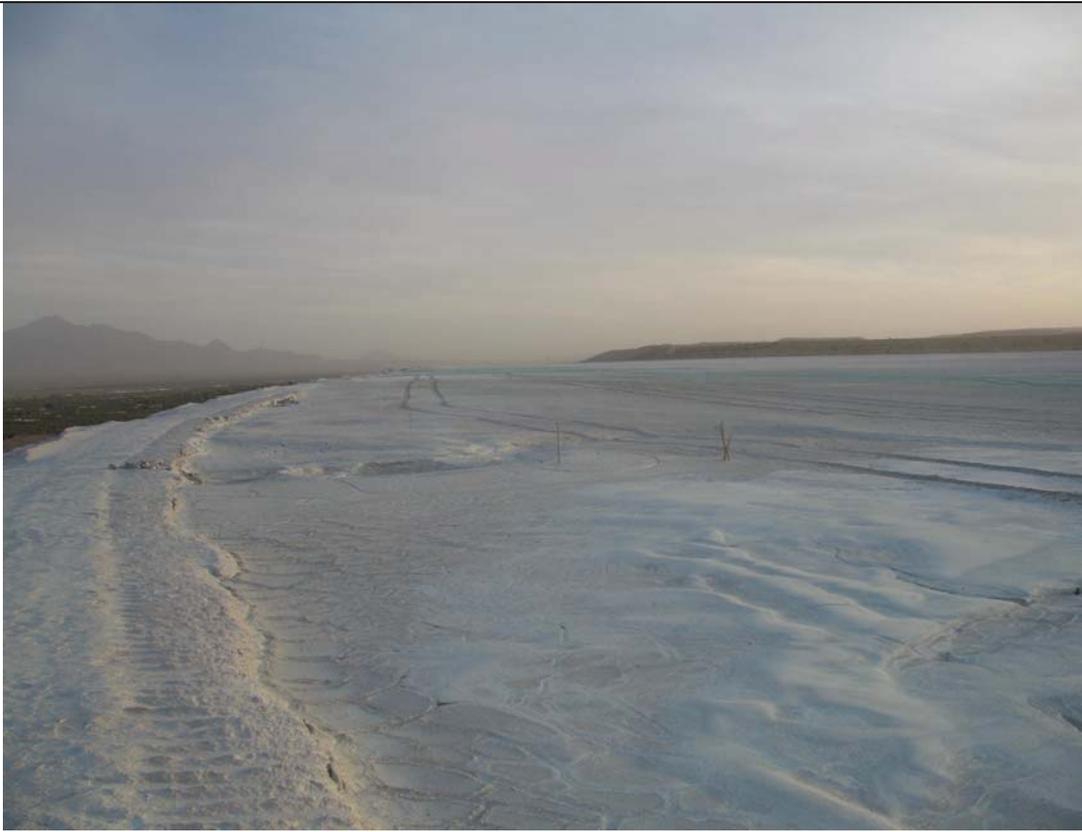
<p>Photo No. 12</p>

<p>Date: 10/27/2009</p>	
<p>Photo Description:</p> <p>View of the top of the #8 tailings surface as observed from the southeast side at 5:15 pm.</p> <p>Fugitive particulate emissions were observed sporadically generated from a few areas of top of the impoundment surface on the areas to the southwest.</p> <p>The windspeed was measured to be 25 mph average with a 29 mph maximum and direction from the southwest.</p>

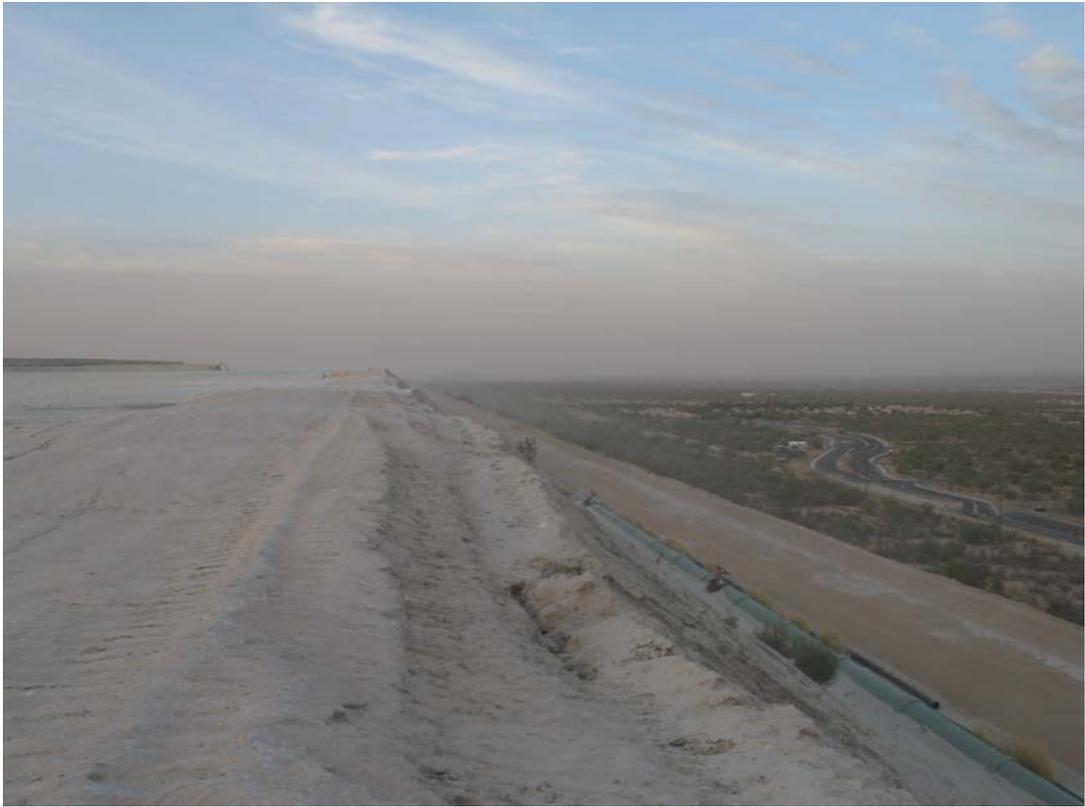
<p>Photo No. 13</p>

<p>Date: 10/27/2009</p>	
<p>Photo Description:</p> <p>View of the top of the tailings #8 before taking Method 9 VE.</p> <p>Light colored particulate matter observed on east side access road deposited by wind from surface of tailings dam #8.</p>

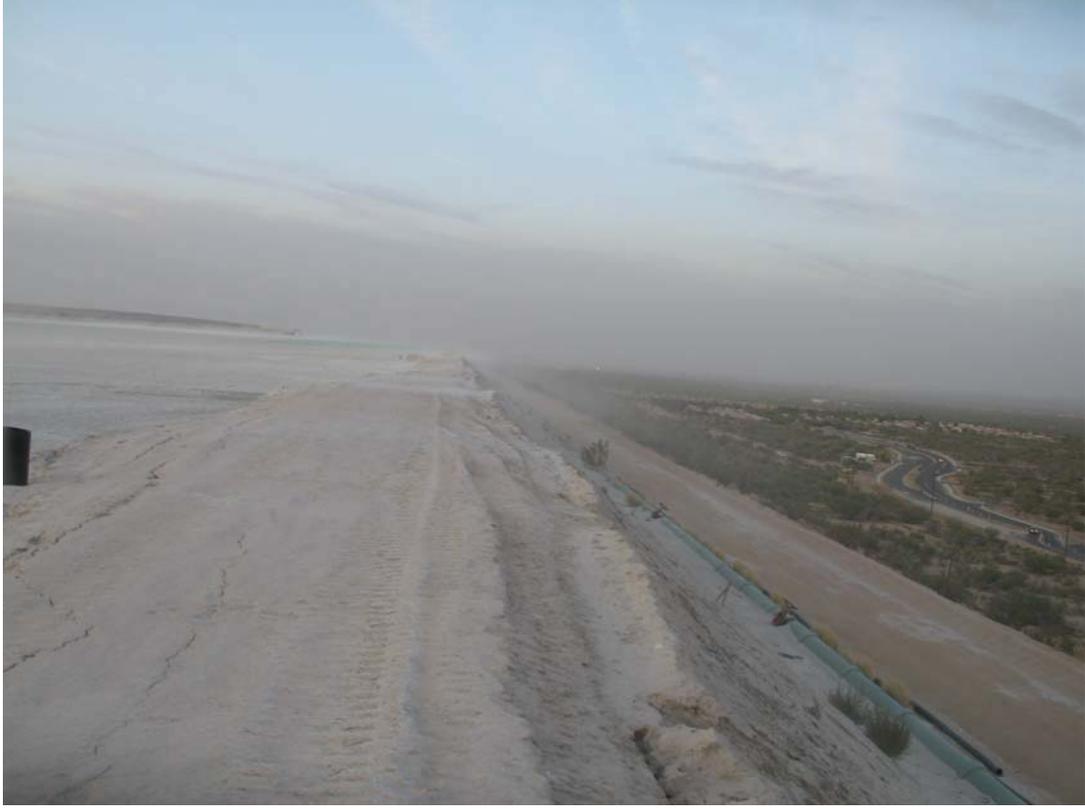
<p>Photo No. 14</p>

inner impoundment surface area were observed by the inspector as they crossed the east slope of the dam. The opacity was measured to be an average 29.8 % between 5:24 and 5:31 pm (Attachment 4).

<p>Date: 10/27/2009</p>	
<p>Photo Description:</p> <p>View of the fugitive particulate emissions from the top of the tailings #8 impoundment surface blowing across the east slope at 5:33 pm.</p> <p>A Method 9 VE was taken of emissions at this location. The emissions were determined to have an average of 29.8 % opacity.</p>
