PIMA COUNTY
DEPARTMENT OF ENVIRONMENTAL QUALITY
33 N. Stone Avenue, Suite 700
Tucson, Arizona 85701-1429
www.deq.pima.gov

January 11, 2013

ASARCO LLC – Mission Complex
Attn: Thomas H. Phillips, General Manager
4201 W. Pima Mine Road
Sahuarita, AZ 85629

NOTICE OF VIOLATION # PC 1212-045

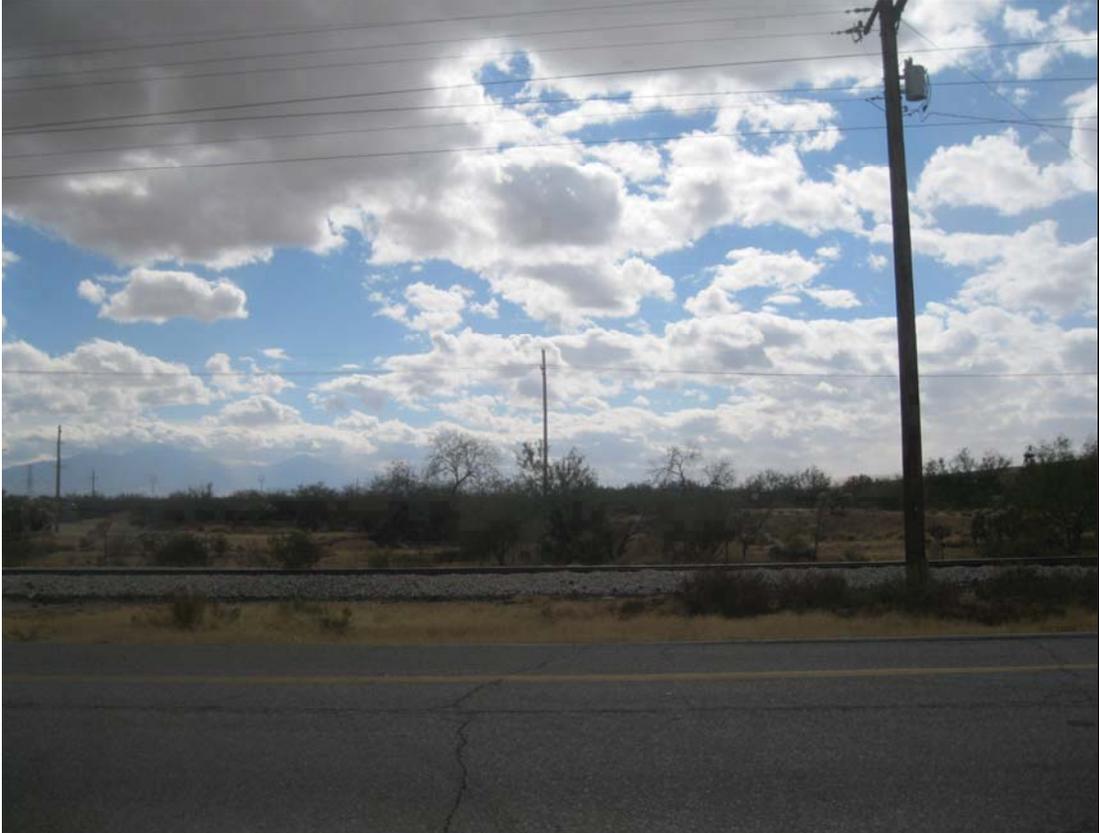
<p>Photo No. 5</p>

<p>Date: 12/13/2012</p>	
<p>Photo Description:</p> <p>View of background and horizon looking toward the south. Fugitive dust can be observed on the horizon in the direction of the telephone pole on the right. This is in the direction of Tailings Impoundments #7 and #8.</p>

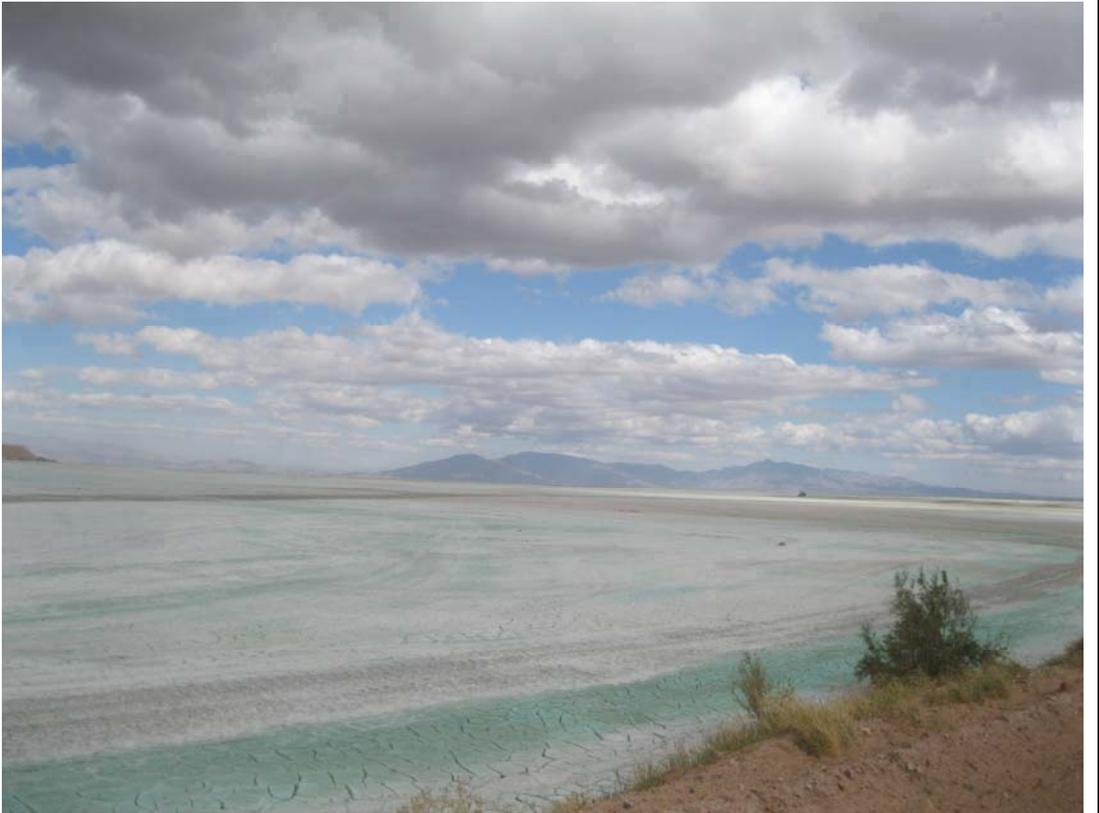
<p>Photo No. 6</p>

<p>Date: 12/13/2012</p>	
<p>Photo Description:</p> <p>View of Tailings Impoundment #8 surface looking toward the northeast. A water truck can be observed on the right.</p>

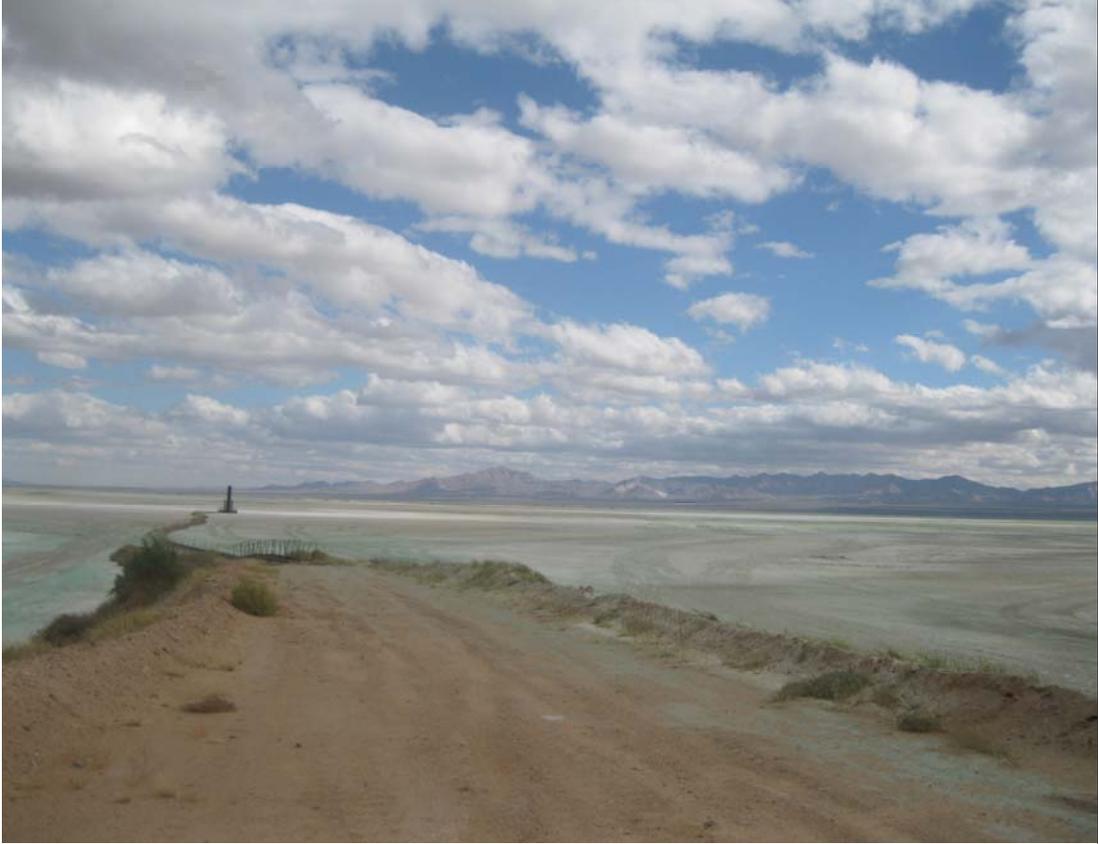
<p>Photo No. 7</p>

<p>Date: 12/13/2012</p>	
<p>Photo Description:</p> <p>View of Tailings Impoundment #8 surface looking toward the east. The decant tower is to the left.</p>

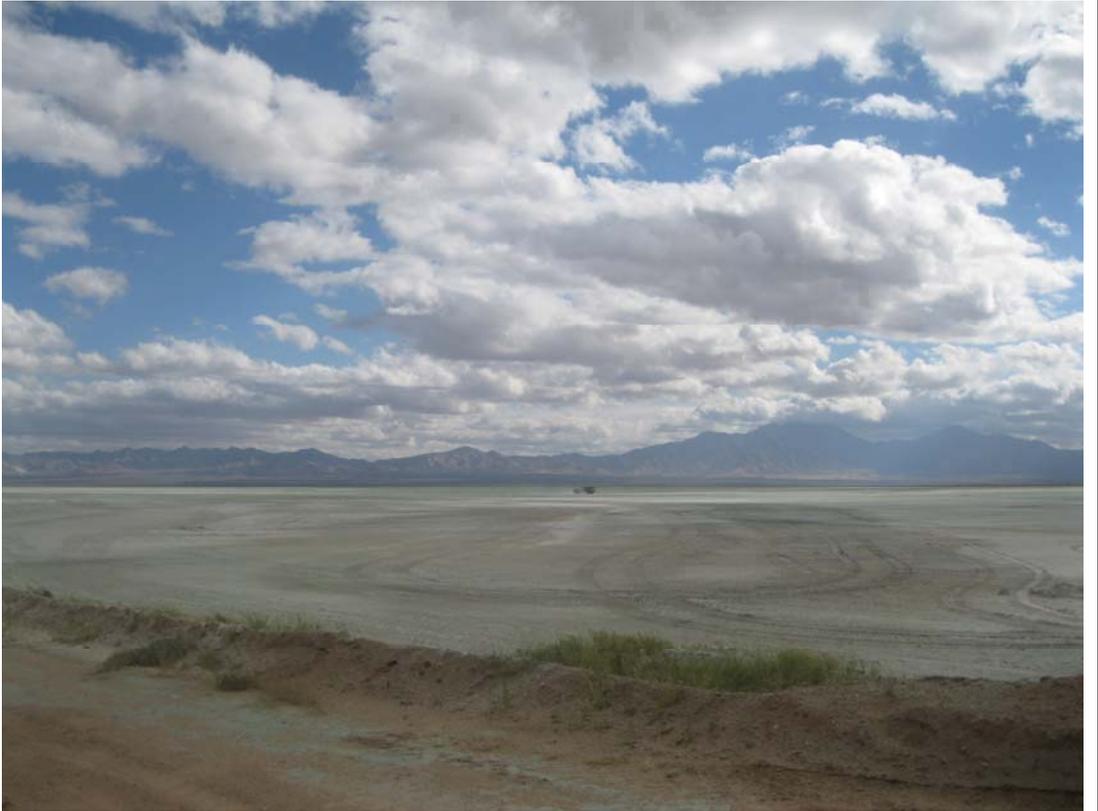
<p>Photo No. 8</p>

<p>Date: 12/13/2012</p>	
<p>Photo Description:</p> <p>View of a second water truck on the impoundment surface looking toward the southeast.</p>

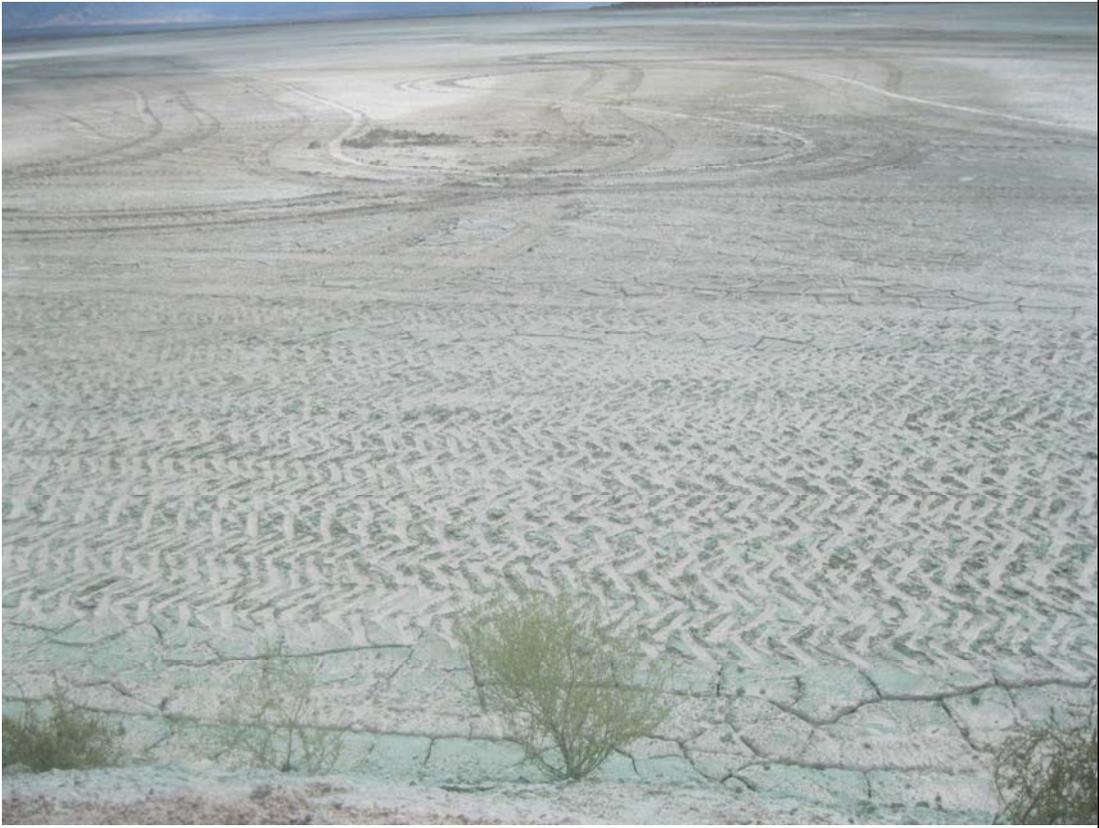
<p>Photo No. 9</p>

<p>Date: 12/13/2012</p>	
<p>Photo Description:</p> <p>View of the impoundment surface looking toward the southeast from the pier. Old and new tire tracks were observed from vehicles traveling on the impoundment surface. Wet areas from recent water applications were also observed.</p>

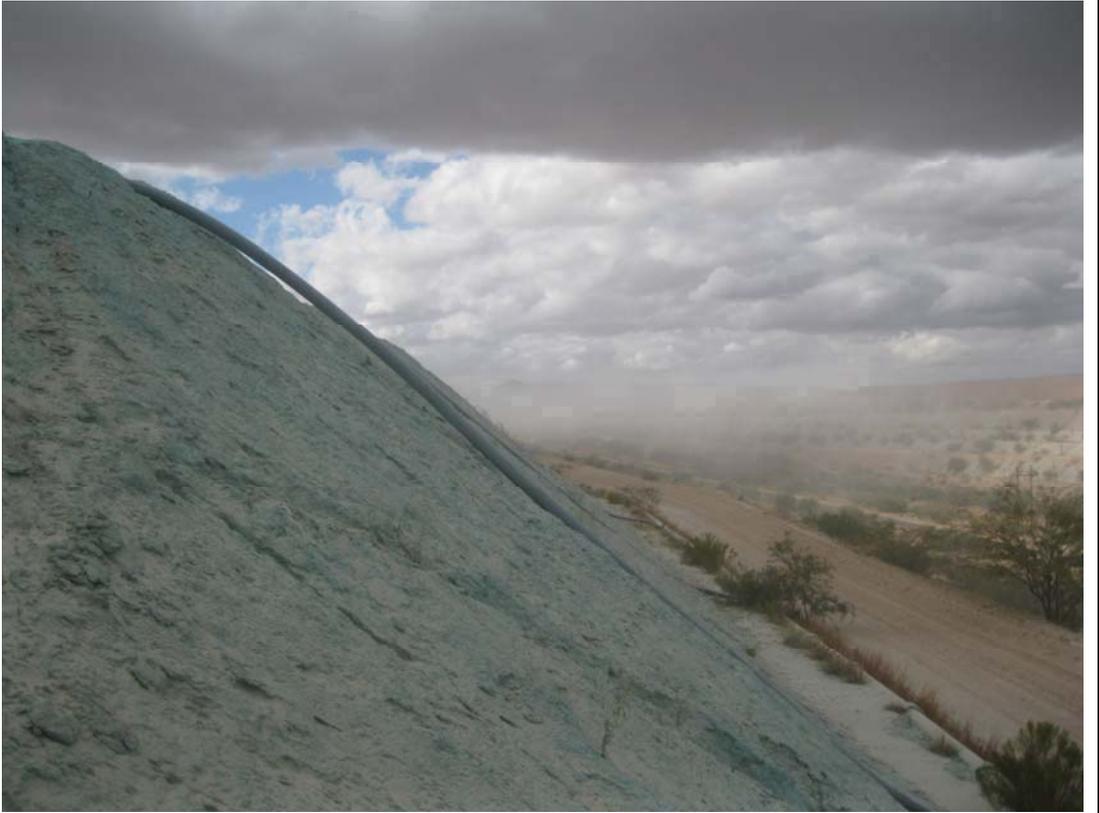
<p>Photo No. 10</p>

<p>Date: 12/13/2012</p>	
<p>Photo Description:</p> <p>View of a dust emission plume over the north slope near the northeast area of the tailings impoundment.</p>

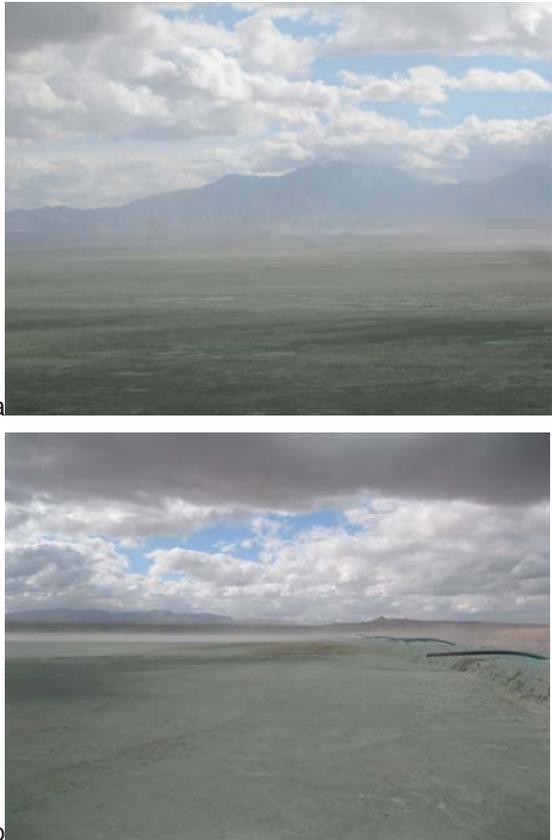
<p>Photo No. 11 a, b</p>

<p>Date: 12/13/2012</p>	
<p>Photo Description: Another view of the dust emissions plumes observed while on the northeast impoundment area.</p>

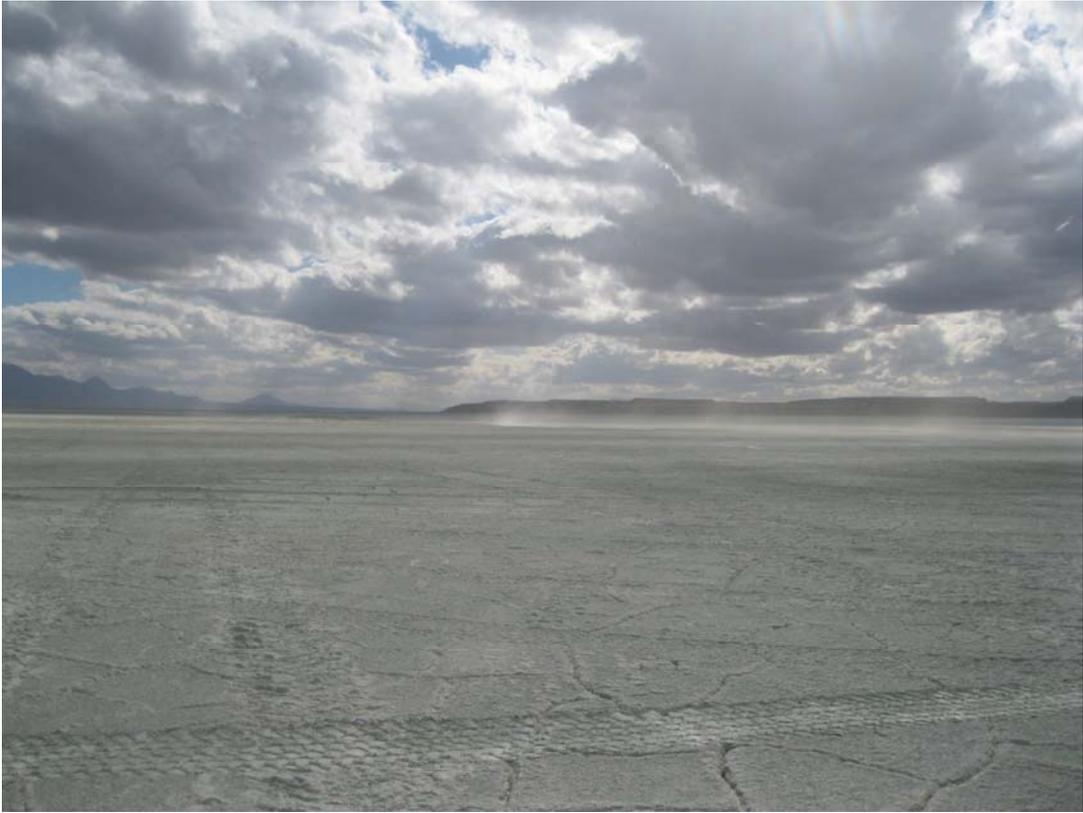
<p>Photo No. 12</p>

<p>Date: 12/13/2012</p>	
<p>Photo Description: View of a brief emission plume generated while examining the surface conditions in the northeast area of the impoundment looking towards the south/southwest.</p>

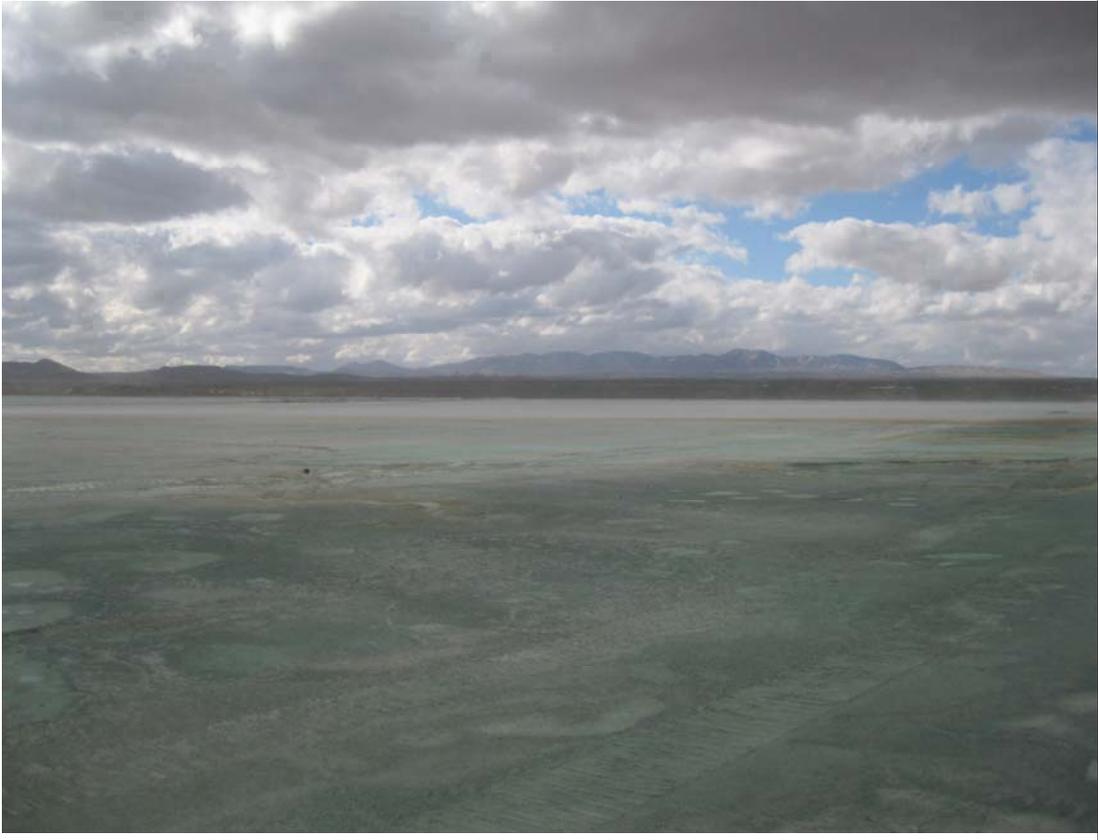
Photo No. 13

Date: 12/13/2012	
Photo Description: View of the impoundment surface in the direction where a dust plume was observed originating.

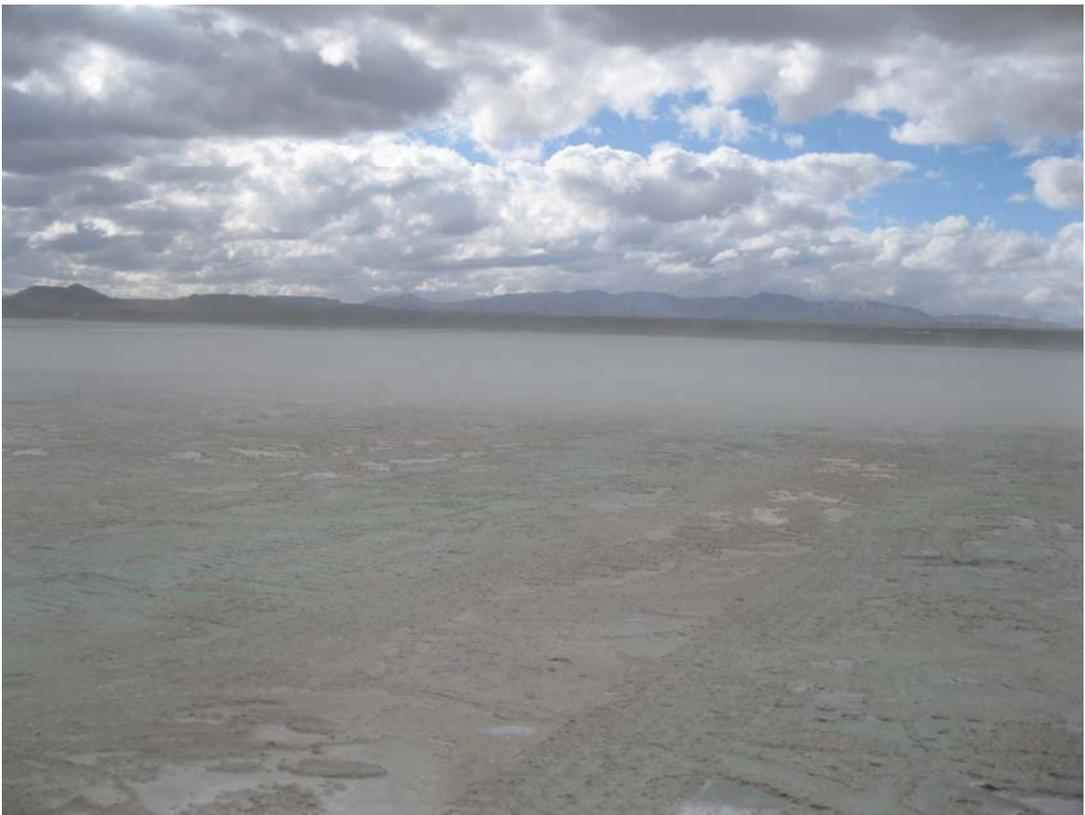
Photo No. 14

Date: 12/13/2012	
Photo Description: View of the surface near the area where dust emissions were occurring at the time.

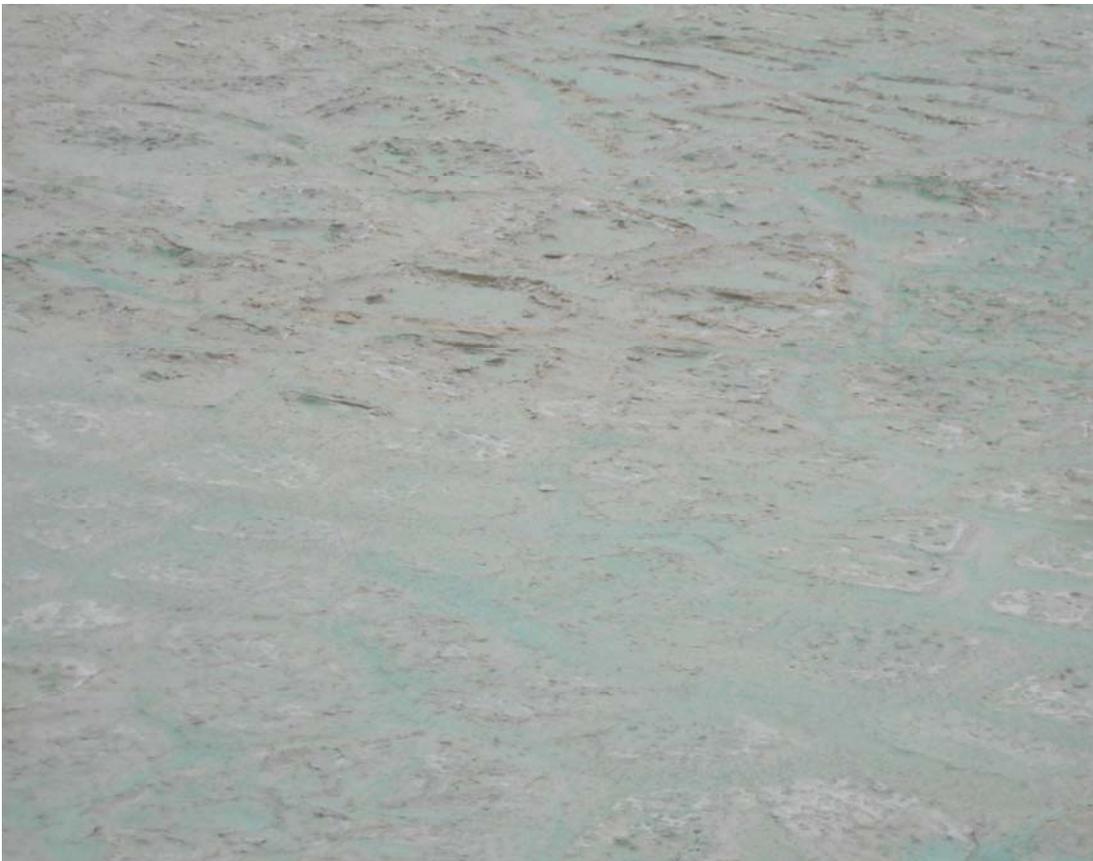
<p>Photo No. 15</p>

<p>Date: 12/13/2012</p>	
<p>Photo Description:</p> <p>View of polymer interspersed on the impoundment surface.</p>

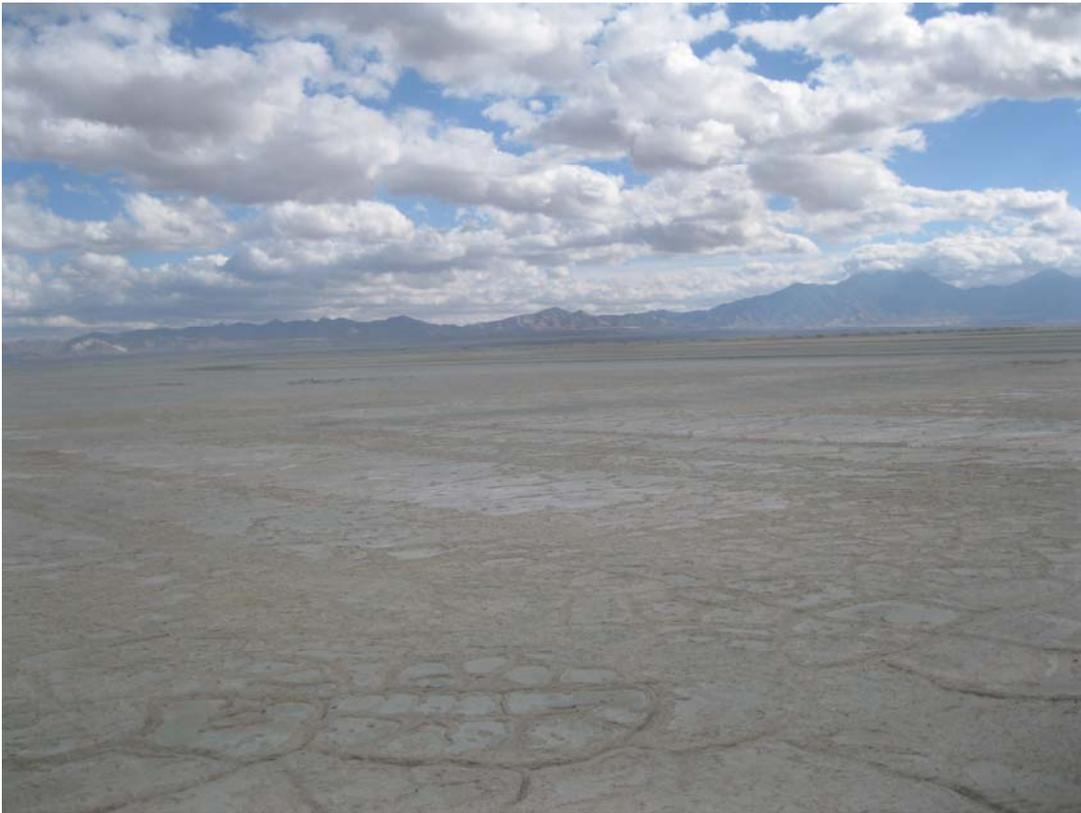
<p>Photo No. 16</p>

<p>Date: 12/13/2012</p>	
<p>Photo Description:</p> <p>View of the surface pattern and condition. The smooth areas have a relatively hard crust. The coarser areas are softer yielding under foot pressure.</p>

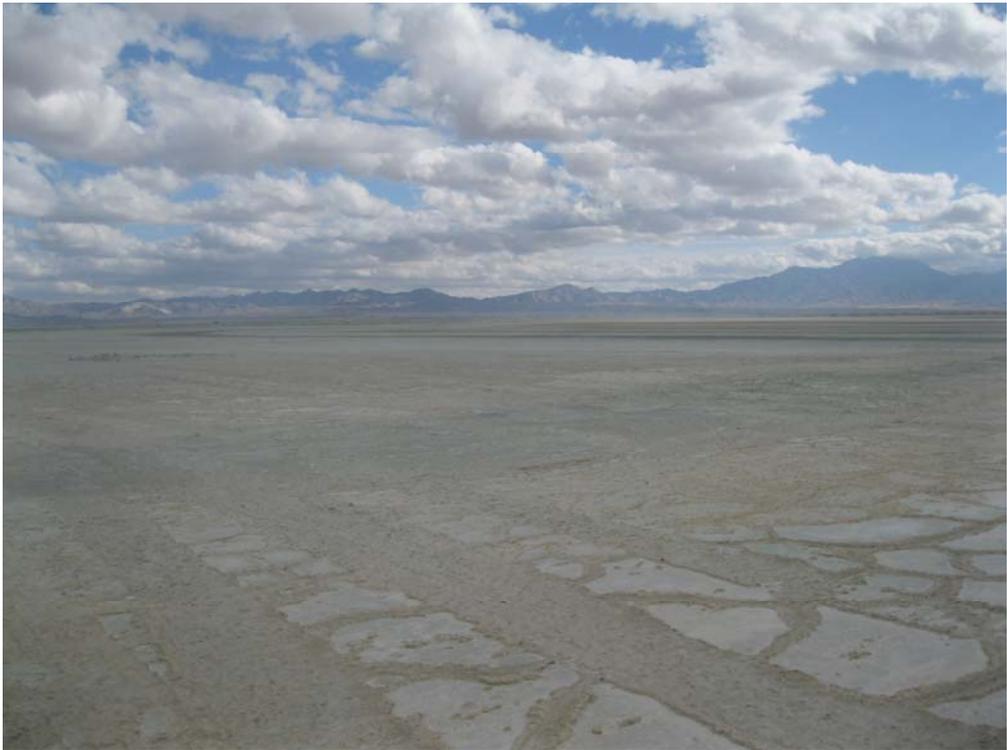
Photo No. 17

Date: 12/13/2012	
Photo Description: Another view of the predominant surface condition observed in the northeast looking towards the southeast.

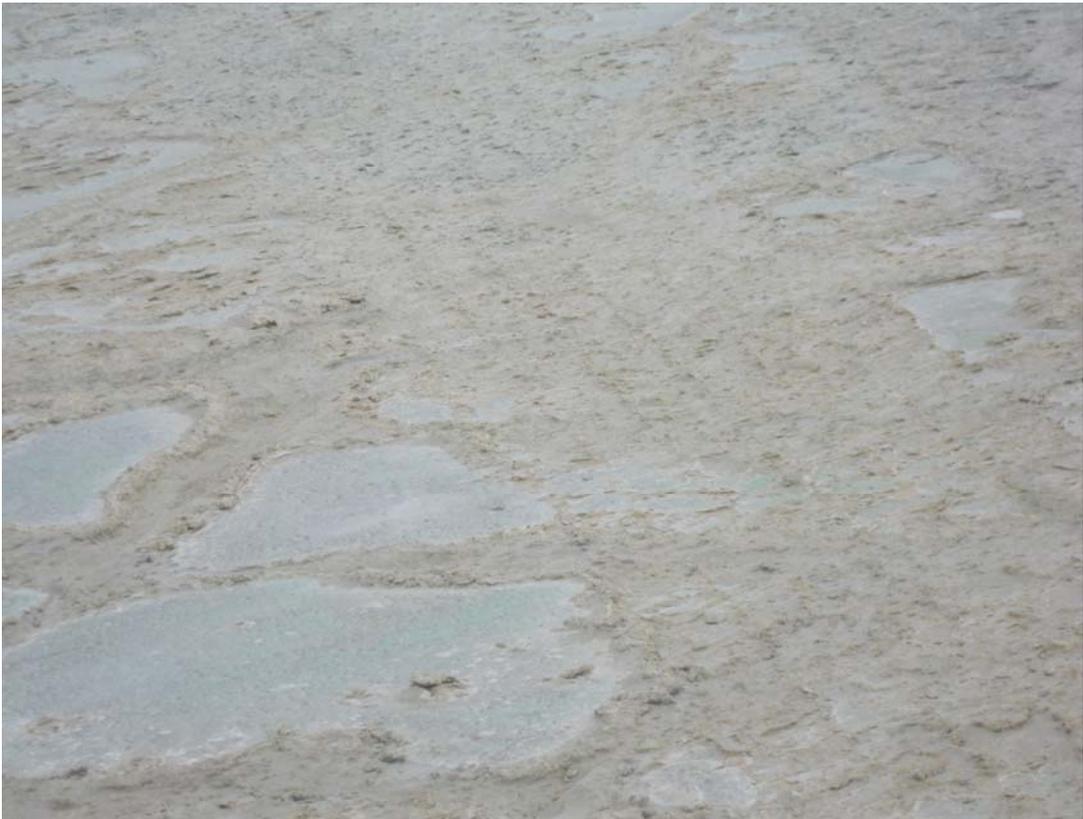
Photo No. 18

Date: 12/13/2012	
Photo Description: Close up view of surface pattern and condition.

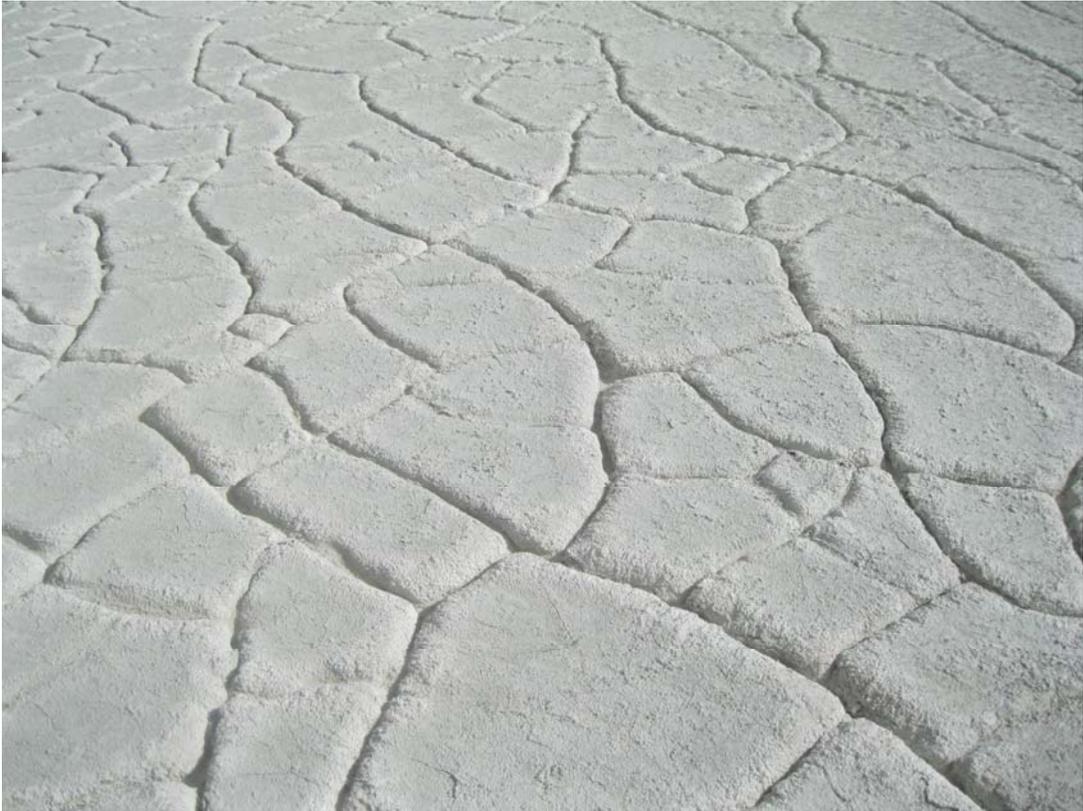
Photo No. 20

Date: 12/13/2012	
Photo Description: View of a different surface texture and condition observed in another part of the northeast area.

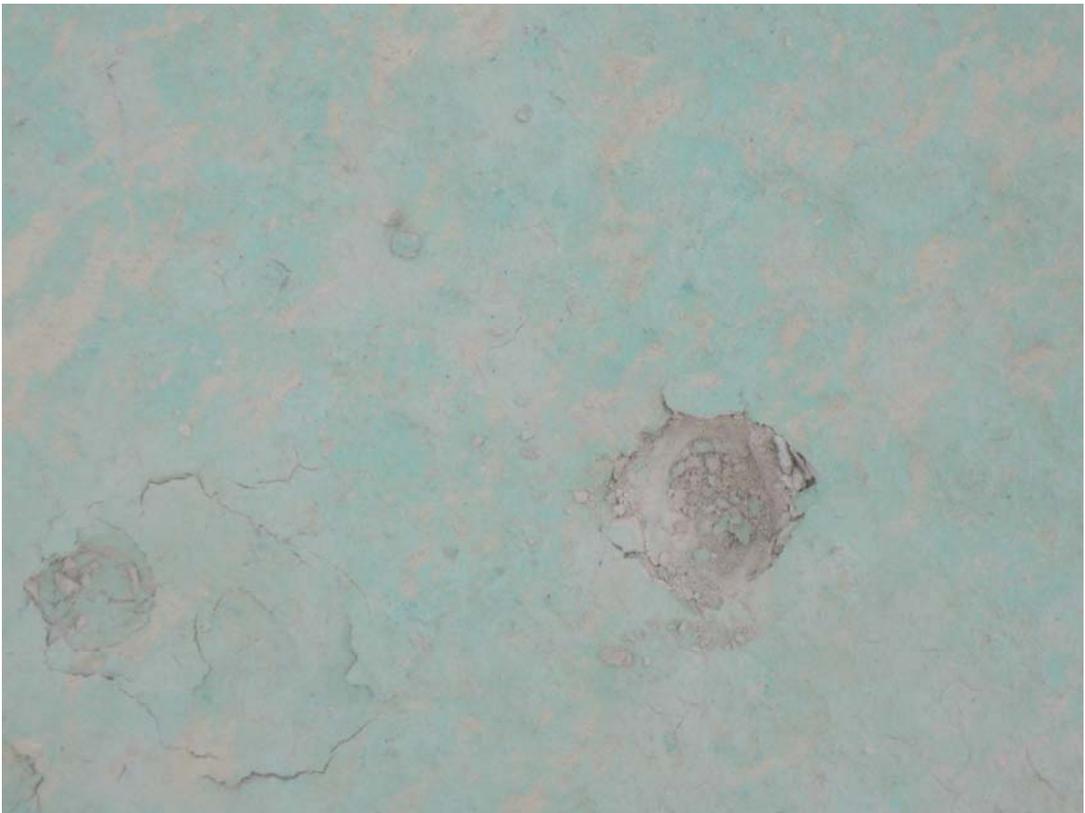
Photo No. 22

Date: 12/13/2012	
Photo Description: View of one of the coarser areas depicted in photo No. 16. The material exhibited a thin crust. The area on the right was made with slight thumb pressure.

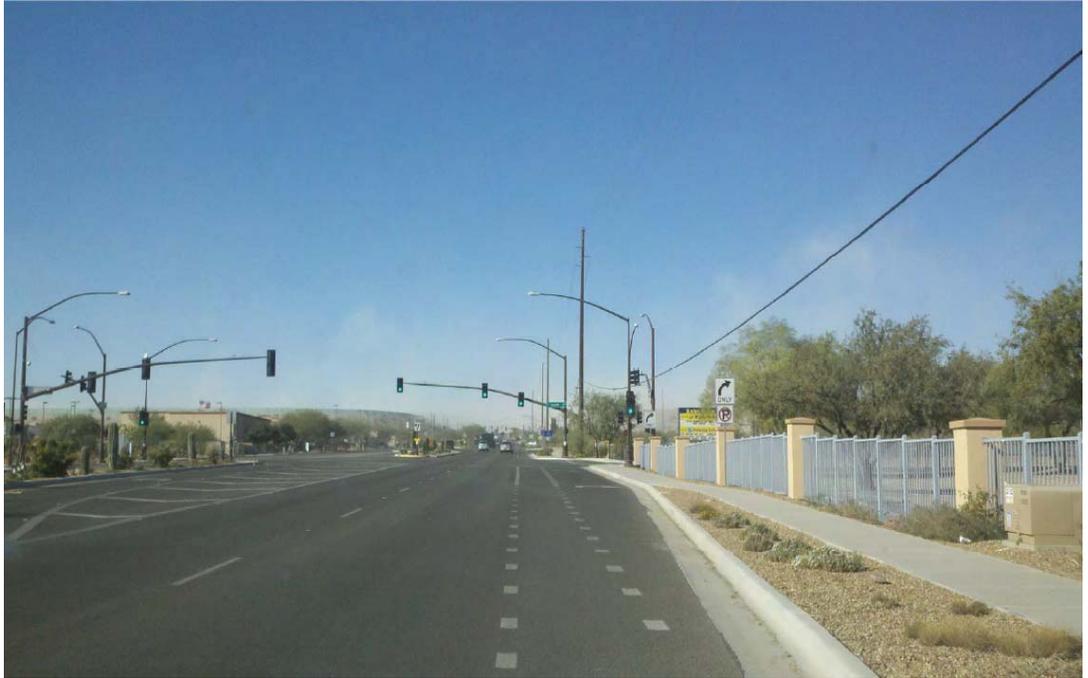
View of the Sahuarita Road looking west at Tailings Impoundment #8.

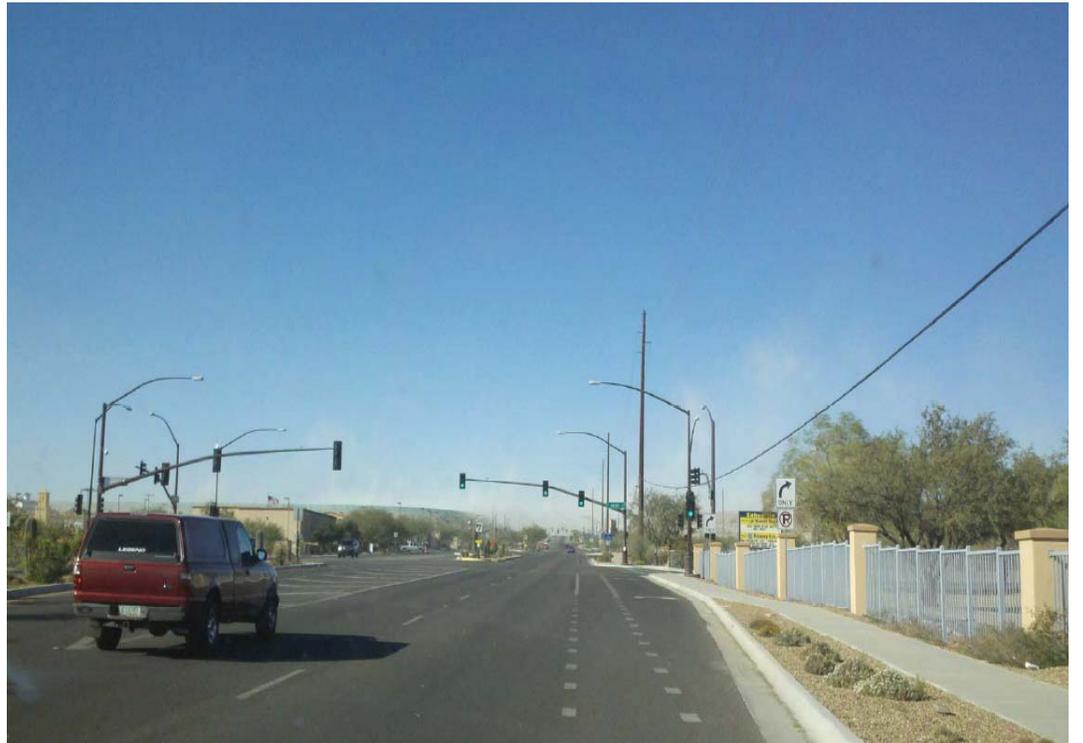
Photo No. 2

View of the Sahuarita Road looking west at Tailings Impoundment #8.

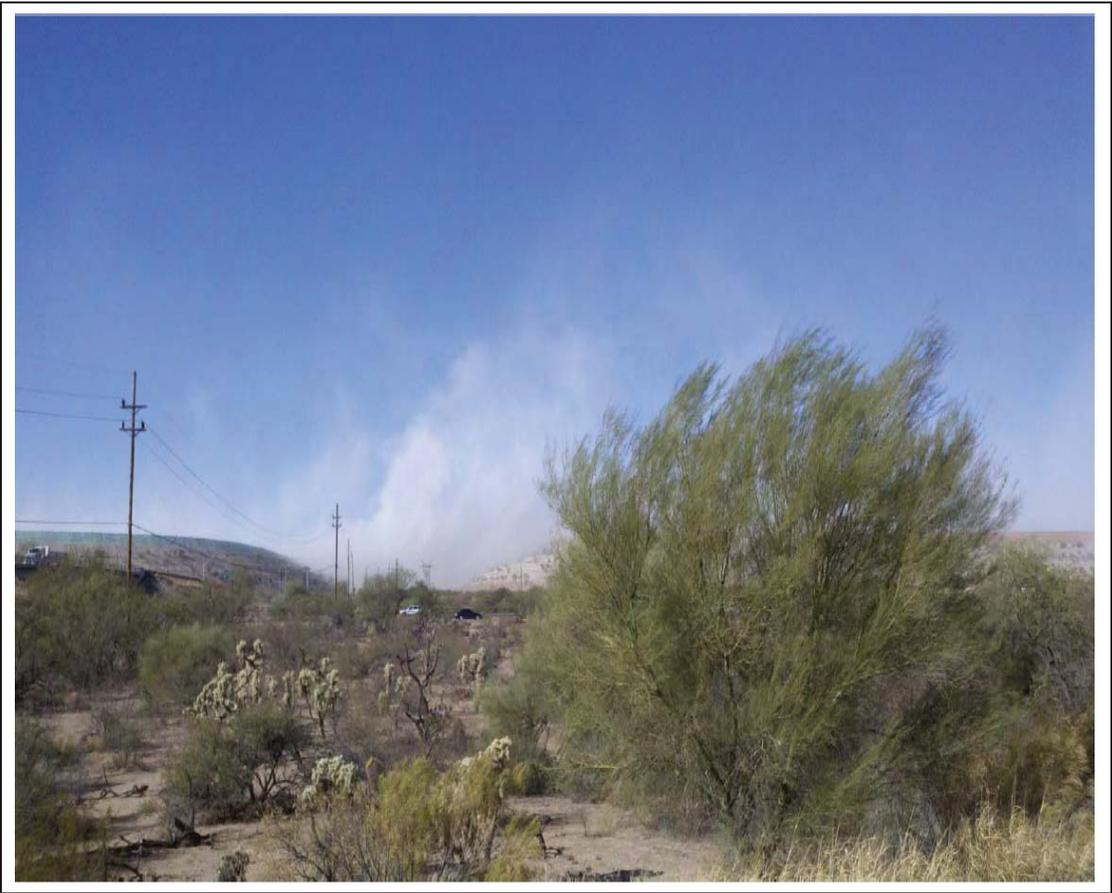
Photo No. 3

Date/Time: 12/13/2012 10:27 AM	
Photo Description: View from northbound on ramp to I-19 looking west at Tailings Impoundment #8.

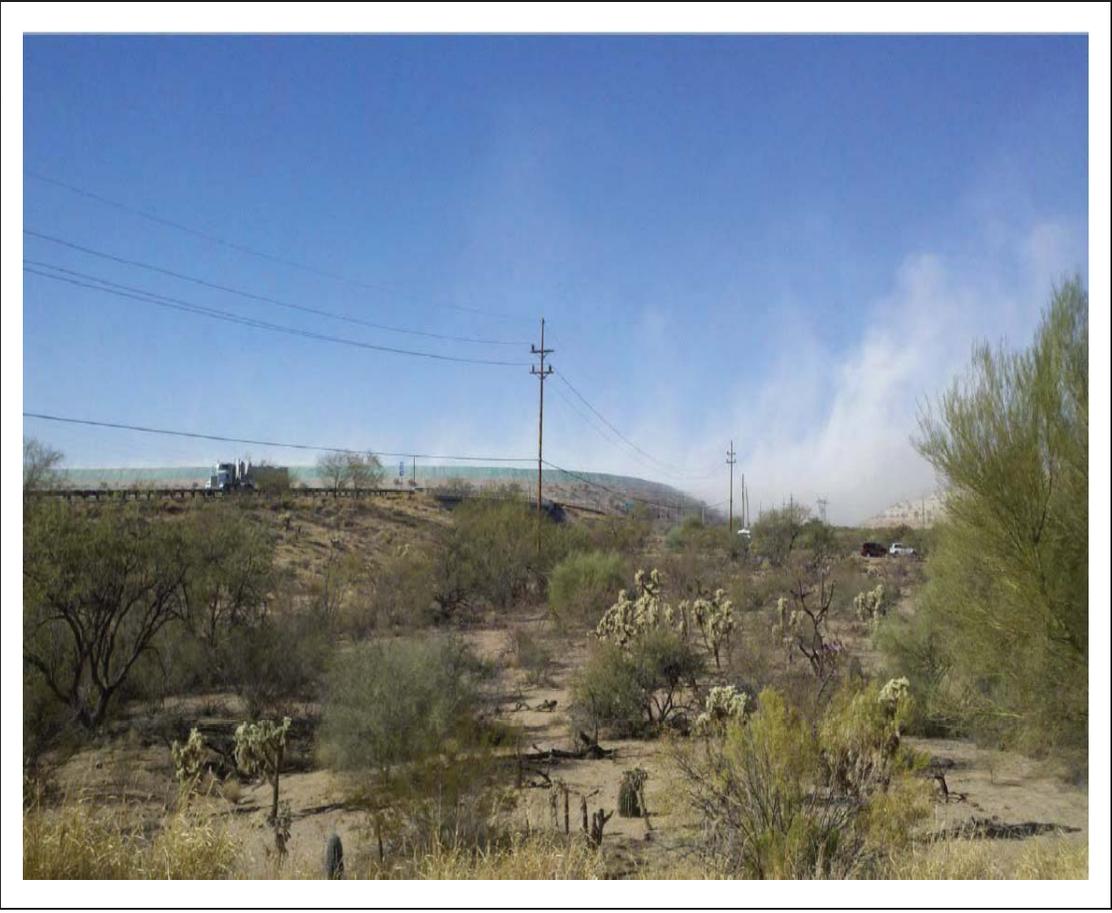
Photo No. 4

Date/Time: 12/13/2012 10:28 AM	
Photo Description: View from northbound on ramp to I-19 looking west at Tailings Impoundment #8.
