ASARCO LLC – Mission Complex
Attn: Thomas H. Phillips, General Manager
4201 W. Pima Mine Road
Sahuarita, AZ 85629

NOTICE OF VIOLATION # PC 1301-055

Site Location: ASARCO LLC – Mission Complex 4201 W. Pima Mine Road, Sahuarita, AZ	Photographer: J. M. Jones	Tracking #: PC 1301-055
--	-------------------------------------	-----------------------------------

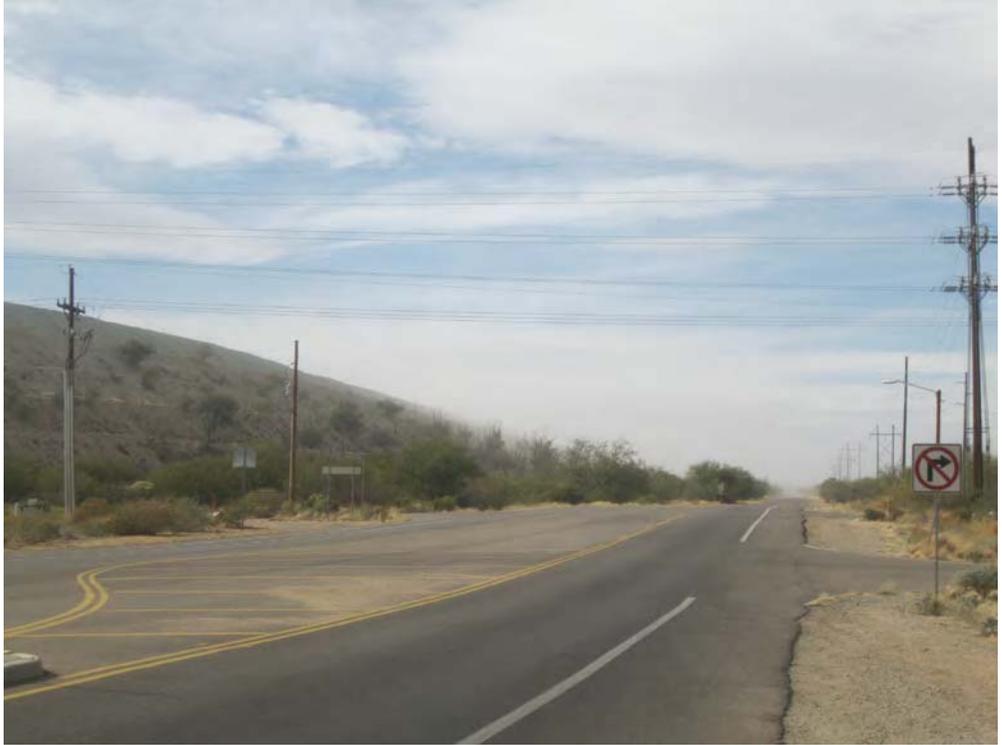
I drove to the Sahuarita Road exit from I-19 and observed particulate emissions generated from the surface of Asarco Tailings Impoundment #8 diffusing north across the property boundary at Helmet Peak Road around 1:15 pm (Attachment 1, Photo No.'s 1-2).

Photo No. 1
Date: 1/10/2013
Photo Description: View of emissions generated from the top of tailings dam #8 diffusing across Helmet Peak Road.

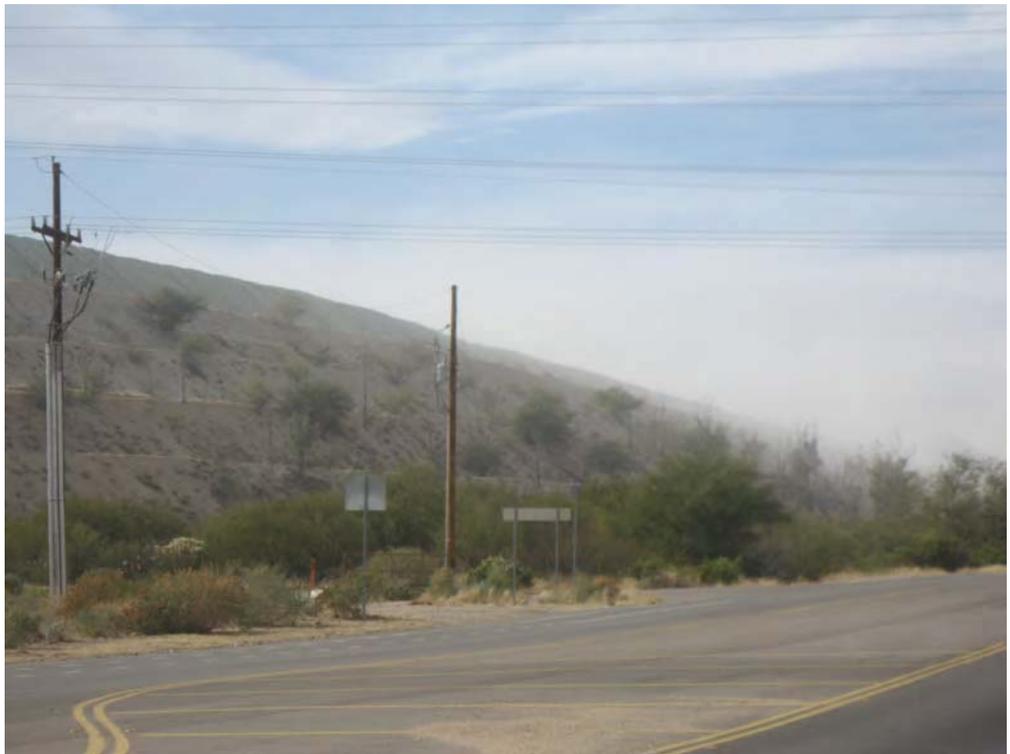
Photo No. 2
Date: 1/10/2013
Photo Description: Closer view of emissions generated from the surface.

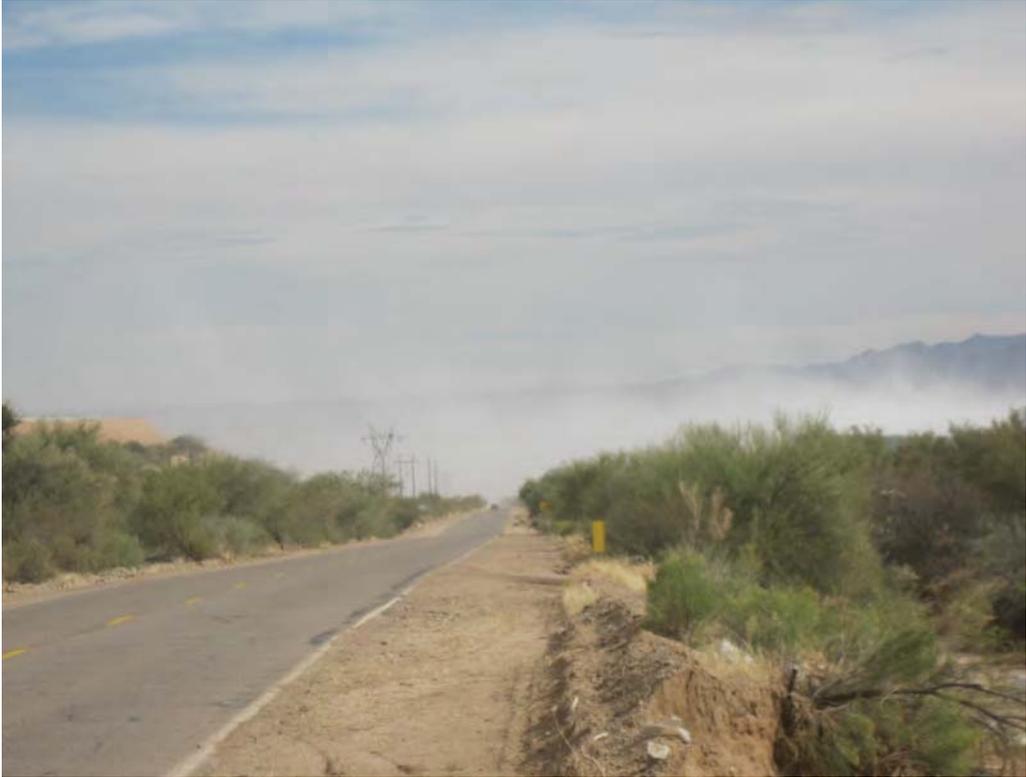
<p>Photo No. 3</p>

<p>Date: 1/10/2013</p>	
<p>Photo Description:</p> <p>View looking east on Helmet Peak Road of particulate emissions from tailings impoundment #8 diffusing across Helmet Peak Road around 1:19 pm</p>

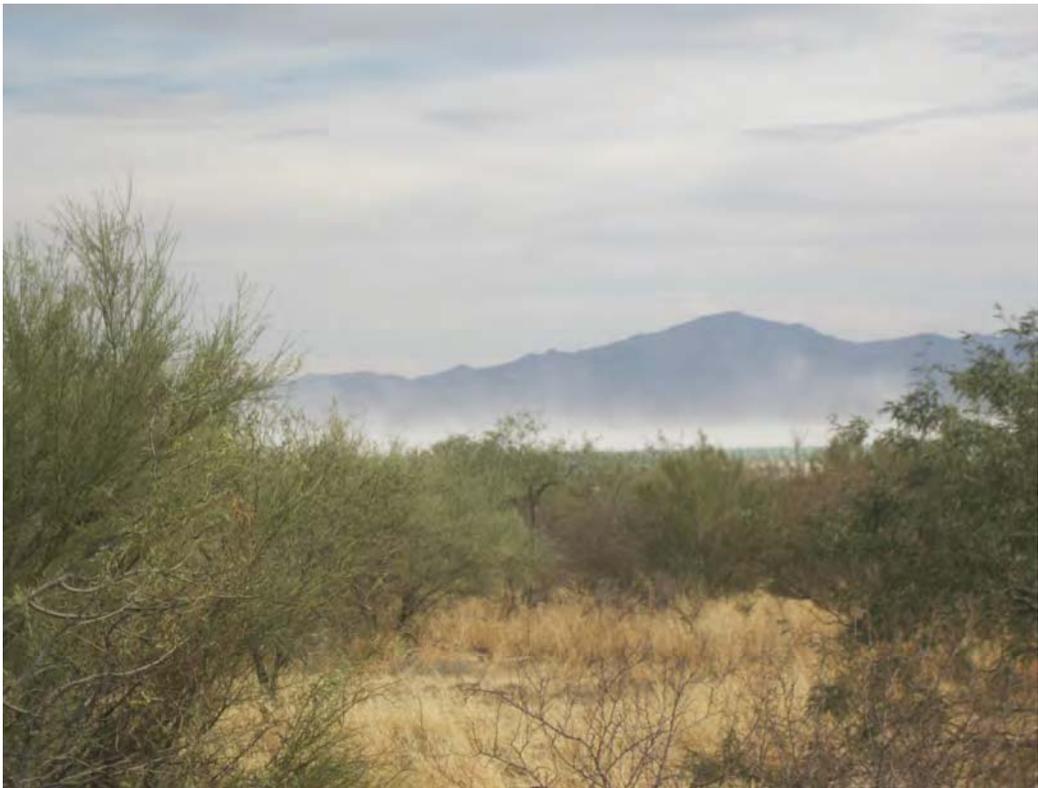
<p>Photo No. 4</p>

<p>Date: 1/10/2013</p>	
<p>Photo Description:</p> <p>Another view looking southeast across the top of the impoundment from the entrance.</p>

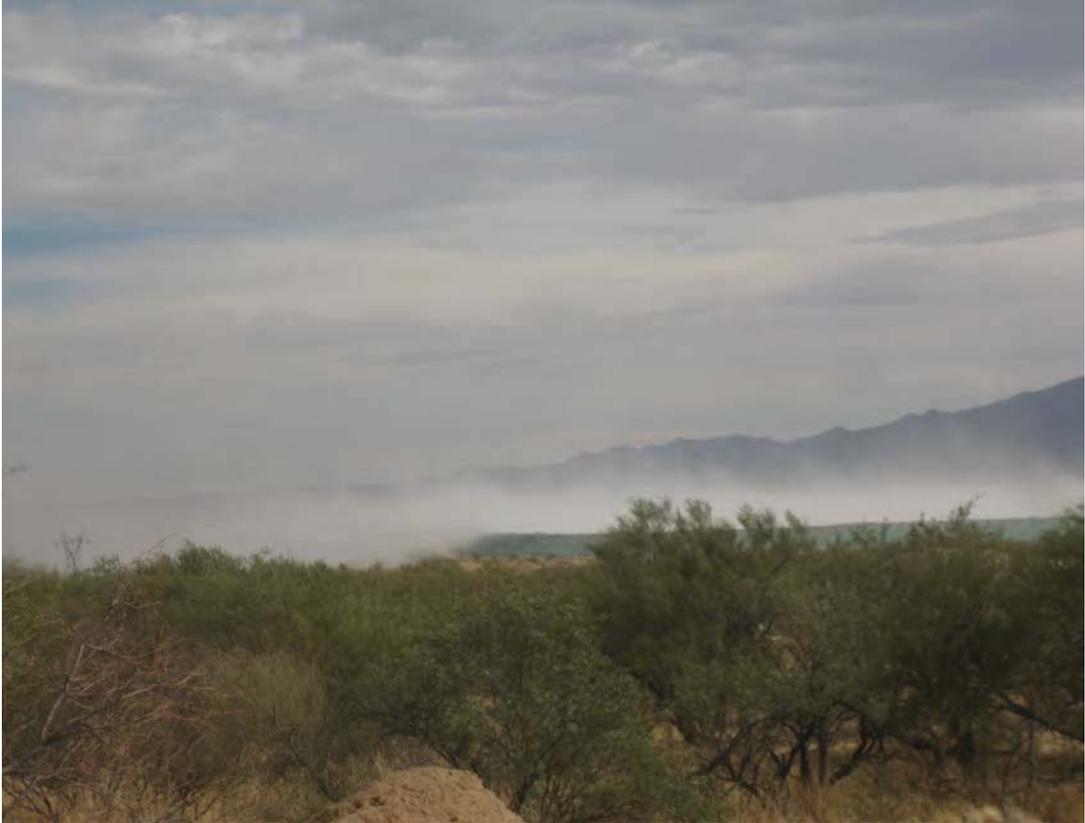
<p>Photo No. 5</p>

<p>Date: 1/10/2013</p>	
<p>Photo Description:</p> <p>View around 1:25 pm looking east from Helmet Peak Road.</p>

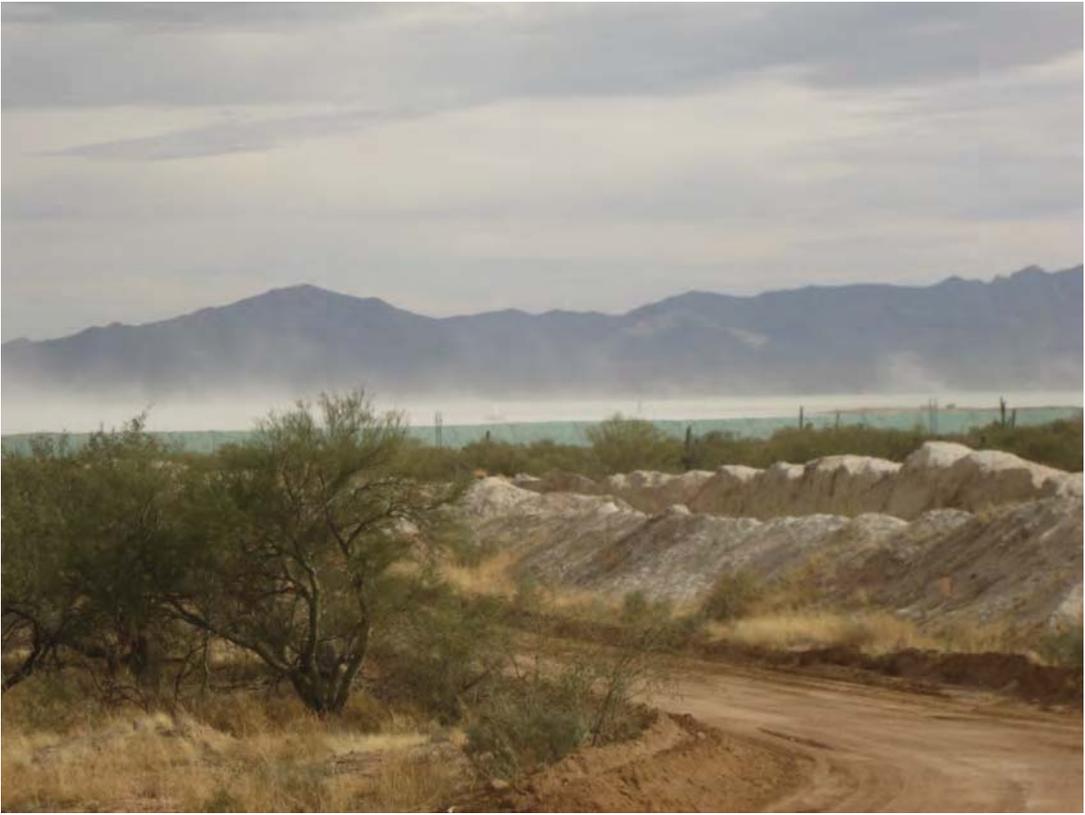
<p>Photo No. 6</p>

<p>Date: 1/10/2013</p>	
<p>Photo Description:</p> <p>View across impoundment of emissions generated on the surface. A water truck can be observed left of center in the photograph upstream of the effluent emissions.</p>

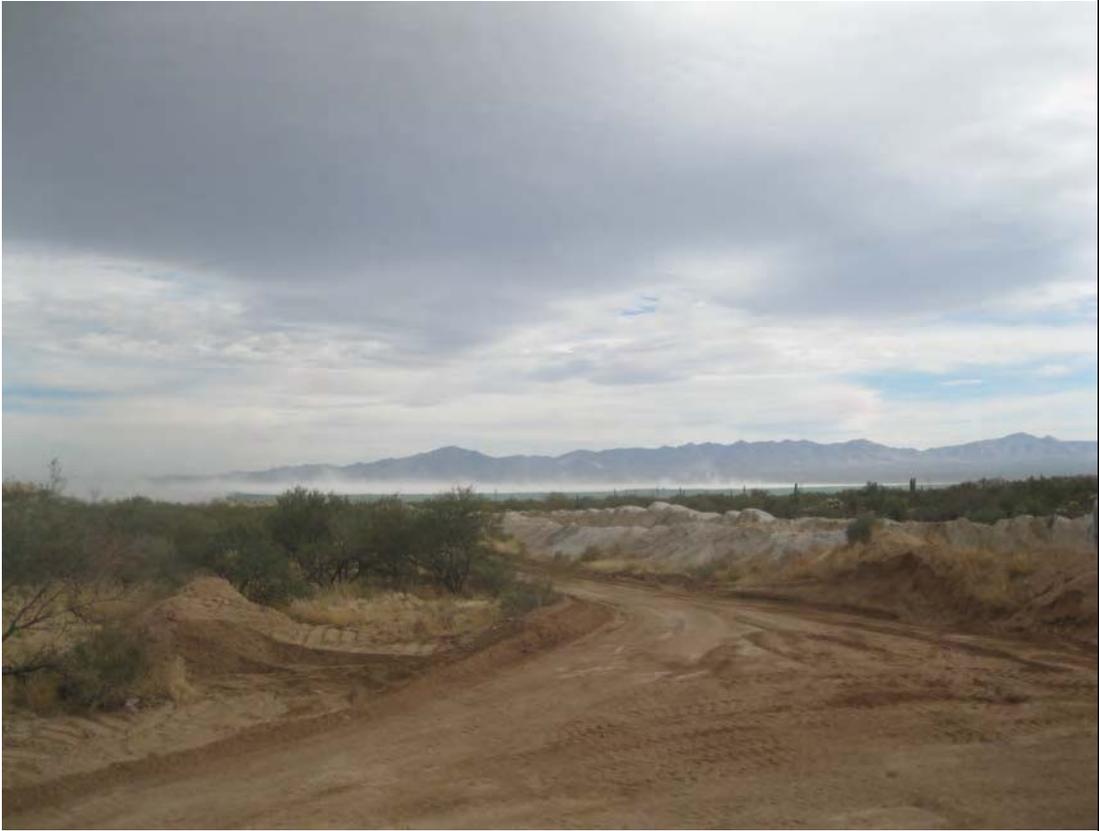
<p>Photo No. 7</p>

<p>Date: 1/10/2013</p>	
<p>Photo Description:</p> <p>Wide angle view of particulate emissions observed around 1:27 pm.</p>

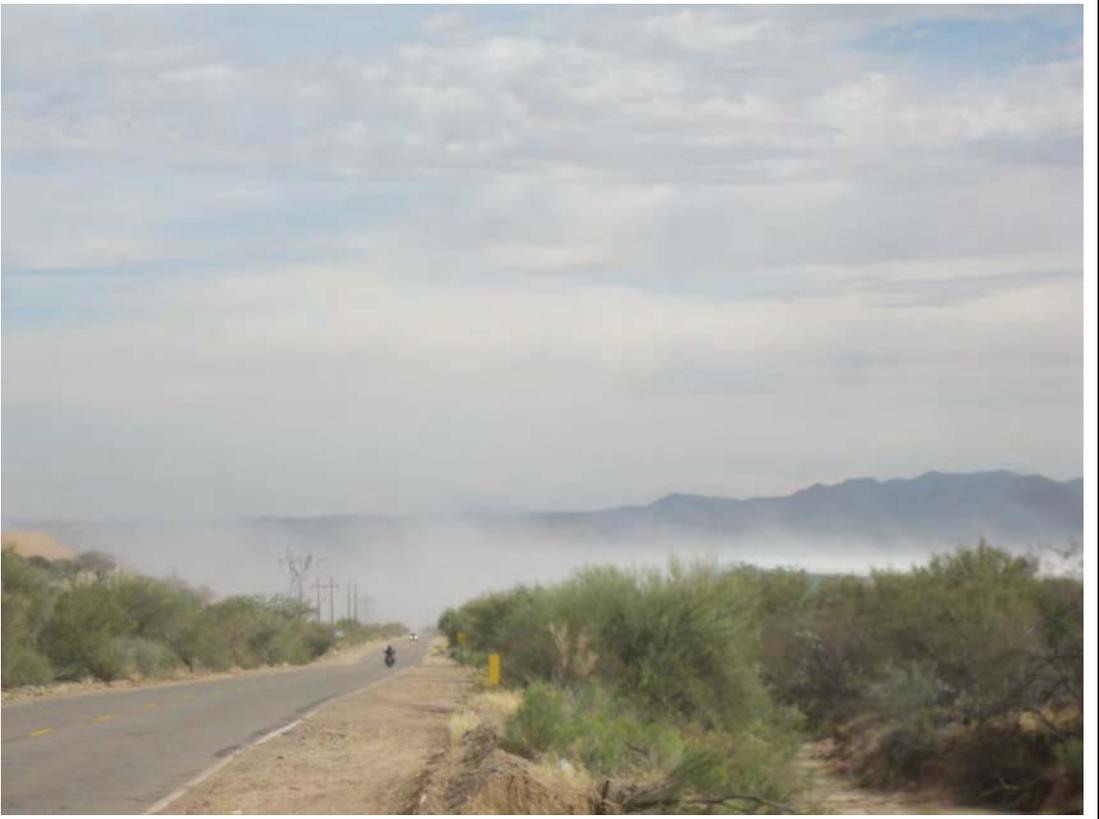
<p>Photo No. 8</p>

<p>Date: 1/10/2013</p>	
<p>Photo Description:</p> <p>View of particulate emissions from tailings impoundment around 1:31 pm.</p>

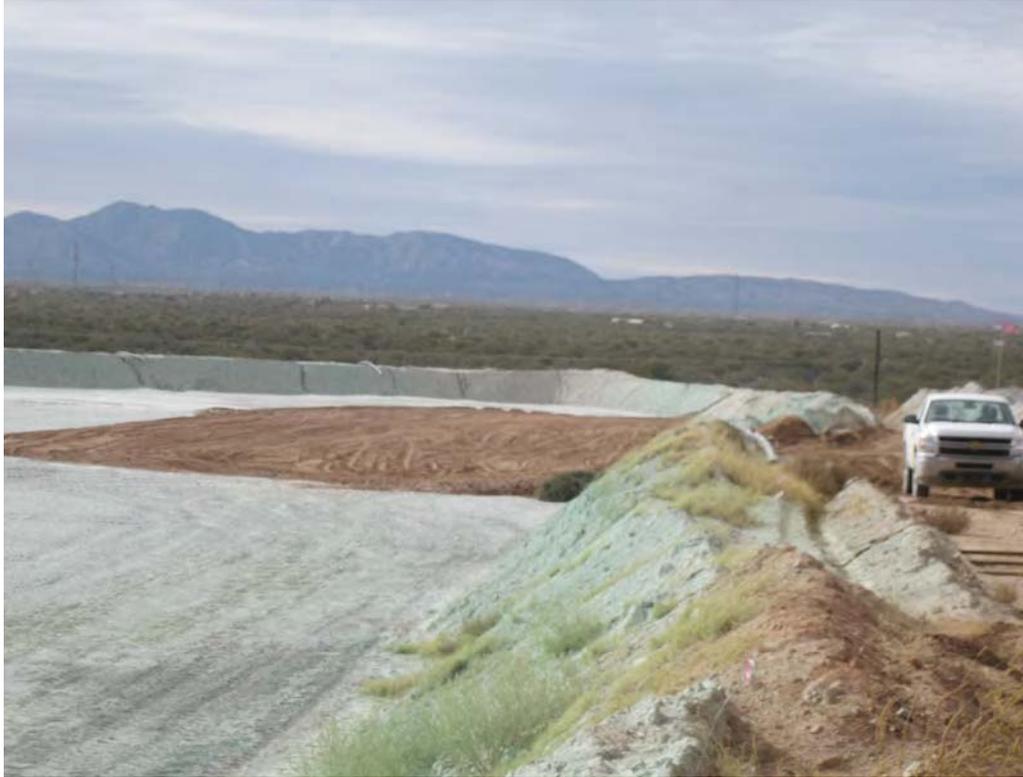
<p>Photo No. 9</p>

<p>Date: 1/10/2013</p>	
<p>Photo Description:</p> <p>View of the beginning of the deposition of alluvial material on the surface of tailing impoundment #8. The roadway and access to the alluvial material was also constructed.</p>

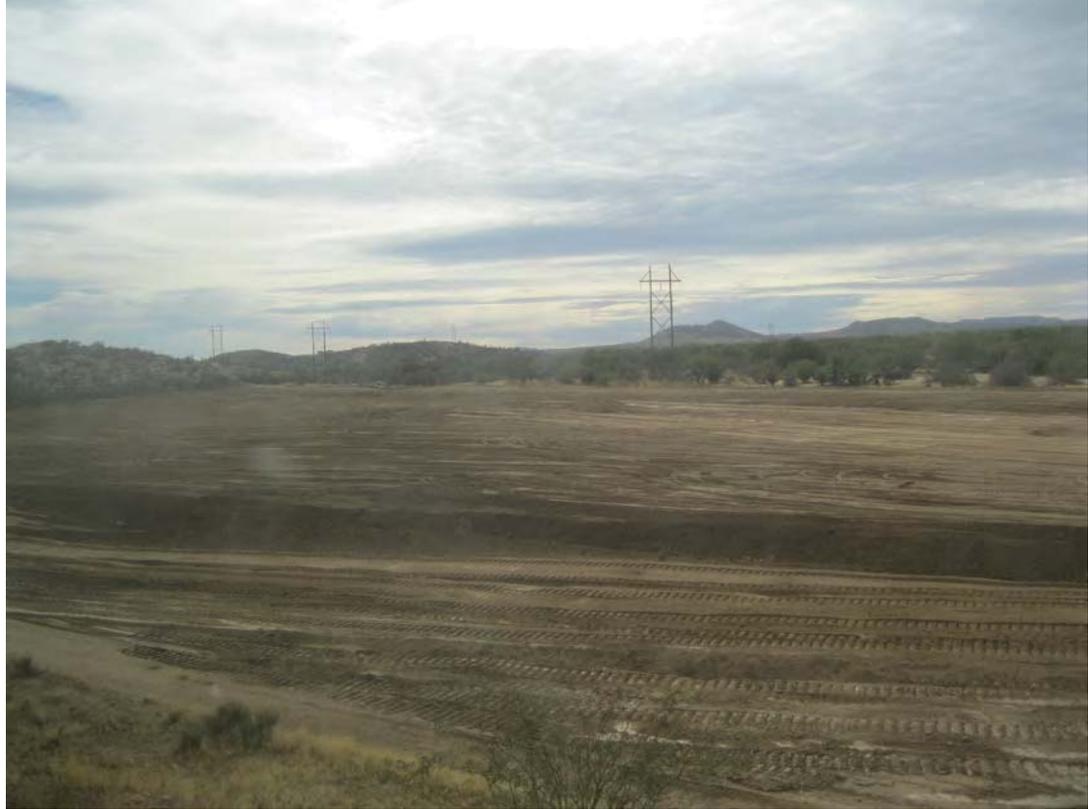
<p>Photo No. 10</p>

<p>Date: 1/10/2013</p>	
<p>Photo Description:</p> <p>View of the area to the west of the west dam of tailings impoundment #8 that where alluvial material is being excavated and in order to begin capping the surface of the impoundment.</p>

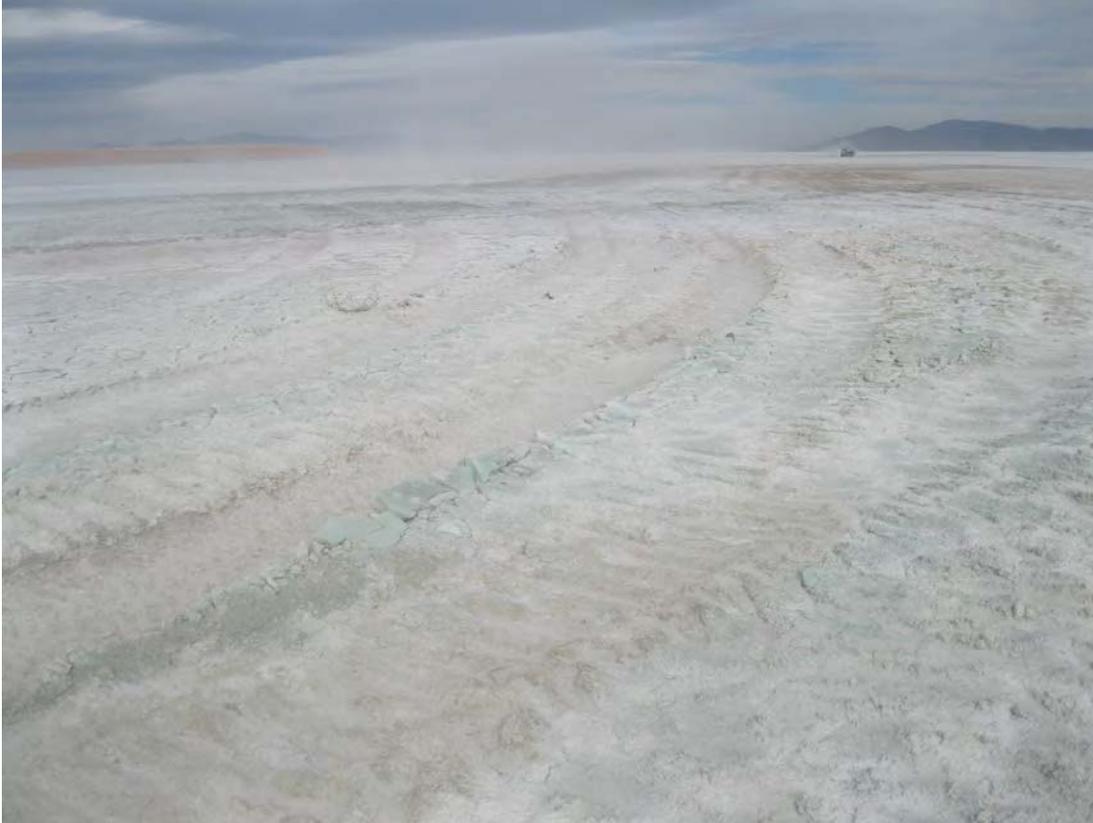
<p>Photo No. 11</p>

<p>Date: 1/10/2013</p>	
<p>Photo Description:</p> <p>View from the surface of the dam looking toward the Northeast from the path to the decant tower. A water truck is visible applying water to the northeast area to mitigate emissions that were being generated from this area. I also observed some deep rutting as observed here that indicated that some regions nearer the decant tower are still susceptible to vehicles getting stuck or having a hard time traversing the surface.</p>

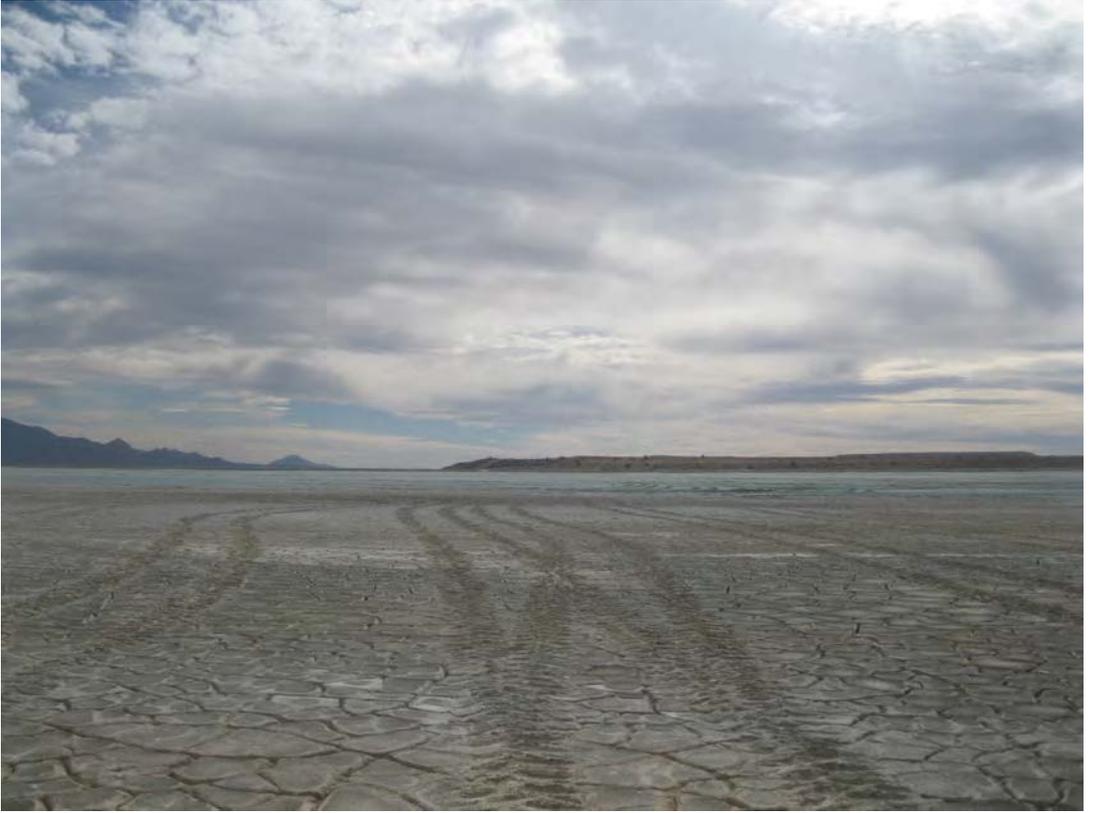
<p>Photo No. 12</p>

<p>Date: 1/10/2013</p>	
<p>Photo Description:</p> <p>View of the surface from in front of the decant tower looking toward the south. I observed some rutted areas to the south where some vehicles had difficulty traversing and the possibility of getting stuck near the decant tower. There was a 200-300' zone around the tower that larger vehicles did not traverse. While little polymer application was visible, the ground was relatively stable and encrusted in this area.</p>

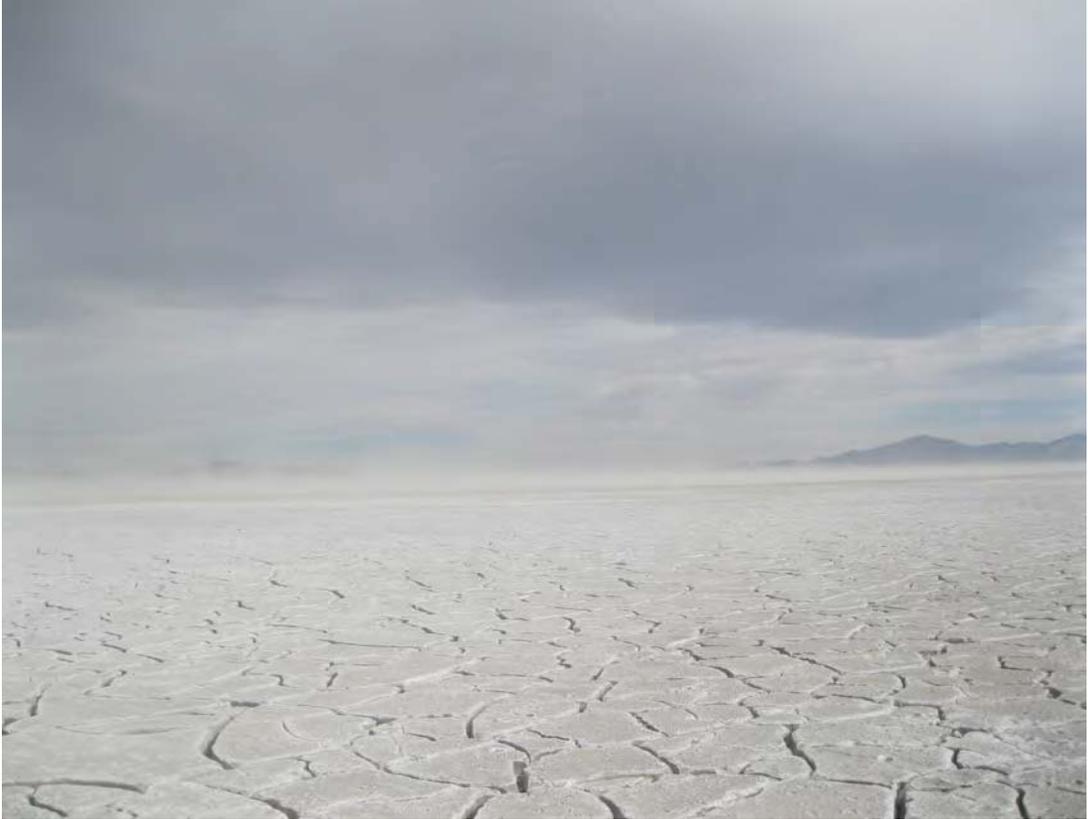
<p>Photo No. 13</p>

<p>Date: 1/10/2013</p>	
<p>Photo Description:</p> <p>View looking toward the east dam from the decant tower. Emissions were generating from an area west of the east dam parallel to the dam through a long section extending from just beyond the midpoint to the north dam.</p>

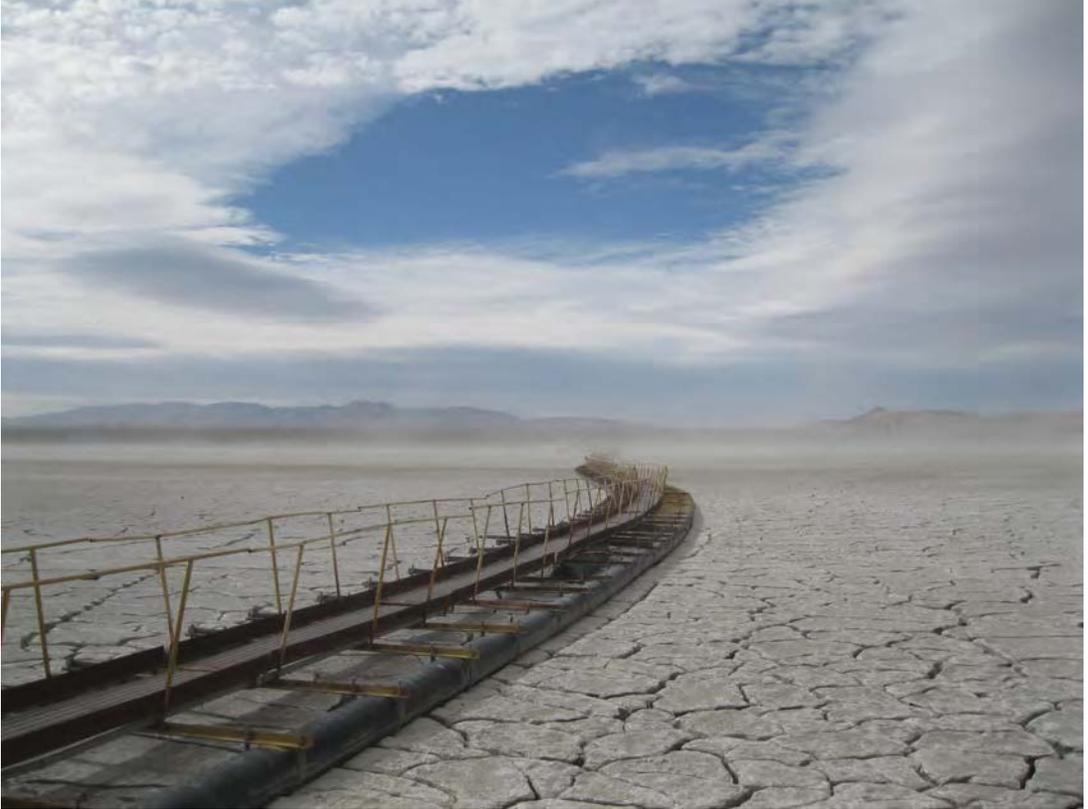
<p>Photo No. 14</p>

<p>Date: 1/10/2013</p>	
<p>Photo Description:</p> <p>View looking west from near the decant tower of emissions generated from a southwest area and flowing north.</p>

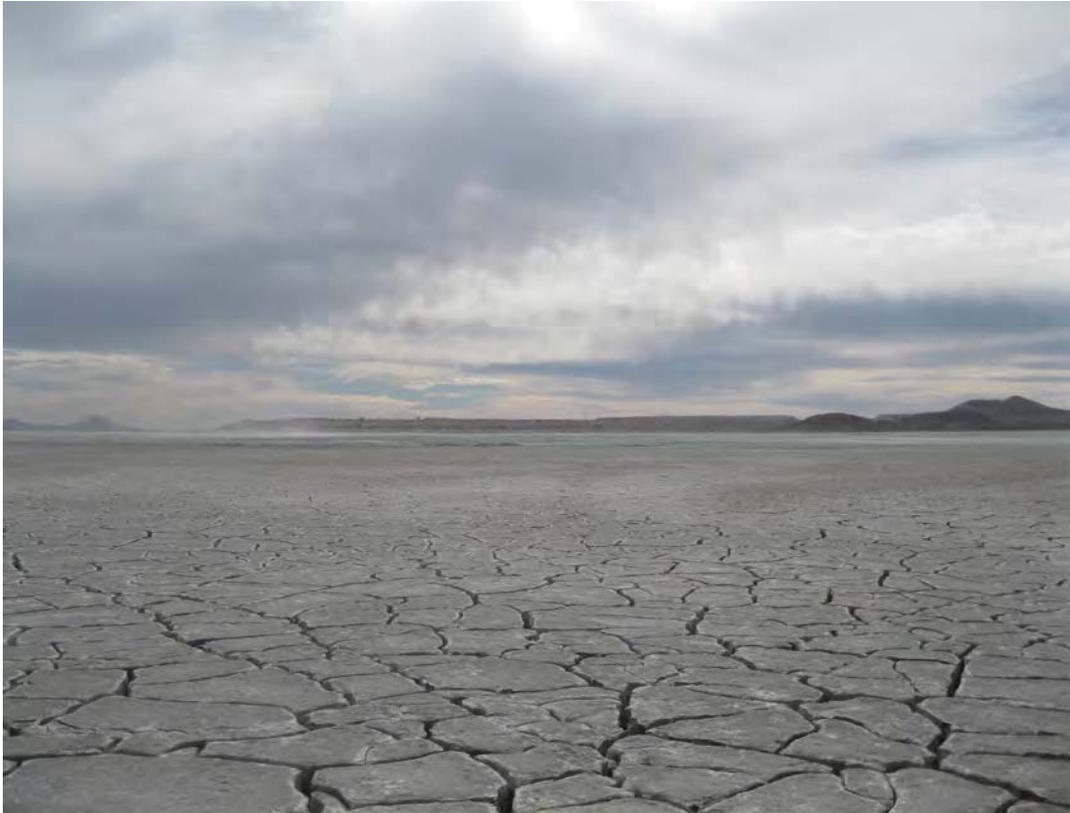
<p>Photo No. 15</p>

<p>Date: 1/10/2013</p>	
<p>Photo Description:</p> <p>View looking towards the south from near the decant tower showing an area towards the south and southeast that was generating particulate emissions. Some areas where the surface has been wetted can be seen in the foreground.</p>

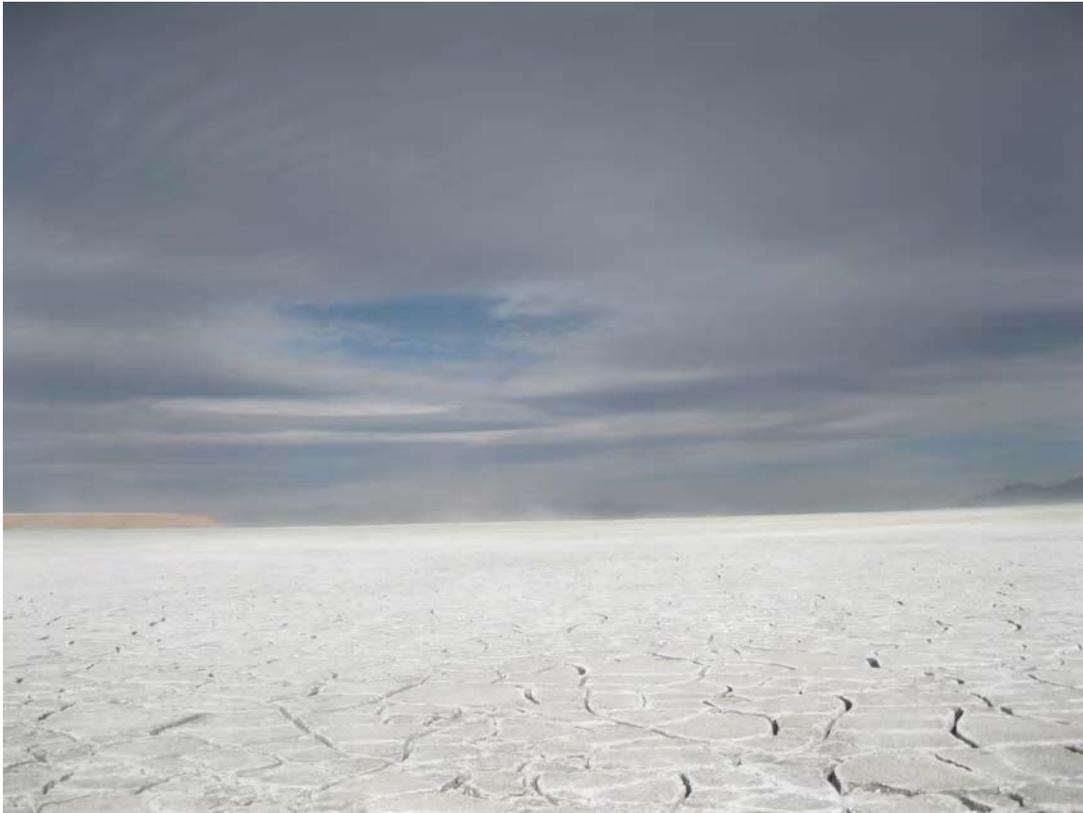
<p>Photo No. 16</p>

<p>Date: 1/10/2013</p>	
<p>Photo Description:</p> <p>View looking Northeast from an area a few hundred feet in front of the decant tower. Tailings dam #7 can be seen to the far left. This photo was taken while walking east toward the area where emissions were observed generated earlier.</p>

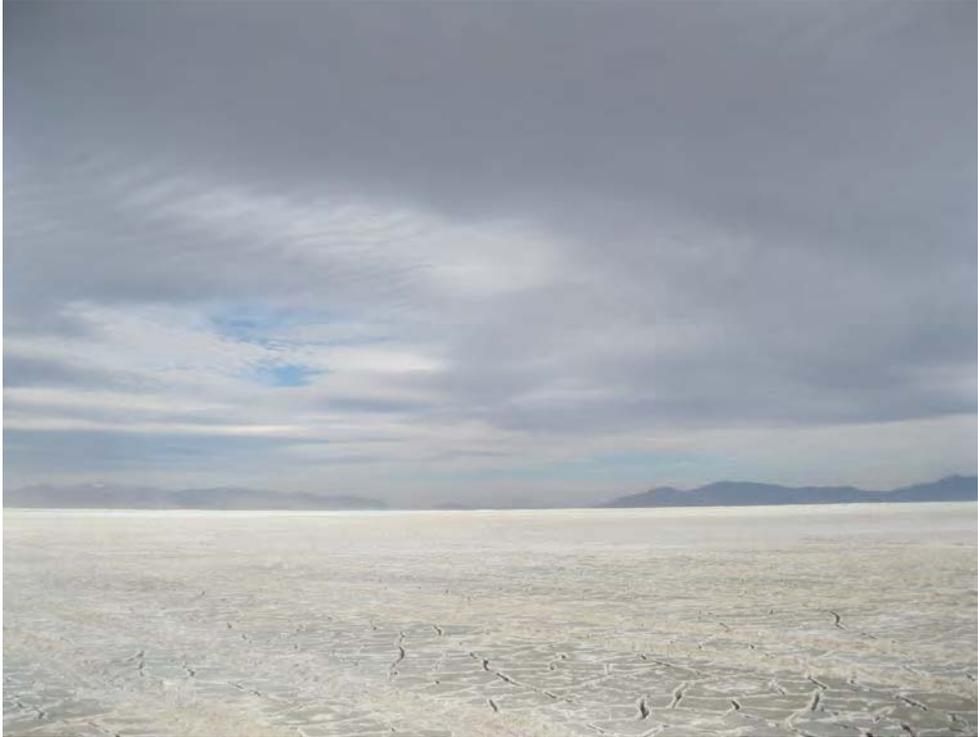
<p>Photo No. 17</p>

<p>Date: 1/10/2013</p>	
<p>Photo Description:</p> <p>View looking northeast after walking a considerable distance east of the decant tower toward the area where emissions were observed generating earlier but still some distance further east.</p>

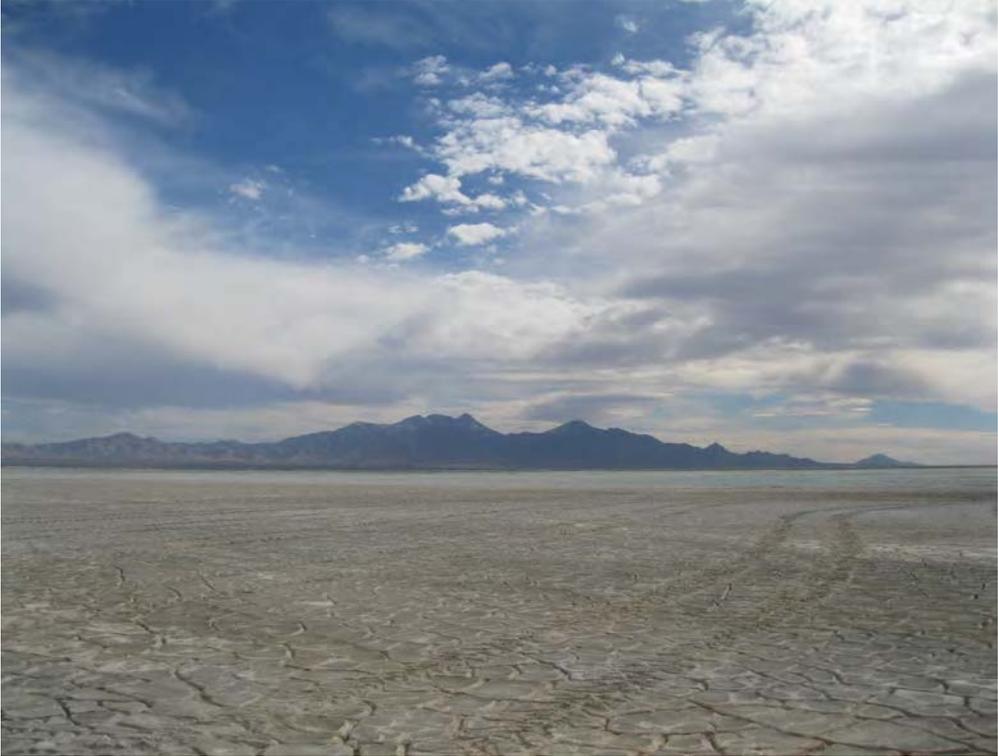
<p>Photo No. 19</p>

<p>Date: 1/10/2013</p>	
<p>Photo Description:</p> <p>View looking toward the southeast from the location above. Areas where polymer has been applied can be observed toward the south.</p>

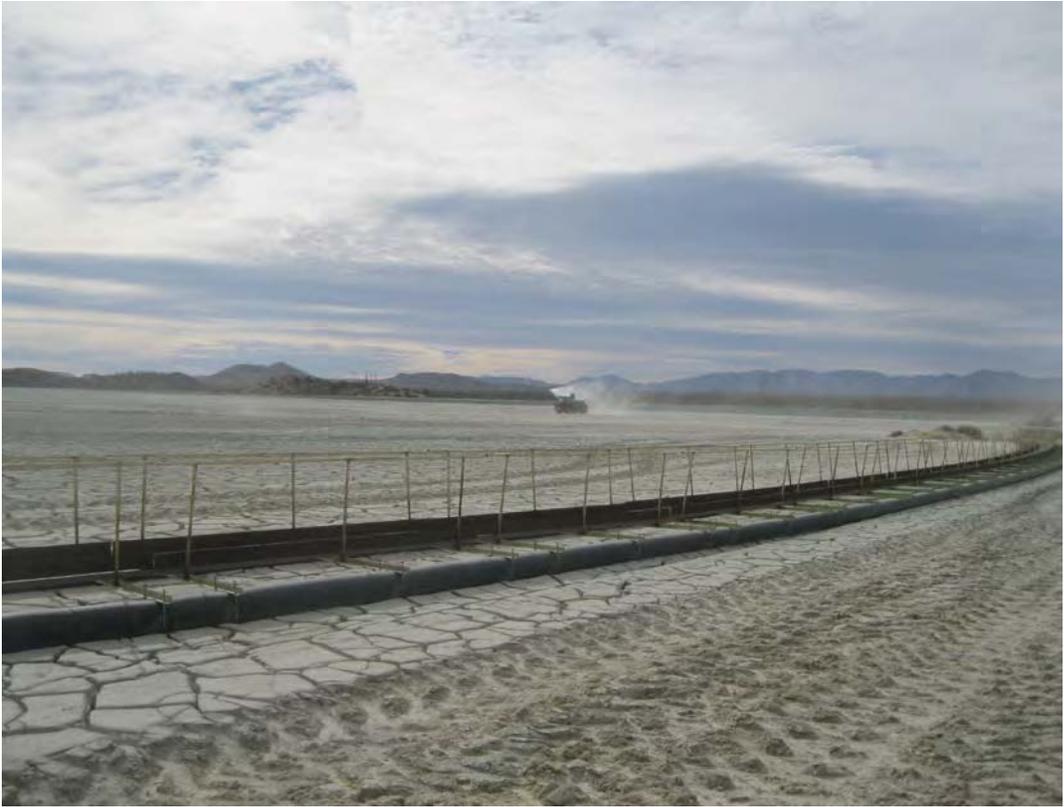
<p>Photo No. 23</p>

<p>Date: 1/10/2013</p>	
<p>Photo Description:</p> <p>View if a water truck applying water to mitigate and stabilize areas to the south of the decant tower pathway.</p>

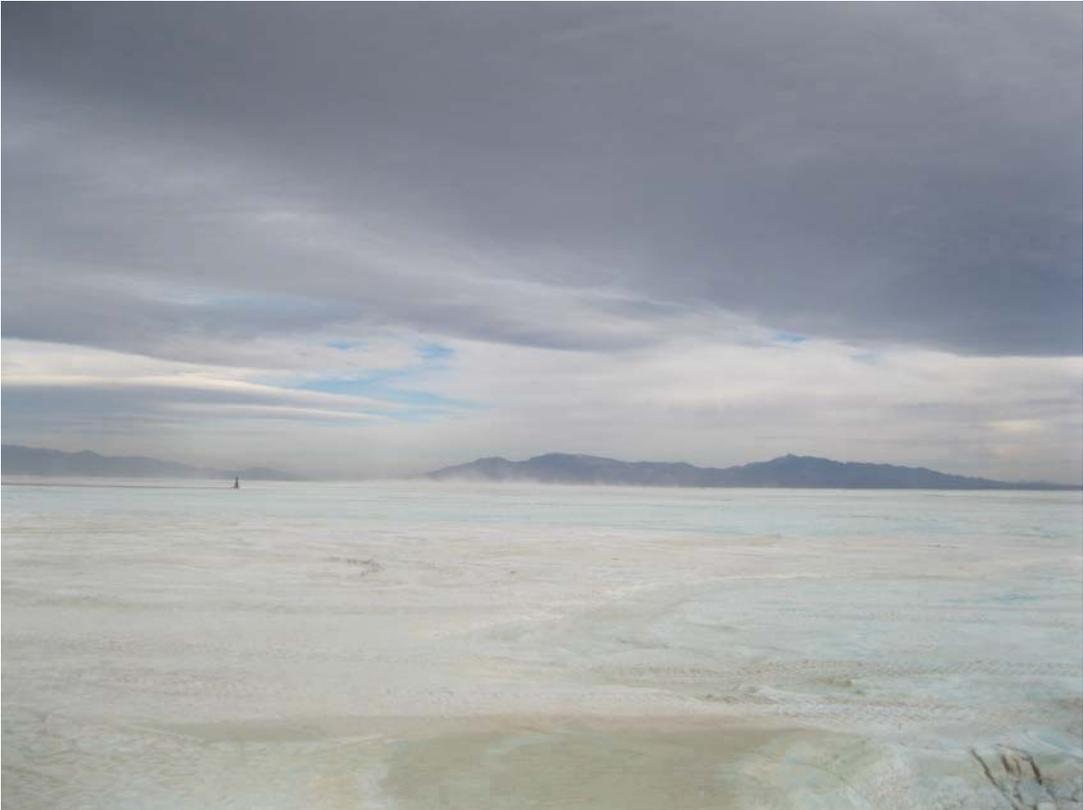
<p>Photo No. 24</p>

<p>Date: 1/10/2013</p>	
<p>Photo Description:</p> <p>View of the surface looking toward the northeast from an area on the west dam near the southwest corner of the impoundment. The decant tower can be seen toward the left.</p> <p>Emissions can be seen generating again from a central area just west of the east dam.</p>

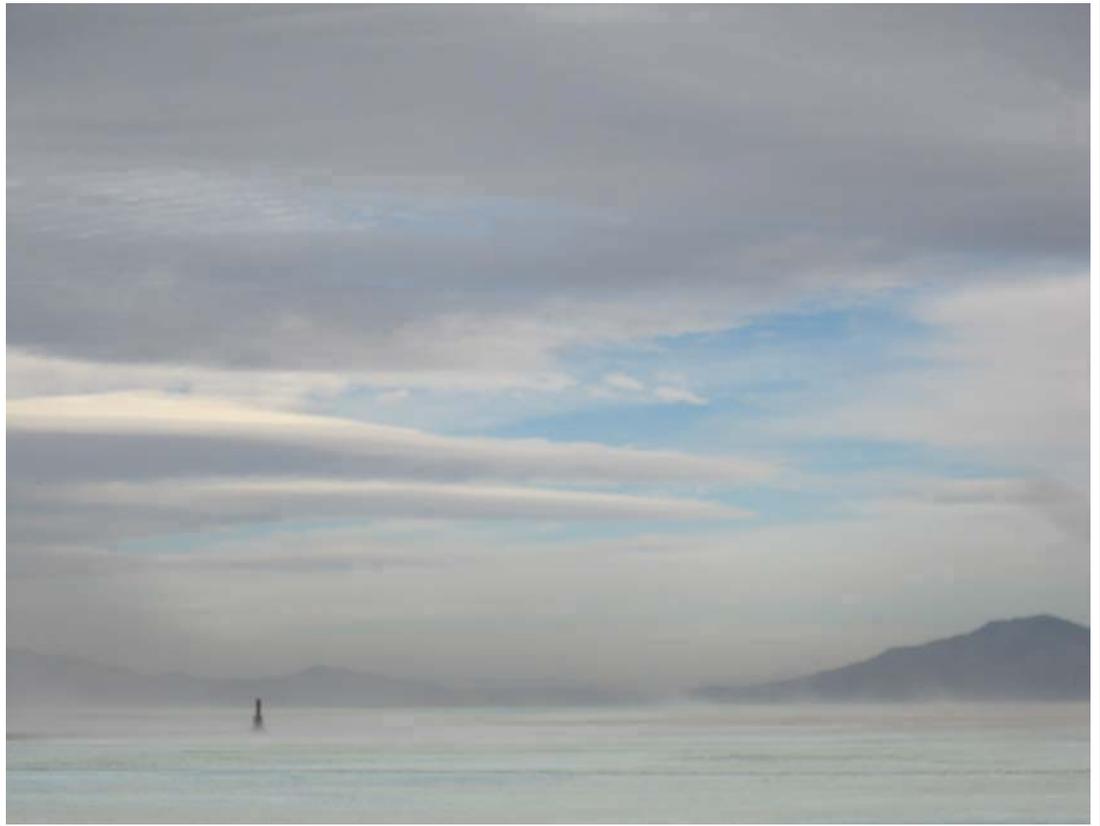
Photo No. 25

Another view showing some emissions generating in the south central area that are partially obscuring the decant tower.

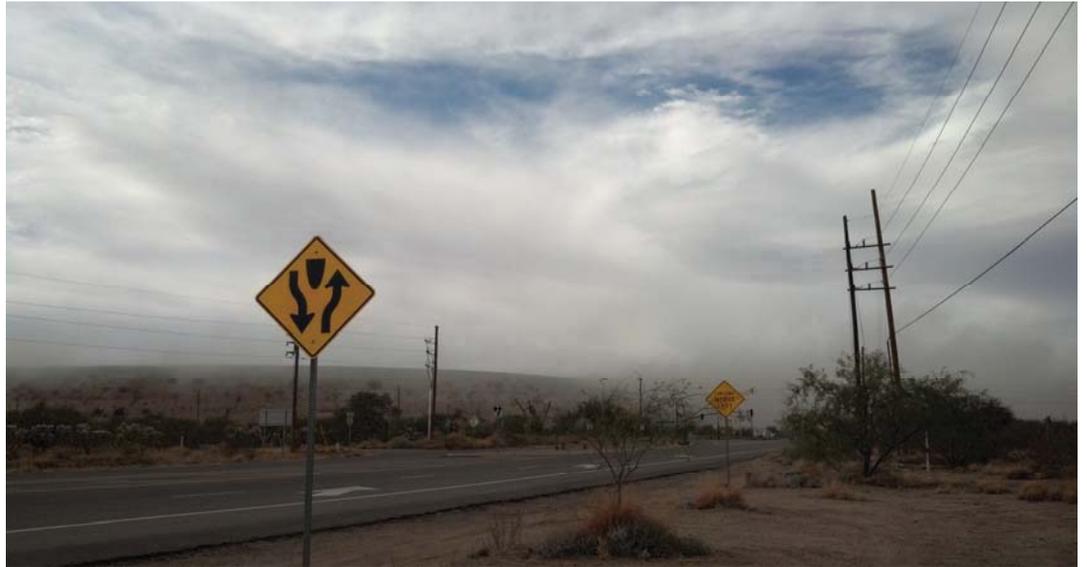
View of emissions from Tailings Impoundment #8. View looking west taken from the north side of Sahuarita Road.

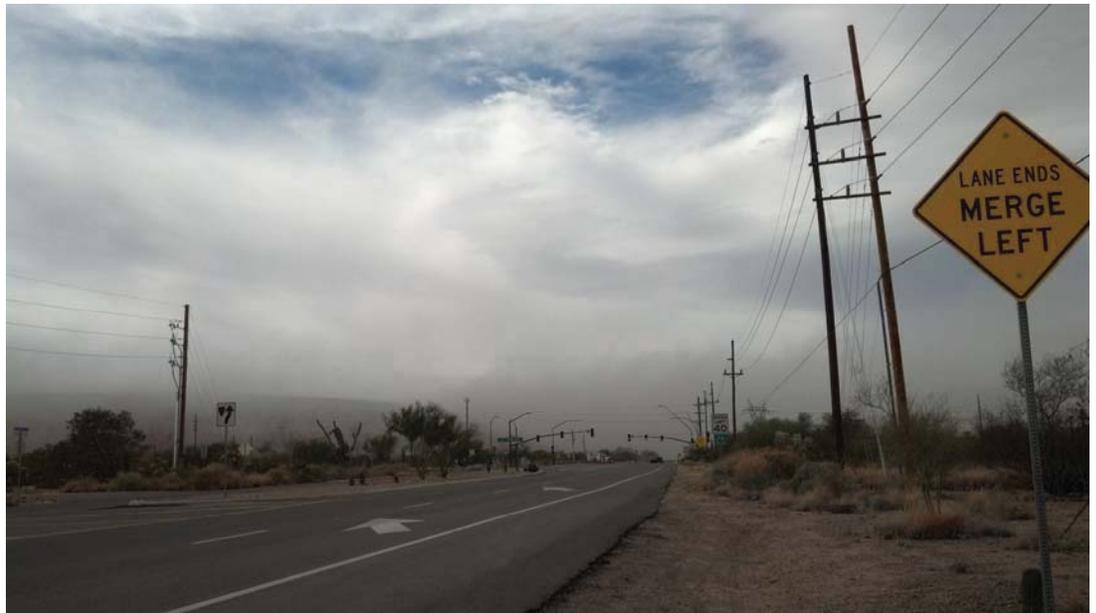
Photo No. 2

Another view of emissions generated from Tailings Impoundment #8. View looking west from north side of Sahuarita Road.

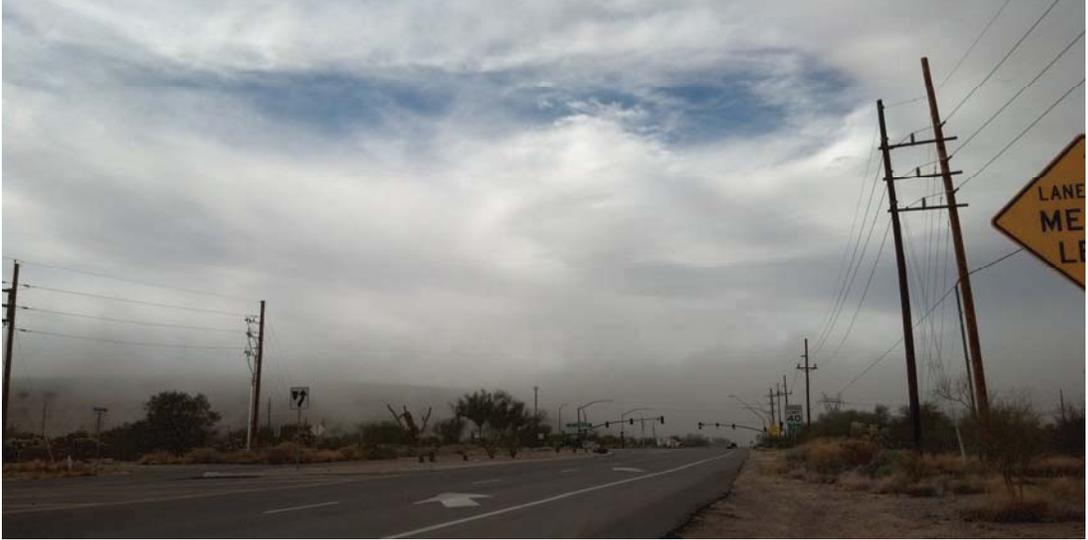
<p>Photo No. 3</p>

<p>Date: 1/10/2013</p>	
<p>Photo Description:</p> <p>Another view of emissions generated from Tailings Impoundment #8. View looking west from north side of Sahuarita Road.</p>
