**NOTICE OF VIOLATION # PC 0912-067**

**Complaint Investigation Report**

**Tracking ID: PC0912-067**

**Source:** ASARCO, LLC - Mission Complex

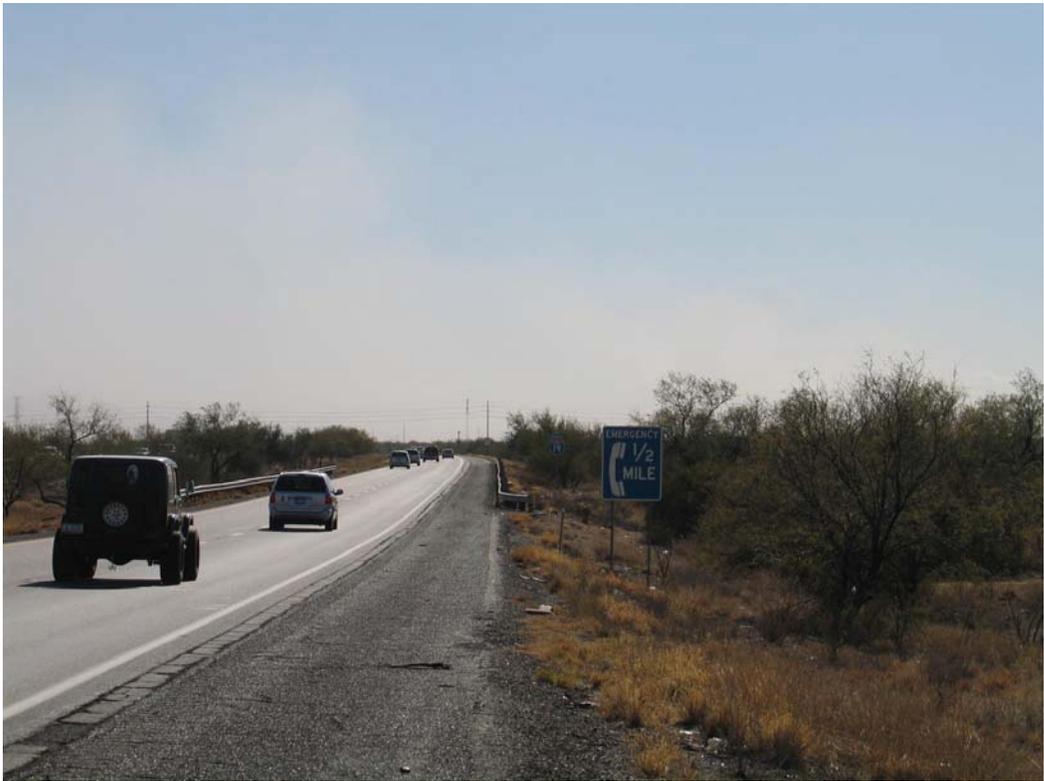
**Photo No. 2**

View of the light colored visible particulate emissions generating from tailings dam #8 at 1:05 pm as viewed from the side of Sahuarita Road west of I-19. The visible emissions can be observed blowing across Helmet Peak Road and obscuring visibility.

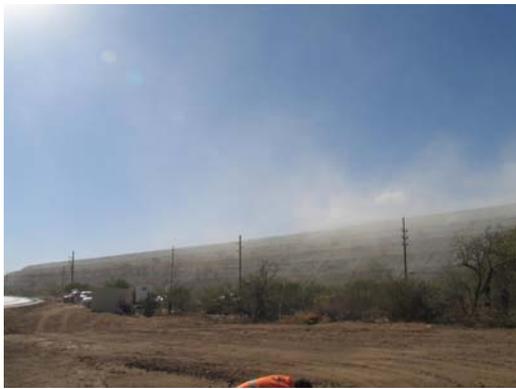
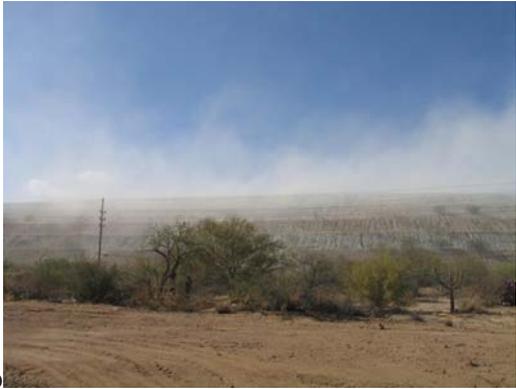
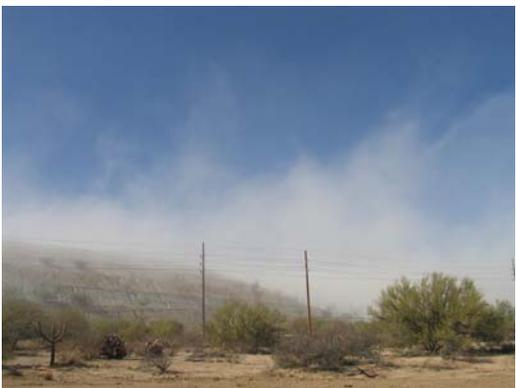
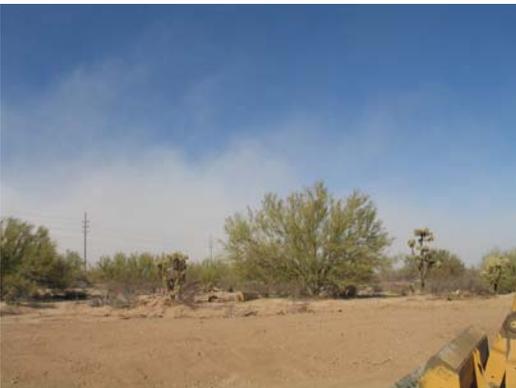
<p><b>Photo No. 3 a,b,c,d</b></p>

<p><b>Photo Description:</b></p> <p>View of visible particulate emissions generating from tailings dam #8 blowing northeast as viewed from La Canada Drive at 1:10 pm.</p>	<p>a</p>

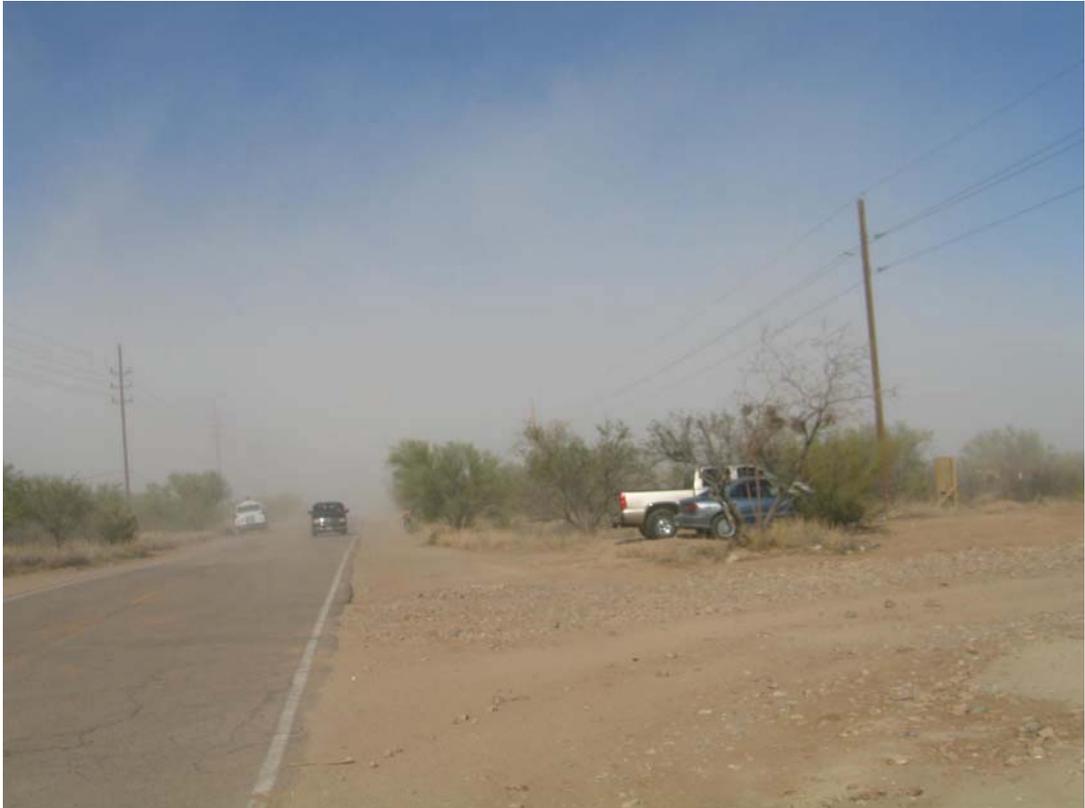
<p><b>Photo No. 4</b></p>

<p><b>Date:</b> 11/22/2009</p>	
<p><b>Photo Description:</b></p> <p>View visible particulate emissions plume generating from tailings dam #8 crossing the east property line at La Canada Drive. The inspector took a VE between 1:15 pm and 1:22 pm using the telephone pole along La Canada Drive as a background and a guide to the east property line of ASARCO, LLC – Mission Complex.</p>

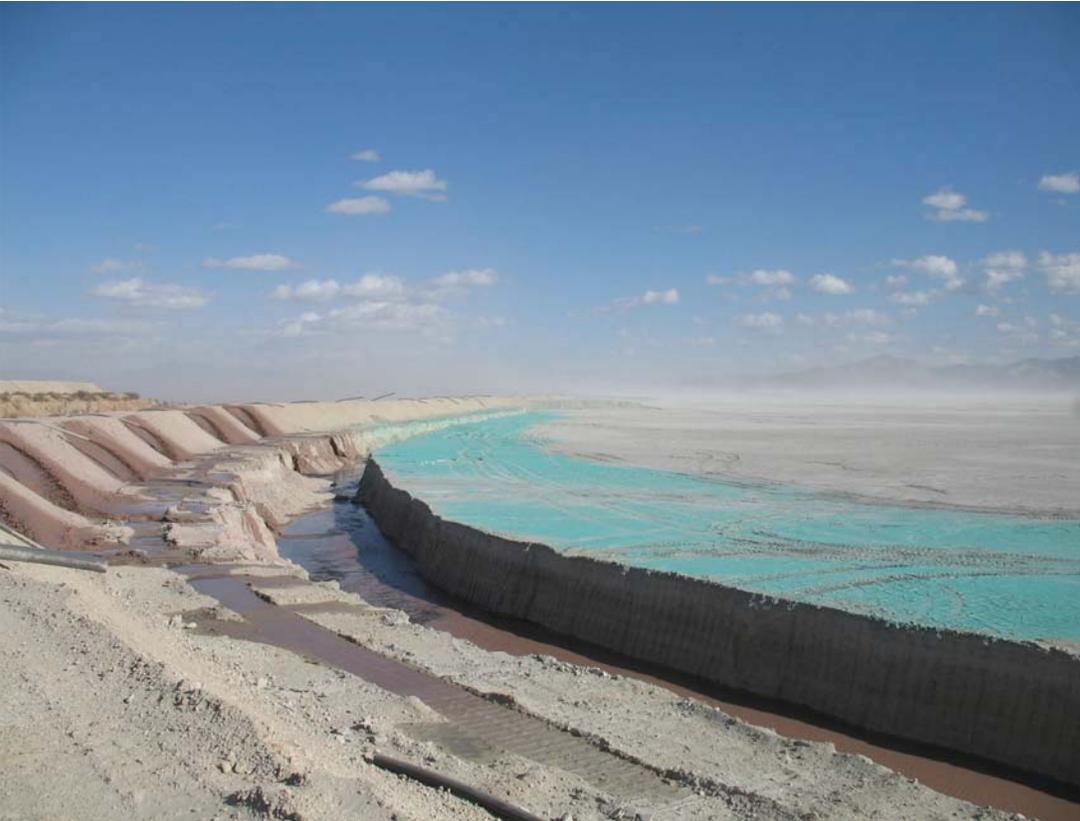
<b>Photo No. 9</b>

The inspector observed pipes placed from the tailings header at the base of the berm over the upper berm at regular intervals around the perimeter along the north slope. Mr. Ekholm indicated they recently began pumping tailings to the fill pipes used to apply the wet tailings slurry to the dam surface. Valves are used to divert the tailings slurry from the header through the pipes. The inspector followed Mr. Ekholm to the top of the dam to view the top surface of the tailings dam. The inspector observed that wet tailings slurry was being pumped and flowing from 6 pipes at the northwest corner and had begun to fill the trench left over from excavating berm material in this section. The inspector inquired why the tailings were not flowing from the other fill pipes around the perimeter. Mr. Ekholm indicated the system only allowed application through a limited number of the pipes at any one time (Attachment 1, Photo No. 9).

The inspector observed the wet tailings slurry flowing into the outer trench that remained from the excavated material used to construct the upper lift of the new berm. The inspector estimated the trench is approximately 8' deep and 15' wide and parallels the inside perimeter of the upper

berm about 20'-30' from the outer berm. The inspector observed that the inner tailings dam surface was dry and asked Mr. Ekholm about how long it would take for the tailings slurry to fill the trench and coat the inner dam surface at the current rate of flow. Mr. Ekholm estimated about two or three weeks.

<b>Date:</b> 11/22/2009	
<b>Photo Description:</b>  View of the fill pipes on the right discharging tailings slurry.  The trench in the foreground must fill before the tailings can wet and smear the inner dam surface.

- Immediately smear the tailings piles with a light coat of fresh, moist tailings on the surface of the tailings dam #8. Ensure that the fresh tailings do not flow into the berm building trench at the outer perimeter of tailings dam #8 and do flow out onto the surface of the tailings where the generation of fugitive dust is occurring.
- Develop and implement a plan to smear the tailings piles with a light coat of fresh, moist tailings on the surface of the dam during future berm building mode at least once every 60 days. Develop criteria when meteorological conditions warrant more frequent application, to control fugitive emissions.

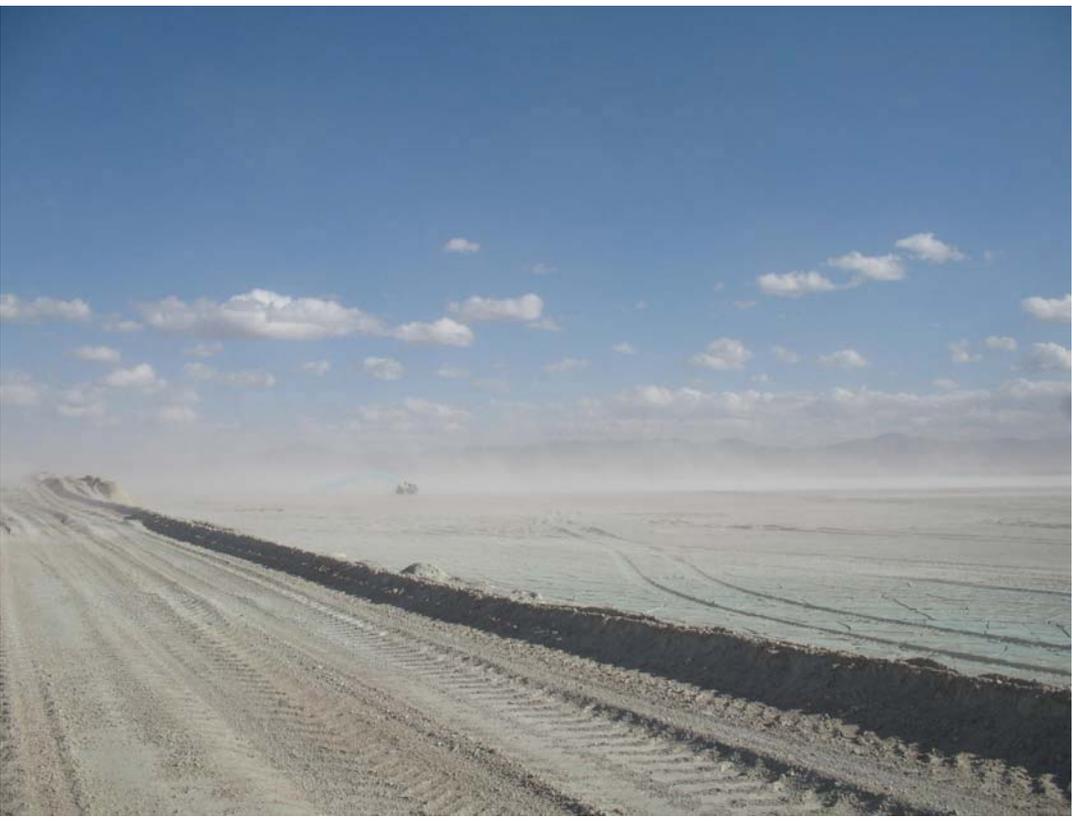
<b>Photo No. 10</b>

The inspector walked to the southeast quadrant of the tailings dam surface and observed that trucks were applying water and polymer to the area on the southeast side of the tailings dam surface. The inspector also observed that only a relatively small portion of upper berm construction was required to complete the berm building.

<b>Date:</b> 11/22/2009	
<b>Photo Description:</b>  View of a truck applying water and polymer on south east quadrant of the tailings dam surface.

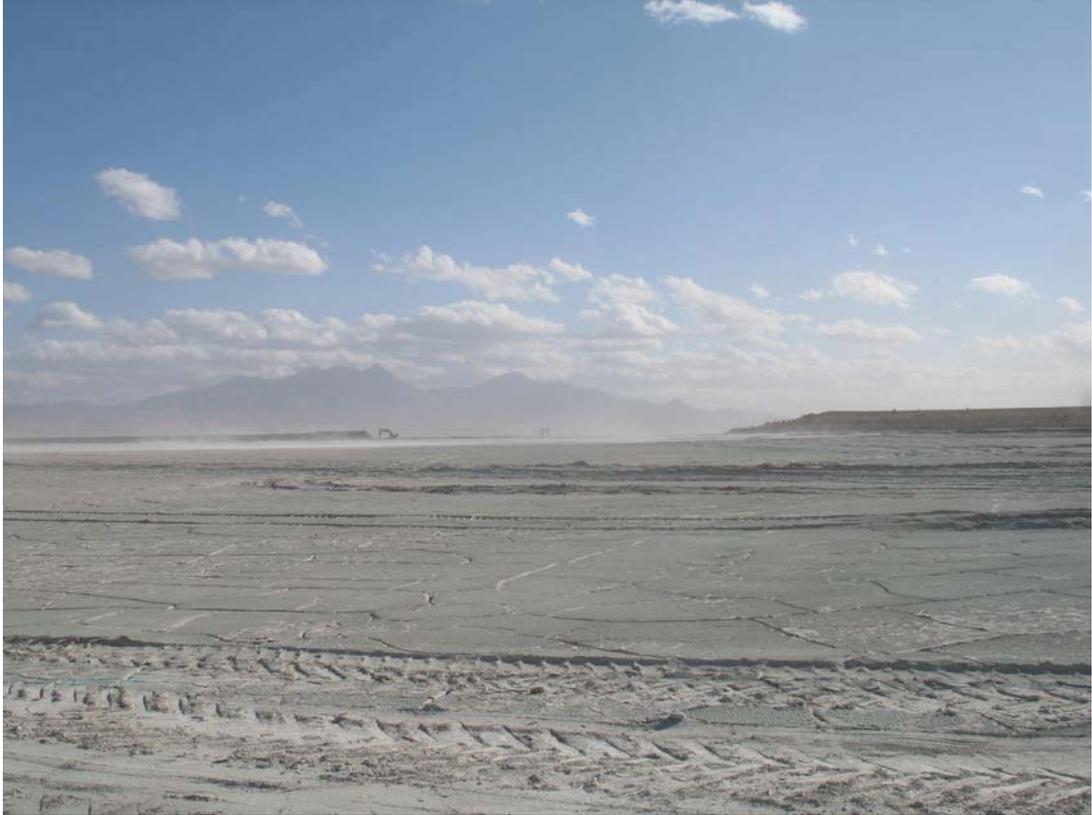
<b>Photo No. 11</b>

<b>Date:</b> 11/22/2009	
<b>Photo Description:</b> View of the end of the berm construction showing the extent of the berm building.

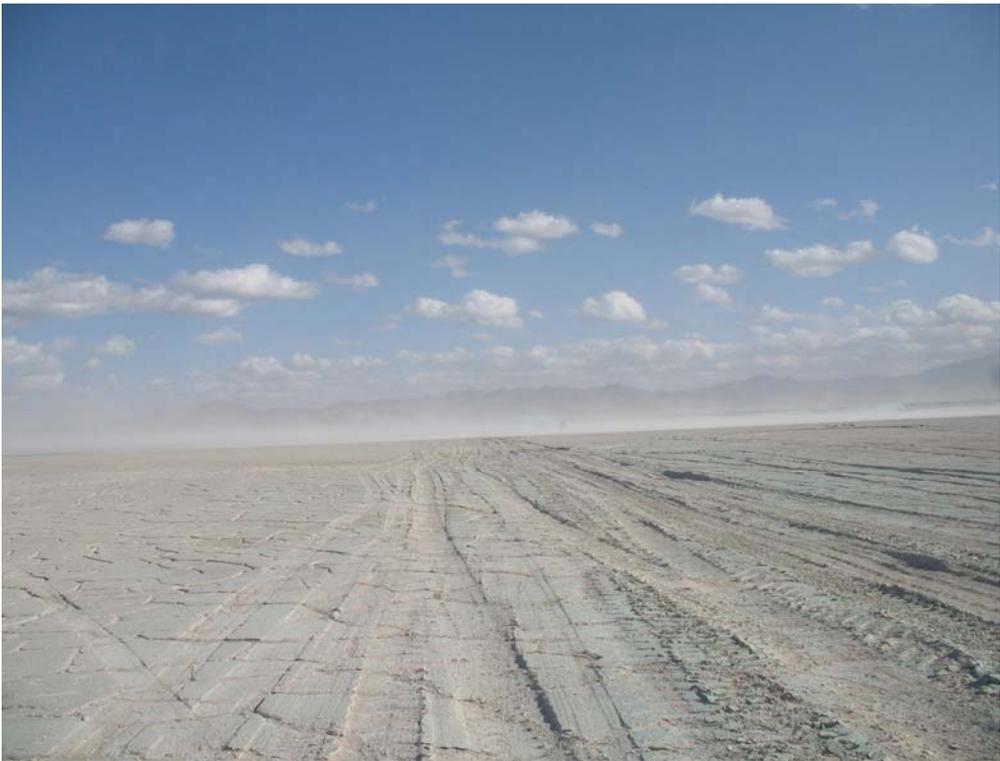
<b>Photo No. 12</b>

<b>Date:</b> 11/22/2009	
<b>Photo Description:</b> View of the particulate emission plume and view at the end of the VE taken in the southwest quadrant of the tailings surface at 2:47 pm.

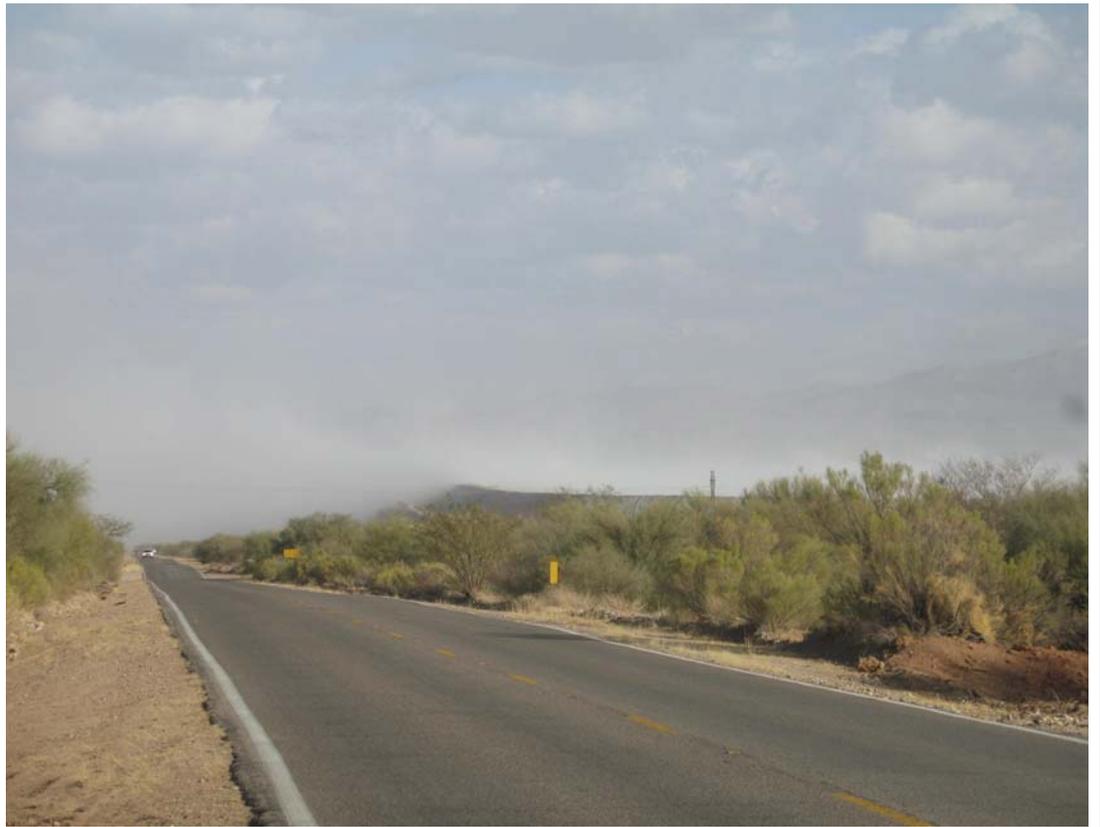
**Photo No. 13**

View of the particulate emission plume and generating from tailings dam #8 blowing across Helmet Peak Road as the inspector views looking east at 3:21 pm.
