2010 Tanque Verde Flood Investigation Report

Site Investigation Date: August 2, 2010

Investigators: Brian Jones and Eric Shepp
Report written by Brian Jones and edited by Eric Shepp

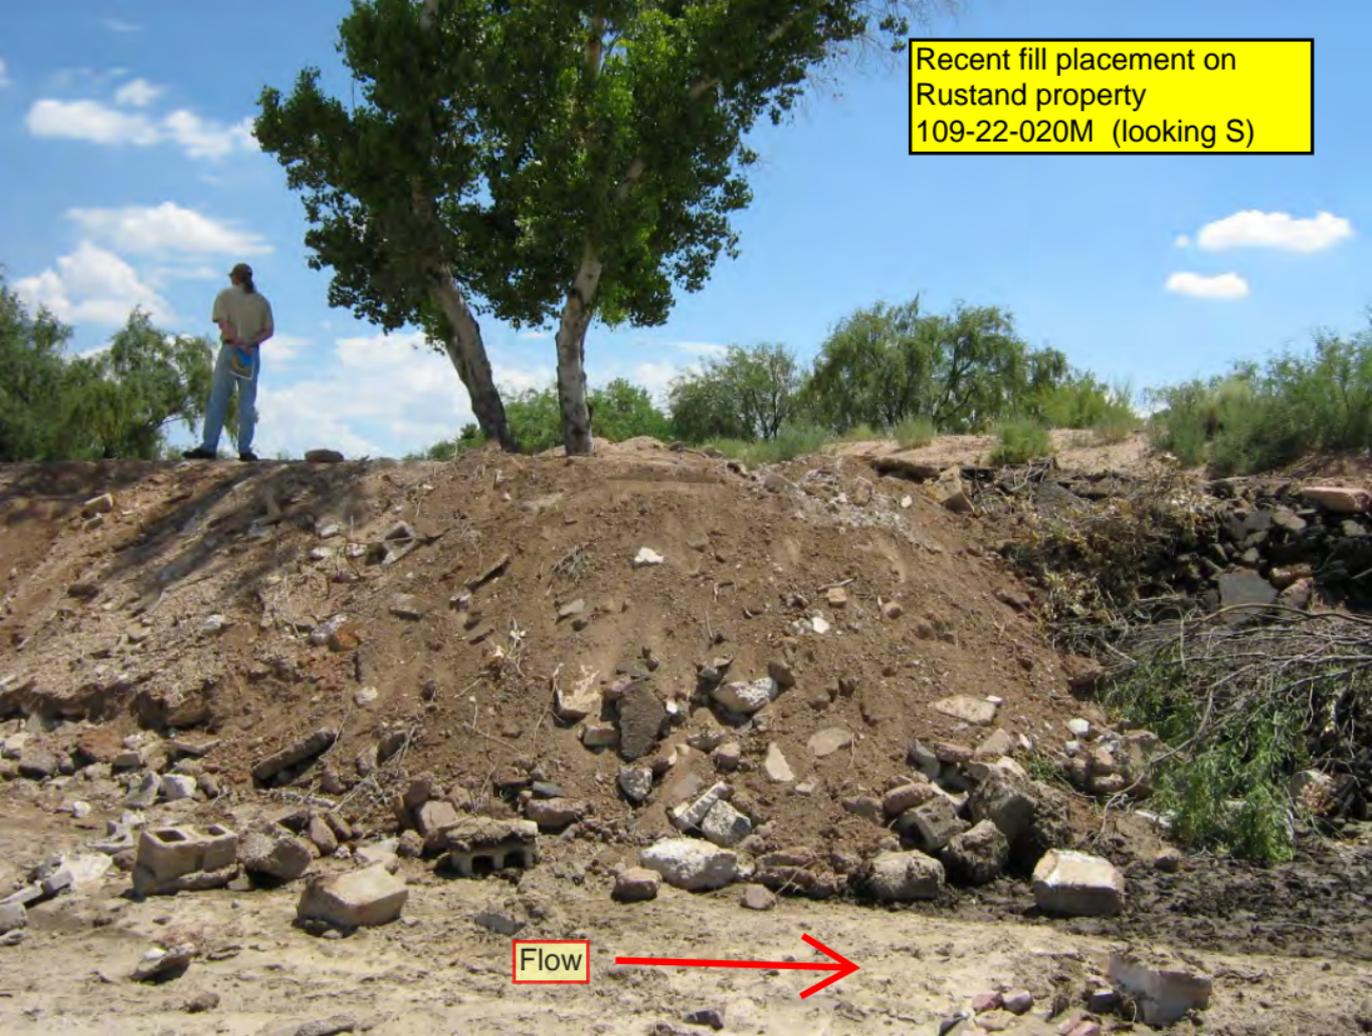
We visited the Rustand property (109-22-020M), the site of an ongoing violation due to placement of fill and debris on the south bank of the Tanque Verde. The debris was noticeably undercut in at least one location, and it appeared that fresh fill/debris had been recently placed in at least one location. Photo taken of recent fill, approximately Lat. 32.269045, Long. -110.871144

Recent fill placement on
Rustand property
109-22-020M (looking S)

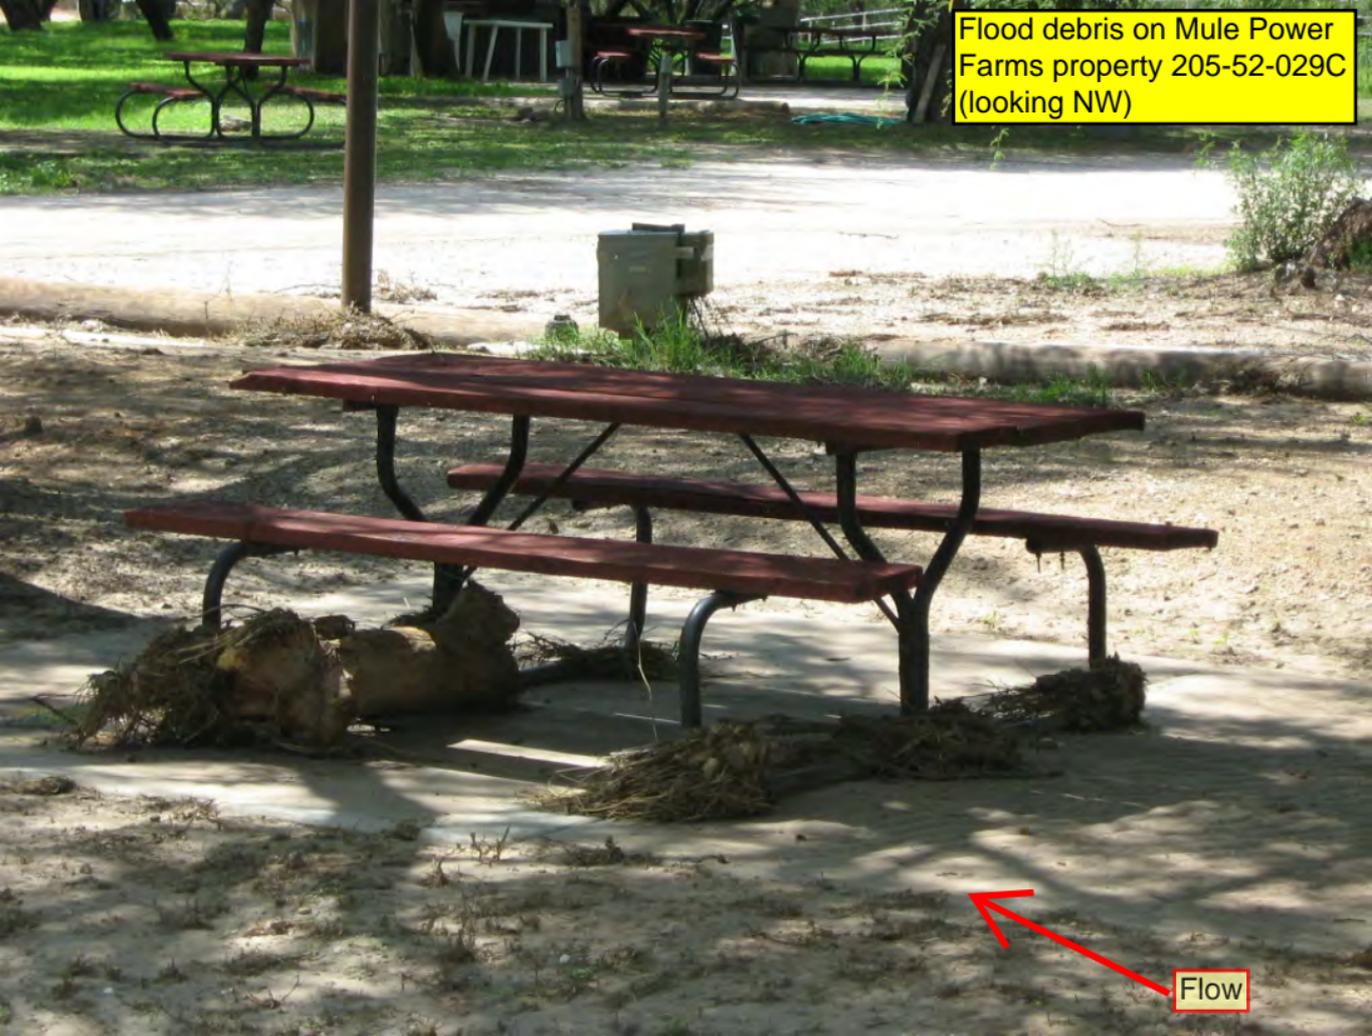
Flood debris on Mule Power Farms property 205-52-029C (looking NW)

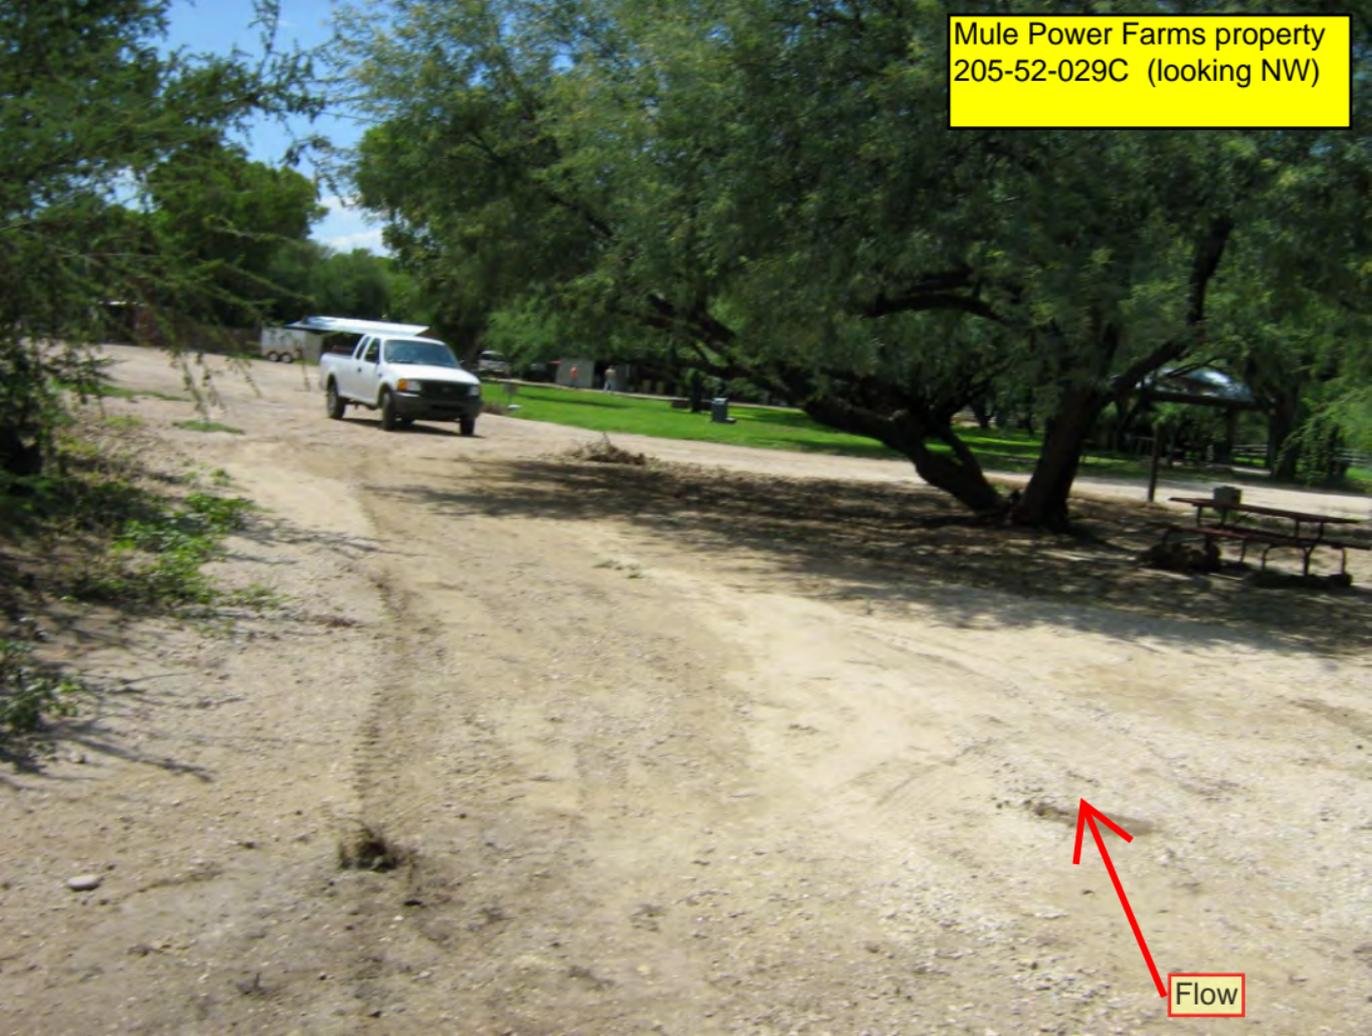
Mule Power Farms property
205-52-029C (looking NW)

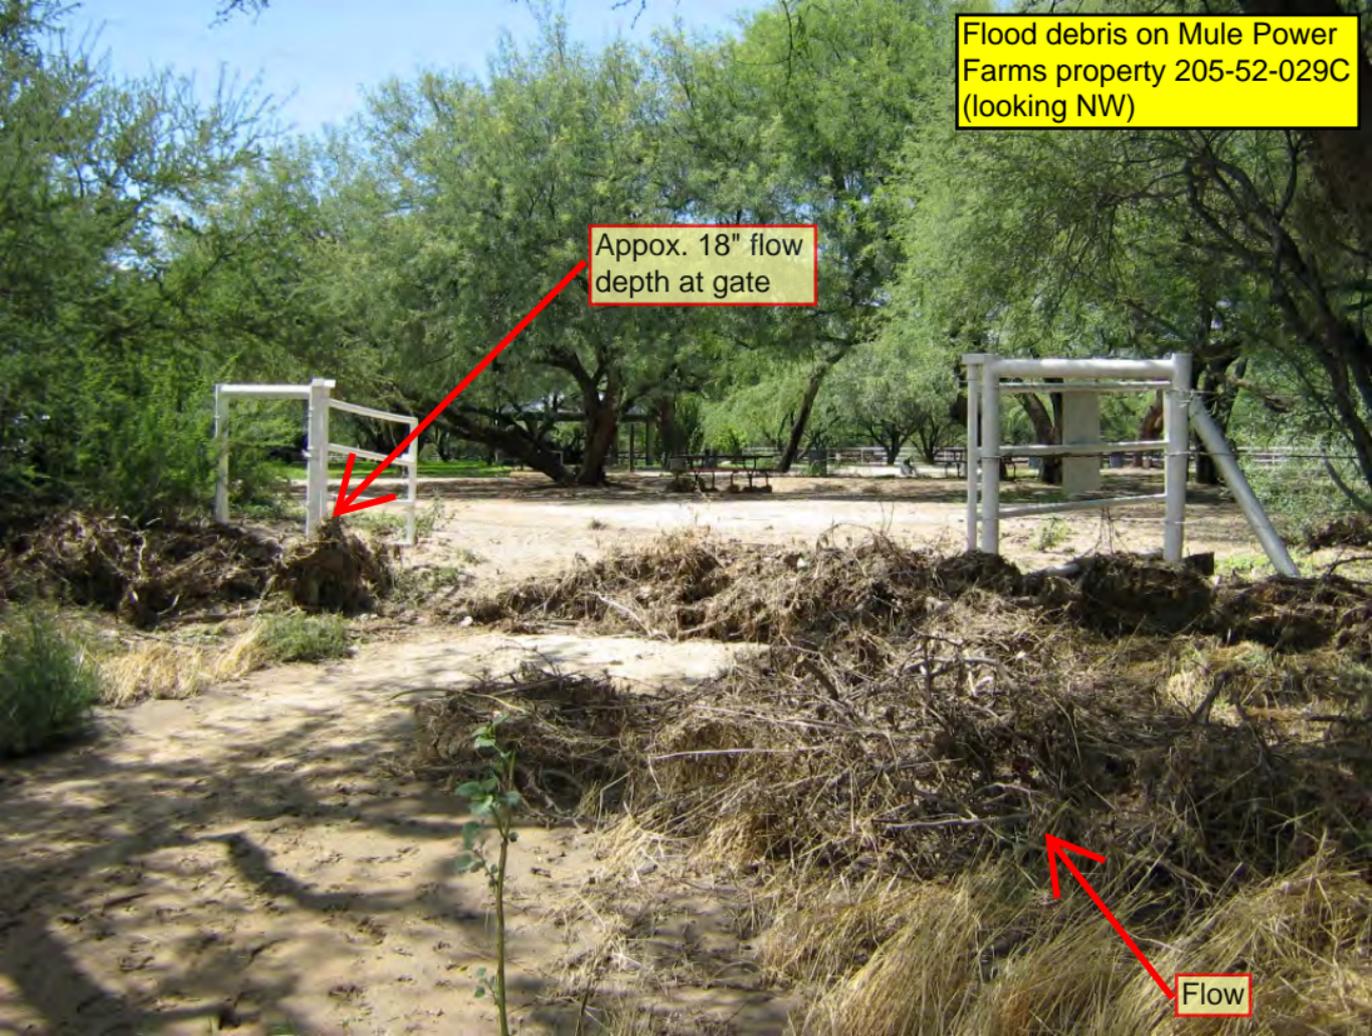
Flood debris on Mule Power Farms property 205-52-029C (looking NW)

Approx. 18" flow depth at gate

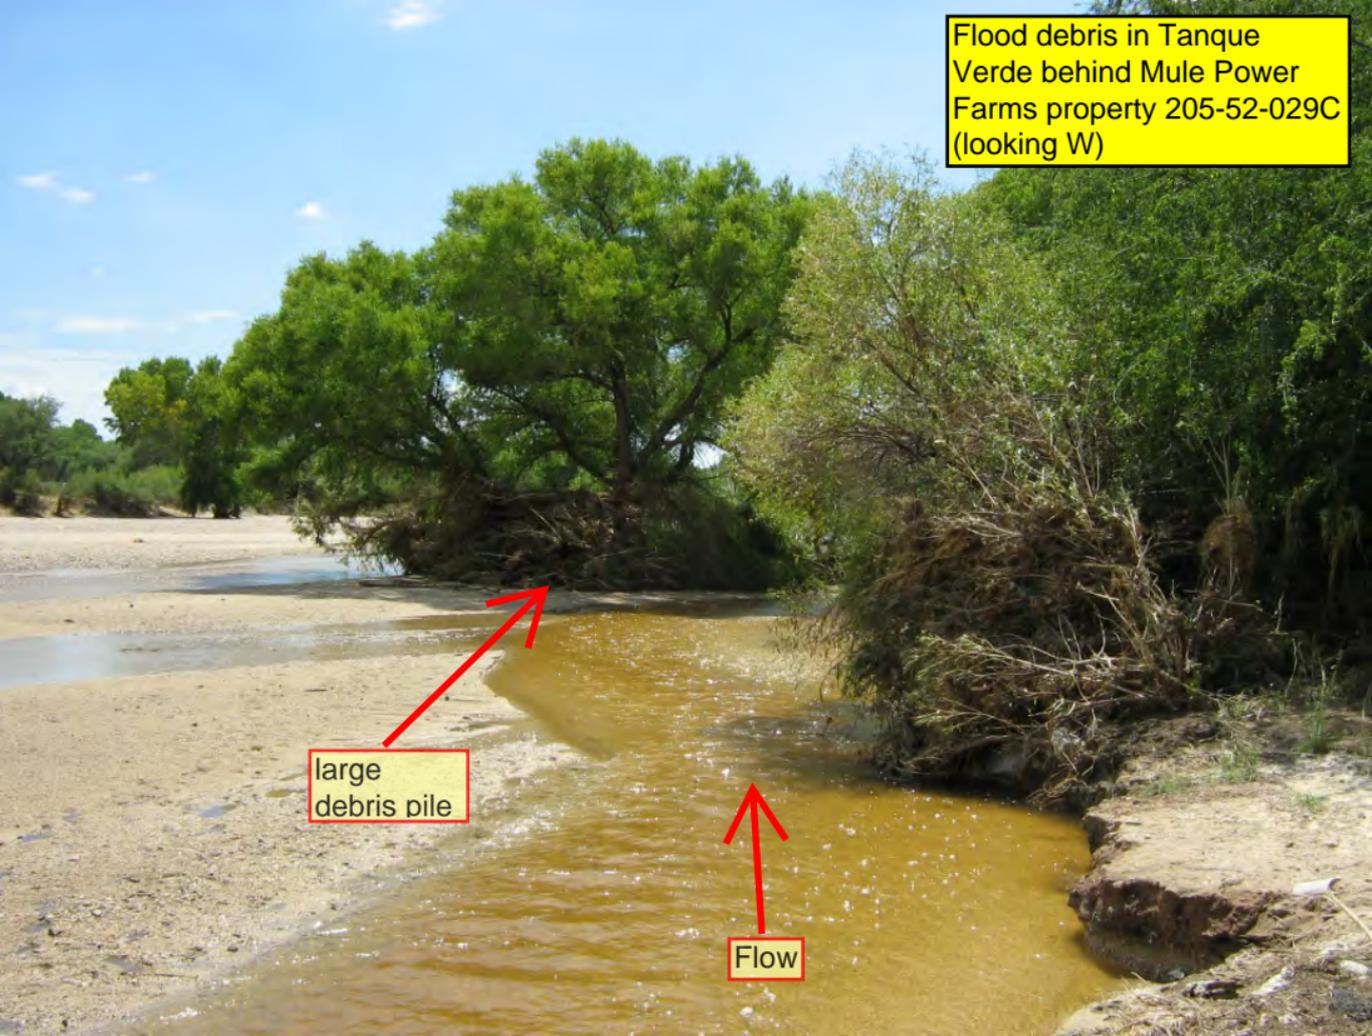
Flood debris in Tanque Verde behind Mule Power Farms property 205-52-029C (looking W)

large
debris pile

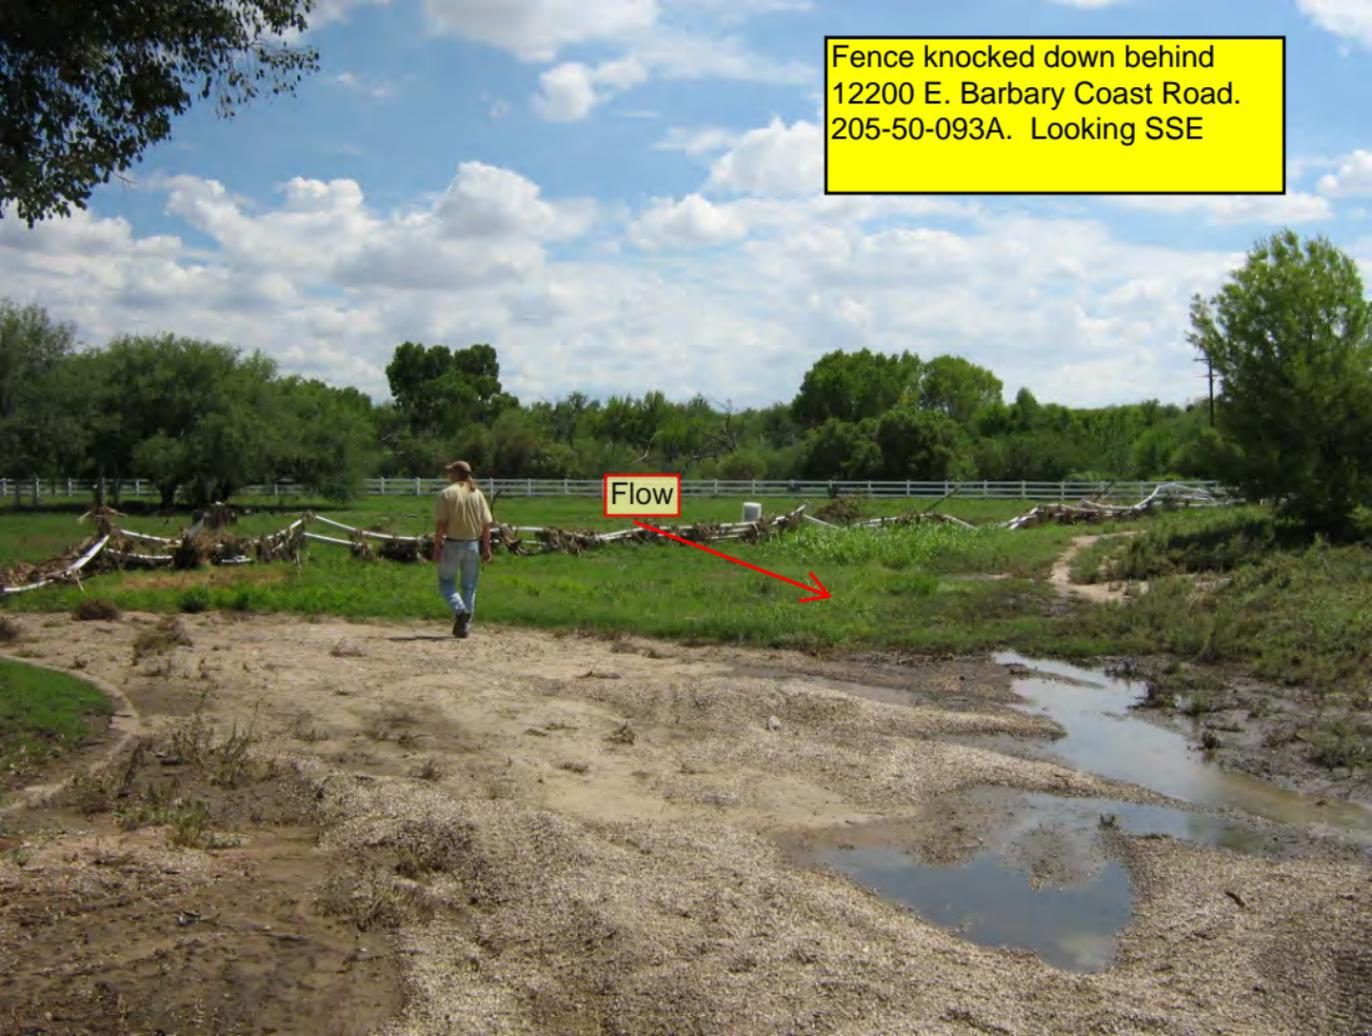
Fence knocked down behind
12200 E. Barbary Coast Road.
205-50-093A. Looking SSE

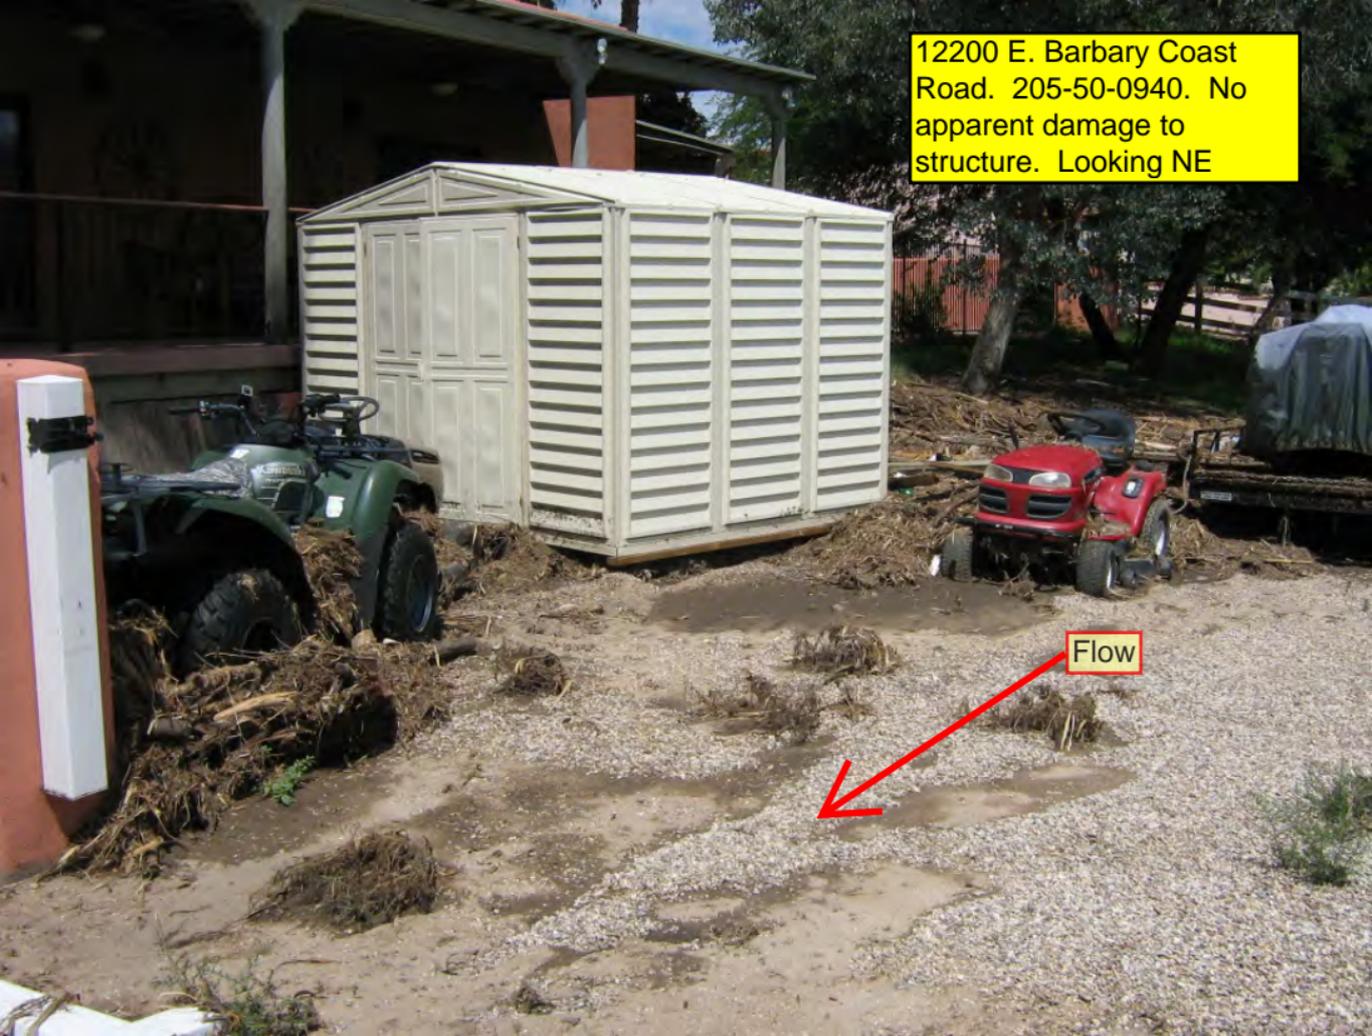
12200 E. Barbary Coast
Road. 205-50-0940. No
apparent damage to
structure. Looking NE

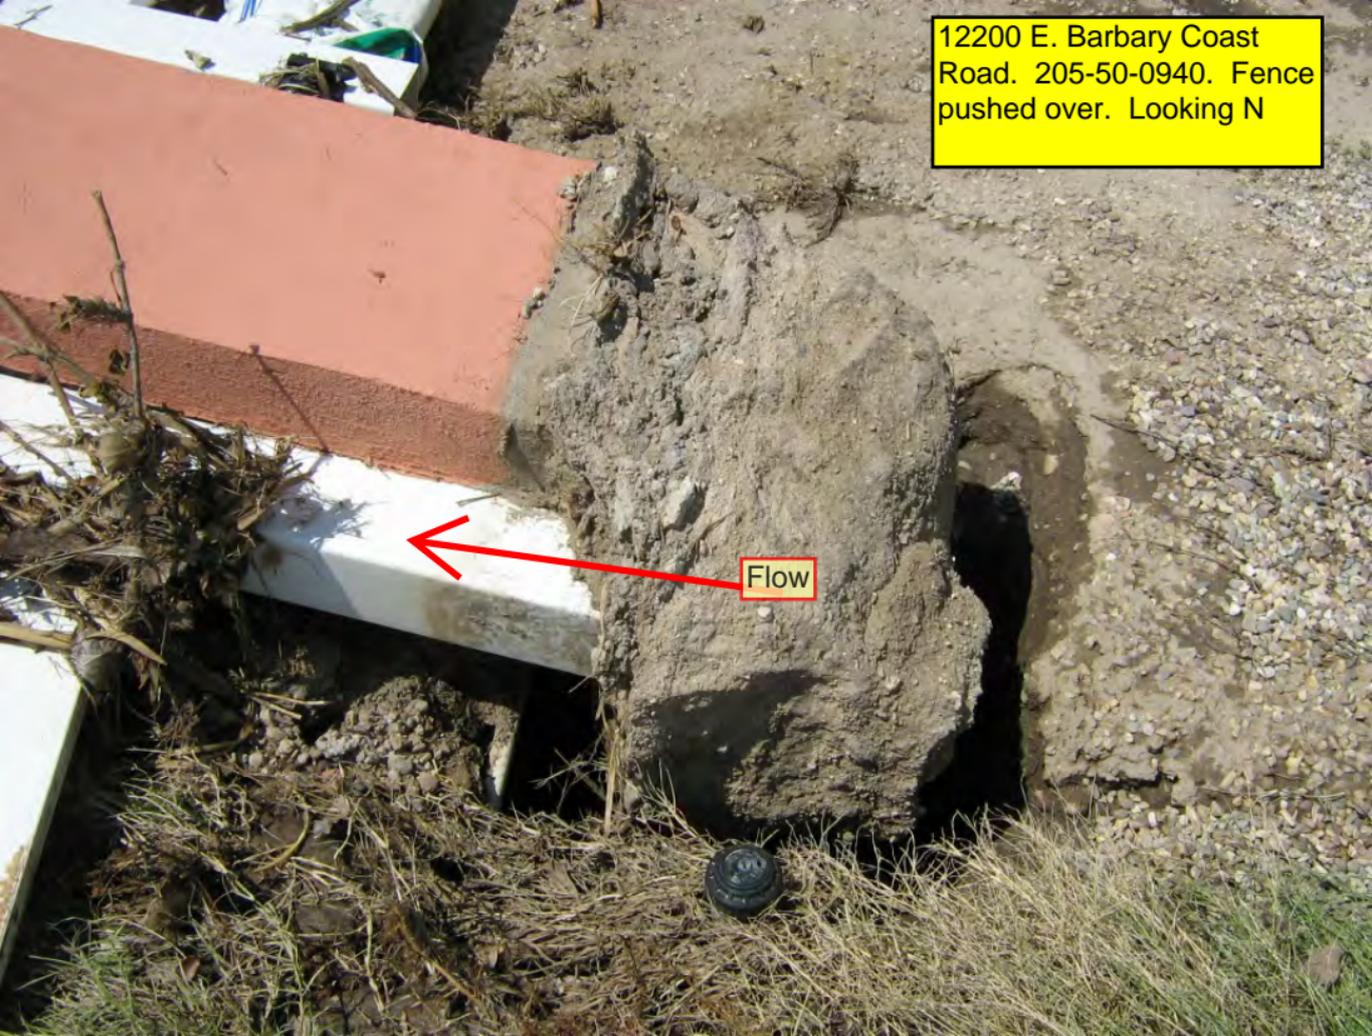
12200 E. Barbary Coast Road. 205-50-0940. Fence pushed over. Looking N

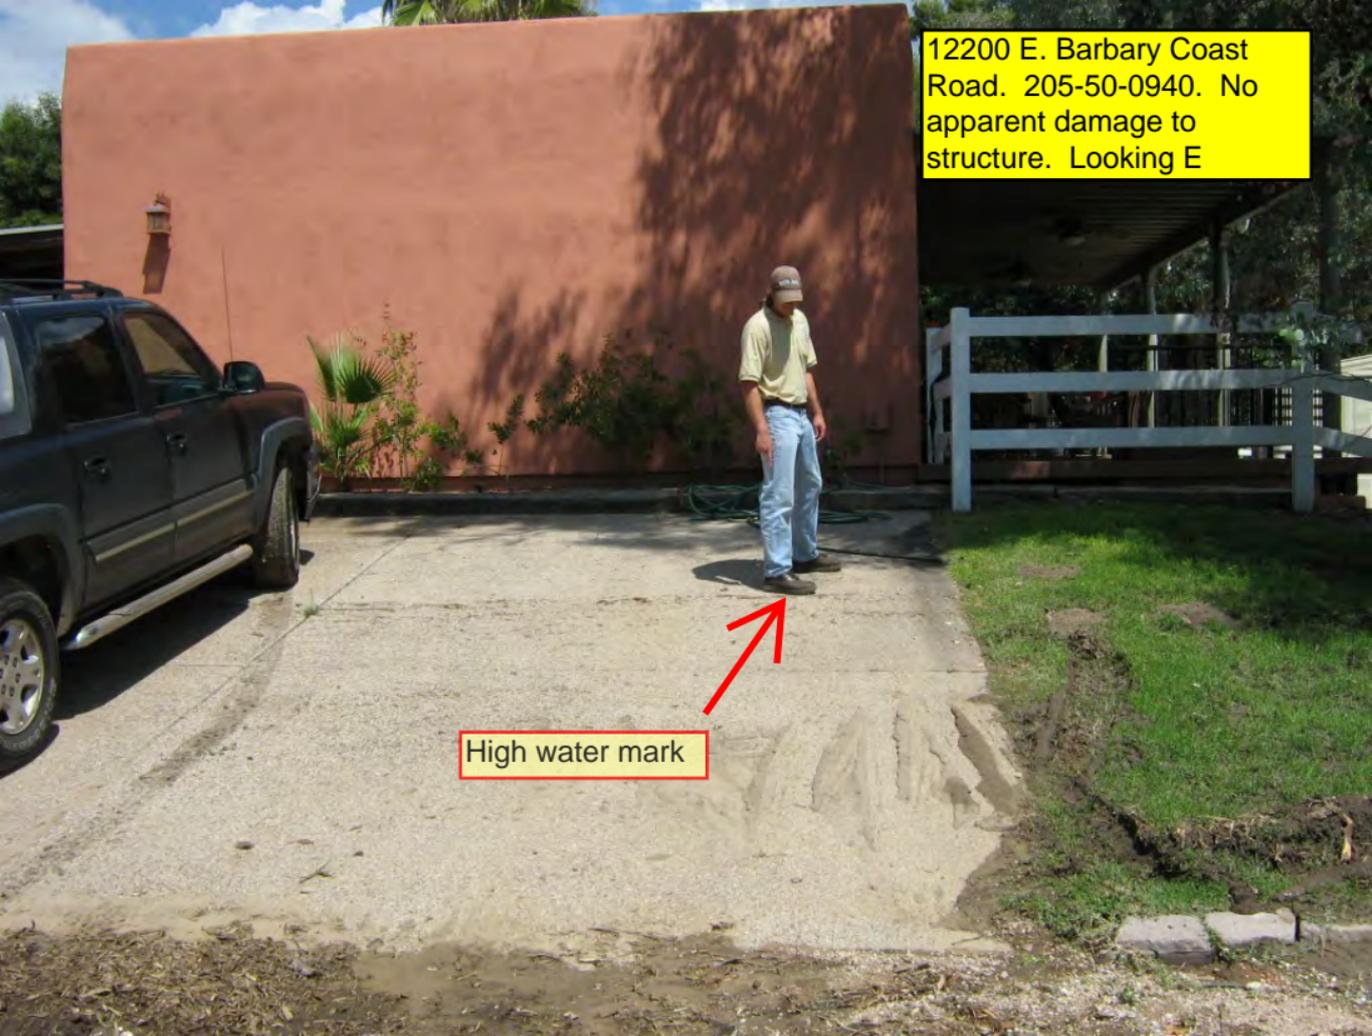
12200 E. Barbary Coast Road. 205-50-0940. No apparent damage to structure. Looking E

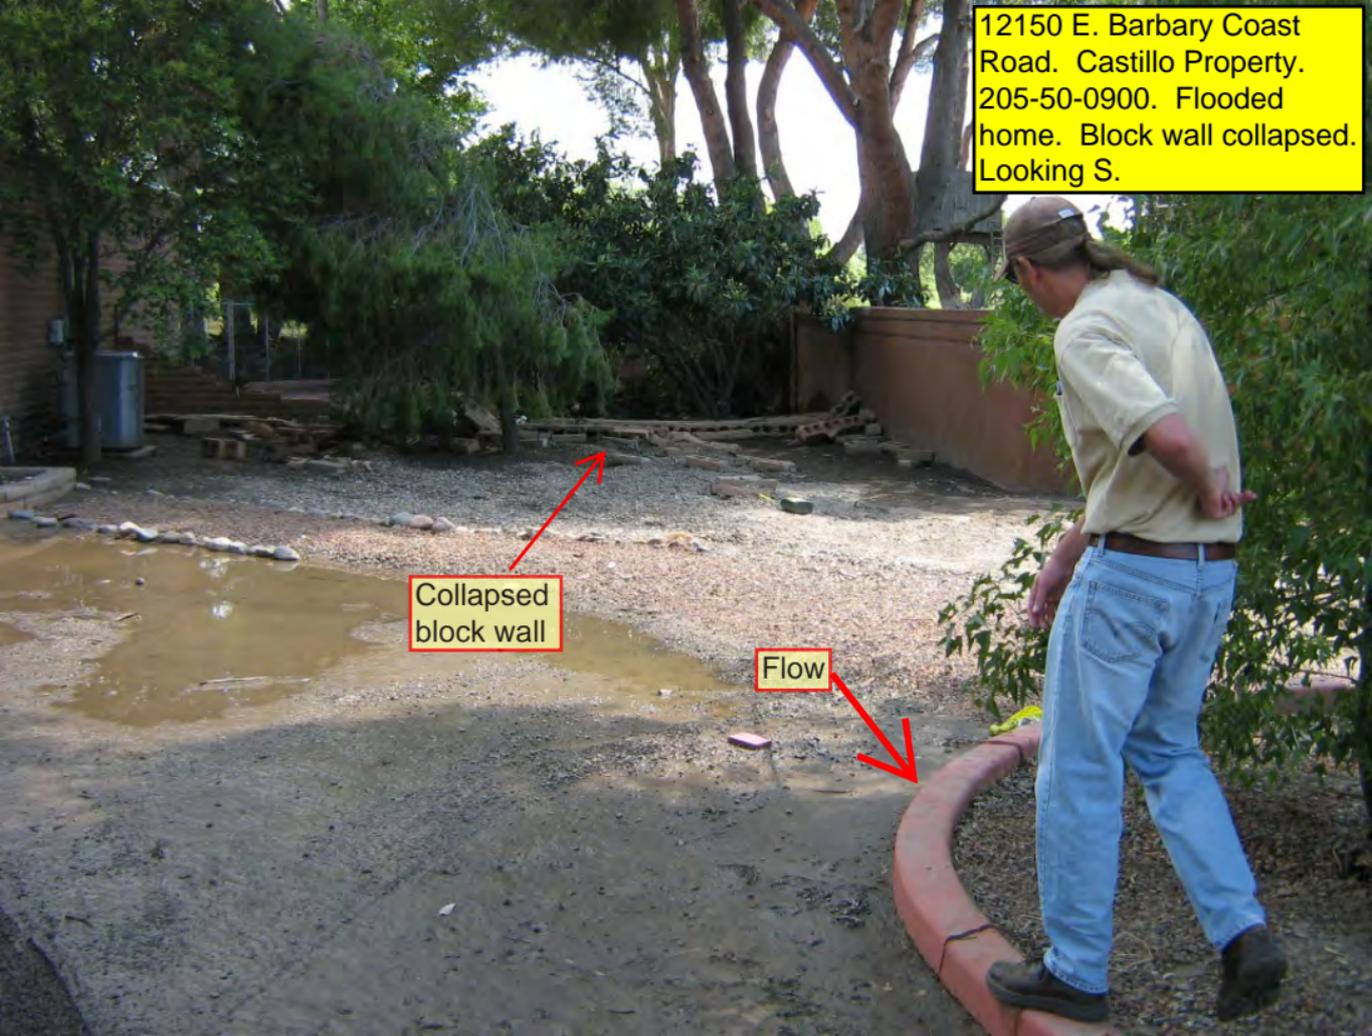
The Castillo residence at 12150 E. Barbary Coast Rd. (205-50-0900) was flooded and two portions of the block wall collapsed. The Castillo's were not home, but a clean-up/restoration crew was working at the house. Based on the evidence, it is believed that the block wall at the rear of the property collapsed first, then water was impounded in the back yard, causing the west side yard wall to collapse. Water marks on the outside of the west side of house were about 34 inches above grade. A water mark on the inside of the western property wall was approximately 36-38 inches above grade. It is possible that this flood height was increased by impounded by the front block wall. It is difficult to say how much mud was deposited as the floodwaters receded, which would affect the flood height during the flood peak. According to the restoration crew, the residence was fairly seriously damaged. Five pictures taken.

12150 E. Barbary Coast Road. Castillo Property. 205-50-0900. Flooded home. Block wall collapsed. Looking S.

Collapsed block wall

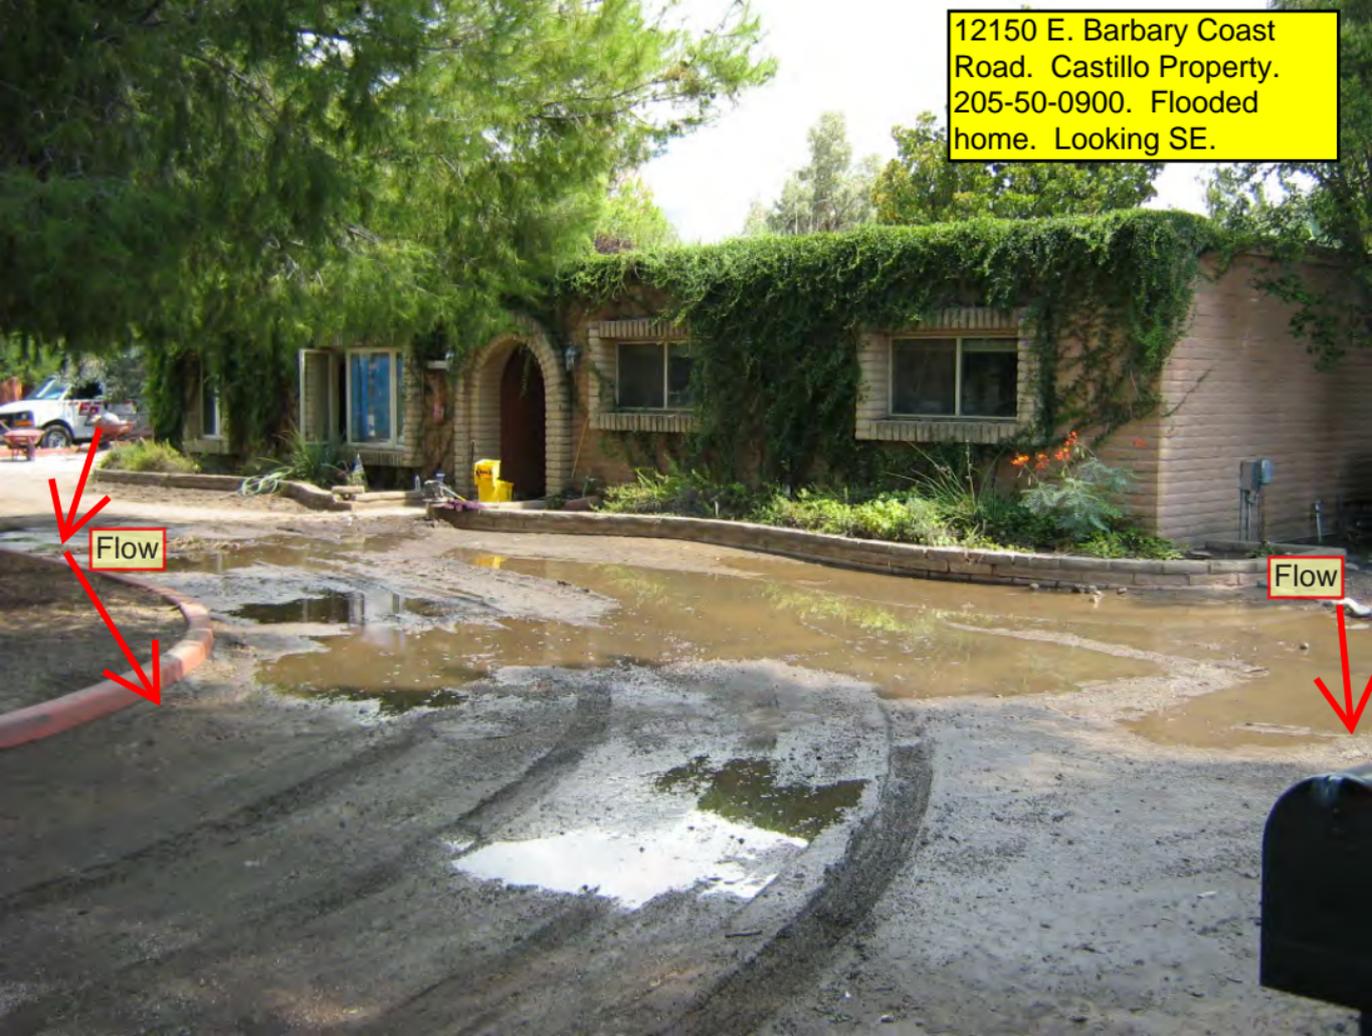
12150 E. Barbary Coast
Road. Castillo Property.
205-50-0900. Flooded
home. Looking SE.

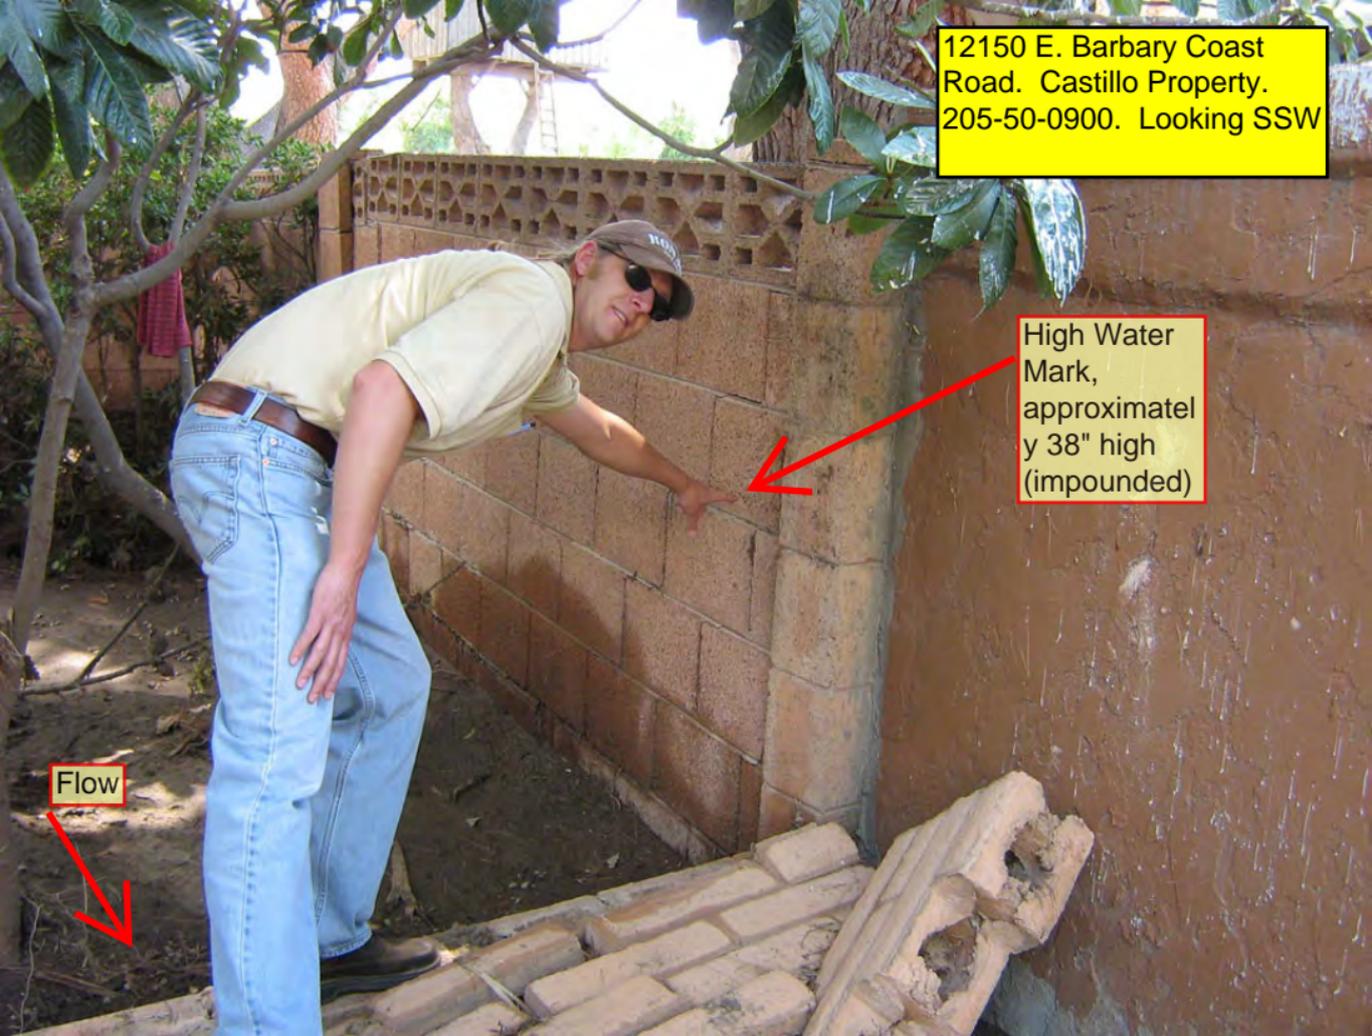
12150 E. Barbary Coast Road. Castillo Property. 205-50-0900. Looking SSW

High Water Mark, approximately 38" high (impounded)

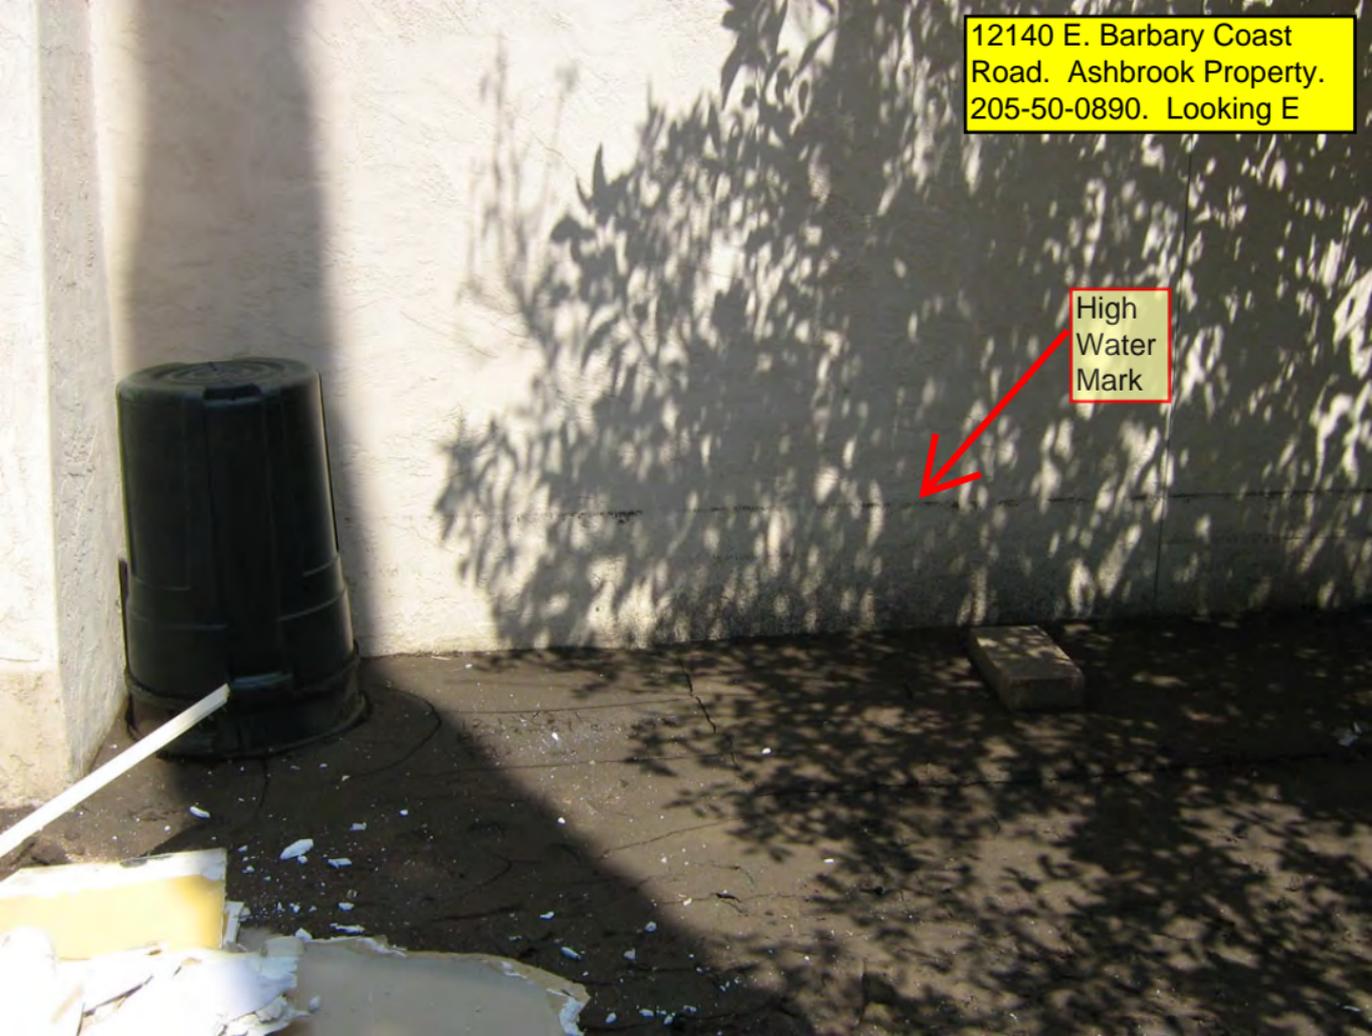
12140 E. Barbary Coast
Road. Ashbrook Property.
205-50-0890. Looking E

High
Water
Mark

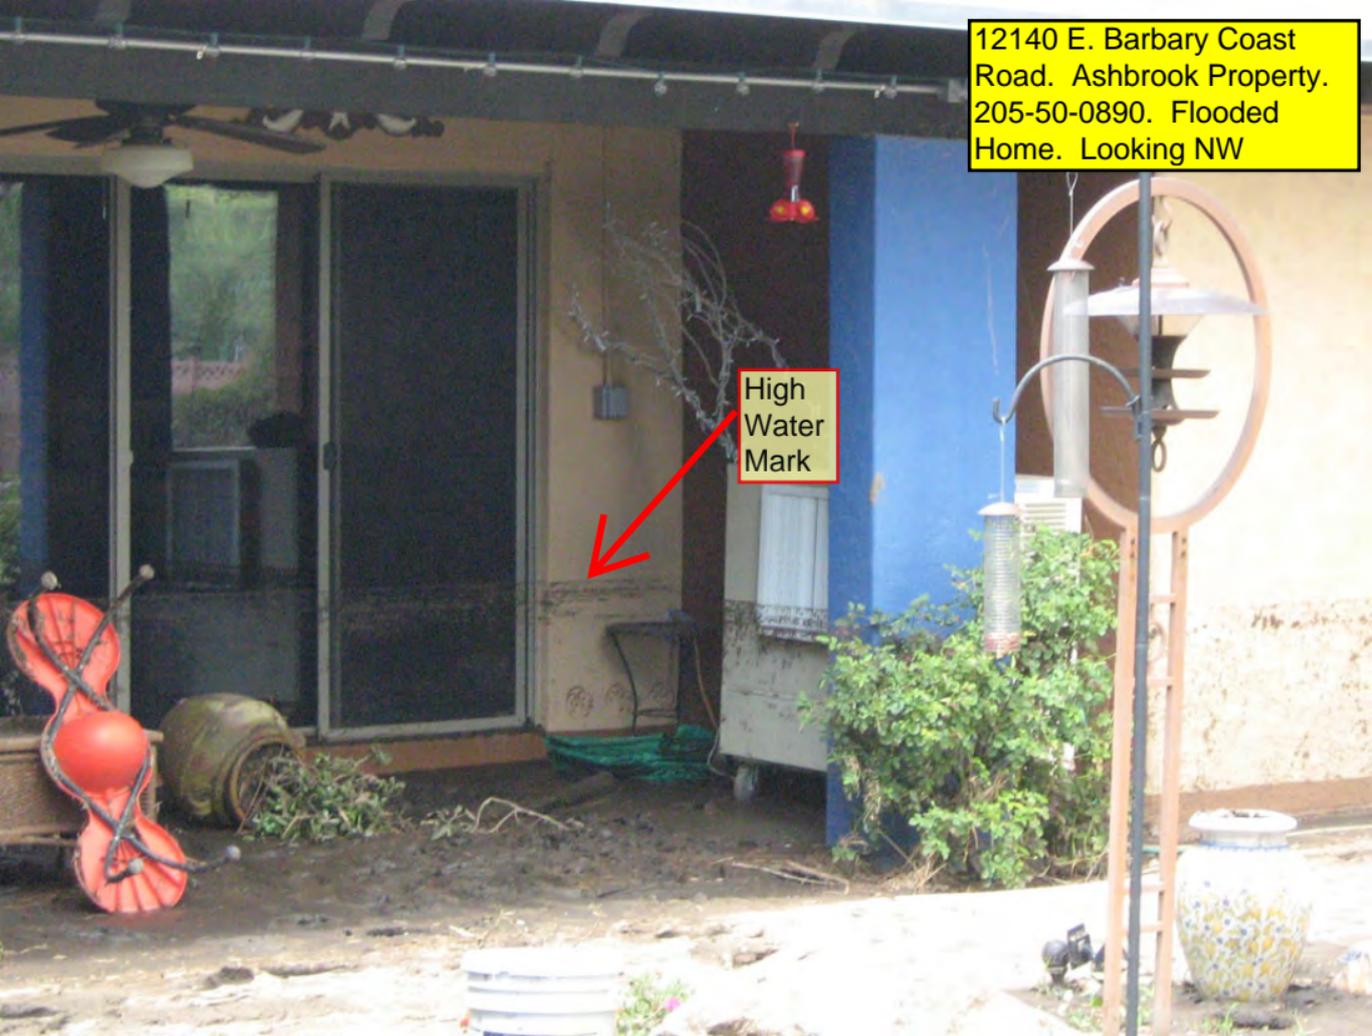
12140 E. Barbary Coast
Road. Ashbrook Property.
205-50-0890. Flooded
Home. Looking NW

High
Water
Mark

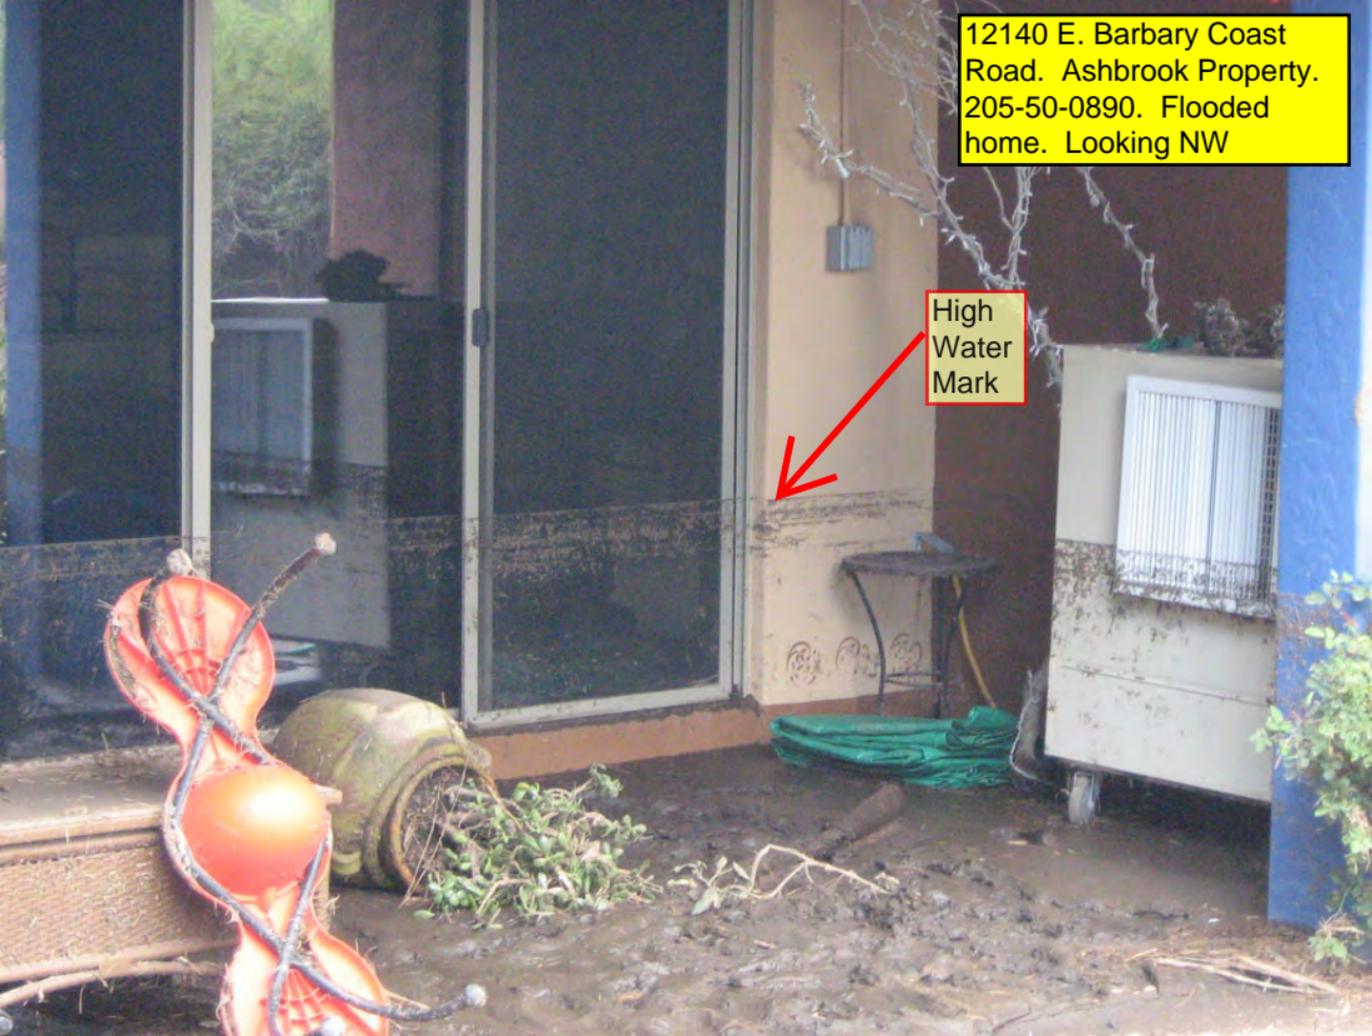
12140 E. Barbary Coast
Road. Ashbrook Property.
205-50-0890. Flooded
home. Looking NW

High
Water
Mark
