2010 Tanque Verde Flood Investigation Report

Site Investigation Date: August 2, 2010

Investigators: Brian Jones and Eric Shepp
Report written by Brian Jones and edited by Eric Shepp

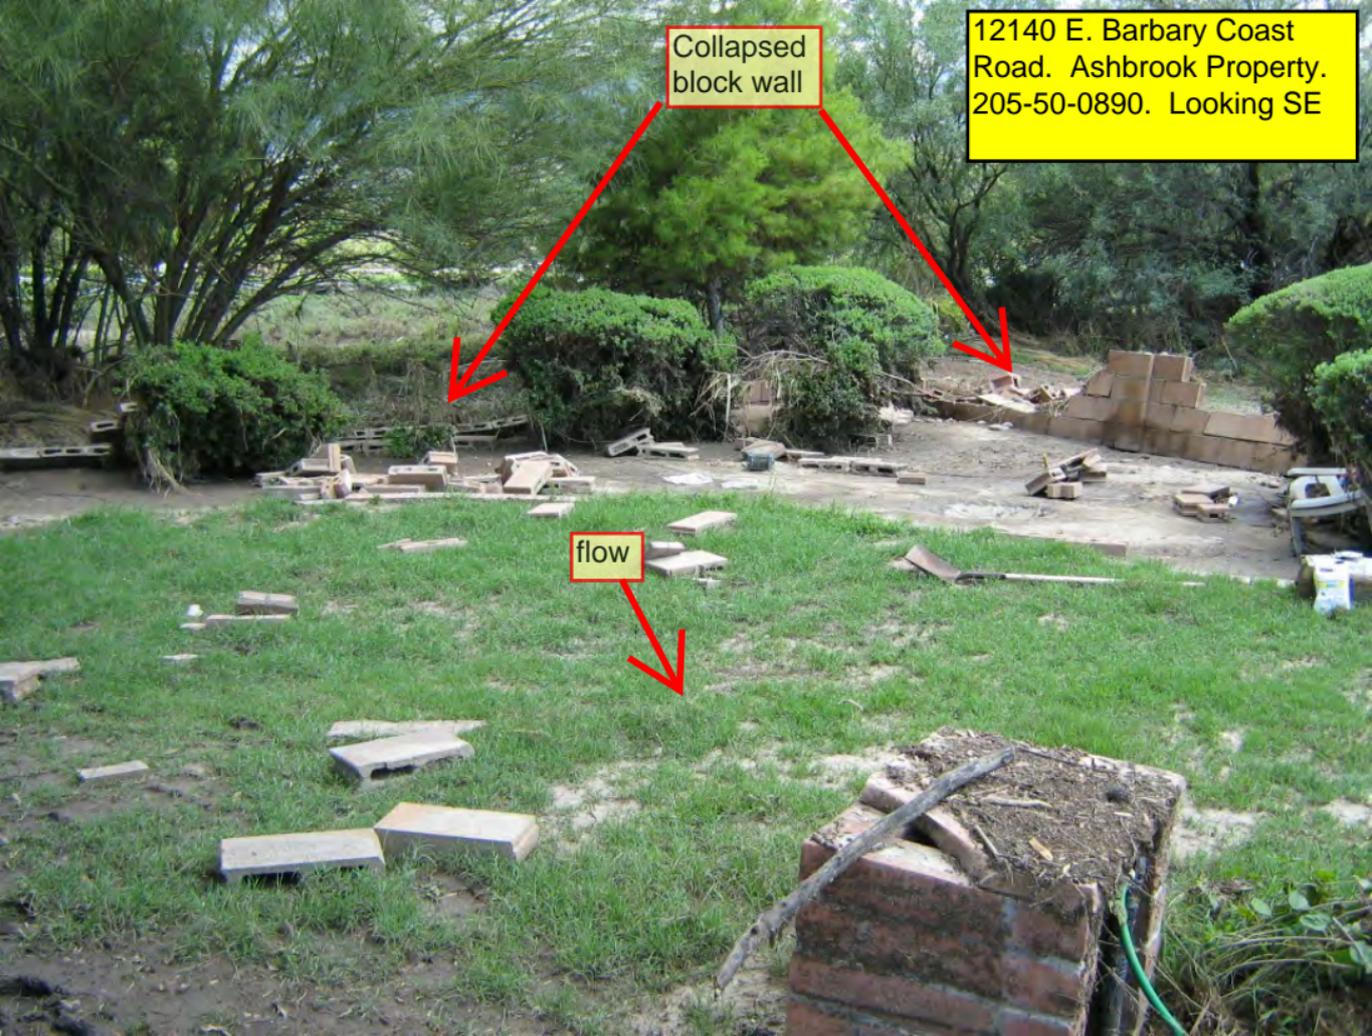
property was largely destroyed. Individual blocks from the wall were found approximately 40 feet downstream from the wall. The Ashbrooks were not at home at the time, but phone contact was made the next day. Five photos were taken.

12140 E. Barbary Coast Road. Ashbrook Property. 205-50-0890. Looking SE

Collapsed block wall

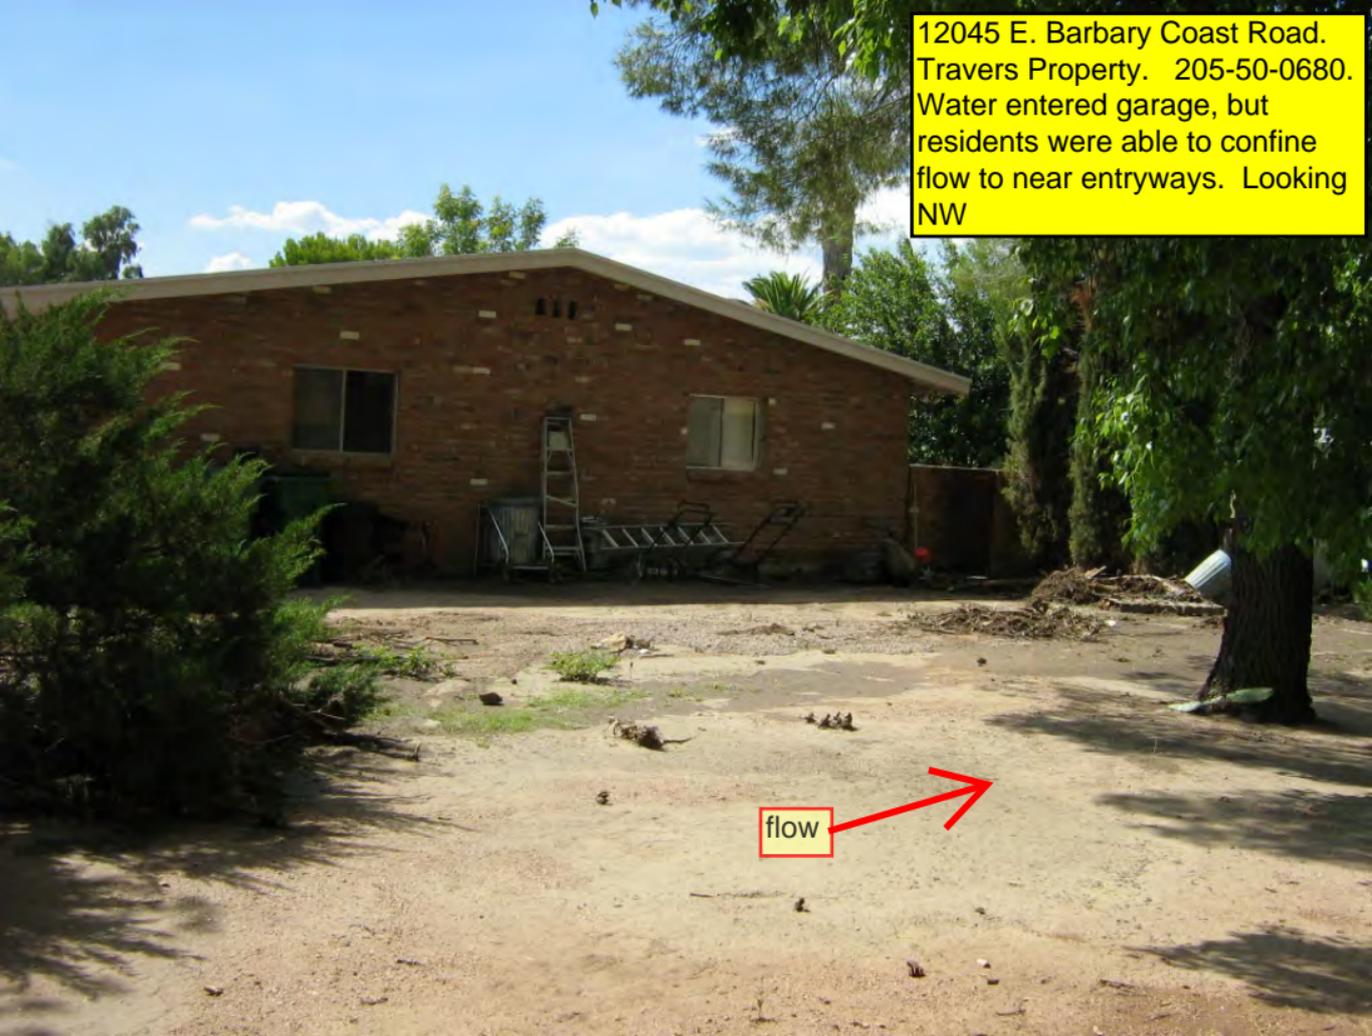
12045 E. Barbary Coast Road.
Travers Property. 205-50-0680.
Water entered garage, but
residents were able to confine
flow to near entryways. Looking
NW

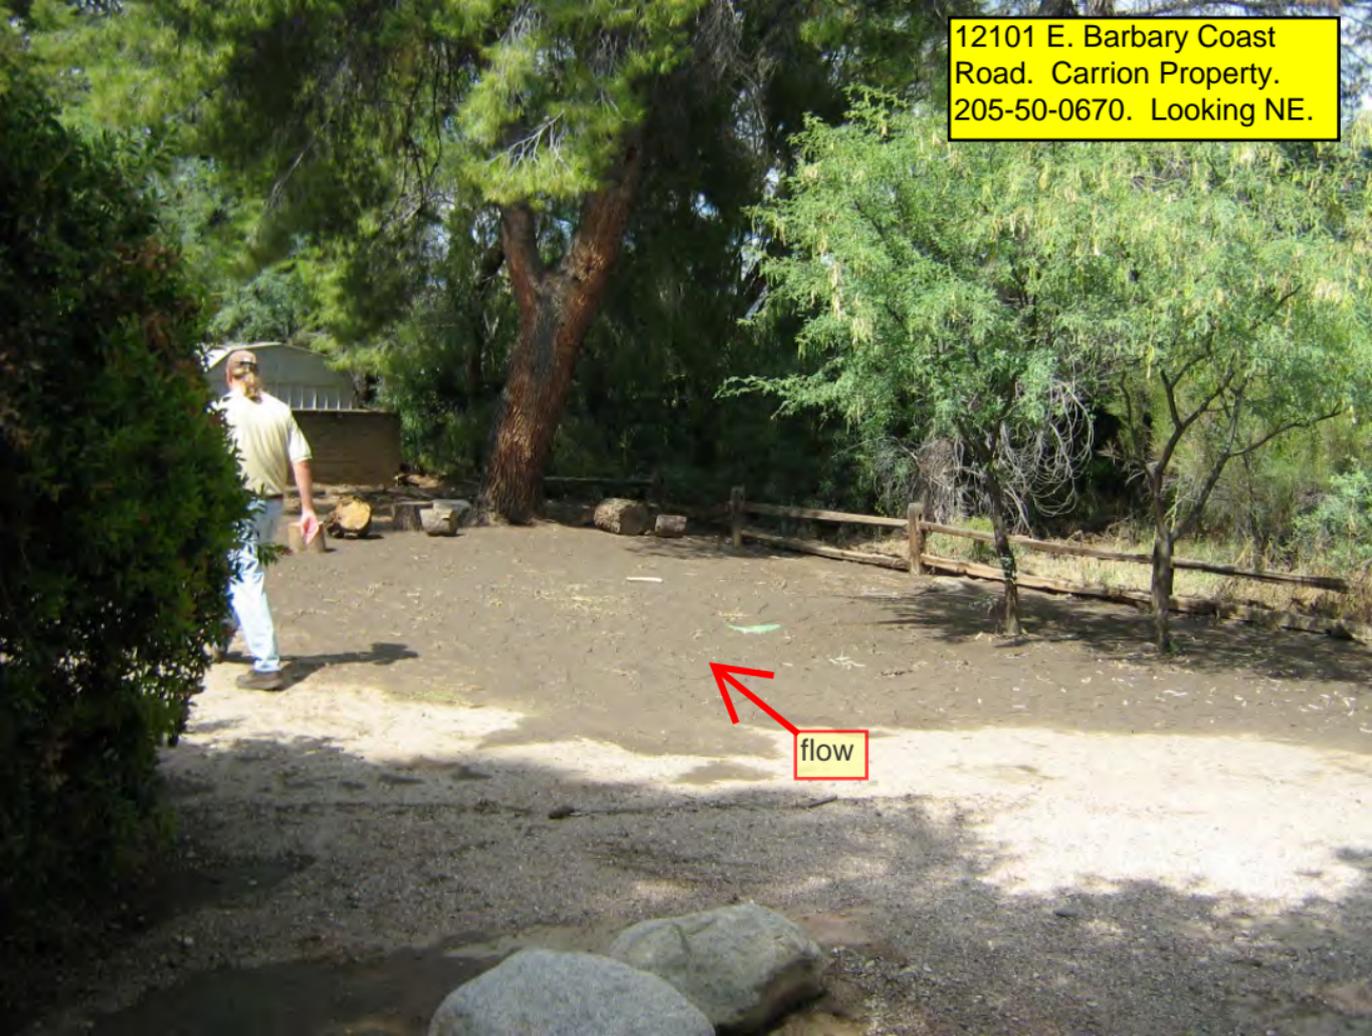
12101 E. Barbary Coast Road. Carrion Property. 205-50-0670. Home and garage flooded. Approx 1" of water in home, deeper in garage. Looking NE.

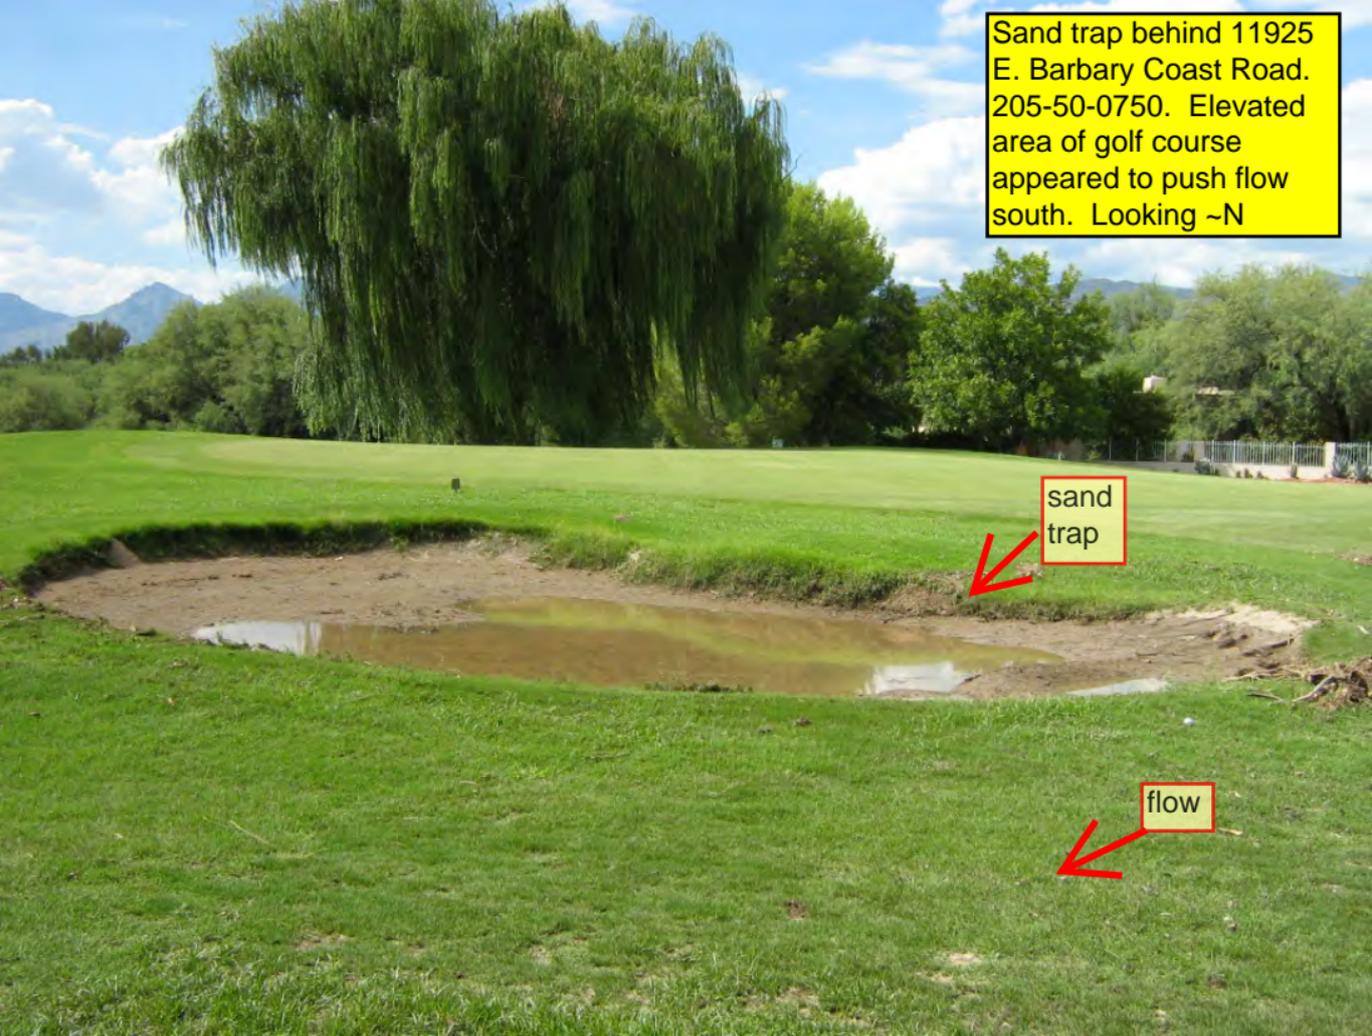
Sand trap behind 11925
E. Barbary Coast Road.
205-50-0750. Elevated
area of golf course
appeared to push flow
south. Looking ~N

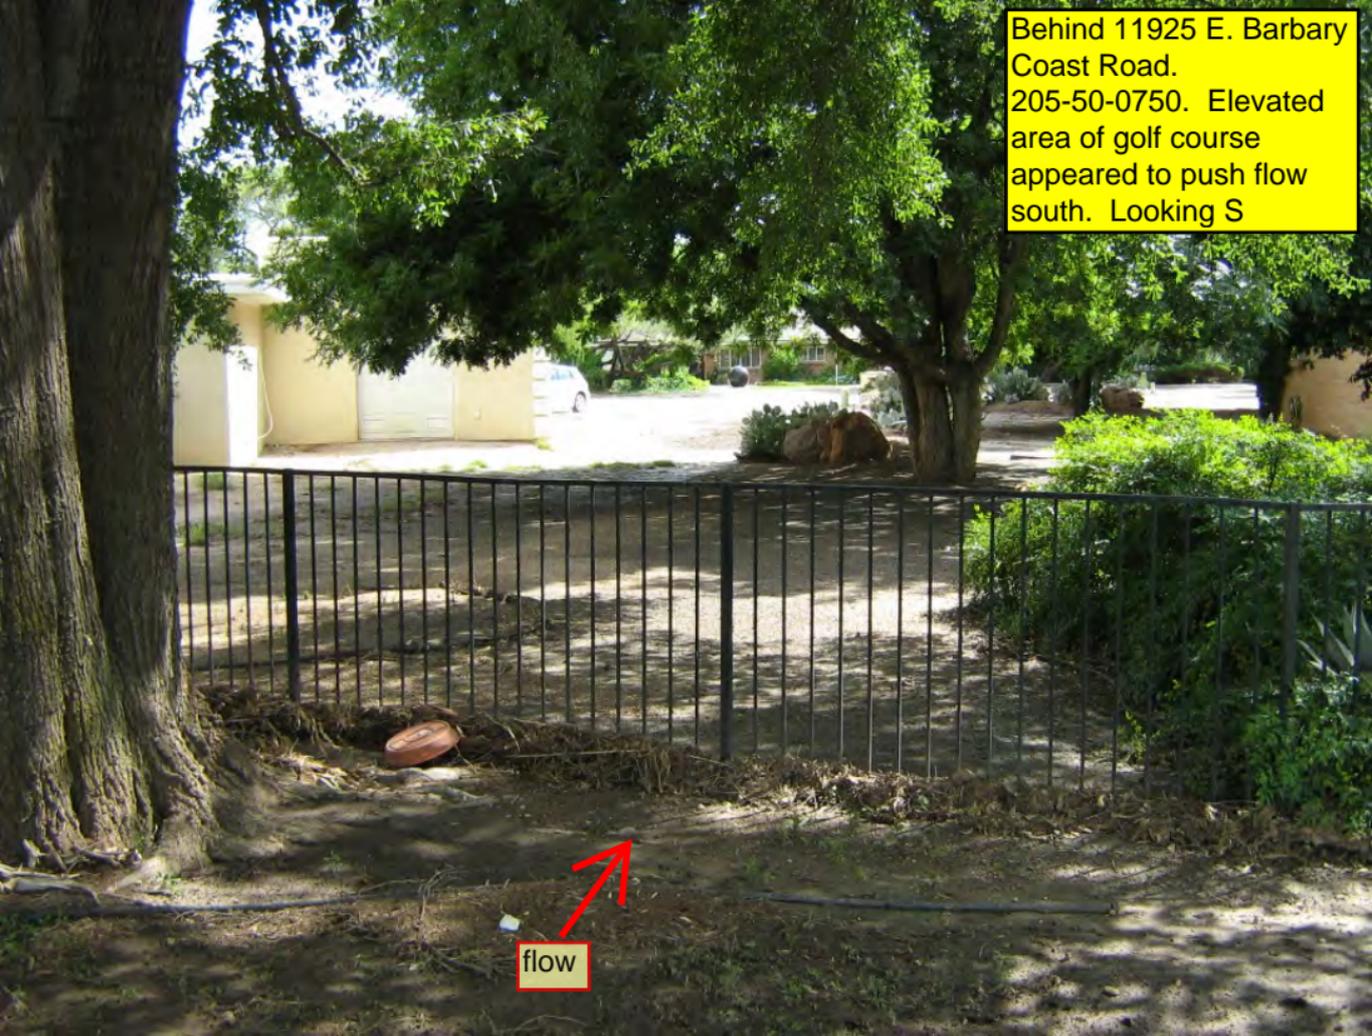
Behind 11925 E. Barbary Coast Road.
205-50-0750. Elevated area of golf course appeared to push flow south. Looking S

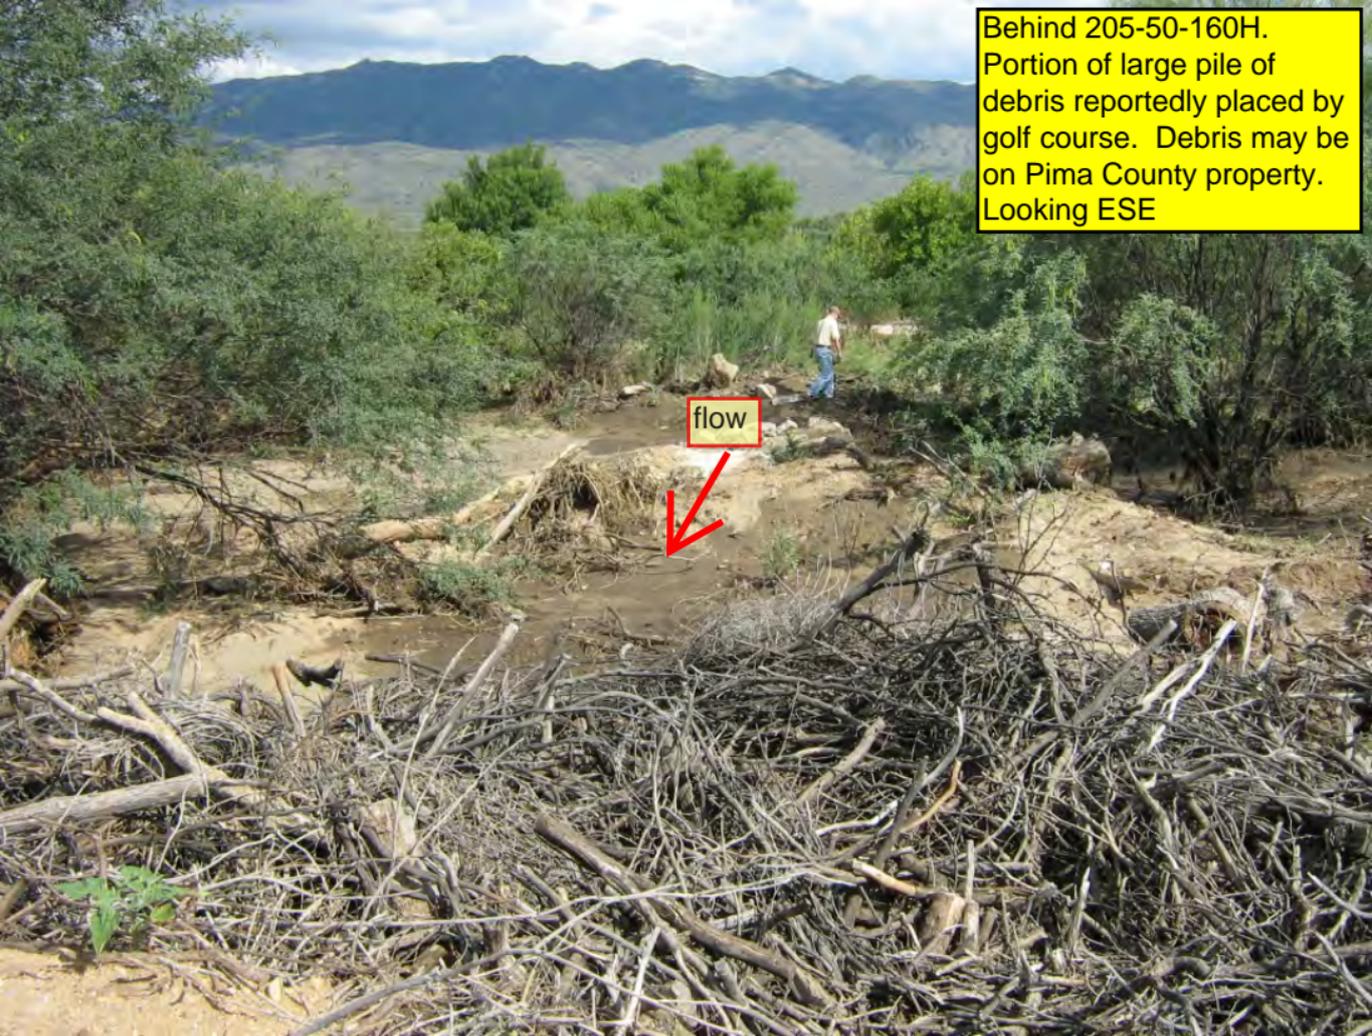
We went to investigate the "dump" and found large piles of debris consisting mainly of tree trimmings and other green waste. Portions of the pile were up to 7 feet tall. The pile was more than 200 feet long and varied in width from about 12 feet to over 25 feet. It appeared that flood waters broke through a ten foot section of the debris pile, flowed across a graded area, then as debris got caught in the thick vegetation at the western end of the graded area, was forced north onto the 7th hole of the golf course and toward the residences at the east end of 49ers. The debris pile is located in the Floodway and is likely not allowed, and some of it may actually be off the golf course property. Eight pictures taken.

Behind 205-50-160H.
Portion of large pile of
debris reportedly placed by
golf course. Debris may be
on Pima County property.
Looking ESE

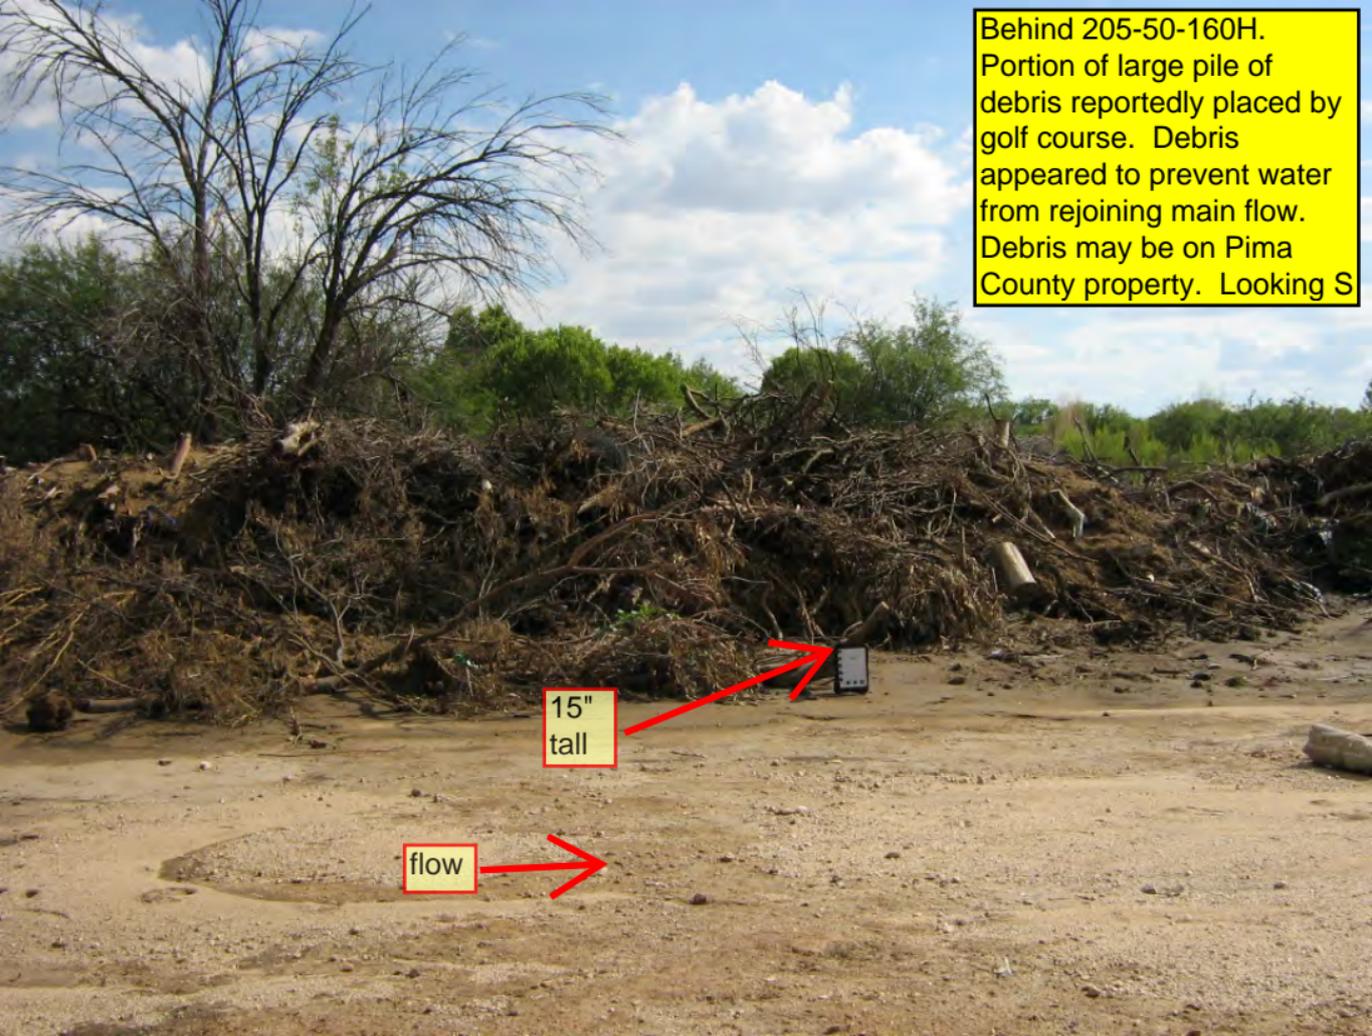
Behind 205-50-160H.
Portion of large pile of
debris reportedly placed by
golf course. Debris
appeared to prevent water
from rejoining main flow.
Debris may be on Pima
County property. Looking S

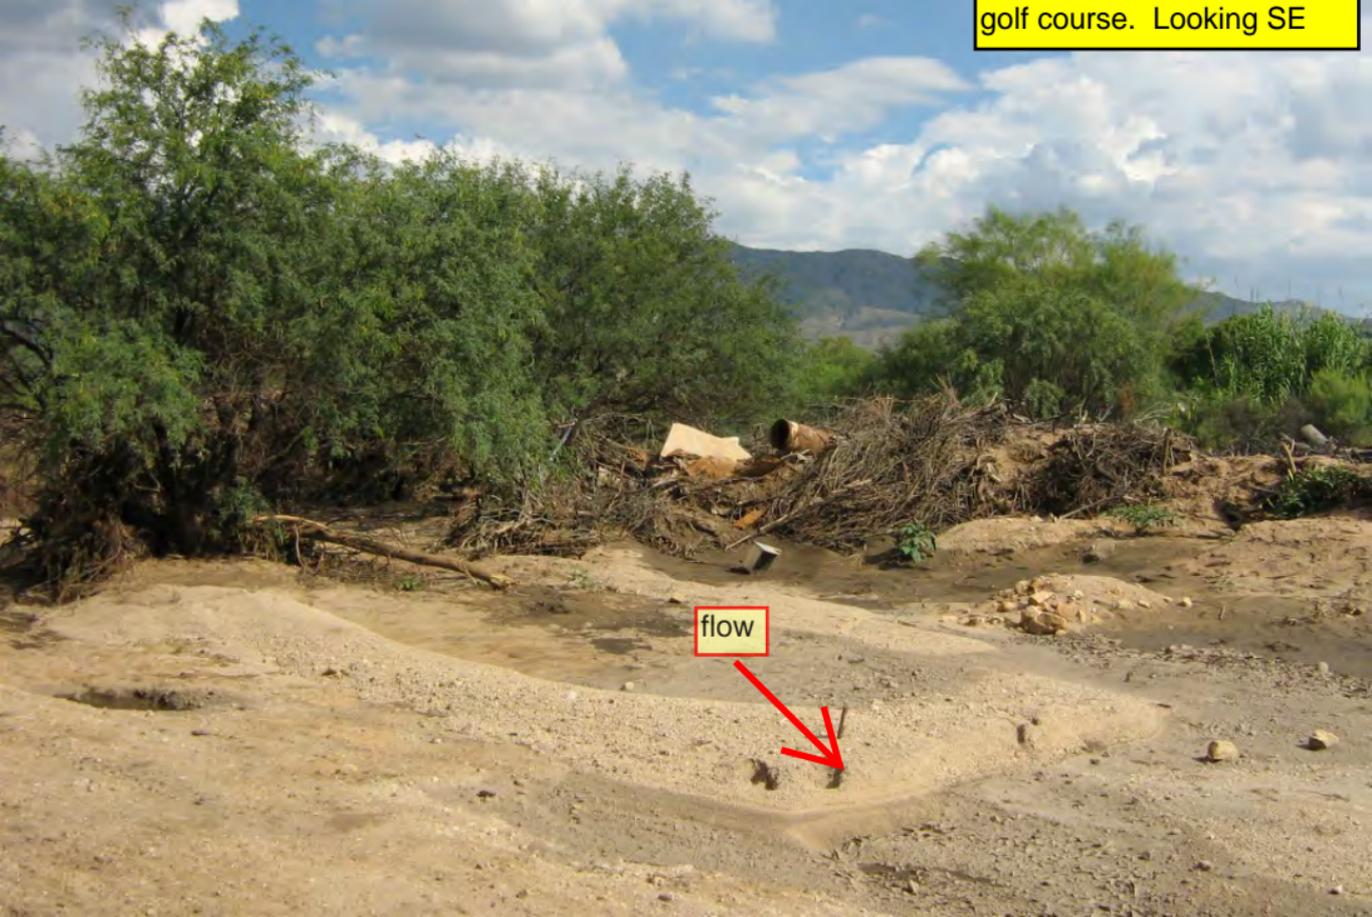
Behind 205-50-160H.
Portion of large pile of
debris reportedly placed by
golf course. Looking SE

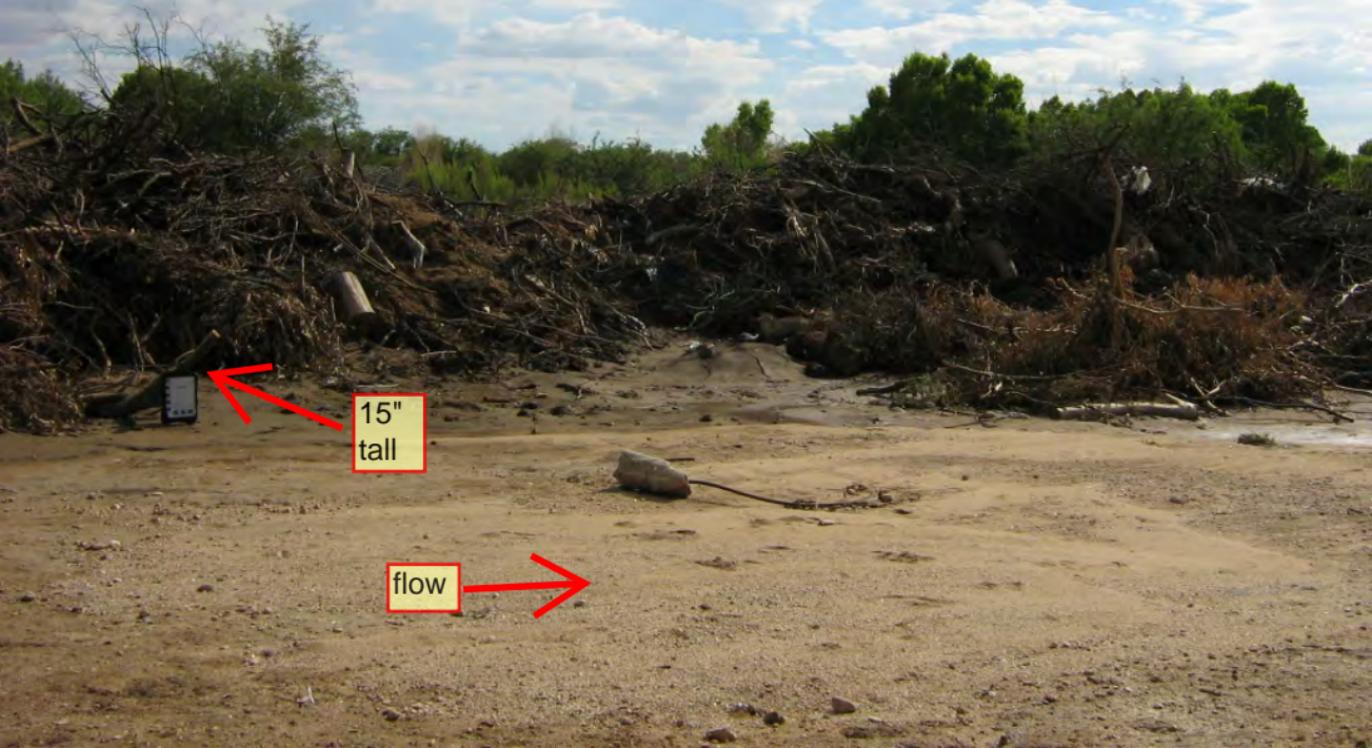
Behind 205-50-160H.
Portion of large pile of
debris reportedly placed by
golf course. Looking SSW

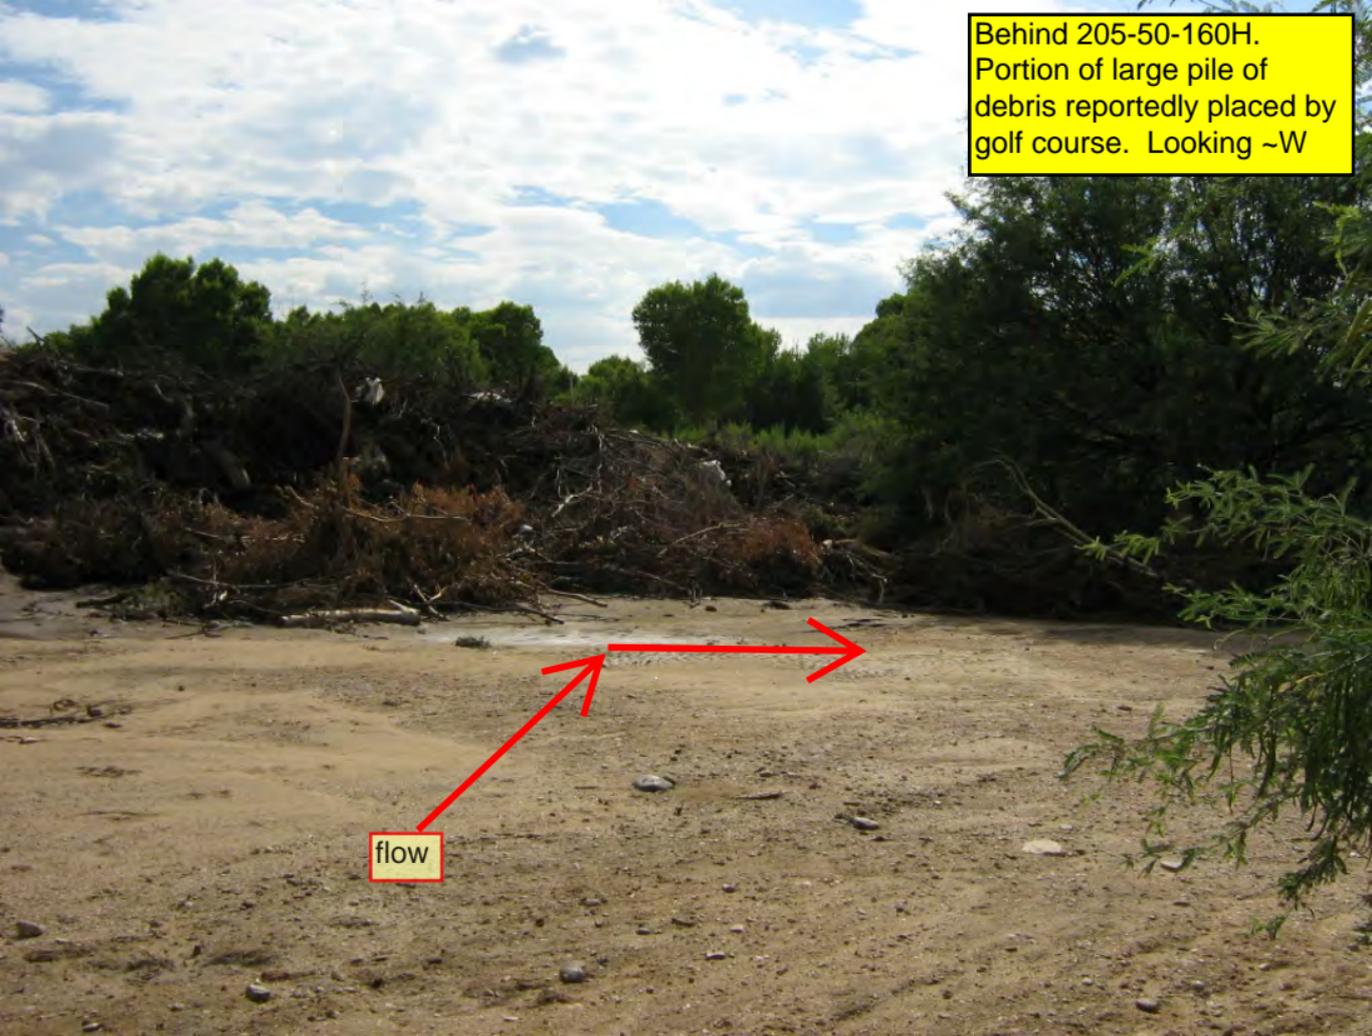
Behind 205-50-160H.
Portion of large pile of
debris reportedly placed by
golf course. Looking ~W

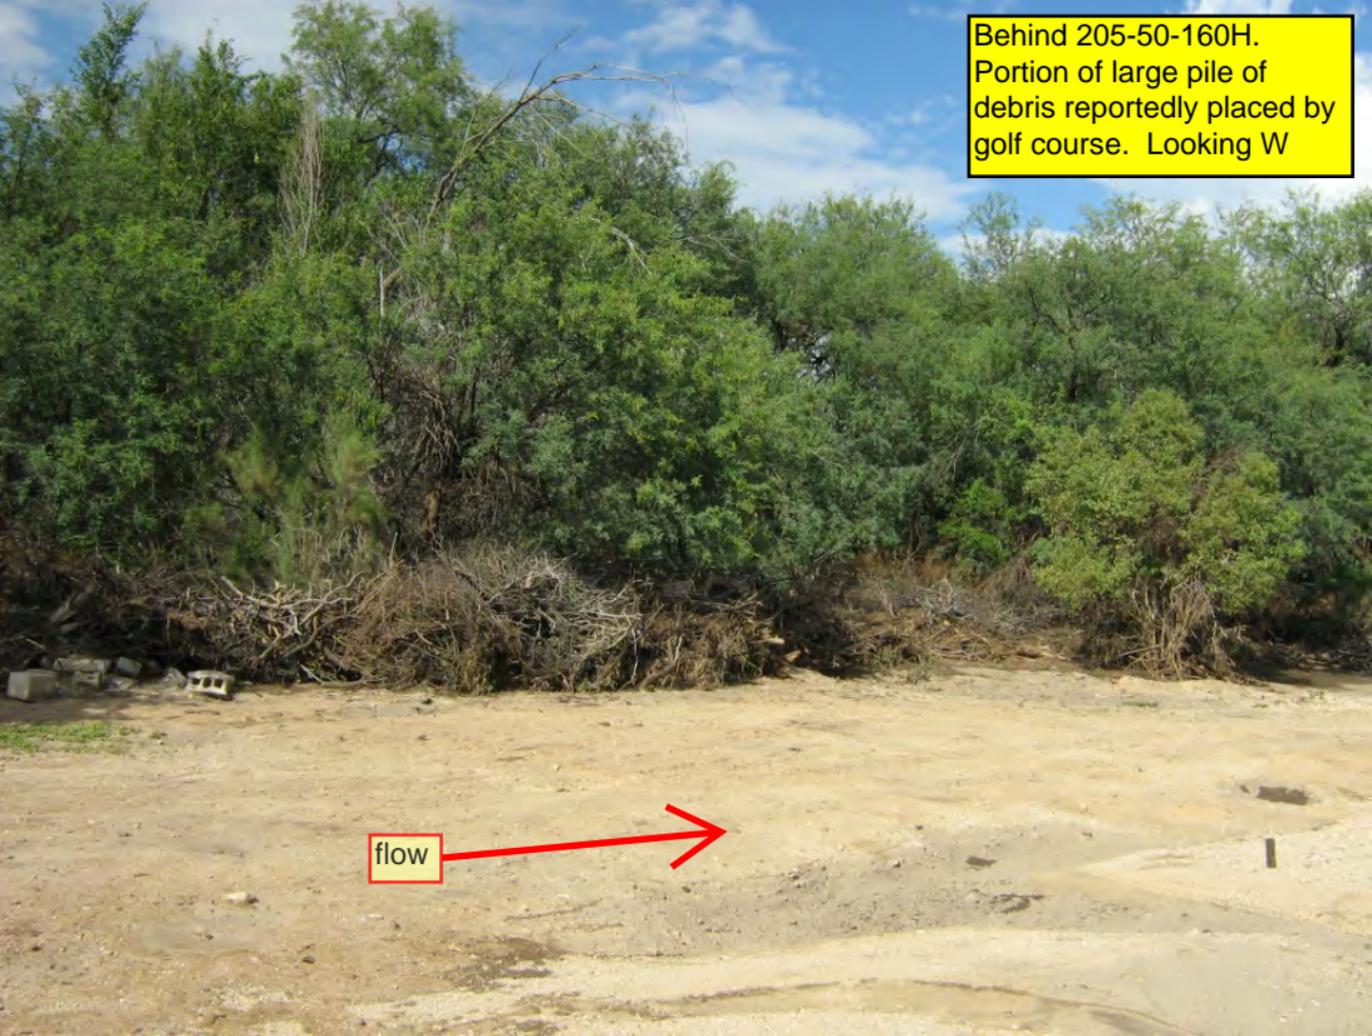
Behind 205-50-160H.
Portion of large pile of
debris reportedly placed by
golf course. Looking W

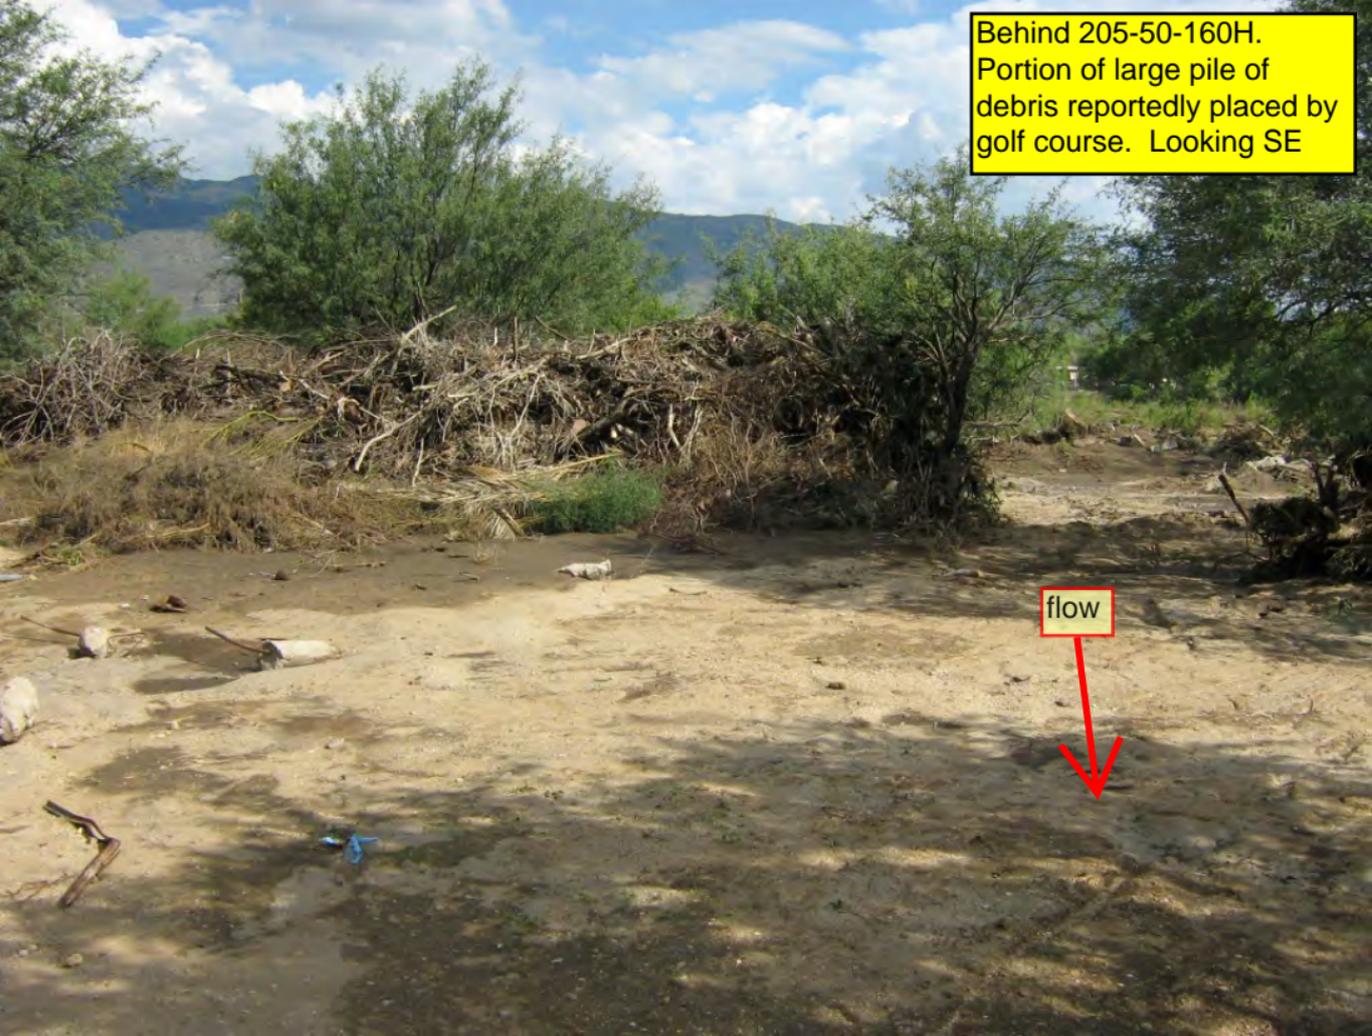
Behind 205-50-160H.
Portion of large pile of
debris reportedly placed
by golf course. Looking SE

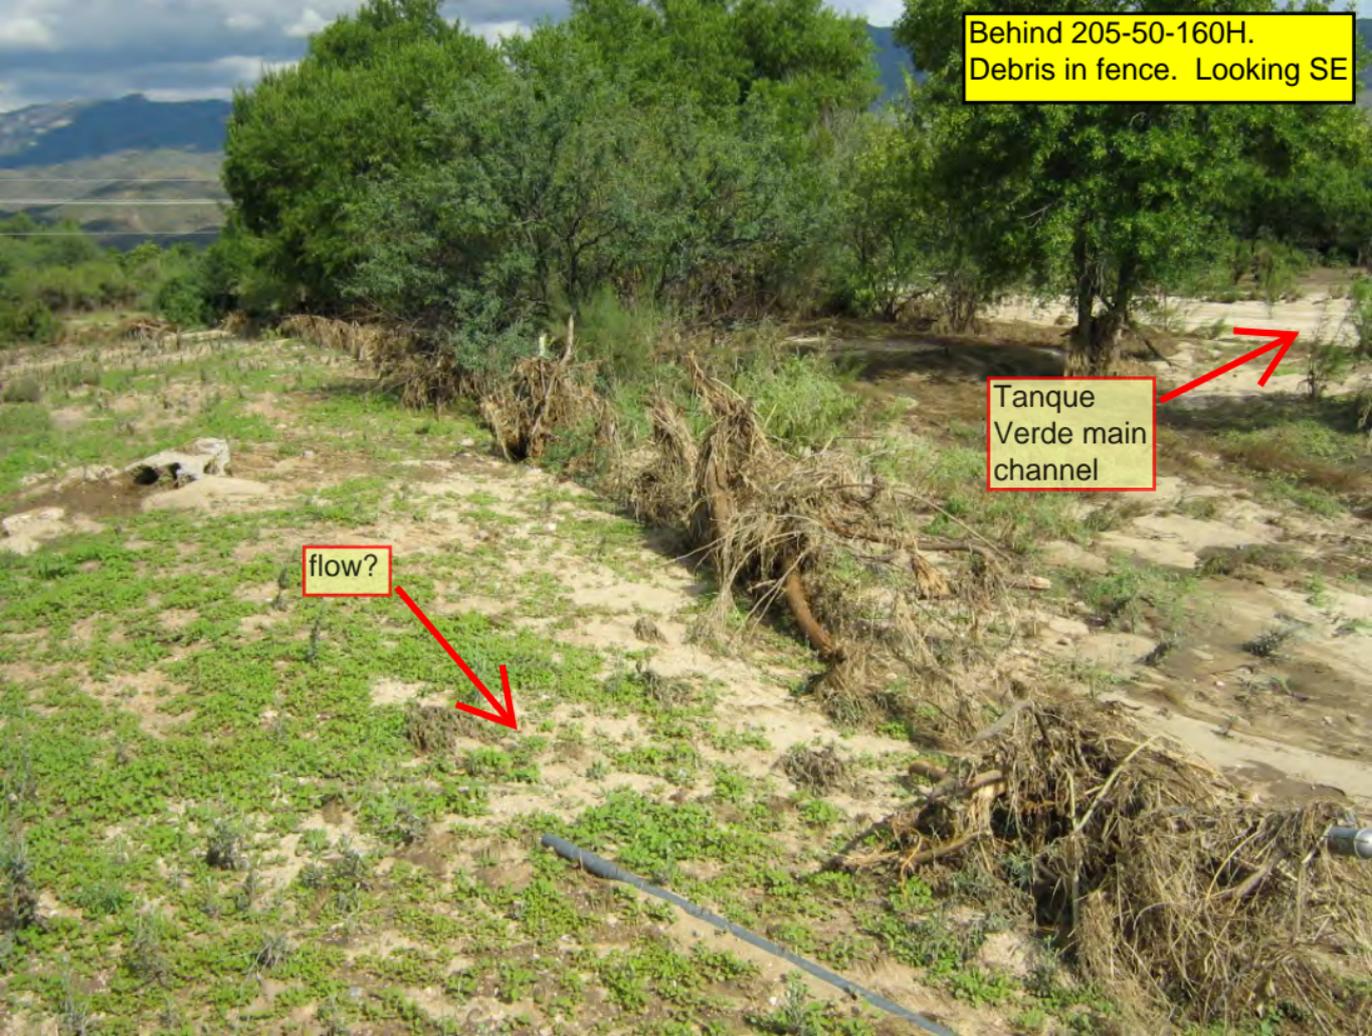
Behind 205-50-160H.
Debris in fence. Looking SE

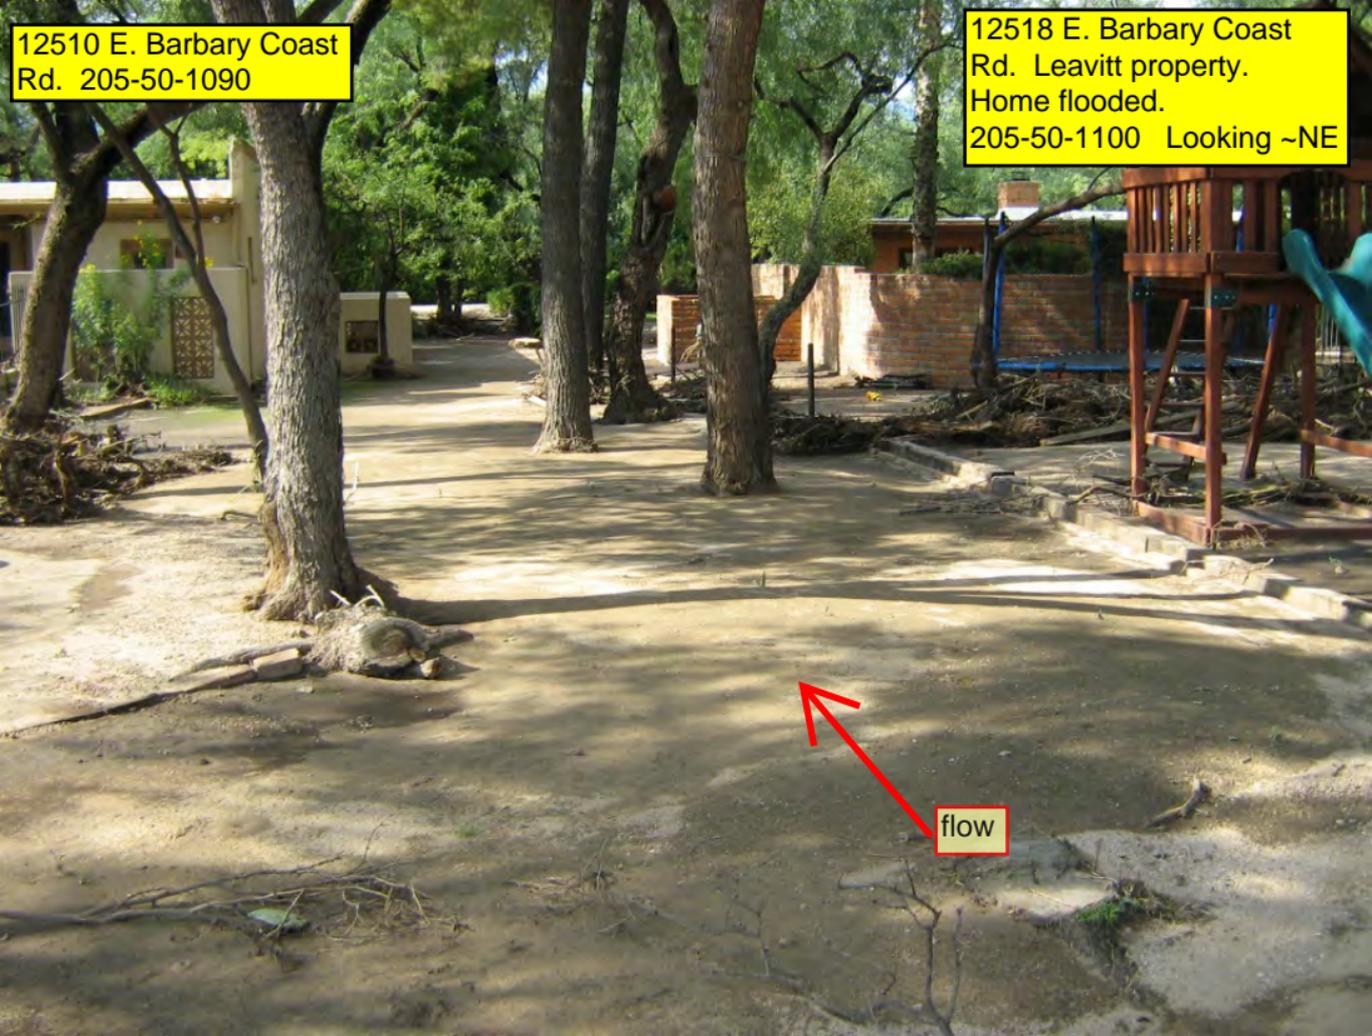
The Leavitt residence at 12518 E. Barbary Coast Rd. (205-50-1100) was flooded with an unknown amount of water, and it appeared that the Drake residence at 12510 E. Barbary Coast Rd. (205-50-1090) was also flooded. Based on the large amount of debris behind and between these two properties, it appeared that at least a foot of water flowed between the homes. A fairly sizeable gravel bar was deposited in the front yard of the Leavitt property. Eight photos taken.

12518 E. Barbary Coast
Rd. Leavitt property.
Home flooded.
205-50-1100 Looking ~NE

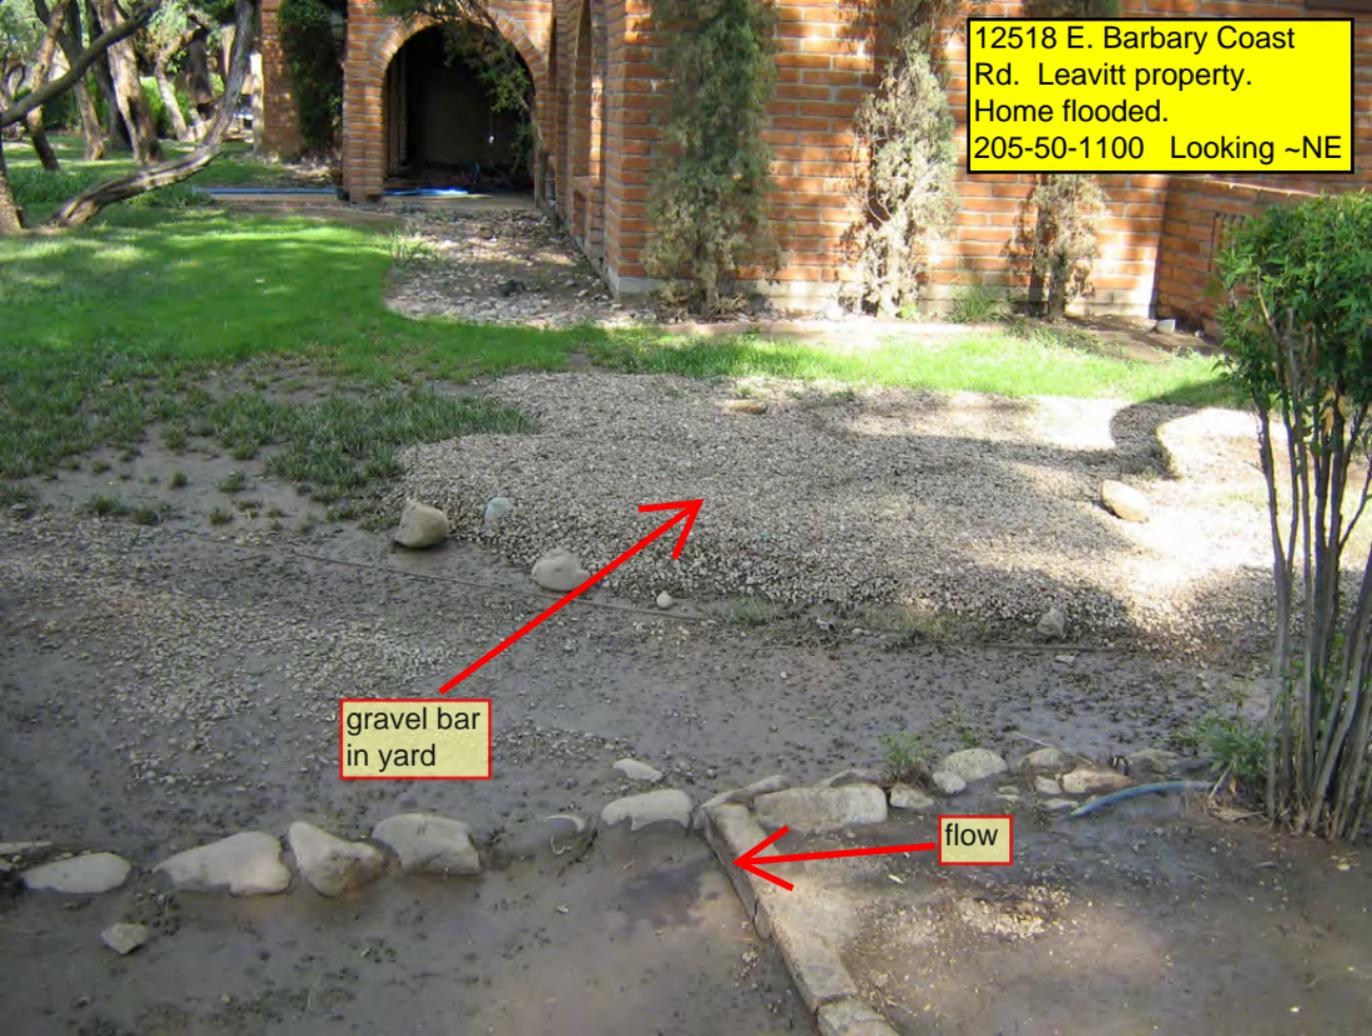
12518 E. Barbary Coast Rd. Leavitt property.
Home flooded.
205-50-1100 Looking ~NE

gravel bar
in yard

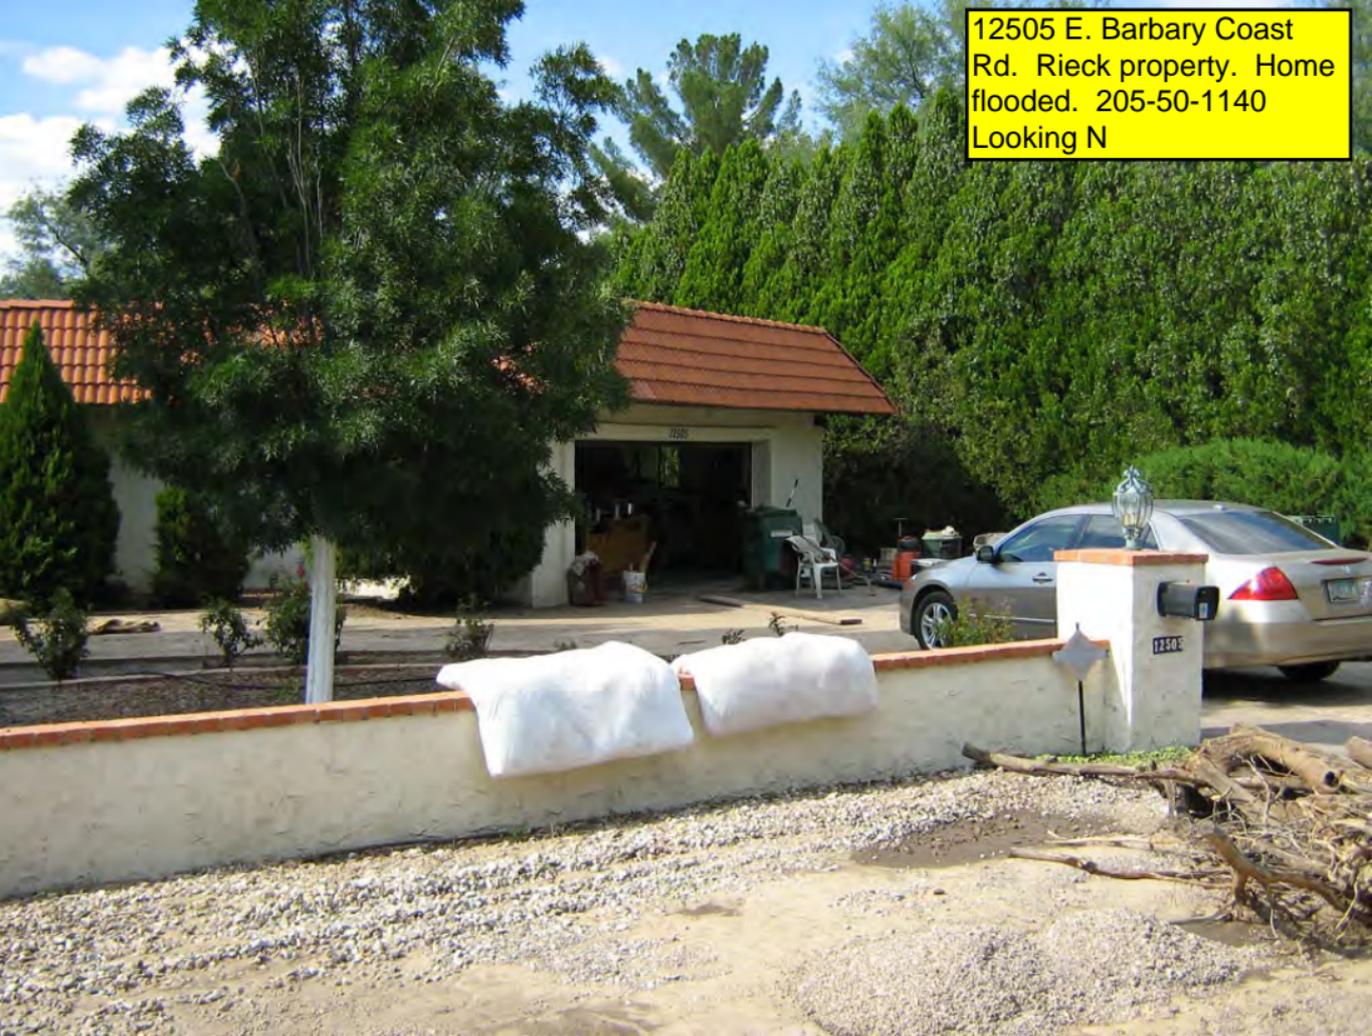
There were household belongings out to dry at the Rieck residence at 12505 E. Barbary Coast Rd. (205-50-1140), which was flooded. One photo taken.

12505 E. Barbary Coast
Rd. Rieck property. Home
flooded. 205-50-1140
Looking N
