Desert Willow Open Space – Trail Project 2018

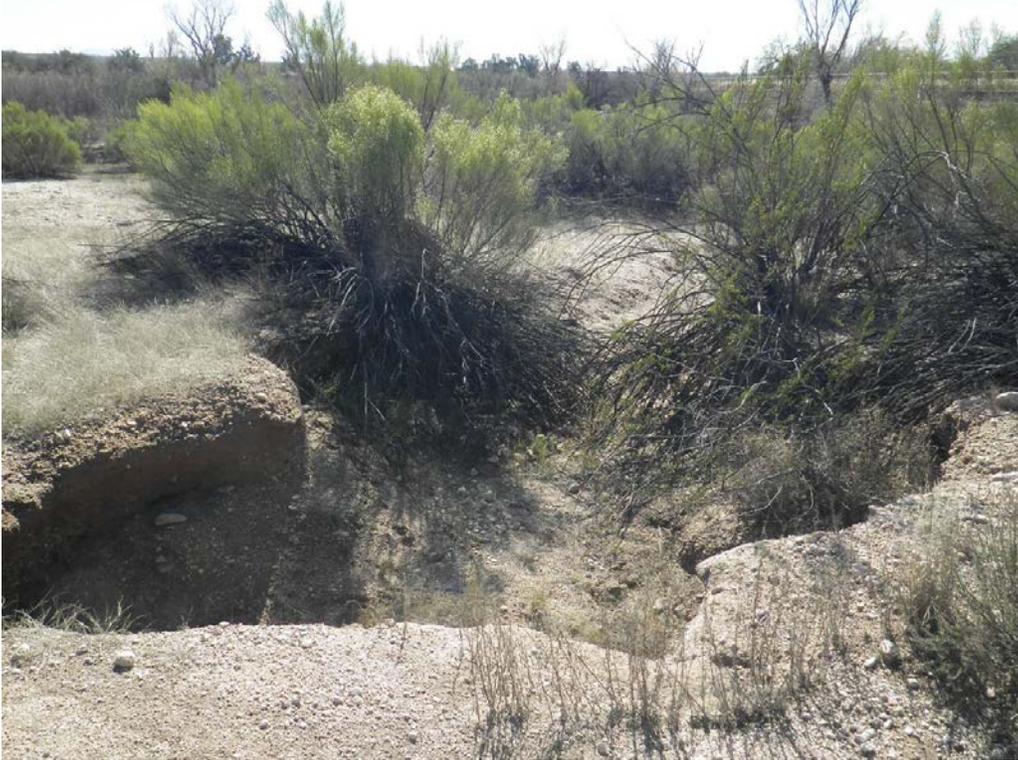
Headcut before treatment

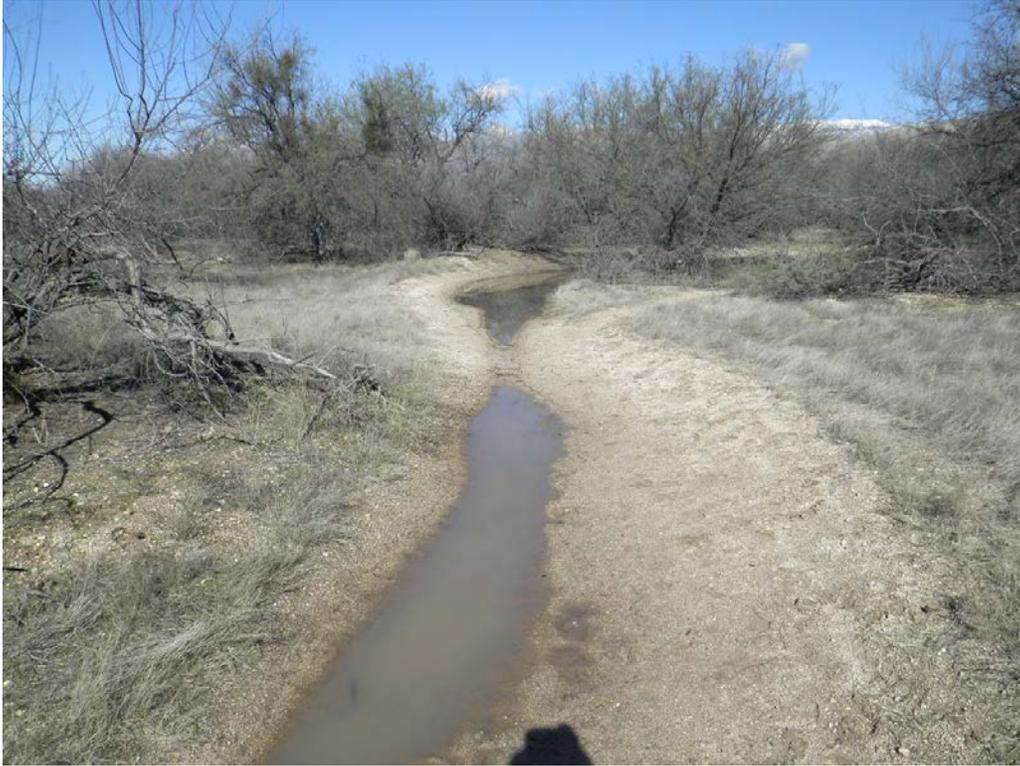
Ponding in trail before treatment

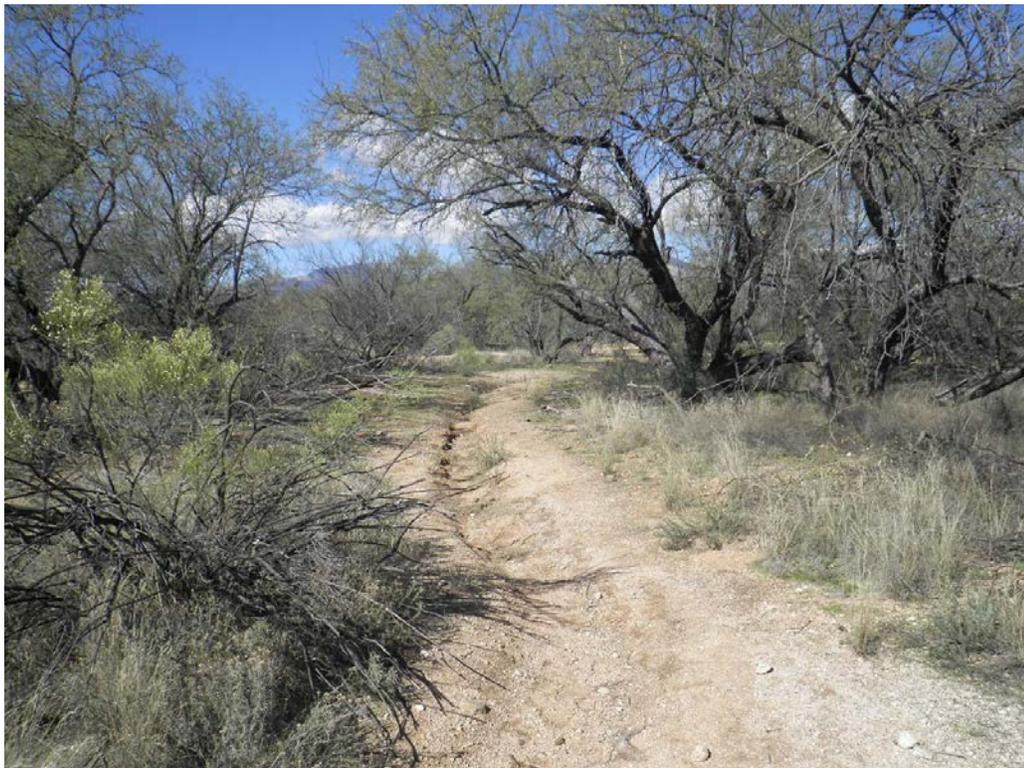
Rill erosion caused by excessive equestrian use on a sloped area, pre-treatment.

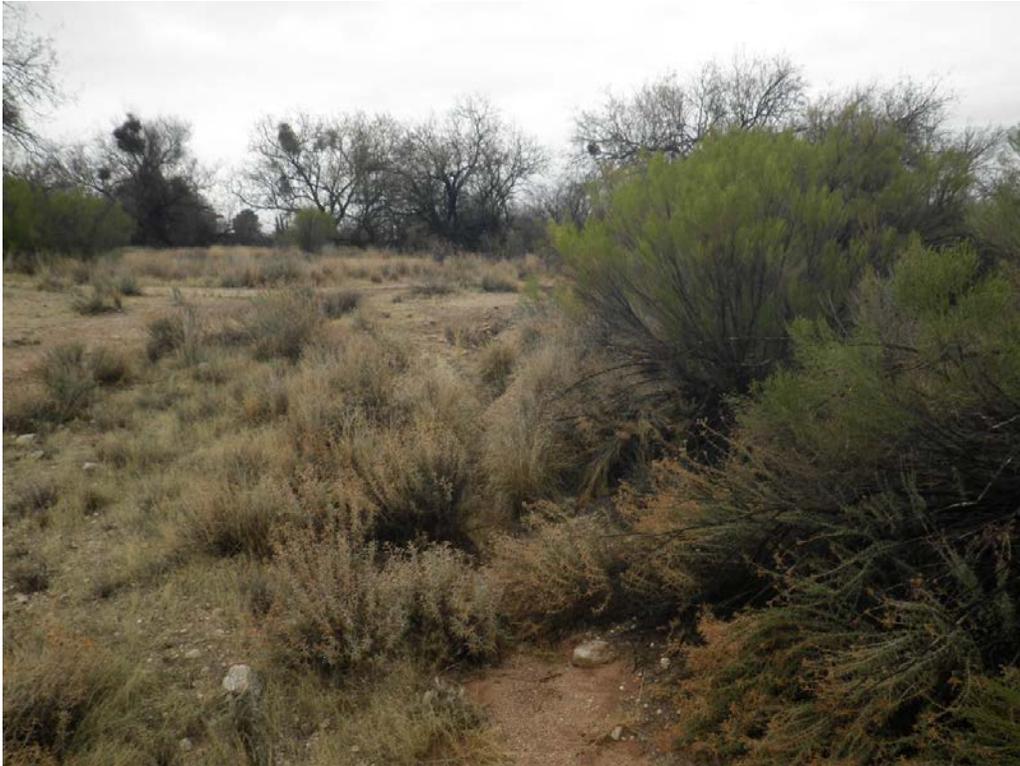
Pre-treatment; a large gully has formed caused by run-off from upstream trails.
