# Paseo de las Iglesias Phase I: Santa Cruz River Bank Protection, Ecosystem Restoration, and Linear Parkway, Ajo Way to Silverlake Road

Site Visit Photos, October 30, 2009

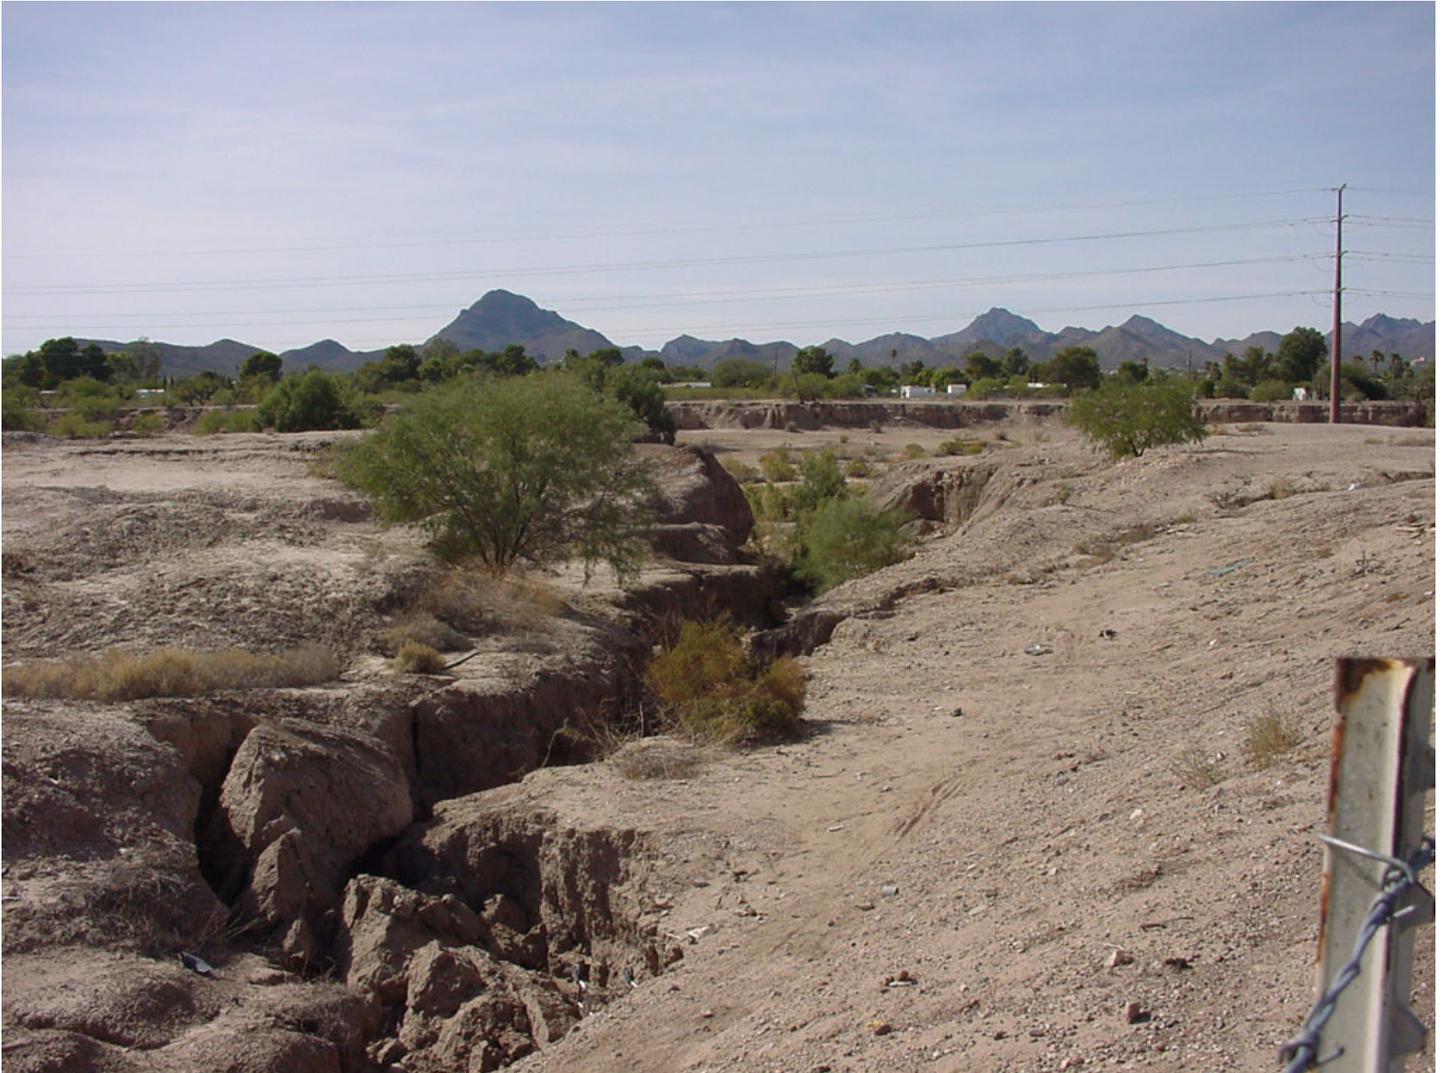
Photo 1 – Headcut looking west towards the Santa Cruz River

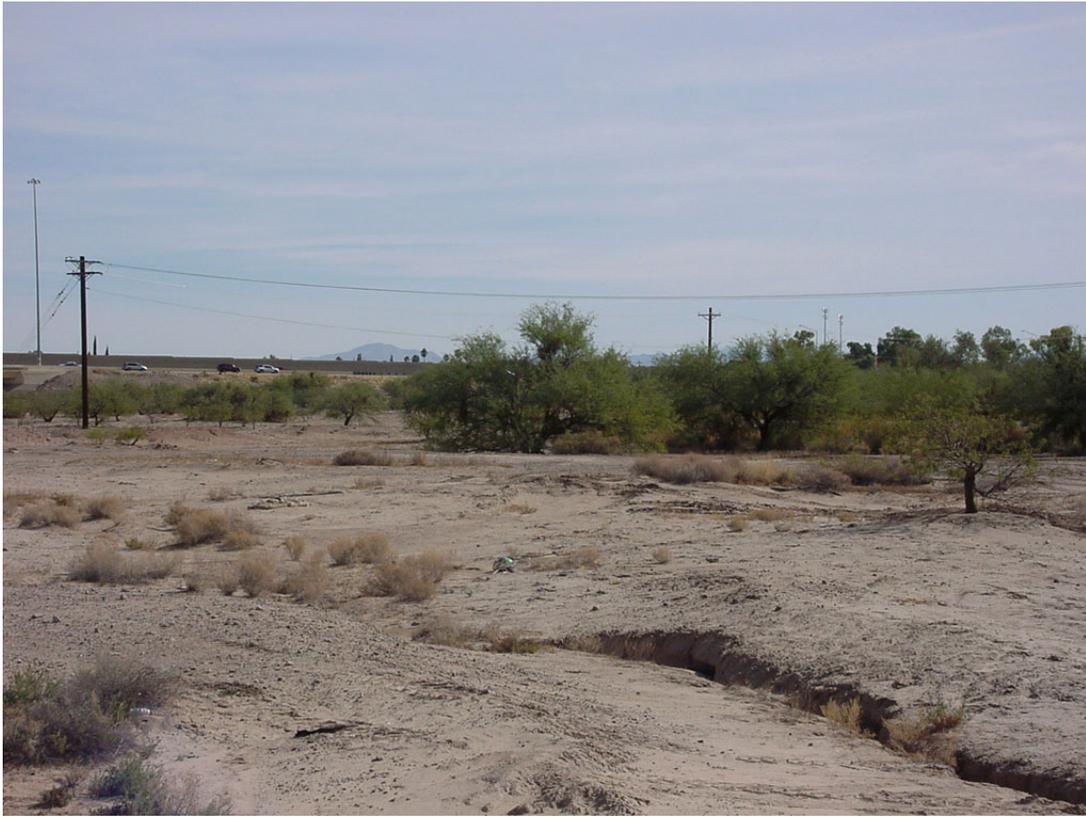
**Photo 2 – East bank of the Santa Cruz River looking east at I-19**

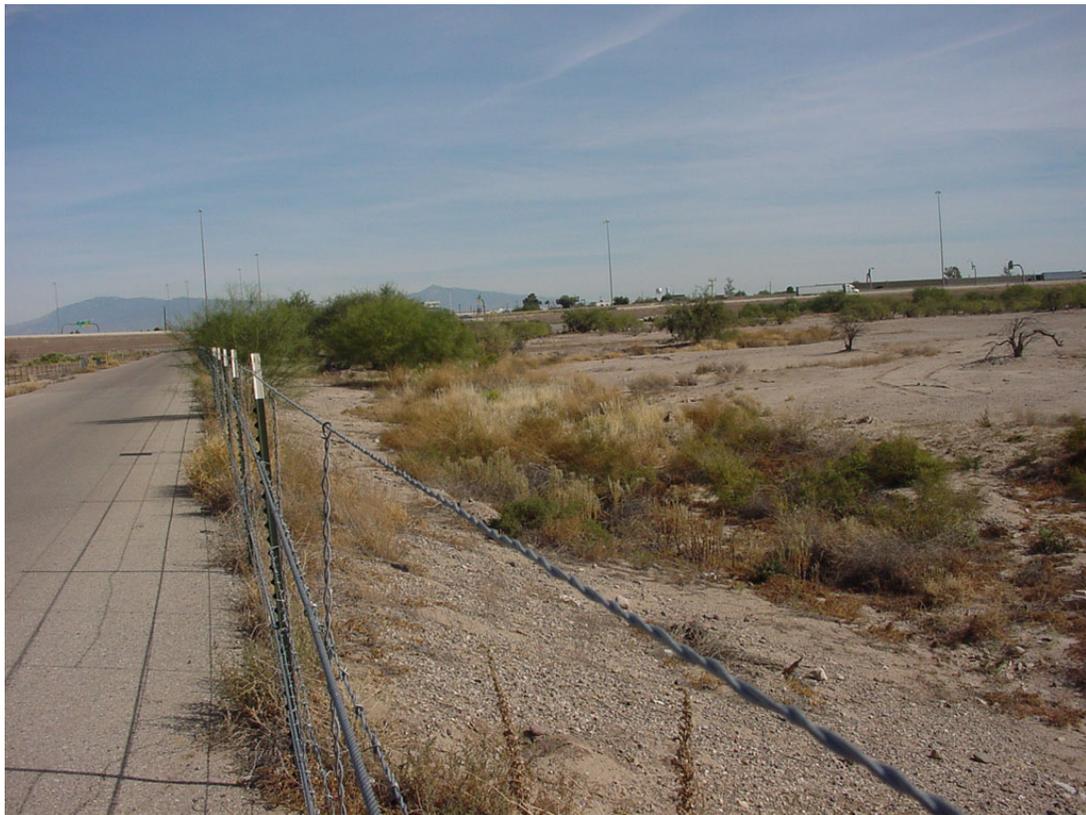
**Photo 3 - East bank of the Santa Cruz River looking east at I-19**

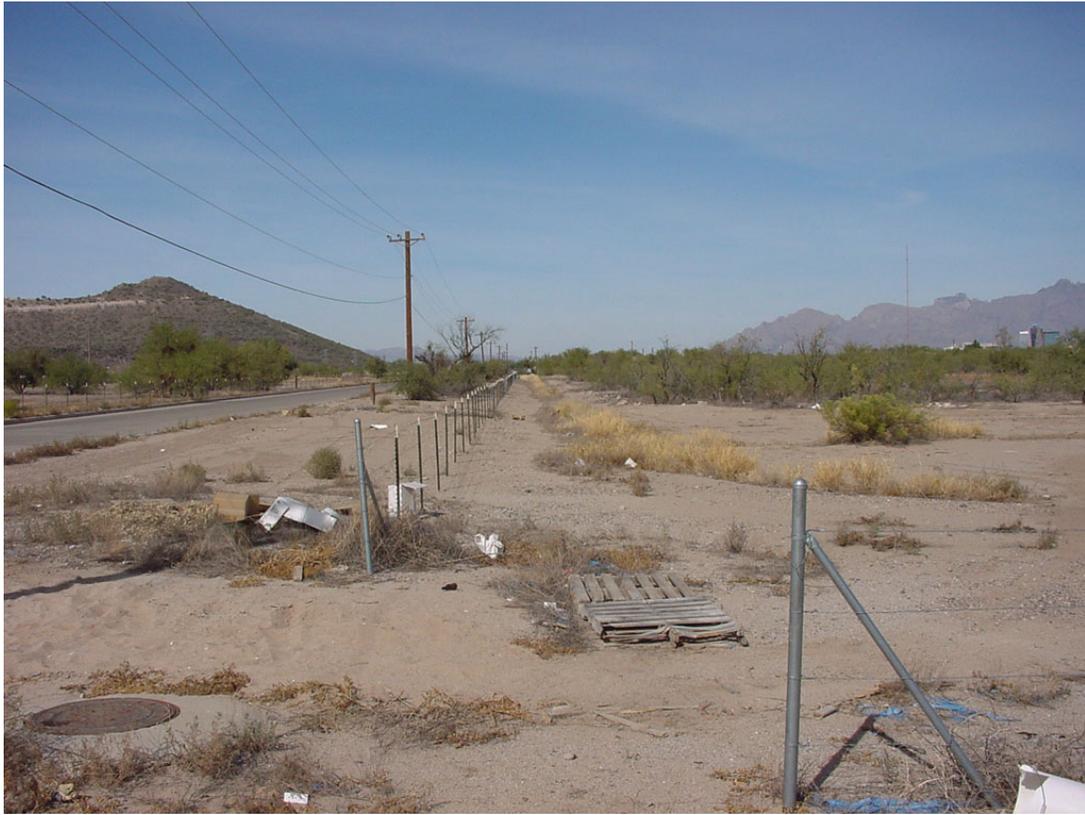
**Photo 4 - West Bank of the Santa Cruz River along Cottonwood Lane**

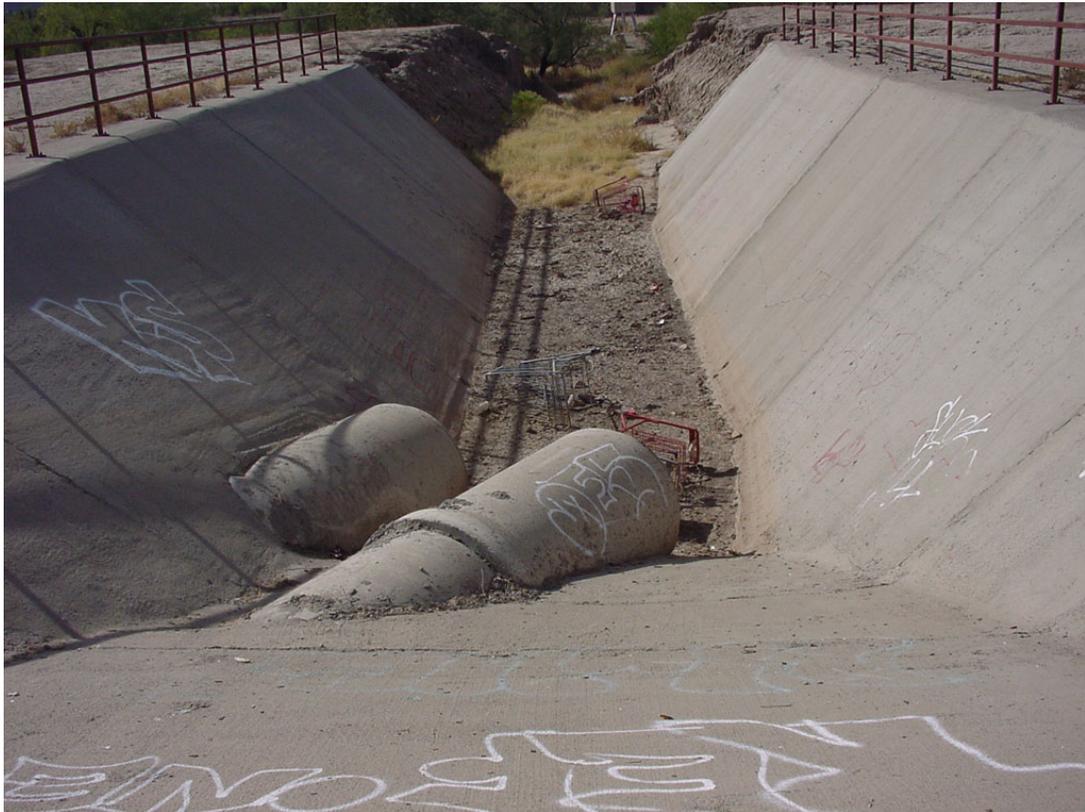
**Photo 5 - East bank tributary drainage structure**

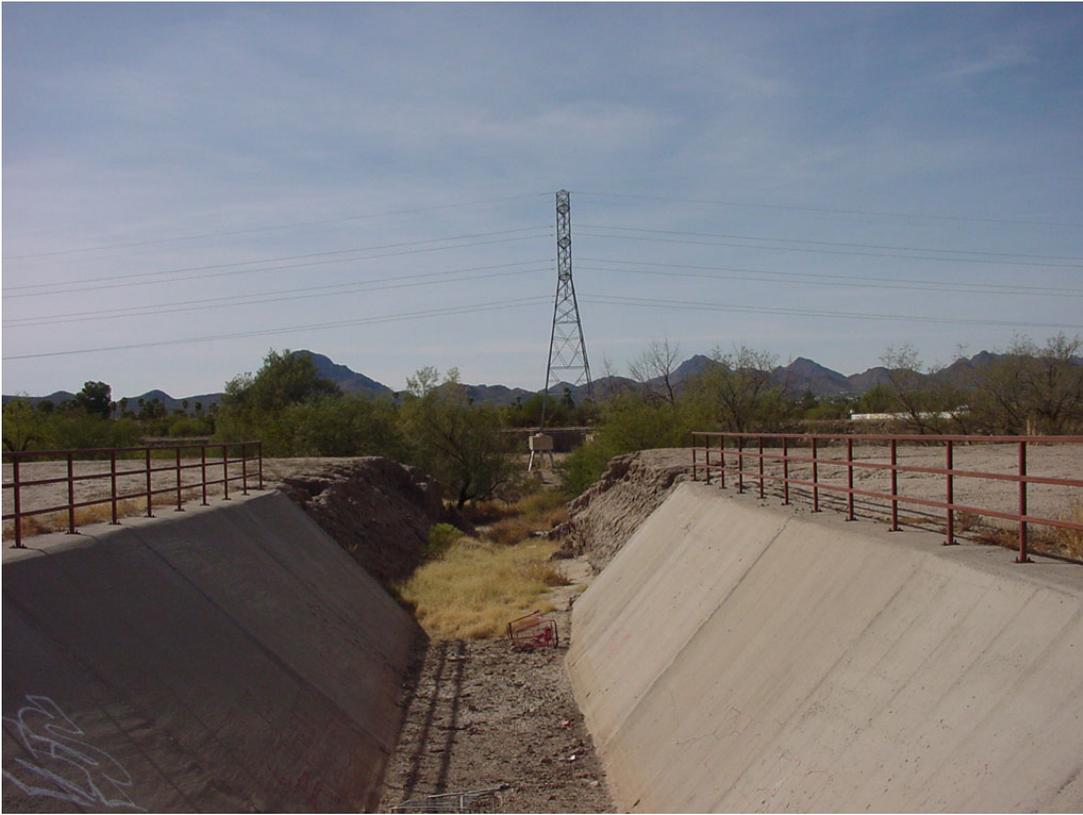
**Photo 6 - East bank tributary drainage structure highlighting bank failure**

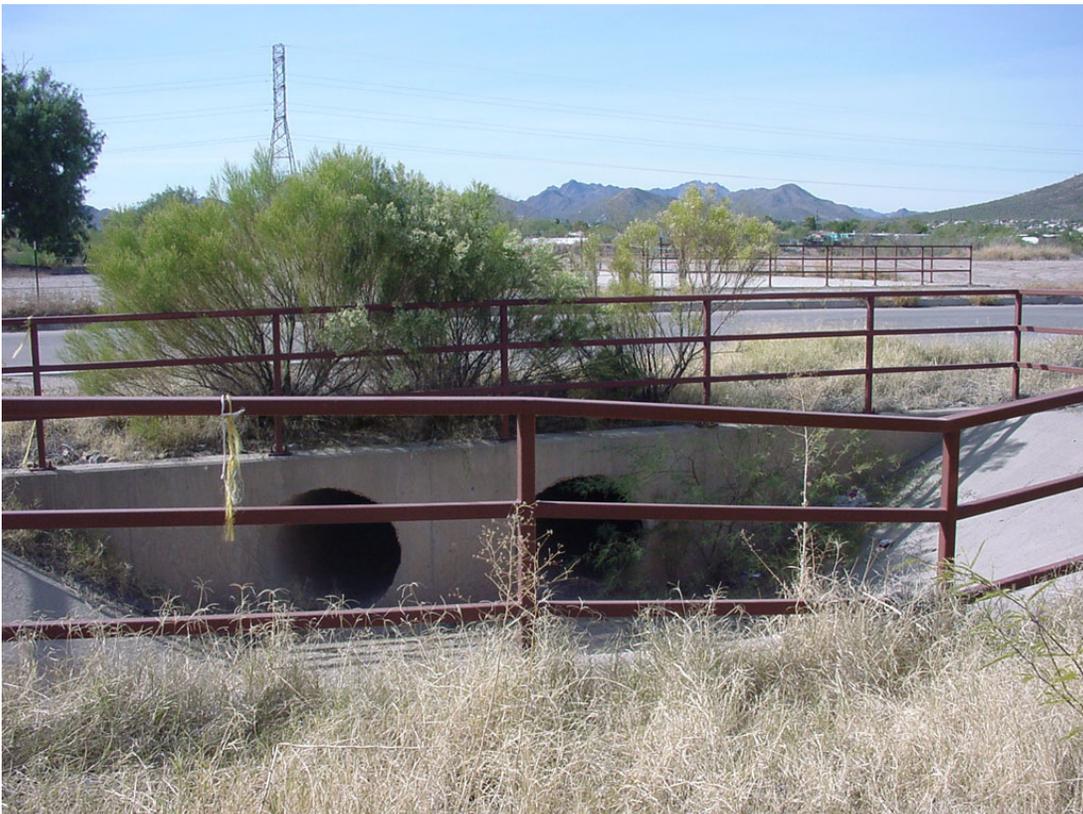
**Photo 7 - View from the east side of Santa Cruz Lane of drop structure for tributary drainage**

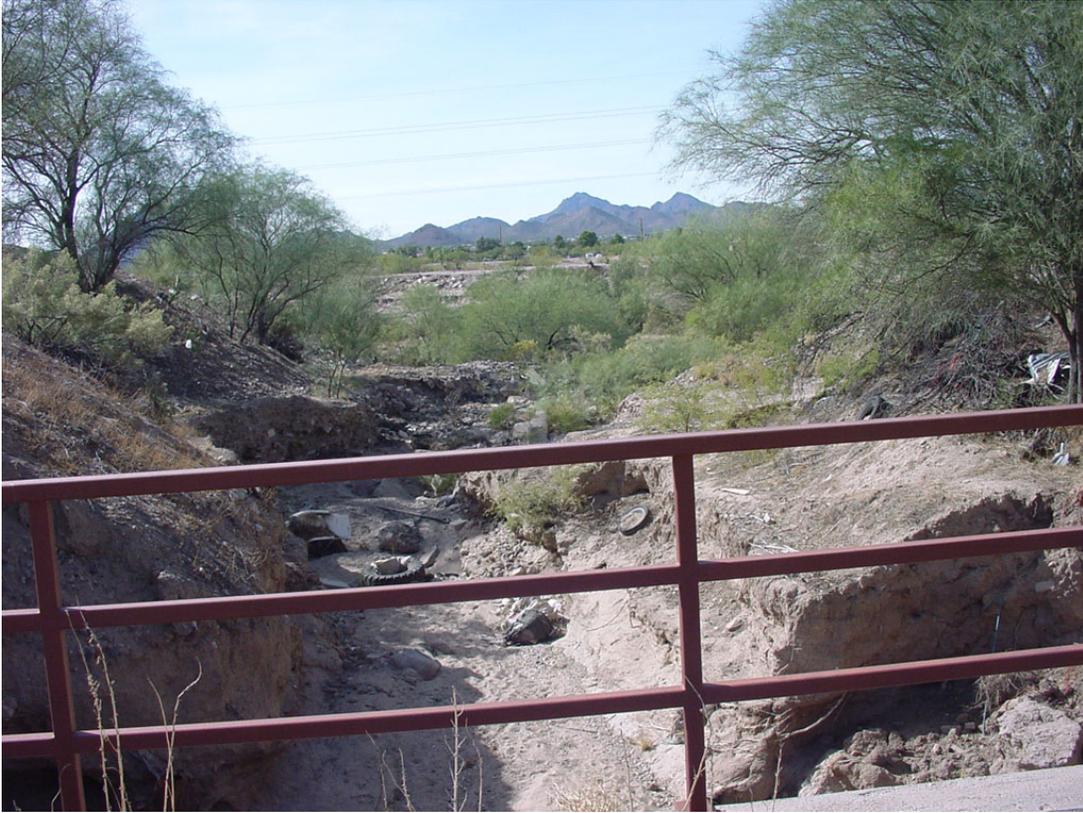
**Photo 8 - Tributary drainage and bank failure looking west towards the Santa Cruz River**

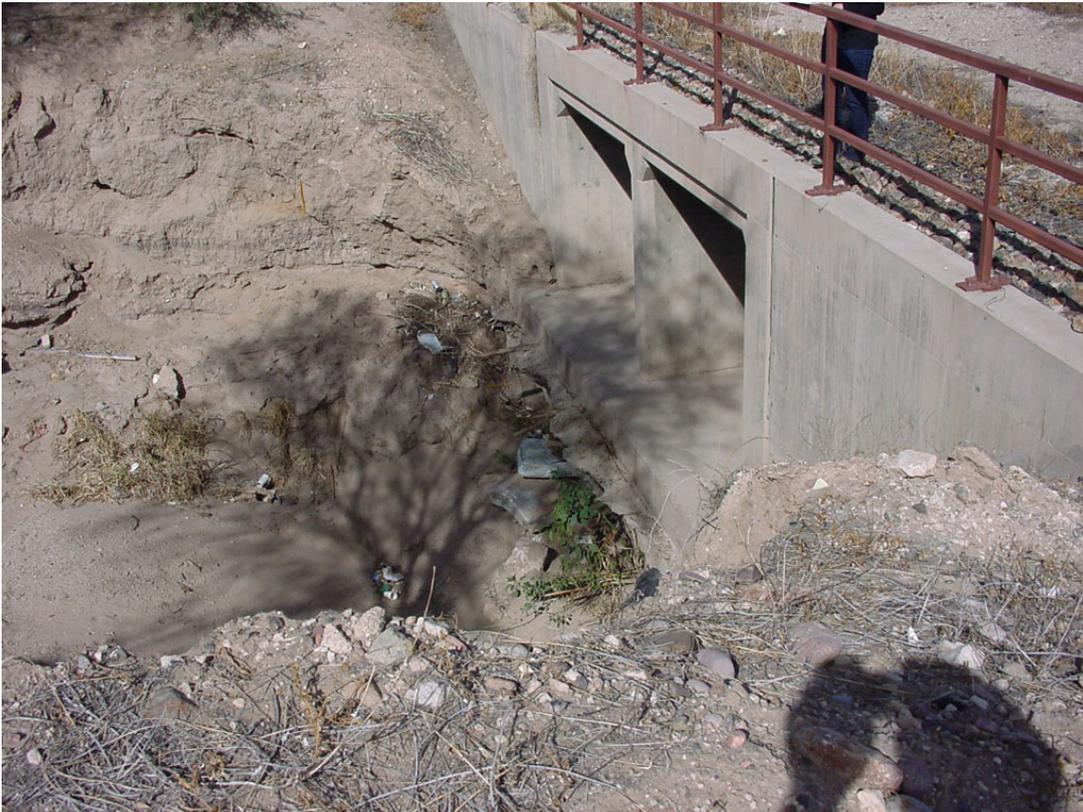
**Photo 9 - Tributary drainage on the east bank of the Santa Cruz River**

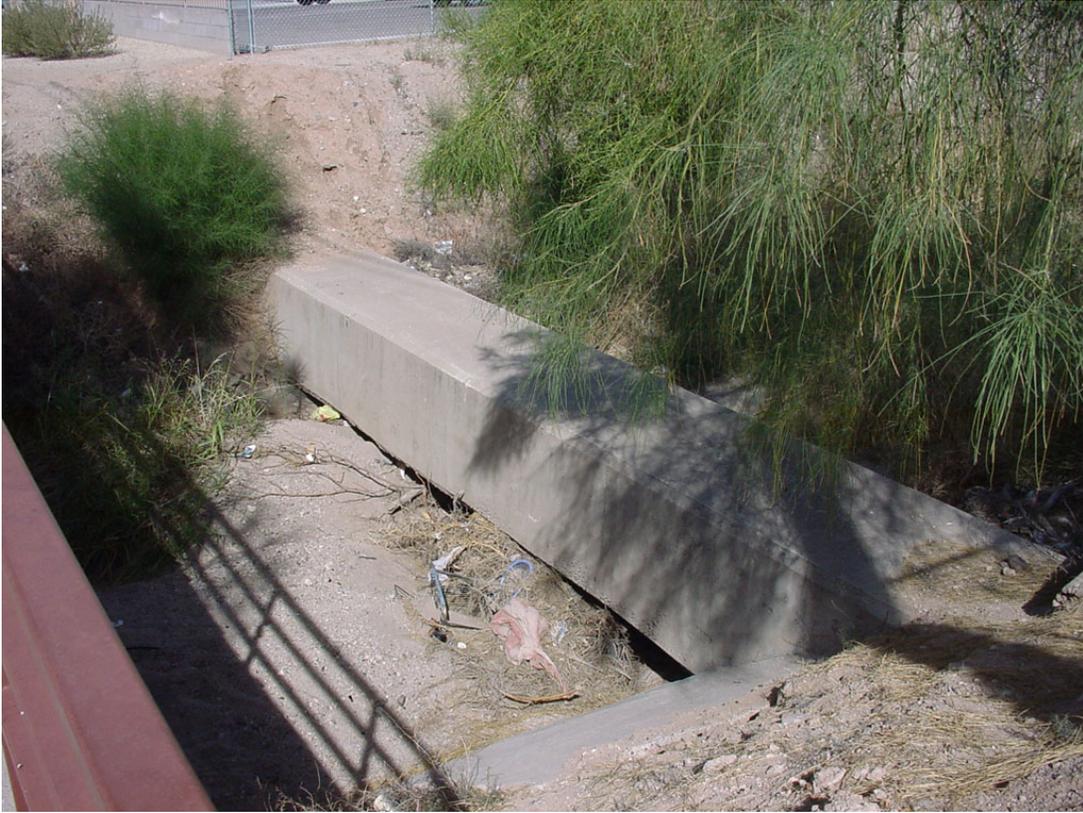
**Photo 10 - Pipe casing east of Santa Cruz Lane**

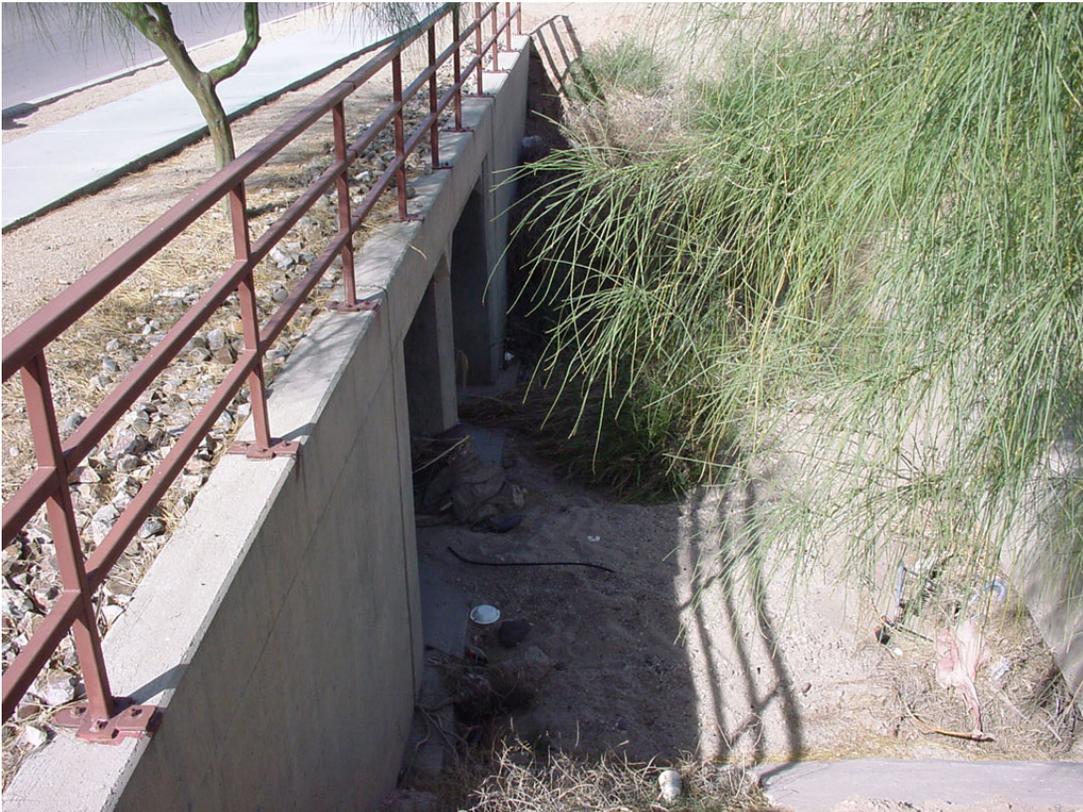
**Photo 11 - Pipe casing and box culverts east of Santa Cruz Lane**

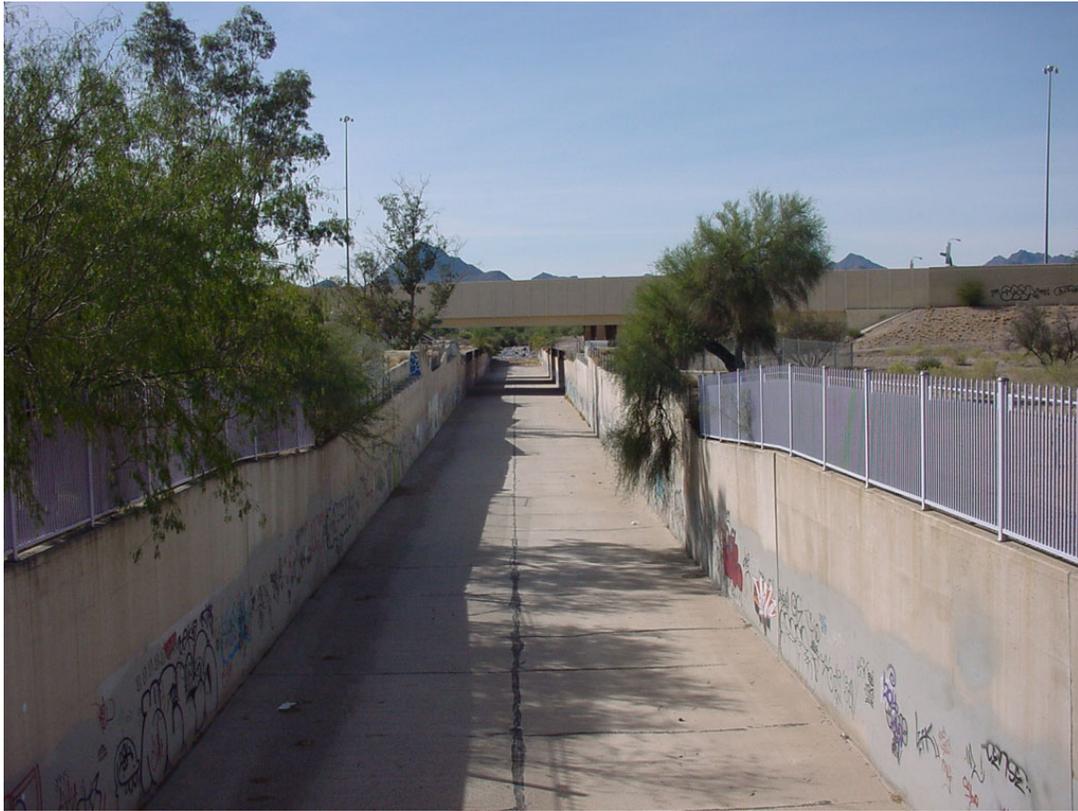
**Photo 12 - Tucson Diversion Channel looking west towards the confluence with the Santa Cruz River**

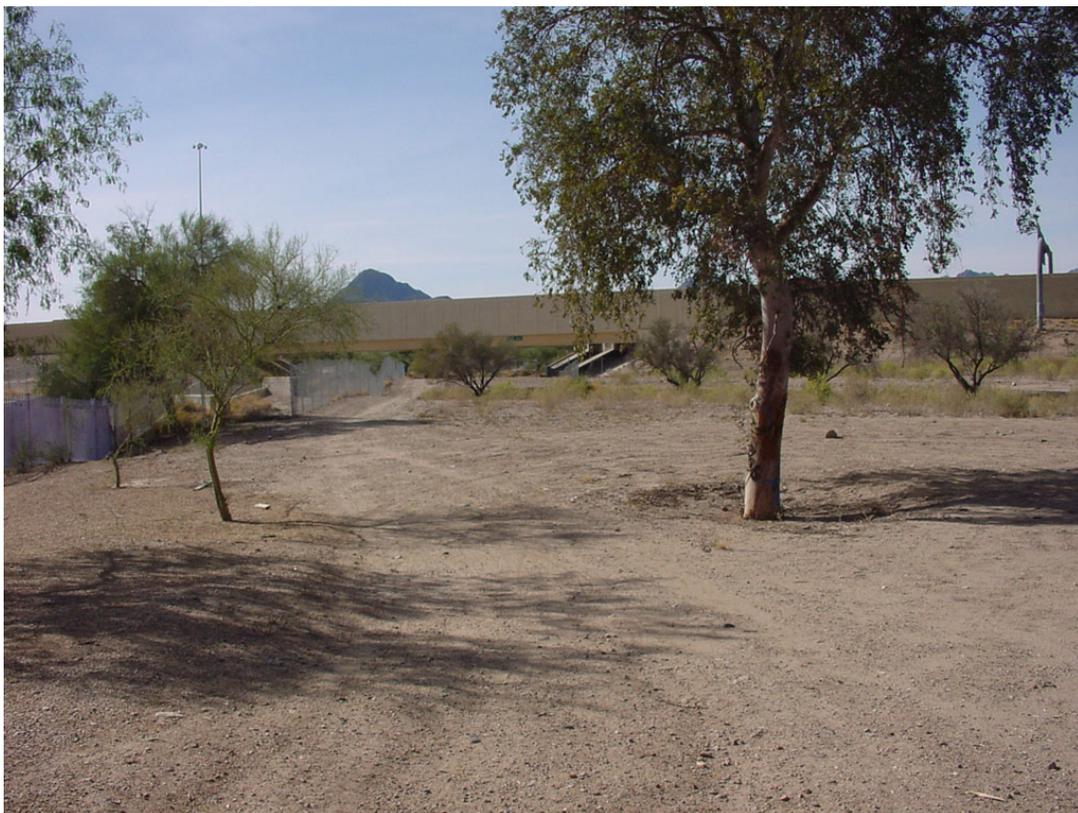
**Photo 13 - View from Yavapai Park looking west towards the Santa Cruz River with the Tucson Diversion Channel and I-19 overpass**

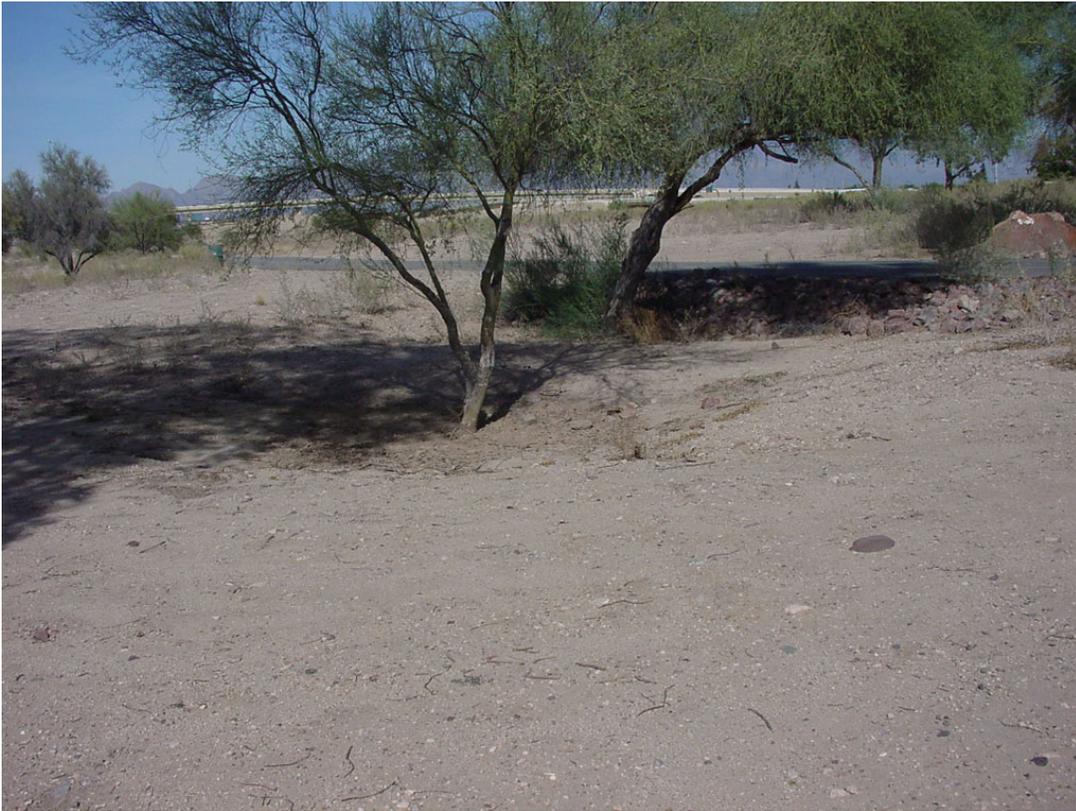
**Photo 14 - Yavapai Park looking west towards I-19 showing existing paved path**

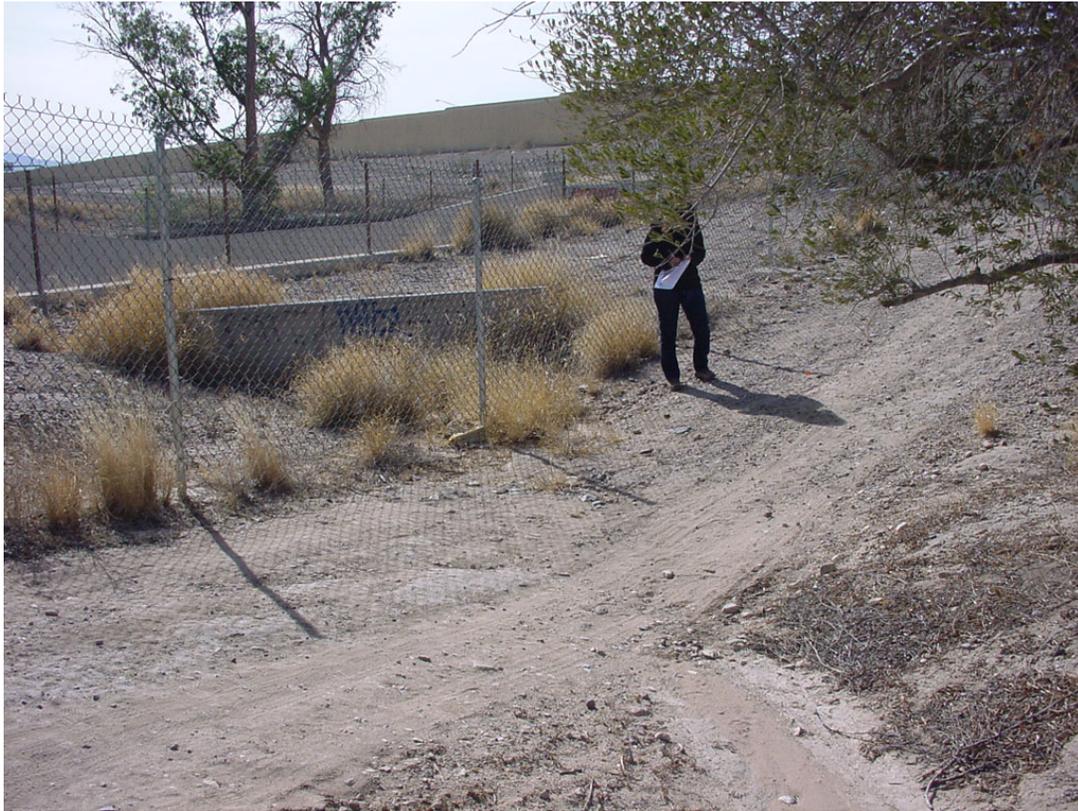
**Photo 16 - Looking south at the Tucson Diversion Channel east of the I-19 underpass**

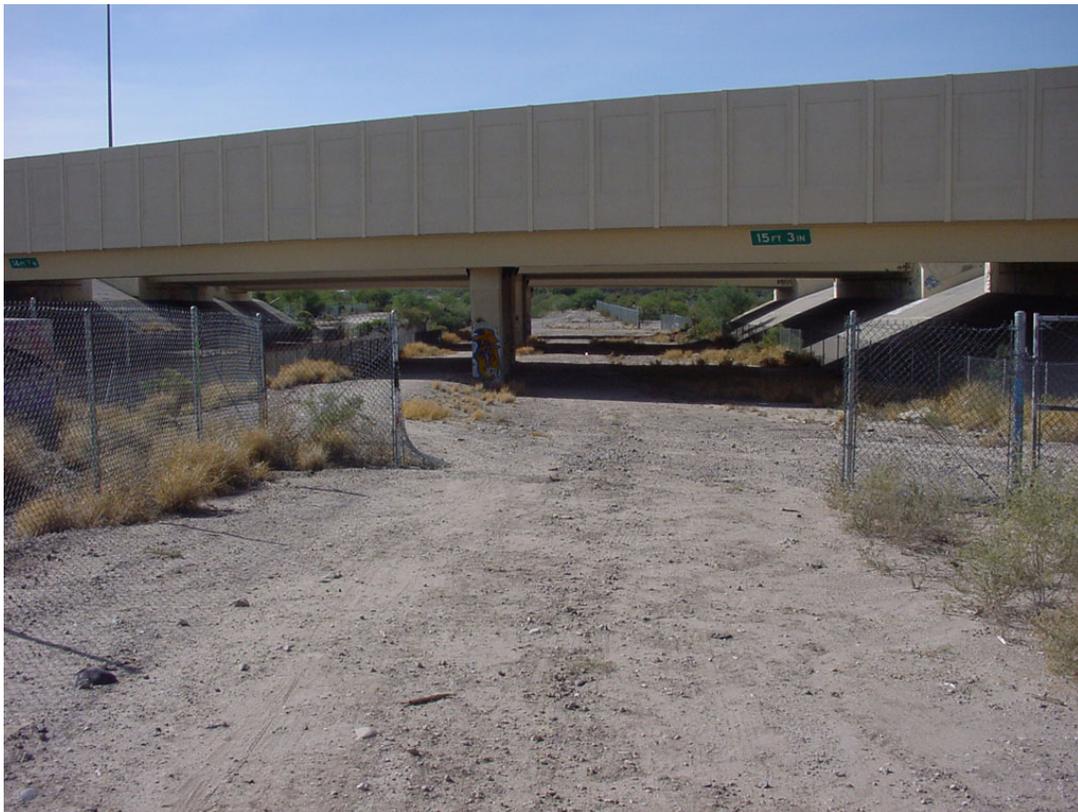
**Photo 17 - Looking west along the Tucson Diversion Channel towards the confluence with the Santa Cruz River**

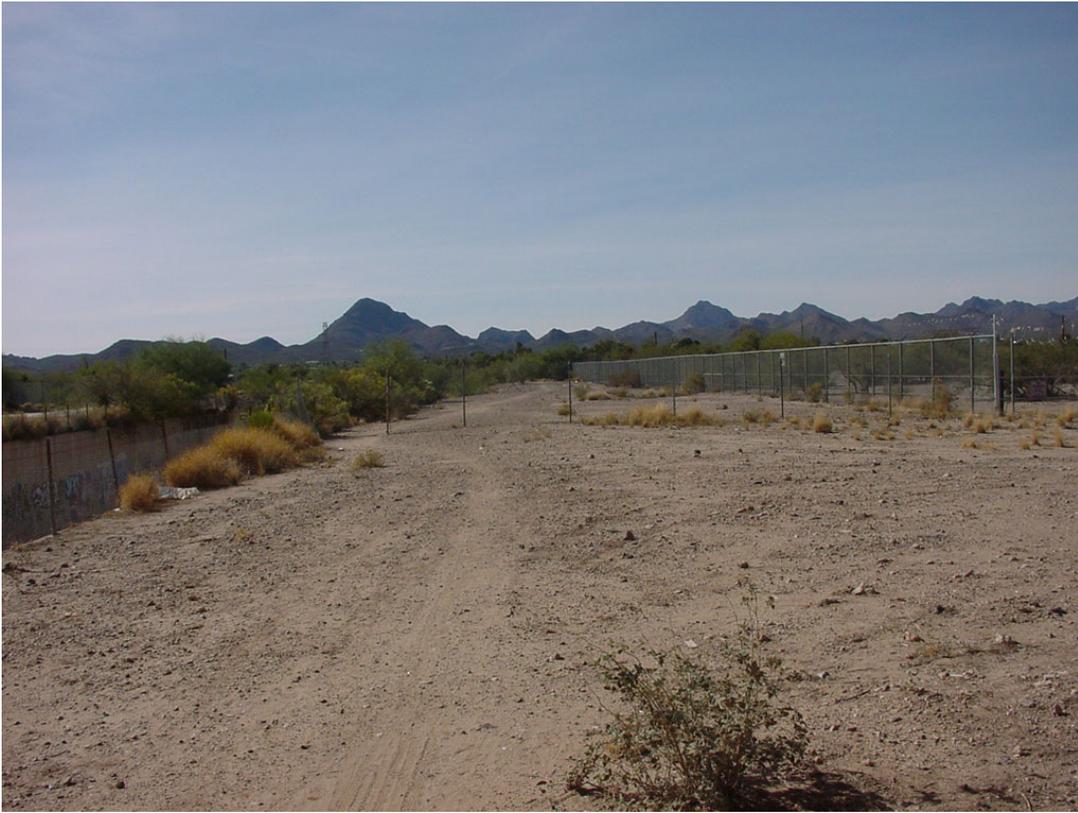
**Photo 18 - Looking west along the Tucson Diversion Channel towards the confluence with the Santa Cruz River**

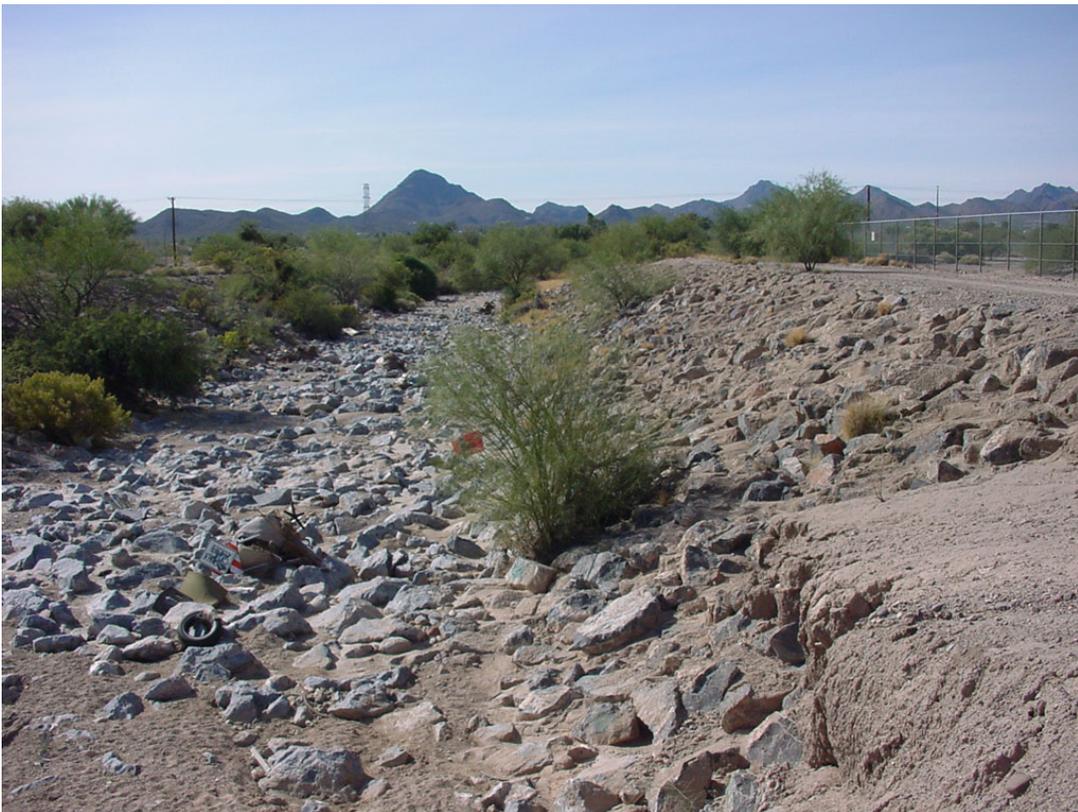
**Photo 19 - Looking west along the Tucson Diversion Channel towards the confluence with the Santa Cruz River**

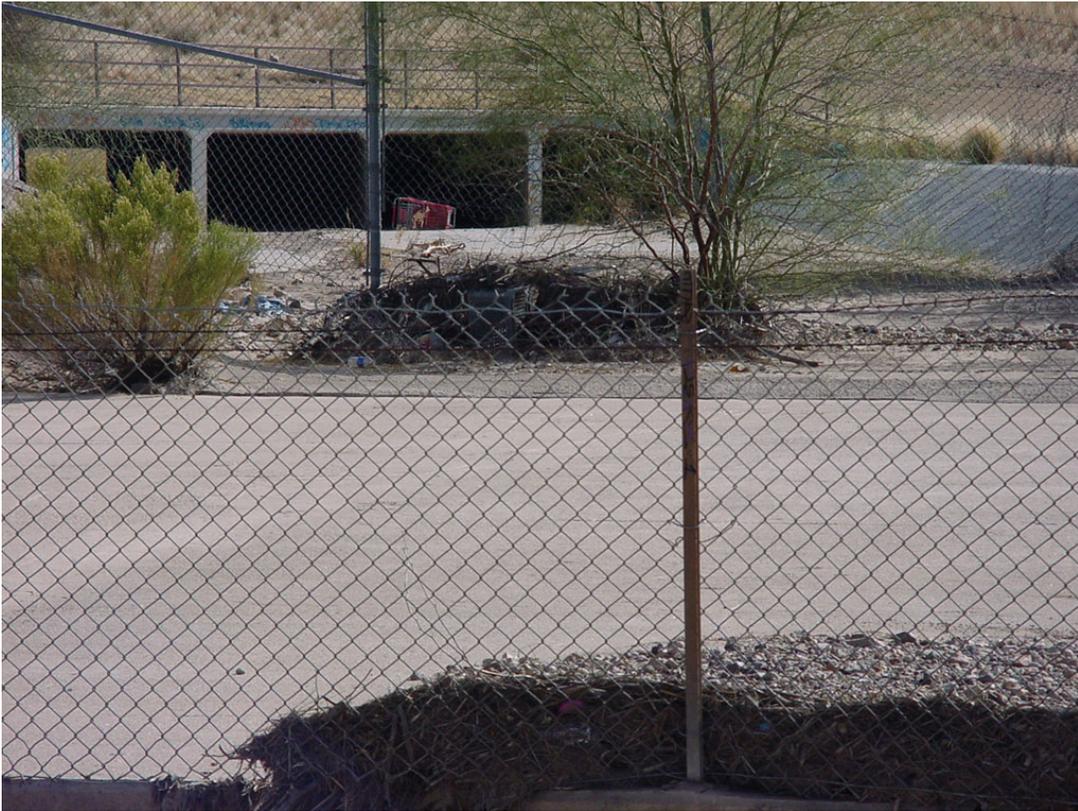
**Photo 20 - Drainage southeast of the Tucson Diversion Channel**

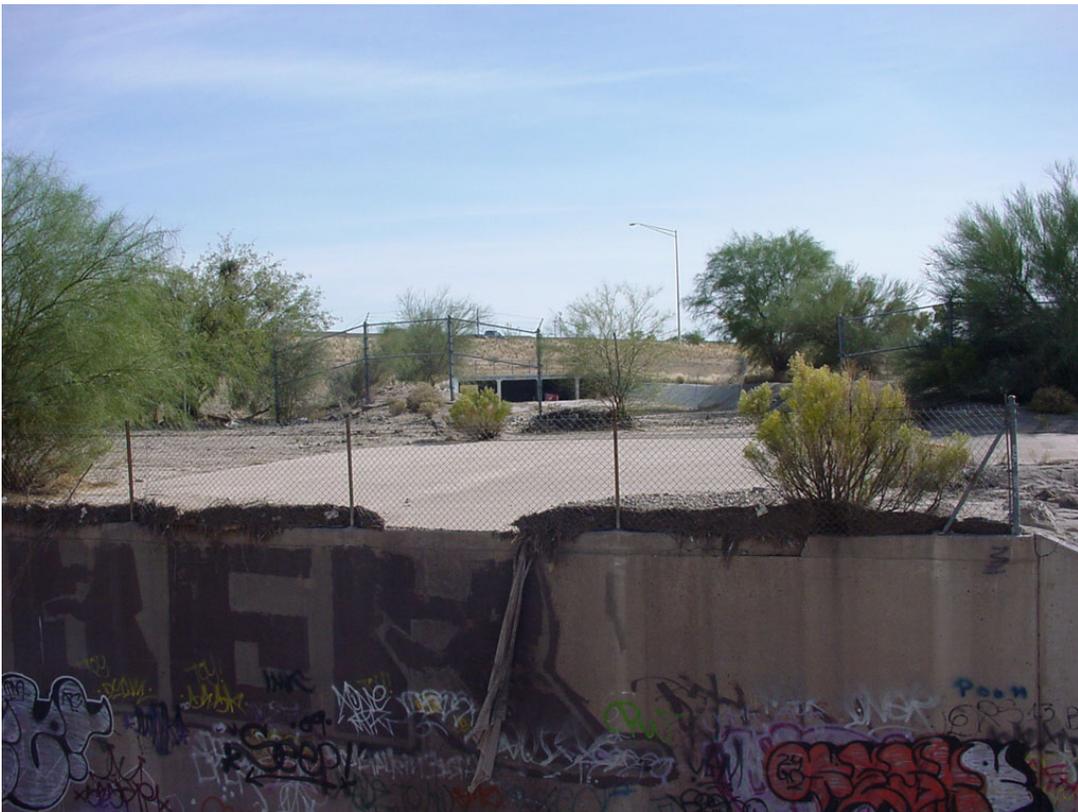
**Photo 21 - Drainage southeast of the Tucson Diversion Channel**

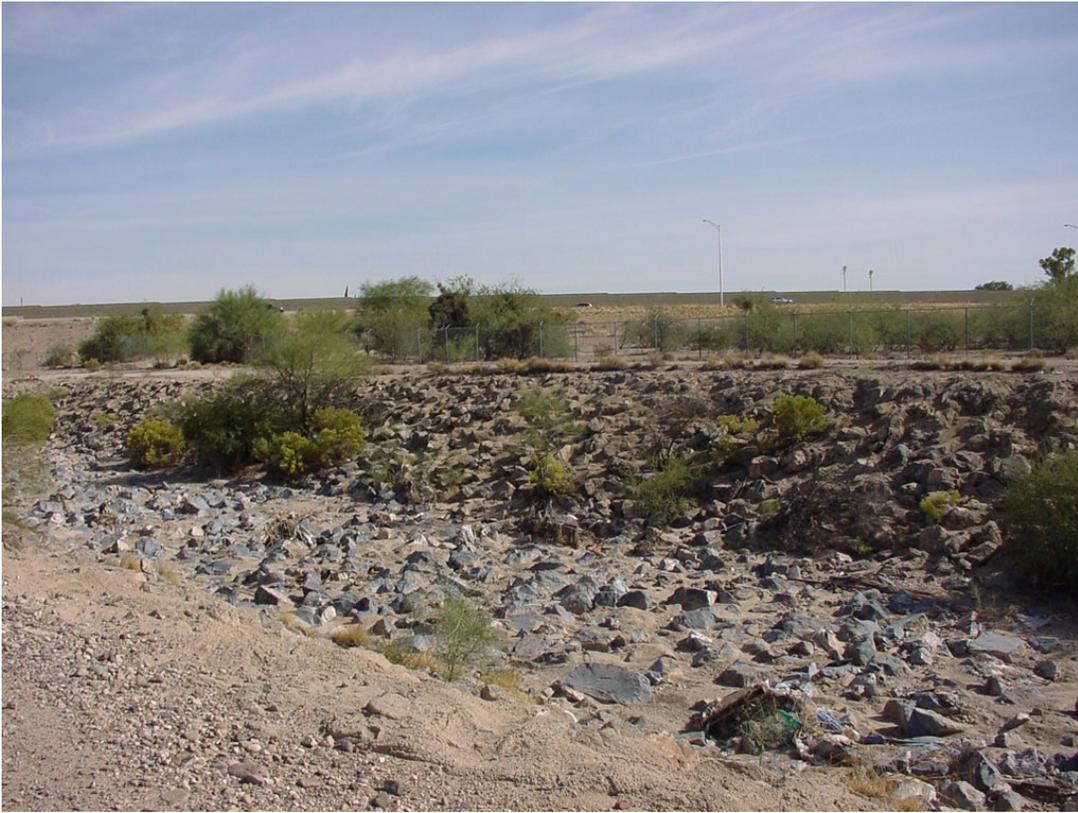
**Photo 22 - Looking south towards Ryland Landfill**

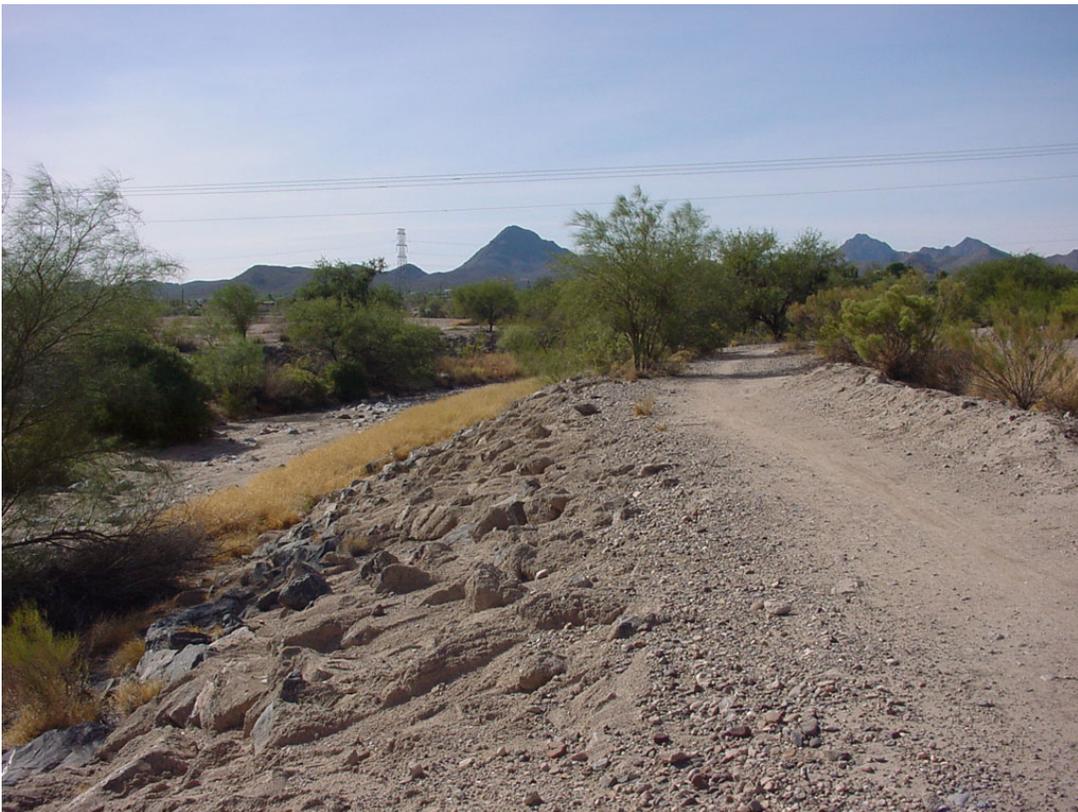
**Photo 23 - Looking west along the Tucson Diversion Channel towards the confluence with the Santa Cruz River**

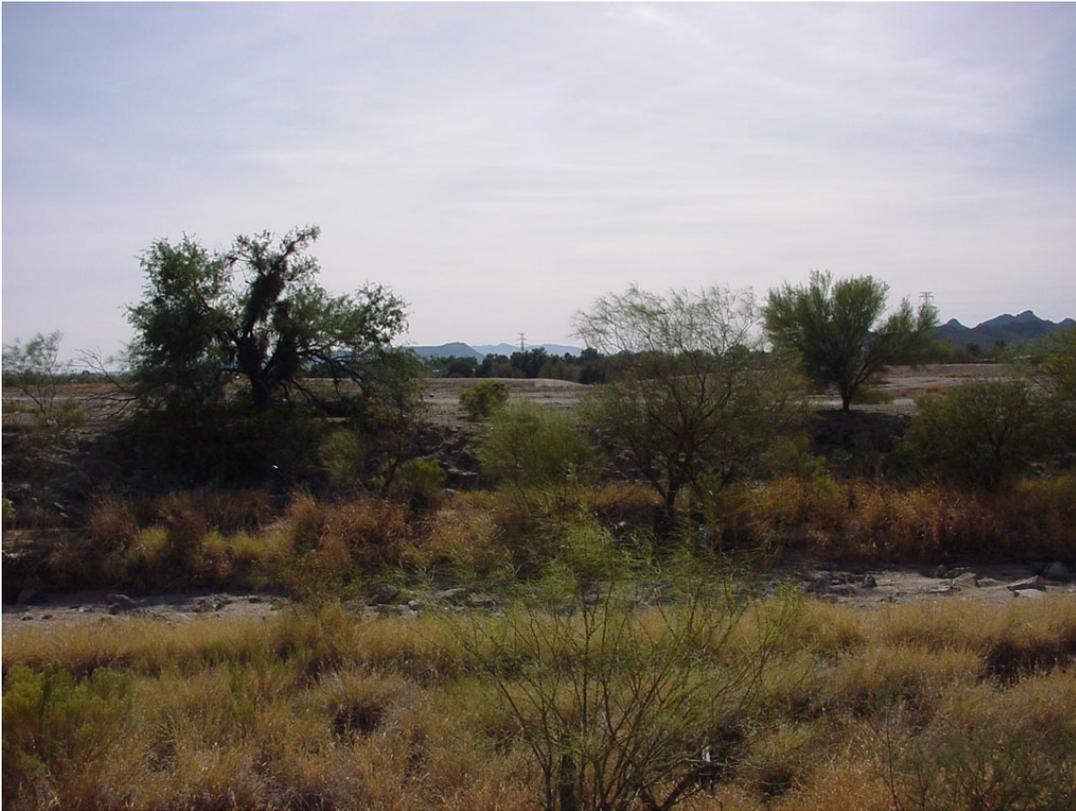
**Photo 24 - Looking south towards Ryland Landfill**

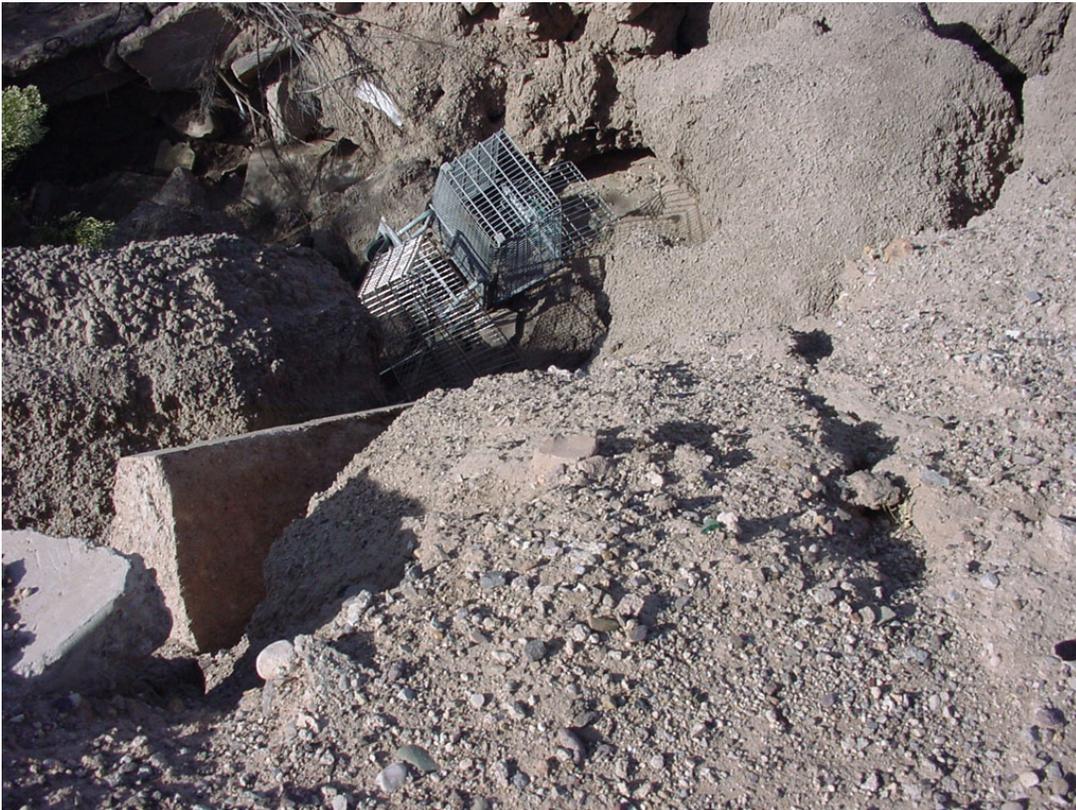
**Photo 25 - Scour hole adjacent to the Tucson Diversion Channel**

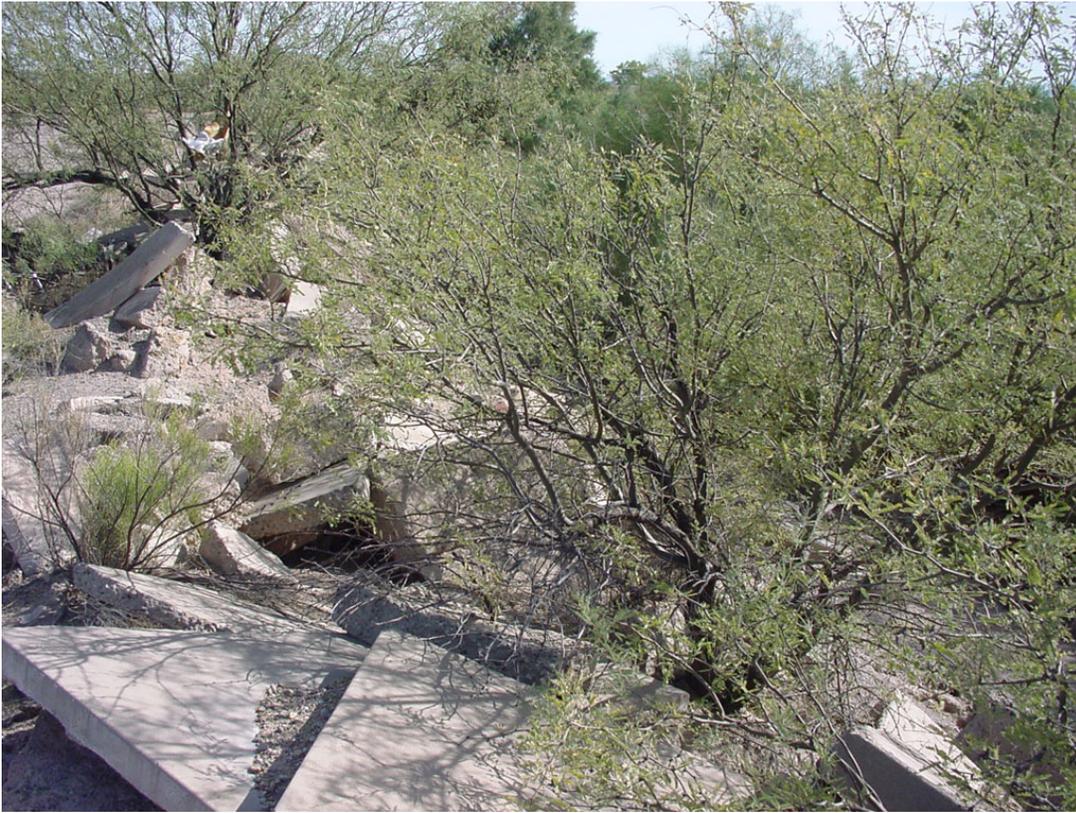
**Photo 26 – “Urbanite” used to stabilize the bank at the confluence of the Tucson Diversion Channel and the Santa Cruz River**
