# Paseo de las Iglesias Phase I: Santa Cruz River Bank Protection, Ecosystem Restoration, and Linear Parkway, Ajo Way to Silverlake Road

Site Visit Photos, October 30, 2009

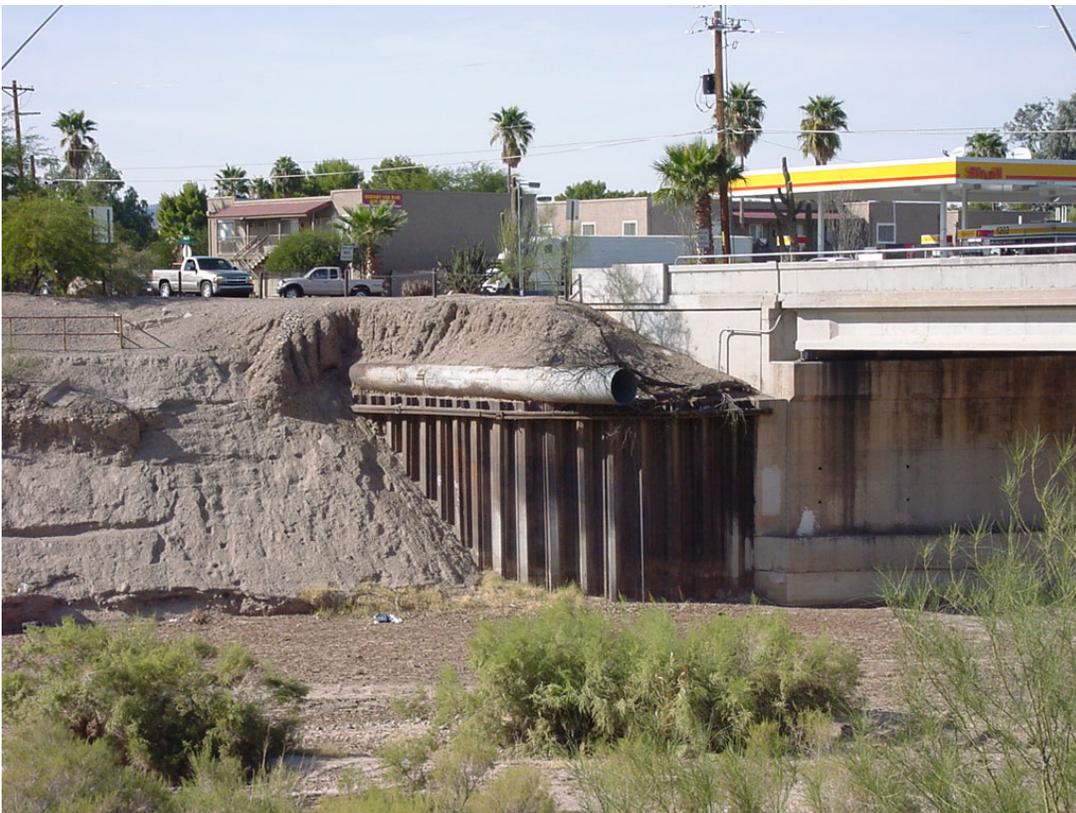
**Photo 27 – Southwest of the Ajo Bridge on the Santa Cruz River**  
Page 14 of 18

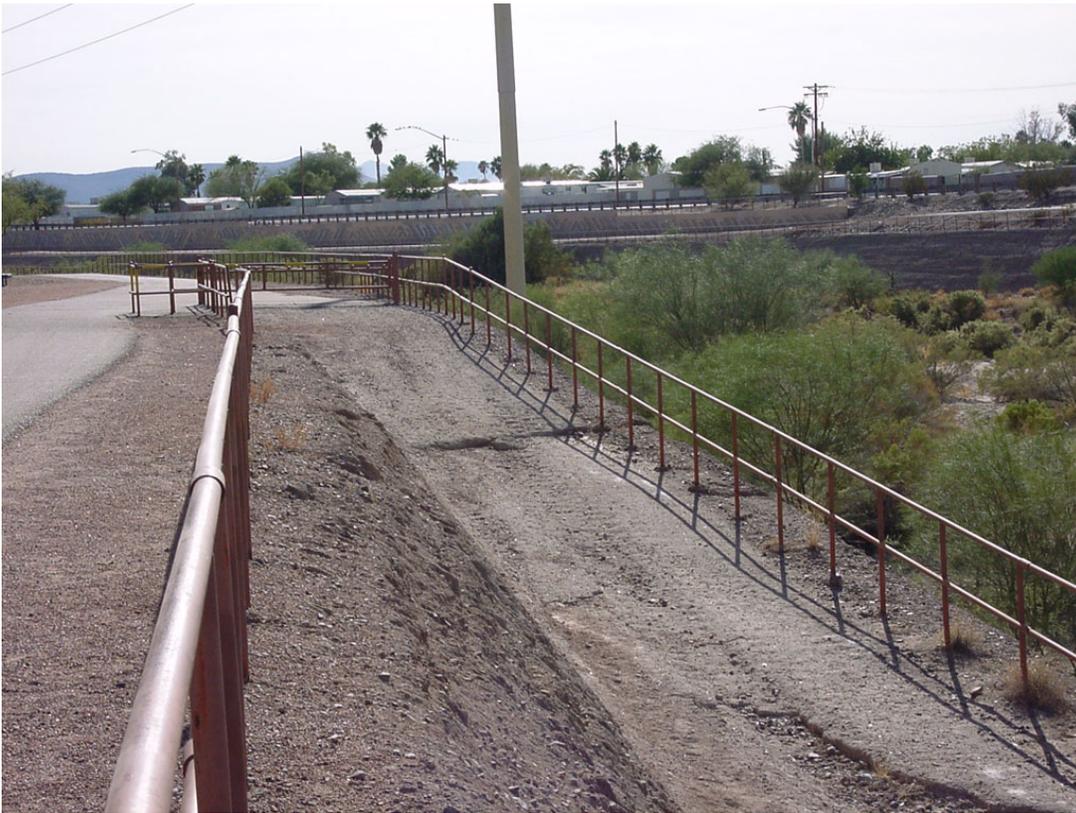
**Photo 28 - Southeast of the Ajo Bridge on the Santa Cruz River looking at the existing ramp**

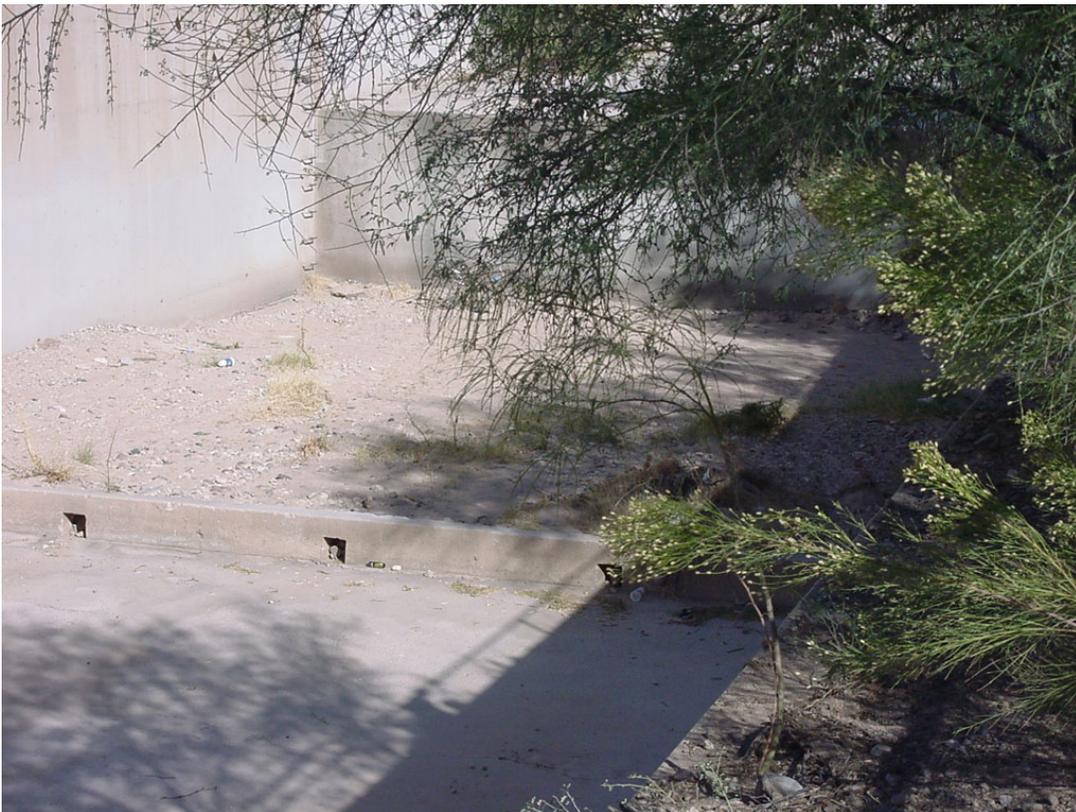
**Photo 29 – Drainage way southeast of the Ajo Way bridge**

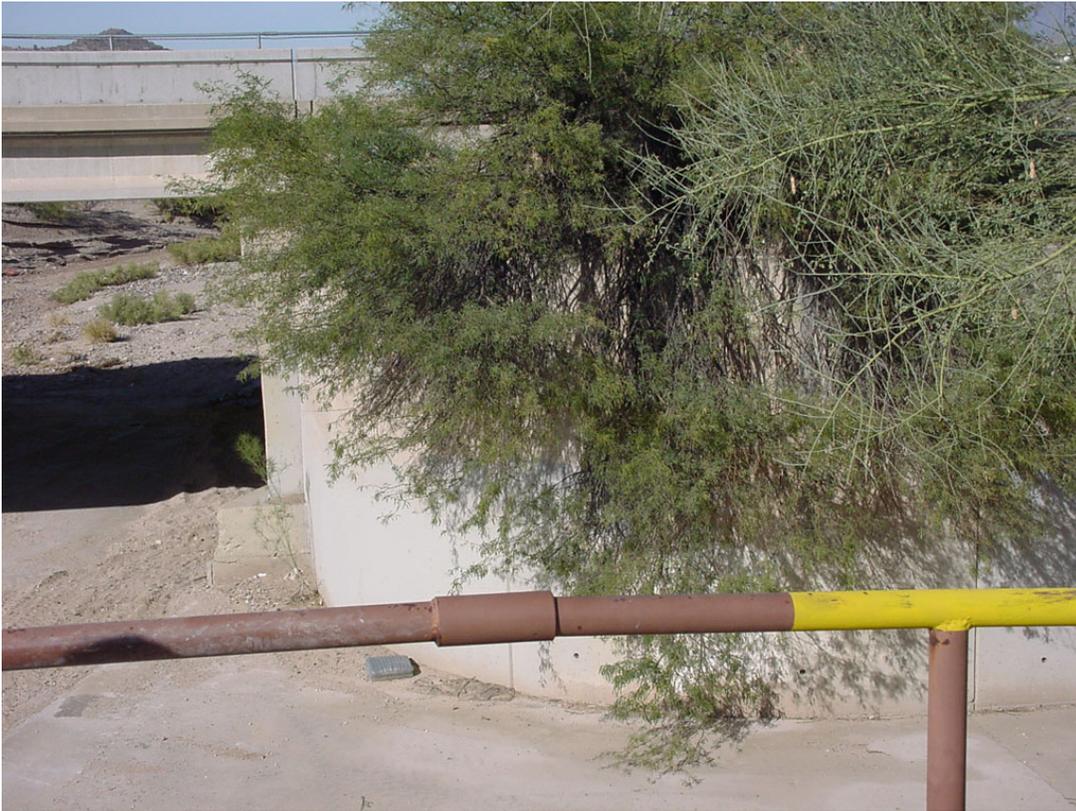
**Photo 30 - Drainage way southeast of the Ajo Way bridge**

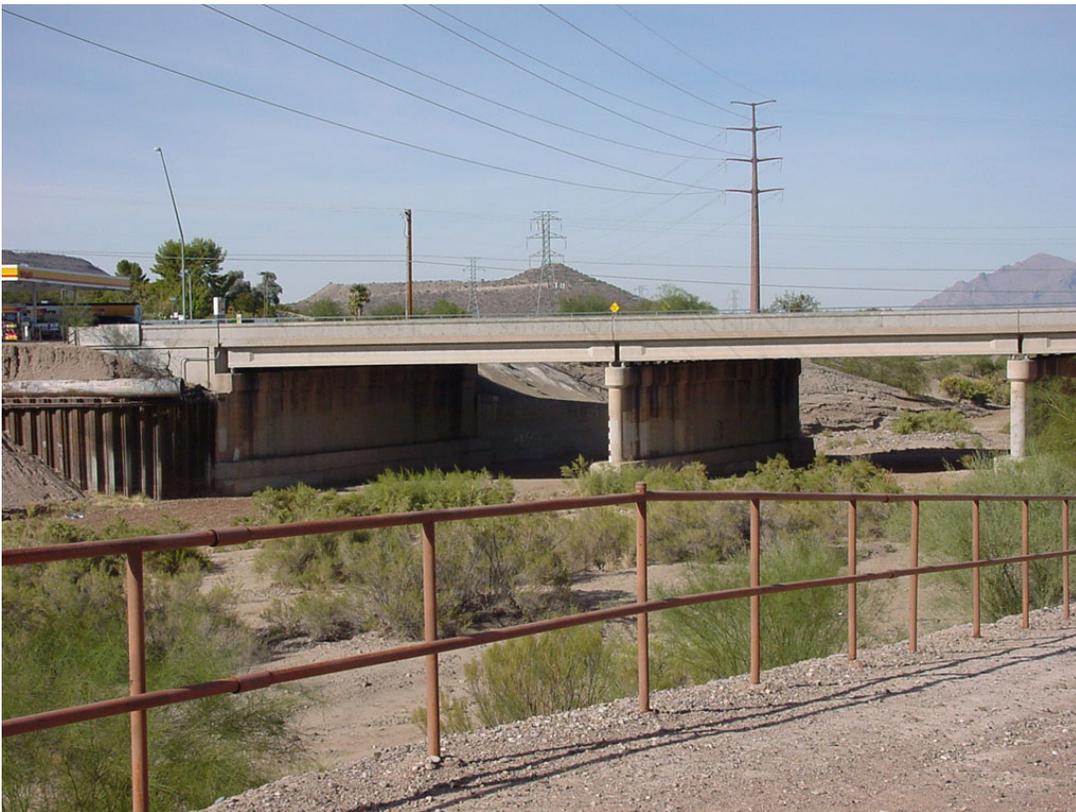
**Photo 31 – Looking north at the Ajo Way bridge**

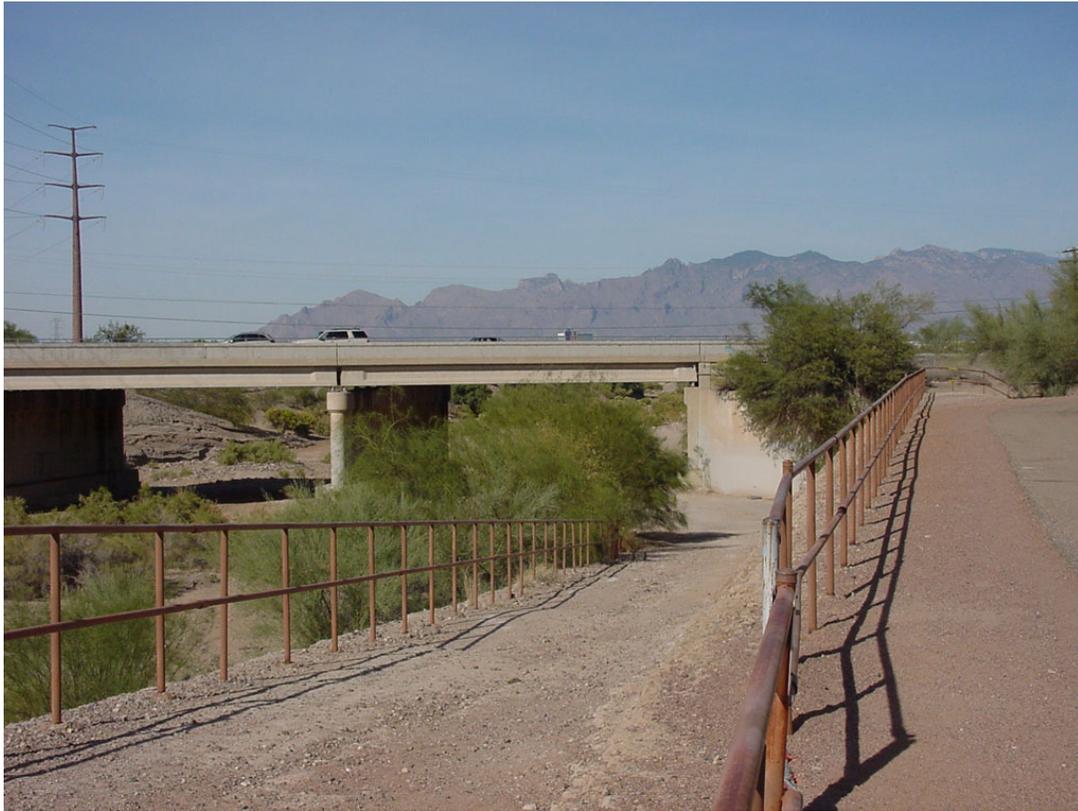
**Photo 32 - Southeast of the Ajo Bridge on the Santa Cruz River looking at the existing ramp**

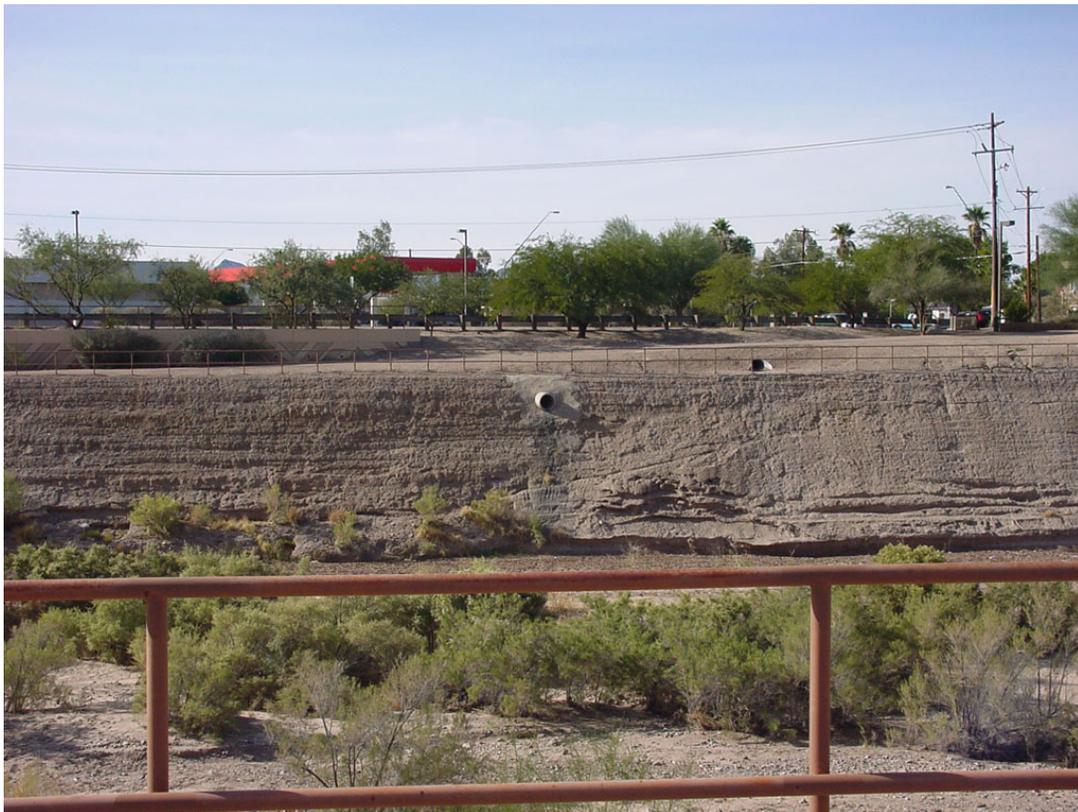
**Photo 33 - Roadway drainage entering the Santa Cruz River on the west bank**

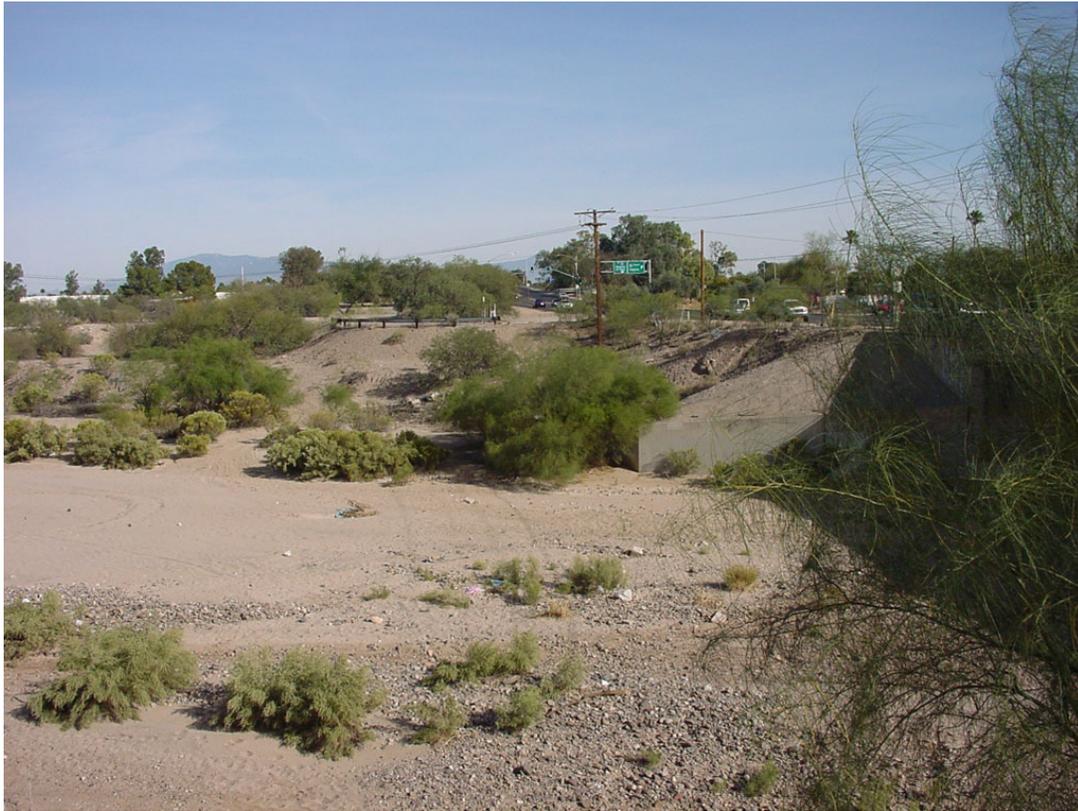
**Photo 34 - Santa Cruz River viewed from the west bank north of the Ajo Way bridge**

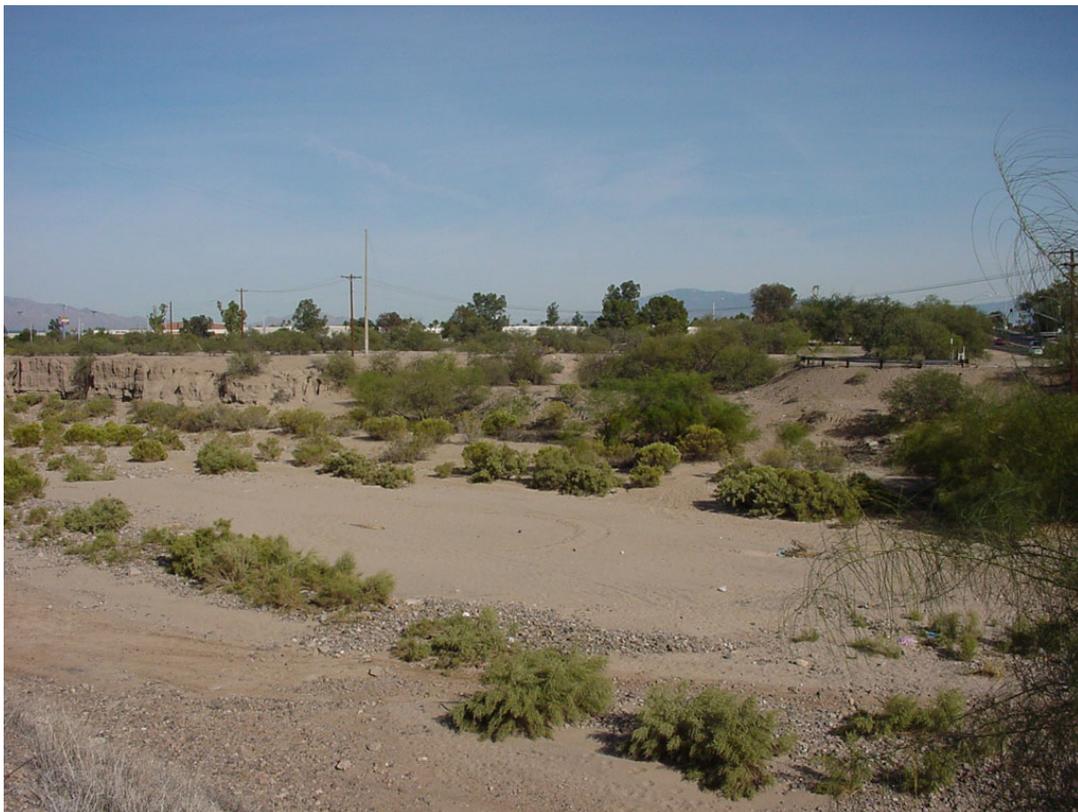
**Photo 35 - Santa Cruz River viewed from the west bank north of the Ajo Way bridge**
