PIMA COUNTY REGIONAL FLOOD CONTROL DISTRICT INFRASTRUCTURE MAINTENANCE DIVISION

Inspection Form

**19-MA-0004 - Santa Cruz River - Miracle Mile to Sweetwater Drive
Confluence of Flowing Wells Wash at Prince Road**

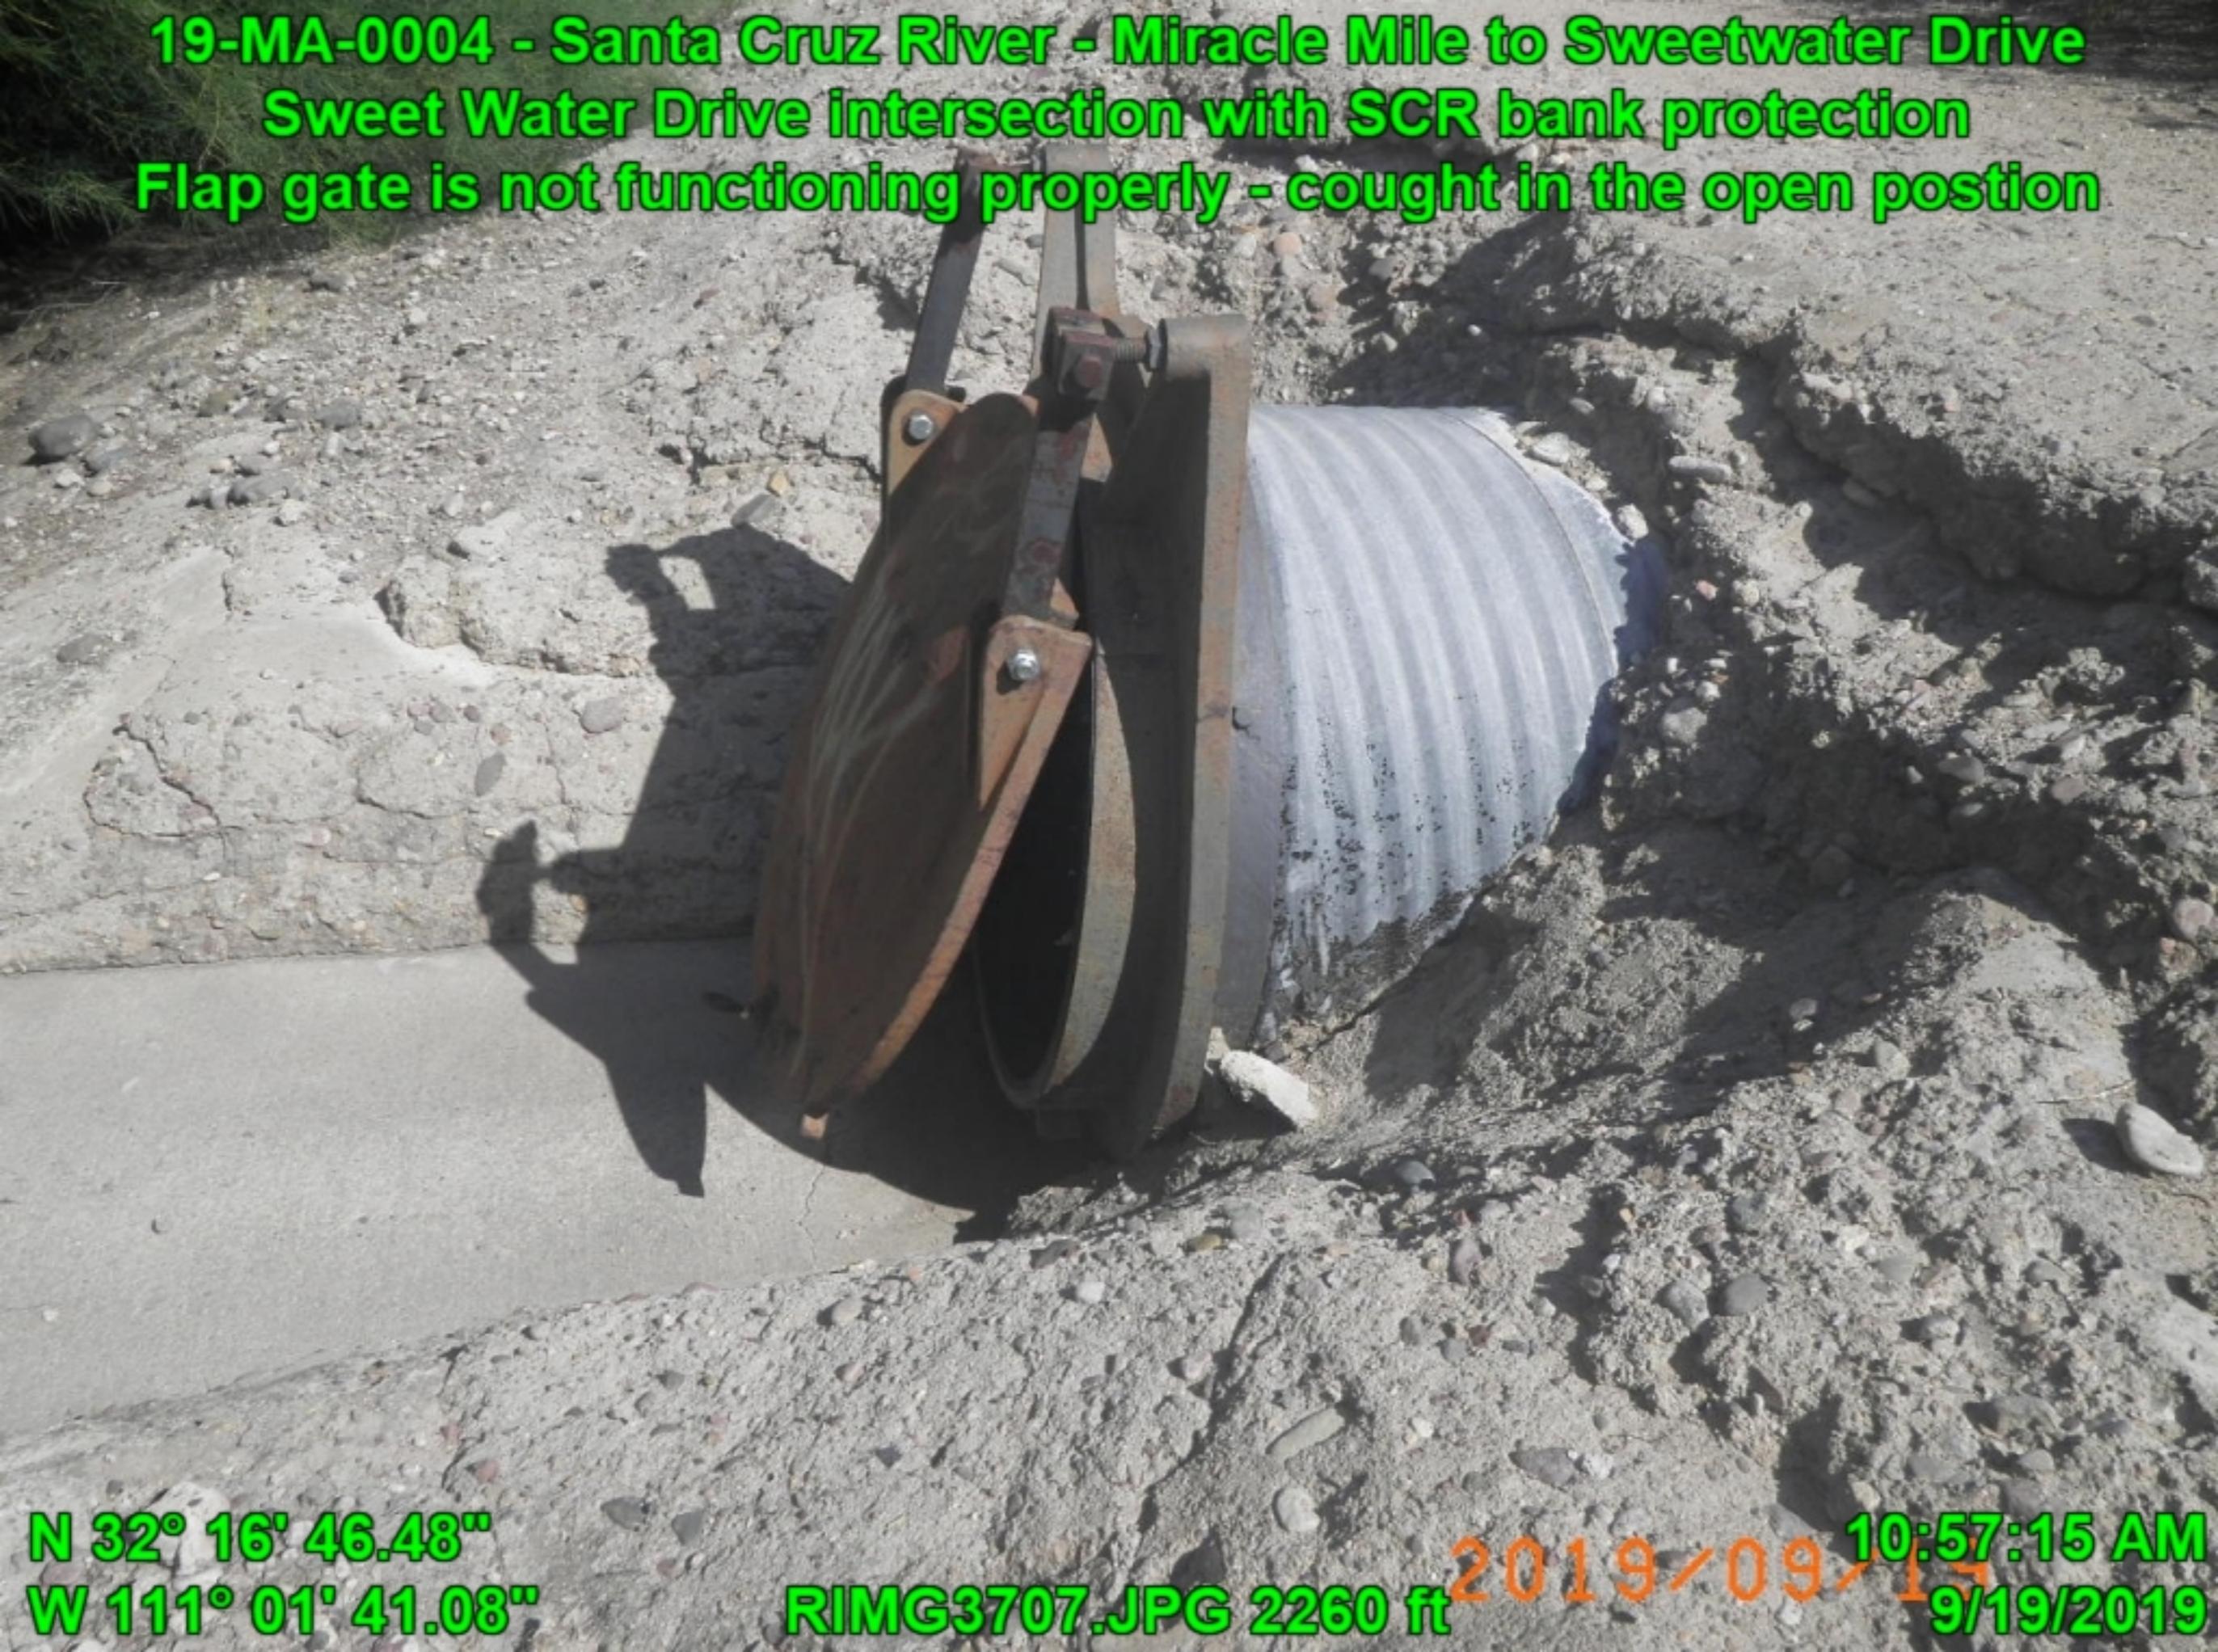
RIMG3707.JPG 2260 ft

The inspection consisted of walking both east and west bank of the Santa Cruz River within this section. Several items were noted, open flap gate at Sweetwater Dr. (location # 9 east bank), also that the grubbing for future low flow channel realignment sediment work to be completed in the near future. During the inspection I did not note any abnormalities with the bank protection, access ramps, or the pipe hand rail. The stuck flap gate at Sweetwater Dr. has been repaired.

19-MA-0004 - Santa Cruz River - Miracle Mile to Sweetwater Drive
Sweet Water Drive intersection with SCR bank protection
Flap gate is not functioning properly - cought in the open postion

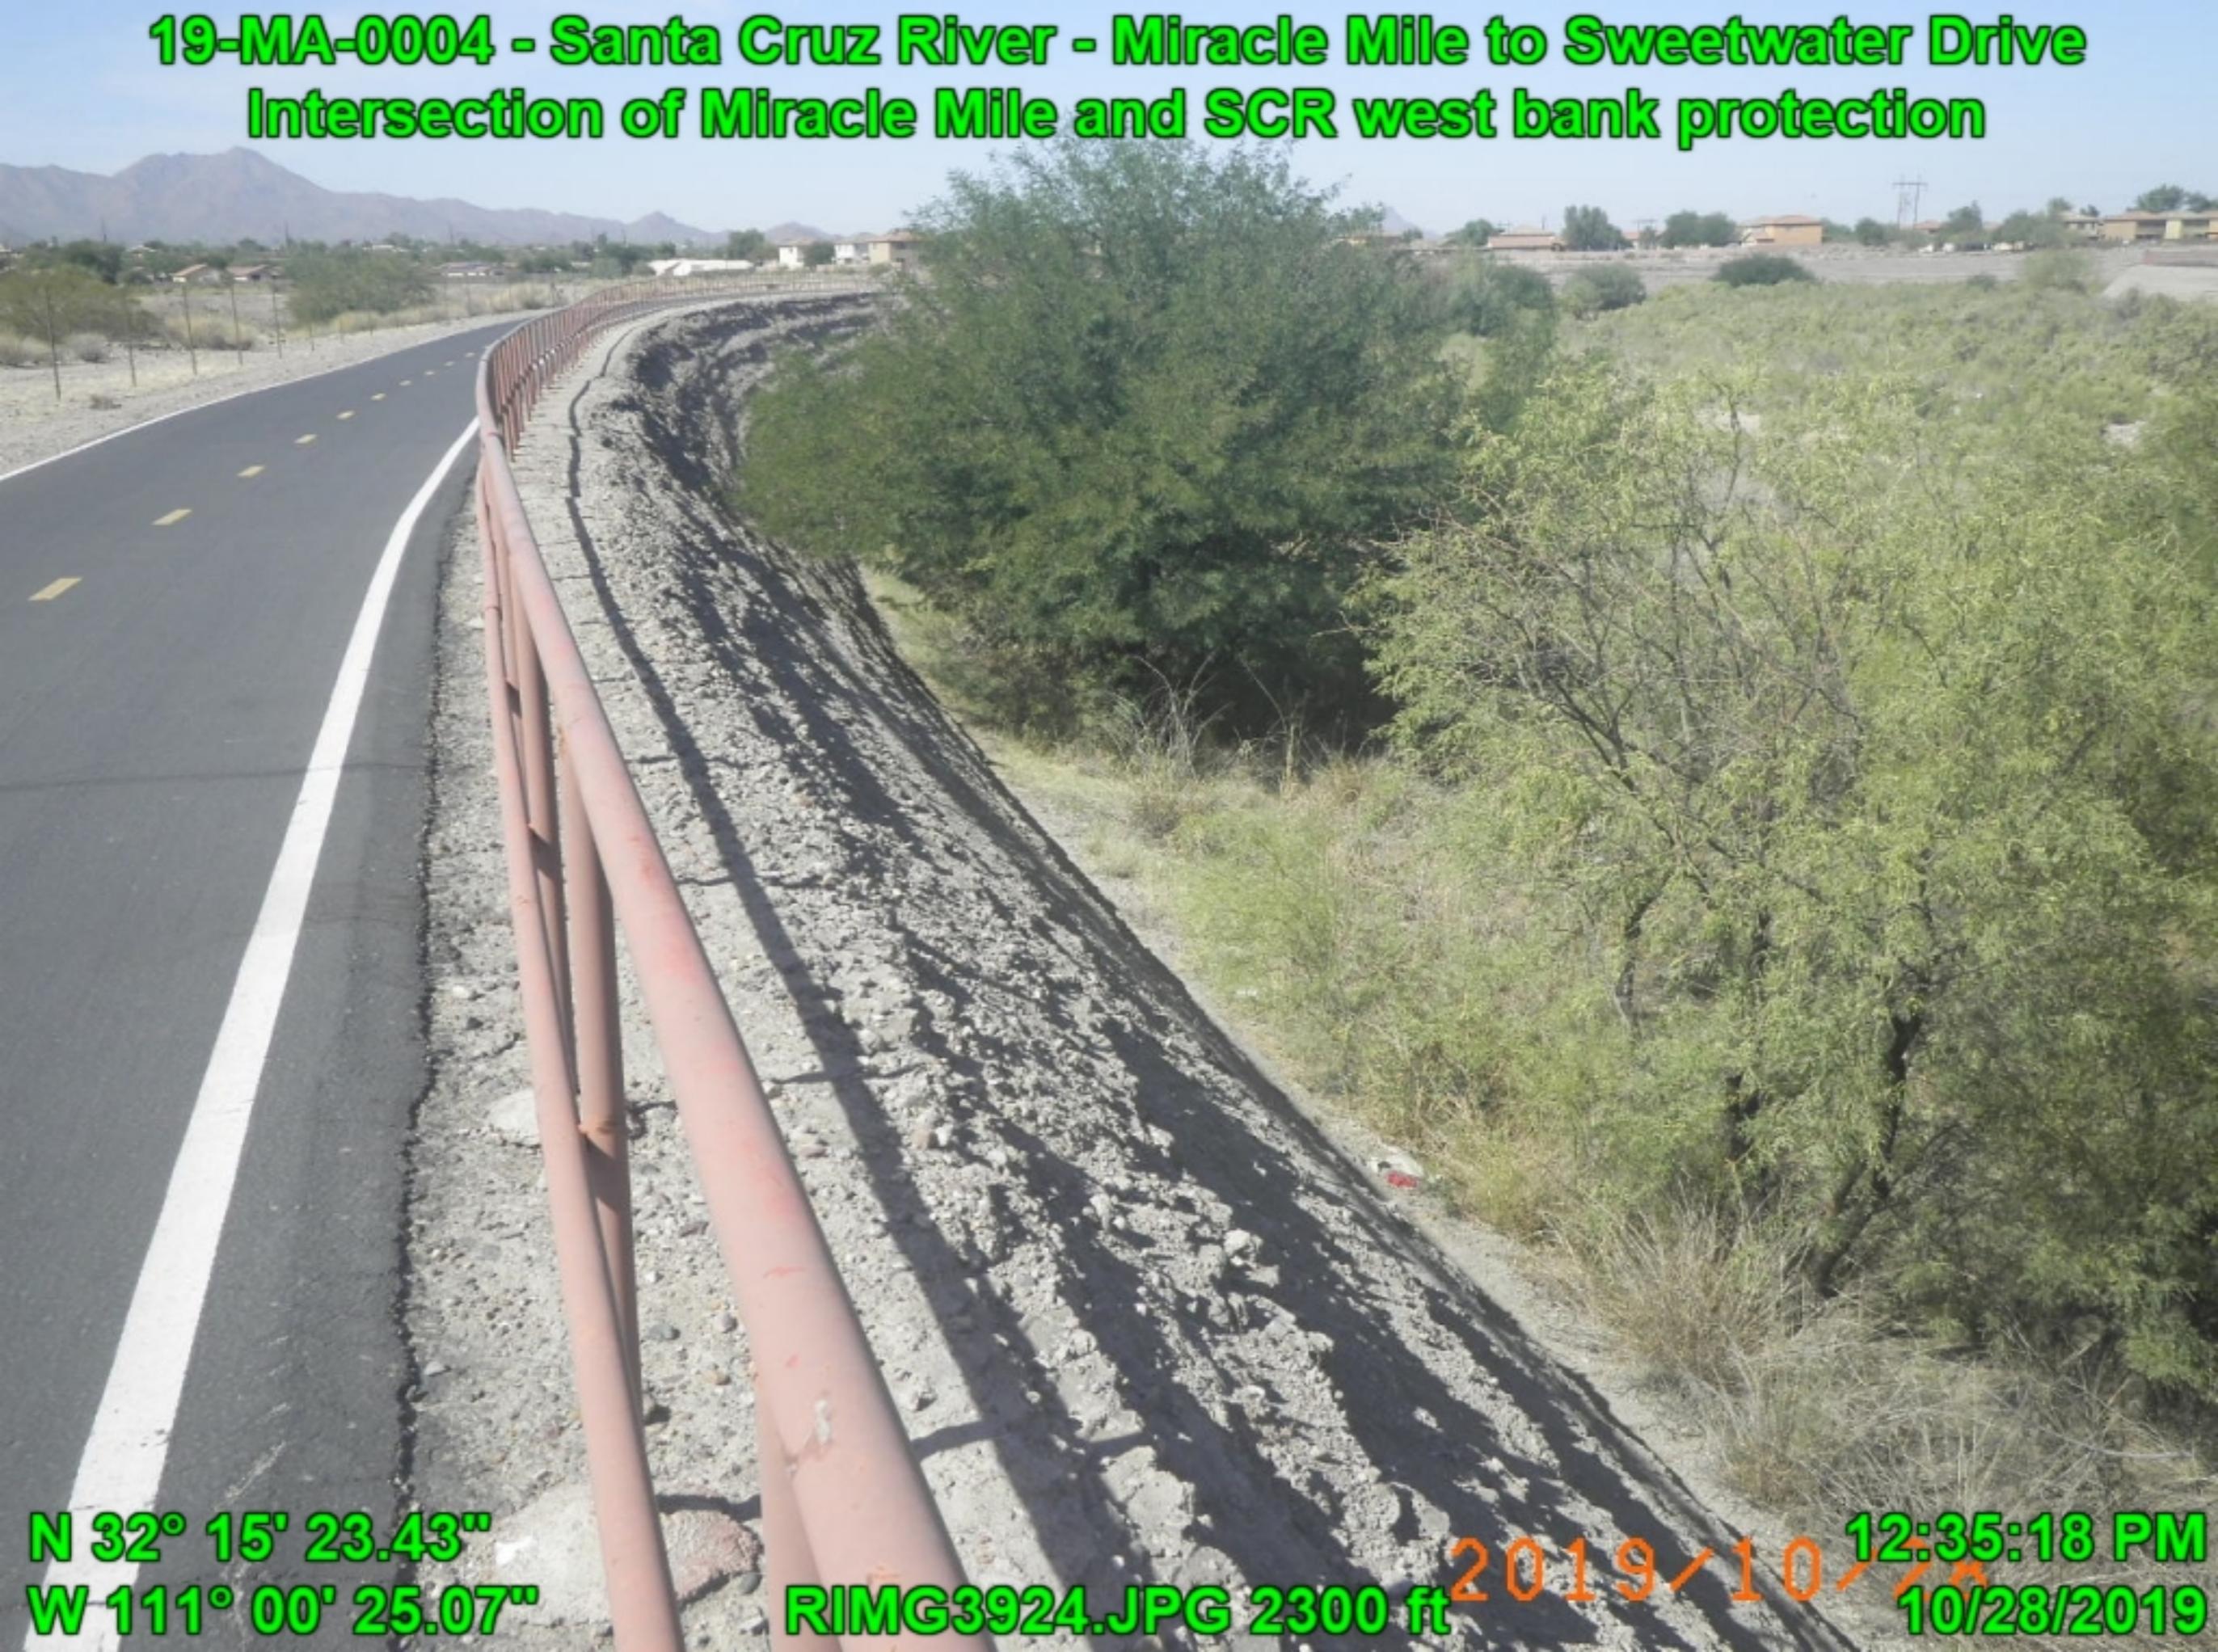
RIMG3924.JPG 2300 ft

19-MA-0004 - Santa Cruz River - Miracle Mile to Sweetwater Drive
Typical photo of hand rail and bank protection for this section

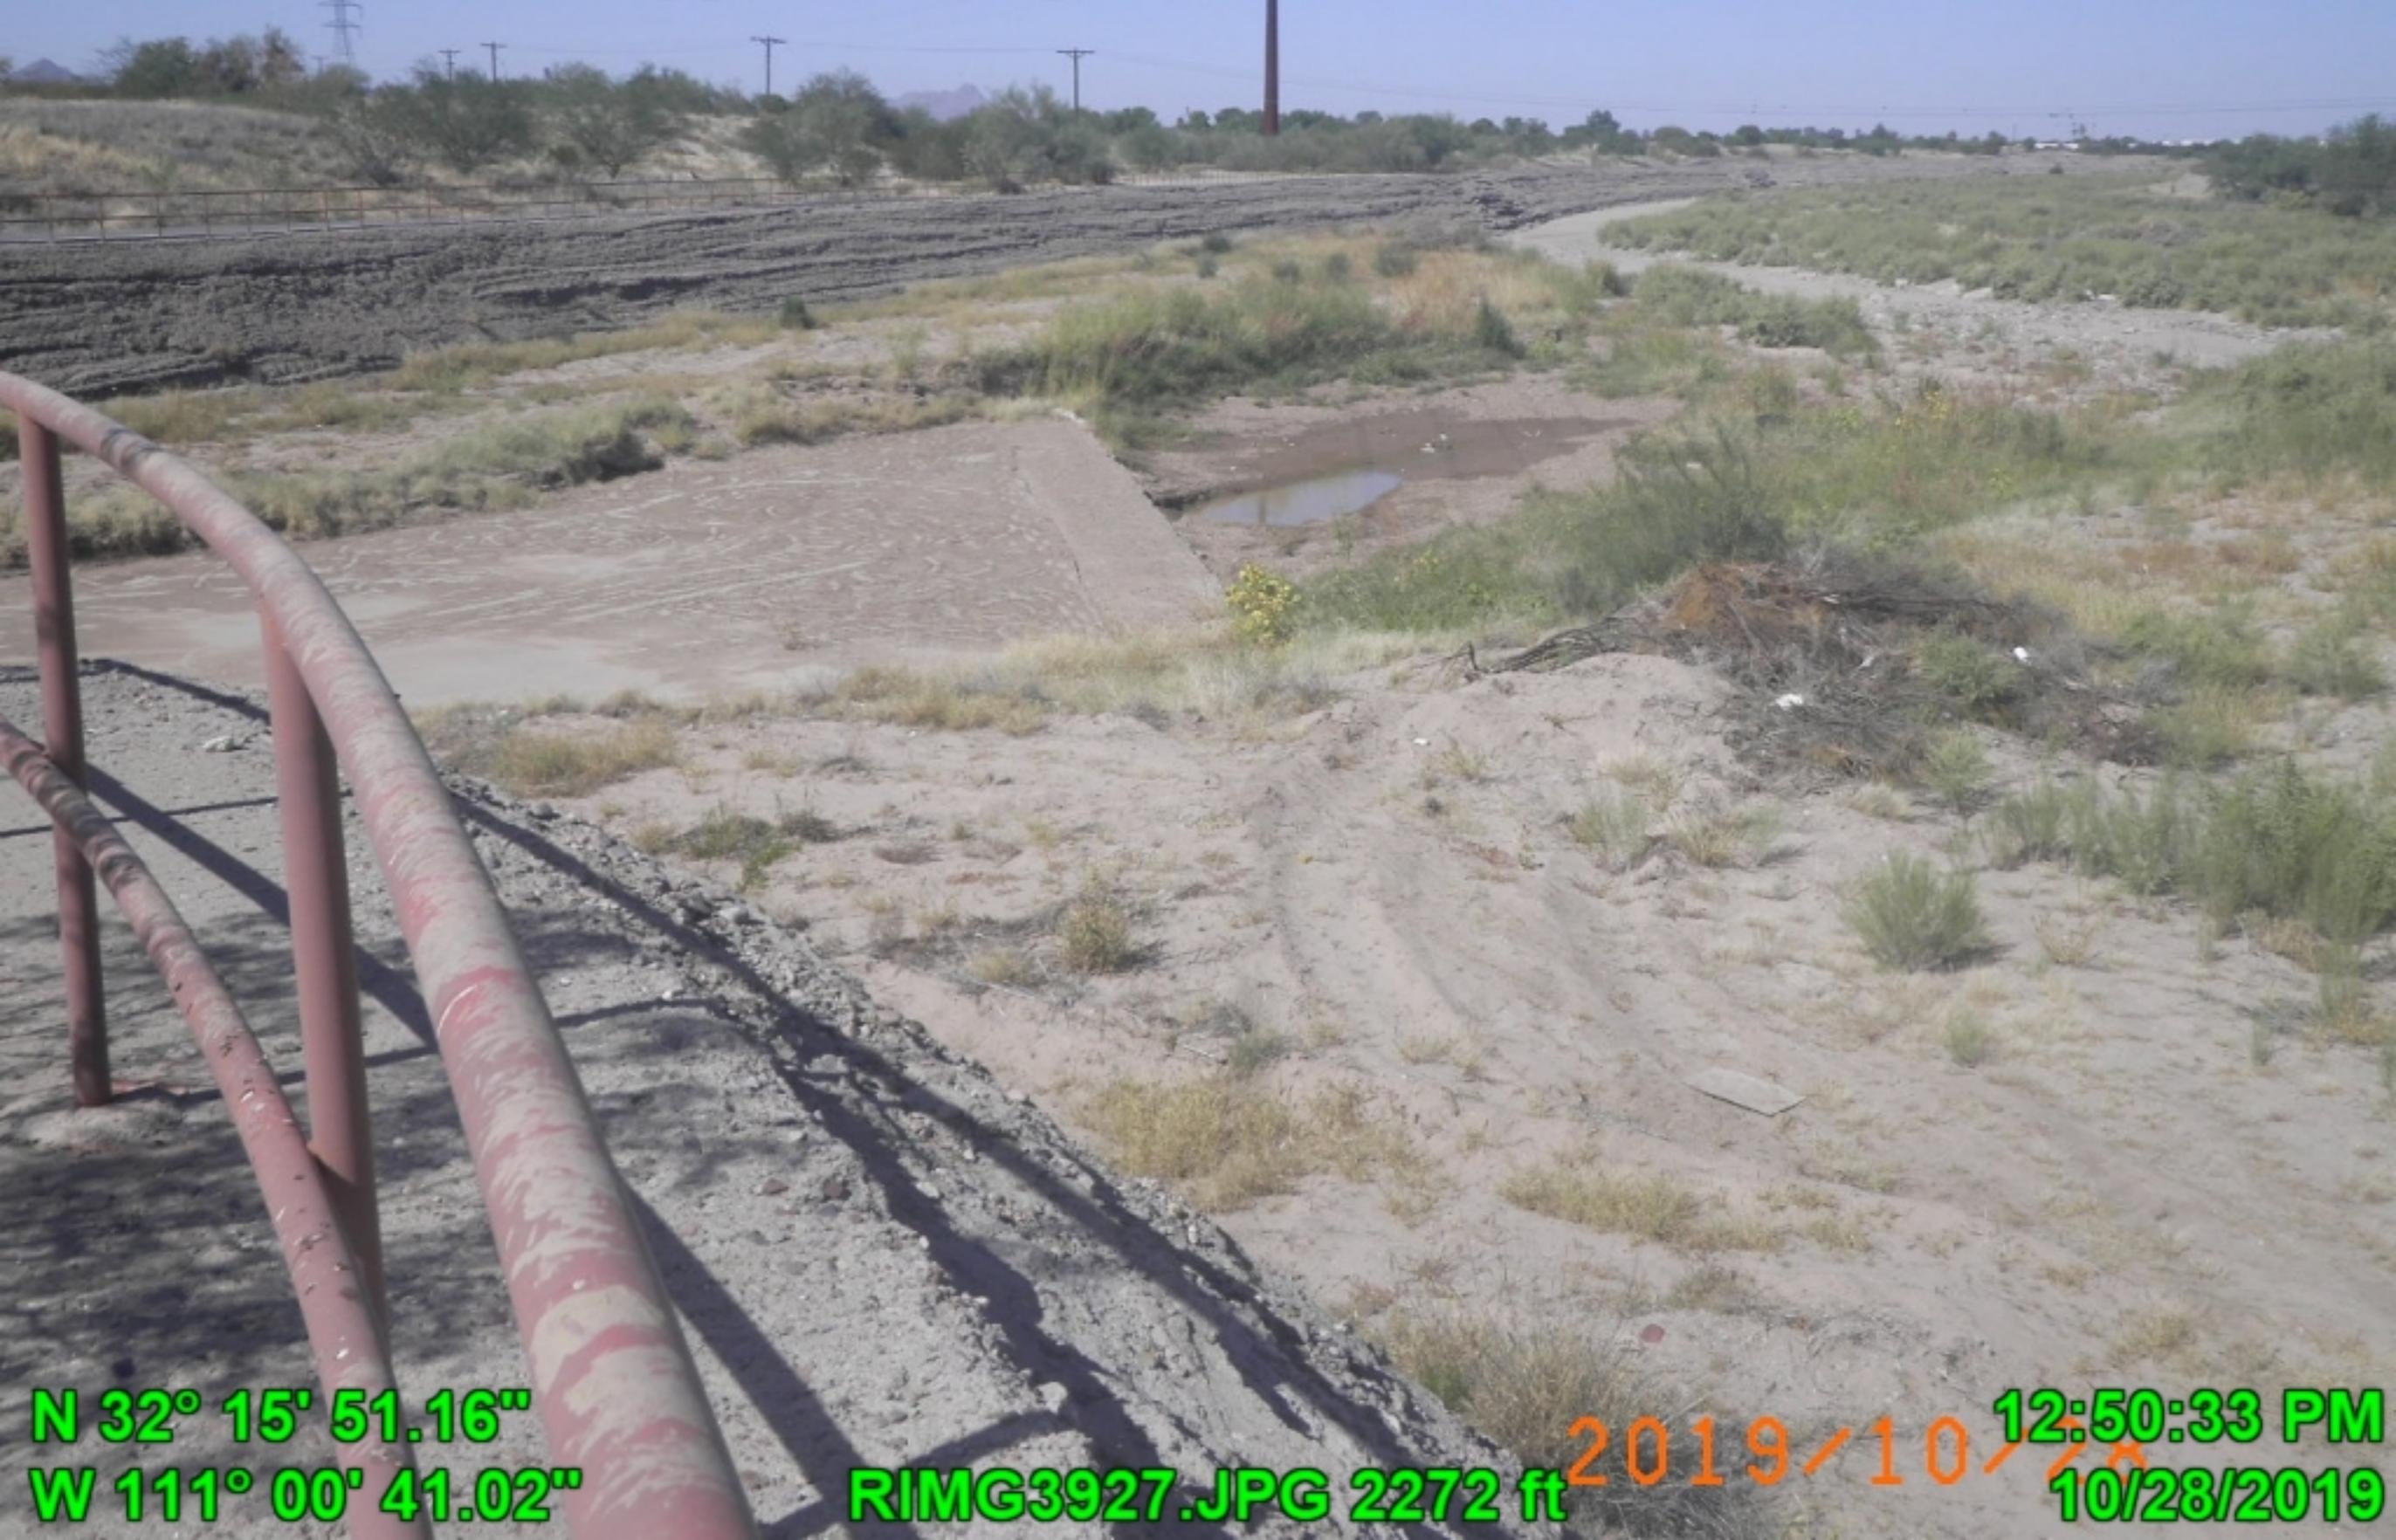
RIMG3927.JPG 2272 ft

19-MA-0004 - Santa Cruz River - Miracle Mile to Sweetwater Drive
Confluence of W. Speedway and the west bank protection
South point of the bank protection
