**Santa Cruz River, Paseo de las Iglesias  
Pima County, Arizona  
Final Feasibility Report  
and  
Environmental Impact Statement**

**APPENDIX F  
GEOTECHNICAL**

APPENDIX F  
GEOTECHNICAL EVALUATION  
FEASIBILITY REPORT  
FOR  
PASEO DE LAS IGLESIAS, FEASIBILITY STUDY  
PIMA COUNTY, ARIZONA

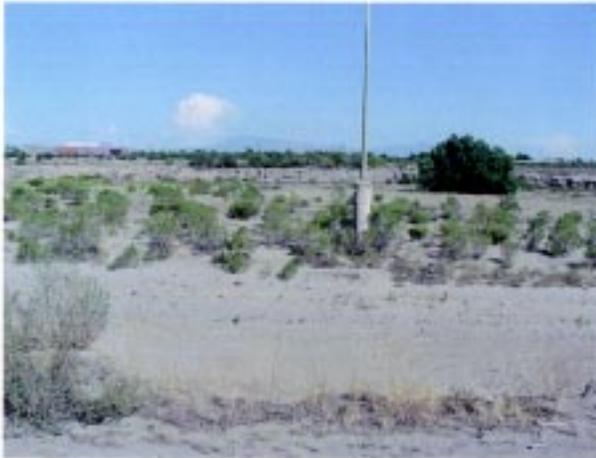
#13: Power pole base in Santa Cruz channel just S. of Drexel

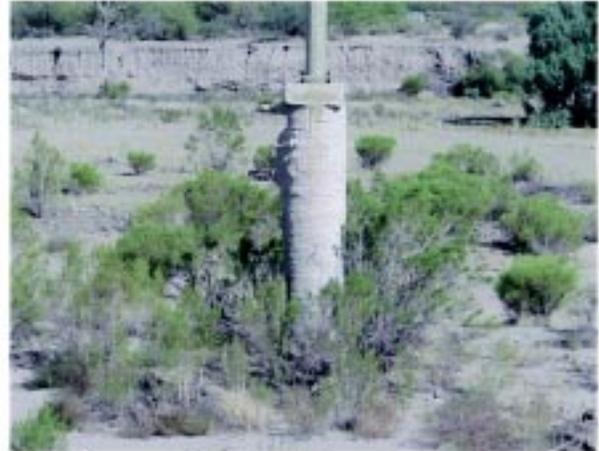
#14: Same pole foundation as previous showing bed degradation

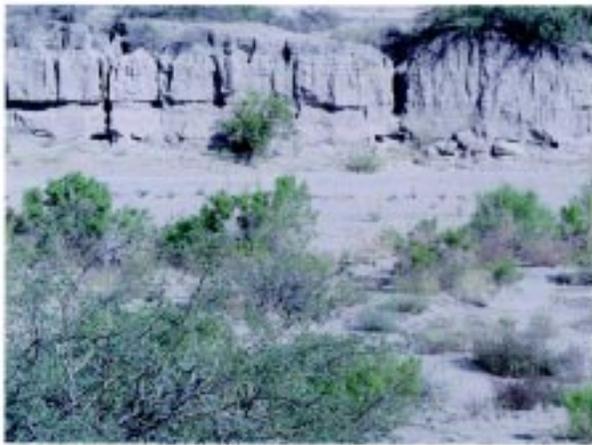
a near vertical inclination at many locations along the reaches of the study (reference photos 14 - 16 and 23-25). The vertical banks, when impacted by the any significant streamflow, are susceptible to being undercut at the bottom and collapsing into the streambed. The undercutting occurs mainly by the water breaking down the weak cementation present in the silty material. The second form of stream bank erosion is piping. As previously noted, the particle size of the slope embankment material is such that it is very susceptible to piping. Either surface or subsurface water flowing over or beneath the banks form large cavities or cave-like structures as the material is removed by piping thru the embankment and out its face.

#15: East bank of Santa Cruz channel just N. of Valencia

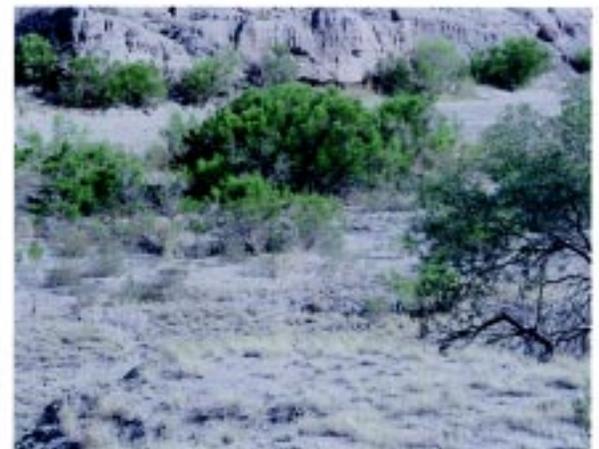
#16: East bank of Santa Cruz channel north of Valencia

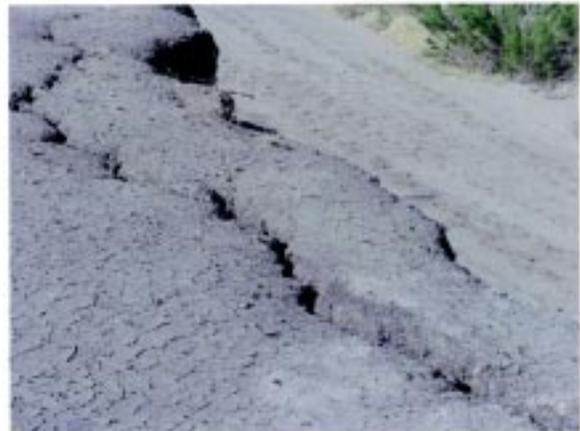
#19: Tension Cracks in W. bank, just S. of Valencia

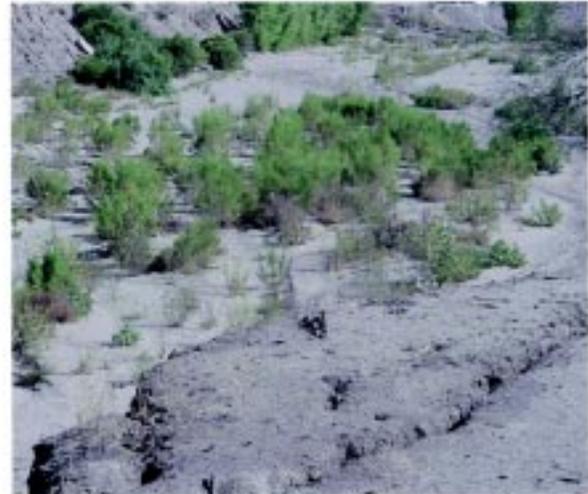
#21: Tension Cracks in W. Bank just S. of Valencia

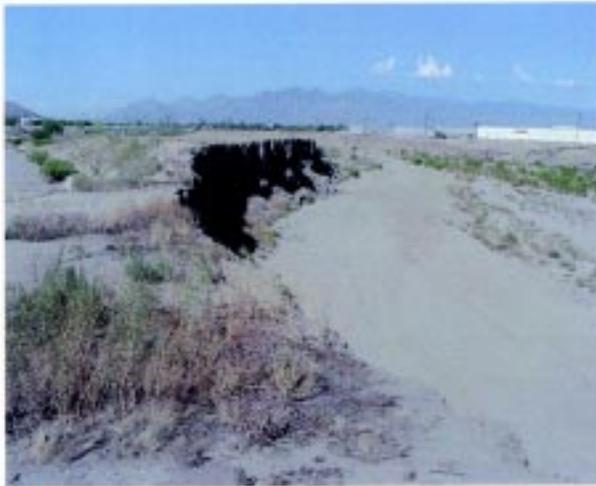
#23: Santa Cruz channel west bank, south of Irvington (view to north)

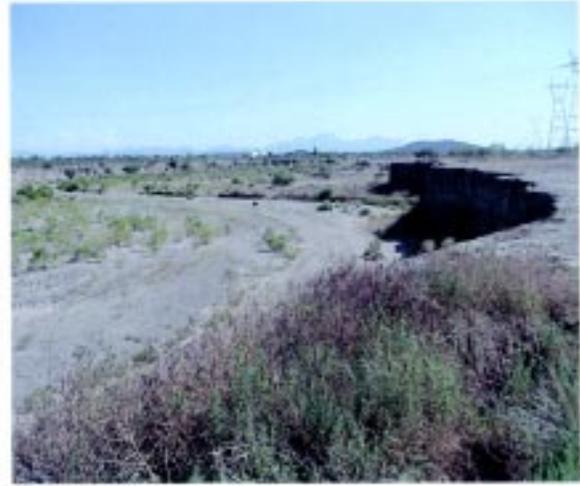
#24: Santa Cruz channel bank, south of Irvington (view to south)

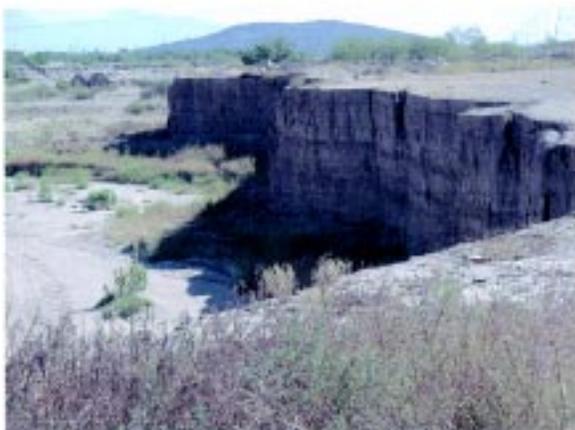
#25: Santa Cruz Riv. bank, south of Irvington (view to south) (closeup of previous photo)

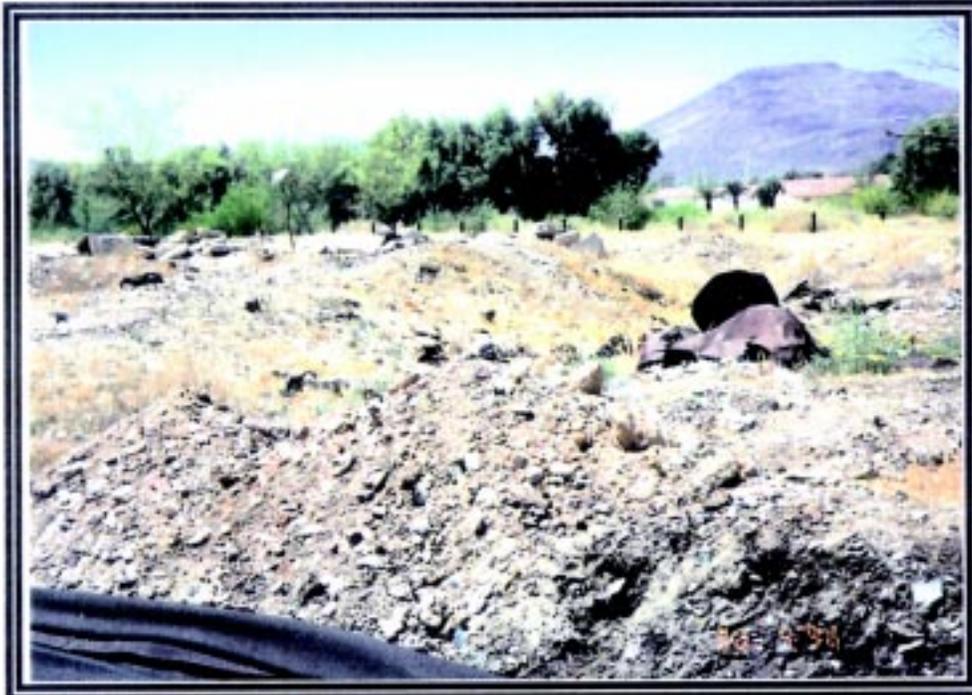
**Photograph 1. Partially exposed landfill at Site 4, view toward the west-northwest.**

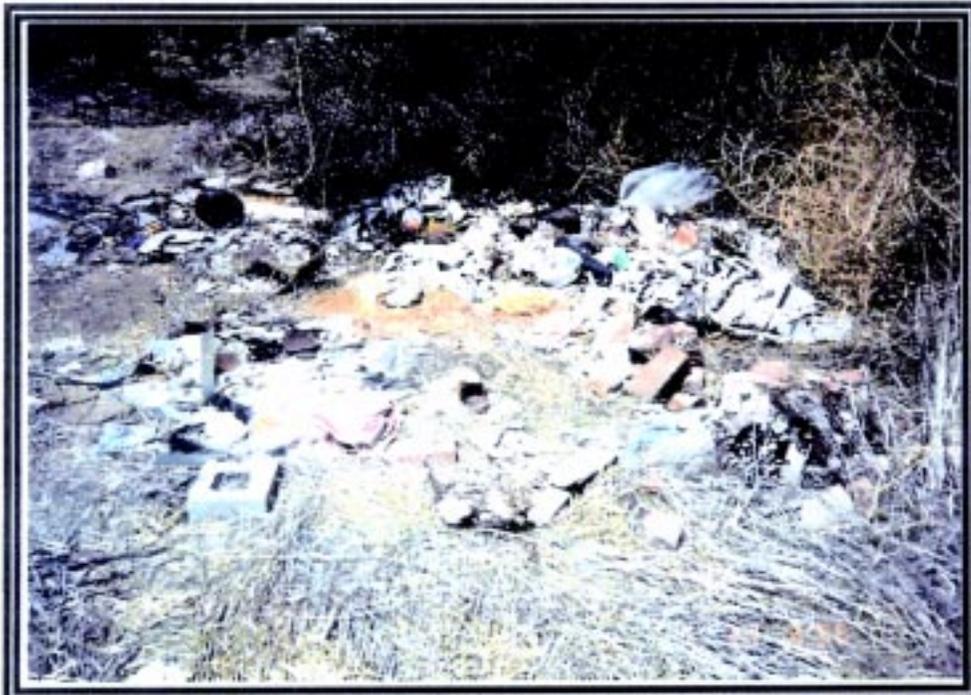
**Photograph 3. Wildcat dump in center of vacant lot at Site 13, view toward the northeast.**

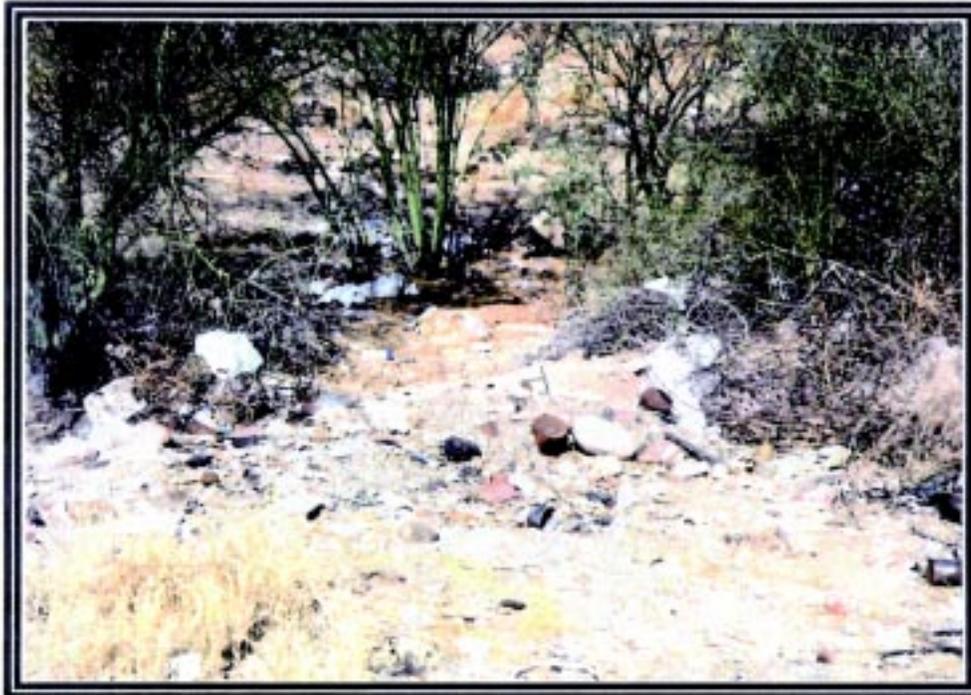
**Photograph 2. Wildcat dump on surface of "A" Mountain Landfill at Site 11, view toward the southeast.**

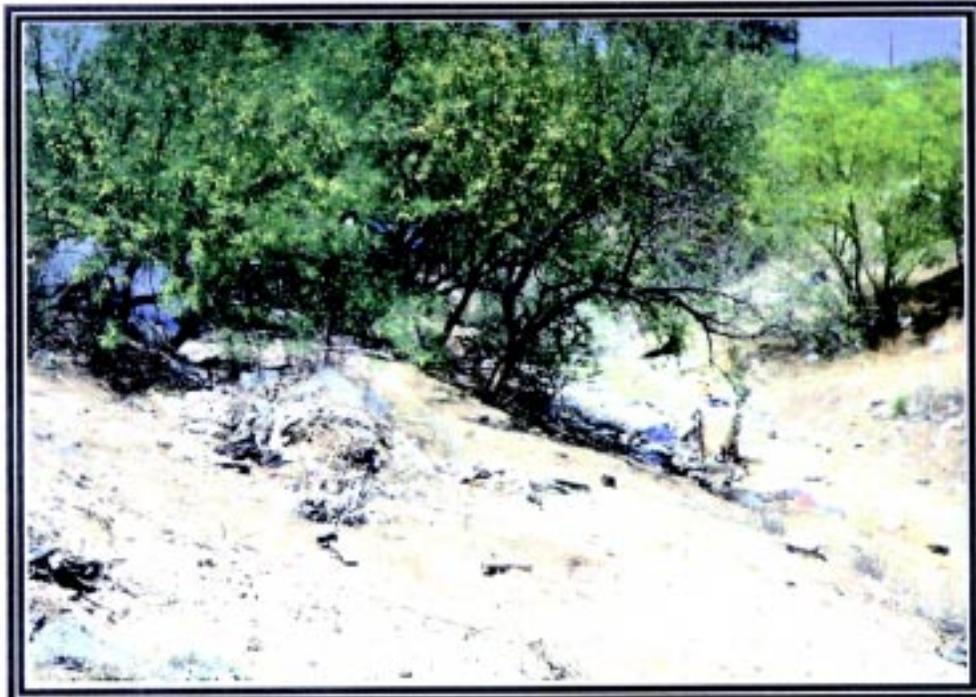
Photograph 4. Wildcat dump in drainage at Site 14, view toward the north.

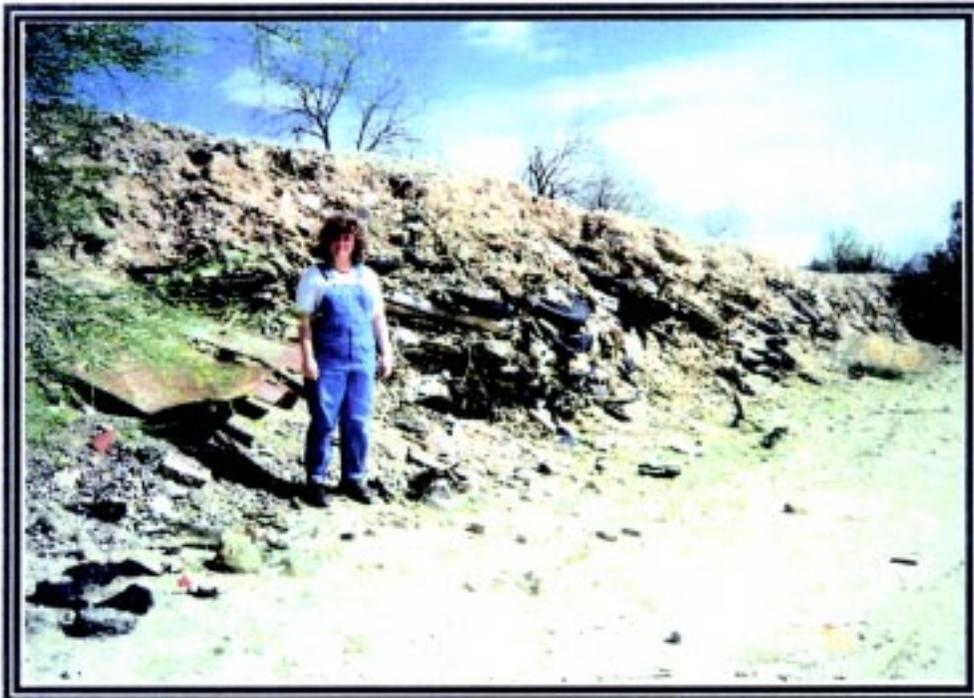
**Field Description:** Ryland Landfill was located at this site. The landfill material exposed along the river bank included glass, cans, paper, wood, plastic, concrete and asphalt debris, bricks, rubber tires, newspaper, and household waste. Photograph #5 shows most of the bank edge of the landfill. Rubber tires were also seen on the surface of the landfill. Access was available from Ajo Way along a dirt road. The surrounding land uses included the river with no bank protection to the west, I-19 to the east, and vacant lots to the north and south. The surface of the landfill was extremely hummocky, which was probably due to differential settling. PAG staff did not see any change in the appearance of the site since the area had been visited in the Spring of 1993.

Photograph 5. Bank edge of Ryland Landfill at Site 22, view toward the southeast.

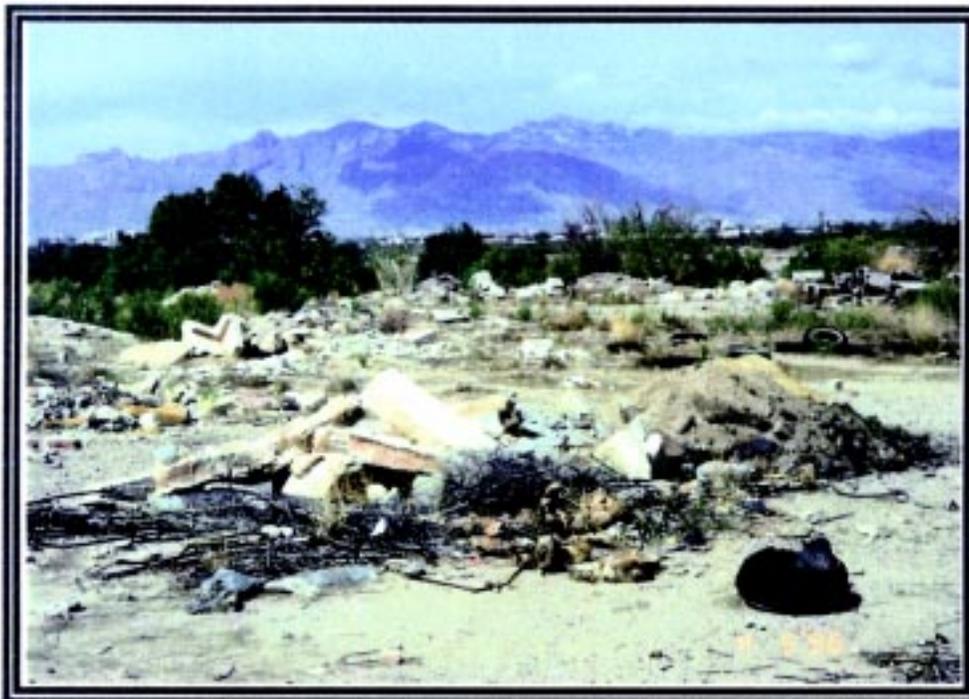
**Photograph 6. Wildcat dump at Site 23, view toward the north.**

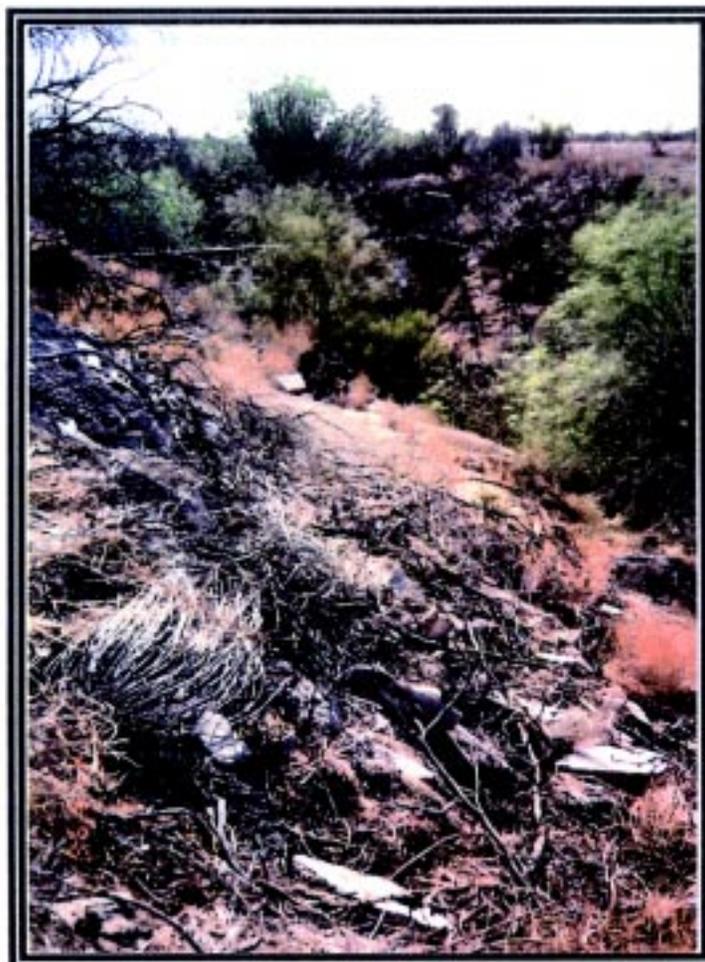
**Photograph 7. Wildcat dump in drainage at Site 27, view toward the east.**

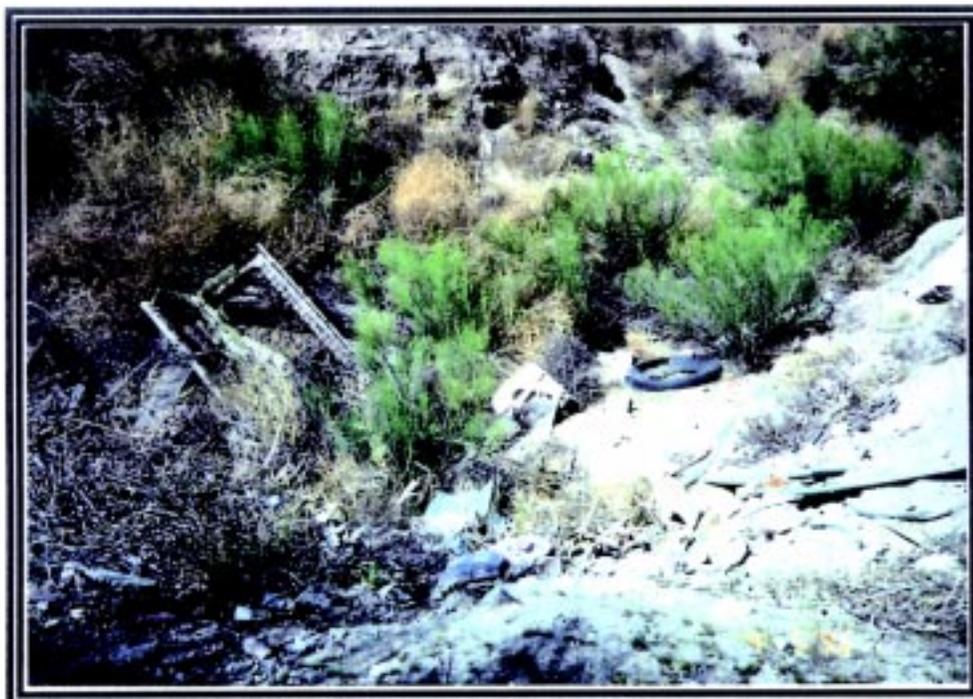
**Photograph 8. Drainage at southern edge of wildcat dump at Site 34, view toward the southwest.**

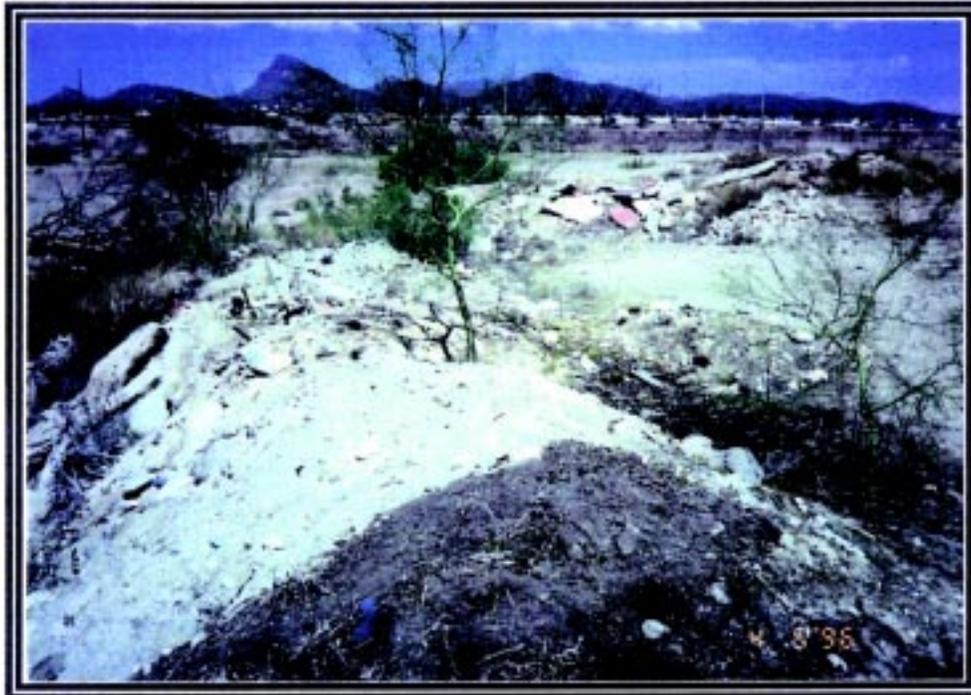
**Photograph 9. Piles of dirt and concrete debris along the western perimeter of a wildcat dump directly east of Santa Cruz River at Site 34, view toward the west-northwest.**

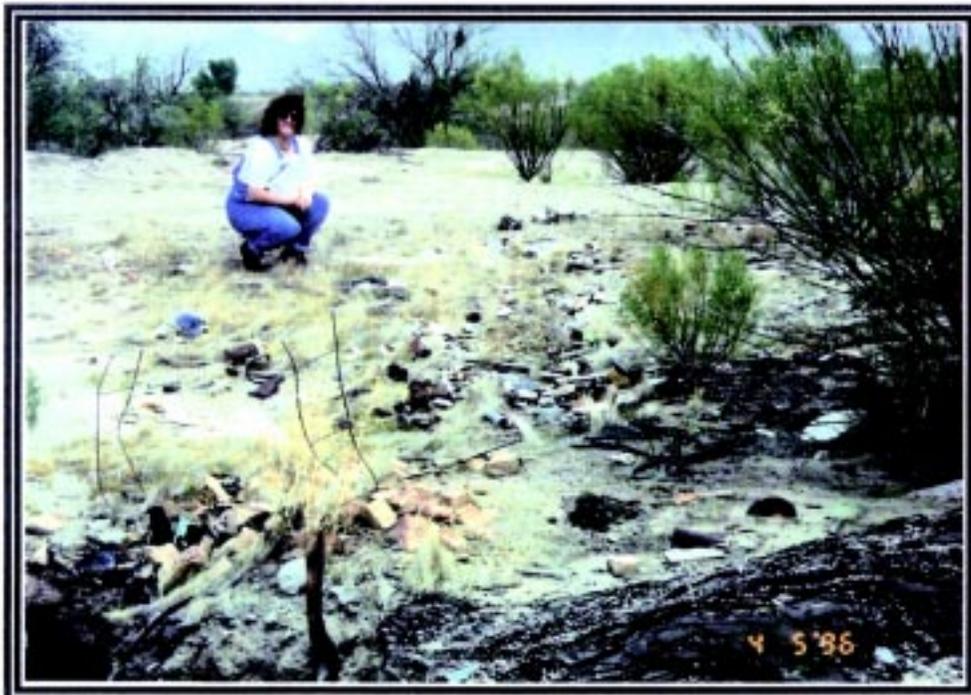
Photograph 10. Wildcat dump at Site 37, view toward the northwest.

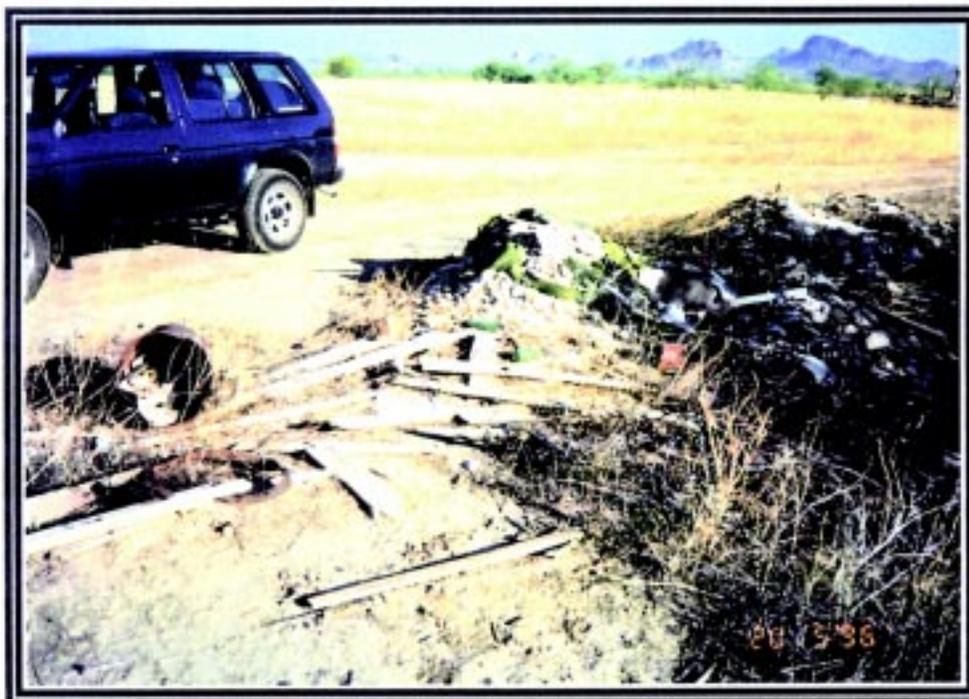
Photograph 11. Wildcat dump at Site 48, view toward the southwest.

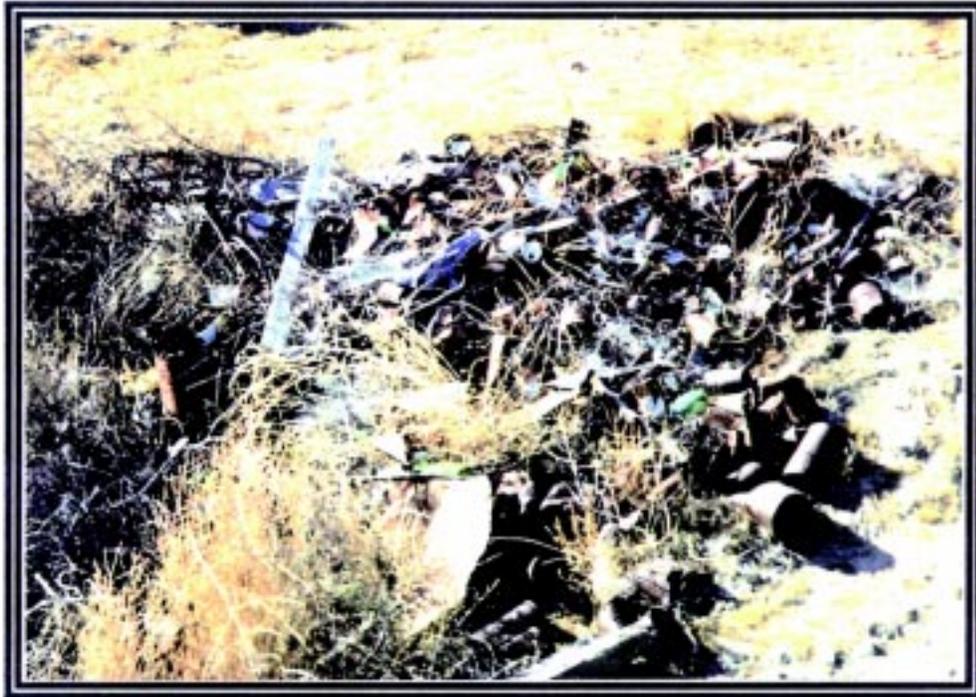
Photograph 12. Wildcat dump at Site 52, view toward the southeast.

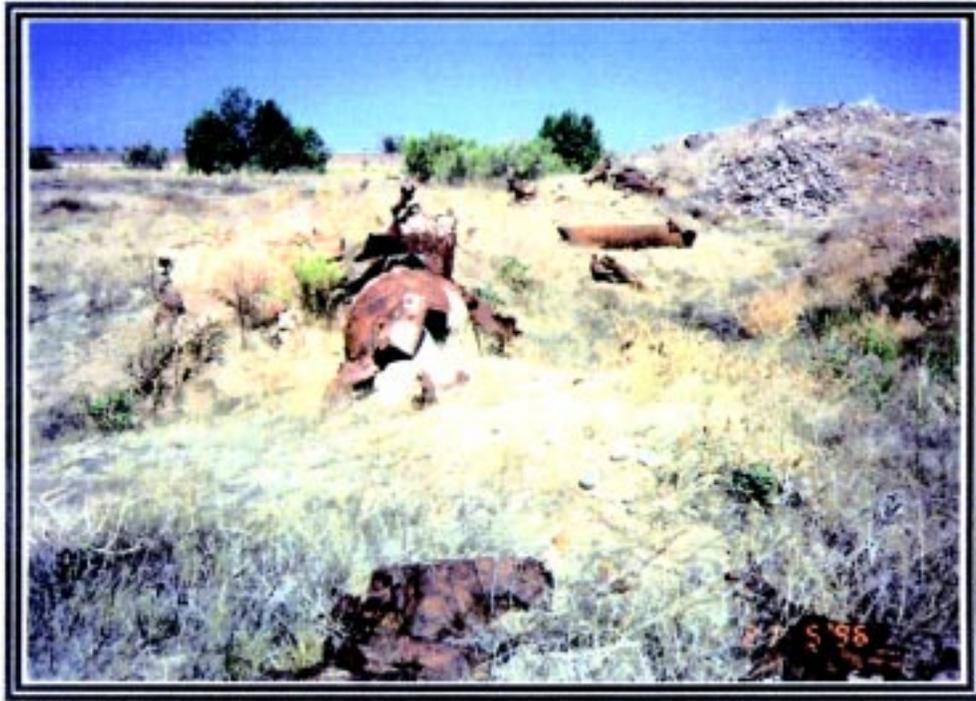
Photograph 13. Piles of concrete debris, dirt, and metal at Site 56, view toward the northwest.

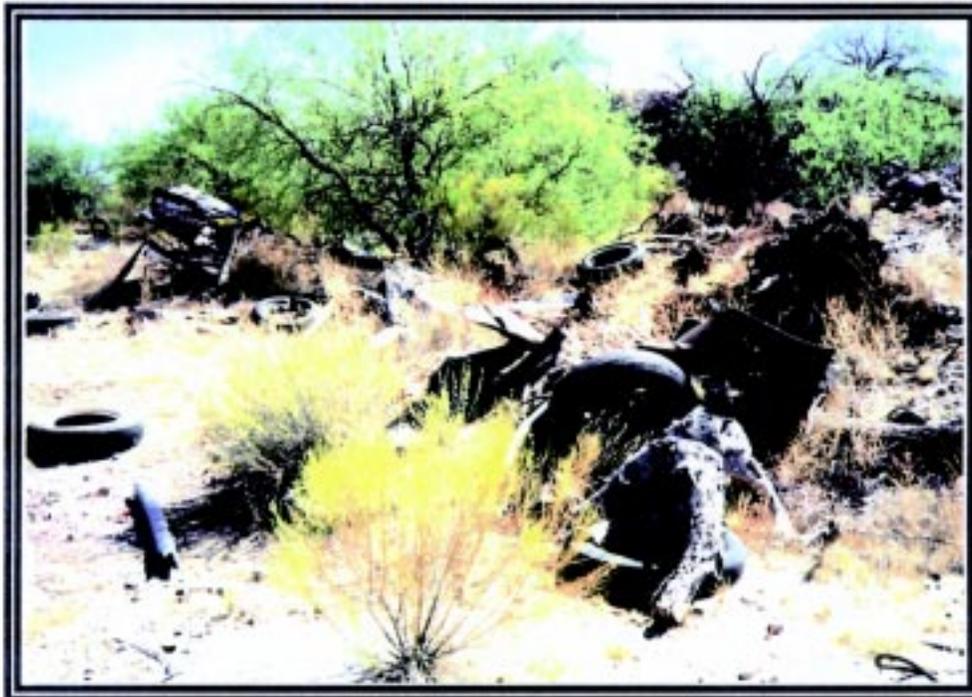
Photograph 14. Wildcat dump at Site 57, view toward the northeast.
