Canoa Ranch

Historic Rehabilitation Work by Pima County:
A sampling of before and after conditions between
2005 and 2014

Bond Funded Construction Phases I-IV 2006 - 2012

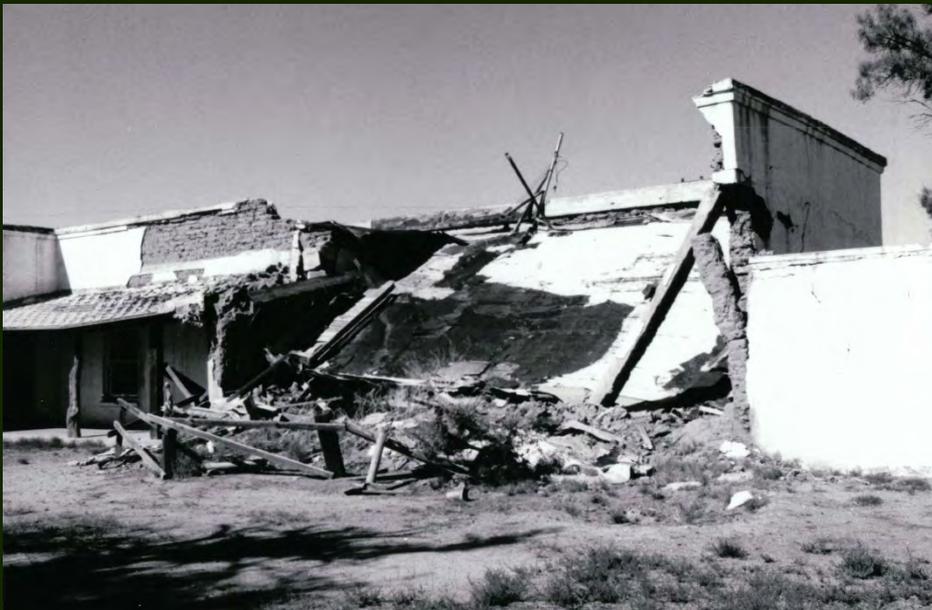
These black and white photos show the Utility Building as it appeared before any work had begun.

The wall and roof had collapsed

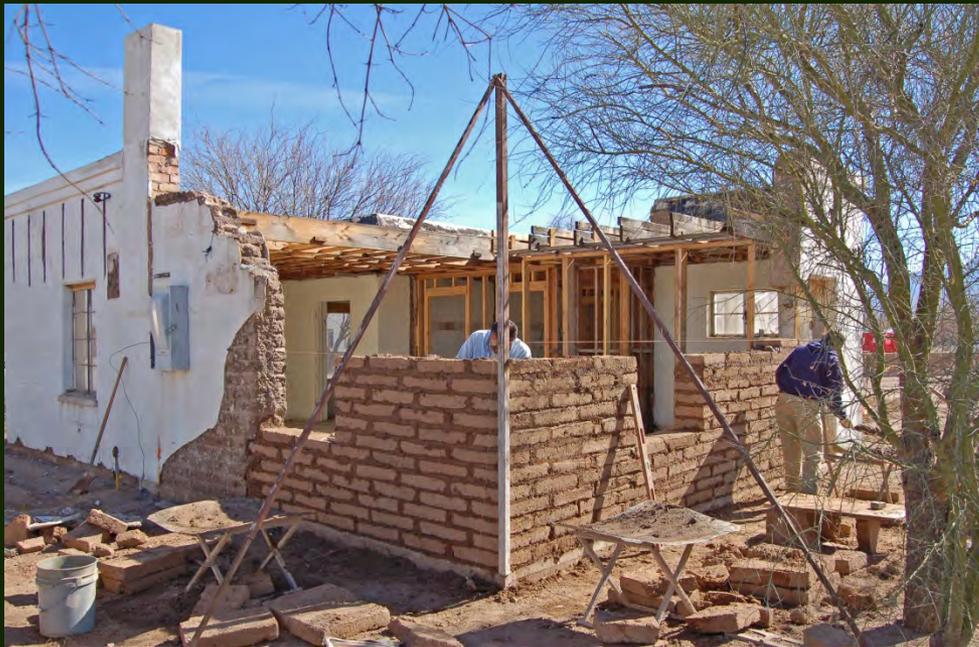
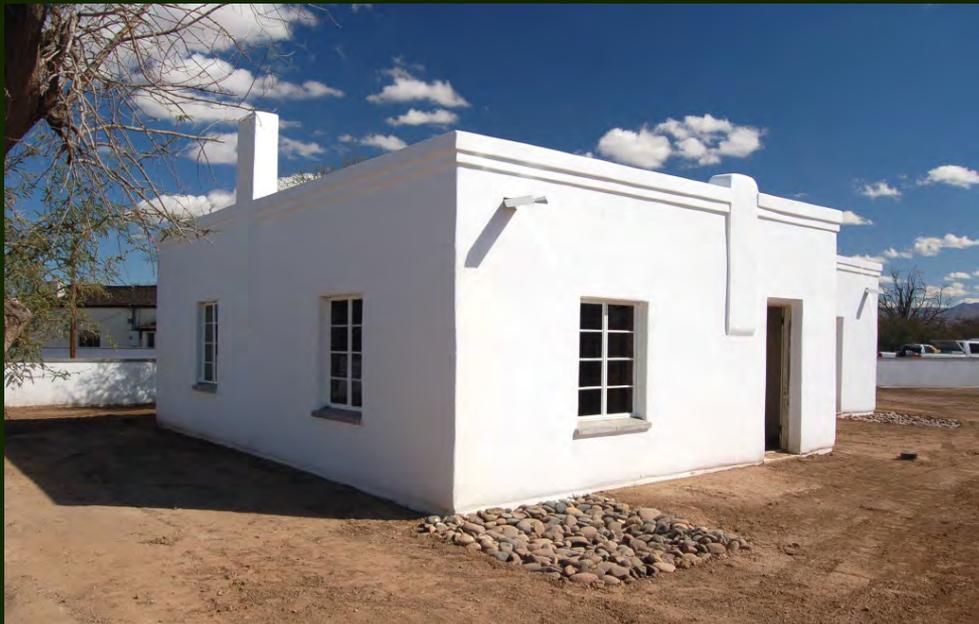
Employee's House

One corner had to be entirely rebuilt using site-made adobe bricks.

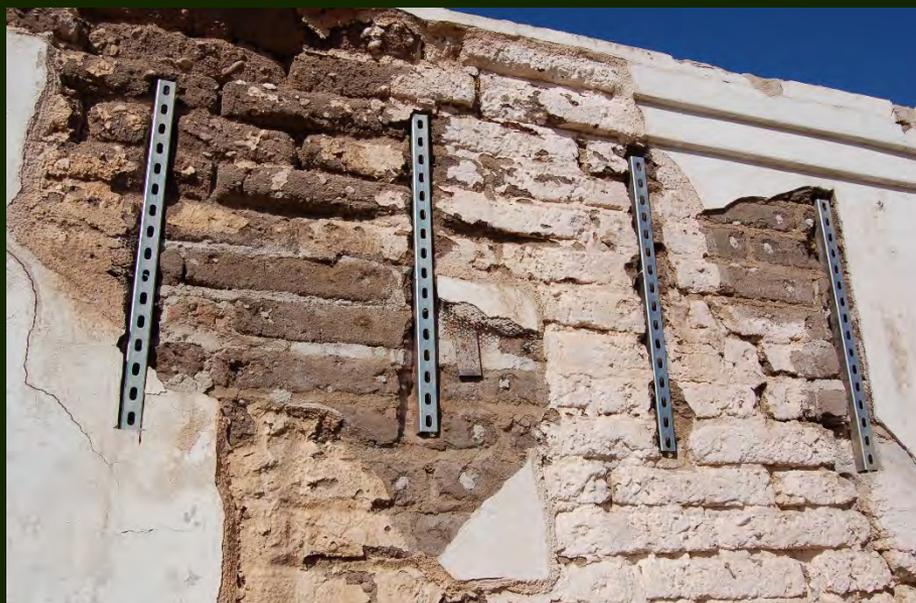
On Bldg. 106, vertical metal channel is embedded into the adobe walls to tie wall and roof systems together.

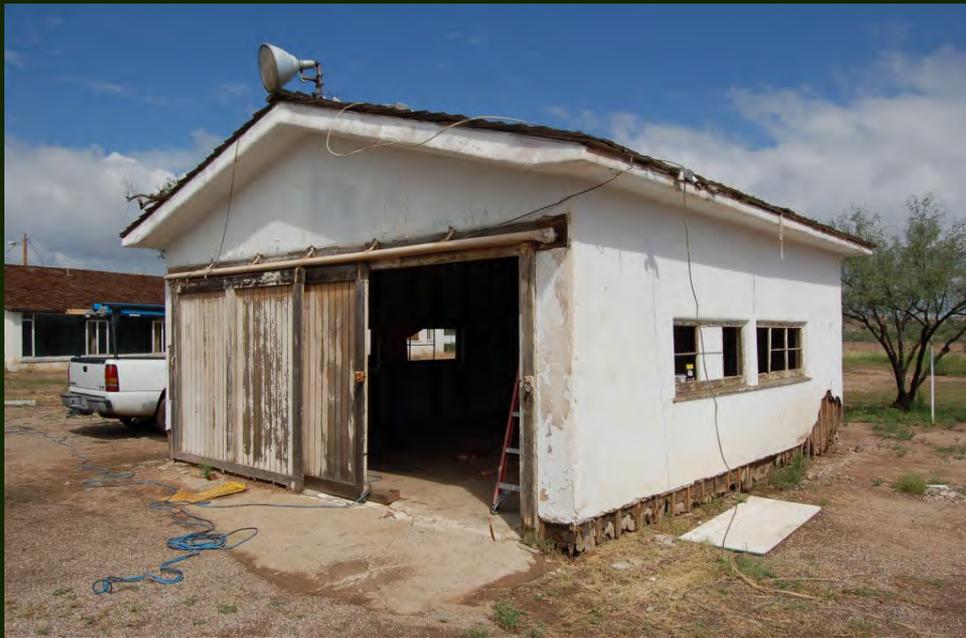
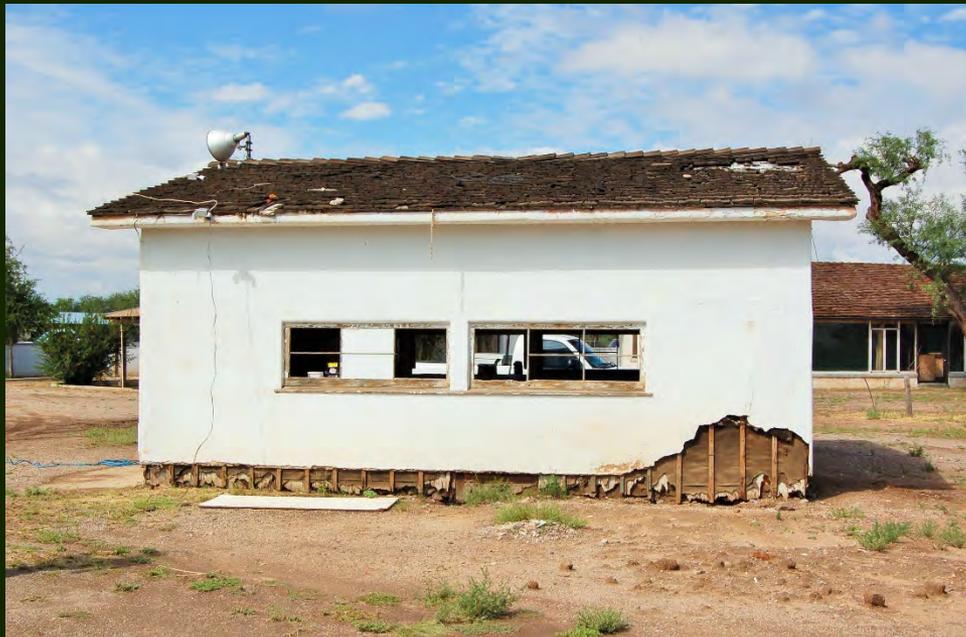
Manning Garage

The former garage was rehabilitated into public restrooms

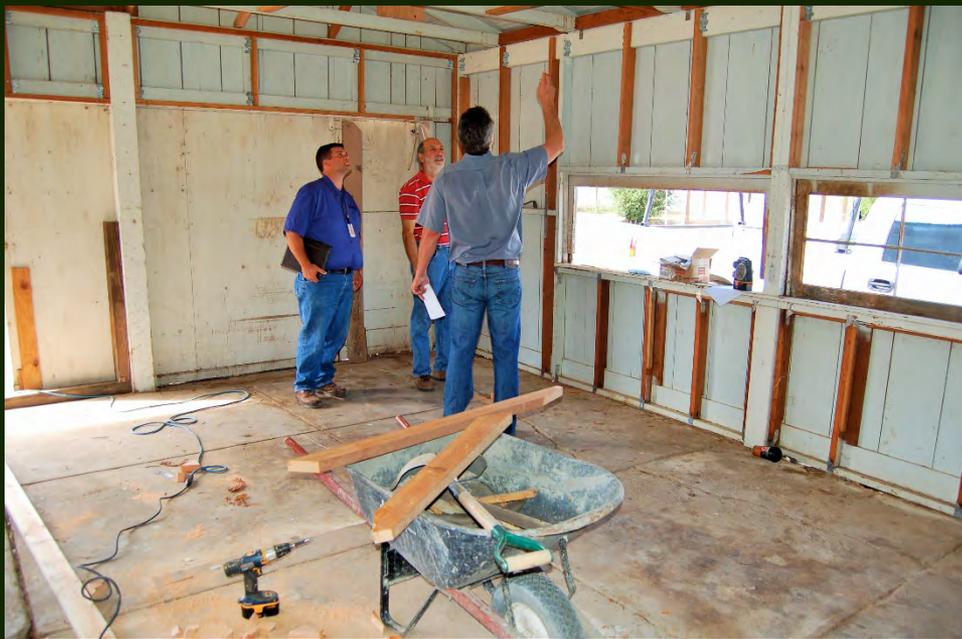
Manning Garage

Interior during repair and rehabilitation work.

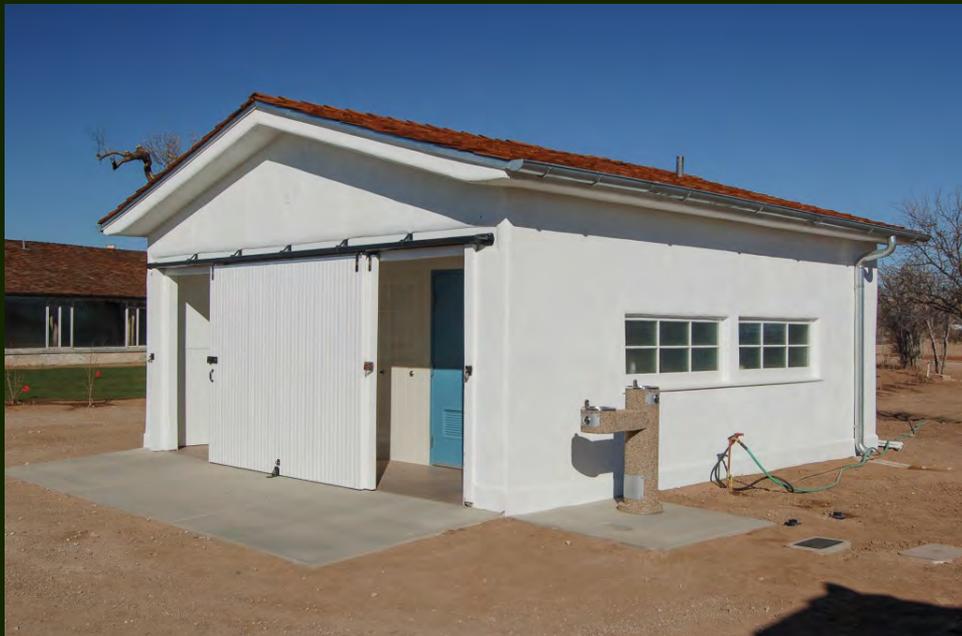
The original sliding doors were retained

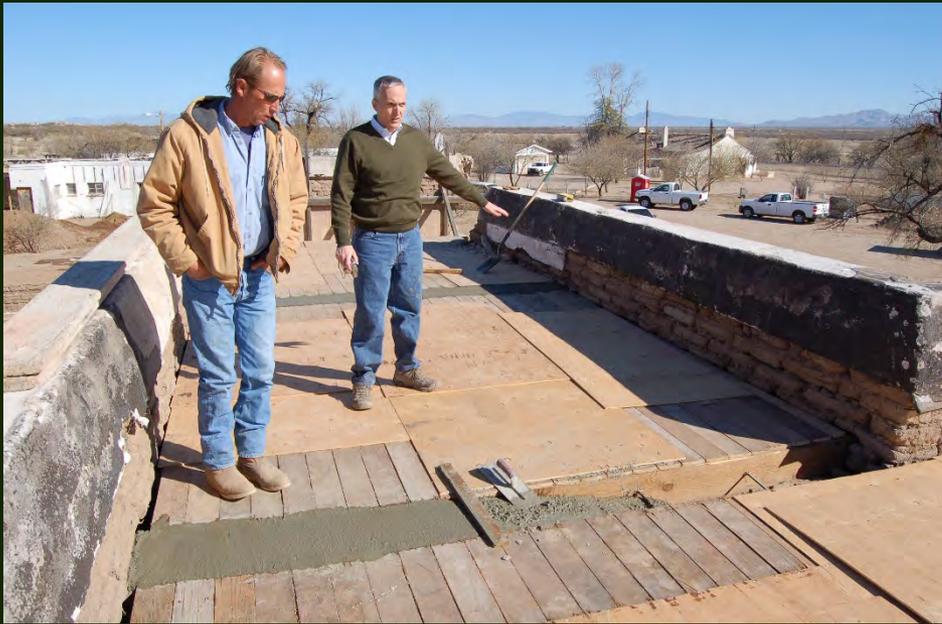
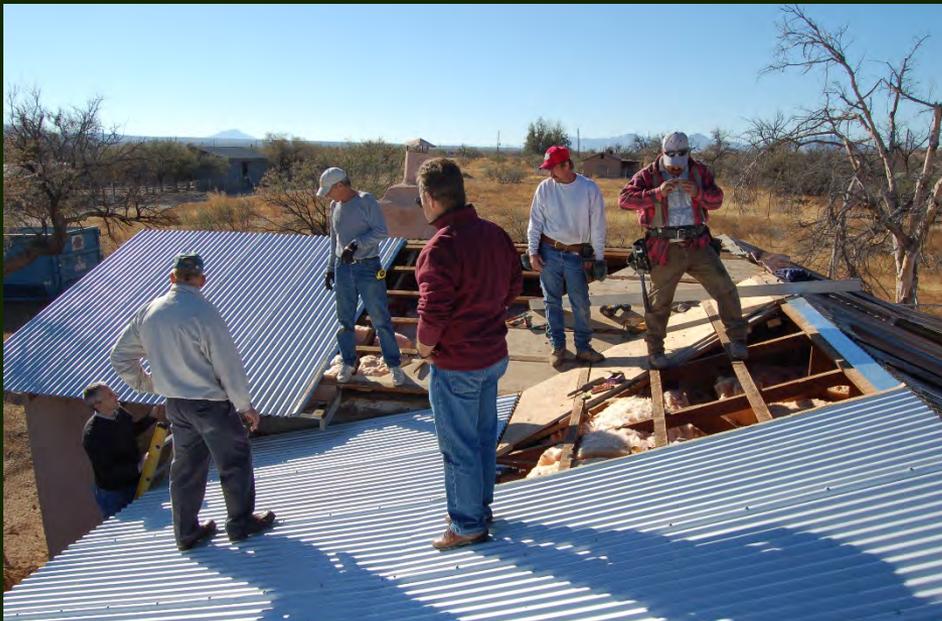
Every building required a new roof surface, and in many cases, extensive structural repair due to the long-term lack of maintenance.

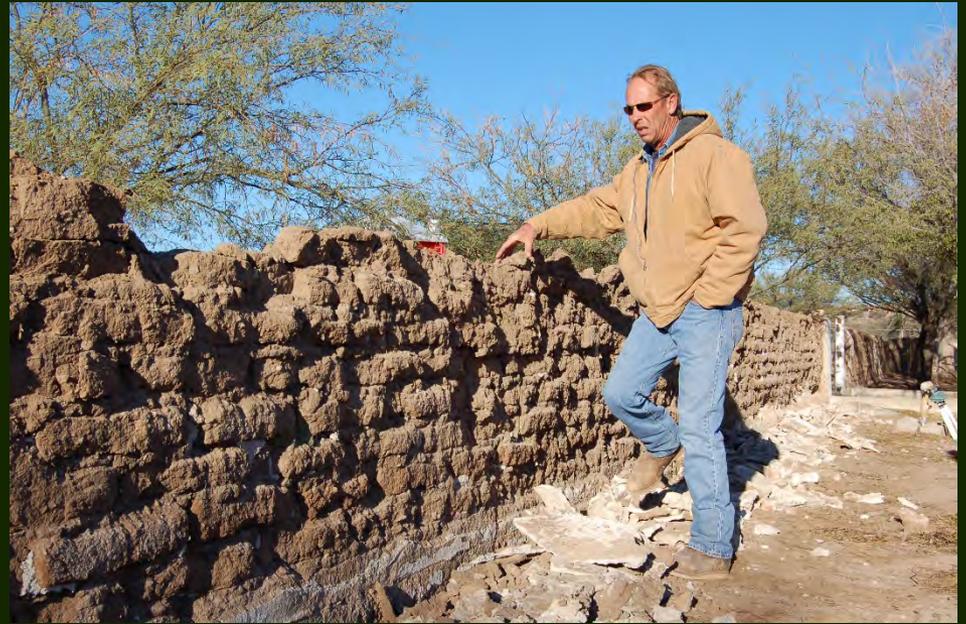
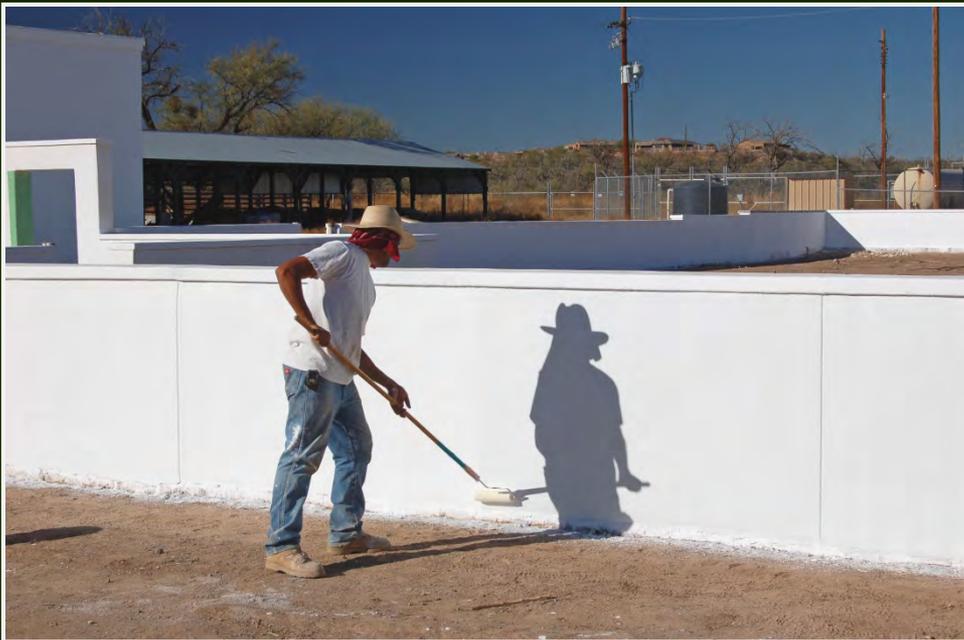
Adobe Site Walls

The crumbling adobe walls in the Headquarters area were extensively repaired, and in some cases, rebuilt.

Traditional materials such as lime plaster and lime wash were used to coat and protect the walls, with modern paints on the original concrete wall-caps.

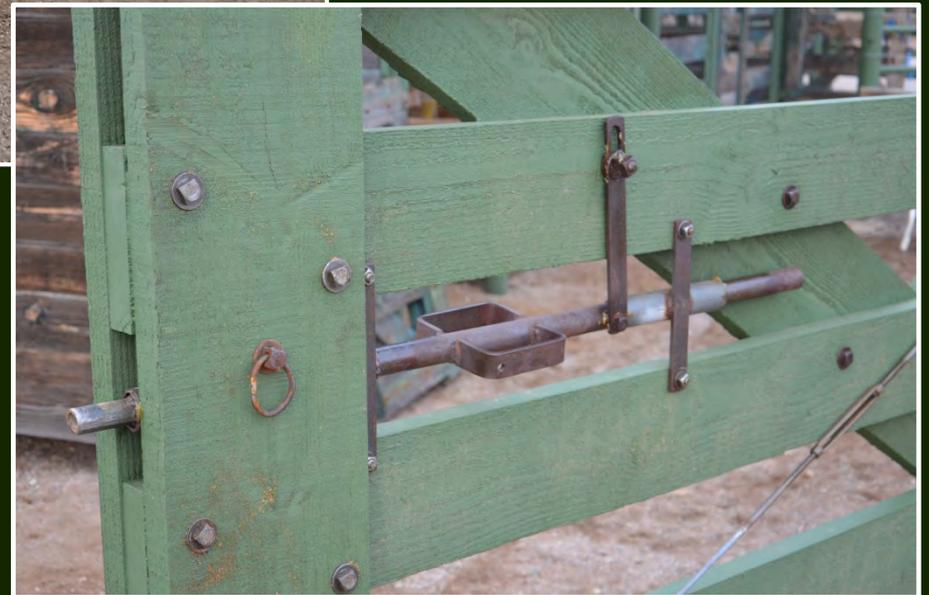
Rebuilt gates retain original hardware
except where too damaged to reuse.
