HISTORIC PRESERVATION ARCHITECTURAL SERVICES: BUILDING CONDITIONS ASSESSMENT REPORTS AND CERTAIN CONSTRUCTION DOCUMENTS
 POSTER FROST ASSOCIATES - WINTER/SPRING 2004

Building 109 Employee's Residence

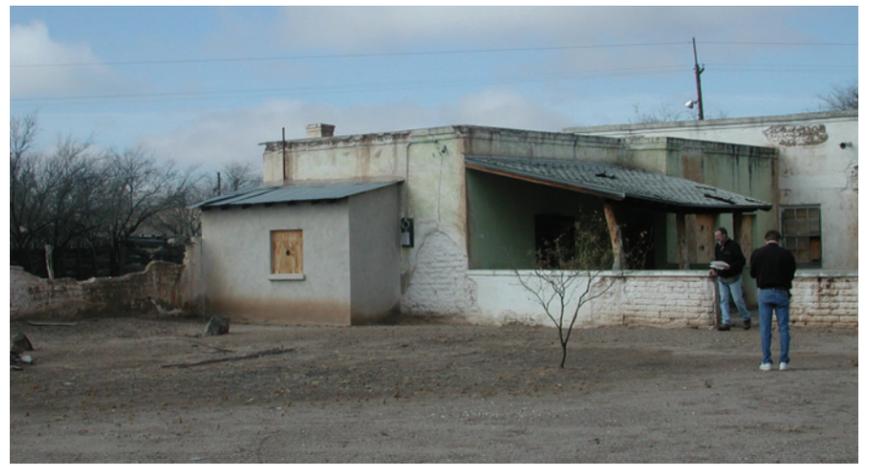
View looking southwest from the northeast
Photo courtesy of Poster Frost Associates, 2004

This Transitional vernacular structure is interconnected with two other structures (107 and 108 to the west) and helps to form the working section of the Ranch. The 890 square feet of interior space includes three chambers arranged from east to west as follows: Bedroom, Living room/Kitchen, and Toilet room. This residential structure was probably an addition to the earlier utility building (107), and probably developed over time. It appears that the large eastern chamber may have been a stand alone single-chamber building connected to building 107 by a high-walled courtyard. At some later date (possibly post-1935) it appears that the courtyard was in-filled to create the bedroom chamber. Many of the construction details used on this “addition”, including doors, windows, and ceiling are very similar to those used on other post-1935 structures on the Ranch. The sequence of construction suggests that the north porch may have been added at this time. And later still, possibly, the toilet room addition may have been added to the east. Interior and exterior walls are mud adobe approximately 15 inch thick and 12 feet high. Roof framing is flat wood joists and roof drainage is via sheet metal canales. Doors are wood plank and panel, windows are wood and steel sash, and floor slab are concrete; no foundations were observed. (Description from PFA Assessment, 2004.)
