Adkins Residence

Adkins Steel Parcel

Building Condition Assessment Report

February 25, 2008

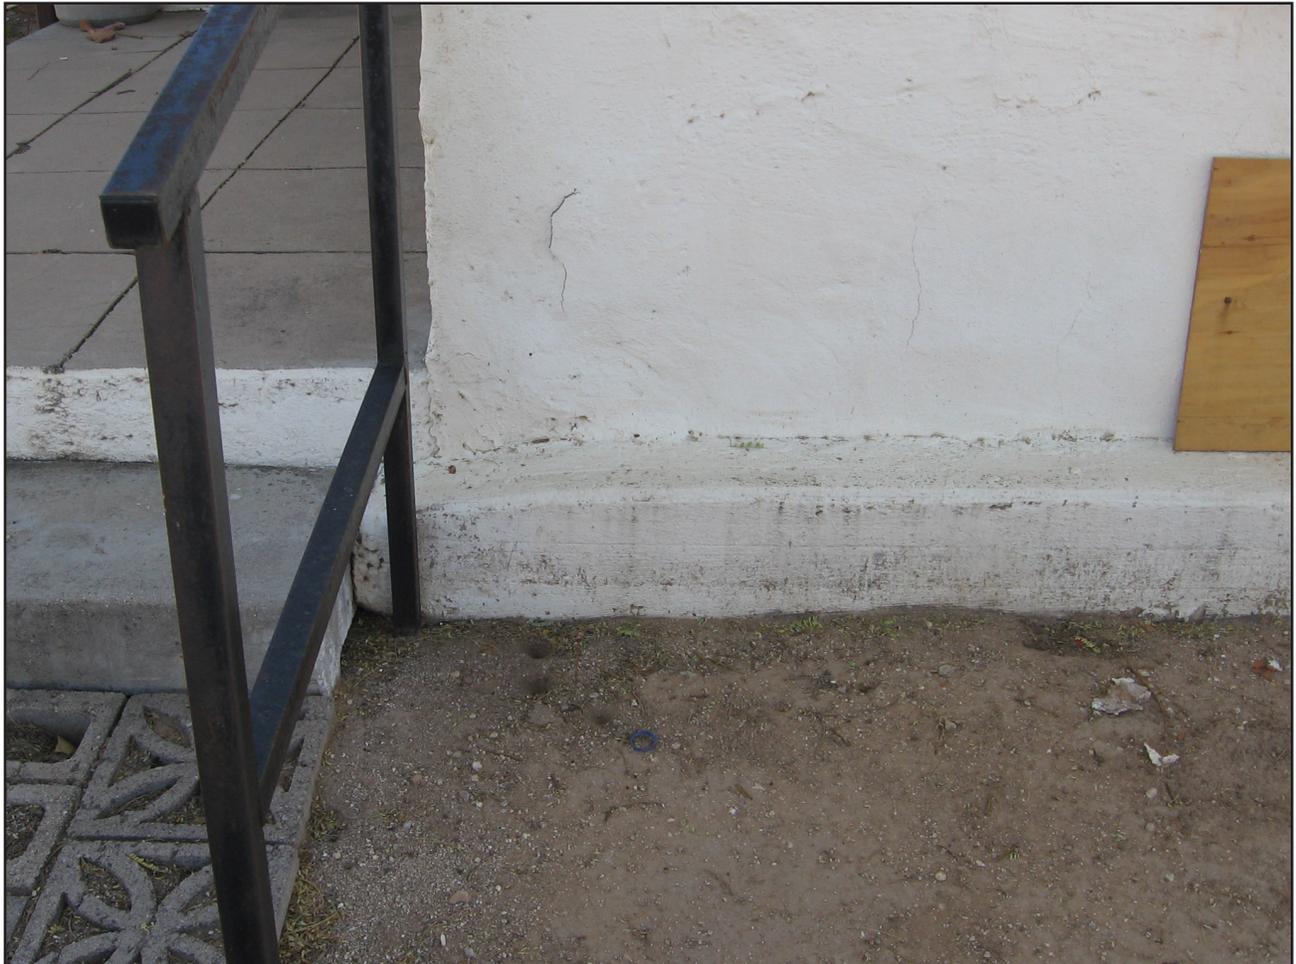
At the west elevation there appears to be a contra-pared that follows grade and is painted to match the wall(Figure 10). It can also be seen in figure 6 item 8. Originally thought to be a stem wall but at crawl space it appears at the surface of the wall only and space behind it is visible. Looking into the wall thru a hole at the northwest corner of the Living Room there is no evidence of concrete; the adobe wall rests on grade.

Figure No. 10 - Contra-pared at west side of building

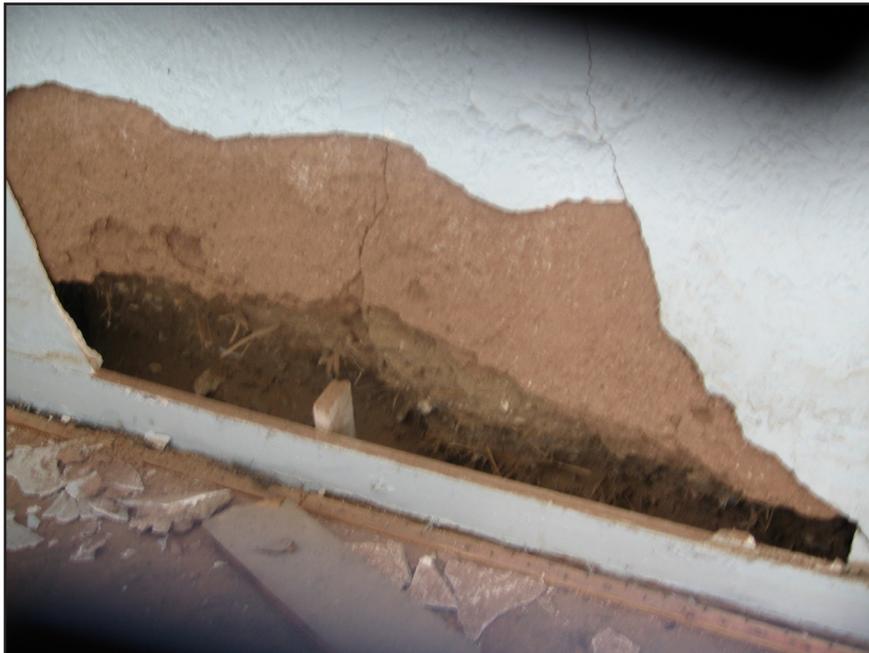
There is a large portion of the mud adobe base of the interior side of the southwest wall missing, and the floor is sagging at the corner of the room on the same wall, it appears to have washed out with a plumbing leak. There was a major plumbing leak on this side of the house which caused a sinkhole and that may have also been the cause of the undercutting visible in the west wall in the bedroom. Though the cause of the leak appears to have been removed, this will have to be investigated and the wall repaired.

Figure No. 14 – Undercut adobe wall at southwest corner of bedroom 2

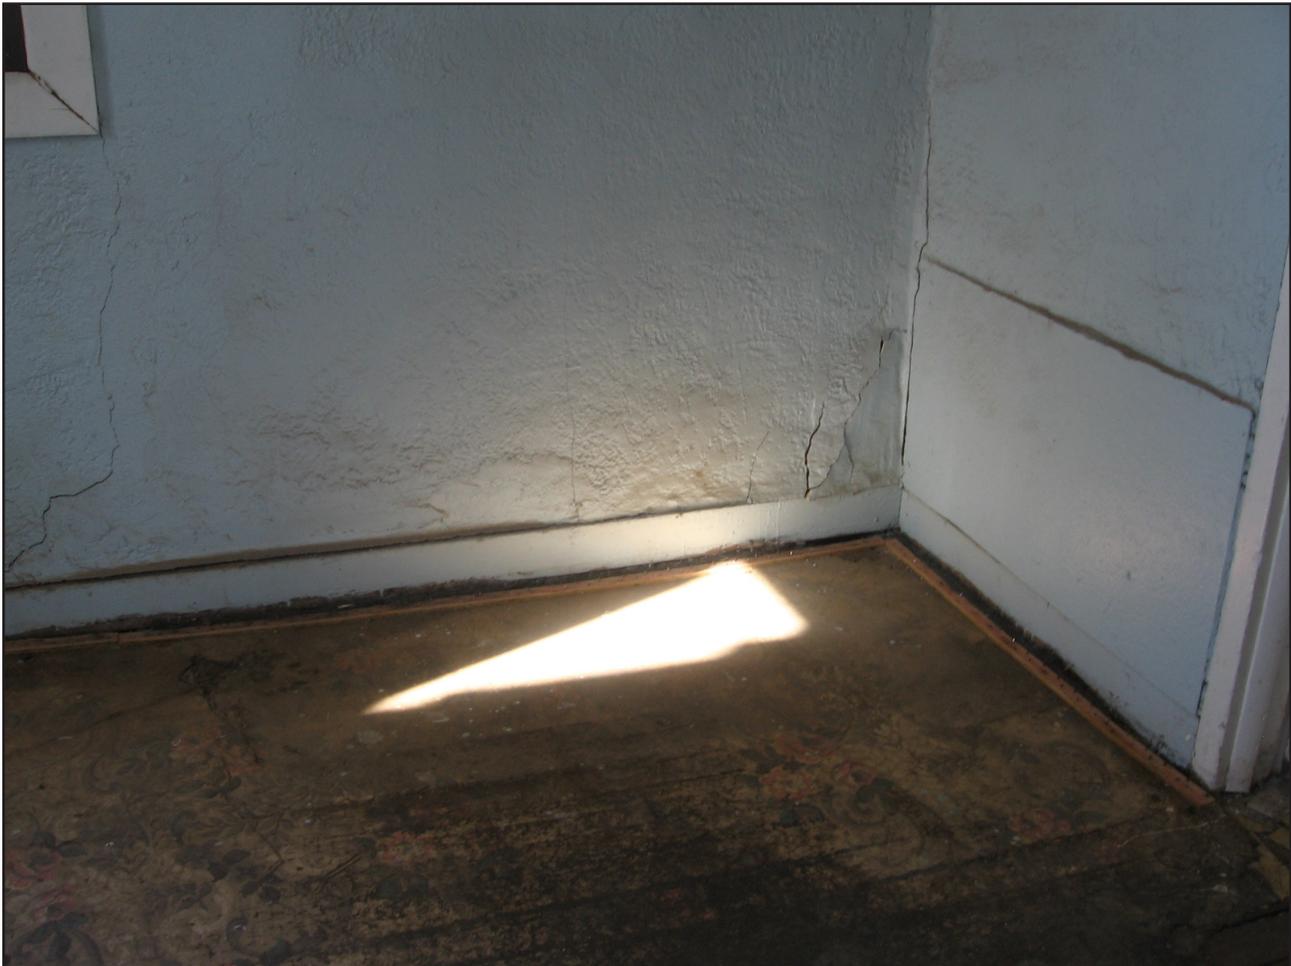
The northwest corner of the bedroom 2 is also sagging – it appears the floor is sagging and there is a settlement crack in that corner. There has also been water intrusion from the roof.

Figure No. 15 – Floor at northwest corner of same room with undercut wall (figure 14) – this is very spongy and the support beam or wood studs down to grade have probably rotted away – this should be reshored

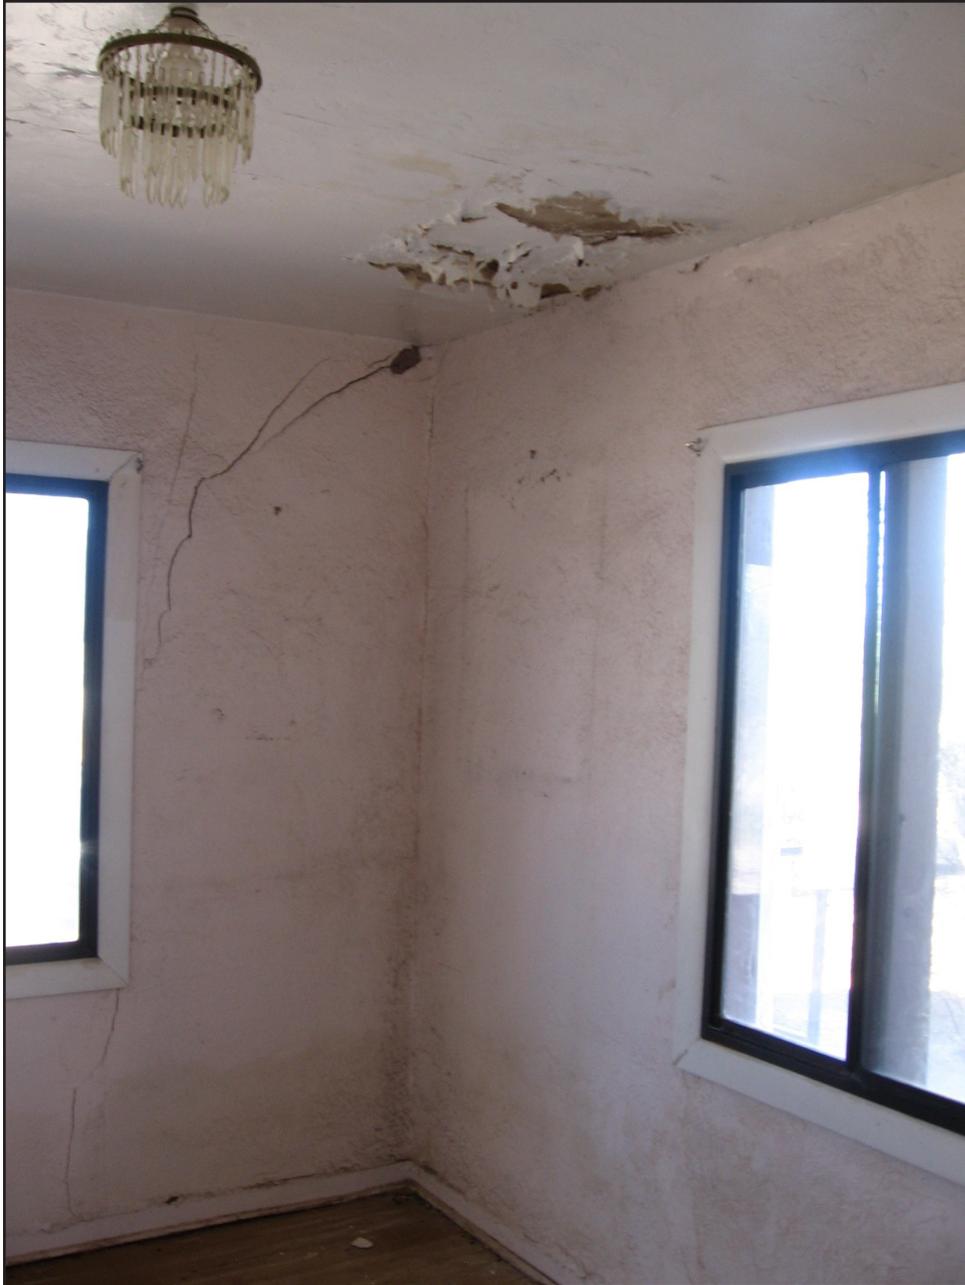
Figure No. 16 – North-west corner of bedroom 1 with settlement crack and ceiling damage from roof leak

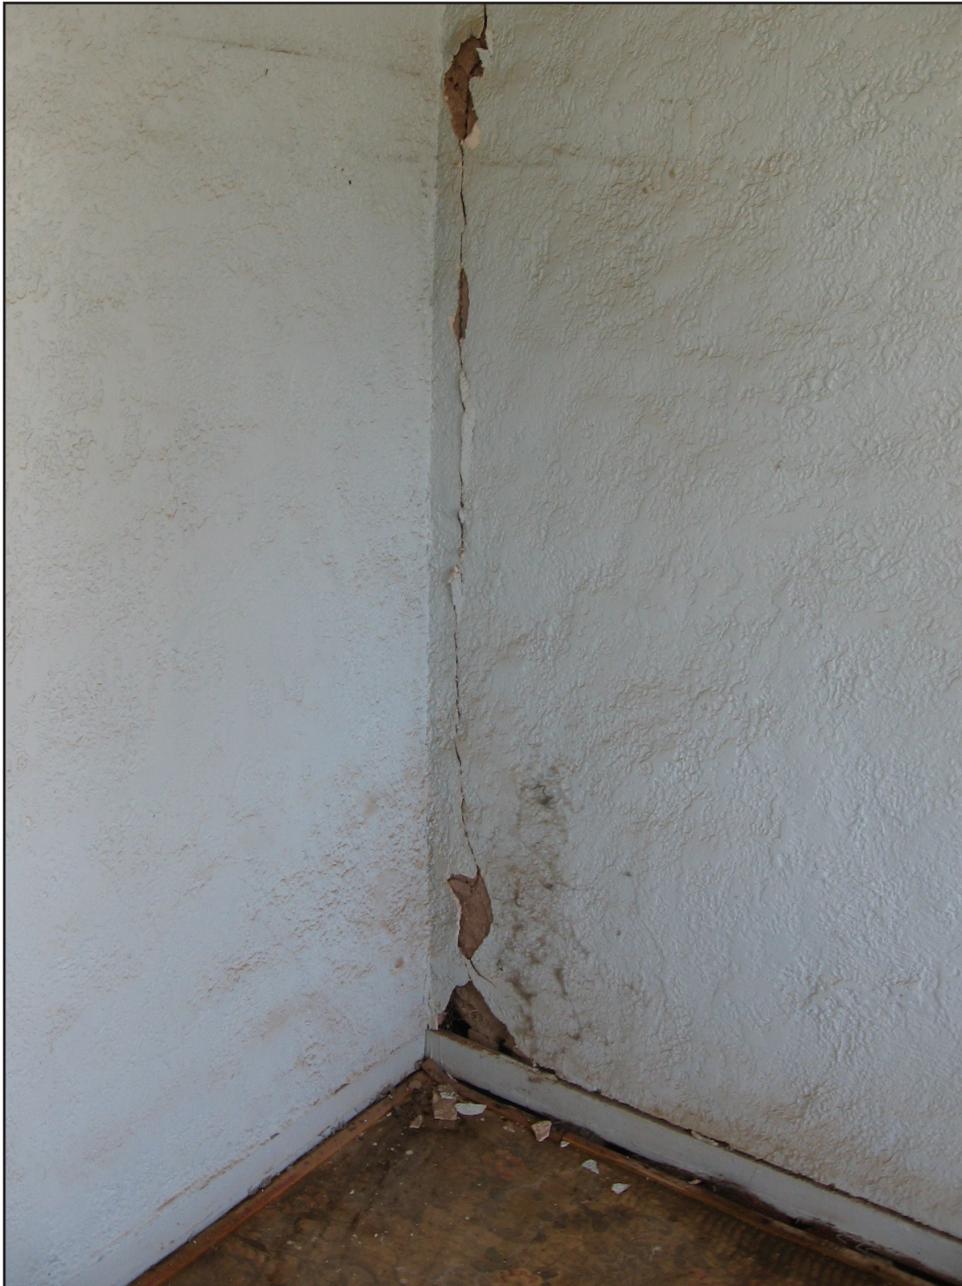
There are separation, settlement cracks at the intersection between the addition walls and the main house walls(Figure 17). These may have been caused by the introduction of the rigid CMU addition to the more flexible adobe building – the cracking occurs right where the CMU is attached to the adobe and the CMU has probably prevented the adobe’s expansion and contraction due to its moisture content fluctuation.

Figure No. 17 – South-west corner of bedroom 2 adjacent to where CMU addition attaches to adobe wall

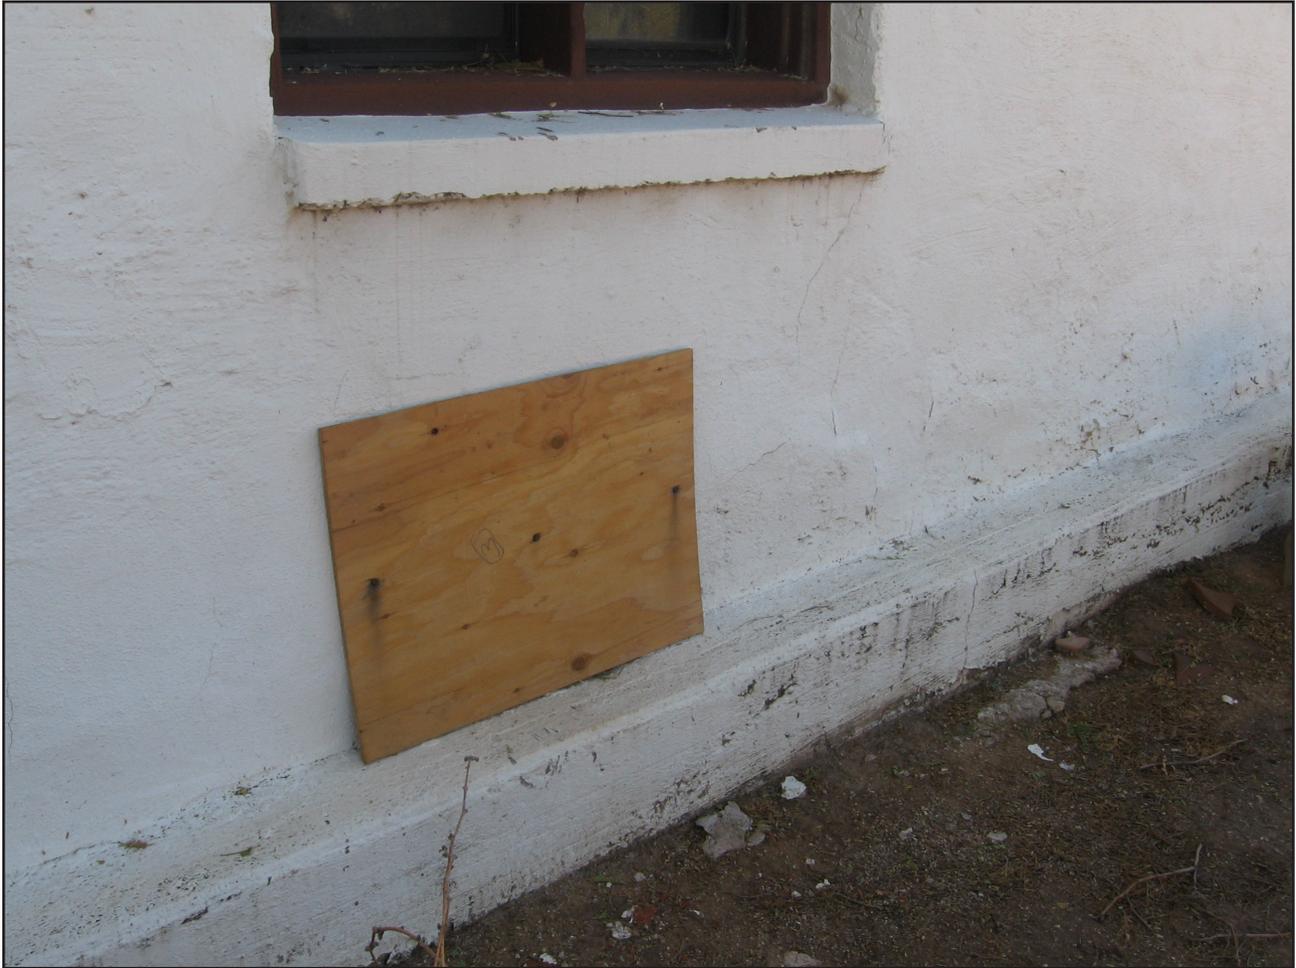
There are openings in the base of the wall to access the crawl space; these have been covered over with plywood to prevent intrusion of wildlife. The covers should be replaced with louvers with insect screens.

Figure No. 19 – Plywood covering access to crawl space

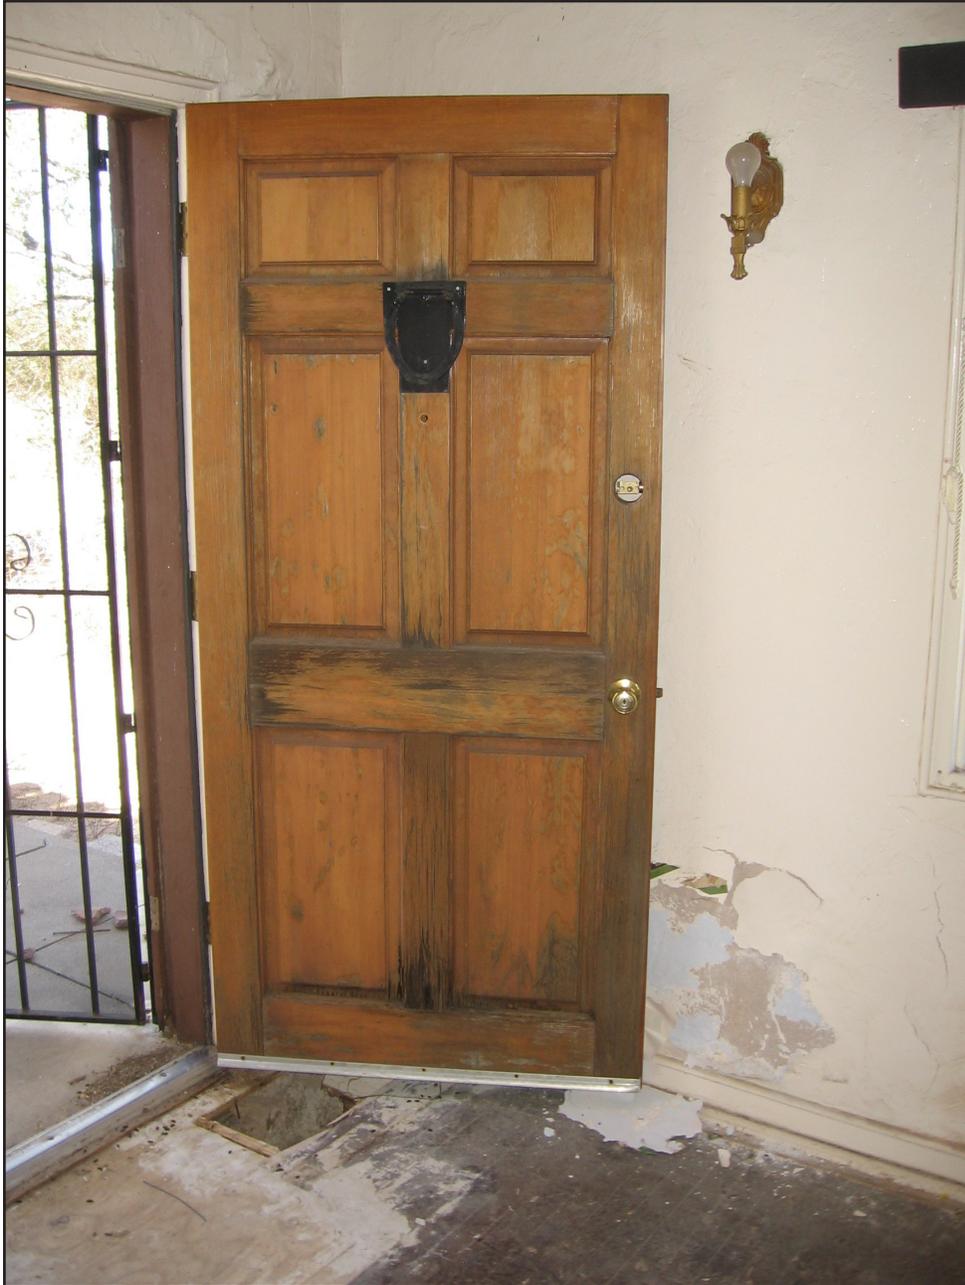
The front door is a stained wood six panel door with a horseshoe knocker and contemporary residential finish hardware, protected by a painted steel security screen door (Figure 20). The door has evidence of moisture damage.

Figure No. 20 – Wood panel entry door

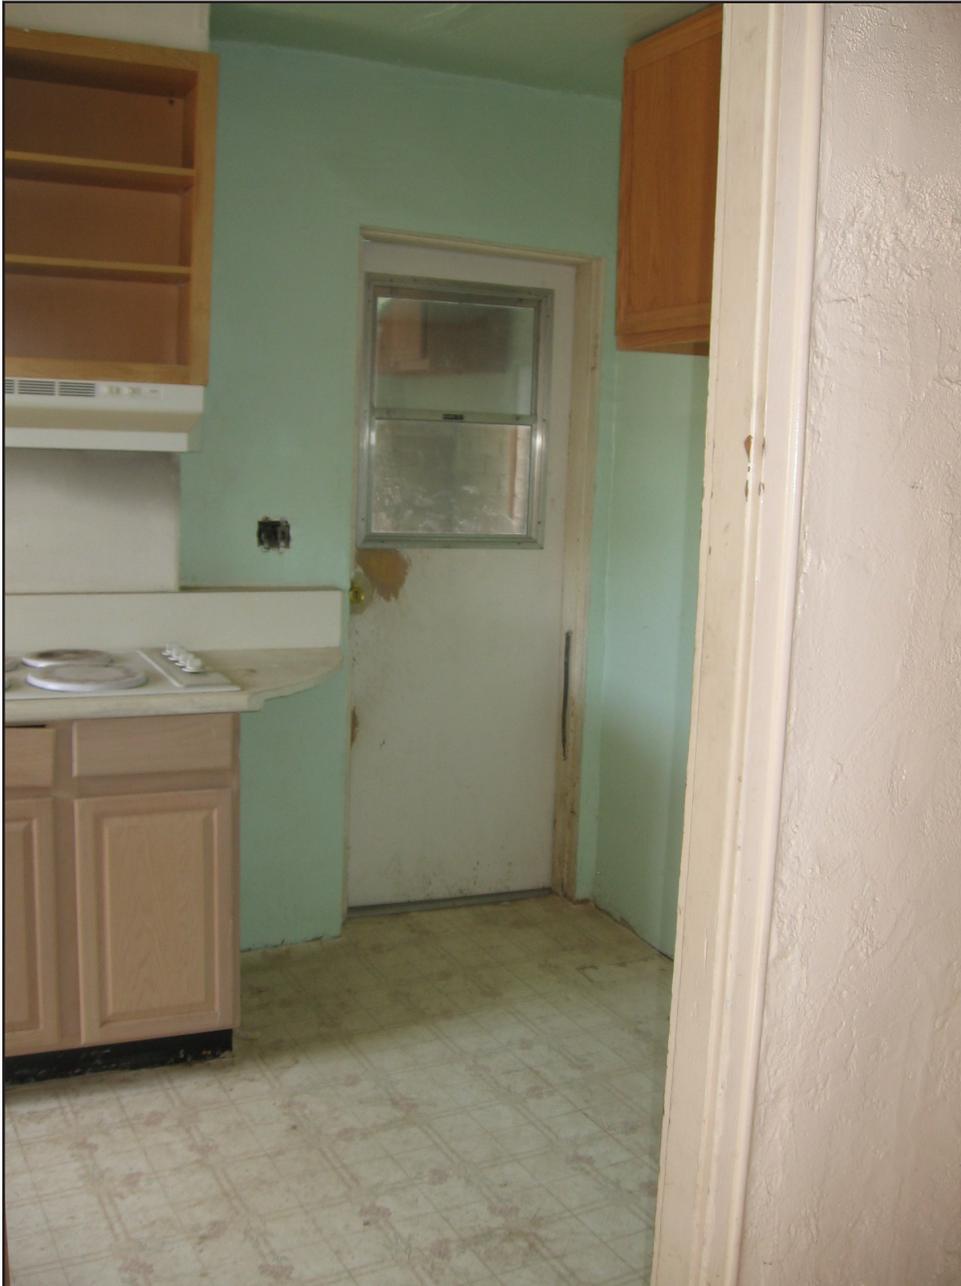
The rear door into the kitchen from the addition is a painted medium density fiberboard door with a vertical sliding aluminum window (Bel-Air Door Co.). It has been modified to accept door hardware and is of poor quality.

Figure No. 21 – Rear door out of kitchen with horizontal sliding aluminum window

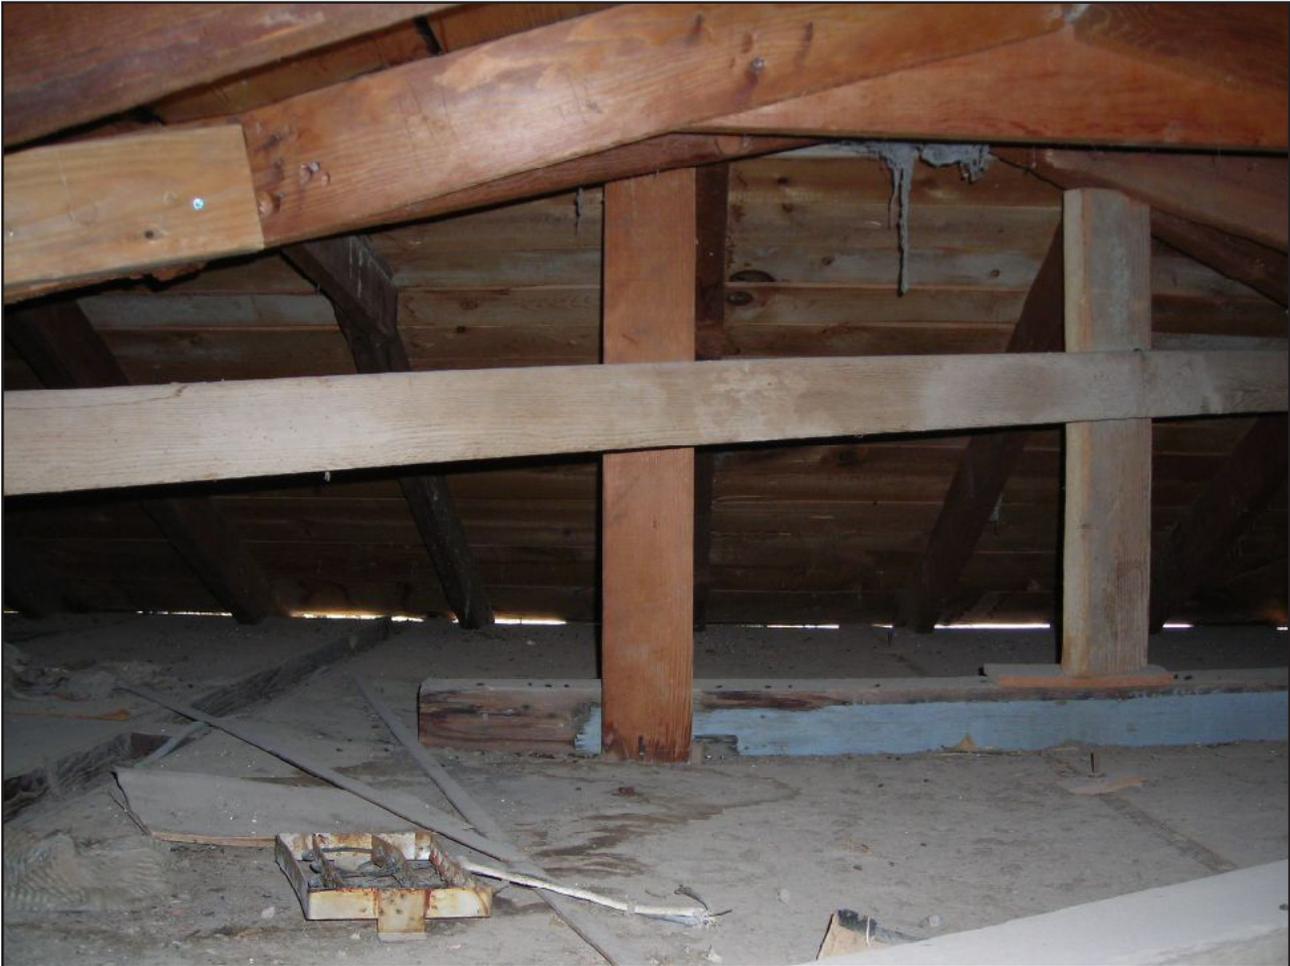
Roof framing could be observed from an attic access hatch. Roof decking consisted of a mix of 1x12 decking and plywood sheathing, supported on roof rafters spaced at 24 inch on center. The roof form is a pair of 90 degree intersecting gables. The gable framing consists of 2x roof joists of several sizes, ceiling joists, and various vertical supports and collar ties. The roof structure is best described as field framed. There are no connections between the members other than face-nailing and toe-nailing. There are no metal connectors or bolted connections. Inside the attic, daylight could be observed at the eave all around the perimeter of the roof structure.

Figure No. 26 – Roof framing with daylight at perimeter

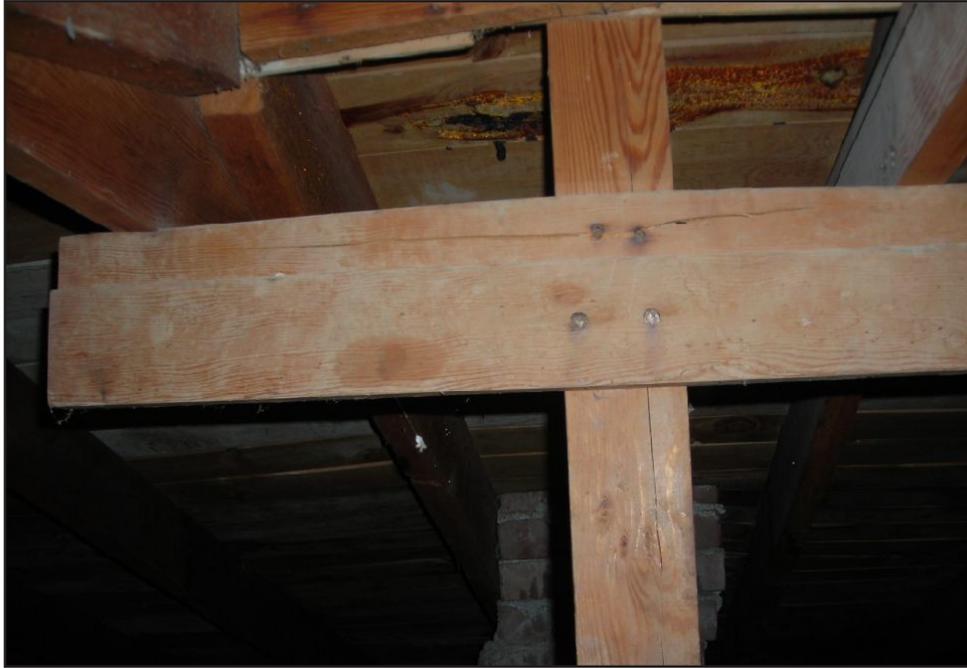
addition has a lower slope roof framed with 2x4's at 16 inches on center. Framing, which may go from roof ridge all the way through to the ground, has given way, which has allowed the roof framing to settle onto the ceiling framing at the dining room ceiling, which has given way.

Figure No. 27 –“T”-shaped ridge support member which appears to be compressing beam in dining room below

3. Shore the beam at the east side of the dining room back to level condition with the rest of the ceiling. This support will have to go through the floor and be supported solidly from the ground beneath the floor.
4. Electrical: Provide new service to house with main service entry, meter, panel and grounding; correct code deficiencies.

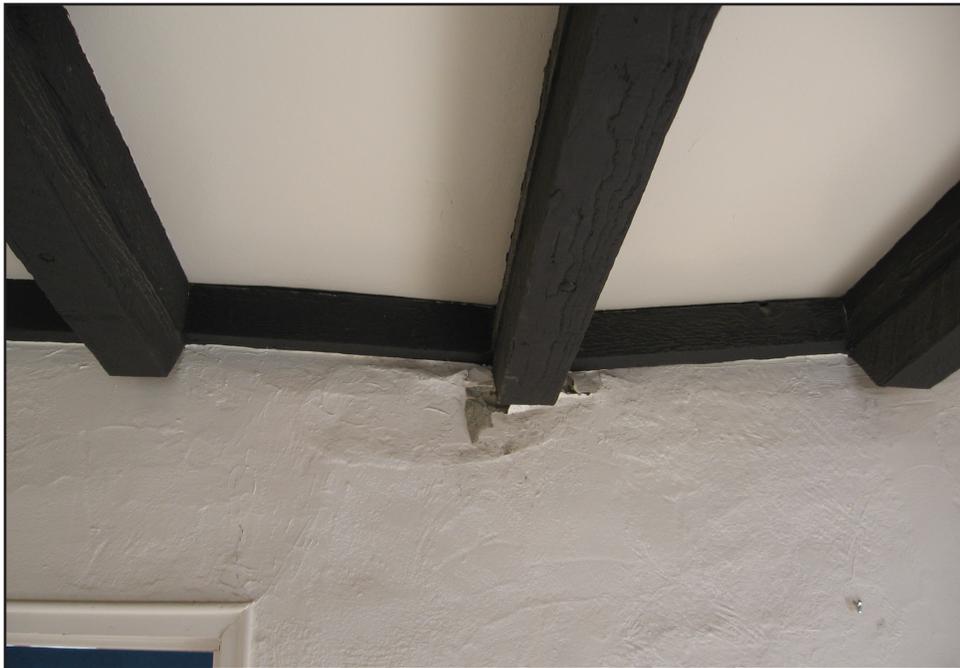
Figure No. 28 - Dining room ceiling being compressed by roof framing

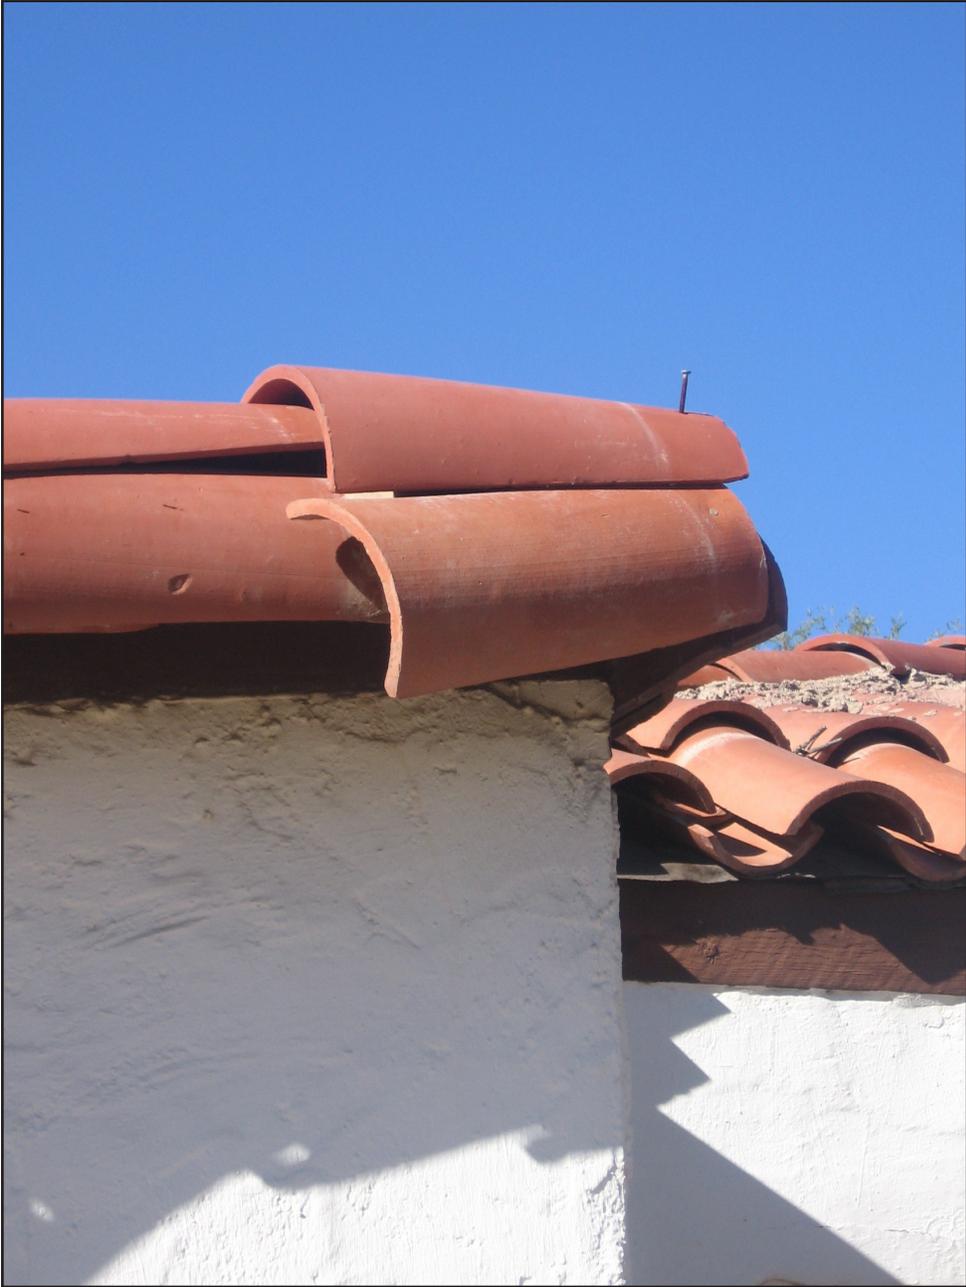
The roof is in fair to poor condition, with cracked, broken, displaced (wind), or missing tiles. The underlayment is shredded and deteriorated or is missing altogether.

Figure No. 30 - Loose tiles with nail almost out

1. Roofing: The existing roofing and roof framing is in poor condition and should be removed. Satisfactory mission tile should be salvaged, the roof sheathing repaired as needed (this appears to be 1x12 planks and plywood sheathing), roof framing repaired and supplemented as needed, and a new roof should be installed, consisting of a waterproof underlayment (such as Grace Ice and Water Shield), sheet metal eave flashing all around, and mission tile roofing nailed to the planking (reusing and matching existing tile as able).

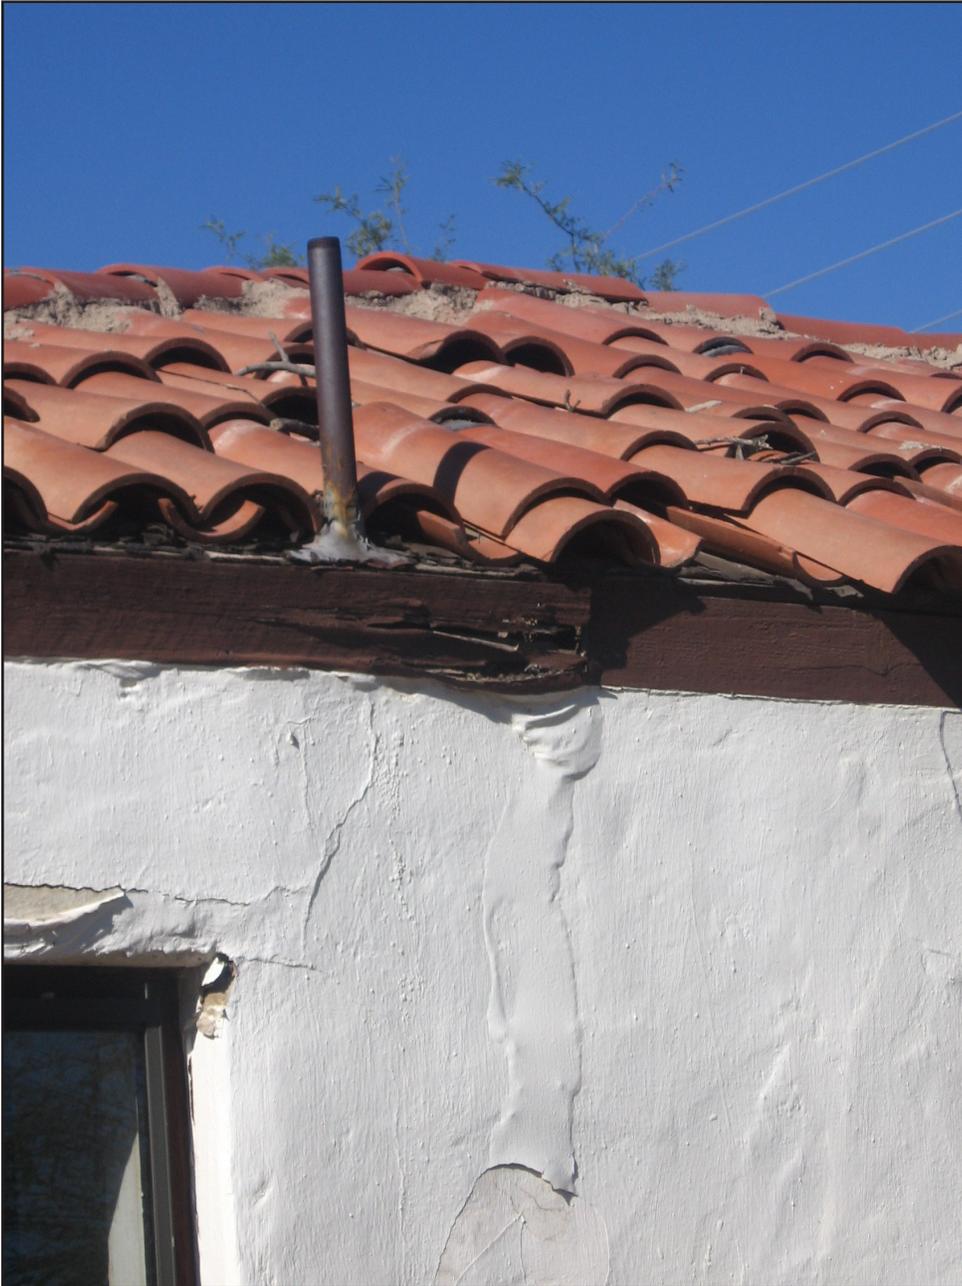
At the east elevation in particular, the roof tile does not cover the edge of the roof so water infiltration has been occurring at the top of the wall. This requires galvanized sheet metal flashing to protect the top of the wall (Figure 31).

Figure No. 31 - Damage to wood fascia and wall surface from lack of flashing

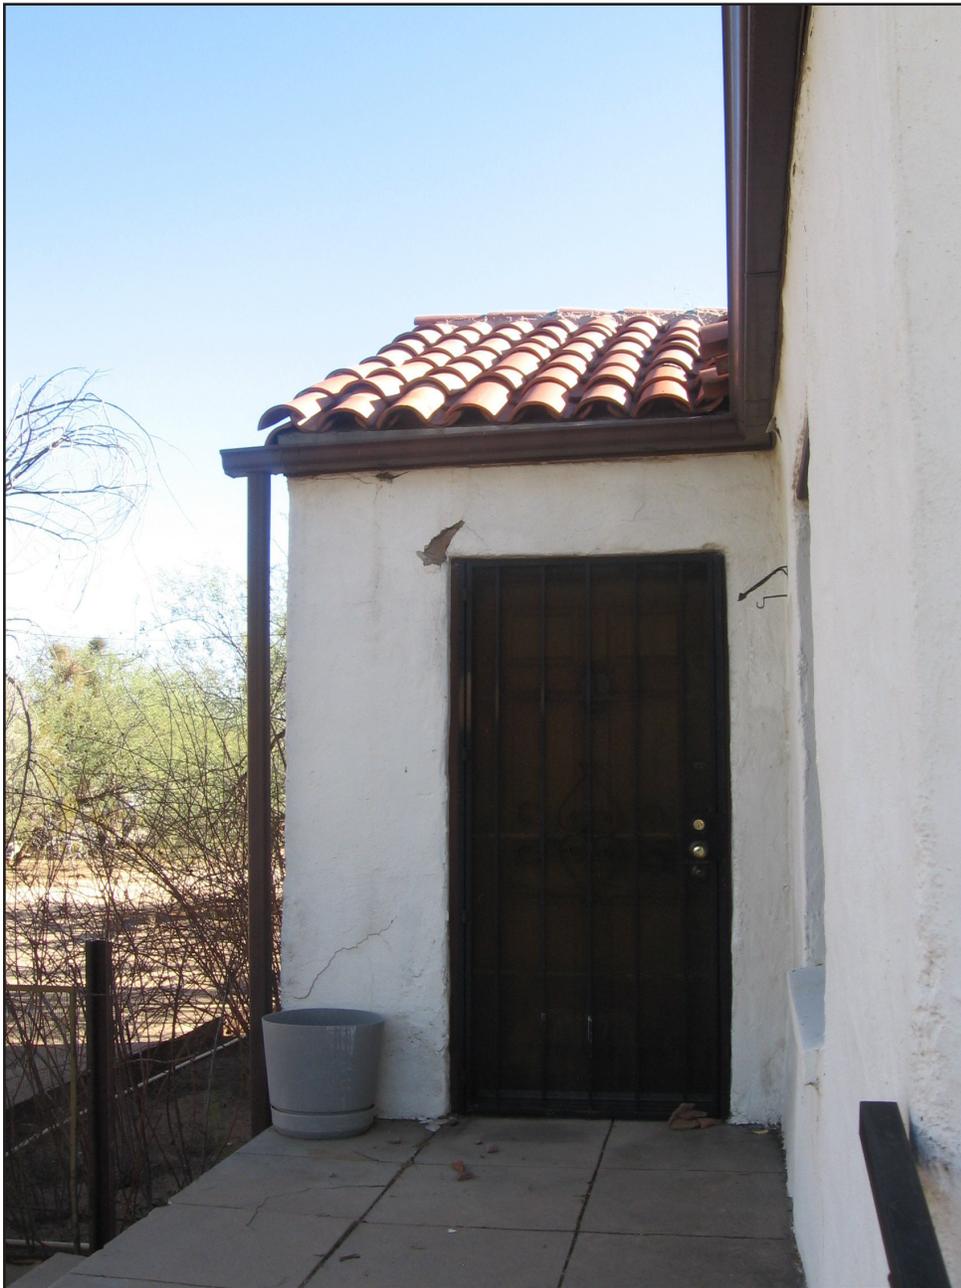
At the north elevation a brown aluminum gutter with downspout has been added to help keep the roof from draining onto the front porch. This downspout carries the water off the roof and dumps it into the flower bed at the north of the front door.

Figure No. 32 - Gutter above entry, flowing into flower bed against house

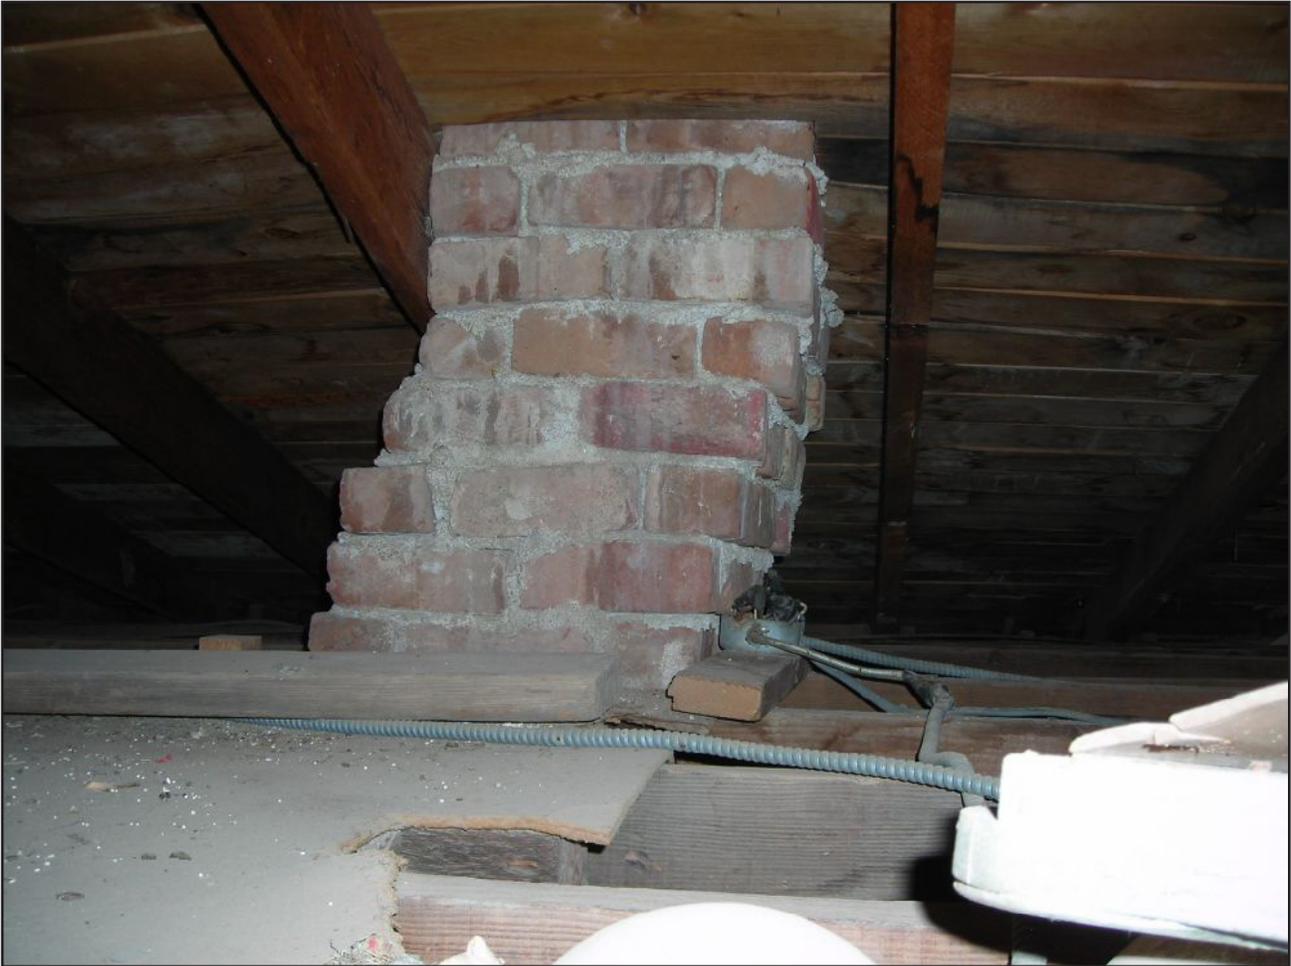
Figure No. 33 - Chimney shifted to avoid roof framing

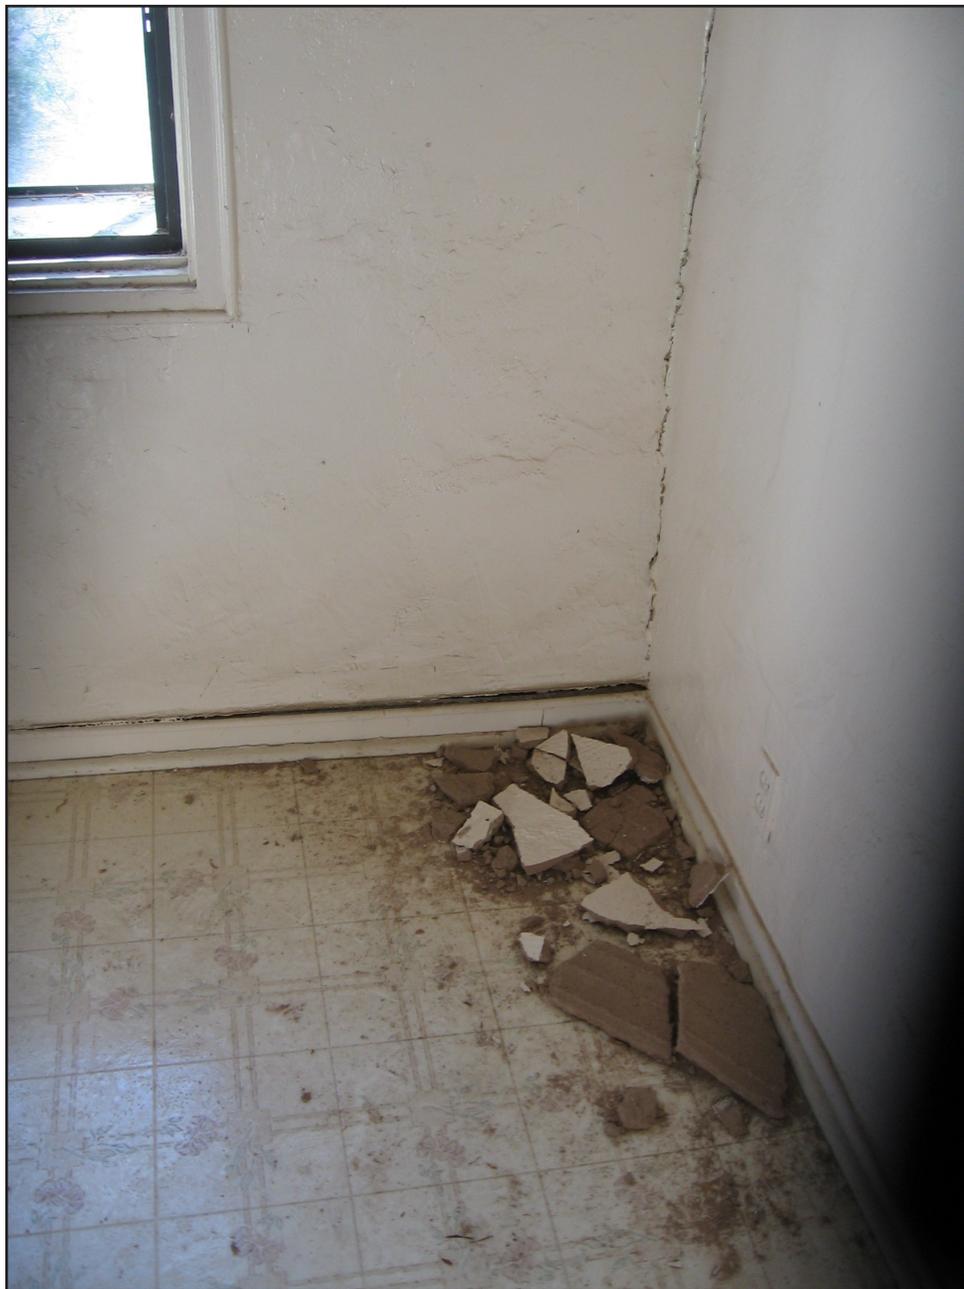
There is settling of the floor at the wall line between the dining room and the kitchen on the east side of the house; it would appear that the wood stub column has rotted or given way causing the floor to buckle. A similar condition has probably occurred at the west wall of the dining room – where the wall stud is no longer solidly supported and the roof beam is bearing down on it, allowing the deflection of the ceiling beam supporting the roof ridge. Also, earlier noted conditions in front and back bedrooms.

Figure No. 35 - Floor at corner collapsing

2. Floor:
 - A. Cut open the floor where it is subsiding between the kitchen and the dining room to ascertain the cause. If the stub column is rotted or collapsed, reshore the floor. The work may be possible to execute from the dining room side; if not, some cabinetry in the kitchen may need to be removed to gain access.

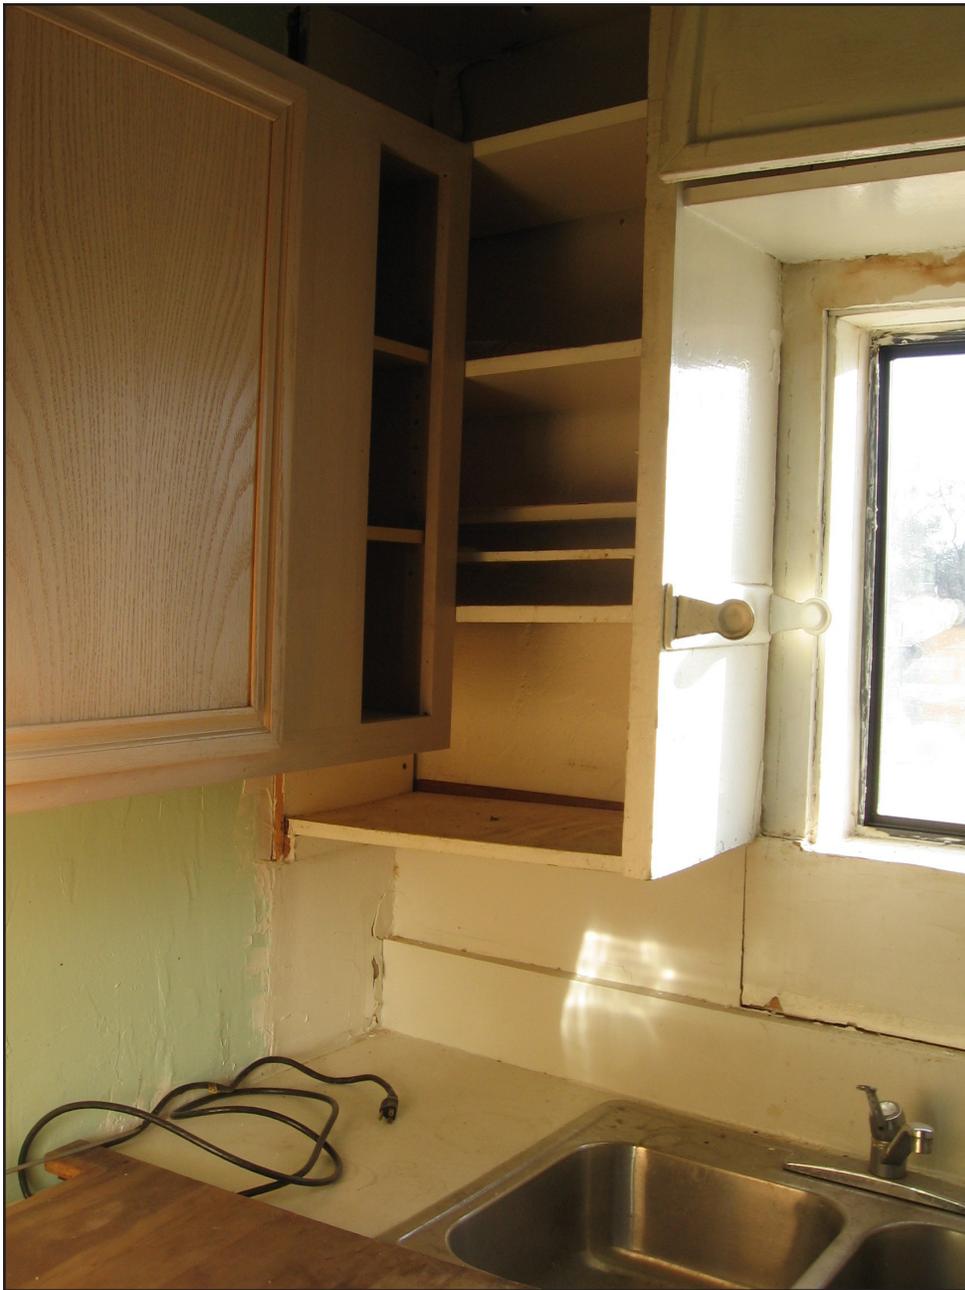
Figure No. 36 - Kitchen cabinet tilting toward left as corner sinks

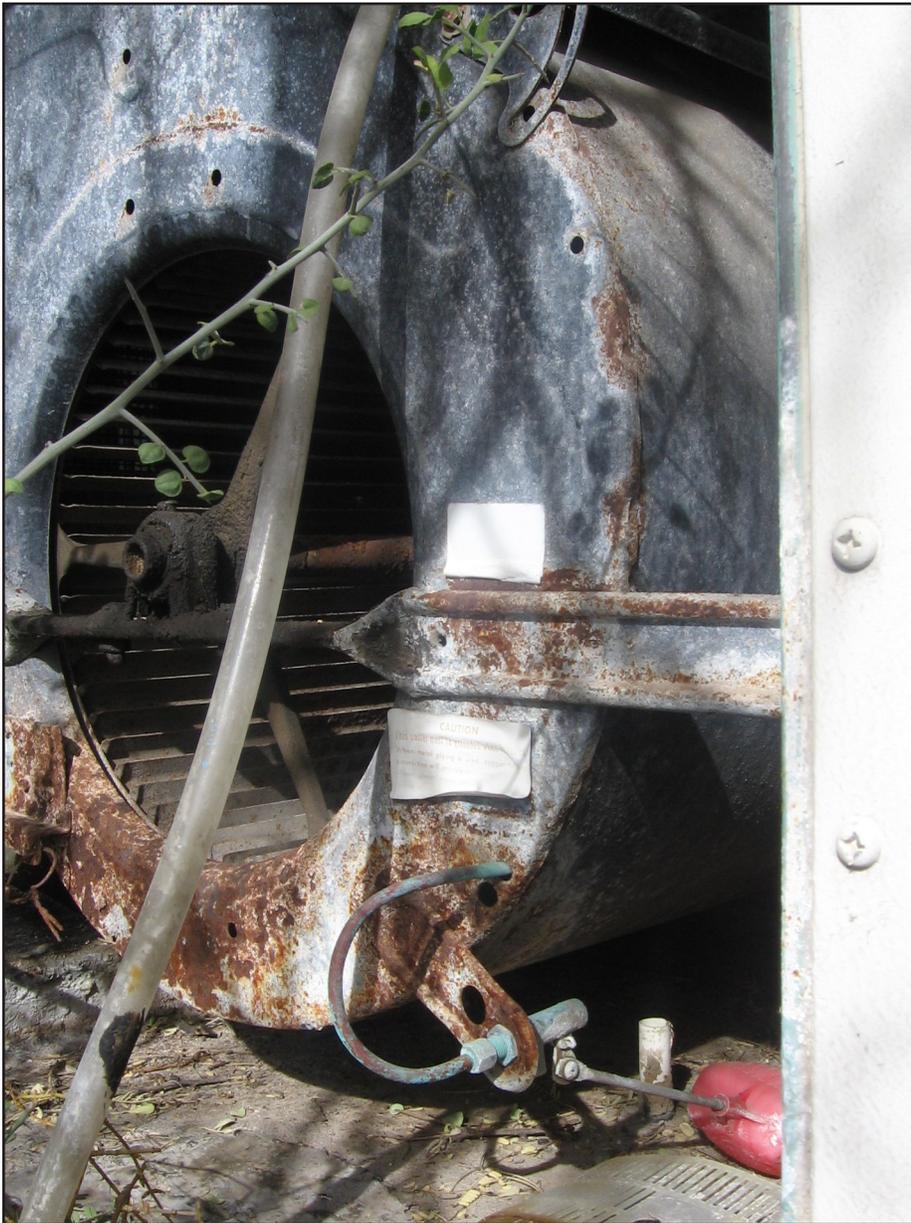
Cooling was provided by a window evaporative cooler serving the living room. Though rusted and in poor condition, the cooler was most likely in use up until the house was vacated.

Figure No. 51 - Cooler interior
