Officer's Quarters No. 1, 2 & 3

Adkins Steel Parcel

Building Condition Assessment Report

February 25, 2008

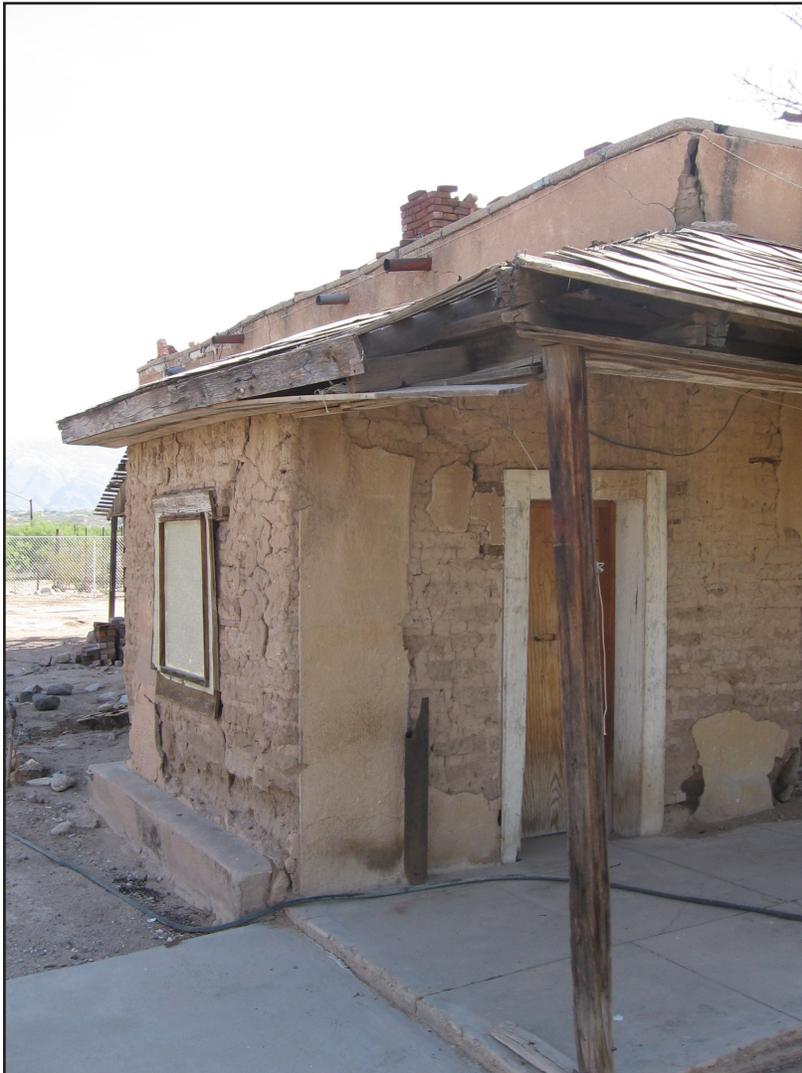
entry door. The existing toilet is located in an adobe addition (ca 1904-1937) and entered through a south facing door on the exterior. The door is short (one must stoop to enter) and narrow (27" wide X 70" tall) and the toilet room is not ADA accessible. If a toilet is required for this building (or to serve all three Officer's Quarters), it should be constructed as a separate structure to meet all accessibility requirements.

Figure No. 3 - Toilet addition at west end of building

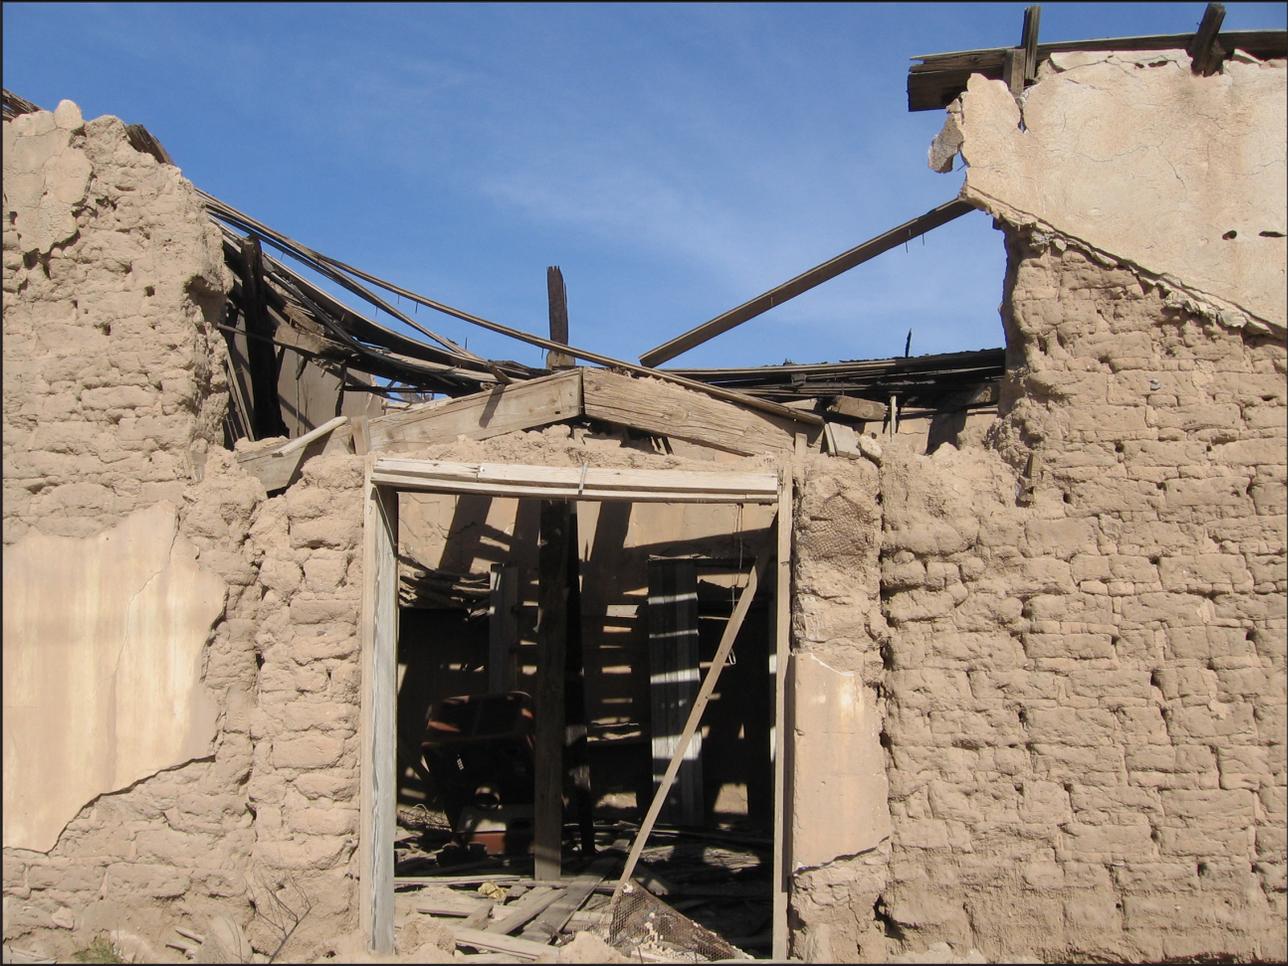
Figure No. 14 - Extensive debris inside building from collapsed roof prior to cleanup

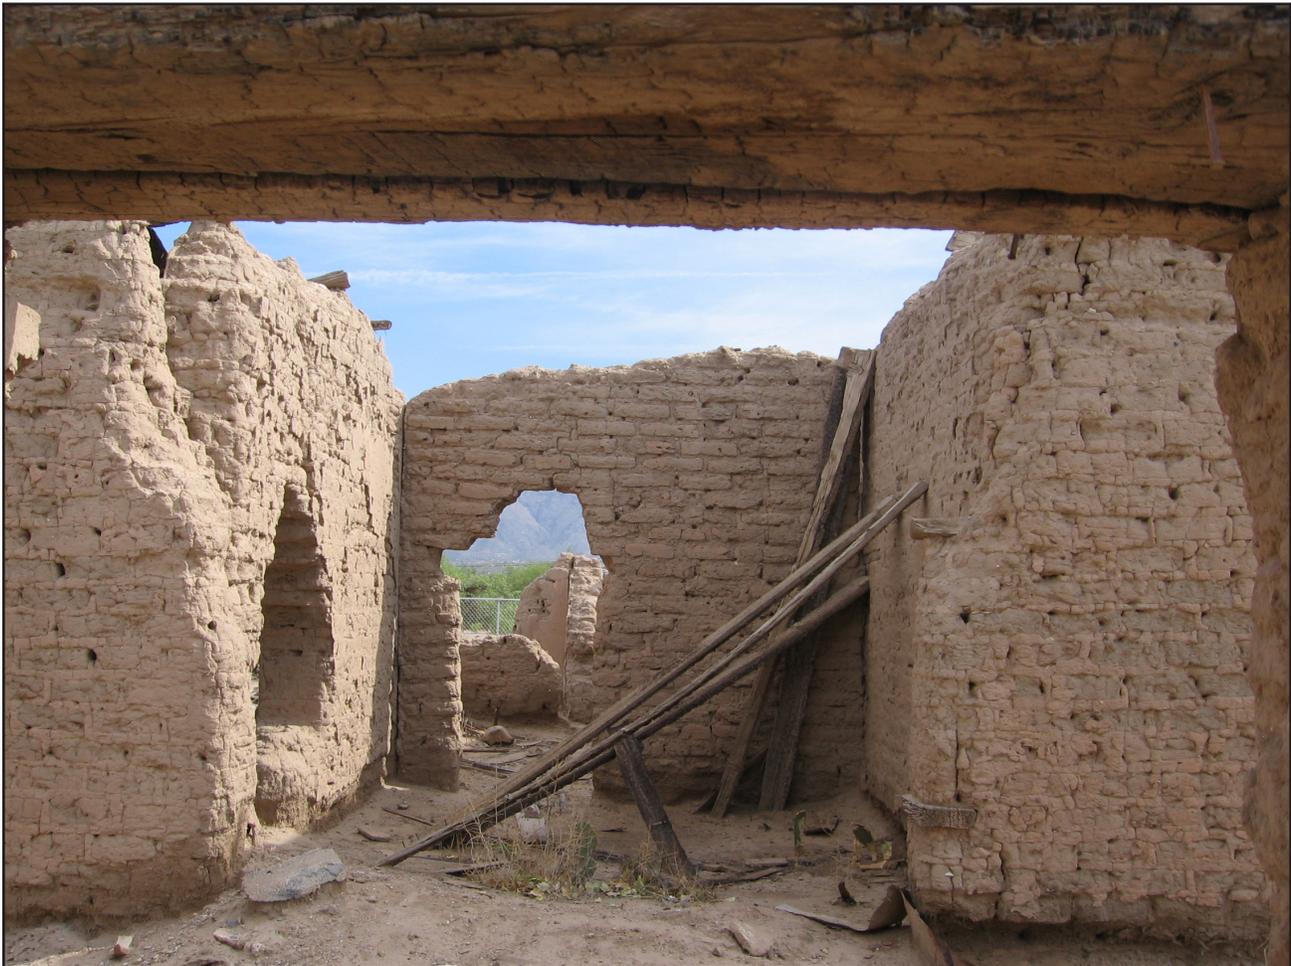
The exterior perimeter of the walls experienced severe basal coving over the years, in the worst cases reducing walls thickness almost by half, and at one area in the Living Room, undercutting through the wall completely. Most areas were infilled with new adobes during the stabilization work.

Figure No. 23 - Coving at base of walls; these areas were infilled with new site-fabricated adobes

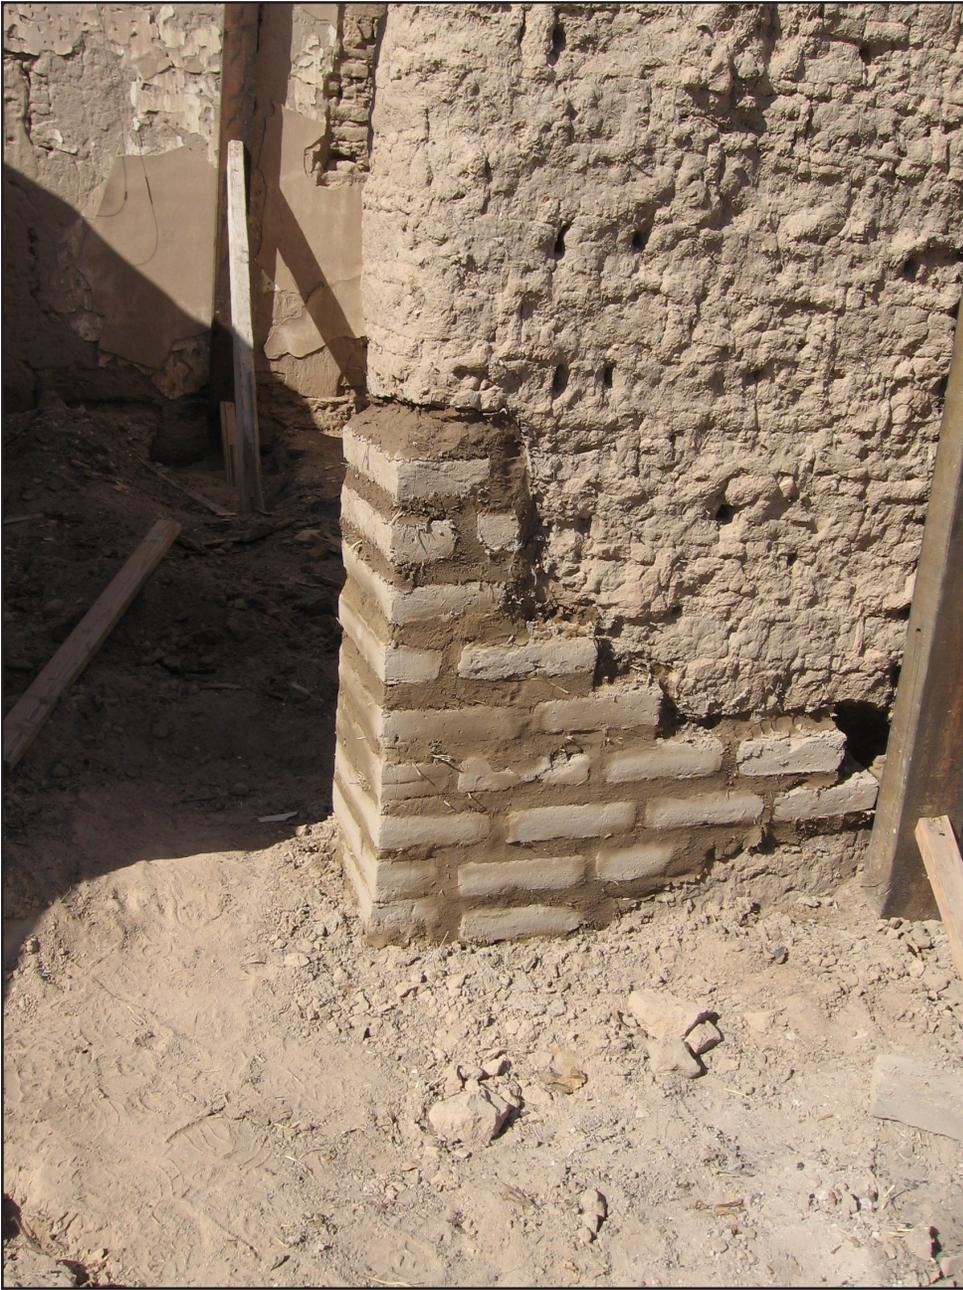
Figure No. 24 -Same area as above after cleanup and infill with adobes

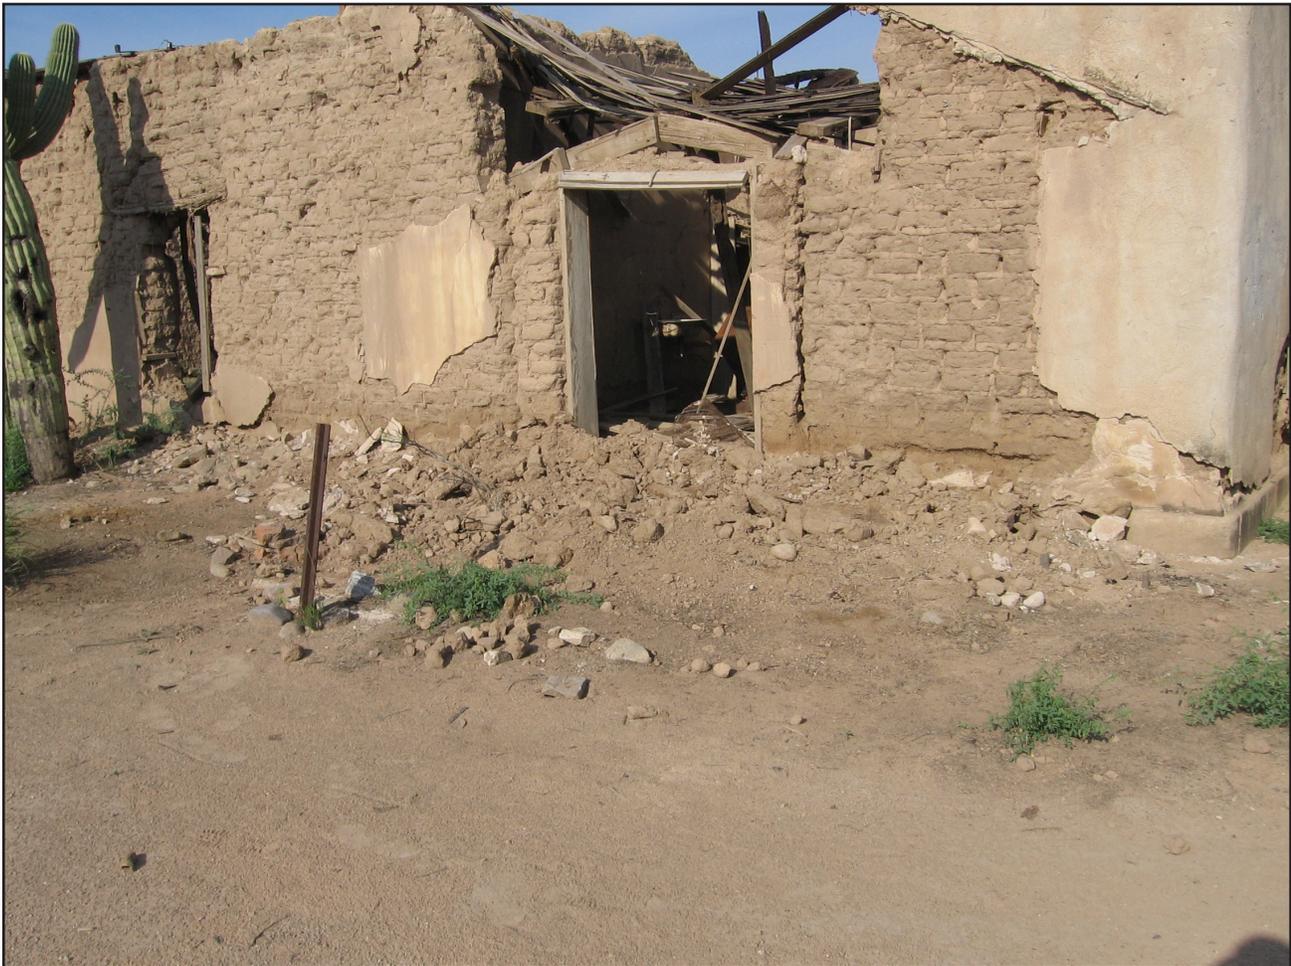
There are contra-pared, typically cast-in-place concrete curbs often fabricated at the bottom face of adobe walls at grade, and intended to moderate the effects of basal coving, but often aggravating the problem by holding more moisture behind them. These are contributing to the erosion at the wall base, all around the kitchen building, and along the east and north sides of the house. These are typically 4” deep thick and average 6” above finish grade (it is not determined how far they go below finish grade at this time). If further treatment is considered at this structure, all the contra-pared should be removed.

Figure No. 25 - East wall of house with contra-pared visible at right; this continued along side of the house under debris(now removed)

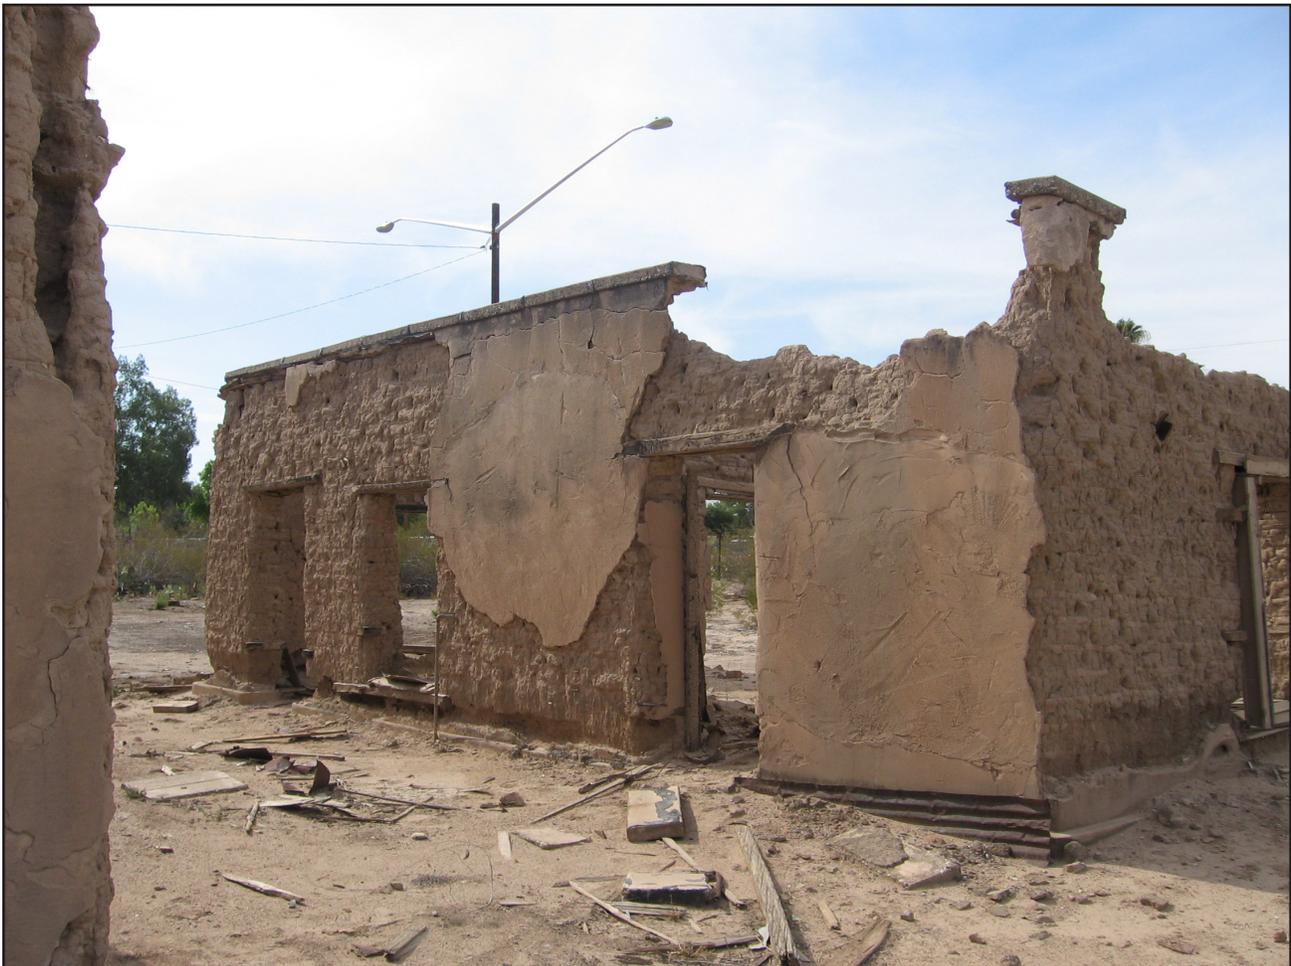
Figure No. 27 - North elevation of kitchen showing precast caps, sections of cement plaster; note severe erosion of walls under caps, the top portion to the right was removed due to its precarious condition; also note basal coving above contra-pared

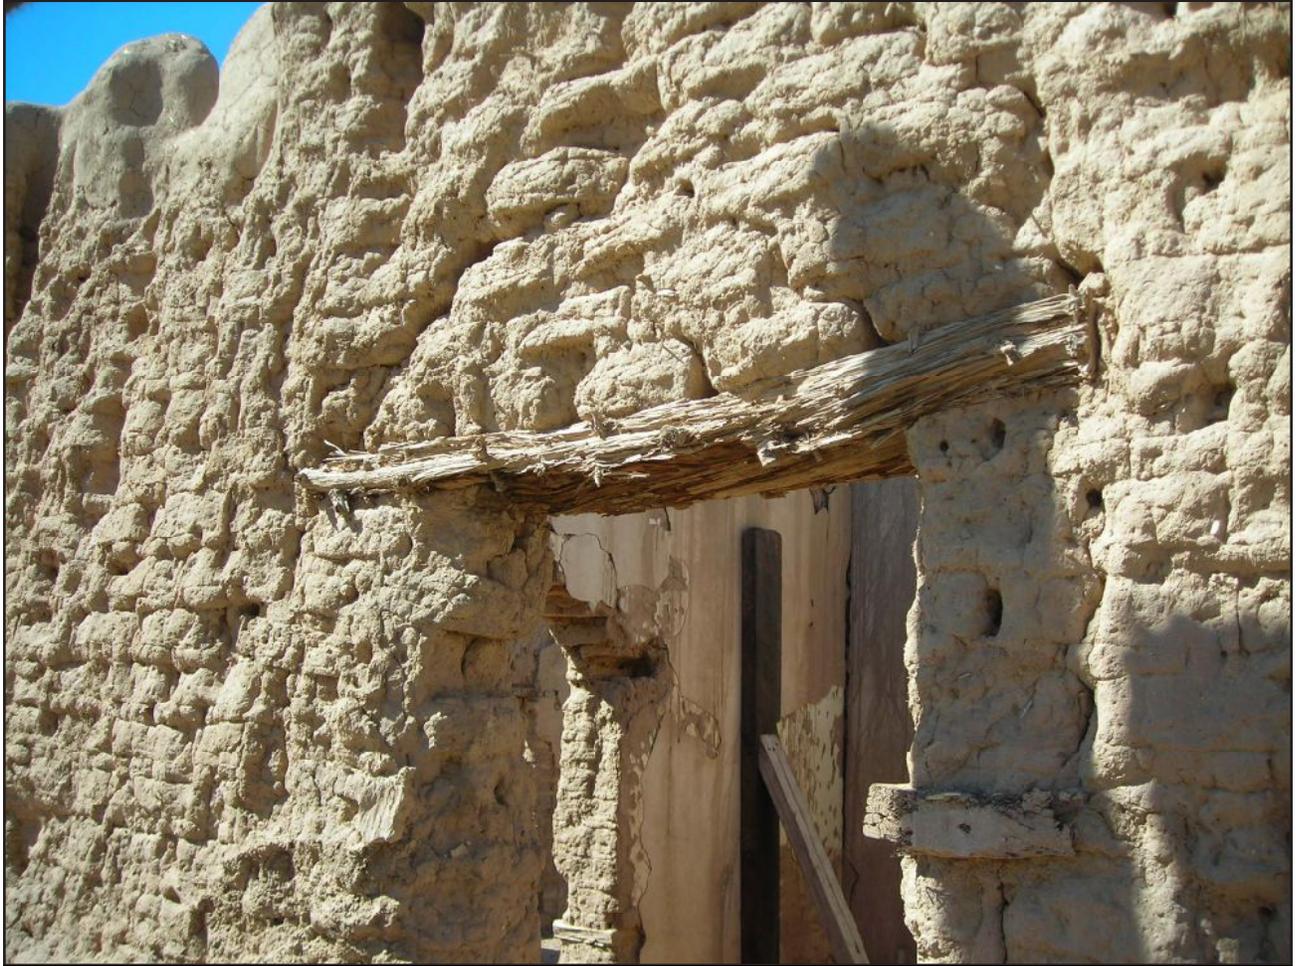
There are no extant doors. Some wood casements and lintels remain in openings, all in a very deteriorated condition. All openings should be braced.

Figure No. 33 - Window opening on east side with severely deteriorated lintel and remaining "gringo blocks" at jamb below

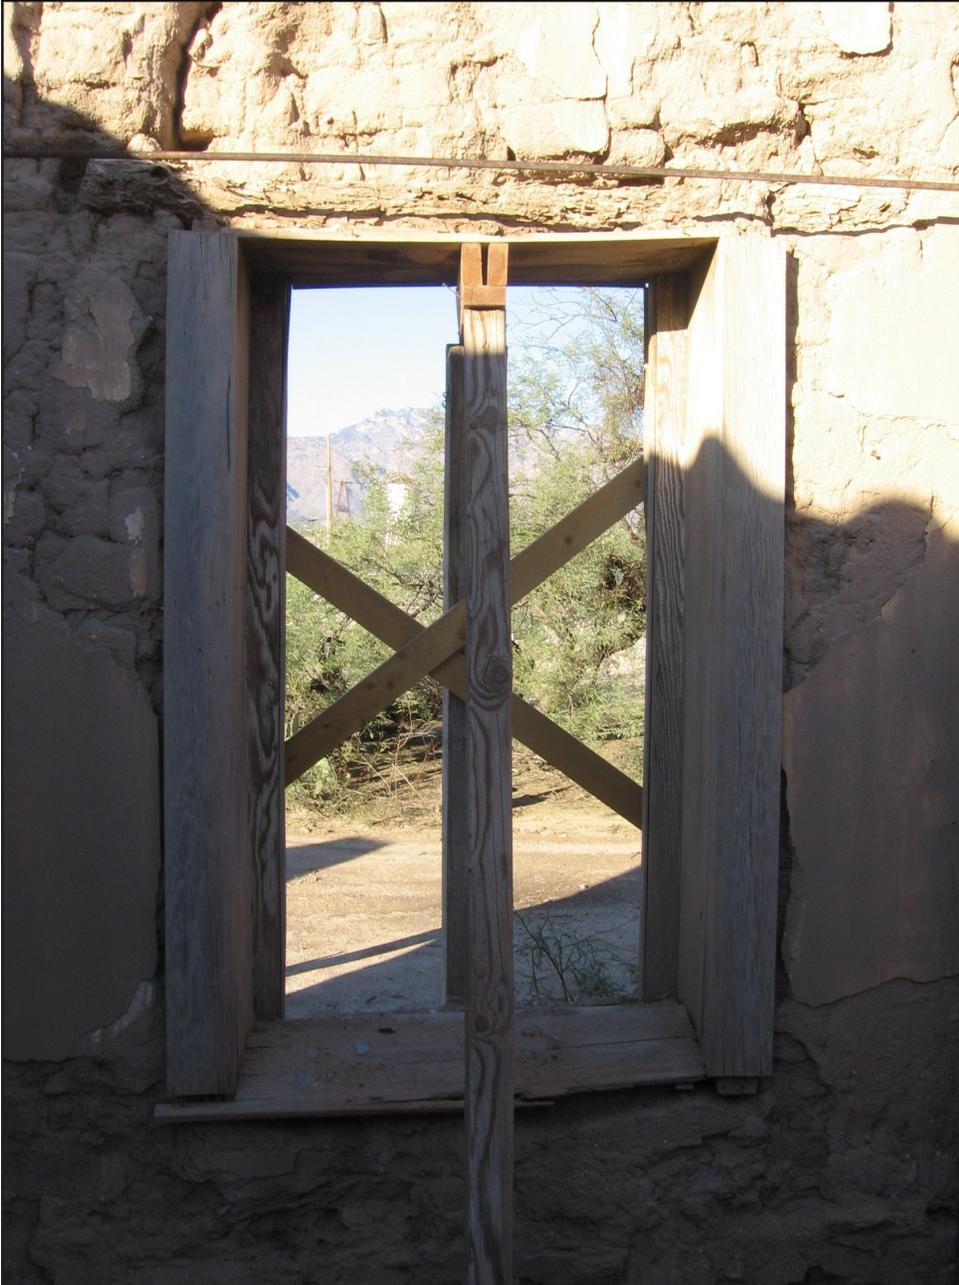
Similar to doors, there are existing casings and lintels, in a very deteriorated condition. At Bedroom 1, the casing for the exterior window to the south exists on the interior of the wall. Its configuration is similar to those at Officer's Quarters No. 3. There are also portions of frames remaining at the Kitchen.

Figure No. 35 - Casing at window of bedroom 1 with bracing

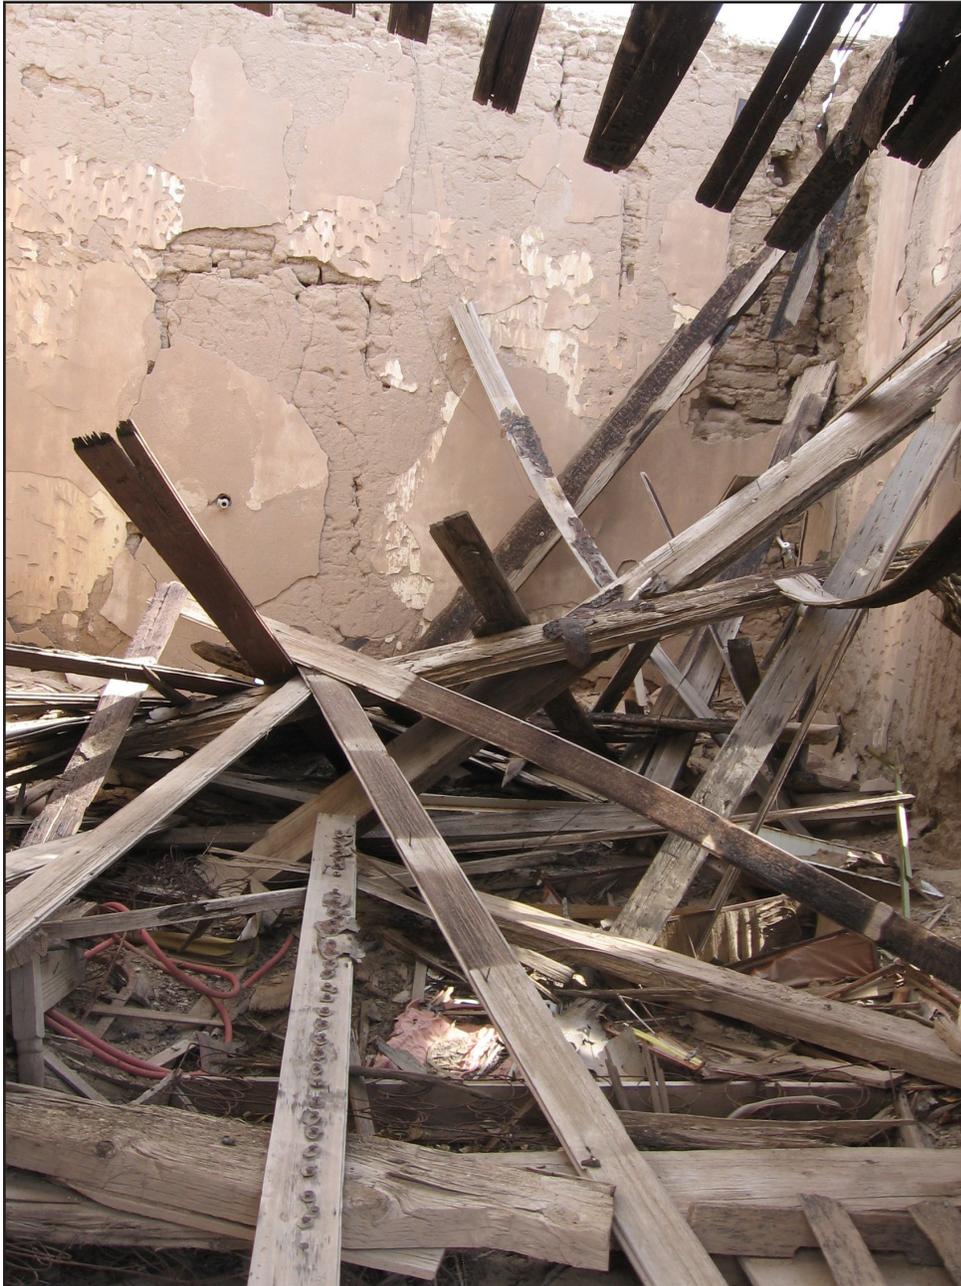
When the building burned most of the roof framing collapsed into the structure. All of this framing was removed during the stabilization process as it presented a safety hazard to the workers and also to the structure – some members were impinging on standing walls. Typical members were saved for reference by the Archaeologist.

Figure No. 37 - Debris of roof structure in Bedroom 1(front bedroom)

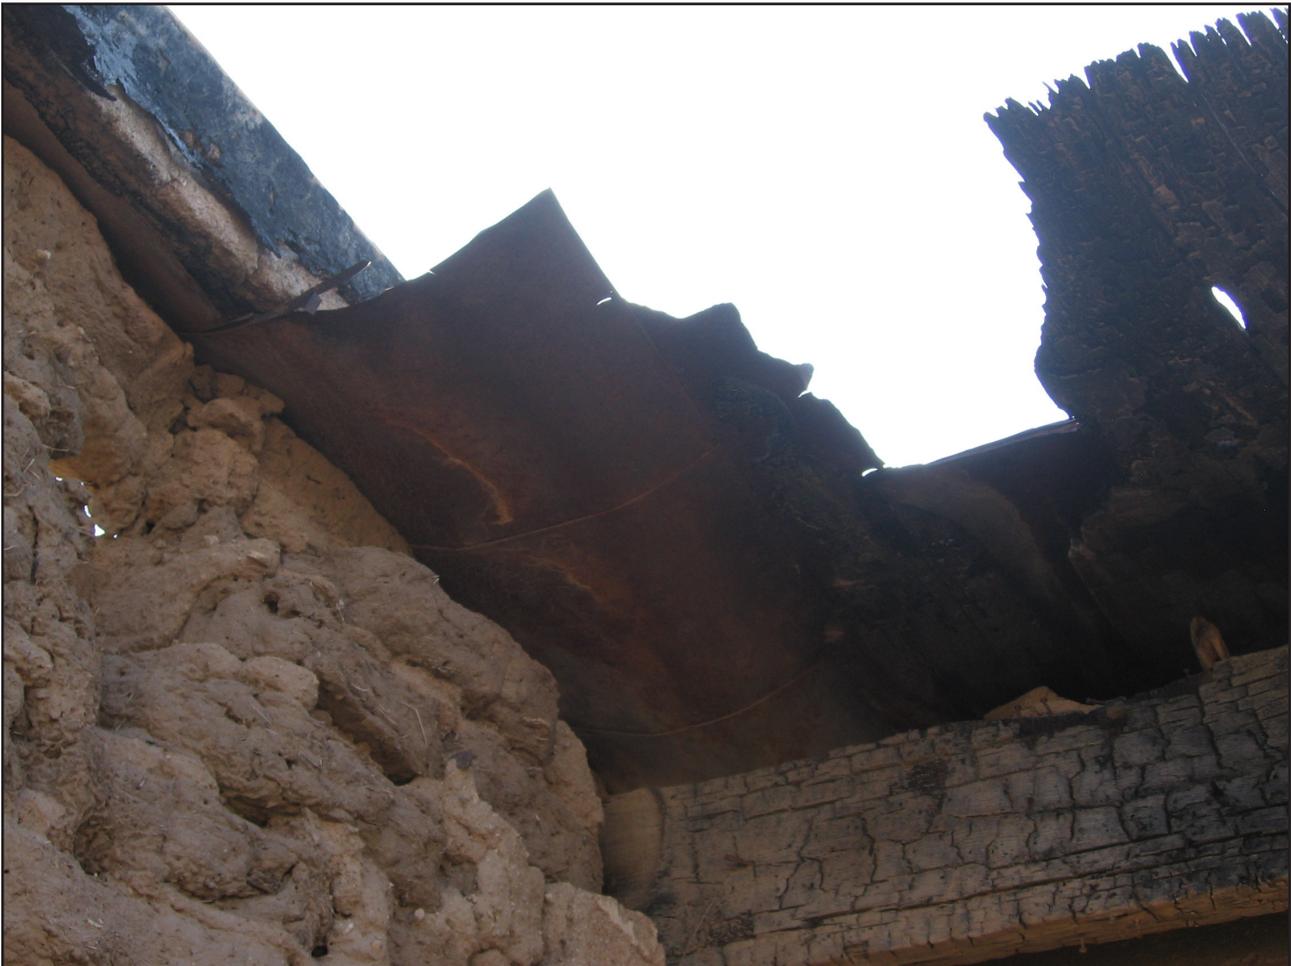
Figure No. 38 - Sheet metal flashing projecting out from under cast concrete cap (with asphalt emulsion coating) at the kitchen; note burned member

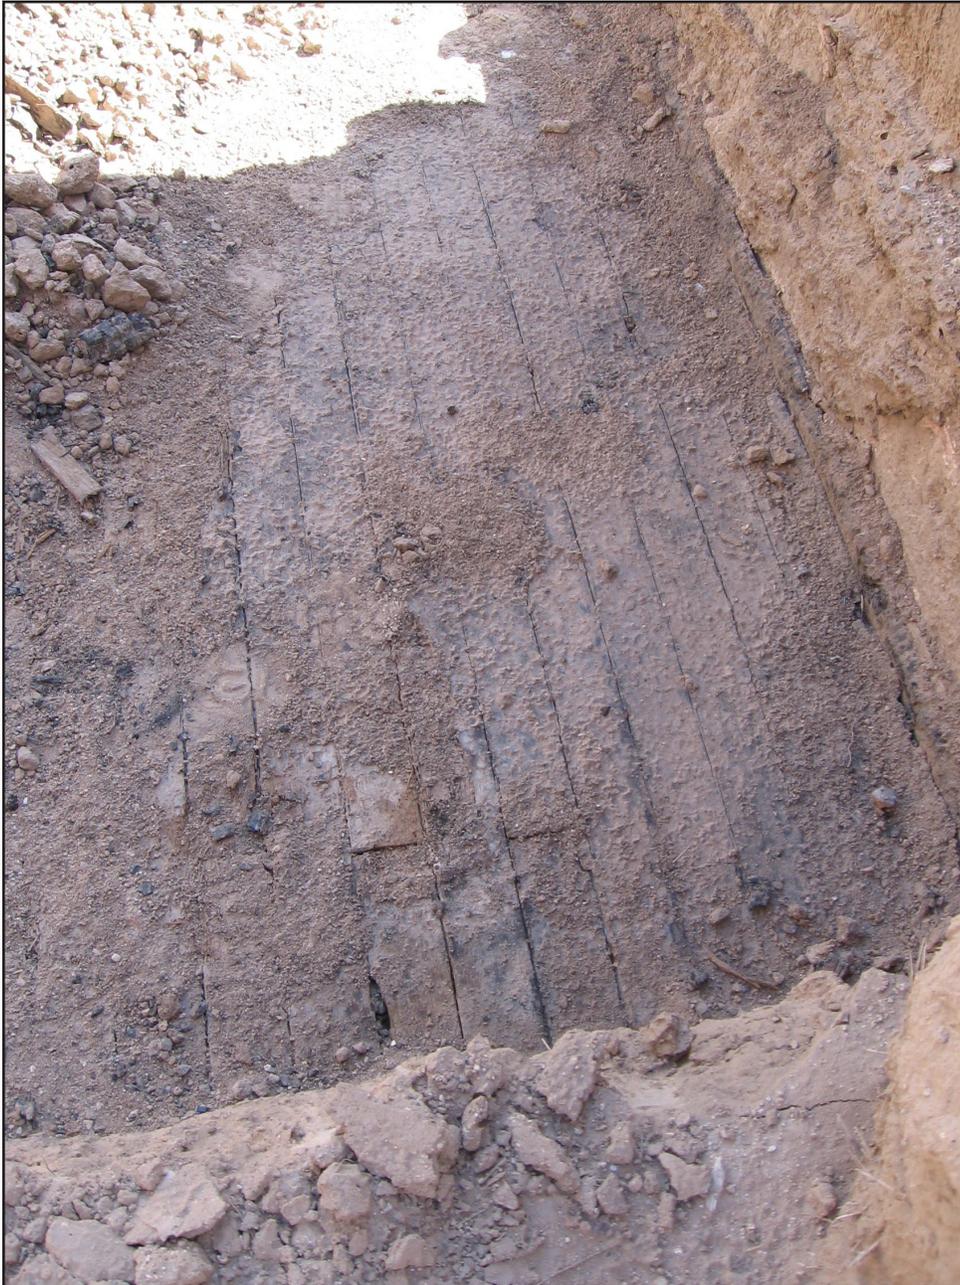
Figure No. 44 - Burned flooring at Kitchen; this was excavated during stabilization and is now being covered again by rains washing dirt over it

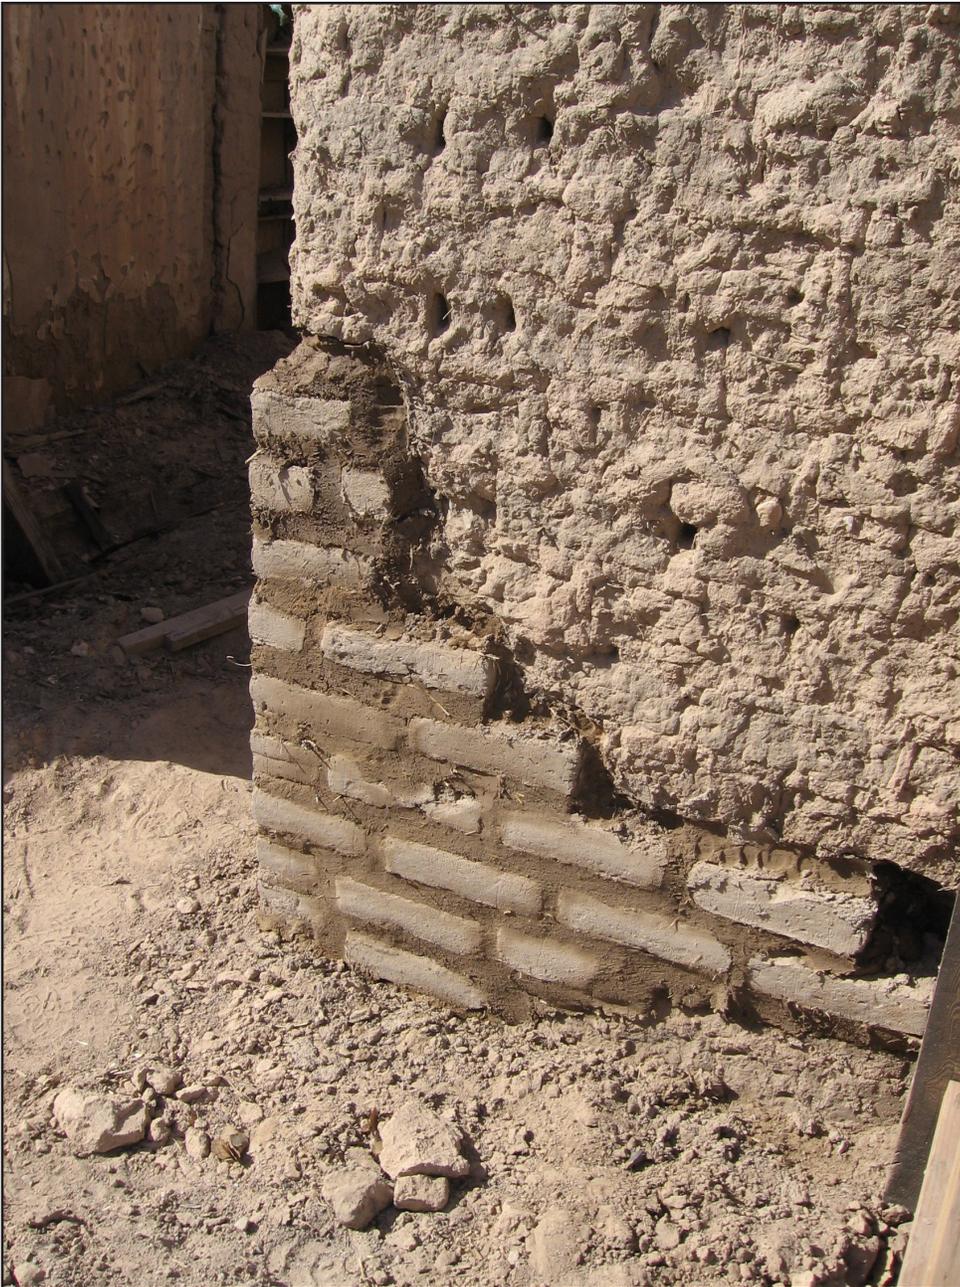
Figure No. 52 - Infill at covered area with site-fabricated adobes; photograph taken 08/30/07

- a. Removal of cast concrete parapet caps and covering of wall tops with a nominal 2" thick coating of adobe mud.
- b. Infill of covered areas at wall base with new site-fabricated mud adobe blocks to prevent further erosion and collapse of wall.

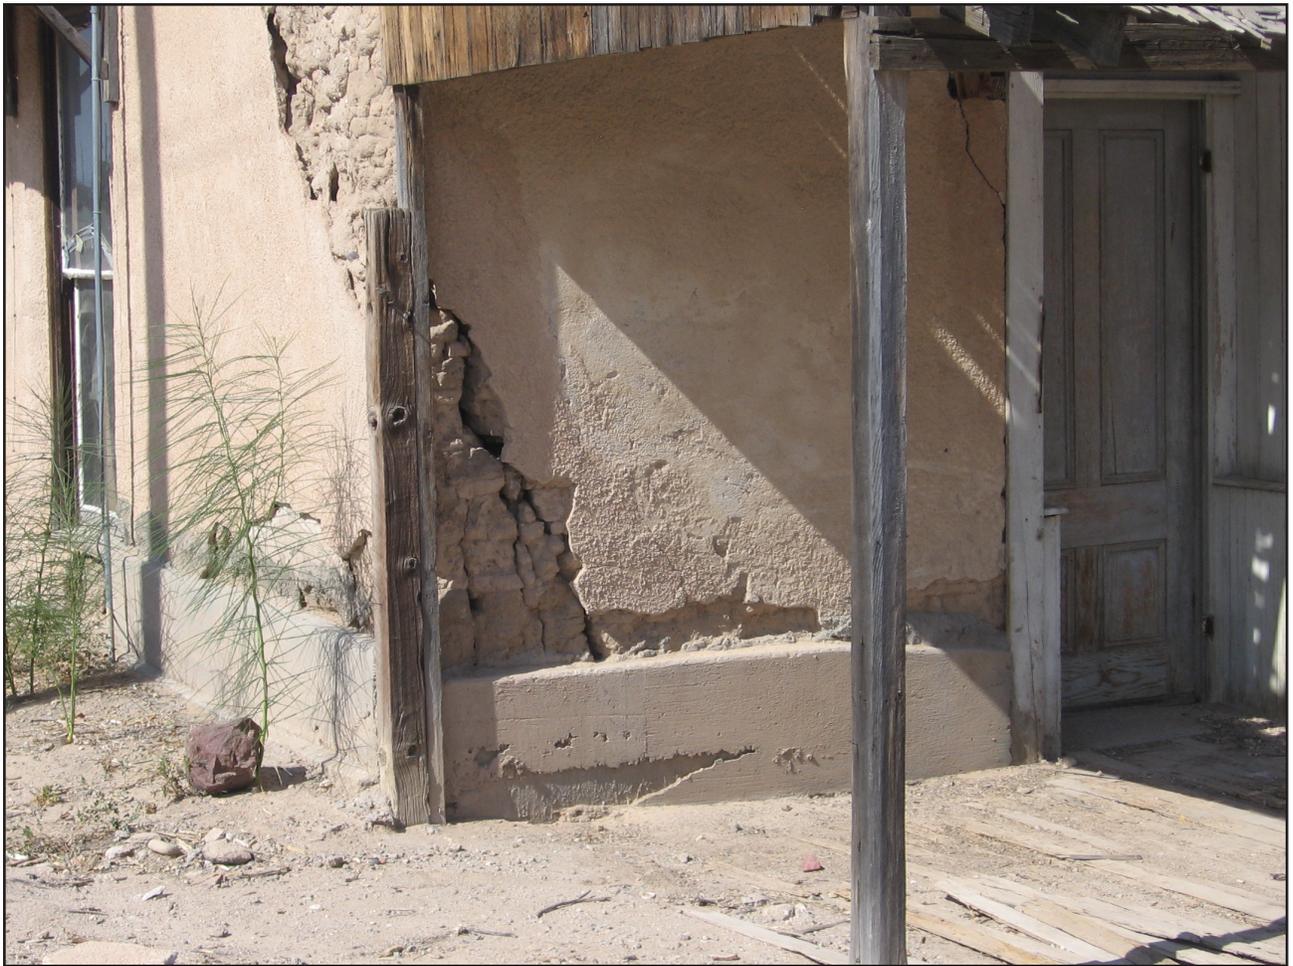
Figure No. 61 - Northeast corner of structure showing severe cracking; both faces (north and east wall) are trying to separate from the building; there is also slab cracking on the interior floor indicating that this corner of the building is subsiding; the swale installed during stabilization will mitigate further damage, but this corner represents a critical structural concern

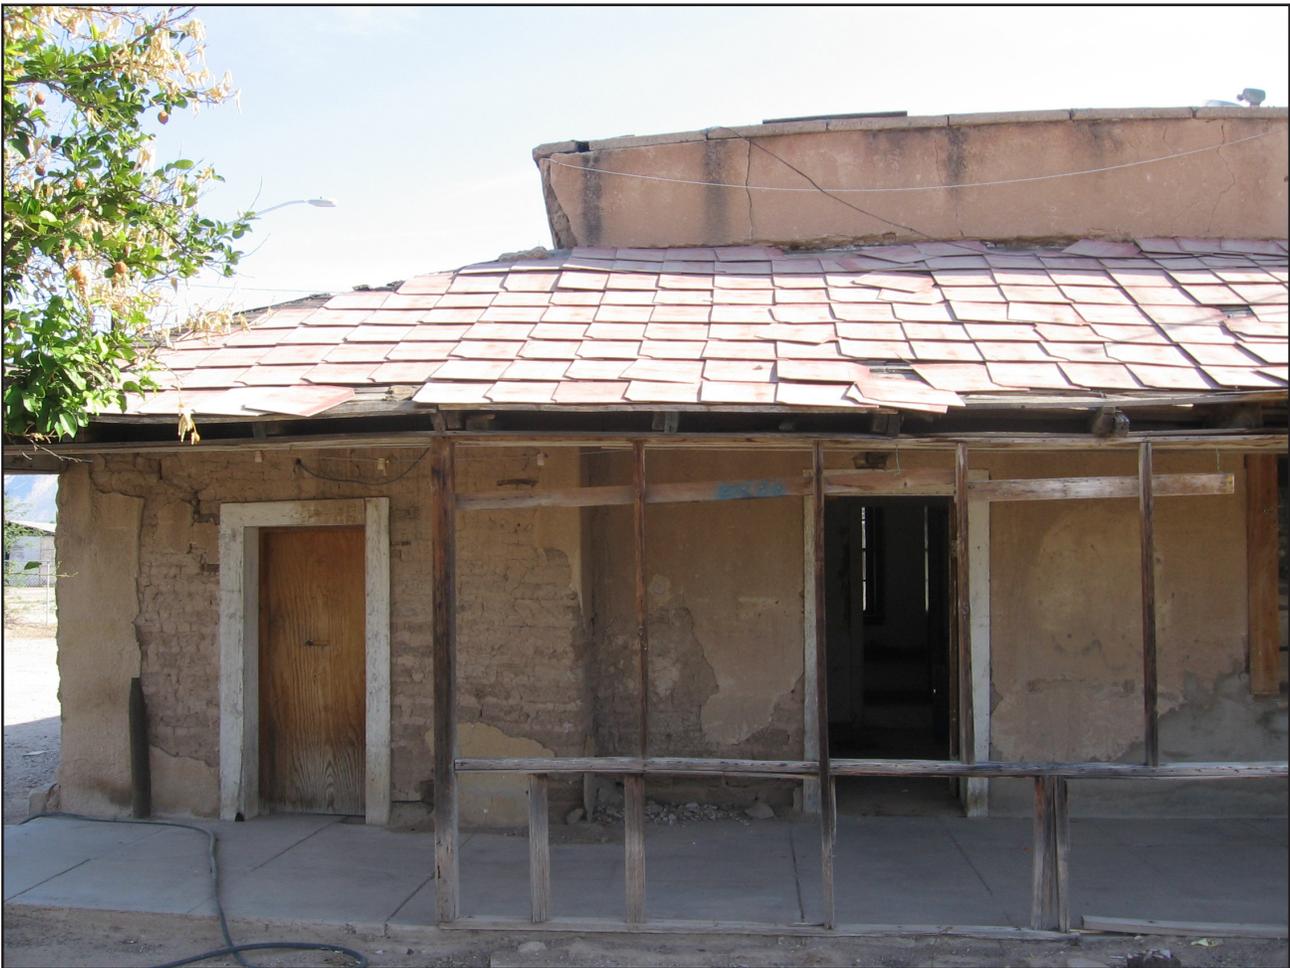
Figure No. 62 - Parapet above Kitchen is peeling away from building; this has been braced during the stabilization process

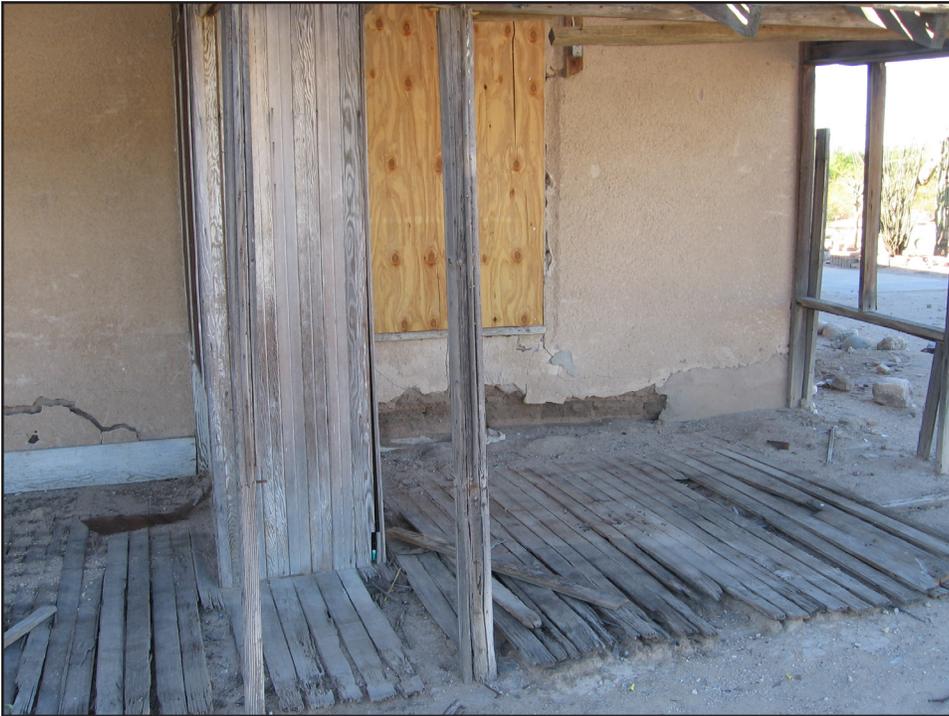
Figure No. 65 - Mortar patching at northwest corner, instead of applied contra-pared, adjacent coved section of wall; wood trim at base of wall appears to be missing at coved area (after stabilization)

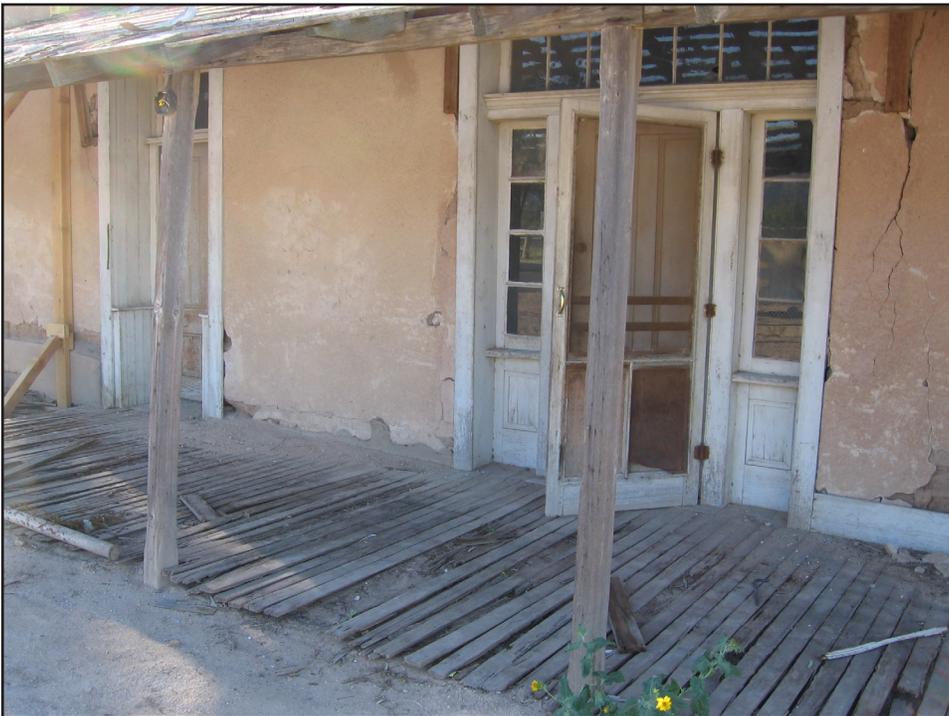
Figure No. 66 - More patching at left of door; indent may indicate location of trim similar to extant on right of door (after stabilization)

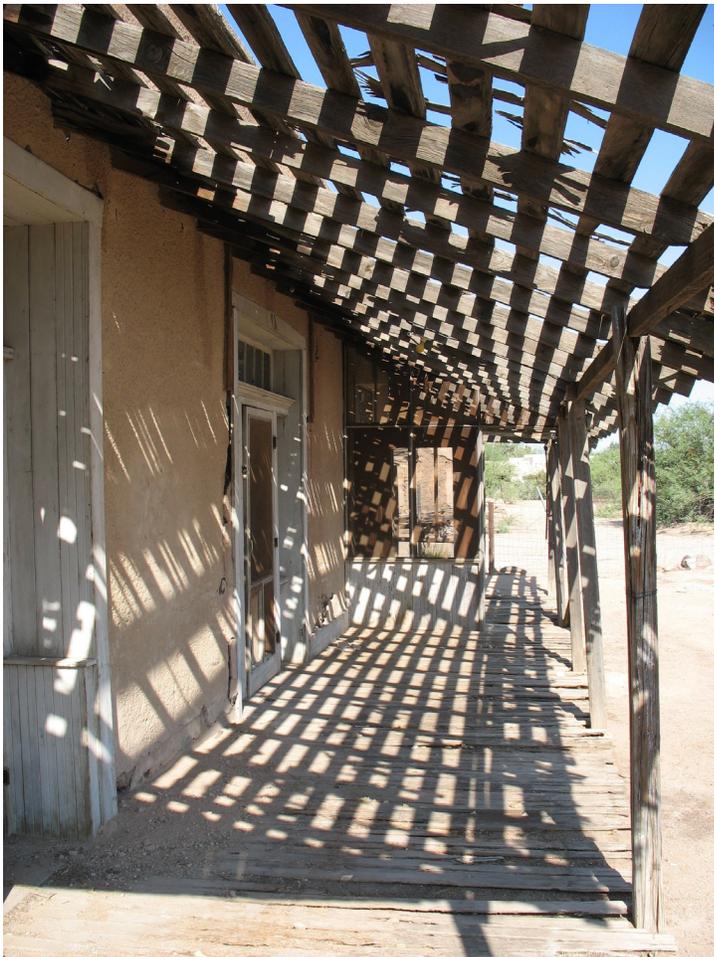
Figure No. 73 - North porch showing remaining primary roof framing and floor that is deteriorating into the ground

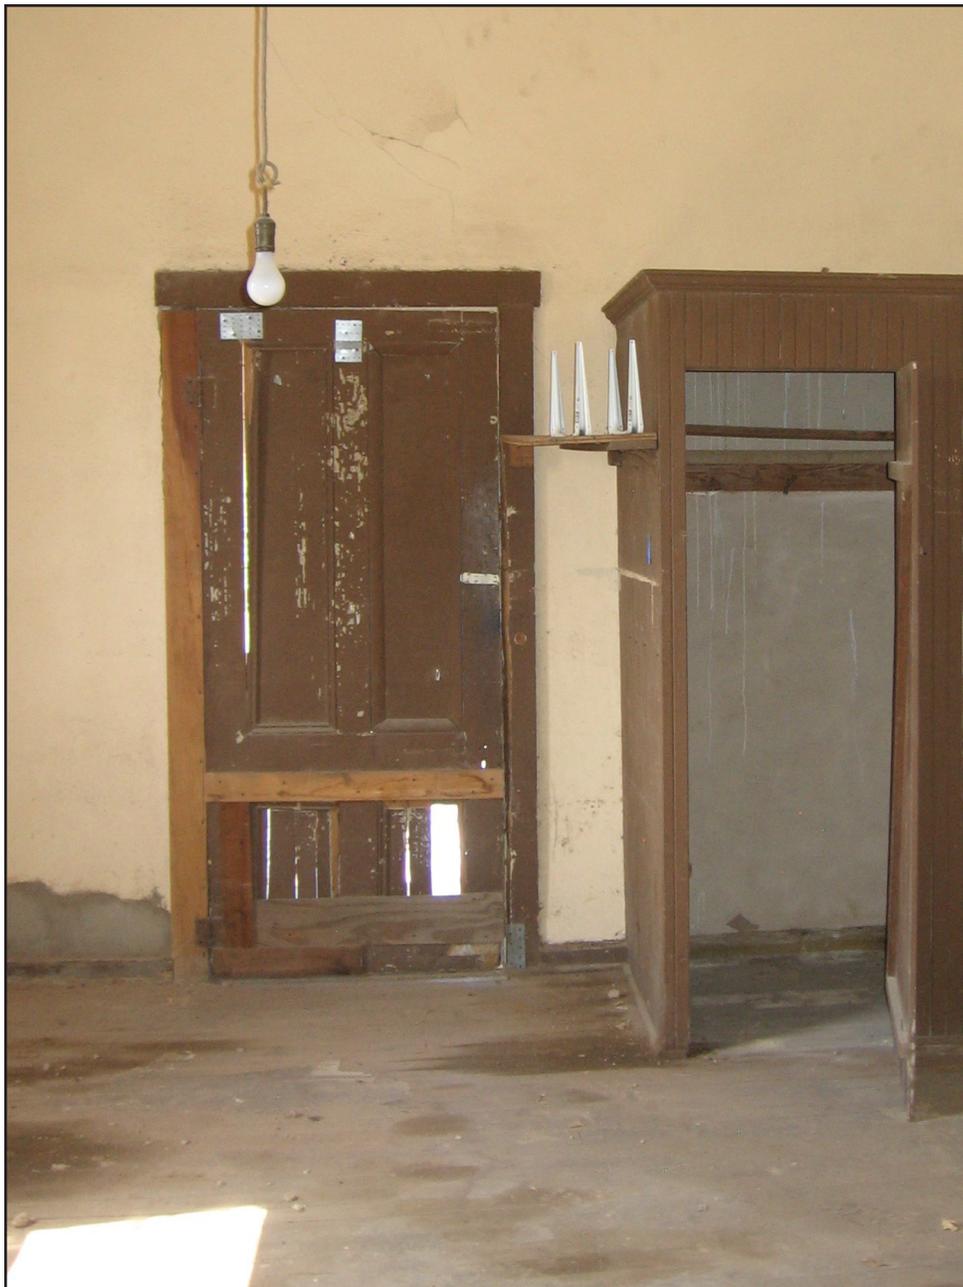
Figure No. 80 - Door to Bedroom 2 with damage and mending

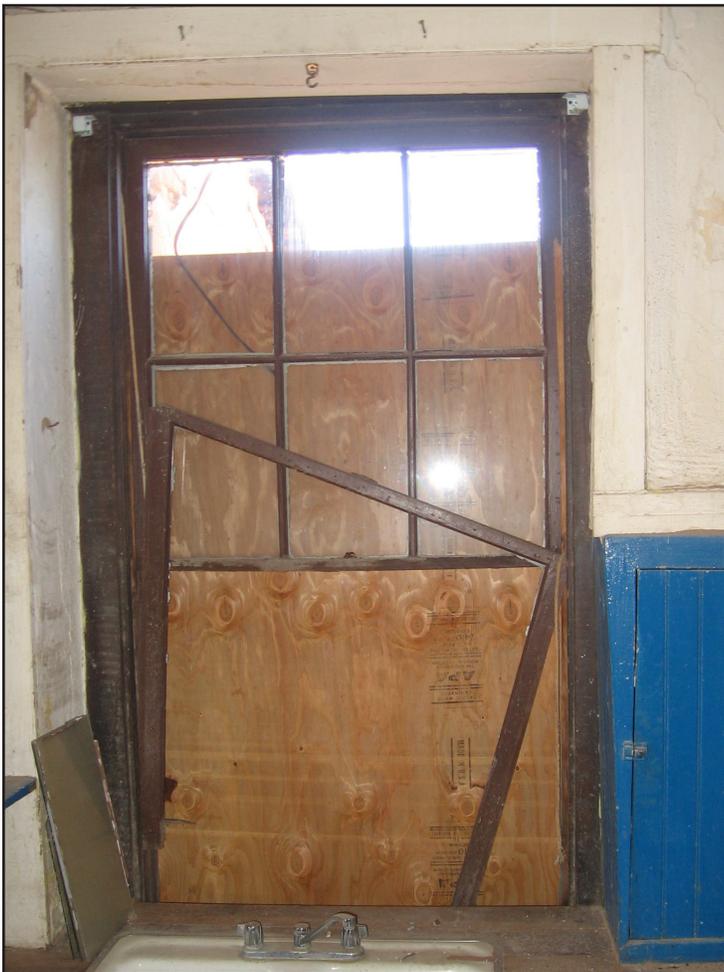
Figure No. 84 - Window at Kitchen looking west; bottom sash has collapsed

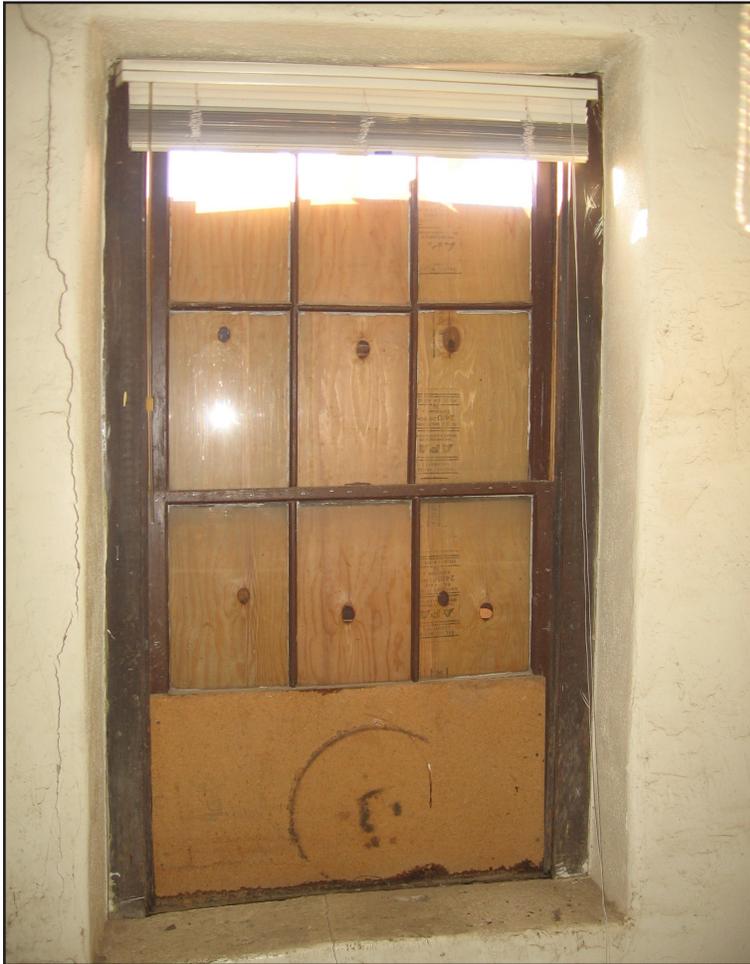
Figure No. 85 - Window at Pantry looking west; particleboard infill was existing condition and it appears that muntins may have been replaced at some time
