Officer's Quarters No. 1, 2 & 3

Adkins Steel Parcel

Building Condition Assessment Report

February 25, 2008

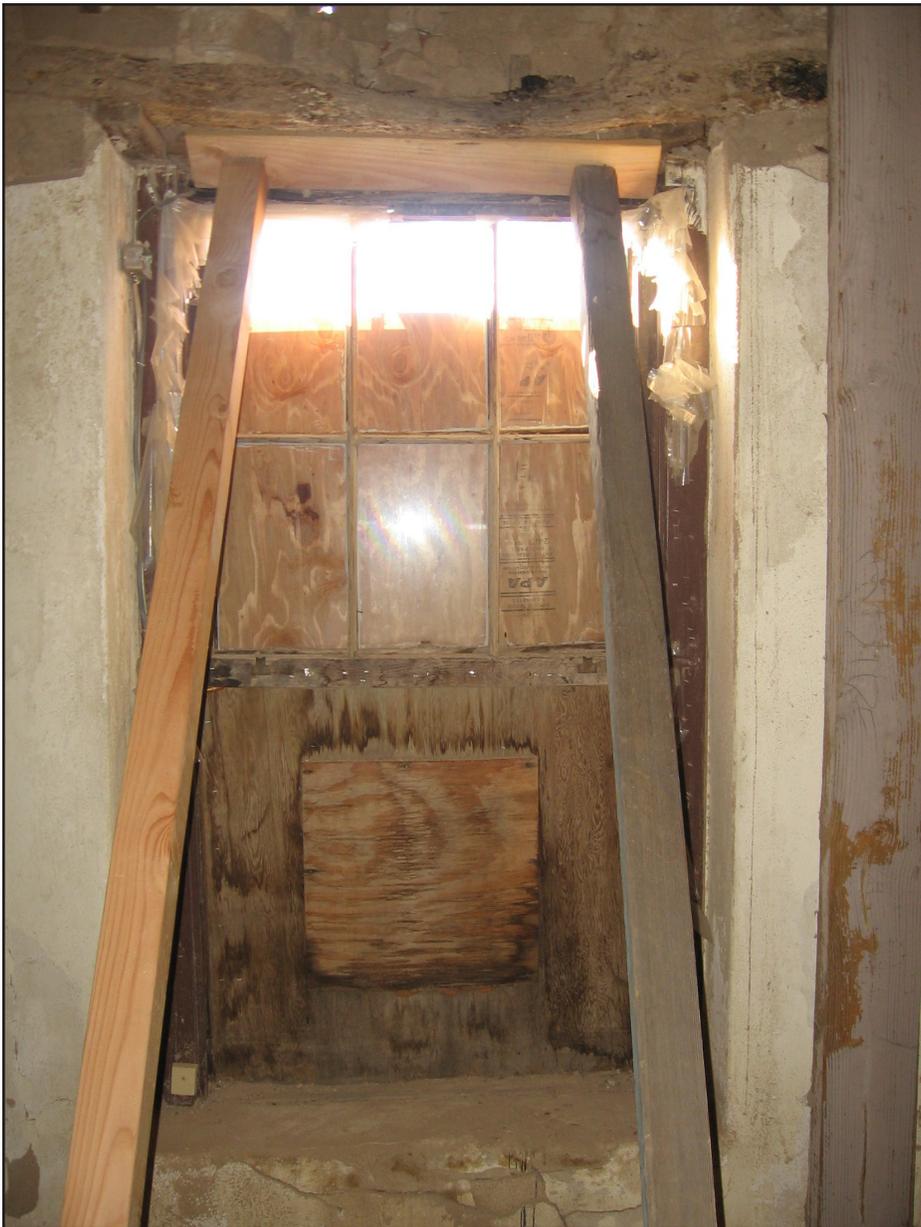
Figure No. 86 - Window at Living Room looking west; bottom sash was replaced with plywood panel with cut-out for side-flow evaporative cooler; electrical supply is up to left; this is the wall section that experienced severe water degradation from canale above

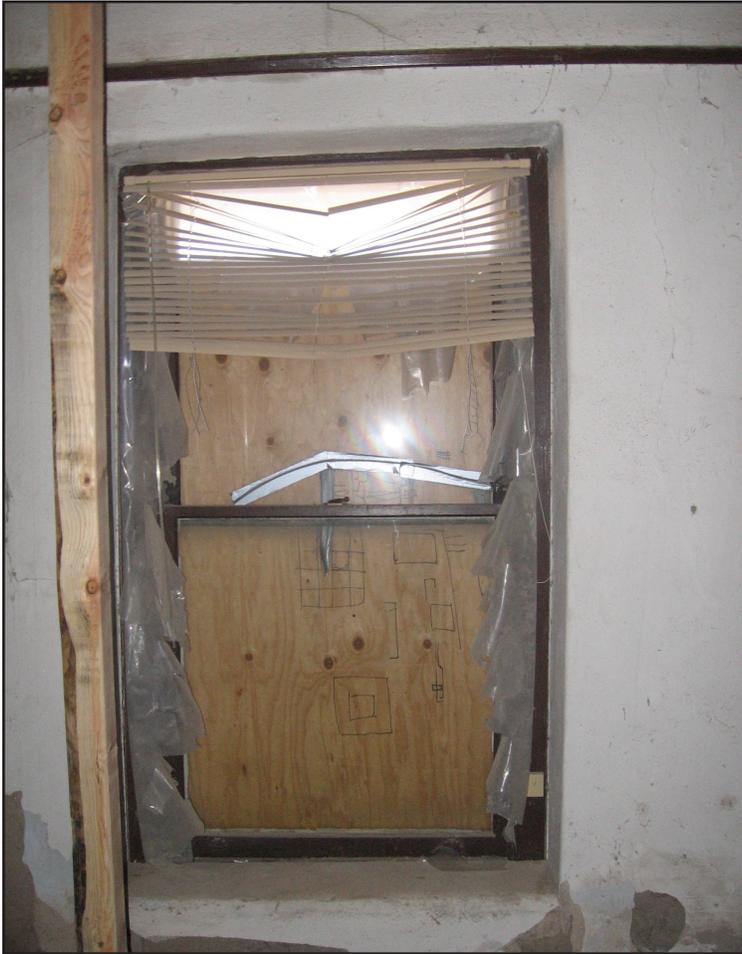
Figure No. 88 - Window looking east out of Bedroom 1; all the muntins are gone and replaced with single panes of glass; there is evidence of a plastic storm liner in window and picture rail above

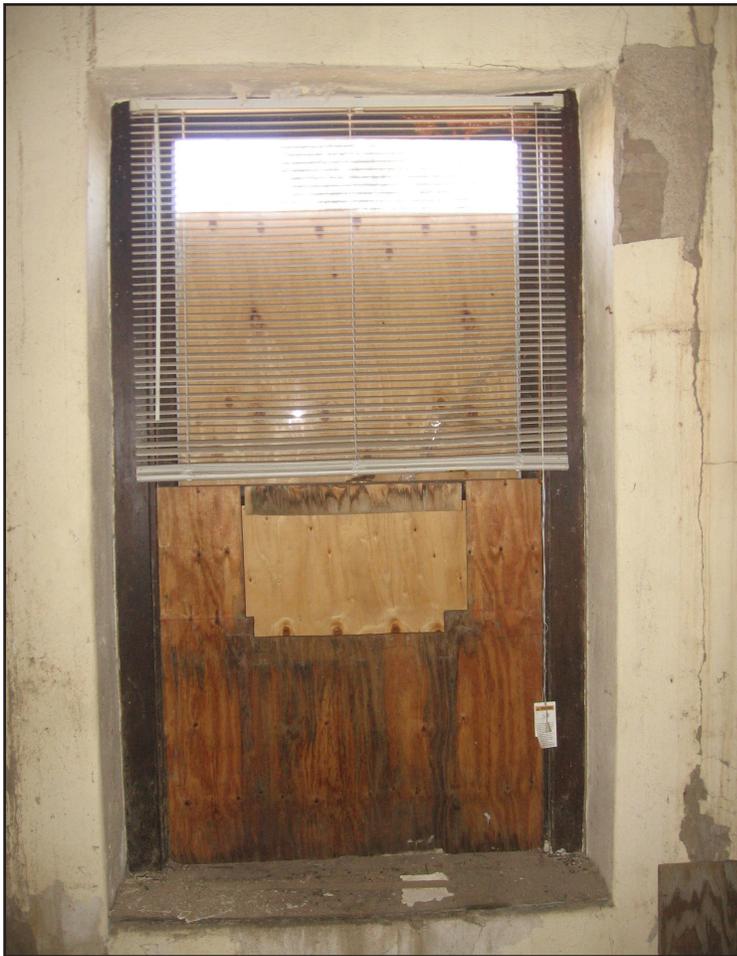
Figure No. 89 - Window at Bedroom 2 looking east; bottom sash replaced with plywood with duct opening; top sash infilled with plywood

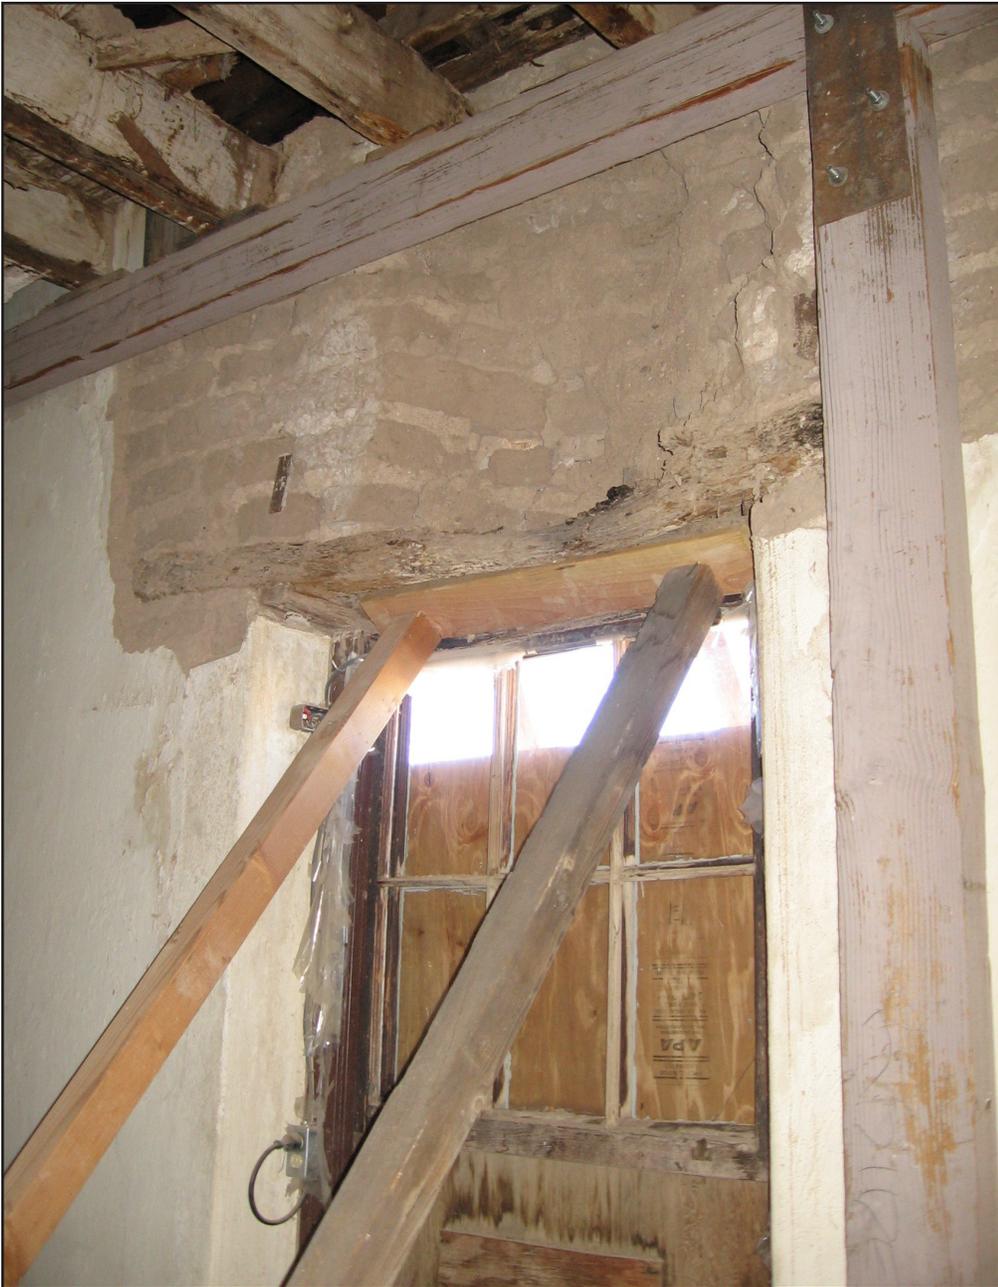
Figure No. 94 - Deteriorated wall/lintel at interior below canale

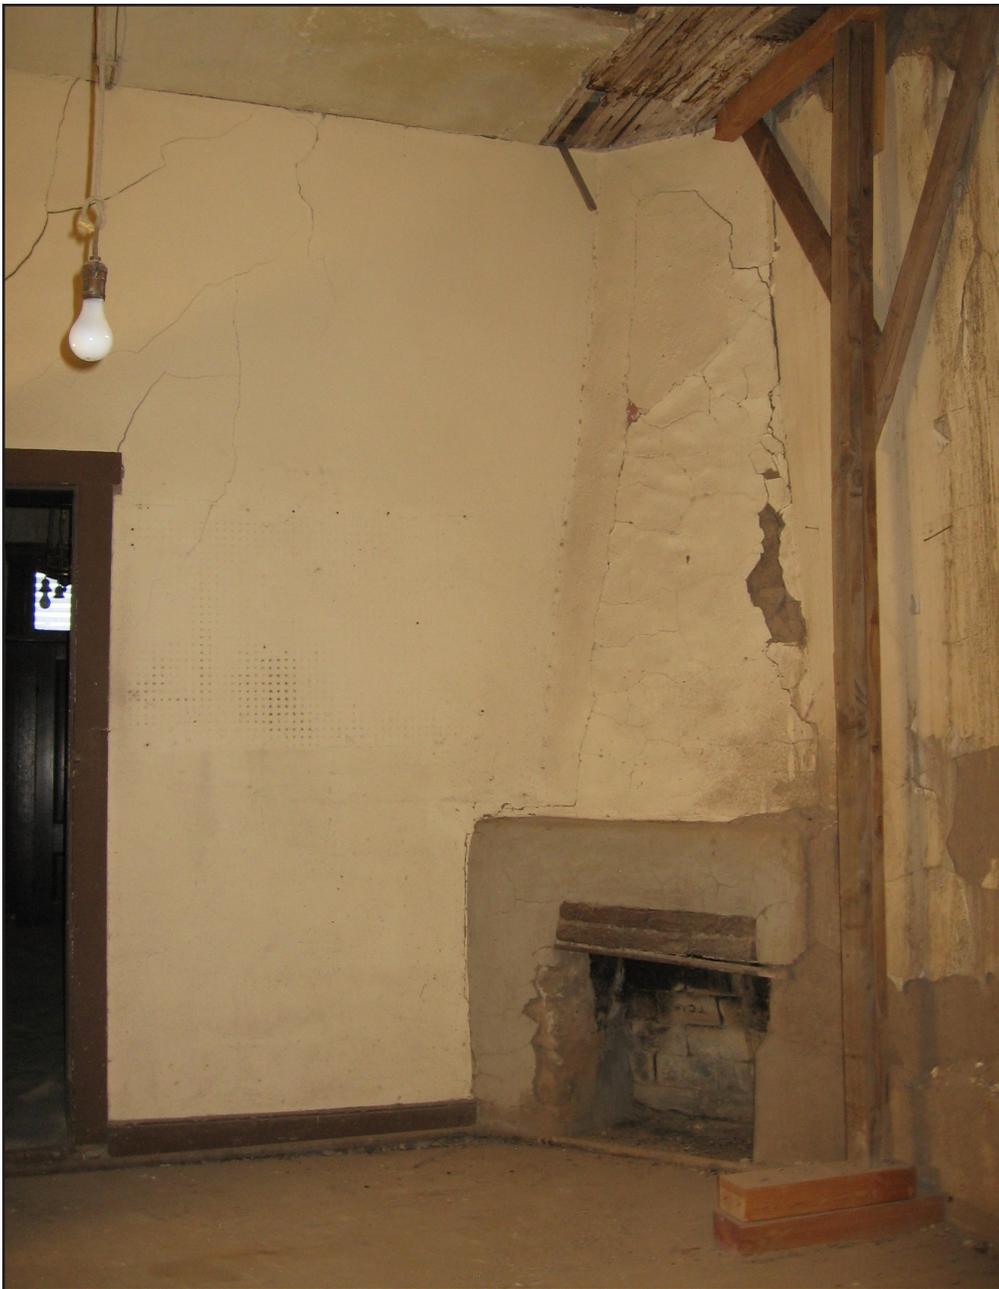
Figure No. 98 -
Fireplace at Bedroom
2 showing patching
with Portland cement
plaster; latillas visible
in exposed ceiling
above and bracing
placed during
stabilization

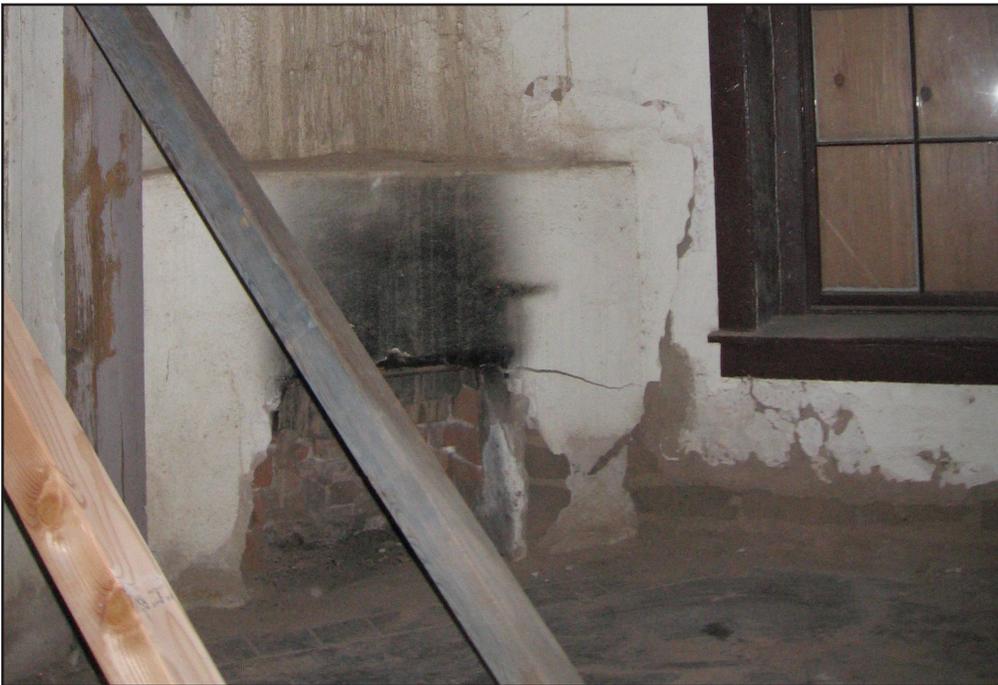
Figure No. 102 - Fireplace at Living Room with evidence of water intrusion from flue

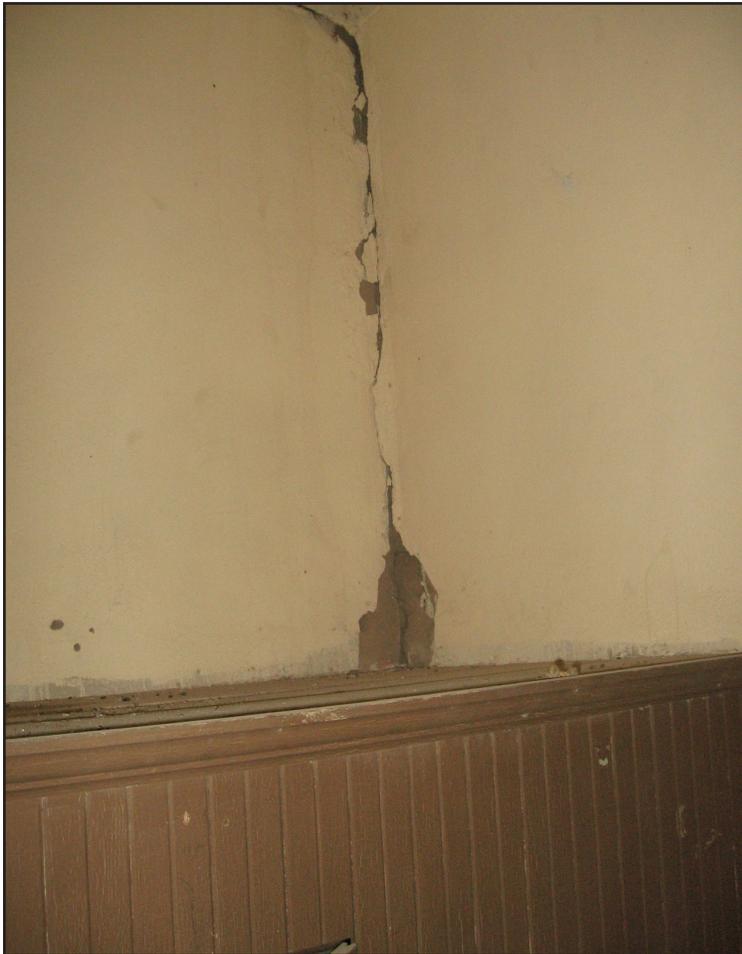
Figure No. 103 - Cracking in southwest corner of Bedroom 2 behind closet

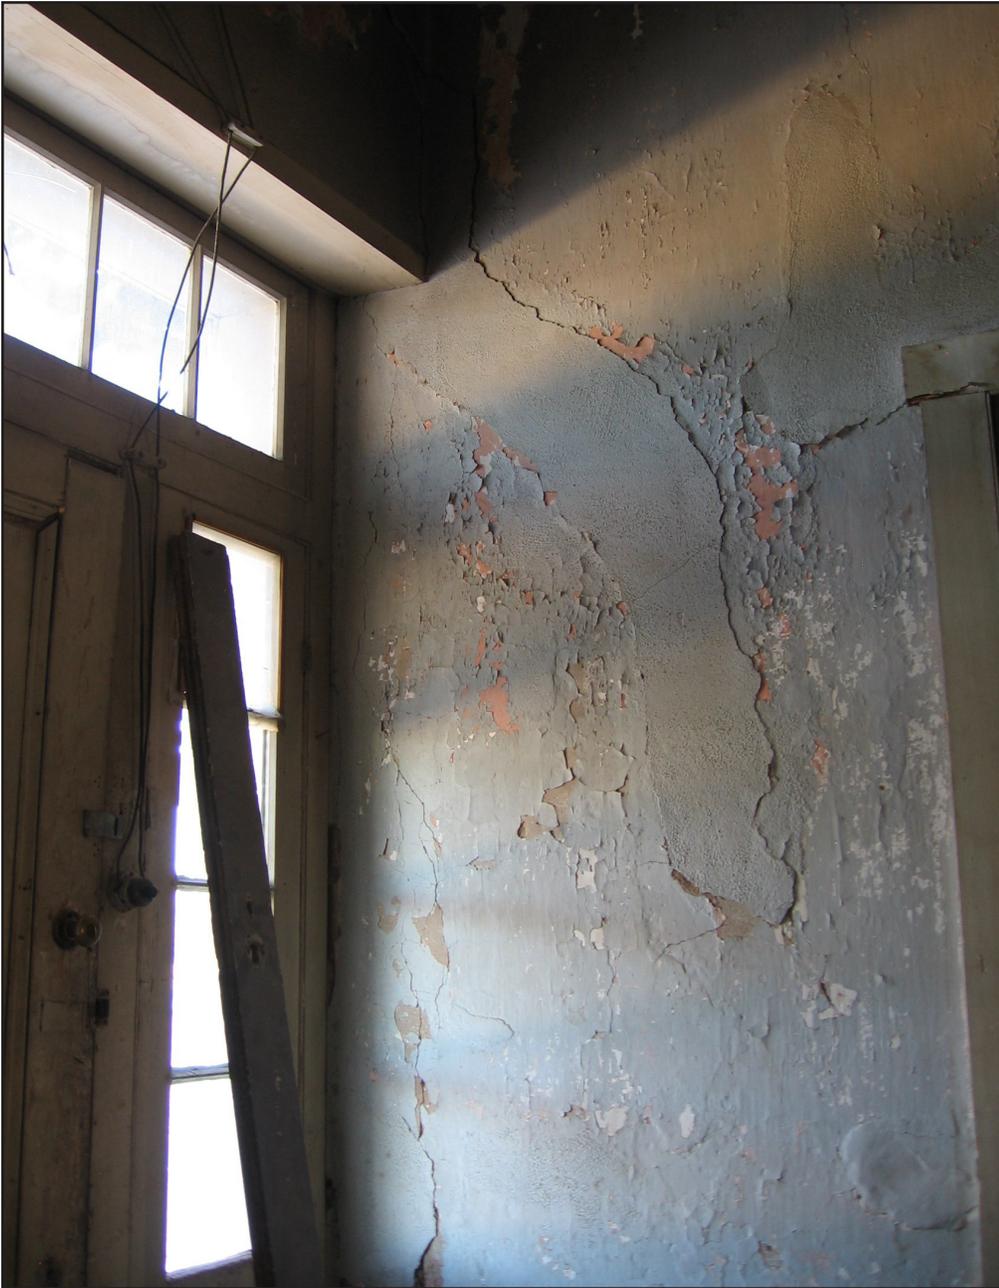
Figure No. 104 - Cracking adjacent entry door; note knob and tube wiring and circular knob light switch by door

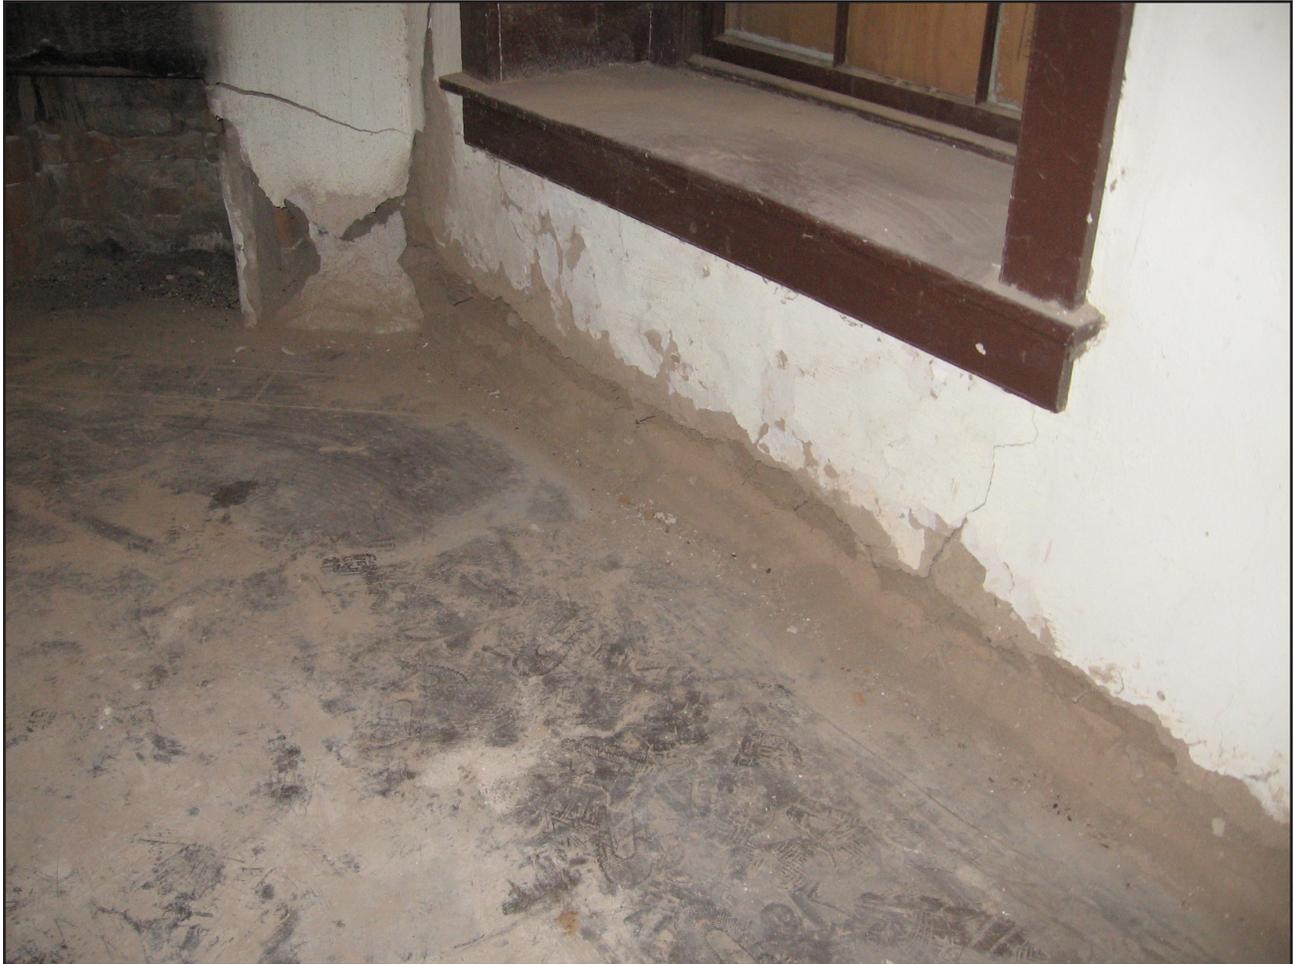
Figure No. 107 - Basal coving under north window at Living Room; right side of fireplace is also disintegrating
