RE: **Performing Arts Center Bond Project**

Downtown Performing Arts Center (Cursillo) Status

Performing Arts Center (Cursillo) 2009 electrical theft

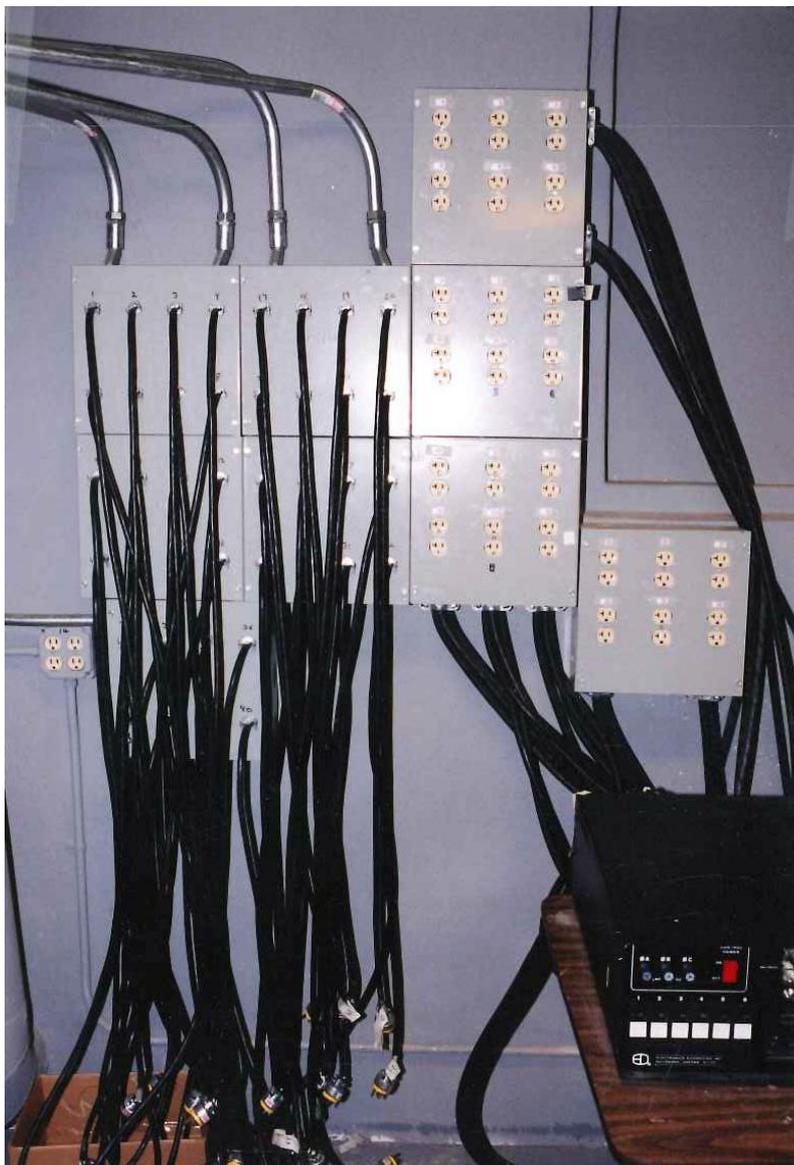
Before

The existing control of the stage lighting system consisted of plugging each light's corresponding extension cord, connected to the panel on the left, into one of the available outlets on the right (see attached photos). The entire system was antiquated when the facility was closed and, if the wire theft had never happened, it would still be far from meeting current electrical codes. Therefore, if the facility continues to be used as a theater, the entire stage lighting control system will need to be replaced before the building reopens. If the building is to be used for some other purpose, the entire system is not needed.

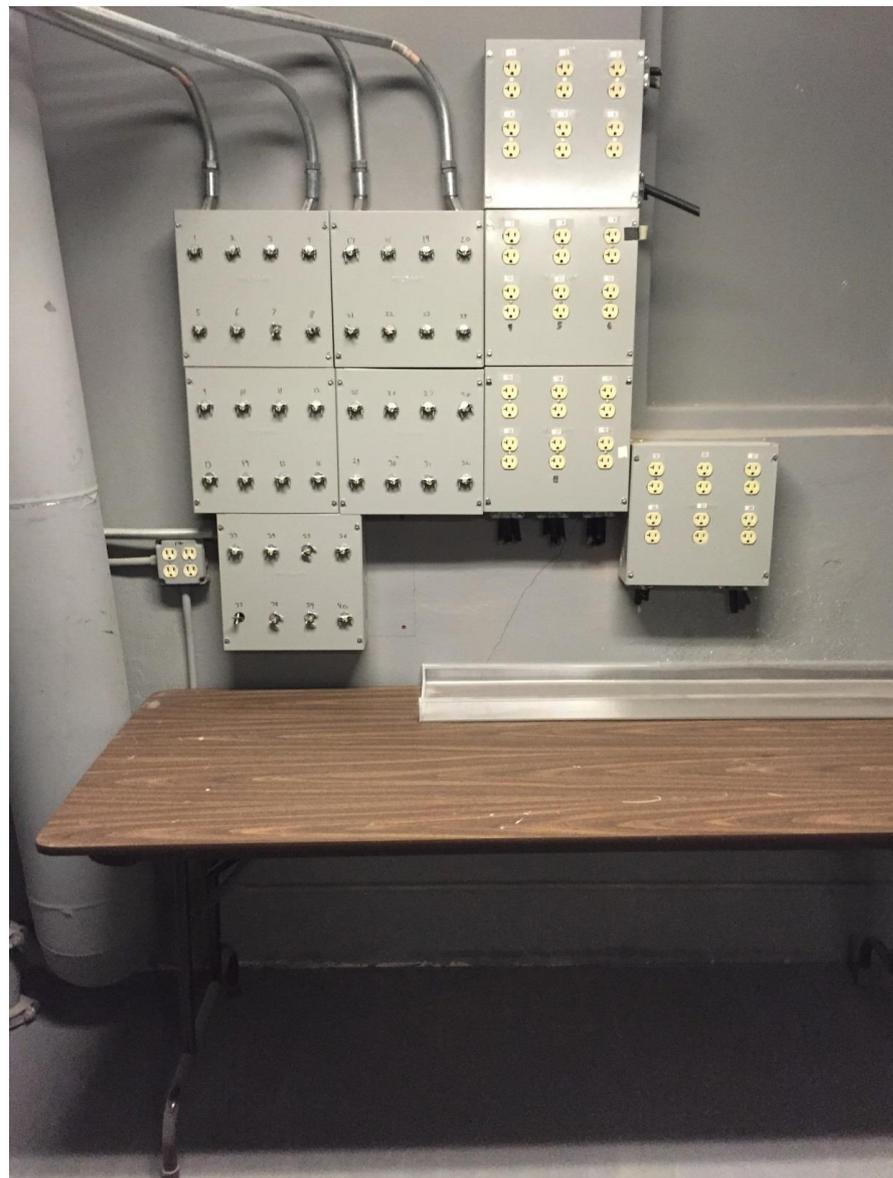
After

A detailed accounting of the stolen equipment is provided below, as well as in the attached “before” and “after” photos, and the related police report, which estimates the value of the equipment at \$1,500.

Over the lobby area is a small second story control and sound room that looks out over the large room. On the north end of the control room is an electrical panel. Forty cables with plugs on the end were cut from the front of the panel. These cables were black, with 3 10-gauge multi-stranded wires inside. They had male plugs with a yellow trim on them. They ranged in length from about 4 feet to 15 feet.

Another part of the electrical panel has about 40 receptacles wired into it. Coming out of the bottom and right side of this panel were 20 more black electrical cables with 3 6-gauge multi-stranded wires inside them. These were also cut off at the electrical panel.
