HIGH PLAINS EFFLUENT RECHARGE PROJECT

BIOLOGICAL MONITORING 2006

Pima County Department
of transportation and Flood
Control District

**HIGH PLAINS EFFLUENT RECHARGE PROJECT
BIOLOGICAL STUDIES
MONITORING REPORT - 2006**

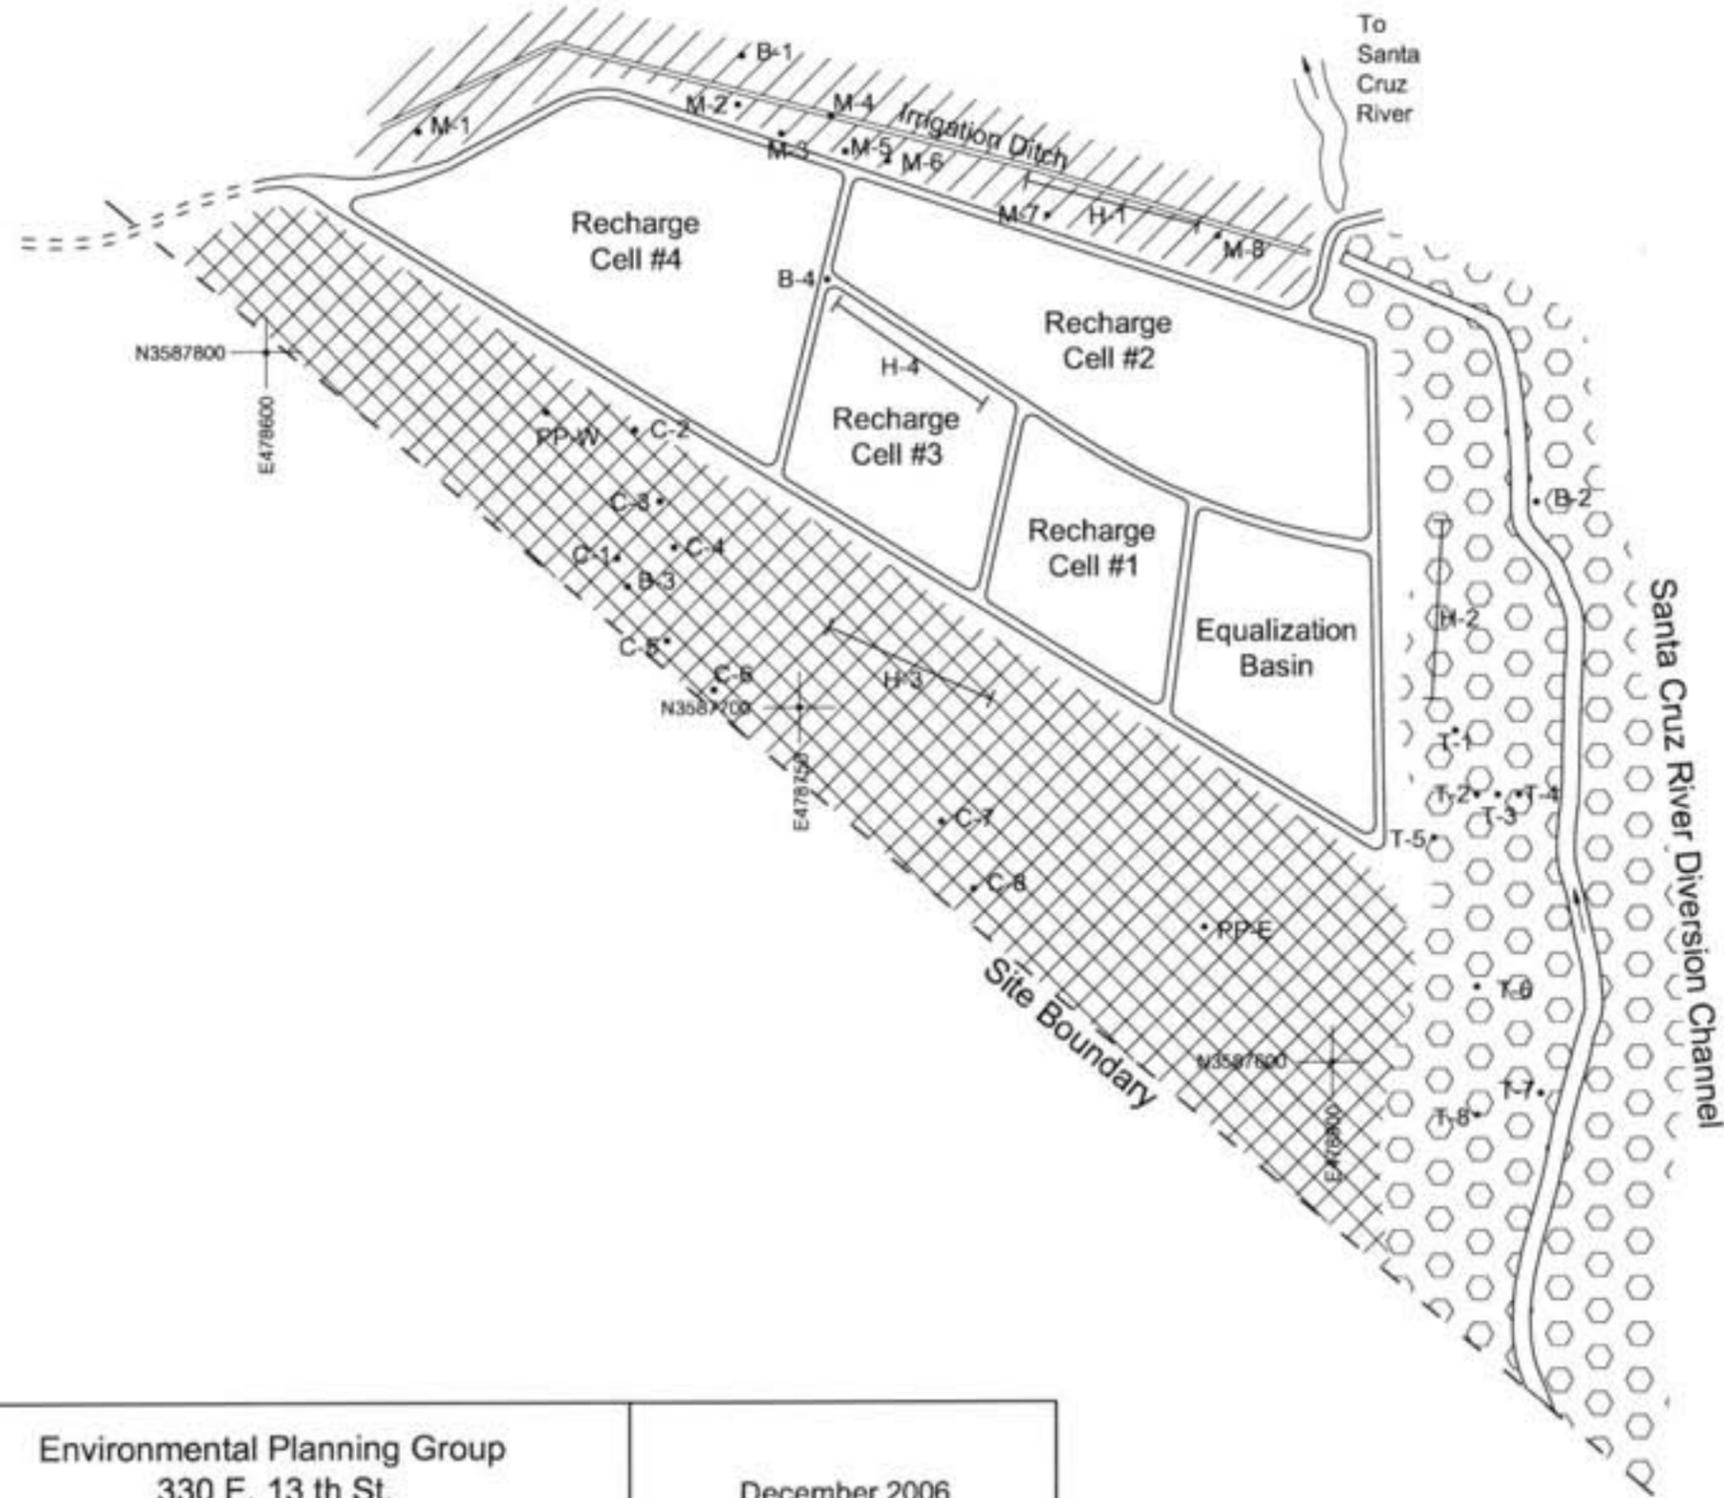
Eight vegetation sample points were selected in each of the three habitats dominated by relatively undisturbed, natural vegetation (Figure 2). Each point selected in this random process was used as the center point of a 4 m by 4 m plot, with an area of 16 sq. m.

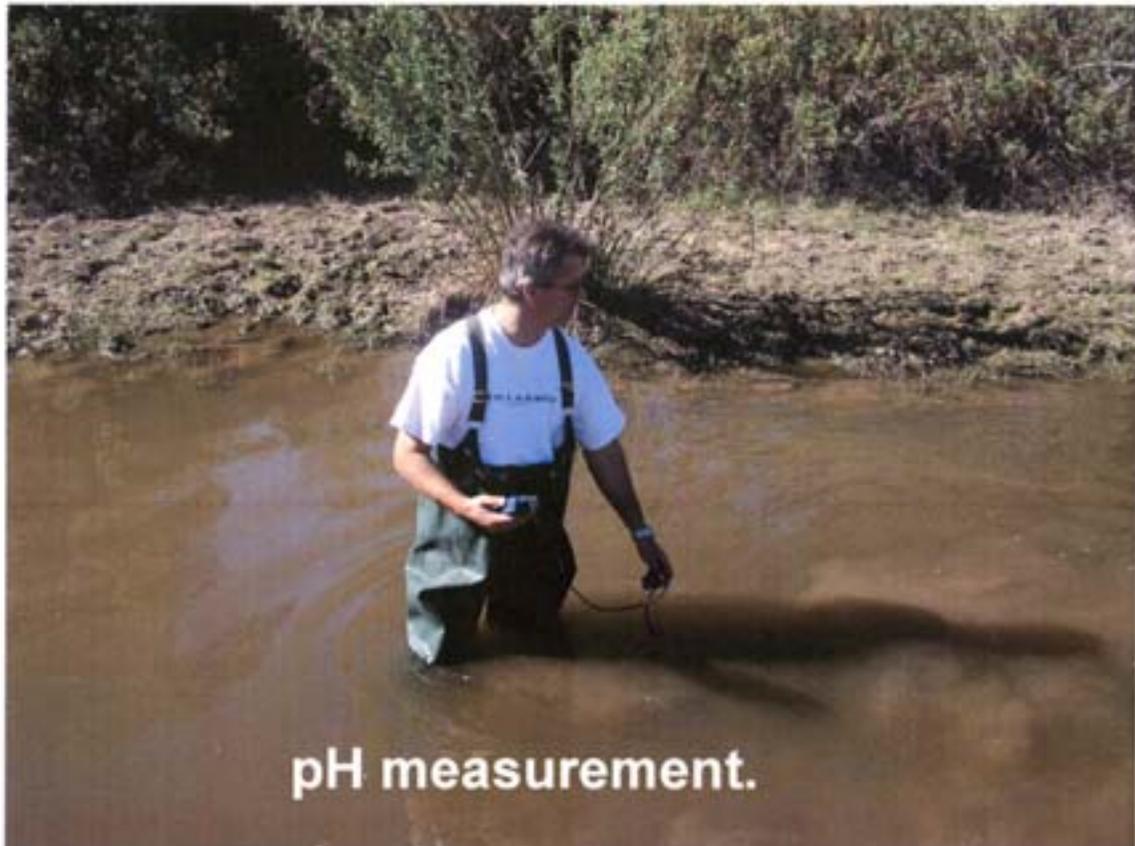
Figure 3. Measuring pH in the diversion channel.

Field temperature and oxygen measurement of the water were made using YSI Model 85 and YSI Model 58 temperature-oxygen meters. Water pH was measured with a YSI Model pH100 meter (Figure 3). Stream bed conditions were described and field measurements were made in accordance with Arizona Department of Environmental Quality guidelines described in "Biological Sampling Protocols: Reference Site Selection and Sampling Methods" (Meyerhoff and Spindler 1994).

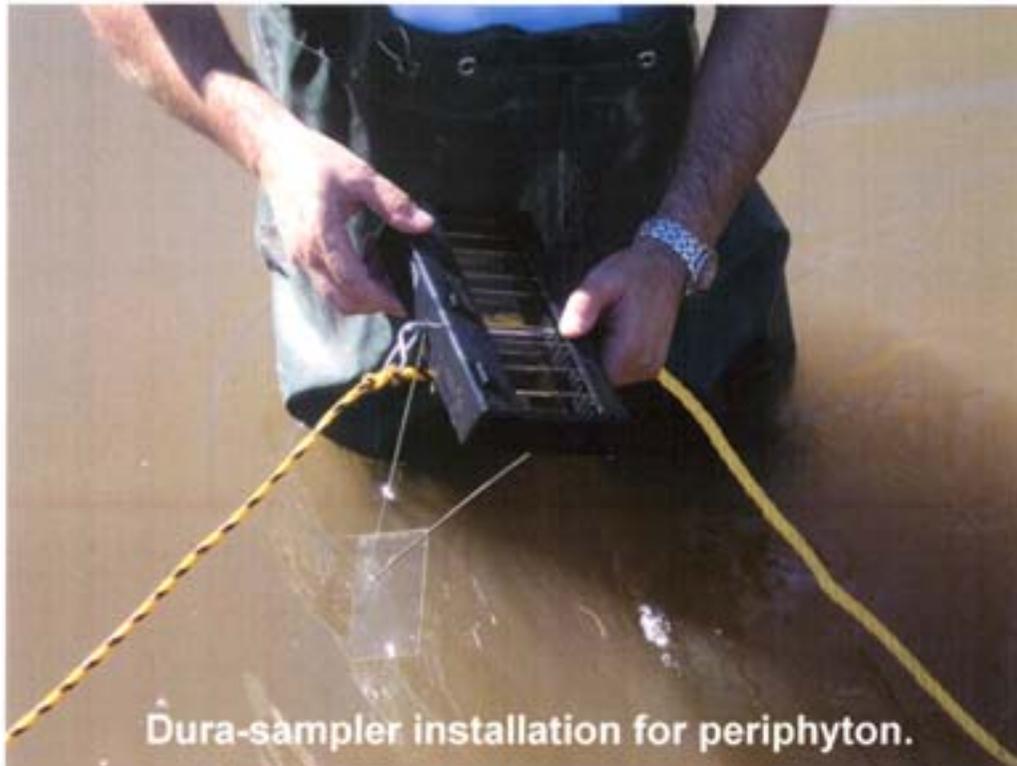
Figure 4. Periphyton Dura-sampler apparatus installation.

Periphyton samples were collected upstream and downstream using variable-depth Dura-sampler artificial substrate samplers (Figure 4). Each unit was fitted with five 25x75 mm glass slides as the colonization substrate. Hestor-Dendy samplers were also installed at upstream and downstream sites to serve as artificial substrate for both macroinvertebrates and periphyton (Figure 5). The units were exposed to the flowing water for one week. Collected material was prepared for microscopic examination using burn mount techniques. Periphyton species densities were computed using ocular micrometer surface area measurements.

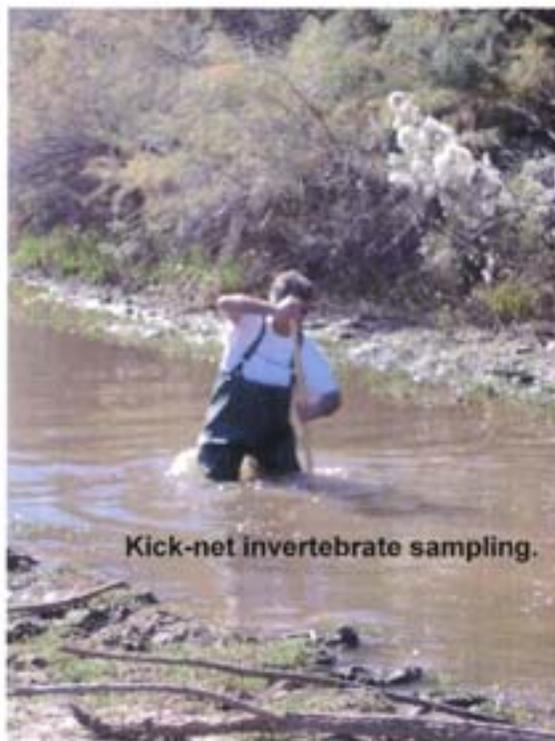
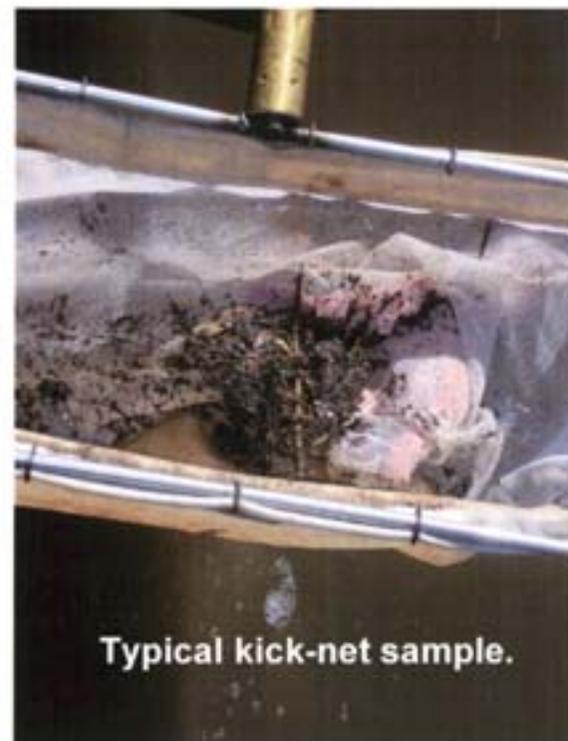
Figures 6 and 7, kick-net sampling and sample.

Aquatic Consulting and Testing, Inc. performed sampling for aquatic invertebrates on November 8, 2006. Stream macroinvertebrates were surveyed using bottom kick net (900-um mesh) collections (2x30-second duration) at each location (Figures 6 & 7). Samples were preserved with alcohol-formalin solution. Initial identifications were made using McCafferty (1998), Thorp and Covich (1991), and Arnett (1993).

Kick-net invertebrate sampling.

Typical kick-net sample.

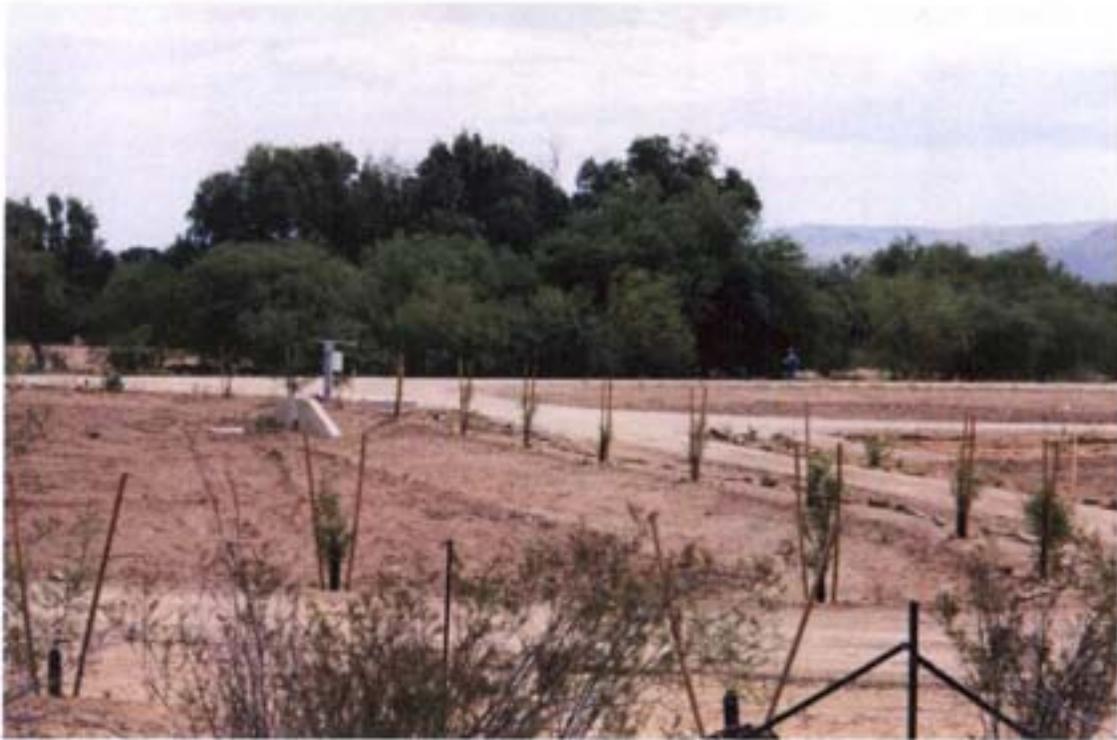
Figure 8. The east end of recharge cell 4, photographed on May 1, 2002. Note the perimeter plantings and the total lack of vegetation in the basin interior.

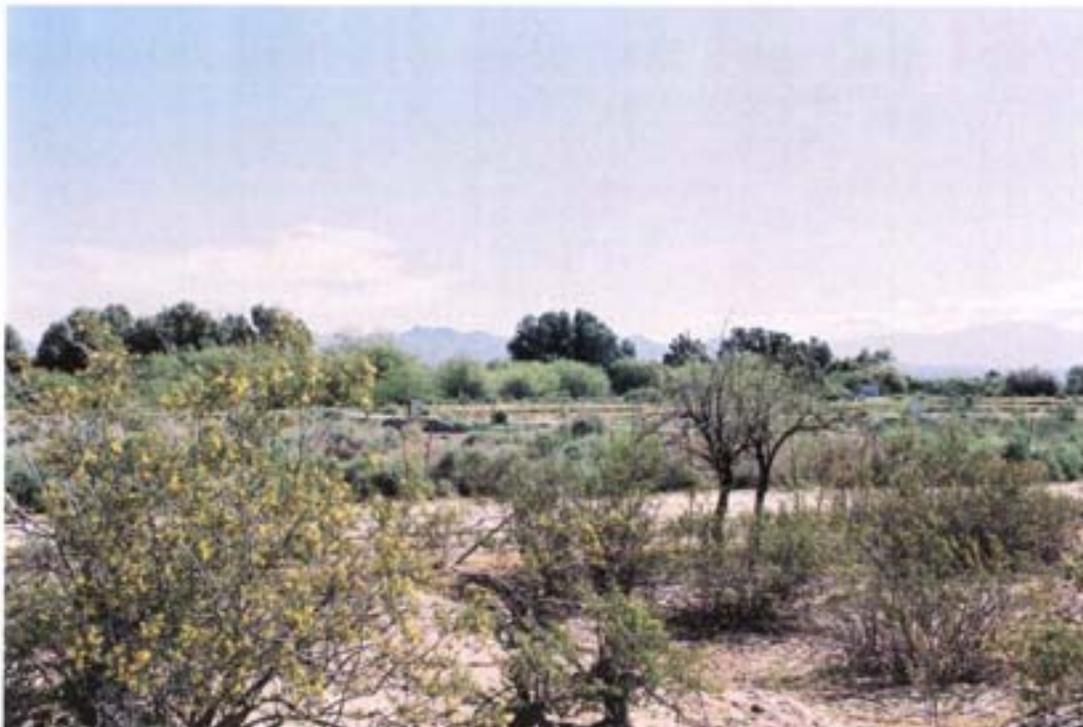
Figure 9. The east end of recharge cell 4 photographed on April 9, 2004. Note the establishment of saltbush species.

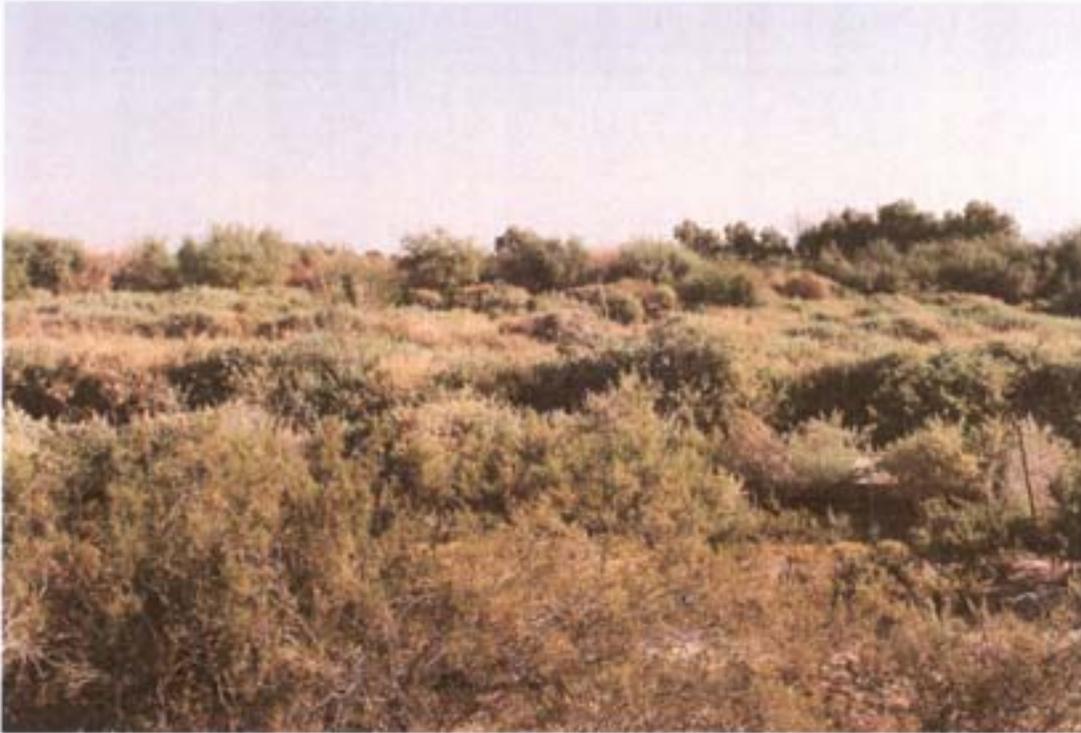
Since the last monitoring effort in 2004 there has been a large increase in density and size of vegetation in the recharge basins, particularly in Cell 4, which contains a different suite of plant species, primarily saltbush (*Atriplex* spp.), than is found in other areas of the project. Other cells contain a variety of primarily annual plants, most of which are grass species. Because of these recent changes in vegetation, butterflies documented in the recharge basin area were also recorded as occurring in a separate, though yet uncategorized, habitat.

Figure 10. The east end of recharge cell 4, photographed on September 22, 2006. Note the almost total coverage of vegetation in cell, some saltbush plants are over two meters in height.

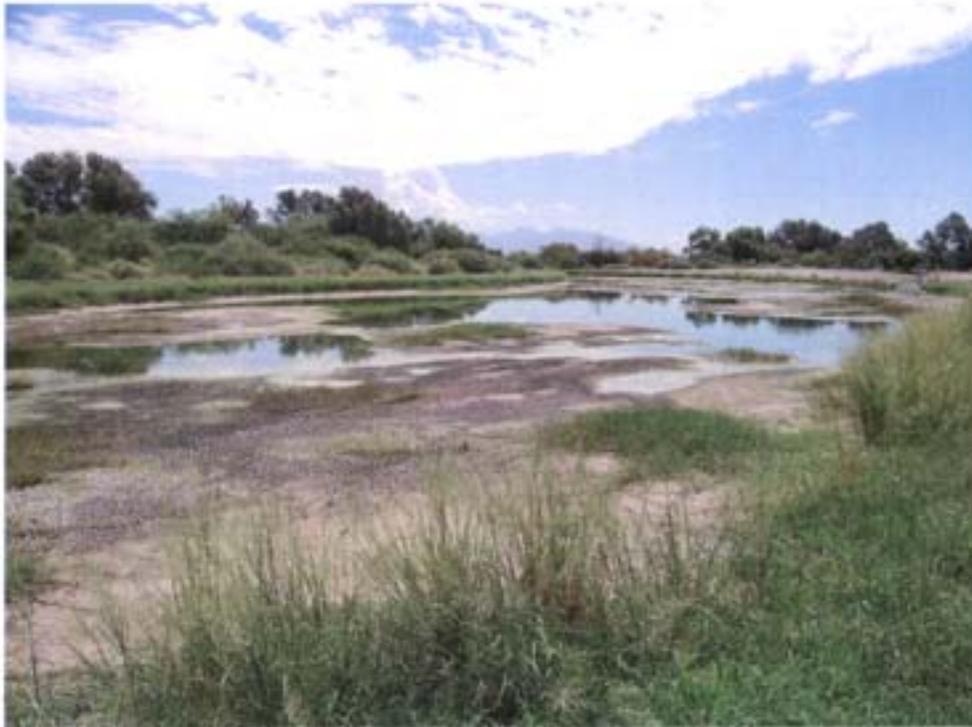
there was very little water in recharge cells 1, 3, and the equalization basin. There is no evidence of the establishment of any emergent plant species in the recharge ponds at this time; however, the increased activity of aquatic bird species at the site is likely to provide a method of introduction of emergent vegetation seed. Many of the trees planted on the pond berms appear to be established, although a few have died since being planted in 2002.

Figure 15. Equalization basin photographed on July 19, 2006, showing grasses on embankments, and initial colonization of the bottom.

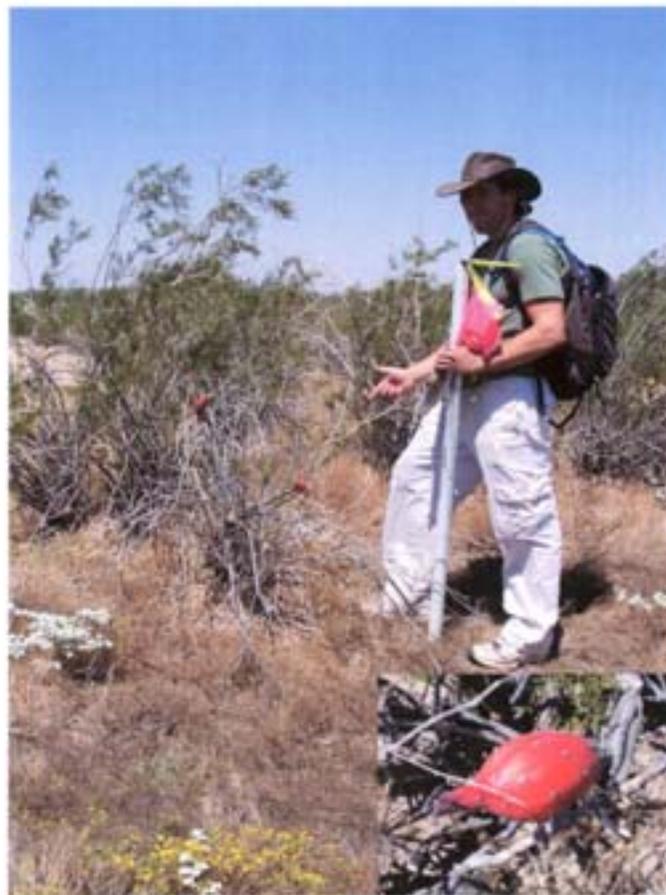
An additional 10 species of plants were added to the site plant list in 2006, including a single night-blooming cereus (*Peniocereus greggii*) in the creosote bush habitat (Figure 16). Some of these species are likely to have been present on the site previous to 2006, but since formal plant surveys are not a component of the project studies, they may have been overlooked. A couple of these species screwbean mesquite (*Prosopis pubescens*) and Wislizenus senna (*Senna wislizenii*) had obviously been planted during the original site landscaping. Some of the newly recorded grass species, mostly from the recharge basin area, have probably been recently introduced. Buffelgrass (*Pennisetum ciliare*), a recently listed Arizona Department of Agriculture prohibited noxious weed species is just beginning to appear on the project site as a few small, isolated clusters. Active control of this species is recommended to preclude it from taking over portions of the site.

Figure 16. Night blooming cereus (*Peniocereus greggii*) in the creosote bush habitat on the site. The inset is a close-up of the mature fruit.

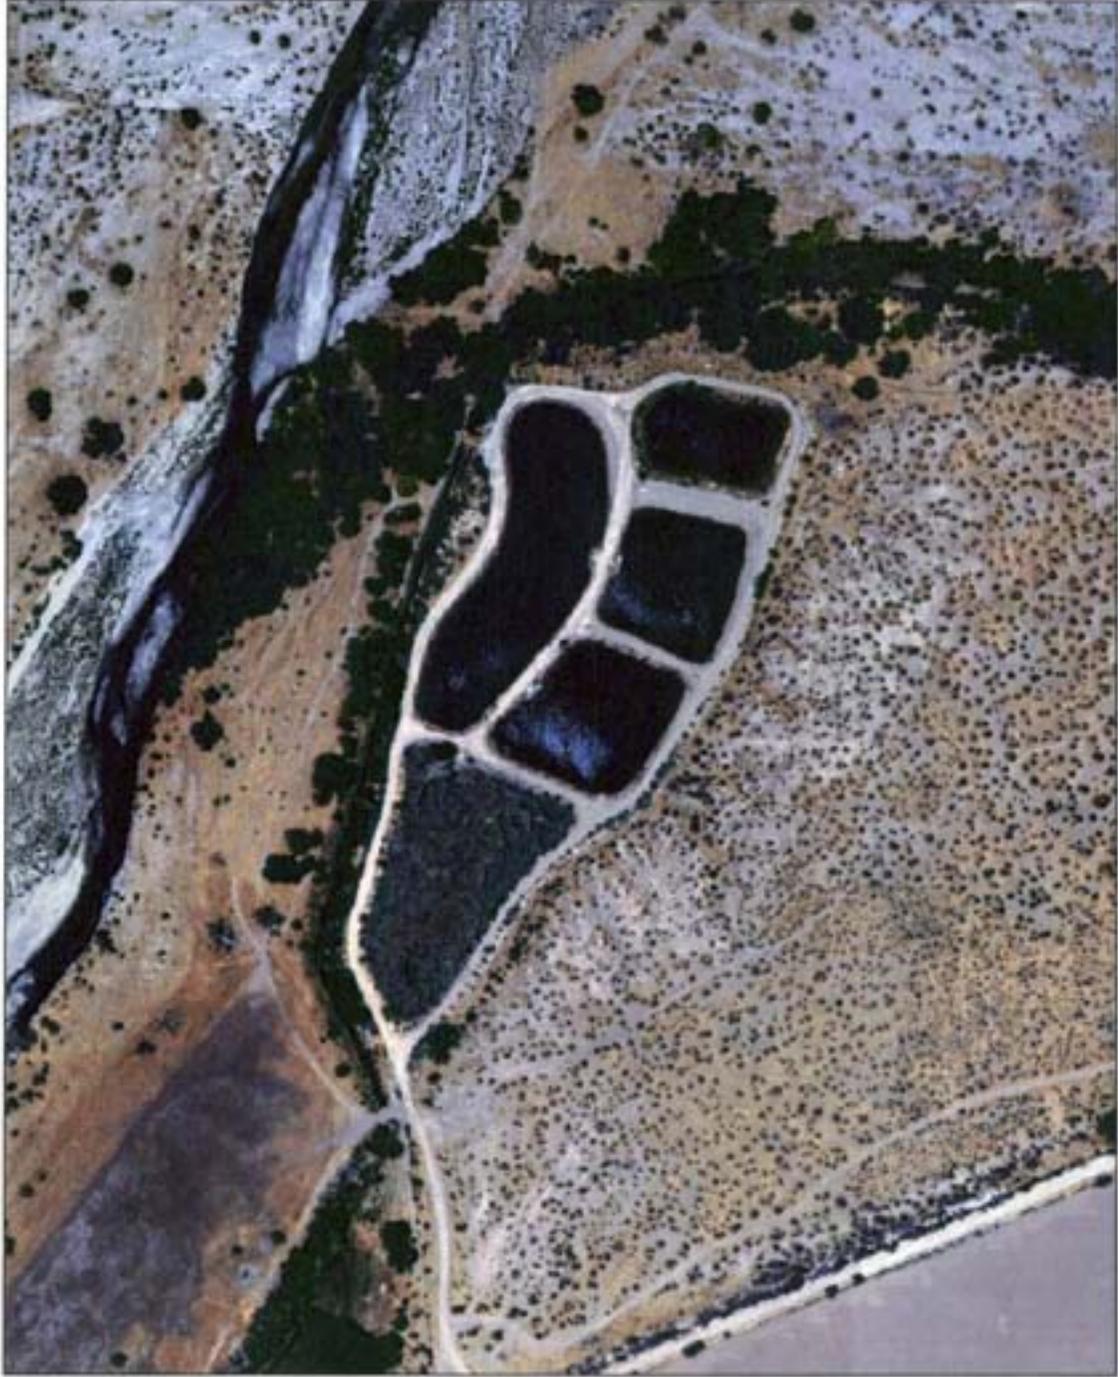
Aerial Photograph 2006

By 2006 (Figure F-3) significant changes in vegetation are apparent on the project site since initiation of operation of the facility in 2002. Recharge basin 4 has become densely filled with vegetation, primarily saltbush plants (Figures 10 and F3). There are crops of annual grasses and other plants around the perimeter of the other recharge basins and the equalization basin (Figures 15 and F-3), and that seasonally fill the bottom of the structures in times between recharge events. The trees planted around the perimeter of basins are larger although there was a loss of some of the plantings. Vegetation along the diversion channel and the irrigation ditch has also visibly increased in size and density with some recruitment evident.
