Revegetating Abandoned Farmland in the Cienega Creek Natural Preserve, Pima County, Arizona

Background

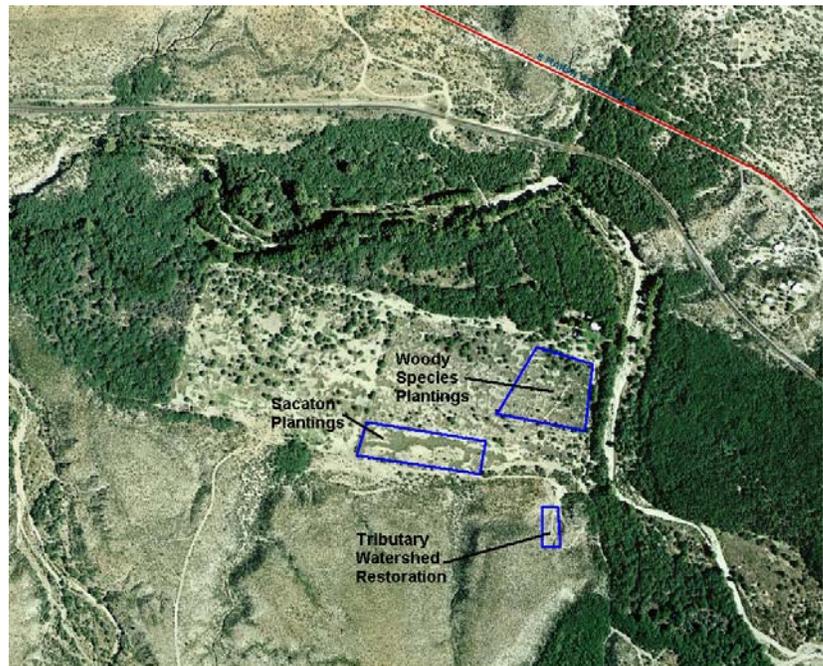
PARTNERS FOR WILDLIFE PROJECT

2002 Aerial Photo from Pima County MapGuide

scale 1 : 13,800

Wright's sacaton, a native grass to the area, was planted by the District in August 1996 with assistance from local volunteers. Water was provided over the course of a few days to help supplement rainfall during the establishment period. Studies conducted by Ron Tiller, University of Arizona, indicated a success rate of 74 percent for the establishment of the grasses.

Woody species that were planted in November 1997 included velvet mesquite, catclaw acacia, netleaf hackberry, desert willow, little-leaf sumac, graythorn, saltbush, wolfberry, and elderberry. Drip irrigation was provided to the majority of the plants over a two-year period. A ten-year monitoring program was initiated for the project in 1998, which included monitoring annually for survival and recruitment in July and photo point monitoring in October to determine relative growth rates. Approximately 60 percent of the plants located within the monitoring plots have been successfully established through 2006. Some of the attrition occurred during the 2002-2004 drought.

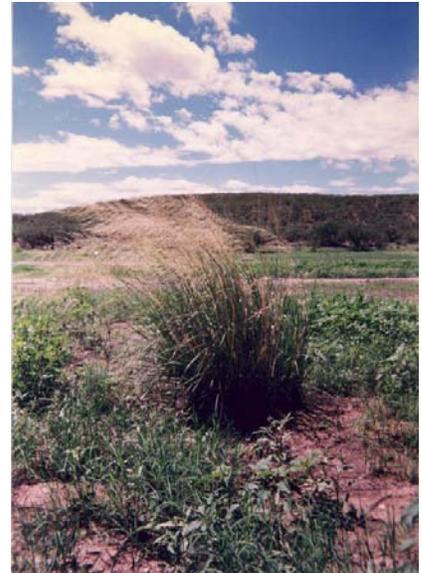
Wright's sacaton (*Sporobolus wrightii*)

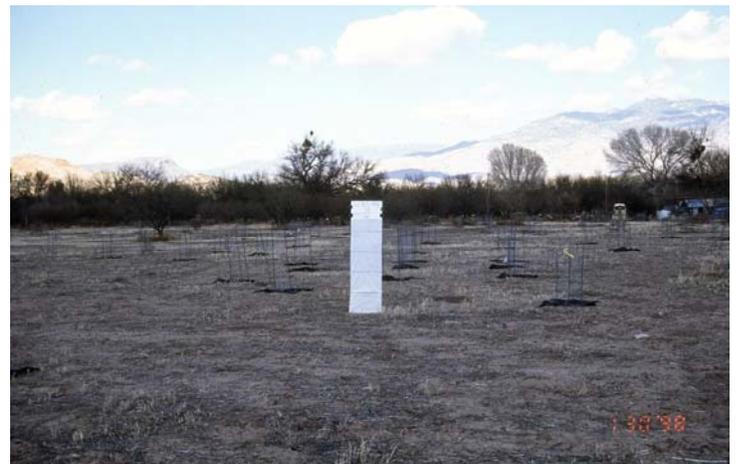
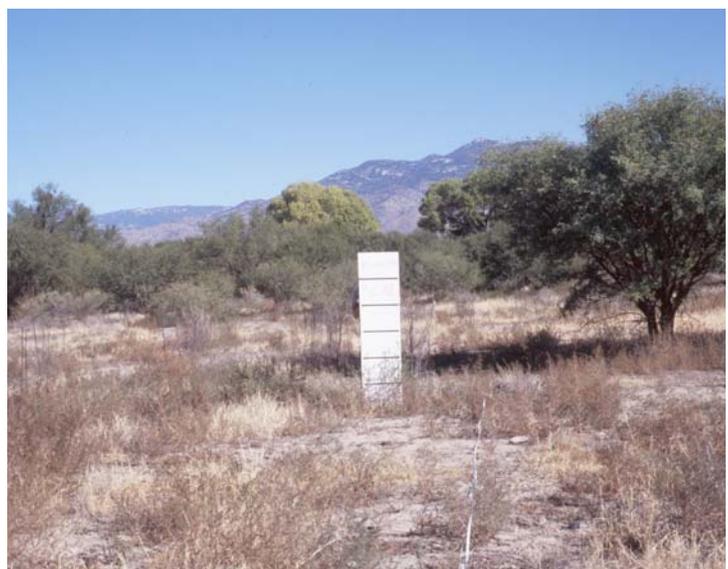
Photo point monitoring at the Partners for Wildlife Project, Southeast Plot looking north – January 1998 photo above, October 2004 photo below

Overall, the project has been successful in reintroducing species that were formerly prominent in the area and increasing the species diversity and structural diversity of vegetation. However, the project has not accelerated natural recruitment of the woodland community at this site. Seed availability is not the likely constraint. Periodic soil-moisture deficits and the dominance of Bermuda grass and other non-native weeds are the main factors for limiting native plant establishment. Efforts to restore the tributary watershed have been successful in changing the channel from a down-cutting, V-shaped arroyo to a wide, meandering channel with associated terraces.

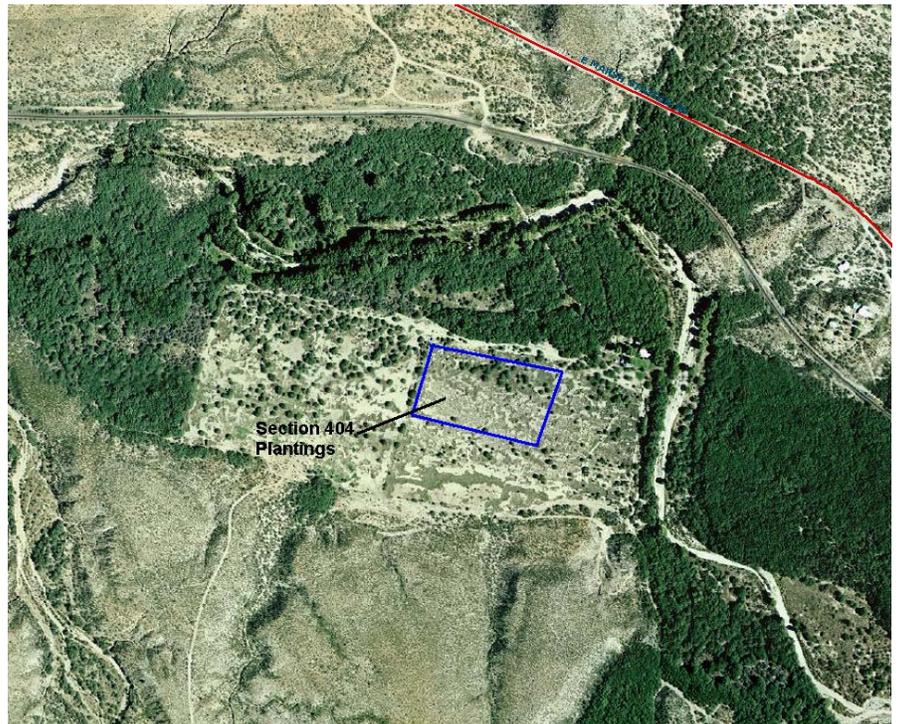
SECTION 404 MITIGATION PROJECT

2002 Aerial Photo from Pima County MapGuide

scale 1 : 13,800

The Section 404 Mitigation Project was developed solely by the District as off-site mitigation for impacts to jurisdictional waters of the United States resulting from the construction of soil cement bank protection along the Santa Cruz River. The project covers approximately 5.5 acres and includes the same species as those planted in the Partners for Wildlife Project. Drip irrigation was provided to the plants over a two year establishment period.

Monitoring of the project was conducted by Westland Resources in January 1999. Approximately 92 percent of the one hundred plants encountered within three monitoring transects had survived over the two-year establishment period. Woody plants accounted for only 10 percent of the canopy cover, mostly from volunteer mesquite trees. Invasive, non-native weeds still provide most of the cover found at this site.

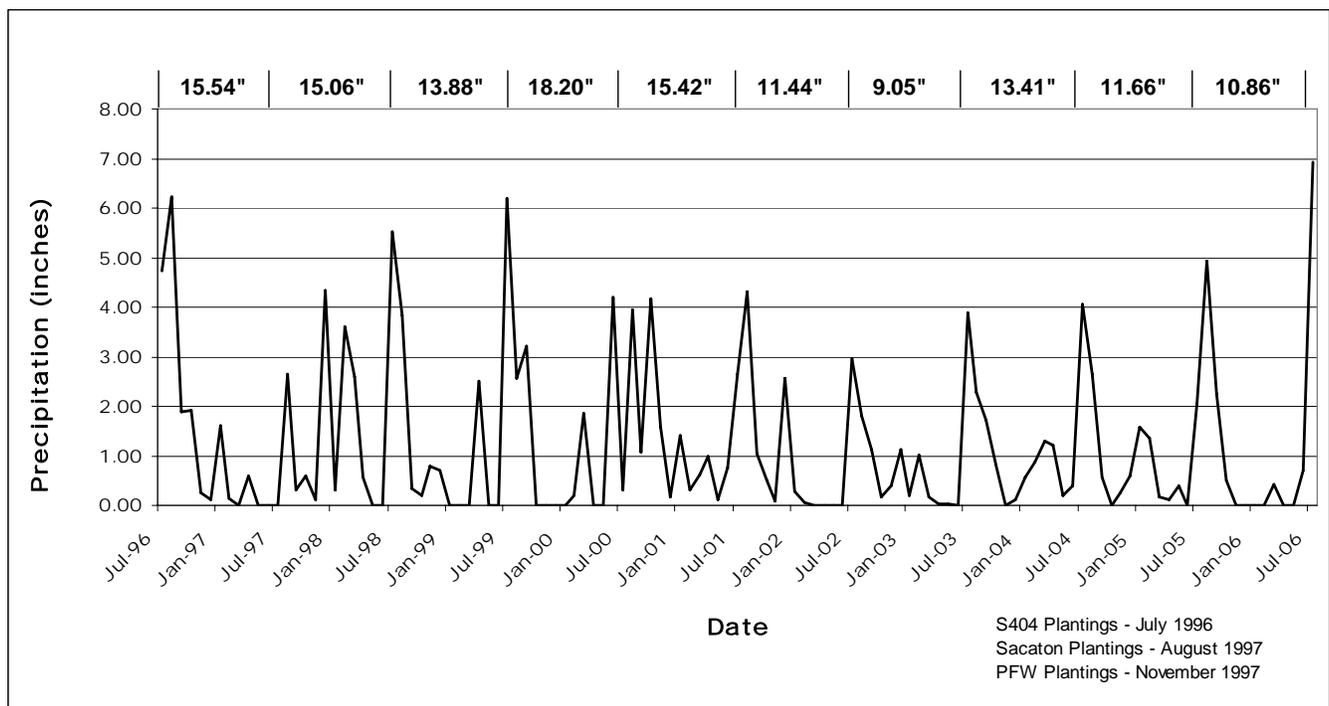
Monthly rainfall at the project site from July 1996 - July 2006 (Annual, July-June, averages on top).
