**Ruthrauff Basin
Management Plan
Existing Conditions Analyses
Final Report**

Appendix A to the DRAFT TSDN

Prepared for:
Pima County Regional Flood
Control District

Prepared by:
Stantec Consulting
5151 E. Broadway, Suite 400
Tucson, Arizona 85711

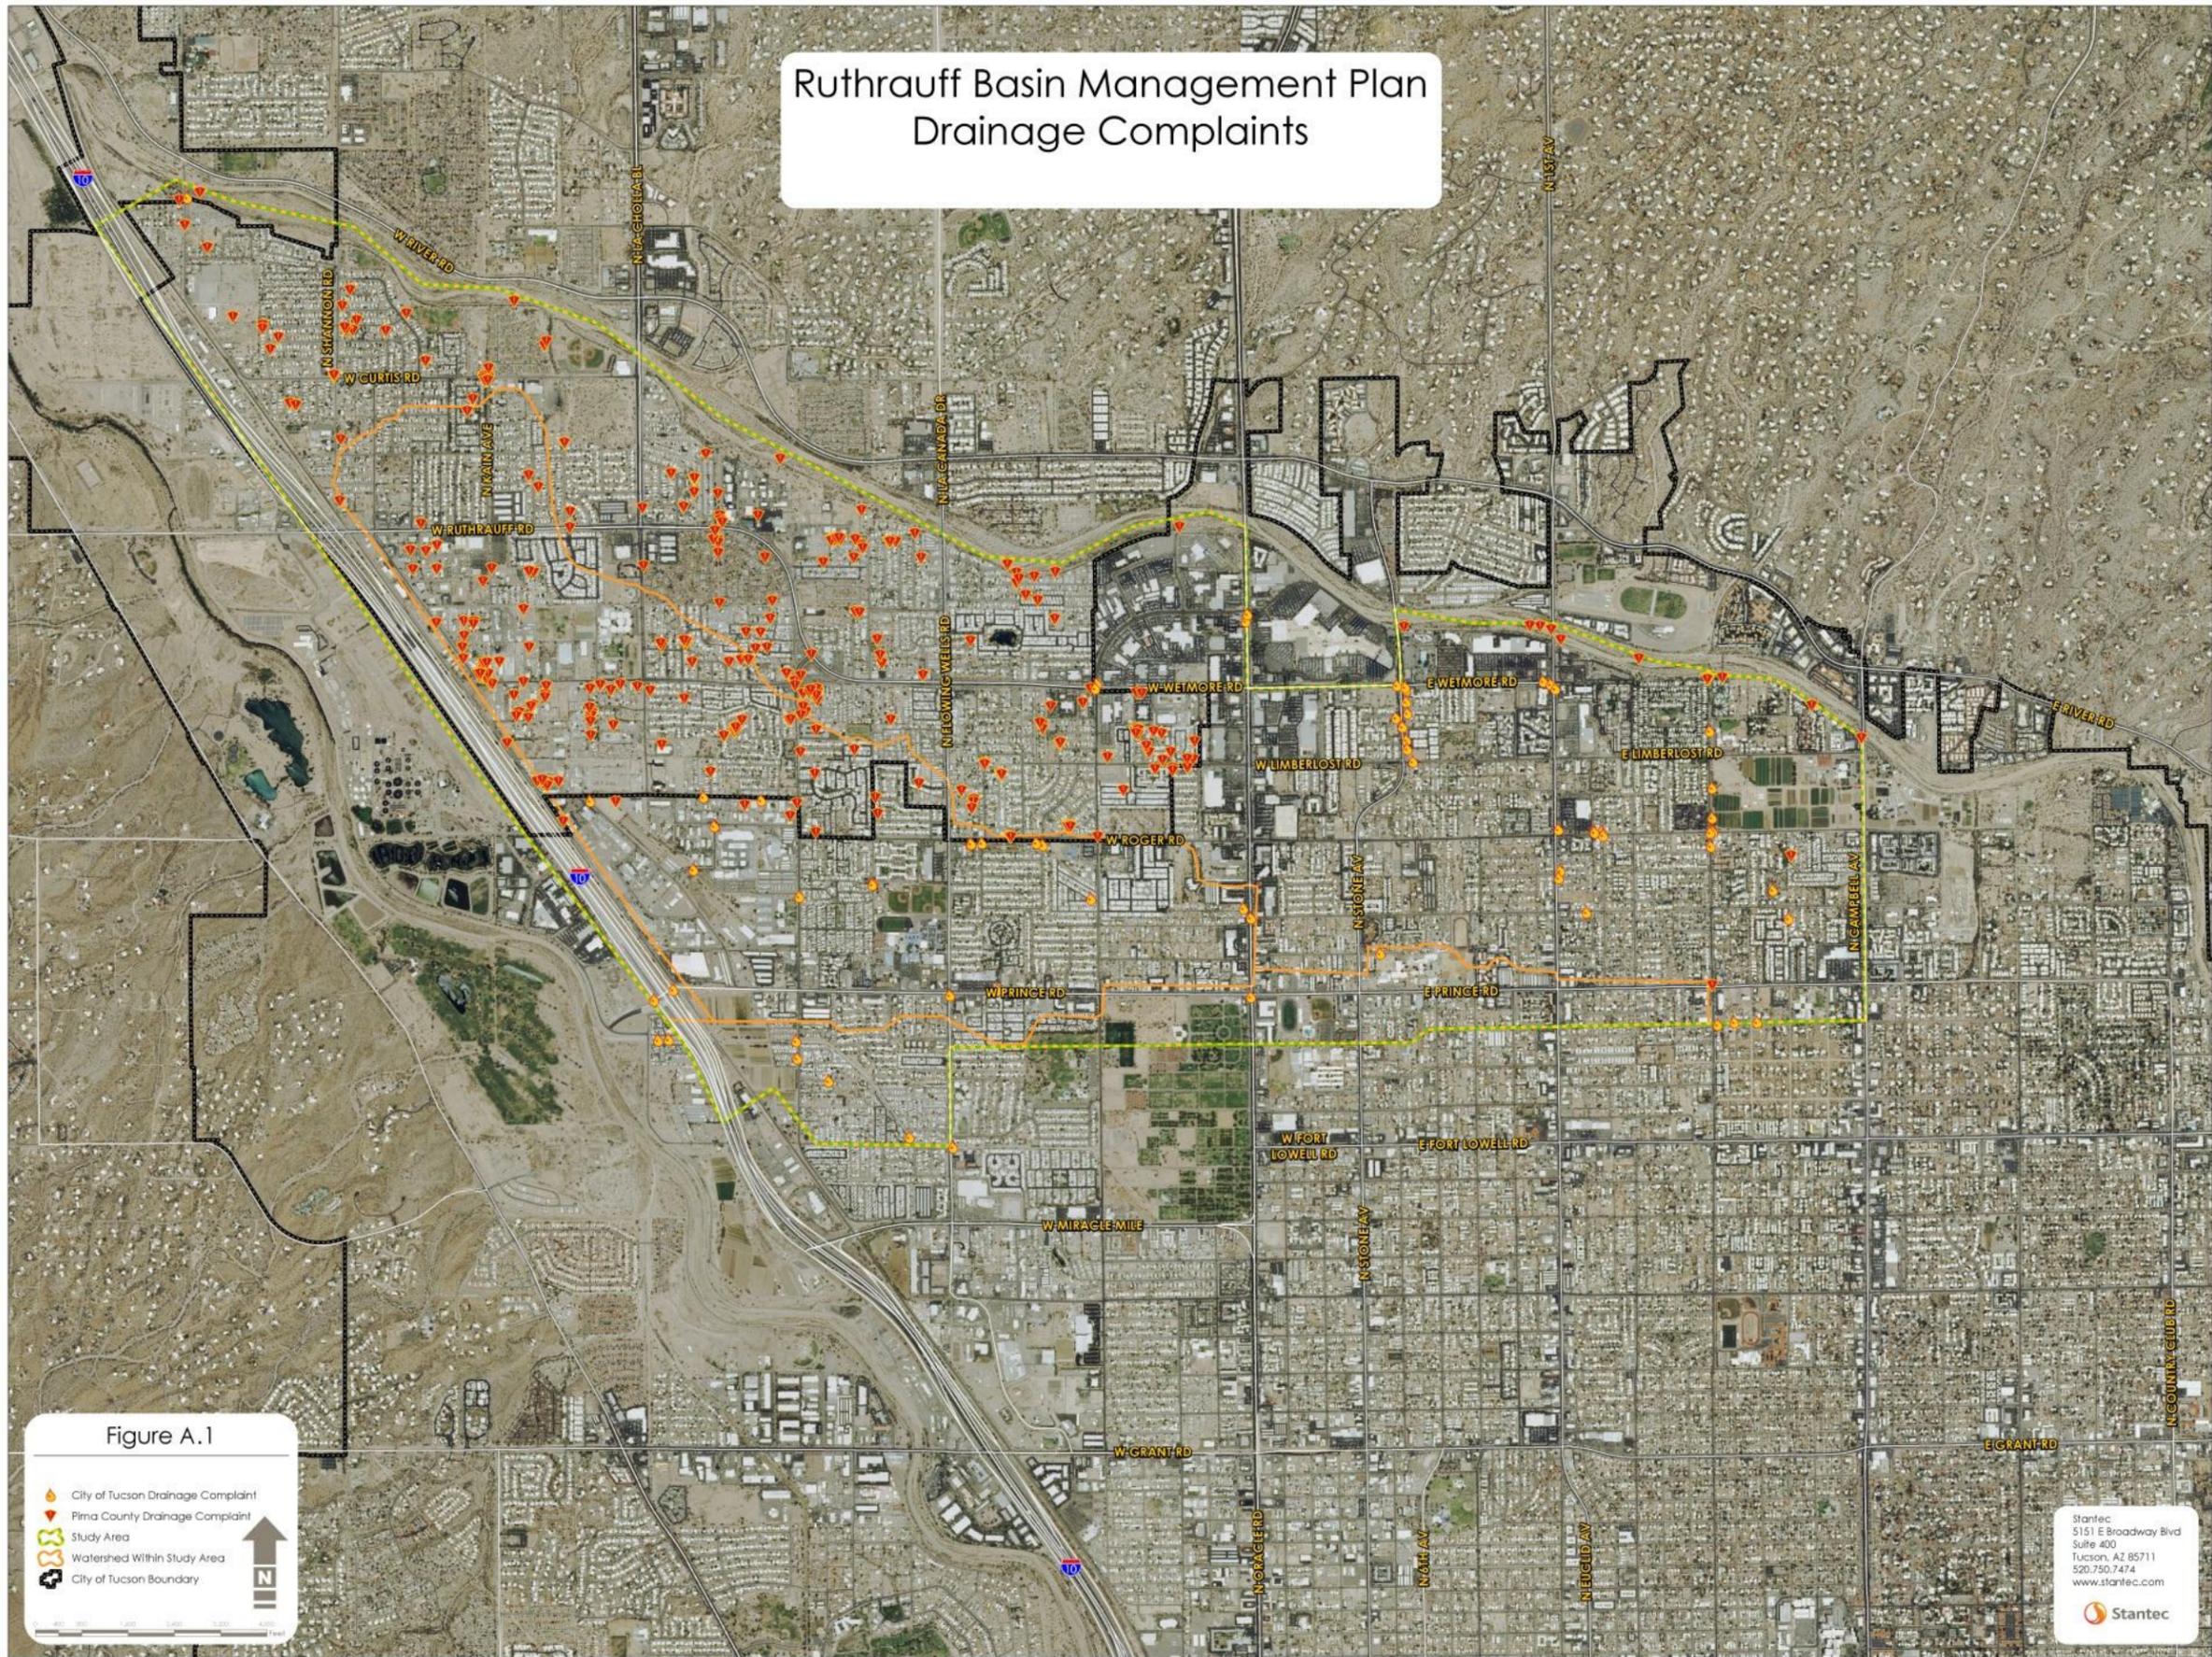
Figure A.1

Drainage complaint records were obtained from the RFCD and COT Planning and Development Services and the Department of Transportation. Exhibit A.1 shows the locations of all the documented drainage complaints. The complaints go back to 1990 in the County and 2008 in the City. Approximately 340 complaints are in the County and approximately 70 complaints are in the City within the study area. Approximately 80% of all the complaints are related to private, lot to lot drainage problems and are not applicable to the scope of the current study. Exhibit A.1 shows the locations of all the documented drainage complaints. ArcGIS shape files with spatially referenced drainage complaint descriptions is provided in the Data Collection Summary CD.

Ruthrauff Basin Management Plan Drainage Complaints

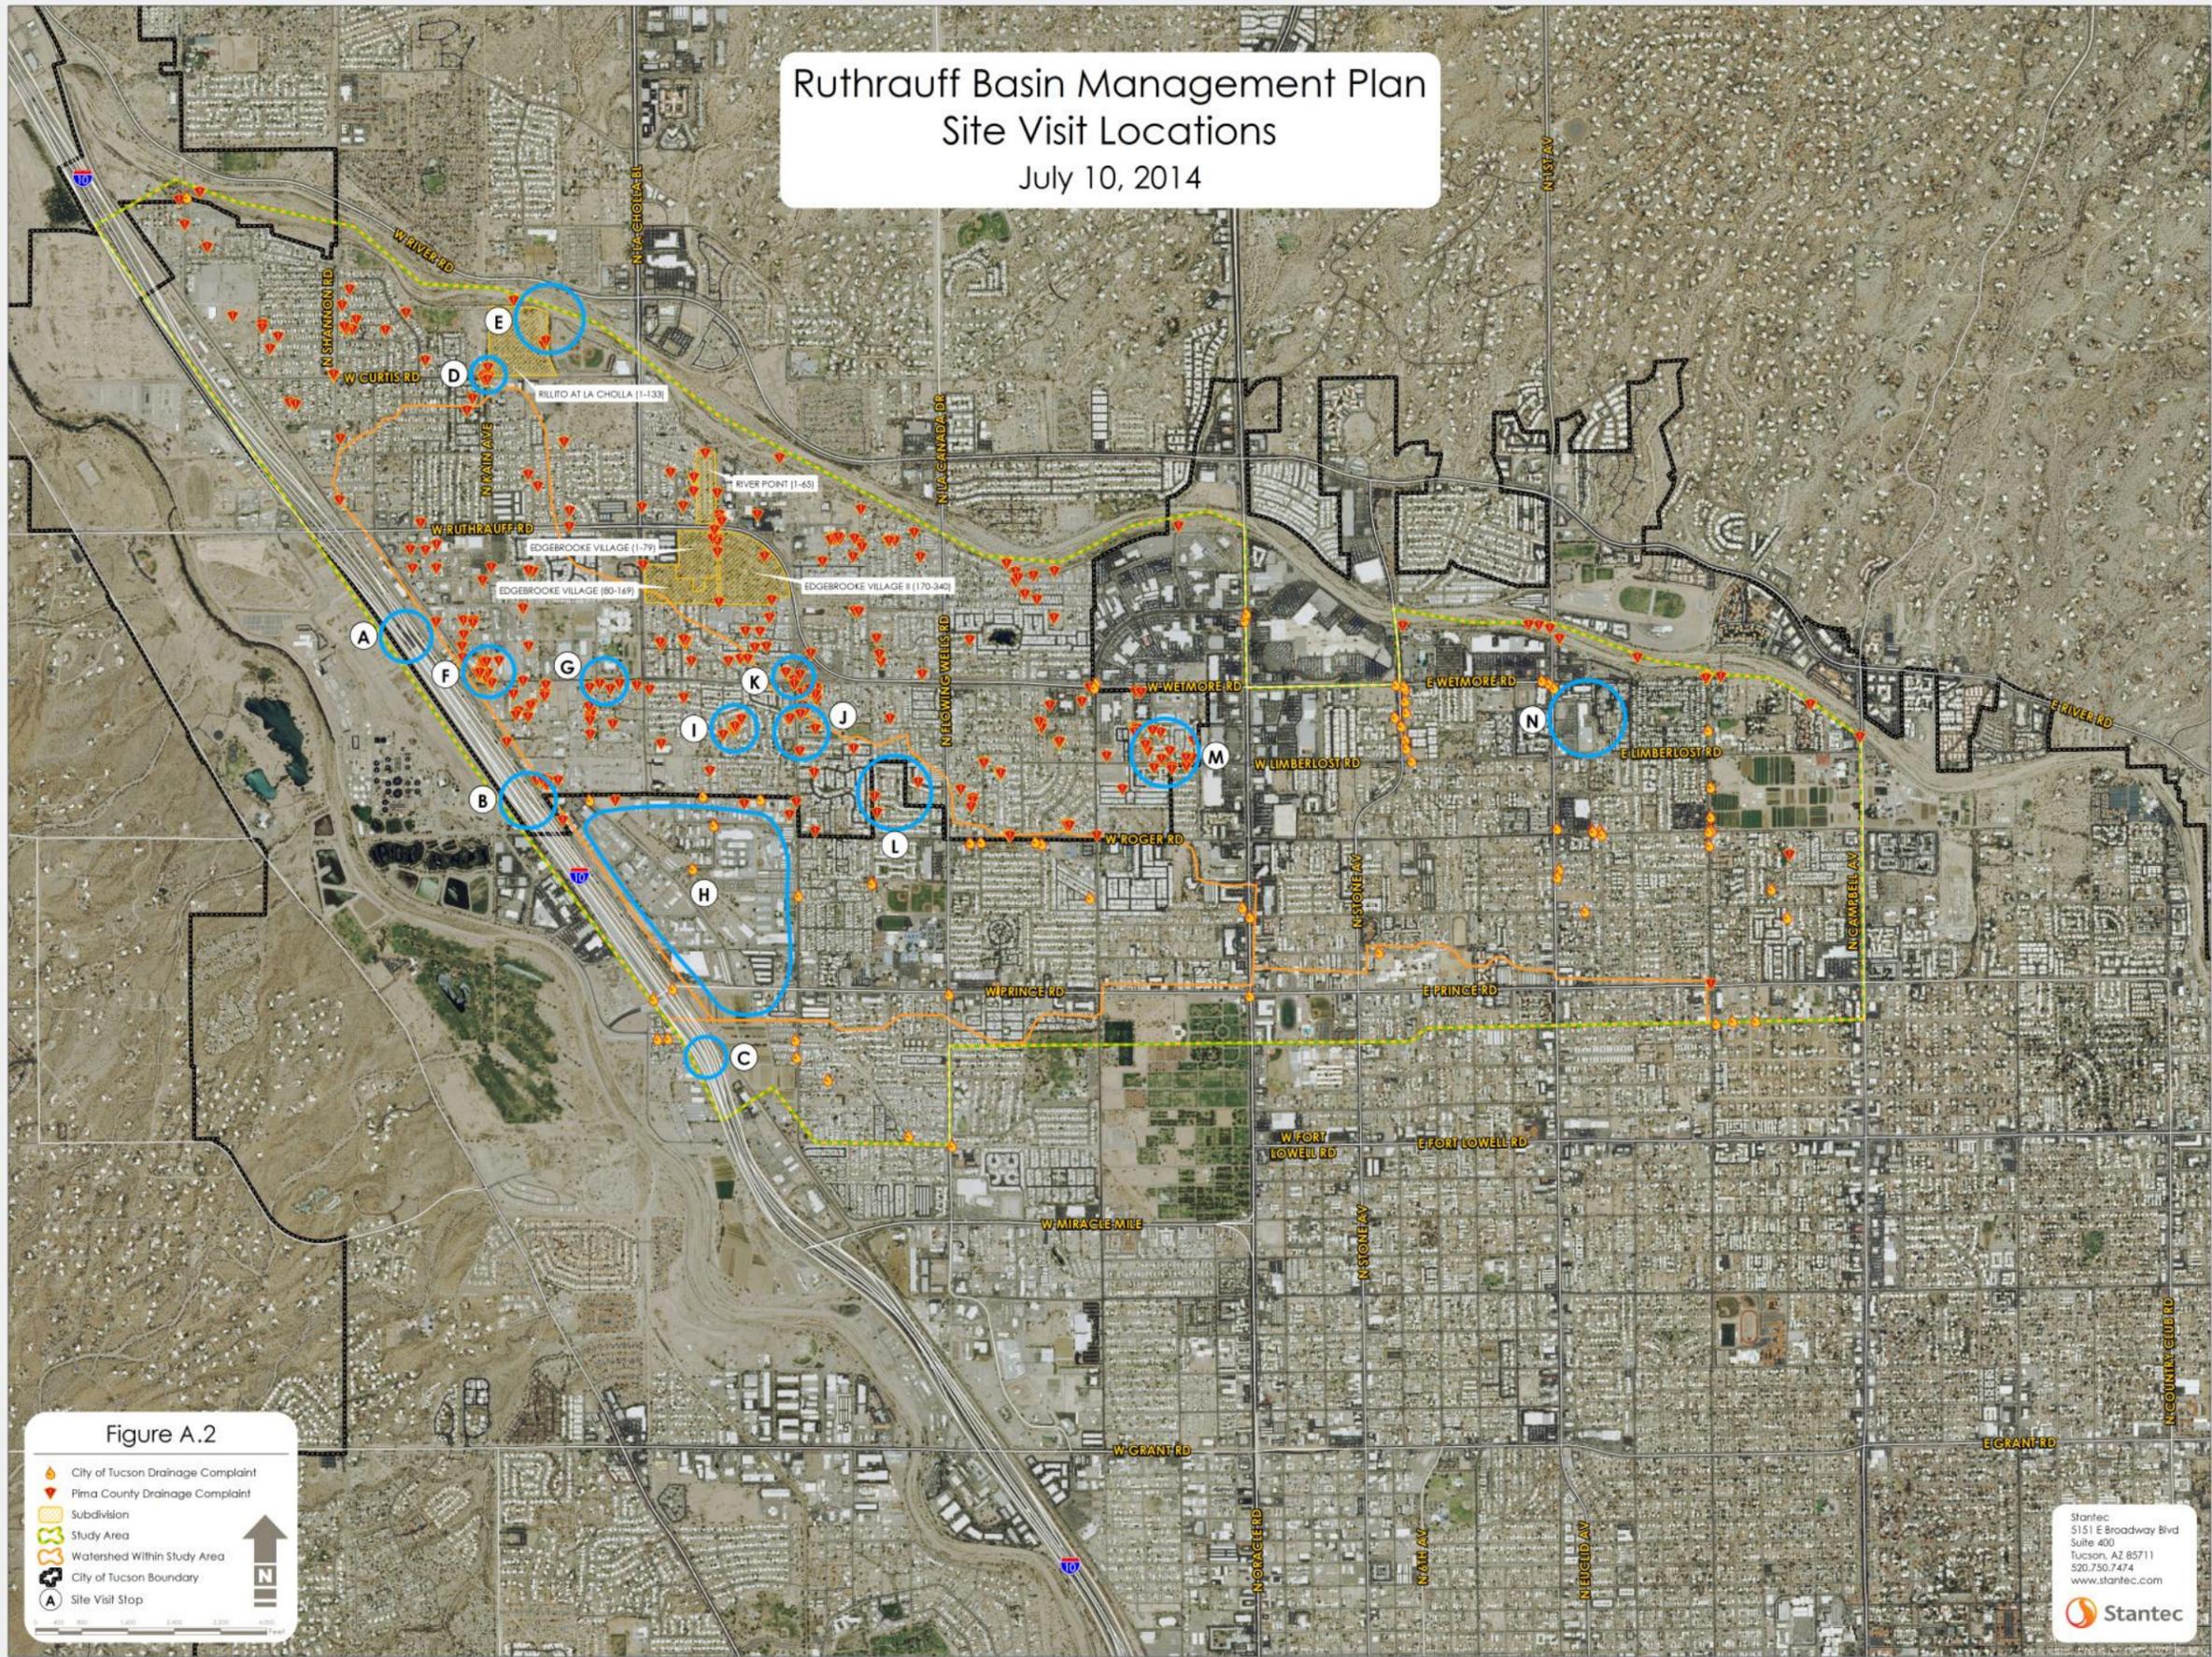
Ruthrauff Basin Management Plan Site Visit Locations July 10, 2014

Site Id	Location	Discussion
A	I-10 and ROMP Culvert (outlet)	ROMP channel completion planned in future, ROW acquisition in process. Ponding water observed at I-10 culvert outlet and within channel. Erosion observed at top of riprap bank protection. I-10 culverts constructed (two closed interim), railroad culverts constructed.
B	I-10 and Gardner Lane Culvert (outlet)	I-10 culvert complete. Upstream railroad culverts will be constructed in the future.
C	I-10 and Flowing Wells Wash Culvert	I-10 culvert complete. Upstream additional railroad culverts to be constructed in the future.
D	Curtis Rd., Kane (alignment) Channel, outlet at Rillito	Ponding in streets and properties. Channel outlet is single pipe at Rillito.
E	Sullinger (alignment) Channel adjacent to Curtis Park, north of Curtis	Failed erosion control for tributary drainage. Sediment accumulation in the Rillito River at the outlet.
F	Wetmore/Highway Dr.	Flows from the east floods businesses/ponding along Wetmore and Highway Dr. No outlets at railroad. New development west and south of curve.

G	Wetmore/Plum	Low finished floors, ponding, small berms.
H	Gardner Industrial Park	Sheet flow throughout, existing AO Zone.
I	Root/Paseo Reforma	Ponding at intersection, no outlet.
J	Romero/Root Lane	Low finished floors adjacent to Romero, existing irrigation ditch.
K	Ruthrauff/Wetmore intersection	Intersection has been re-constructed, drainage issues may remain.
L	Pomona/Gardner	Irrigation ditch west side of Pomona, adjacent to mobile homes, No outlet at alley at Gardner.
M	Limberlost/14th Av.	14th Ave channel outlets at Limberlost stormdrain inlet. Grate inlet gets clogged.
N	NE Corner Limberlost/First Ave.	Existing commercial development detention basin outlet is inadequate. Ponding occurs on upstream properties Storm drain inlet is fabricated out of wood.

A site visit was conducted on July 10, 2014. The project team, including representatives from the RFCD, COT, Stantec, JE Fuller and Wheat Design Group were in attendance. This initial team site visit provided the opportunity for Team Members to become more familiar with the project area problems and existing conditions. This was accomplished by visiting 14 problem locations as identified by reviewing drainage complaints, interviewing Regional Flood Control District Maintenance and Floodplain Personnel as well as input from the City of Tucson. The site visit allowed the team to more fully understand drainage problem, identified additional data needs, and initiated discussions relative to potential alternative approaches for future considerations. Exhibit A.2 indicates the site visit locations; the drainage complaints are summarized on Table A.3. Table A.4 summarizes the Teams' observations during the site visit.

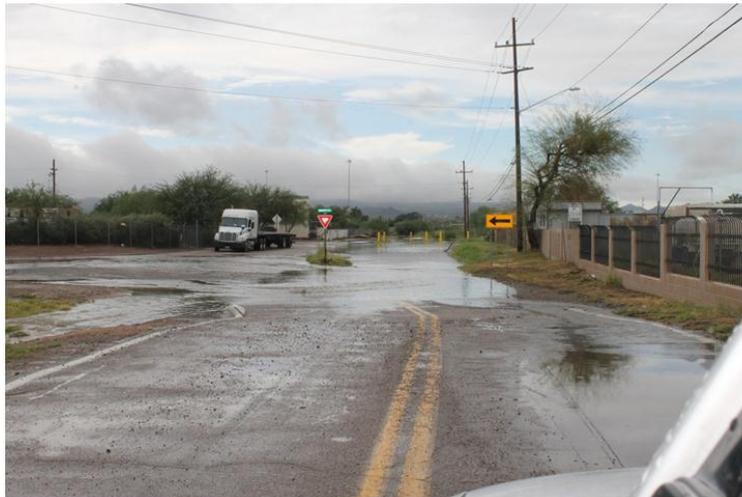
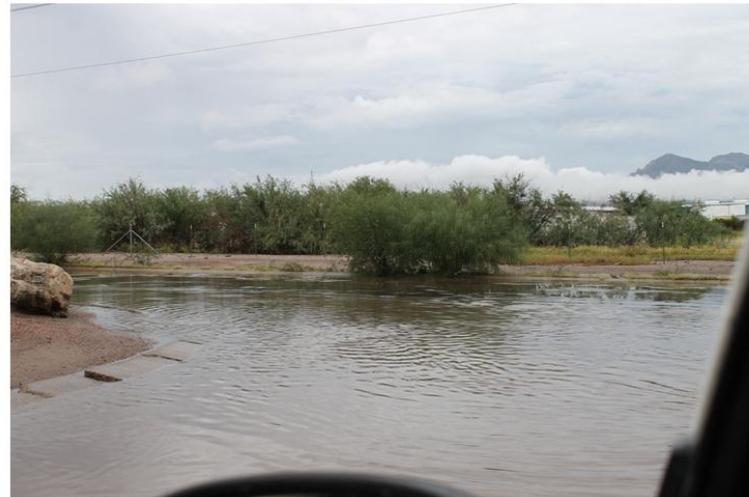
Figure A.4
Sheet 1 of 4

The Gardner Lane Industrial Park is located south of Gardner Lane and north of Prince Rd, between Romero Rd. and Interstate 10. The majority of this area is mapped as an AO Zone (1 ft. depth) on the currently effectively Flood Insurance Rate Map for Pima County and Incorporated Areas (Panel 04019C1669L, June 16, 2011), see Figure A.3. This area is primarily drained by an under-capacity channel along Gardner Lane which outlets to the west and the Union Pacific Railroad (UPRR) tracks. Currently flow is impeded by the railroad tracks and railroad spurs to the north, because no drainage structures exist. A future drainage structure is proposed at the UPRR at this location. This structure is expected to accommodate all 100-year flow concentrating at Gardner Lane and convey it to an existing, new structure under I-10. Photos were taken of the area during a significant rain event on September 8, 2014. Estimated 24-hour rainfall in the area was in excess of 1 inch. Photos are provided as Exhibit A.4.

Freeway (Gardner Lane) Industrial Park 9/8/2014

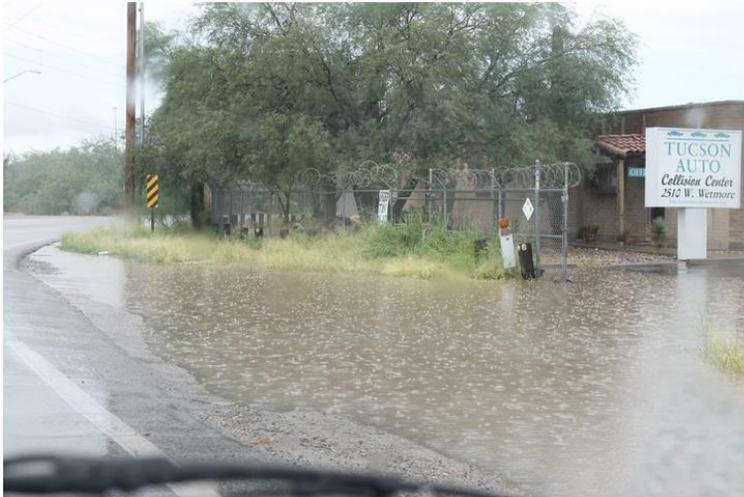
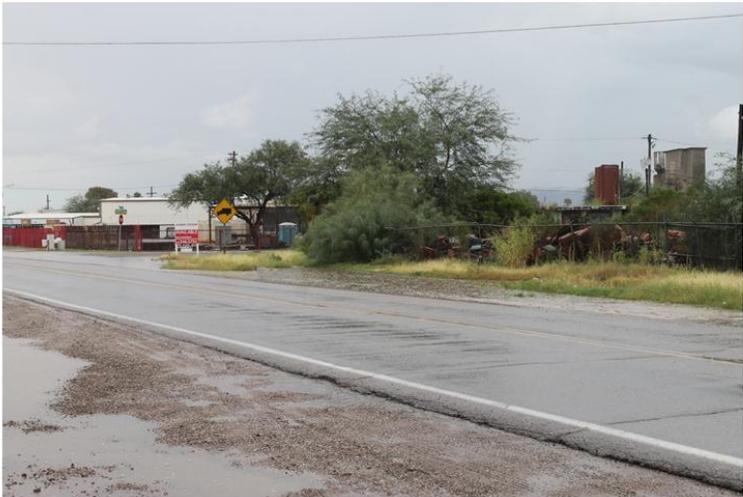
Figure A.4
Sheet 2 of 4

Several businesses have experienced flooding in the area. Ponding along Wetmore Rd. and Highway Dr. is prevalent.

Wetmore Rd. and Highway Dr. 9/8/2014

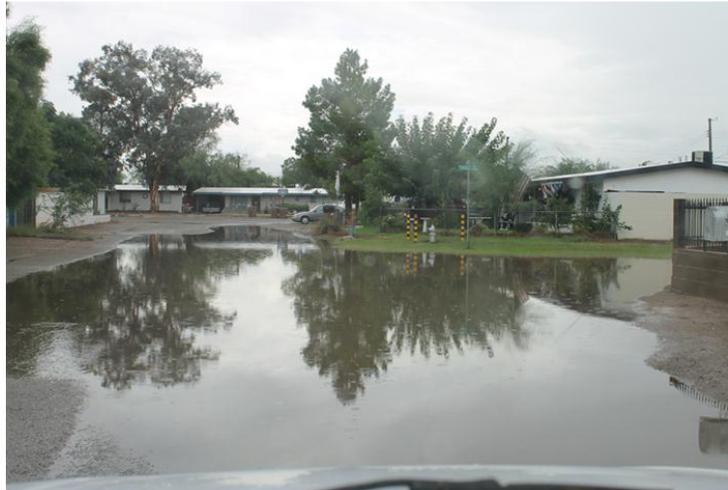
Figure A.4
Sheet 3 of 4

Root Lane is located west of Romero Rd. and south of Wetmore Rd. Due to inadequate conveyance to the west, runoff ponds at Root Lane and. Paseo Reforma. Homeowners have reported ponding depths above the street curbs. Photos from the September 8, 2014 event of this area are contained in Exhibit A.4. In addition, homes adjacent to Romero Rd. have low finished flows and portions of an old irrigation ditch have been filled in. One homeowner in this area has reported flooding.

Root Lane at Paseo Reforma 9/8/2014

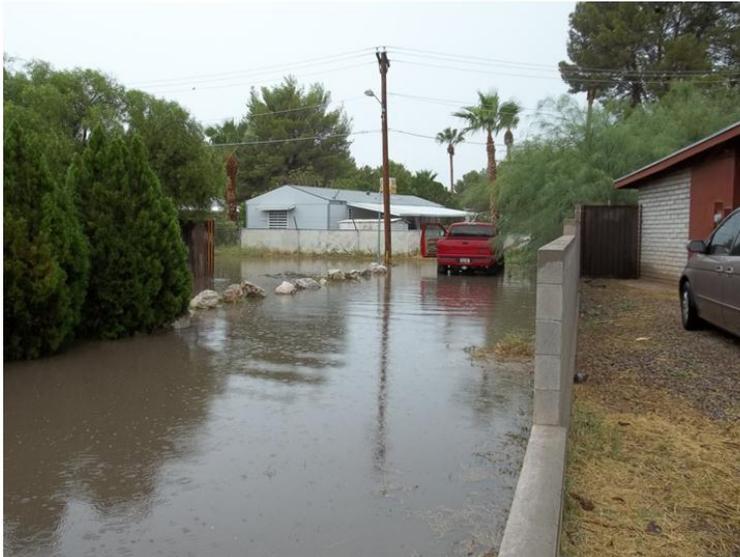
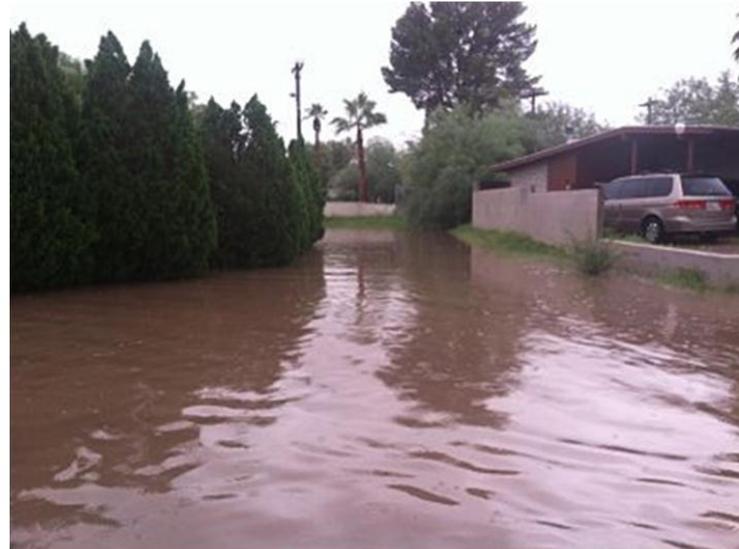
Figure A.4
Sheet 4 of 4

This area is located north of Prince Rd. and West of Fairview Ave. Runoff in this area drains to an alley, south of Pelaar St. and to a stormdrain at the corner of Pastime and Flowing Wells Road. Ponding occurs upstream to Tuttle Ave. and Simmons St. Ponding depths above the curbs and into driveways have been reported. Pictures of the area have been provided by the City for two storm events, August 12, 2014 and September 8, 2014 (see Exhibit A.4).

Simmons/Tuttle Area 8/12/2014

Simmons/Tuttle Area 9/8/2014
