Unique Waters Nomination

DAVIDSON CANYON

*Prepared by Pima Association of Governments Watershed Planning
Prepared for Pima County Regional Flood Control District*

Unique Water Nomination
for
Davidson Canyon

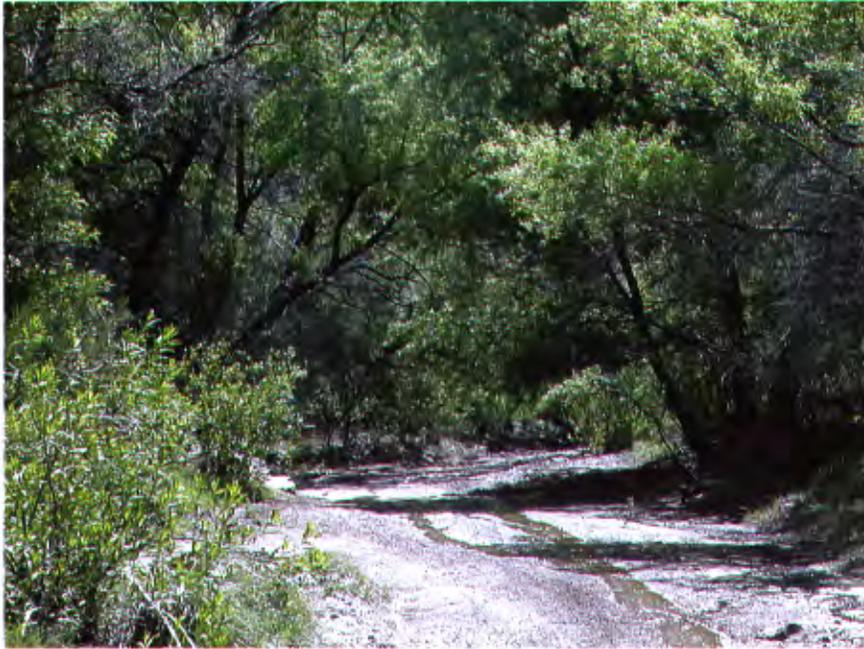
Davidson Canyon near the spring south of I-10 (looking upstream). Photograph by Gloria Browne, November 2004.

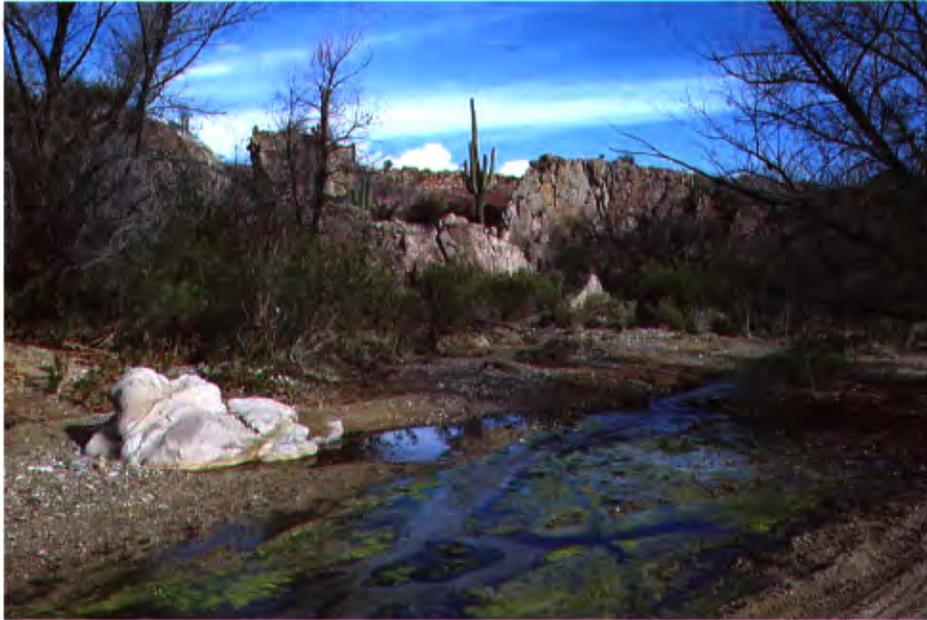
Davidson Canyon near spring south of I-10. Photograph by Linwood Smith, January 2004.

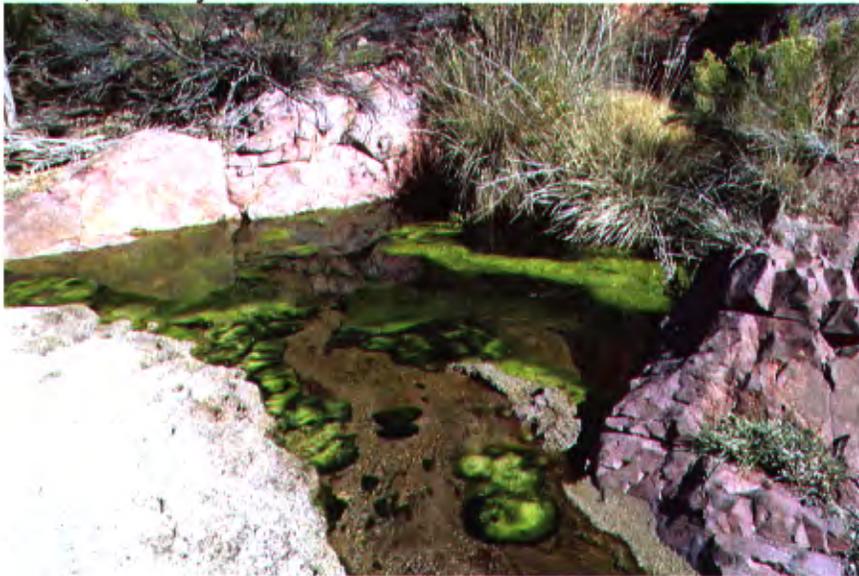
Instream pool in Davidson Canyon near spring south of I-10. Photograph by Linwood Smith, January 2004.

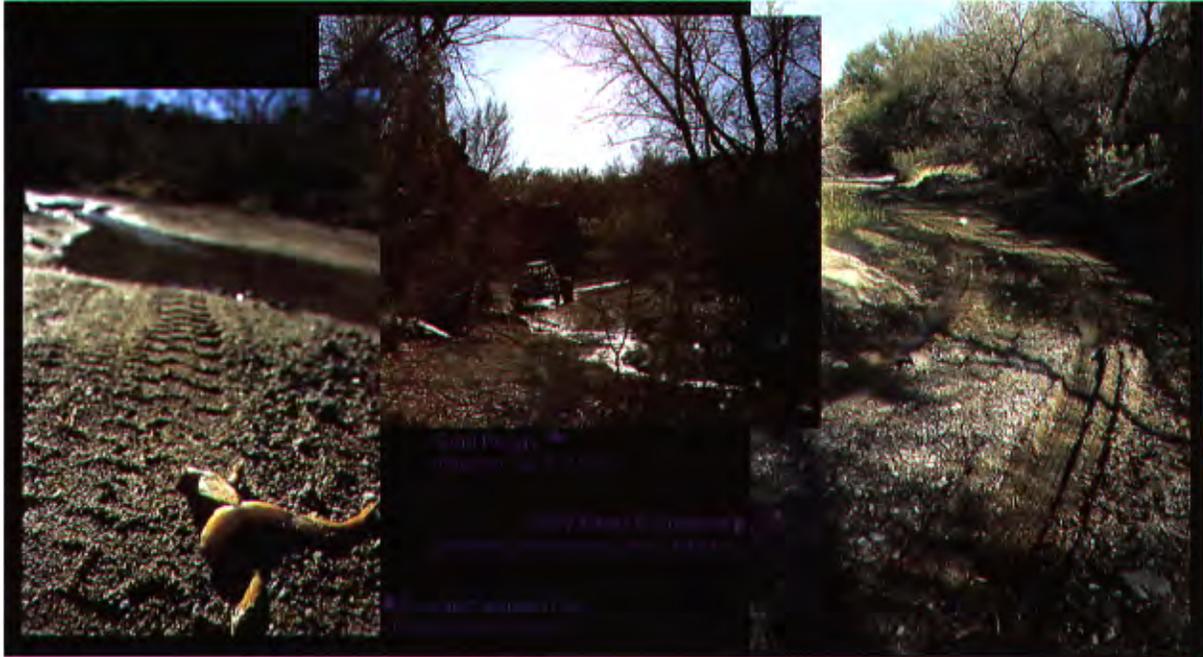
Series of photos showing streamflow and the hazards of ORV use in Davidson Canyon. Notice the dead lowland leopard frog (left). Photographs by Dennis Caldwell, February 2003.
