# La Cholla Boulevard Ruthrauff Road to River Road

## Biological Review

July 2008

Pima County Department of Transportation  
Work Order No. 4LCITR

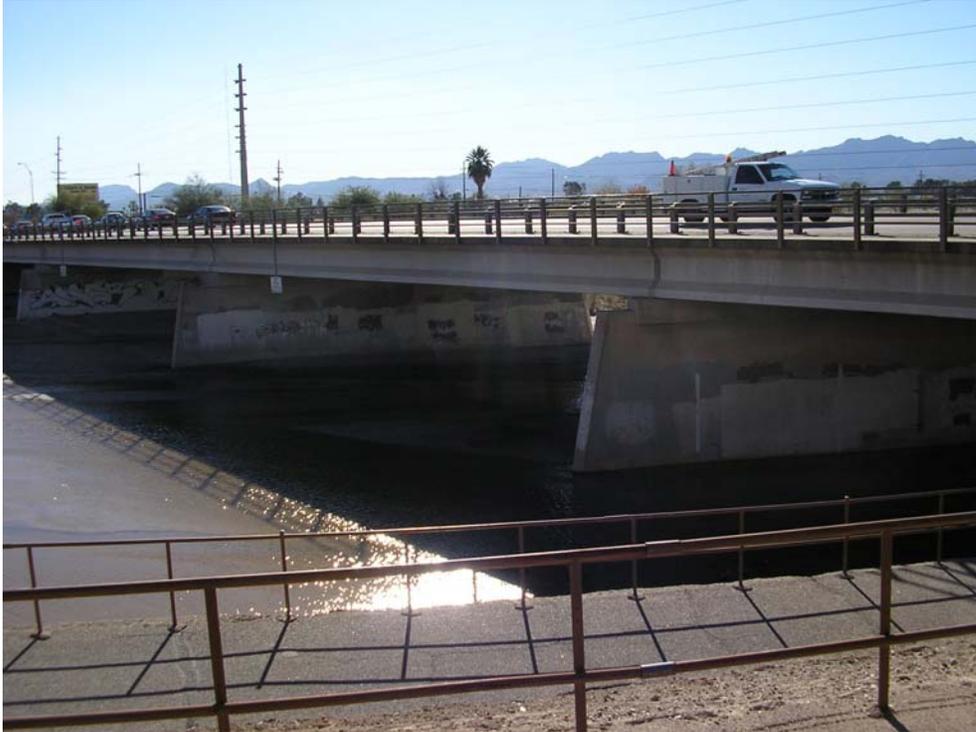
Photo 7 – La Cholla Boulevard, bridge over the Rillito River, view to the southwest.

While this project will not affect endangered species, two species protected under the International Migratory Bird Treaty Act, the swallow and burrowing owl, will require consideration prior to construction. Remnants of mud swallow nests were observed on the underside of the bridge over the Rillito River on July 24, 2007. Prior to the swallow breeding season (approximately March through July), it is recommended that any nest remnants be removed from the bridge. In addition, it may be necessary to coat the underside of the bridge deck with plastic (Salmon and Gorenzel 2005) or some other material such as netting to prevent the birds from rebuilding their nests (Arizona Wings-N-Stings LLC).

- Bridge demolition be conducted outside of the swallow breeding season (after June and prior to March).
- Alternatively, if it is necessary to conduct bridge demolition during the breeding season (March through June), exclusion measures are needed. These measures include removing swallow nest remnants prior to the swallow breeding season, and preventing swallows from rebuilding their nests. More detail regarding exclusion measures is included in Appendix E. The swallow exclusion measures are ranked below based on their safety for birds:
  - The placement of plastic tarp across the bottom of the bridge to prevent nest attachment.
  - The placement of ¾ inch netting across the bottom of the bridge to prevent nest attachment.

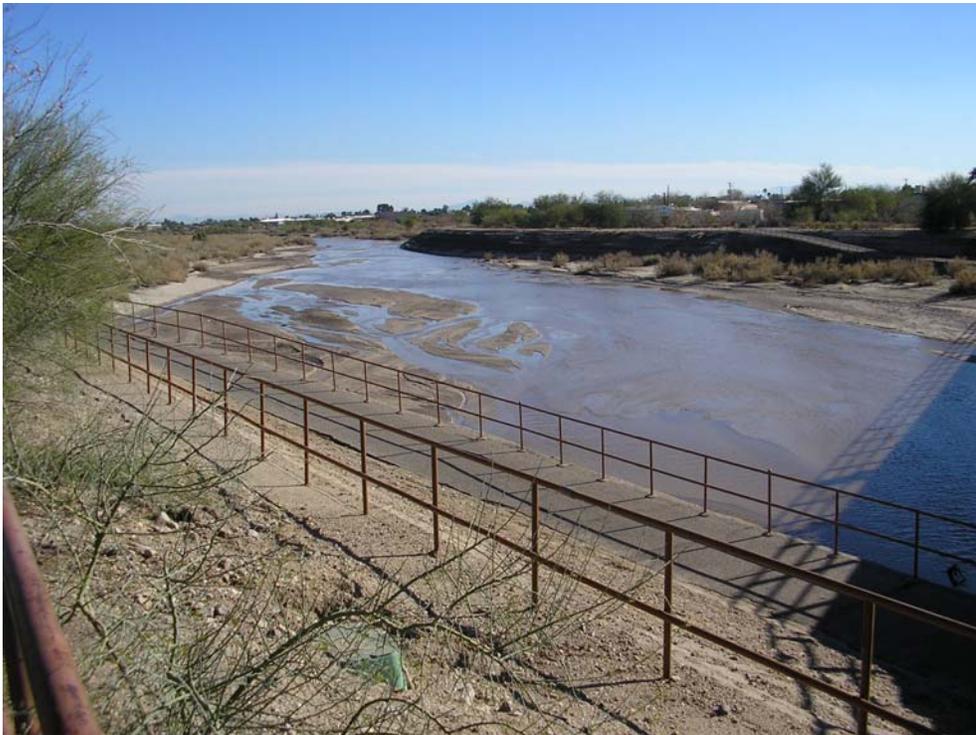
Photo 8 – Rillito River at La Cholla Boulevard, view to the east.

The Rillito River, at its crossing with La Cholla Boulevard, is a 300-foot-wide ephemeral stream with lined banks. The streambed is comprised of medium to coarse sand with some gravel and cobbles. The bed is vegetated with a typical assortment of desert vegetation.

The banks of Rillito River are soil cemented and areas of scour sufficient for a burrow were not identified; therefore, no habitat for burrowing owls was identified along the banks of the Rillito River. Potential burrowing owl habitat was identified on a vacant lot at the northwest corner of Curtis Road and La Cholla Boulevard. The vacant lot has low and open native vegetation. Ground disturbance will occur at this location during the construction of a new path. The construction will require the acquisition of 50 feet of new R/W west of La Cholla Boulevard between Curtis Road and the Rillito River. Based on technical assistance from AGFD, preconstruction surveys for this area will be needed.

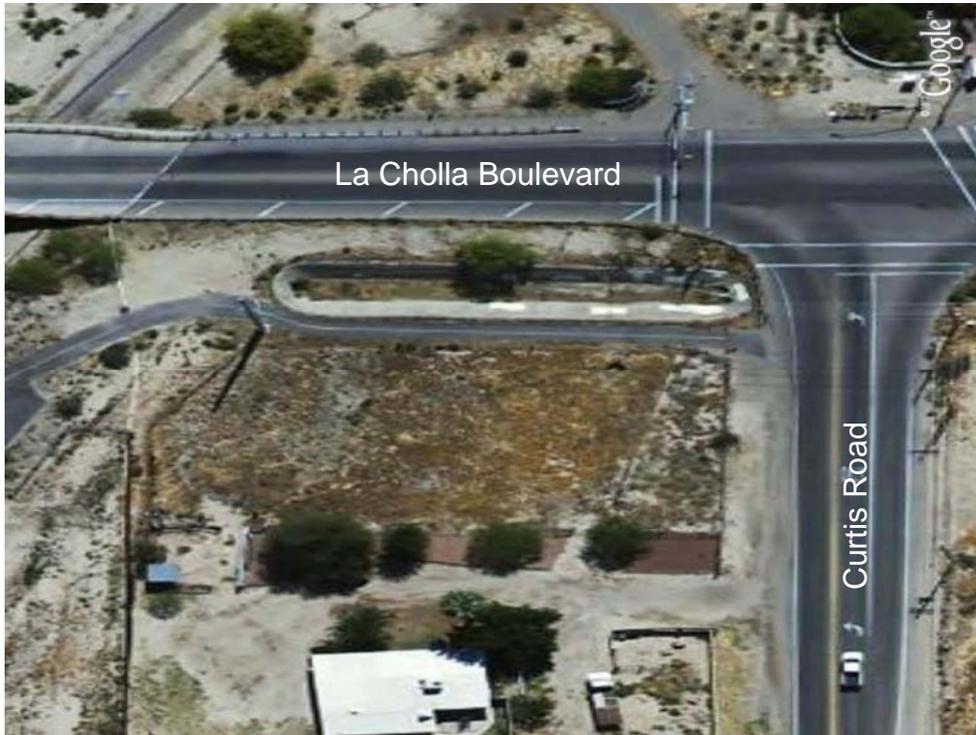
Photo 10 – The vacant lot at the northwest corner of La Cholla Boulevard and Curtis Road.

- Ground disturbance at the northwest corner of La Cholla Boulevard and Curtis Road, be scheduled outside of the breeding season for the burrowing owl (after mid-July and prior to March).
- A burrowing owl survey be completed at the northwest corner of La Cholla Boulevard and Curtis Road at least 90 days before construction or equipment staging is expected at this location (AGFD 2008). If owls are absent during the 90 day survey, conduct a follow-up survey 30 days prior to planned activity to confirm continued absence of the owl.
