Re: **Regional Flood Control District Storm Report for July 8 and 10, 2018**

SUBJECT: Storm Report for July 8 and July 10, 2018

SUBJECT: July 10, 2018: Post-Flood Investigation – Massingale Basin & Countryside Basin

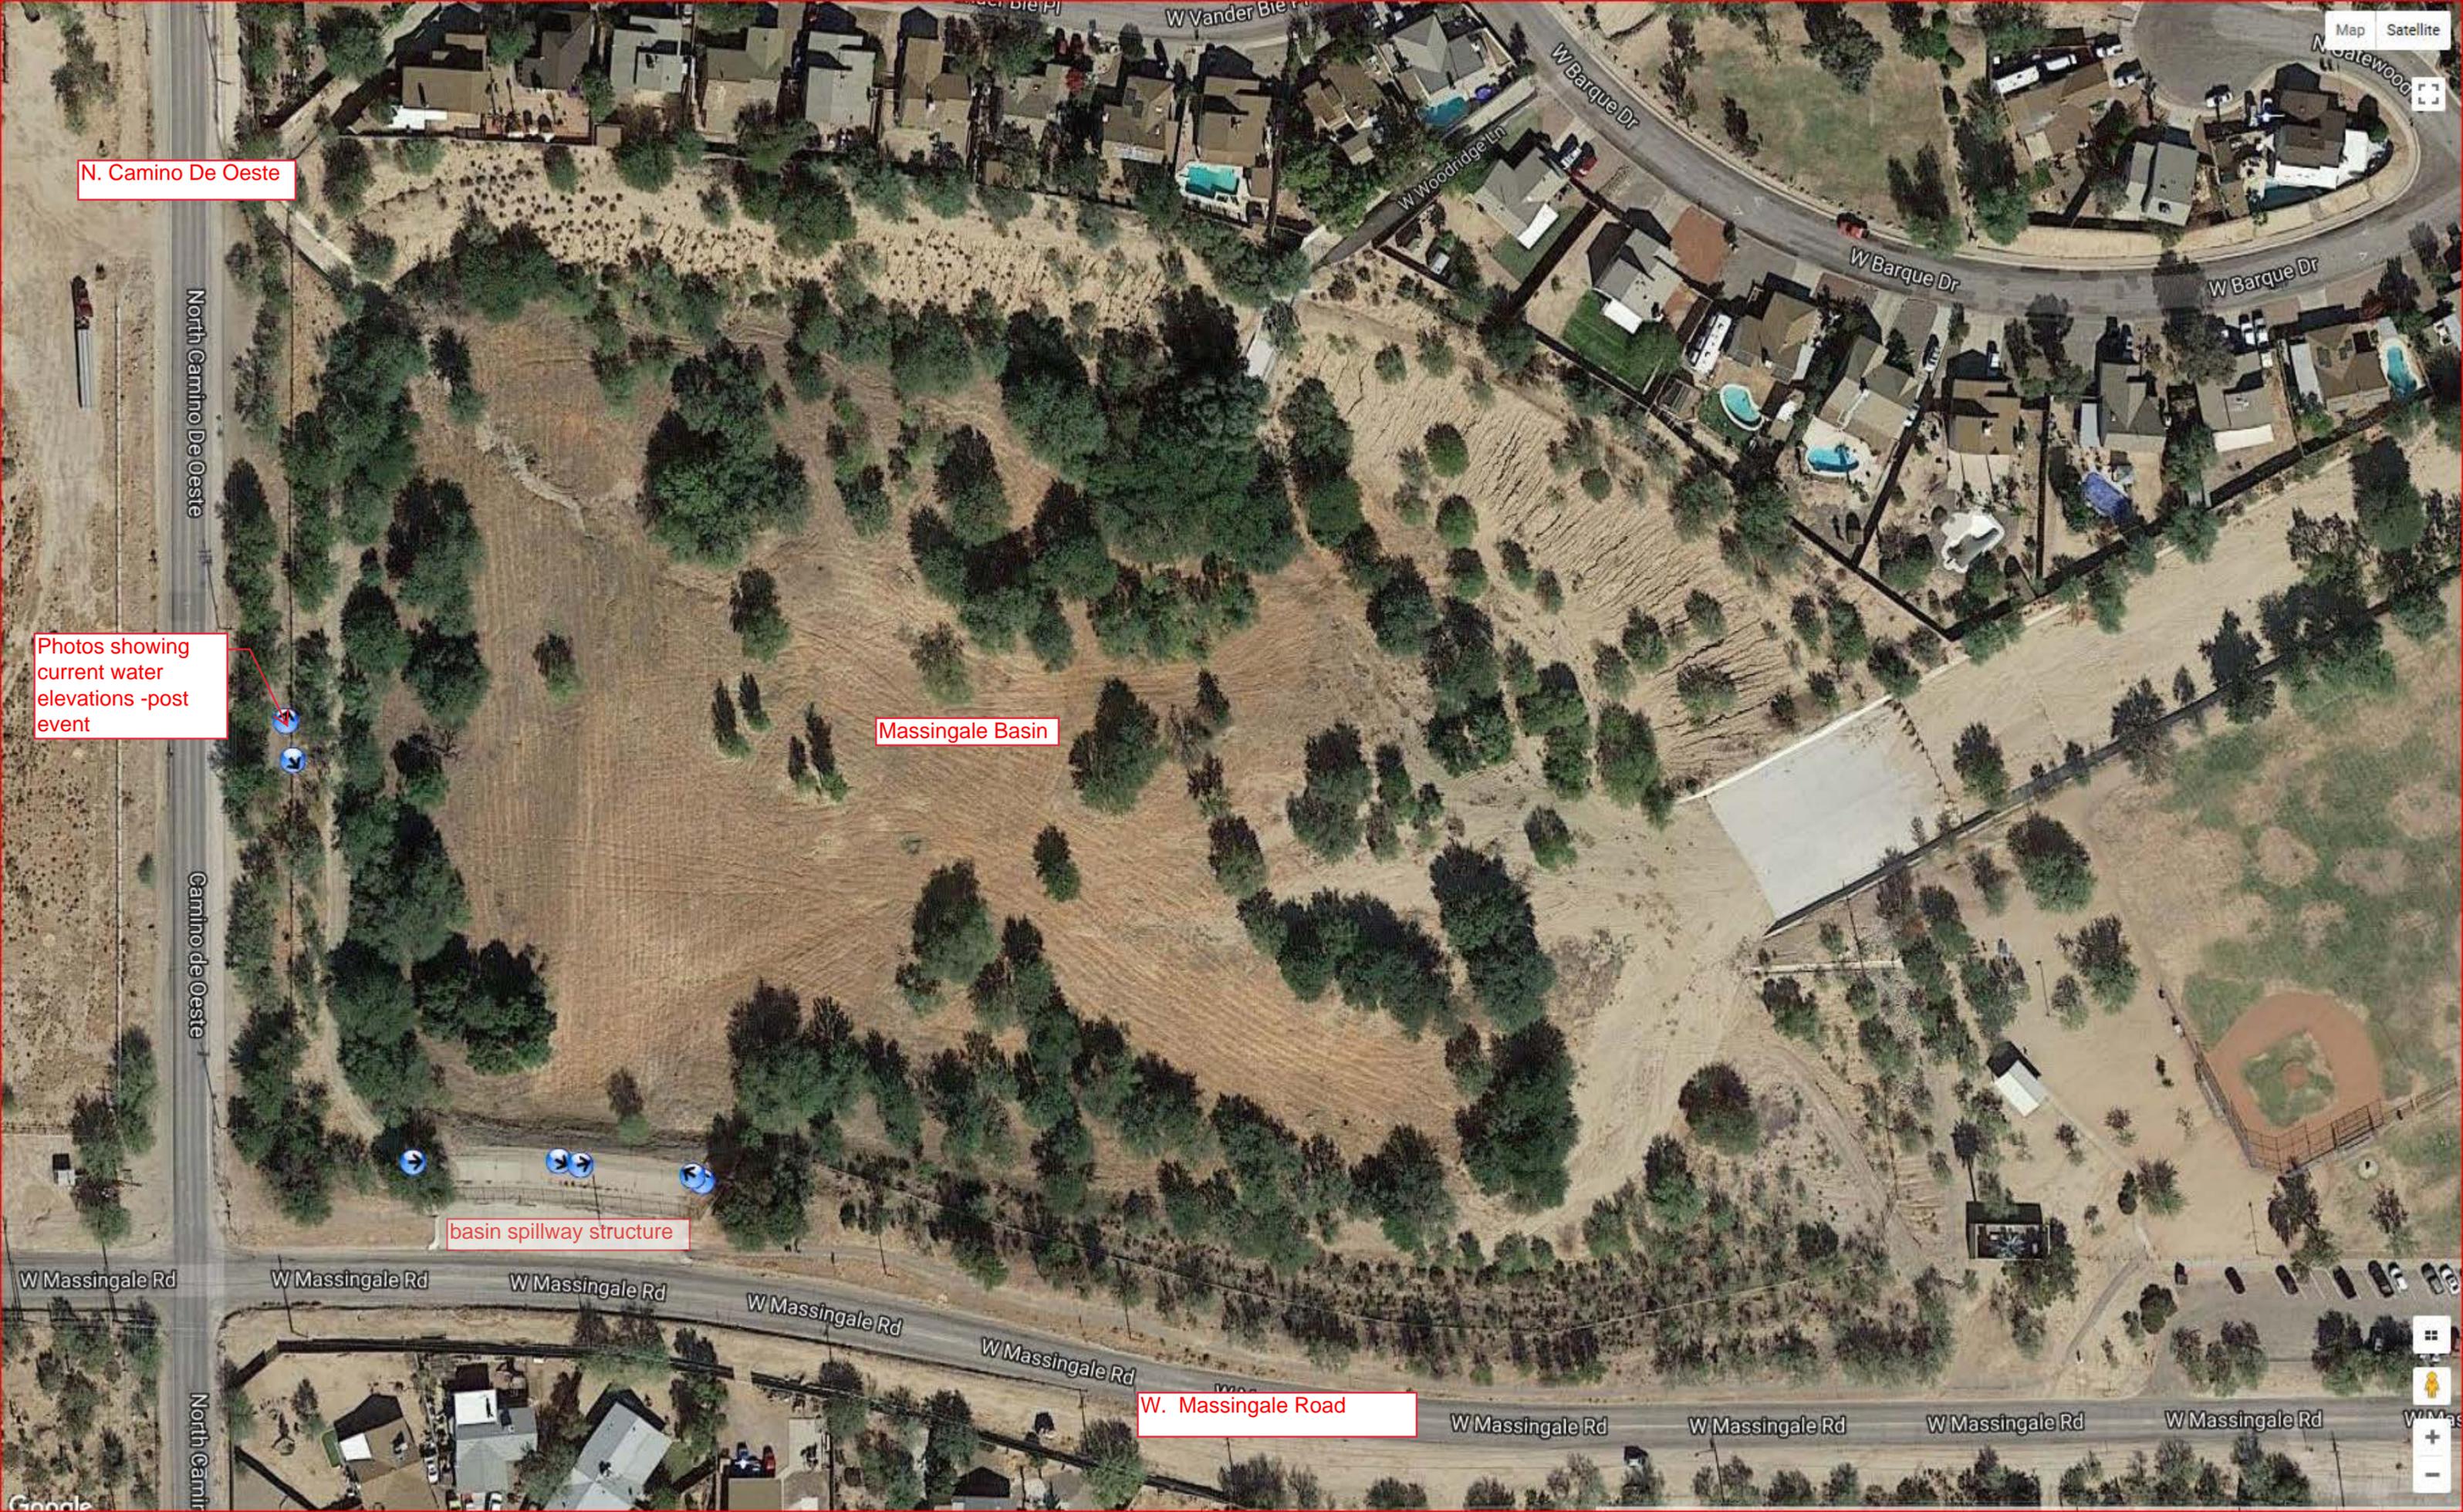
Photos showing current water elevations -post event

basin spillway structure

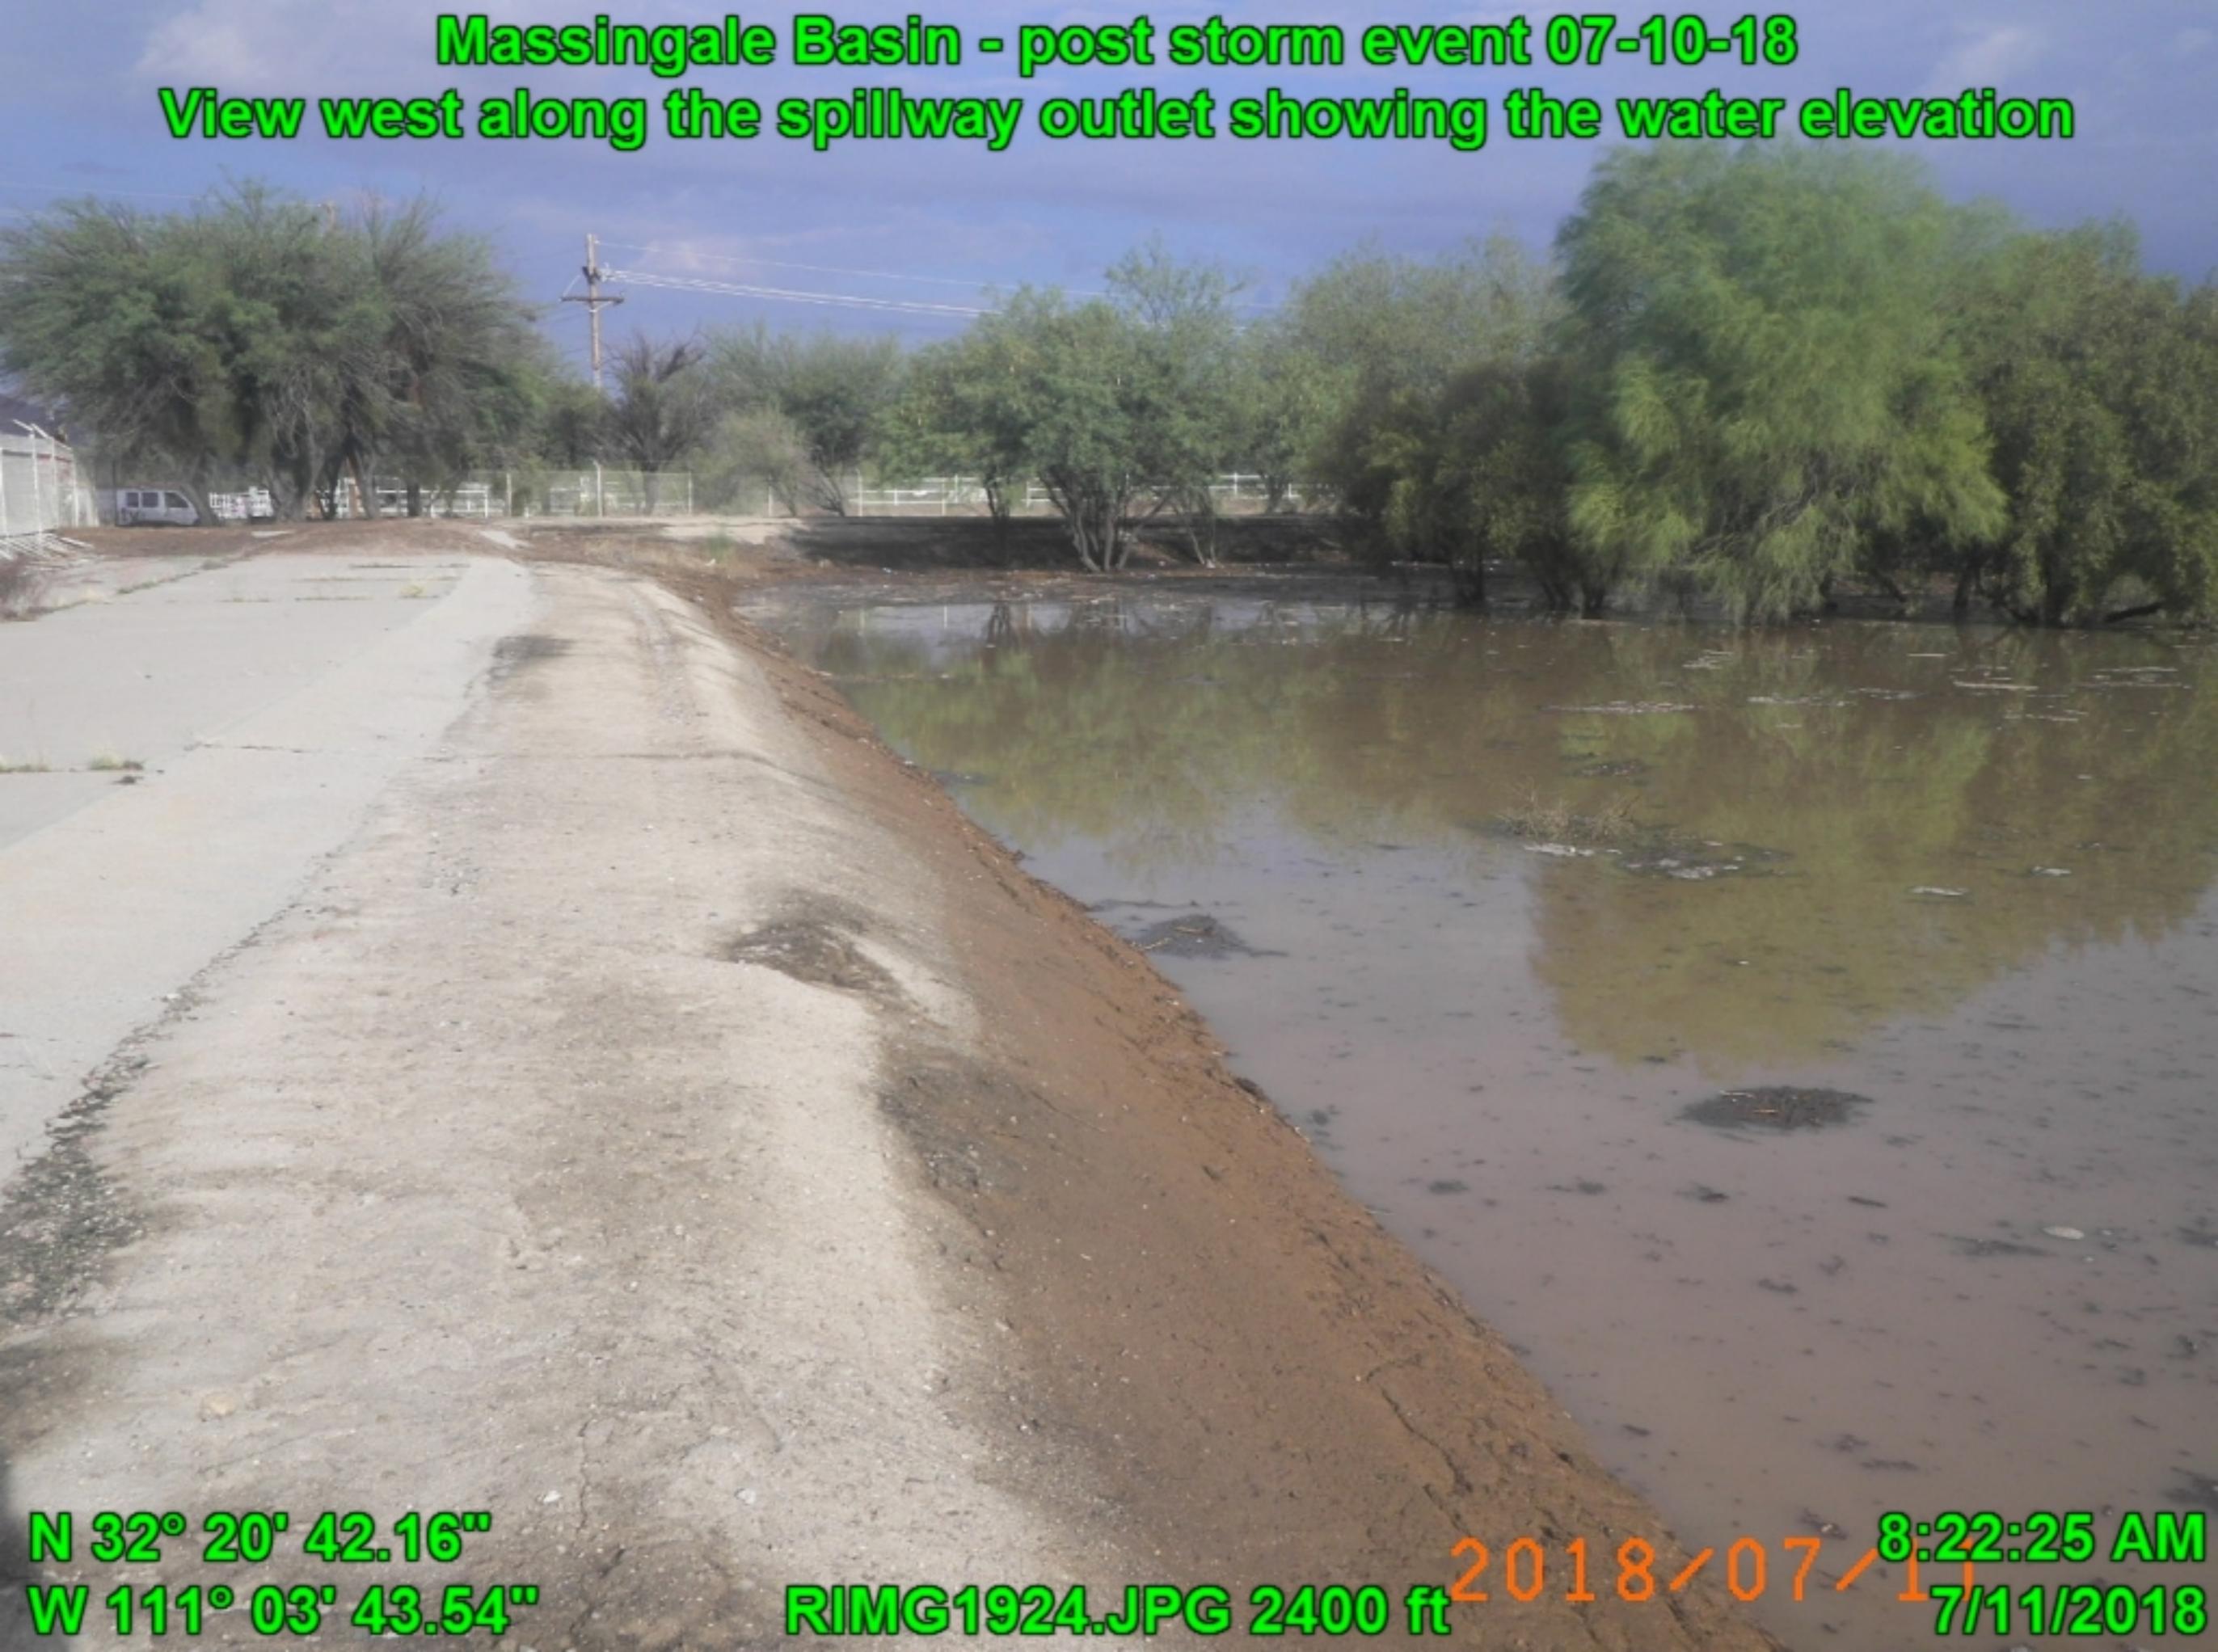
Massingale Basin - post storm event 07-10-18
View west along the spillway outlet showing the water elevation

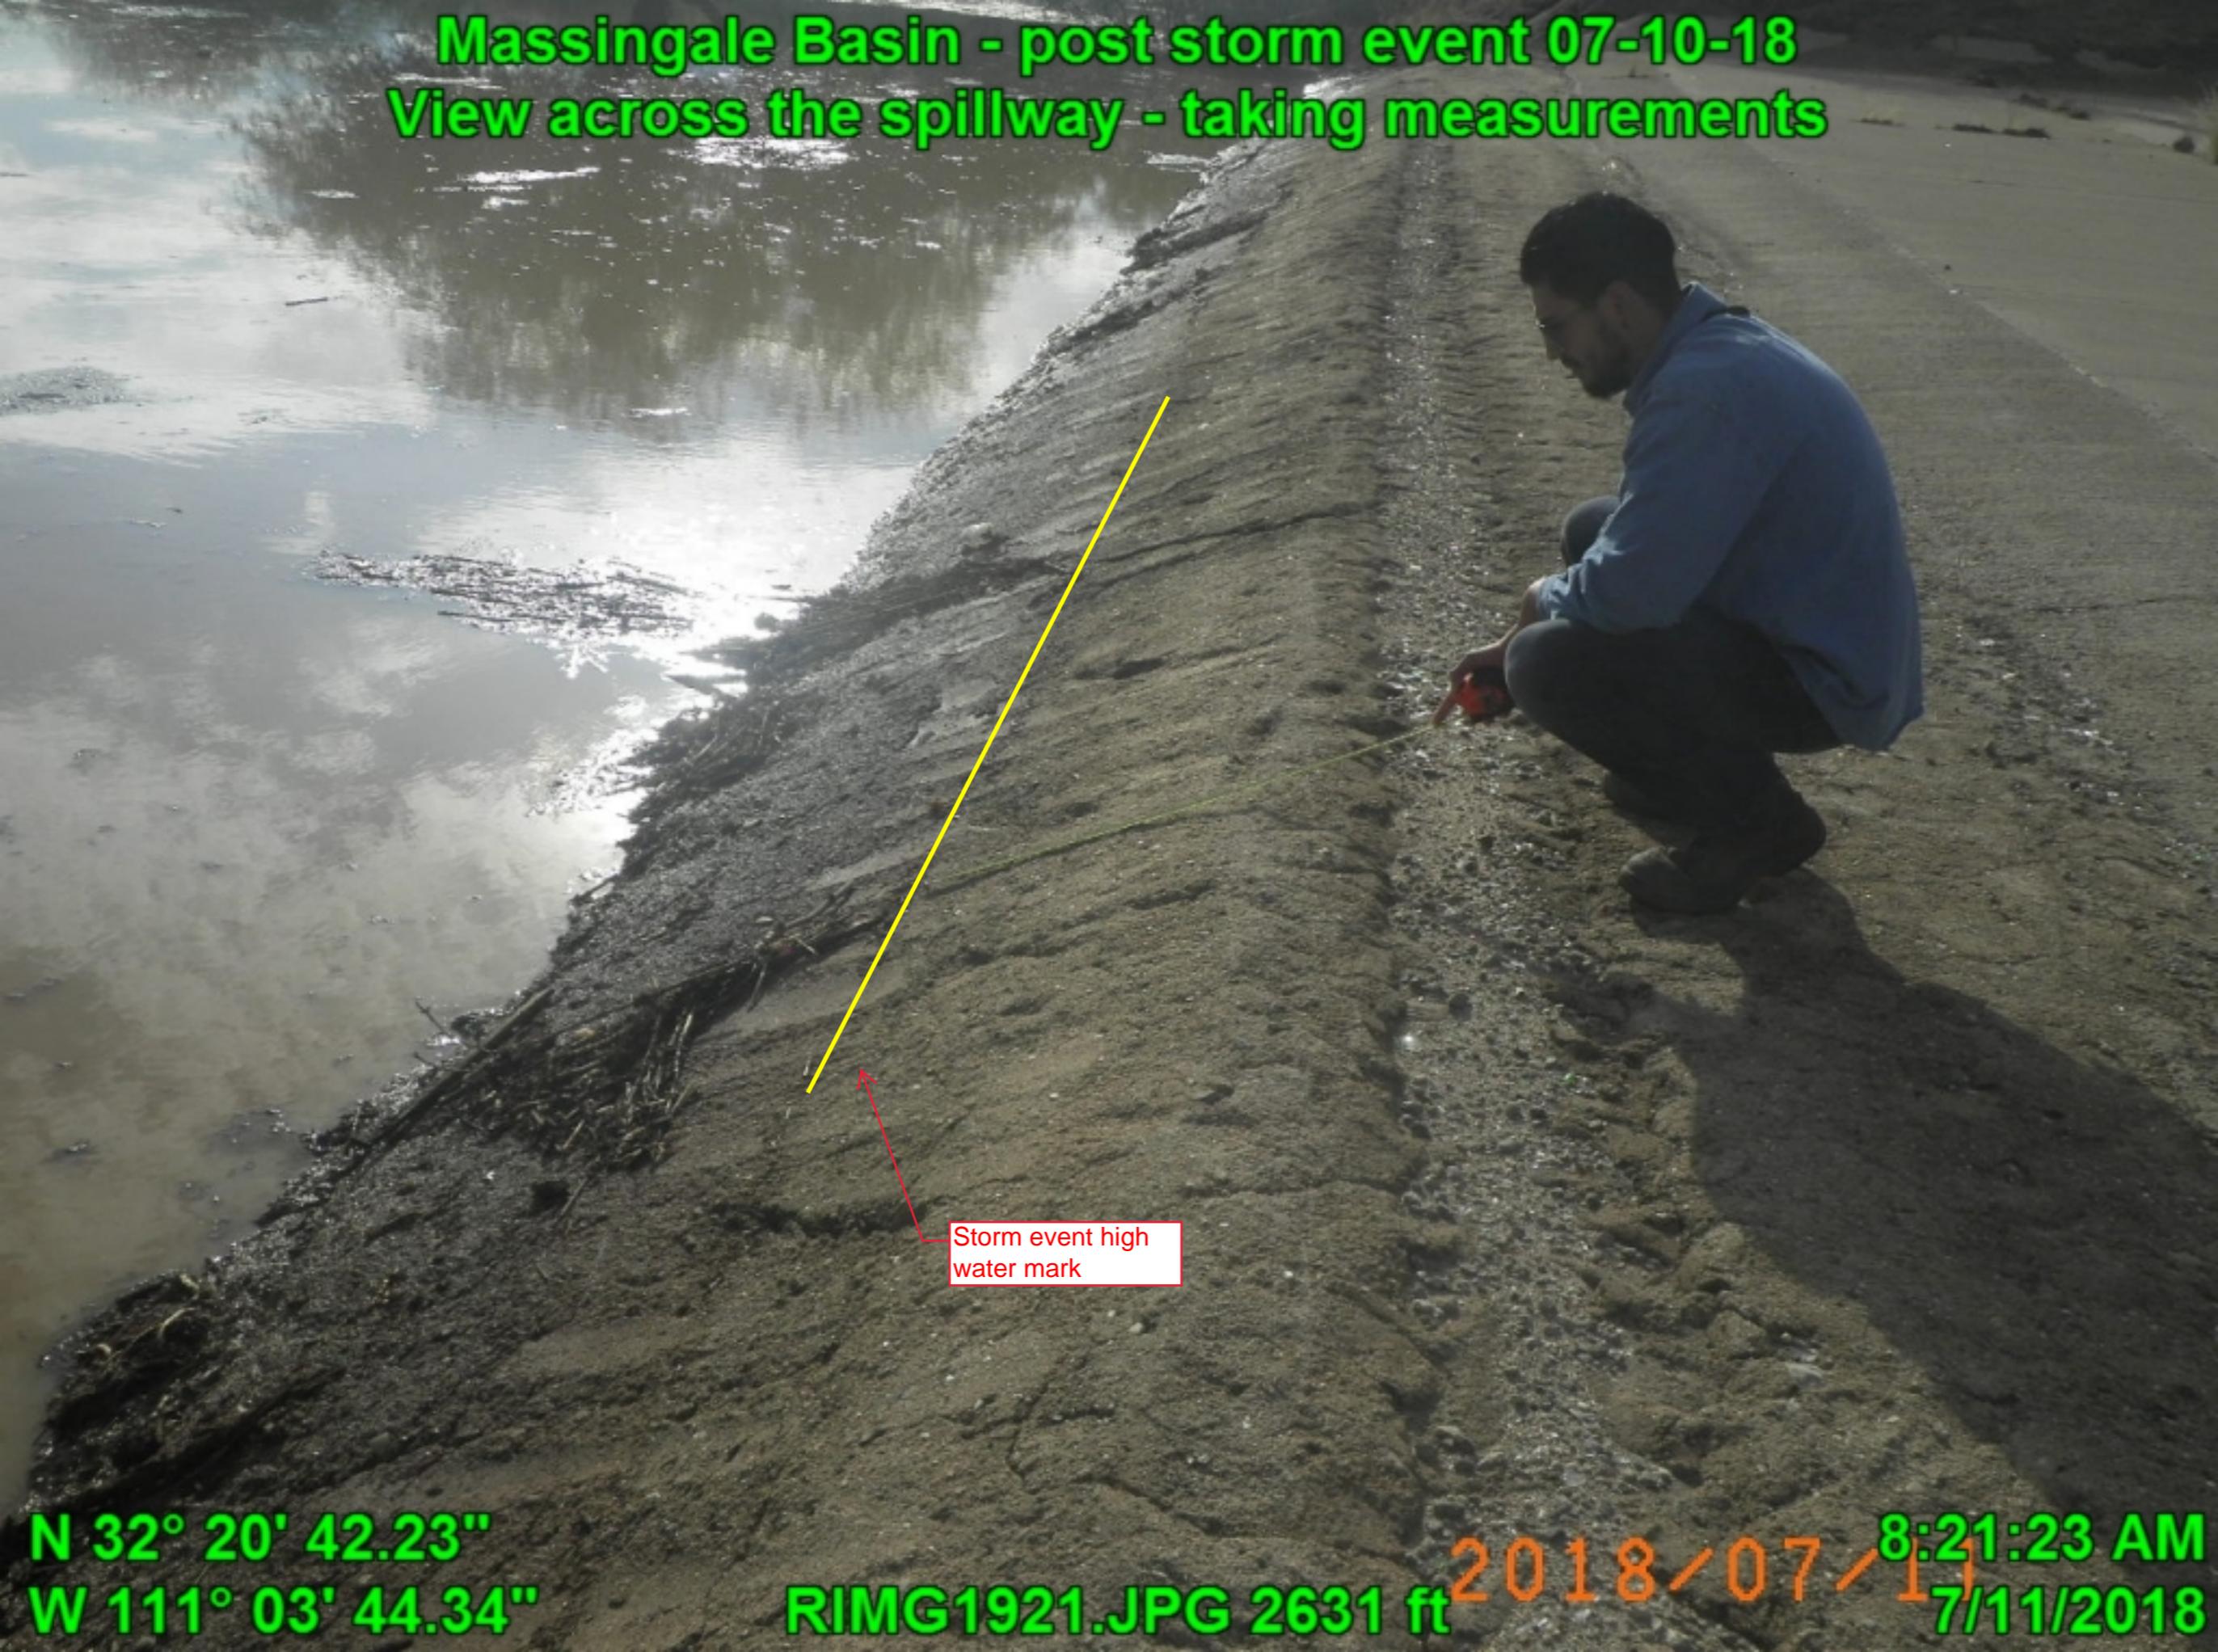
Massingale Basin - post storm event 07-10-18
View across the spillway - taking measurements

Storm event high
water mark

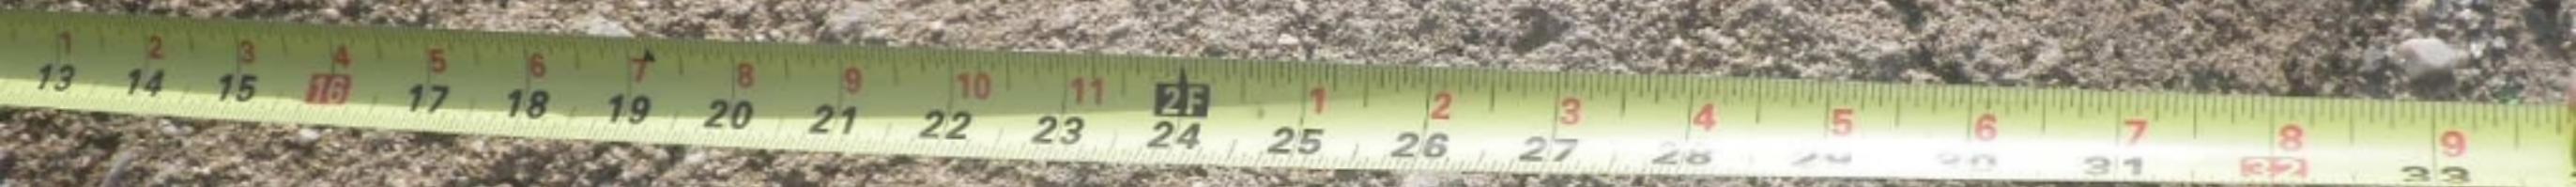
Massingale Basin - post storm event 07-10-18
Close up of the high water mark for the storm event
24" of freeboard at the spillway

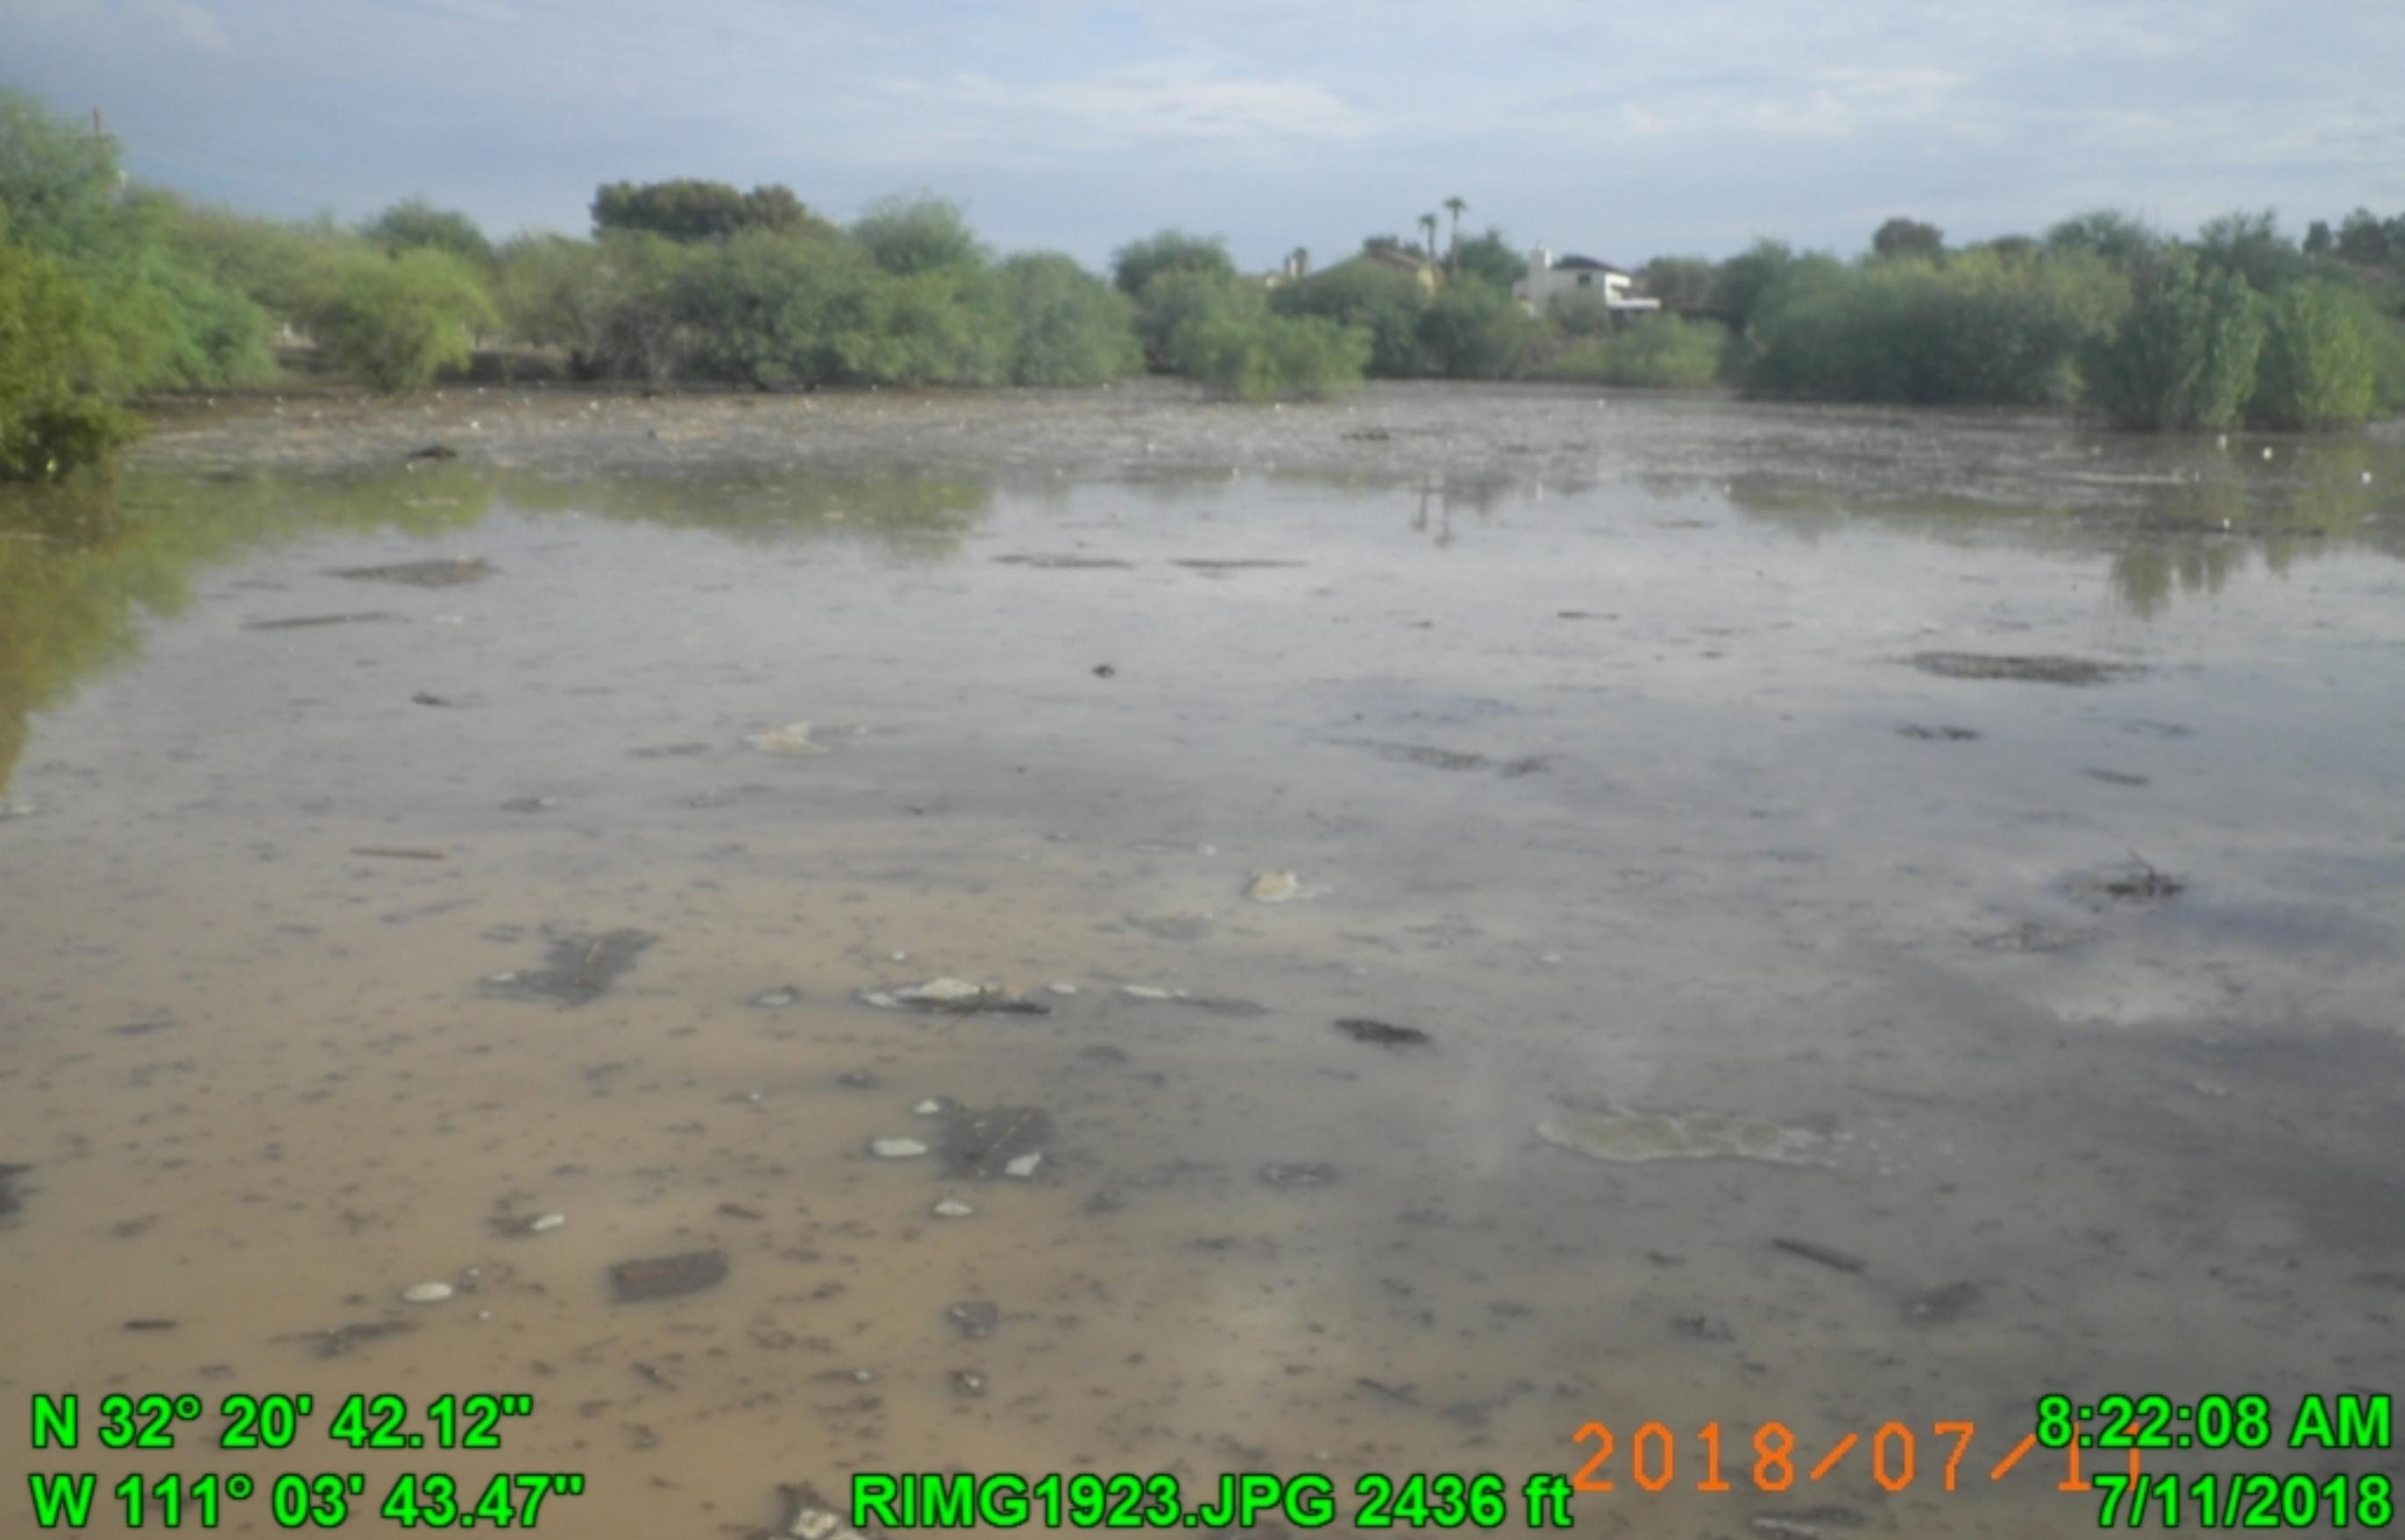
Massingale Basin - post storm event 07-10-18

View north across Massingale Basin

Only the tops of the mature trees sticking out of the water

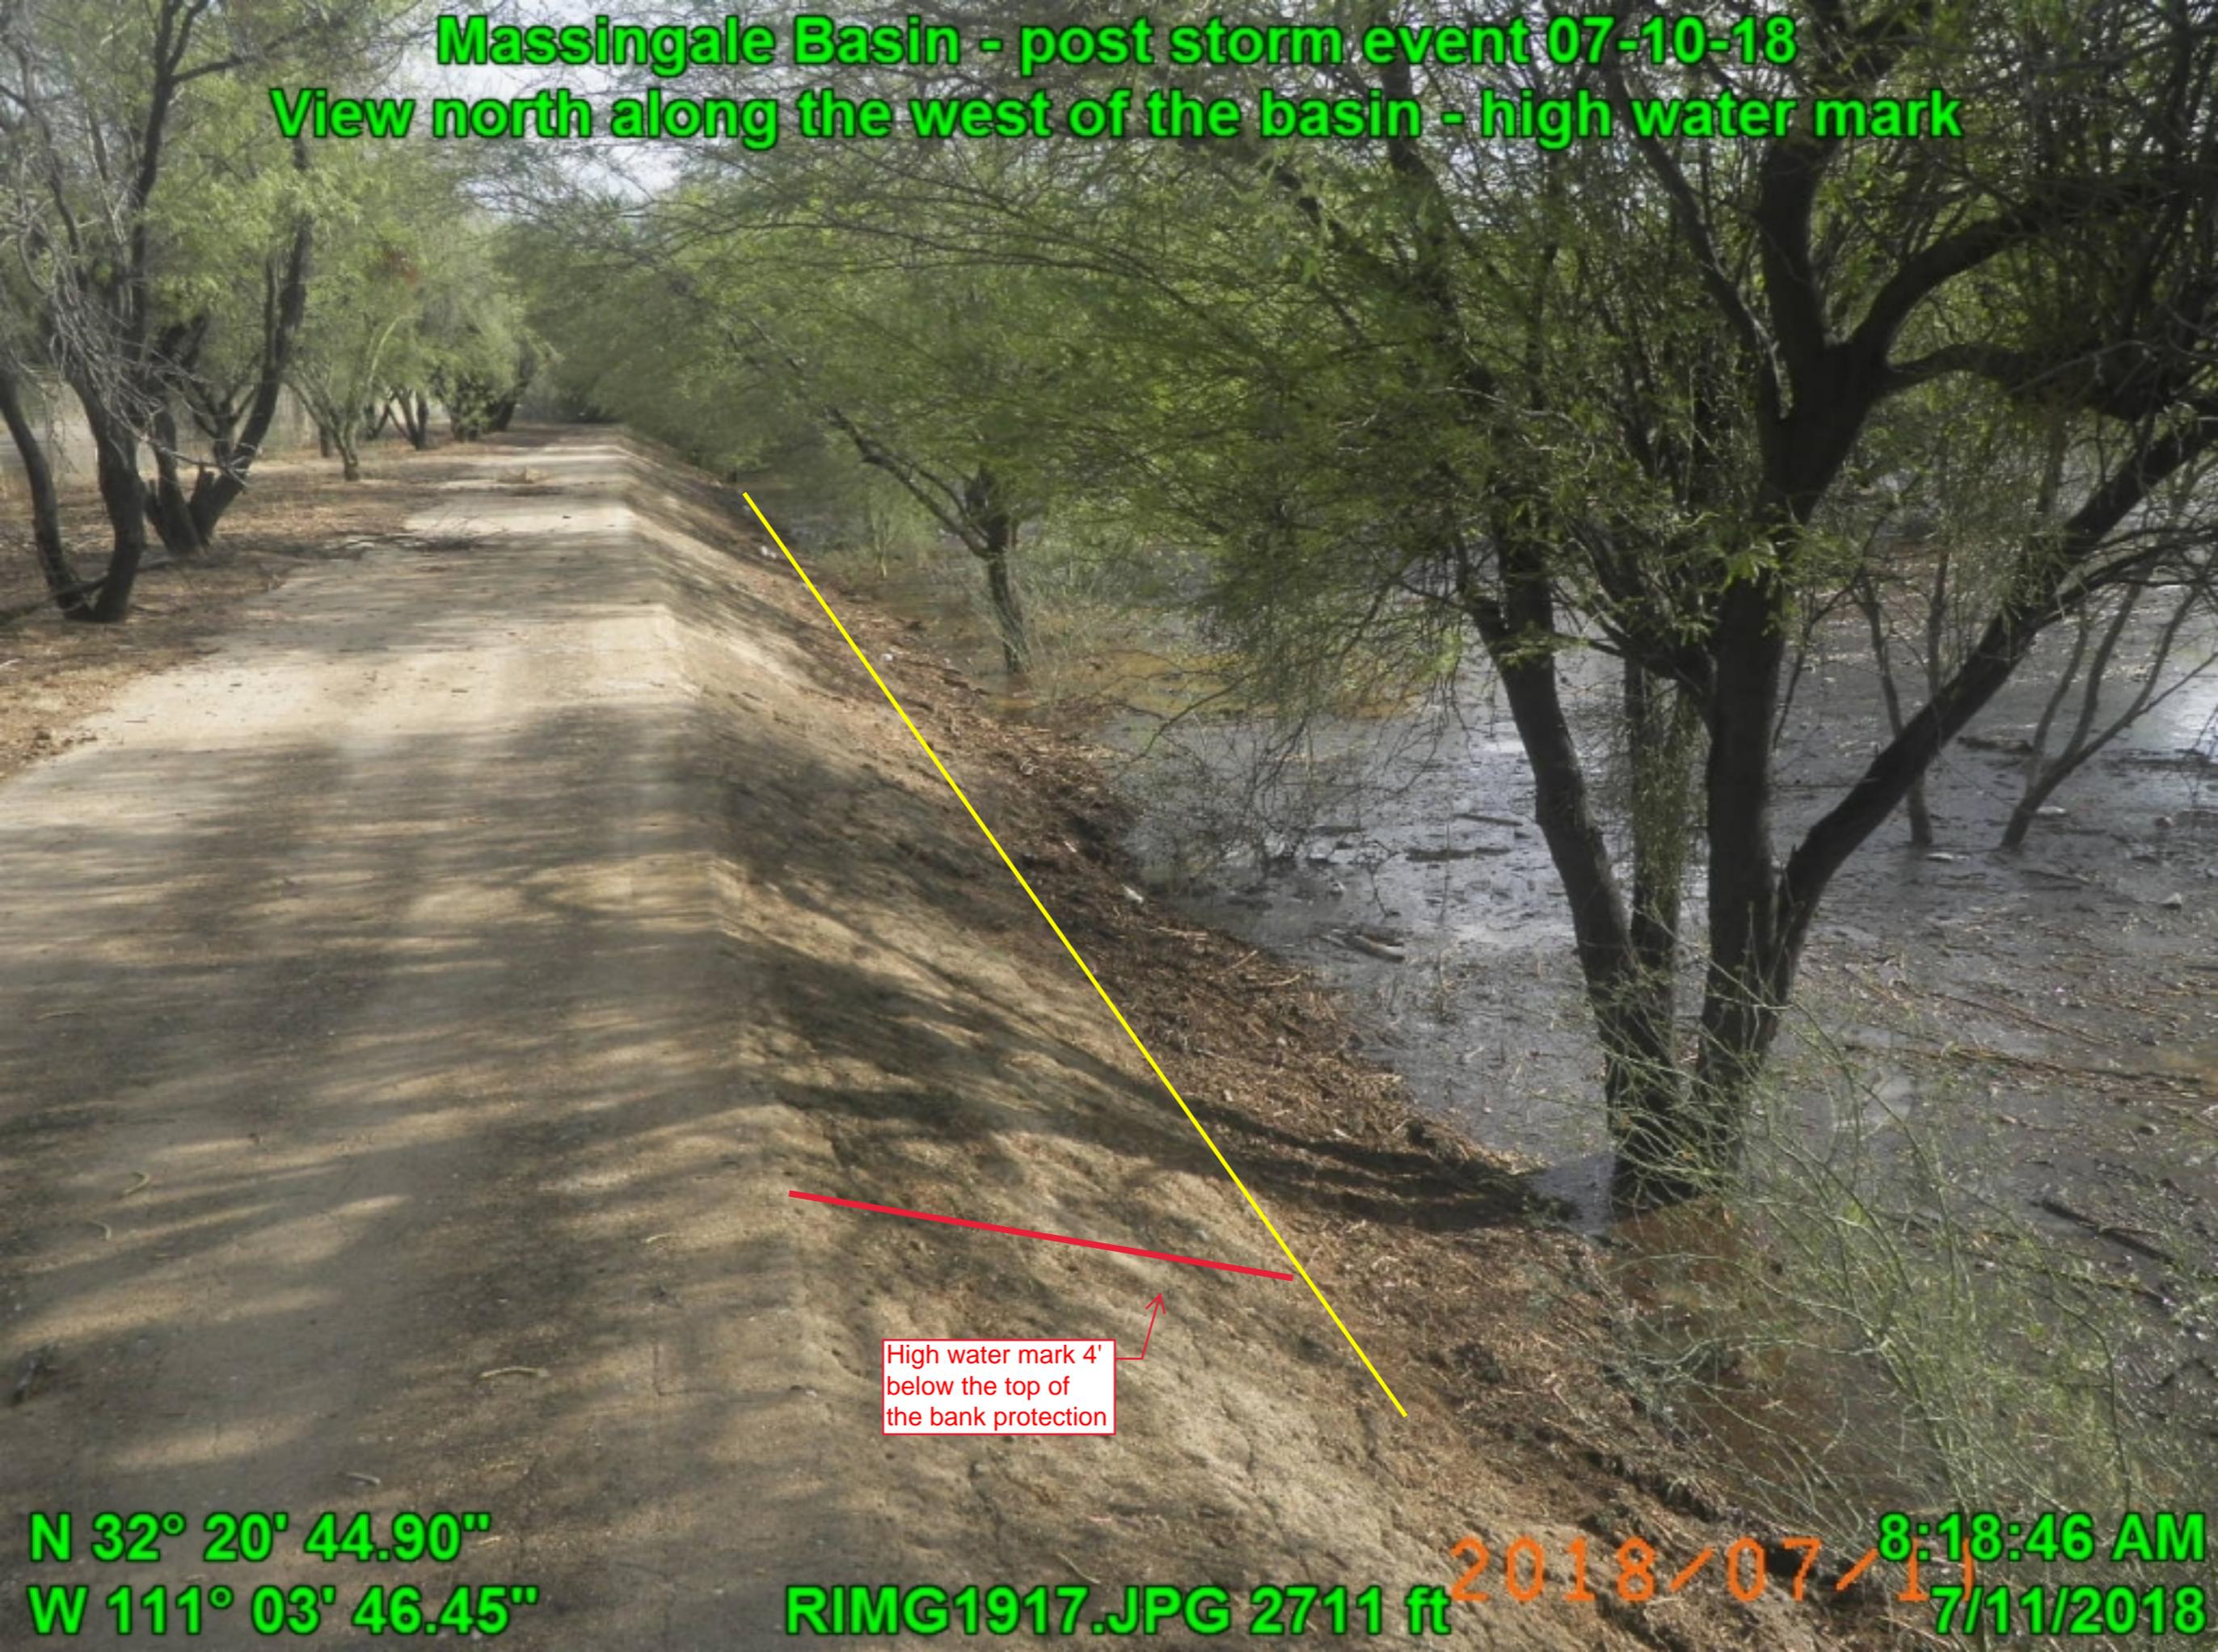
Massingale Basin - post storm event 07-10-18
View north along the west of the basin - high water mark

High water mark 4'
below the top of
the bank protection

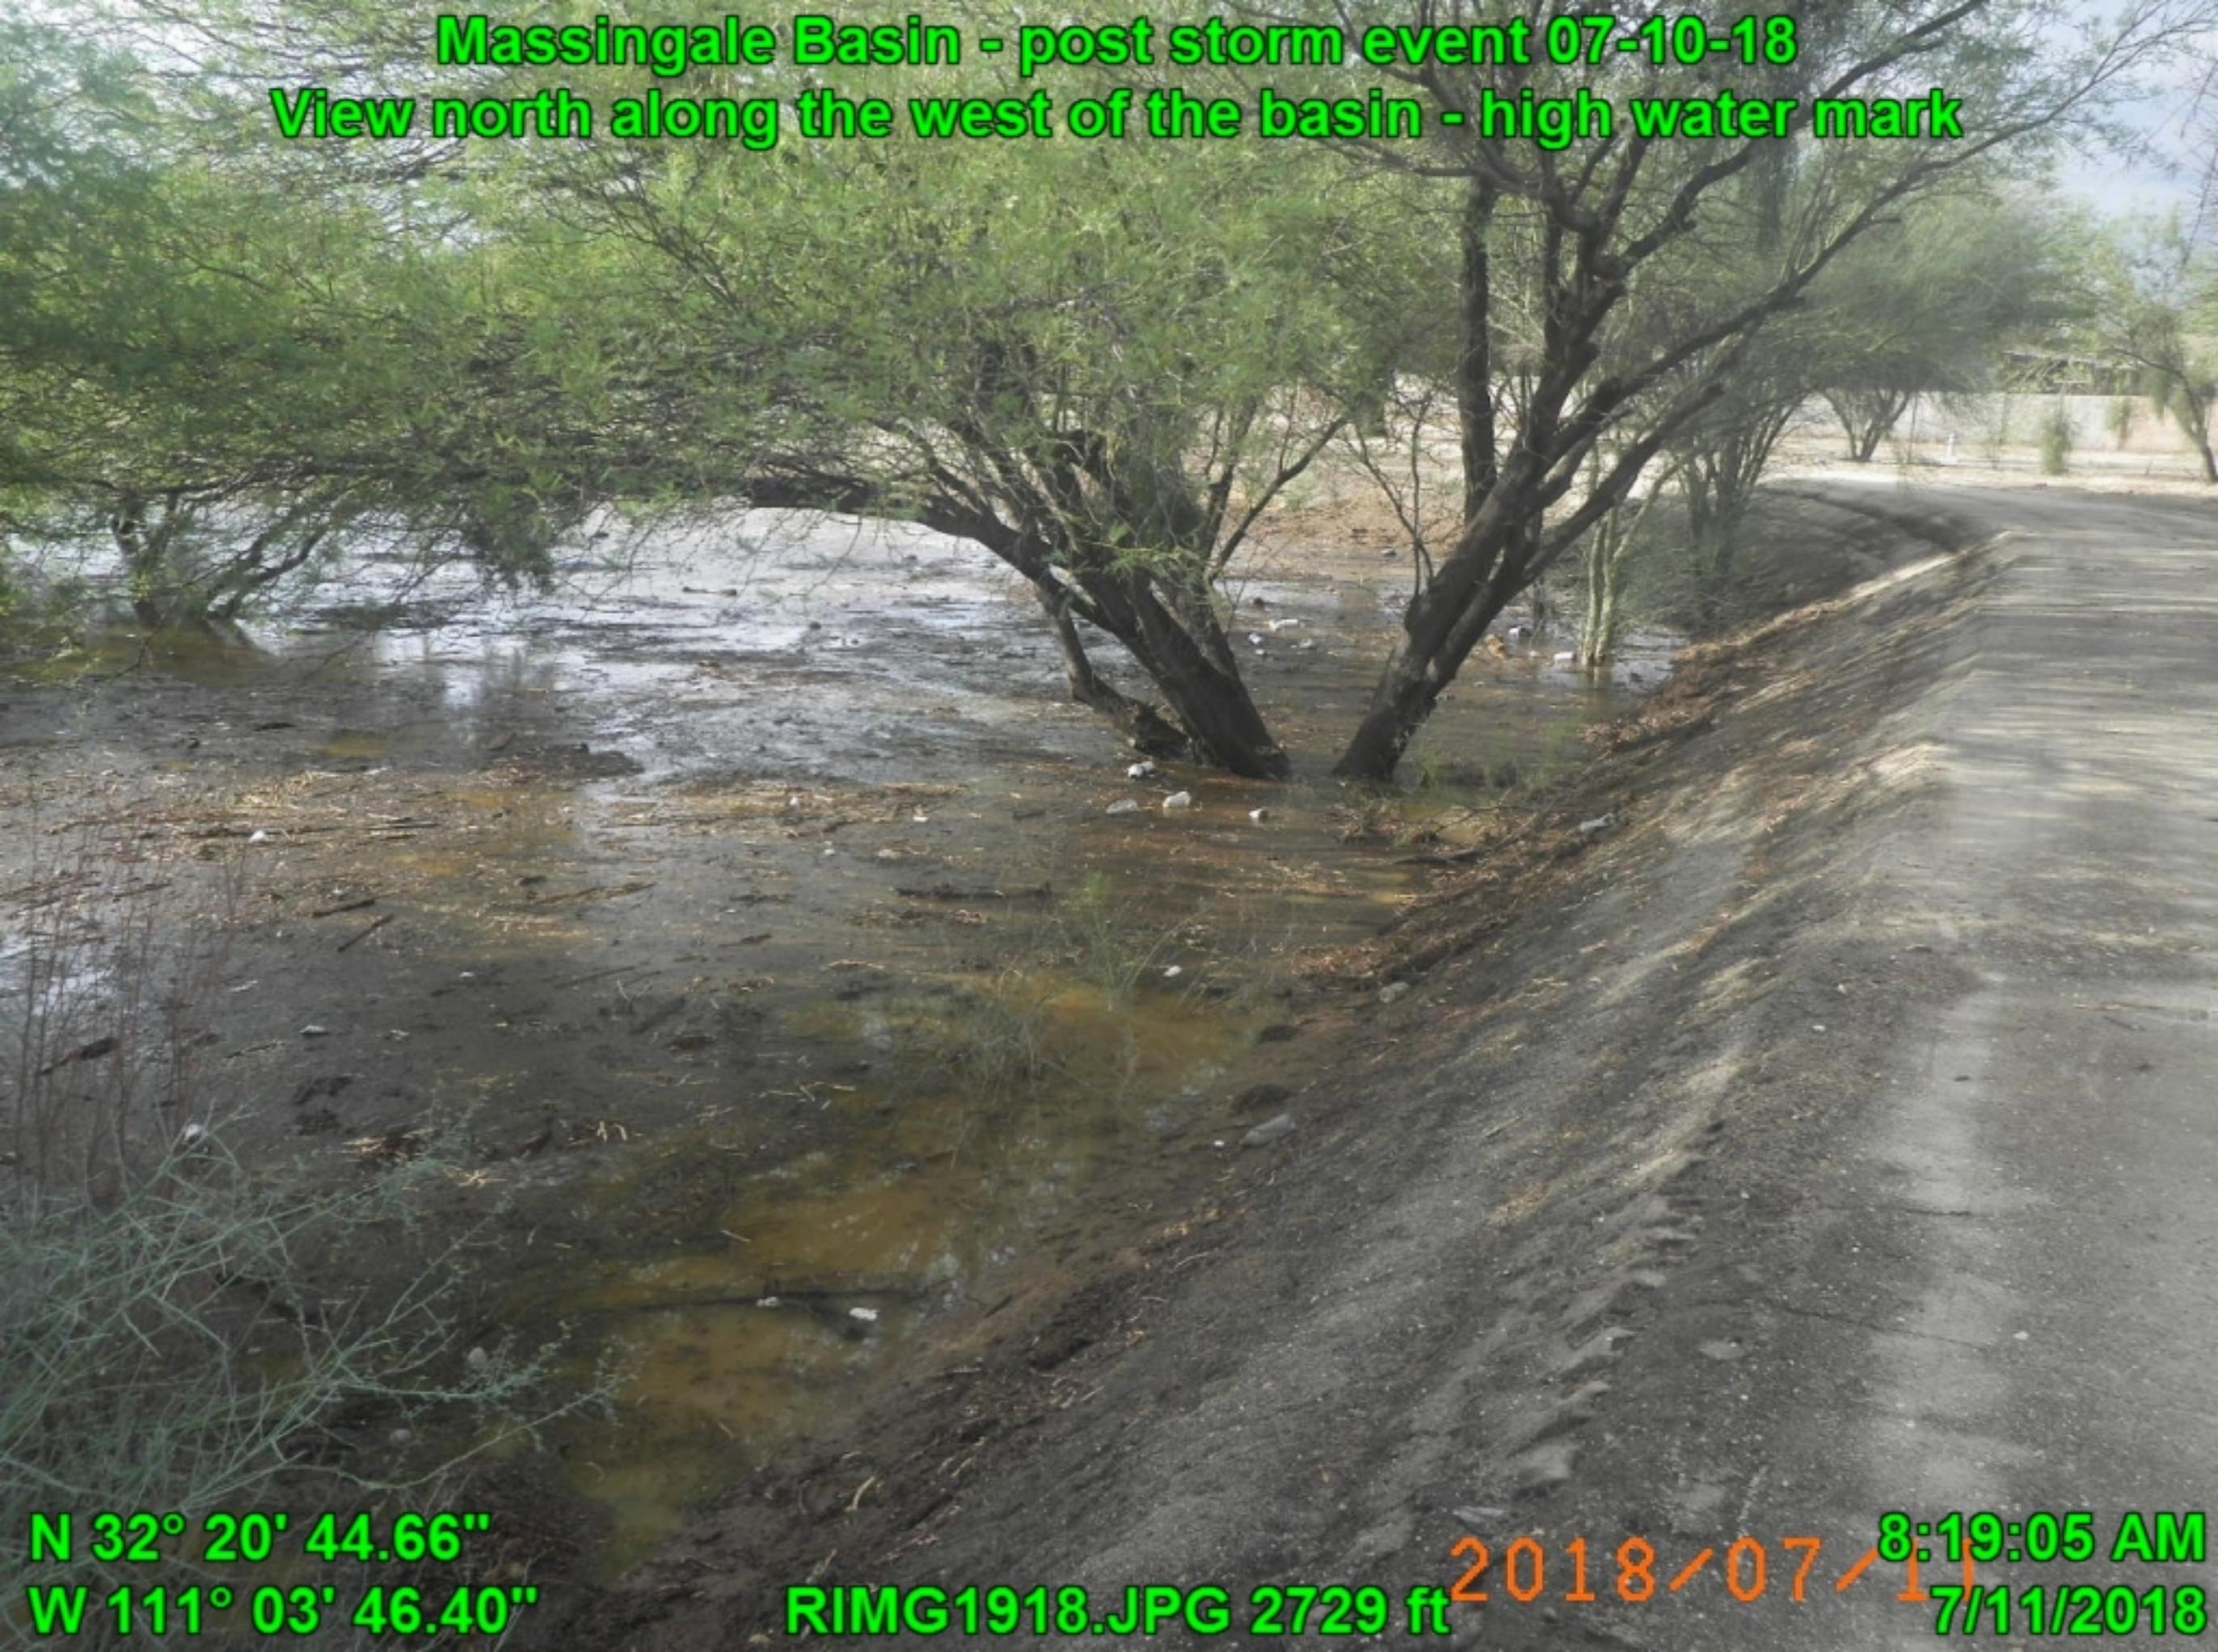
Massingale Basin - post storm event 07-10-18
View north along the west of the basin - high water mark
