Re: **Regional Flood Control District Storm Report for July 8 and 10, 2018**

SUBJECT: Storm Report for July 8 and July 10, 2018

SUBJECT: July 10, 2018: Post-Flood Investigation – Massingale Basin & Countryside Basin

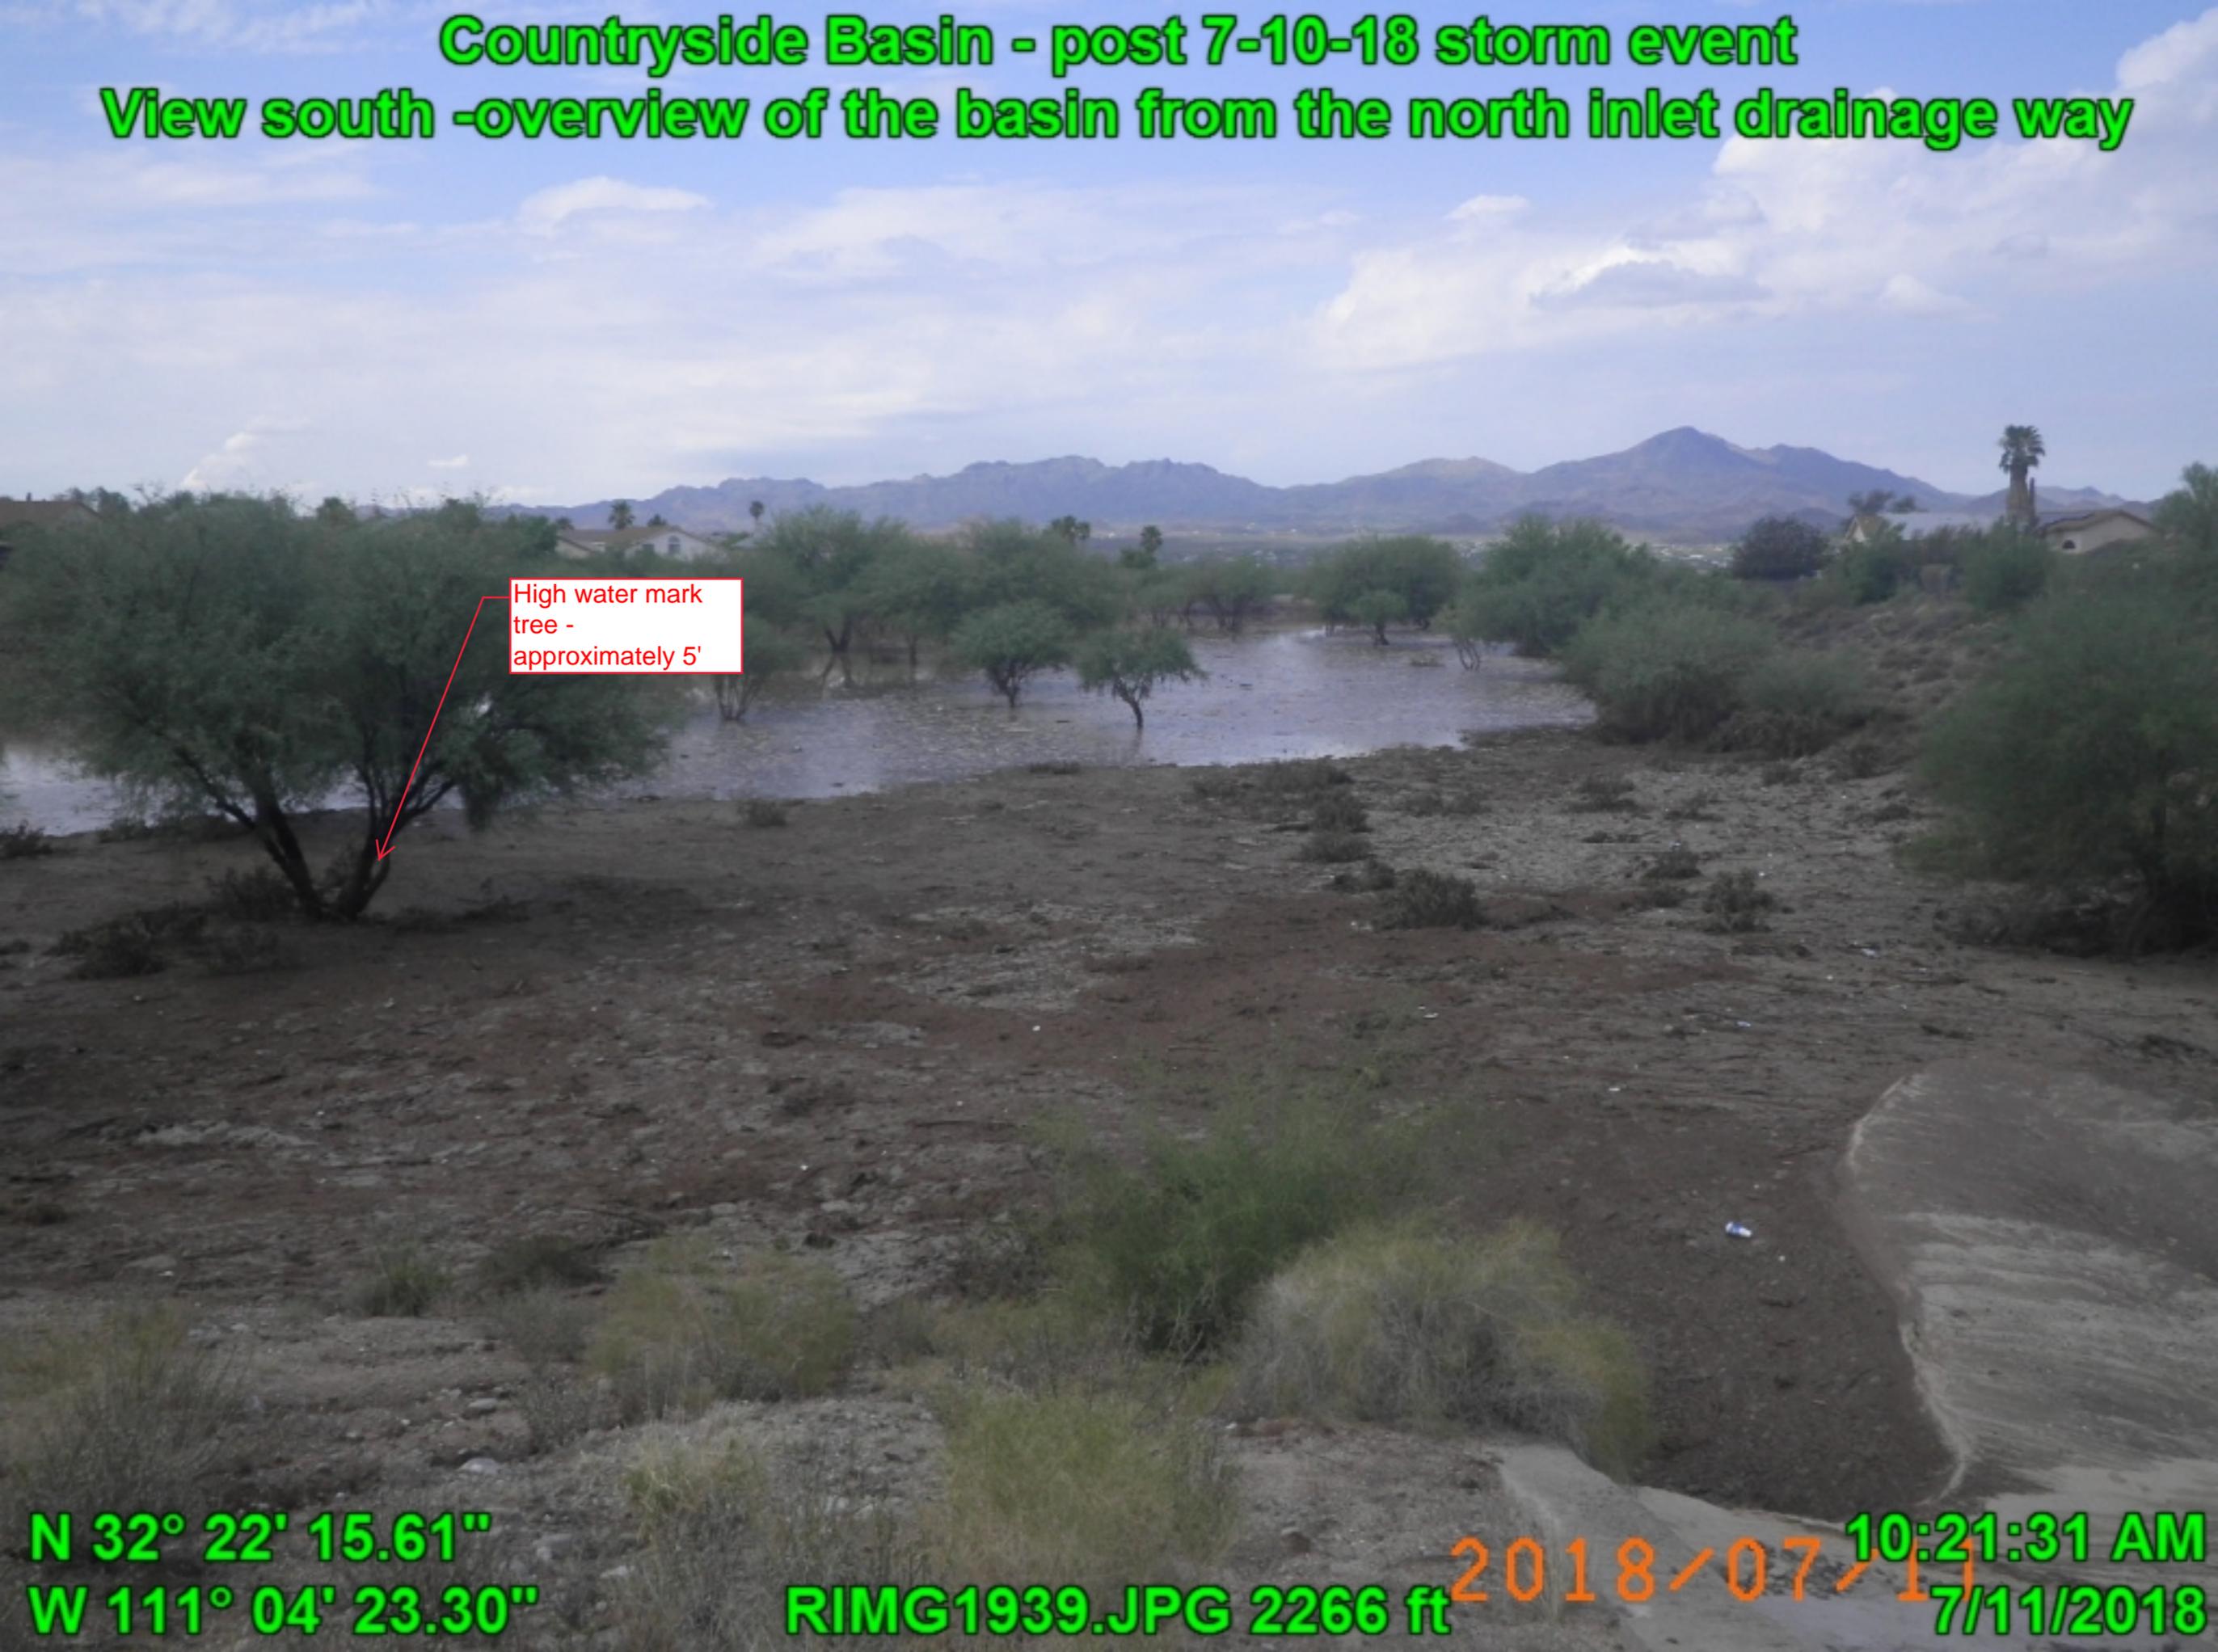
View south -overview of the basin from the north inlet drainage way

High water mark
tree -
approximately 5'

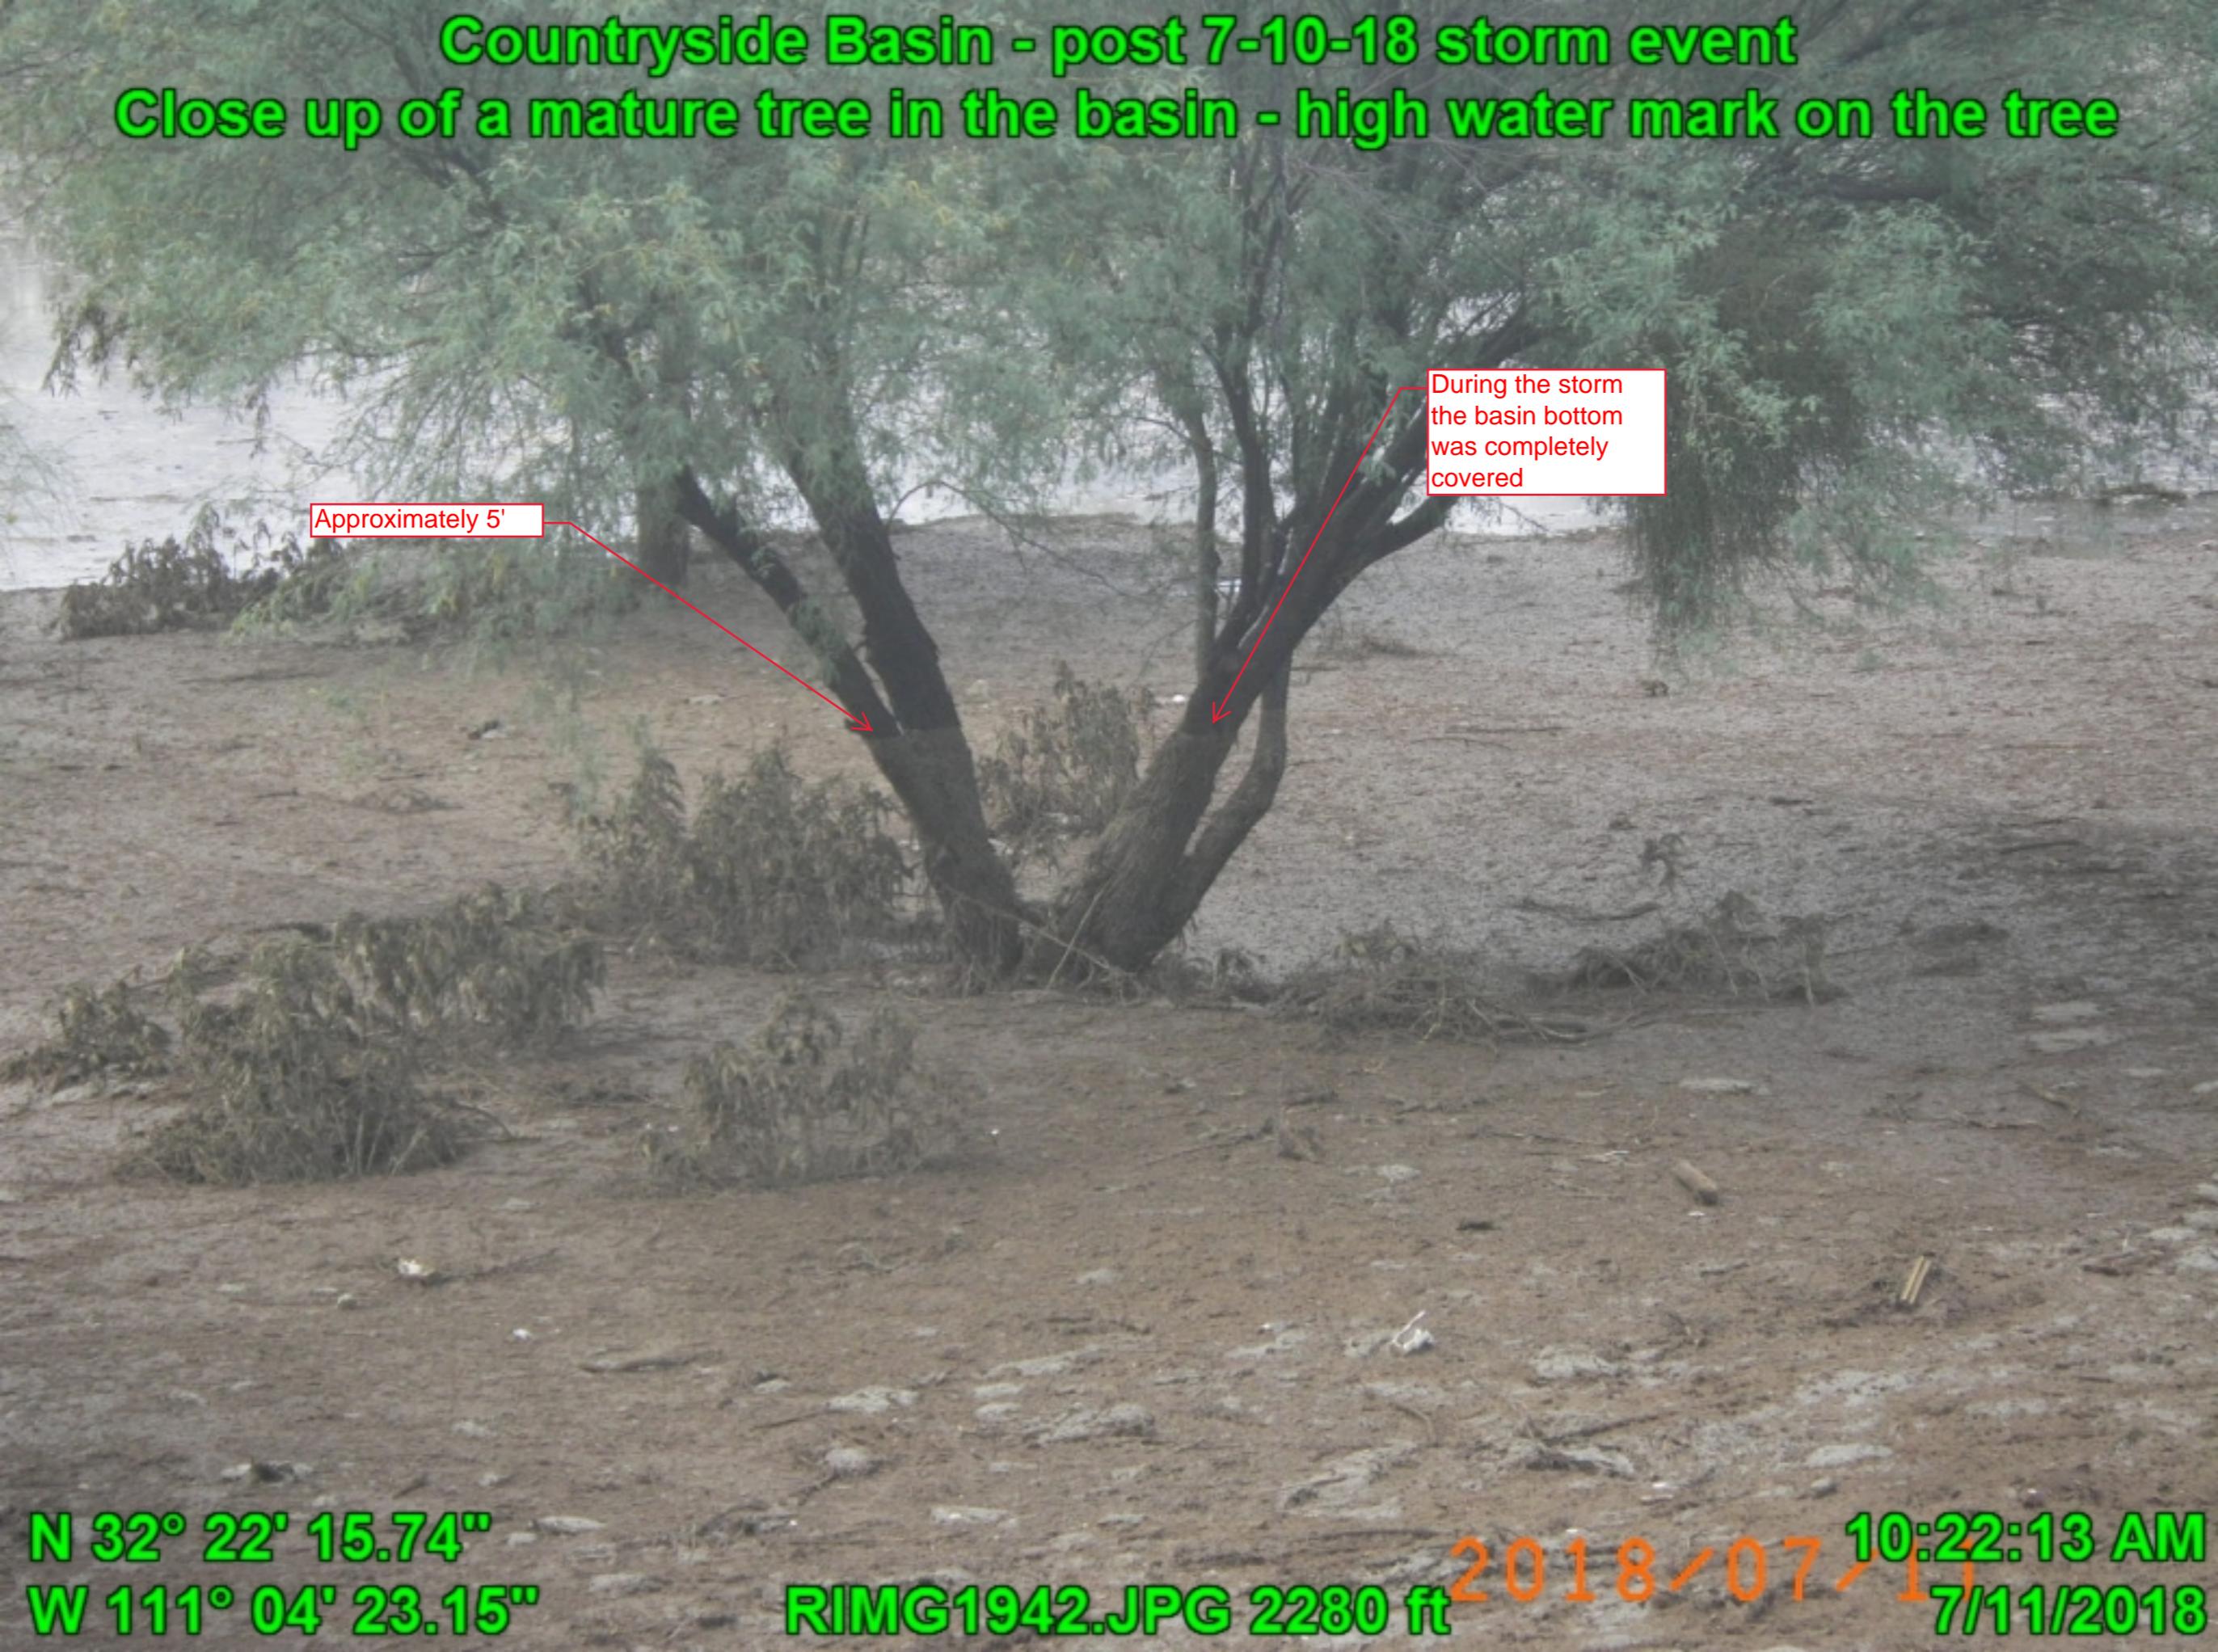
Countryside Basin - post 7-10-18 storm event
Close up of a mature tree in the basin - high water mark on the tree

Approximately 5'

During the storm
the basin bottom
was completely
covered

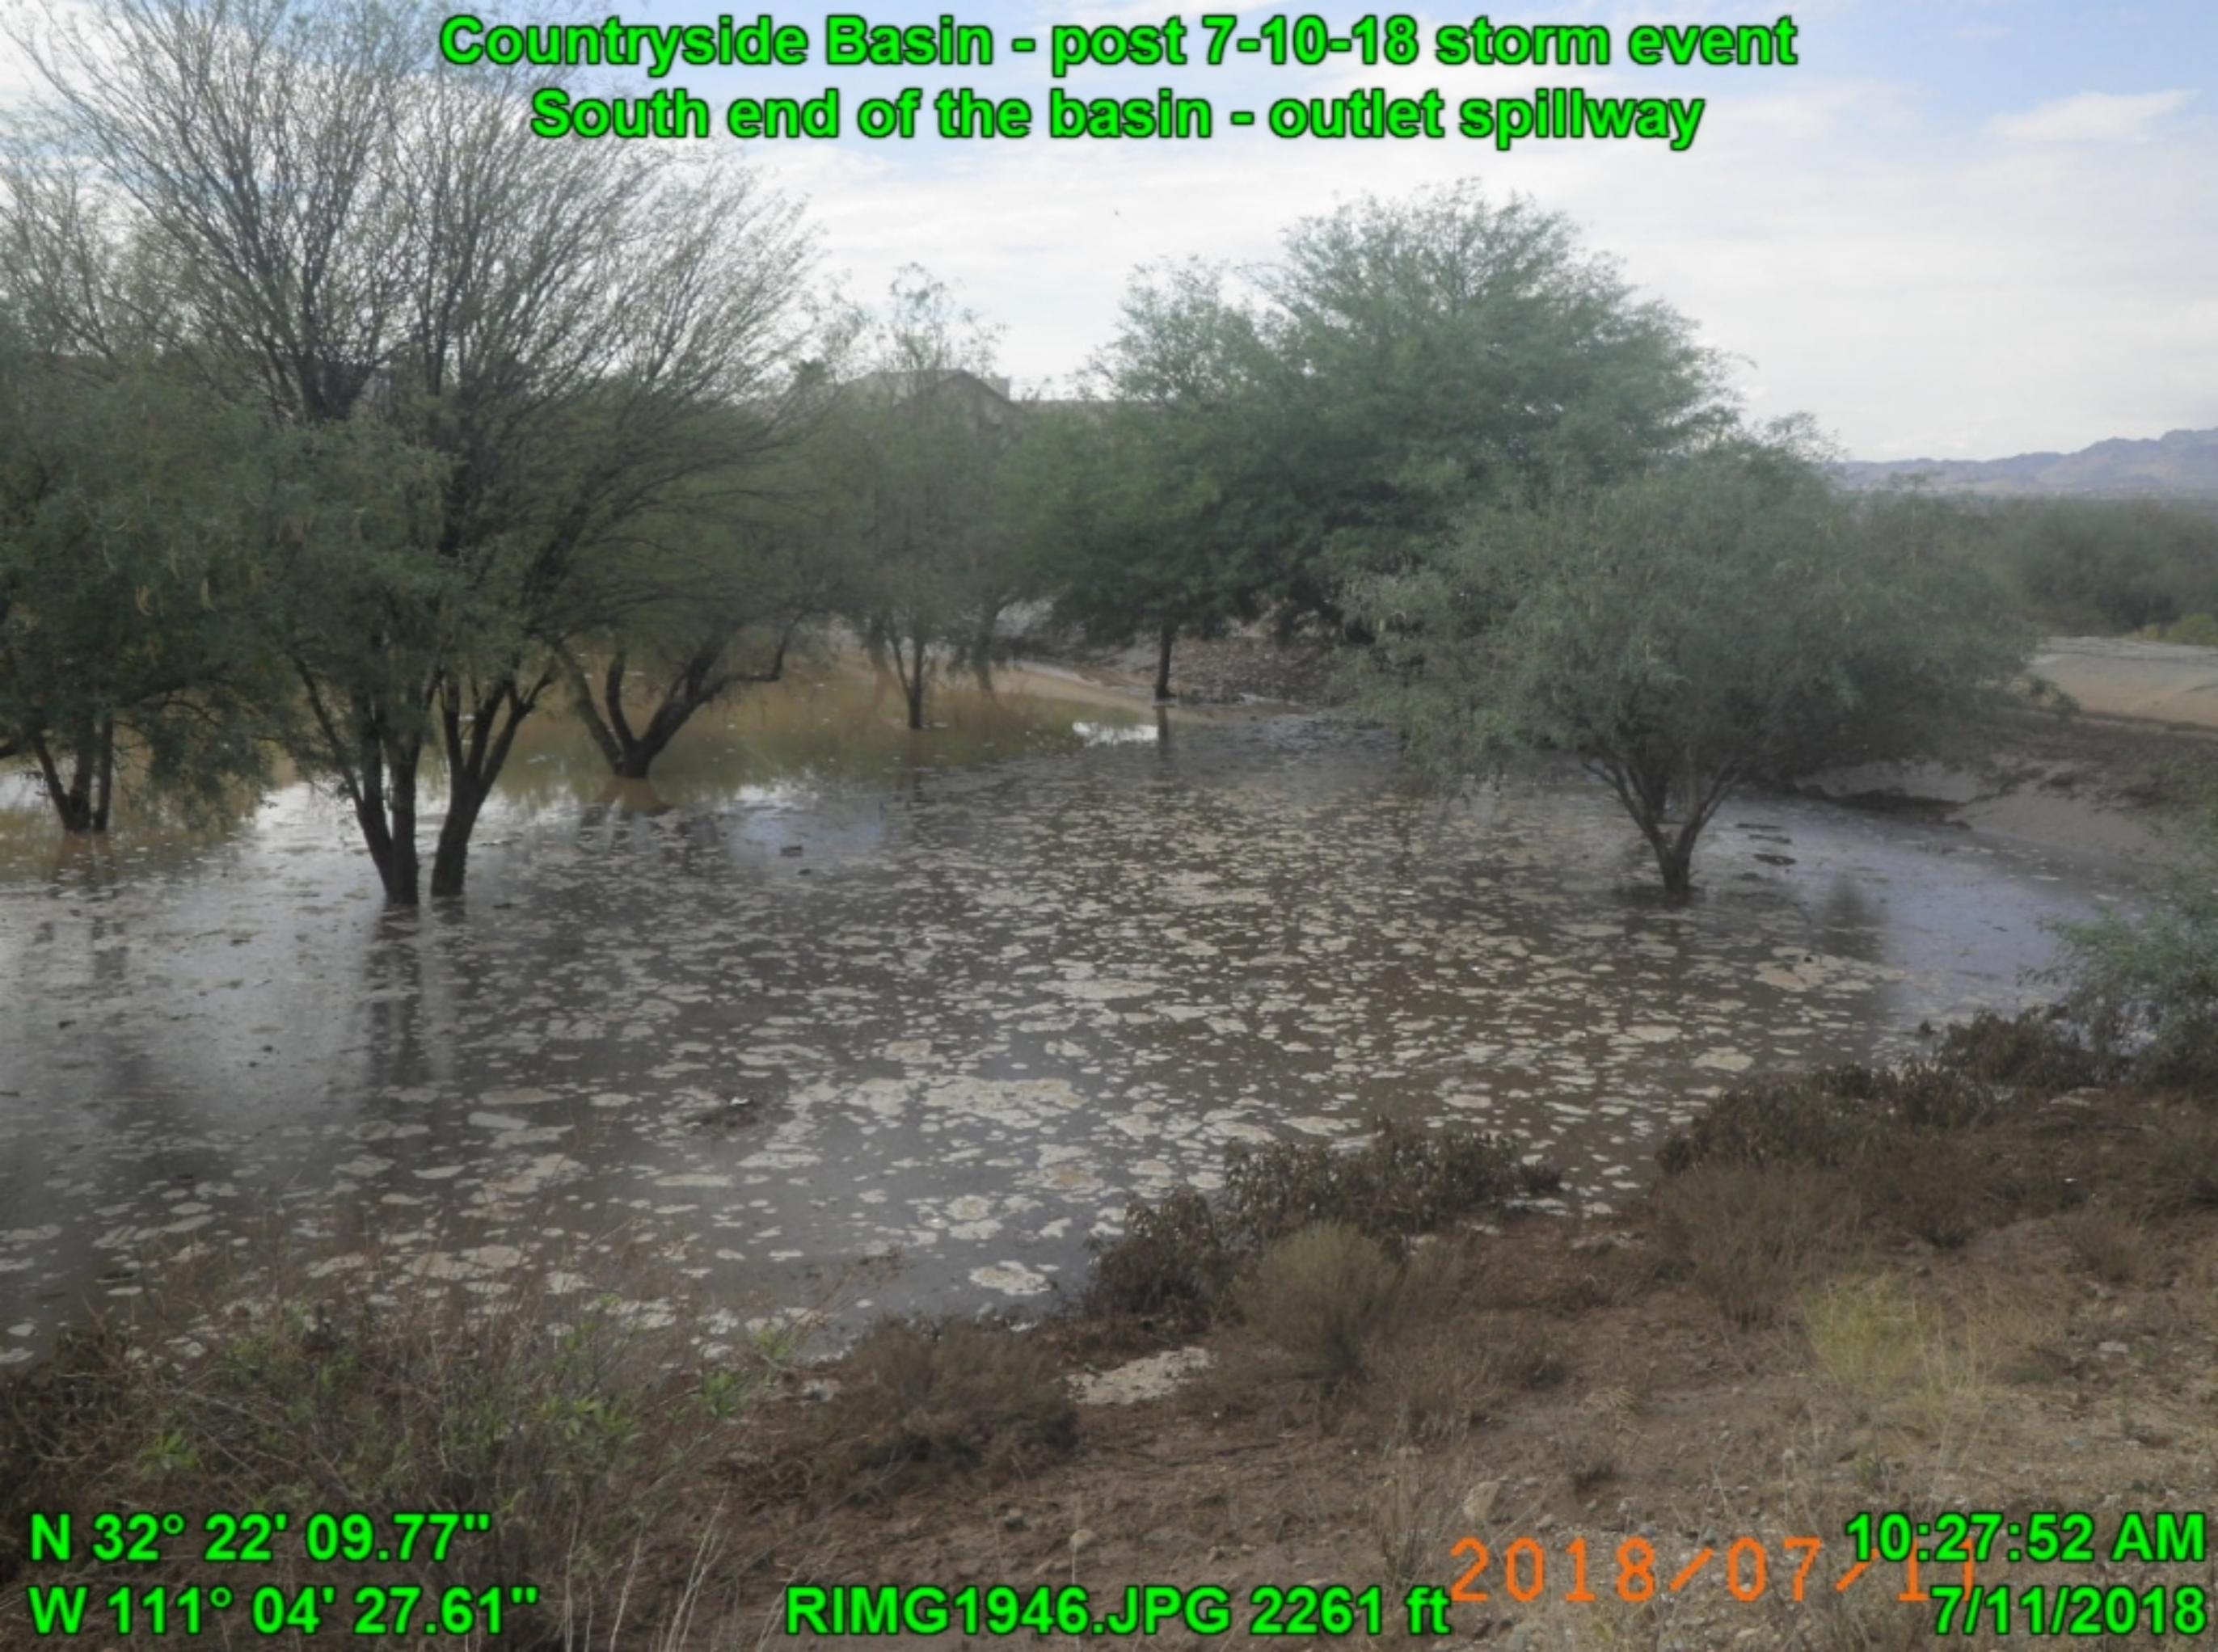
Countryside Basin - post 7-10-18 storm event
South end of the basin - outlet spillway

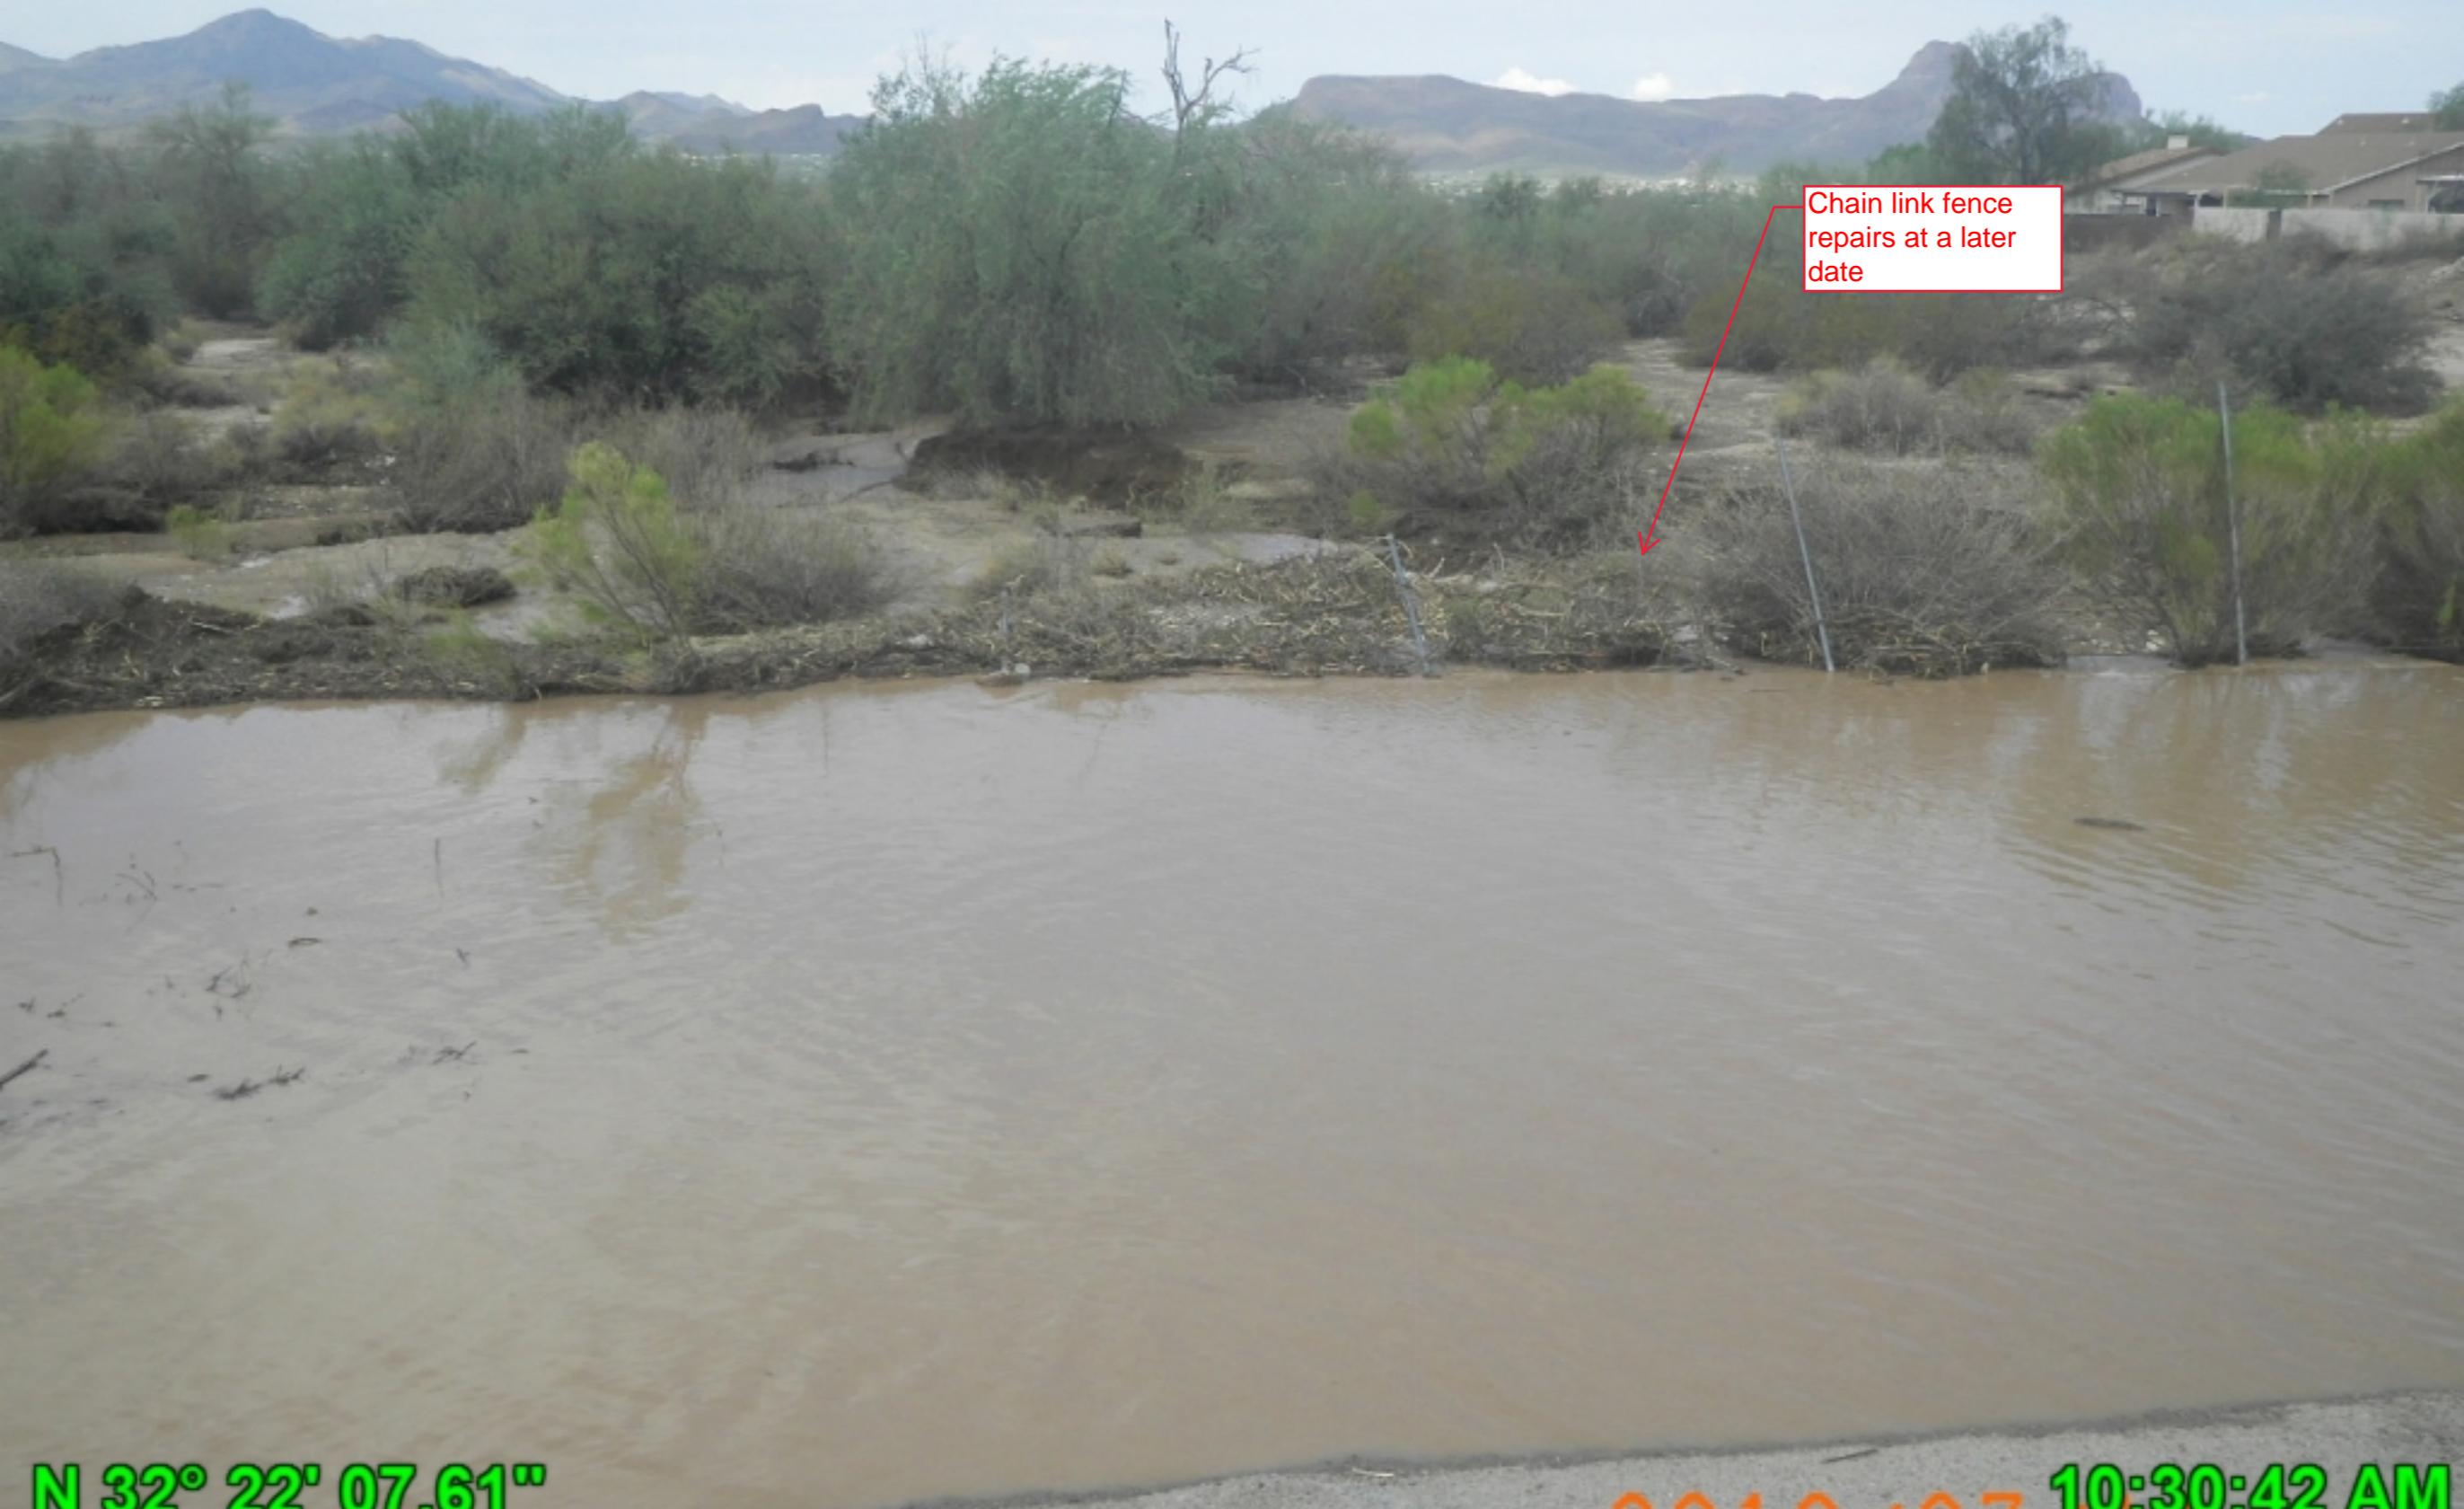
High water mark on the outlet spillway

High water mark
12" below the
spillway

Countryside Basin - post 7-10-18 storm event
Sizeable section of the chain link fencing had been knocked down

Chain link fence repairs at a later date

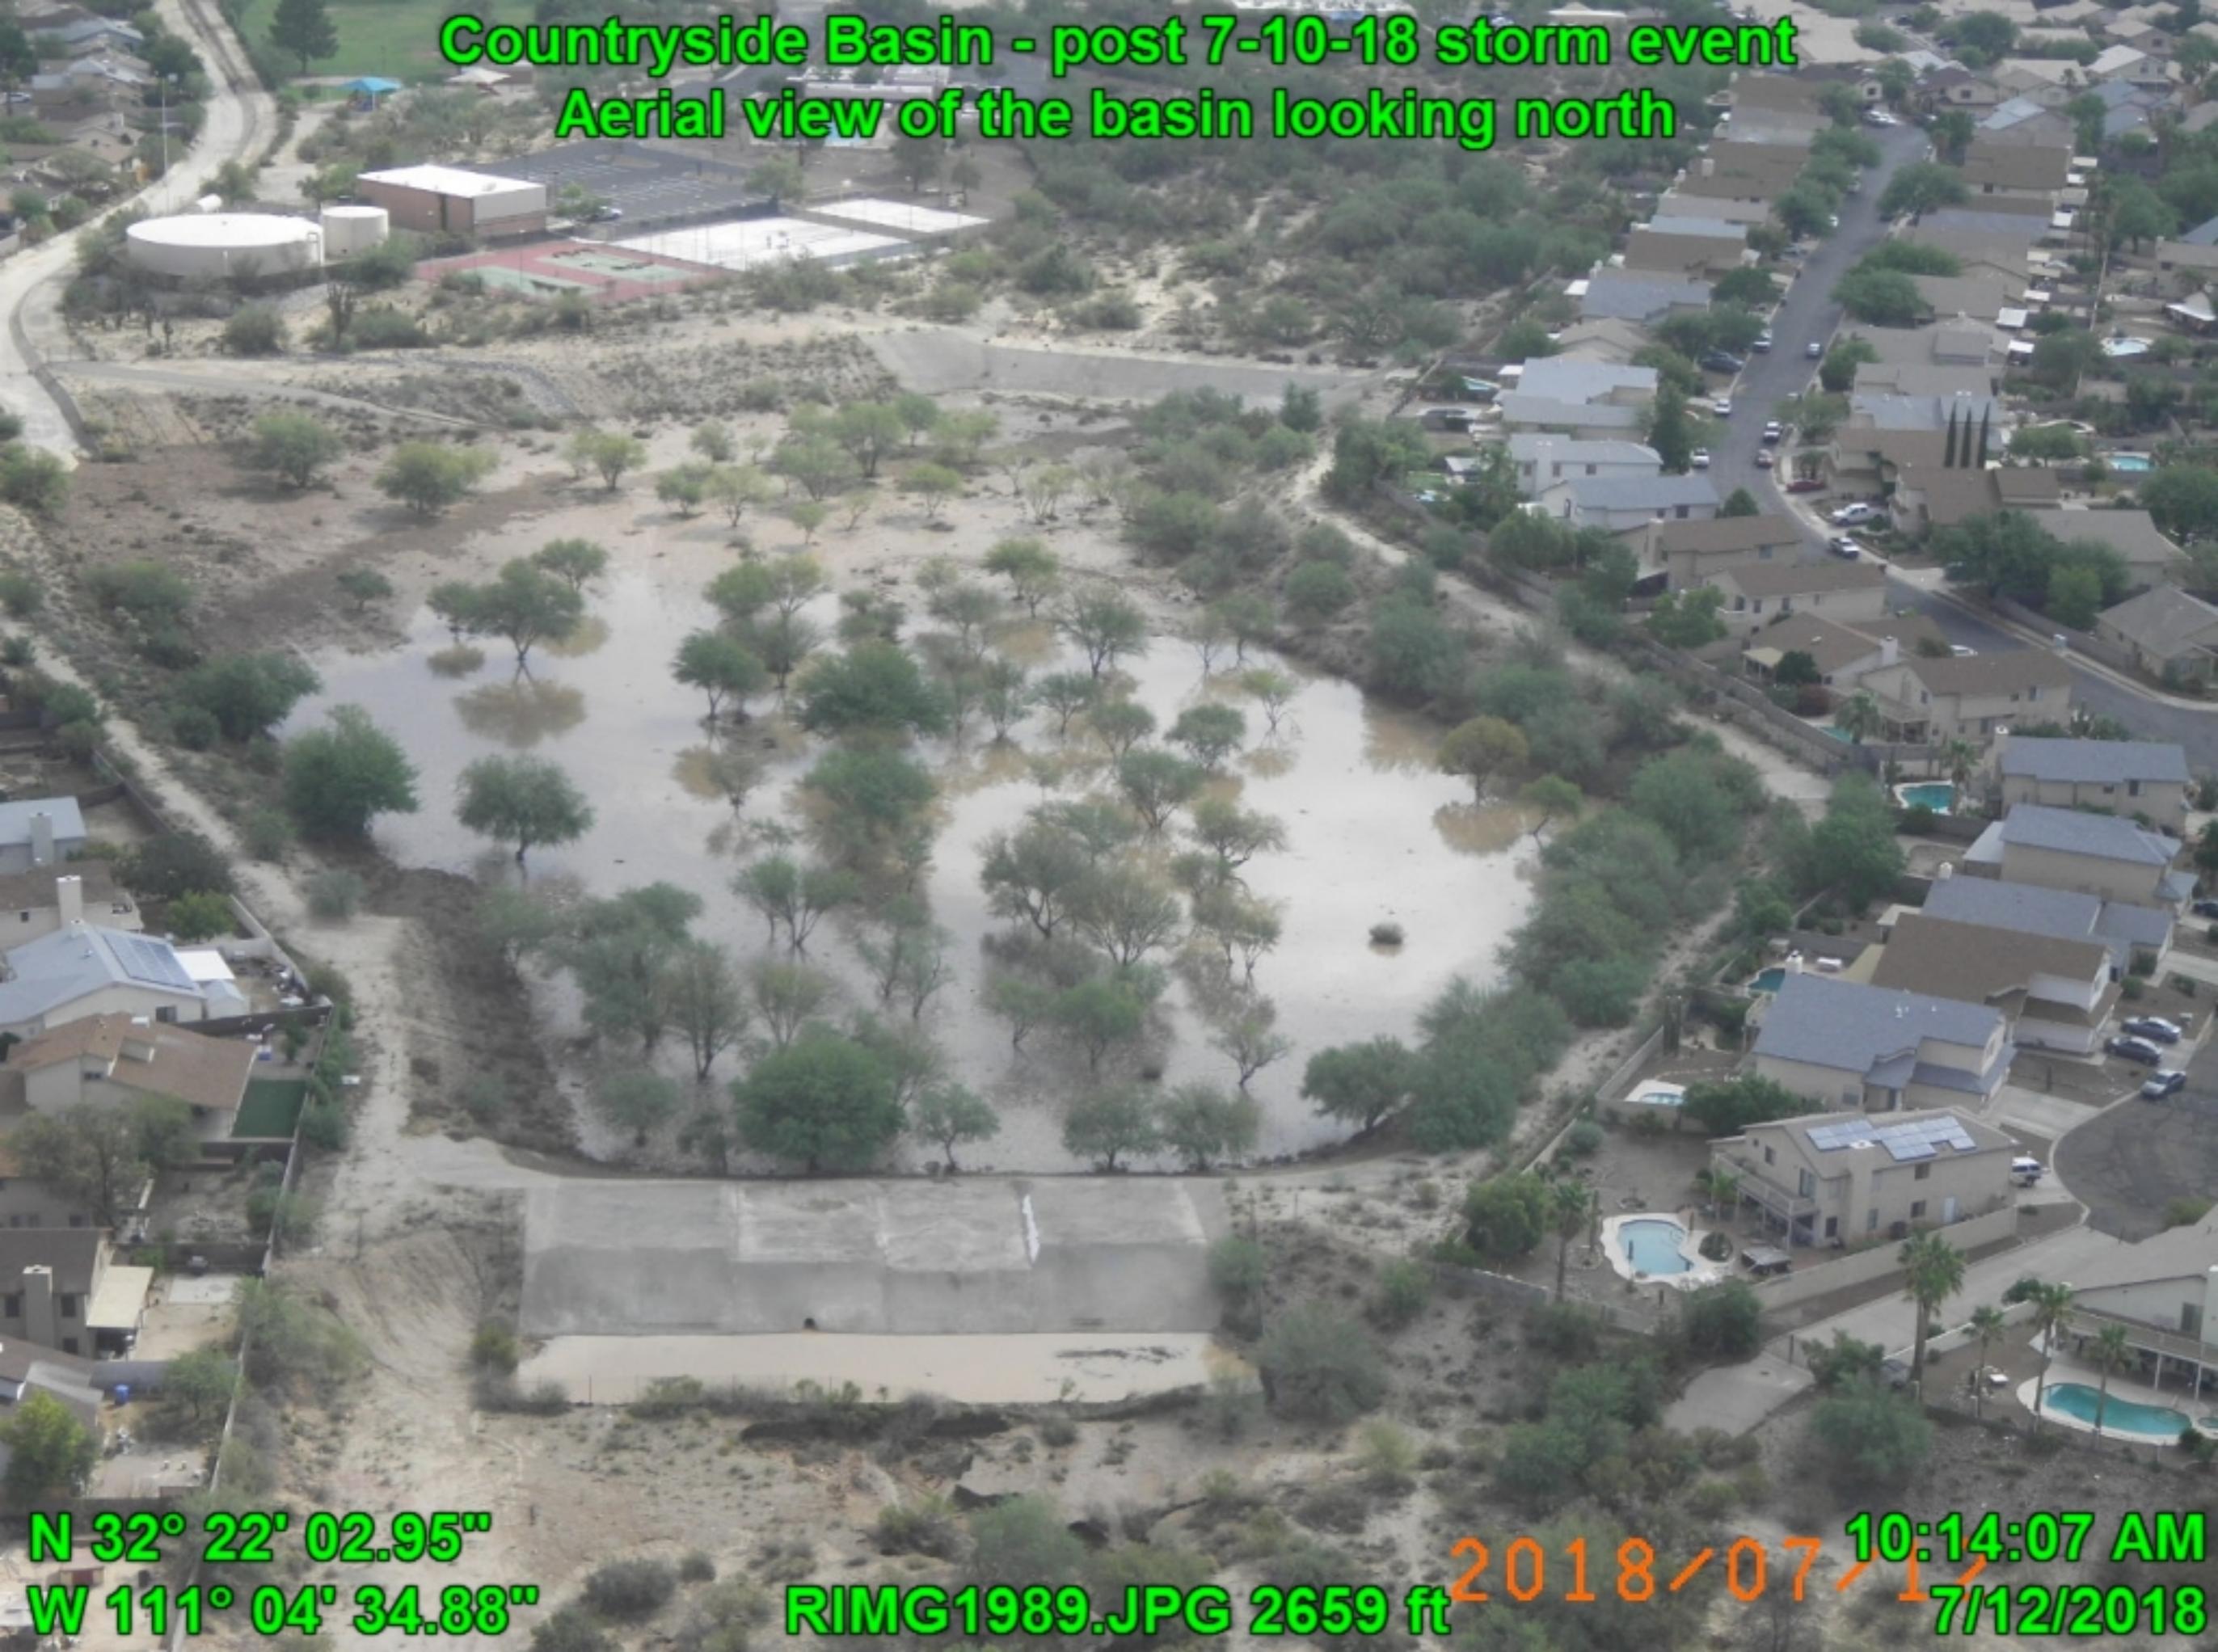
Countryside Basin - post 7-10-18 storm event
Aerial view of the basin looking north

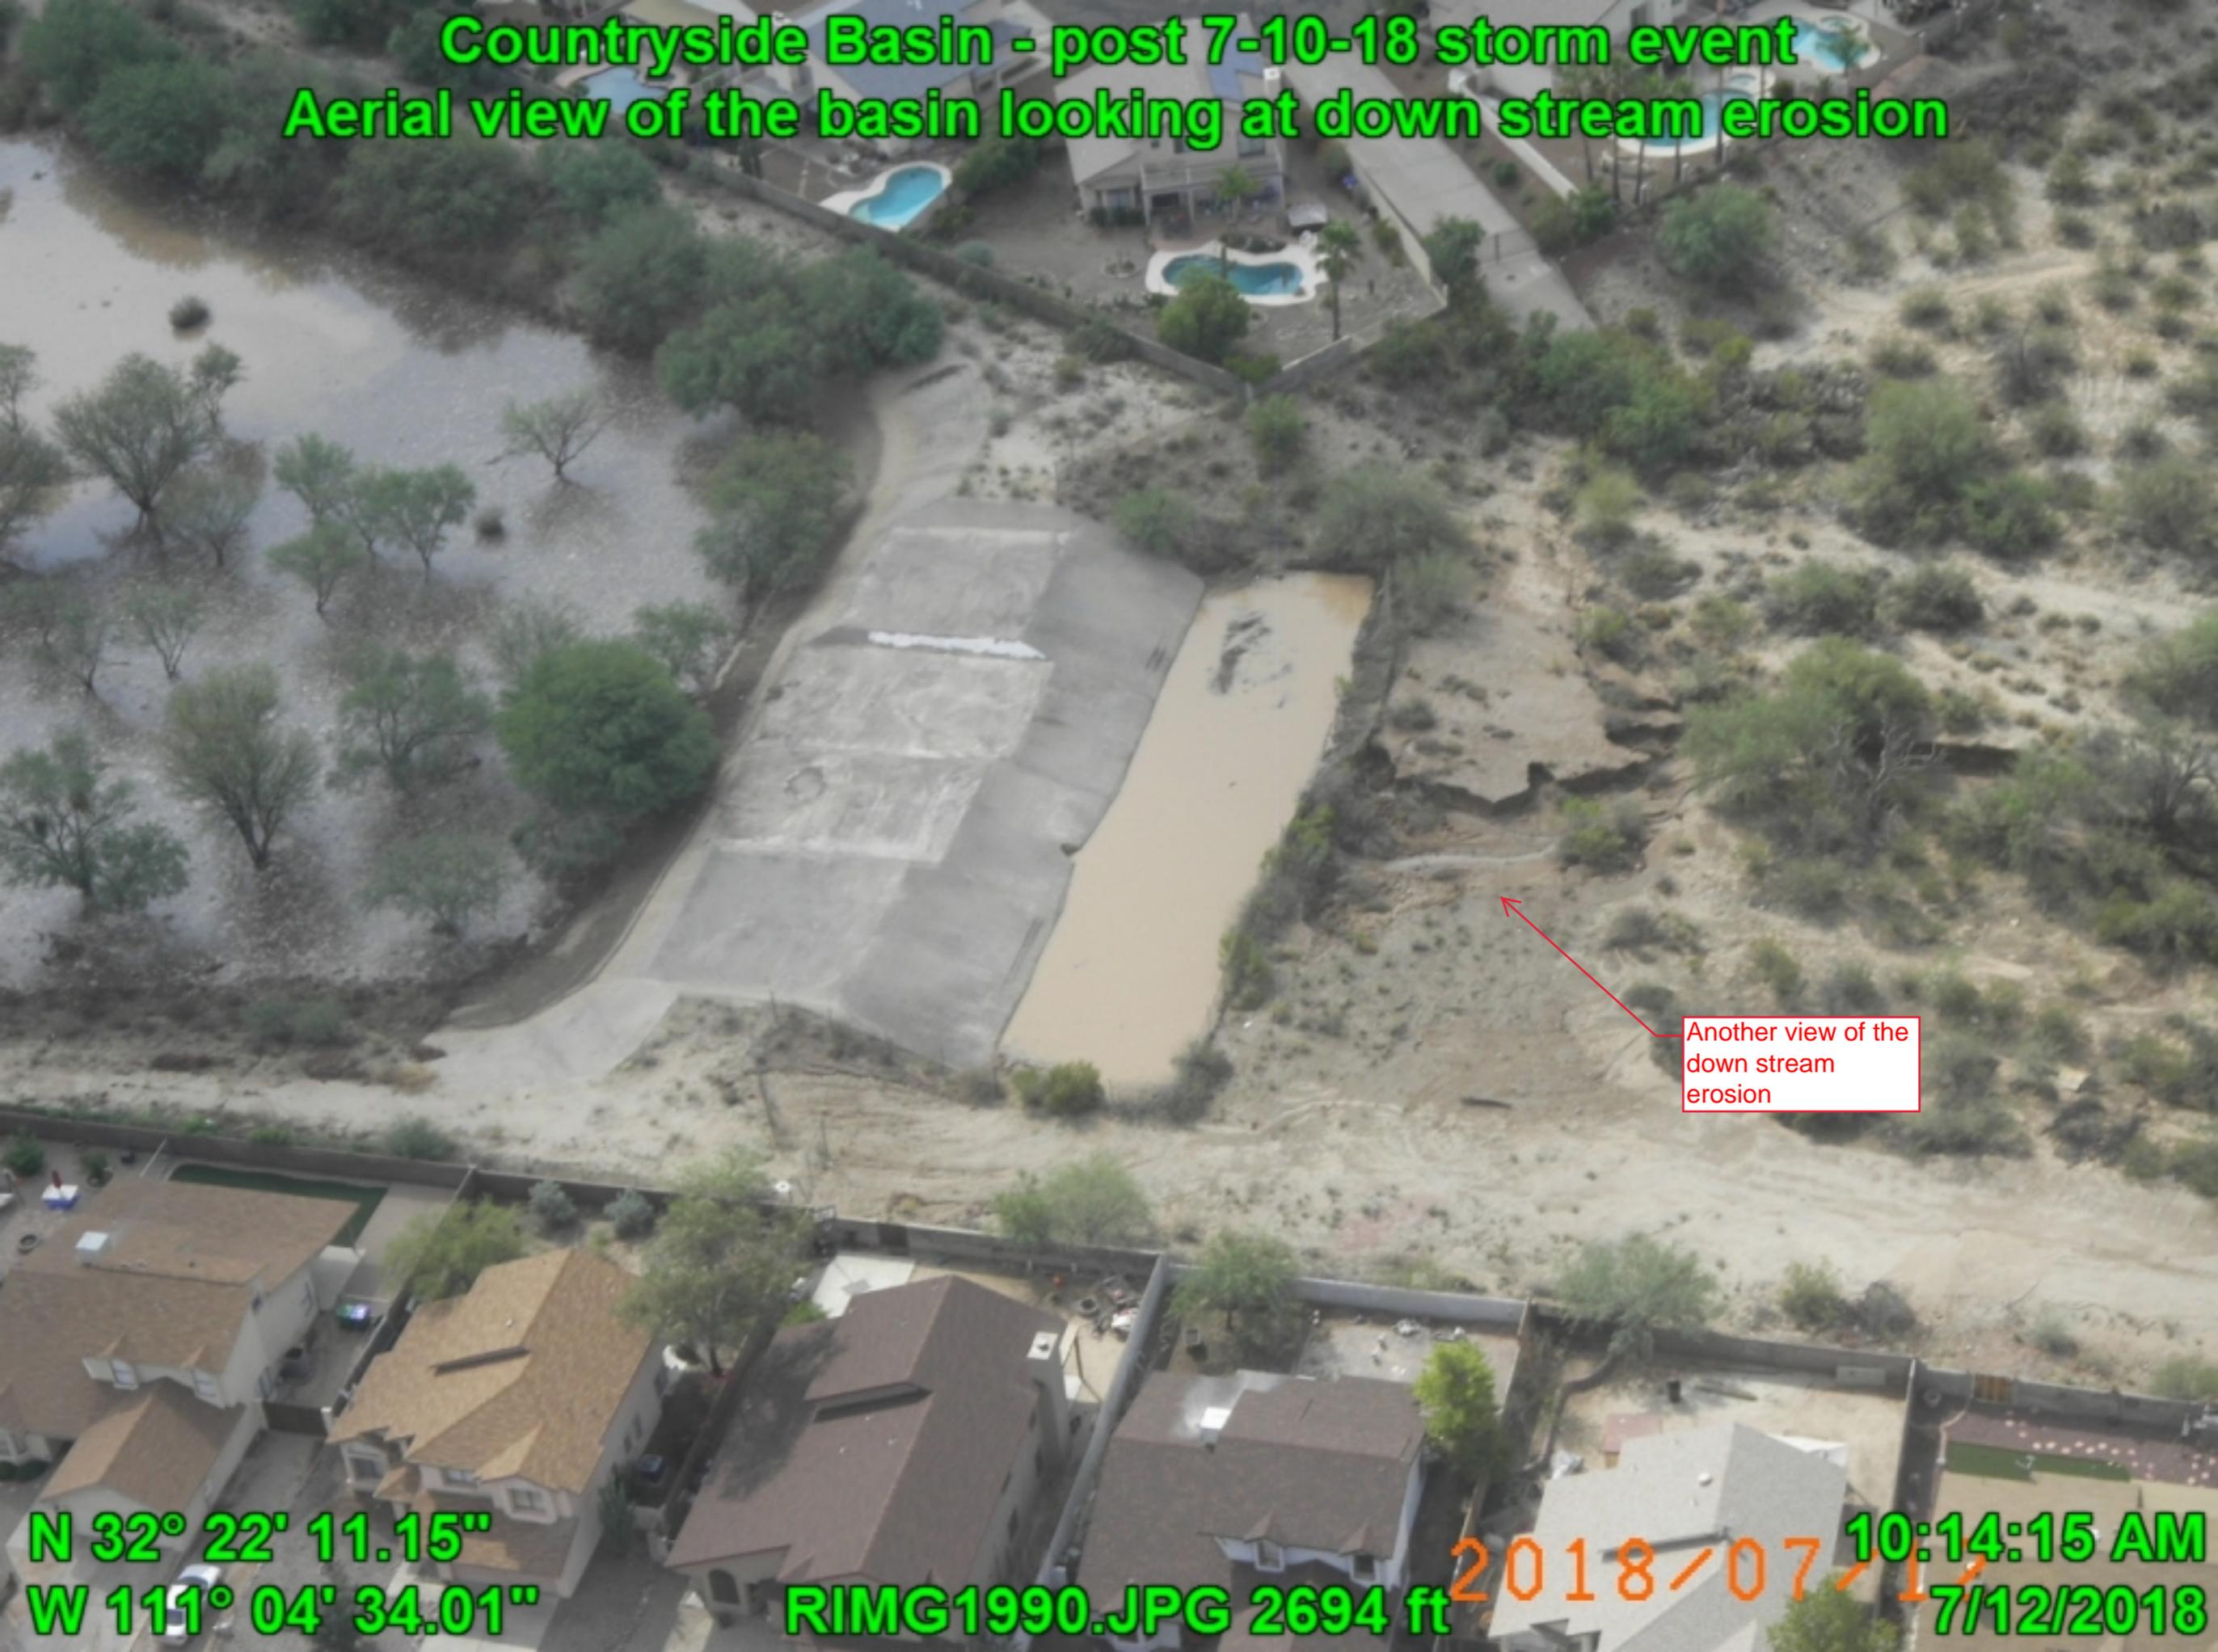
Countryside Basin - post 7-10-18 storm event
Aerial view of the basin looking at down stream erosion

Another view of the
down stream
erosion

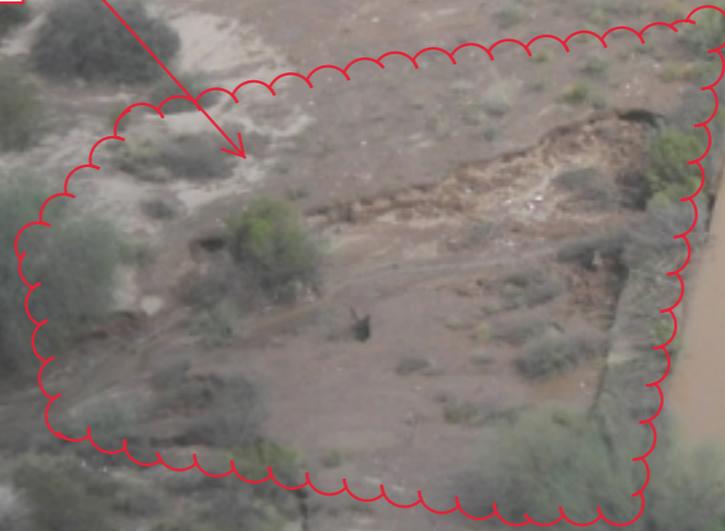
Countryside Basin - post 7-10-18 storm event
Aerial view of the basin looking at down stream erosion

Downstream
erosion
