Re: **Regional Flood Control District Storm Report for July 8 and 10, 2018**

SUBJECT: Storm Report for July 8 and July 10, 2018

SUBJECT: July 10, 2018: Post-Flood Investigation – Massingale Basin & Countryside Basin

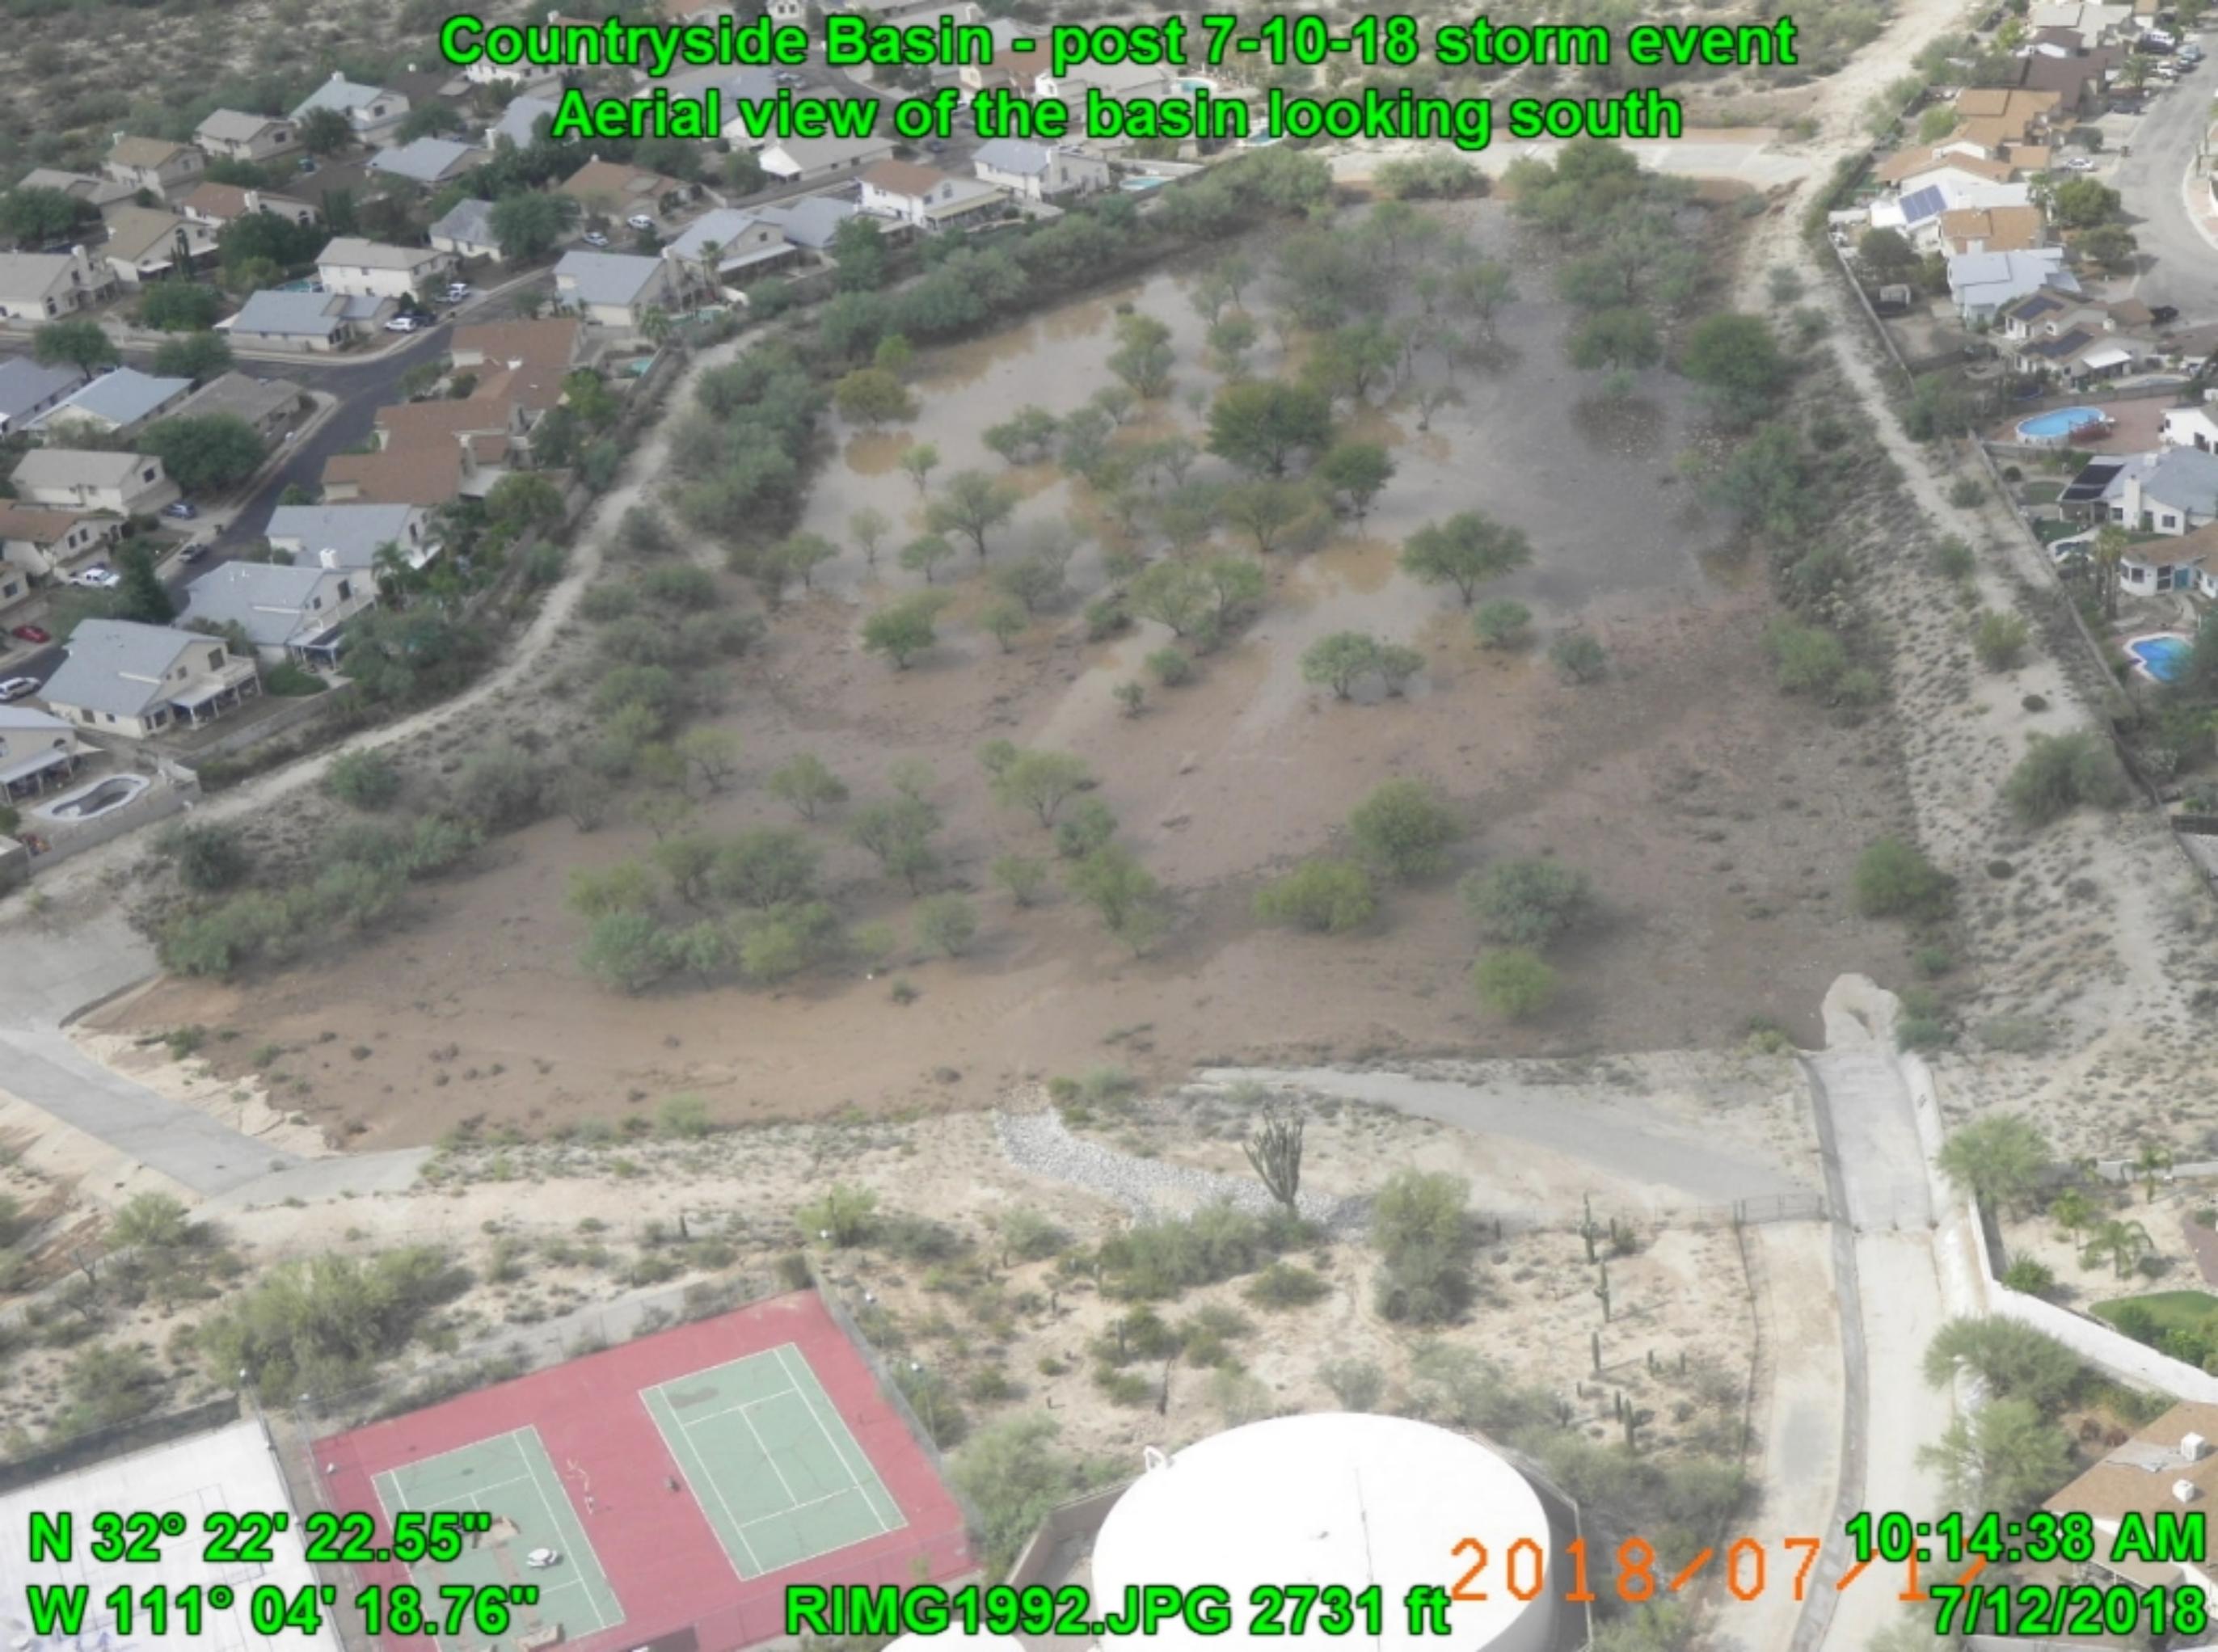
Countryside Basin - post 7-10-18 storm event
Aerial view of the basin looking south
