Re: **Preliminary Storm Report for Amado, Arizona in the Sopori Wash**

SUBJECT: Preliminary Storm Report for September 2 and 3, 2018

SUBJECT: Sopori Wash Flood field investigation September 4, 2018

Sopori Wash/Amado Flood Event 9/2/18

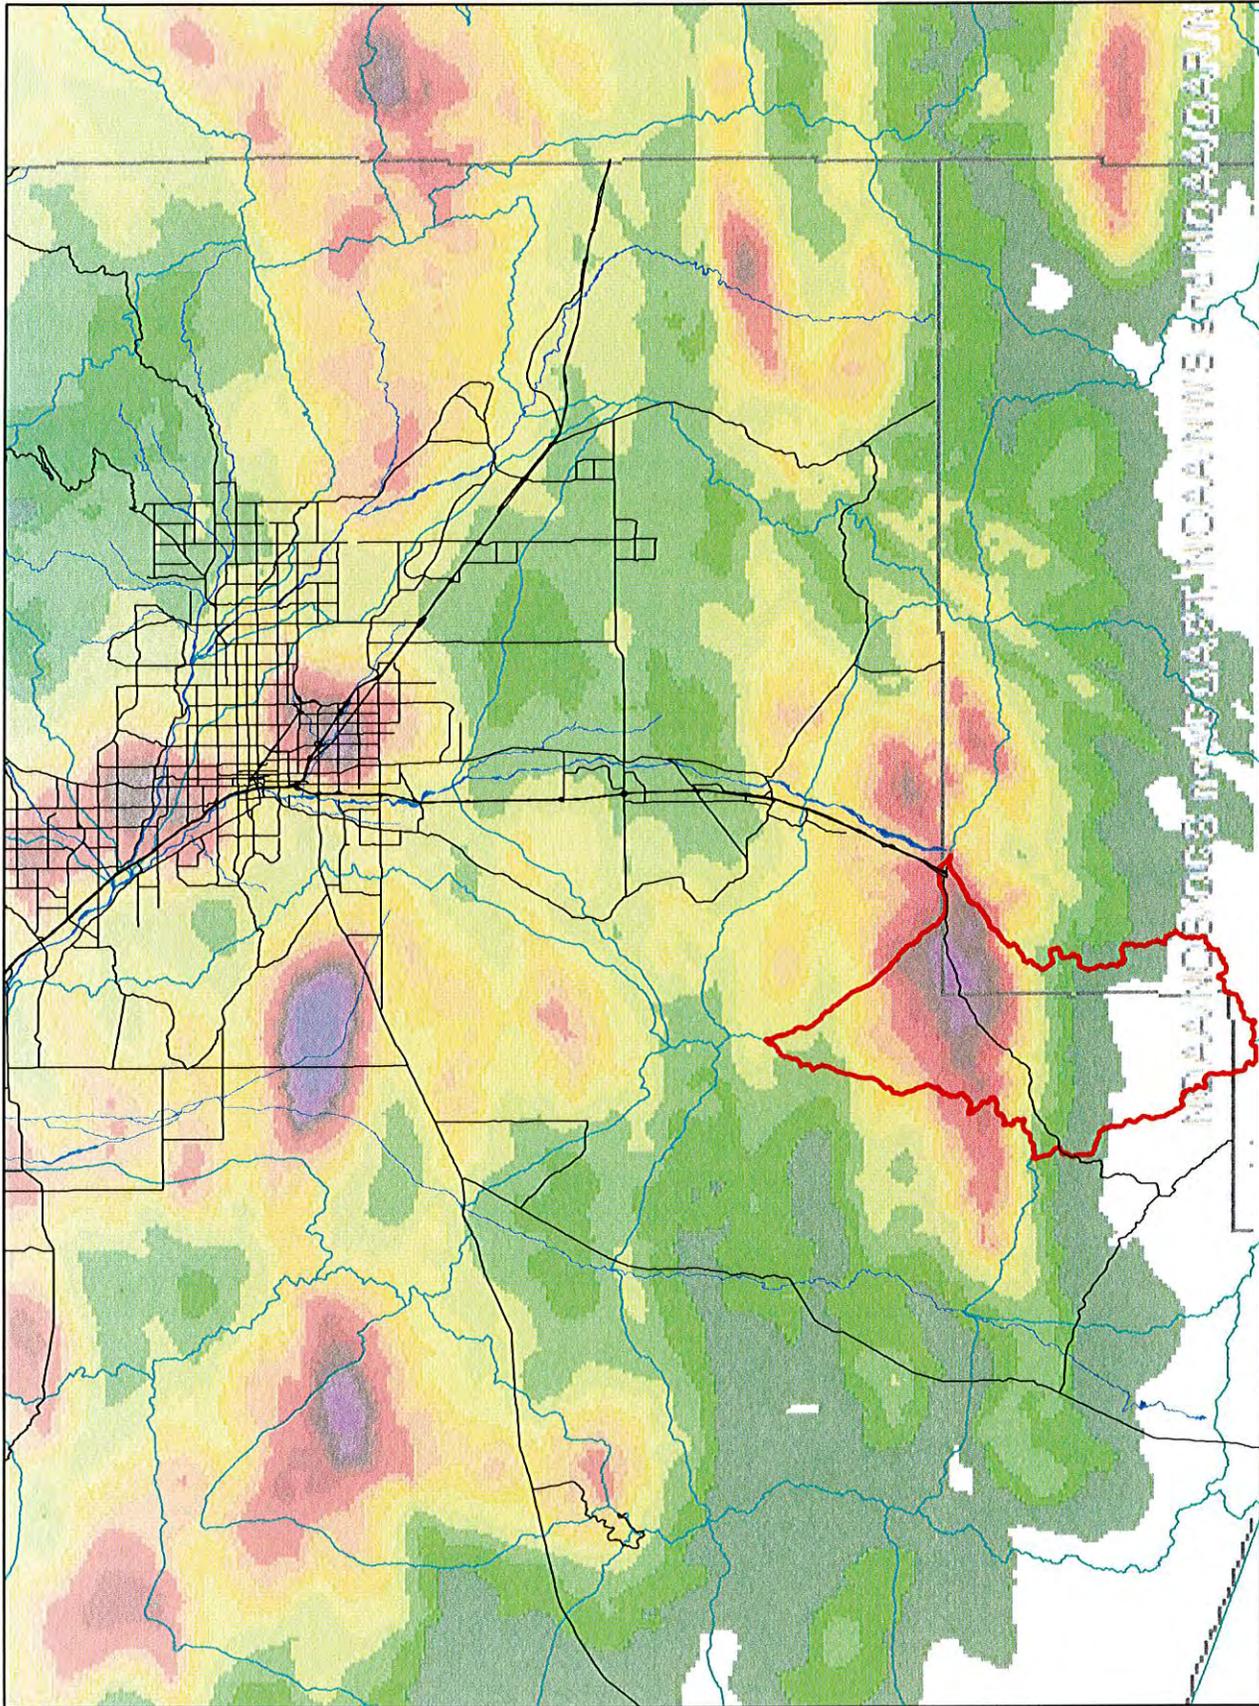
September 2, 2018 23:55 PM
24 Hour QPE

Residents in Amado reported approximately three inches of rain. Floodwaters over topped the Sopori Wash channel resulting in flooding of properties in both Santa Cruz County and Pima County (see radar data for September 2, 2018).

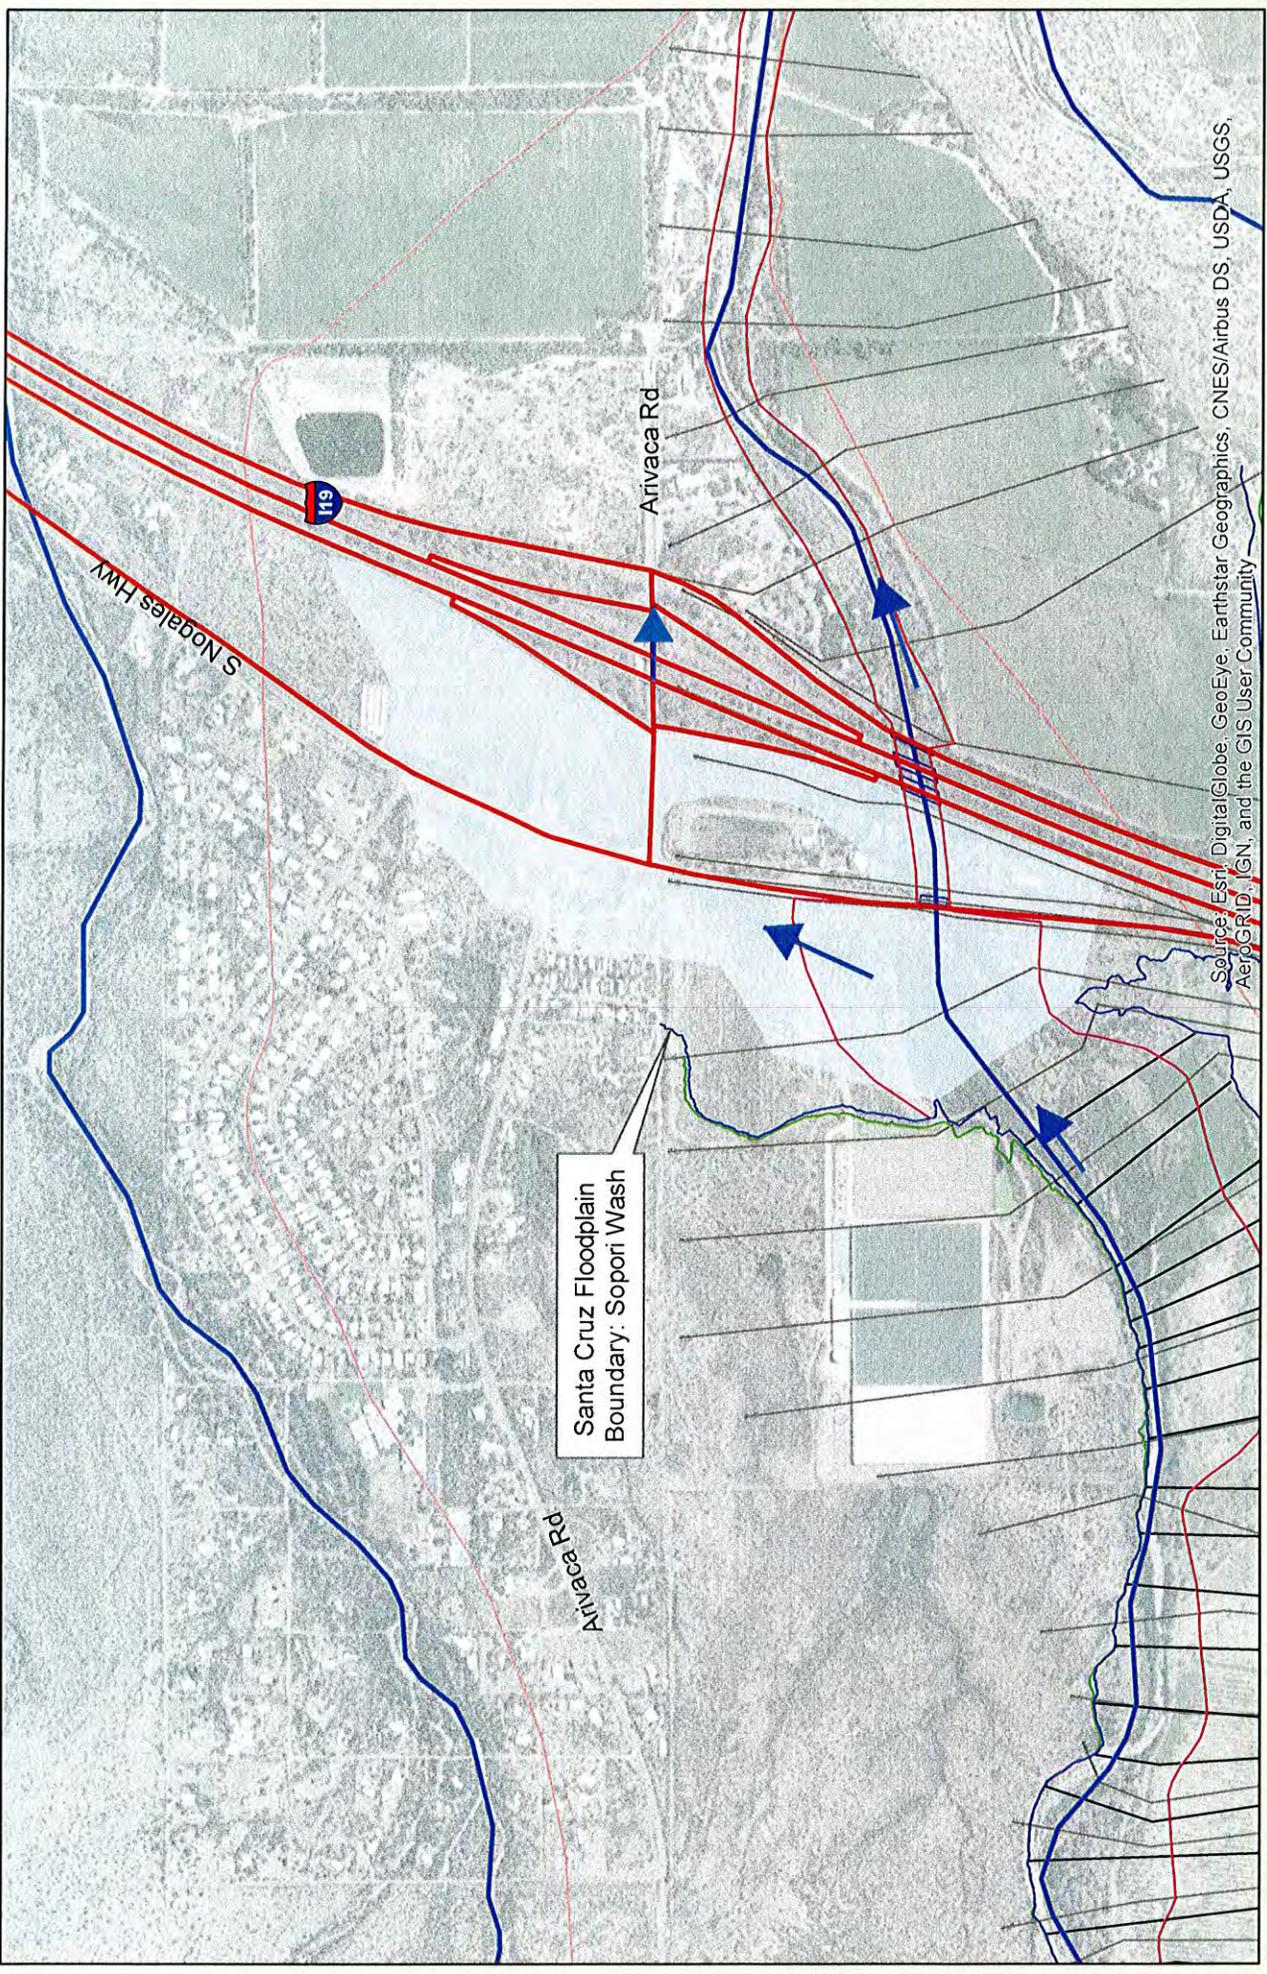
Inundation Area

District staff performed field inspections on September 4 and 5 to document and investigate the flooding (see attached reports). The attached map illustrates the area of inundation in Amado.

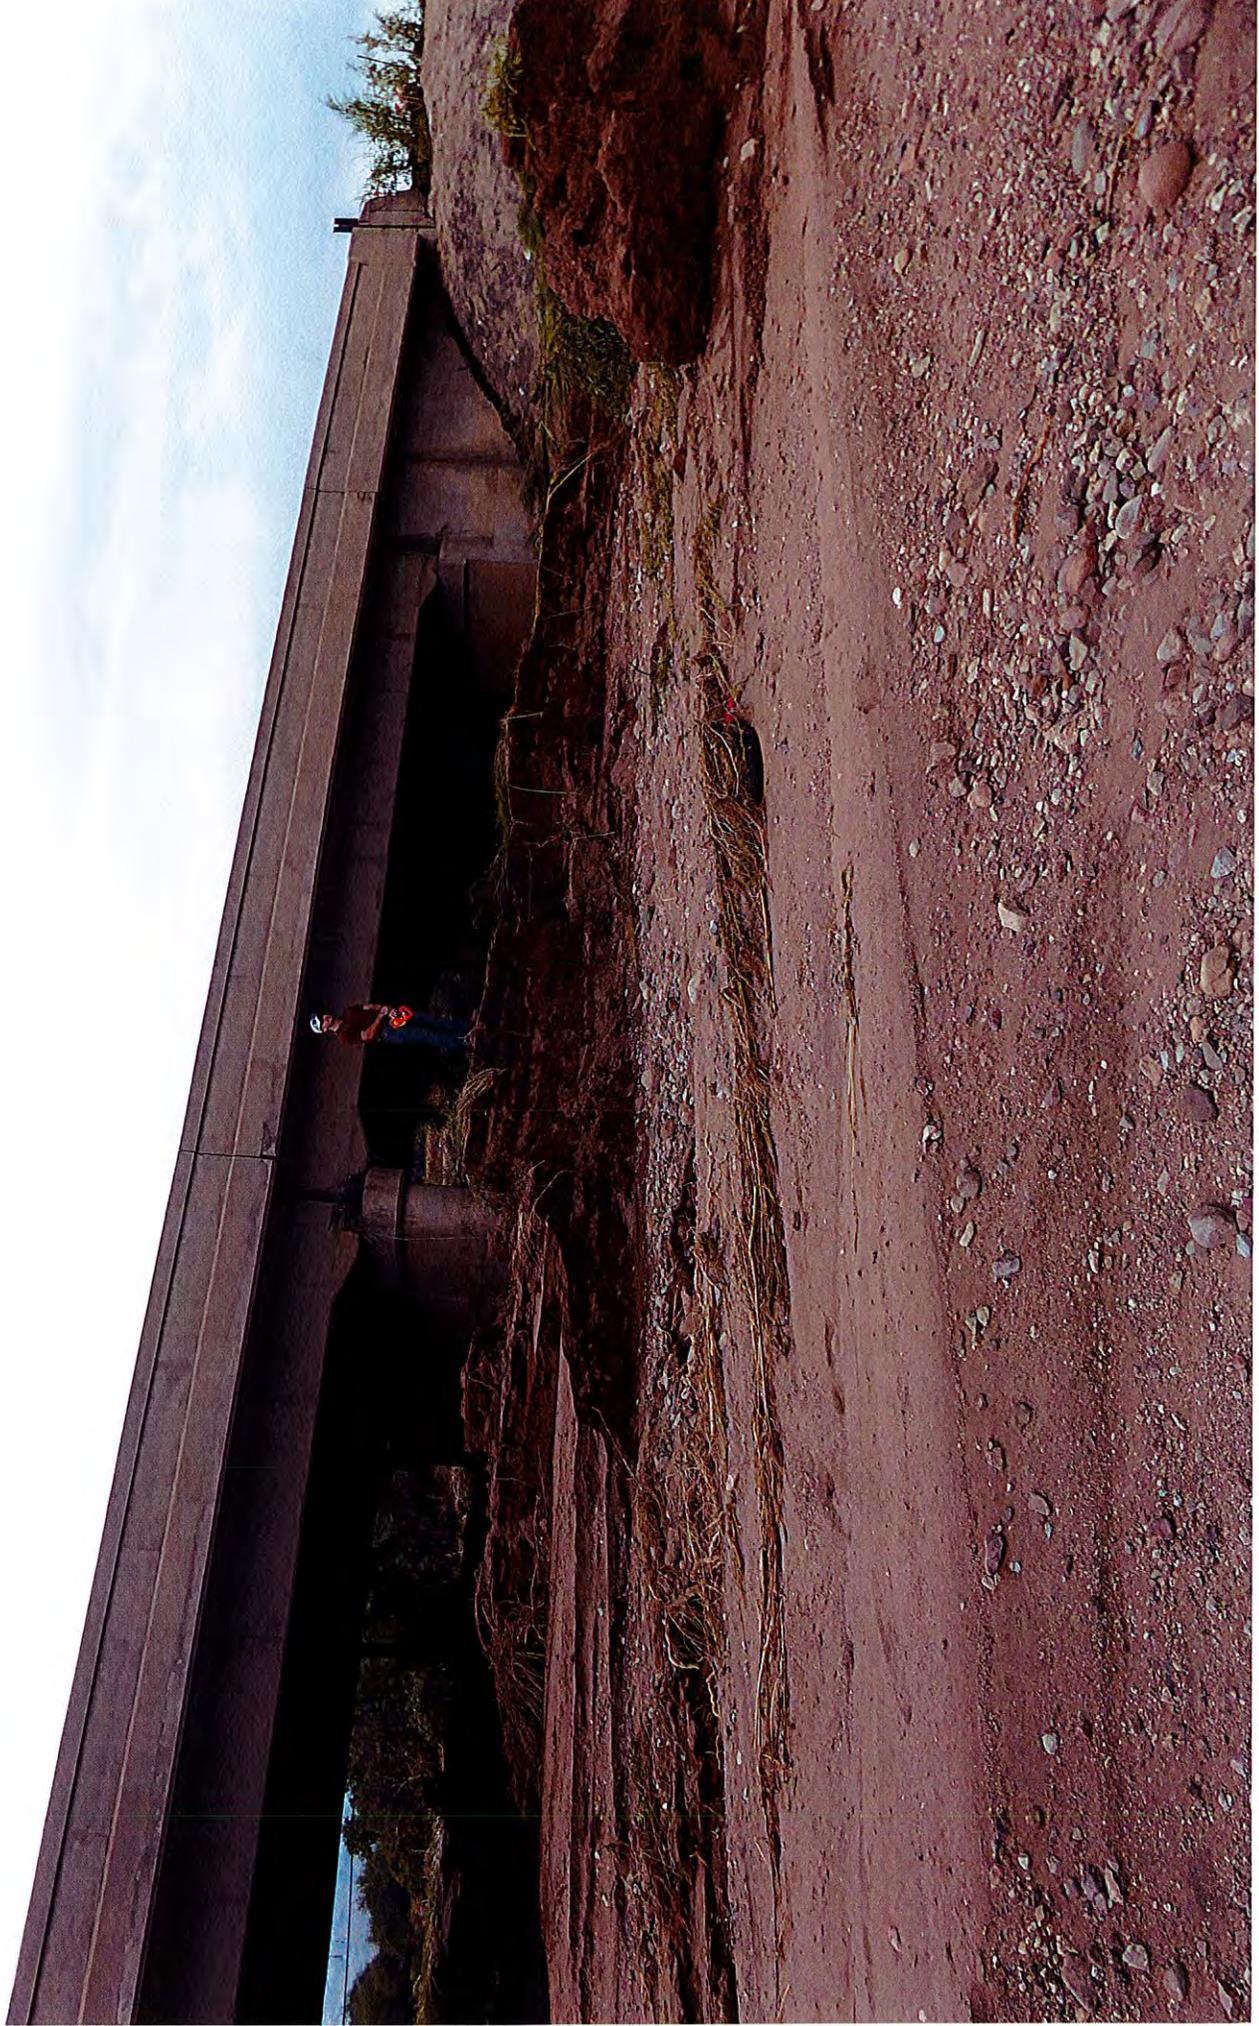
South cells of Sopori Wash bridge on
Nogales Hwy, view to E

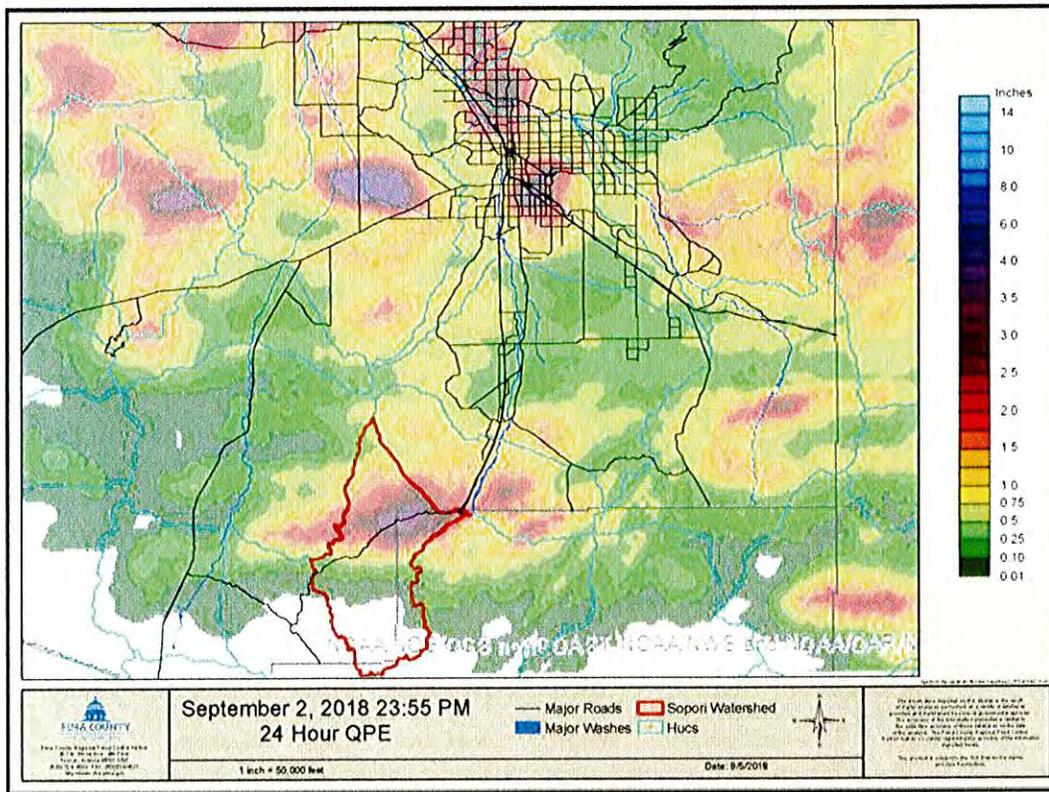
Figure 1

On September 4, 2018, Jeff Mangold and I went to the Sopori Wash around Amado (Arivaca Junction) to document flooding that occurred the night of Sunday September 2. There was a significant rainfall within the northern half of the Sopori Wash Watershed (see Figure 1). The areas of inundation are to be delineated by Psomas via an upcoming drone survey. Flooding occurred in both Pima and Santa Cruz County.

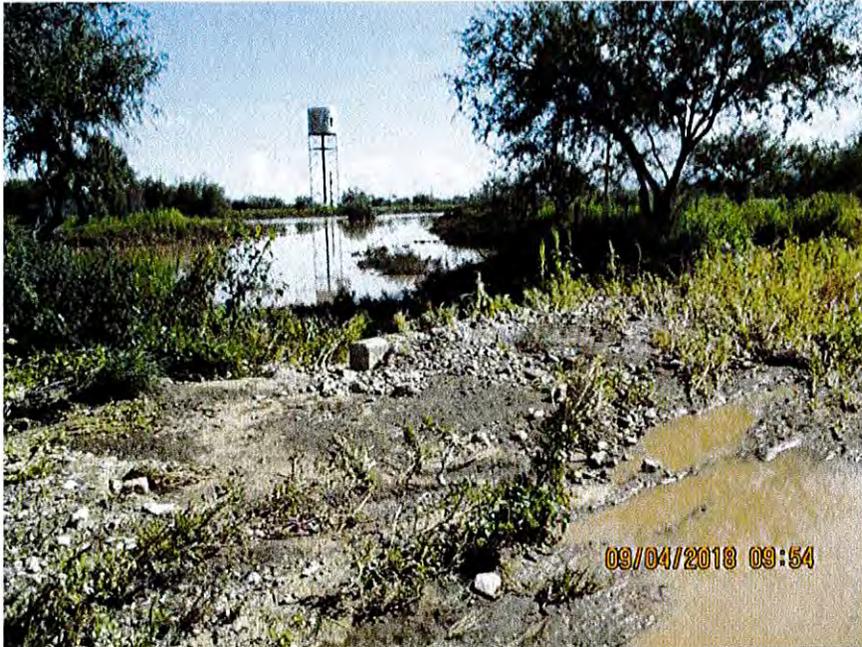
Looking northeast from the northeast corner of the New Arivaca Road and the Nogales Highway. It appeared the flood water overtopped the intersection

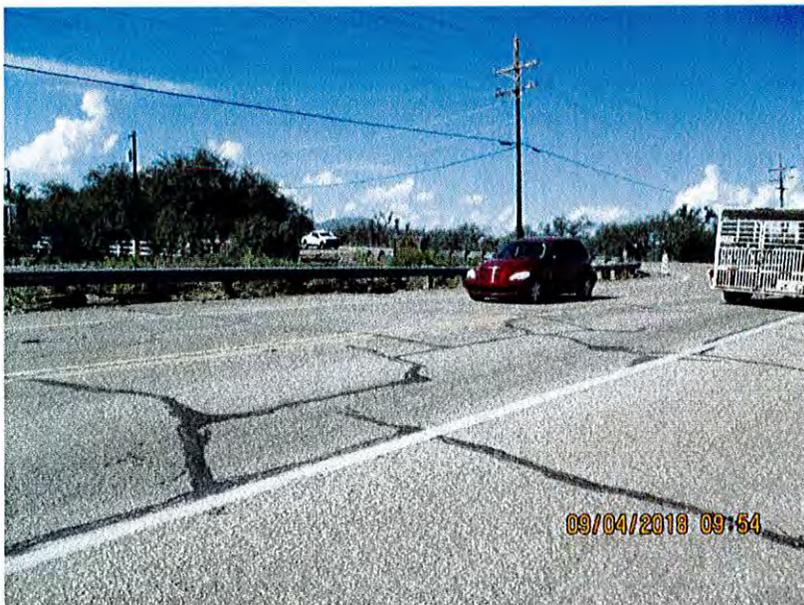
Looking southwesterly at the guardrail on the south side of Arivaca Road east of the Nogales Highway. Flow when under the guardrail and crossed the roadway.

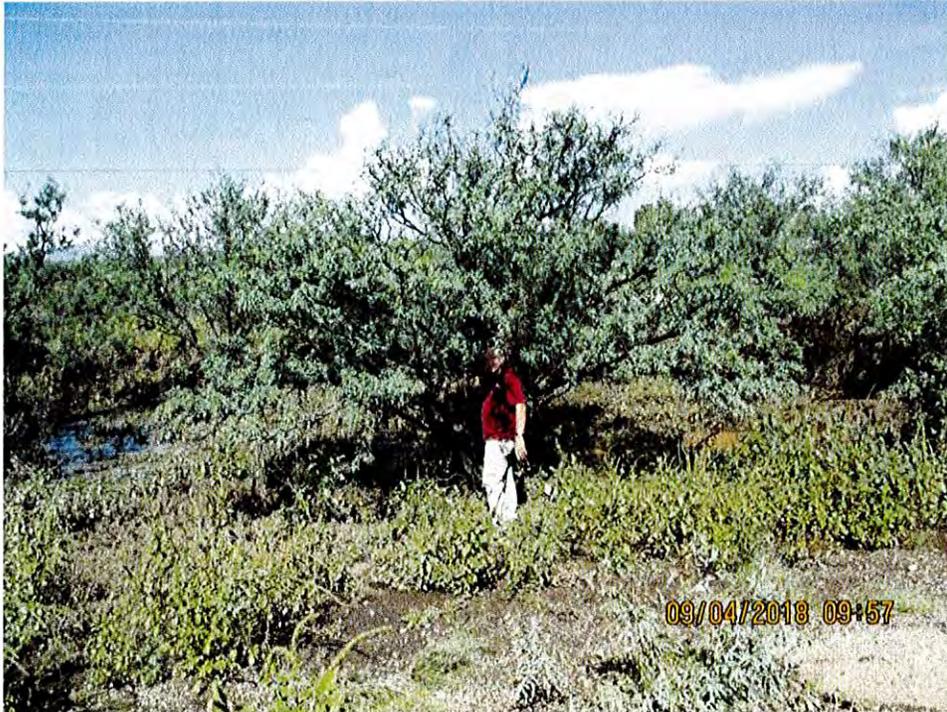
Pointing to a debris line in the vegetation southwest of the intersection of the Nogales Highway and Arivaca Road.

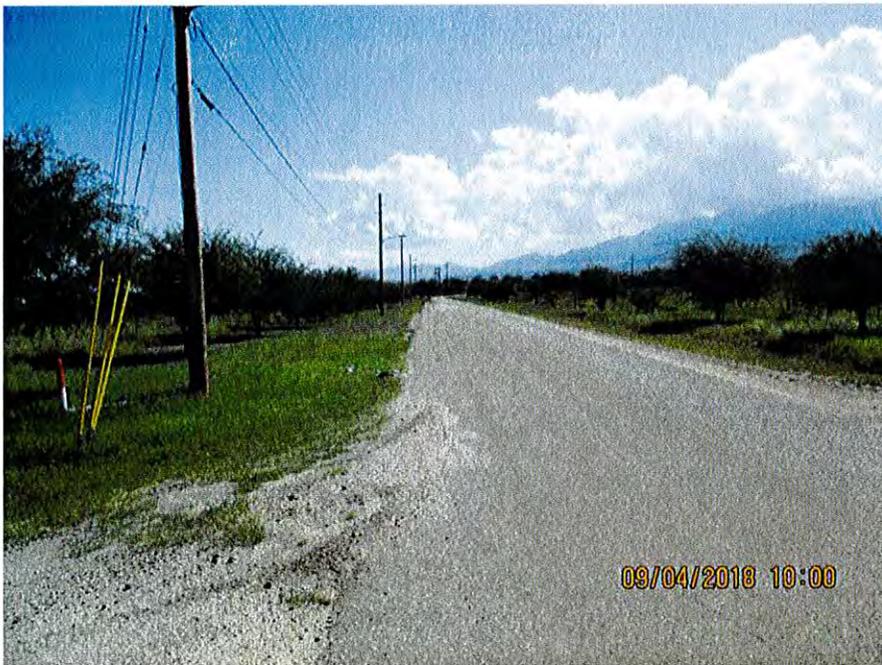
Looking east along the access road to the agricultural facility south of the county line and west of the Nogales Highway. The flow width across this road was 600 feet +/-.

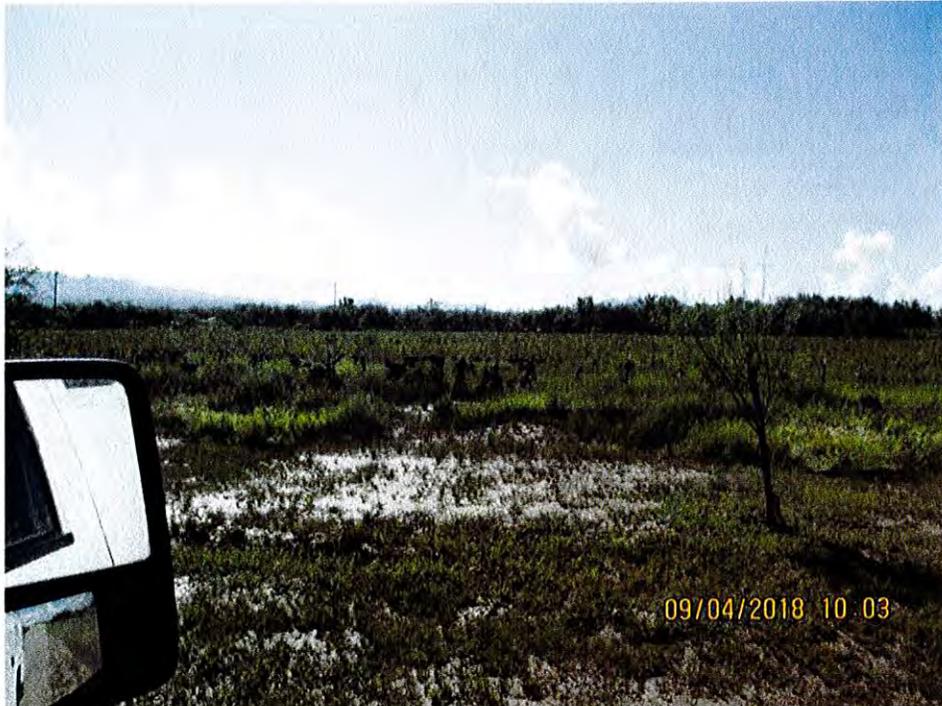
Looking south from the access road to the agricultural facility south of the county line and west of the Nogales Highway. Notice the debris on the wire fence indicates the fence was overtopped.

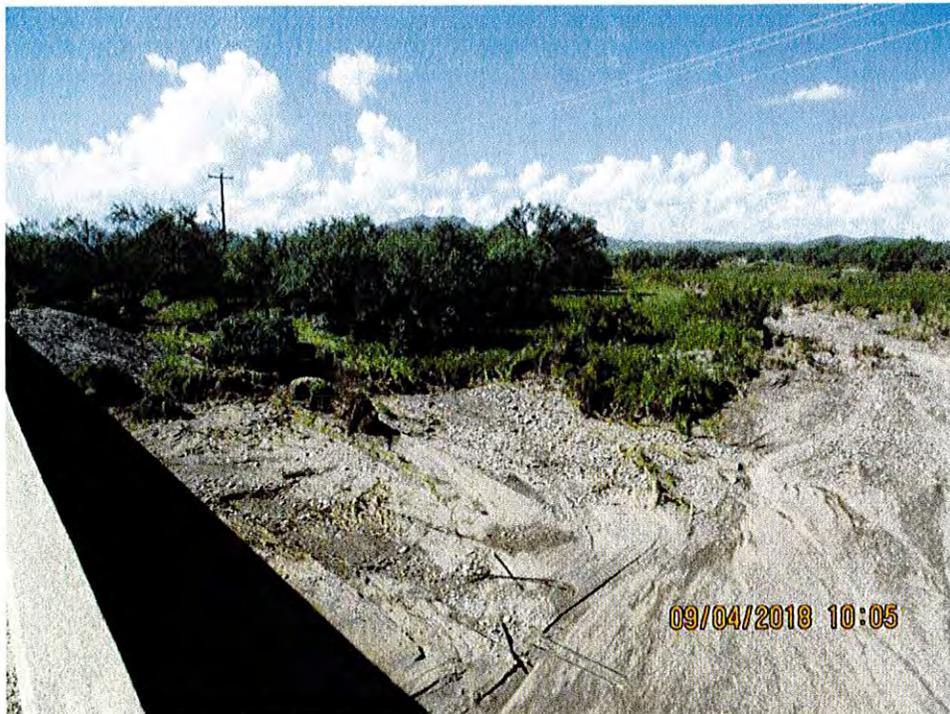
Looking upstream into the Sopori channel while standing on the Nogales Highway.

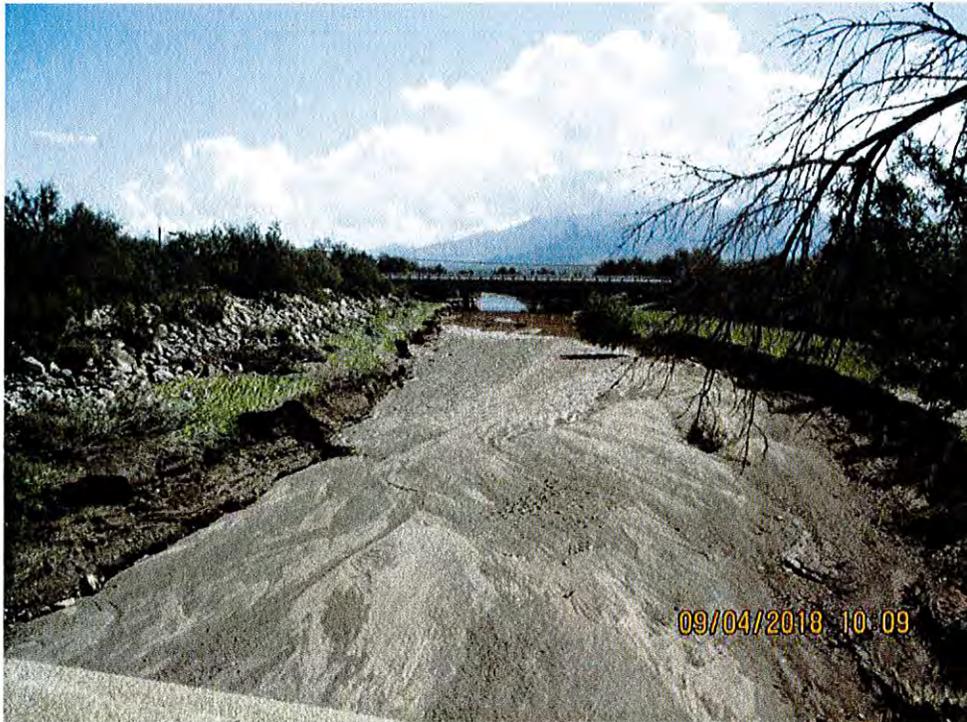
Looking downstream into the Sopori channel while standing on the Nogales Highway.

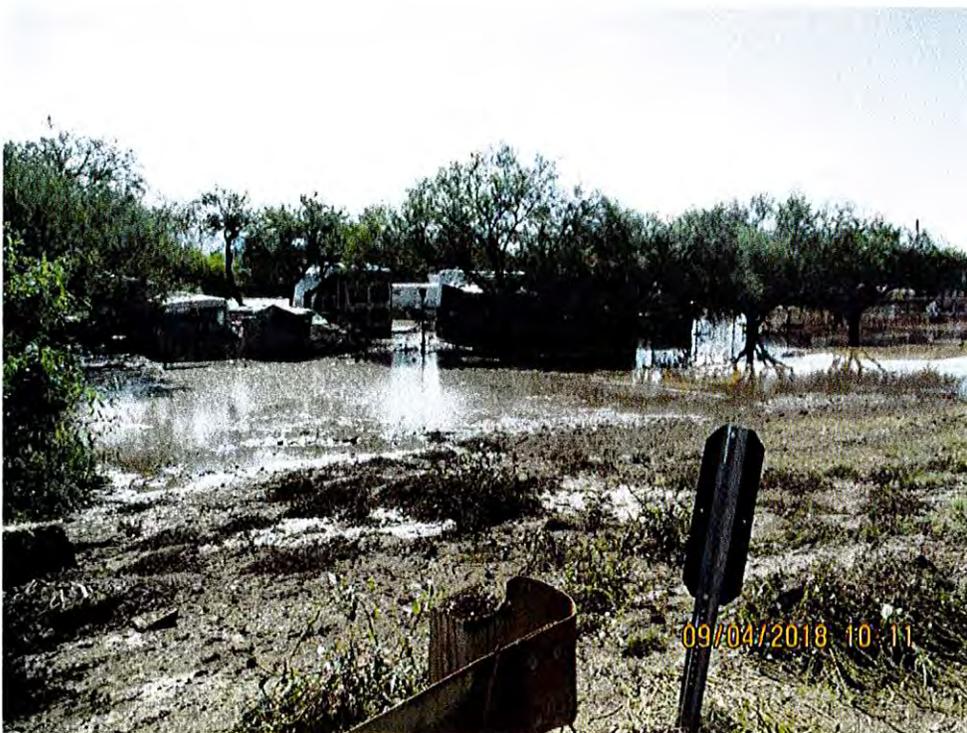
A flooded business east of the Nogales Highway and south of the Sopori Wash. The ponded water is trapped on the property due to a levee like berm along the south side of the Sopori wash Channel.

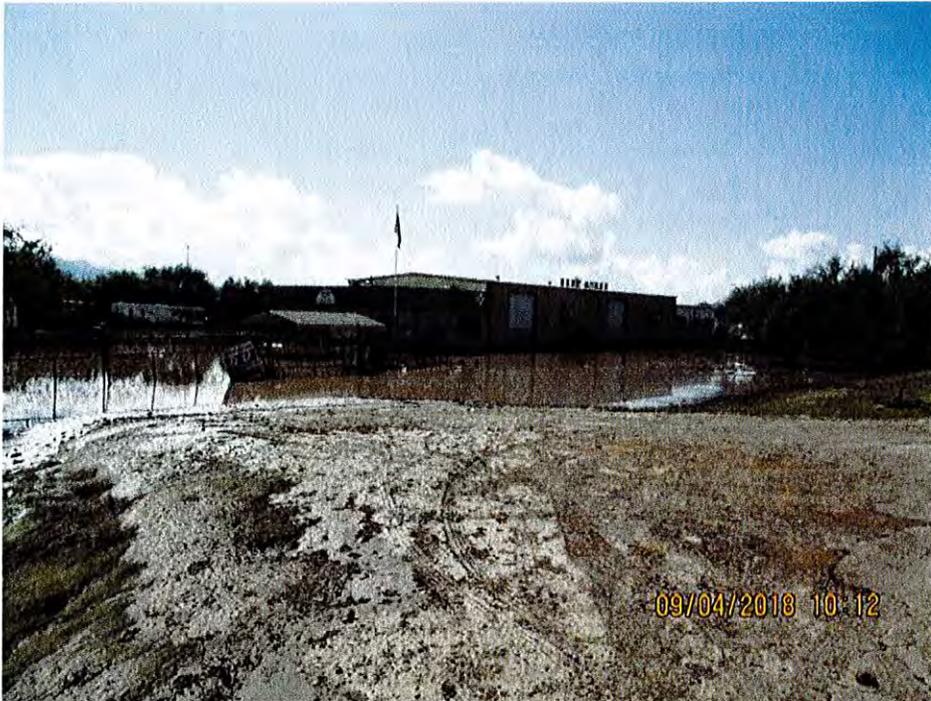
A flooded business east of the Nogales Highway and south of the Sopori Wash. The ponded water is trapped on the property due to a levee like berm along the south side of the Sopori wash Channel.

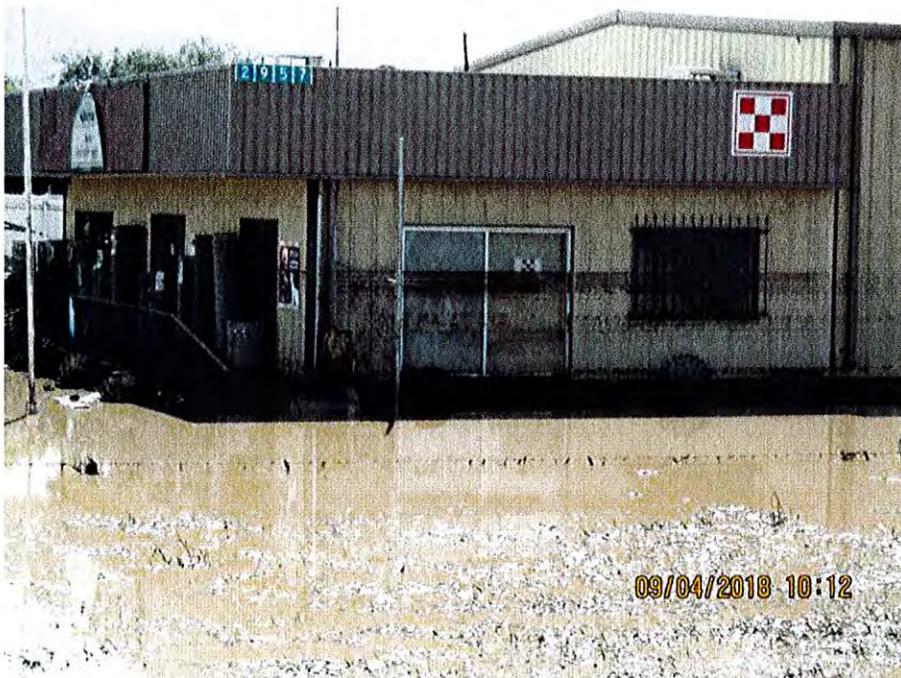
A flooded business east of the Nogales Highway and south of the Sopori Wash. Sopori wash Channel.

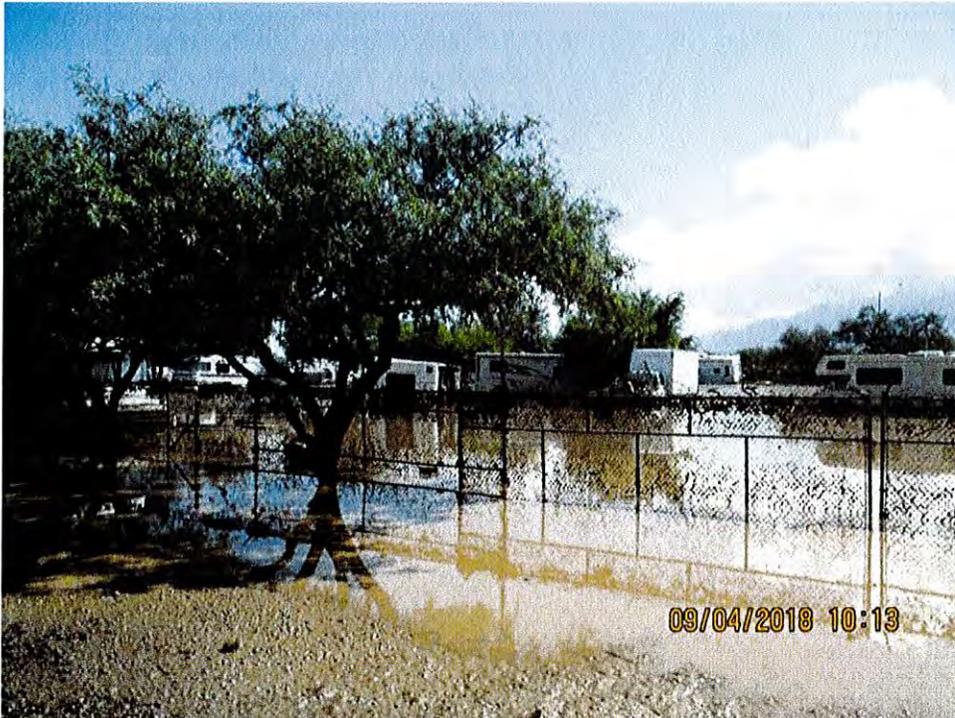
A flooded business east of the Nogales Highway and south of the Sopori Wash. Sopori wash Channel.

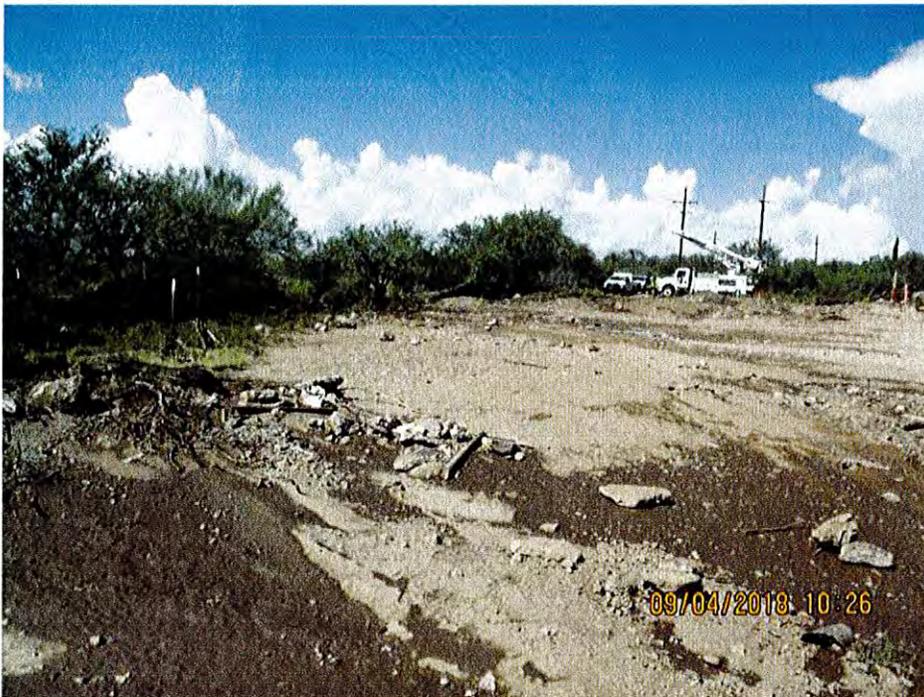
Looking west at the southern side of the Dollar General store under construction just north of the county line.

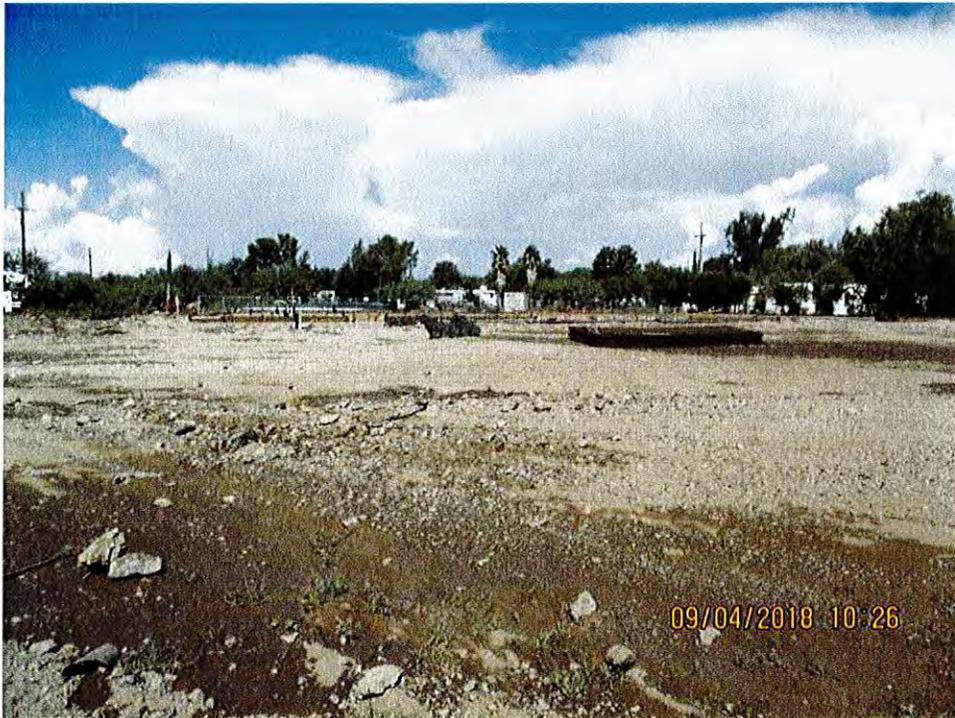
Looking west at the Dollar General store just north of the county line. The framing for the building pad was over topped by flow at the southwest corner.

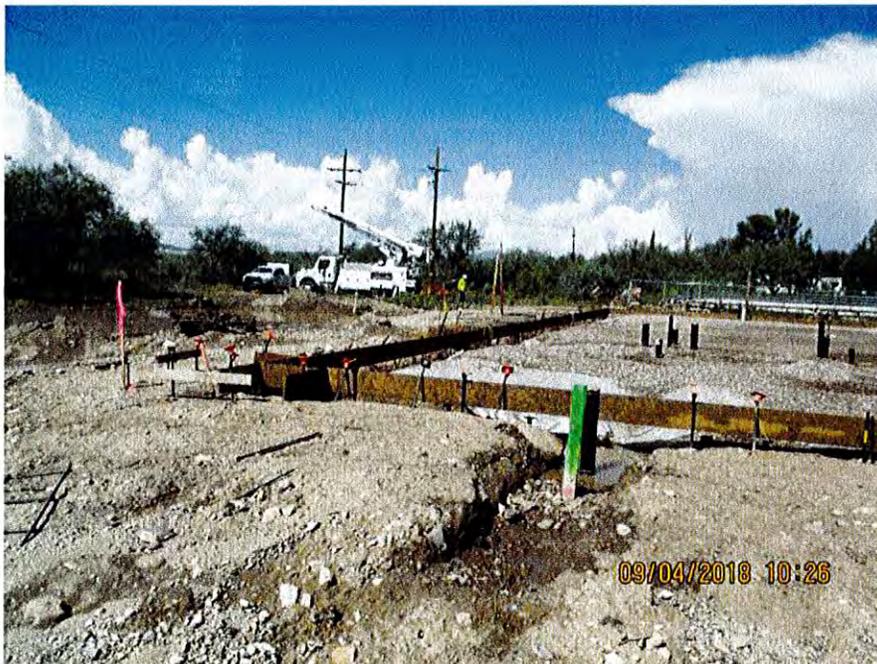
Residents expressed concerns over the construction activities of the future Dollar Store. A field inspection on September 4 showed erosion of the building pad and debris on the wooden forms for the foundation. The District issued a stop work order, and is currently reviewing the plans and site conditions.

A closer view of the Dollar General building pad showed erosion damage to the foundation framing in part, due to how a utility trench captured flow. Erosion protection is needed.

Advised John Cambra, construction superintendent of Dollar General, to stop work on building pad. He called his supervisor, Russ Salmon, to advise. Stated that they were not planning any work on the building for the rest of the week anyway. Advised him we’d update him by the end of the week.

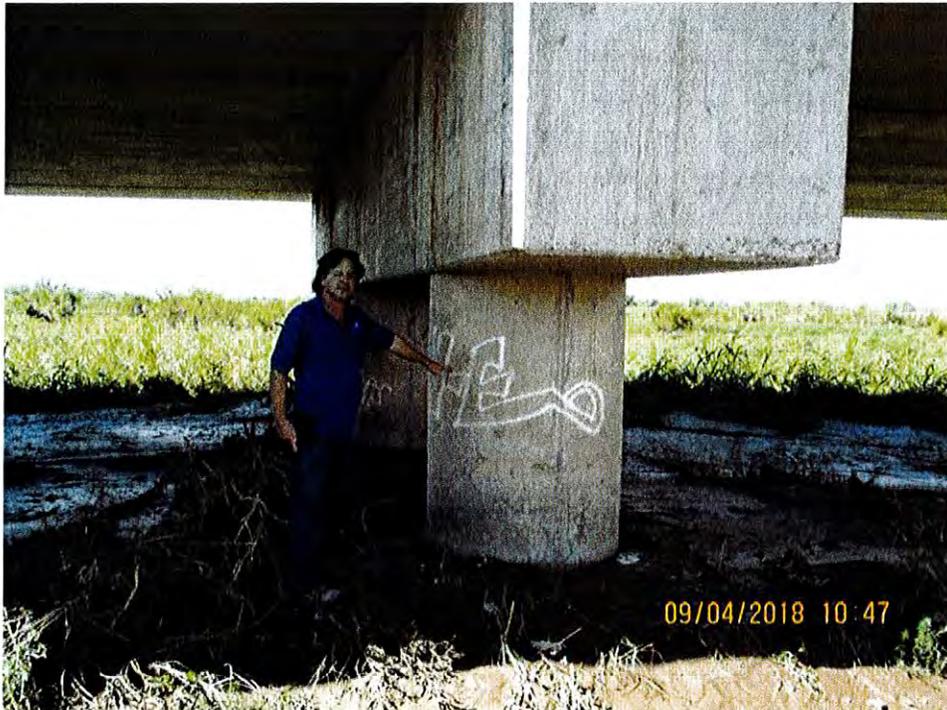
Pointing to the approximate high-water mark on a bridge pier on the Elephant Head Bridge on the Santa Cruz River. This was the second set of piers from the east embankment. Flow in the Santa Cruz was bank to bank.

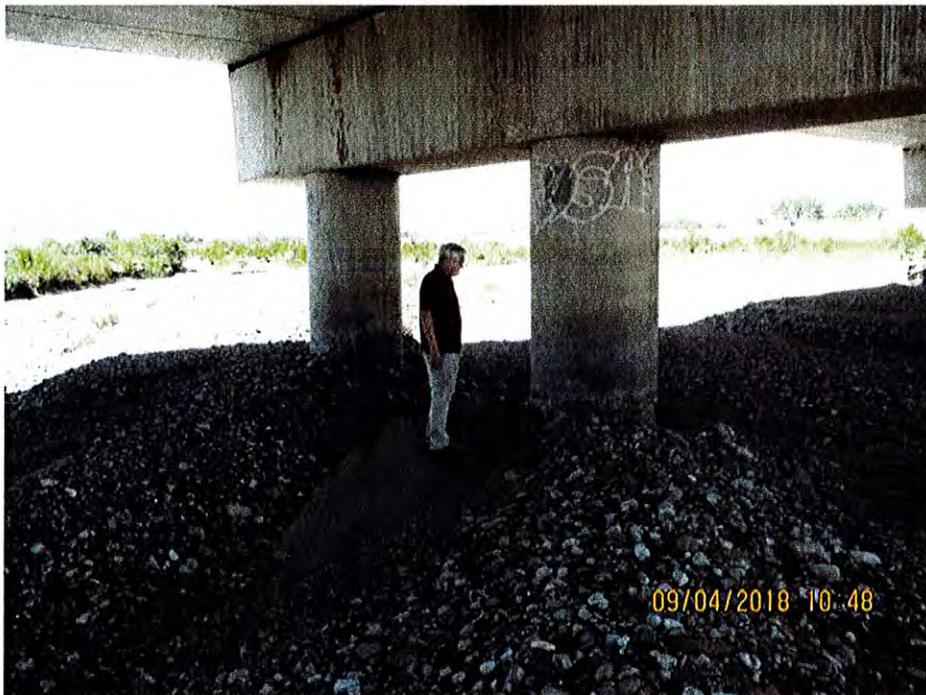
Looking a surface evidence or Pier Scour at the Elephant Head Bridge over the Santa Cruz River. Flow in the Santa Cruz River was bank to bank.

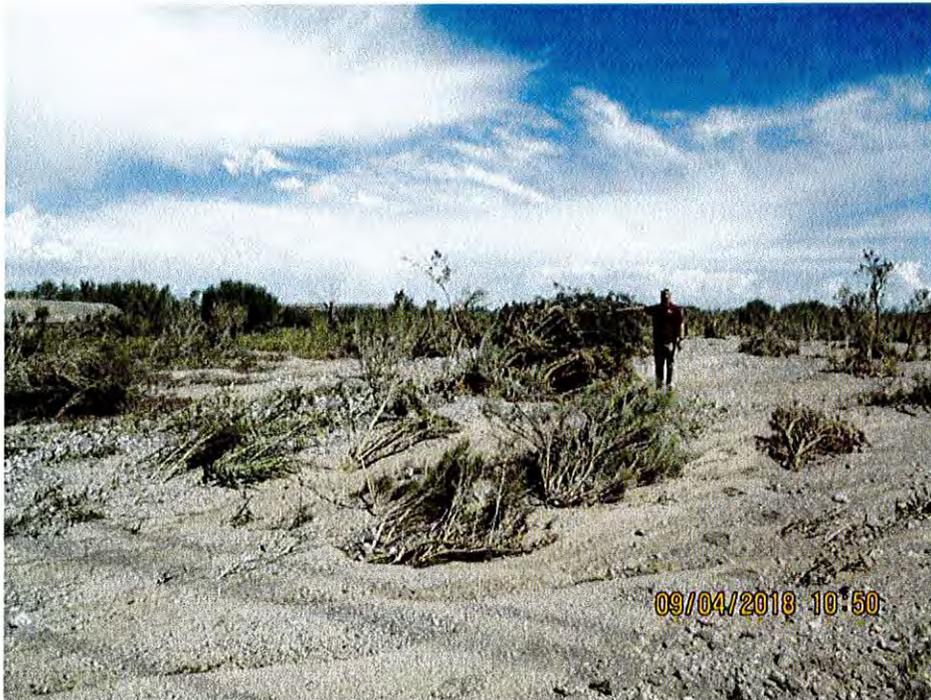
Looking at the debris line on a sand bar just downstream of Elephant Head Bridge the Santa Cruz River downstream.

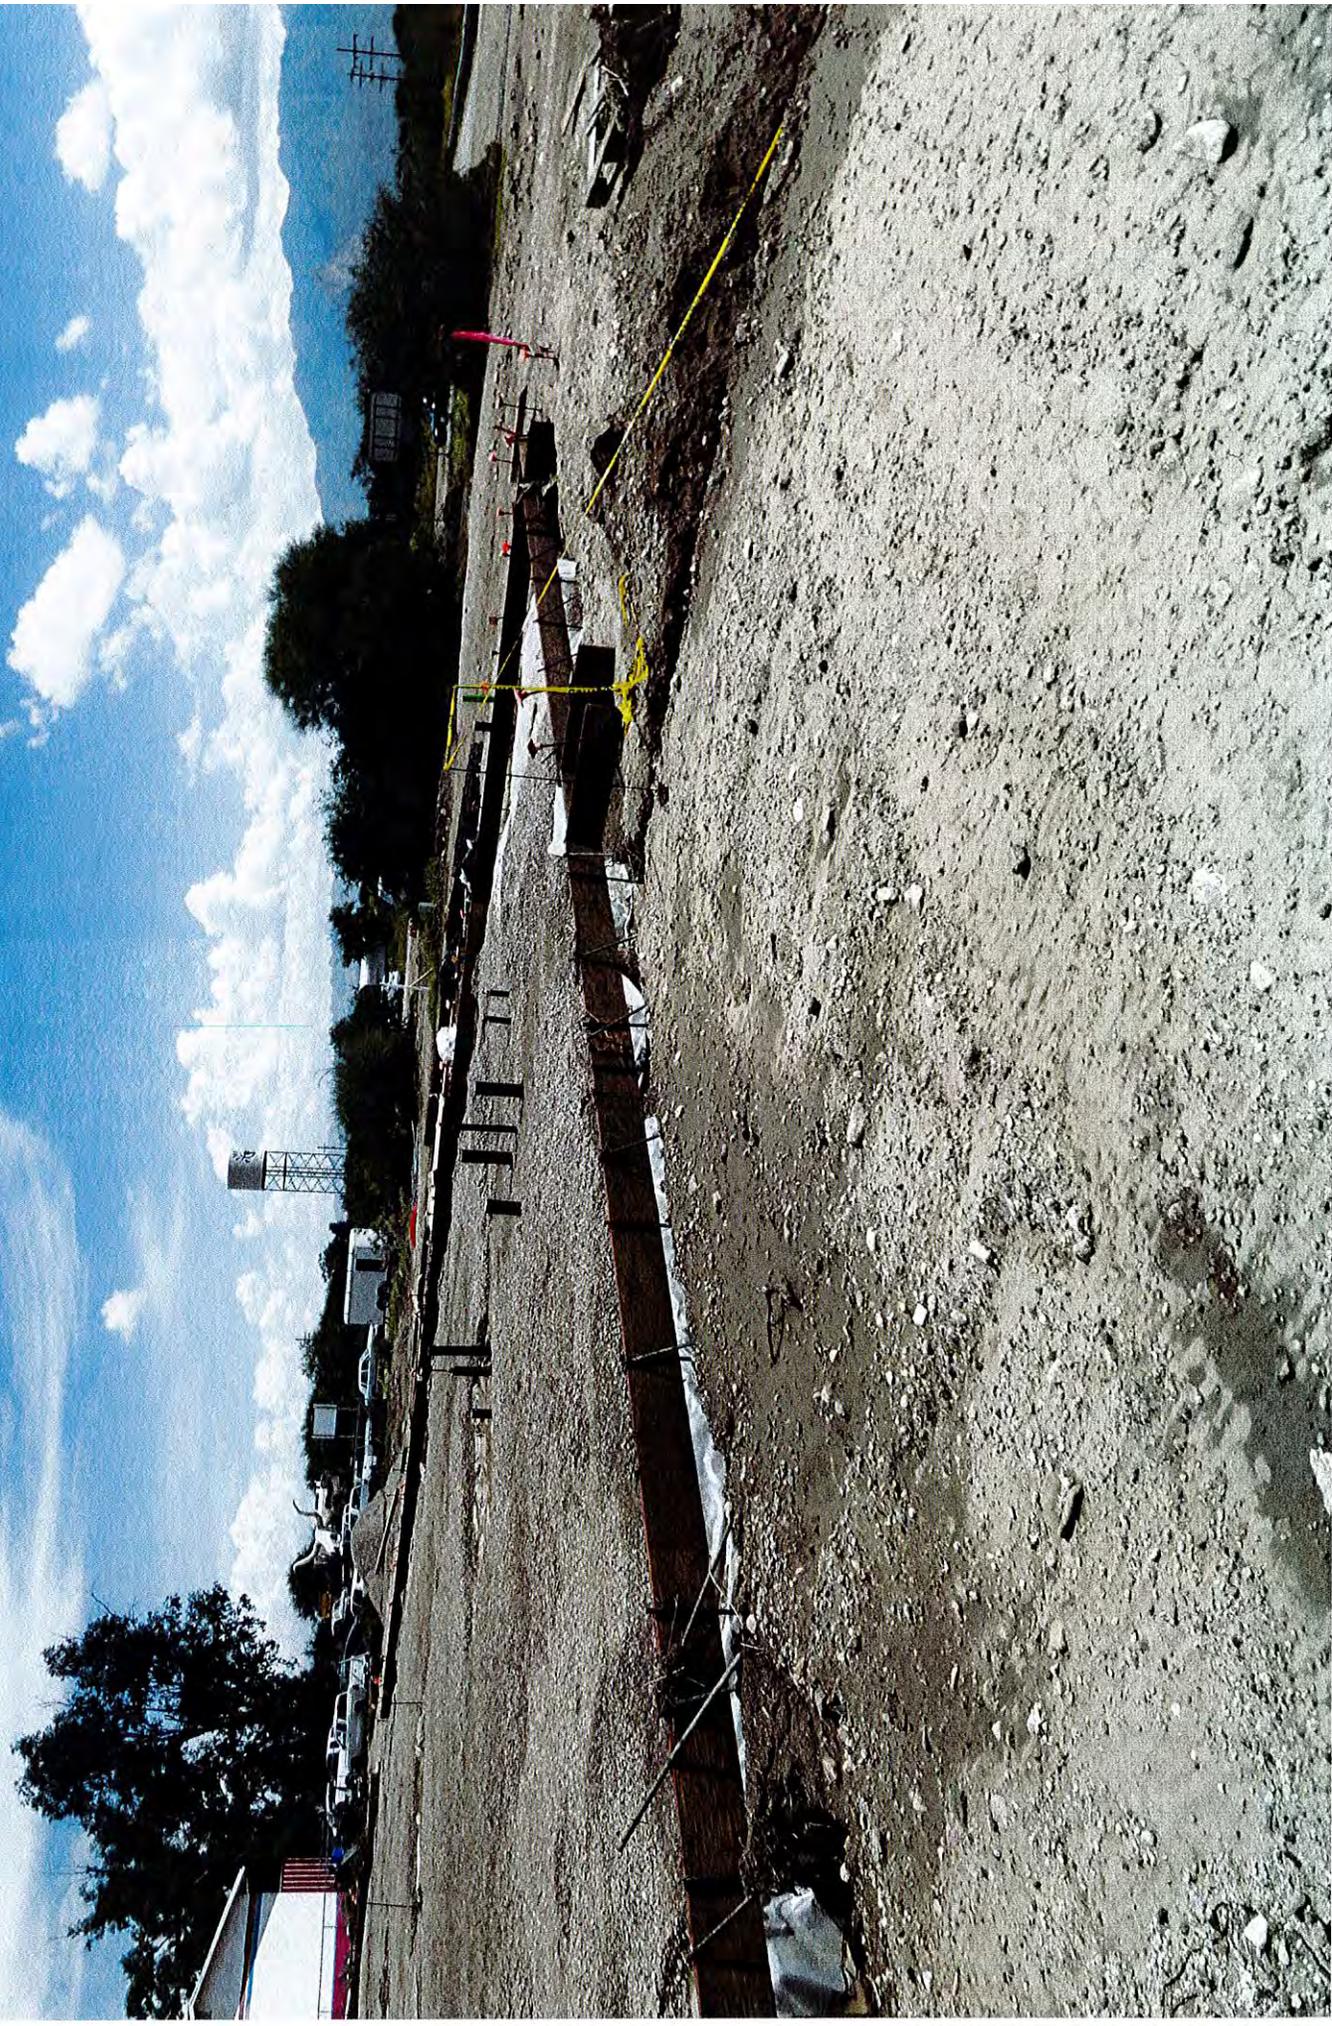
Dollar General building site at 28890 S Nogales Hwy: spoke with construction superintendent John Cambra. He stated that the building pad "was not touched" (however, photo taken at the time shows debris caught on wood forms on south side of pad). Did not observe significant erosion or scour on pad. John stated that the construction trailer was carried north across property, ending up at the northeast corner. John said that the flood occurred around 9 pm Sunday night. The onsite rain gauge for the SWPPP showed 3" of rain.

Dollar General building pad,
28890 S Nogales Hwy, view
to NE
