Re: **Preliminary Storm Report for Amado, Arizona in the Sopori Wash**

SUBJECT: Preliminary Storm Report for September 2 and 3, 2018

SUBJECT: Sopori Wash Flood field investigation September 4, 2018

Sopori Wash/Amado Flood Event 9/2/18

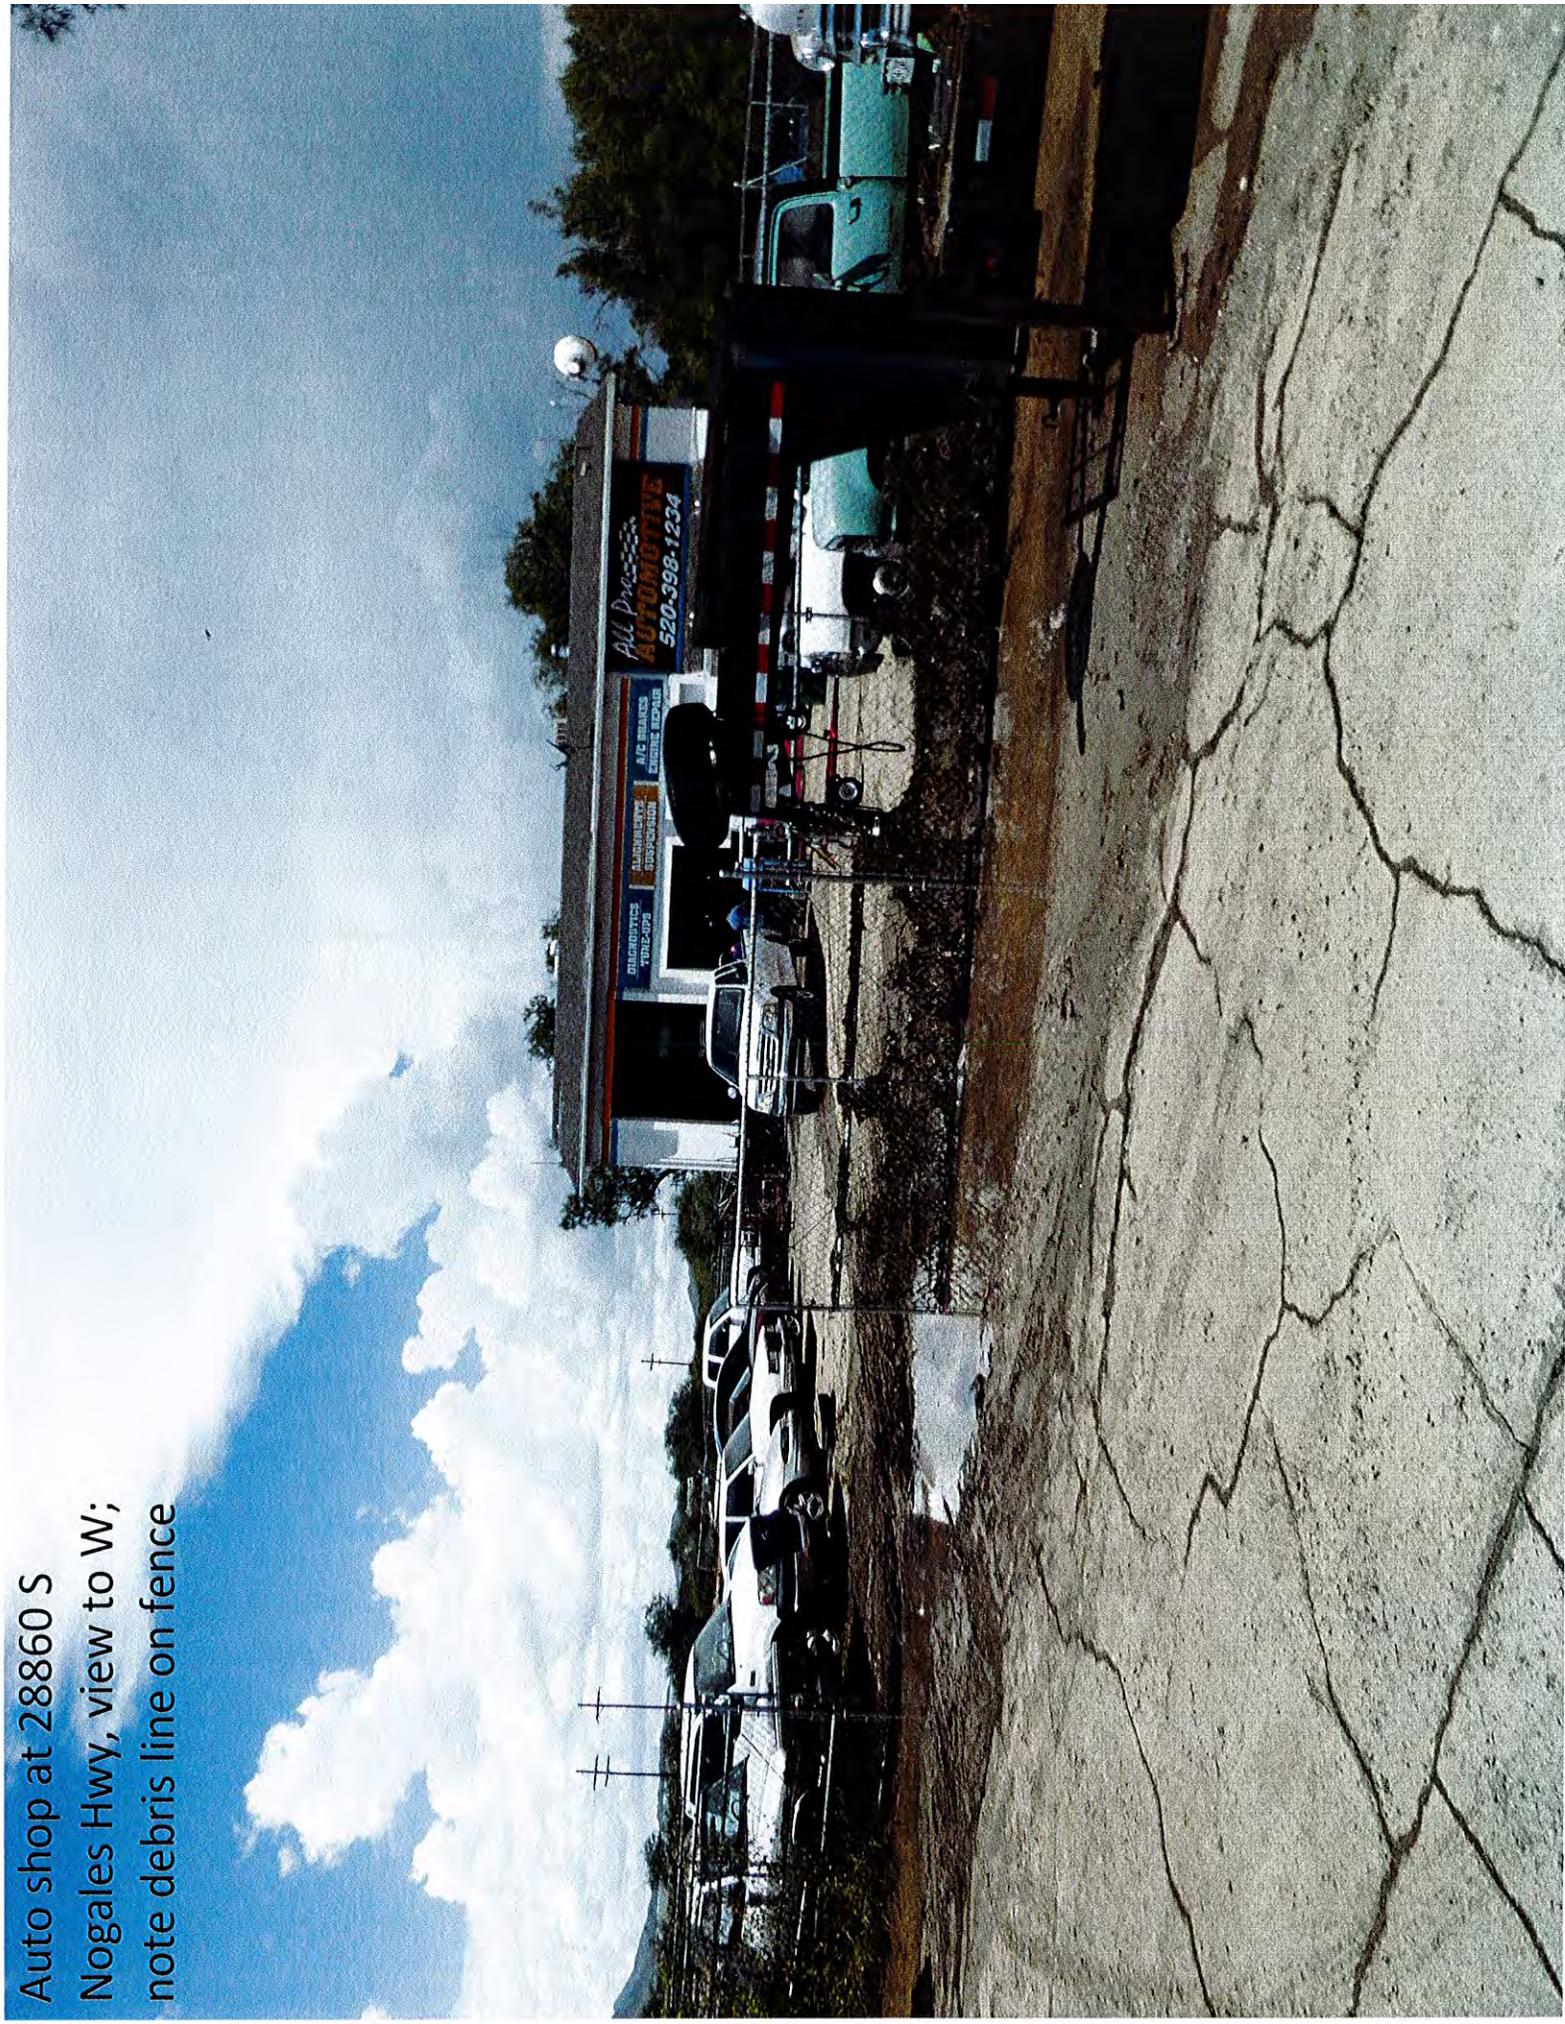
Auto repair shop at 28860 S Nogales Hwy: did not speak with anybody there. High water mark on west side of building and debris line on chain-link fence on east side of property indicate at least 2' of flow across site.

Auto shop at 28860 S
Nogales Hwy, view to W;
note debris line on fence

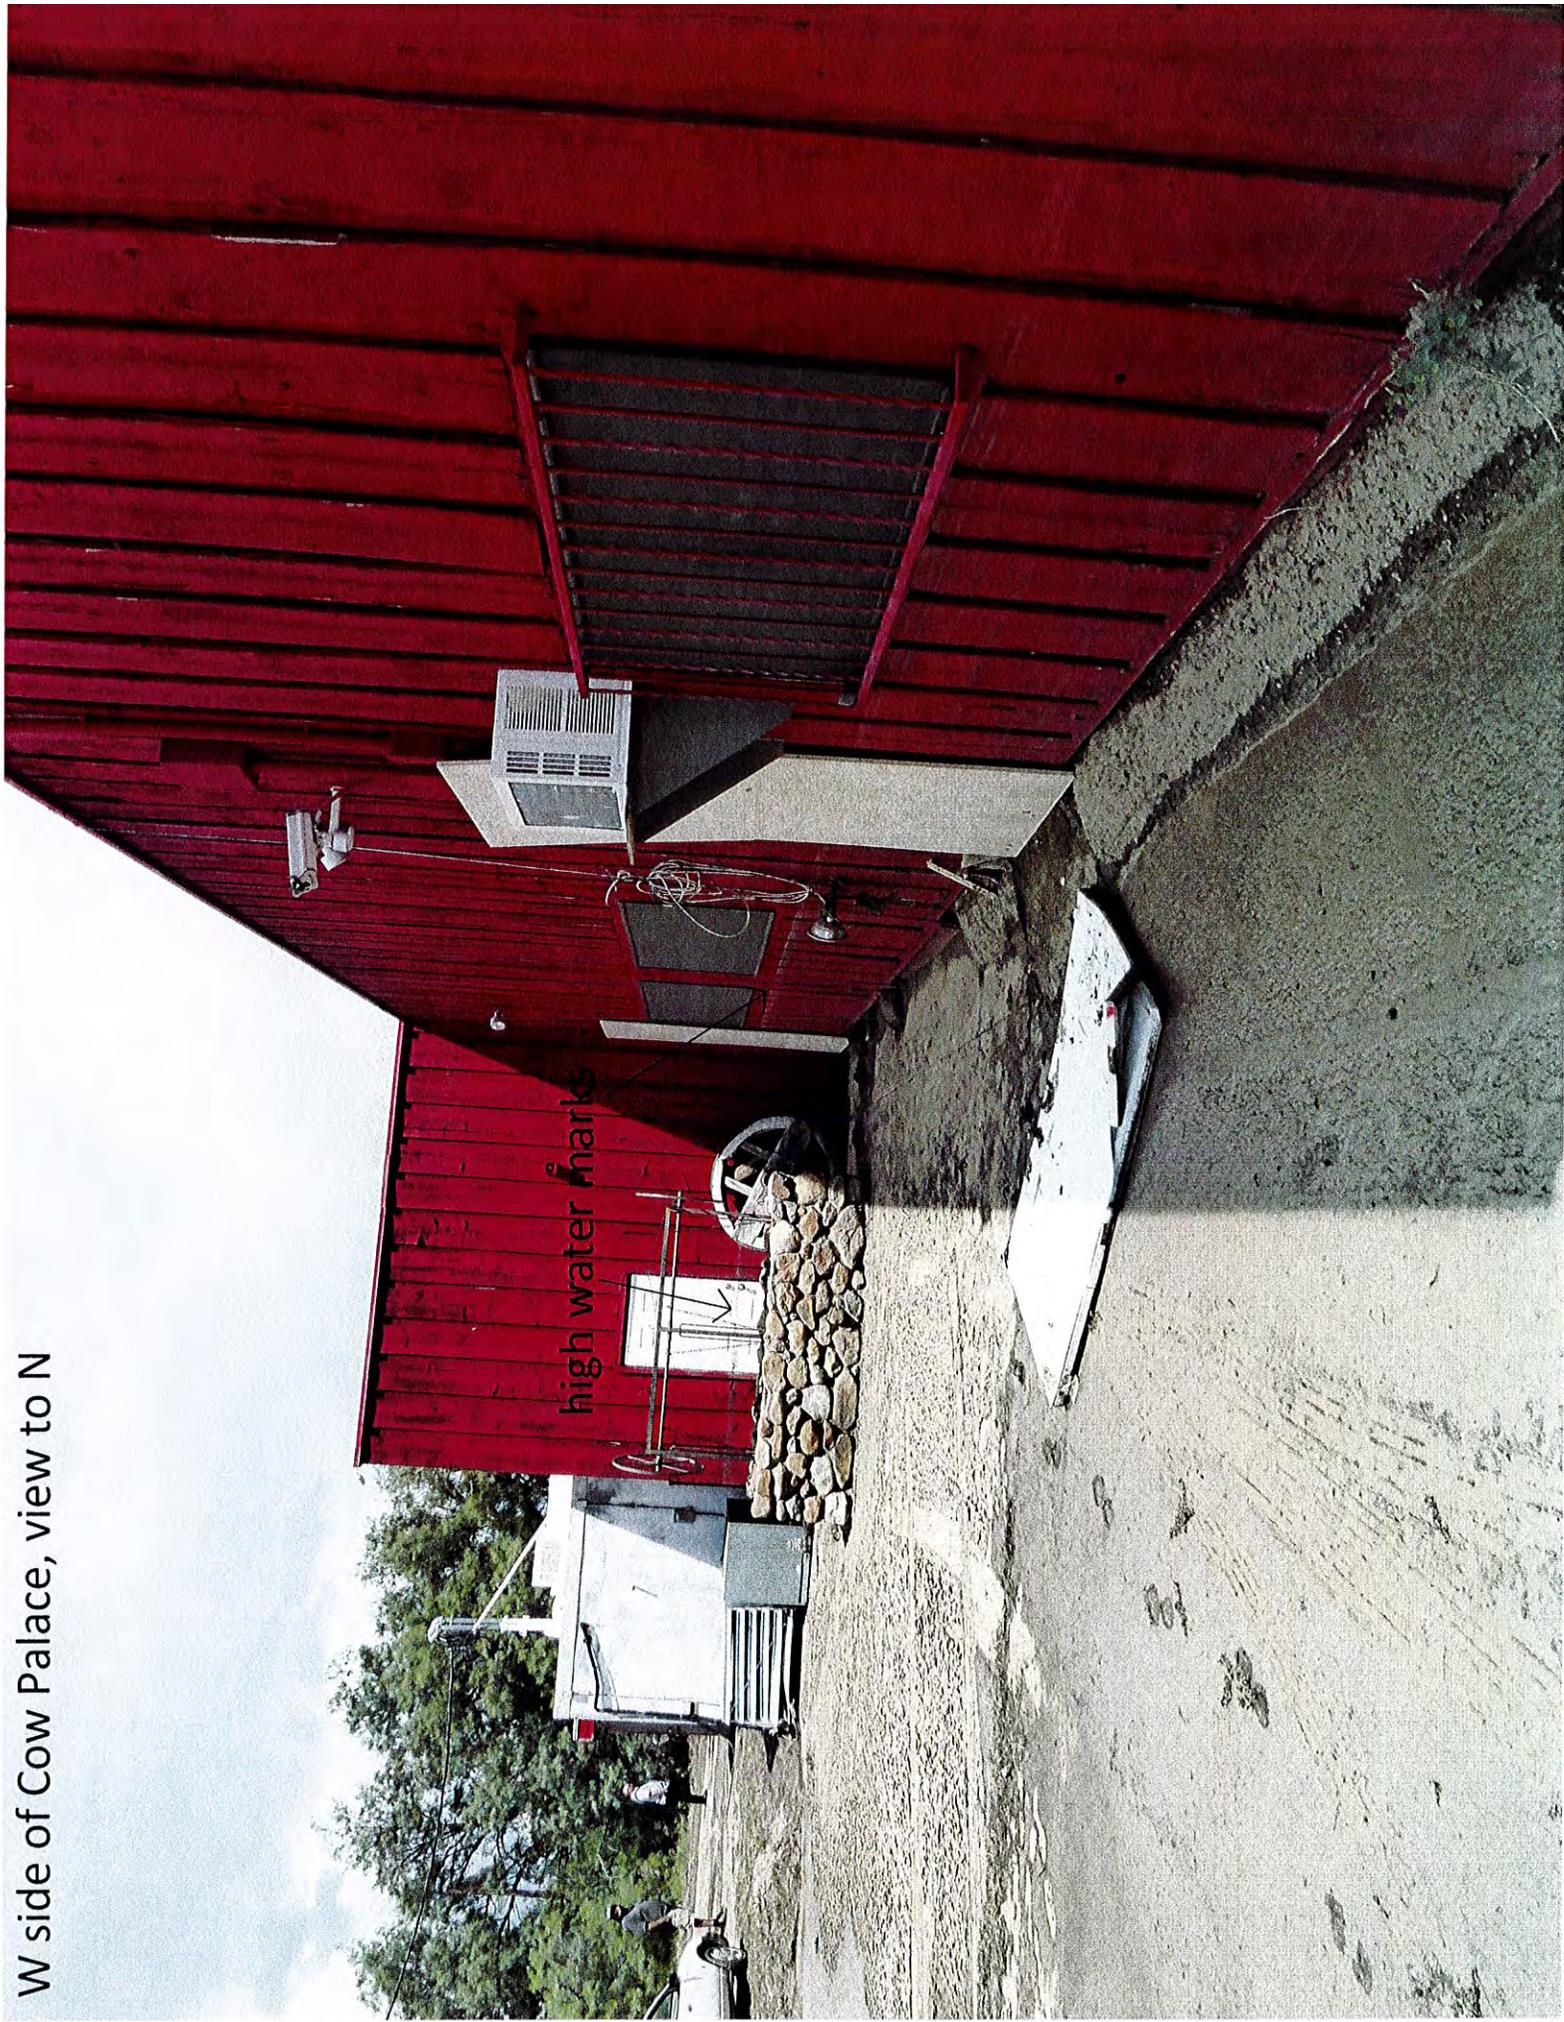
Cow Palace Restaurant at 28802 S Nogales Hwy: spoke with owner Lynn Greenes. She has owned property for five years. I asked if she had a mortgage and flood insurance; she stated that she does not have a mortgage and didn't think she had flood insurance, mentioned having "storm insurance." Workers were carrying out furniture and items from restaurant. PC Health Dept had been there and ordered them to get rid of food since electricity was turned off. The restaurant was closed at the time of the event. High water mark on west side of building close to 3'. High water mark on interior of east side of building measured at 28".

W side of Cow Palace, view to N

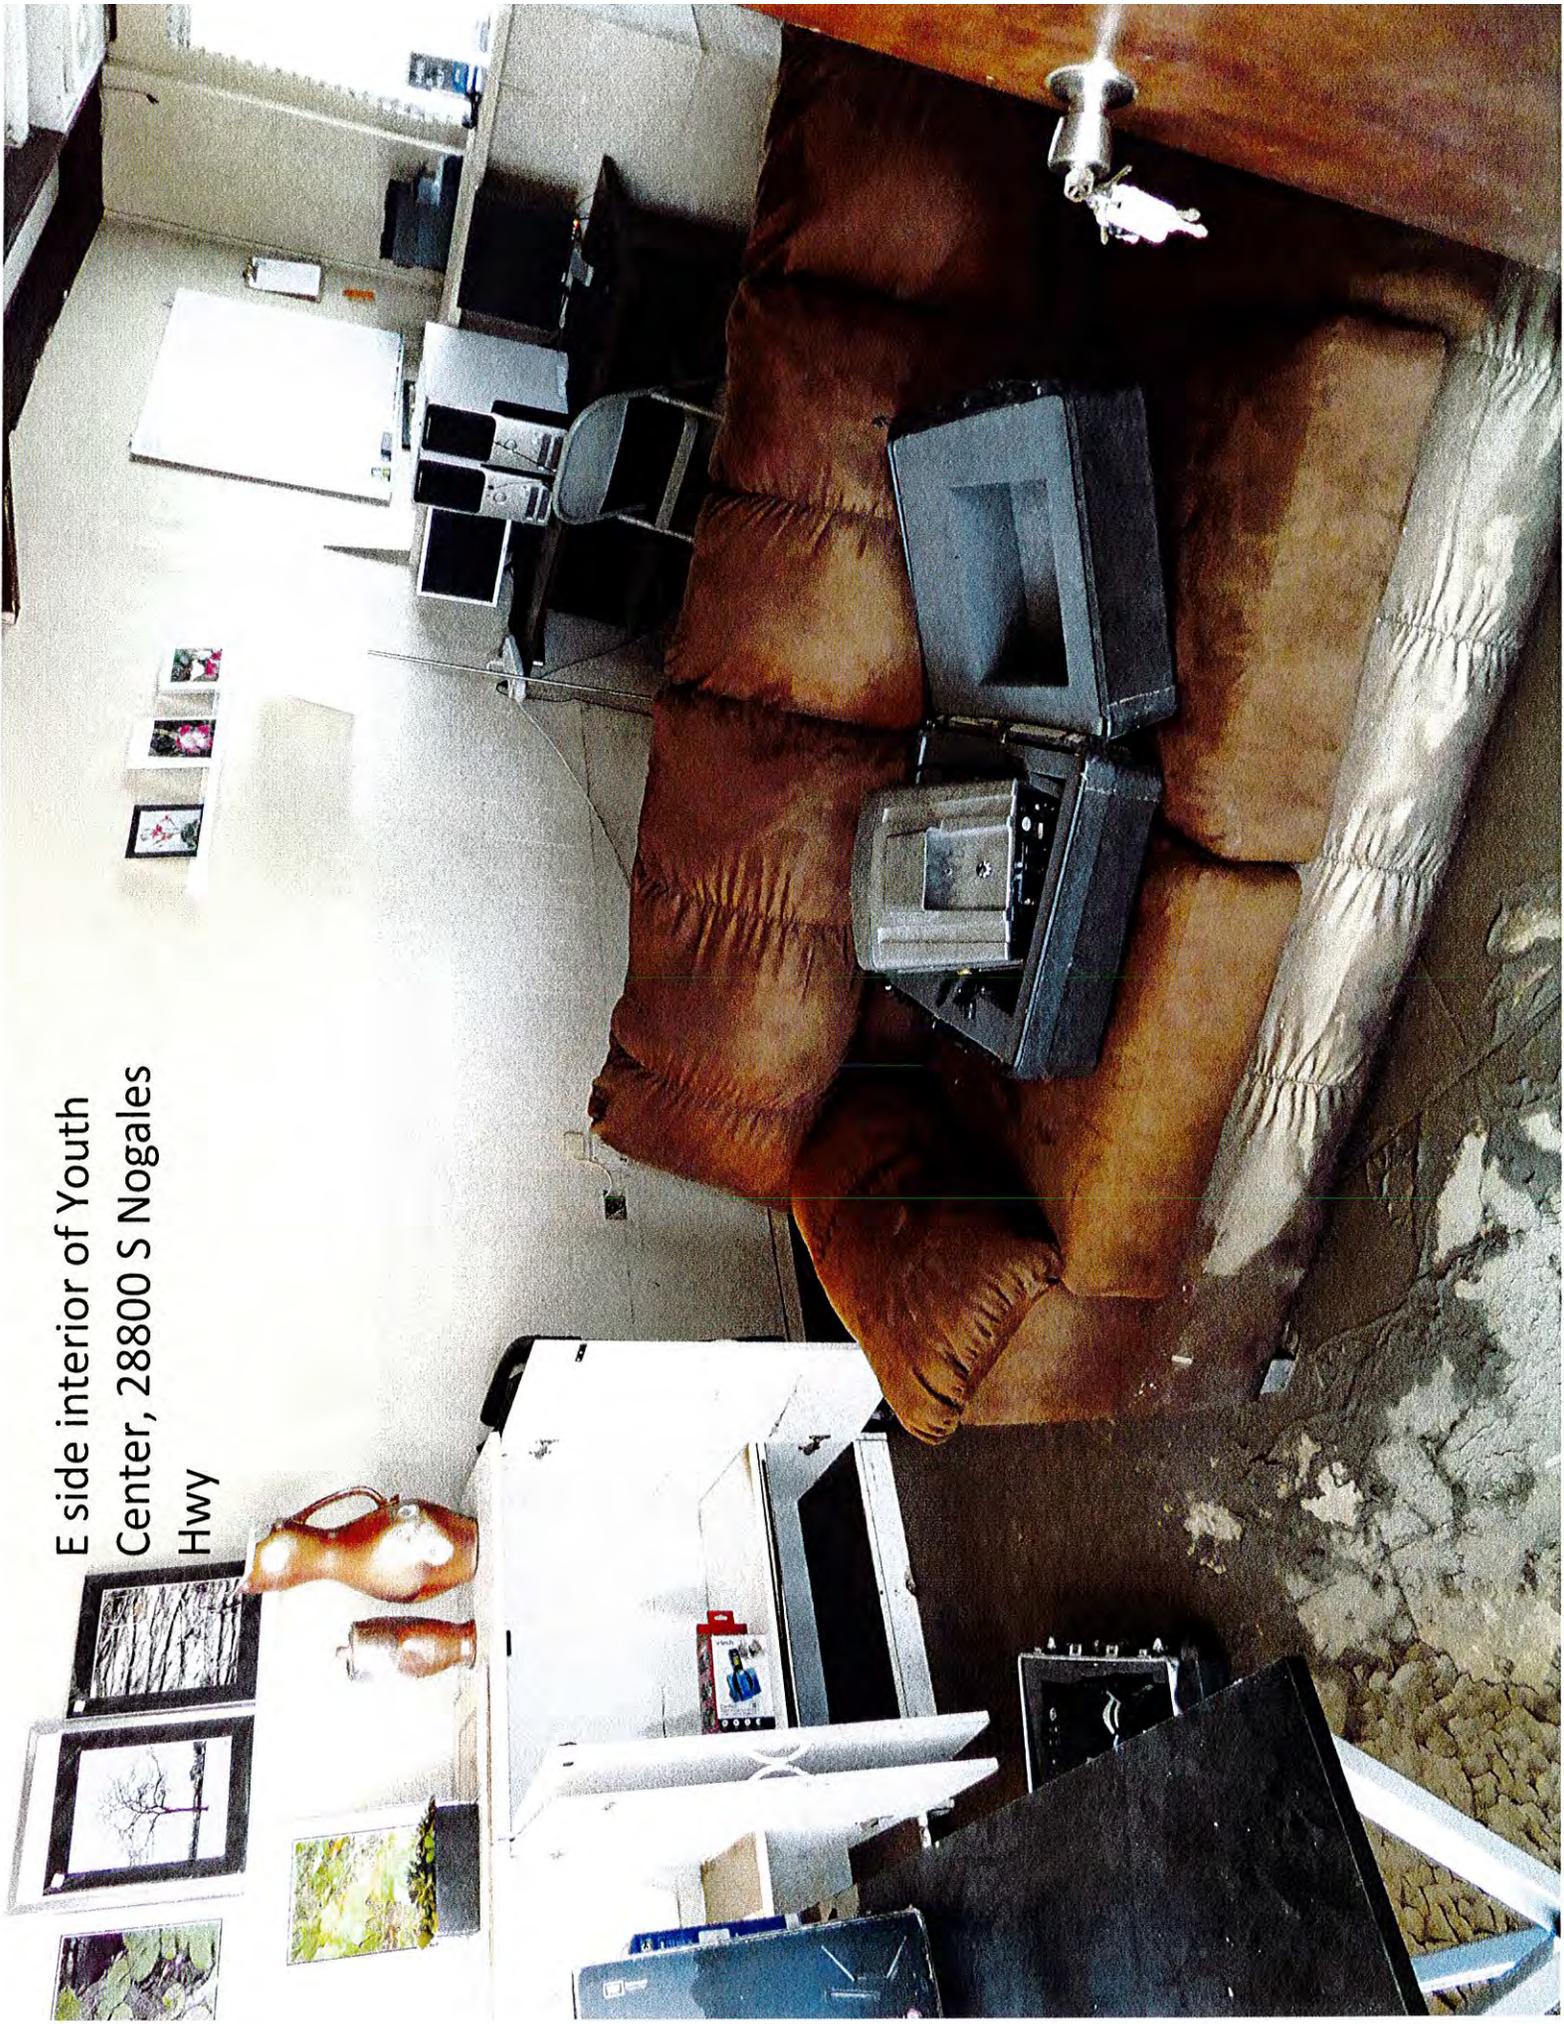
Amado Youth Center at 28800 S Nogales Hwy: spoke with coordinator Tony Bruno. High water mark close to 2' in interior of south end of building; much less at north end of building. He lives near Elephant Head and said his rain gauge shows 3" of rain.

E side interior of Youth
Center, 28800 S Nogales
Hwy

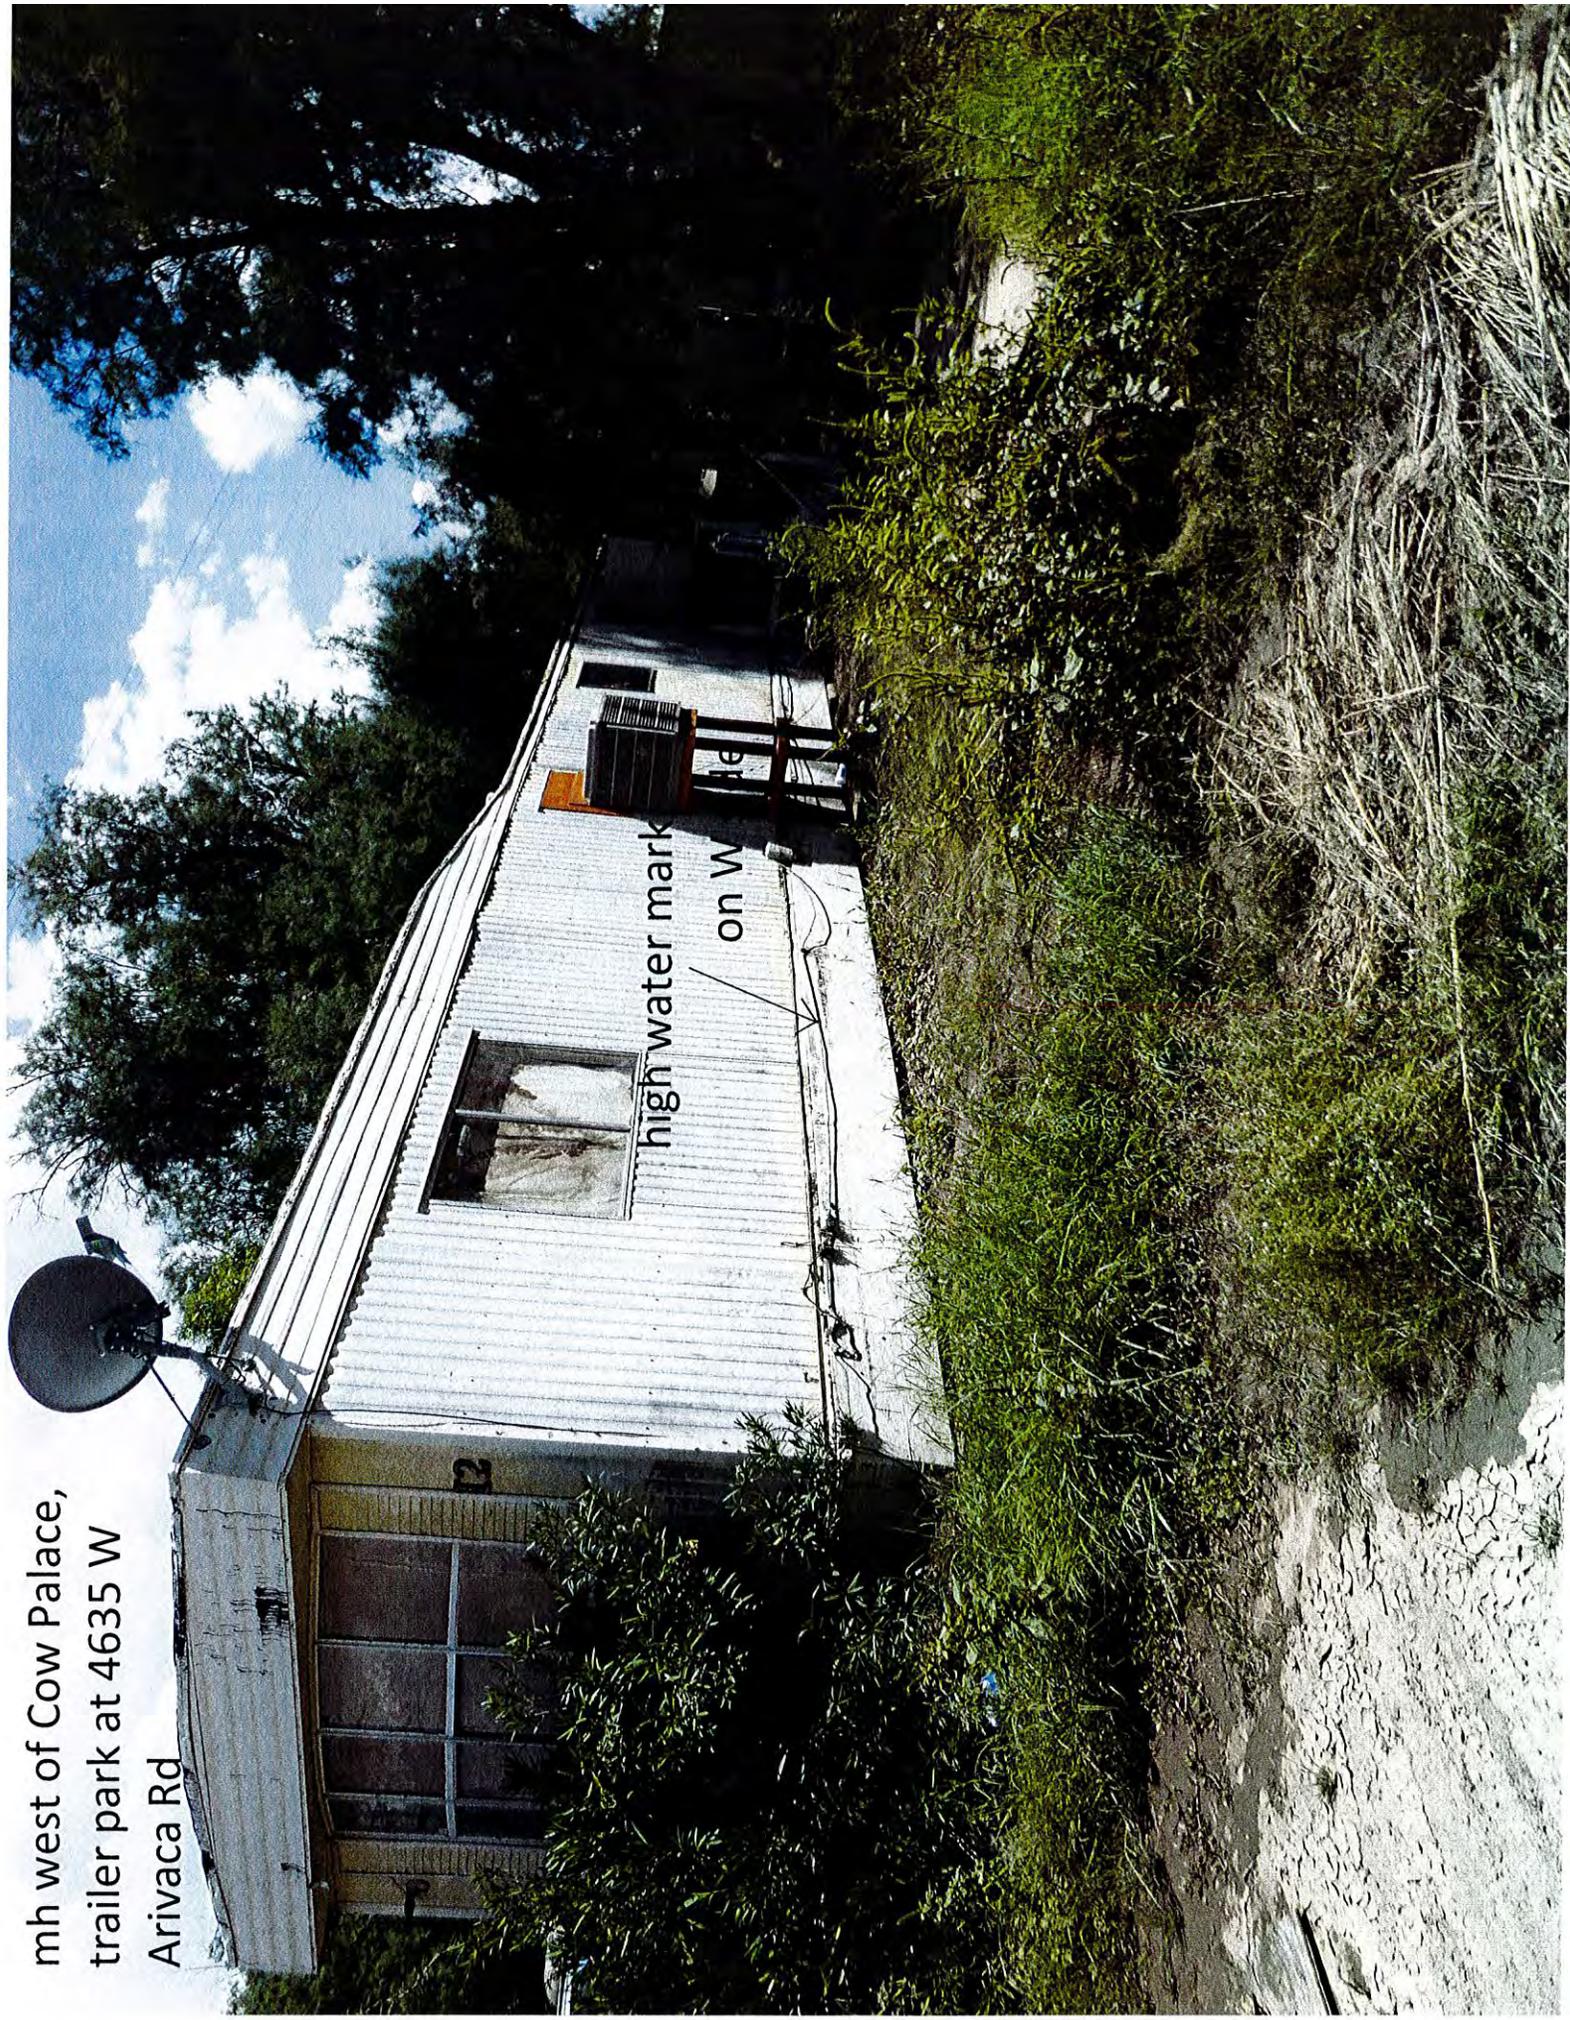
Mobile home park at 4635 W Arivaca Rd. Spoke with Russell Valenzuela, a 40-year resident of area. He stated that this severe a flooding event has never happened before, not even in 1983. High water marks on structures around 2'. He had water right up to his door but not inside mobile home. Said that residents of the other mobile home park on the west side of Arivaca Pl had some damage to items that were

1.5
mi
west of Cow Palace,
trailer park at 4635 W
Arivaca Rd

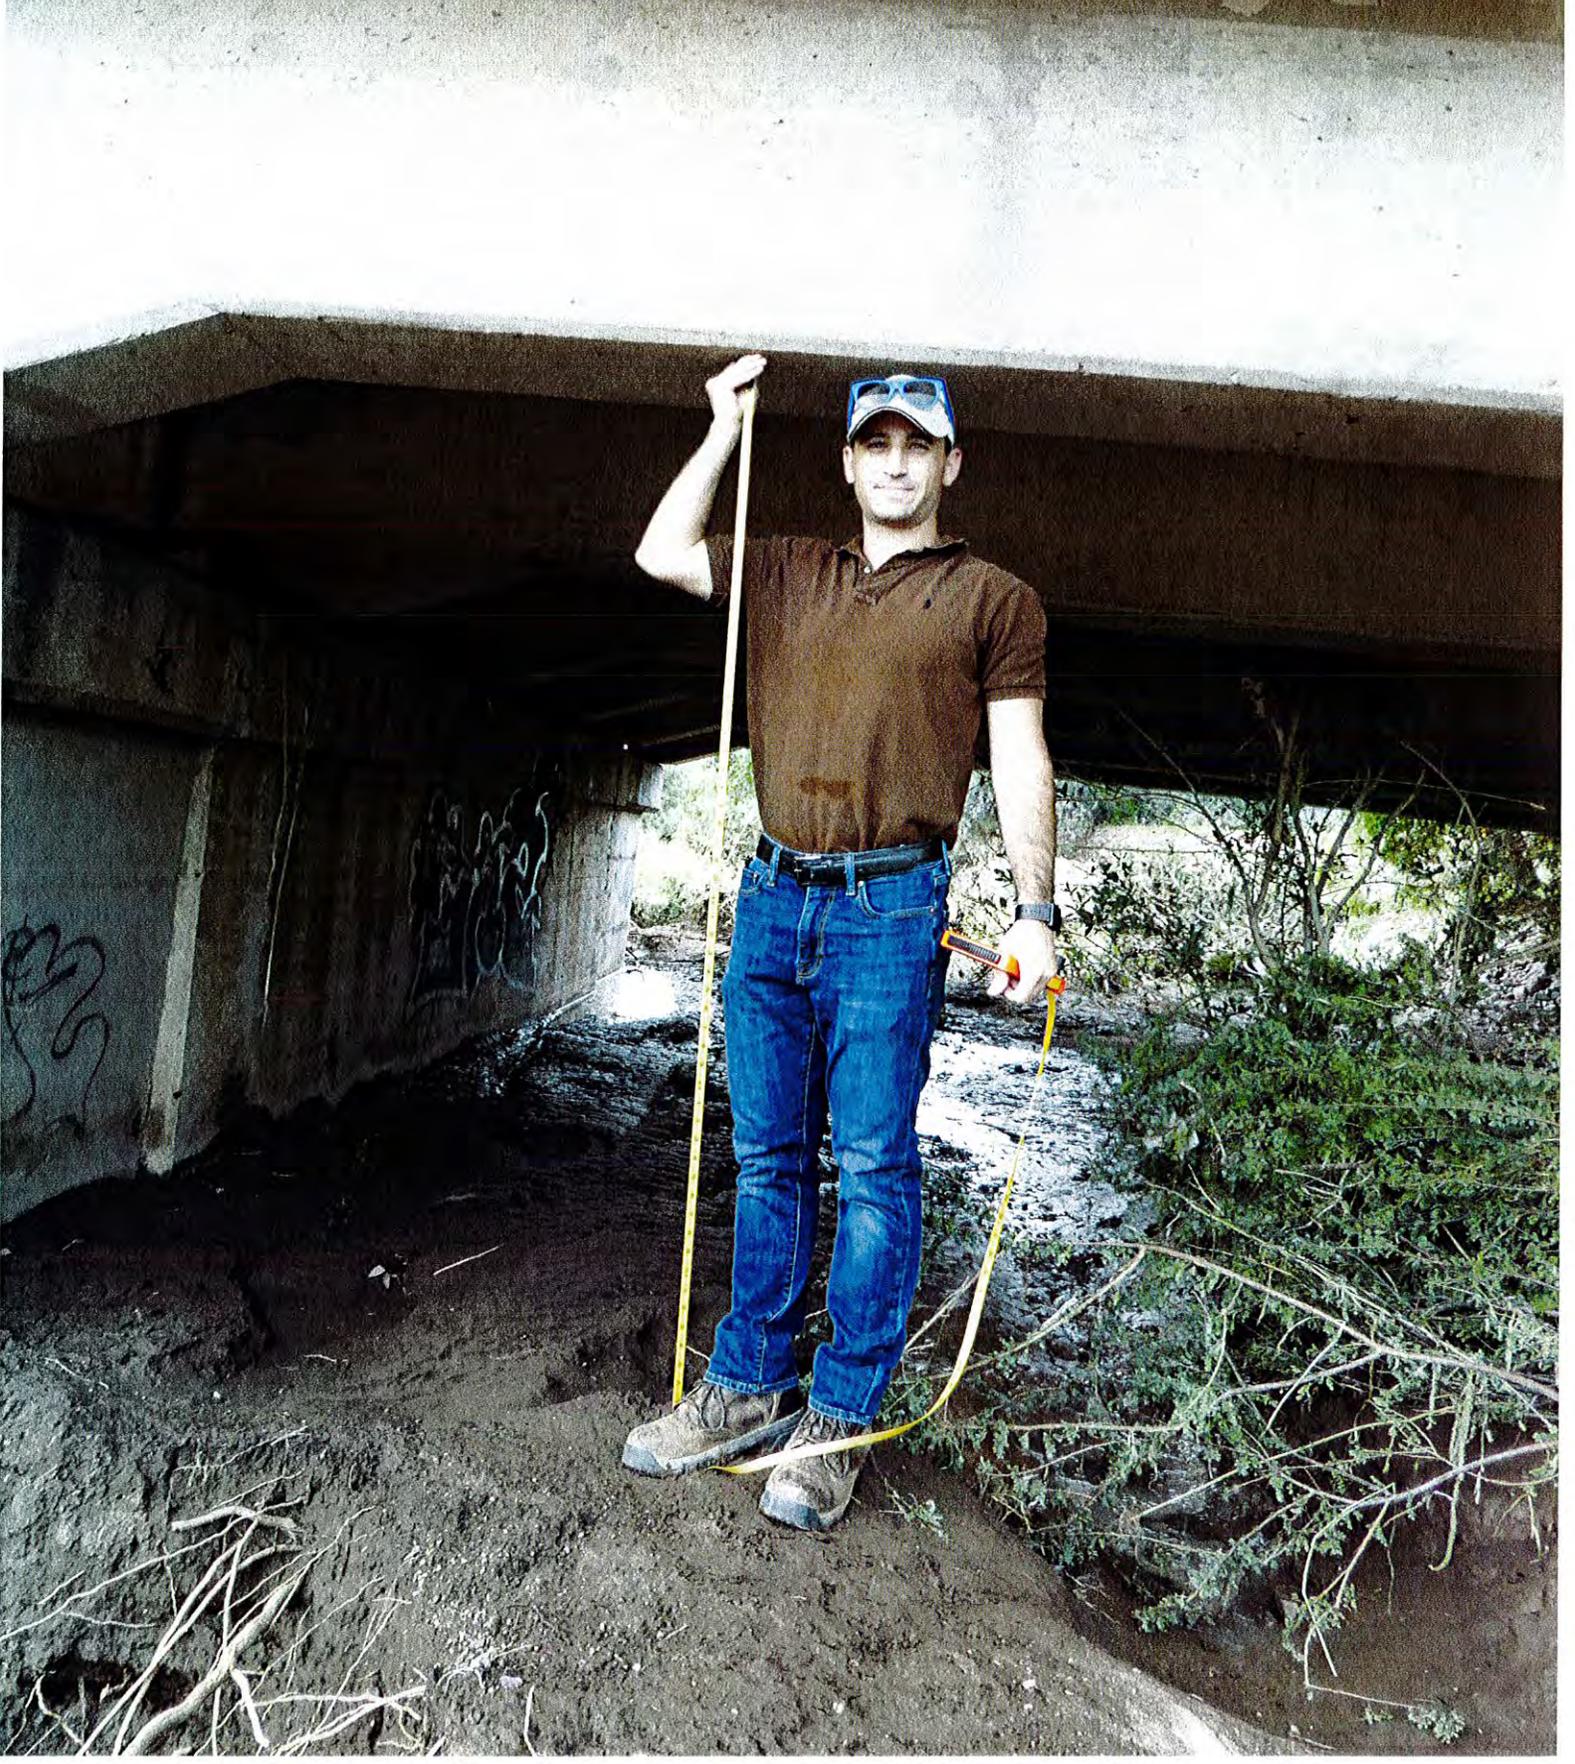
Photographs were taken. Top of sandbar at south bridge cells measured 5’8” from bottom of bridge. North bridge cells were open and measured around 15 feet from channel. Northward flow on west side of Nogales Hwy eroded out much of the sandbar during the event. Flow indications on north bank of the Sopori Wash west of the bridge, including debris on chain-link fence on top of and paralleling north bank and pushed over grass and trees, seem to indicate that flow in the river was that high. However, riprap on north bank east of bridge is undisturbed. Excavator was still working on south bank.

5'8" from top of sand bar to bottom
of bridge over Sopori Wash on
Nogales Hwy (south cells)

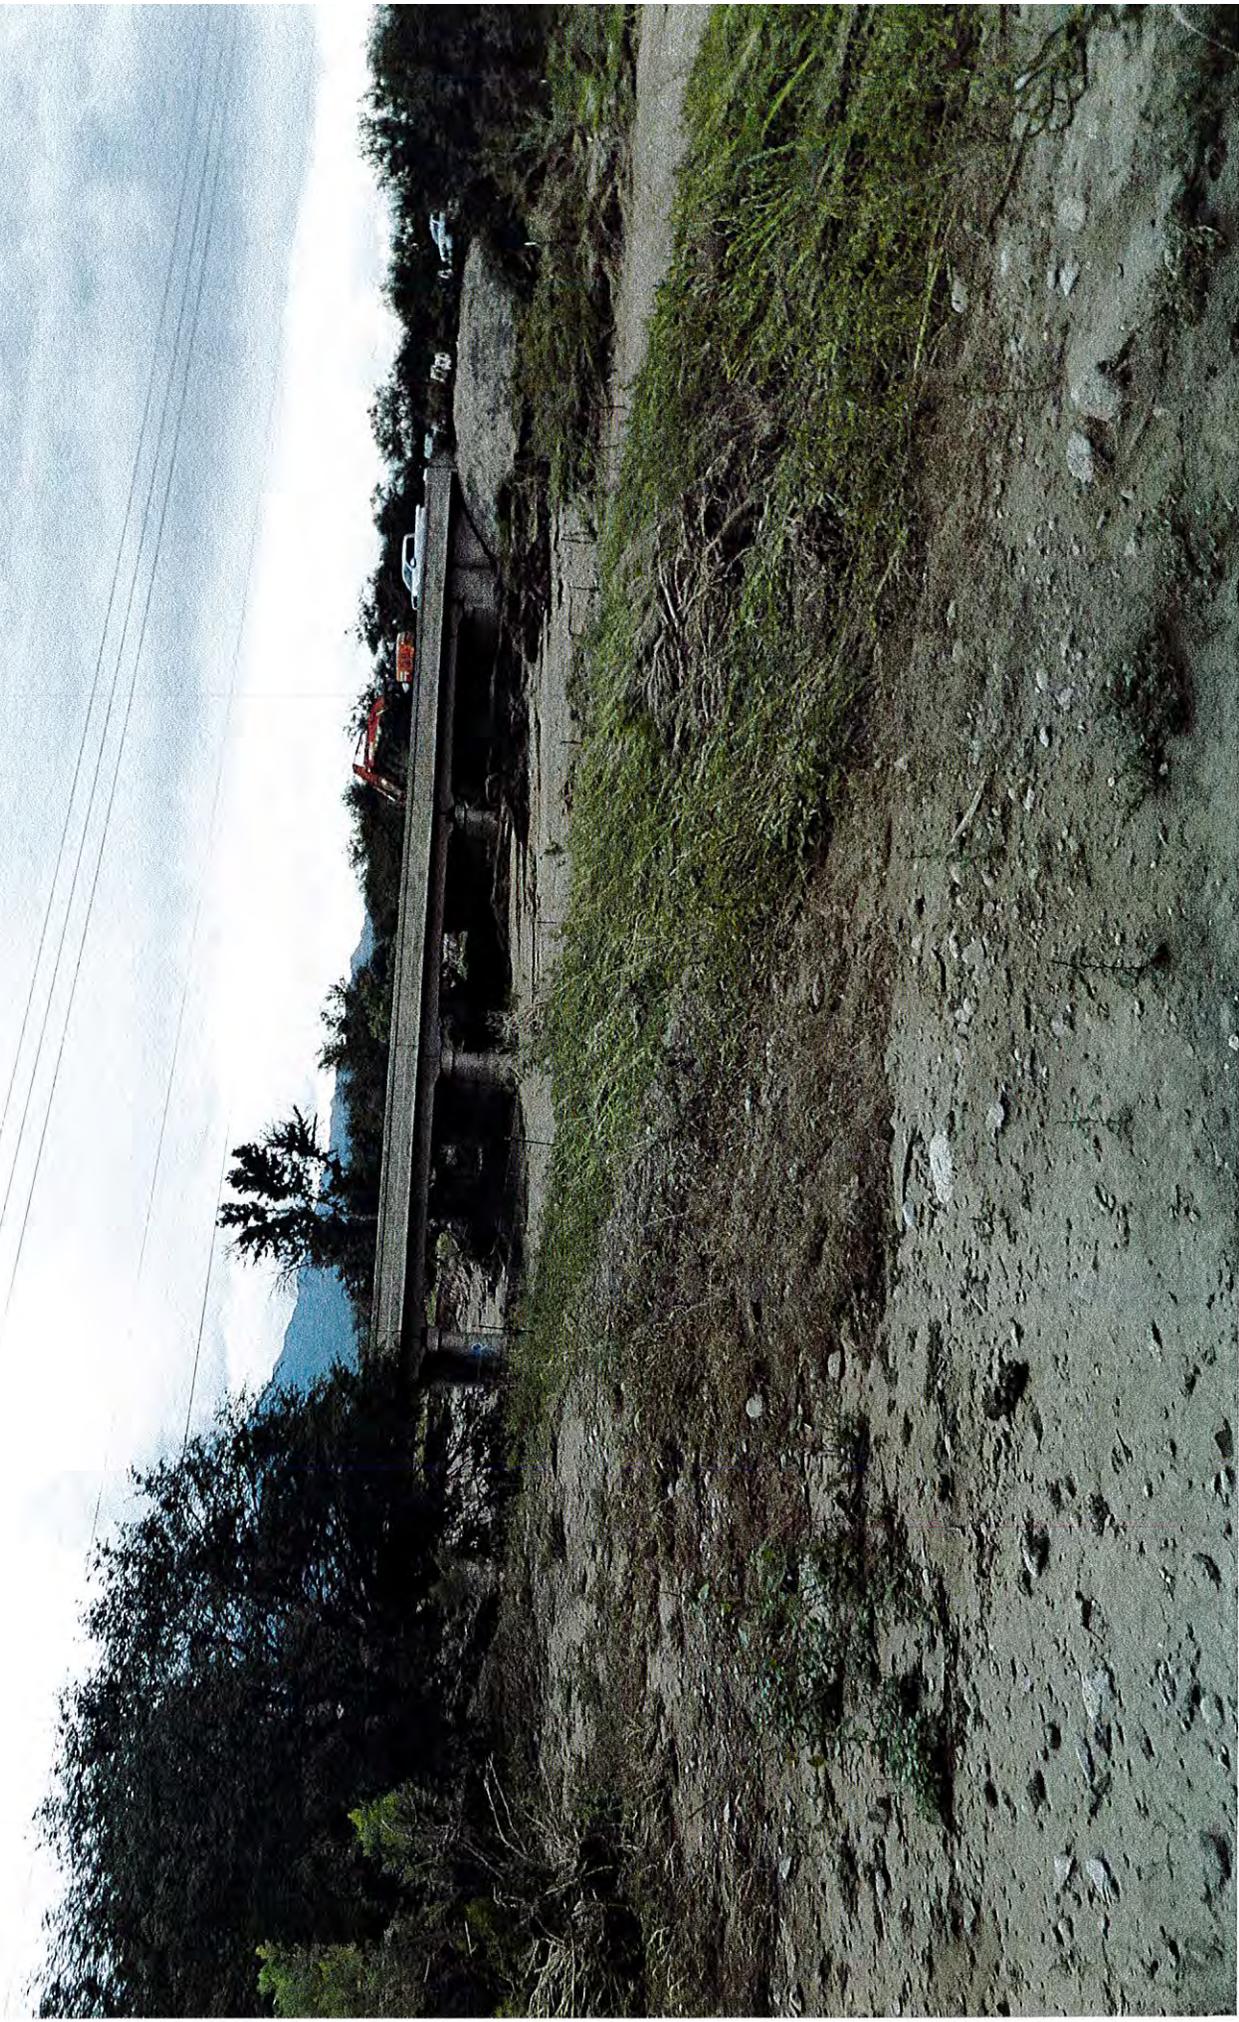
Bridge over Sopori Wash on
Nogales Hwy, view to E
