Cienega Creek & Davidson Canyon Monitoring Update

Presented to the Local Drought Impact Group
November 13, 2019

Pima Association of Governments

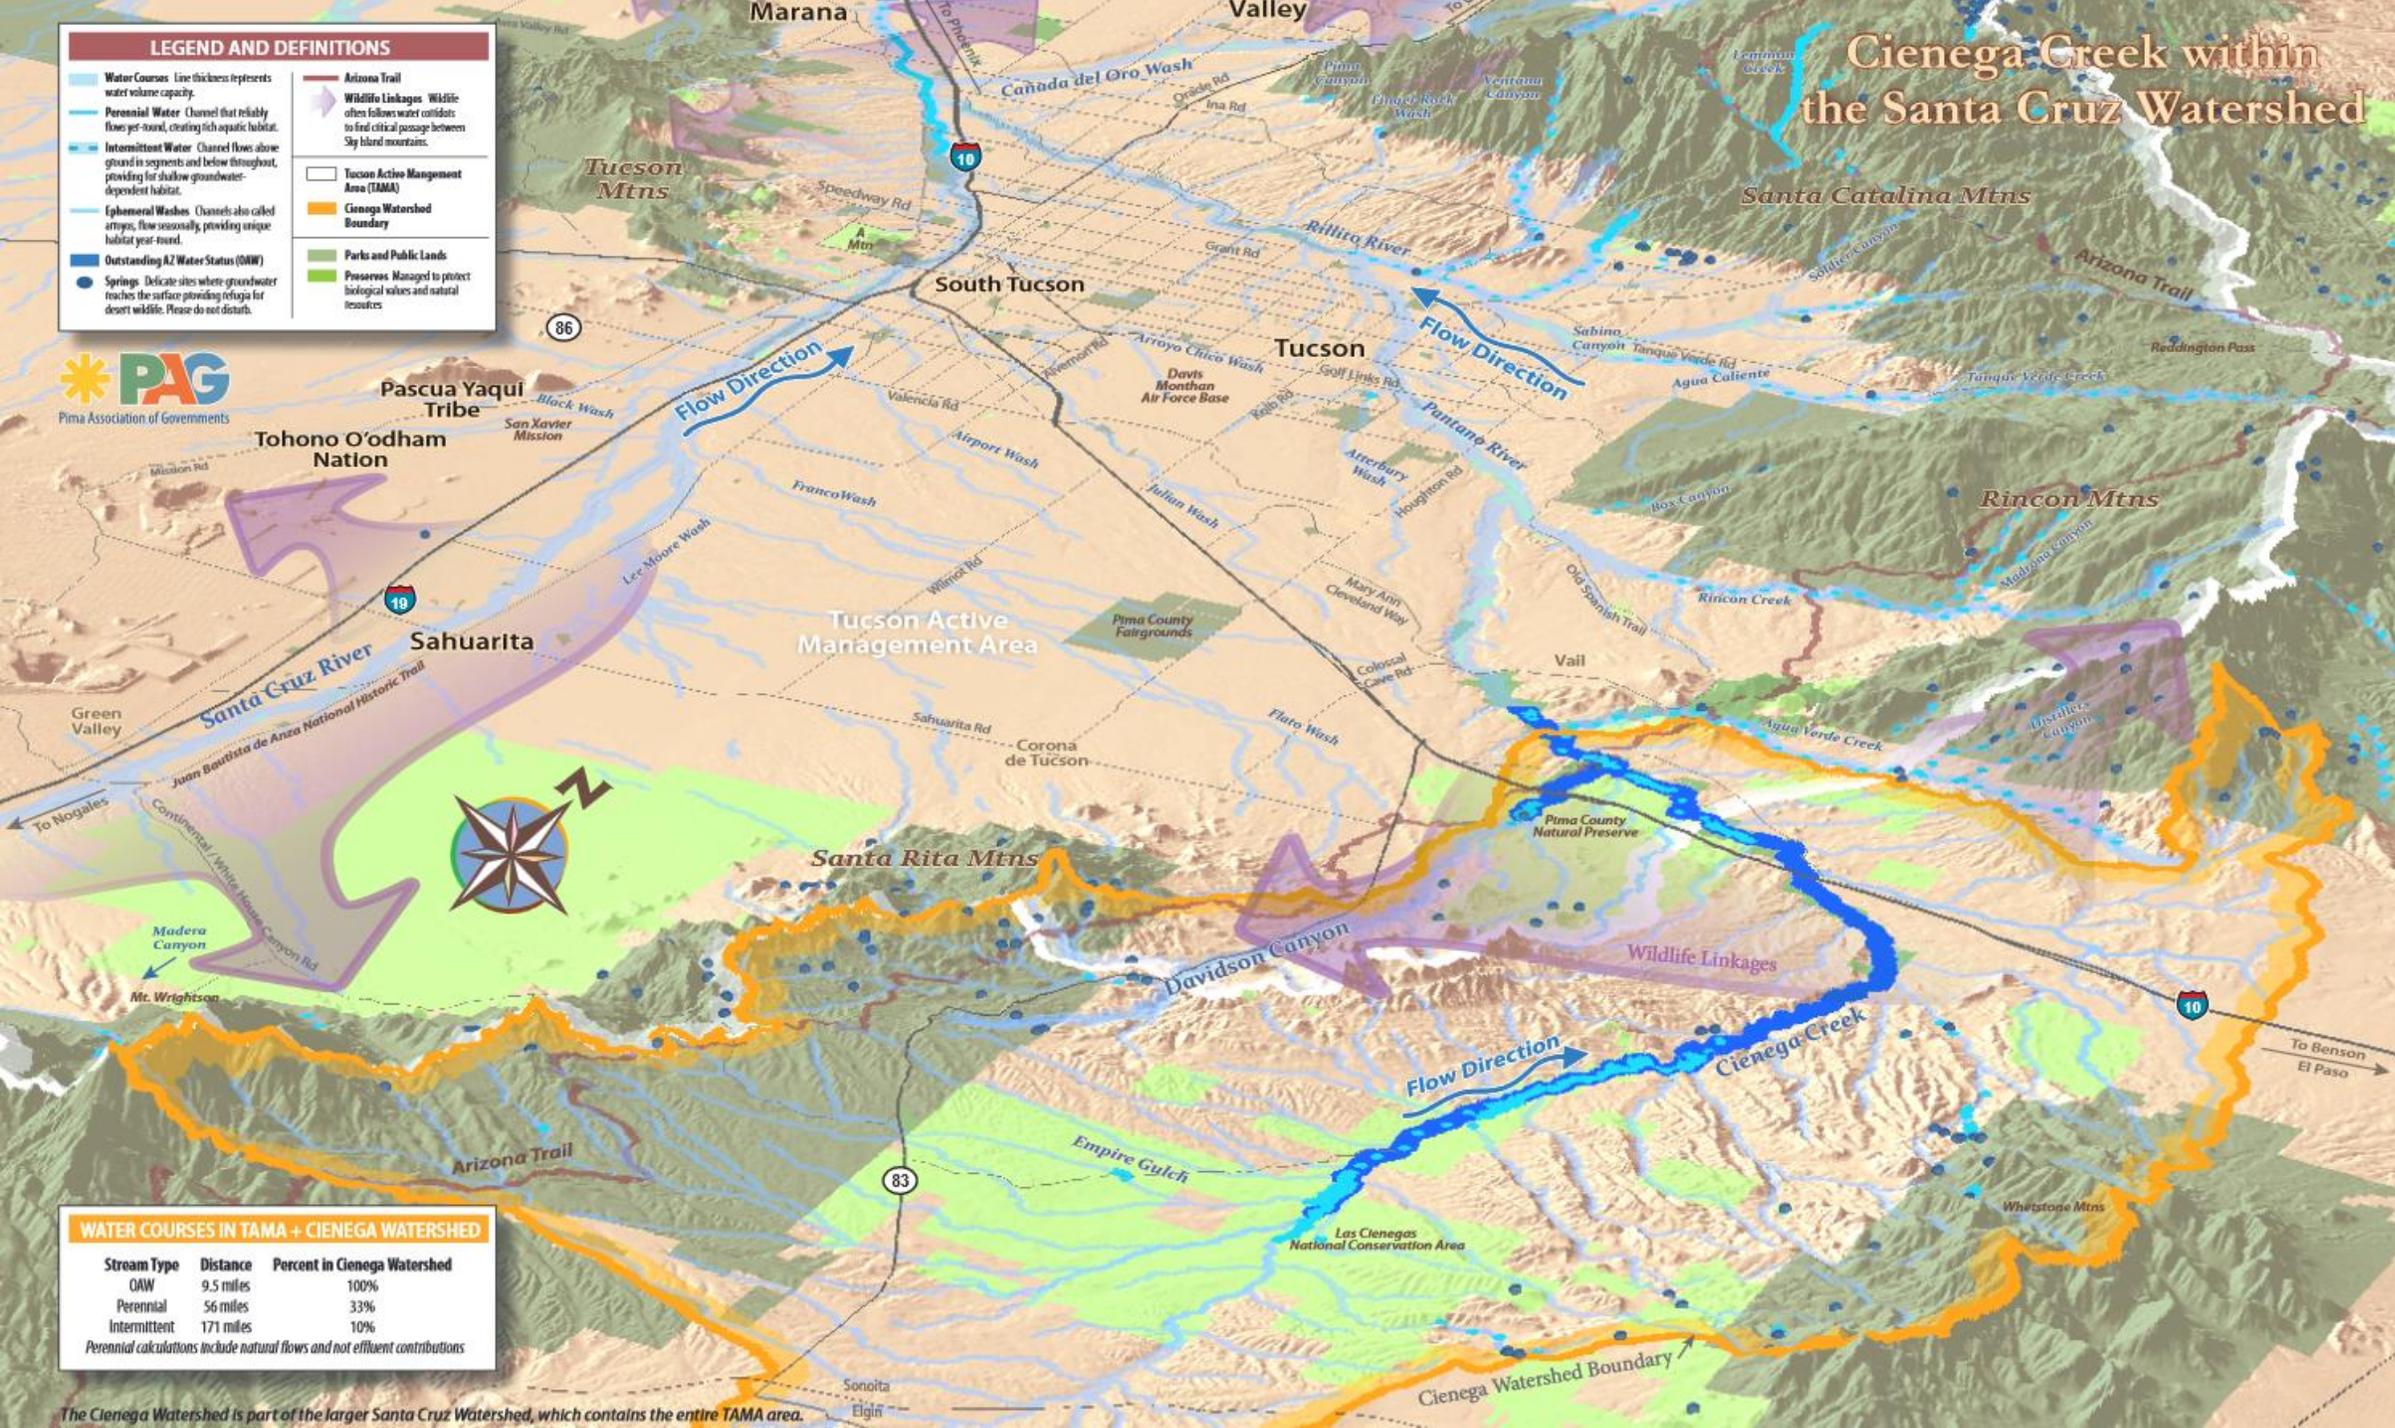
Cienega Creek within the Santa Cruz Watershed

WATER COURSES IN TAMA + CIENEGA WATERSHED		
Stream Type	Distance	Percent in Cienega Watershed
OAW	9.5 miles	100%
Perennial	56 miles	33%
Intermittent	171 miles	10%

Perennial calculations include natural flows and not effluent contributions

The Cienega Watershed is part of the larger Santa Cruz Watershed, which contains the entire TAMA area.

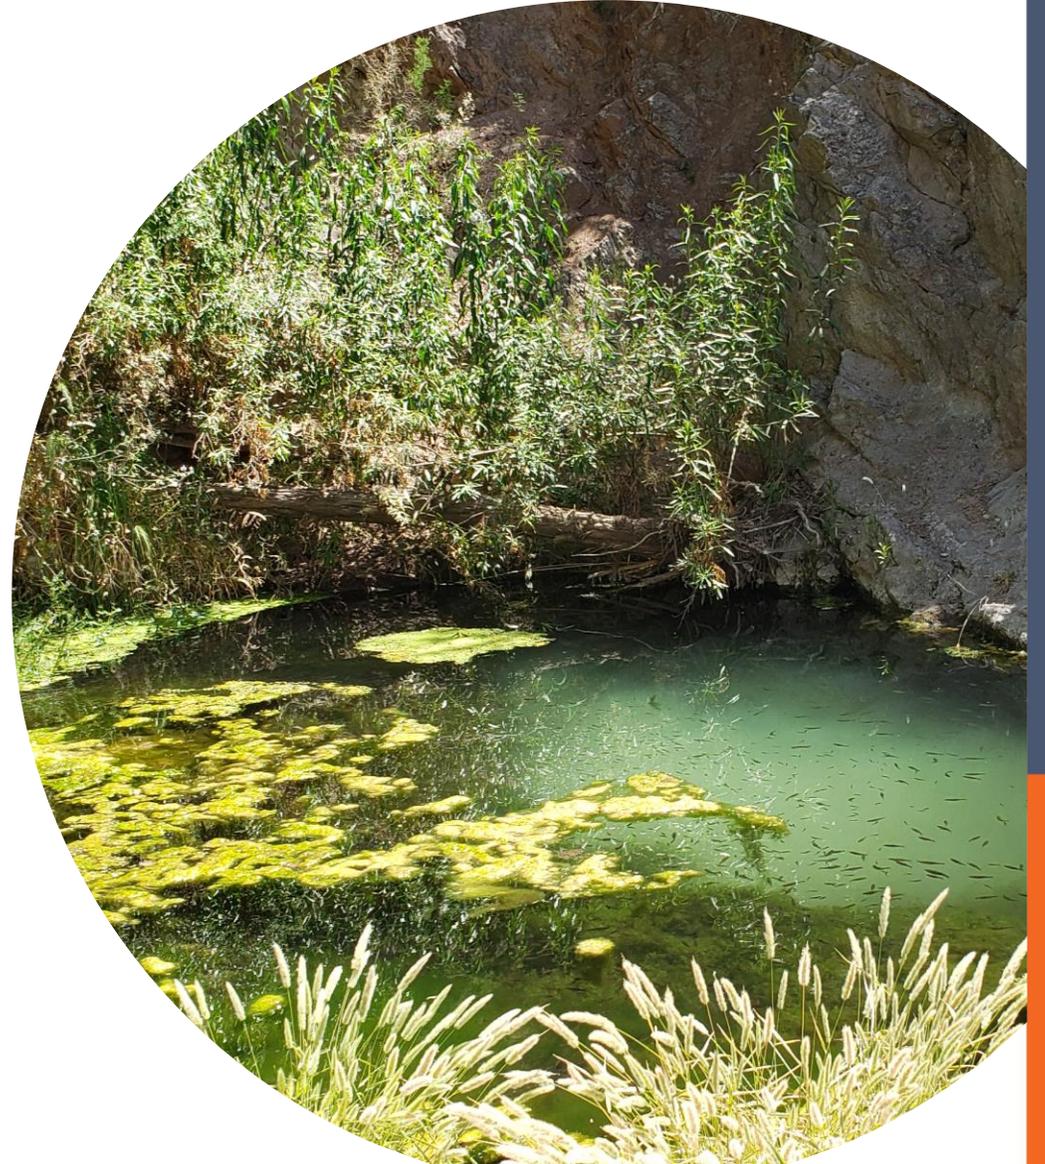
>> Pre-Monsoon “Perennial” Flows

- Measured in June
- Typically minimum annual flow - perennial
- Aligns with other wet/dry efforts

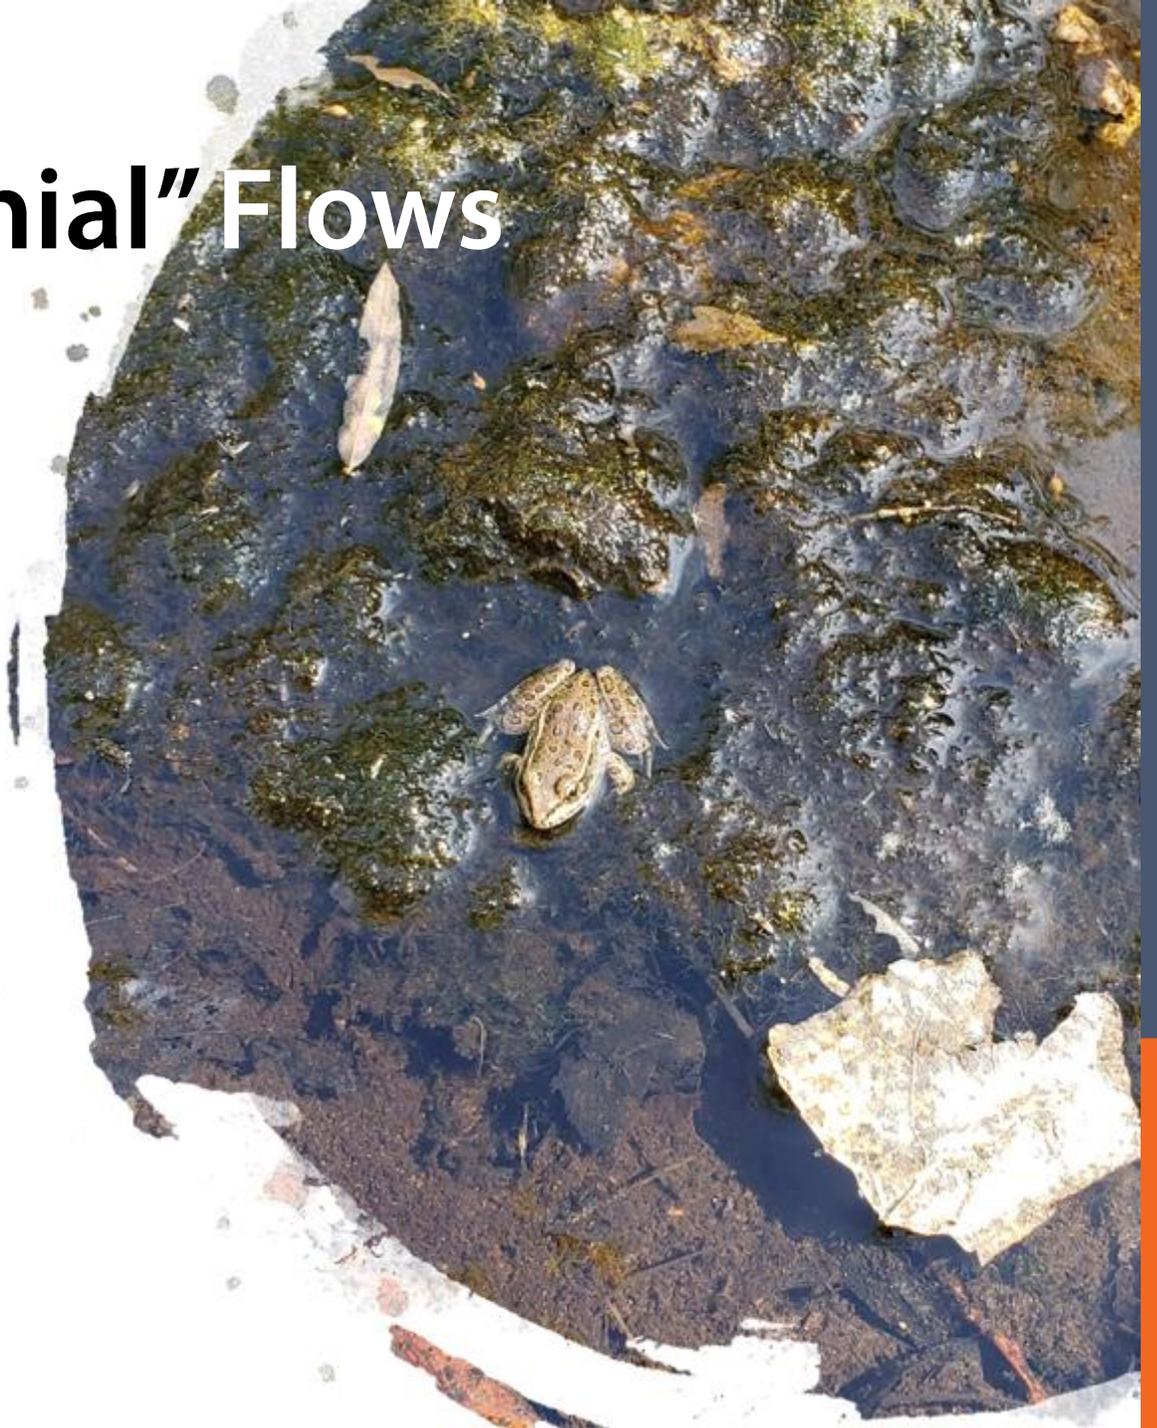
>> Pre-Monsoon “Perennial” Flows

- June 2019 – Cienega Creek
 - 1.8 miles of flow
 - Third wettest in 10 years
- June 2019 – Davidson Canyon
 - Dry

In 2019, PAG observed an increase in Cienega Creek's perennial flow extent, with June flows along 19 percent of the 9.5-mile monitoring extent. This was the third greatest June flow for Cienega in the past ten years. As shown on the linear comparison chart on page 2, the flowing stretch near the Marsh Station Road crossing was longer and less segmented than in recent years. In addition, the upper stretch of the creek saw greater total flows than have been observed in nearly a decade. Davidson Canyon, however, was dry in June 2019, closing out a monitoring year with below average seasonal flows. This follows three years of sustained year-round flows.

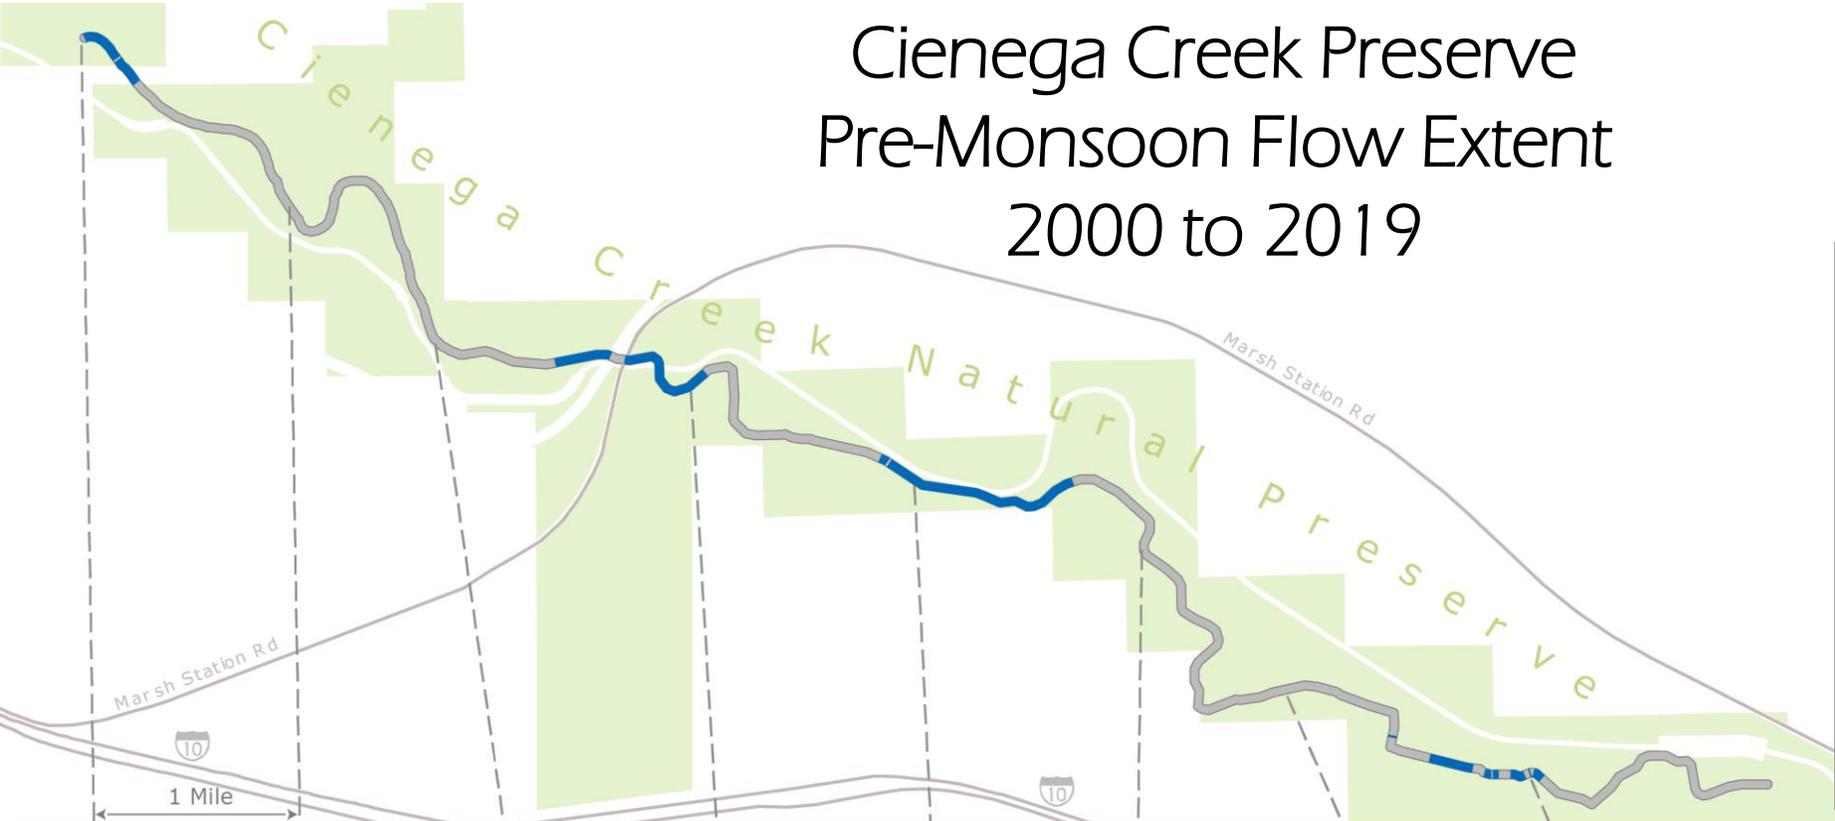
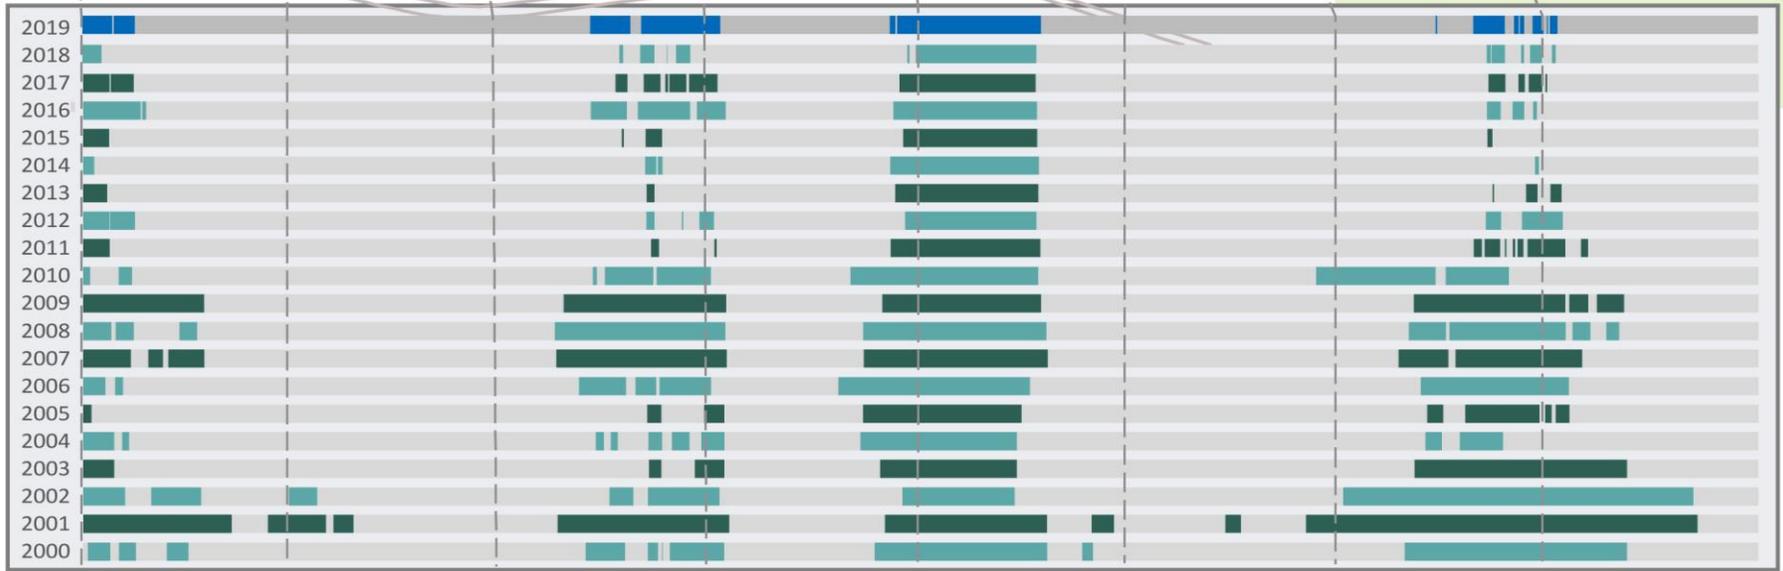
Cienega Creek Preserve Pre-Monsoon Flow Extent 2000 to 2019

- █ Flowing segment (2019)
- █ Flowing segment (even year)
- █ Flowing segment (odd year)
- █ Dry stretch (2019)
- █ Dry stretch (past years)
- █ Cienega Creek Natural Preserve

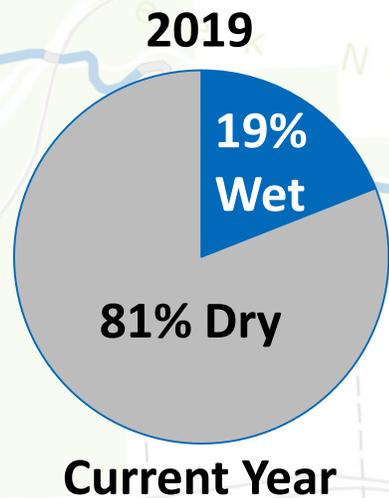
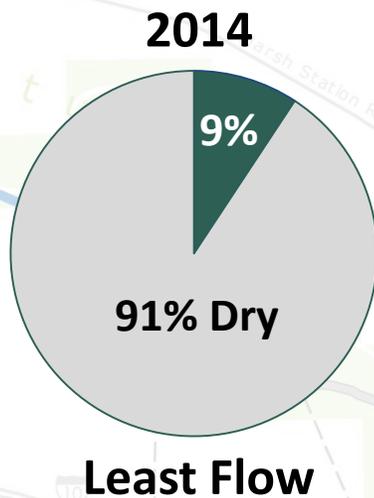
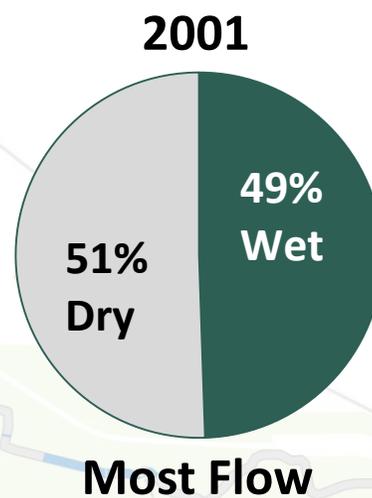
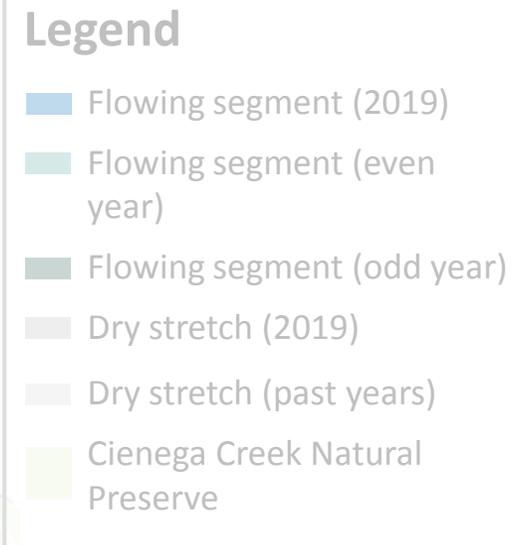
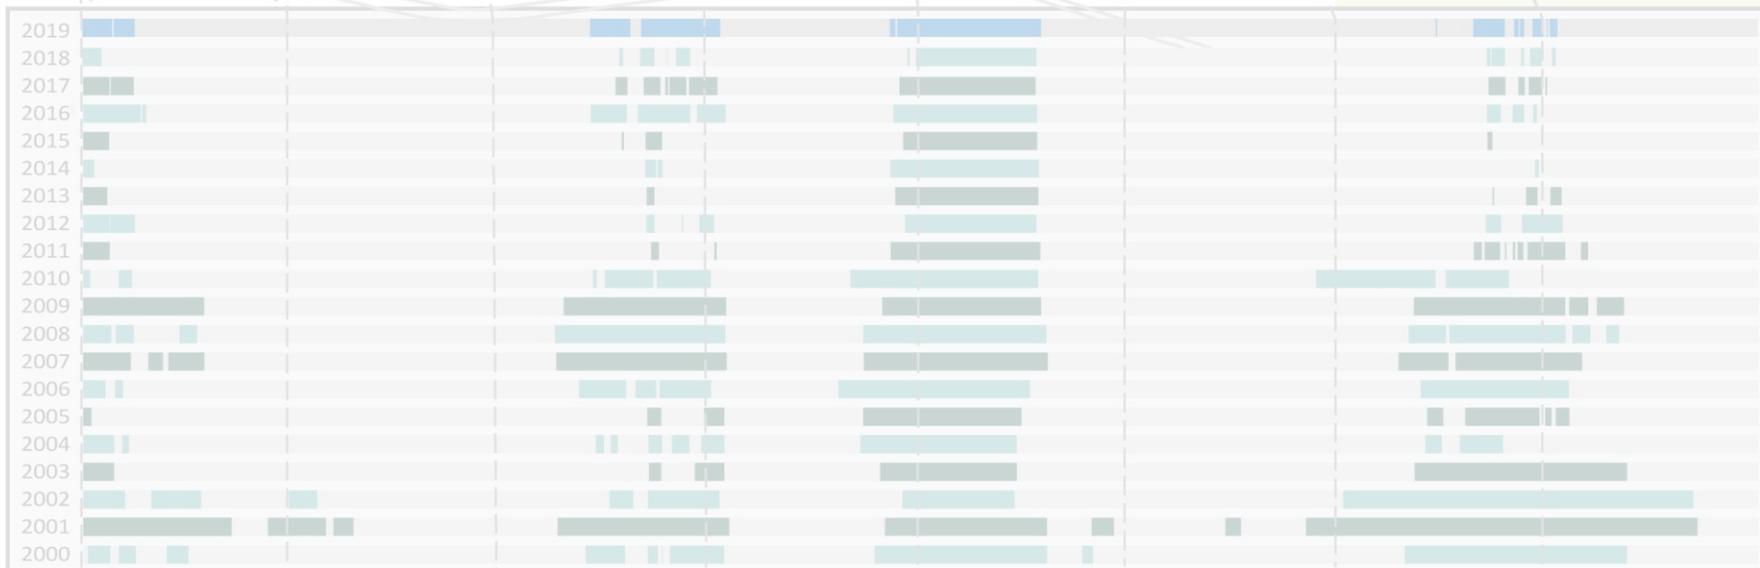
Cienega Creek Preserve Pre-Monsoon Flow Extent 2000 to 2019

Marsh Station Rd
10
1 Mile
