## **NOTICE OF VIOLATION # PC1710-013**

## **Inspection Report**

**Tracking ID: PC1710-013**

**Source:** Freeport-McMoRan Sierrita, Inc.

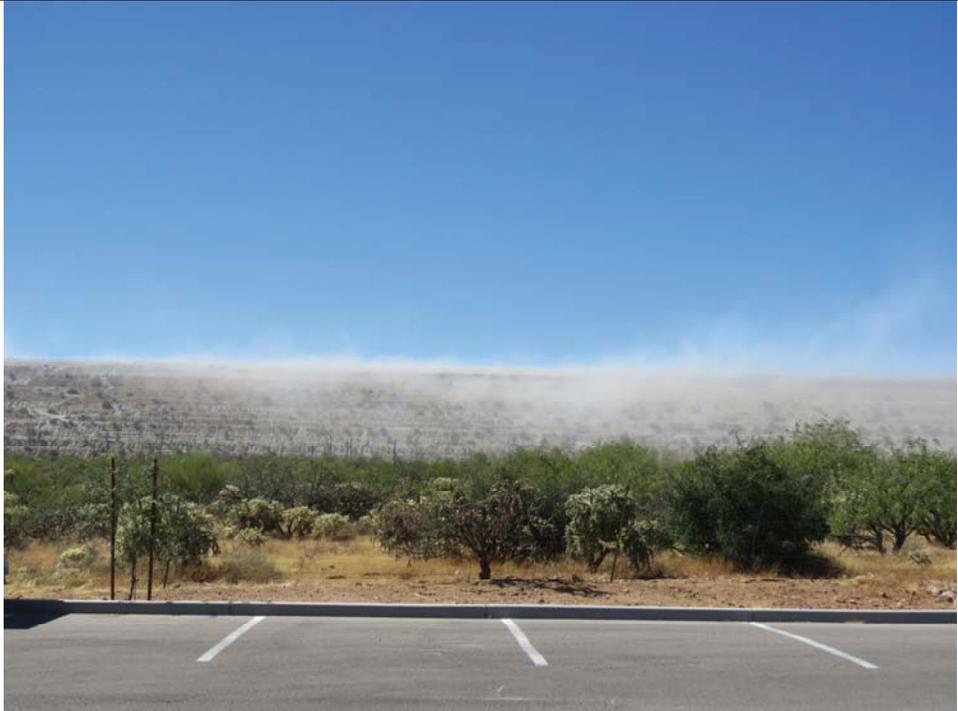
**Photo No. 1**

As I was heading south on Camino Del Sol, I observed more plumes of dust emitting from the east side of the FMSI tailings dam. I parked in the Evangelical Free Church of Green Valley parking lot at 1393 W. Mission Twin Buttes Road and photographed plumes of dust rolling over the berm on the central eastern portion of the tailing impoundment (Attachment 1, photos 1 & 2). The origin of the dust appeared to be from the interior surface area of the impoundment within the outer berm. I did not observe the dust crossing property lines. I observed several water trucks applying water to the sides of the eastern berm (Attachment 1, photo 3). I was unable to obtain a proper viewing position to perform an EPA Method 9 observation.

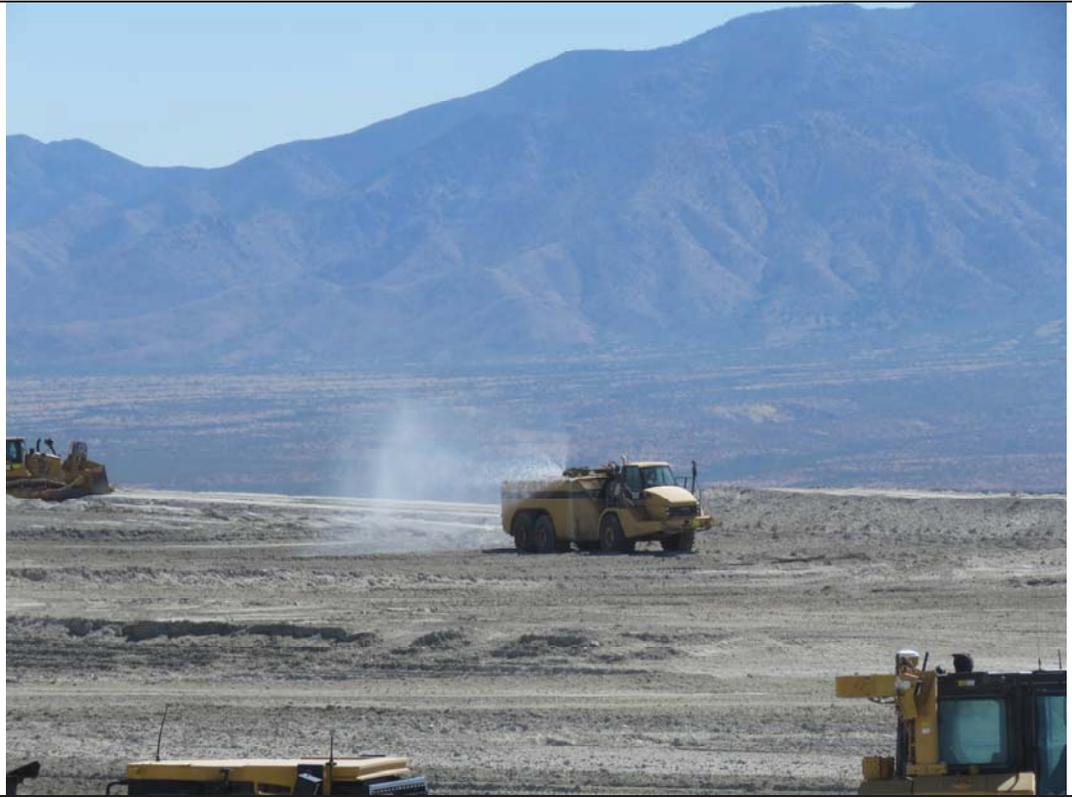
**Photo No. 5**

During my interview with Mr. Durazo I noticed plumes of dust generating between the edge of the berm construction area and the center of the tailings impoundment in Phase 2 of the South dam (Attachment 1, photo 8). The plumes dissipated in the winds and did not leave the impoundment. I asked Mr. Durazo if what I was observing was similar to the dust event on the previous day and he said yes. I asked him how it occurs and he said that the surface in the central area of the impoundment can have "pockets" of disturbances. Sometimes the surface can have an effect known as "potato chipping". That is where the surface cracks into small chip-like fragments and those fragments can be lifted by the wind, exposing fine uncrusted material below to be windblown.

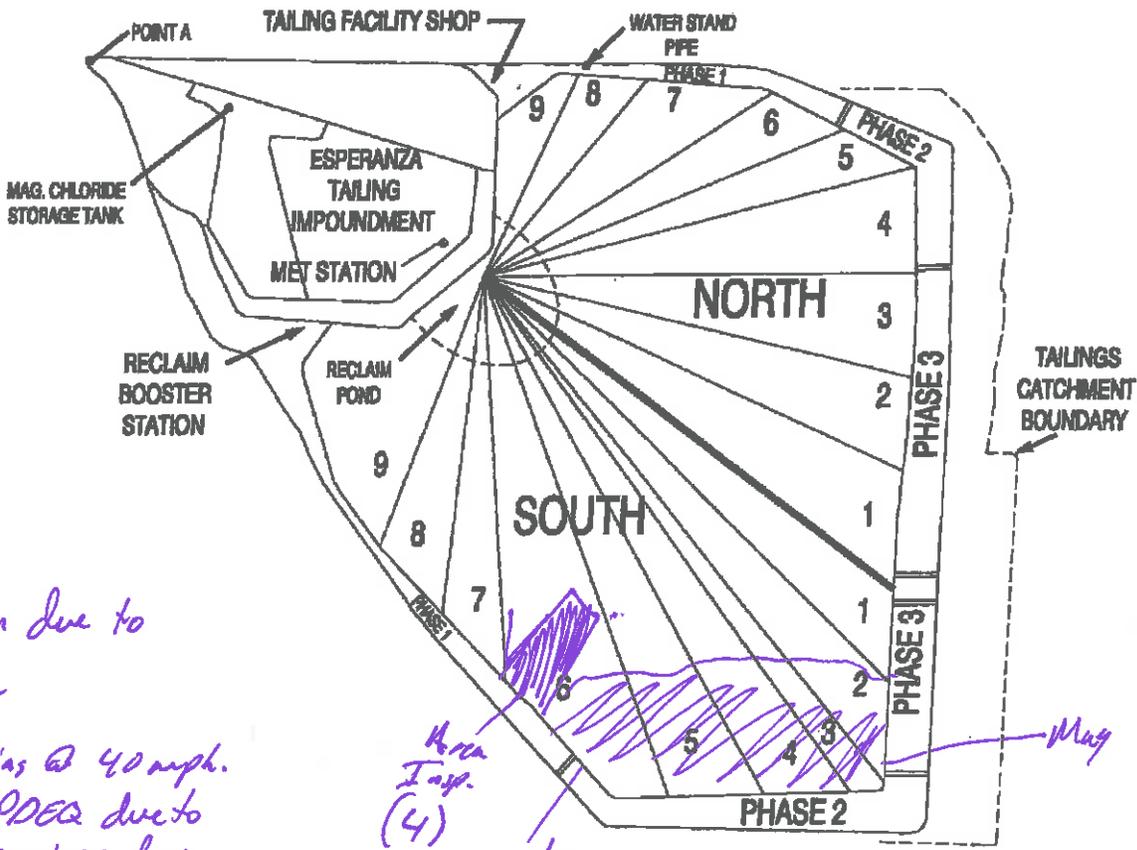
### Tailings Impoundment Surface Inspection

Date: 10/3/17  
 Time: 10:30  
 Conditions: Windy  
 Dam Inspected: 5 Phase(s) 1  
 Inspected by: E. Durazo

*N. 10 down due to crusher fire.*

*Winds peaking @ 40 mph. Visit from PDEQ due to dust from previous day*

Weather Conditions: Wind Speed 20 Gusts To 50 Temperature 90 Precipitation Last 24 Hrs. Y/N

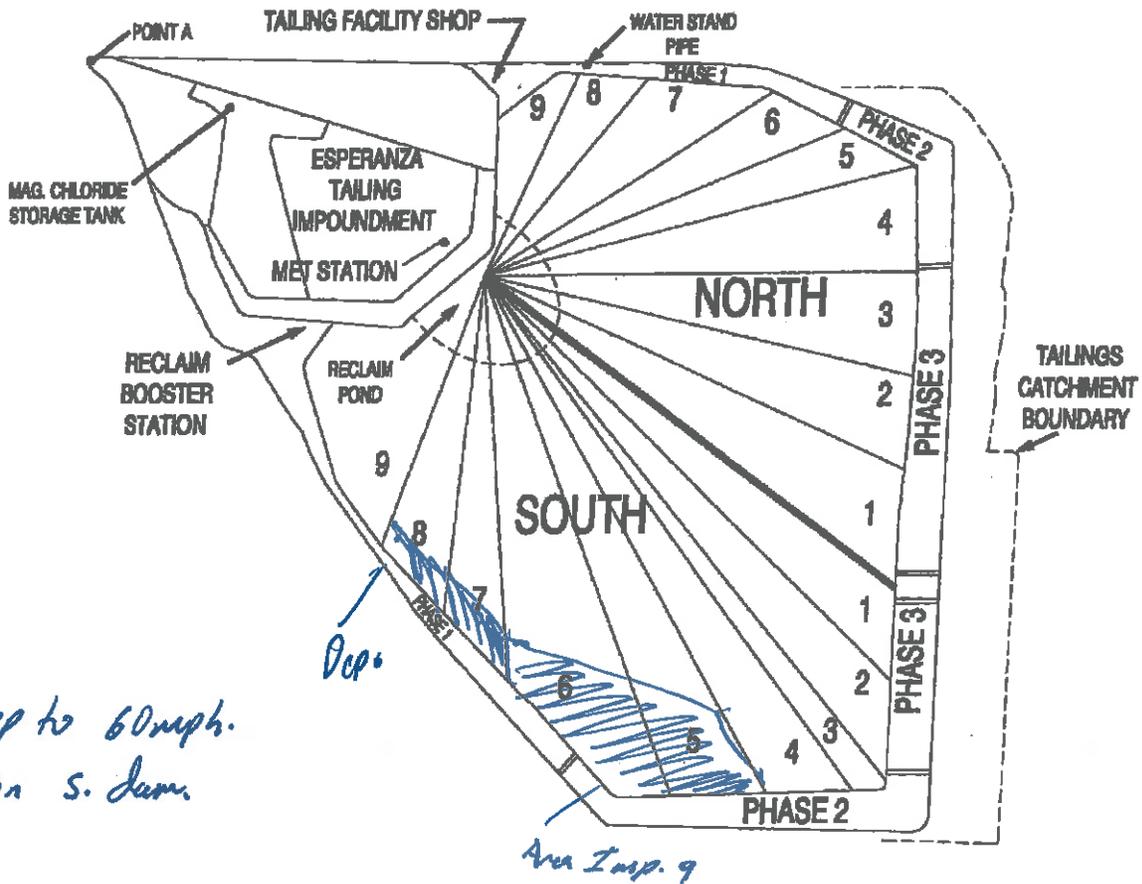
### Tailings Impoundment Surface Inspection

Date: 10/2/17  
 Time: 9:00  
 Conditions: Windy  
 Dam Inspected: 5 Phase(s) 2/3  
 Inspected by: F. Quince

*High winds up to 60 mph.  
 Broke crust on S. Dam.*

*Area Insp. 9*

Weather Conditions: Wind Speed 25 Gusts To 55 Temperature 84 Precipitation Last 24 Hrs. Y (N)

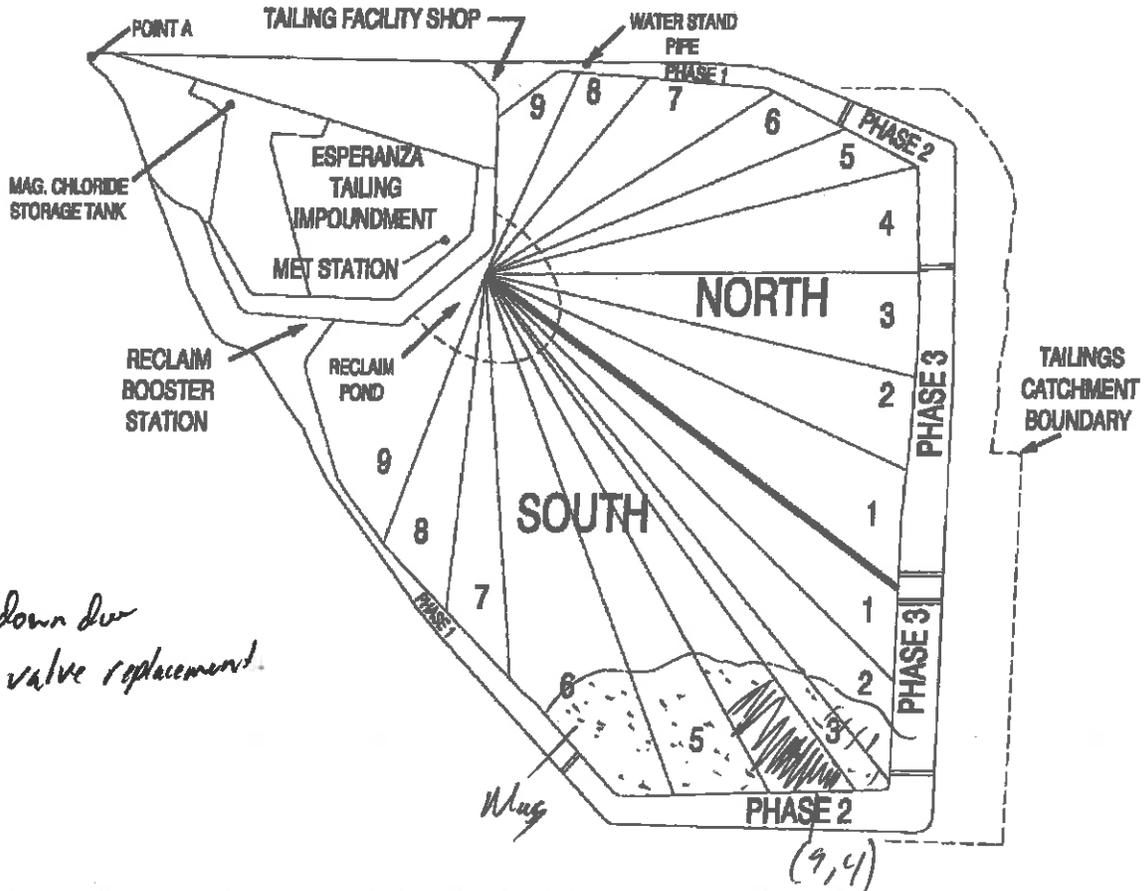
**Tailings Impoundment Surface Inspection**

Date: 9/22/17  
 Time: 9:00  
 Conditions: \_\_\_\_\_  
 Dam Inspected: \_\_\_\_\_ Phase(s): \_\_\_\_\_  
 Inspected by: \_\_\_\_\_

\* Pump station down due to the 102 valve replacement.

Weather Conditions: Wind Speed 17 Gusts To 30 Temperature 78 Precipitation Last 24 Hrs. Y/N

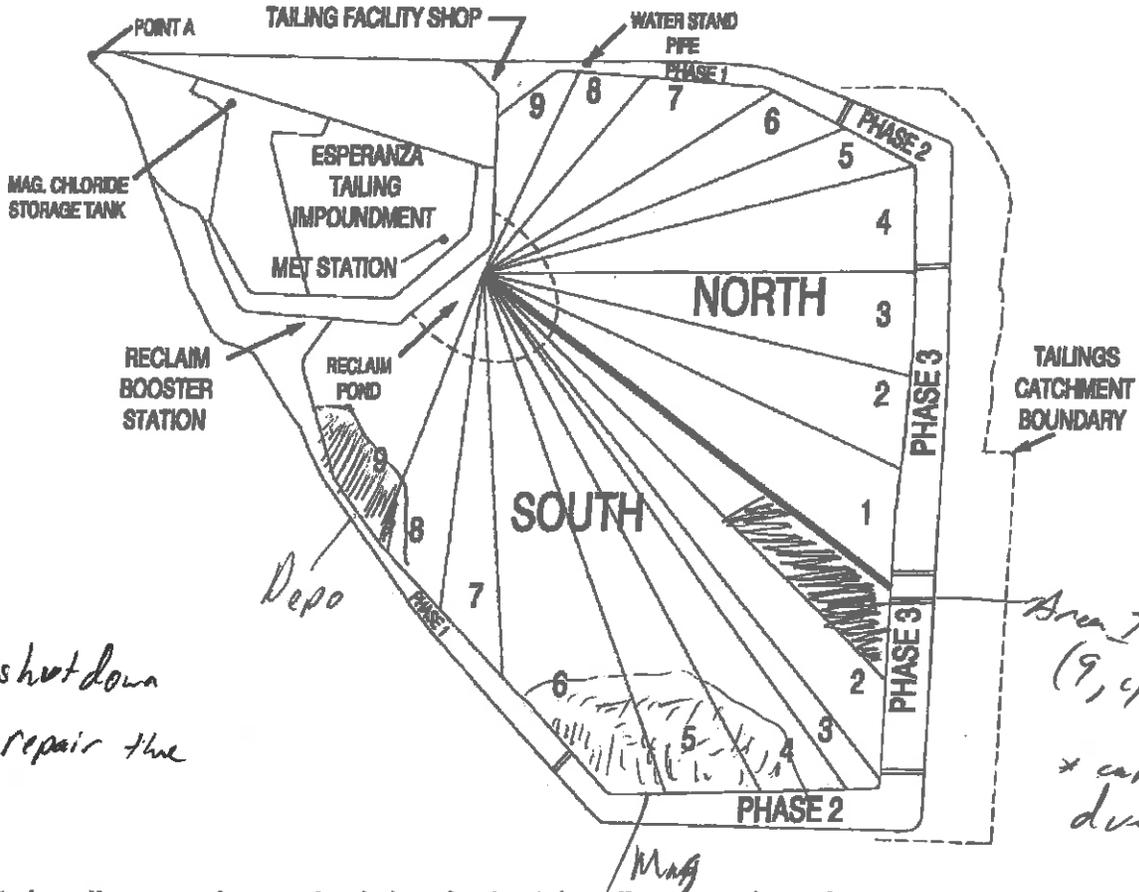
**Tailings Impoundment Surface Inspection**

Date: 9/29/17  
 Time: 10:00  
 Conditions: Windy  
 Dam Inspected: 5 Phase(s): 3  
 Inspected by: \_\_\_\_\_

indicated shutdown due to repair the 102 valve.

Area Insp. (9, 4)  
 \* called E1w due to dust.

Weather Conditions: Wind Speed 10 Gusts To 30 Temperature 90 Precipitation Last 24 Hrs. Y (N)

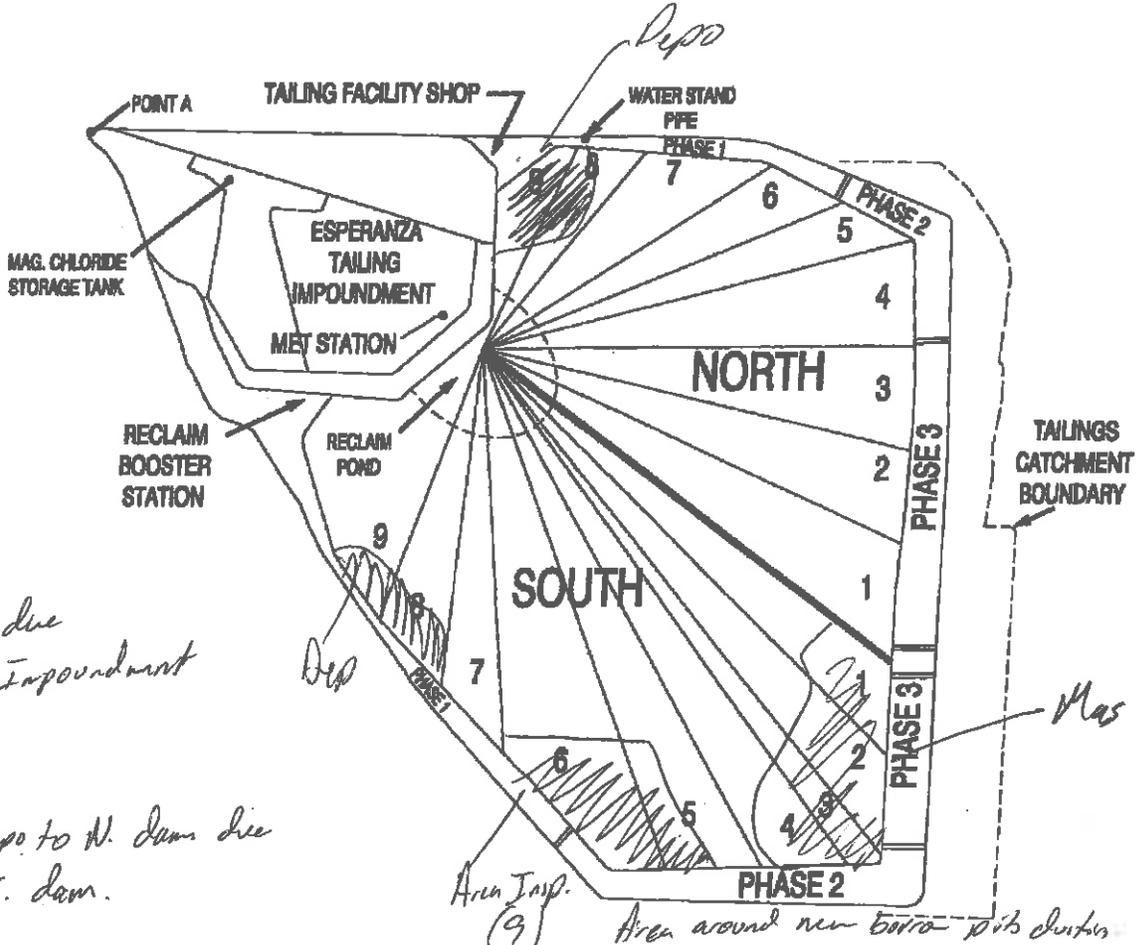
**Tailings Impoundment Surface Inspection**

Date: 9/20/17  
 Time: 1:00  
 Conditions: Strong winds  
 Dam Inspected: S Phase(s): 1/2  
 Inspected by: F. Duran

*Called Ehw due to dust on Impoundment*

*Had to move depo to N. Dam due to hole on S. Dam.*

Weather Conditions: Wind Speed 15 Gusts To 30 Temperature 95 Precipitation Last 24 Hrs. Y (N)

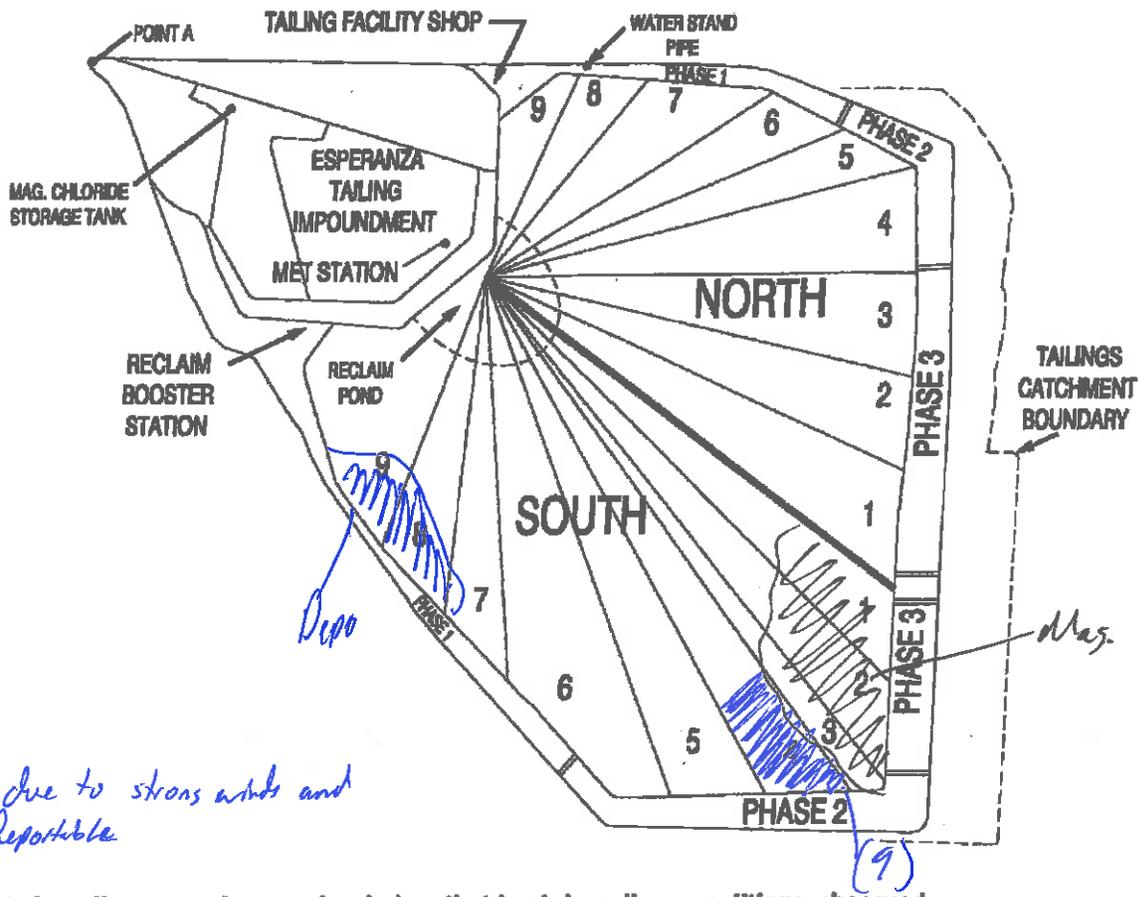
**Tailings Impoundment Surface Inspection**

Date: 9/19/17  
 Time: 10:00  
 Conditions: Breezy / strong winds  
 Dam Inspected: 5 Phase(s): 2  
 Inspected by: Ellenzo

*Called ELL due to strong winds and dust. Non-Reportable*

Weather Conditions: Wind Speed 15 Gusts To 25 Temperature 90 Precipitation Last 24 Hrs. Y/N
