NOTICE OF VIOLATION # PC1811-151

The Pima County Department of Environmental Quality (PDEQ) has reason to believe Freeport-McMoRan Sierrita Inc. (FMSI) has violated requirements of PDEQ Air Quality Operating Permit #6067 and the Pima County Code (PCC). PDEQ discovered the violations alleged below during a surveillance inspection of the Sierrita Tailings Impoundment in Green Valley, Arizona, conducted on November 29, 2018, and upon review of reports submitted by FMSI dated November 19, 2018, and December 4, 2018.

Freeport-McMoRan Sierrita, Inc. allowed visible fugitive dust emissions generated from the Sierrita Tailings Impoundment to cross northward across Duval Mine Road on November 29, 2018.

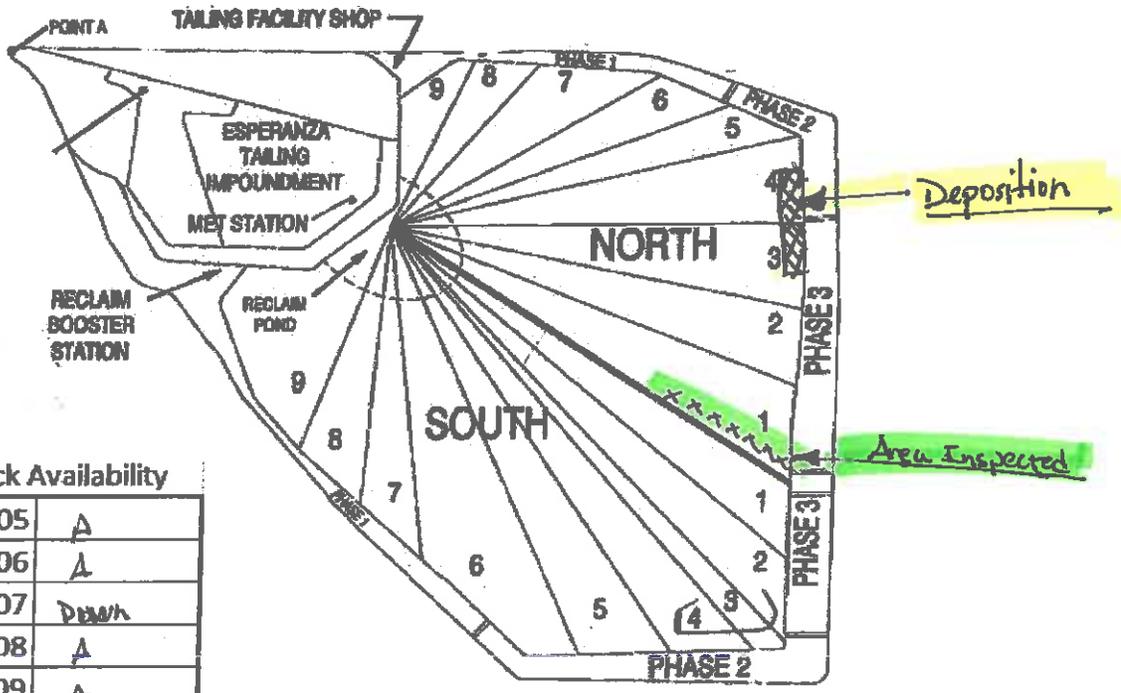
Tailings Impoundment Surface Inspection

Date: 10.12.2018
 Time: 7:30 am
 Conditions: Rain
 Dam Inspected: North Phase(s) 3
 Inspected By: Jesus Hernandez

70105	A
70106	A
70107	Down
70108	A
70109	A

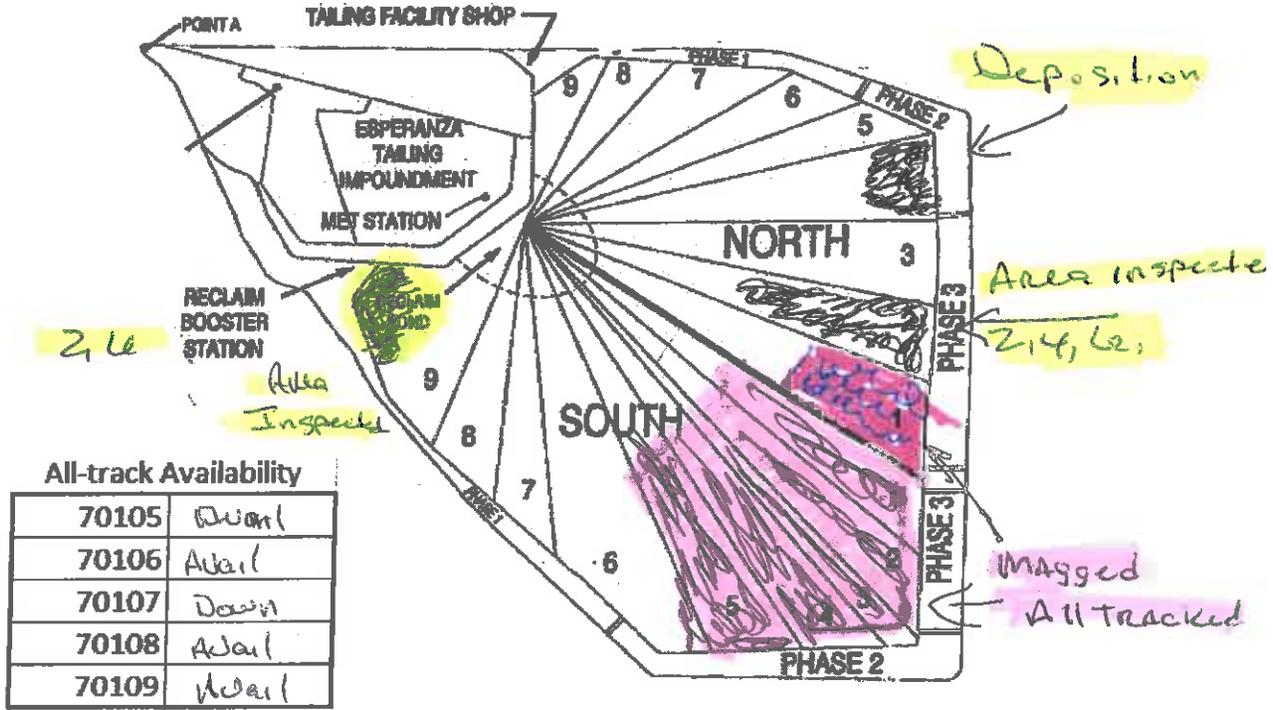
Tailings Impoundment Surface Inspection

Date: 10-11-18
 Time: 2:30-4:30 pm
 Conditions: Windy Partly Clouded
 Dam Inspected: S/N Phase(s) 1, 3
 Inspected By: Granico J

70105	Down
70106	Down
70107	Down
70108	Down
70109	Down

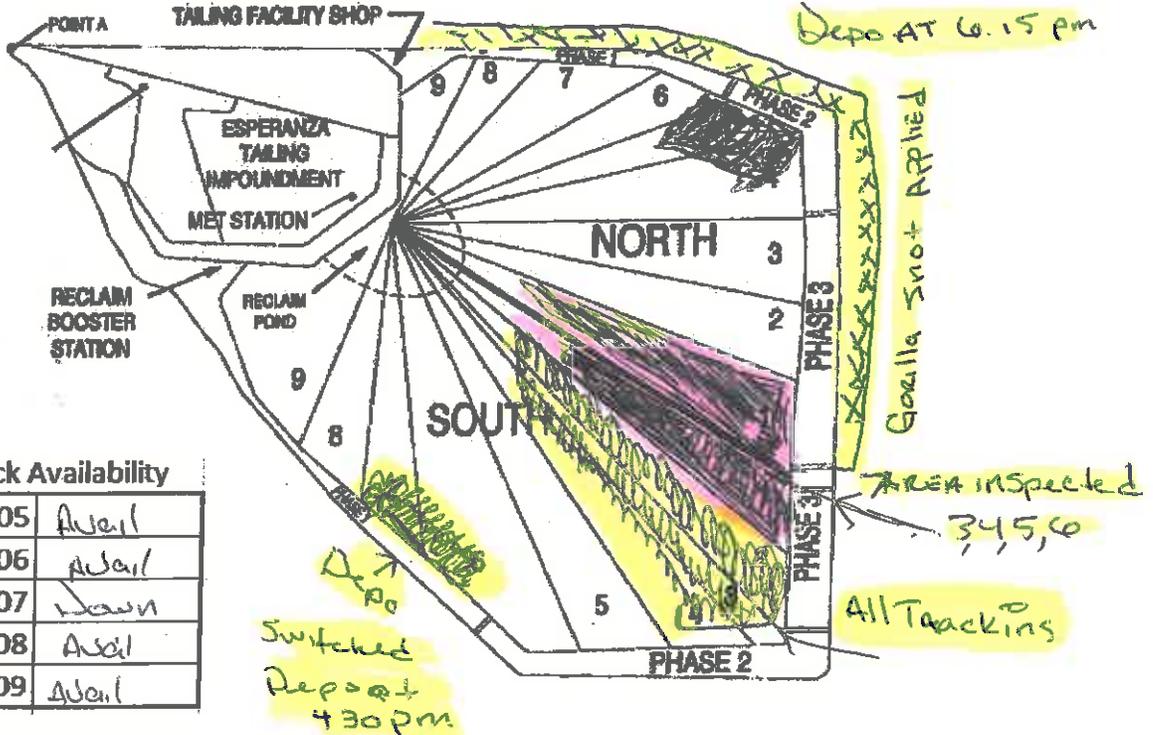
Tailings Impoundment Surface Inspection

Date: 10-10-18
 Time: 5:00 pm
 Conditions: Light winds Cloudy Partly
 Dam Inspected: N/S Phase(s) 3
 Inspected By: Granillo Joe

70105	Up/ail
70106	Up/ail
70107	Down
70108	Up/ail
70109	Up/ail

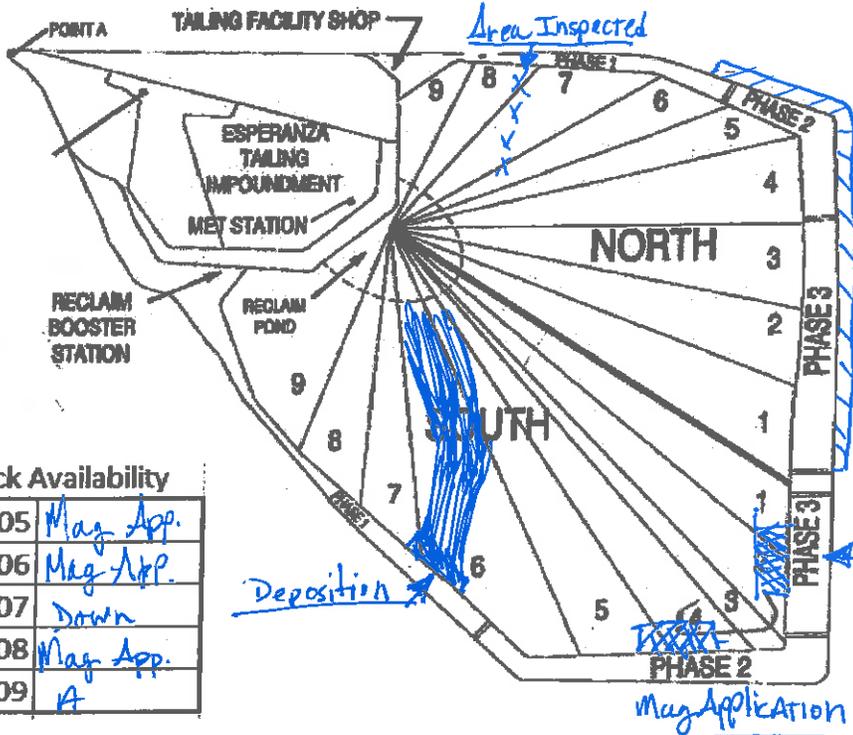
Tailings Impoundment Surface Inspection

Date: 10.9.2017
 Time: 5:30pm-
 Conditions: clear
 Dam Inspected: North Phase(s) 8
 Inspected By: Jesus Hernandez

Gorilla Snot 1650 gallons Application on berm

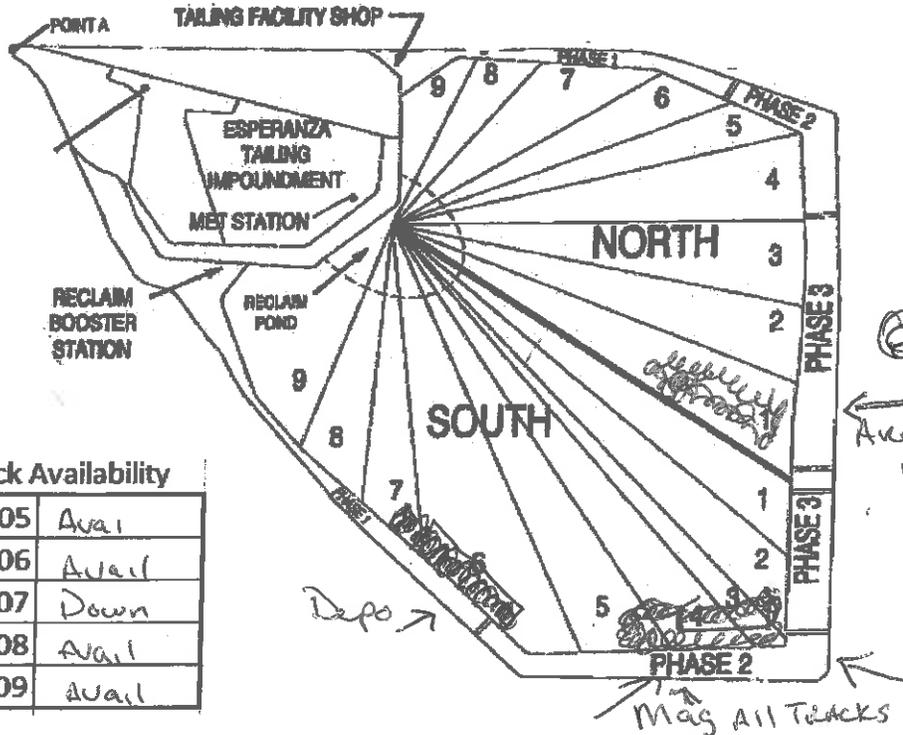
Tailings Impoundment Surface Inspection

Date: 10-9-18
 Time: 11:00
 Conditions: Sunny/Cloudy
 Dam Inspected: A1 Phase(s) 3
 Inspected By: Cranillo Joe

70105	Avail
70106	Avail
70107	Down
70108	Avail
70109	Avail

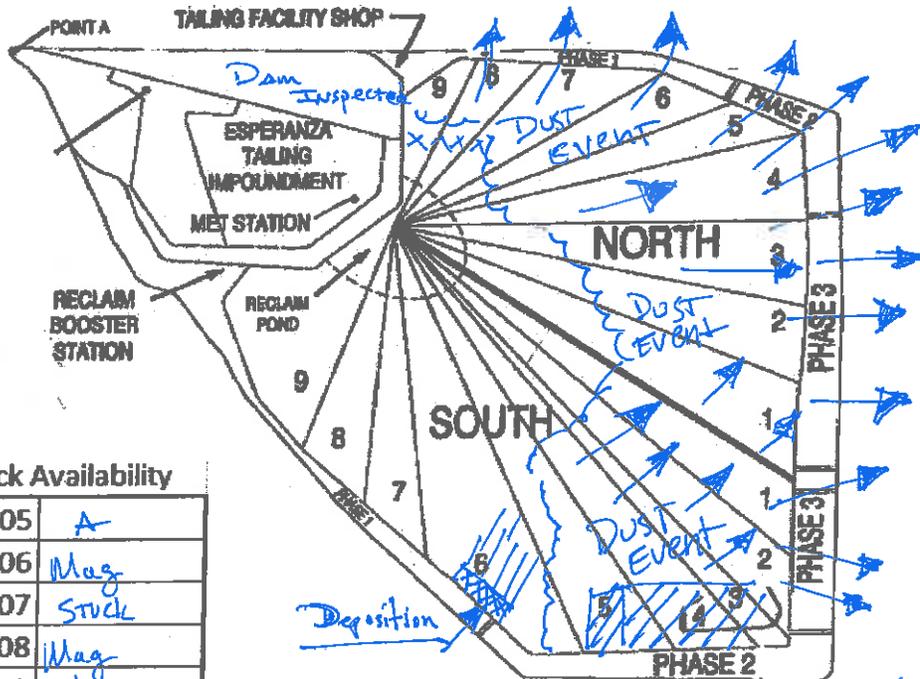
Tailings Impoundment Surface Inspection

Date: 10-7-2018
 Time: 8:00am-
 Conditions: High Winds
 Dam Inspected: North Phase(s) 1
 Inspected By: Jesus Hernandez

70105	A
70106	Mag
70107	Stuck
70108	Mag
70109	A

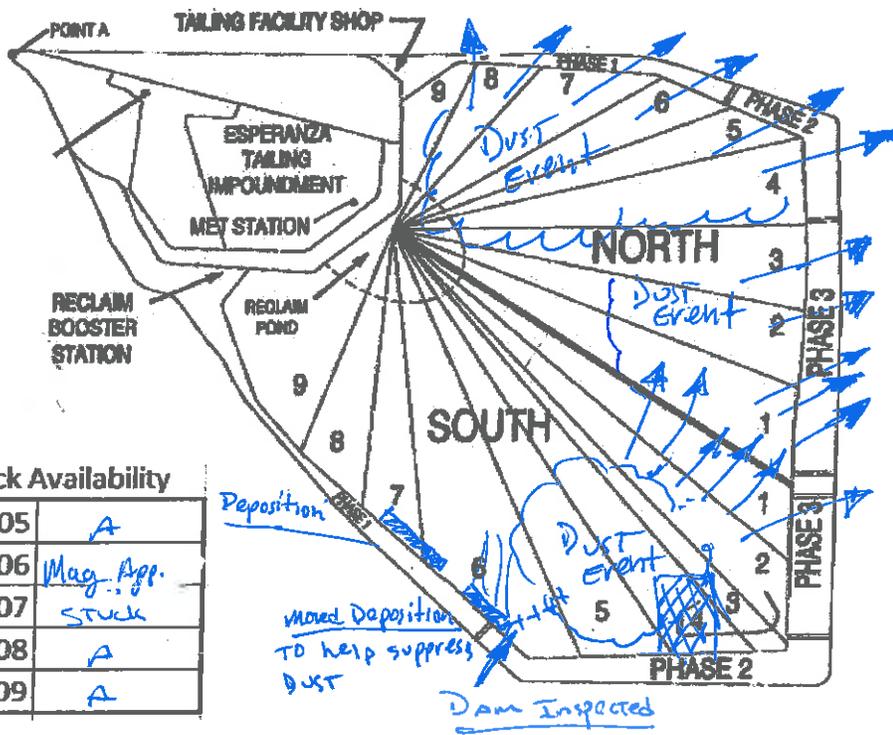
Tailings Impoundment Surface Inspection

Date: 10.6.2018
 Time: 1:00 pm-
 Conditions: High Winds
 Dam Inspected: South Phase(s) 1 (6-5)
 Inspected By: Jesus Hernandez

70105	A
70106	Mag. App.
70107	STUCK
70108	A
70109	A

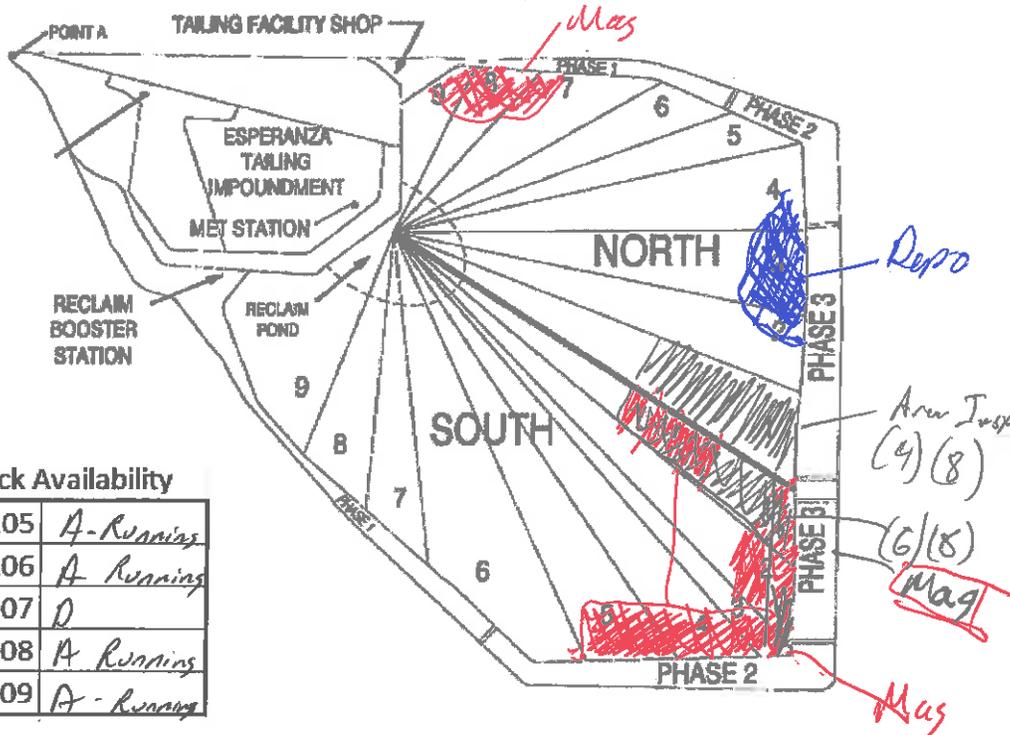
Tailings Impoundment Surface Inspection

Date: 10/19/18
 Time: 10:00
 Conditions: Calm
 Dam Inspected: N/S Phase(s) 3
 Inspected By: E. Durazo

70105	A-Running
70106	A-Running
70107	D
70108	A-Running
70109	A-Running

Action Plan: 4 All tracks / 1 water truck
 Dust Suppressant Applied: Mag
 Operators: Rudy / Eddie / Jesse / John / Kevin
 Weather Conditions:

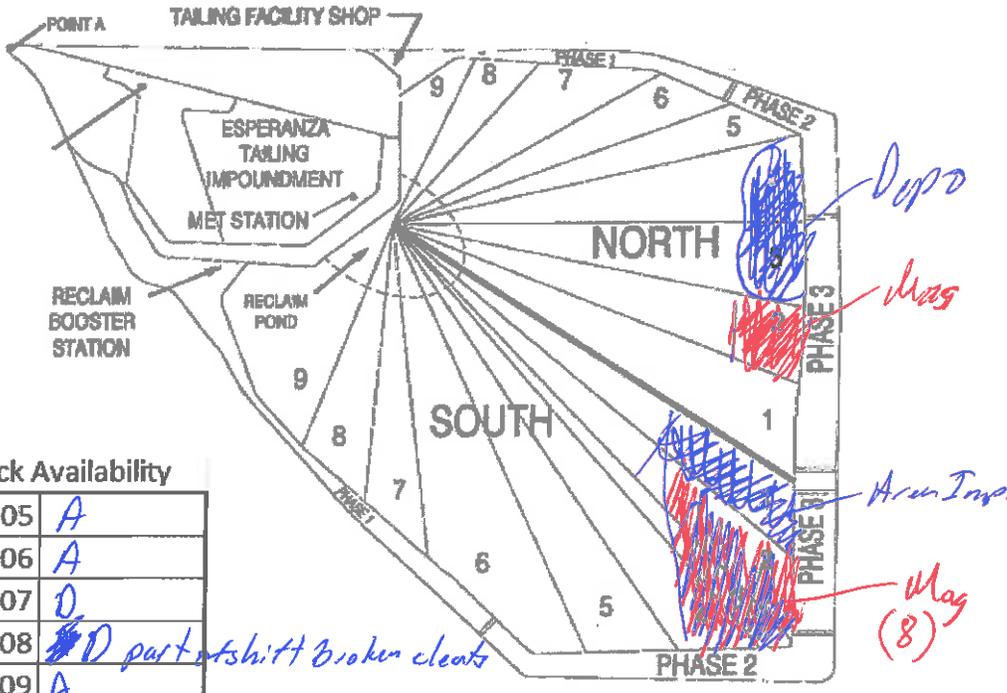
Tailings Impoundment Surface Inspection

Date: 10/18/18
 Time: 2:00
 Conditions: Small Breeze
 Dam Inspected: 5 Phase(s) 3
 Inspected By: E. DeGroot

70105	A
70106	A
70107	D
70108	D part of shift broken cleats
70109	A

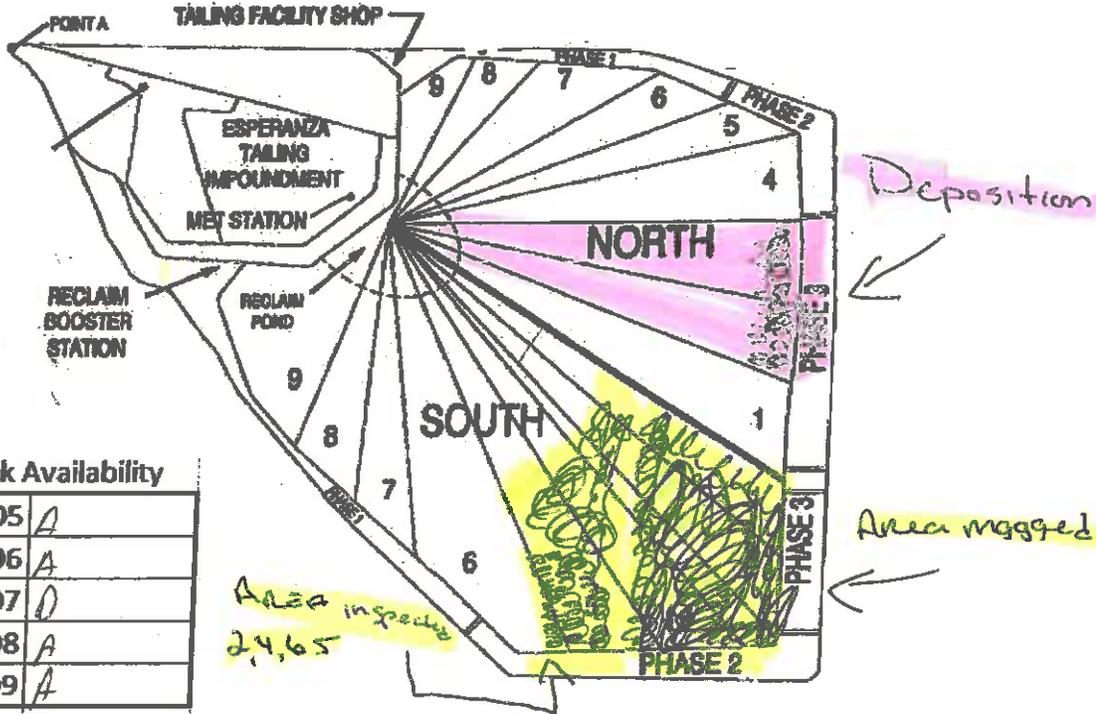
Tailings Impoundment Surface Inspection

Date: 10-17-18
 Time: 2:00
 Conditions: Foggy
 Dam Inspected: 5 Phase(s) 2
 Inspected By: Carroll

70105	A
70106	A
70107	D
70108	A
70109	A

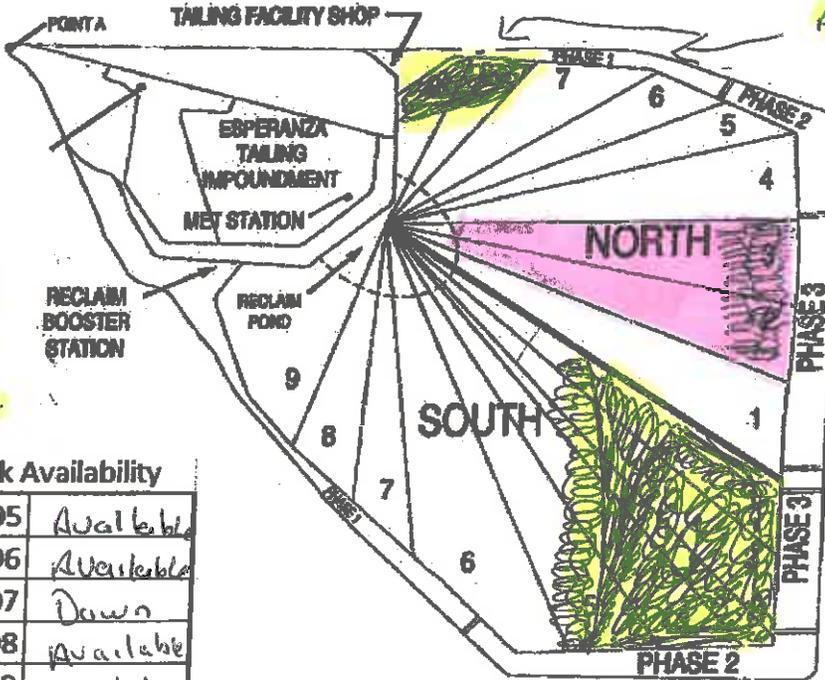
Date: 10-16-18
 Time: 12:30
 Conditions: Sunny Cloudy
 Dam Inspected: N Phase(s) 1
 Inspected By: Guillermo

AREA 8, 9
 Soft Area
 Will Run
 Marsh Maske
 and Transport
 All Track
 To Area
 Inspected

AREA inspected
 2, 3, 4, 6

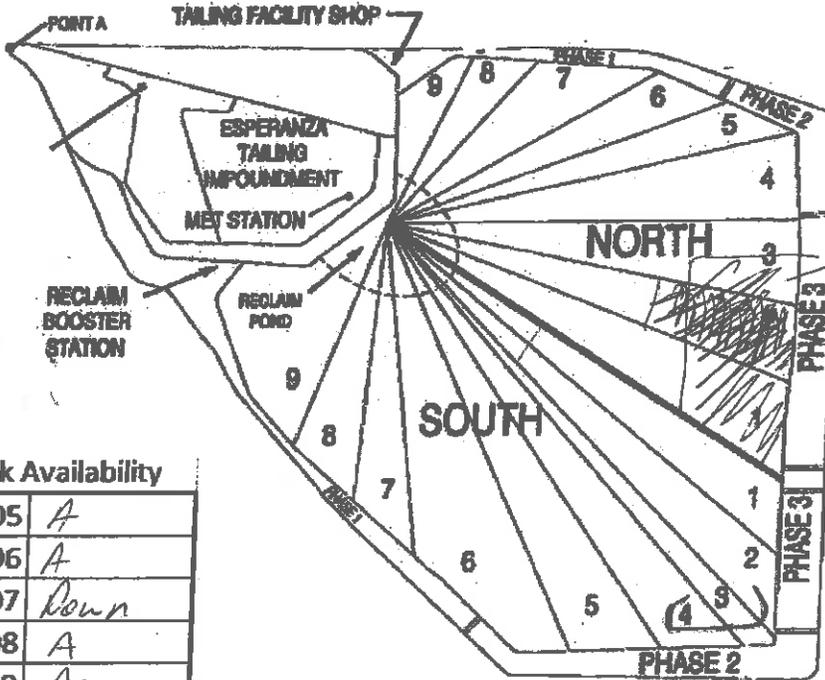
Tailings Impoundment Surface Inspection

Date: 10/15/18
 Time: 10:00
 Conditions: Calm
 Dam Inspected: N Phase(s) 3
 Inspected By: F. Duran

70105	A
70106	A
70107	Down
70108	A
70109	A

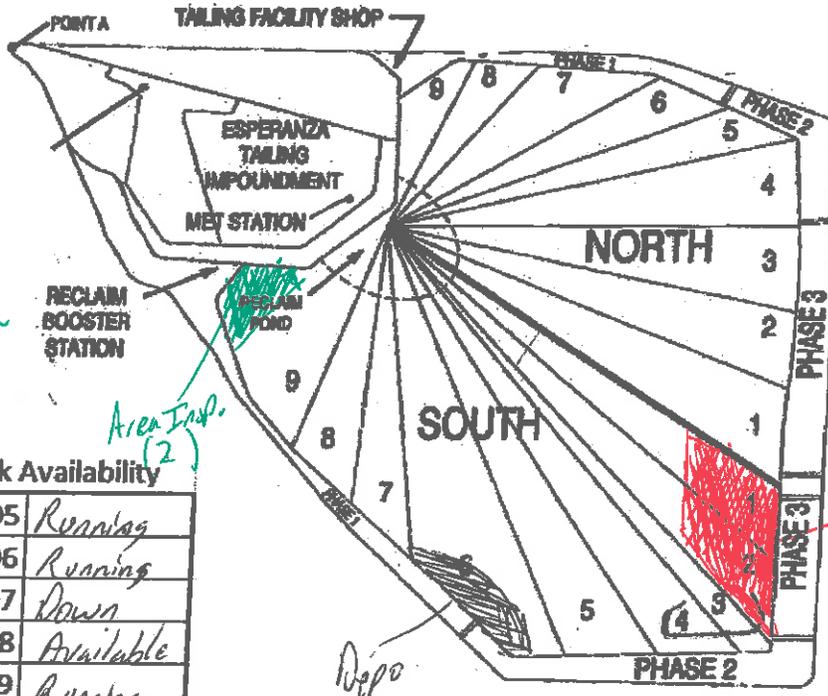
Tailings Impoundment Surface Inspection

Date: 10/26/18
 Time: 11:00
 Conditions: Calm
 Dam Inspected: W Phase(s) 1
 Inspected By: F. Rivera

* Area Wet. Still muddy from Rain.

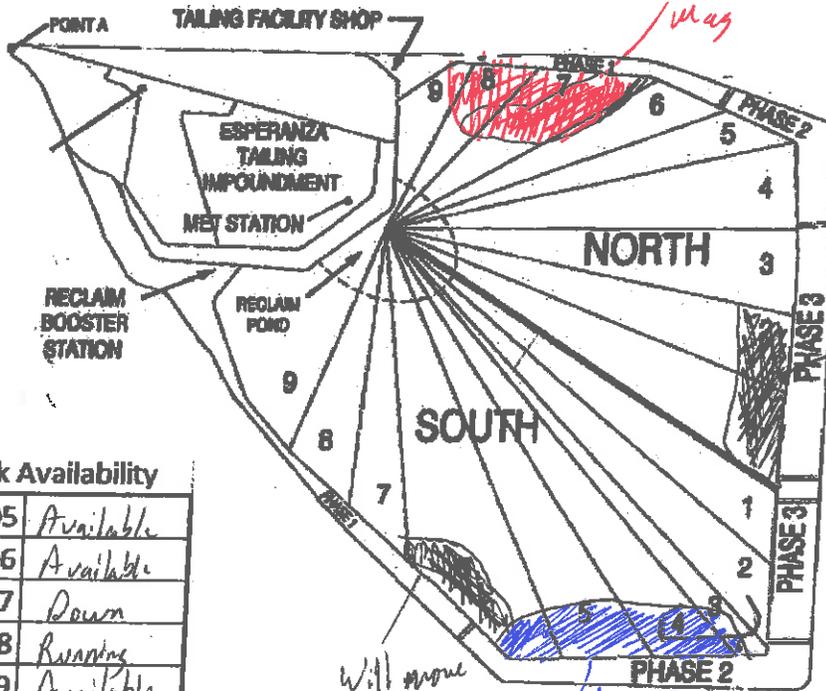
Tailings Impoundment Surface Inspection

Date: 10/25/18
 Time: 9:30
 Conditions: Calm
 Dam Inspected: 5 Phase(s) 2
 Inspected By: F. Pucaro

Depo shut down @ 2:00 am due to Pump issues

70105	Available
70106	Available
70107	Down
70108	Running
70109	Available

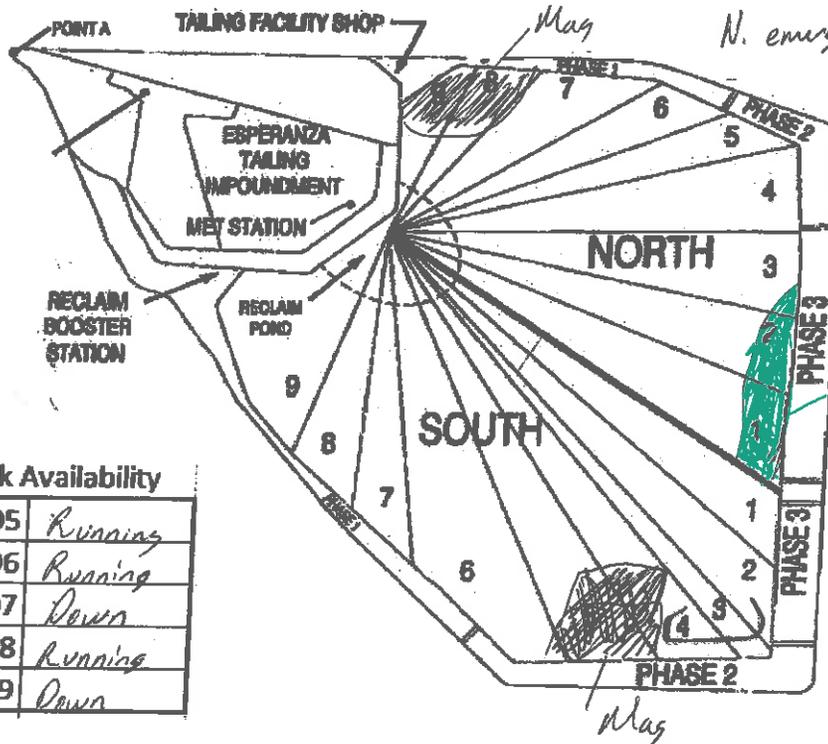
Tailings Impoundment Surface Inspection

Date: 10/24/18
 Time: 17:00
 Conditions: Calm
 Dam Inspected: All Phase(s) All
 Inspected By: F. DiVito

N. emergency running

Most Recent Depo
 * Pump station down due to pump issues.
 Airboats running for maintenance on barges

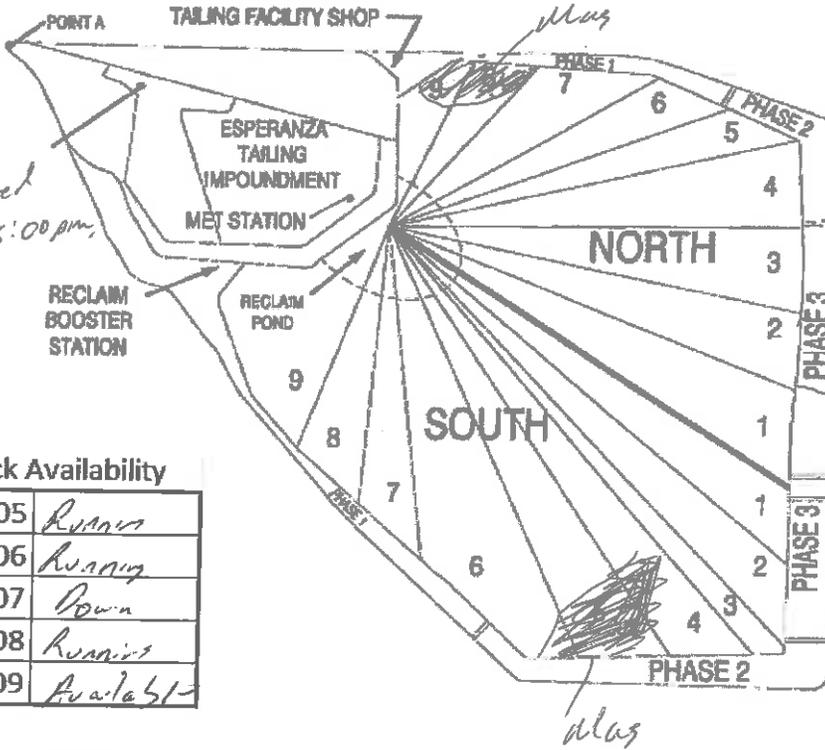
Tailings Impoundment Surface Inspection

Date: 10/23/18
 Time: 1:00
 Conditions: Rainy
 Dam Inspected: Phase(s)
 Inspected By: F. Durazo

** Rain started around 11:00. Rained and sprinkled until 6:00 pm, 1" total*

Depo down due to feed issues + power issues

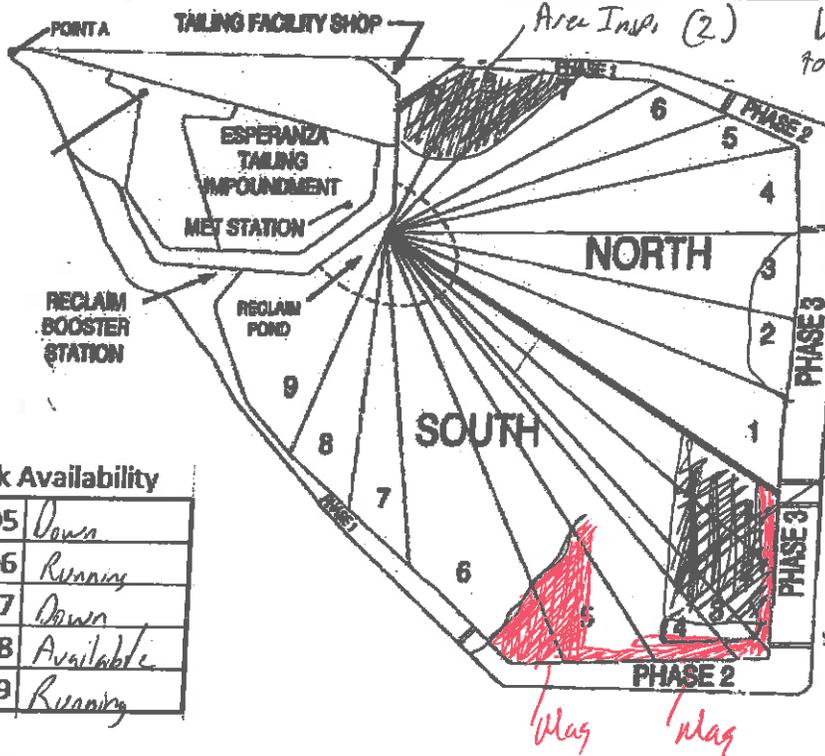
Tailings Impoundment Surface Inspection

Date: 10/22/18
 Time: 8:00 / 2:47
 Conditions: _____
 Dam Inspected: N/S Phase(s) 1/2
 Inspected By: R. Duran

Walked first thing
to wet for all-track.

Depo down since
10/21 @ 2:00 am due to
hole in Mine/Power issues.

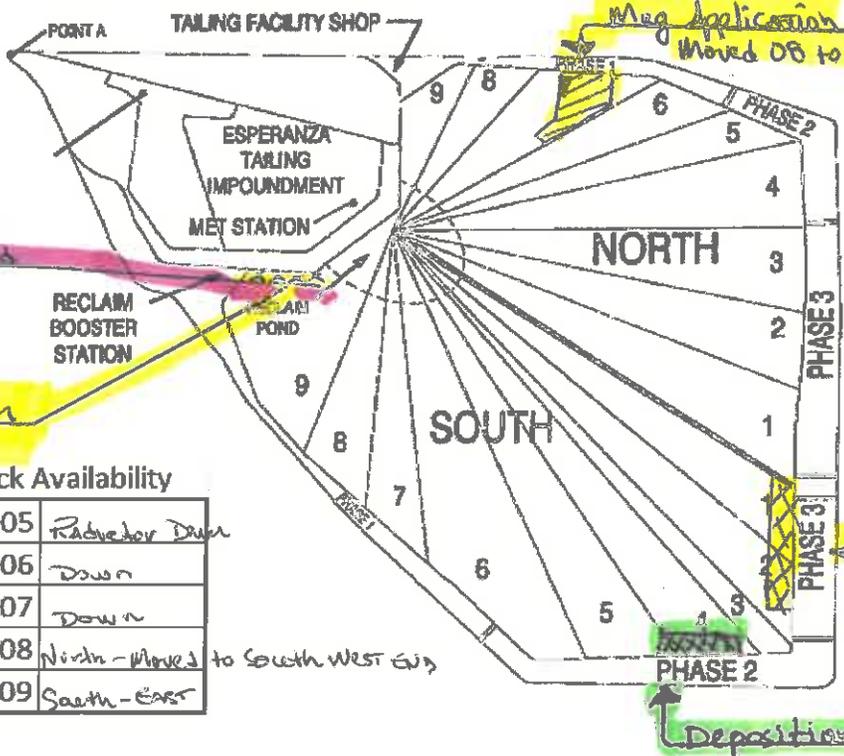
Tailings Impoundment Surface Inspection

Date: 11-2-2018
 Time: 7:30am
 Conditions: Clear / CALM
 Dam Inspected: South Phase(s) 1
 Inspected By: Jesus Hernandez

70105	Radvector Dam
70106	Down
70107	Down
70108	North - Moved to South West side
70109	South - East

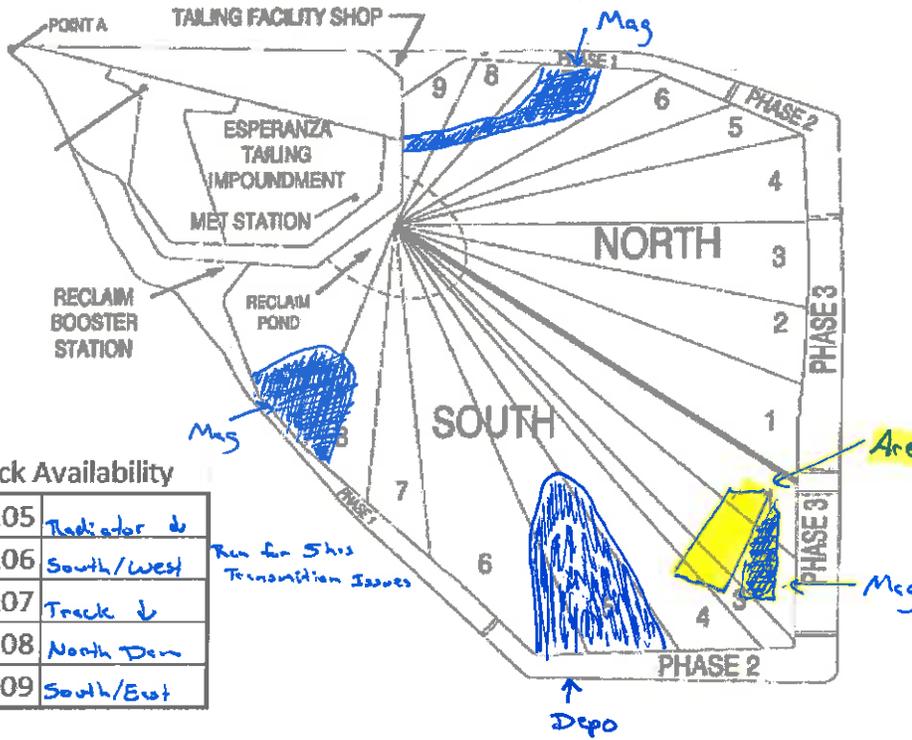
Tailings Impoundment Surface Inspection

Date: 11-1-18
 Time: 13100
 Conditions: Sunny / calm
 Dam Inspected: South Phase(s) 3
 Inspected By: Dereck Berry

70105	Radiator ↓
70106	South/West
70107	Track ↓
70108	North Dem
70109	South/East

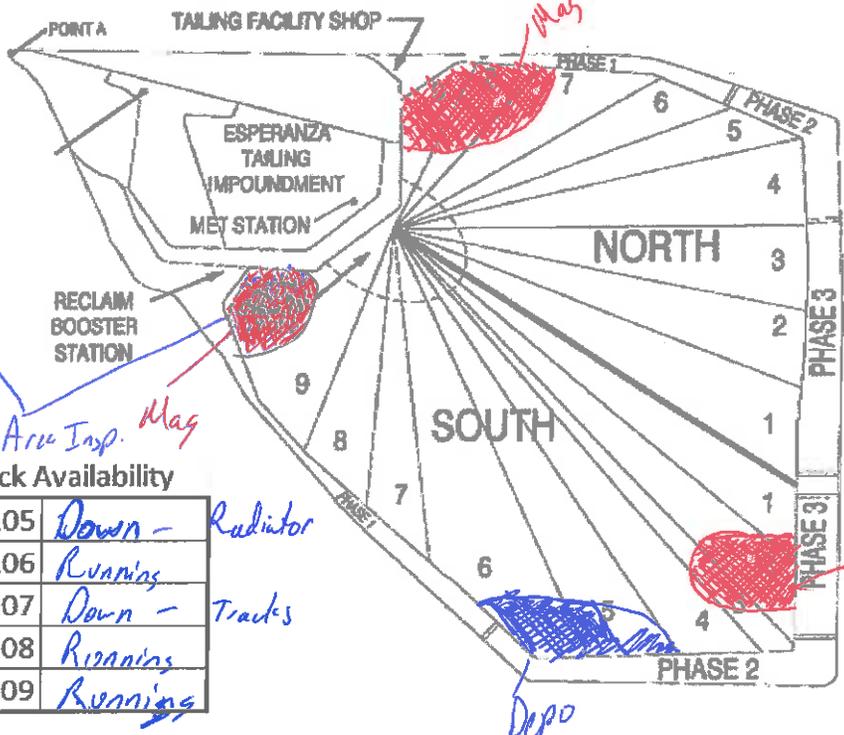
Tailings Impoundment Surface Inspection

Date: 10/31/18
 Time: 12:00
 Conditions: Breezy
 Dam Inspected: 5 Phase(s) 1
 Inspected By: F. Durazo

70105	Down - Radiator
70106	Running
70107	Down - Tracks
70108	Running
70109	Running

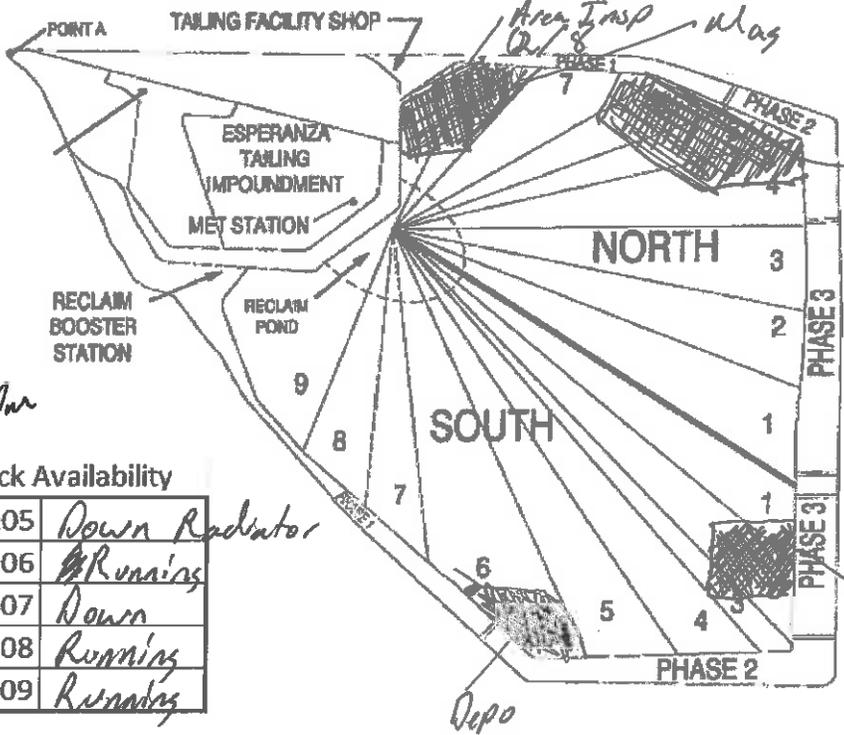
Tailings Impoundment Surface Inspection

Date: 10/30/18
 Time: 7:30
 Conditions: Breezy
 Dam Inspected: Phase(s) 1
 Inspected By: F. Durazo / C. Larren

Area Insp. @ 12:00
 (2/34)
 Area that has soft spots for All-tracks from starting depo here on 10/11.
 Wind 24 / Gusts @ 36

Ran for 2 hrs in Am Radiator Leak

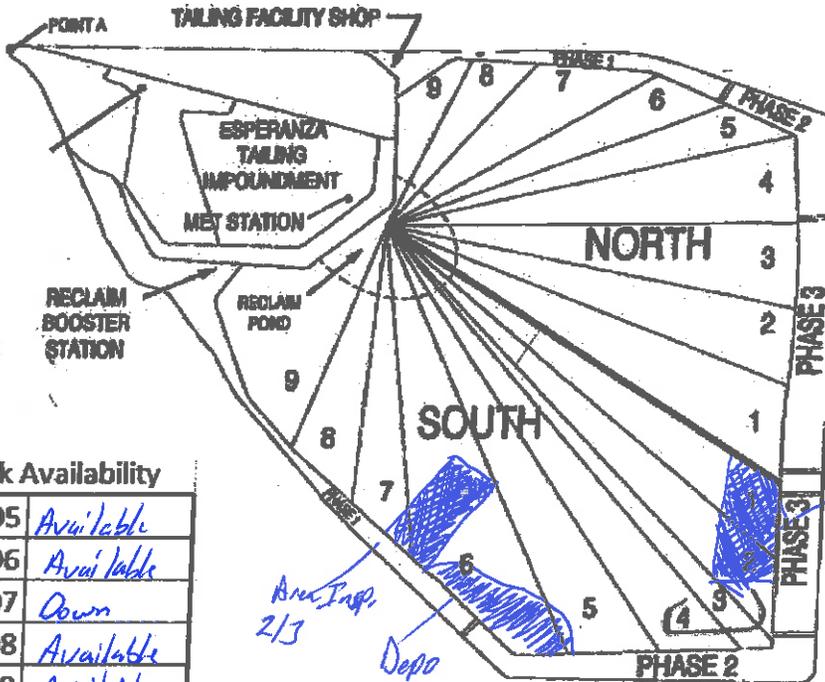
Tailings Impoundment Surface Inspection

Date: 10/29/18
 Time: 10:00 am
 Conditions: Breezy
 Dam Inspected: S Phase(s) 1/3
 Inspected By: F. Durazo

70105	Available
70106	Available
70107	Down
70108	Available
70109	Available

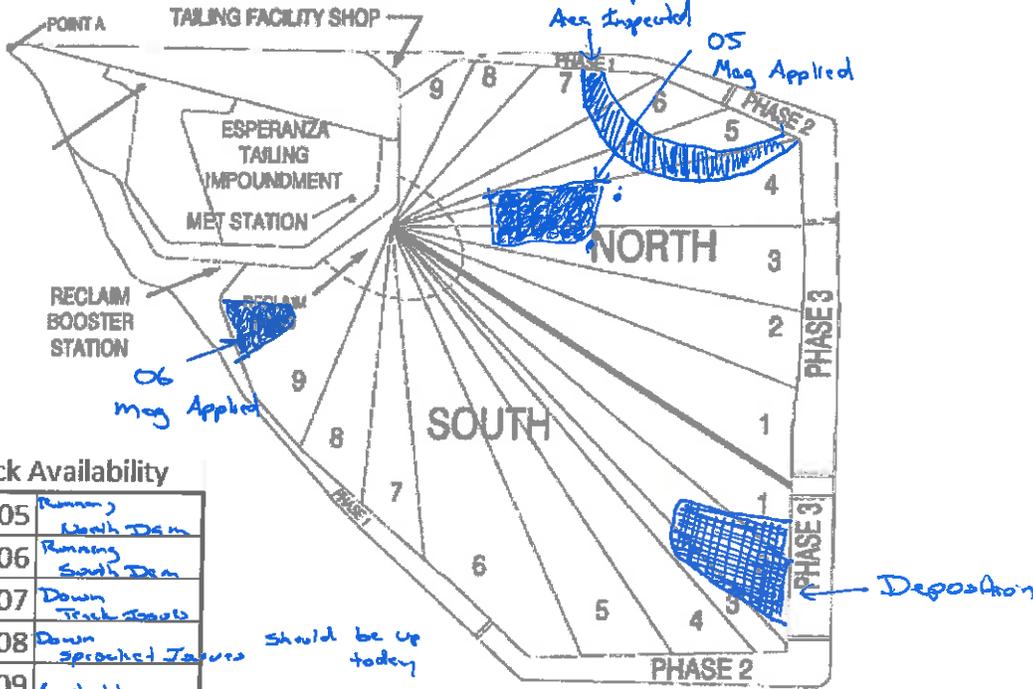
Tailings Impoundment Surface Inspection

Date: 11-8-18
 Time: 16:00
 Conditions: Slightly Breezy
 Dam Inspected: North Phase(s) 1+2
 Inspected By: Desek Besny

70105	Running North Dam
70106	Running South Dam
70107	Down Track Scale
70108	Down Sprinkler Towers
70109	Available

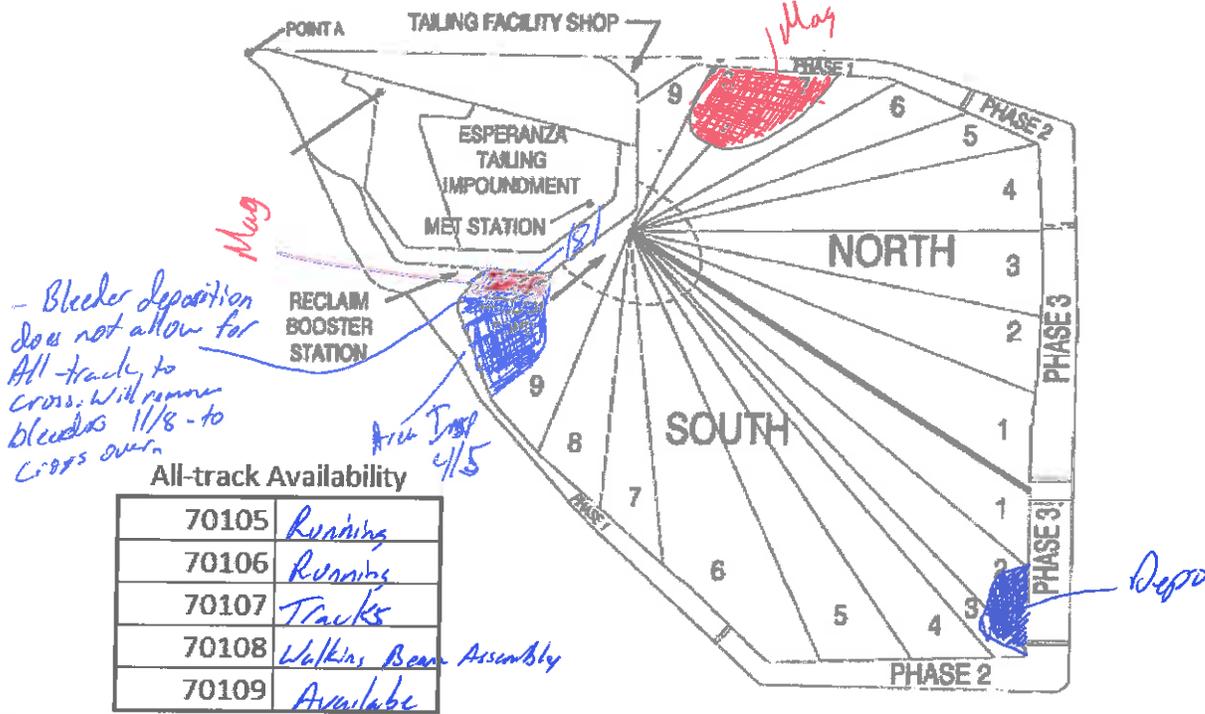
Tailings Impoundment Surface Inspection

Date: 11/7/18
 Time: 1:30
 Conditions: Breezy/Windy
 Dam Inspected: S Phase(s) 1
 Inspected By: F. Puroad

70105	Running
70106	Running
70107	Tracks
70108	Walkins Beam Assembly
70109	Available

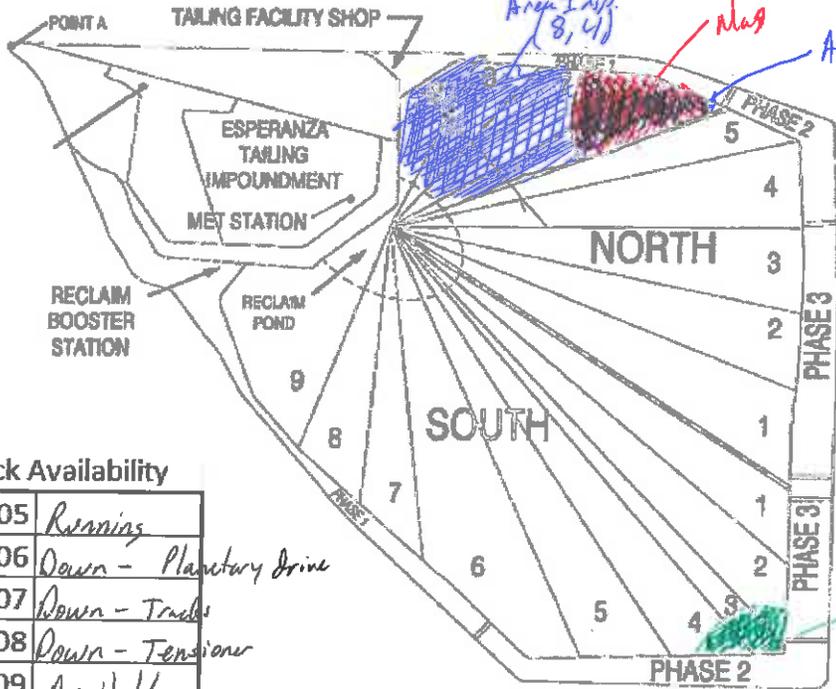
Tailings Impoundment Surface Inspection

Date: 11/6/18
 Time: 12:30
 Conditions: Windy
 Dam Inspected: N Phase(s) 1
 Inspected By: F. Alvarez

70105	<u>Running</u>
70106	<u>Down - Planetary Drive</u>
70107	<u>Down - Trucks</u>
70108	<u>Down - Tensioner</u>
70109	<u>Available</u>

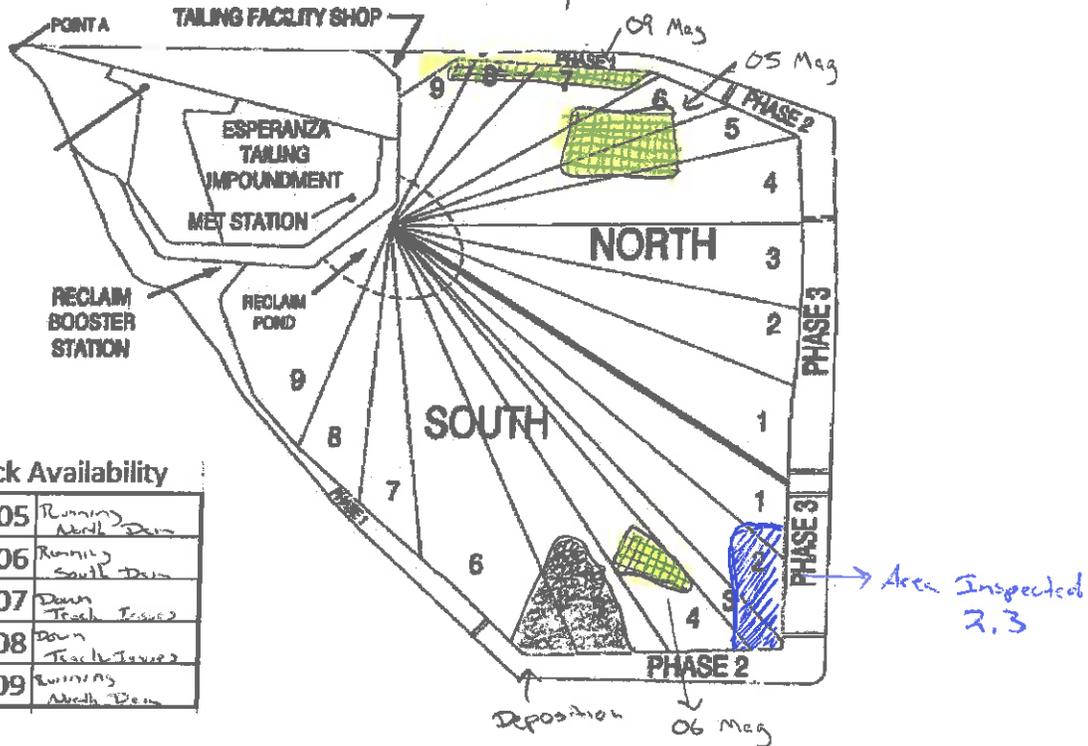
Tailings Impoundment Surface Inspection

Date: 11-16-18
 Time: 8:30 am
 Conditions: Calm
 Dam Inspected: South Phase(s) 2/3
 Inspected By: Derek Brown

70105	Running North Dam
70106	Running South Dam
70107	Down Track Issues
70108	Down Track Issues
70109	Running North Dam

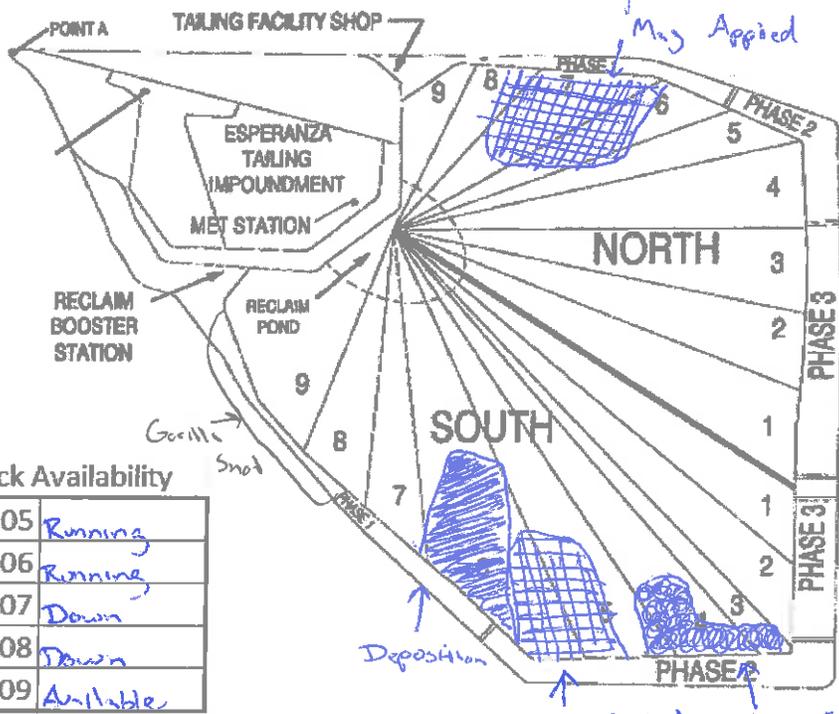
Tailings Impoundment Surface Inspection

Date: 11-15-18
 Time: 1100
 Conditions: Calm
 Dam Inspected: S/E Phase(s) 2
 Inspected By: Derek Brown

70105	Running
70106	Running
70107	Down
70108	Down
70109	Available

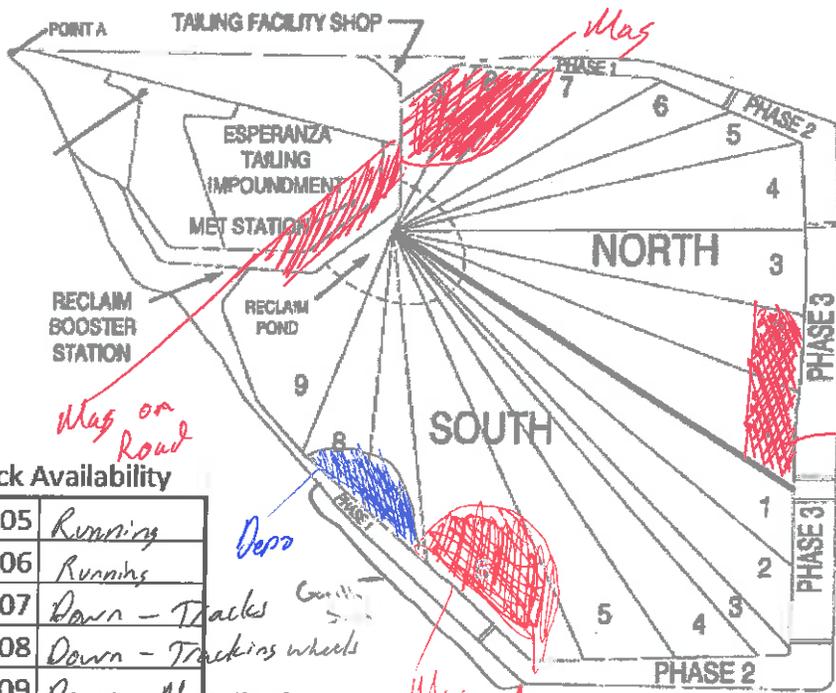
Tailings Impoundment Surface Inspection

Date: 11/14/18
 Time: 3:00
 Conditions: Calm
 Dam Inspected: S/W Phase(s) 1/3
 Inspected By: F. Durazo

70105	Running
70106	Running
70107	Down - Tracks
70108	Down - Tracking wheels
70109	Down - Mag pump

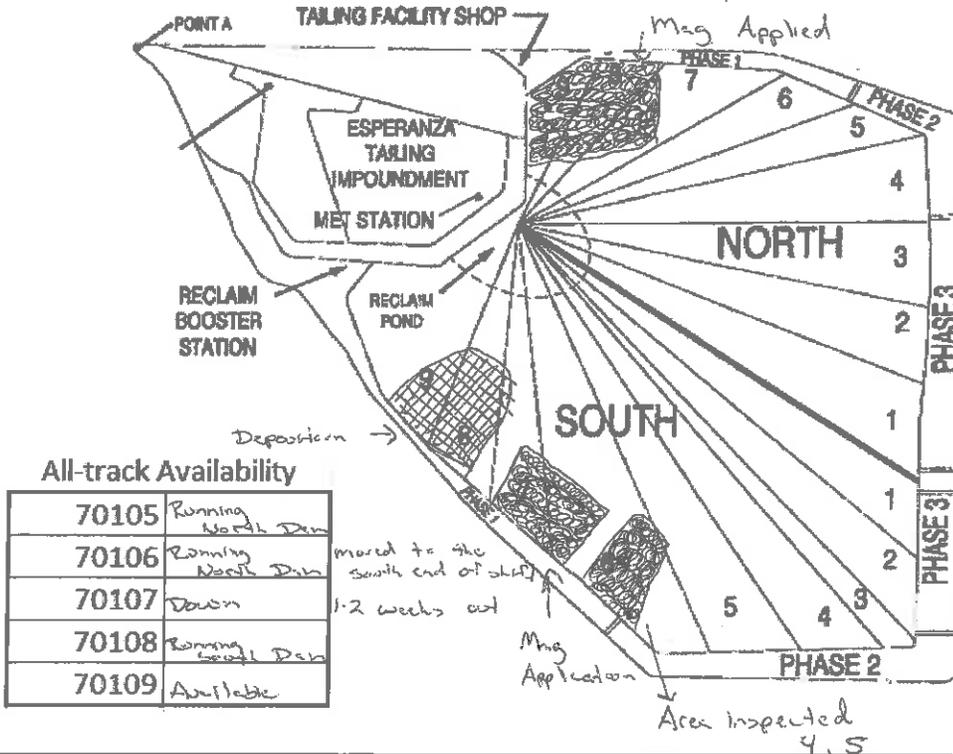
Tailings Impoundment Surface Inspection

Date: 11-13-18
 Time: 15:30
 Conditions: Windy
 Dam Inspected: South Phase(s) 1/2
 Inspected By: Derek Berry / Joe Granillo

Action Plan: Move spread once surface is wet to water 3 All-Trucks, 5 Water Trucks

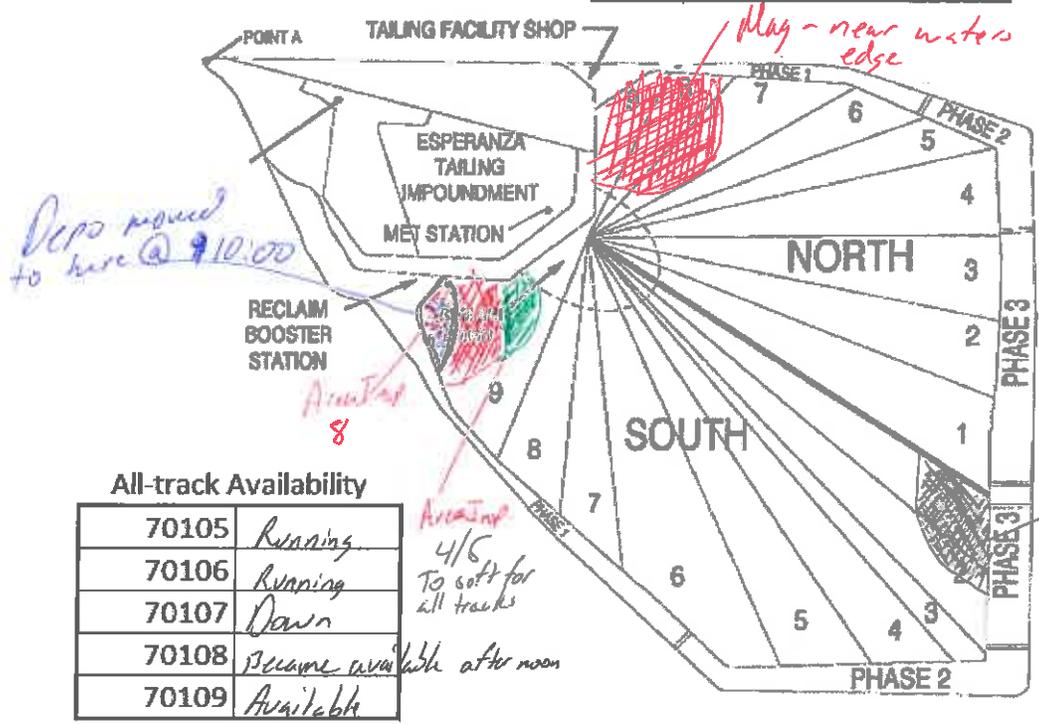
Tailings Impoundment Surface Inspection

Date: 11/12/19
 Time: 8:00
 Conditions: Breezy
 Dam Inspected: W Phase(s) 1
 Inspected By: Flvarez

70105	Running
70106	Running
70107	Down
70108	Became available after noon
70109	Available

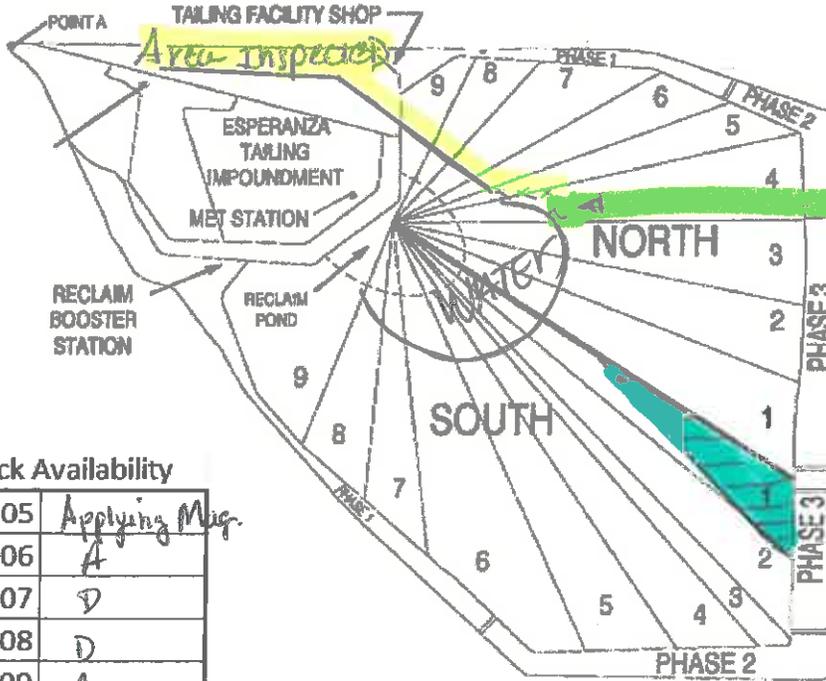
Tailings Impoundment Surface Inspection

Date: 11-10-2018
 Time: 2:30 AM
 Conditions: Clear
 Dam Inspected: North Phase(s) 7-6
 Inspected By: Jesus Hernandez

70105	Applying Mag.
70106	A
70107	D
70108	D
70109	A
