NOTICE OF VIOLATION # PC1811-151

The Pima County Department of Environmental Quality (PDEQ) has reason to believe Freeport-McMoRan Sierrita Inc. (FMSI) has violated requirements of PDEQ Air Quality Operating Permit #6067 and the Pima County Code (PCC). PDEQ discovered the violations alleged below during a surveillance inspection of the Sierrita Tailings Impoundment in Green Valley, Arizona, conducted on November 29, 2018, and upon review of reports submitted by FMSI dated November 19, 2018, and December 4, 2018.

Freeport-McMoRan Sierrita, Inc. allowed visible fugitive dust emissions generated from the Sierrita Tailings Impoundment to cross northward across Duval Mine Road on November 29, 2018.

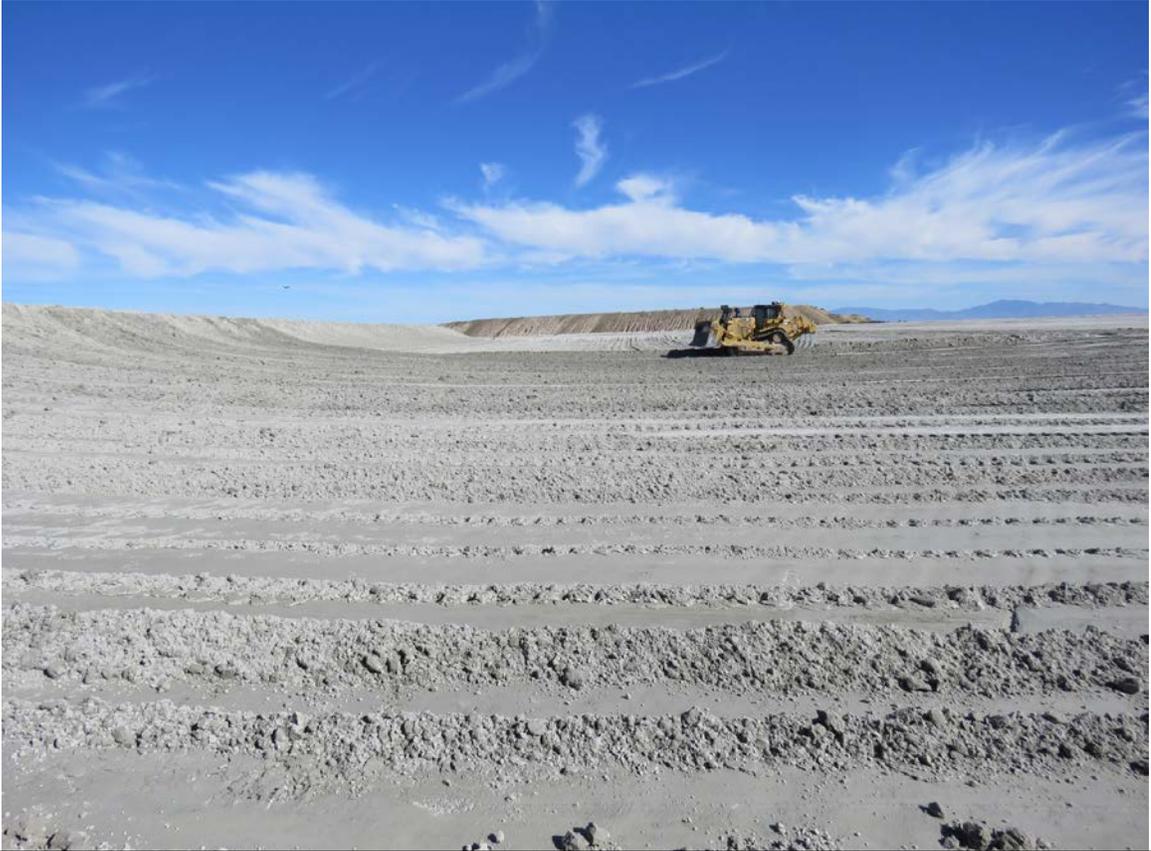
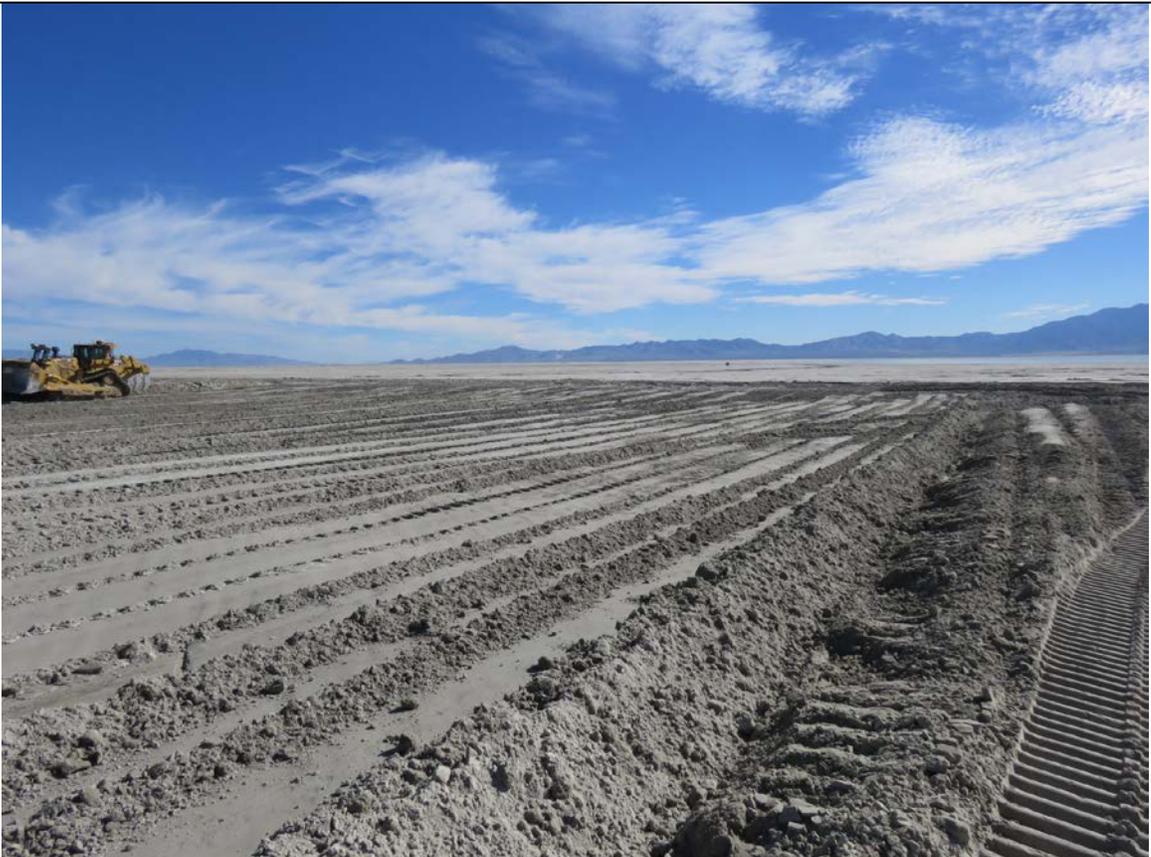
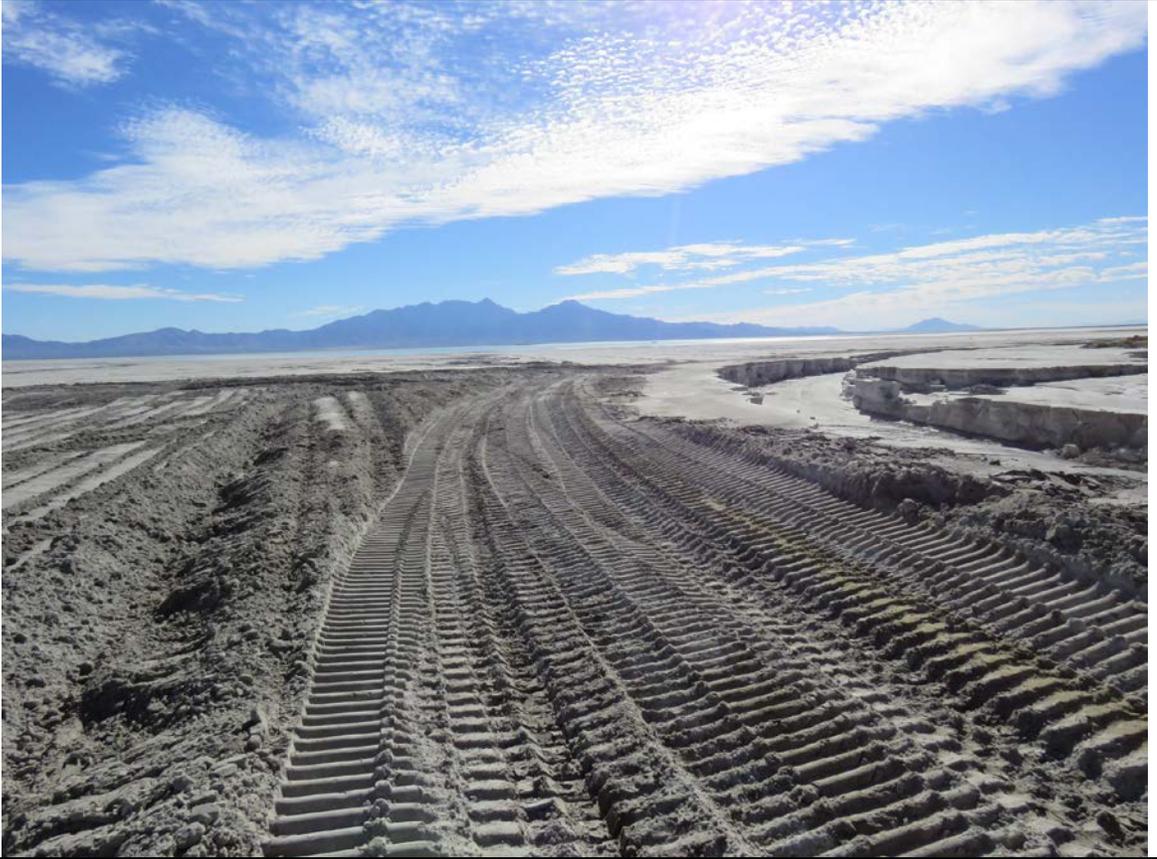
Bulldozers were ripping the surface of the North Dam, Phase 1, Section 9, for berm construction, which had started the week prior. (Attachment 2, Photos 1-3). The ripped material appeared dark and moist. Just south of the ripped area was the north emergency fill area where a large pit was present beneath the fill pipe and a wide canyon extended out toward the pond (Attachment 2, Photos 4-5). An all-track vehicle was applying magnesium chloride ($MgCl_2$) to the tailings surface in the North Dam, Phase 1, beyond the ripped area (Attachment 2, Photo 6). We proceeded to the North Dam, Phase 1, Section 6, and observed spigot lines where deposition left wide pooled depression areas in the vicinity of the pipes and canyons extending toward the pond (Attachment 2, Photos 7-10). The surfaces in the area appeared moist and stable. The remaining freeboard appeared minimal; approximately a foot or less. We went to the east side of the North Dam, around the transition from Phase 2 to Phase 3, and observed spigot line extensions in place (Attachment 2, Photos 11-14). There were pooled depressions near the pipes but minimal canyons extending toward the pond. The underlying material appeared moist but the surface showed evidence of drying to a lighter color. The remaining freeboard appeared minimal; approximately a foot. Walking farther south along the North Dam, Phase 3, Section 3, the pools below the spigot lines appeared moister from relatively more recent deposition (Attachment 2, Photos 15-16).
