**BEFORE THE CONTROL OFFICER OF THE
PIMA COUNTY AIR QUALITY DISTRICT**

**SETTLEMENT
AGREEMENT**

November 13, 2018 Notice of Violation

NOTICE OF VIOLATION # PC1810-033

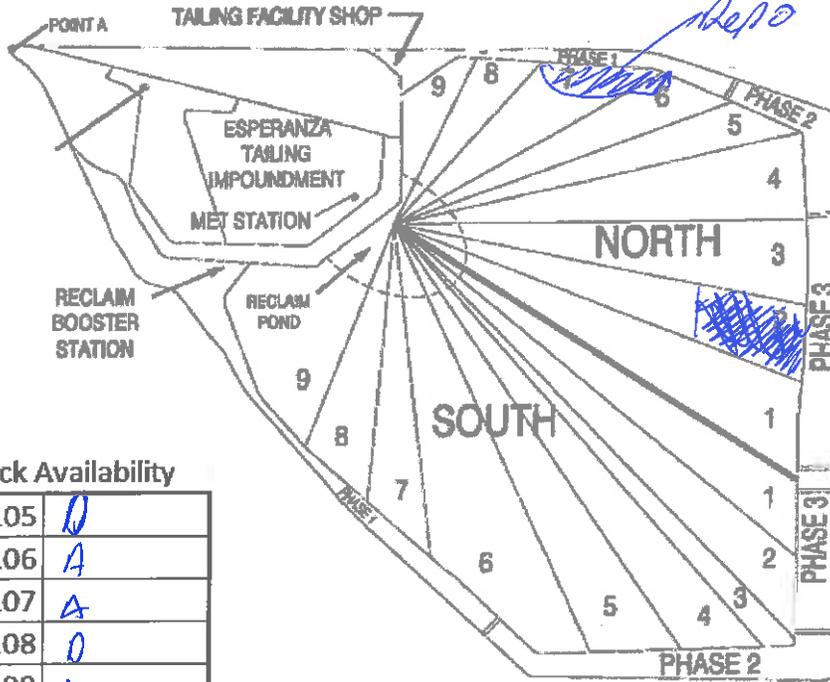
Date: 9/4/18
 Time: 8:00
 Conditions: Calm
 Dam Inspected: 311 Phase(s) 3
 Inspected By: F. Durazo

Area Insp.
 (2/3)
 Dam moist
 due to rain from
 weekend

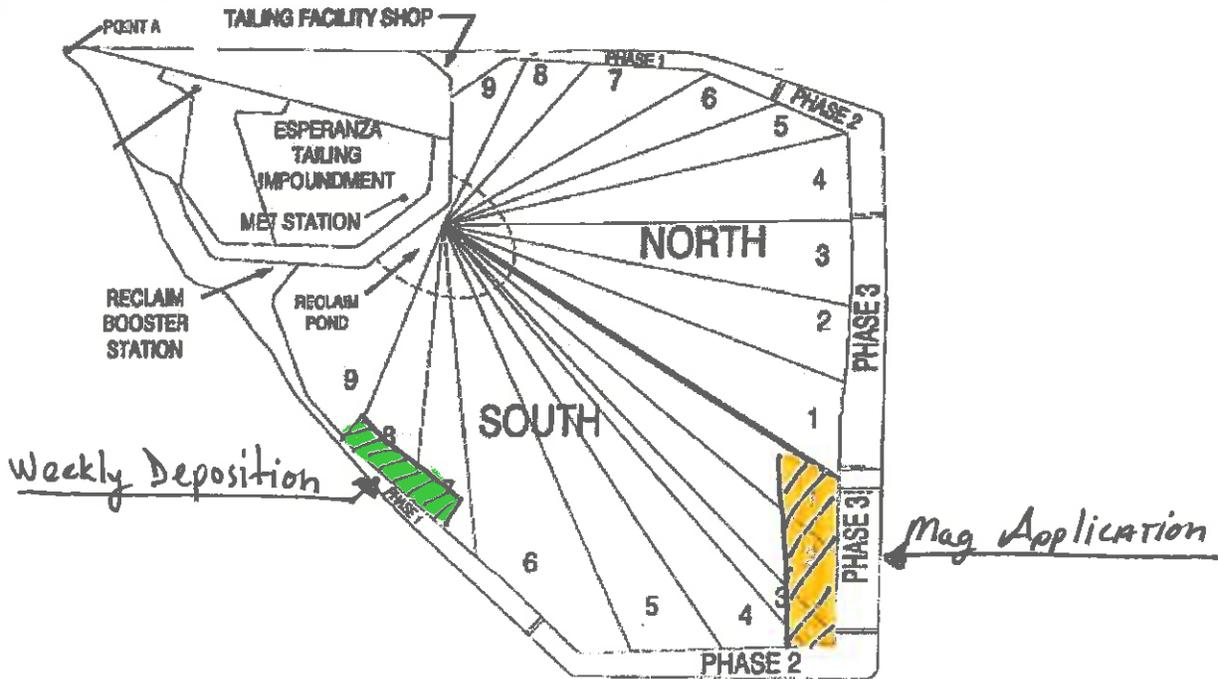
Comments: ETI/STI construction ongoing
Dust event on 9/12/2018 - contact was made to ELW
Deposition in South Emergency - 9.13-9.14

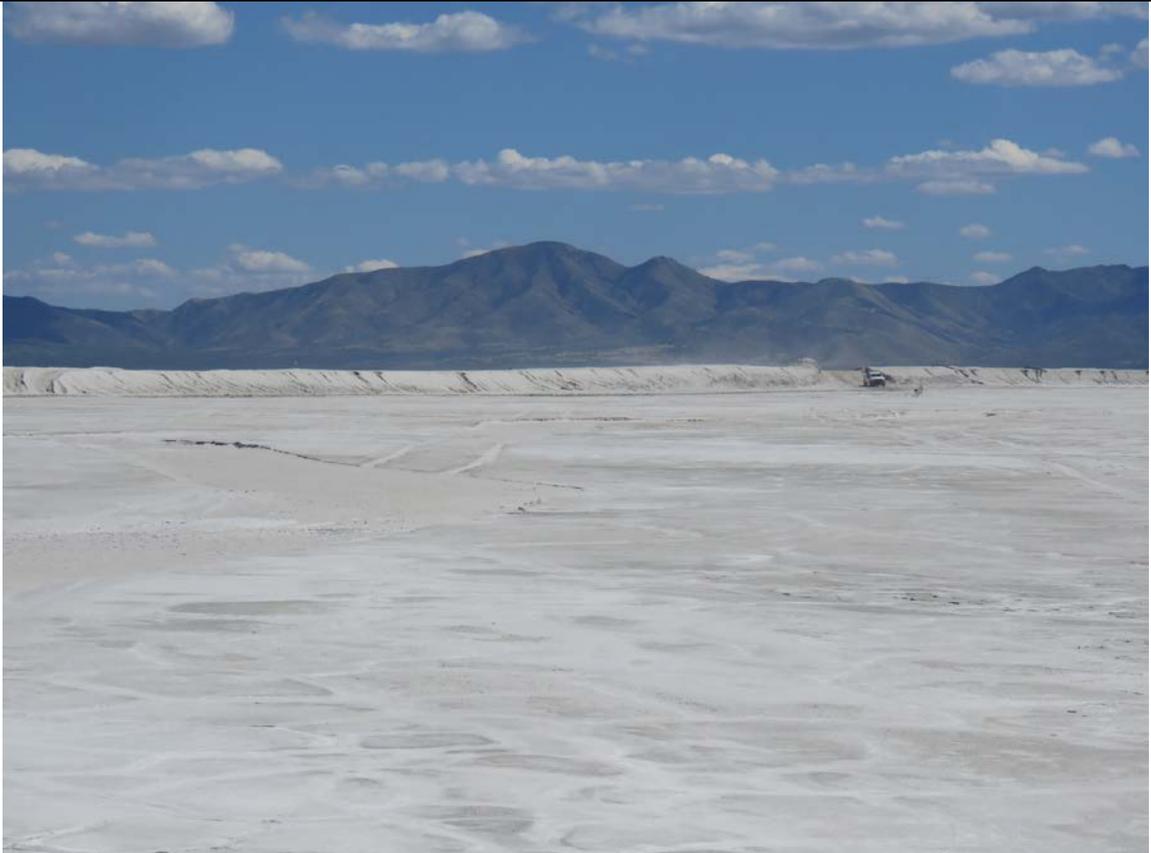
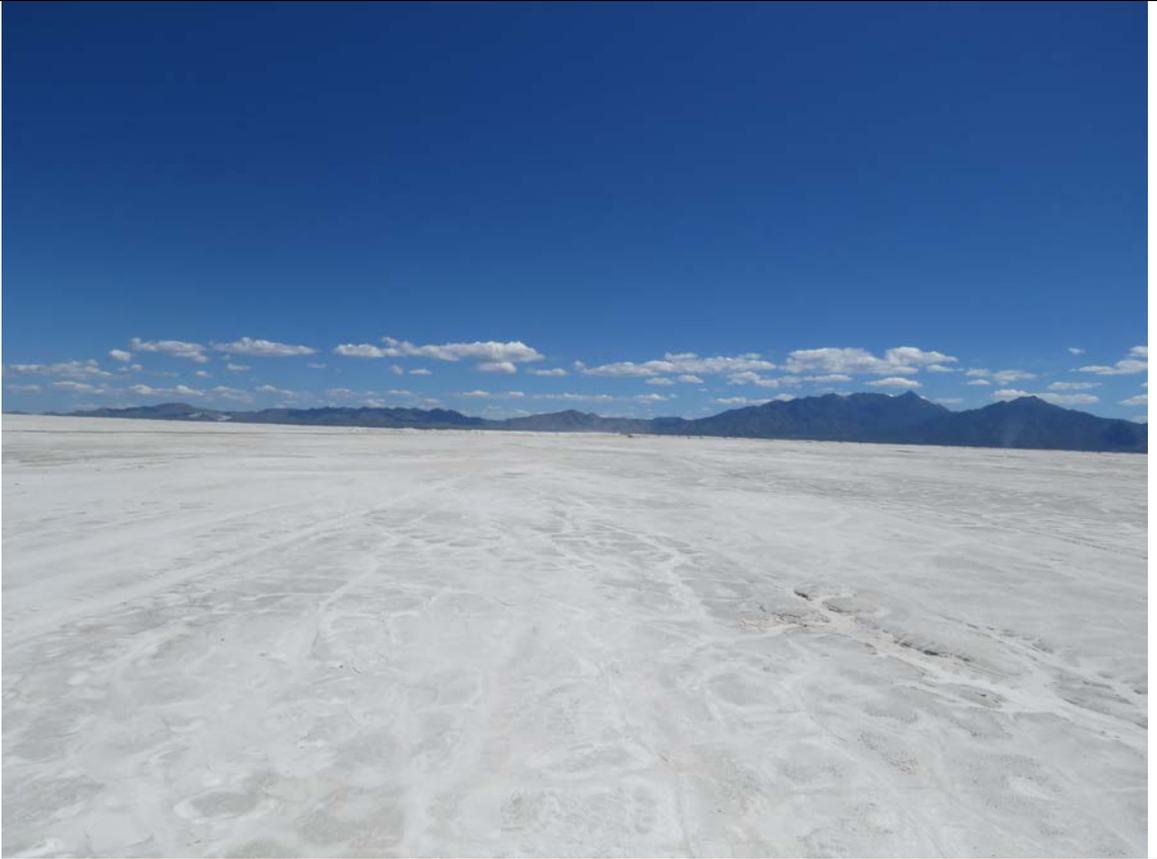
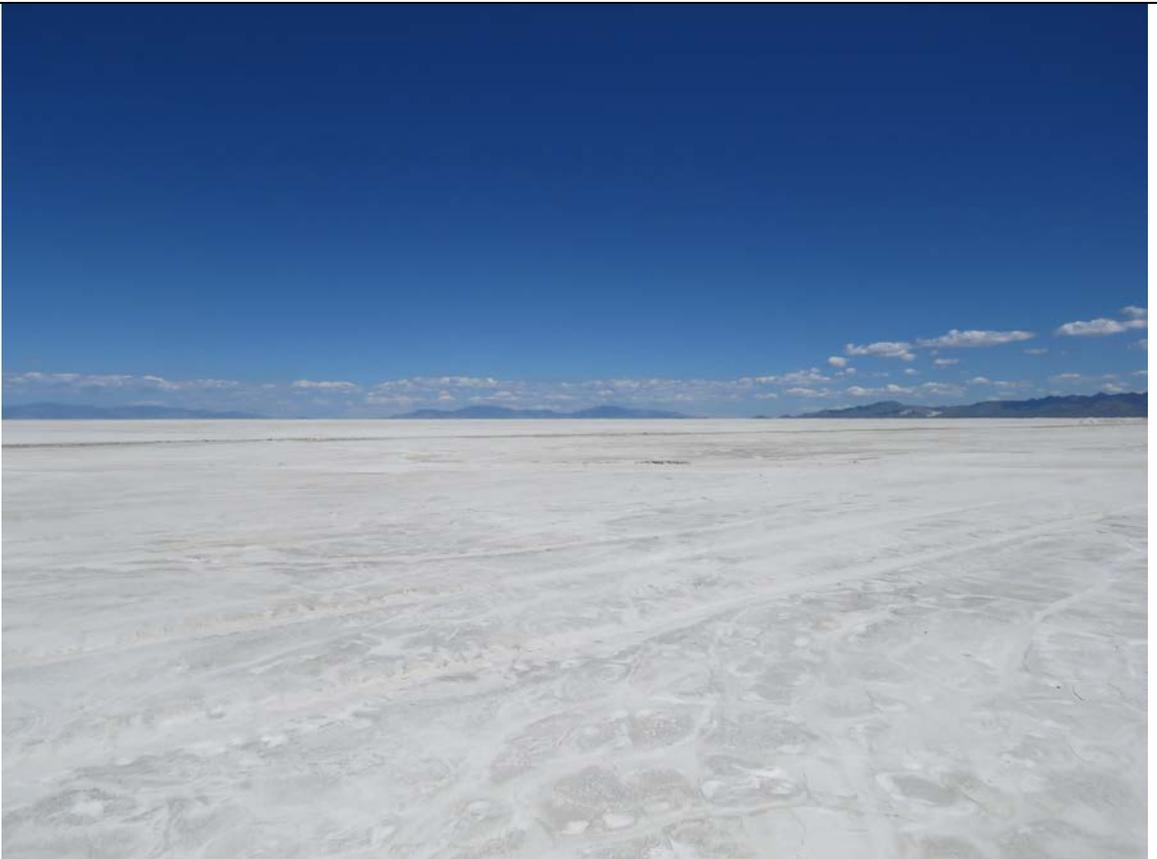
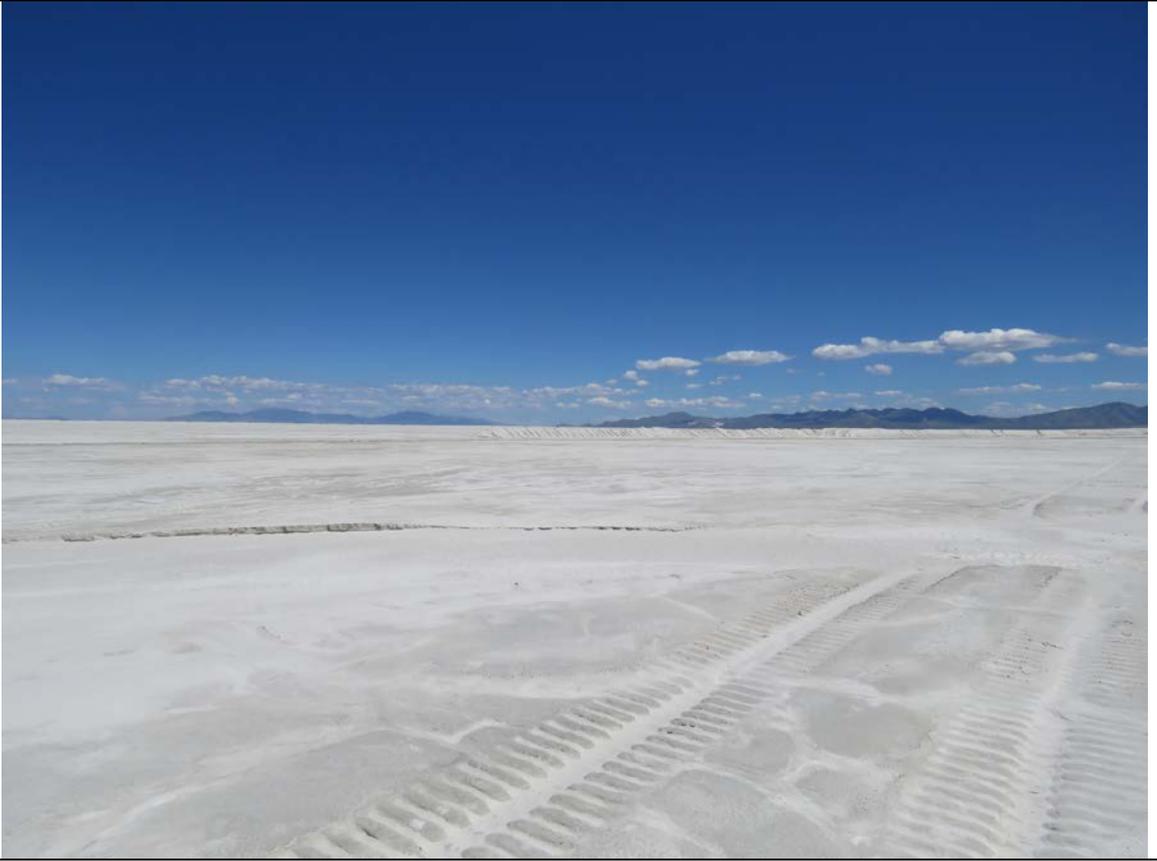
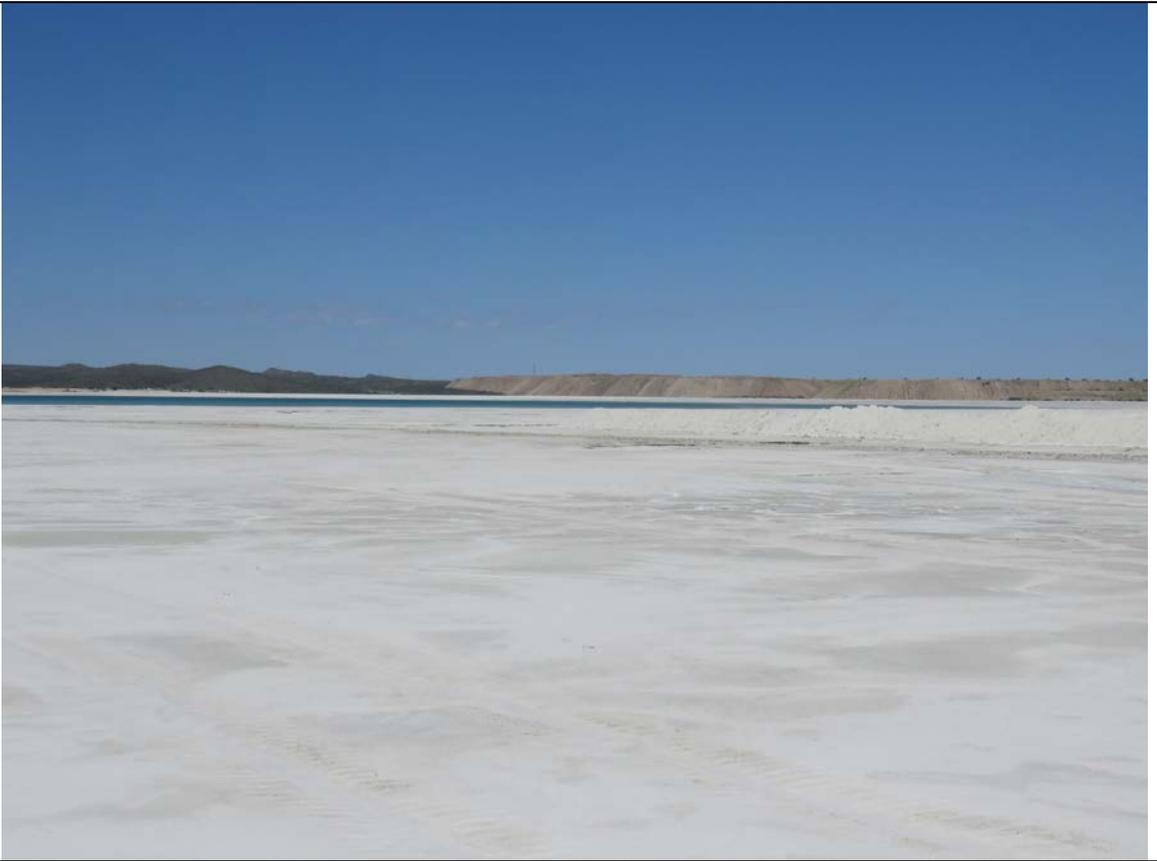
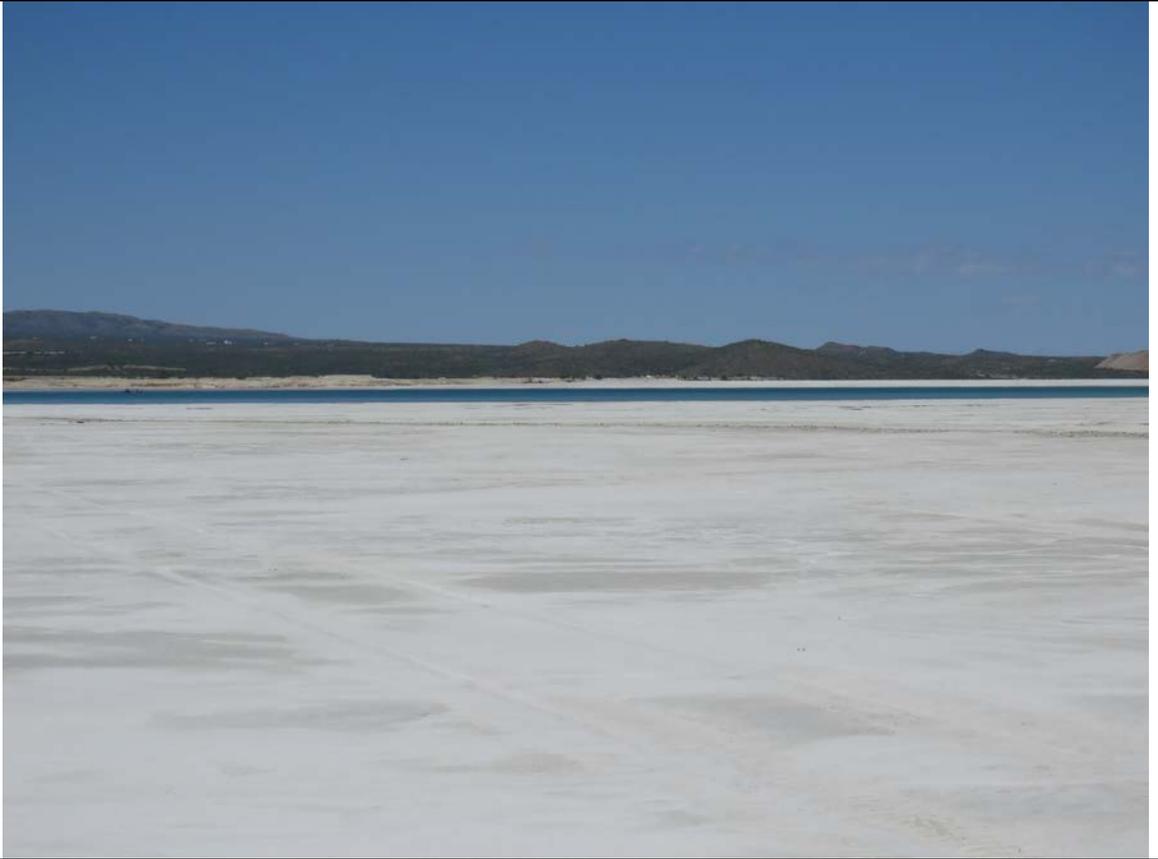
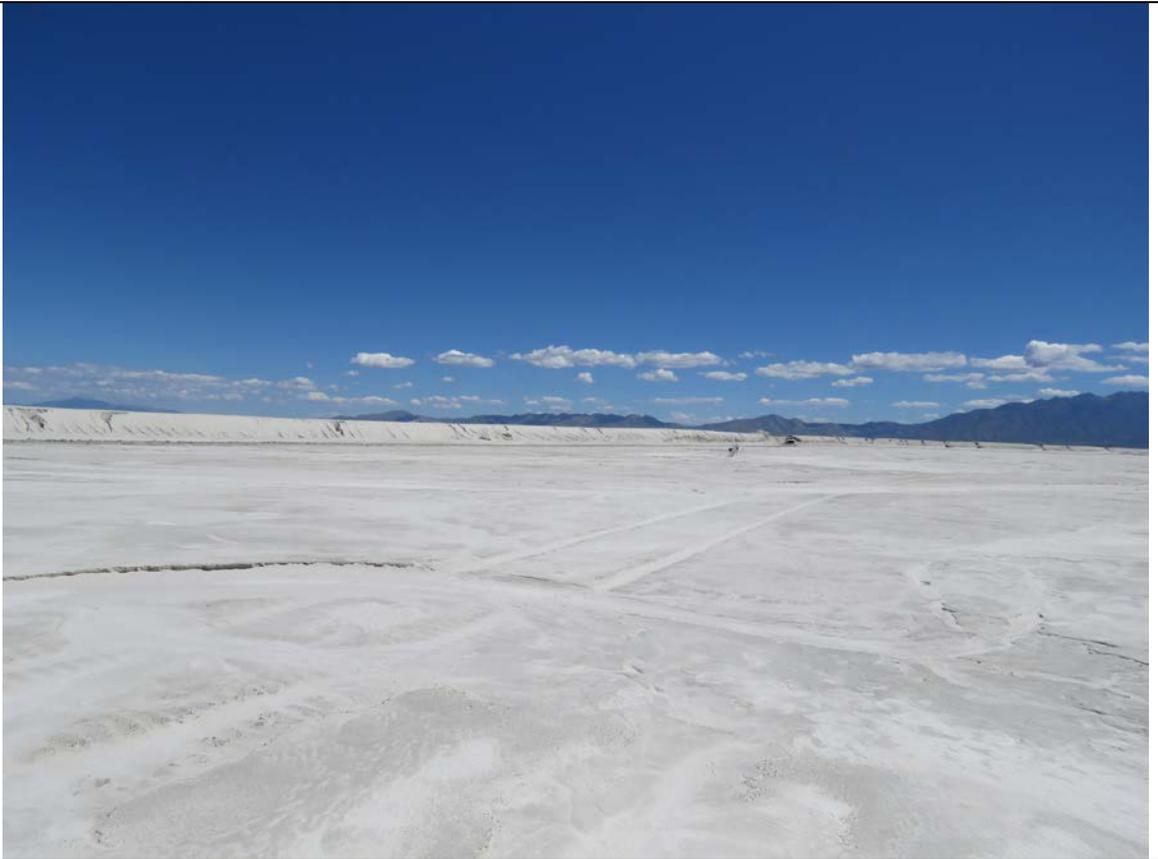
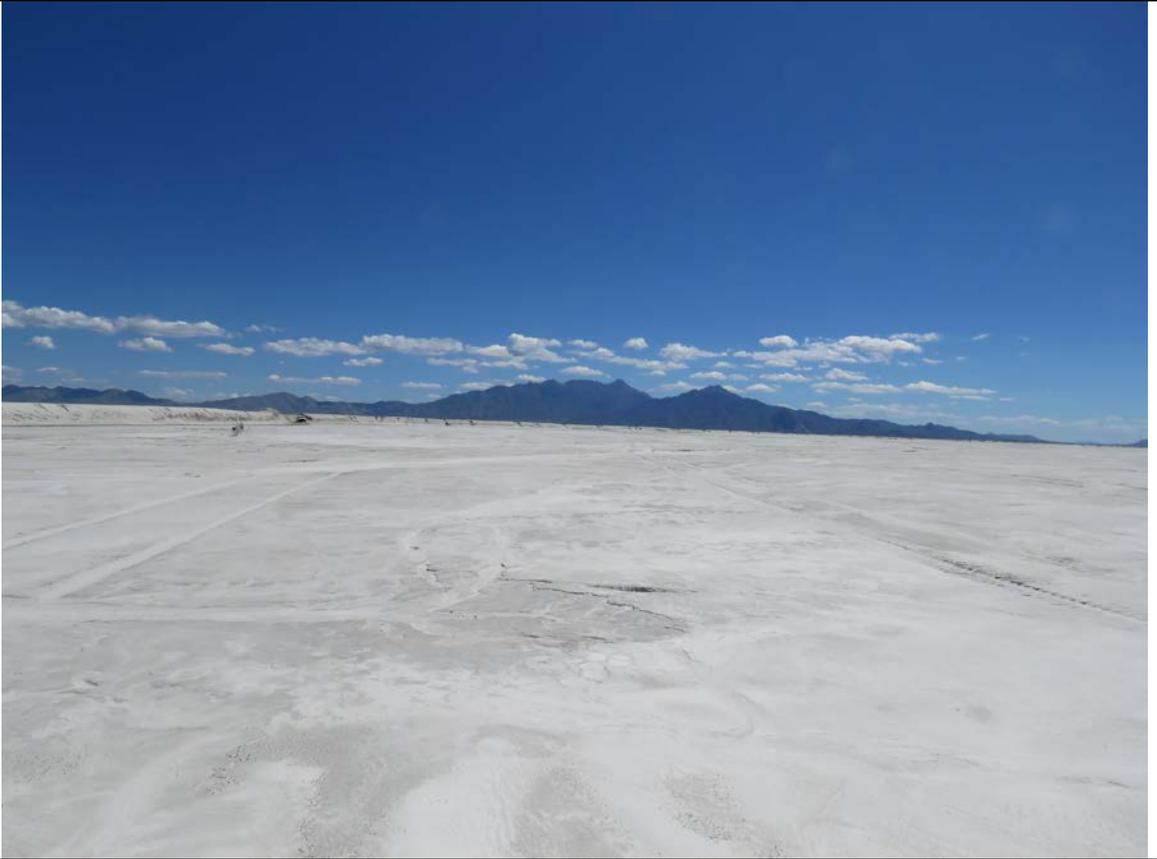
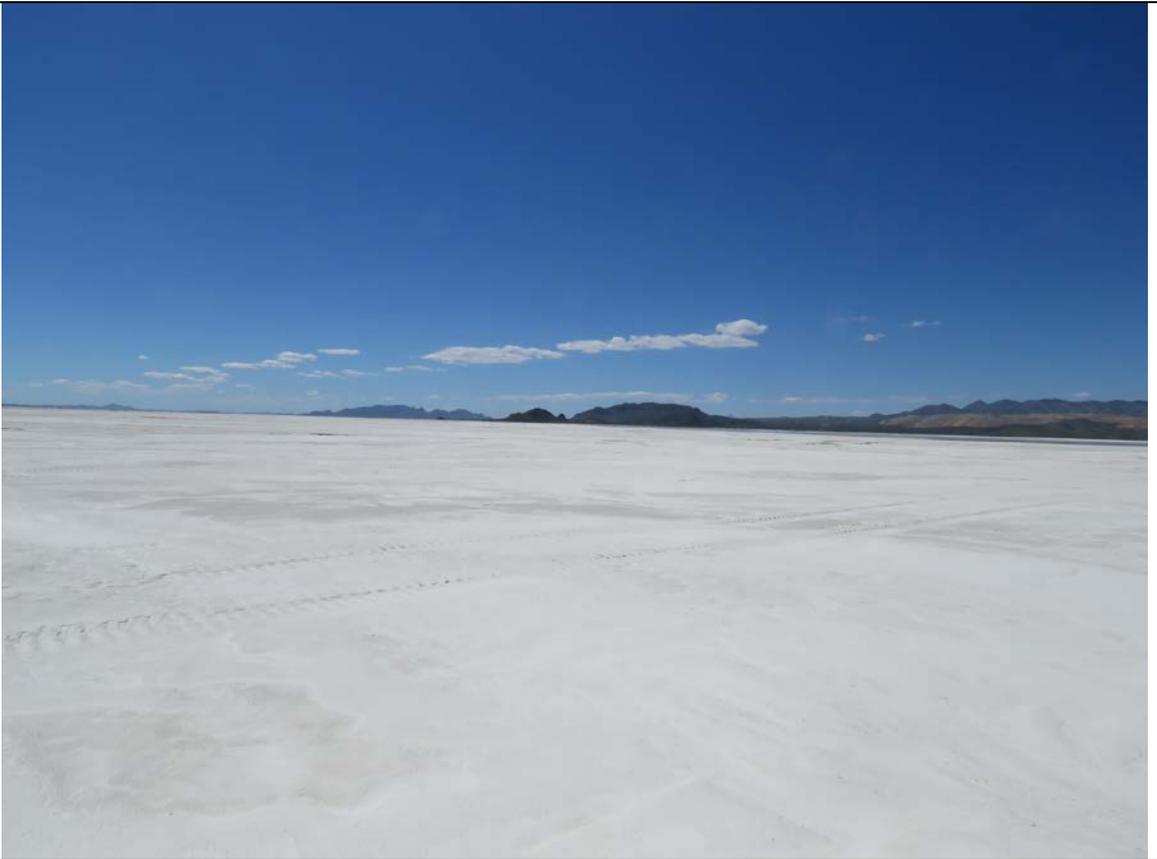
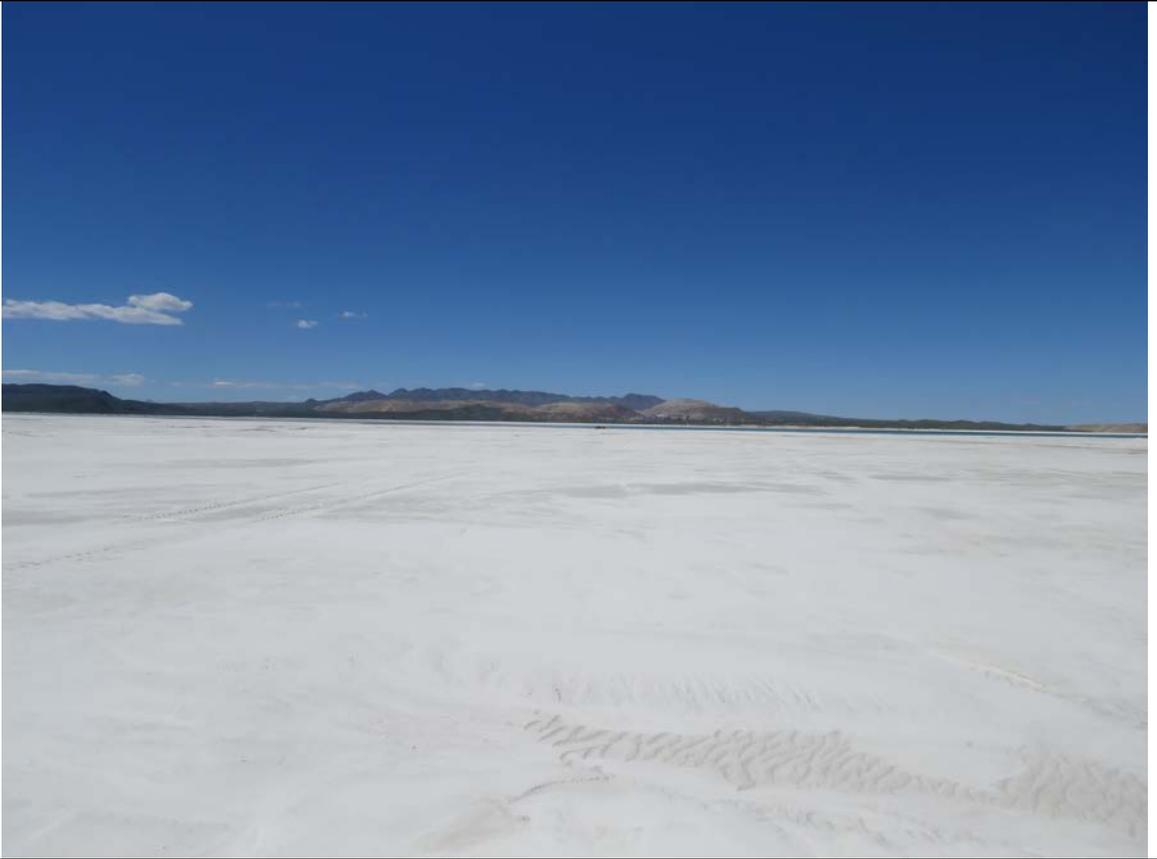
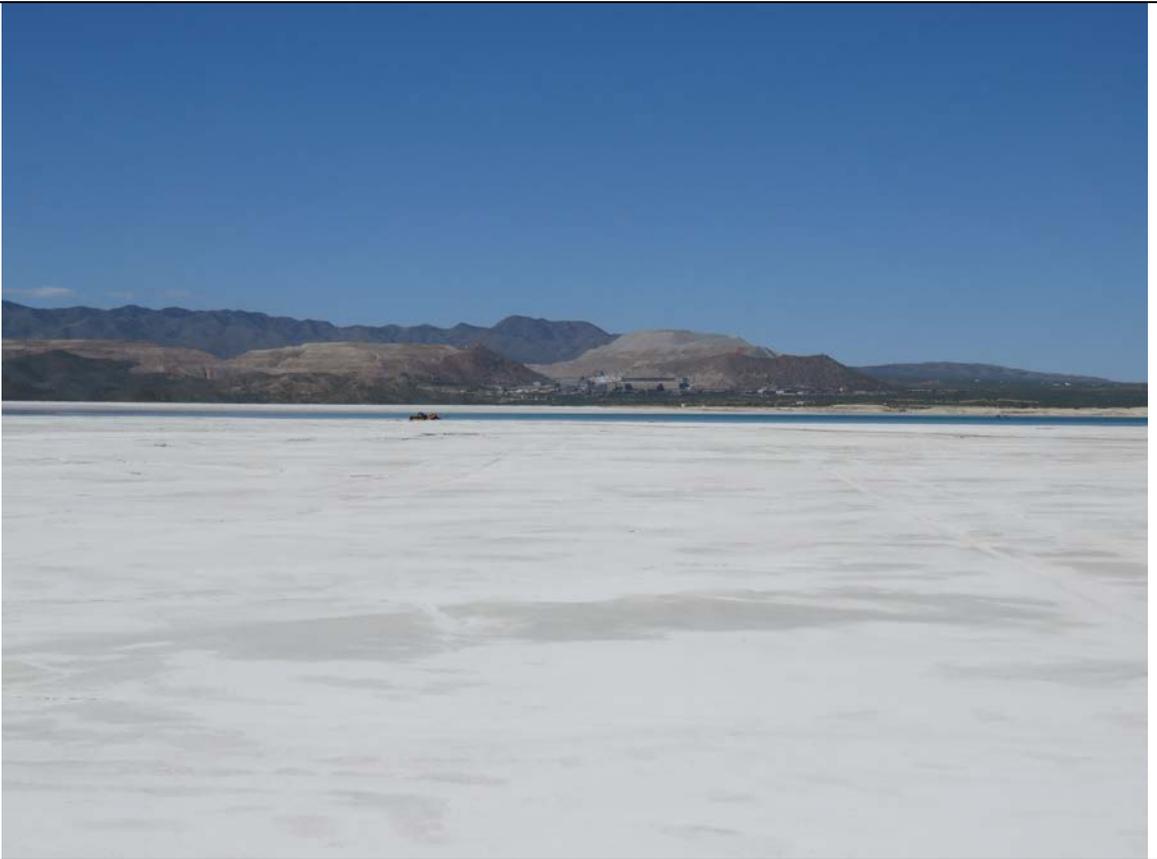
observed the surface, as well as viewed and photographed phases 2 and 3 of the South dam (Attachment 2, photos 2 - 12). The surface was able to support my weight without creating deep foot prints. Additionally the surface was moist, and did not yield any fine particles when touched. The crust of the surface surrounding the divider appeared worn and eroded, with areas of uncrusted tailings material in channels where water had previously flowed across the surface and in cracks between crusted plates. I observed that slurry deposition was occurring in sections of phases 1 and 2 of the South dam. The majority of the tailings impoundment surface in phases 2 and 3 of the South dam appeared light in color.

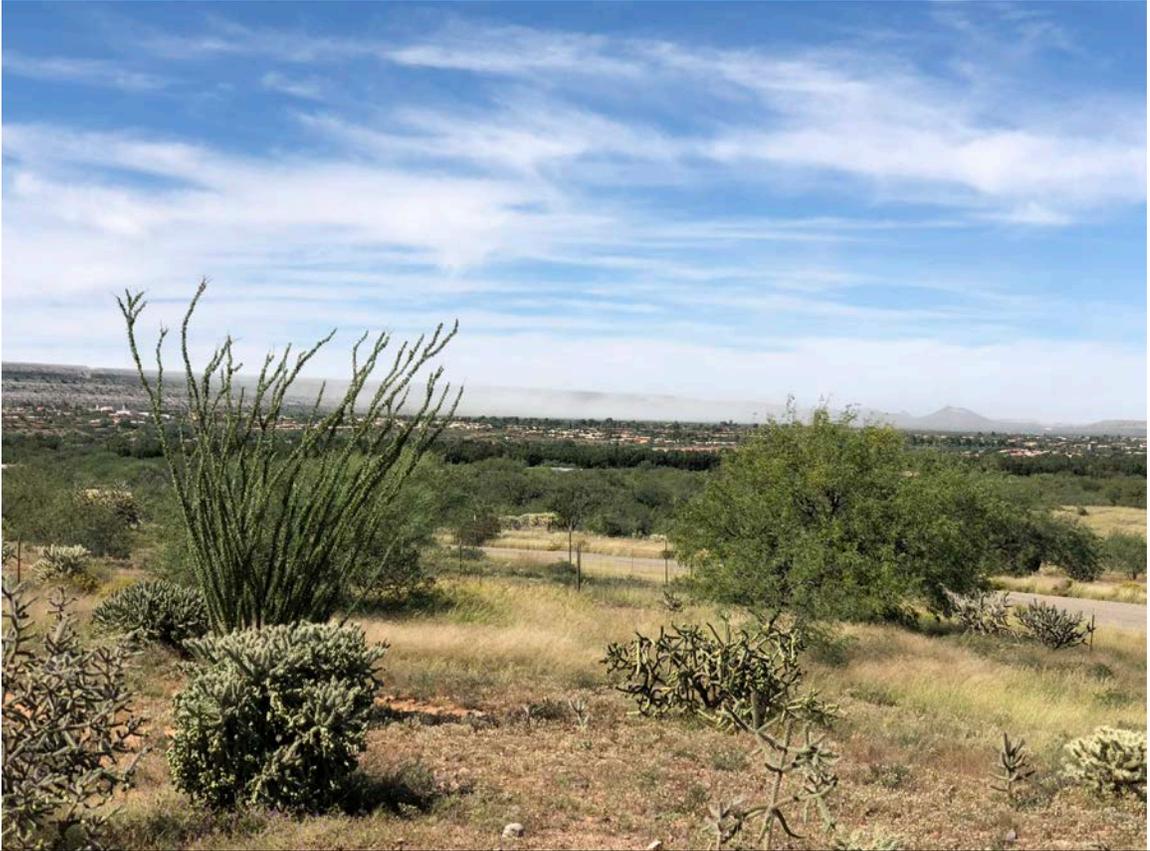
1.

On October 6, 2018, at approximately 1:45 pm, I observed dust emanating from the east side of the Freeport-McMoRan Sierrita Inc. (FMSI) Sierrita Tailings Impoundment (Attachment 2: Photo 1). In response to my observation I conducted offsite surveillance for a duration of approximately four hours. My surveillance consisted of observation points at multiple locations in Green Valley. Attachment 1 is a Google Earth map with pins marking the locations where I stopped and photographed the dust event. The following narrative will refer to these pinned locations. Attachment 2 consists of the photographs that were taken at the pinned locations.

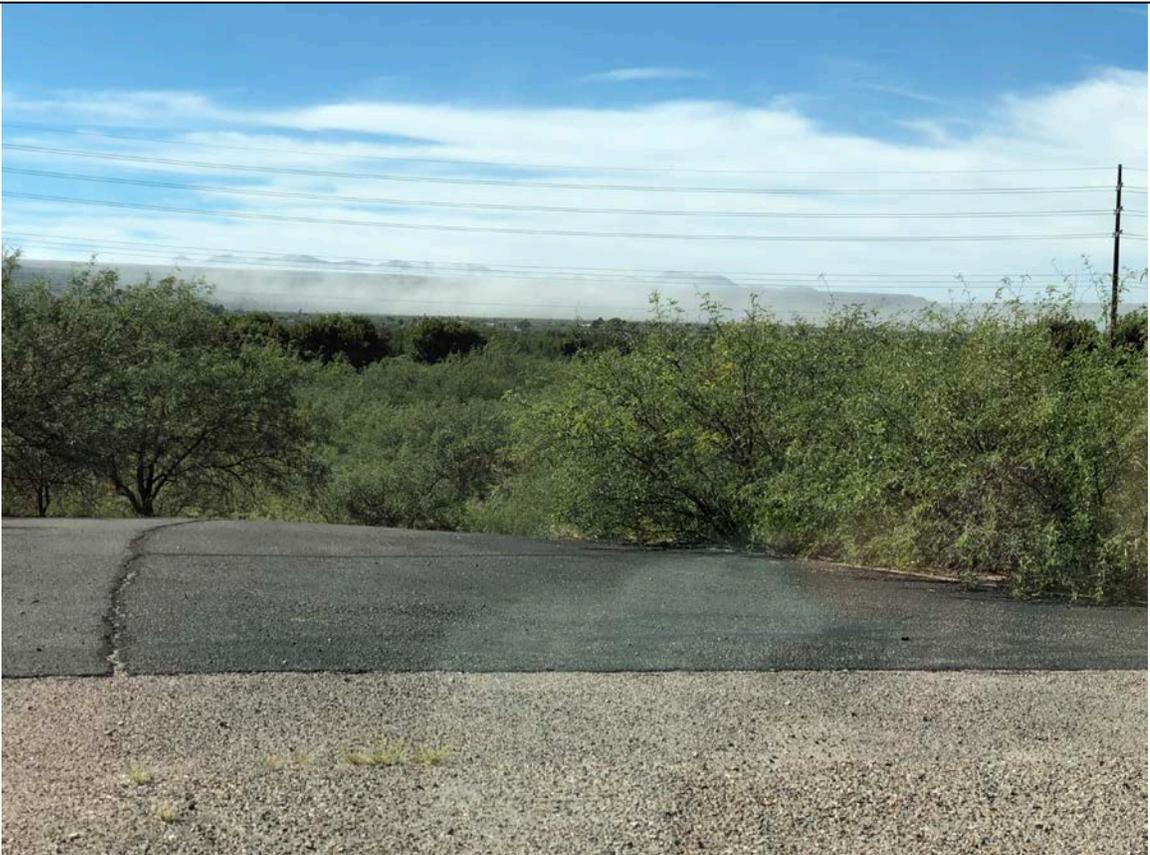
2.

I arrived at my second location on Camino de la Canoa at approximately 2:29 pm (Attachment 2: Photo 2). I observed dust emanating from the center of the east side of the tailings dam and moving in a northeasterly direction. I arrived at location 3 on Continental Road (Attachment 1) at approximately 2:39 pm. I observed dust plumes drifting off the tailings dam (Attachment 2: Photo 3). I continued northwest on Continental Road and arrived at Location 4 (Attachment 1) at approximately 2:40 pm. I observed dust plumes emanating from the tailings dam and moving in an easterly direction across Continental Road (Attachment 2: Photos 4, 5 & 6). The northeast corner of the tailings dam was obscured by the dust (Attachment 2: Photo 7). I did not observe any dust plumes, at the same location, looking southeast on Continental Road (Attachment 2: Photo 8). I arrived at location 5 on Continental Road at approximately 2:44 pm. I observed Continental Road was obscured by the dust moving across the road that was generated from the tailings dam and moving east northeast from the tailings dam (Attachment 2: Photos 9, 10 & 11). I arrived at location 6 on Continental Road at approximately 2:45 pm. I observed dust plumes emanating from the northeast corner of the tailings dam (Attachment 2: Photo 12). The plumes were rolling off the top of the tailings dam moving in an easterly direction. I observed the plumes rising at least 100 feet into the atmosphere (Attachment 2: Photo 13). The plumes were crossing Continental Road to the east and obscuring the utility poles on both sides of Continental Road (Attachment 2: Photos 13 & 14). At the intersection of Continental Road and Duval Mine Road I headed west. I stopped at location 7 at approximately 2:48 pm. I observed mostly clear skies and unobscured views of the mountains looking west on Duval Mine Road (Attachment 2: Photo 15). Looking east on Duval Mine Road I observed dust plumes emanating from the tailings dam and crossing Duval Mine Road; obscuring the view of the Santa Rita Mountains in the background

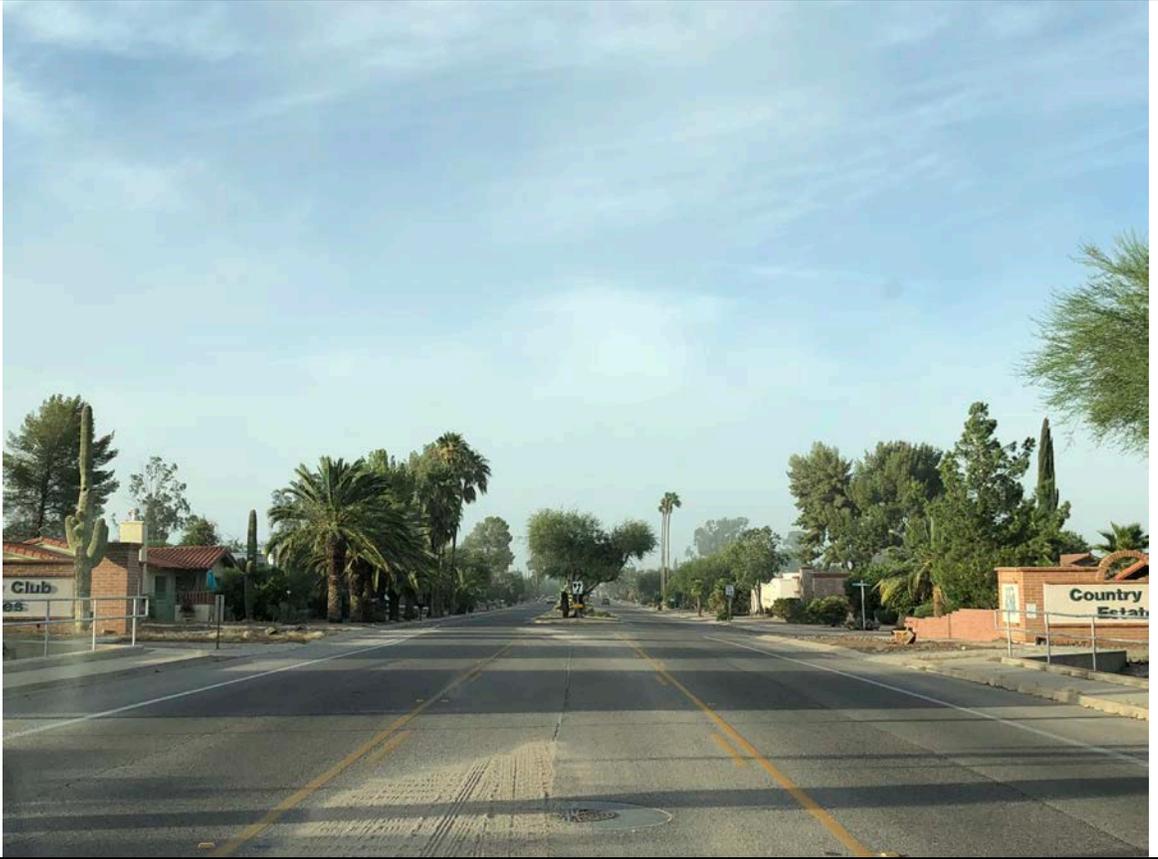
47.

north I observed dust moving across Abrego Drive (Attachment 2: Photo 47). Further north on Abrego Drive I stopped at location 23 at approximately 5:08 pm. I observed dust obscuring the vegetation, building and road (Attachment 2: Photo 48). I continued north on Abrego Drive and stopped at location 24 at approximately 5:13 pm. Looking east at that location I observed the dust plume was moving east towards the Santa Rita Mountains obscuring most of the mountains as it was moving east (Attachment 2: Photo 49). At location 25 slightly to the northeast of location 24 I observed the dust plumes still wafting toward the east (Attachment 2: Photo 50). I drove back to Abrego Drive and headed south to Esperanza Blvd to location 26. I observed clear skies absent of dust plumes (Attachment 2: Photo 51). Further south on Abrego Drive I stopped at location 27 at approximately 5:24 pm. I observed a clear view of the Santa Rita Mountains (Attachment 2: Photo 52). I continued to Continental Road and headed south to location 27, arriving at approximately 5:26 pm. Looking north I observed the dust plume obscuring the Catalina Mountains (Attachment 2: Photo 53). I traveled to Camino de la Canoa arriving at location 28 at approximately 5:29 pm. Looking in a westerly direction I observed plumes of dust still emanating from the tailings dam (Attachment 2: Photo 54). I returned to location 1, where I started, at approximately 5:46 pm, 4 hours later and observed the dust plume still visible and obscuring the Catalina Mountains (Attachment 2: Photo 55).

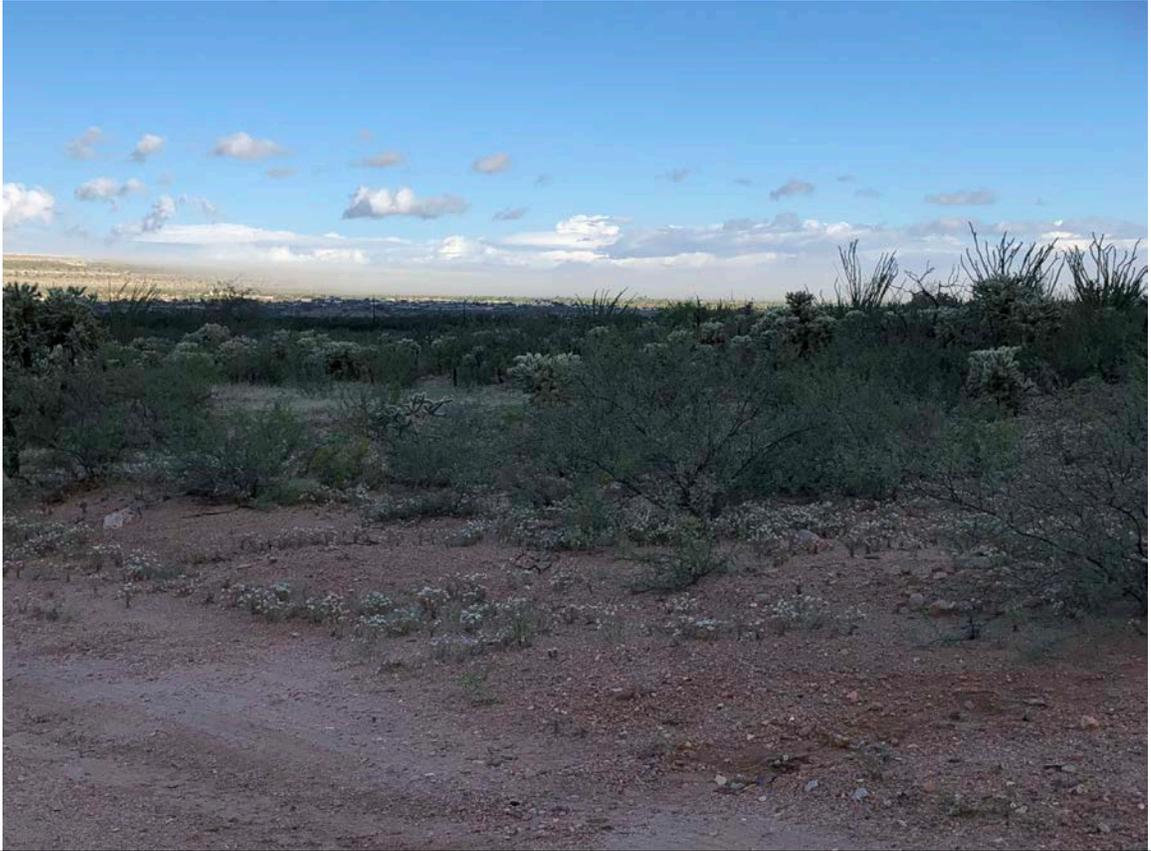
1.

On October 7, 2018, at approximately 8:13 am, I observed dust emanating from the east side of the Freeport-McMoRan Sierrita Inc. (FMSI) Sierrita Tailings Impoundment (Attachment 2: Photo 1). In response to my observation I conducted offsite surveillance for a duration of approximately three hours. My surveillance consisted of observation points at multiple locations in Green Valley. Attachment 1 is a Google Earth map with pins marking the locations where I stopped and photographed the dust event. The following narrative will refer to these pinned locations. Attachment 2 consists of the photographs that were taken at the pinned locations.

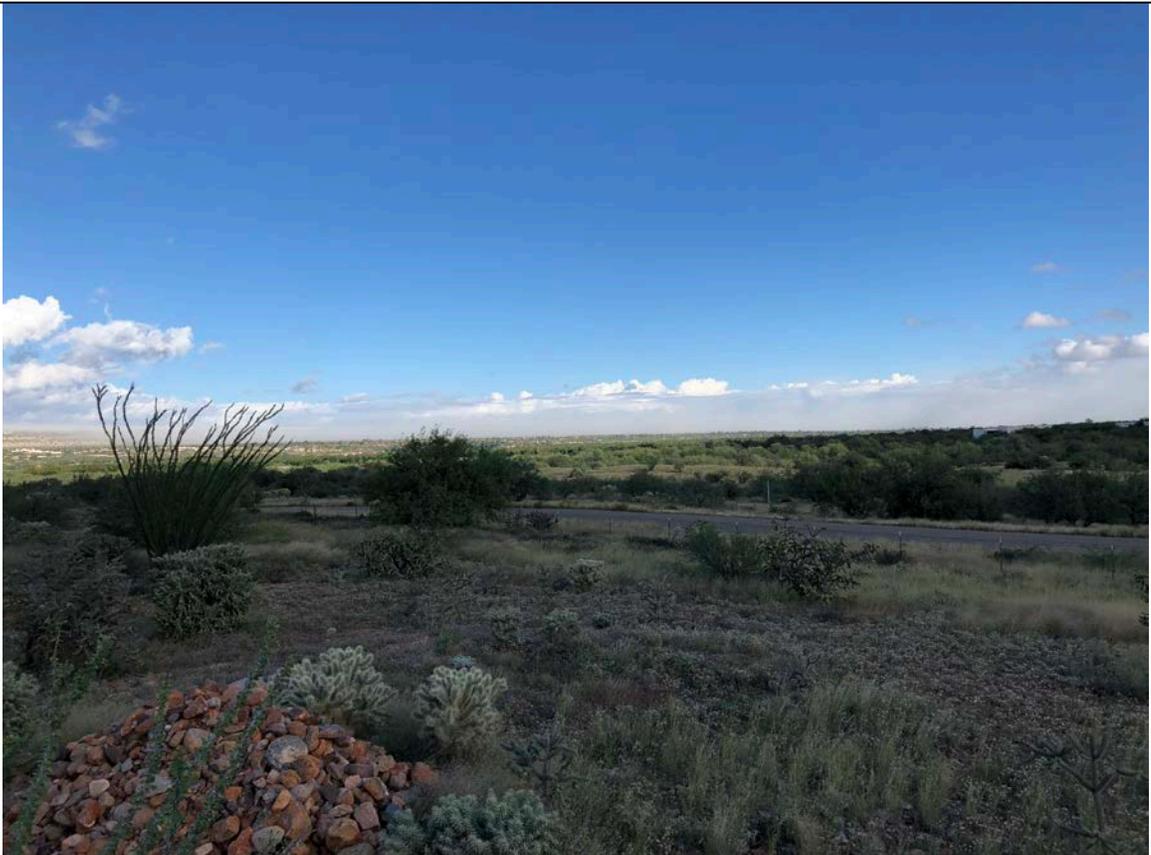
2.

I arrived at my second location on Camino de la Canoa at approximately 8:30 am (Attachment 2: Photo 2). I observed dust emanating from the northeast side of the tailings dam and moving in a northeasterly direction for a least 4 miles. I arrived at location 3 on Camino de la Canoa at approximately 10:19 am. I observed dust plumes drifting off the tailings dam (Attachment 2: Photo 3). I continued northwest on Camino de la Canoa and arrived at location 4 (Attachment 1) at approximately 10:21 am. I observed dust plumes emanating from the tailings dam and moving in a northeasterly direction (Attachment 2: Photo 4). I arrived at location 5 on Camino de la Canoa at approximately 10:22 am. I observed most of the tailings dam was obscured by the dust and large dust plumes continue to travel in a northeasterly direction. (Attachment 2: Photos 5 & 6). I arrived at location 6 on White House Canyon Road at approximately 10:28 am. I observed dust plumes emanating from the east side of the tailings dam (Attachment 2: Photo 7 & 8). I arrived at location 7 on Continental Road at approximately 10:54 am. The dust was completely obscuring the tailings dam to the northwest (Attachment 2: Photo 7). I arrived at location 8 on Continental Road at approximately 10:58 am. The dust was crossing Continental Road and completely obscuring the view of the tailings dam as well as the road (Attachment 2: Photos 10 & 11). I observed white to gray dust becoming airborne, kicked up by a car driving northwest on Continental Road (Attachment 2: Photo 12). I arrived at location 9 on Continental road at approximately 11:00 am. I observed dust moving across Continental Road looking to the southeast (Attachment 2: Photo 13) and looking to northwest (Attachment 2: Photo 14) completely blocking out the background. The tailings dam was completely obscured by the dust (Attachment 2: Photos 15 & 16). I continued northwest on Continental Road and arrived at location 10 at approximately 11:01 am. The dust was very dense at this location. Dust plumes were crossing

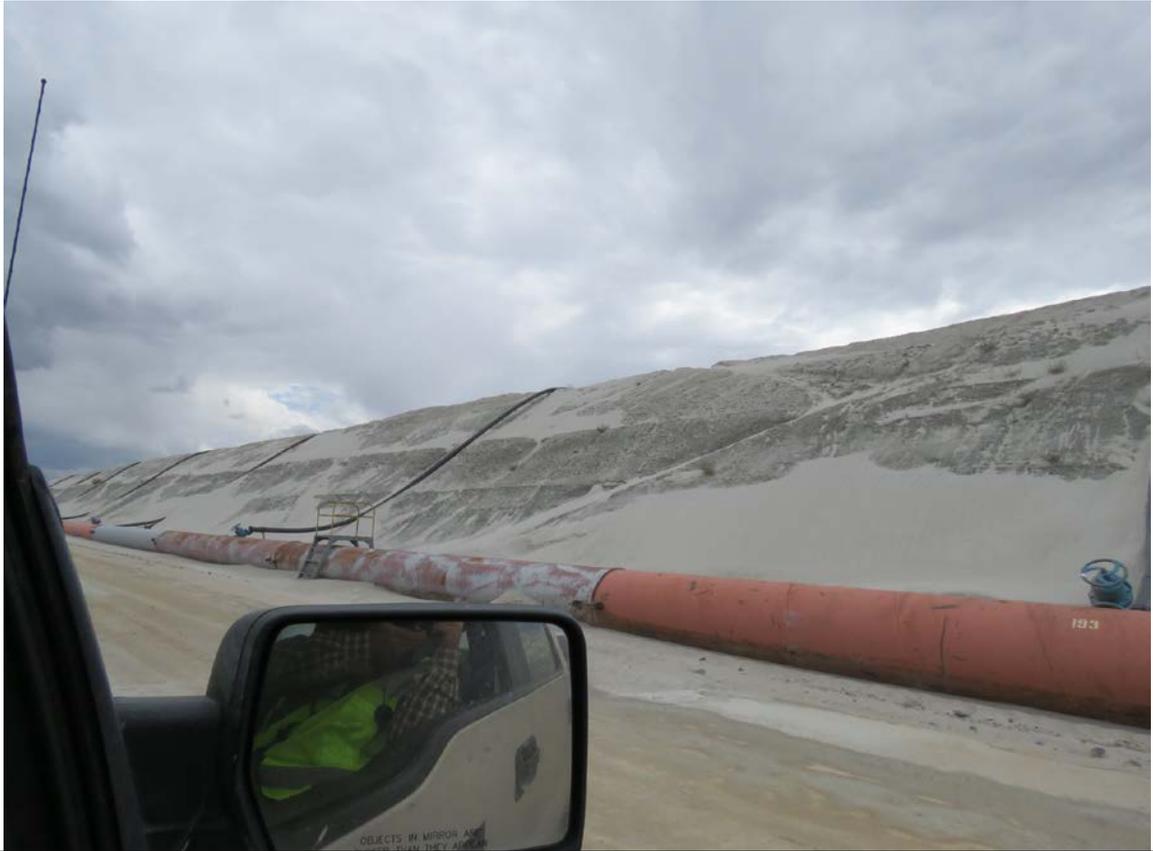
1.

While driving on the Sierrita Tailings Impoundment road, I observed a large amount of light colored fine material on the outward facing sloped embankments of the north and east dam faces (Attachment 2, Photos 1-4). The material appeared to be windblown tailings material from the impoundment surface and was covering some sections of berm faces in their entirety. The dry loose tailings material had accumulated and built up along the inside of the pipeline and on the road. The windblown material had not been present during my previous inspections on August 21 and September 26, 2018.

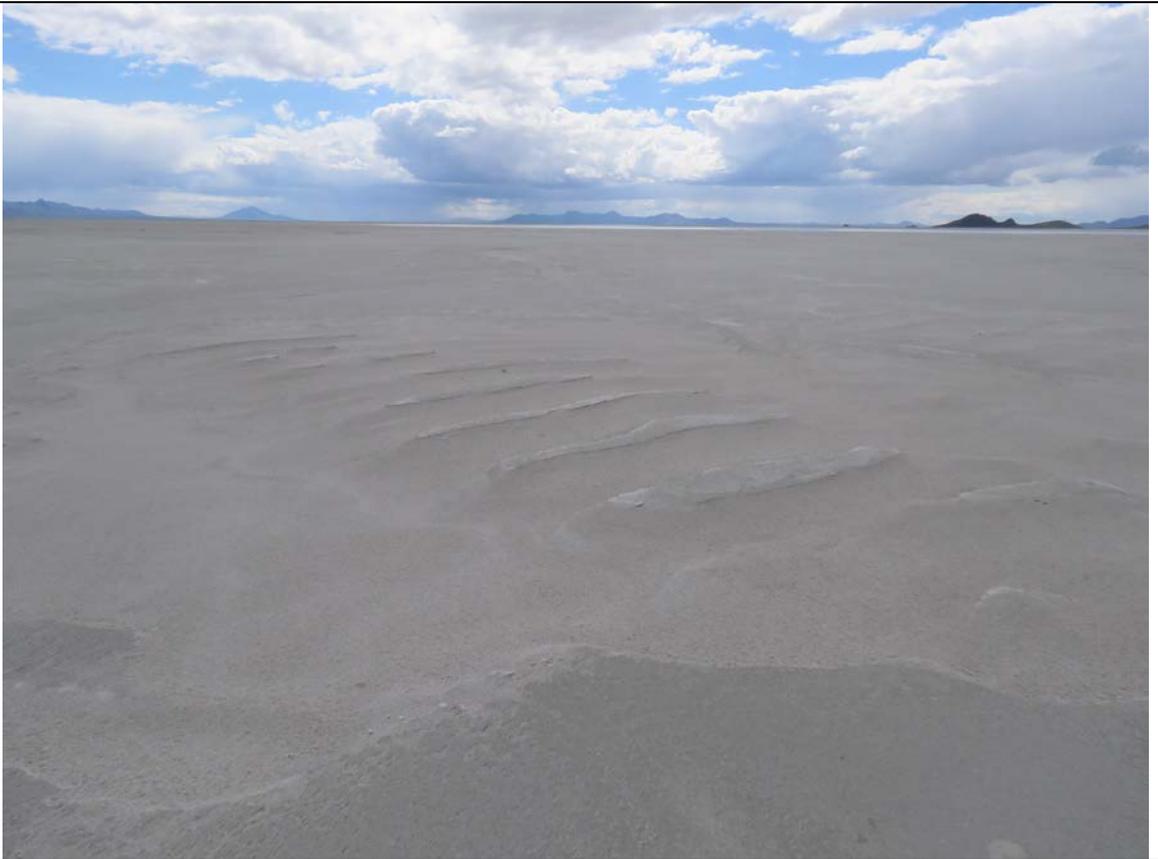
8.

We then inspected the surface of the North dam near the boundaries of Phases 1 and 2. While on top of the berm we observed that there was approximately one to two feet of freeboard from the top of the berm to the surface of the impoundment (Attachment 2, Photo 5). The impoundment surface was partially moist and able support my weight without my boot sinking more than an inch (Attachment 2, Photo 6). The surface crust appeared approximately a quarter inch thick in many areas that we observed (Attachment 2, Photo 7). There were large areas observed where the wind and rain had eroded the crust away completely and exposed loose sandy tailings material

(Attachment 2, Photos 8 & 9). Several areas had developed channels up to a foot deep and several feet wide that appeared to been created by erosion of tailings material from surface water flow (Attachment 2, photos 10 - 12). We also observed a water truck applying water to the side slope of the berm during our inspection (Attachment 2, Photo 13).
