**BEFORE THE CONTROL OFFICER OF THE
PIMA COUNTY AIR QUALITY DISTRICT**

**SETTLEMENT
AGREEMENT**

November 13, 2018 Notice of Violation

NOTICE OF VIOLATION # PC1810-033

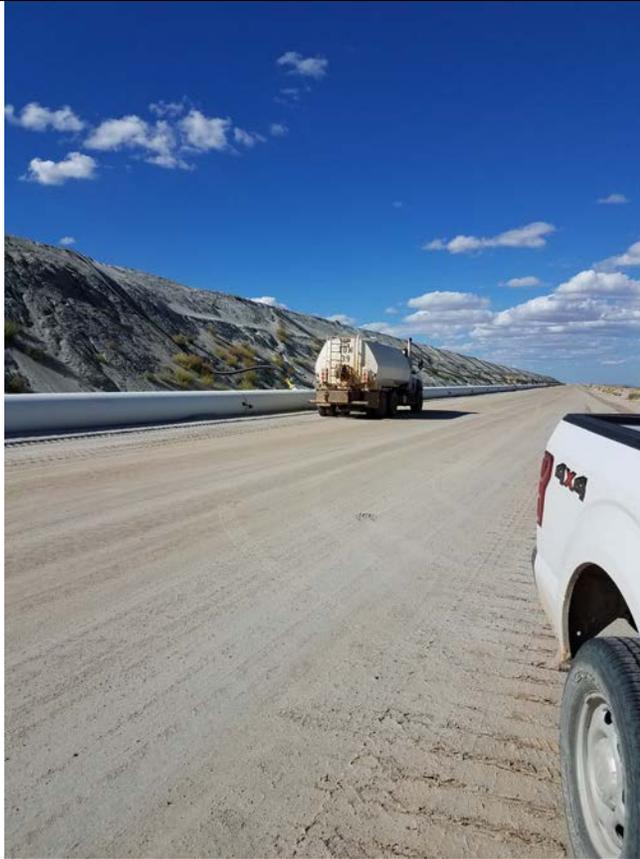
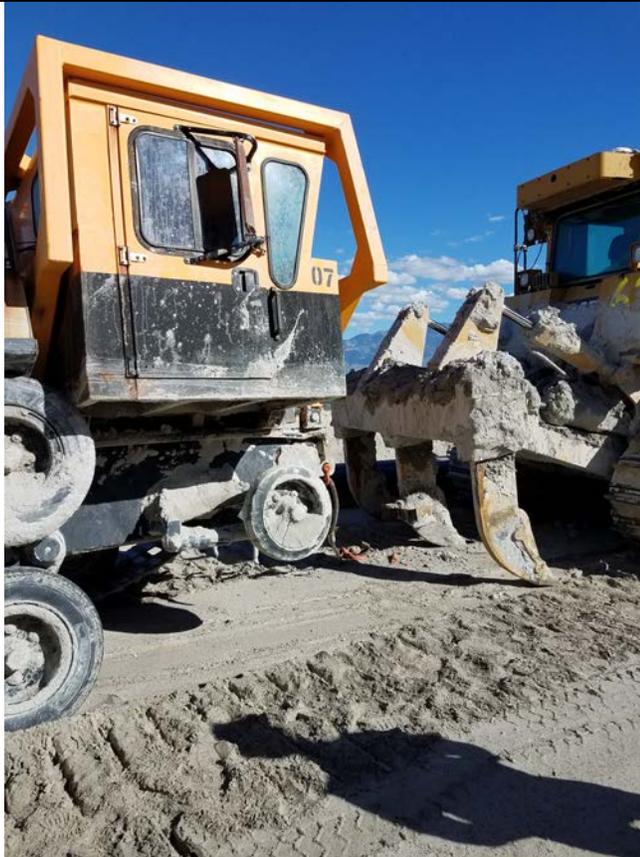
3.

When we arrived to the divider area, we observed the damaged all-track vehicle that had been previously lodged in the tailings impoundment and had been removed along with other equipment (Attachment 2, Photos 4 & 5). We also observed the larger capacity Terramac all-track vehicle that FMSI was parked on the tailings road, unable to deploy at the time of the inspection due to the softness of the tailings impoundment surface (Attachment 2, Photo 6).

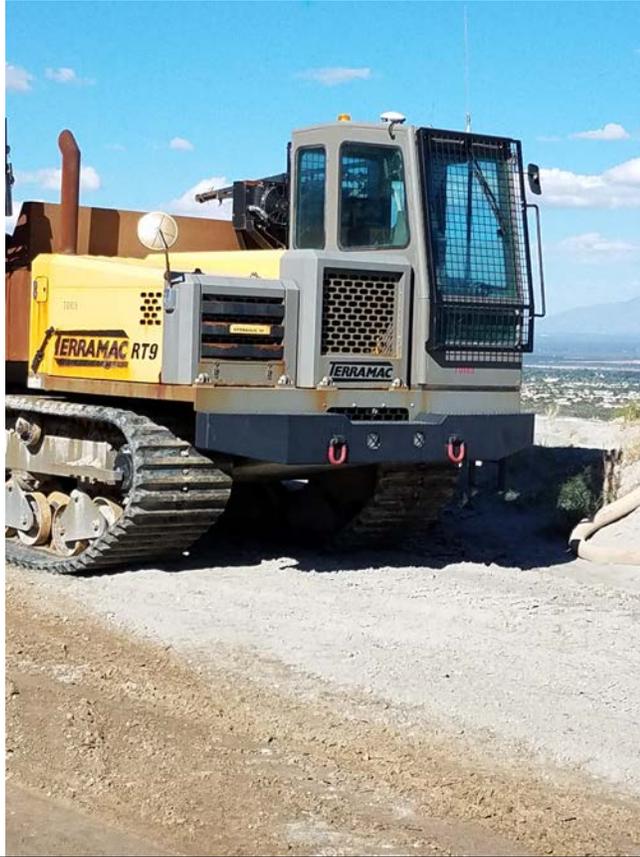
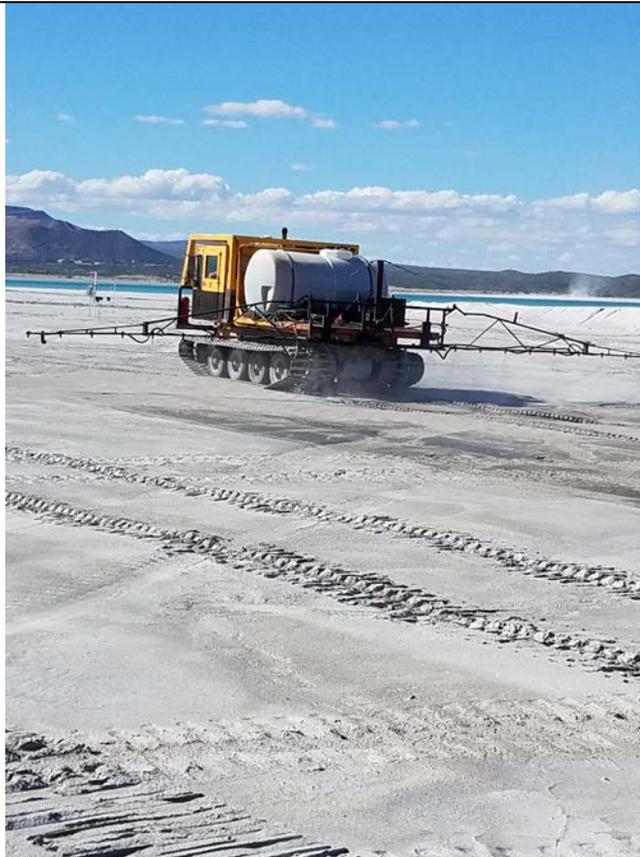
7.

While on the tailings surface, we observed the three remaining all track vehicles in operation (Attachment 2, Photo 7 & 8). They were applying magnesium chloride ($MgCl_2$) to the surface of the southeast portion of the South dam. The surface of the tailings impoundment appeared to have increased track marks from additional $MgCl_2$ application since our inspection October 8, 2018, and appeared to have a harder crust in areas of recent $MgCl_2$ application (attachment 2 photos 9 - 11).

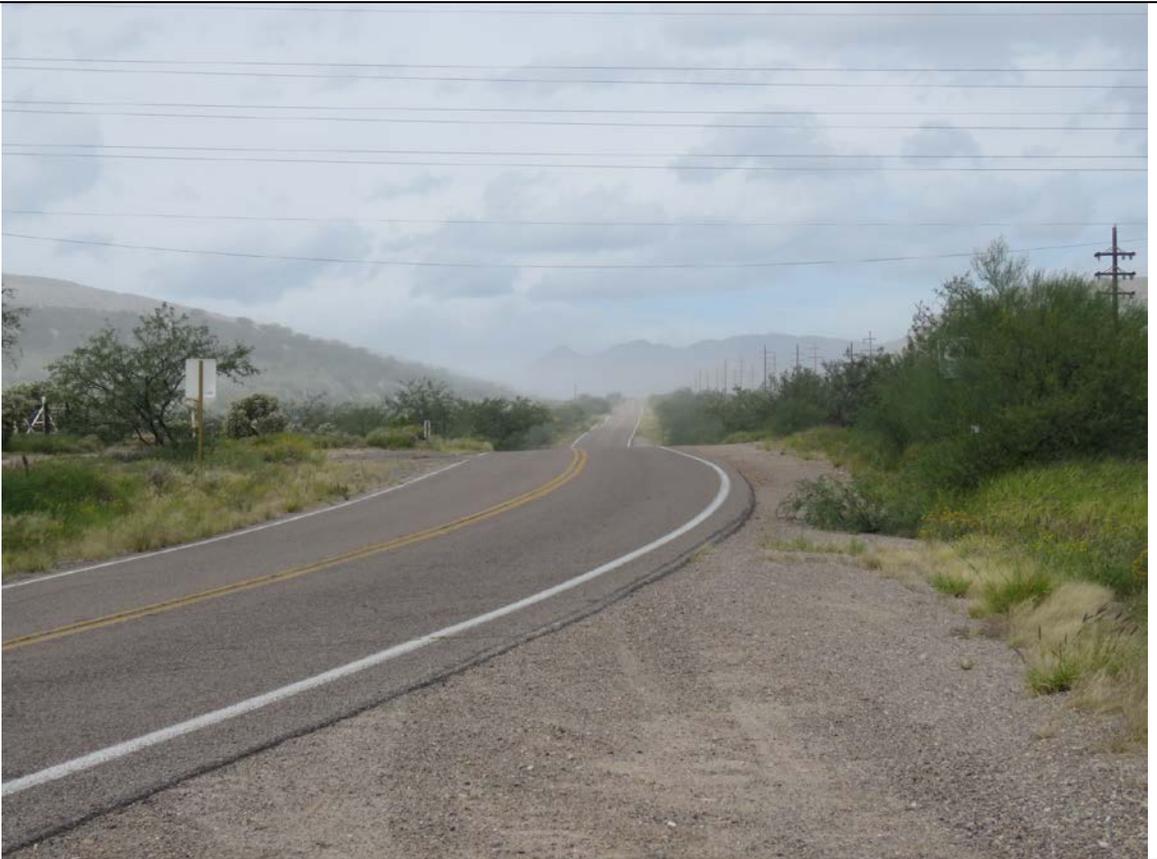
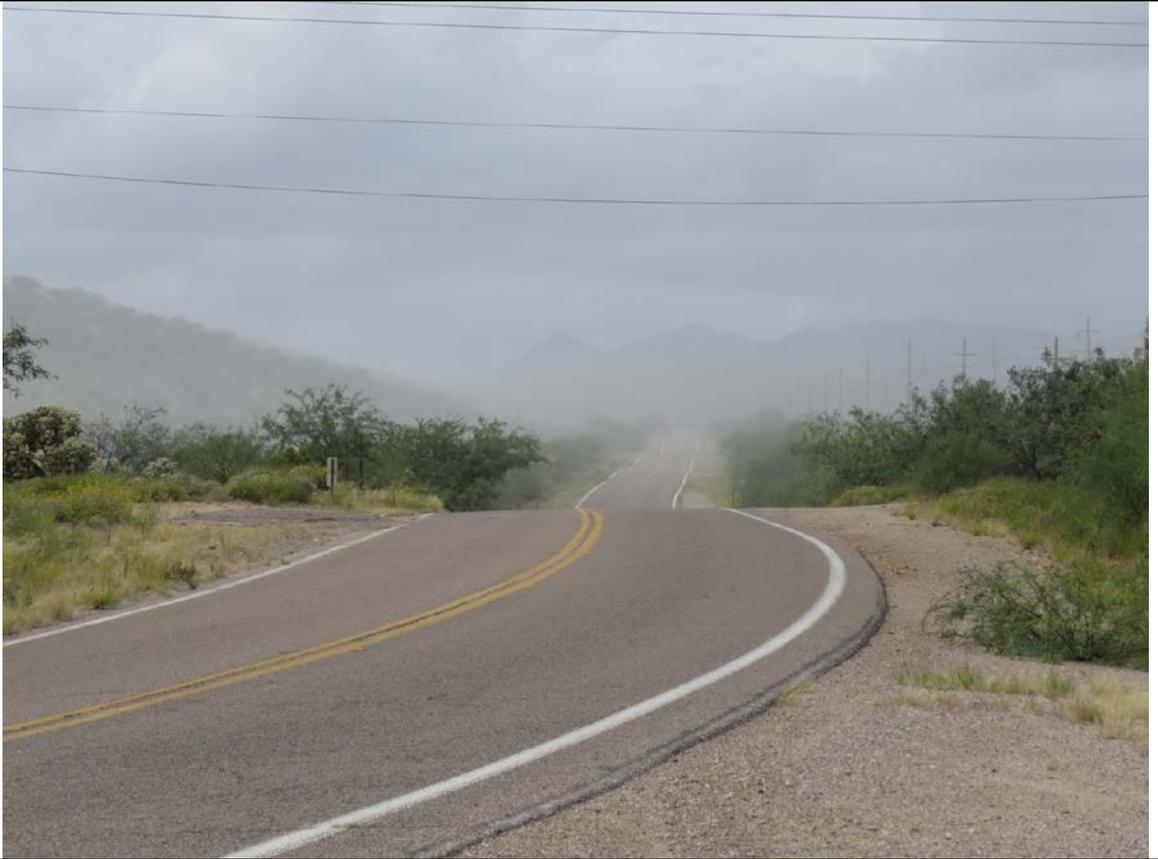
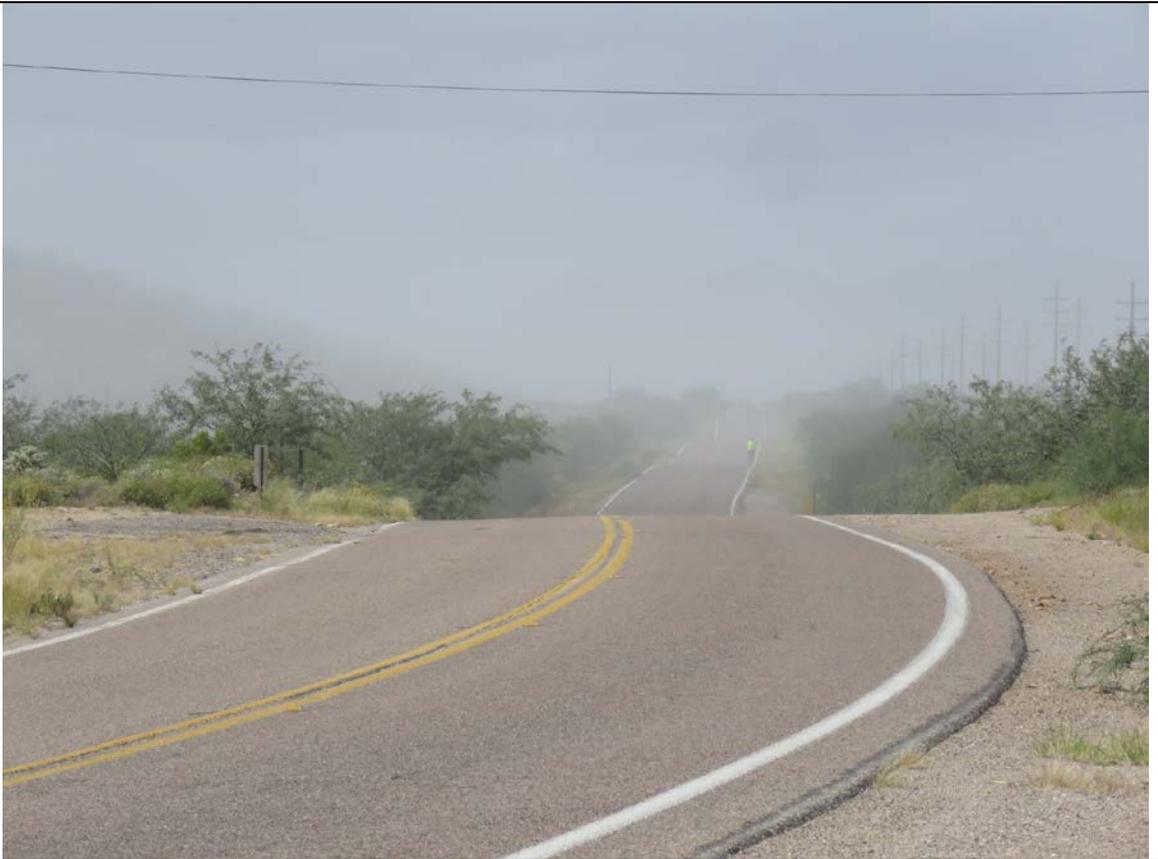
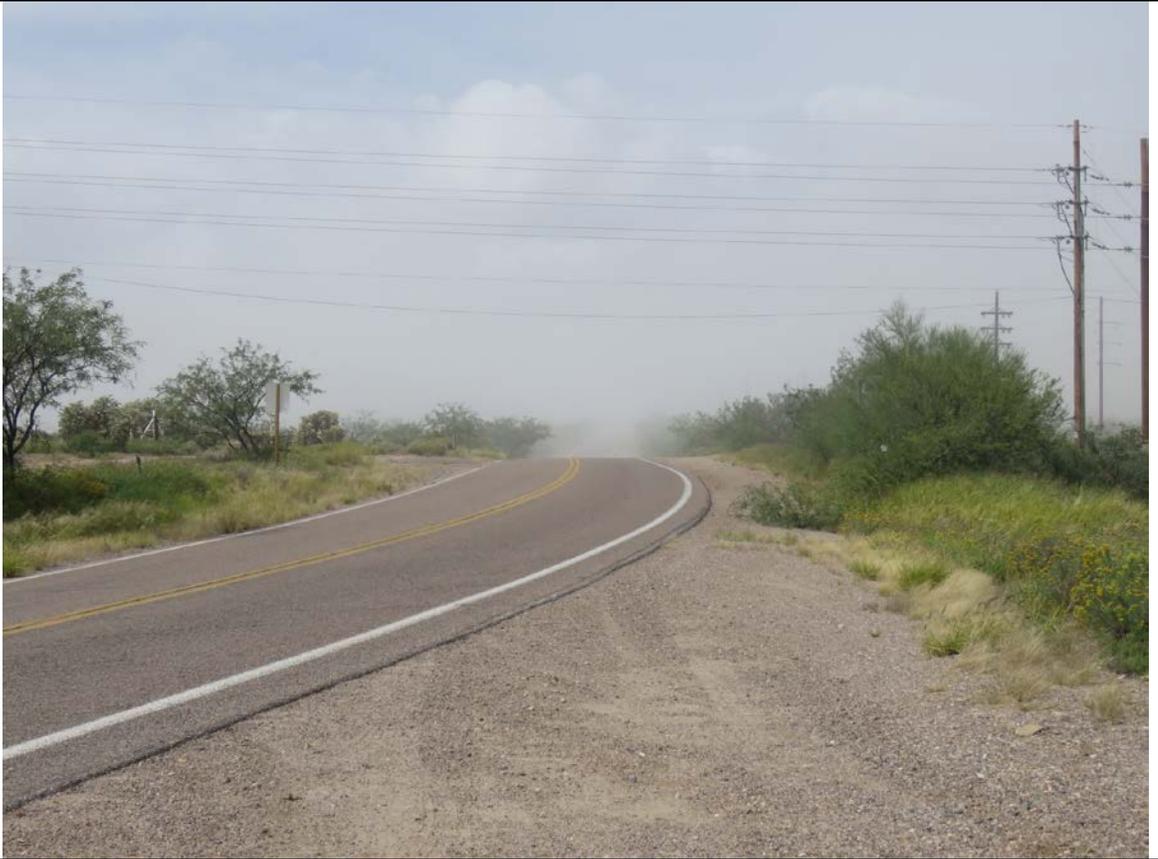
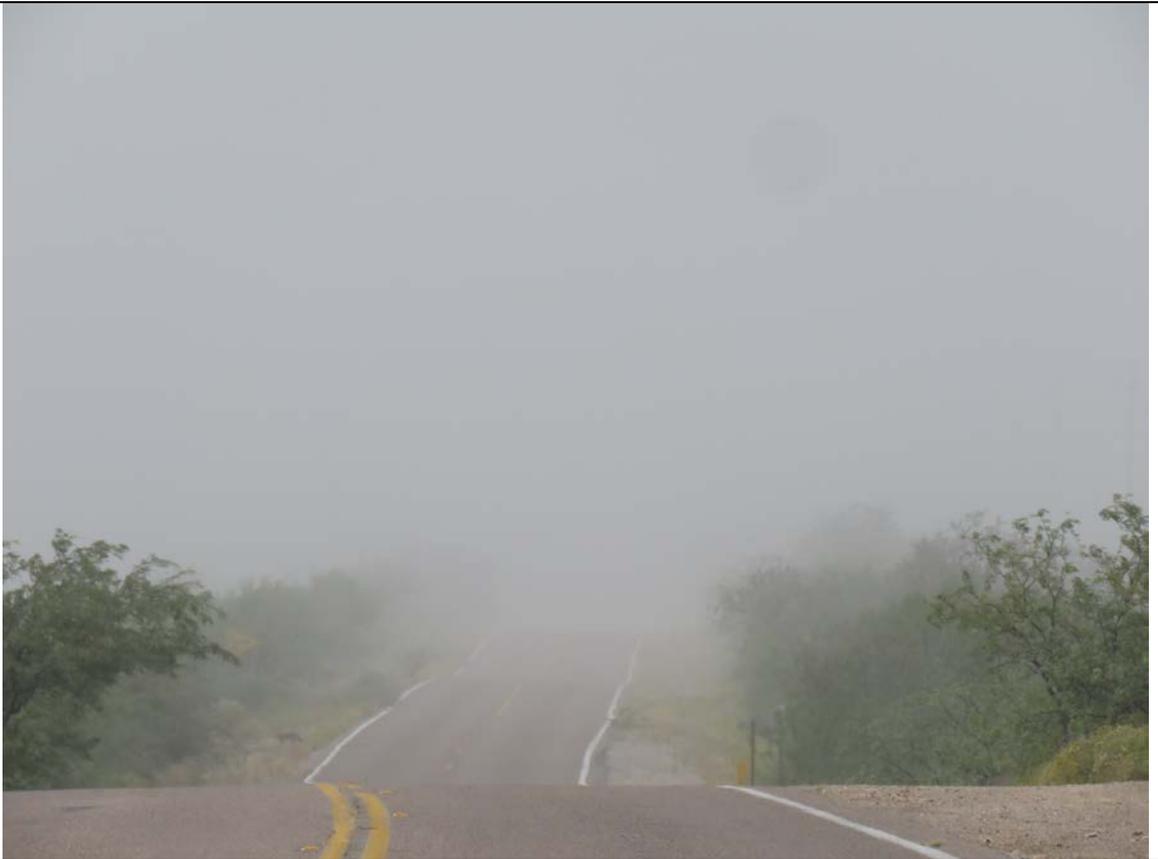
8.

Simultaneously, PDEQ Air Compliance Manager, Dustin Fitzpatrick set up a Canon SX 60HS camera along W. Continental Rd. east of W. Duval Mine Rd. (Attachment 1, Photos 8 – 12). He observed visible dust emissions from the Sierrita Tailings Impoundment crossing W. Duval Mine Rd. and W. Continental Rd. from 10:20 am – 11:40 am and conducted seven series of Alt-082 VEOs, five of which were valid observations (Attachment 3, DF 01 – DF 05). He recorded wind speeds between 4 – 11 mph at the location.

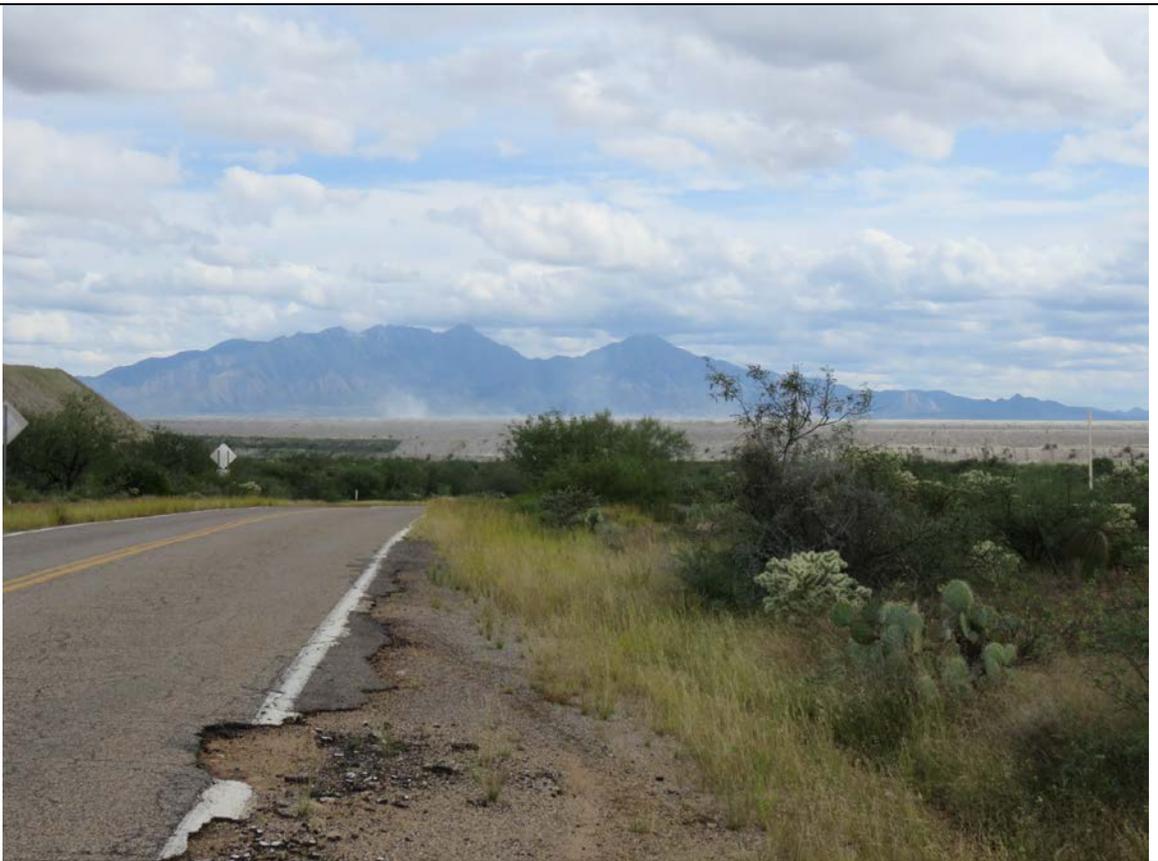
18.

Mr. Fitzpatrick and I took a break for lunch approximately between 12:00 pm and 1:00 pm. We are unable to perform Alt-082 VEOs at that time due sun position and plume direction. After lunch I returned to the parking lot on 1393 W. Mission Twin Buttes Rd. I did not observe any significant releases of dust from the tailings impoundment. During that time period Mr. Fitzpatrick located himself northwest of the tailings impoundment along S. Mission Rd. and observed plumes of dust generating on the top surface of the impoundment at approximated 2:25 pm (Attachment 1, Photo 18).

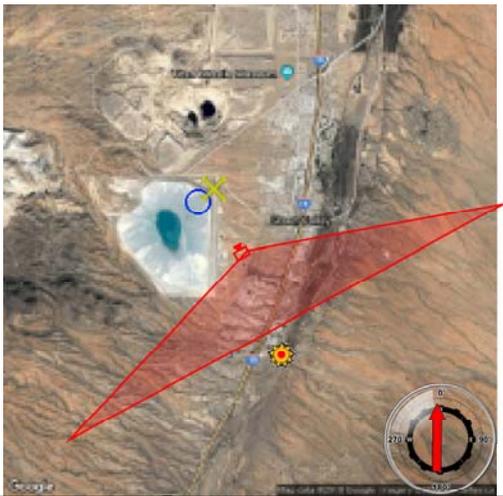
Describe Emissions Start Furnigating End Same			
Emission Color Start Dust End Same	Water Droplet Plume Attached: (<input checked="" type="checkbox"/>) Detached: (<input type="checkbox"/>) N/A: (<input type="checkbox"/>)

Describe Plume Background Start sky End Same			
Background Color Start Blue End Same	Sky Conditions Start Overcast End Same		
Wind Speed Start 9 End Same	Wind Direction Start 180 End Same		
Ambient Temp. Start 73 End Same	Wet Bulb Temp. Start 51 End Same	RH Percent Start 46 End Same

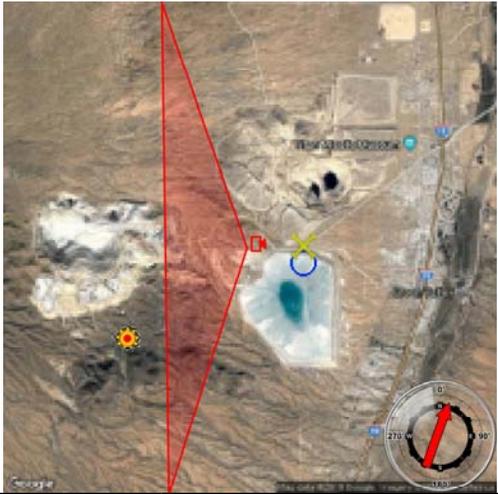
Describe Emissions Start Light colored dust plume End Same		Water Droplet Plume Attached: (<input checked="" type="checkbox"/>) Detached: (<input type="checkbox"/>) N/A: (<input type="checkbox"/>)	
Start Dust	End Same

Describe Plume Background Start Santa Rita Mountains End Same			
Background Color Start Gray End Same		Sky Conditions Start Overcast End Same	
Wind Speed Start 11 End Same		Wind Direction Start 200 End 180	
Ambient Temp. Start 73 End Same	Wet Bulb Temp. Start 51 End Same	RH Percent Start 46 End Same

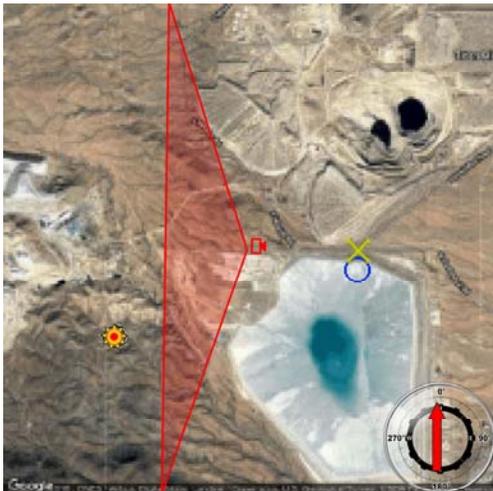
Describe Plume Background Start Santa Rita Mountains End Same			
Background Color Start Dark Blue End Same		Sky Conditions Start Overcast End Same	
Wind Speed Start 7 End Same		Wind Direction Start 180 End Same	
Ambient Temp. Start 73 End Same		Wet Bulb Temp. Start 51 End Same	
RH Percent Start 46 End Same

Comments
1	55	50	55	50	
2	55	55	60	65	
3	65	70	65	70	Avg. Opacity = 61.042
4	65	65	65	65	
5	70	70	70	70	
6	60	55	50	45	
7	N/A	N/A	N/A	N/A	
8	N/A	N/A			
9					
10					
11					
12					
13					
14					
15					
16					
17					
18					
19					
20					
21					
22					
23					
24					
25					
26					
27					
28					
29					
30					
31					
32

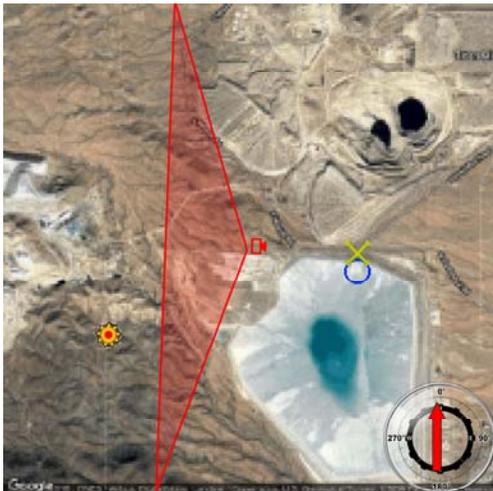
Describe Emissions Start Light colored dust plume End Same		Water Droplet Plume Attached: (<input checked="" type="checkbox"/>) Detached: (<input type="checkbox"/>) N/A: (<input type="checkbox"/>)	
Start Dust	End Same

Describe Plume Background Start Santa Rita Mountains End Same			
Background Color Start Dark Blue End Same		Sky Conditions Start Overcast End Same	
Wind Speed Start 9 End Same		Wind Direction Start 180 End Same	
Ambient Temp. Start 73 End Same	Wet Bulb Temp. Start 51 End Same	RH Percent Start 46 End Same

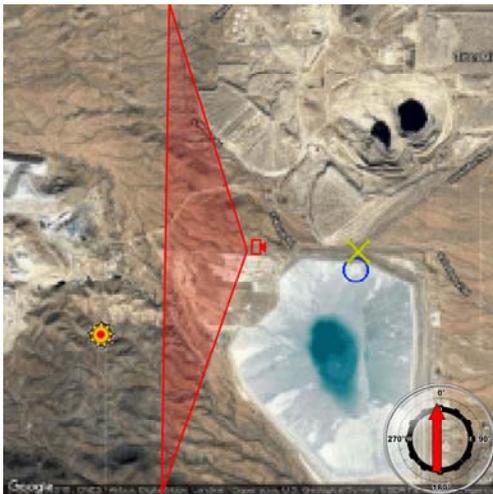
Describe Emissions Start Light colored dust plume End Same			
Emission Color Start Dust End Same	Water Droplet Plume Attached: (<input type="checkbox"/>) Detached: (<input type="checkbox"/>) N/A: (<input type="checkbox"/>)

Describe Plume Background Start Santa Rita Mountains End Same			
Background Color Start Dark Blue End Same	Sky Conditions Start Overcast End Same		
Wind Speed Start 7 End Same	Wind Direction Start 180 End Same		
Ambient Temp. Start 73 End Same	Wet Bulb Temp. Start 51 End Same	RH Percent Start 46 End Same

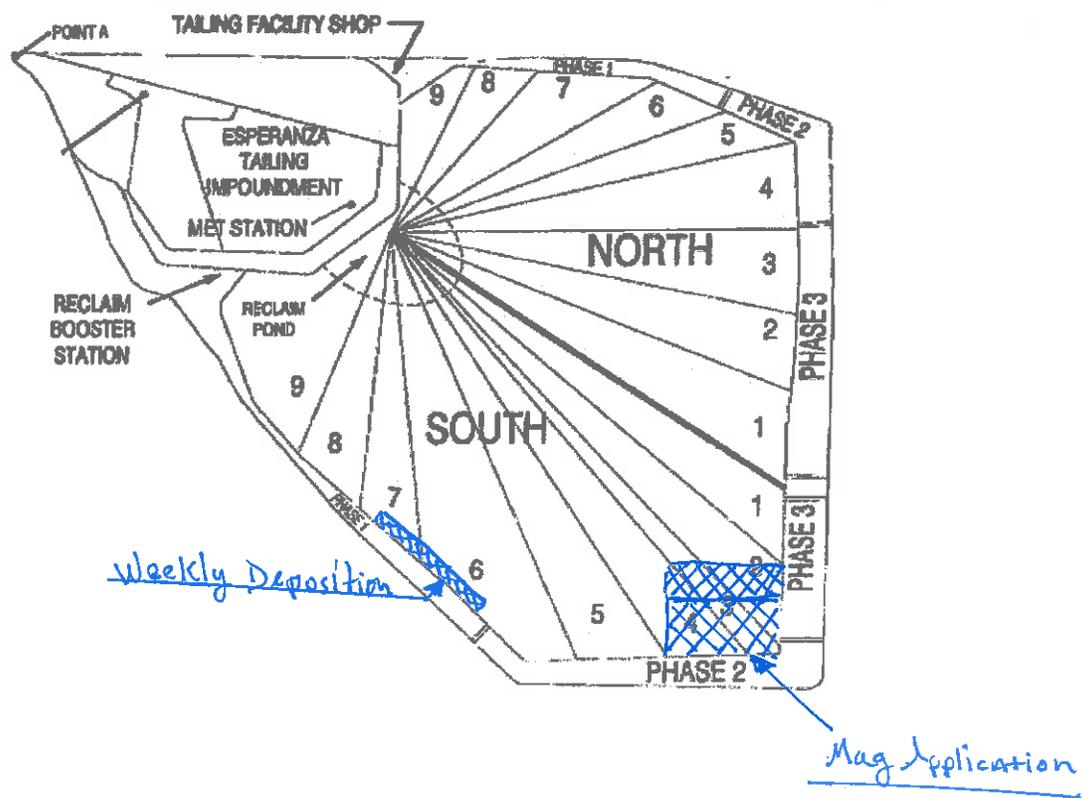
Comments: ETI/STI Construction ongoing
Deposition on South Dam.
On 10/4, ELW was called to report dust within the impoundment -
did not leave property.

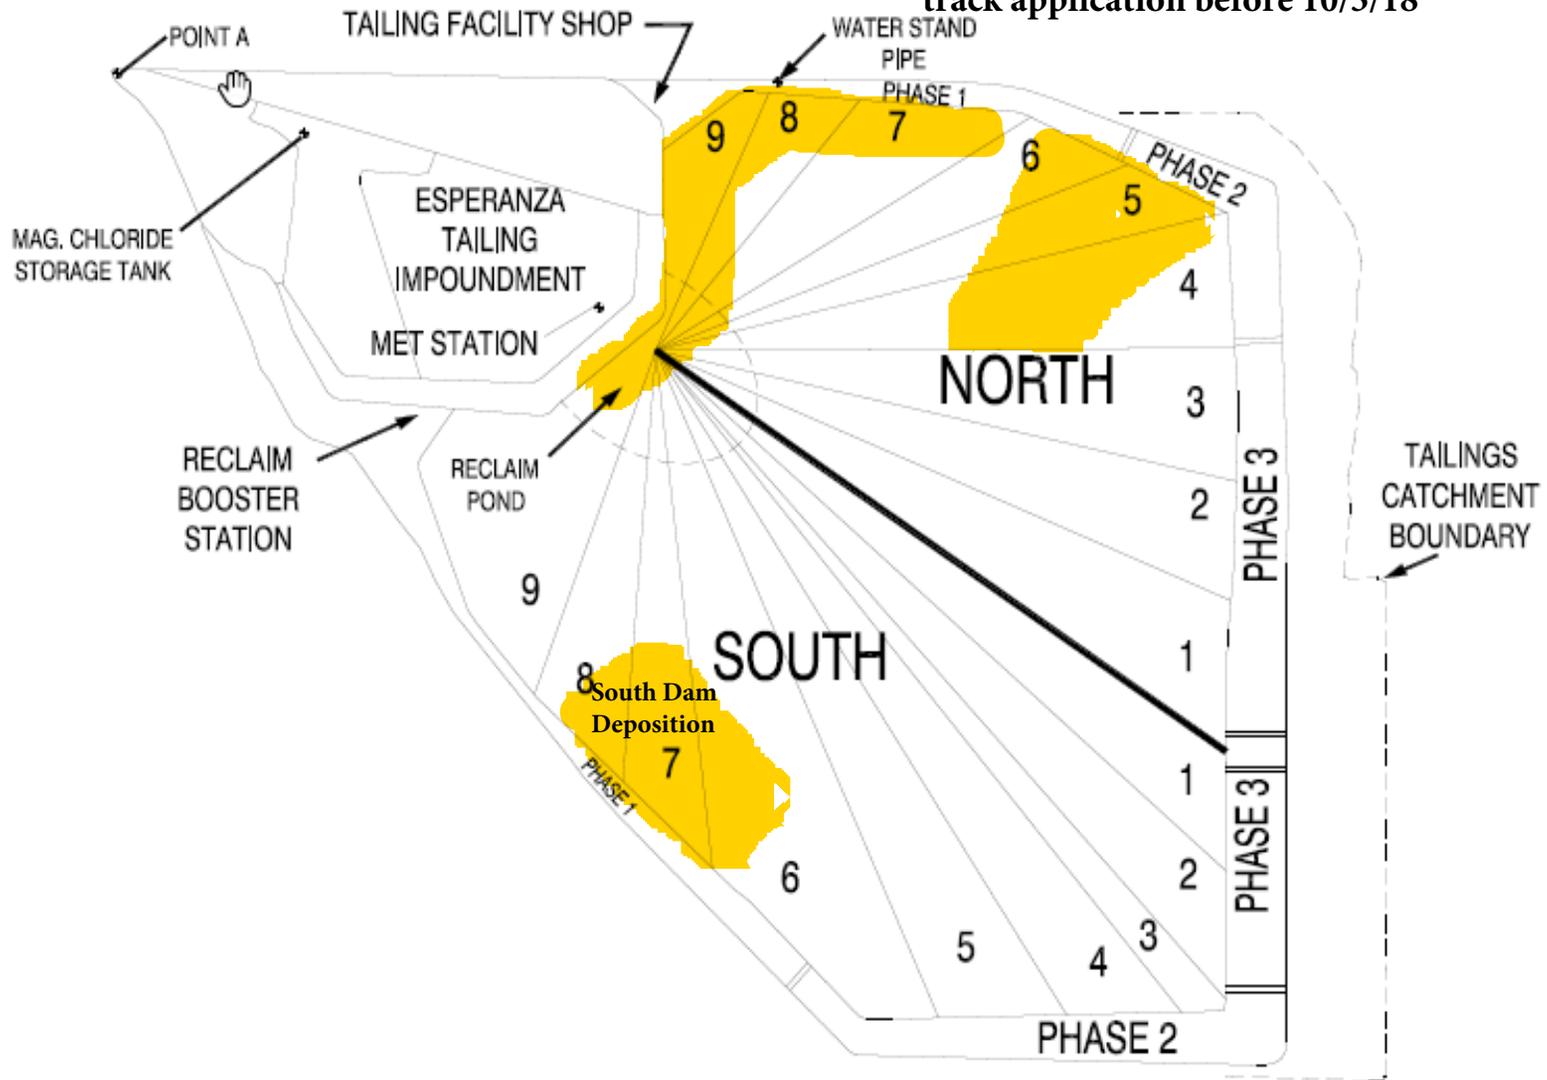
Attachment D

North Dam Affected Areas (highlighted in yellow): Phase 1 and 2 was too moist for all track application before 10/5/18

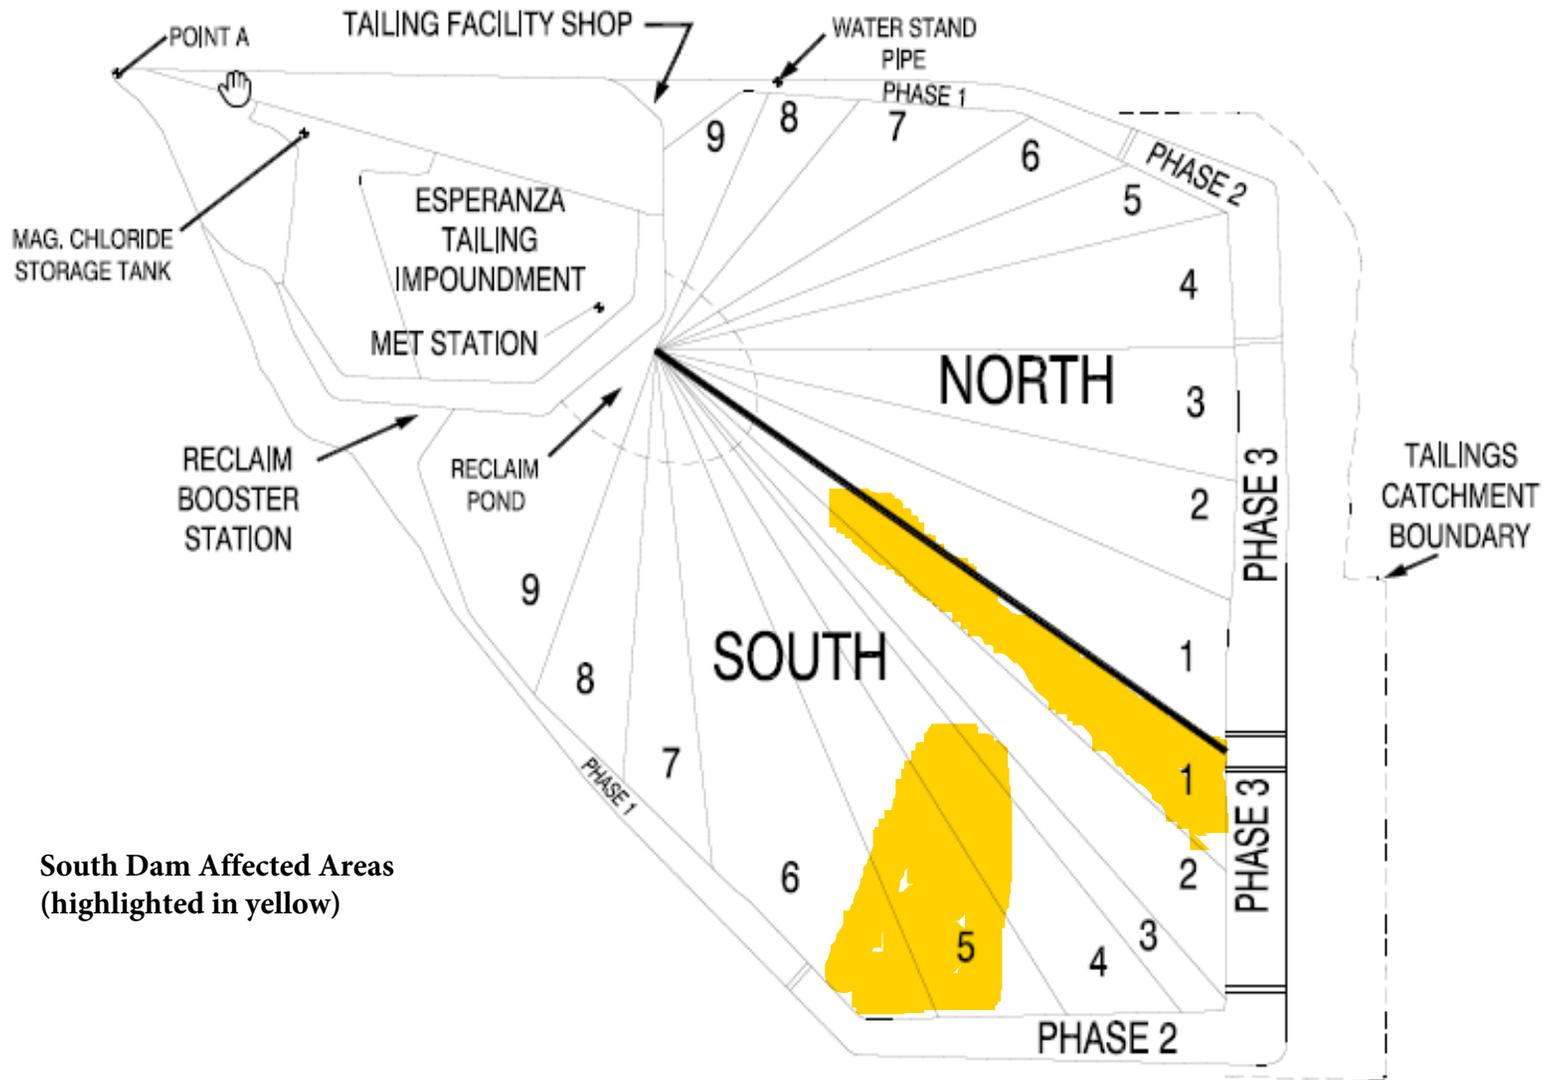
Attachment E

October 2nd, 2018 Storm Event

**South Dam Affected Areas
(highlighted in yellow)**

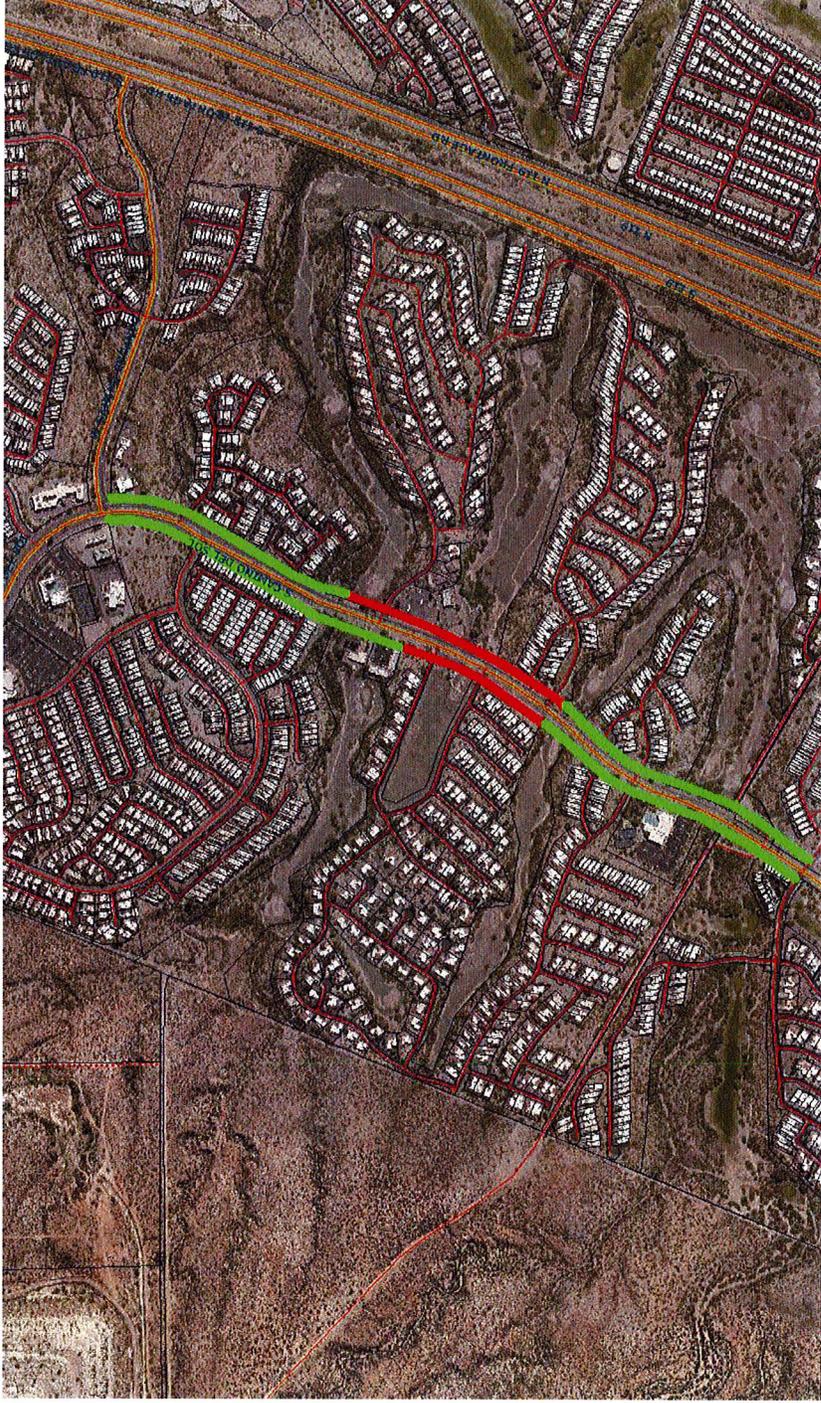
Camino Del Sol Path Paving

Portion to be completed by RFCD
