## **NOTICE OF VIOLATION # PC 1004-134**

## Site Inspection Report

Tracking ID: 2026-181

**Source:** ASARCO LLC - Mission Complex

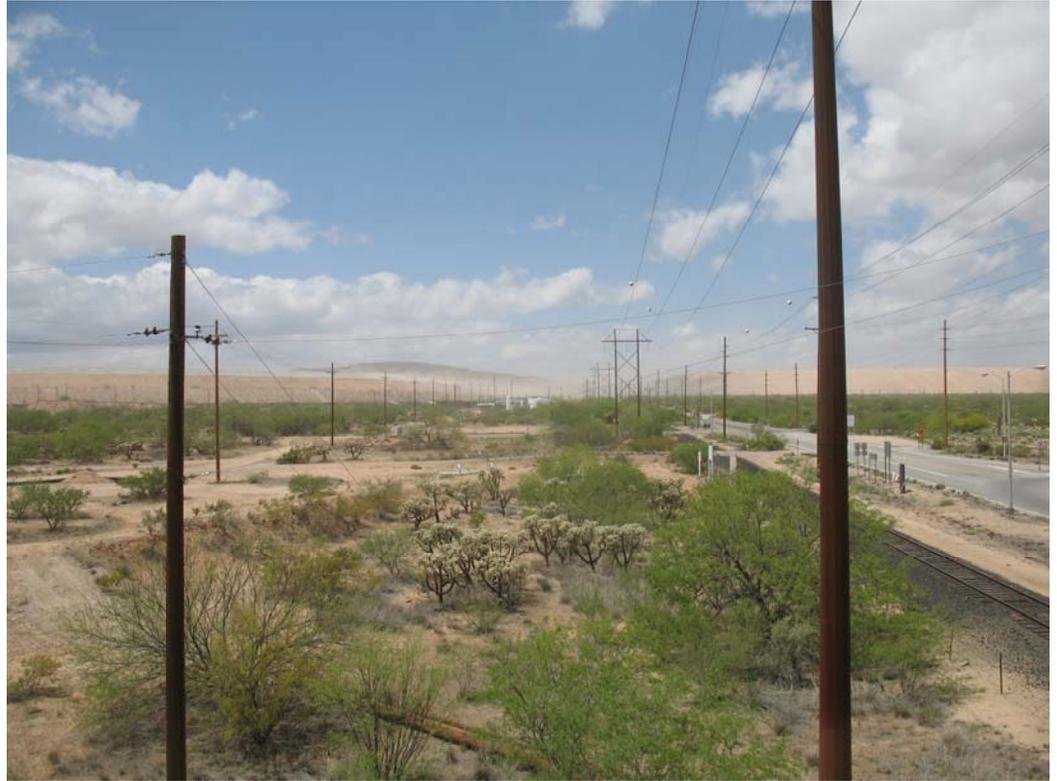
**Photo No. 1**

View of tailings dam # 4. Fugitive particulate plume was observed over the northeast slope for a duration of approximately 3-6 minutes.

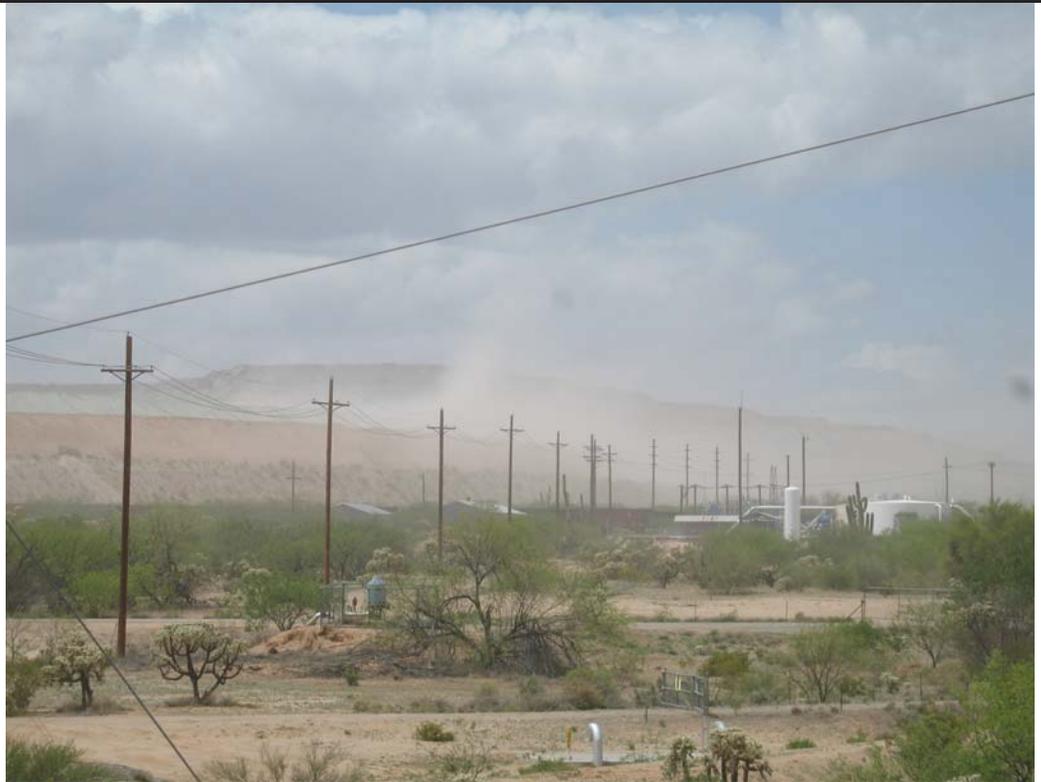
**Photo No. 2**

View of tailings dam # 4 emission plume.

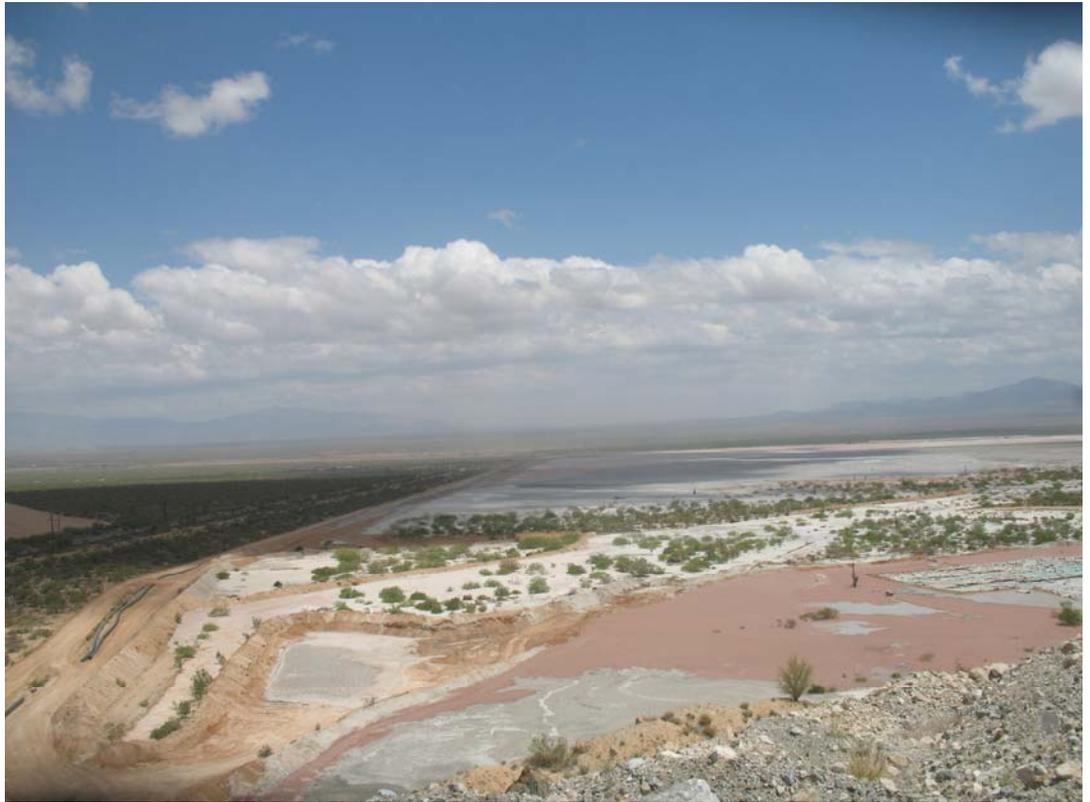
**Photo No. 5**

View of the tailings dam from the mine area to the west overlooking the northeast area.

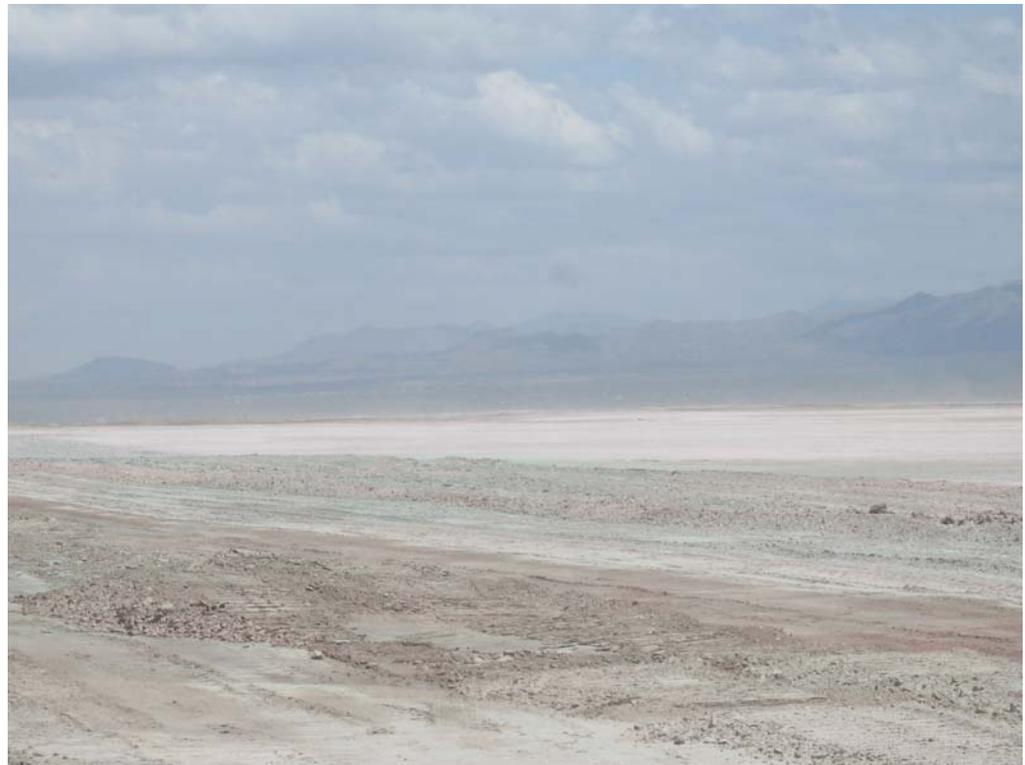
**Photo No. 6**

View of the dry surface area towards the interior of the northeast area of tailings dam #4 in the background.

The area in the foreground is the approximately 200' wide area where equipment has disturbed the outer edge of the tailings surface.

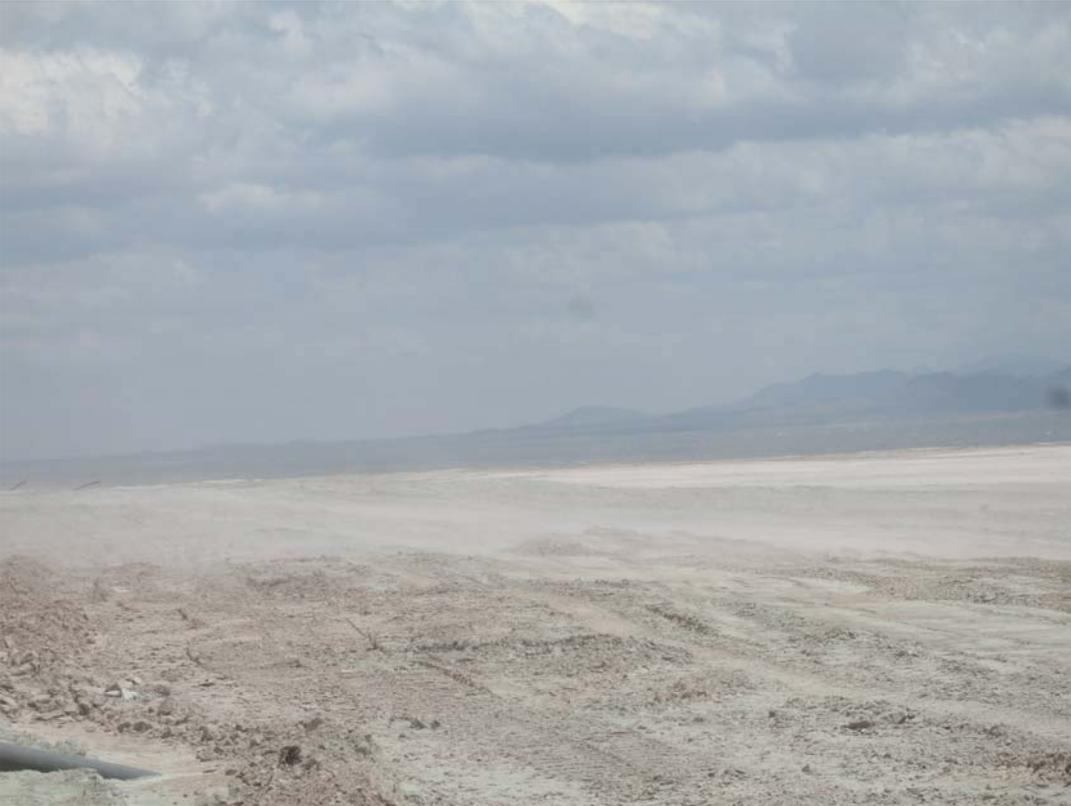
<p><b>Photo No. 7</b></p>

<p><b>Date:</b> 04-21-2010</p>	
<p><b>Photo Description:</b></p> <p>A particulate emission plume generated from the surface of the dam. Taken prior to Method 9 VE observations.</p> <p>Time: 1:10 pm</p>	
<p><b>Photo No. 8</b></p>

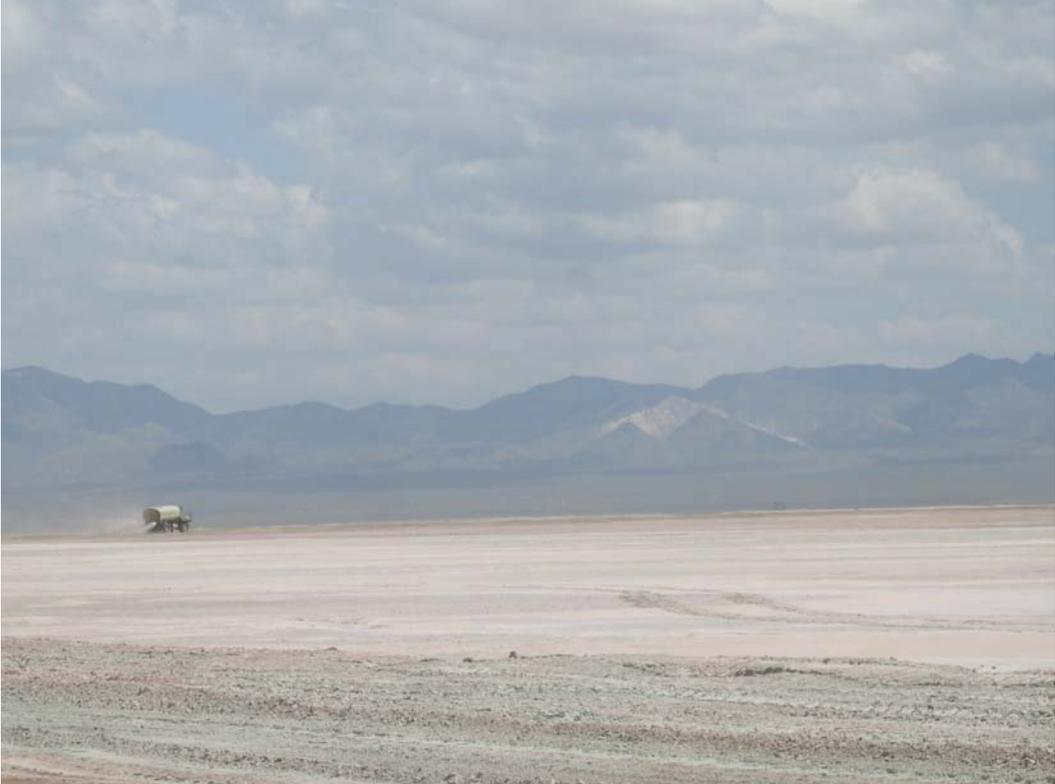
<p><b>Date:</b> 04-21-2010</p>	
<p><b>Photo Description:</b></p> <p>View of water truck applying suppressant to the outer area of the dam.</p>

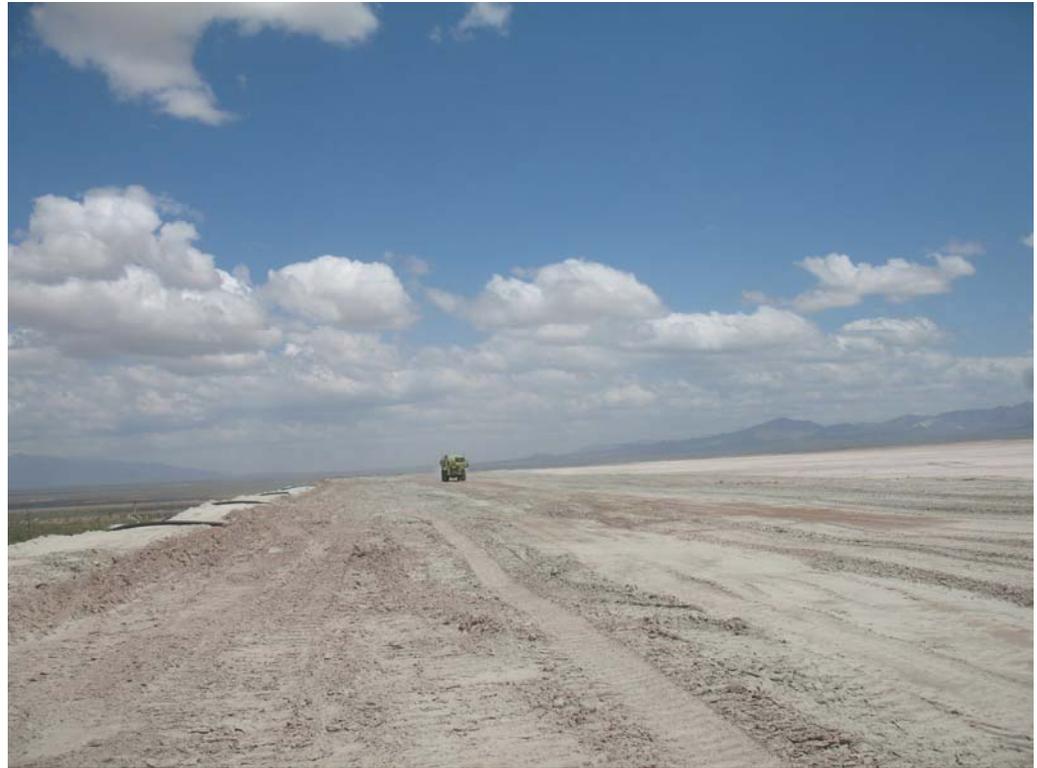
**Photo No. 9**

View of a water truck on the outer area of the dam.
