# Pima County 2019 Annual Stormwater Report

July 2018 – June 2019  
AZPDES Permit No. AZS000002

# Annual Stormwater Report

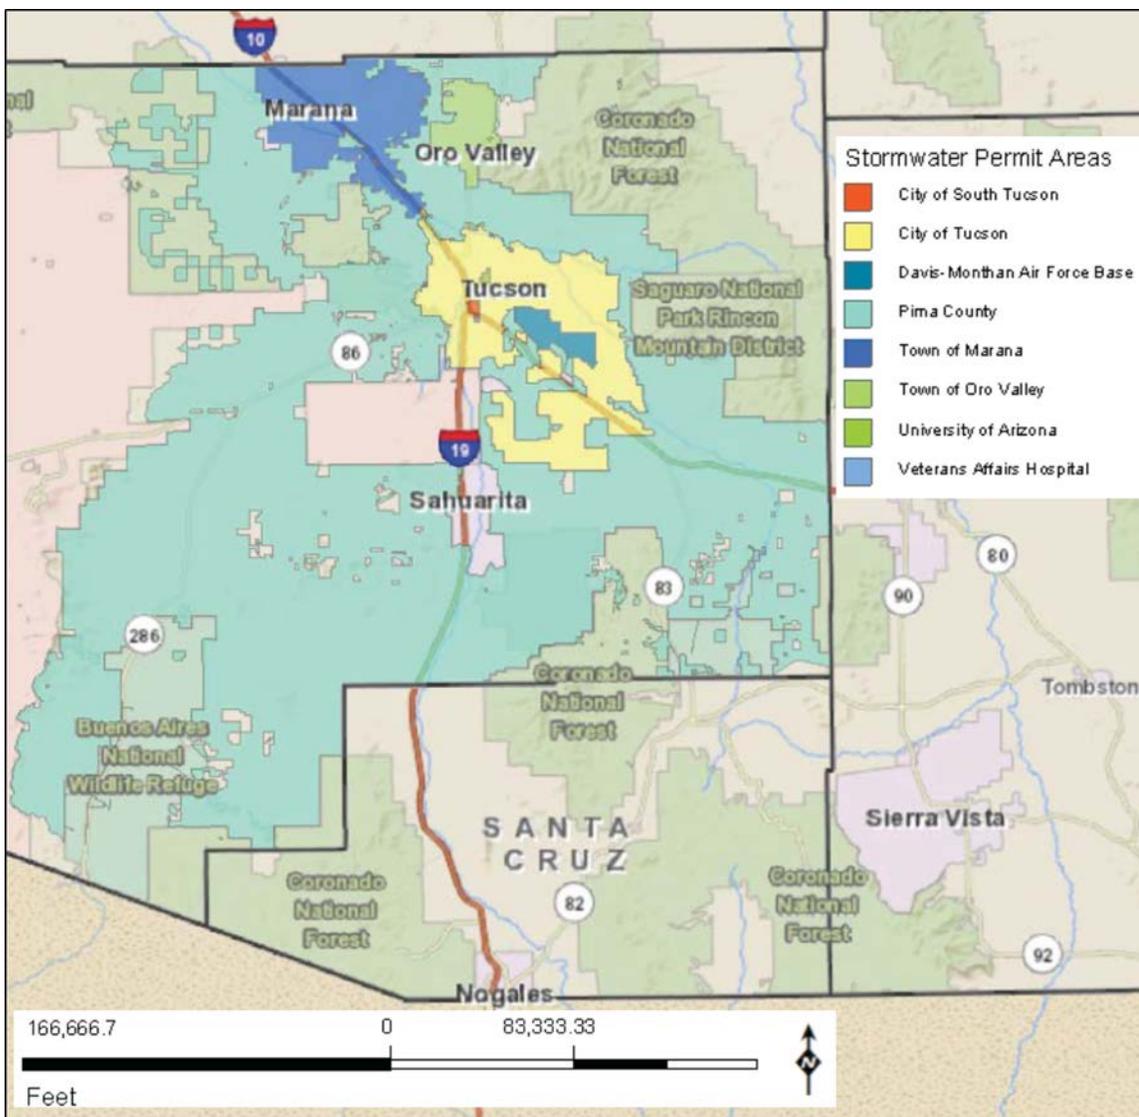
Figure 1. 2019 AZPDES Permit Area Map

The physical components within the permit area include 2,339 miles of roadway, 58.6 miles of storm drains and appurtenances that collect and convey runoff from precipitation events, with lengths reported by Pima County Department of Transportation (PDOT) and Regional Flood Control District (RFCD), respectively. The permit area is unincorporated Pima County within the Santa Cruz River watershed (Figure 1-1, blueish-green area). In both rural areas and metropolitan areas, runoff collects in ephemeral stream channels and infiltrates into alluvial deposit in the valley (USGS, 1973). Flows in ephemeral stream channels occur in response to rainfall events that are larger than 0.2 inches. Most runoff infiltrates within Pima County.

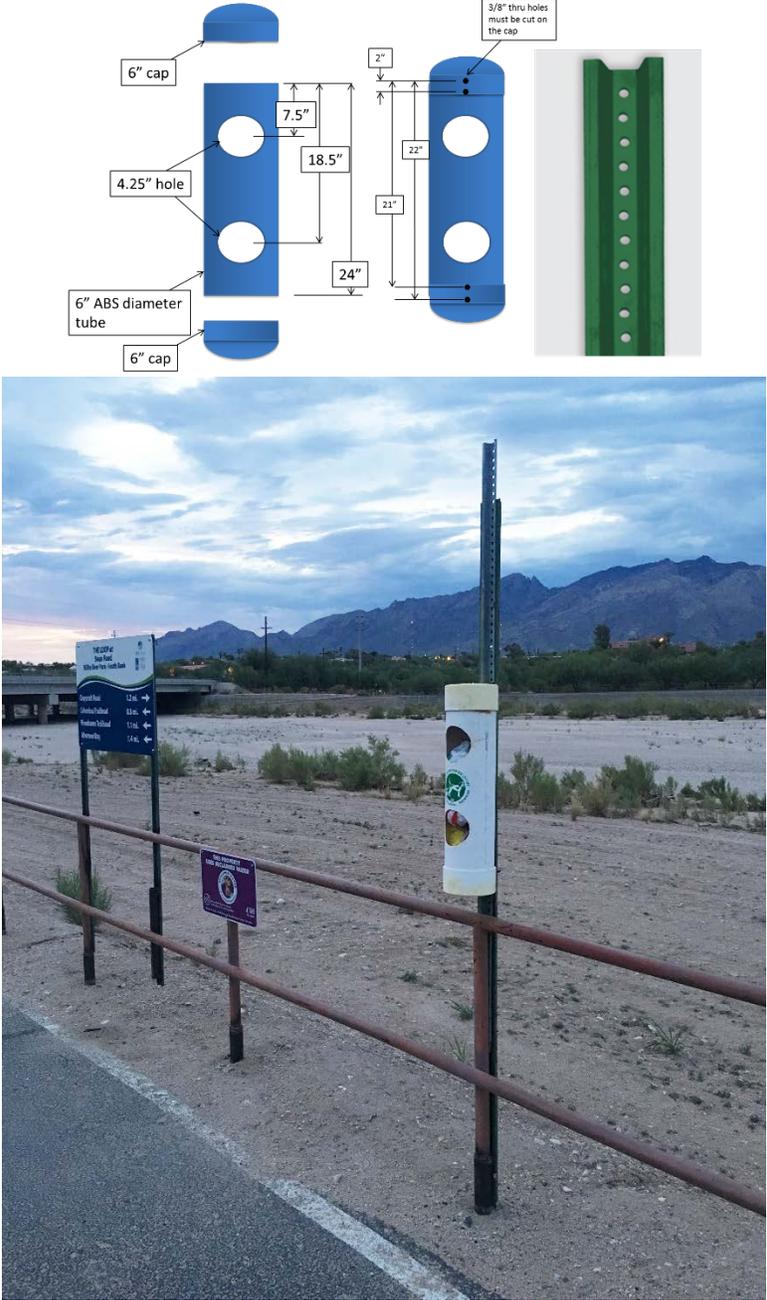
Figure 2. Pet waste station design and intallation

MS4s within Pima County. ADEQ and the construction industry met four times at the Stormwater Management Working Group (SWMWG) hosted by Pima Association of Governments (PAG) to develop a stormwater message for the area. PAG won a grant through ADEQ 604(b) Funding for Watershed Planning and implemented a project to install pet waste stations in cooperation with the Pima County. Pima County Natural Resources, Parks and Recreation (NRPR) developed the design of the stations and provided the materials for the stations. Staff from the Pima Animal Control Center built the pet waste stations. NRPR installed 30 along The Loop and 20 in public parks. PAG provided the stickers carrying the message “Scoop it. Bag it. Trash it.” (Figure 2).

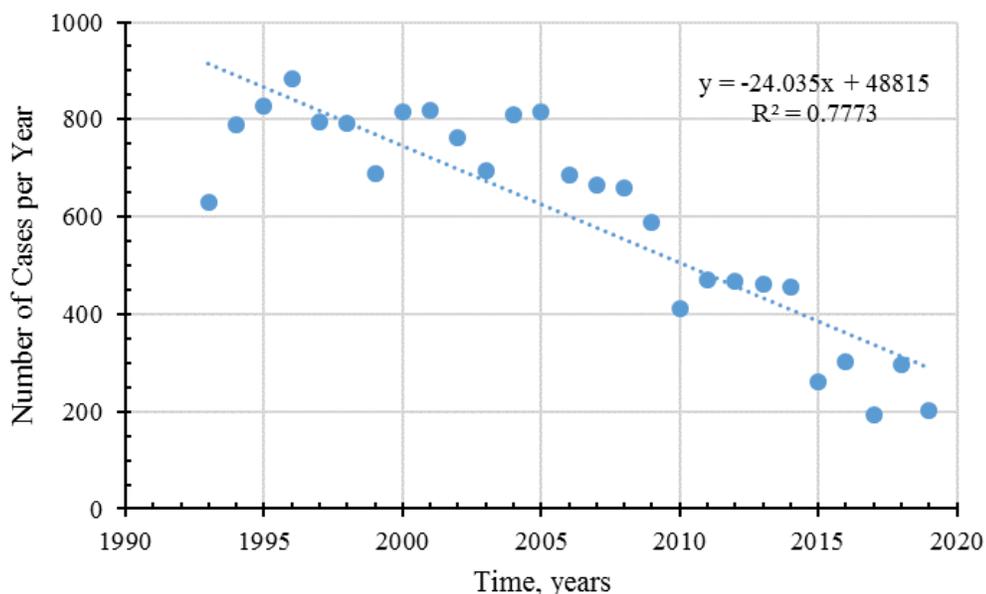
Figure 2. Number of Enforcement Cases related to Pollutants Exposed to Rain or Runoff

PDEQ frequently issues NOVs for solid waste on private property and wildcat dumping on public land in the Upper Santa Cruz watershed and the Brawley watershed. The average annual number of enforcement cases is declining by about 23 cases each year. The general trend is significant as the annual number of NOVs in 1996 reached nearly 900 and fell in fiscal year 2019 to 201.

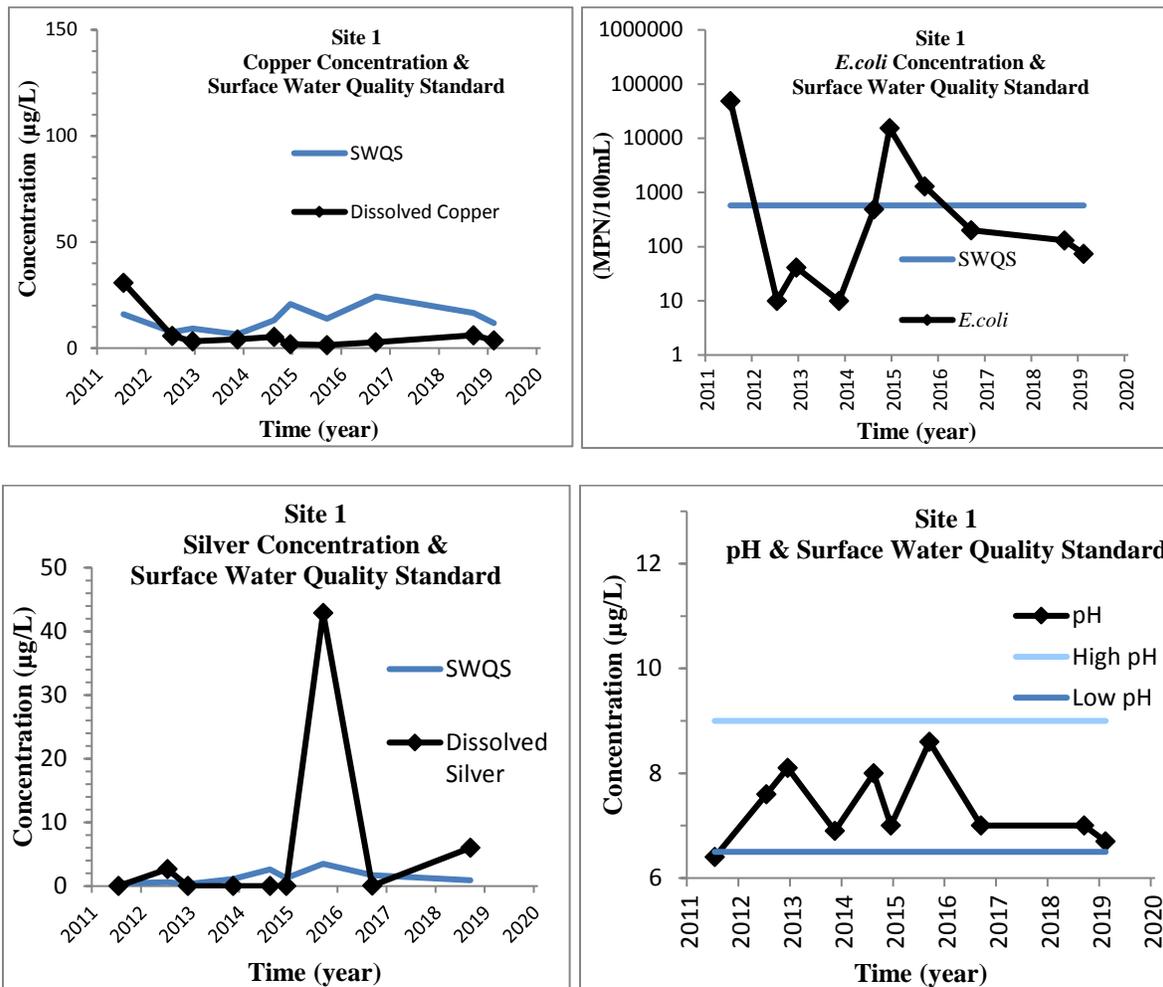
**Figure 3. Comparison of copper, silver, pH and *E. coli* Concentration to SWQS at Site #1**

Dissolved copper concentrations have been below the SWQS since July 2012. The watershed and road draining to the monitor site has low traffic, which is the anticipated source of copper. *E. coli* concentrations were above the SWQS three times, with two samples occurring consecutively, and the remaining sample events were below the SWQS since 2016. The high *E. coli* concentrations could be related to improper pet waste management or wildlife waste. The site is next to a wash, which acts as a wildlife corridor. Dissolved silver concentrations have been higher than the standard three times and all were isolated occurrences. There was a one-time occurrence of pH that was outside the SWQS and slightly acidic in 2011. The pH remained within standards since 2012.

Further actions are not recommended for this wet weather monitoring site.

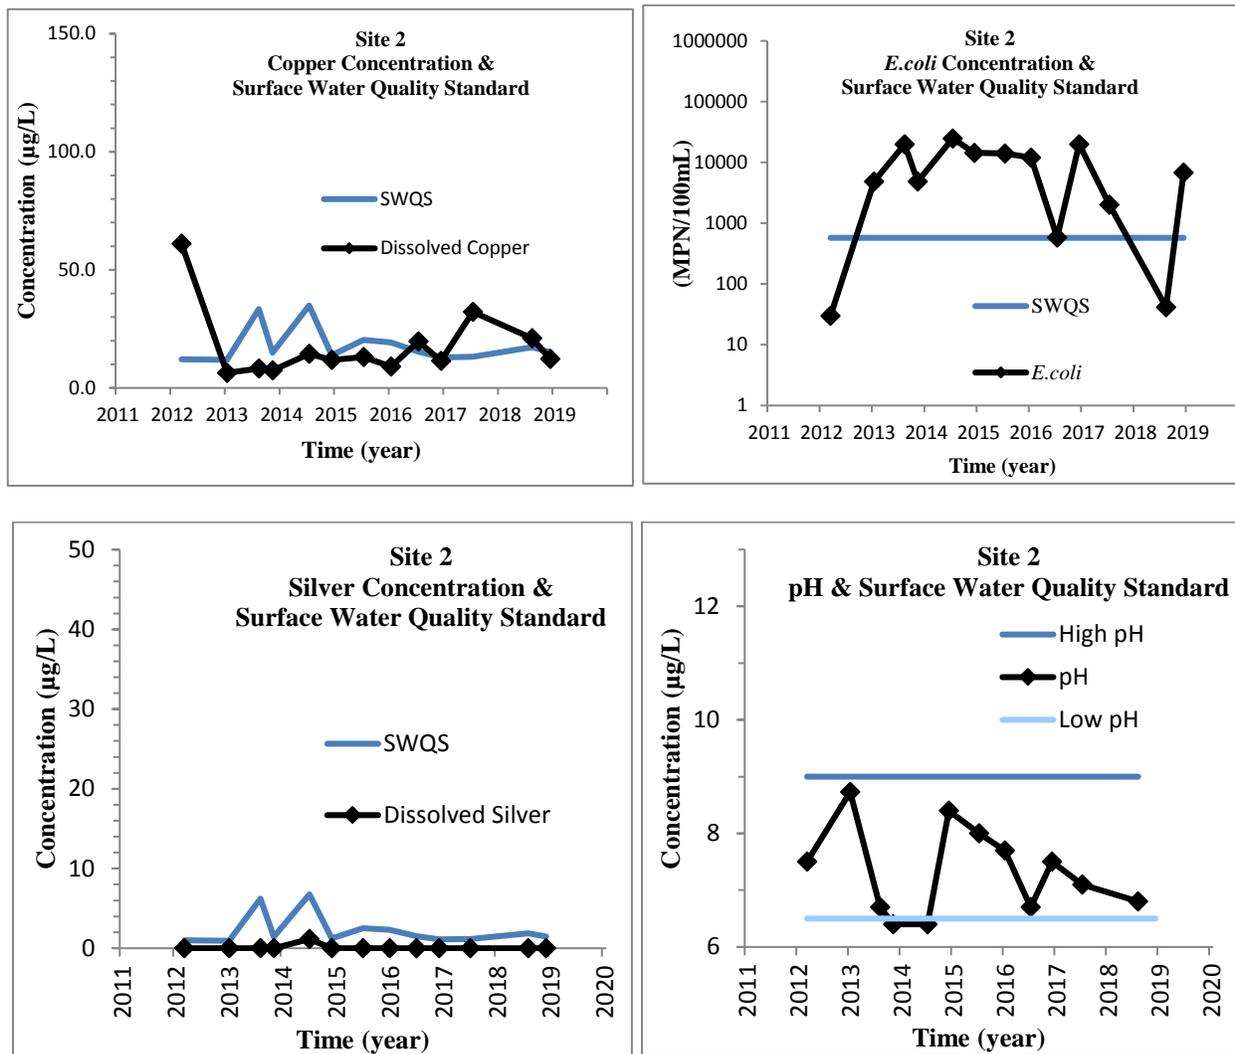
**Figure 4. Comparison of copper, silver, pH and *E. coli* Concentration to SWQS at Site #2**

The overall trend for water quality at Site #2 shows dissolved copper concentrations are typically below the SWQS. The *E. Coli* concentrations have been consistently higher than the SWQS since the first sampling in 2011. The high *E. coli* concentrations could be related to improper pet waste management in the medium density residential neighborhood. An outreach program is being developed to educate the neighborhood. Four samples had copper concentrations higher than the standard. Two samples had a pH slightly outside the SWQS indicative of acidic conditions in the second half of 2014. The pH has been in the normal range since 2015.

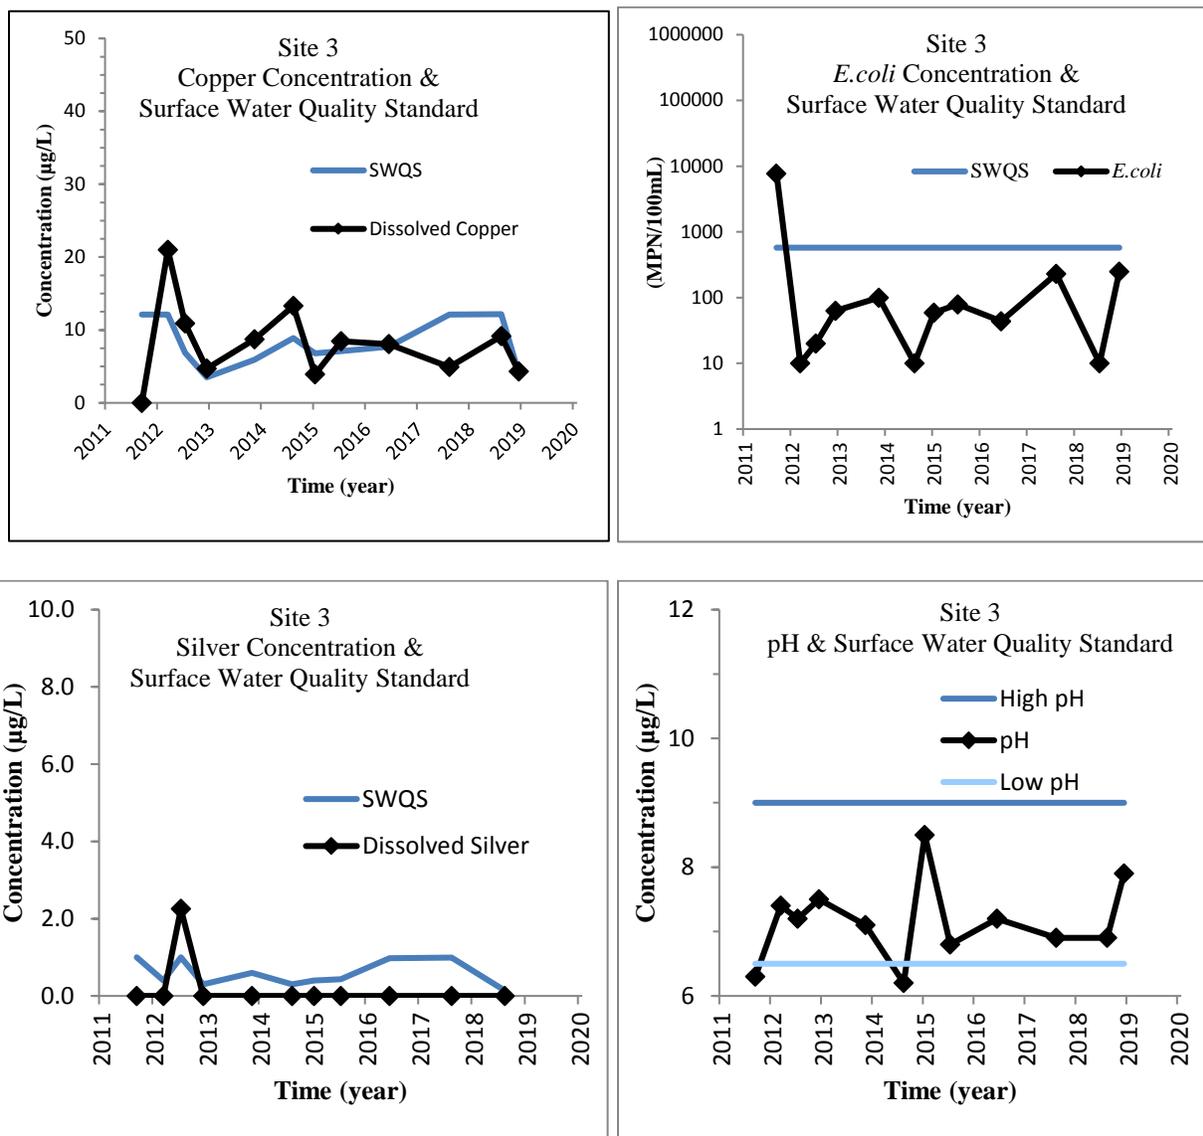
**Figure 5. Comparison of copper, silver, pH and *E. coli* Concentration to SWQS at Site #3**

The overall trend for water quality at Site #3 shows dissolved copper concentrations were consistently slightly higher than the SWQS until 2017 when the concentrations have consistently been below standards. With the exception of the first sampling event, *E. Coli* concentrations have consistently been below the SWQS, reflective of the neighborhood members taking pet waste management seriously. The dissolved silver concentration was higher than the SWQS once and has been non-detect for all other samples. The pH has been outside the SWQS range twice.

No further actions are recommended for this wet weather monitoring site.

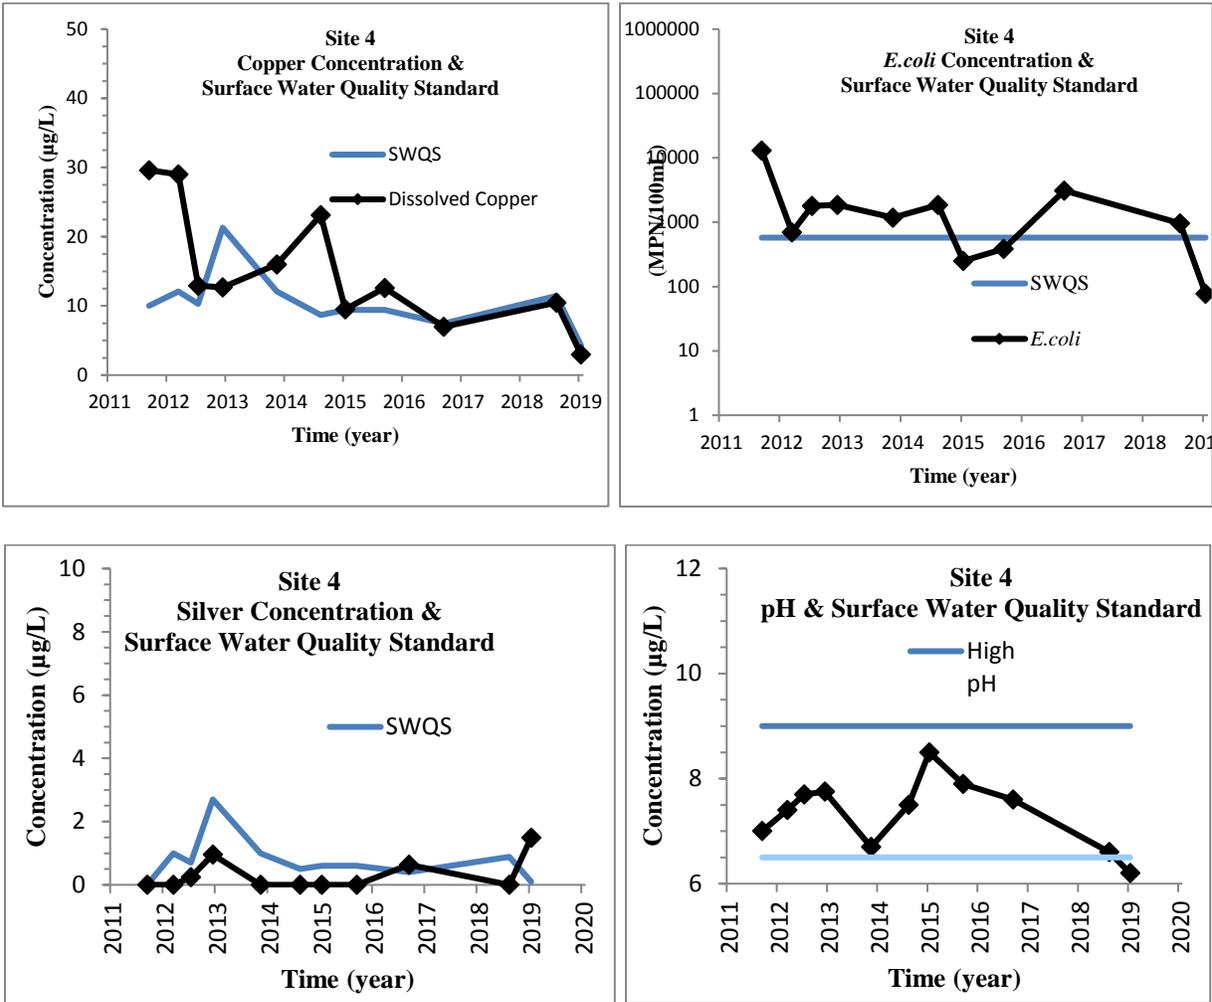
**Figure 6. Comparison of copper, silver, pH and E. coli Concentration to SWQS at Site #4**

The overall trend for water quality at Site #4 shows dissolved copper concentrations have declined over the years such that concentrations have been below the standard since 2016. *E. coli* concentrations have been above the SWQS, with the exception of the 12/14/12, 09/07/16 and 01/06/19 samples. The dissolved silver concentration was higher than the SWQS twice and these samples were non-consecutive. In the most recent sample, the pH was just outside the standard indicating acidic conditions.

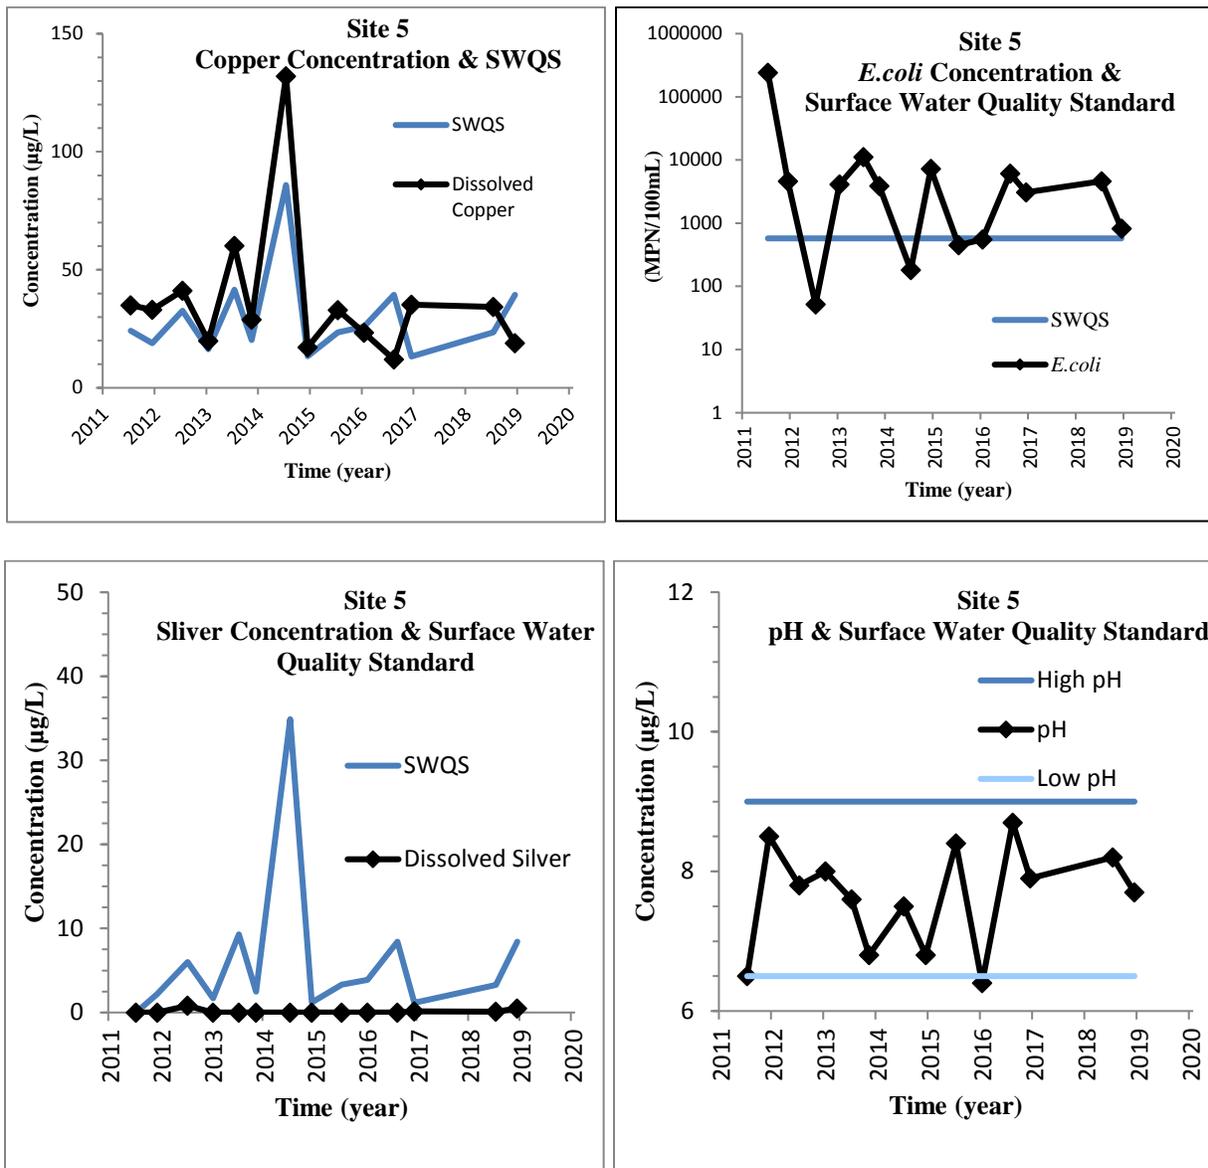
**Figure 7. Comparison of copper, silver, pH and *E. coli* Concentration to SWQS at Site #5**

The overall trend for water quality at Site #5 shows that dissolved copper was consistently above the SWQS, until 2016 when half are below and half are above. The summer 2014 sample was anomalously high for metals and Total Suspended Solids. Summer concentrations are relatively higher than winter samples indicating seasonal influences. *E. coli* concentrations have been higher than the SWQS seven times in five years. One pH has been outside the SWQS.

Sources of copper in stormwater include vehicle brake pads; architectural copper; copper pesticides in landscaping, wood preservatives and pool, spa, and fountain algacides; industrial copper use; deposition of air-borne copper emissions from fossil fuel combustion and industrial facilities; and vehicle fluid leaks and dumping (TDC Environmental, 2006). The Brake Pad Partnership showed brakes account for 35 to 60 percent of copper in California's urban watershed runoff (Copper Development Association, 2013). A study of runoff from copper roofs and gutters shows first flush concentrations immediately downstream from the roof have a mean greater than 1,340 ug/L for both total and dissolved copper (Michels, et al, 2001). This study noted roofs with the oxidation by-product brochantite release about half as much as cooper roofs exposed to air.
