FIELDNOTES

From The Arizona
Bureau Of Geology And Mineral Technology

THE "FLOODS" OF OCTOBER 1983

by H. Wesley Peirce
and Peter L. Kresan

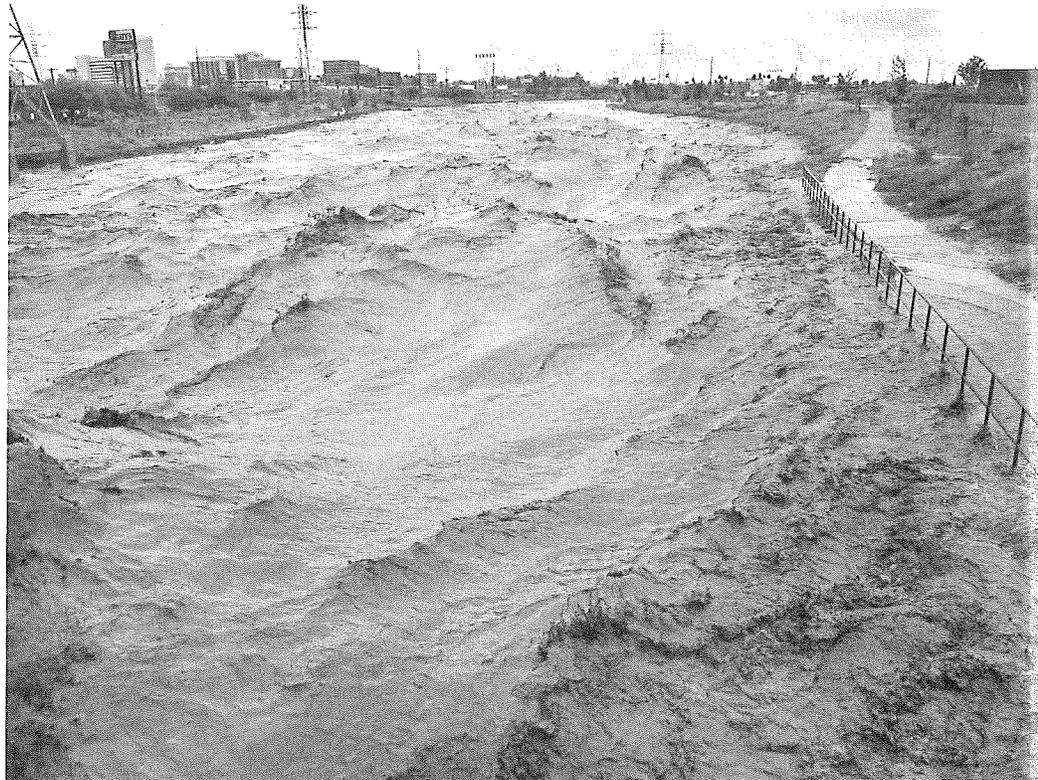
Figure 1. Raging waters of the brimful Santa Cruz River. Looking upstream to the south from St. Mary's Bridge. Photo taken on October 2, 1983 by Peter Kresan.

Those who witnessed one or more of the major drainages in action were reminded of the frightening power of rushing, roily water (Figure 1). A flow rate of 25,000 cubic-feet-per-second (estimated for Rillito Creek) is about equivalent to an 800-ton mass moving past a given point each second. (An 800-ton mass weighs more than two 747 Jumbo Jets, which weigh 775,000 pounds each.)

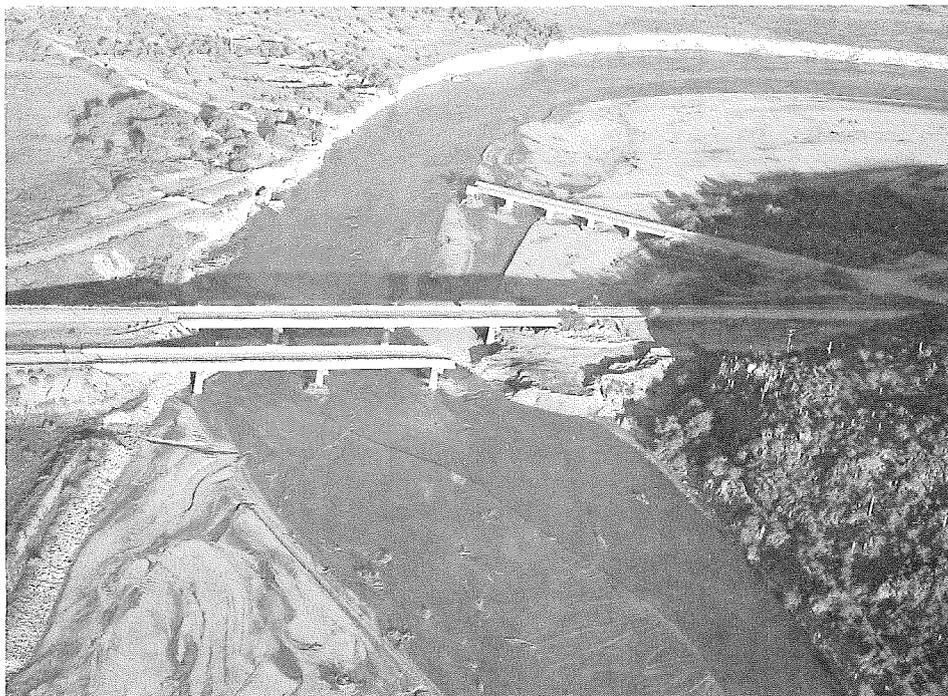
Figure 2a. Severe bank-cutting along the Santa Cruz River near I-19 and San Xavier Road. Looking northwest. Bridge segment nearest viewer collapsed when support washed out. Bridge in distance did *not* fail. Bank retreated from west end of bridge to present position. Distance between bank and midstream end of bridge is measure of amount of bank erosion that occurred. Photo taken on October 9, 1983 by Peter Kresan.

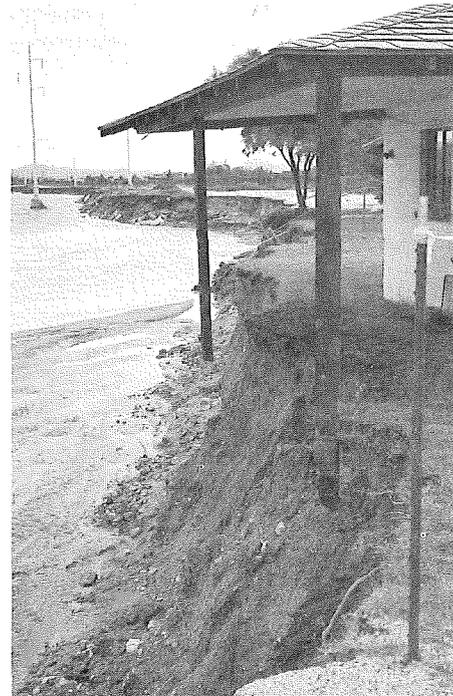
Figure 2b. Bank-cutting along north bank of Rillito Creek at N. 1st Avenue. Looking downstream. Photo by Peter Kresan.

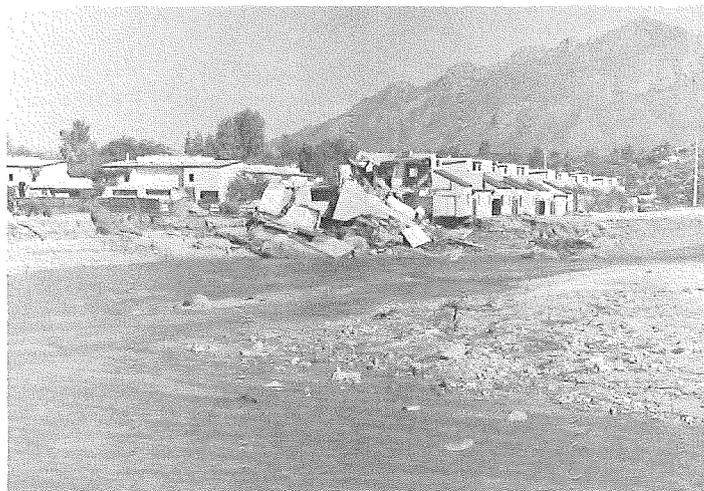
Figure 2c. Bank-cutting on outside of bend along Rillito Creek. Looking downstream near Prince and Country Club Roads. Photo by Tad Nichols.

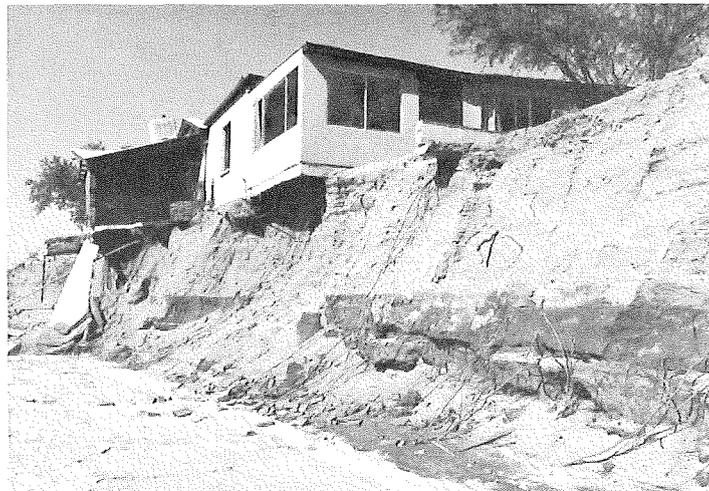
Figure 2d. Bank erosion along north bank of Rillito Creek. Looking downstream. Photo by Ken Matesich.

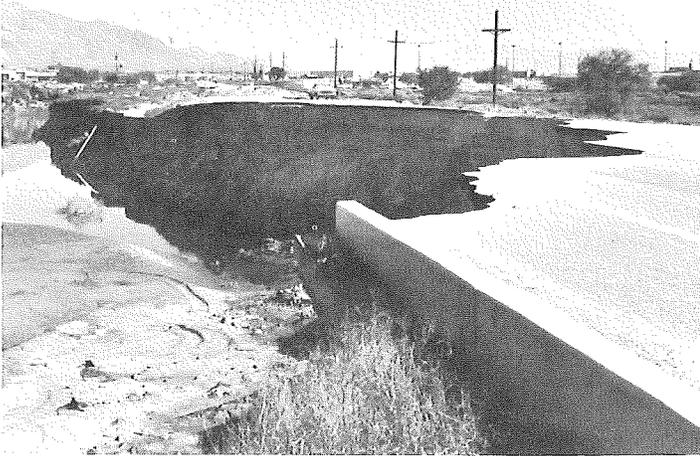
Figure 3a. Ina Road undercut by water from adjacent Santa Cruz River. Looking northeast. Photo by Ken Matesich.

stream from the confluence of Rillito Creek and Canada del Oro with the Santa Cruz River. Water spread out laterally over a distance of 4 or 5 miles, causing a true flood. The channels through the city of Tucson, on the other hand, are deeply entrenched and barely managed to contain the October runoff within their banks. Nevertheless, this "saving grace" did not prevent the turbulent waters from damaging bridges, roads, buildings, vehicles, utility lines, crops, livestock, certain bank-protection devices, etc. (Figures 3a-d).

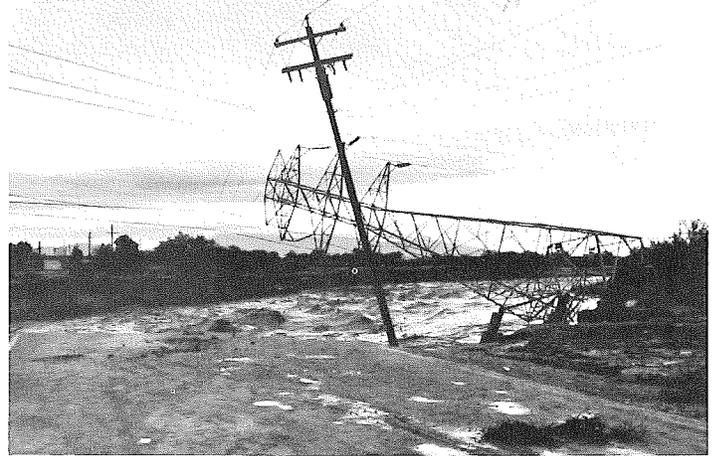
Figure 3b. Wipeout of bridge and utility tower at Sunset Road crossing of Santa Cruz River. Looking southeast. Photo taken on October 2, 1983 by Steve Reynolds.

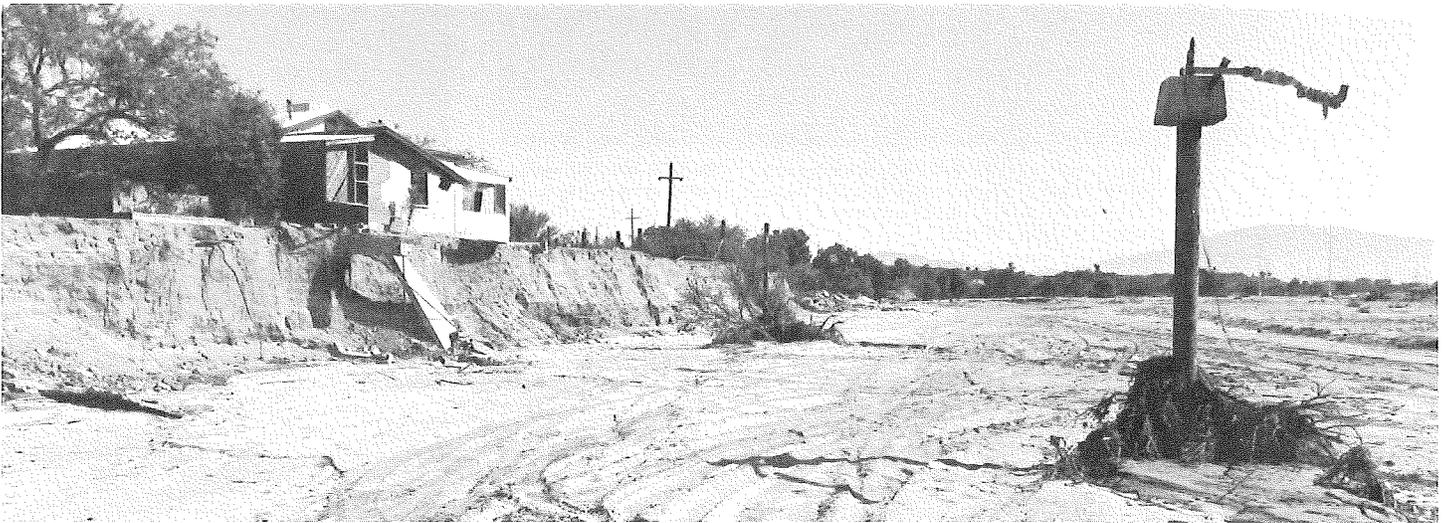
Figure 3c. Same area as Figure 2d. Looking upstream at water well that was on left side of bank before erosion. Photo by Ken Matesich.

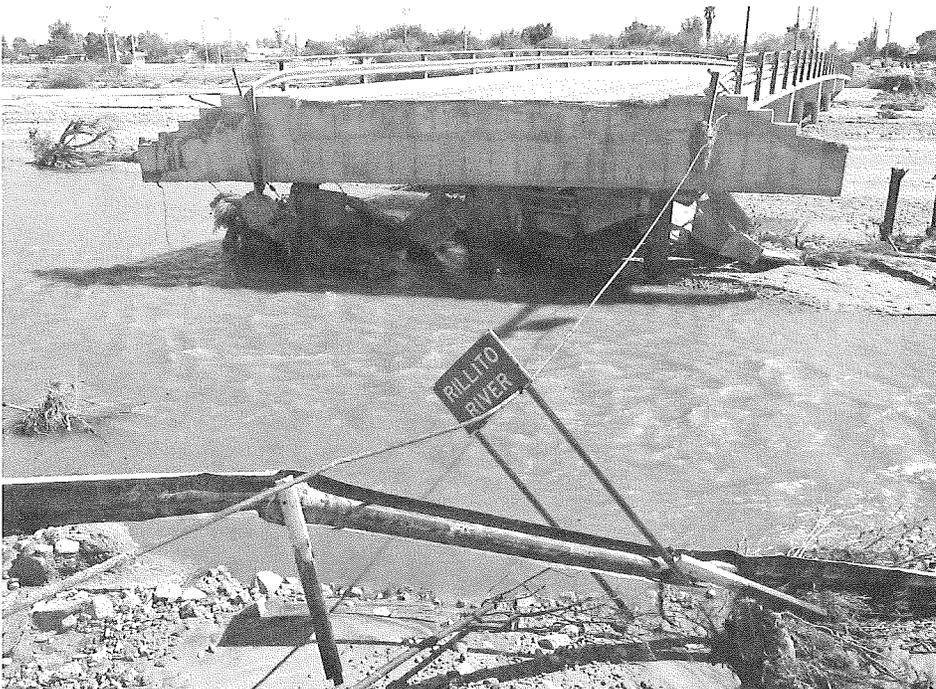
Figure 3d. Wipeout of northern approach to Dodge Boulevard Bridge over Rillito Creek. Looking south. Photo by Peter Kresan.

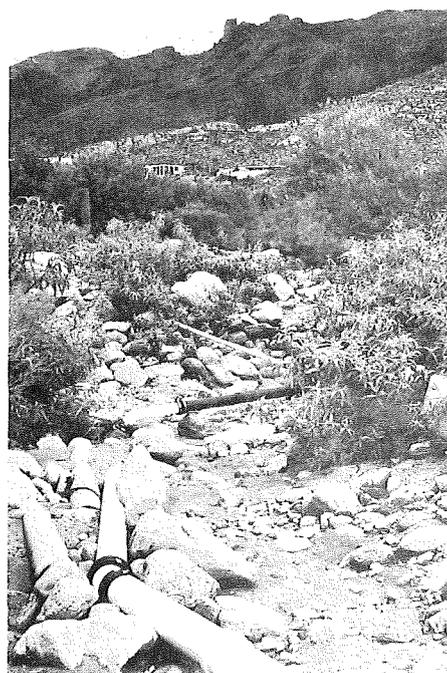
Figure 4. Sewer line, buried for 11 years, uncovered by erosion along bottom of Finger Rock Wash in foothills of Santa Catalina Mountains. Smaller pipe is natural gas line, also exposed by erosion. Looking upstream toward the northwest. Photo by H. Wesley Peirce.

fects were widespread. Small washes scoured their banks and bottoms, often finding things of man to damage (Figure 4).

Local residents might expect a future rash of aggravating maintenance work where utilities were buried along and beneath foothill washes several years ago. In some cases, various lines, buried until 1983, were uncovered by wash-bottom scour and broken at least three times in the latter half of the year (Figure 4). Many more lines are now closer to the surface because of erosion above them.

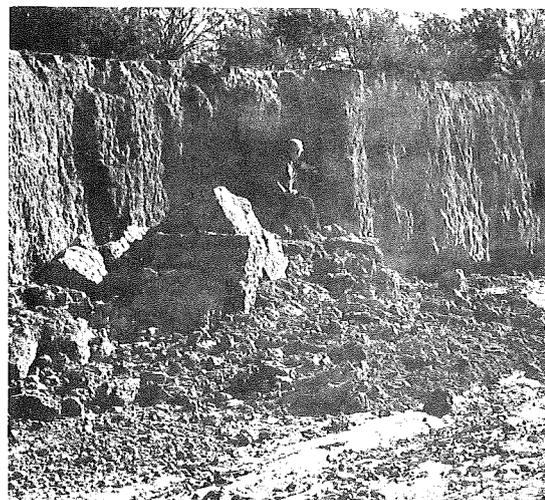
Figure 5. East bank of Pantano Wash collapsing after flow ceased. Scene depicts instability of banks and attendant hazard. Photo by H. Wesley Peirce.

mechanism. Vibrations of any sort, loading at the top by even one person, and undercutting by cave-making youngsters could cause a bank to collapse, with potentially tragic results (Figure 5).

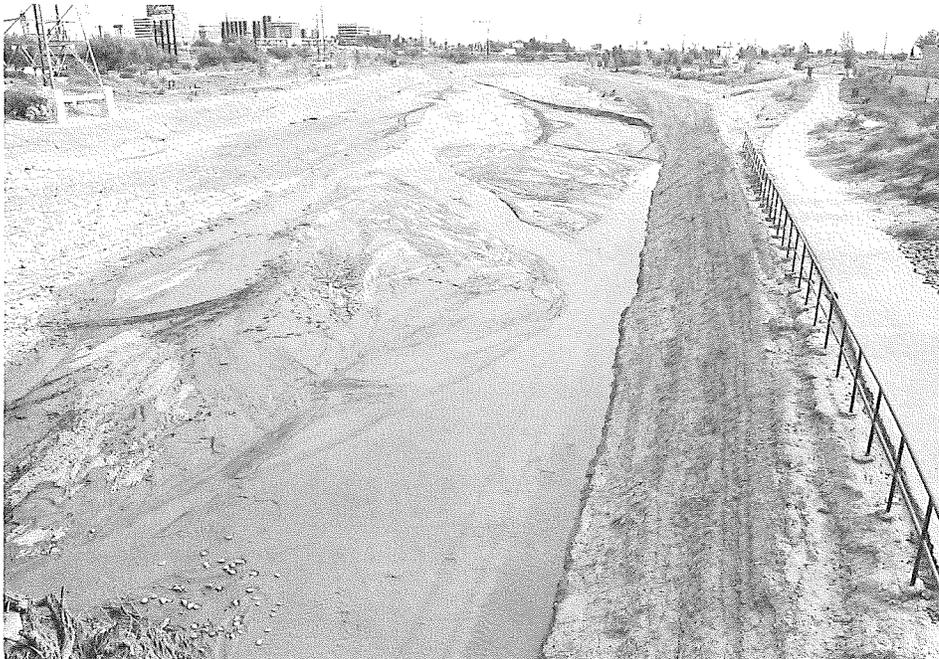
Figure 6a. Same area as Figure 1 after passage of major flow. Right bank with railing is undamaged soil cement. Photo by Peter Kresan.

Considerable experience was gained about various methods of protecting banks. Almost anything will protect a bank, as long as the protective device is not tested too severely. A recently developed technique, which involves the use of soil cement, received its baptism in October. Except for minor problems, the technique tested well (Figures 6a and 6b). On the other hand, some of the more classic protective measures failed during the big October test (Figures 7a and 7b). For regulatory purposes, Pima County now recognizes only one type of bank protection: soil cement. Several soil-cement projects, funded by Federal monies, are underway at the places deemed to be most critical.

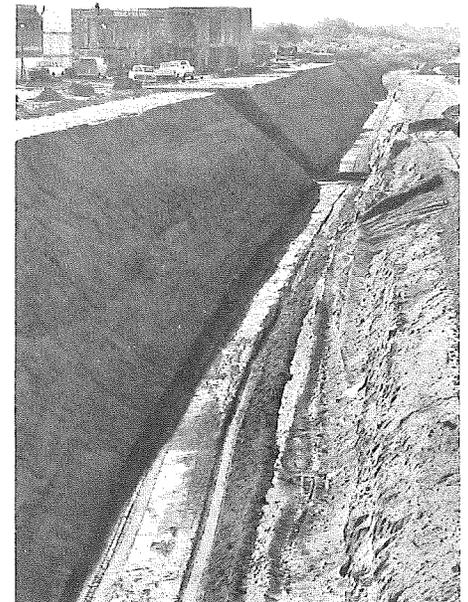
Figure 6b. Pantano Wash bank undergoing soil cement process. Photo by Ken Matesich.

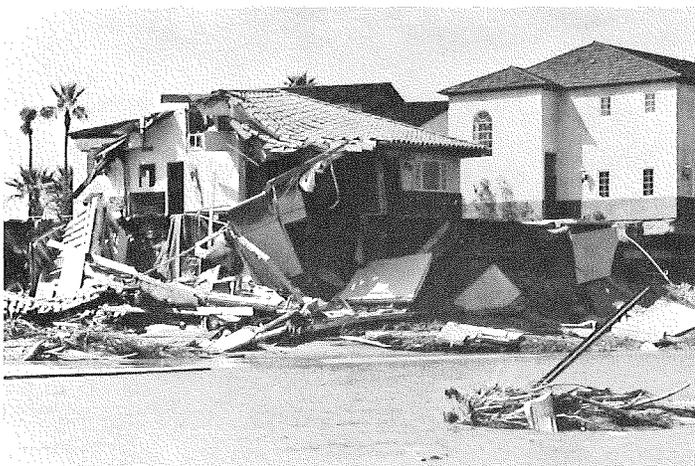
Figure 7a. Post in foreground marks position of bank-protection device prior to October 1983. South bank of Rillito Creek near N. 1st Avenue. Photo by Peter Kresan.

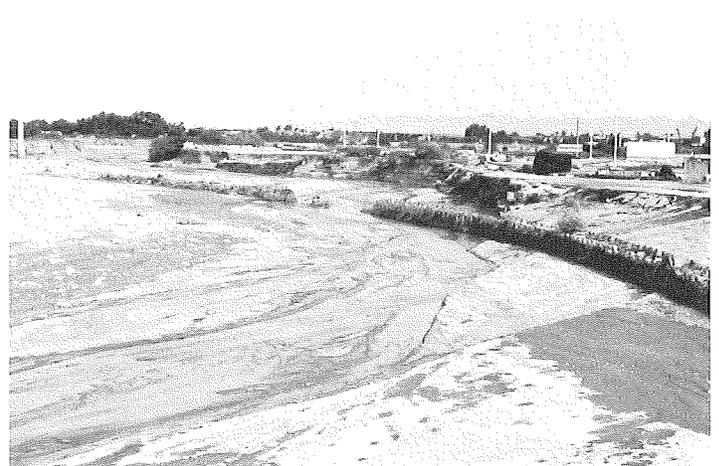
Figure 7b. Rock-and-wire-mesh bank-protection device breached and overtopped in October 1983. Looking north along Santa Cruz River from bridge at W. Grant Road. Photo by H. Wesley Peirce.

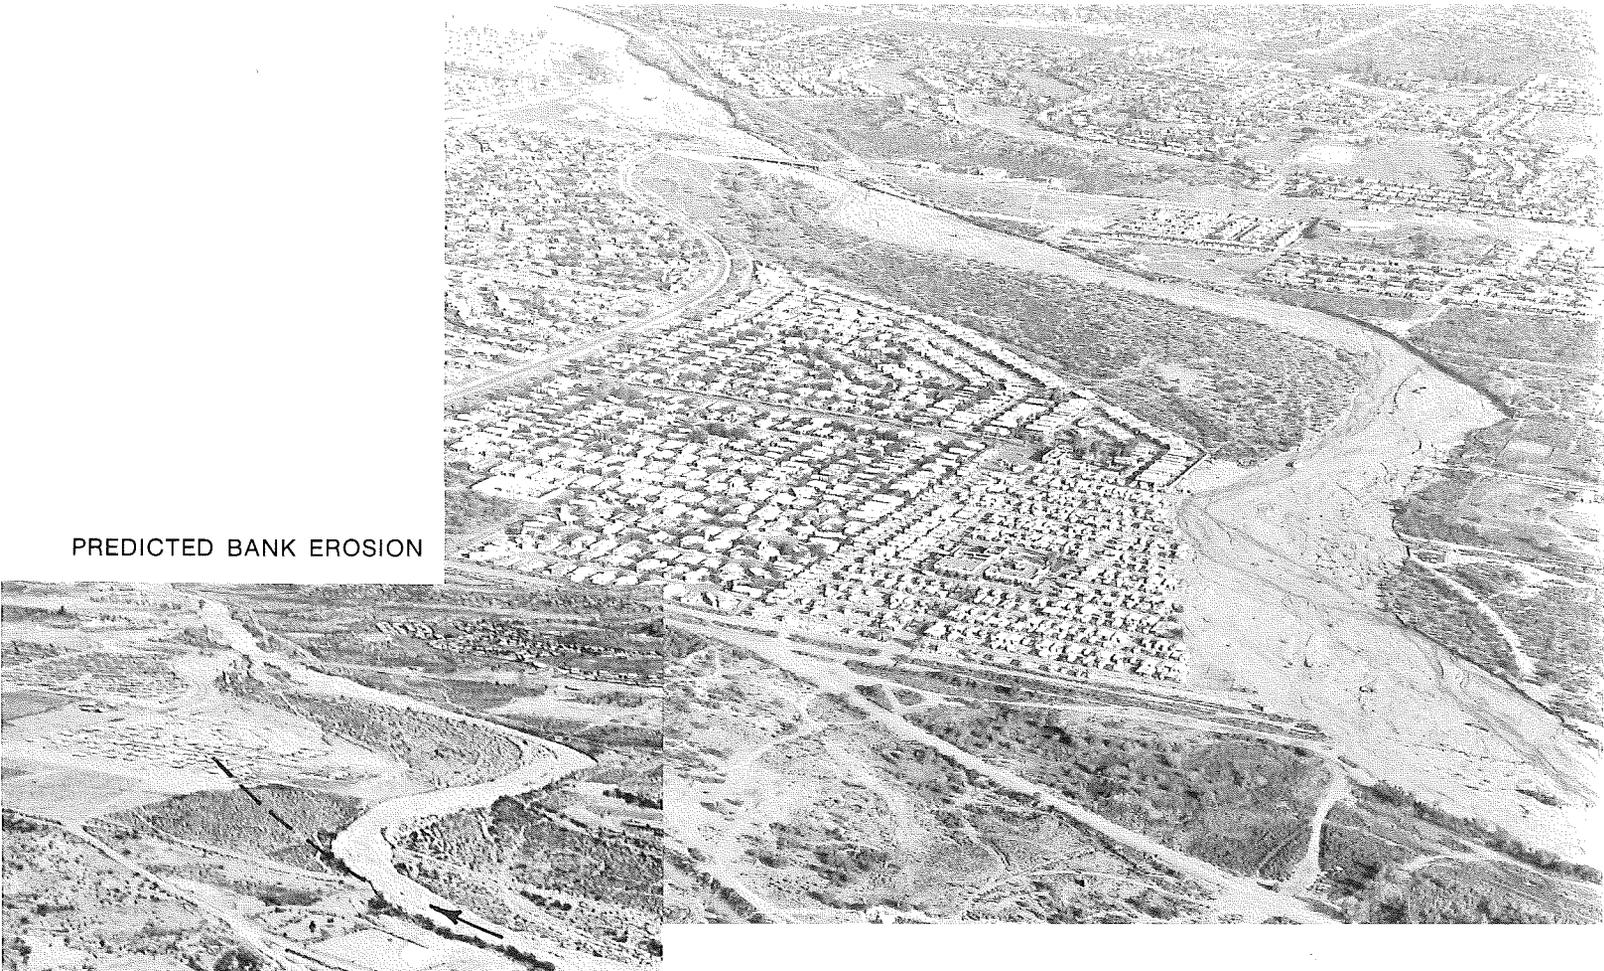
Figure 8. Bank-cutting at outside of bend along west bank of Pantano Wash, south of Golf Links Road. Photo taken on October 9, 1983 by Peter Kresan.

Inset: Same area as main photo, as seen in 1972. Dashed line indicates trend of future bank-cutting, as predicted in *Fieldnotes* in September 1972. Note erosion along predicted trend. Also note expansion of development toward wash. Photo by H. Wesley Peirce.

The October runoff event demonstrated how difficult it is to protect works of man that encroach upon major drainages. The largest drainages, such as Pantano Wash, Rillito Creek, and the Santa Cruz River, reached man-made structures that had been built many years ago. The runoff event was large, powerful, and persistent enough to cause hundreds of feet of lateral bank migration in several places. The areas where the soft banks would be cut away were predictable (Figure 8 with inset); the *size* and *power* of the runoff event, however, were *not* anticipated.

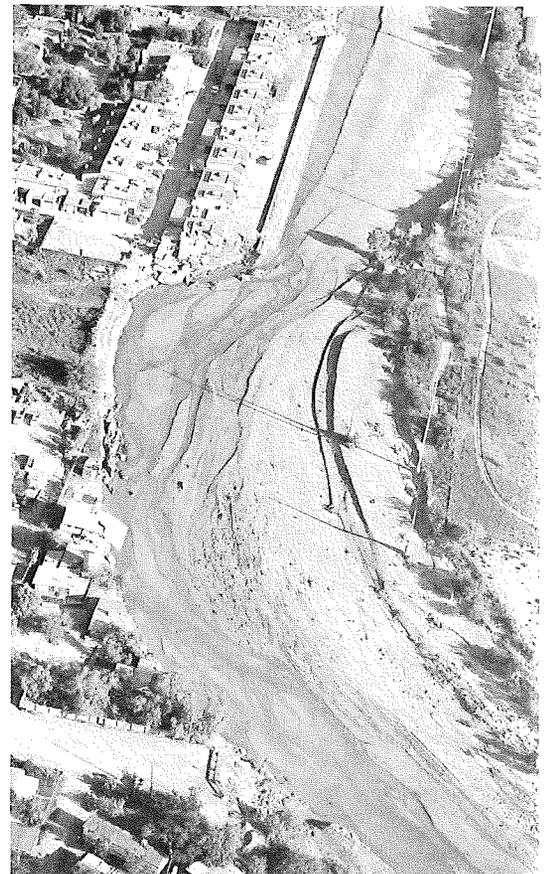
Figure 9. Bank collapse after Rillito Creek got behind upstream end of soil-cement protective device and undermined buildings. Flow is from bottom to top. There was no bank protection for buildings in lower left position. Near intersection of Prince and Country Club Roads. Photo taken on October 9, 1983 by Peter Kresan.

Because the channels, banks, and adjacent flood plains along major drainages are usually privately owned, it has not been possible to treat these systematically. A shopping-center owner can afford to invest more heavily in protection than can an average home or trailer-park owner. The result is "piecemealing," a condition that a raging flow of water will test in search of a weakness. Bank protection devices necessarily end at property boundaries, a situation that leaves the devices especially vulnerable at their points of termination. This is also true of soil cement. Water can erode the efficacy of any protective device if it gets behind the upstream end or overtops the structure (Figure 9). Selective application of soil cement is itself a form of "piecemealing" that will leave unprotected banks free to migrate (Figure 9). How this migration will eventually affect the protected parts remains to be seen.
