# High Plains Effluent Recharge Project: Biological Monitoring, 2002

PIMA COUNTY  
DEPARTMENT OF TRANSPORTATION  
AND FLOOD CONTROL DISTRICT  
October 29, 2002

**HIGH PLAINS EFFLUENT RECHARGE PROJECT**  
**BIOLOGICAL STUDIES**  
**MONITORING REPORT - 2002**

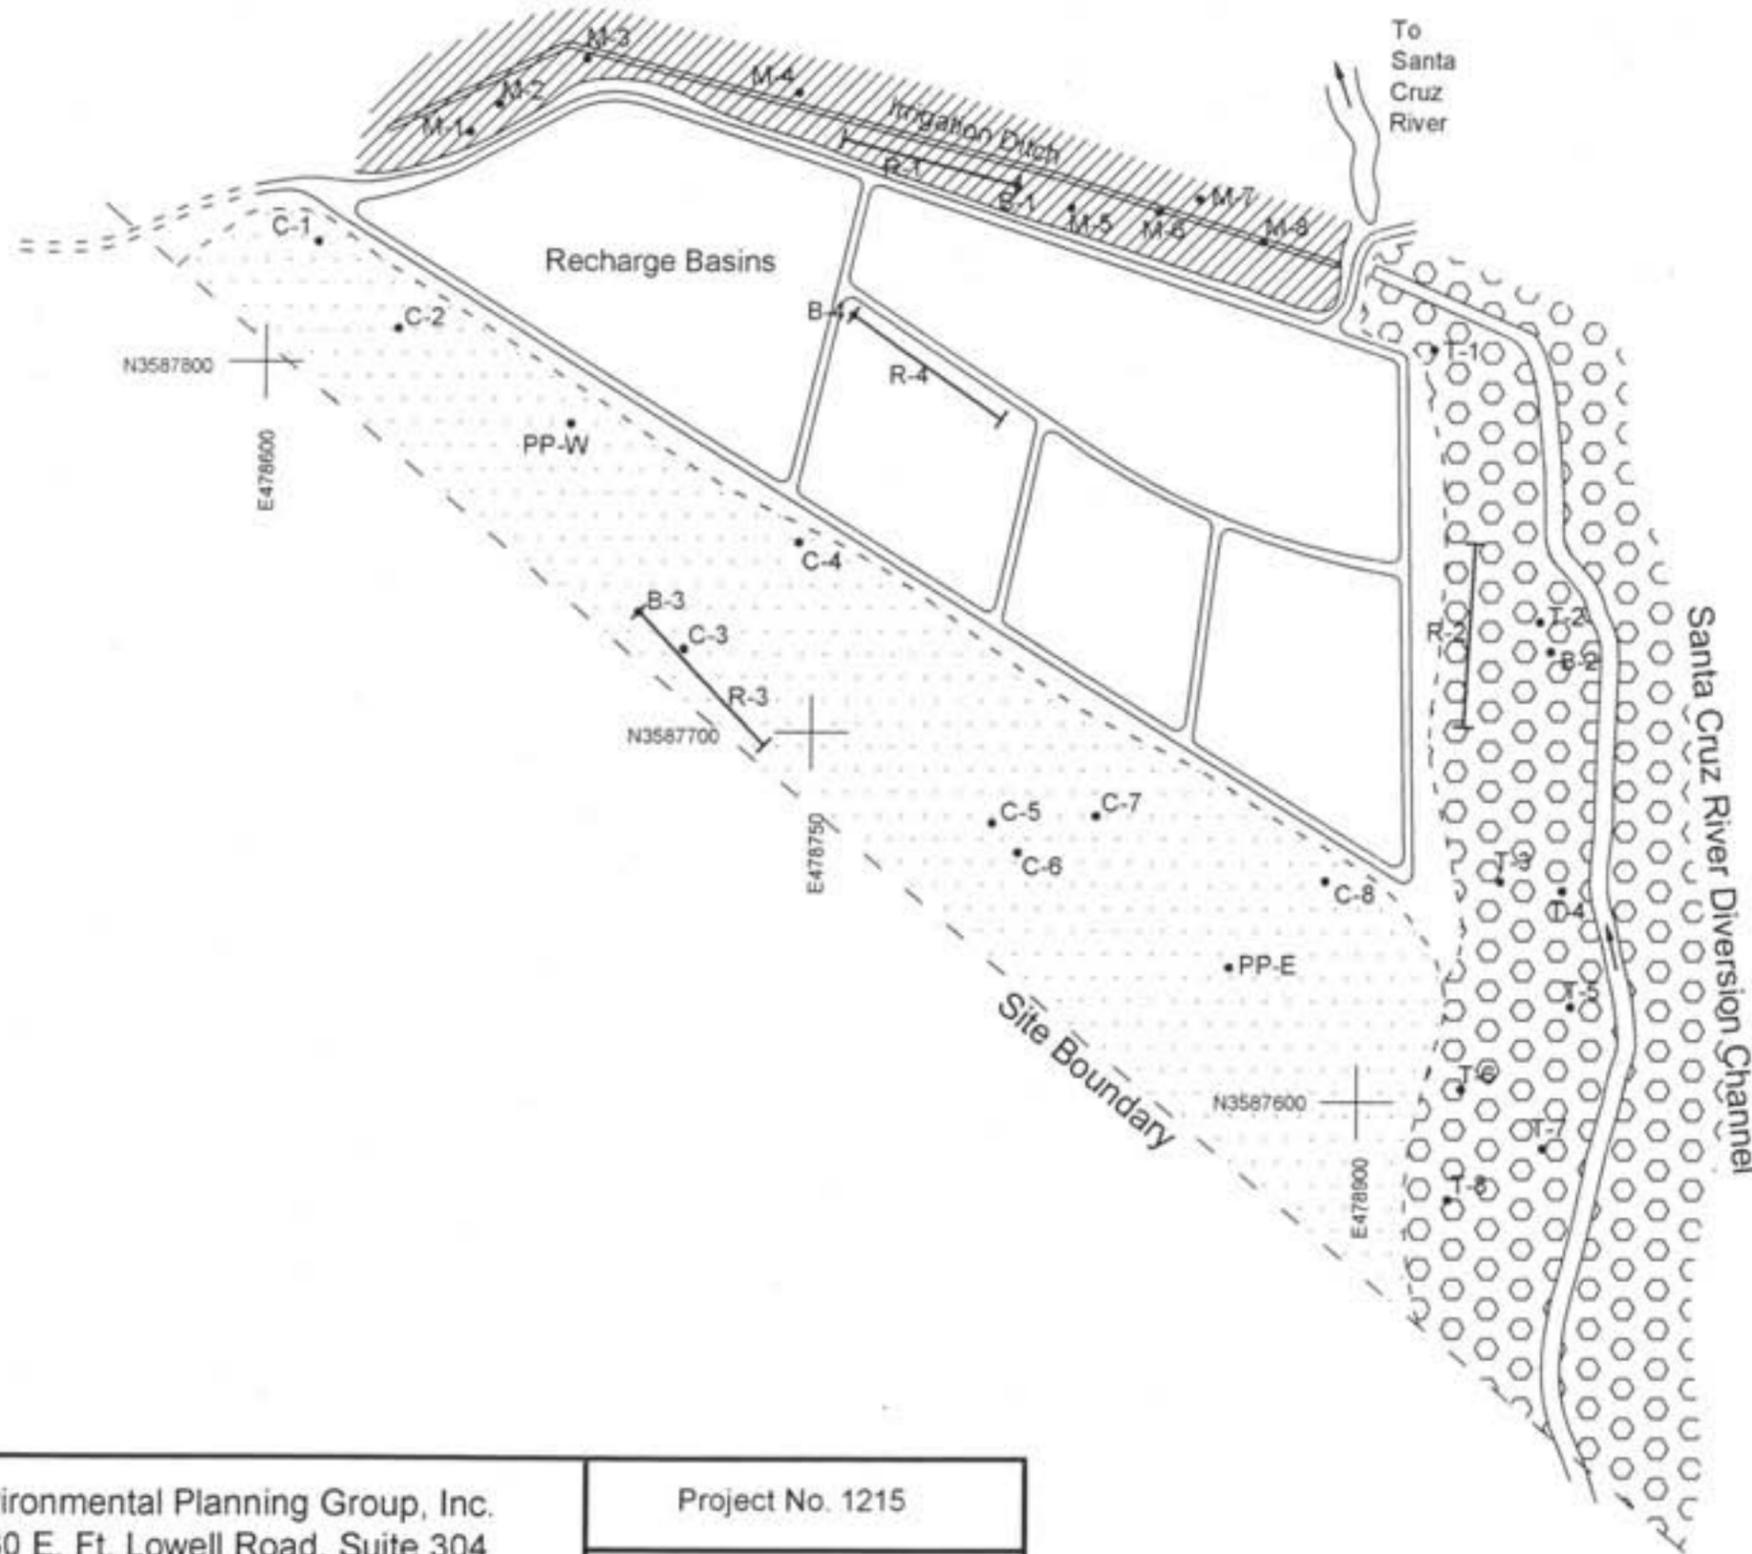
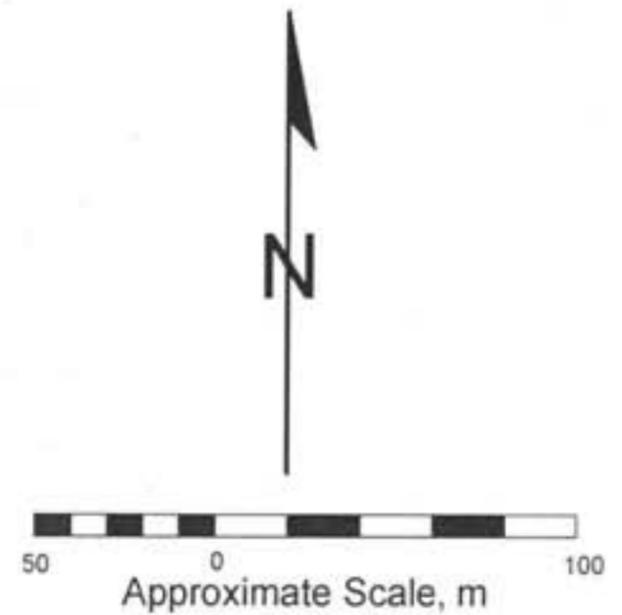
Figure 2. Site Plan Sketch  
 High Plains Effluent Recharge Site  
 Pima County Floodwater District

Point counts for birds were conducted using the variable circular-plot method described by Reynolds et al. (1980). Counts were made at four locations on the property, with one point in each of the habitat types (see Figure 2). During each census, all birds observed (seen or heard) were recorded, with an estimated distance from the central point. For each individual, the habitat use was recorded as in the habitat of the central point, in an adjacent habitat, or flying over the site. Each point was censused twice during May, to include the early breeding season and the end of the spring migration. From the combined results, it is possible to estimate the density of species observed within the habitat of the central point.

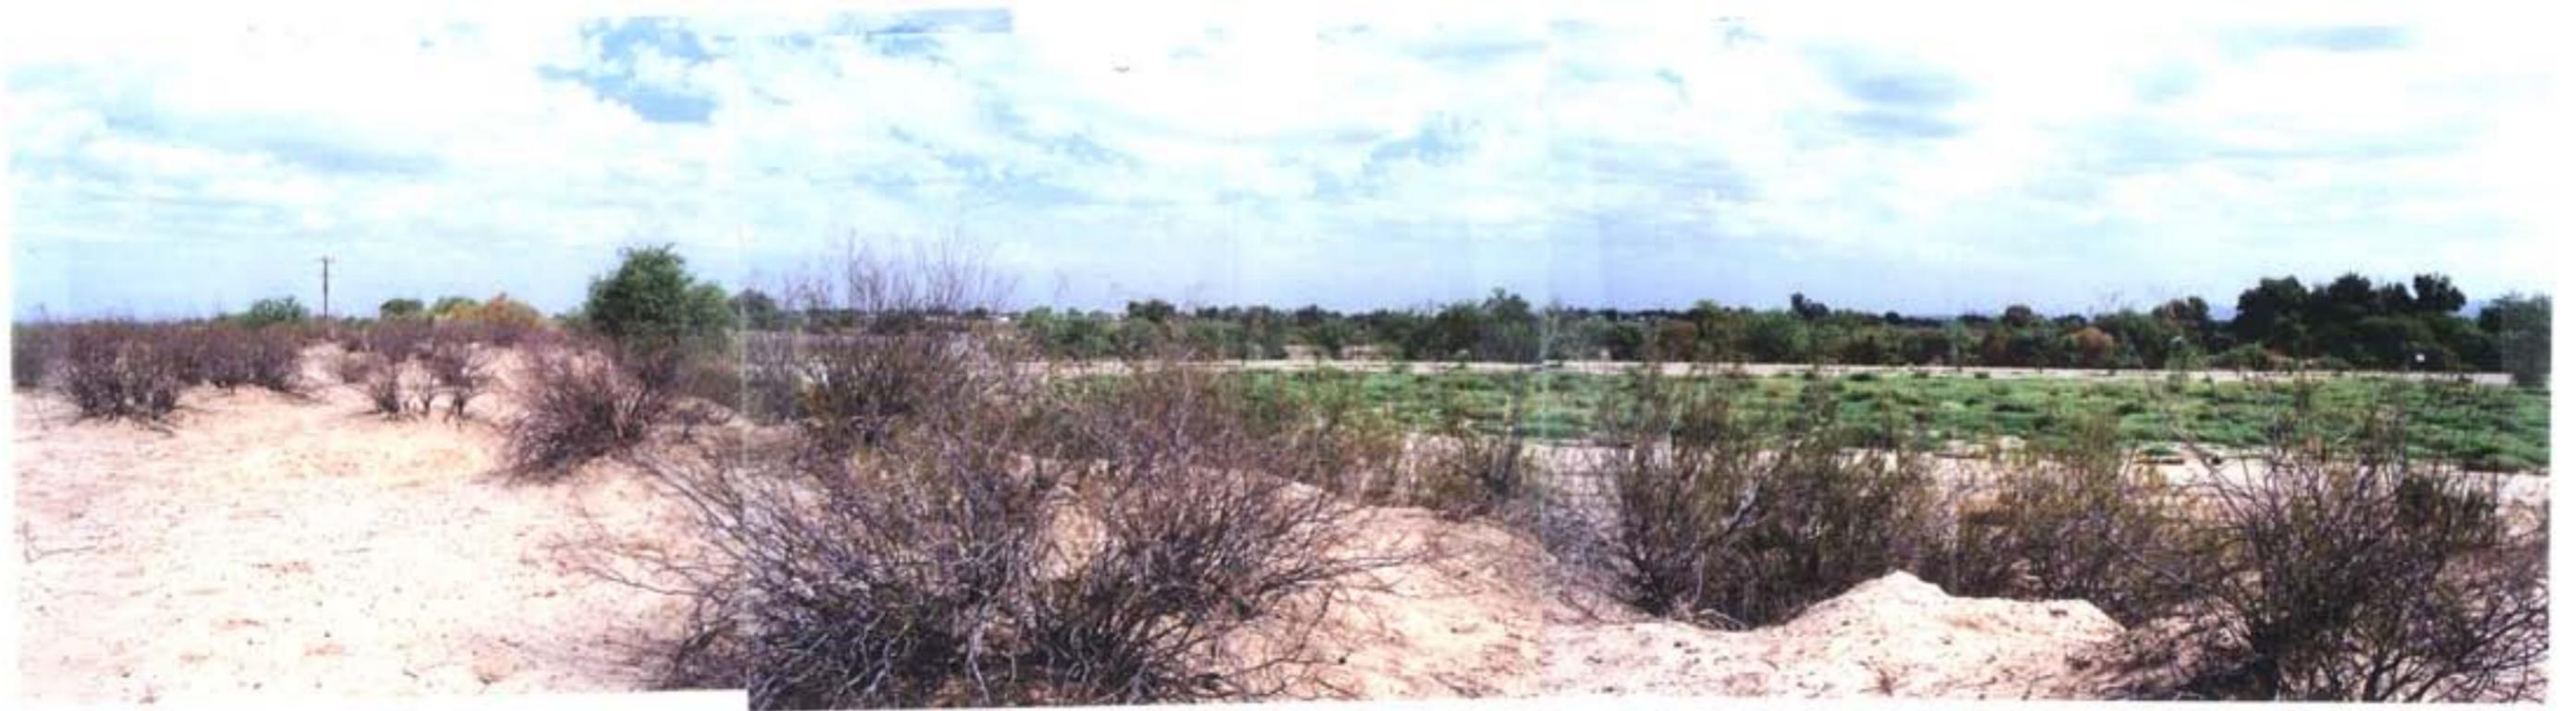
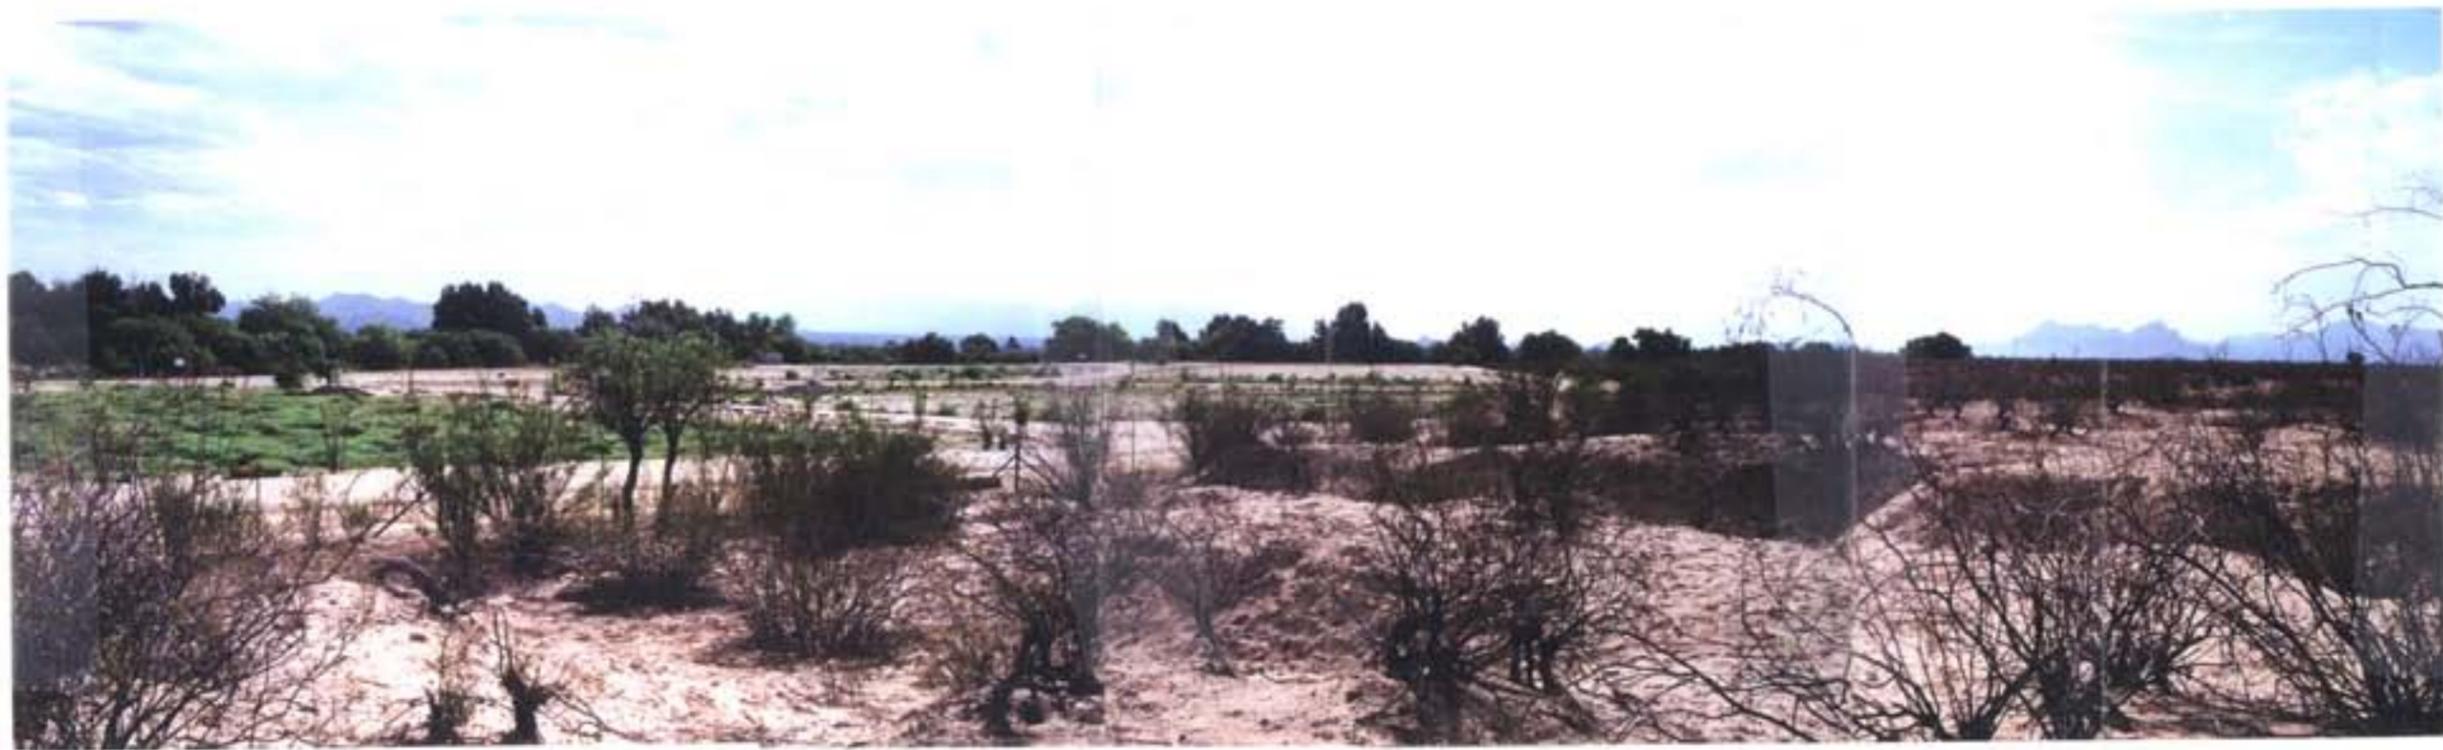
Figure E-1. Panoramic photograph, 35 mm lens, August 28, 2002, from west photo point (see Figure 2)

Panoramic sets of photographs were taken from the same two points used by ENTRANCO (1998). Stakes indicating these locations were still present on the site. At each point, the camera was mounted on a tripod and series of overlapping photos were taken with 55-mm and 35-mm lenses. These panoramic photos are shown in Appendix E.

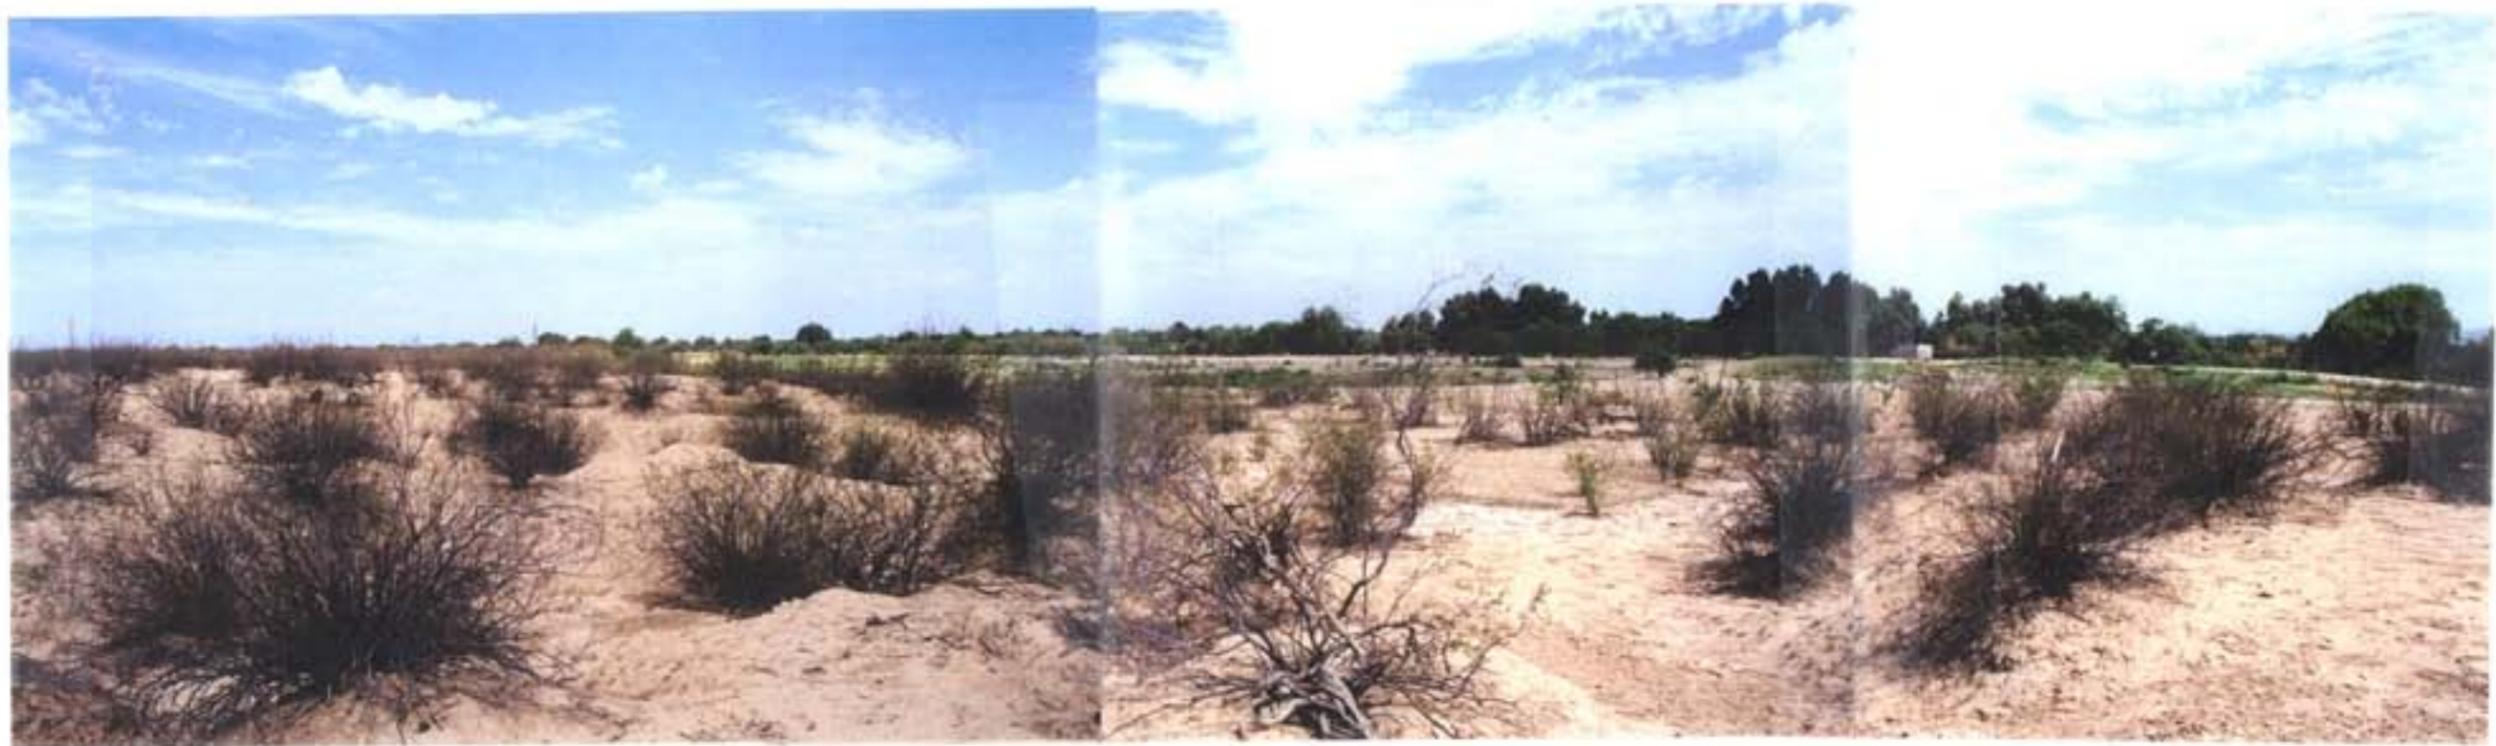
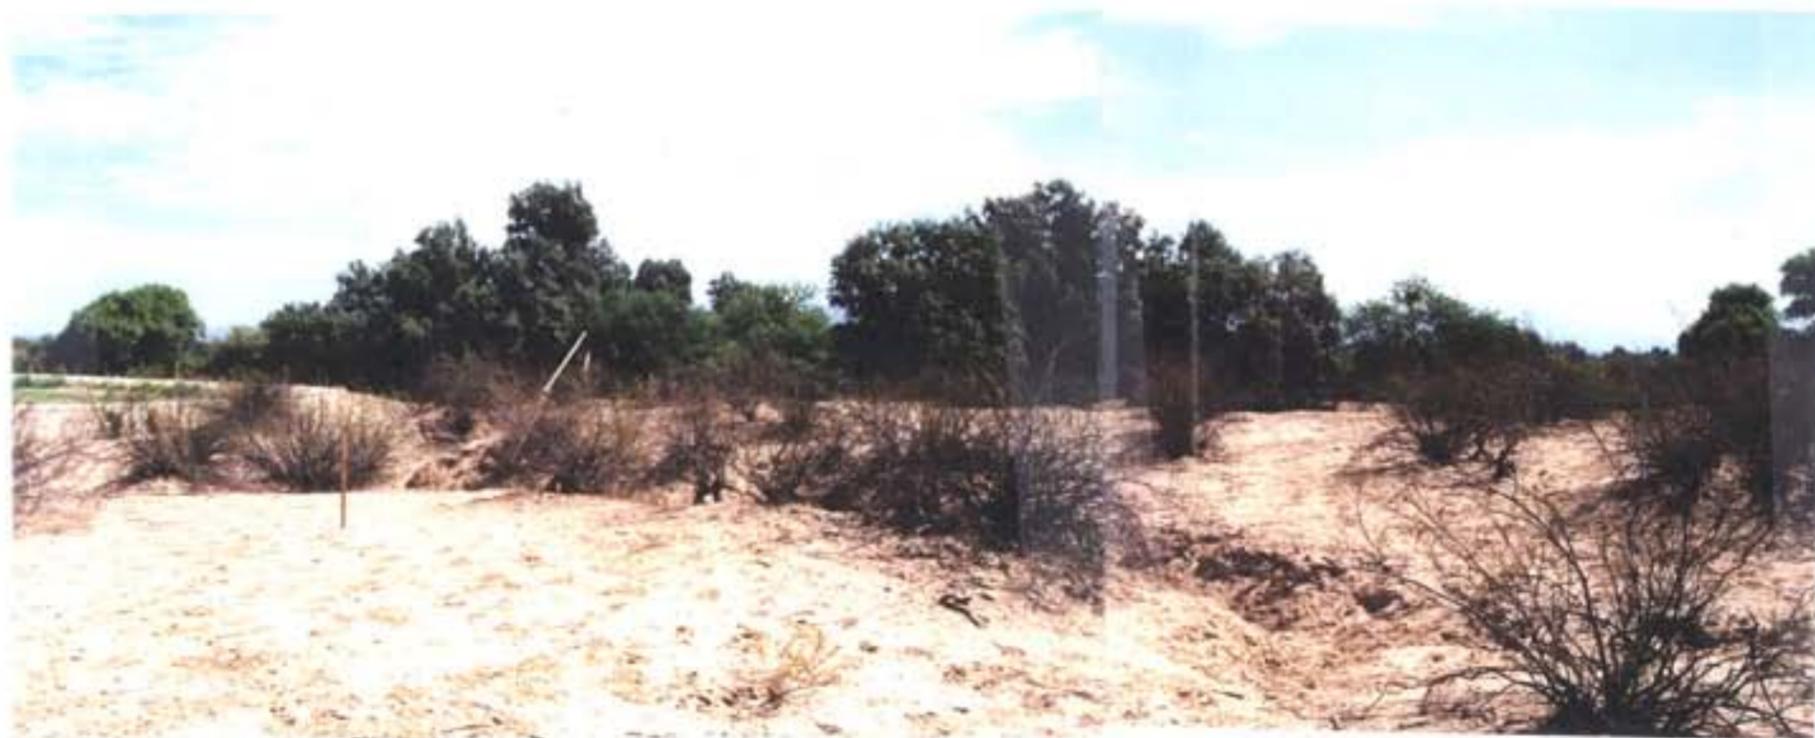
Figure E-2. Panoramic photograph, 35 mm lens, August 28, 2002, from east photo point (see Figure 2)

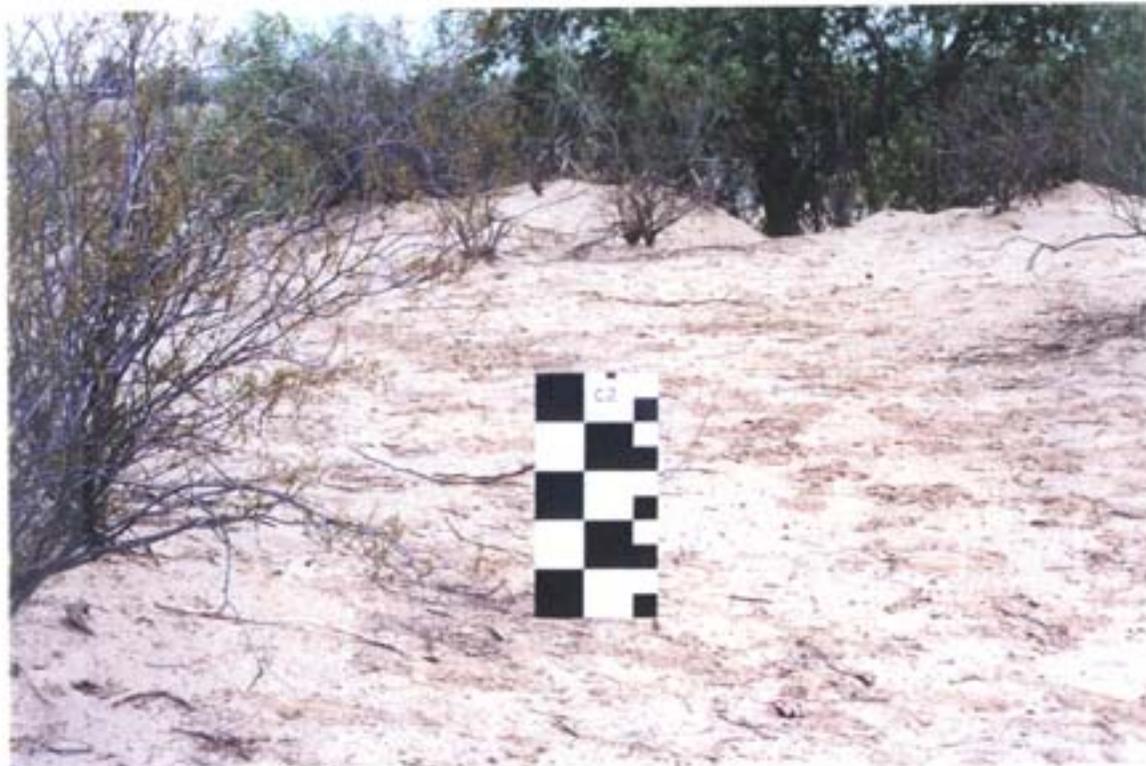
Figure E-3a. Vegetation Plot C-2, Creosote Bush Association, view north, August 28, 2002, 55-mm lens. Black and white board is 25 x 50 cm and 4 m from lens.

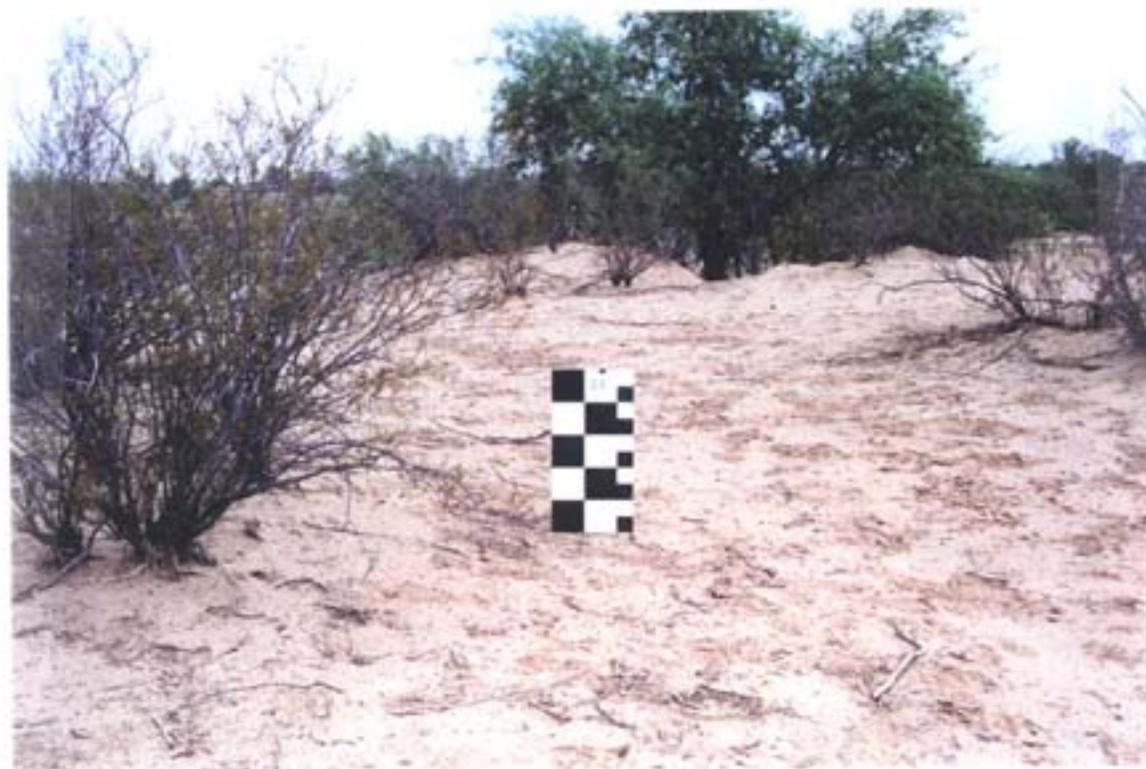
Figure E-3b. Vegetation Plot C-2, Creosote Bush Association, view north, August 28, 2002, 35-mm lens. Black and white board is 25 x 50 cm and 4 m from lens.

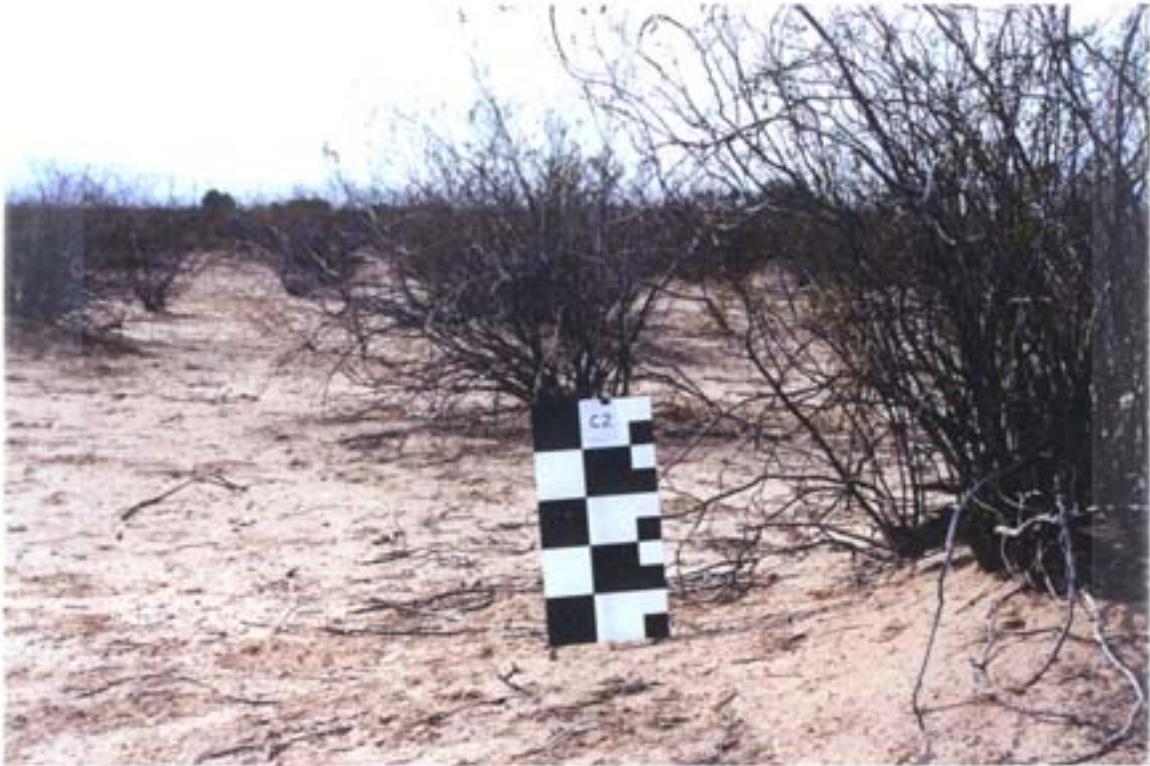
Figure E-3c. Vegetation Plot C-2, Creosote Bush Association, view south, August 28, 2002, 55-mm lens. Black and white board is 25 x 50 cm and 4 m from lens.

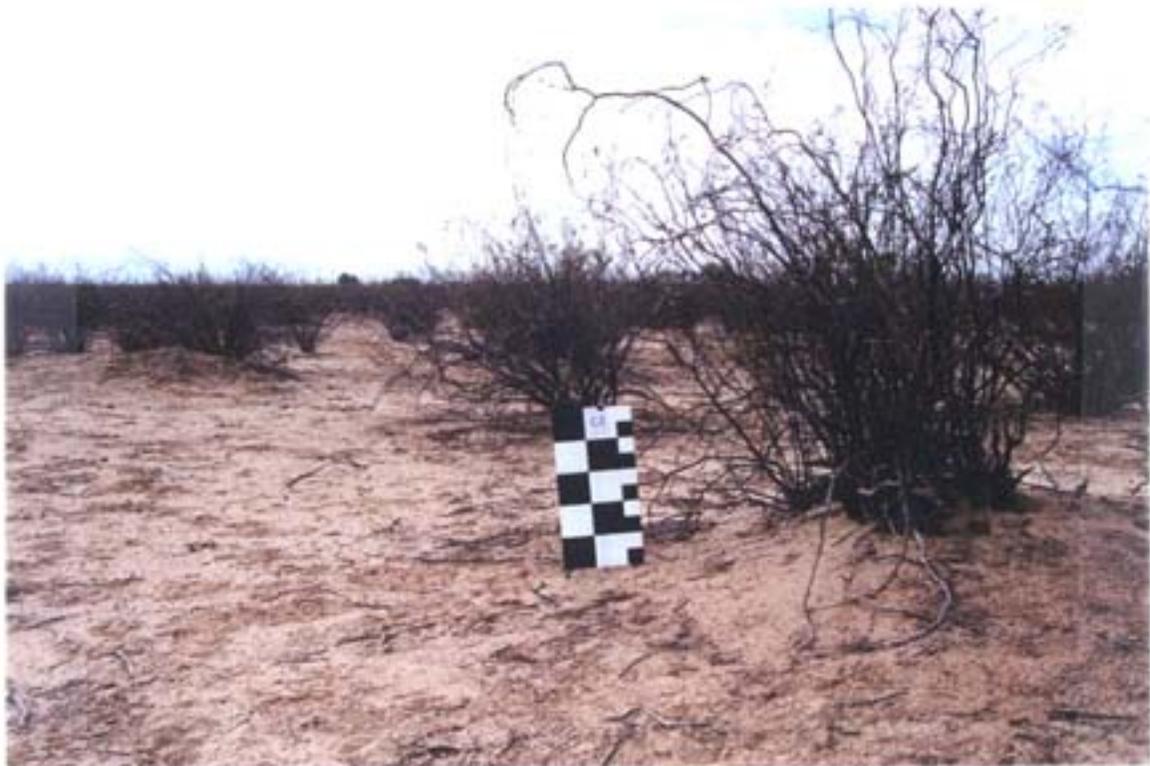
Figure E-3d. Vegetation Plot C-2, Creosote Bush Association, view south, August 28, 2002, 35-mm lens. Black and white board is 25 x 50 cm and 4 m from lens.

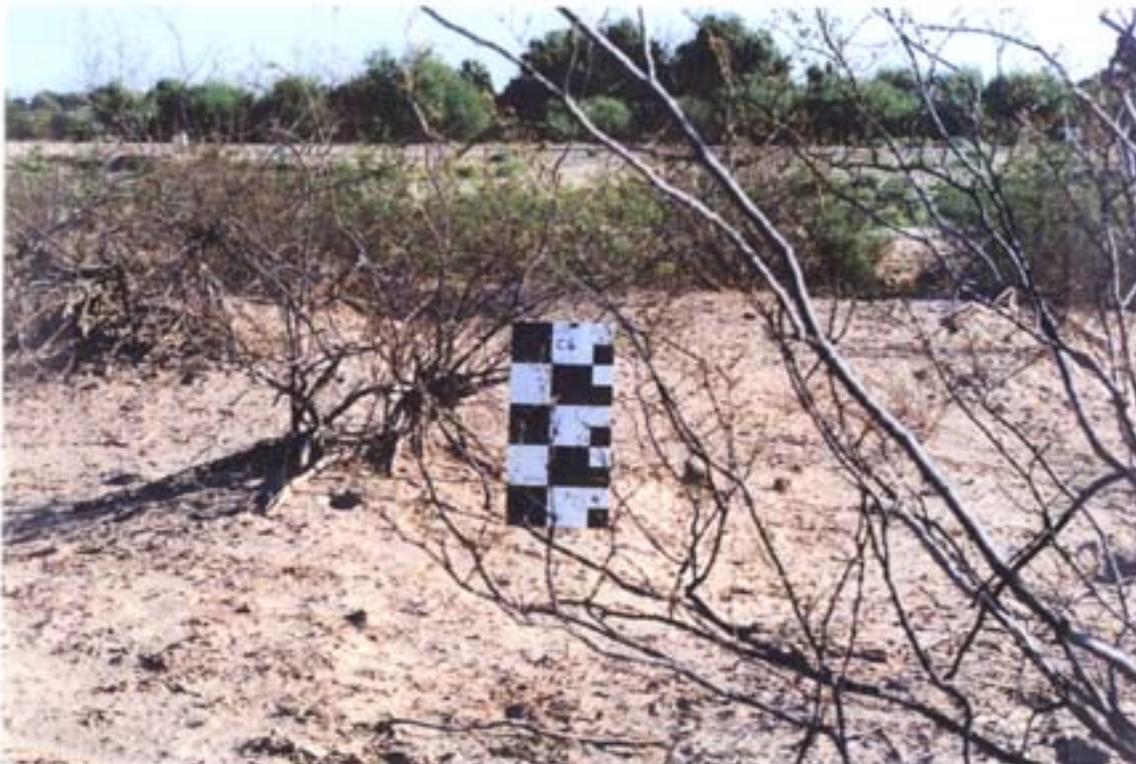
Figure E-4a. Vegetation Plot C-6, Creosote Bush Association, view north, September 4, 2002, 55-mm lens. Black and white board is 25 x 50 cm and 4 m from lens.

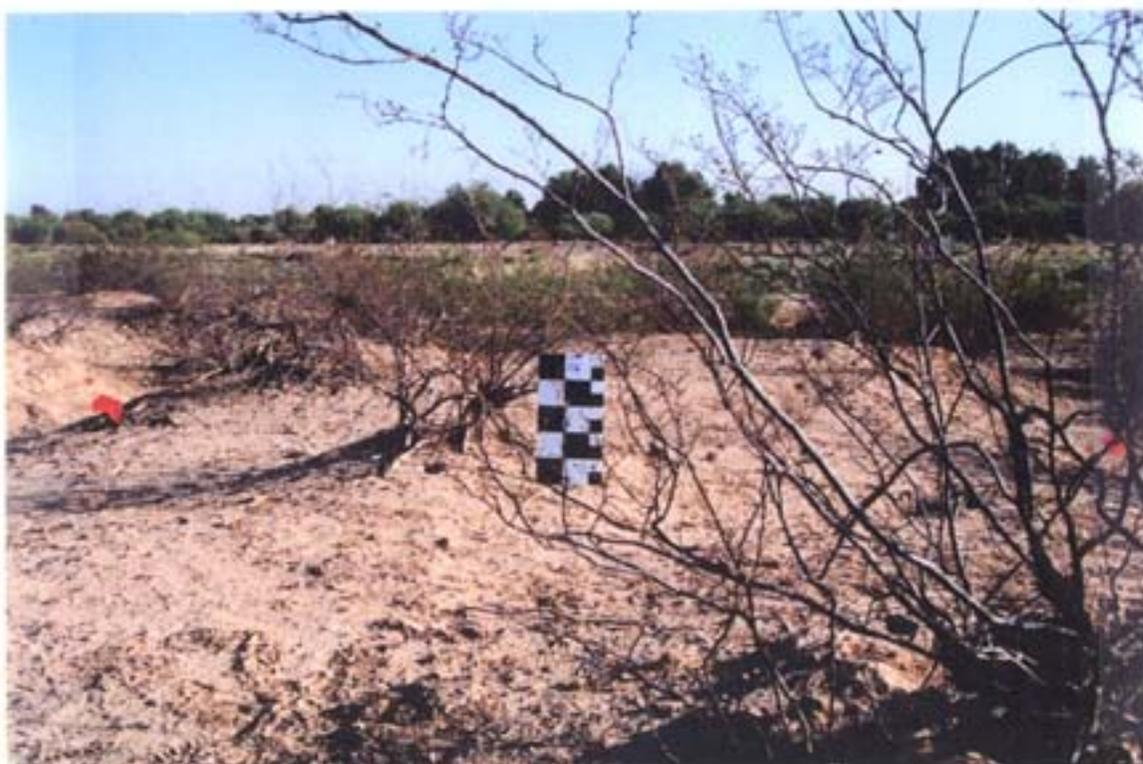
Figure E-4b. Vegetation Plot C-6, Creosote Bush Association, view north, September 4, 2002, 35-mm lens. Black and white board is 25 x 50 cm and 4 m from lens.

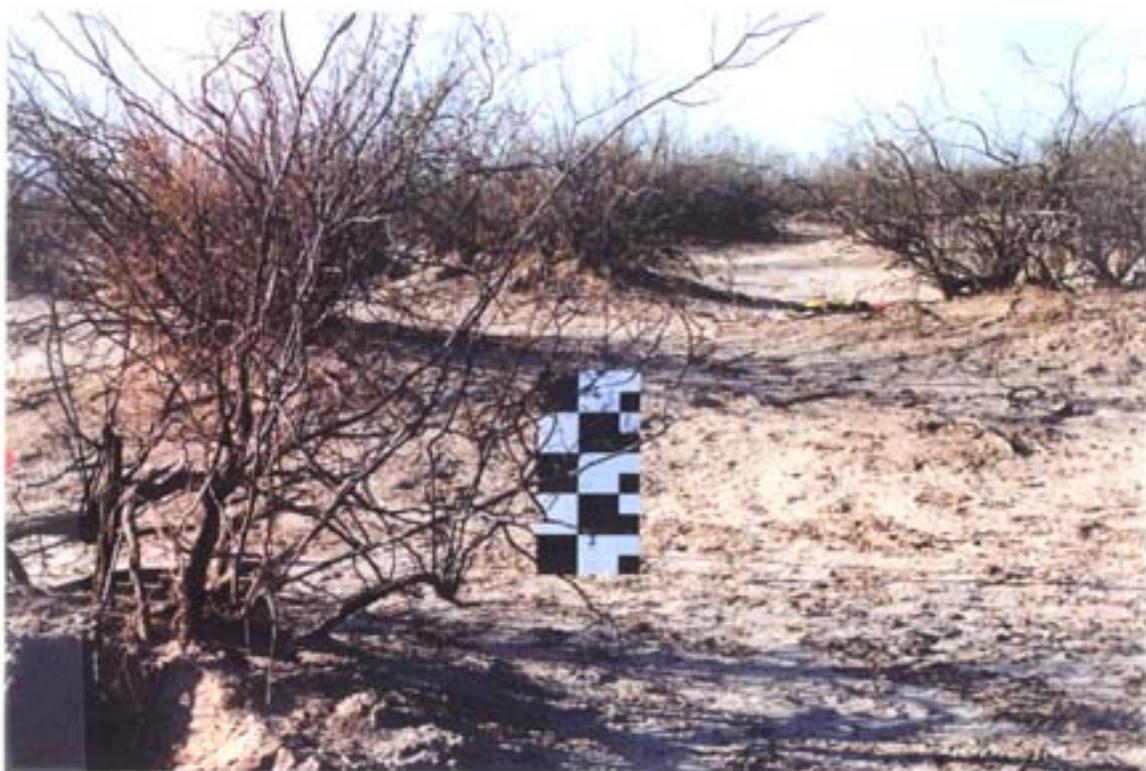
Figure E-4c. Vegetation Plot C-6, Creosote Bush Association, view south, September 4, 2002, 55-mm lens. Black and white board is 25 x 50 cm and 4 m from lens.

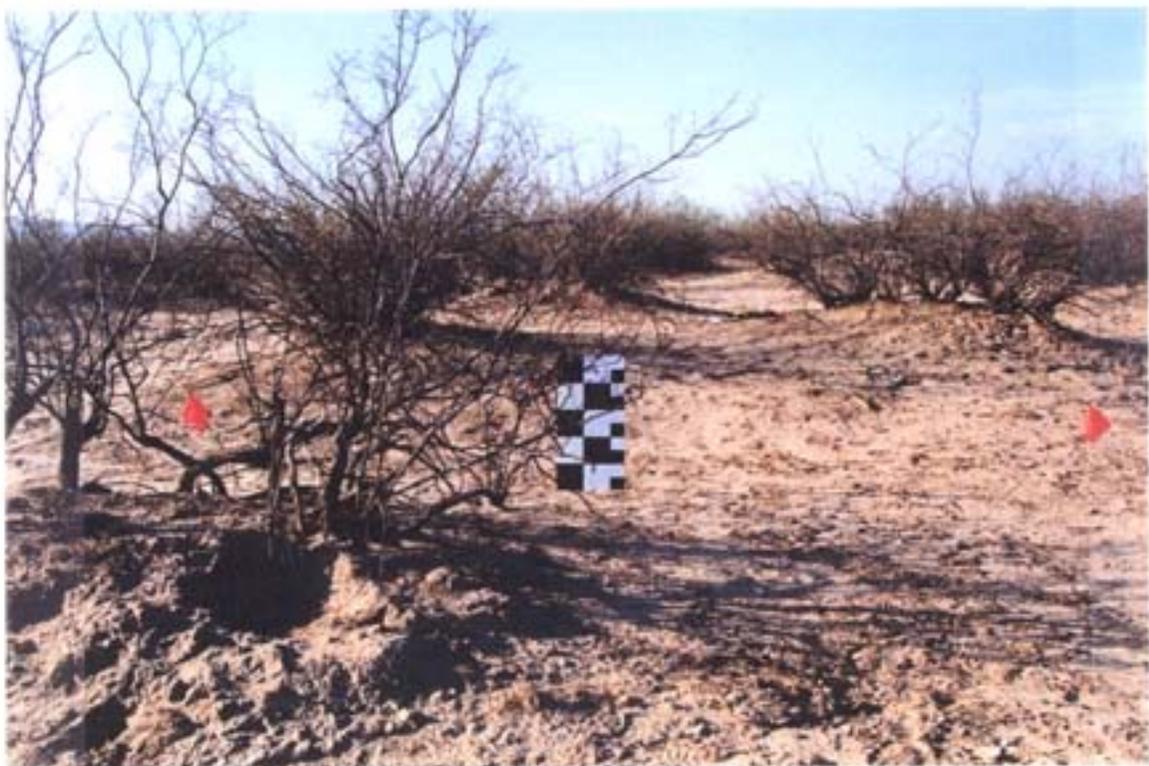
Figure E-4d. Vegetation Plot C-6, Creosote Bush Association, view south, September 6, 2002, 35-mm lens. Black and white board is 25 x 50 cm and 4 m from lens.

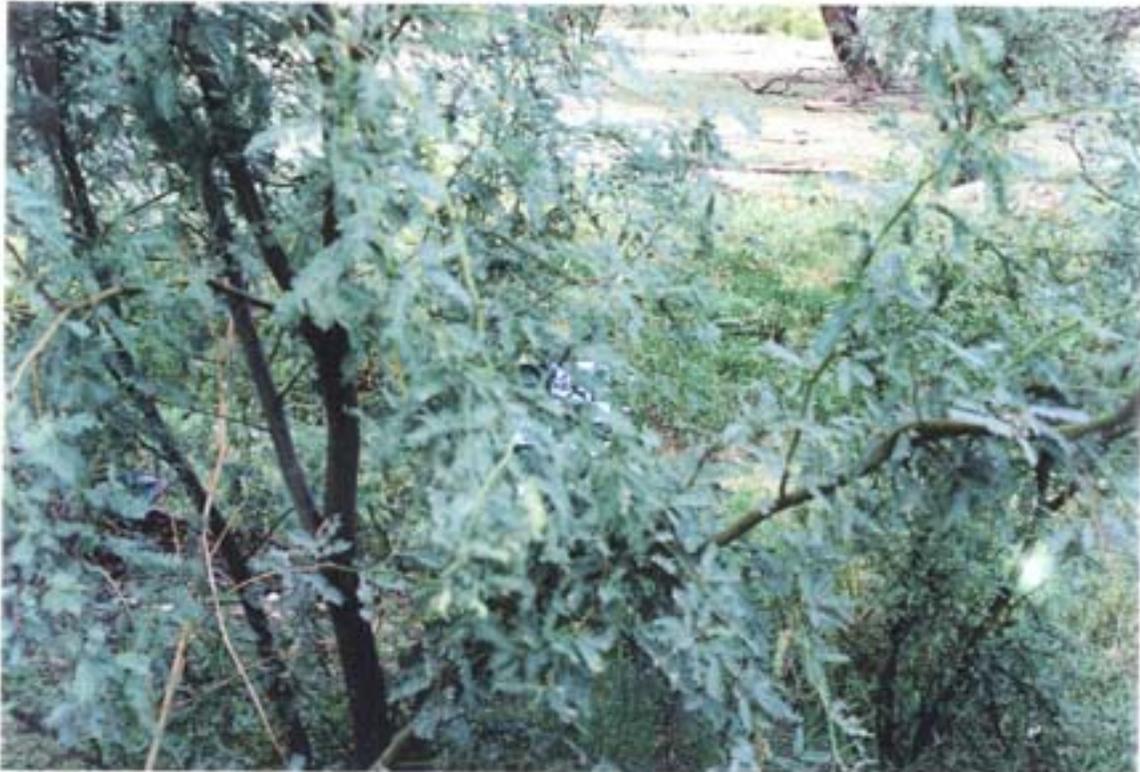
Figure E-5a. Vegetation Plot M-3, Mesquite-Palo Verde Association, view north, September 18, 2002, 55-mm lens. Black and white board is 25 x 50 cm and 4 m from lens.

The plant species composition of this habitat appears to be different from that previously reported. In the ENTRANCO (1998) study, velvet mesquite, baccharis species, and Mexican elderberry were recorded in these study plots. In the recent evaluation, velvet mesquite is also common, but desert broom is minimal and no Emory baccharis was observed. Mexican elderberry was observed in the habitat, but it was not recorded on any of the study plots. Mexican palo verde is now present in this habitat, but it may have been planted following the road construction. Representative photos from this habitat are given in Figures E-5 and E-6, Appendix E.

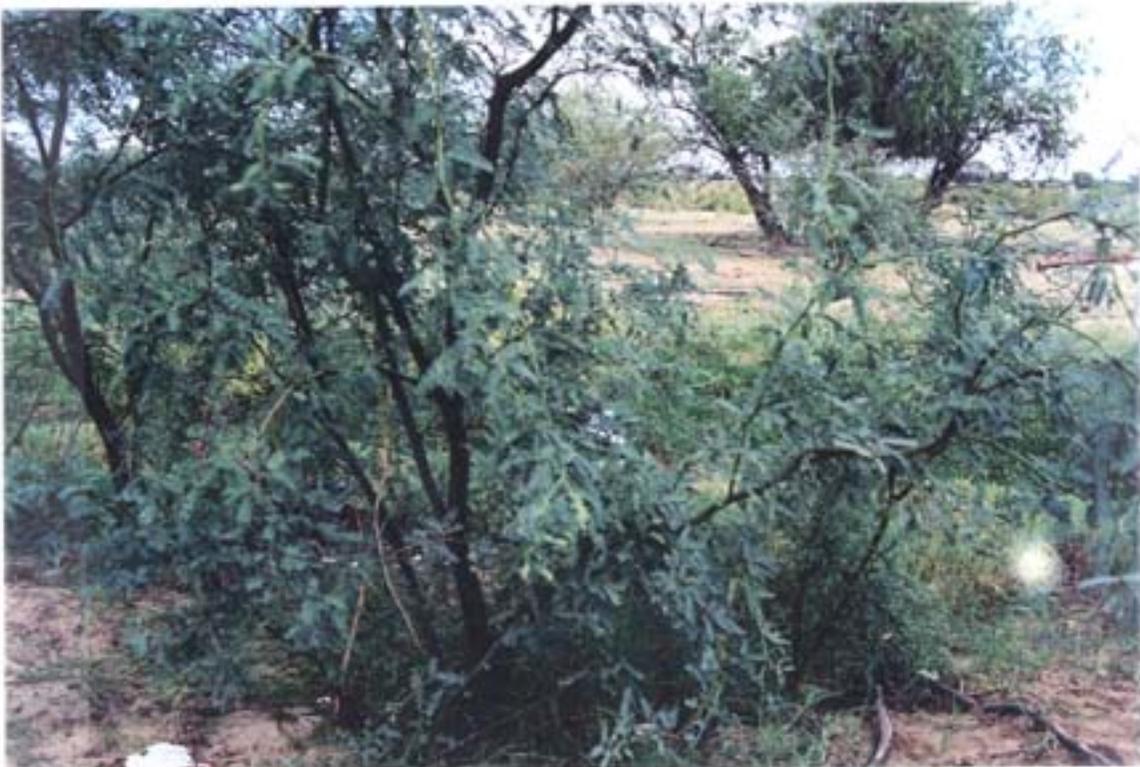
Figure E-5b. Vegetation Plot M-3, Mesquite-Palo Verde Association, view north, September 18, 2002, 35-mm lens. Black and white board is 25 x 50 cm and 4 m from lens.

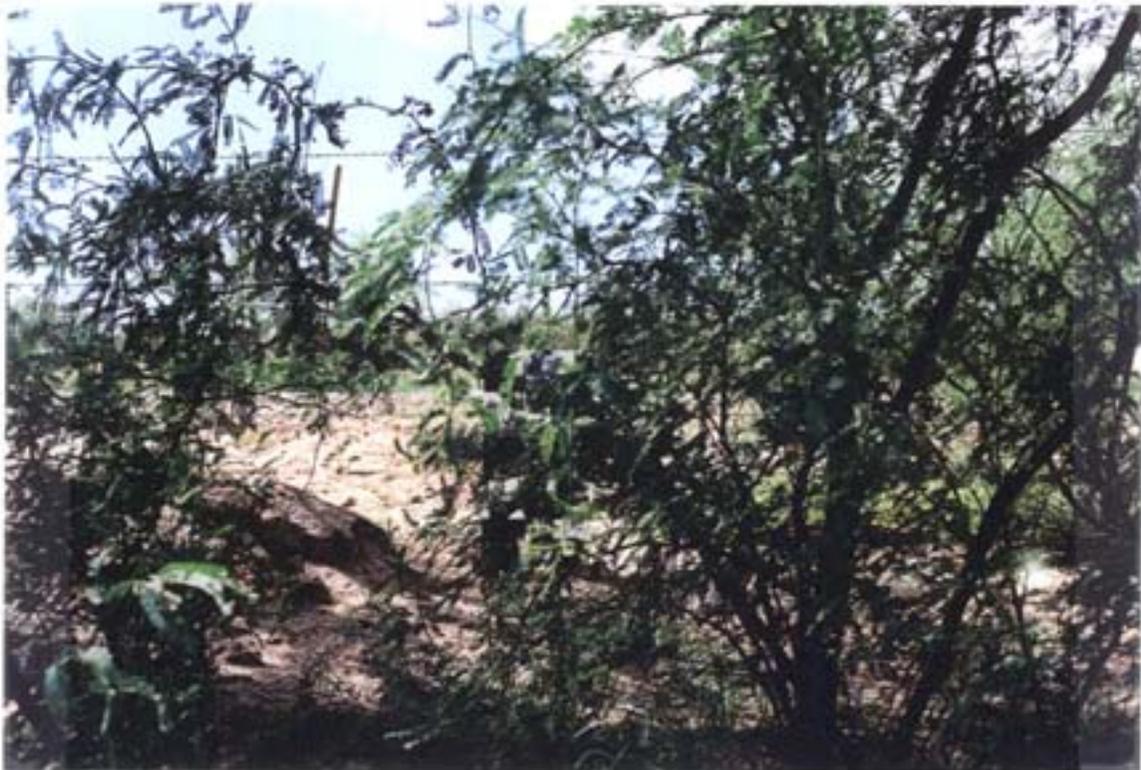
Figure E-5c. Vegetation Plot M-3, Mesquite-Palo Verde Association, view south, September 18, 2002, 55-mm lens. Black and white board is 25 x 50 cm and 4 m from lens.

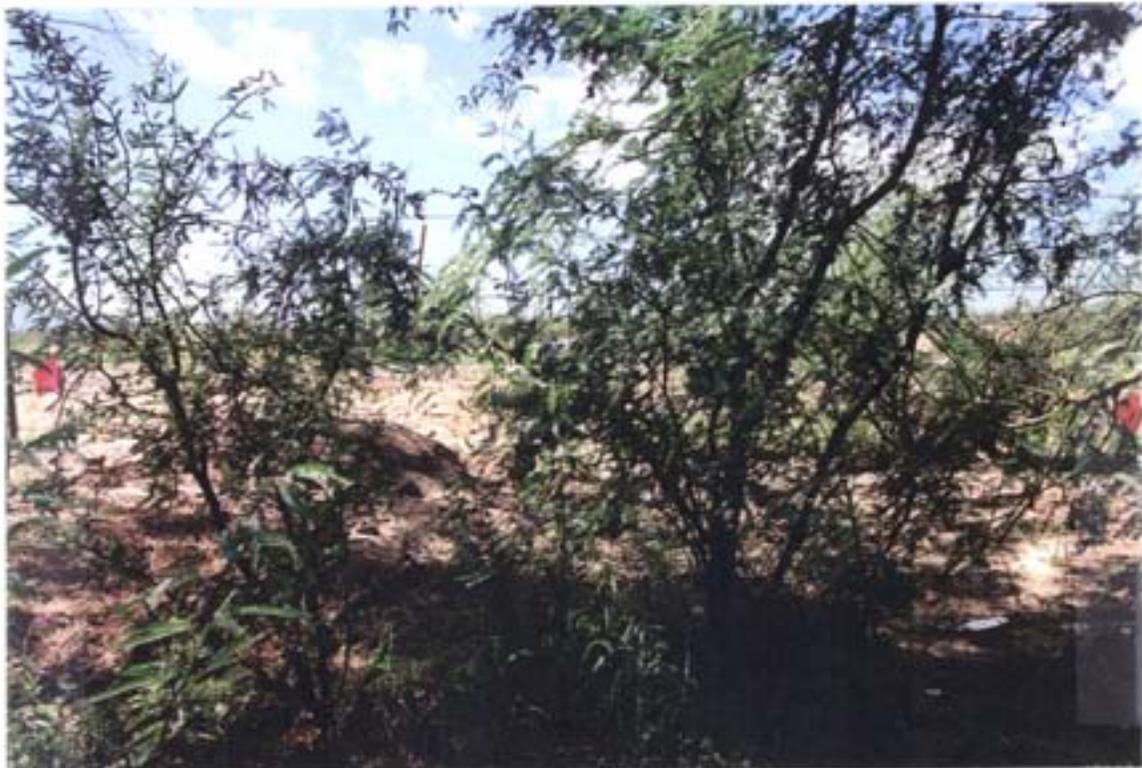
Figure E-5d. Vegetation Plot M-3, Mesquite-Palo Verde Association, view south, August 28, 2002, 35-mm lens. Black and white board is 25 x 50 cm and 4 m from lens.

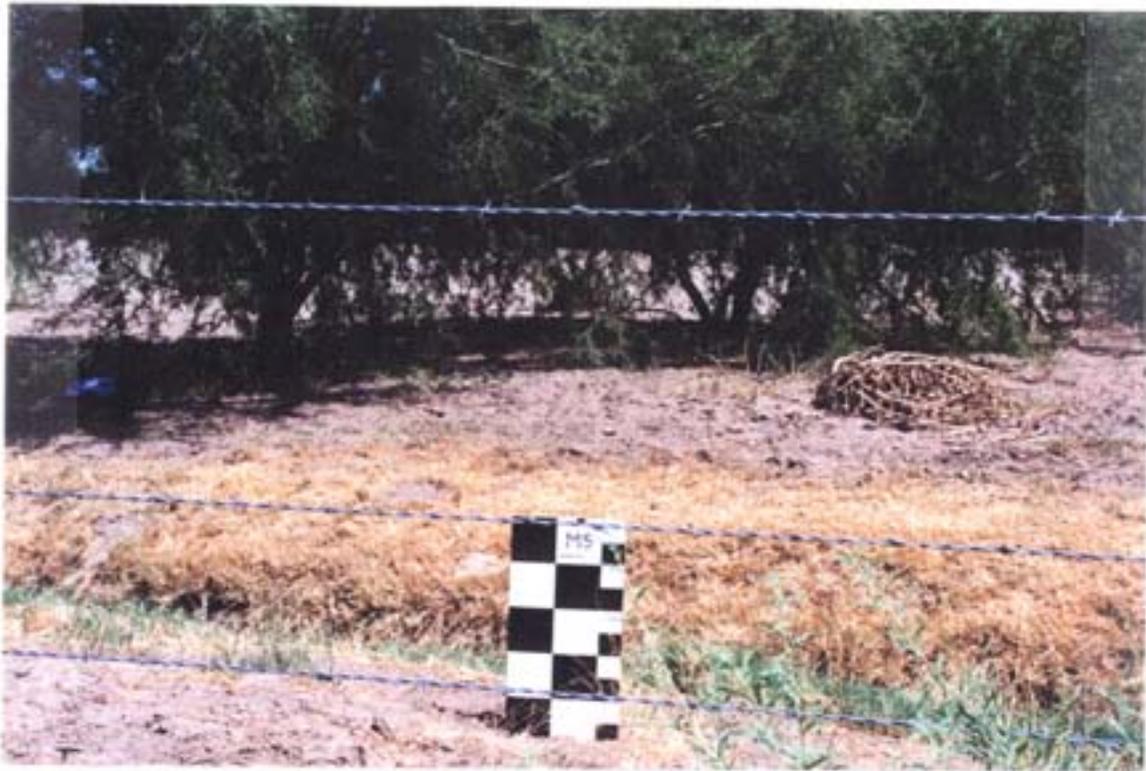
Figure E-6a. Vegetation Plot M-5, Mesquite-Palo Verde Association, view north, September 4, 2002, 55-mm lens. Black and white board is 25 x 50 cm and 4 m from lens.
