# High Plains Effluent Recharge Project: Biological Monitoring, 2002

PIMA COUNTY  
DEPARTMENT OF TRANSPORTATION  
AND FLOOD CONTROL DISTRICT  
October 29, 2002

**HIGH PLAINS EFFLUENT RECHARGE PROJECT**  
**BIOLOGICAL STUDIES**  
**MONITORING REPORT - 2002**

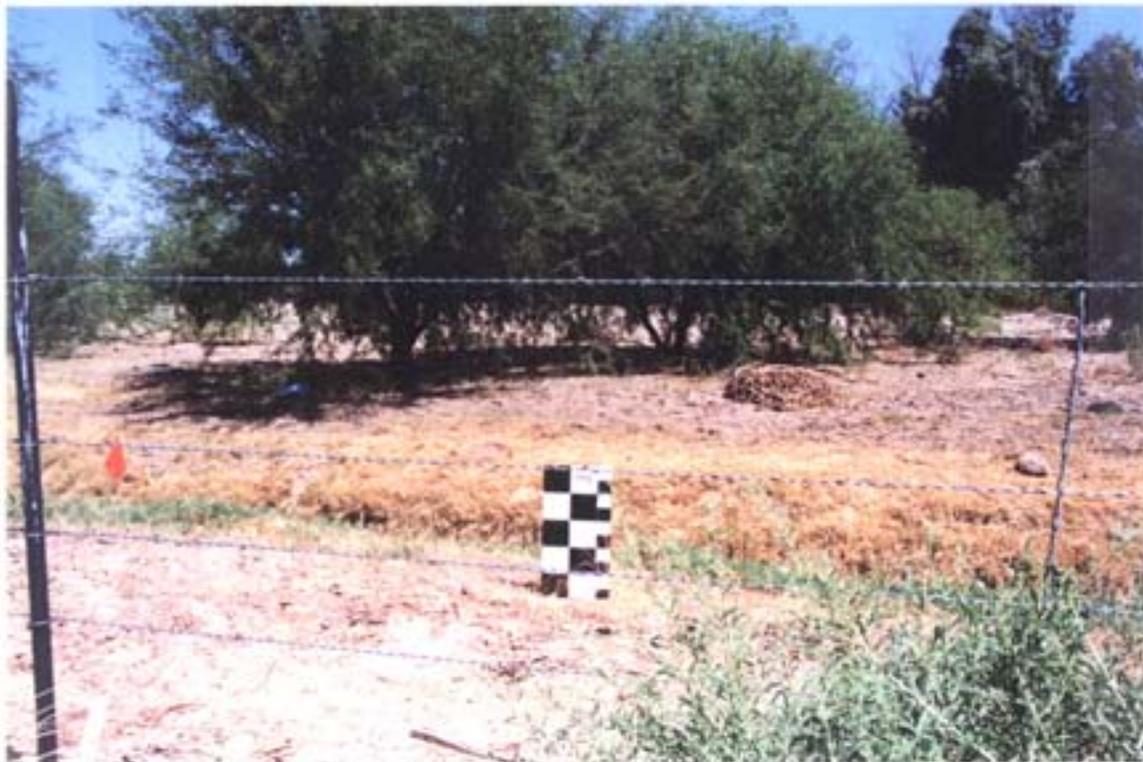
Figure E-6b. Vegetation Plot M-5, Mesquite-Palo Verde Association, view north, September 4, 2002, 35-mm lens. Black and white board is 25 x 50 cm and 4 m from lens.

The plant species composition of this habitat appears to be different from that previously reported. In the ENTRANCO (1998) study, velvet mesquite, baccharis species, and Mexican elderberry were recorded in these study plots. In the recent evaluation, velvet mesquite is also common, but desert broom is minimal and no Emory baccharis was observed. Mexican elderberry was observed in the habitat, but it was not recorded on any of the study plots. Mexican palo verde is now present in this habitat, but it may have been planted following the road construction. Representative photos from this habitat are given in Figures E-5 and E-6, Appendix E.

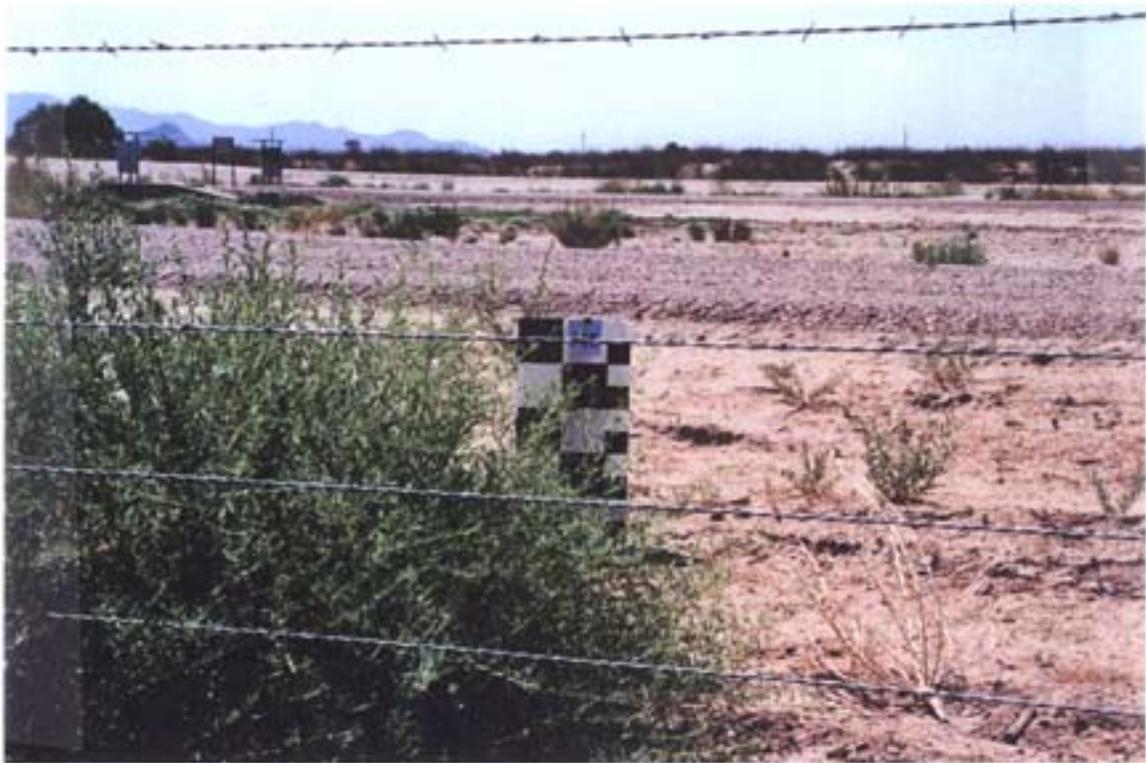
Figure E-6c. Vegetation Plot M-5, Mesquite-Palo Verde Association, view south, September 4, 2002, 55-mm lens. Black and white board is 25 x 50 cm and 4 m from lens.

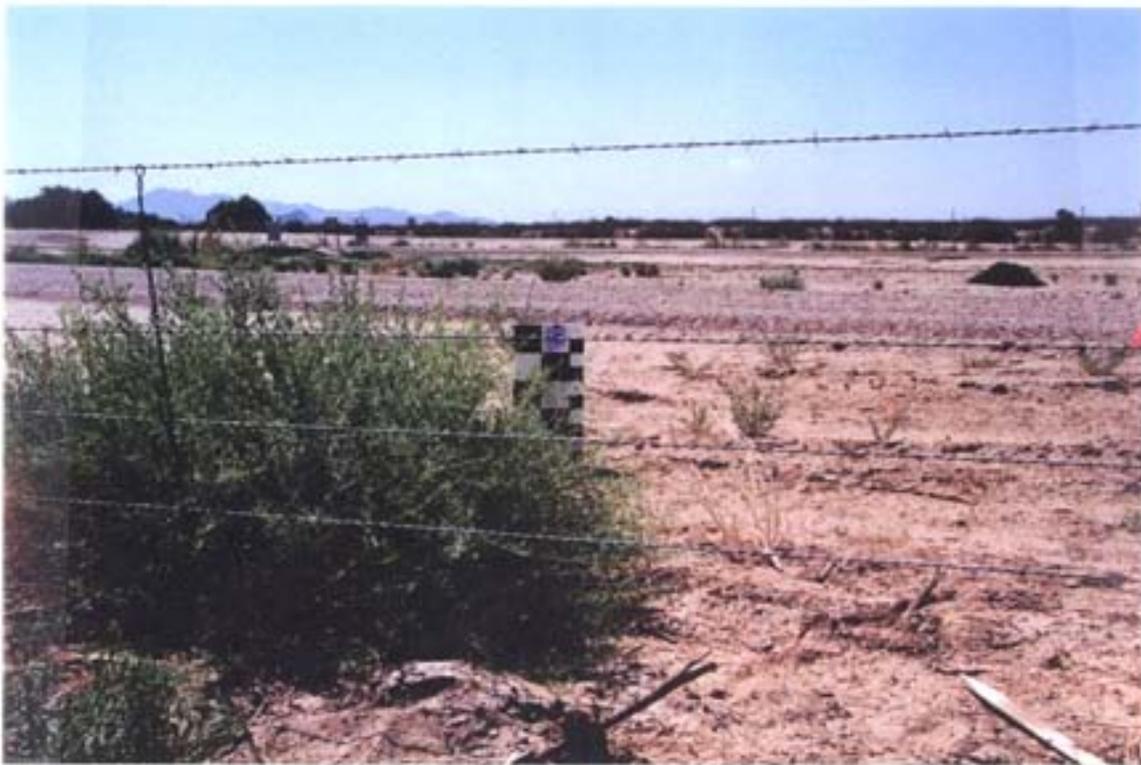
Figure E-6d. Vegetation Plot M-5, Mesquite-Palo Verde Association, view south, September 4, 2002, 35-mm lens. Black and white board is 25 x 50 cm and 4 m from lens.

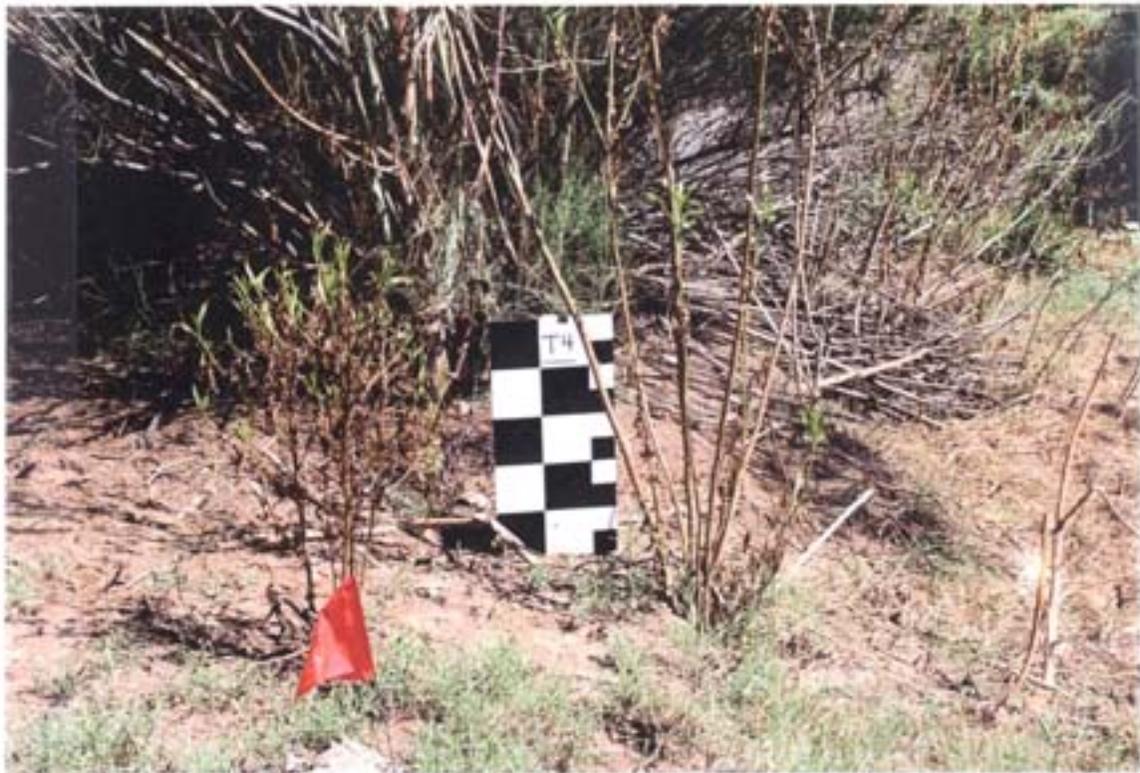
Figure E-7a. Vegetation Plot T-4, Tamarisk-Willow Association, view north, September 11, 2002, 55-mm lens. Black and white board is 25 x 50 cm and 4 m from lens.

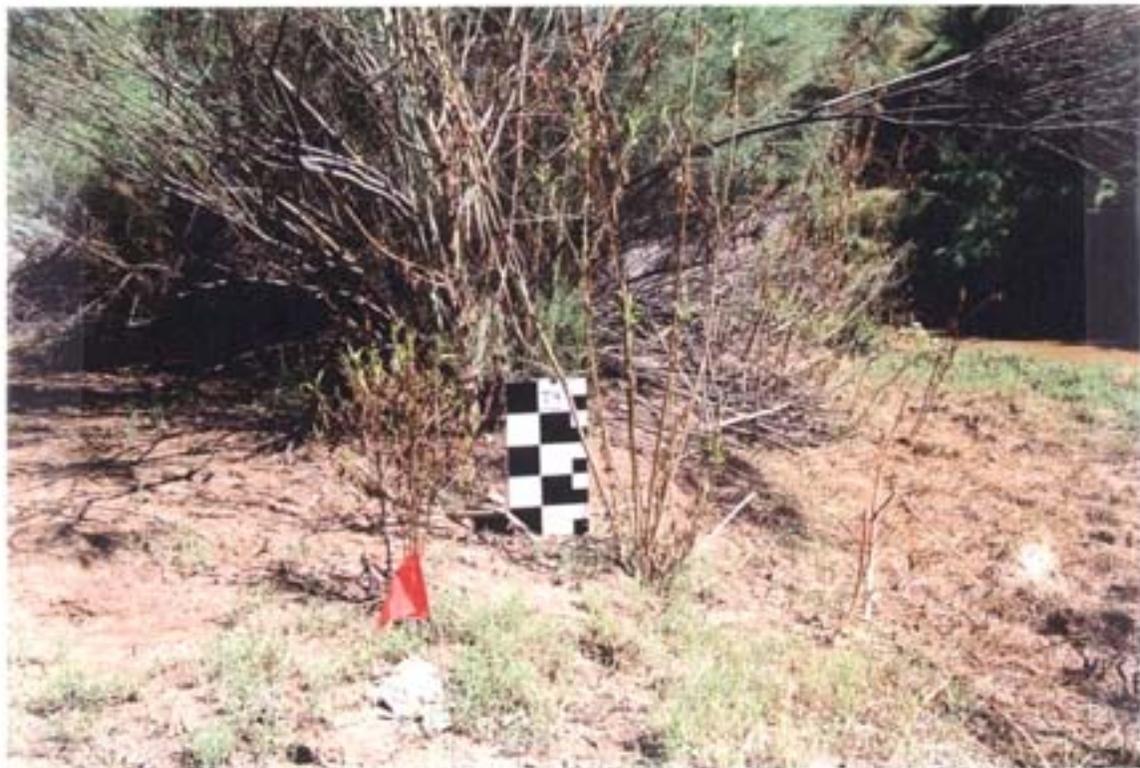
Figure E-7b. Vegetation Plot T-4, Tamarisk-Willow Association, view north, September 11, 2002, 35-mm lens. Black and white board is 25 x 50 cm and 4 m from lens.

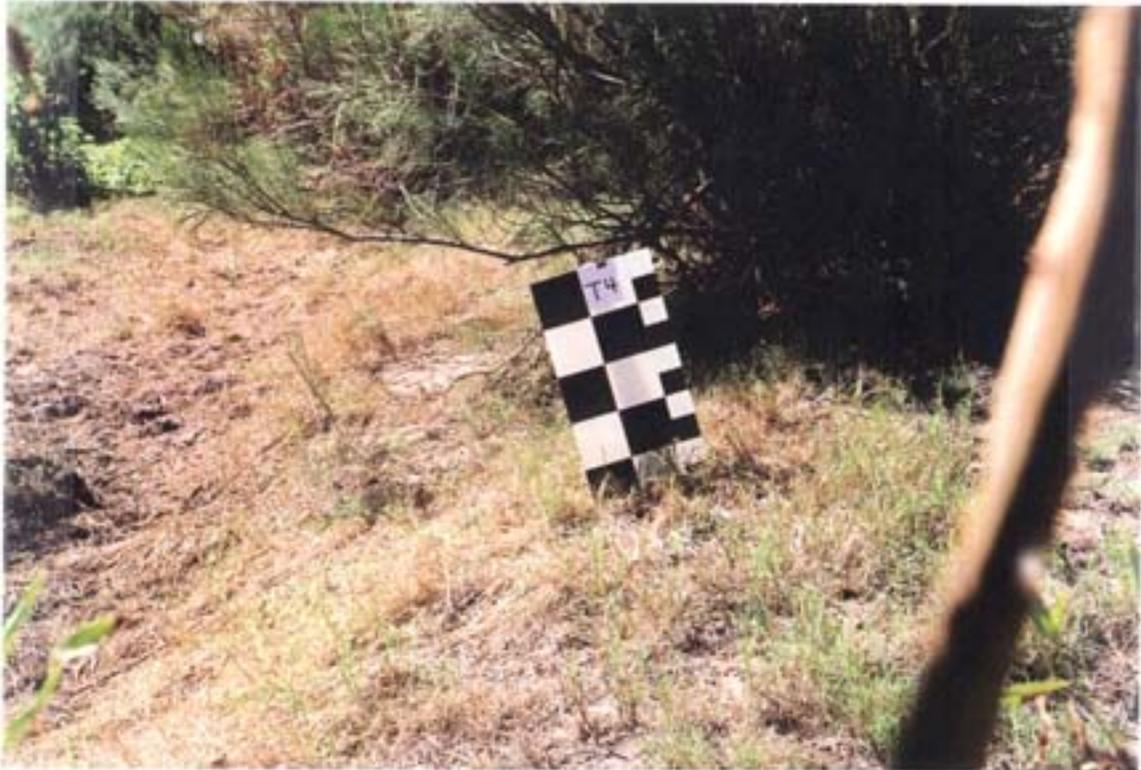
Figure E-7c. Vegetation Plot T-4, Tamarisk-Willow Association, view south, September 11, 2002, 55-mm lens. Black and white board is 25 x 50 cm and 4 m from lens.

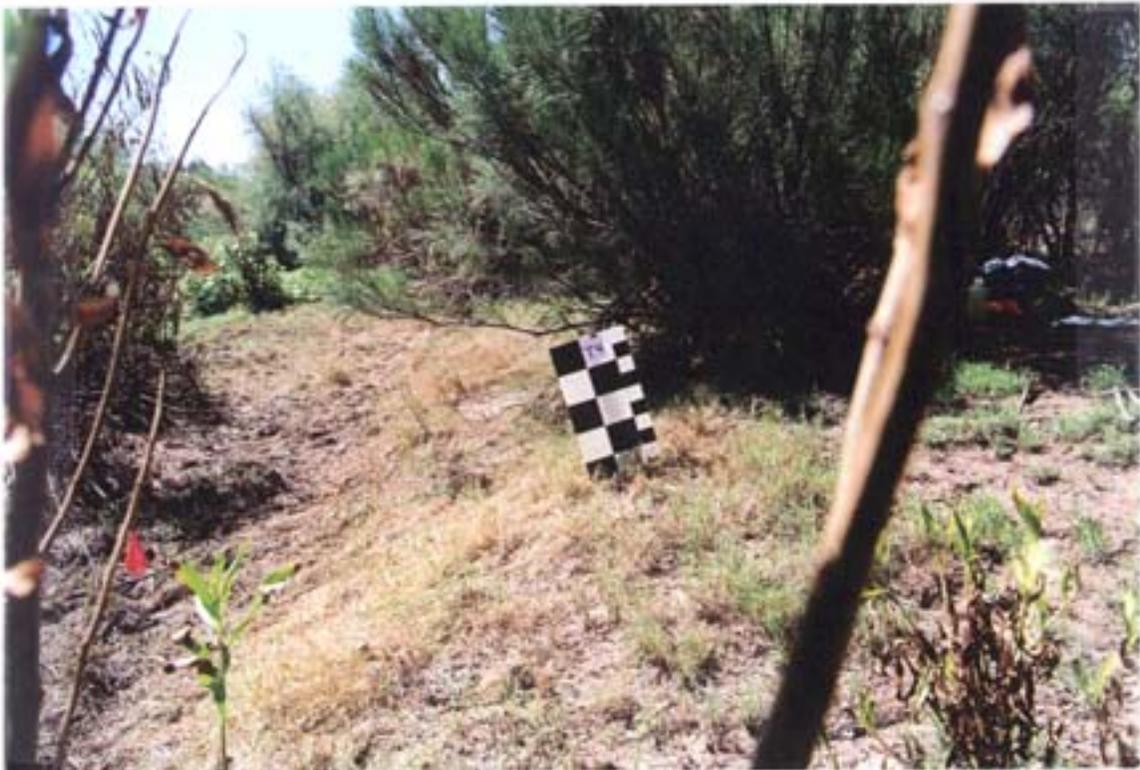
Figure E-7d. Vegetation Plot T-4, Tamarisk-Willow Association, view south, September 11, 2002, 35-mm lens. Black and white board is 25 x 50 cm and 4 m from lens.

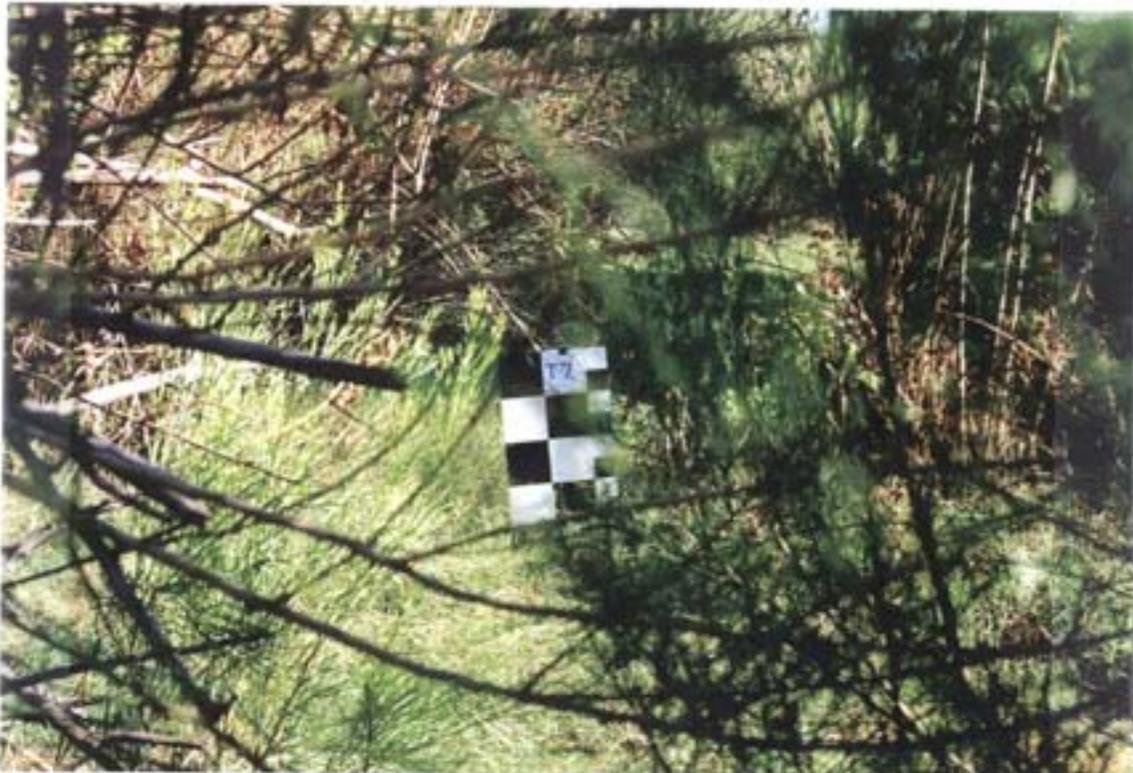
Figure E-8a. Vegetation Plot T-7, Tamarisk-Willow Association, view north, September 18, 2002, 55-mm lens. Black and white board is 25 x 50 cm and 4 m from lens.

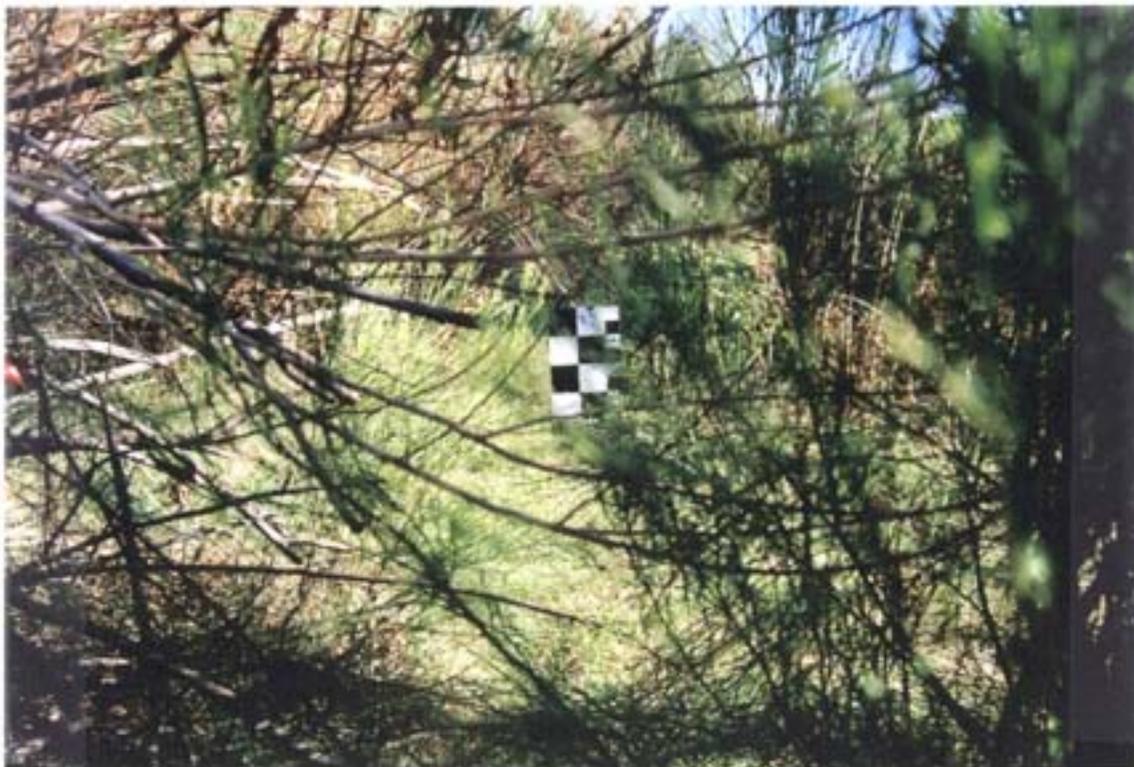
Figure E-8b. Vegetation Plot T-7, Tamarisk-Willow Association, view north, September 18, 2002, 35-mm lens. Black and white board is 25 x 50 cm and 4 m from lens.

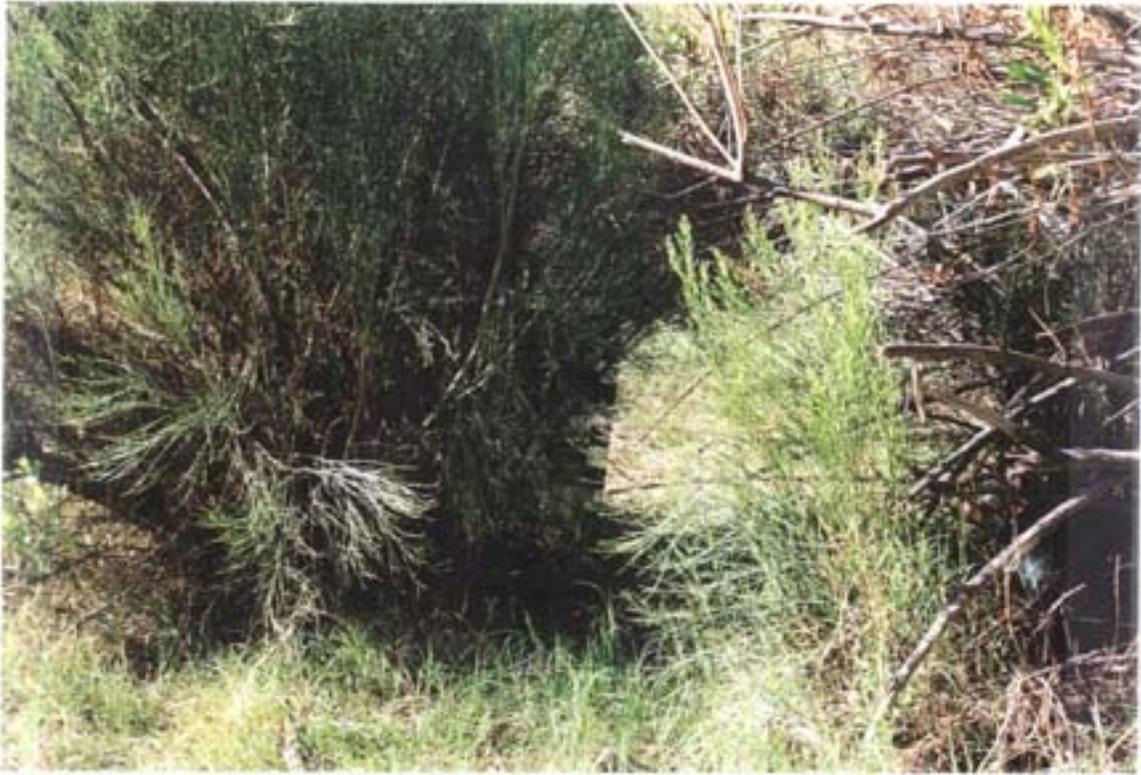
Figure E-8c. Vegetation Plot T-7, Tamarisk-Willow Association, view south, September 18, 2002, 55-mm lens. Black and white board is 25 x 50 cm and 4 m from lens.

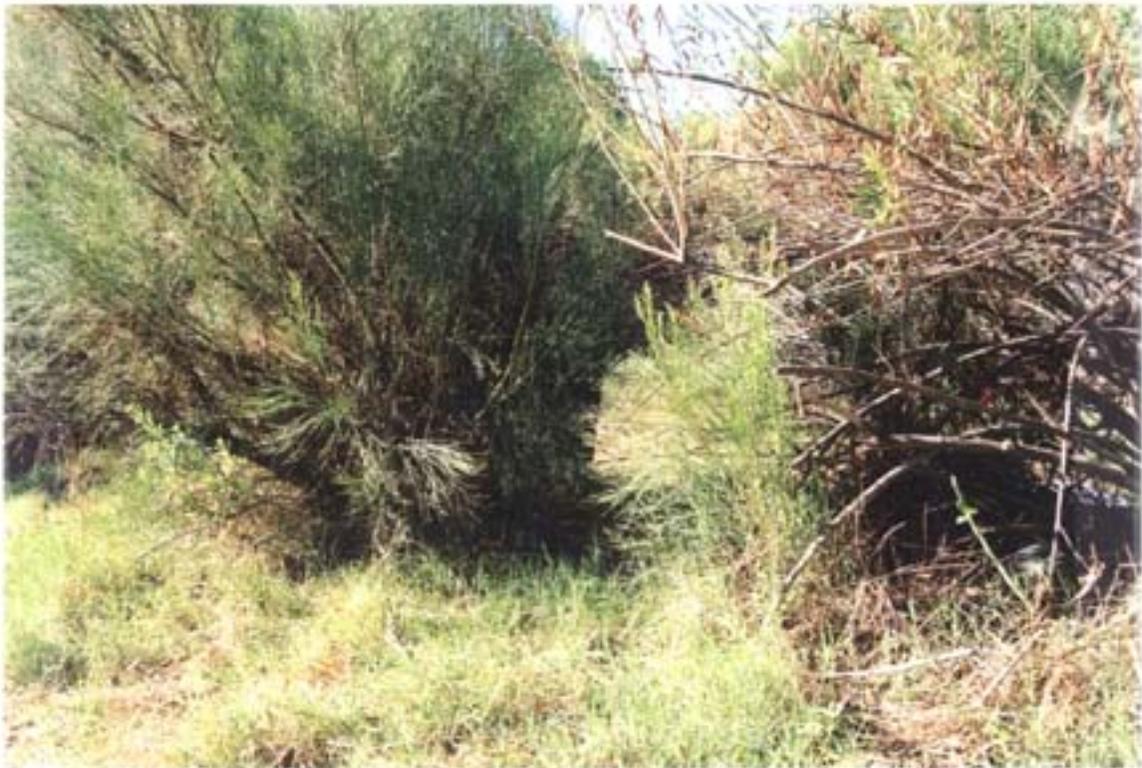
Figure E-8d. Vegetation Plot T-7, Tamarisk-Willow Association, view south, September 18, 2002, 35-mm lens. Black and white board is 25 x 50 cm and 4 m from lens.
