# BASIS OF DESIGN REPORT FOR PANTANO WASH BANK PROTECTION AND RIVER PARK PHASE 3 & 4: TANQUE VERDE TO CRAYCROFT

PREPARED FOR:  
Pima County Regional  
**FLOOD CONTROL**  
DISTRICT

NOVEMBER 2013

PCRFCDD PROJECT NO. 5PWFLT

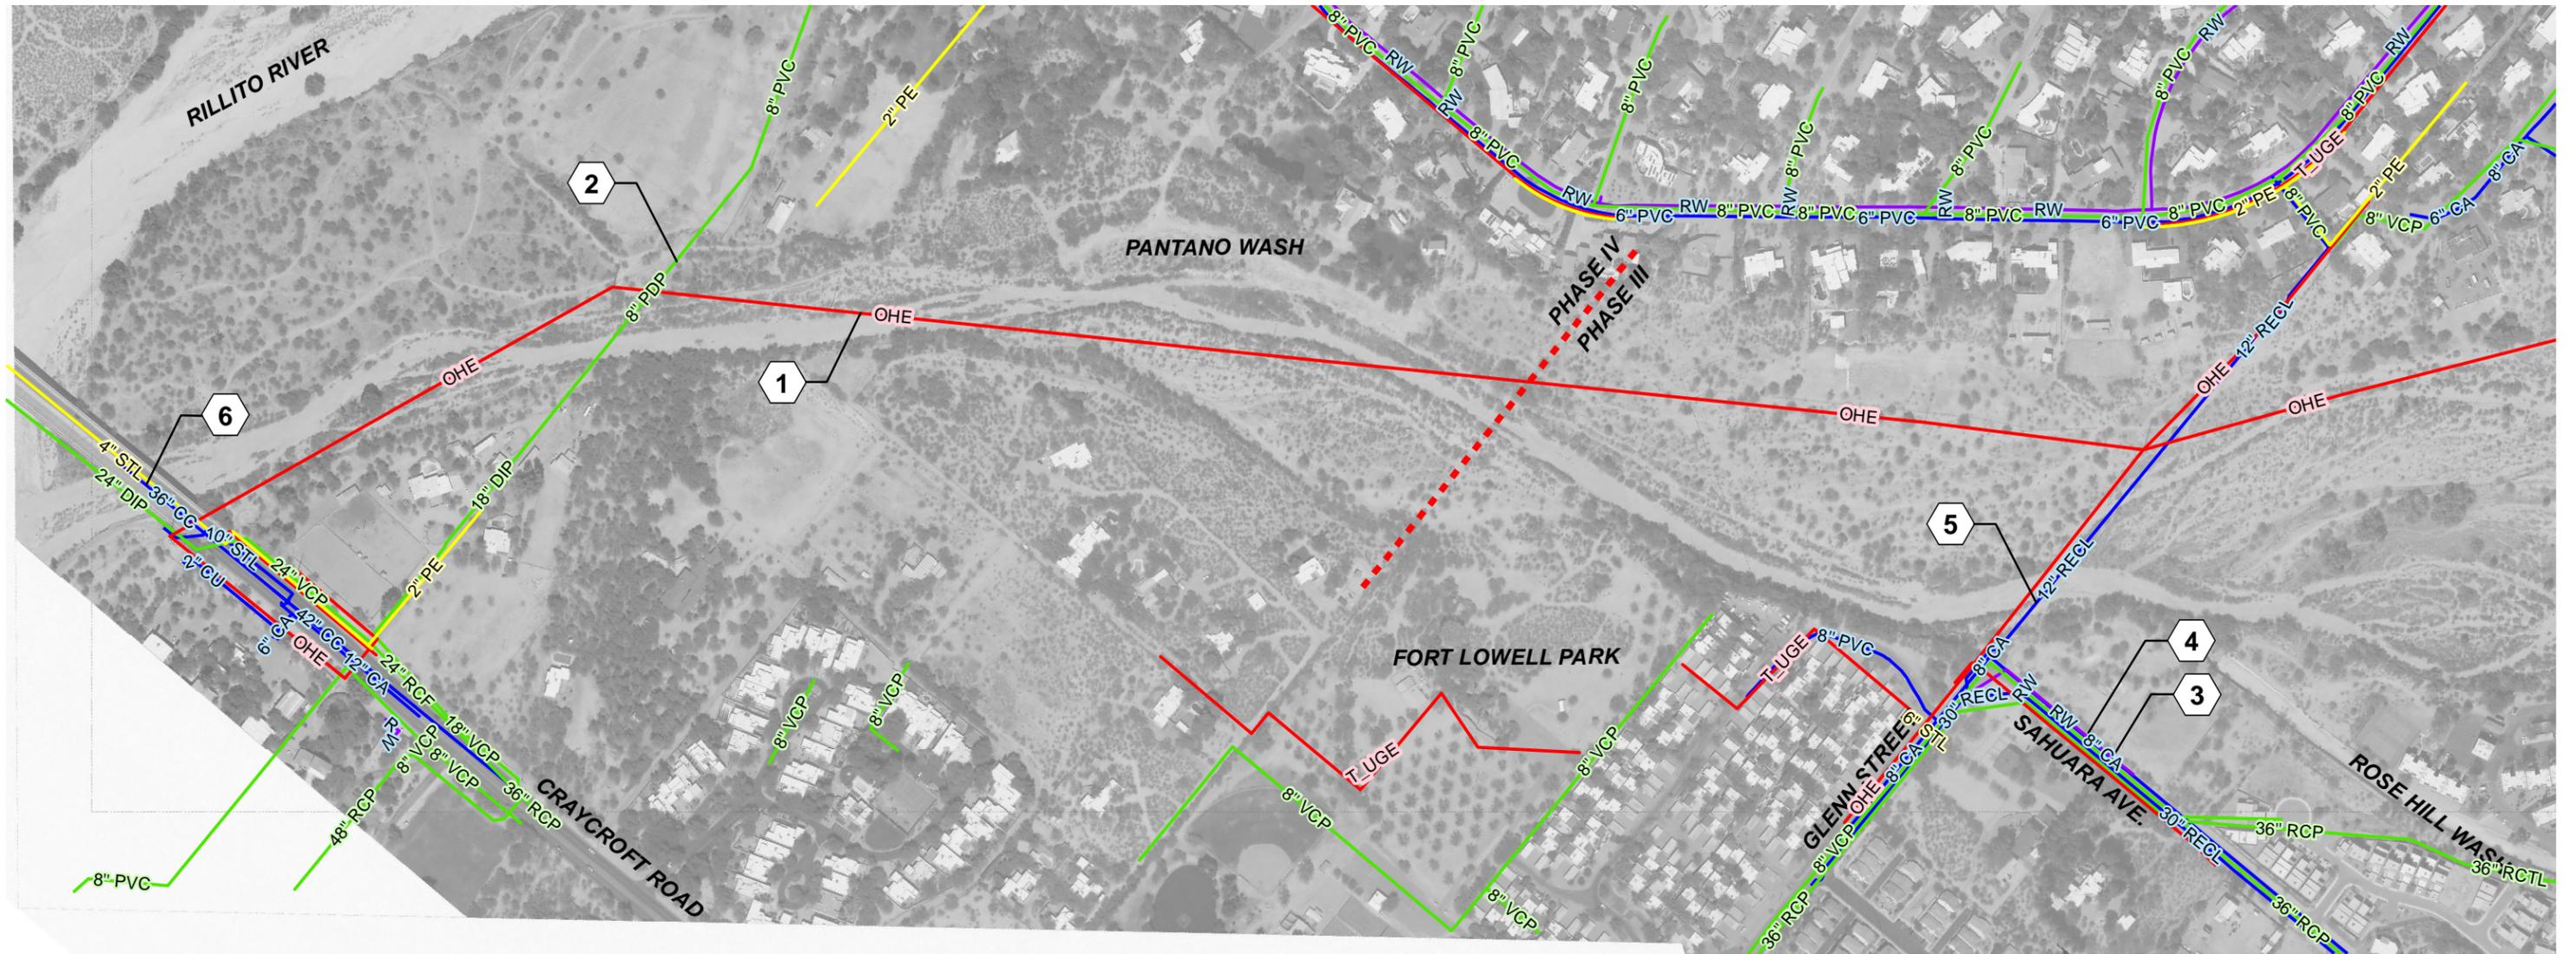
**FIGURE 3.3.1  
EXISTING UTILITIES MAP  
(SHEET 1 OF 2)**

SEE TABLE 3.3.1 IN REPORT FOR KEYNOTE EXPLANATION
